## APPENDIX E.11

### Freshet Monitoring Report

**BAFFINLAND IRON MINES CORPORATION**  
**MARY RIVER PROJECT****Freshet 2020 Monitoring Report****Rev 0**

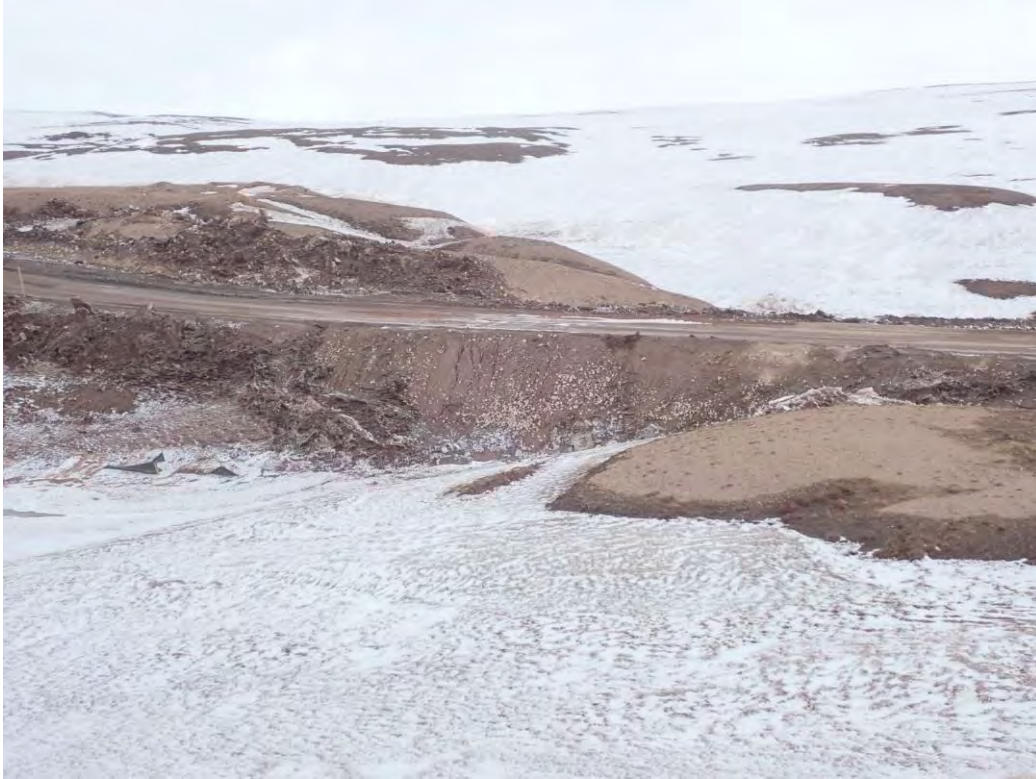
**Photo 1. Snow Clearing at the Outlet of BG-01 (May 14, 2020)**

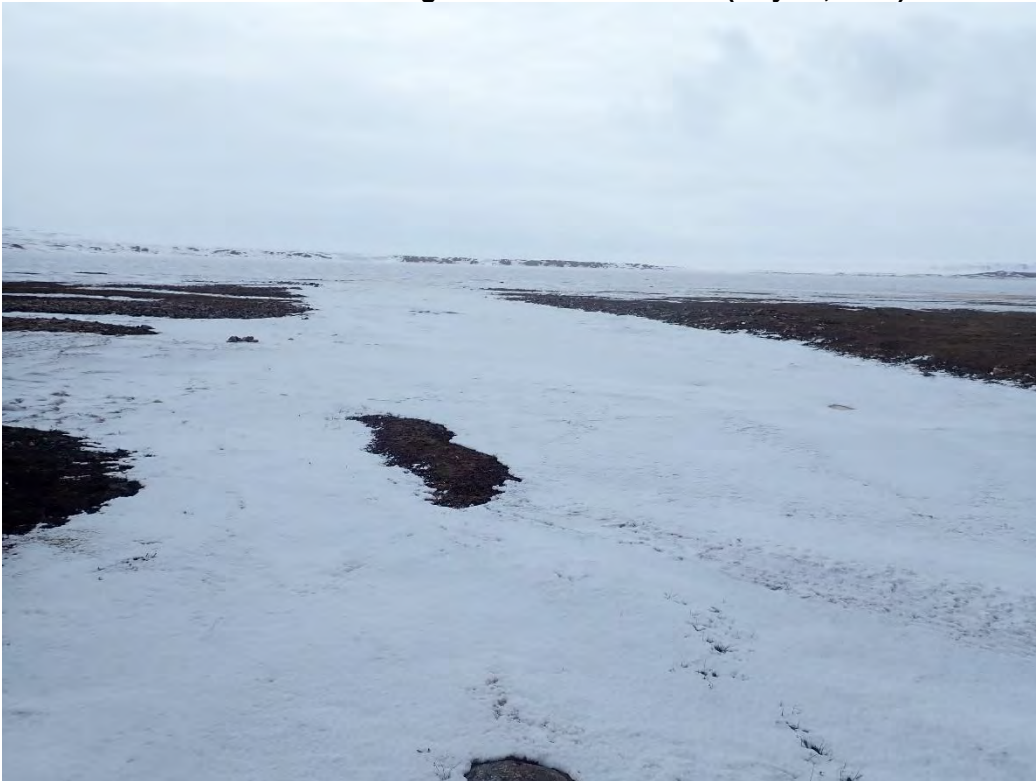
**Photo 2. CLT Outfall on May 14, 2020**

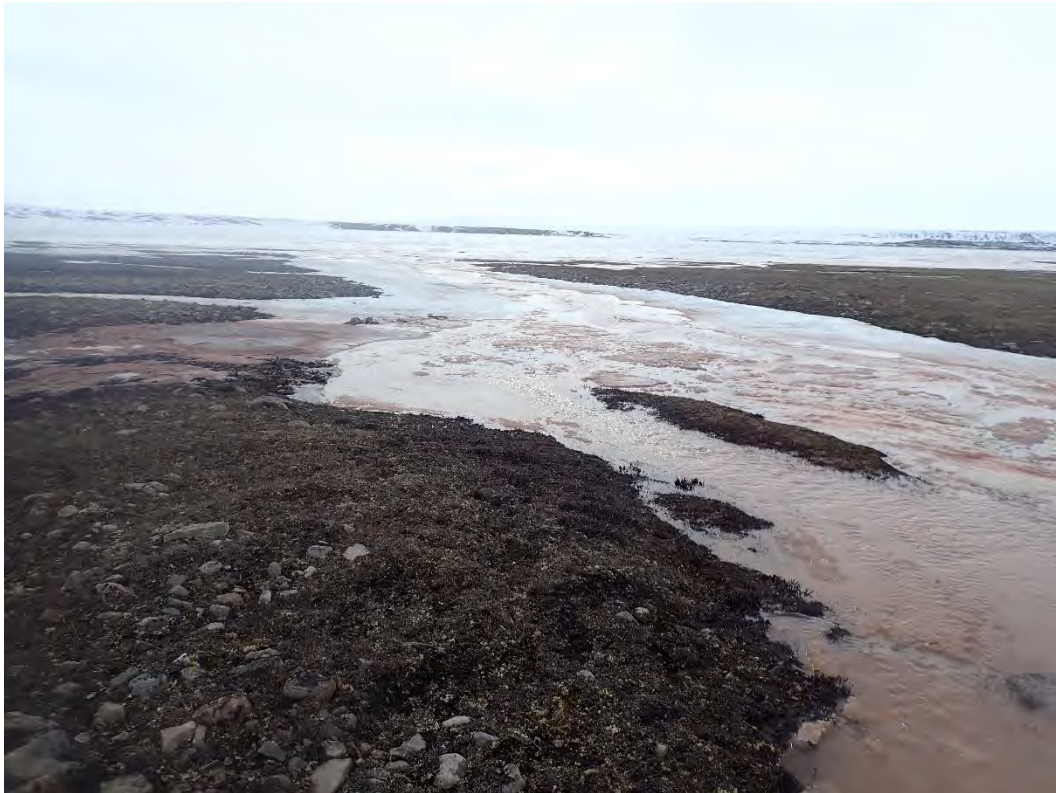
**Photo 3. CLT Outfall on May 16, 2020**

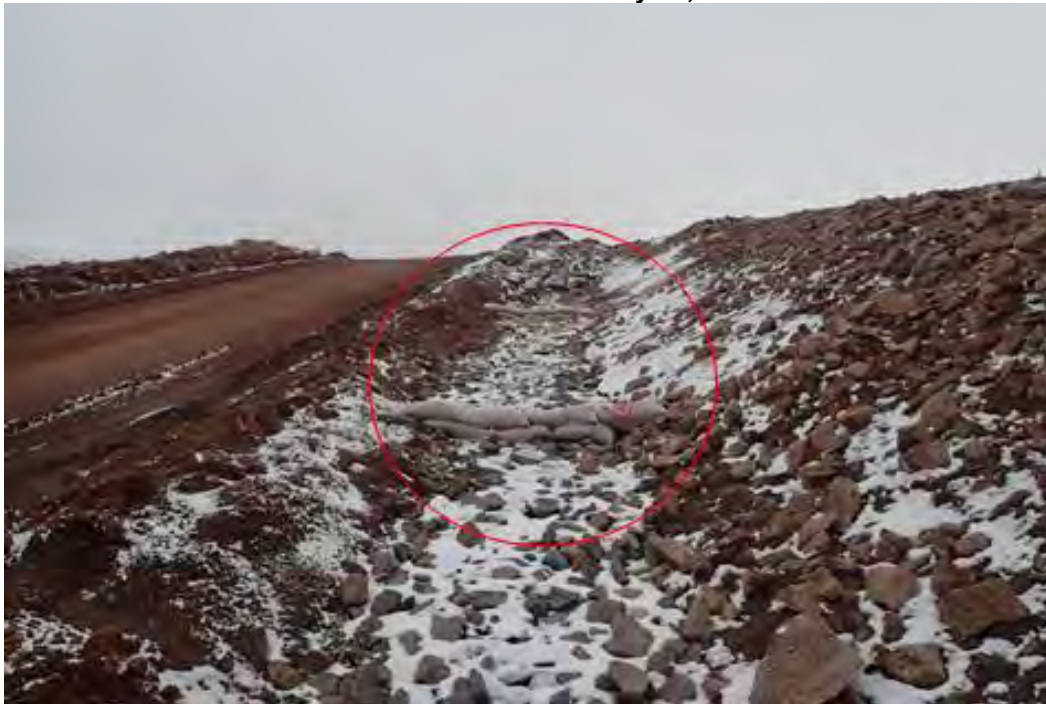
**Photo 4: BG-01 Downstream Ditch with Sand Bags (May 18, 2020)**

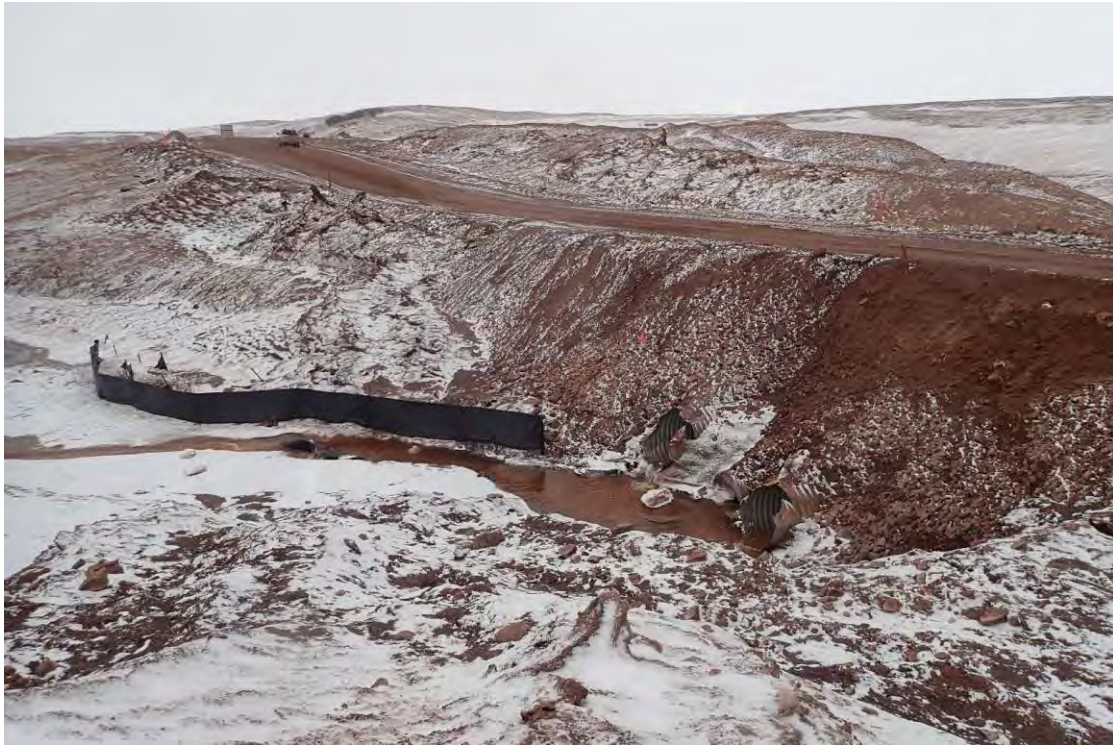
**Photo 5. Silt Fencing at the Outlet of BG-01 (May 18, 2020)**

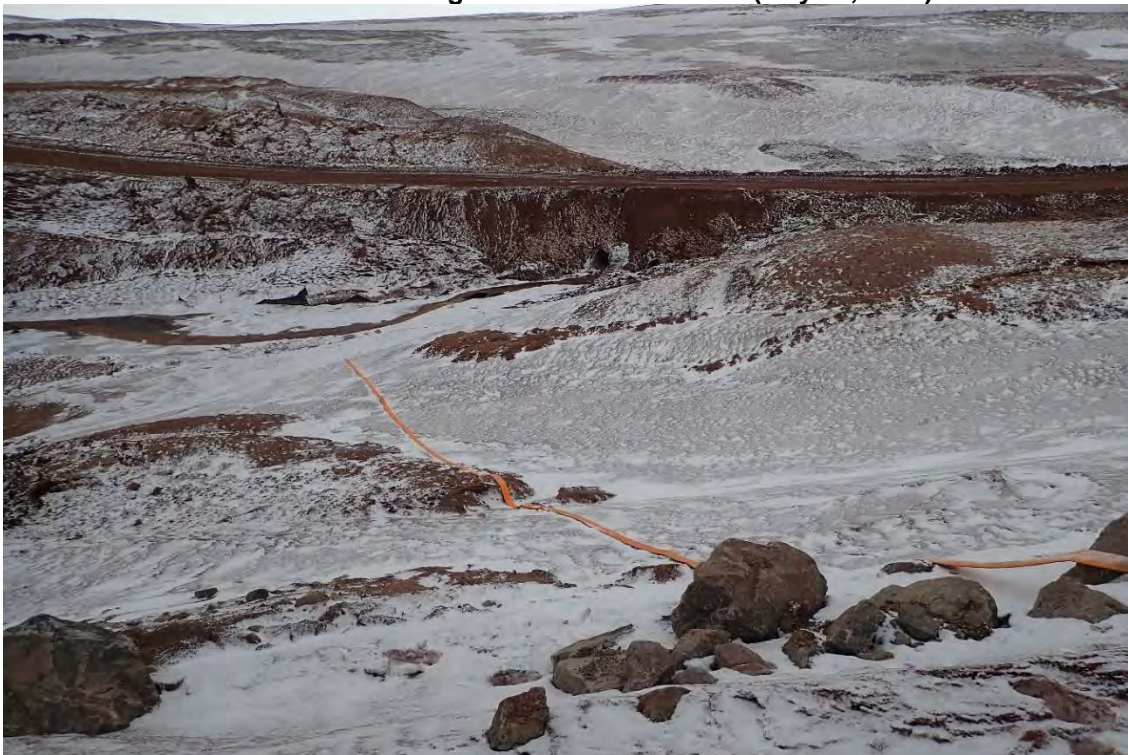
**Photo 6. Pumping Diversion from Unstable Sandy Slope at the Outlet of BG-01 (May 18, 2020)**

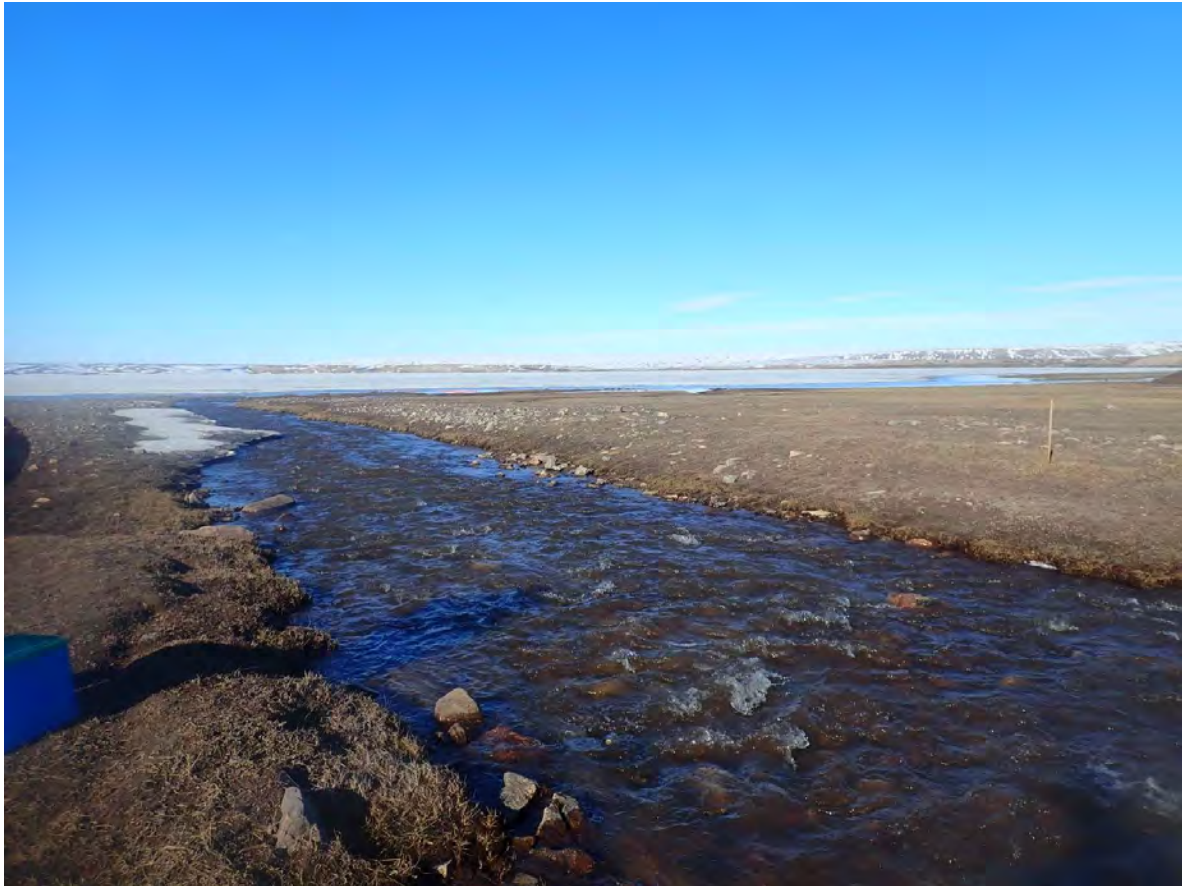
**Photo 7. CLT Outfall on June 11, 2020**

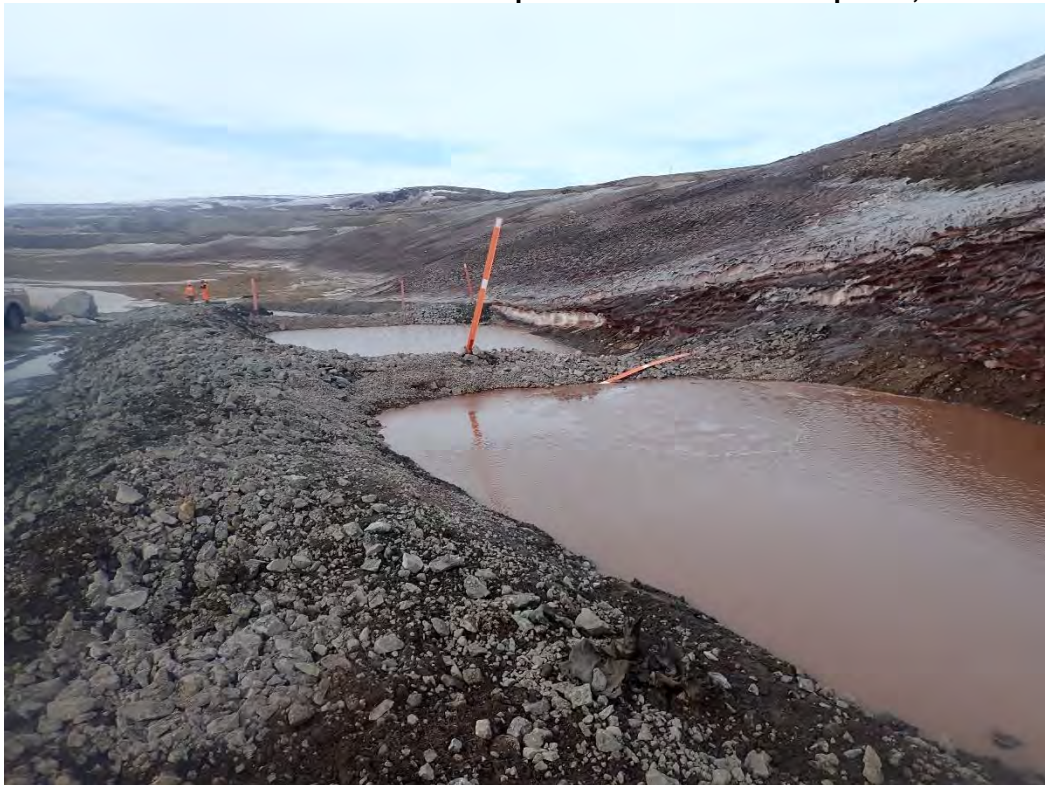
**Photo 2. Camp Lake Check Dams on May 16, 2020**

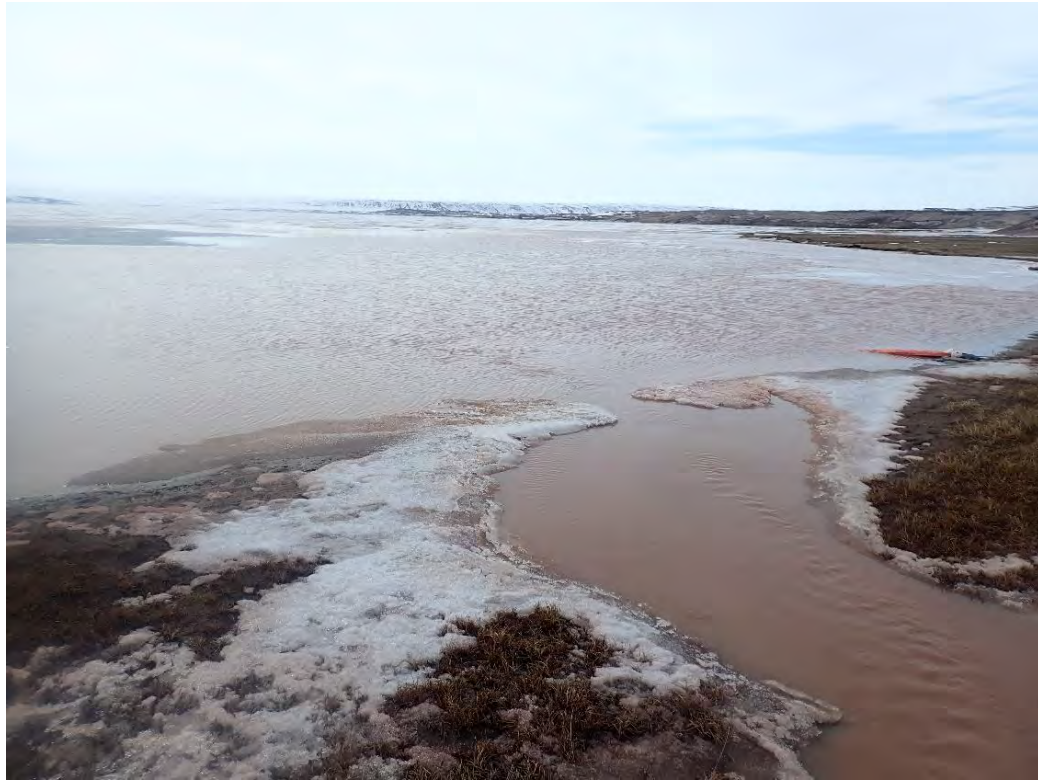
**Photo 3: CLSP Outfall on May 16, 2020**

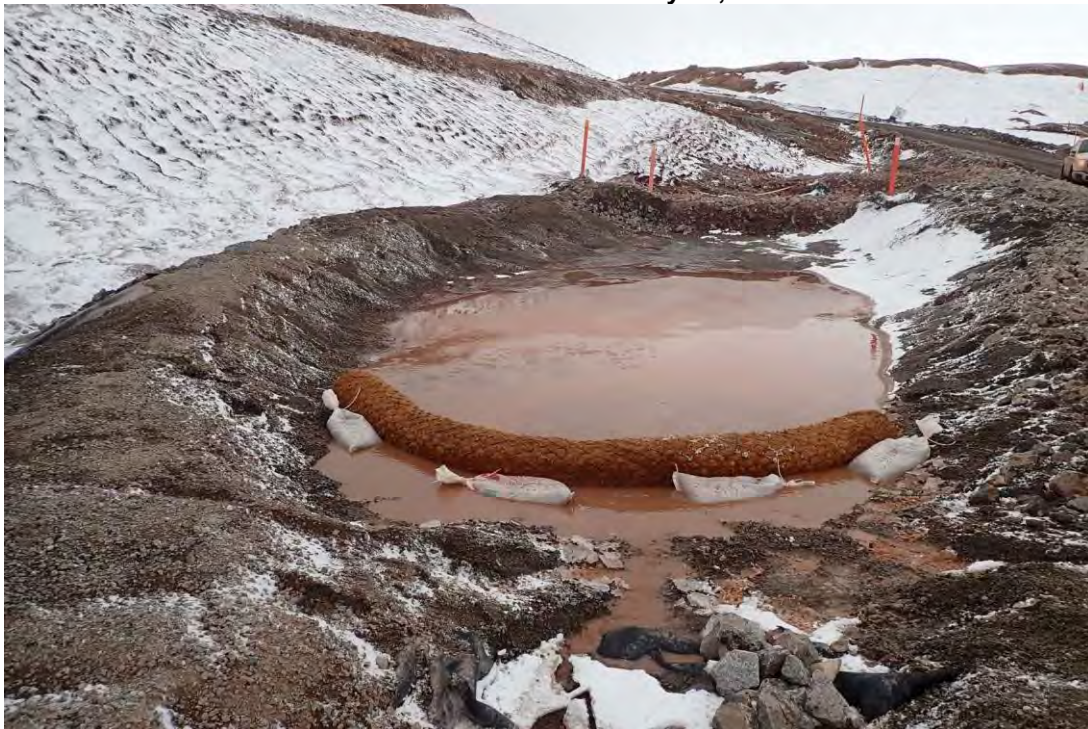
**Photo 4: Camp Lake Sump with Coir Log on May 18, 2020**

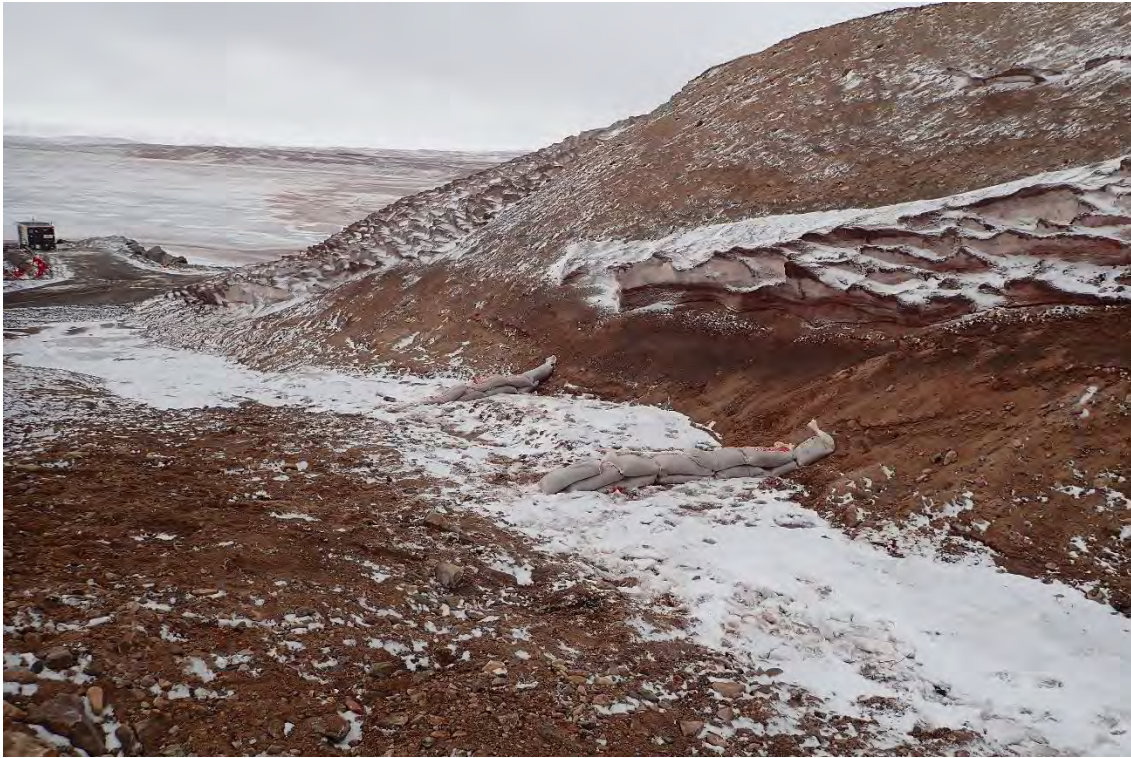
**Photo 5: Camp Lake Check Dams with Sand Bags on May 18, 2020**

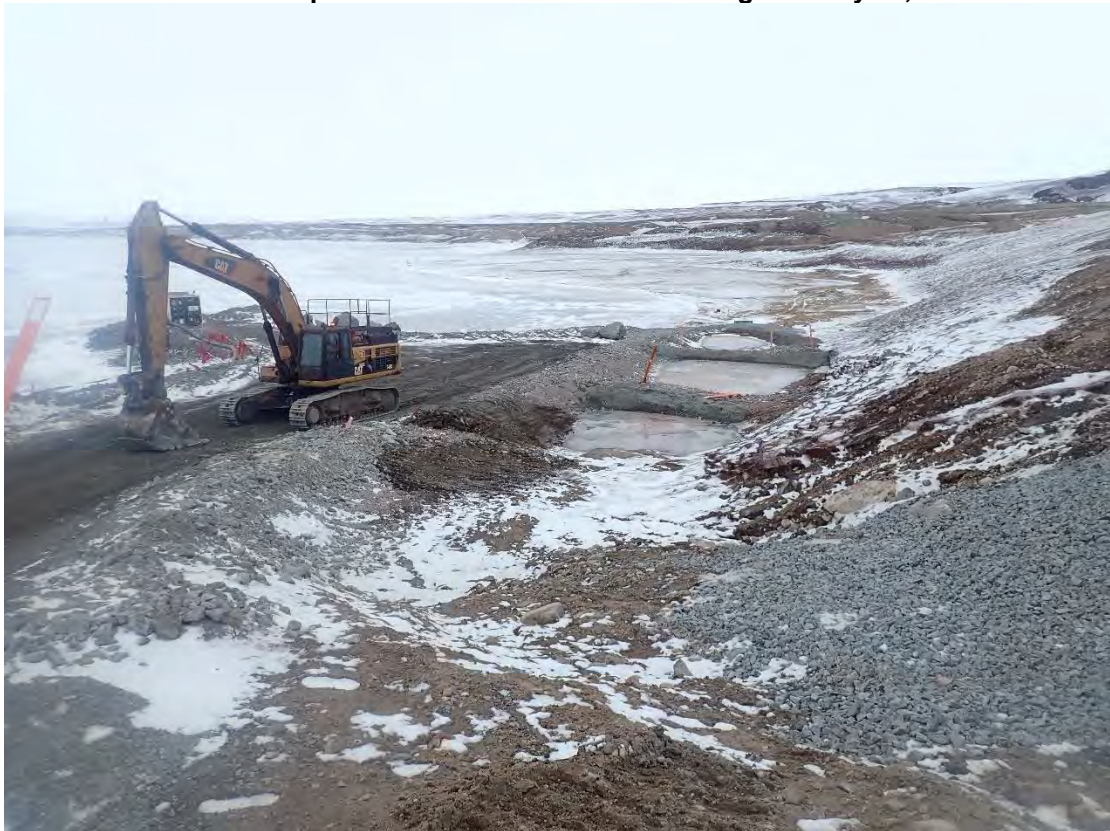
**Photo 6: Camp Lake Settling Improvements on May 21, 2020**

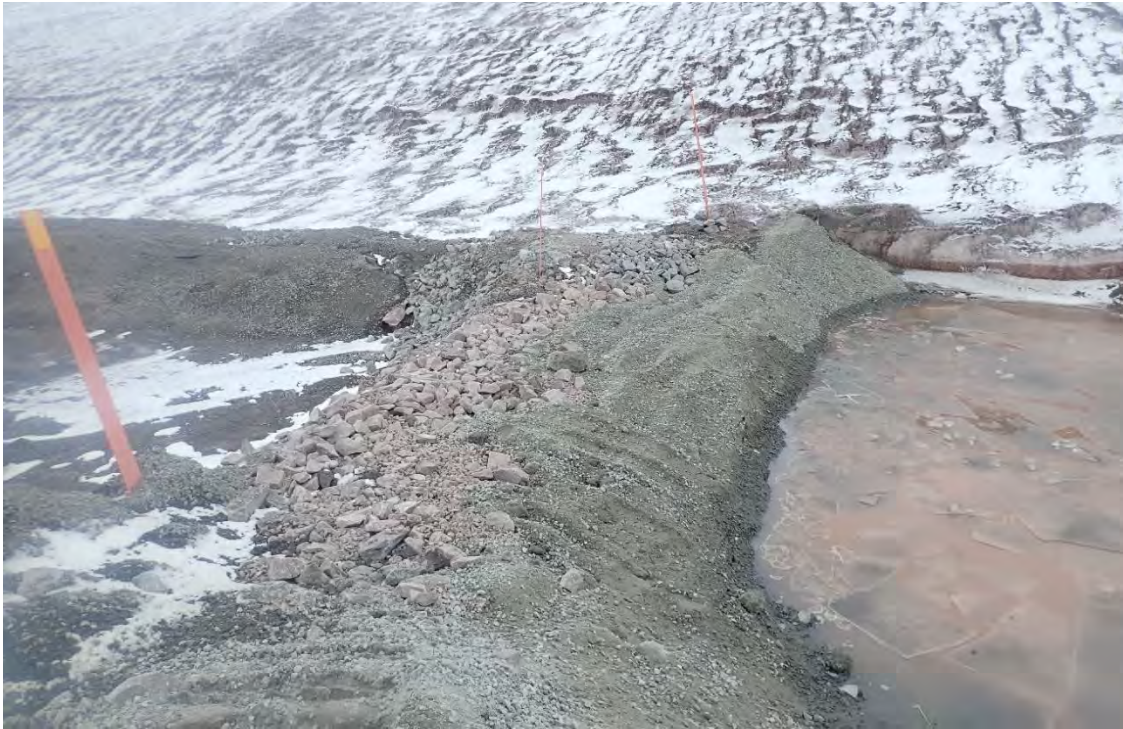
**Photo 7: Camp Lake Check Dam Improvements on May 21, 2020**

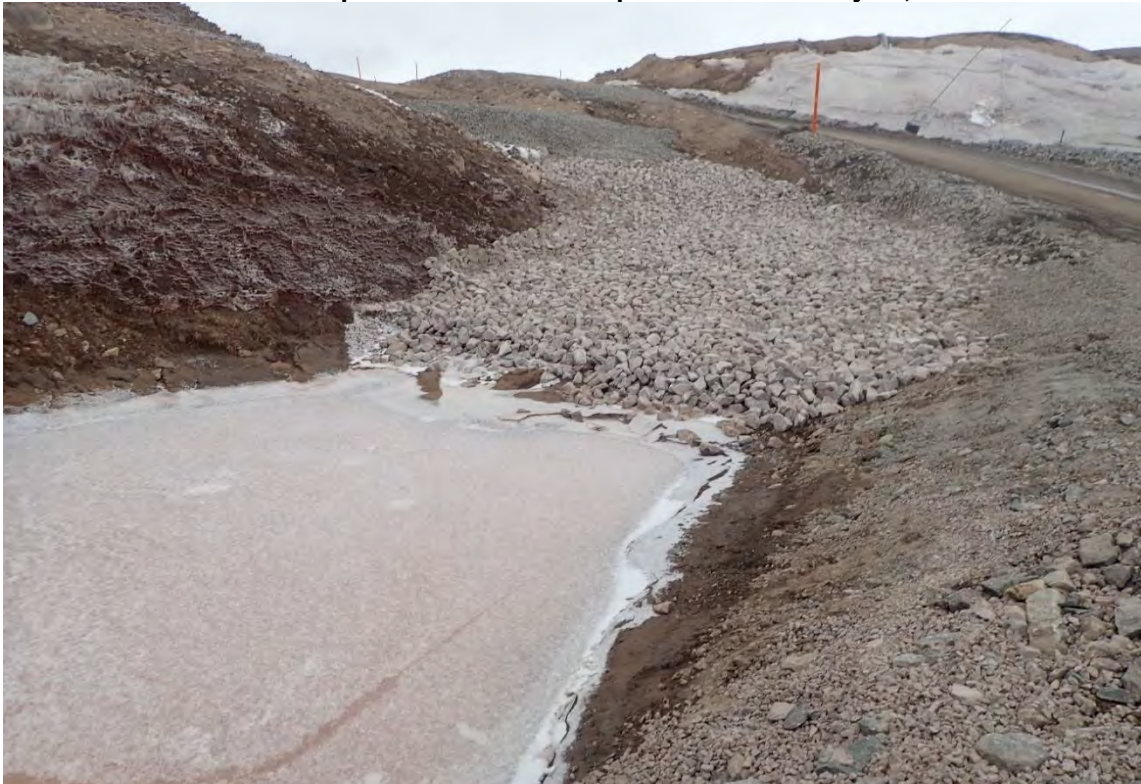
**Photo 8: Camp Lake Slope Rip Rapping on May 23, 2020**

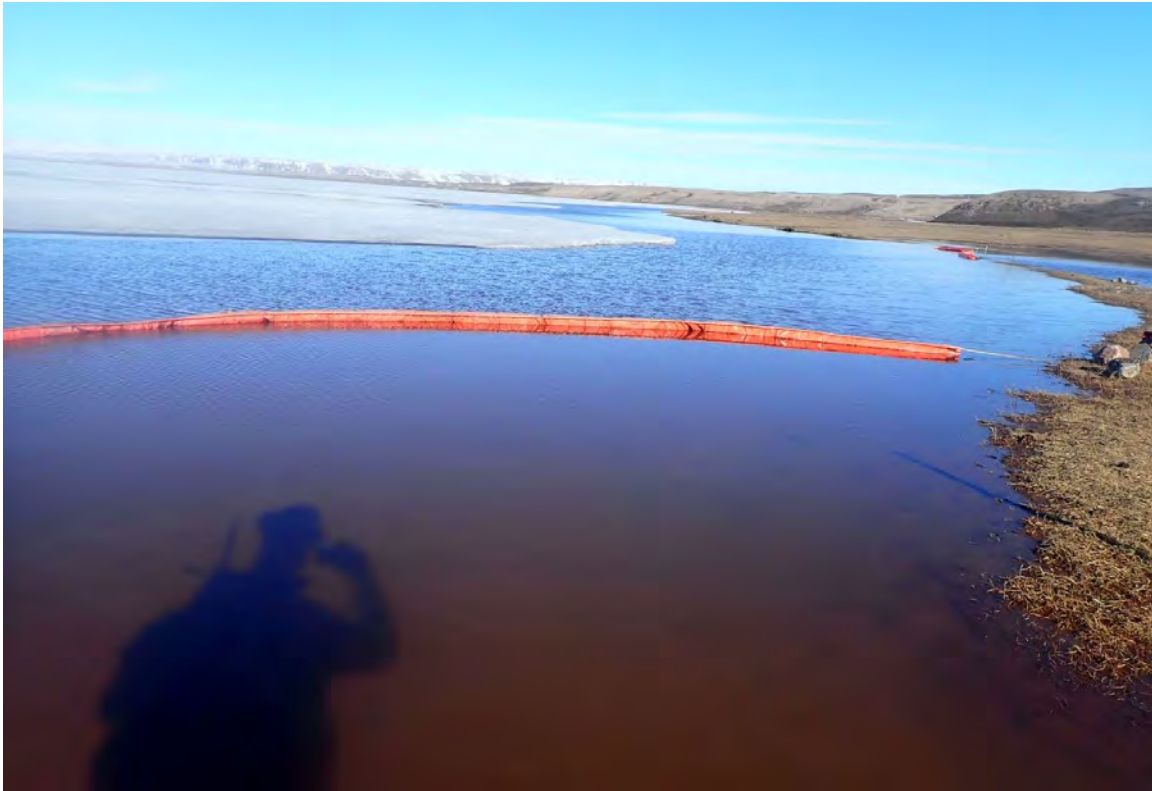
**Photo 9: CLSP Outfall into Silt Curtain on June 11, 2020**

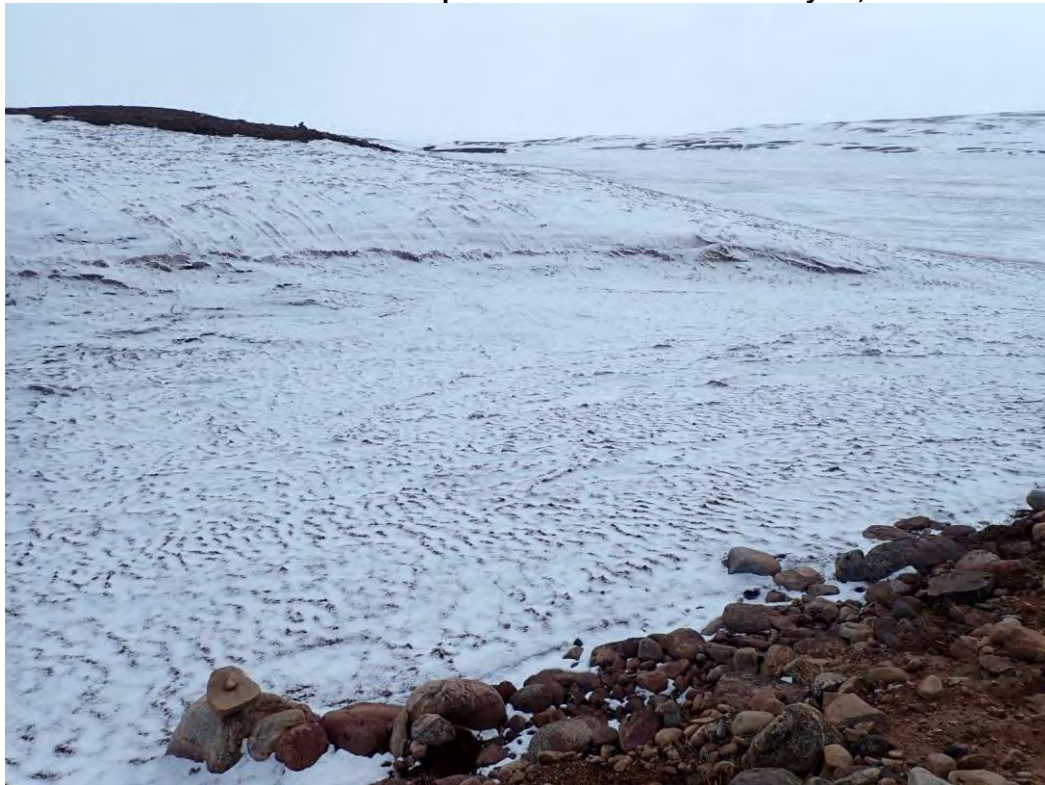
**Photo 2: SDLT Outfall on May 14, 2020**

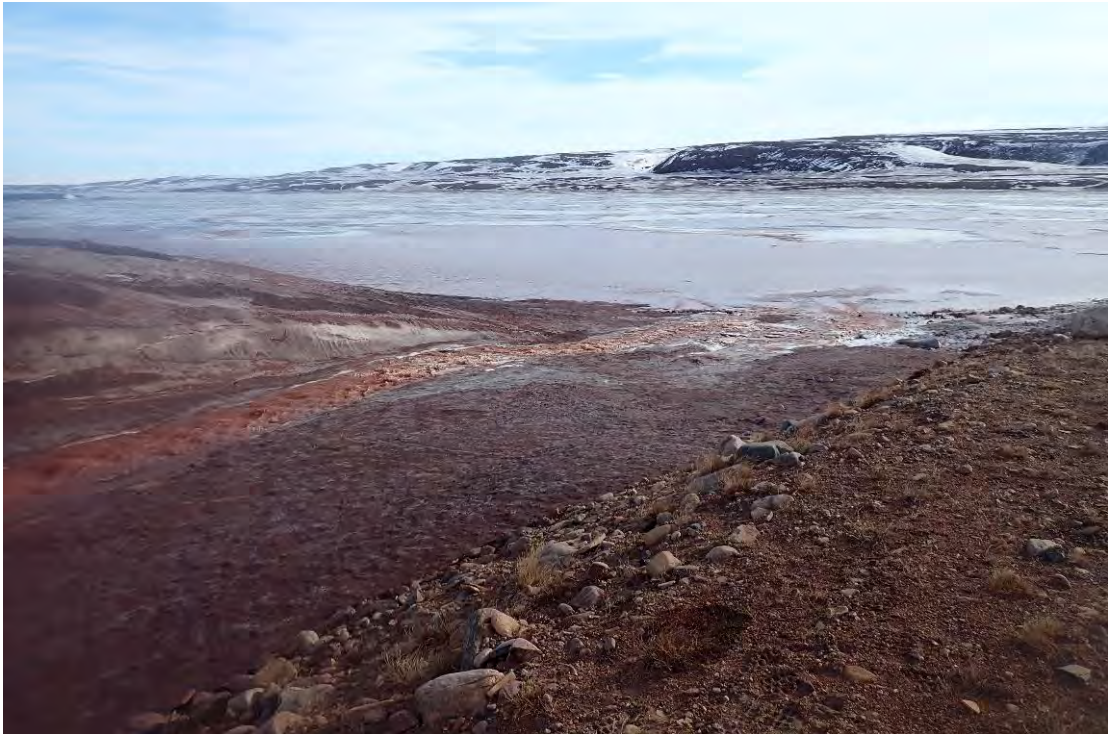
**Photo 3. SDLT Outfall on May 16, 2020**

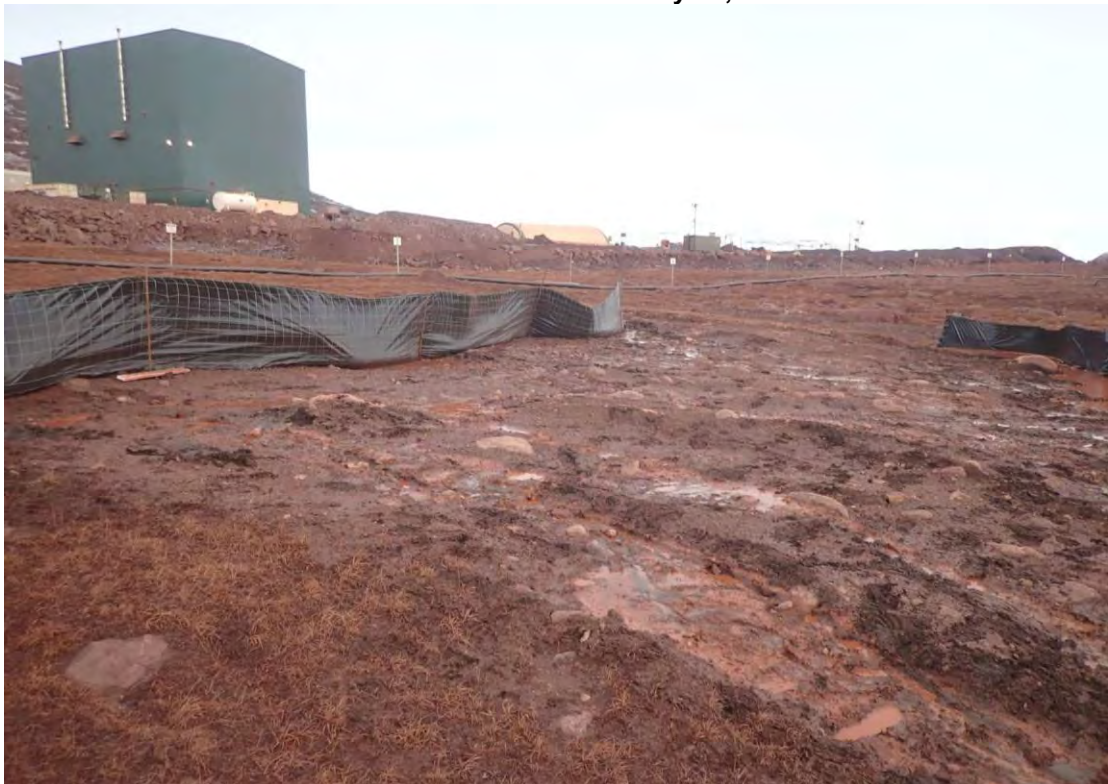
**Photo 4. Erosion and Sediment Control Down Slope of Power Generation Building Minimizing Sediment Entering CV-187 (May 22, 2020)**

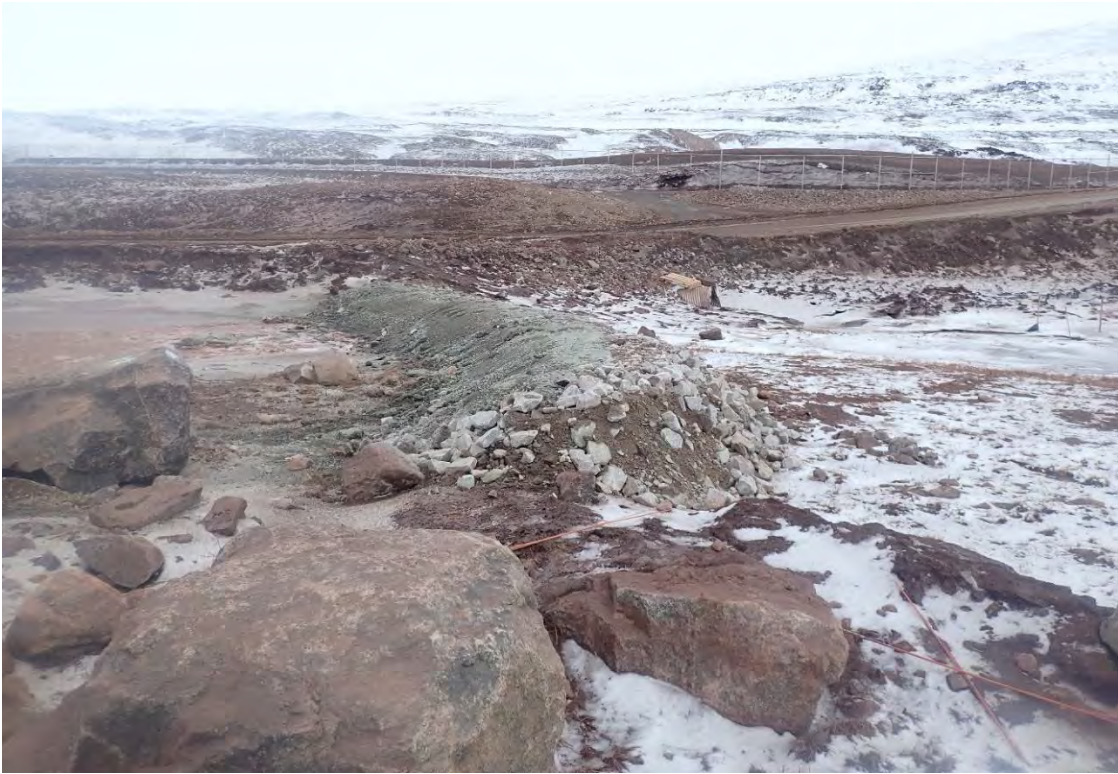
**Photo 5. Check Dam Reinforcement and Expansion at the Inlet of CV-187 (May 20, 2020)**

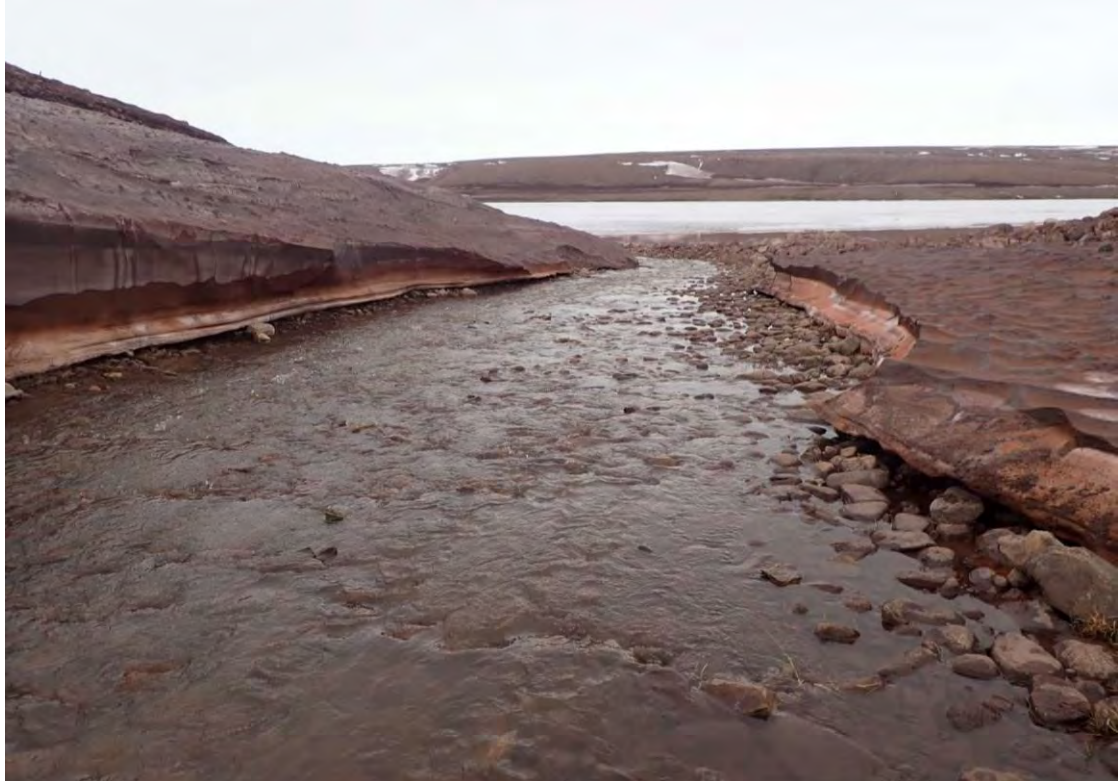
**Photo 6: SDLT Outfall on June 13, 2020**

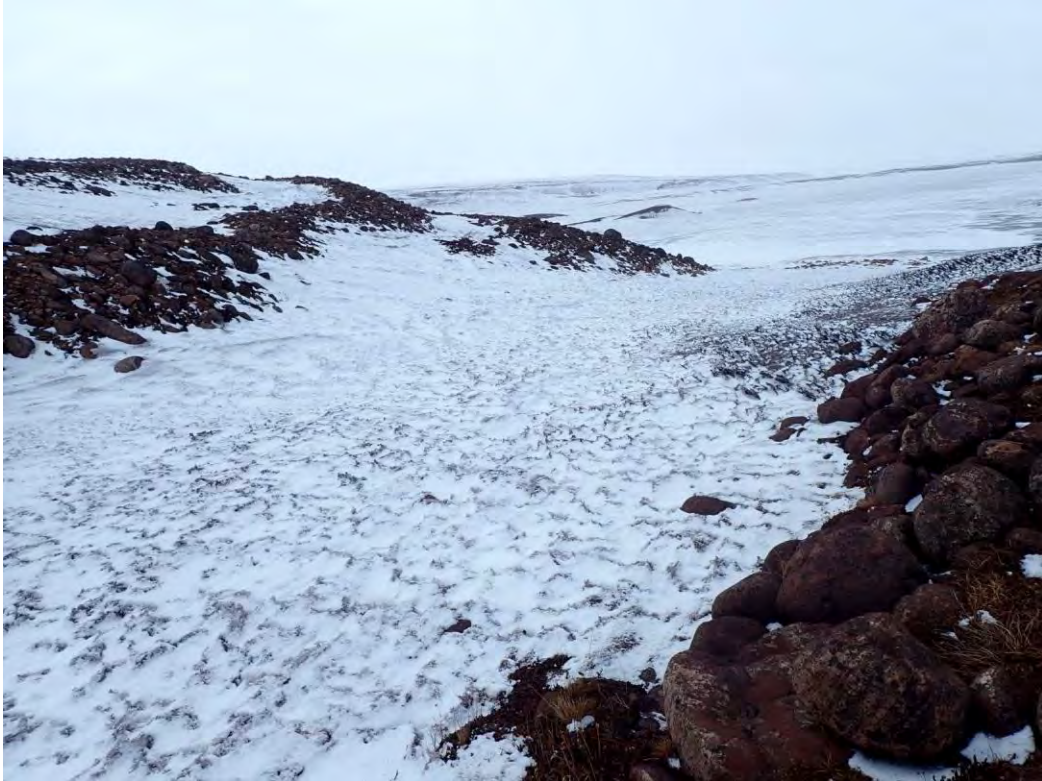
**Photo 1: LDFG Outfall on May 14, 2020**

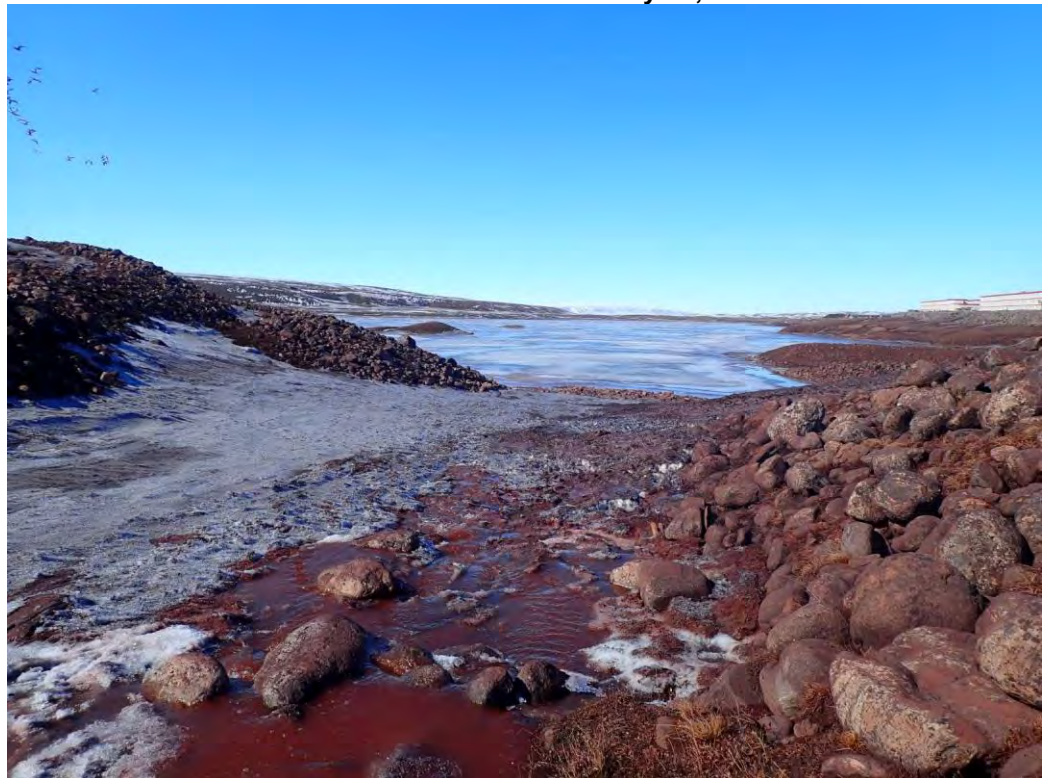
**Photo 2: LDGF Outfall on May 17, 2020**

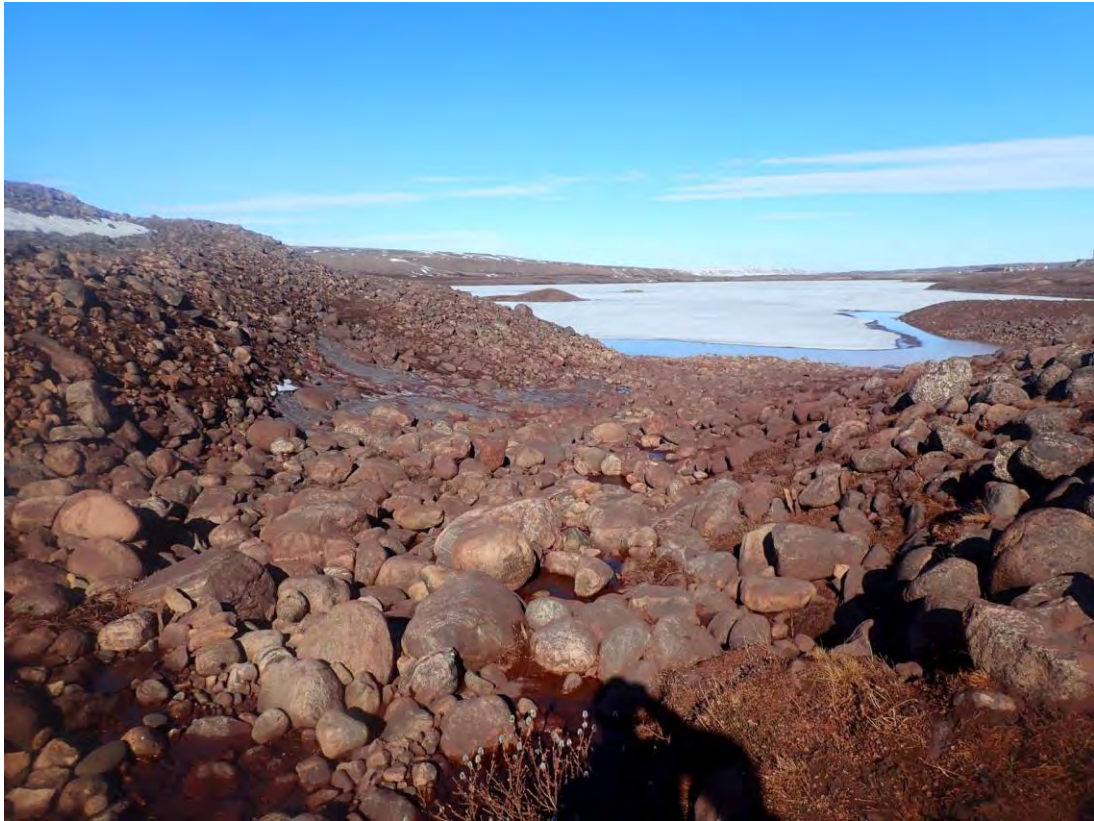
**Photo 3: LDGF Outfall on June 11, 2020**

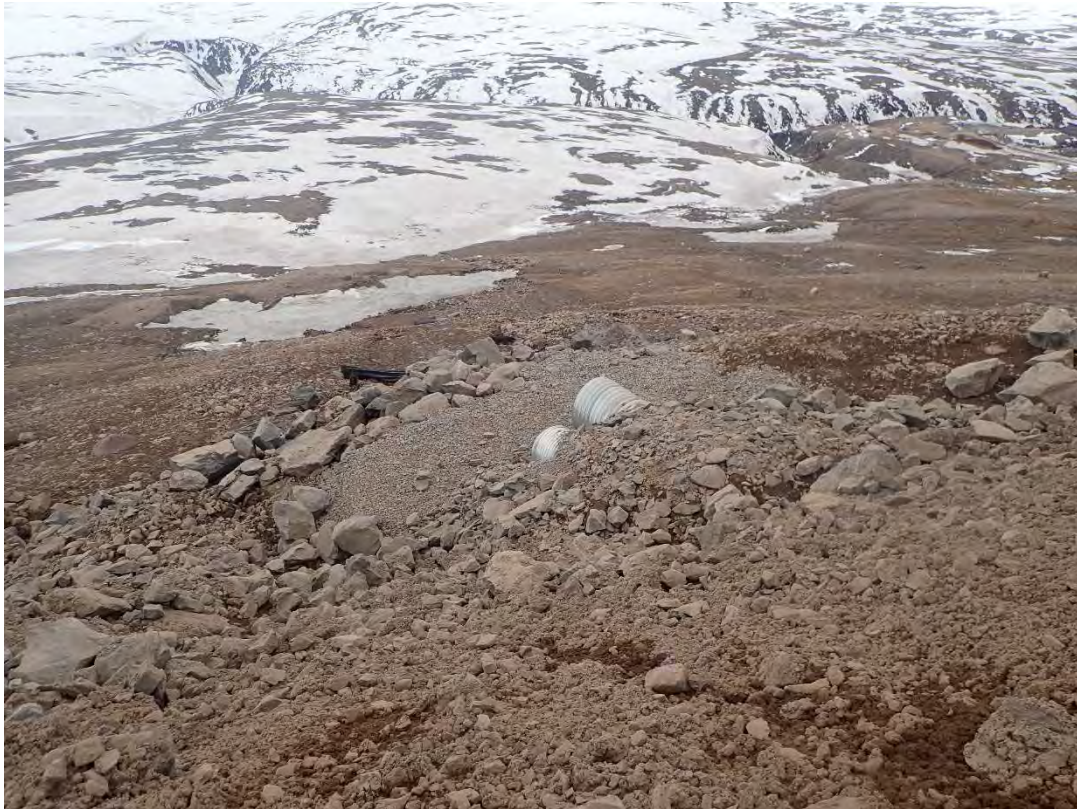
**Photo 1.**

**KM106.5 Extended Culvert with Rip Rap**

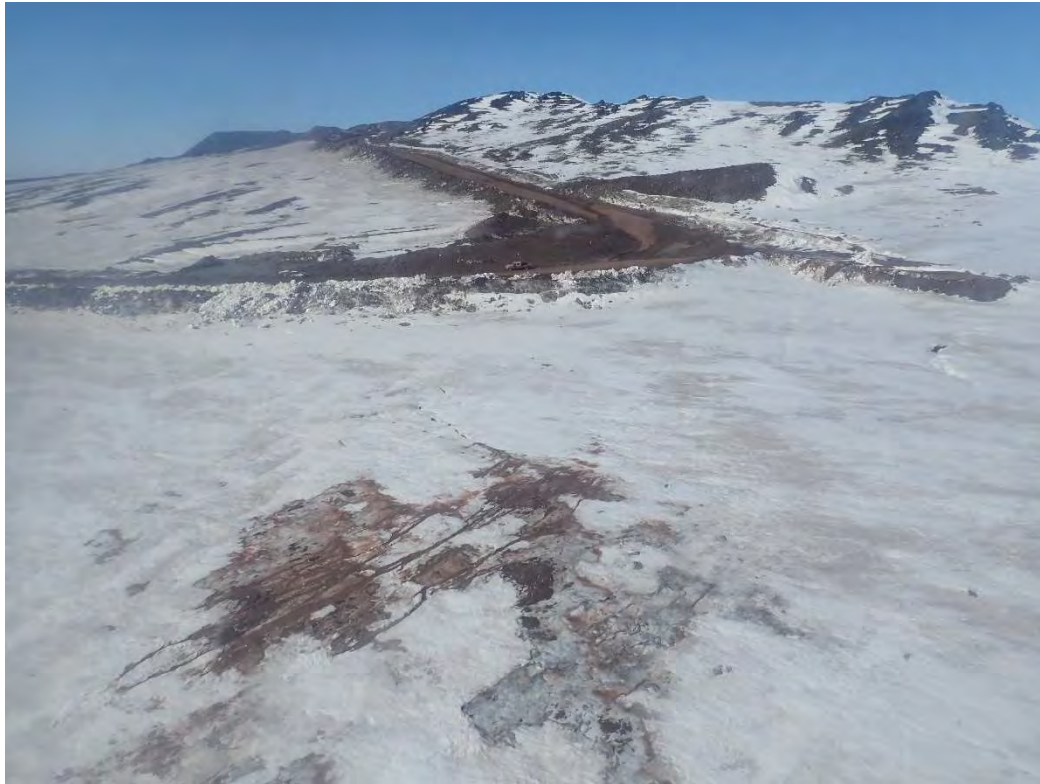
On June 14<sup>th</sup> 2020, temperature fluctuations experienced on Deposit 1 caused rapid snow melt/runoff from the Mine Haul Road ditches at km 108.5, 107 and 106.5 to flow onto the tundra. Water flowing through the road's ditching and culvert system resulting in sediment-impacted water traveling across the mountain tundra, entering the Mary River Tributary and Mary River.

**Photo 2. Sediment impacted water traveling across the tundra on June 15, 2020**

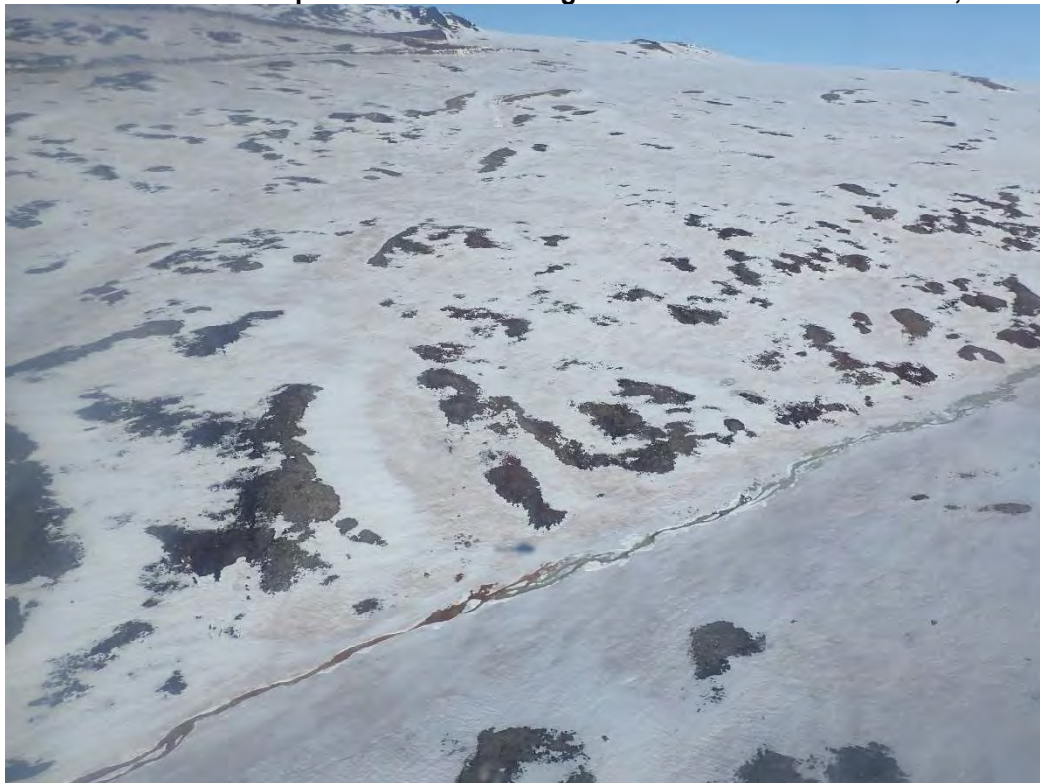
**Photo 3. Sediment impacted water traveling across the tundra on June 15, 2020**
