## APPENDIX E.11

### Freshet Monitoring Report

**BAFFINLAND IRON MINES CORPORATION**  
**MARY RIVER PROJECT****Freshet 2020 Monitoring Report****Rev 0**

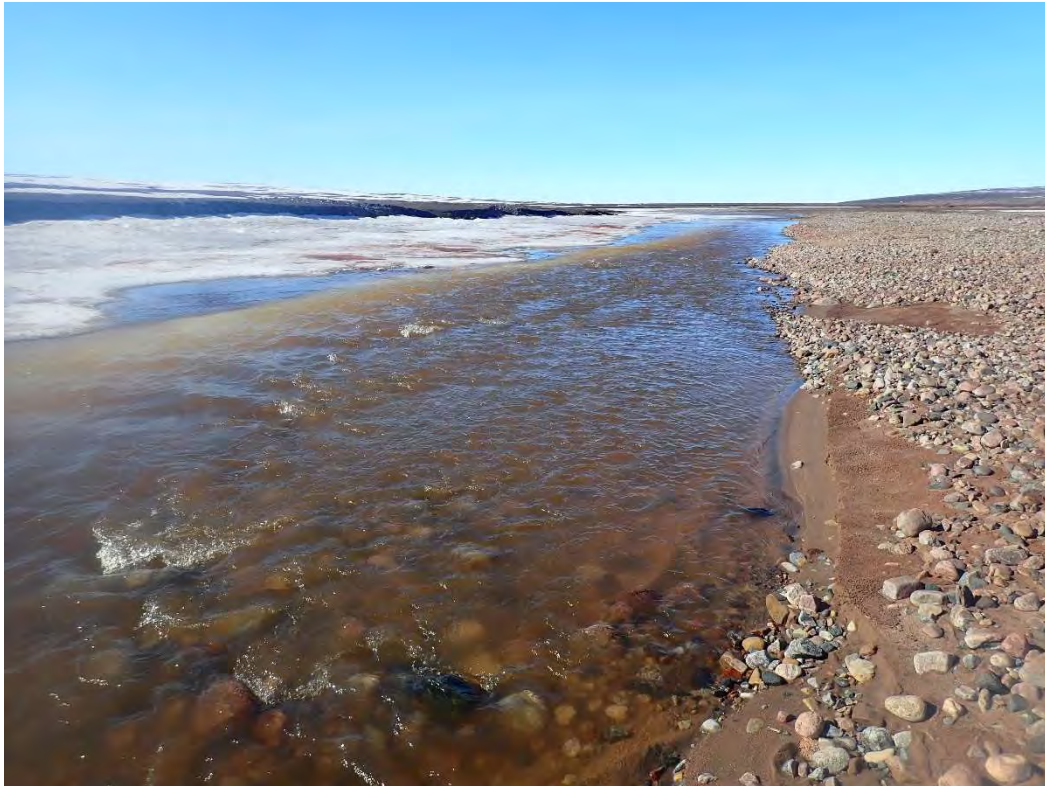
**Photo 4. Sediment-impacted water quality at E0-20 on Mary River on June 15, 2020**

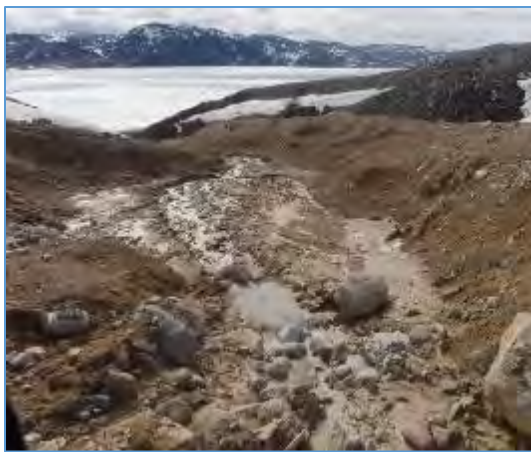
Description: Substrate in the natural sedimentation event area is an unconsolidated glacial till that is poorly sorted and has a high content of clay and silt (Fig. 1). There are seasonal streams and permanent ponded areas in the area where the natural sedimentation event occurred (Fig. 2). Water quality samples collected upstream and downstream of the confluence of the affected area on June 17, 2020 indicated that downstream total suspended solids (TSS) increased to 209 mg/L from the upstream TSS of 7.9 mg/L due to the event. The affected area is a seasonal drainage (Fig. 3) that is affected by natural sedimentation events each year during freshet and will be monitored again in 2021.

Figure 1. Substrate of affected area.

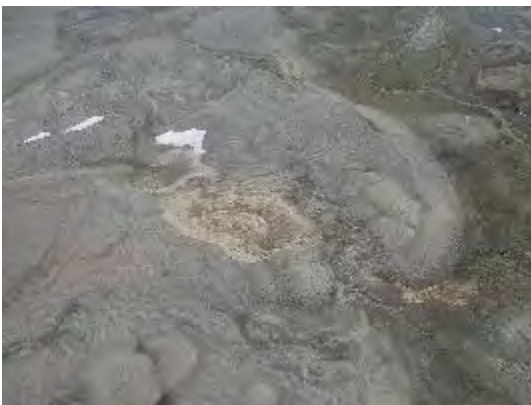
Figure 3. Overview of the affected area.

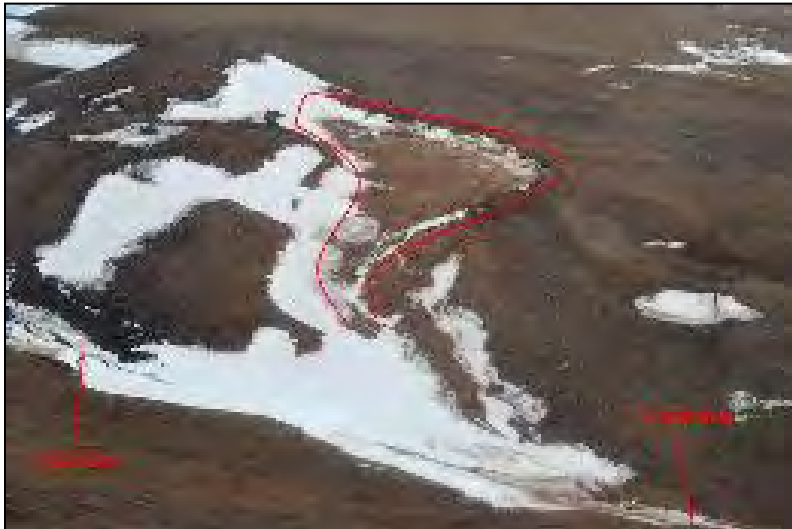
Description: The source of the natural sedimentation event identified as MIL-NATSED-2 was determined to be a sloughed hillslope of what appeared to be glacial till that was partially covered with snow (Fig. 1). The sloughed hillslope was causing sediment loading into the braided stream resulting in elevated turbidity in the downstream water bodies. Water quality samples collected upstream and downstream of the affected area on June 17, 2020 indicated that downstream total suspended solids (TSS) increased to 346 mg/L from the upstream TSS of <2.0 mg/L due to the event. The affected area is a seasonal drainage that is affected by natural sedimentation events each year during freshet and will be monitored again in 2021.

Figure 1. Overview of affected area.

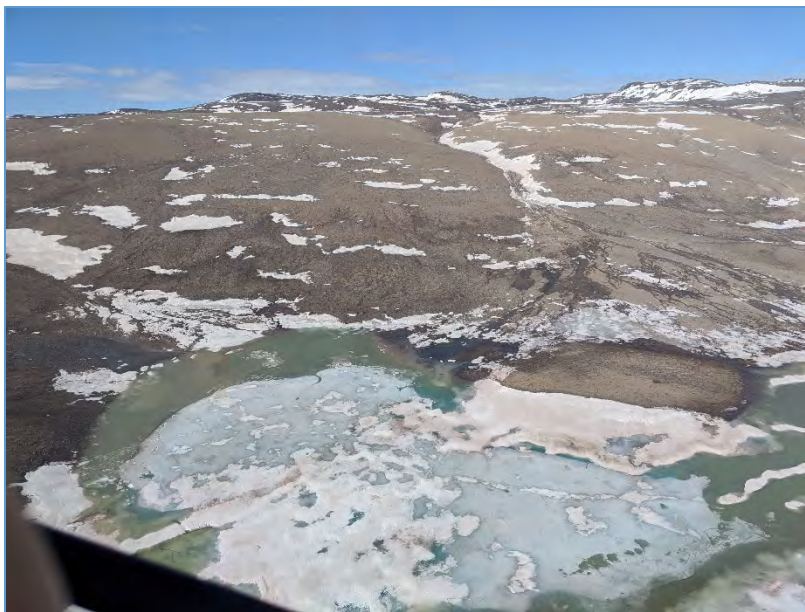
Description: Substrate in the natural sedimentation event area is an unconsolidated glacial till that is poorly sorted and has a high content of gravel, clay and silt. A seasonal stream drains through the affected area during freshet and carries sediment into the downstream water body. Water quality samples collected upstream and downstream of the affected area on June 17, 2020 indicated that downstream total suspended solids (TSS) increased to 168 mg/L from the upstream TSS of 7.1 mg/L due to the event.

Figure 1. Overview of the natural sedimentation event area.

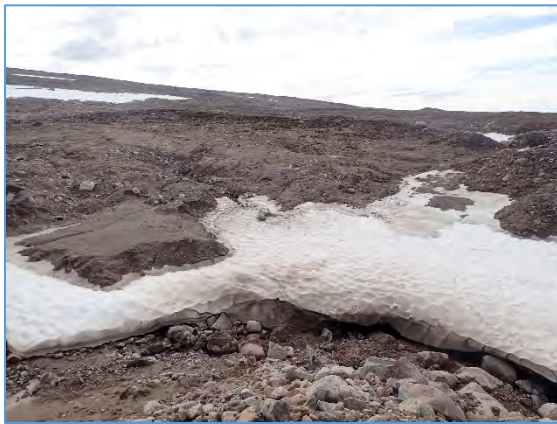
Description: Substrate is an unstable mix of gravel, sand/silt and large boulders (Fig. 1). Turbid flow from the mudslide was observed entering the Mary River (Fig. 2). Instream water quality monitoring performed upstream (Fig. 3) and downstream (Fig. 4) of the affected stream section on July 15, 2020 indicated that downstream turbidity increased to 38.5 NTU from the upstream turbidity of 30.5 NTU due to the event. When the site was inspected on July 15, 2020, it appeared that the mudslide was not at risk of further movement at that time and the effects on the Mary River water quality would likely be short-lived.

Figure 1. Substrate of mudslide area.

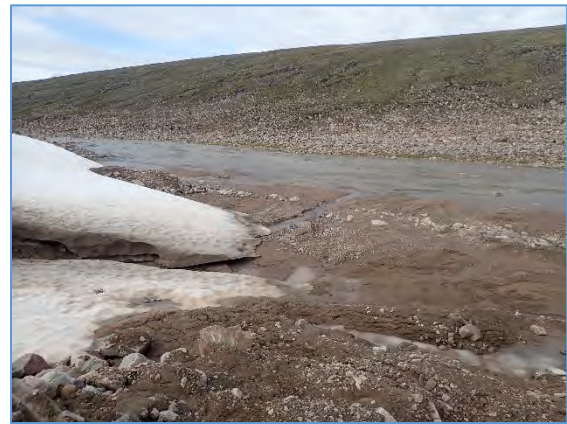
Figure 2. Turbid flow entering the Mary River.

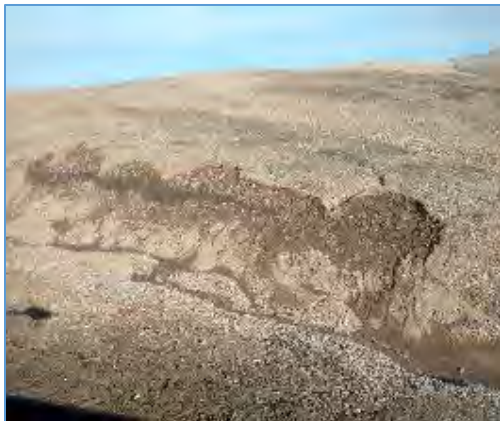
Description: Substrate is an unstable mix of gravel, cobble and sand/silt (Fig. 1). Sediment from the sloughed hillside was observed entering the tributary of the Mary River (Fig. 2). The sediment carried into the Mary River from the affected tributary was observed to increase turbidity in the Mary River downstream of the confluence. UTM coordinates for a water quality monitoring location downstream of the confluence are NAD83, Zone 17N, 574946 E, 7920199, N. UTM coordinates for a water quality monitoring location upstream of the confluence are NAD83, Zone 17N, 574934 E, 7920838 N. Water quality samples collected upstream and downstream of the confluence of the tributary with the Mary River on July 15, 2020 indicated that downstream total suspended solids (TSS) increased to 18.1 mg/L from the upstream TSS of 15.5 mg/L due to the event. Water quality samples collected upstream and downstream of the confluence of the tributary with the Mary River on July 19, 2020 indicated that downstream TSS increased to 16.8 mg/L from the upstream TSS of 6.4 mg/L due to the event. The sloughed hillslope is considered an active source of sedimentation loading into the Mary River and will be monitored again during the 2021 freshet season.

Figure 1. Substrate of sloughed hillside.

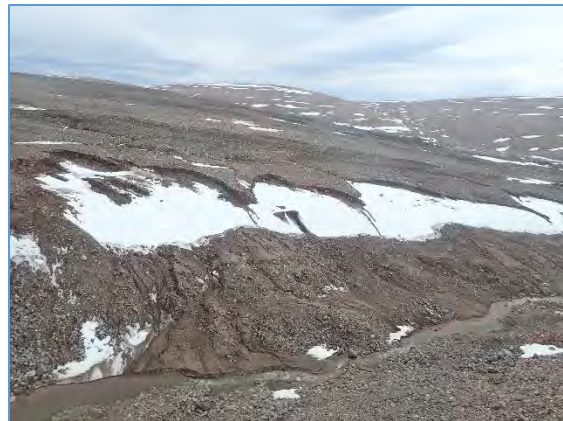
Figure 2. Sediment entering the tributary.

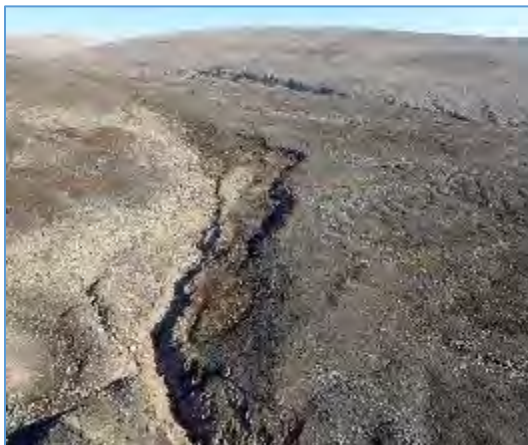
Description: Substrate is an unstable mix of gravel, cobble and sand/silt (Fig. 1). Sediment from the sliding slope was observed entering the Mary River (Fig. 2). The sediment carried into the Mary River from the affected slope was observed to increase downstream turbidity in the Mary River. UTM coordinates for a water quality monitoring location downstream of the confluence are NAD83, Zone 17N, 573616 E, 7925011 N. UTM coordinates for a water quality monitoring location upstream of the confluence are NAD83, Zone 17N, 573616 E, 7925011 N. Water quality samples collected upstream and downstream of the affected section of the Mary River on July 15, 2020 indicated that downstream total suspended solids (TSS) increased to 18.6 mg/L from the upstream TSS of 10.8 mg/L due to the event. Water quality samples collected upstream and downstream of the affected section of the Mary River on July 19, 2020 indicated that downstream total suspended solids (TSS) increased to 11.8 mg/L from the upstream TSS of 3.9 mg/L due to the event.

Figure 1. Substrate of sliding slope.

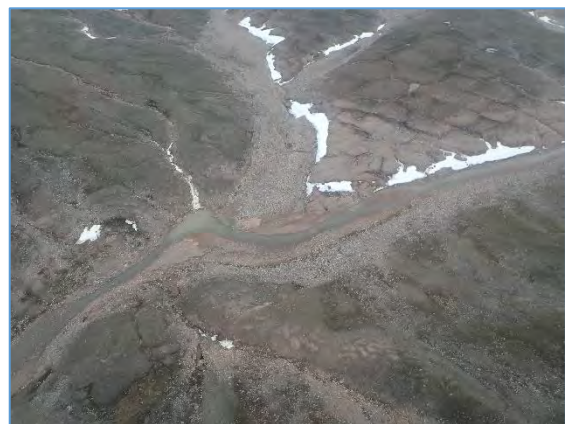
Figure 2. Sediment entering the Mary River.

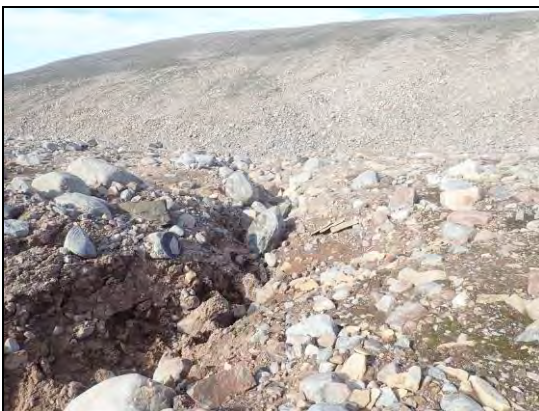
Description: Substrate is an unstable mix of gravel, sand/silt and large boulders (Fig. 2). Flow from the slumping hills enters a tributary that joins the Mary River downstream (Fig. 3).

Figure 2. Substrate of slumping hills.

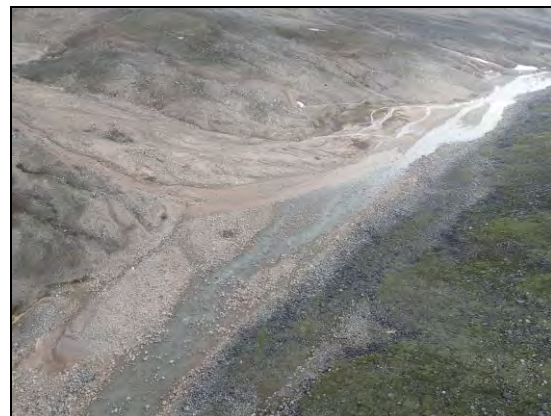
Figure 3. Turbid flow from MR-NATSED-4 entering the Mary River.

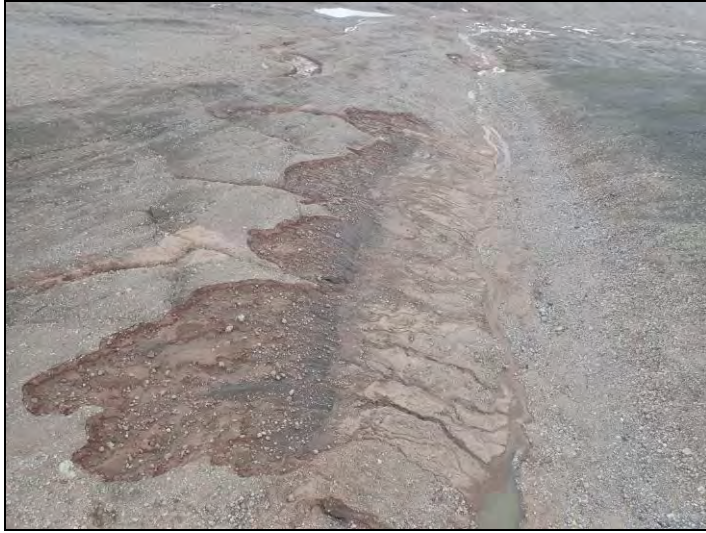
Figure 4. Aerial photograph of sloughed hillside.
