RE: Water Licence 2AM-MRY1325 February 2020 Inspection – Follow Up

2AM-MRY1325 February 2020 Inspection Report

INSPECTION FORM

A water licence inspection was conducted at Mary River and Milne Inlet to ensure compliance with the terms and conditions of the Water Licence 2AM-MRY1325. This inspection was conducted by Water Resource Officer JONATHAN MESHER on February 17th through 18th, 2019.

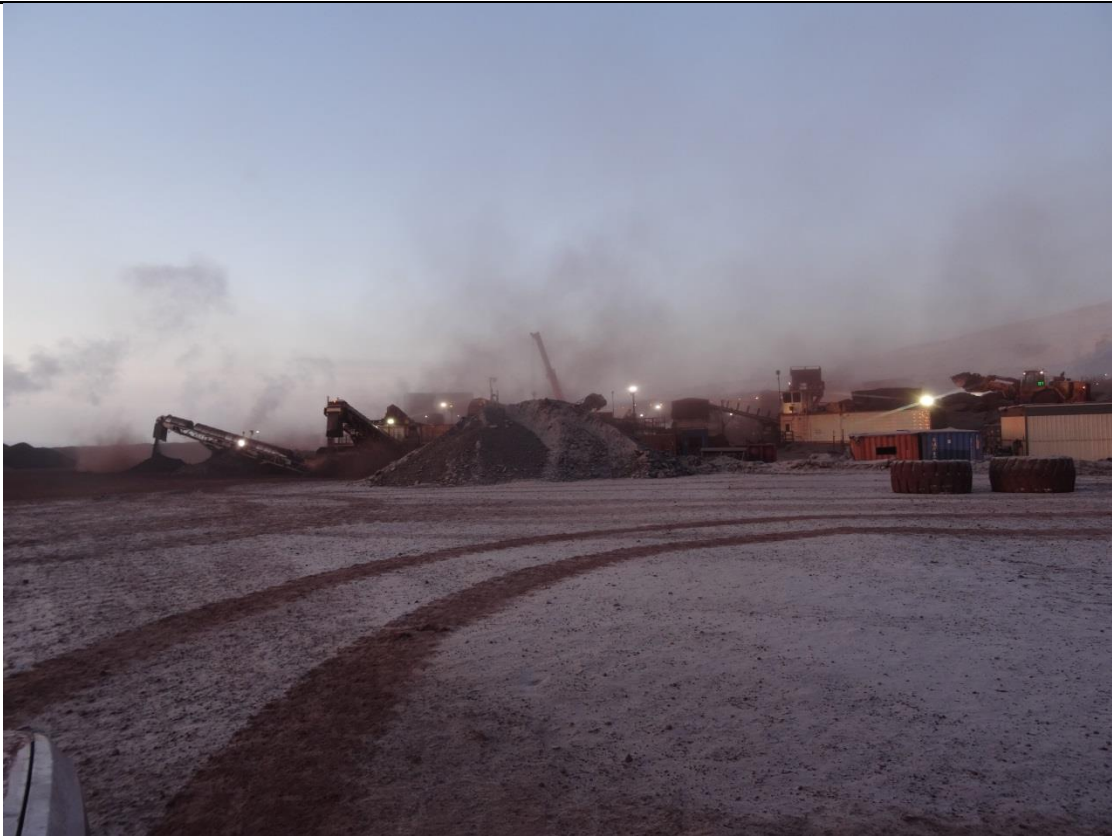
Date	Camera	Inspector	Authorization
	Sony Cyber-shot	J.Mesher	2AM-MRY
Photo Log		Location Iqaluit	
Photo 6

- b) Since May, 2016 CIRNAC has identified pooling water within the crusher pad, the inability of BIMC to effectively manage surface water in the facility is a continual problem on this unlined Pad. This Pad is only approved as described in the As-built and IFC drawings, in the engineered drawings the surface water should flow to the ditches without the need for human intervention such as pumps, due to the slope of the pad. The licensee is to develop a plan to ensure this facility is appropriately maintained, the inspector is requesting that this plan include schedules for grading of the facility to ensure that this pooling discontinues, grade is maintained throughout the seasons and the ditches surrounding the facility are operating as intended. See photos 5 and 6 for the ore crushing pad.

Description: Crushing area looking Northeast.

c) The licensee is to develop a plan to ensure that the ore stockpile pad is appropriately maintained, the inspector is requesting that this plan include schedules for grading of the facility to ensure that this pooling discontinues, grade is maintained throughout the seasons and the ditches surrounding the facility are operating as intended.

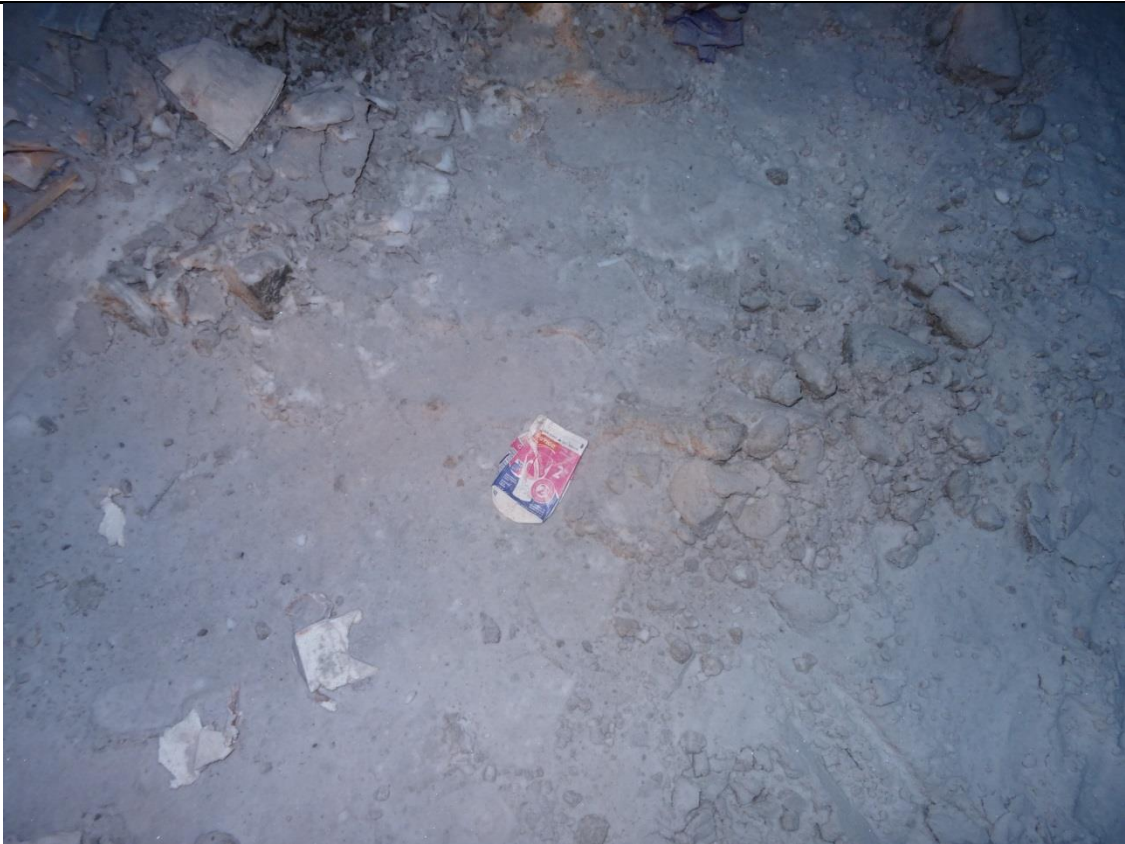
Date	Camera	Inspector	Authorization
	Sony Cyber-shot	J.Mesher	2AM-MRY
Photo Log		Location Iqaluit	
Photo 7

Description: Food waste within landfill.

b) The inspector noted small amounts food waste within the Landfill, see photo 7 for the food waste identified. In section 3.7 of BIMC's Waste Management Plan (BAF-PH1-830-P16-0028) Baffinland states that: "Disposal of all domestic (food) waste, hazardous and biomedical materials at the Landfill Facility is prohibited." BIMC is encouraged to continue to educate its employees in order to prevent further unapproved deposits of food waste into this facility.	<p>Baffinland is committed to adhering to the current Waste Management Plan, and is conducting weekly inspections of the Landfill Facility. The inspections are documented and the reports will be shared with CIRNAC.</p> <p>In January 2020, the Environment Department assessed the life cycle of waste from source control to segregation and final disposal of products across the Project. Through the assessment, items requiring corrective action were identified and follow up actions implemented. Findings from the waste assessment were shared with employees across site through the departmental bi-weekly safety meetings. In addition to ongoing employee education, routine inspections of Landfill Facility operations are completed with a focus on waste volume, composition and overall conformance to the</p>

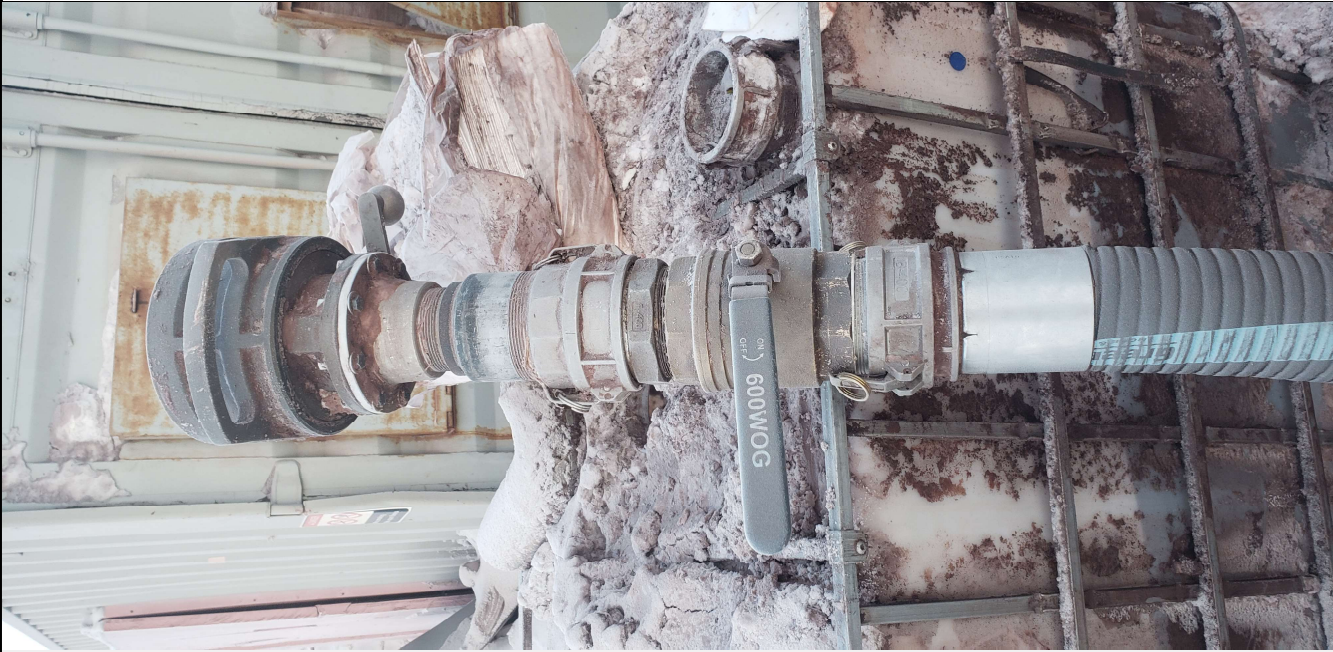
Photographs and Drawings

very slight fuel drip from API coupler when transferring fuel from tank #5 to fuel farm

While tanker operator was transferring fuel from tank #5 it was reported that there was a slight drip from the API coupler that was hanging over at open tote with a duck pond surrounding it prior to the drip being reported. All valves at the present time were closed just a small amount of fuel in the 5 foot hose.

Extreme cold weather caused seals in API coupler to shrink and a slight drip occurred

1.1	due to extreme cold seals in API coupler shrunk		
1.2	was no ball valve at base of API coupler		
Corrective Actions:			
No.	Description	Issued To	Due Date

1.2	Installed ball Valve at base of API coupler	Jeff Byers	20-Feb-20
Investigation Team and Factors Limiting the Investigation (if Any)			
Name	Position	Signature	
Jeff Byers	Supervisor	Investigation Accepted <input checked="" type="checkbox"/>

Name	Comment	Date
Jeff Byers	Ball Valve installed at base of API coupler immediately after report was made	21-Feb-20
