BAFFINLAND IRON MINES CORPORATION

MARY RIVER PROJECT

Construction Summary Report
Mine Site Waste Rock Facility Expansion and Drainage System
Construction of West Ditch and East Ditch phase 2021
December 2021

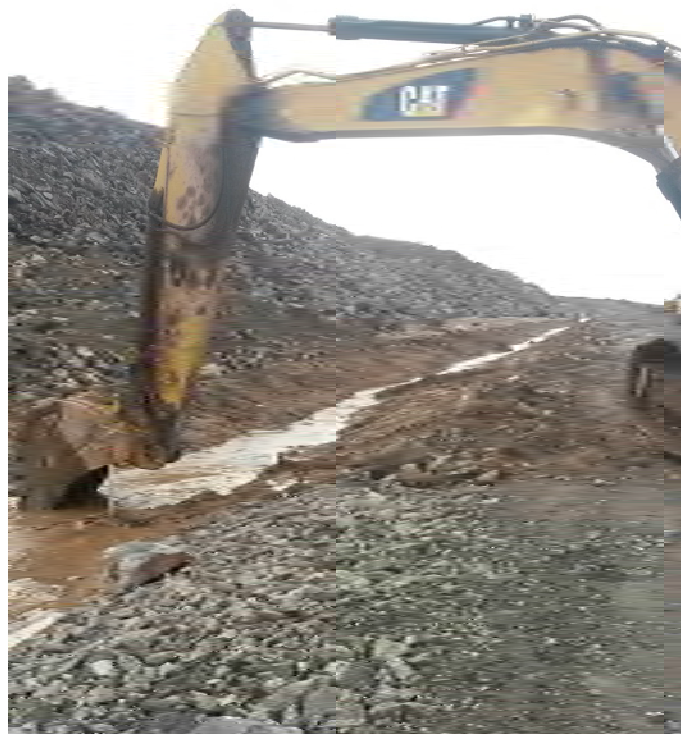
Photograph 9- West Ditch excavation in soft soil, July 1, 2021.

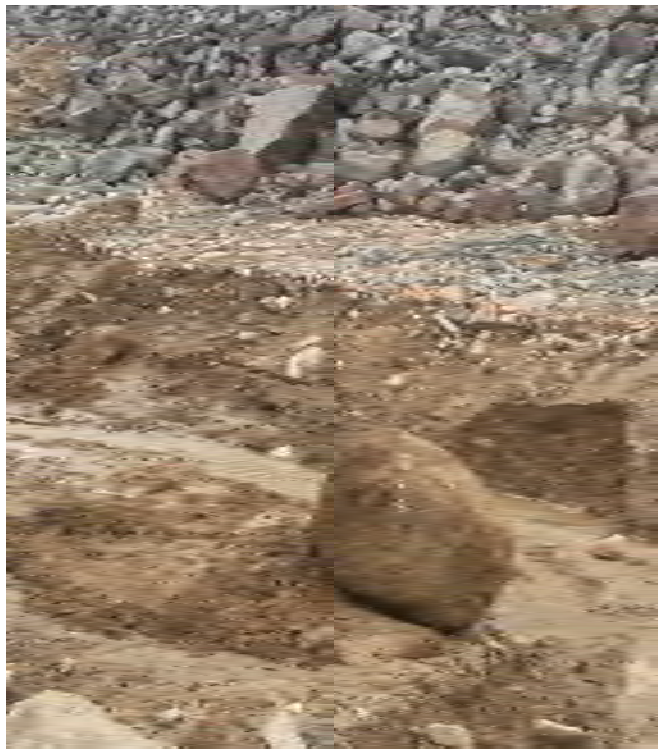
Photograph 12- West Ditch boulder removal, July, 2 2021.

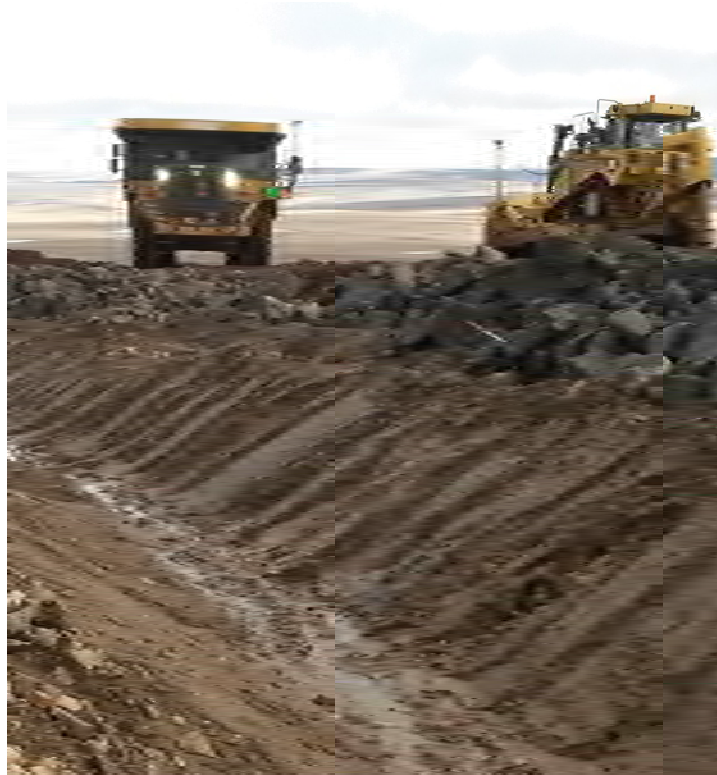
Photograph 18- East Ditch excavation in soft soil, August 10, 2021.

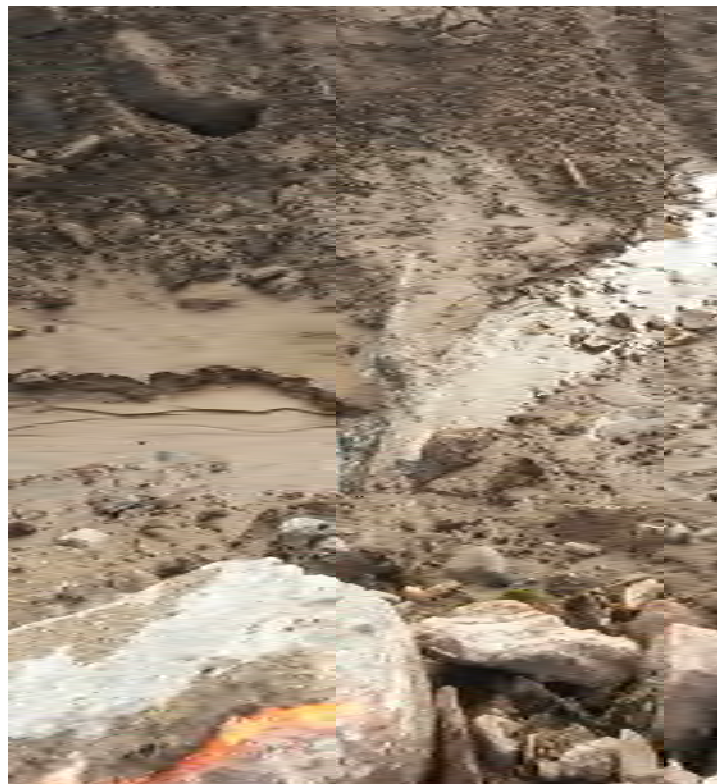
Photograph 19- East Ditch boulder removal during construction, August 10, 2021.

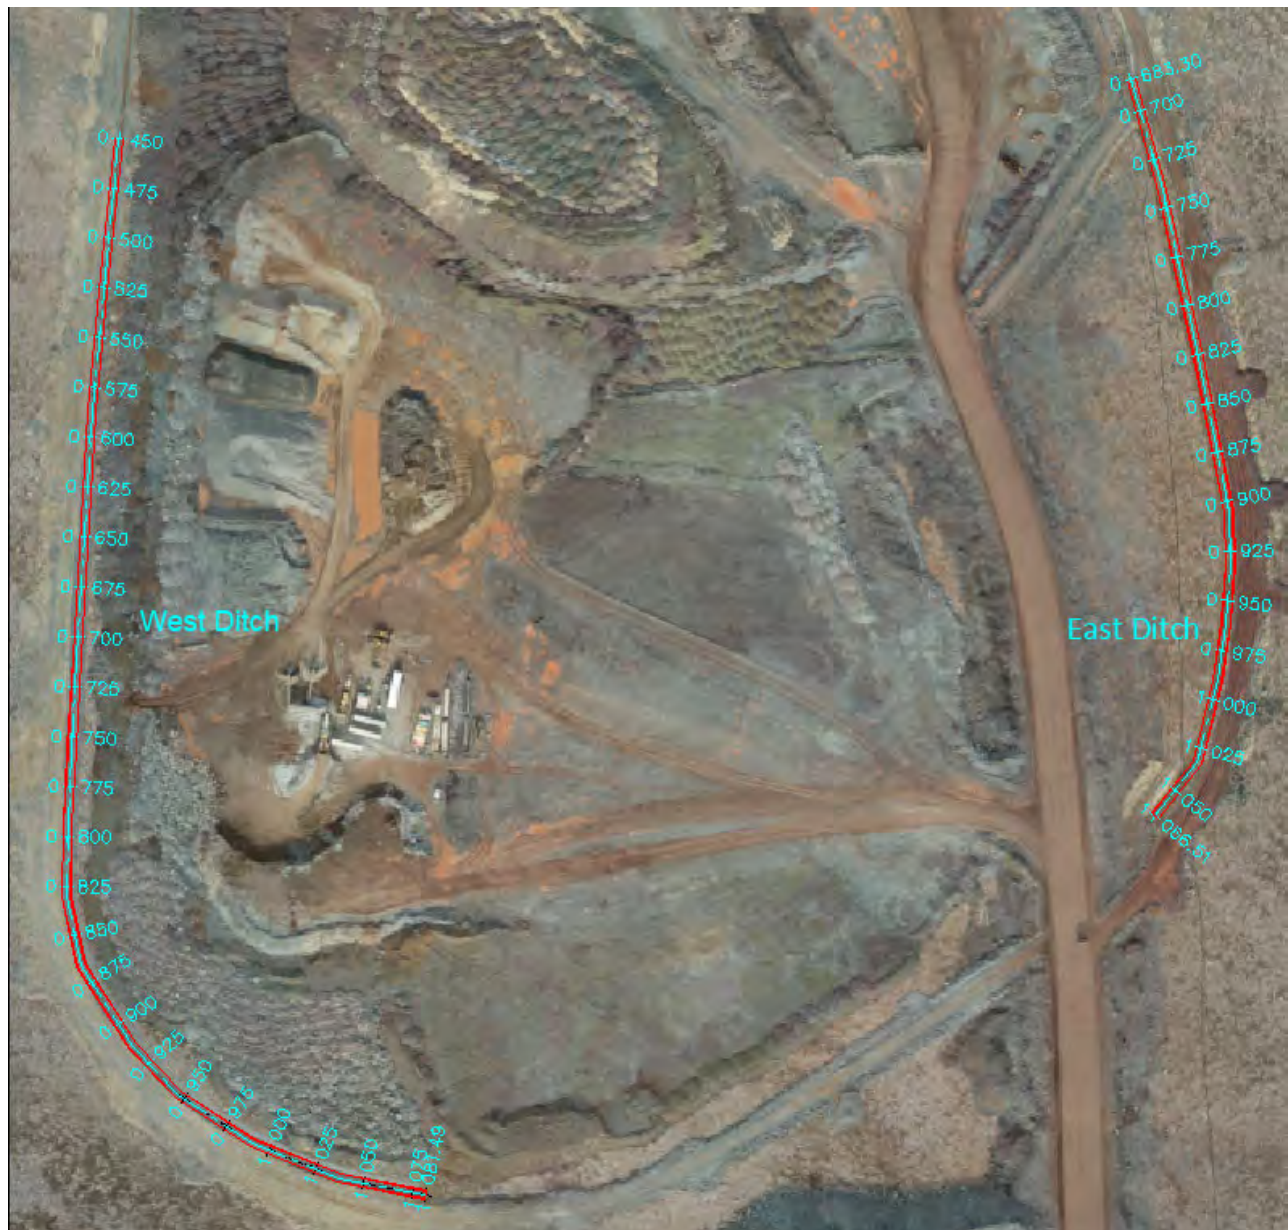
Figure-25 includes a recent drone image taken after the construction which clearly shows the real changes on the ground compared to the design drawings. The development of the WRF can be clearly seen in the image where the West and East Diversion Berms extend to intercept and direct the runoff to the two ditches.

Figure 3- Photograph after completion of West and East Ditches with As-Built Overlay (see As-Built Drawing in Appendix E).

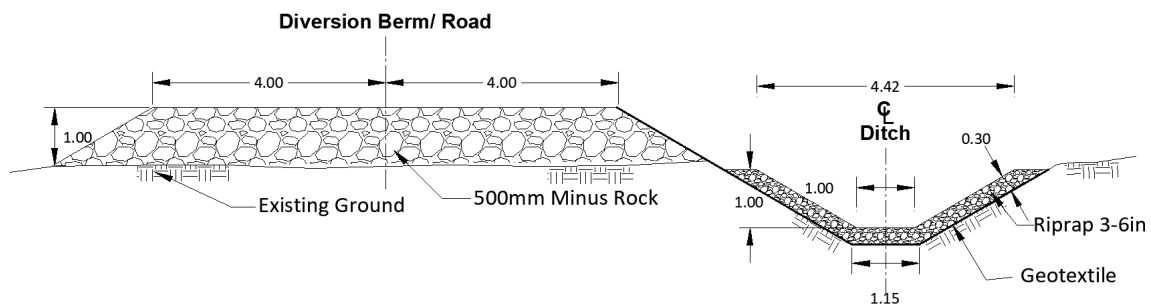
Figure 4 - Ditch and modified Diversion Berm typical cross section.

- As mentioned in the Construction Summary Report for the 2020 phase of this work, the Diversion Berm was modified from the original design. In drawing C-130 produced by Golder (Appendix A), the crest width of the berm was designed to be 1 m, with side slopes 2 m horizontal to 1 m vertical. Baffinland's Engineer increased the total width of the Diversion Berm, for both ditches, from 1 m to 8 m while maintaining the slope of the side slopes (see Figure 24). This modification was necessary to provide construction equipment with stable access during the summer construction period. After construction, the berm will provide the maintenance team with year-round access to the WRF Pond and West and East Ditches. The two diversion berms form a ring road that runs around the Waste Rock Facility with a total length greater than 2.5km.

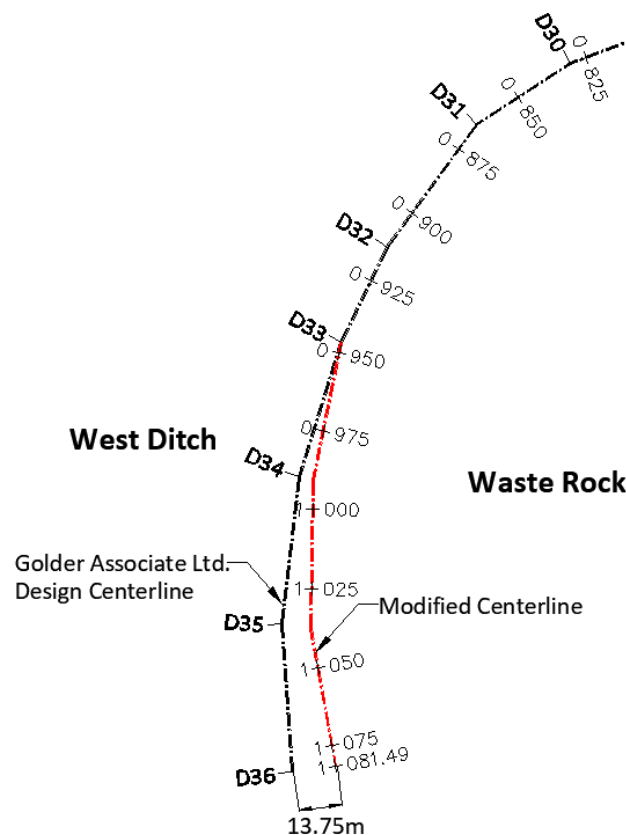
Figure 5 – West Ditch alignment modification.

- Baffinland's Engineer has modified the alignment of the West Ditch from station (0+947) to (1+081.49) as shown in Figure 25 and in Appendix D. The amount of shifting from IFC drawing number G-200 produced by Golder is 0 m (zero) at (D33) station (0+947) to around 14 m at (D36) station (1+081.49). This modification was deemed necessary based on site observations and engineering judgement. With this modification, the West Ditch is within the limit of minimum 3m buffer from the waste rock and better oriented to capture the contact water runoff flows to be directed to the WRF Sediment Pond.

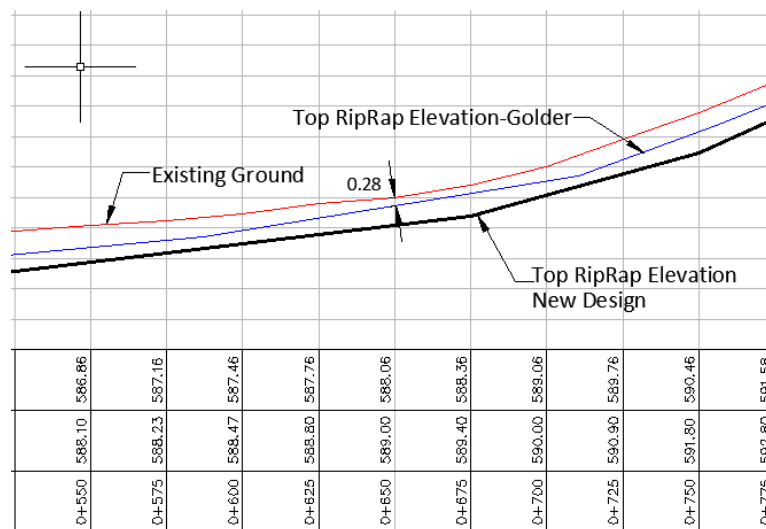
Figure 6 – West Ditch Golder grade line close to existing ground.

- 3- Golder designed the vertical alignment for the West Ditch based on available topographic survey data. Elevations with coordinates of setout points from D19 to D36 were included in drawing G-200 in Appendix A. The design elevations for the top surface of the riprap are shown in Table 6. Graphical representation of the design elevation along with recent survey data for the existing ground clearly shows that the proposed grade is higher than it should be. As designed the minimum ditch depth could not be achieved. The profile in Figure 26 was scaled 10 times greater in the vertical direction to show the difference in elevations. For example, in station (0+850) the finished grade line of the ditch bottom is only 0.28 m beneath the existing surface ground.

Baffinland's Engineer has modified the design to meet the dimensions of the typical ditch cross section prepared by Golder. The new design, provided in Appendix C1-C3, maintained the original horizontal alignment without changing the coordinates of the setout points. A new design was proposed after studying the topographic survey data collected by drone, and the available hydrological information. The new design focused on creating longitudinal slopes that can provide a flow velocity that will avoid hydrodynamic scour and sediment transport. This is considered an extra precaution in addition to the erosion and sediment control provided by the geotextile and riprap in the ditches. The new design reduced the number of longitudinal slopes and change points in both ditches. In the West Ditch alignment the number of slopes was reduced from 12 to 5, in the East Ditch it was reduced from 8 slopes to 2.

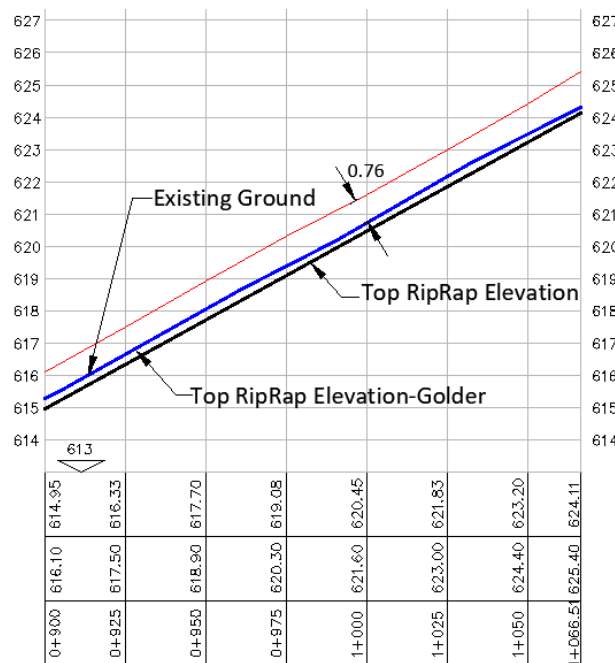
Figure 7 – East Ditch Golder grade line close to existing ground.

The problem of placing the finished grade line close to surface exists in the East Ditch as well. Table-7 includes Setout coordinates and elevations for points D1 to D18. In Figure-27 station (1+000) the finished grade line is 0.76 m beneath the existing ground surface.
