GEOTECHNICAL INSPECTION REPORT

Baffinland Iron Mines Corporation

August 23, 2021,
Project #: TC190307.2021

Annual Geotechnical Inspections – 2021 Report 1. Mary River Project – Nunavut

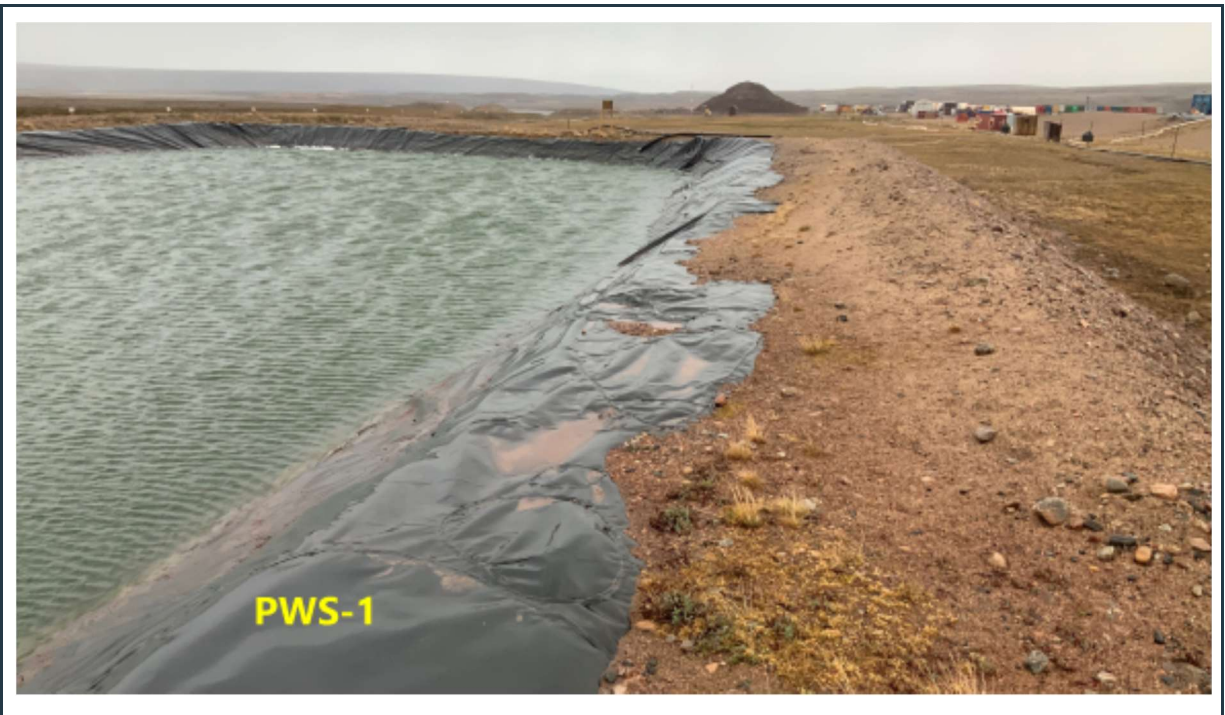
As shown in the relevant images, the berms around the three (3) ponds appear to be stable, having shallow downstream slopes. They were built by using non-frost-susceptible compacted granular materials. Based on site observations, it appears that the subgrade around the berms comprise thaw-stable, predominantly granular soils with trace to some fines. With this observation, the berms are assumed to have stable foundations, which is further supported by the fact that there are no indications of ground displacement or sloughing at and around the berms. In summary, the robust berms are structurally stable with no sign of seepage from any of the three (3) ponds.

Figure 10: PWS pond #1. Well maintained stable perimeter berm and liner.

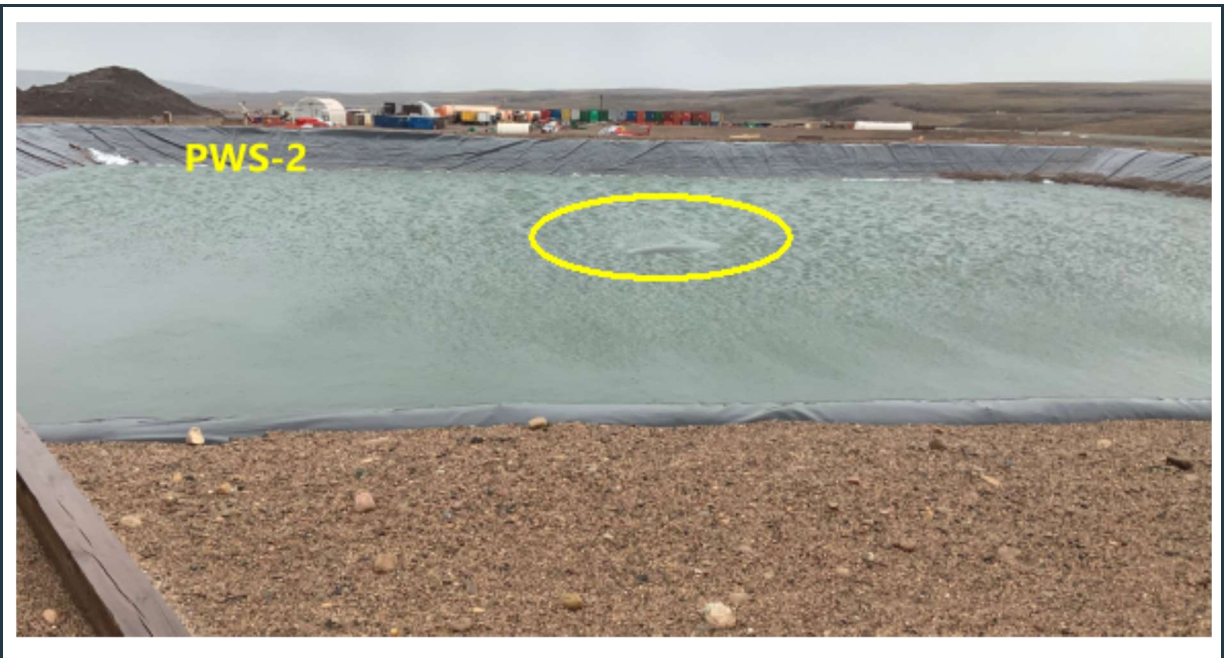
A relatively common issue (not a problem) in water storage ponds is the appearance of so-called “whales” within the ponds. Whales are sections of the liners which have risen (float) above the surface of shallow water, particularly in shallow ponds, where the weight of water above the liner is minimal. Such small “whales” were visible during the June 2021 inspection at PWS ponds #2 and #3, as shown in Figures 11 and 12. Similar “whales” were noticed and recorded during previous inspections in the past; however, no damage to the liner or seepage from the ponds was visible, including during the current survey/inspection.

Figure 11: PWS pond #2 – Stable, well-maintained berm around the pond. – A small “floating” section of the liner is visible in the center of the pond (yellow circle).

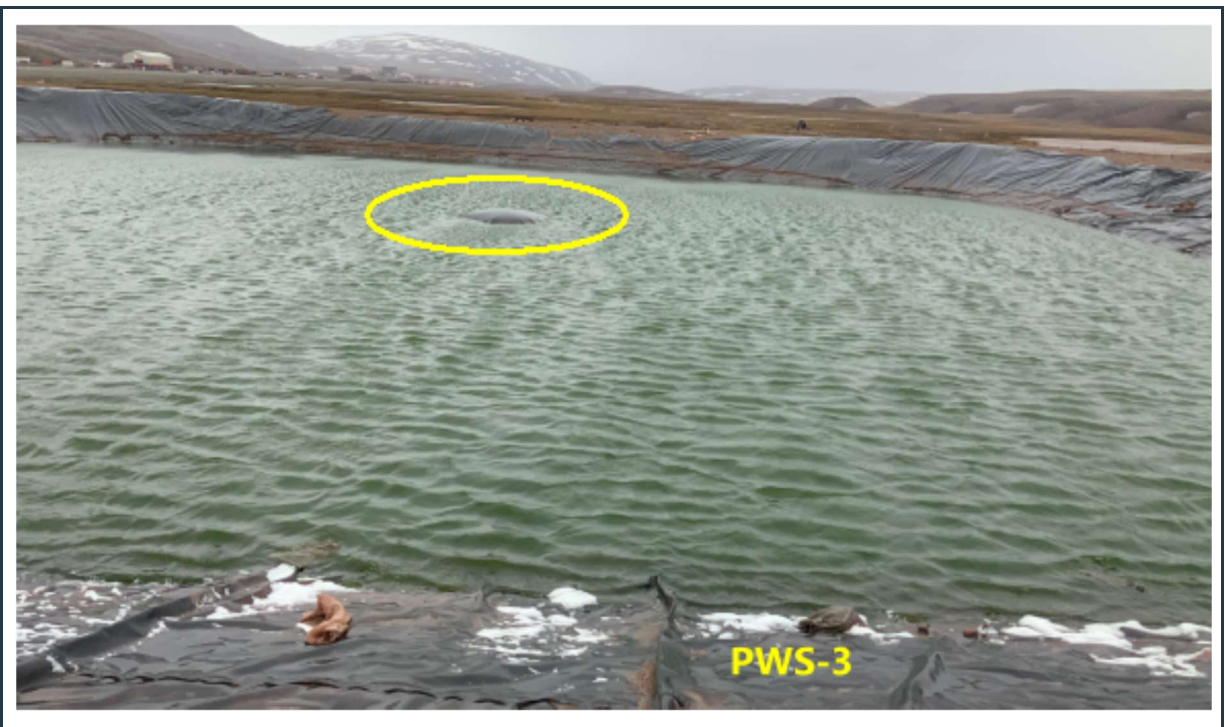
Figure 12: Stable perimeter berms around PWS pond #3 – A small “floating” section of the liner is visible in the pond (yellow circle).

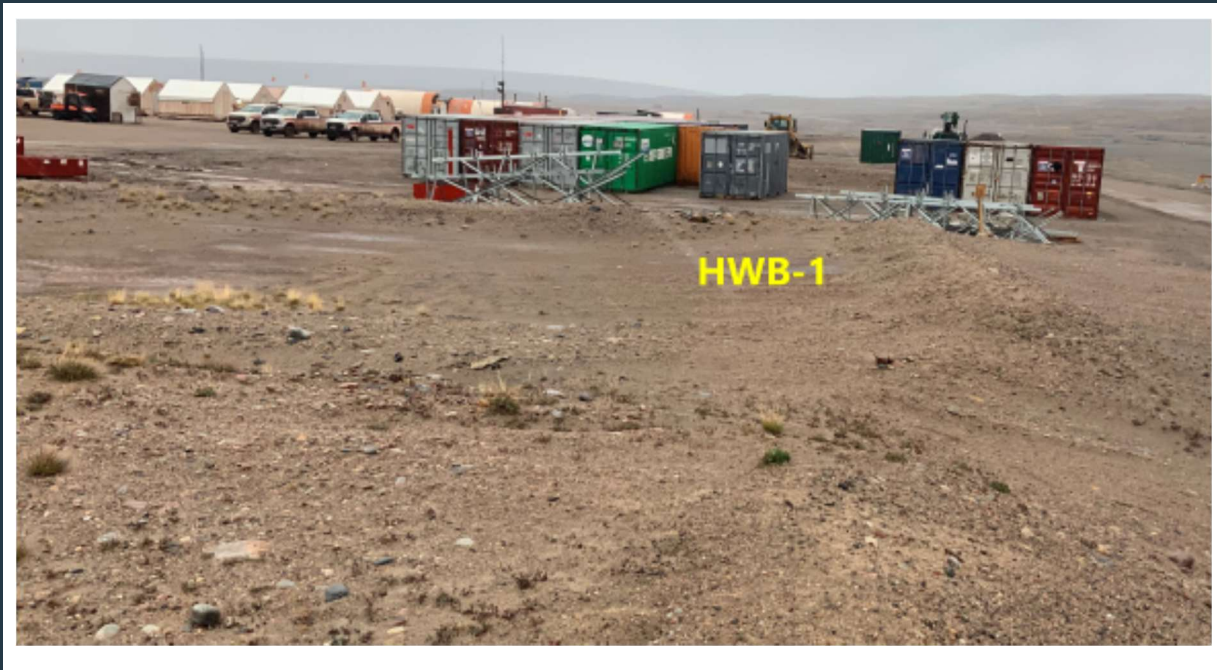
a) HWB-1

This cell is currently empty, as shown in Figure 13. Based on information obtained during the 2019 summer inspection, concerns had been raised in the past to suspected potential liner damage within this cell, and consequently no material has been stored in this cell since this concern was identified. It may be advisable to remove the old liner from this cell and replace it with a new one and take advantage of the renewed storage capacity in the future.

Figure 13: View of HWB-1 – Currently this cell is empty.

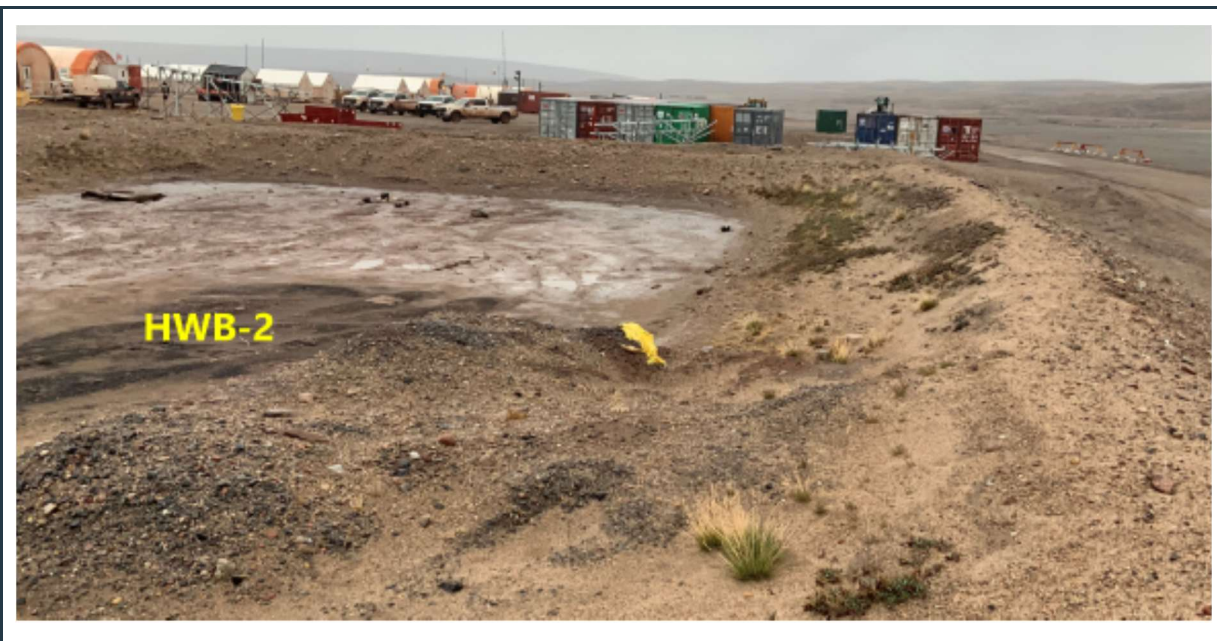
b) HWB-2

As shown in Figure 14, this cell is currently empty. It is also shown in the relevant image that the perimeter berms around the cell appear to be stable. No visible seepage from the cell was noted around the berm, and the cell operates as intended, although no material is currently stored in this cell.

Figure 14: View of stable berms around HWB-2. The cell is currently empty.

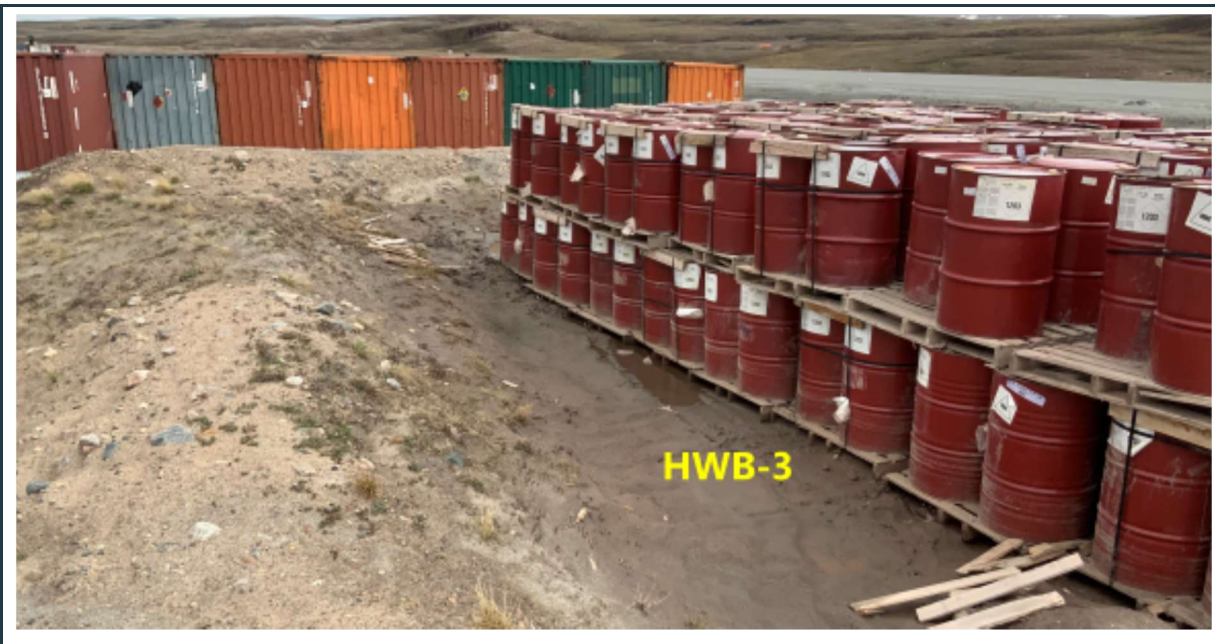
These cells were constructed as "twin-cells" and were called "Fuel Containment" cells in historic inspection reports. As shown in Figures 15 and 16, there are fuel barrels stored on wooden pallets in both cells (jet-fuel and diesel). The berms and liner around and within the cells appear to be in good condition.

Figure 15: View of stable berms and stored fuel barrels in HWB-3.

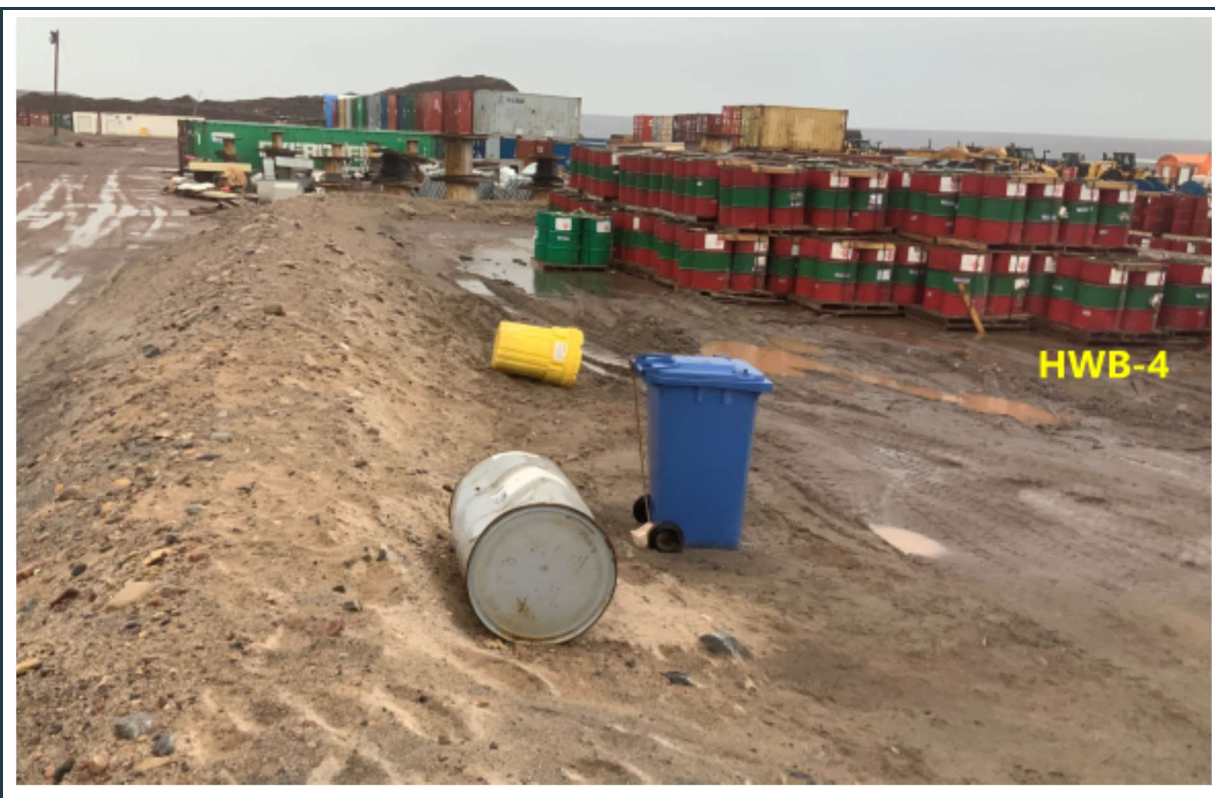
Figure 16: View of stable berms at HWB-4, with jet-fuel barrels stored on wooden pallets.

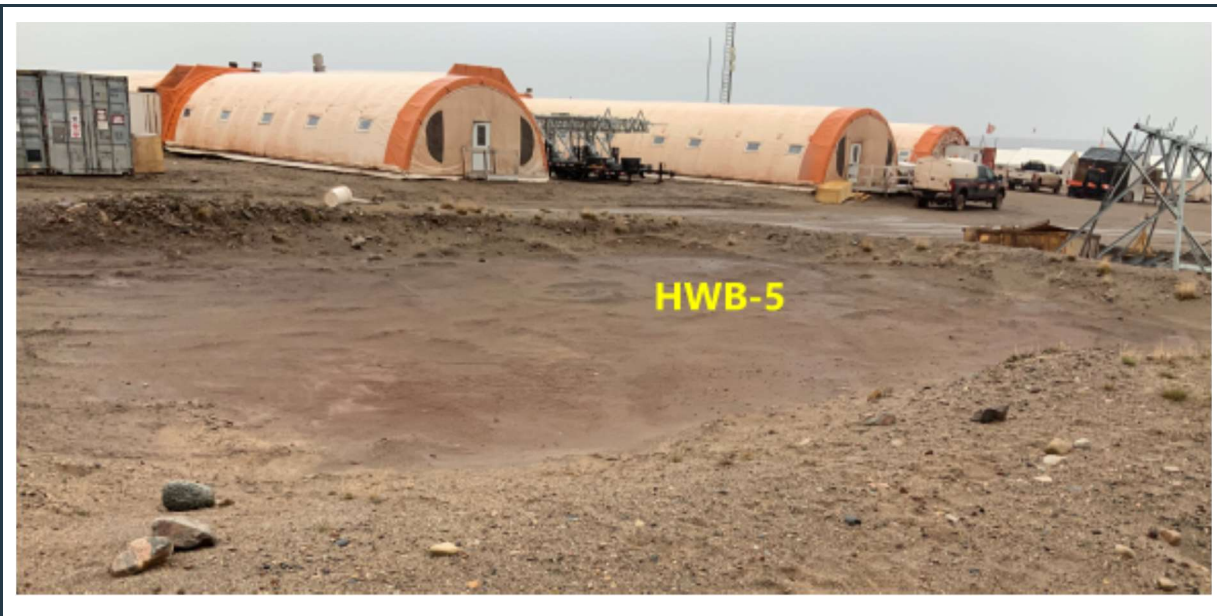
d) HWB-5

As shown in Figure 17, this cell is currently empty. It is also shown in the relevant image that the shallow berms around this cell appear to be stable and there is no visible liner damage. Should material be stored in this cell again it may become necessary to regrade the granular fill within the cell to prevent potential liner damage in the future.

Figure 17: View of the berms around the currently empty HWB-5 cell.

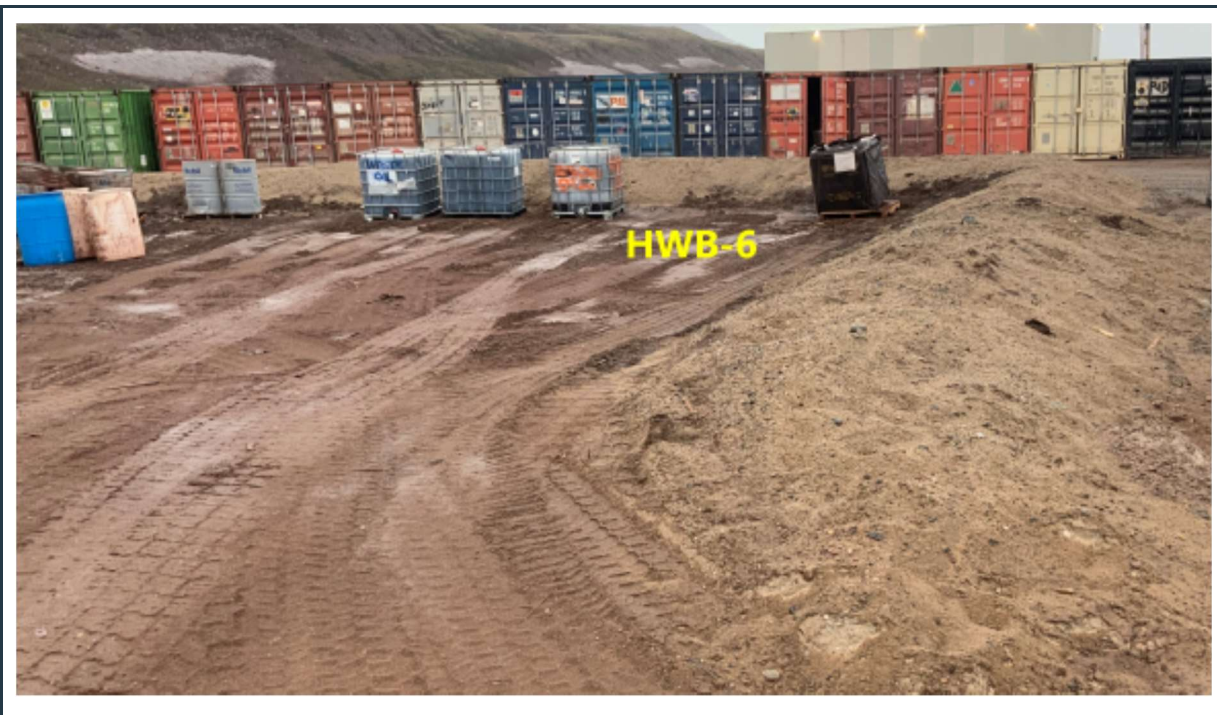
e) HWB-6

Figure 18: View of the recently upgraded stable berm and interior granular fill protecting the liner at the HWB-6 cell.

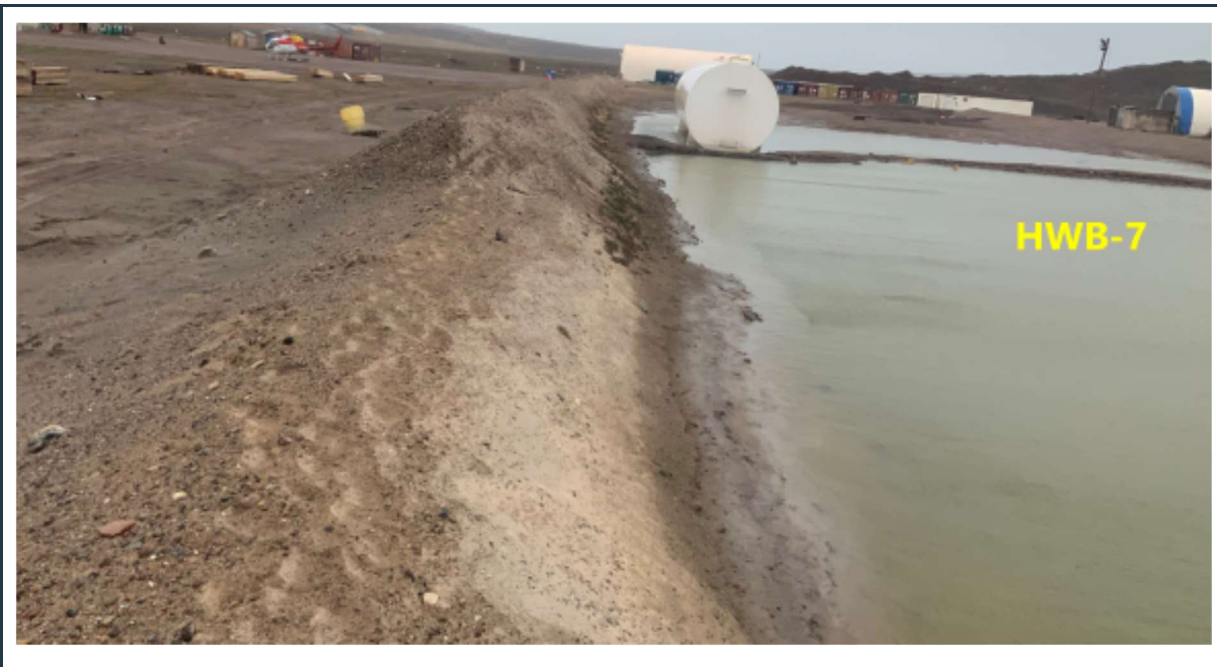
f) HWB-7

Figure 19: View of the large, flooded HWB-7 cell, with only one fuel tank stored.

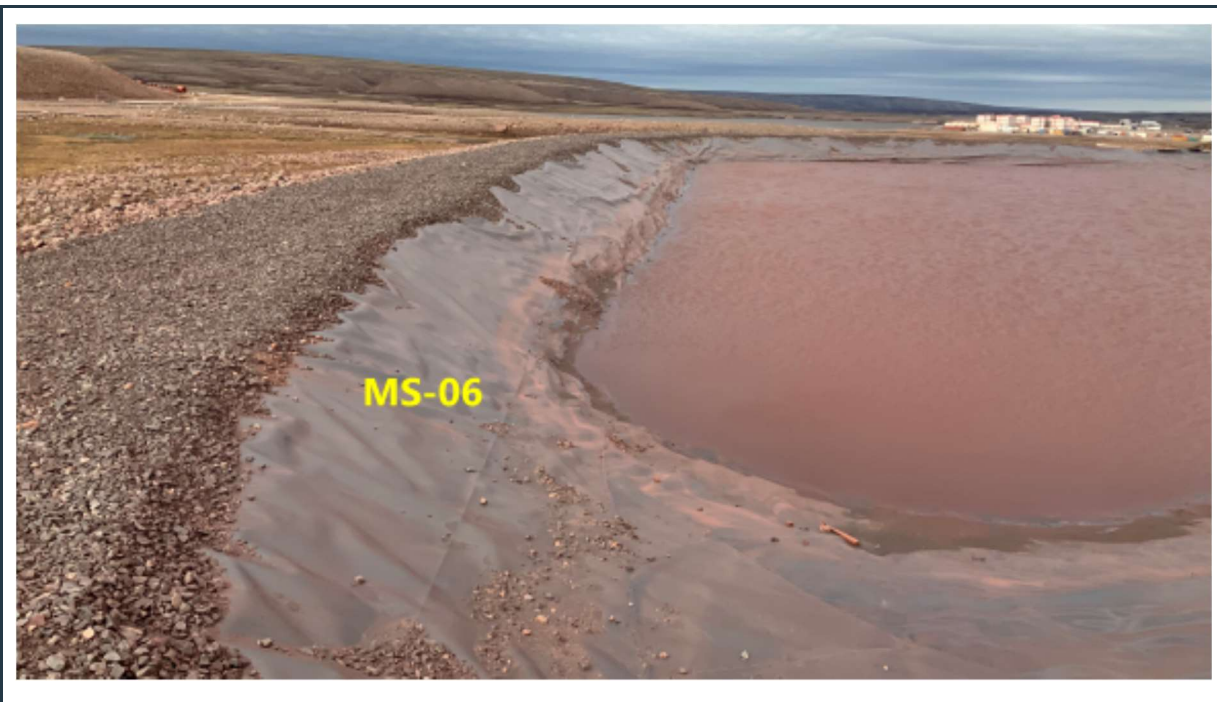
Figure 20: MS-06 surface-water collection and settling pond with robust, stable berms and intact liner.

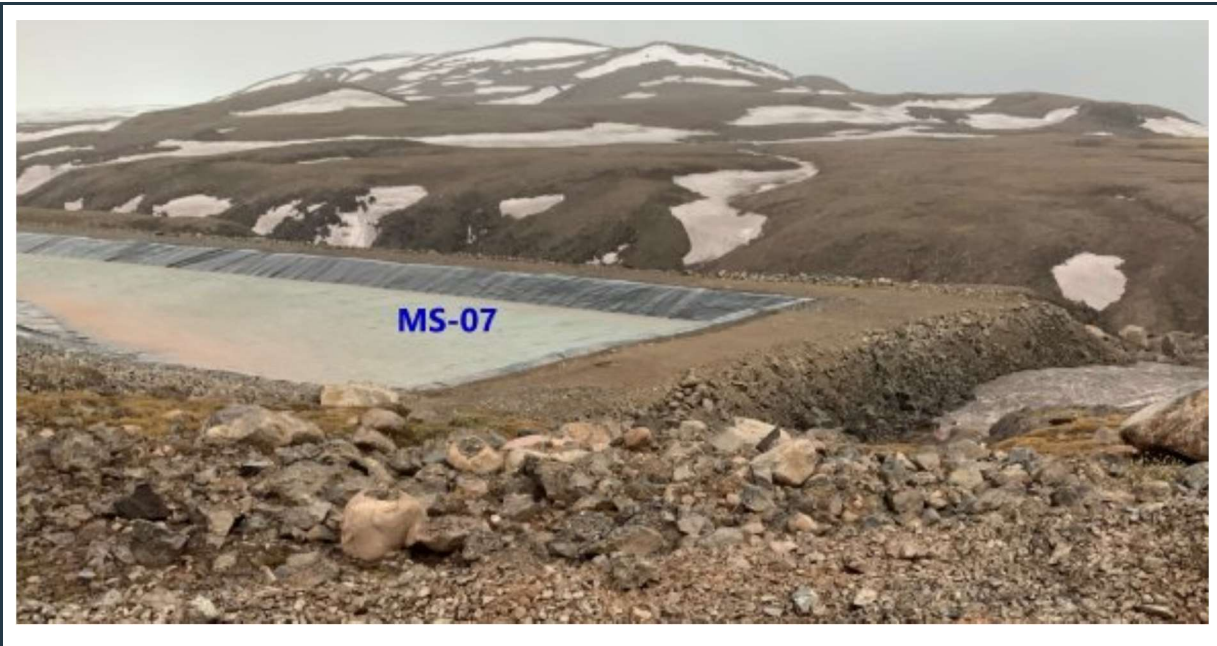
The MS-07 settling pond has been completed recently adjacent to the KM-106 ore stockpile area. The pond has robust perimeter berms and geomembrane liner, as shown in Figure 23. No stability or seepage related problems were observed at this pond during the recent site visit.

Figure 23: View of the recently completed MS-07 surface-water collection pond with robust, stable berms and intact liner.

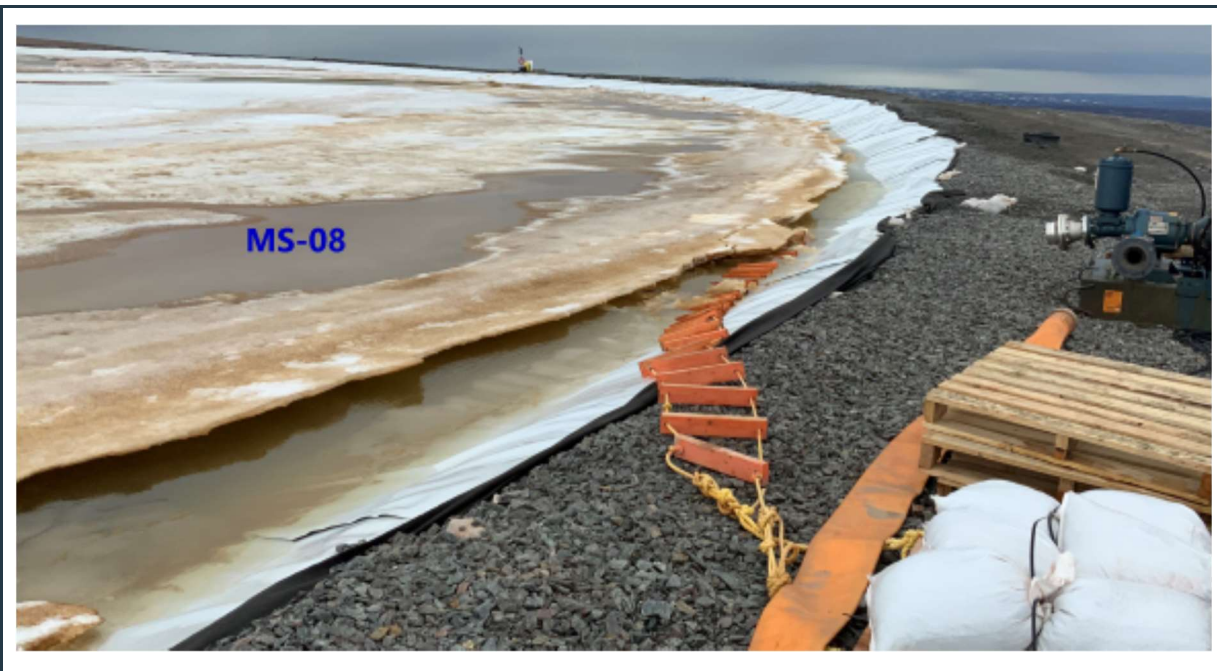
Figure 24: View of stable berm and intact liner at the MS-08 pond. Ice is still present at the end of June.

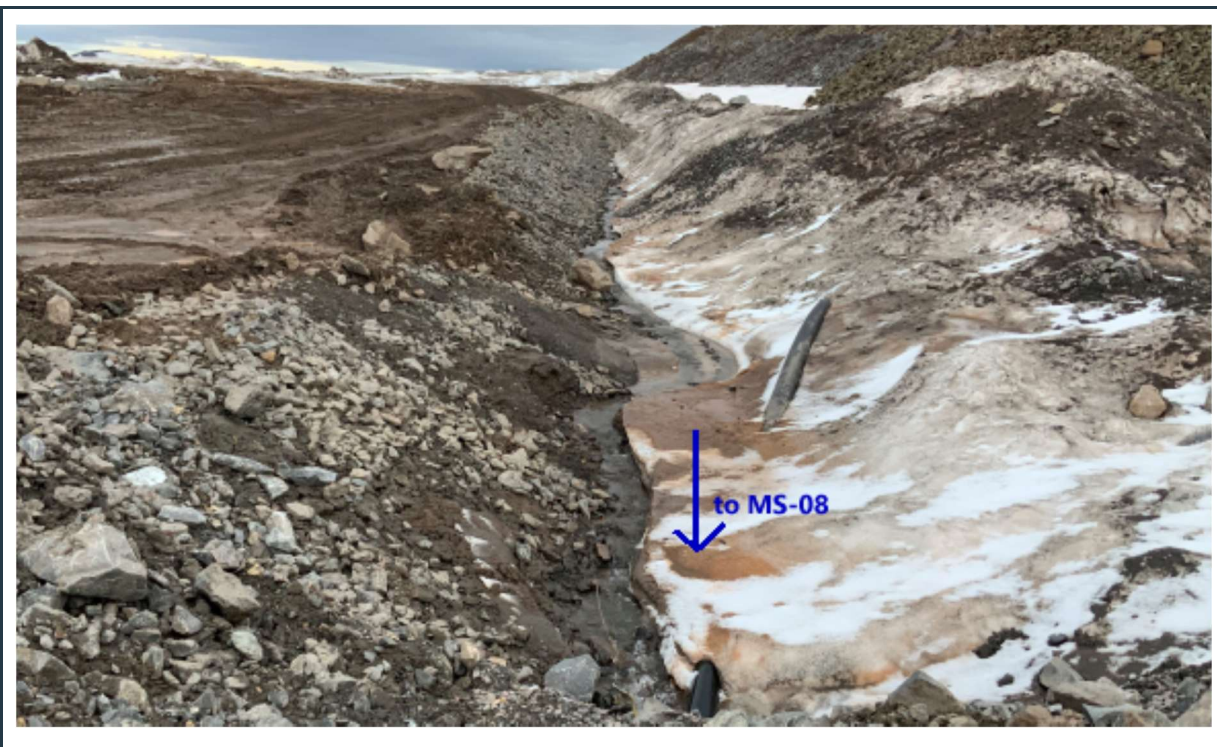
Figure 26: Snow-filled drainage ditch around the east side of the waste rock facility, leading to the MS-08 pond.

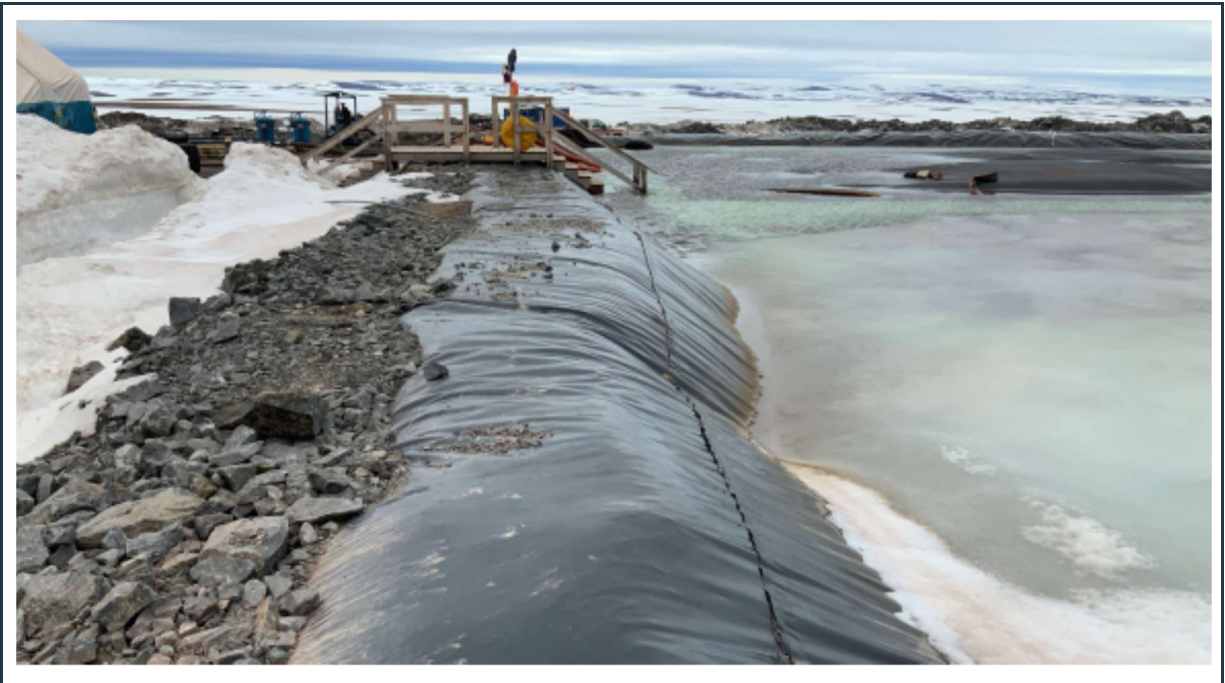
Water from the MS-08 pond is pumped to the nearby designated facility for treatment, if required. There is a lined treatment cell in good condition located immediately next to the WRF water treatment plant with stable perimeter berms, shown in Figure 27.

Figure 27: Stable rock fill berm at the water treatment pond, adjacent to the waste rock facility.

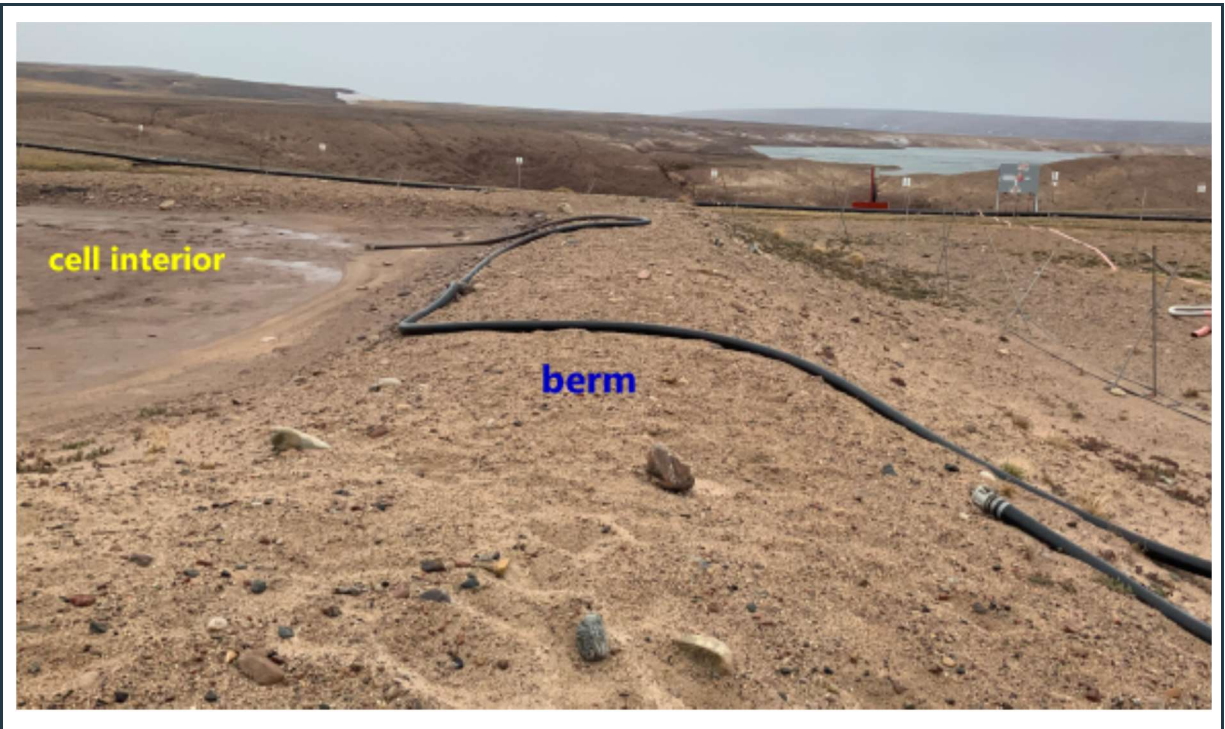
This pond has previously contained fuel bladders for the generators; however, the cell is currently empty. The pond is located immediately adjacent to the power generators, south-west of the hazardous waste cells (Figure 2). As shown in Figures 28 and 29, the perimeter berm around the pond generally comprises granular materials and the pond is lined.

Figure 28: View of the stable berm around the "generator fuel bladder" cell. The cell is currently empty.

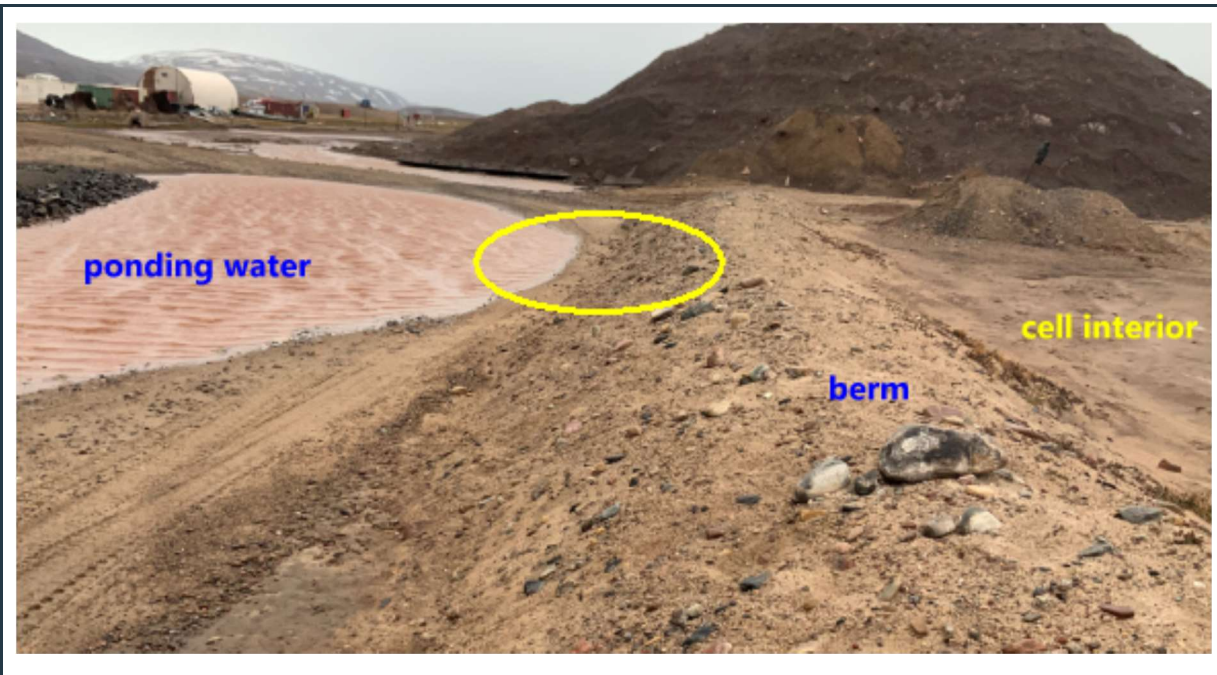
A large area of the adjacent road was flooded by melting snow at the time of the June inspection, as shown in Figure 29. Trucks bypassing the ponding water continuously encroach into the toe of the berm and this encroachment requires re-establishment to the original berm configuration using compacted granular fill, to prevent potential for local berm instability (i.e., regressive erosion / sloughing). To prevent further deterioration of the pond's berm, the drainage of the melting snow in the area must be rectified. The surface water should be redirected away from the berms by excavating properly designed and constructed drainage ditches in the area.

Figure 29: View of ponding water adjacent to the north-east berm of the “fuel bladder” cell. Trucks bypassing the ponding water on the road are “cutting” into the toe of the berm (yellow circle).

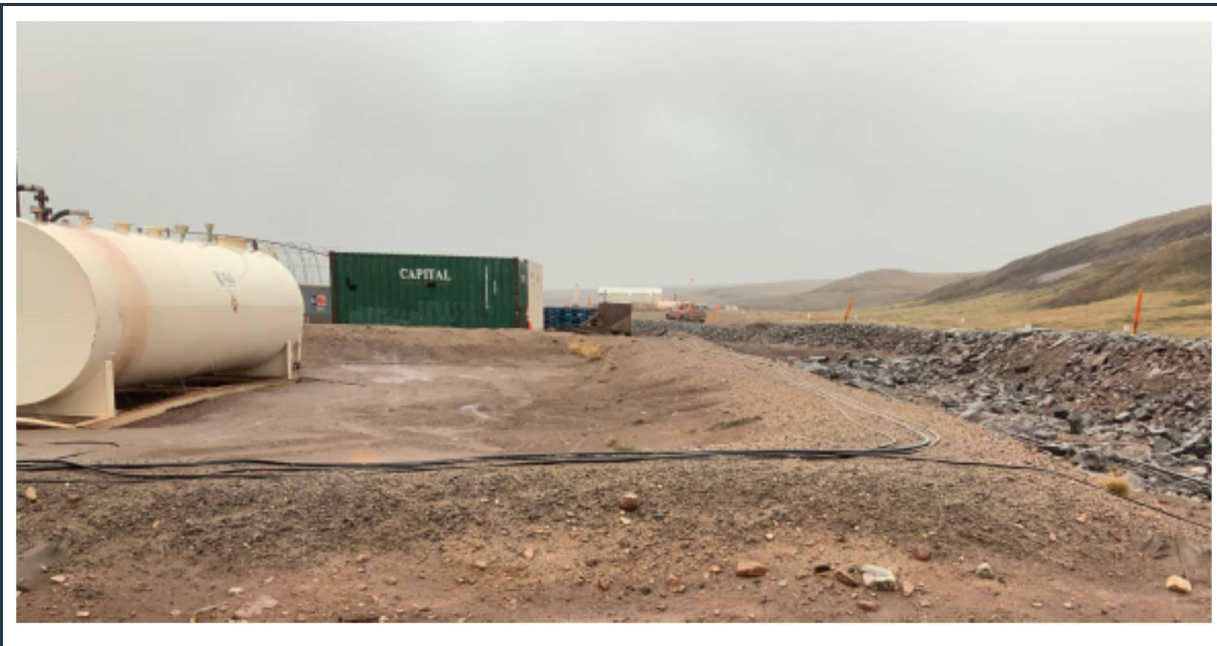
The jet-fuel tank farm is located at the aerodrome, and it is surrounded by a stable perimeter berm, as shown in Figure 30. In addition, a second berm, constructed from crushed rock fill, provides additional protection at two (2) sides (Tote Road and airport parking sides) of the facility. The facility is lined to the crest of the perimeter berms, and the liner within the cell appears to be in good condition.

Figure 30: View of the well-maintained sand and gravel berm at the lined jet-fuel storage facility, with the additional rock fill protective berm, constructed between the cell and the tote road.

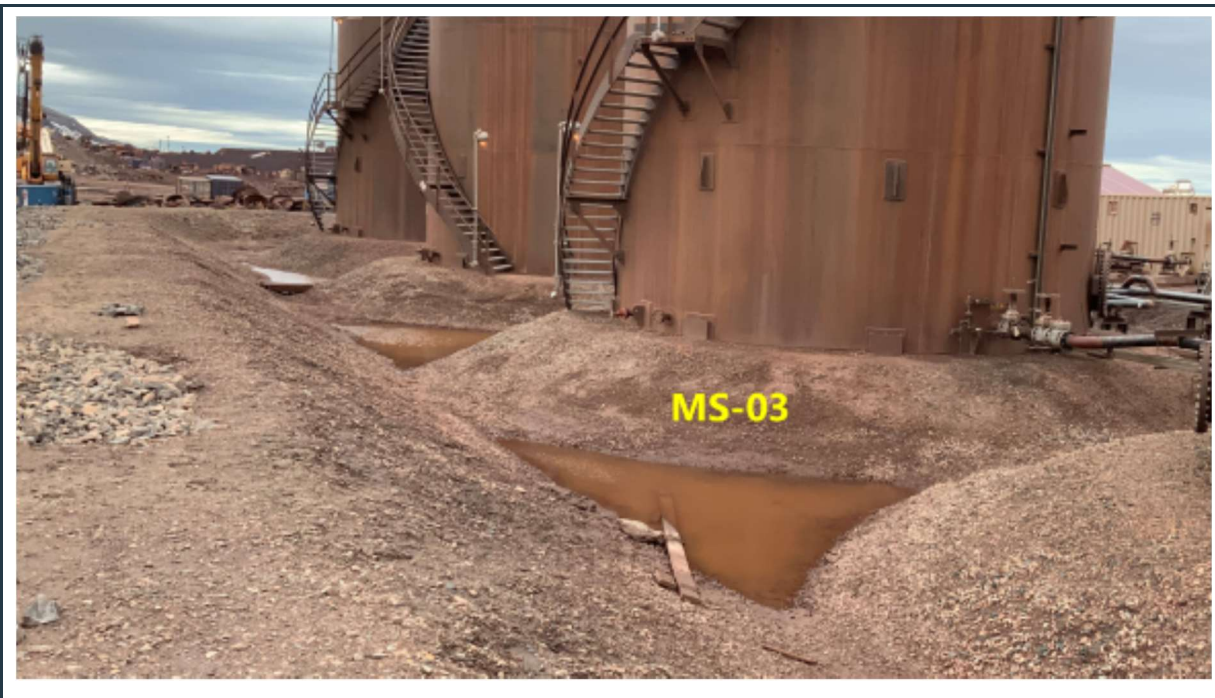
The stable berms around the "old" diesel fuel tank farm are in excellent condition (see Figure 31) and they are well maintained. The collected rainwater (and melted snow) within the cell appears to be clean and its presence indicates that the liner system is fully functional (i.e., no seepage from the cell is visible

Figure 31: Well-maintained, stable berms around the MS-03 diesel fuel farm, with some ponding water.

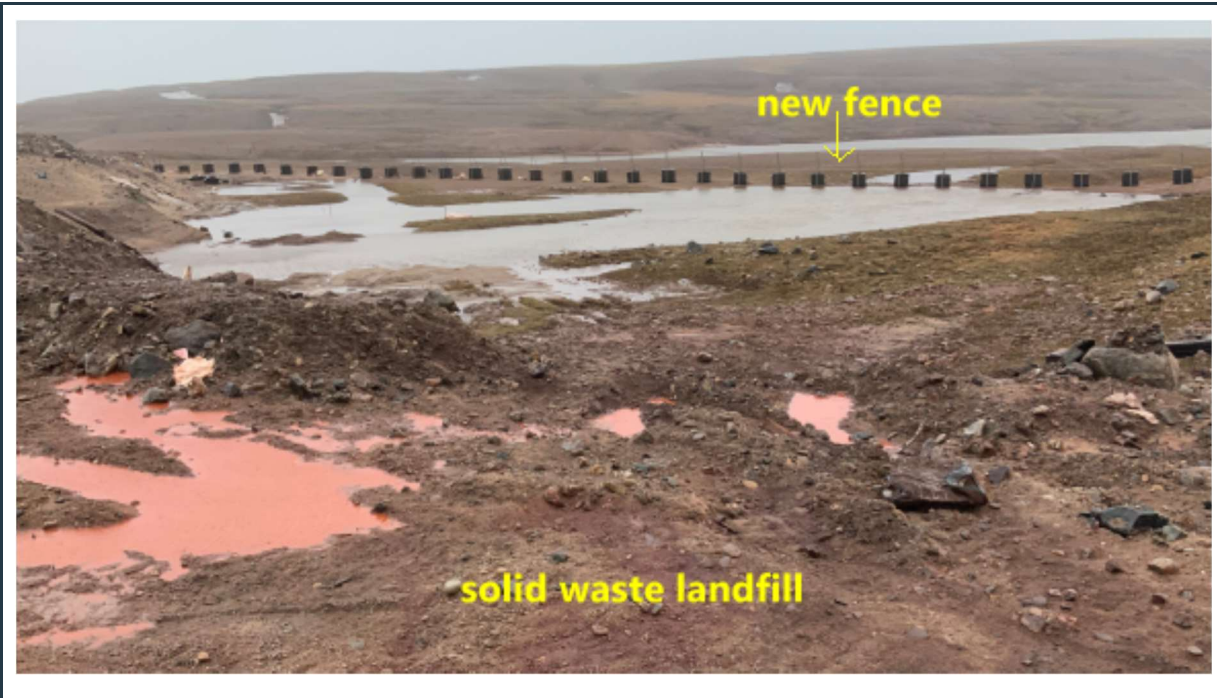
Figure 33: Solid waste landfill facility with ponding water along a section of the new perimeter fence.

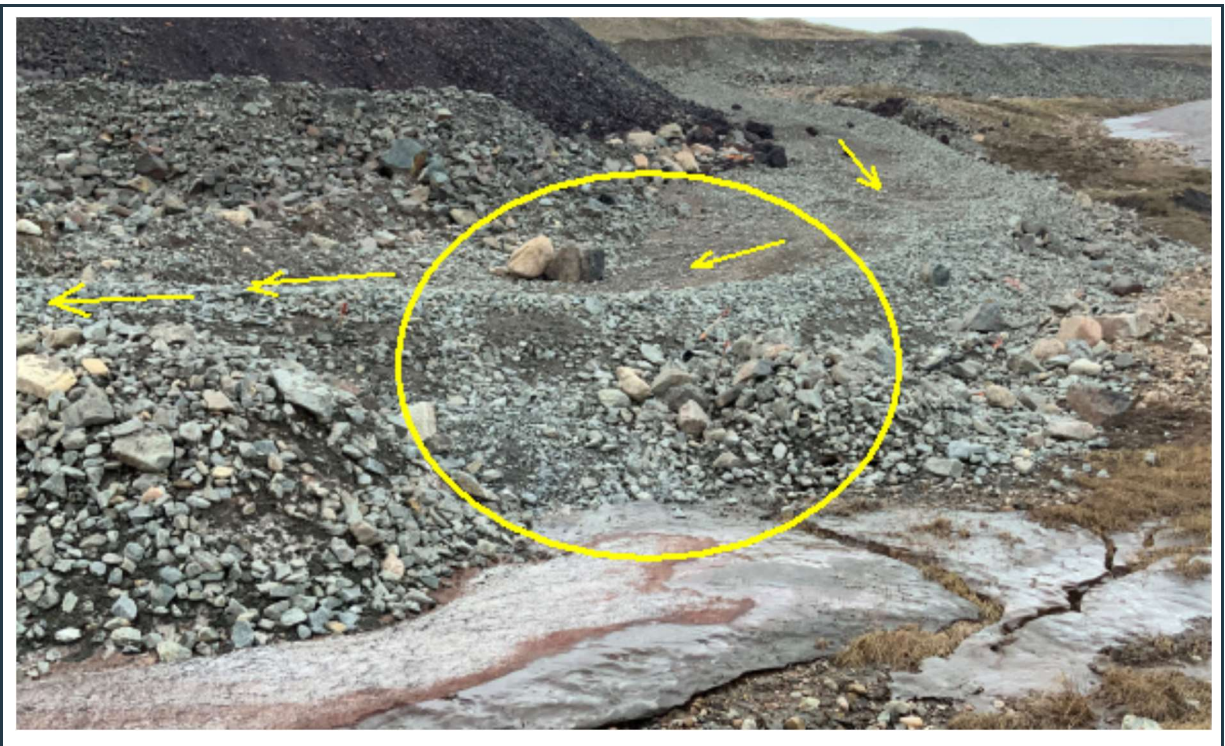
As shown in the image, the "diversion" berms are constructed from granular fill that may not function well in diverting all surface runoff to the adjacent MS-07 pond. The presence of ice along the downstream toe of one (1) of the berms shows that some of the surface run-off seeps through the permeable berm and the water spreads around the toe of the downstream slope instead of flowing into the MS-07 pond, as it was intended in the design. Consideration shall be given to add a fine-grained core into the granular berms at the critical locations where seepage through the berms is noted (like the area marked by the yellow circle in Figure 40).

Figure 40: View of the surface water diversion berm at the new KM-106 ore stockpile area.
