Baffinland Iron Mines Corporation

August 23, 2021
Project #: TC190307.2021

Annual Geotechnical Inspections – 2021 Report 1.

APPENDIX "B" – Milne Port Site - Photographs

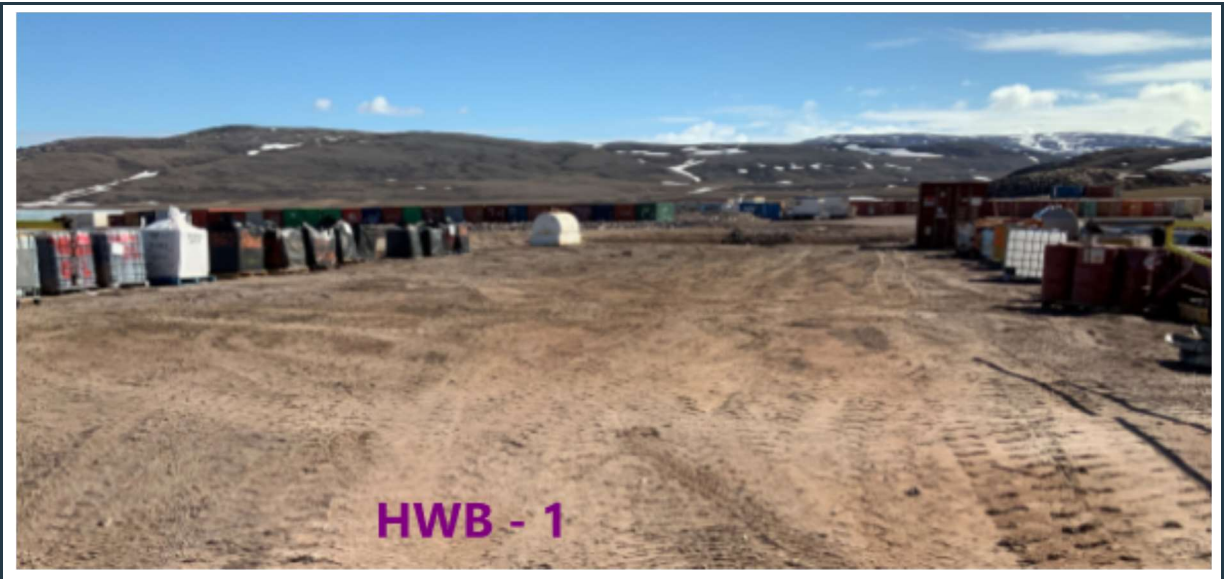
Figure 41: View of the practically empty HWB-1 cell with upgraded (regraded) cell floor.

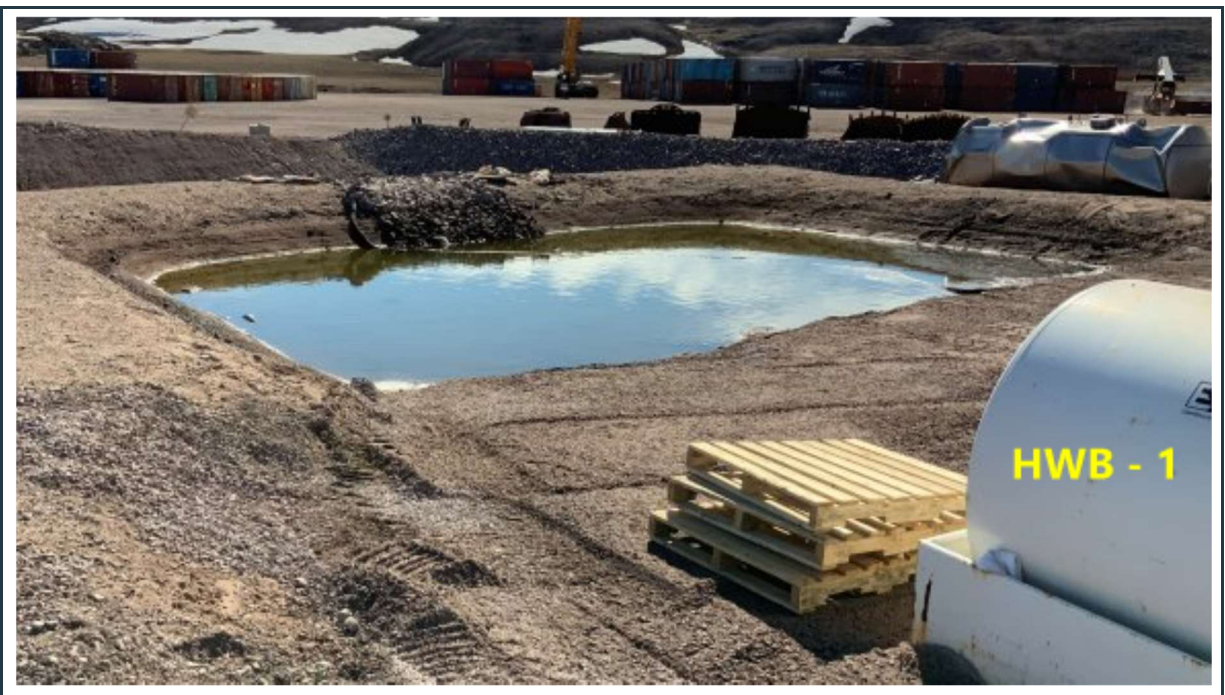
Figure 42: View of the back of the HWB-1 cell, with ponding water and upgraded (regraded) cell floor.

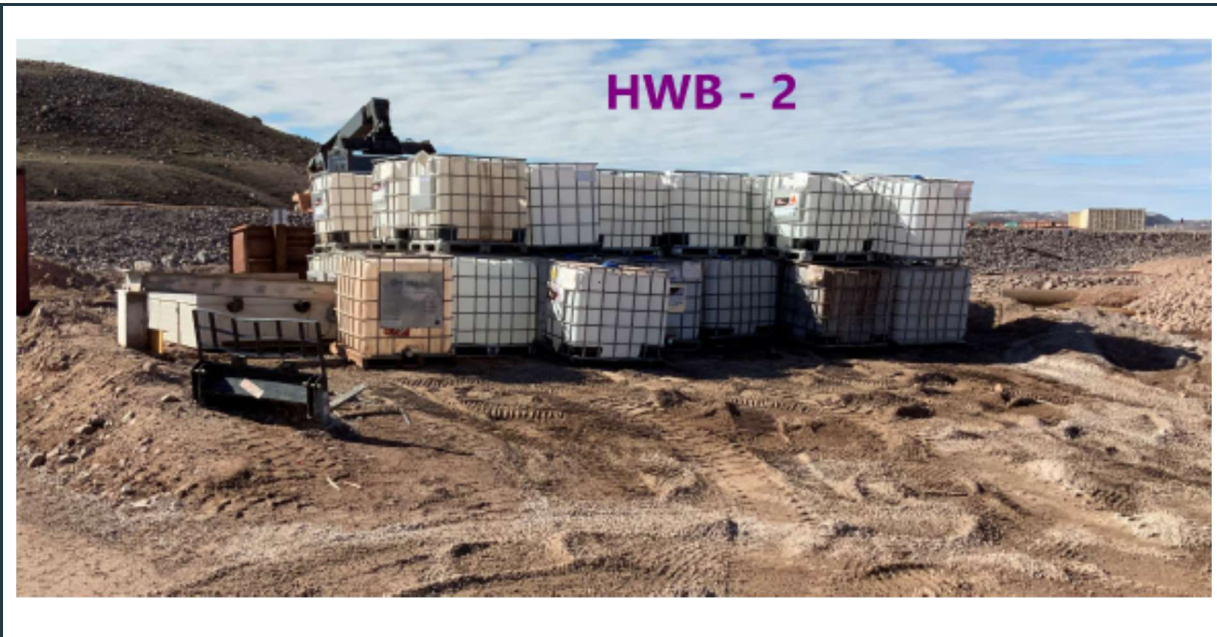
Figure 43: View of the former HWB-2 cell, with only empty containers stored on the top of clean sand and gravel fill pad. No hazardous waste is stored in this cell.

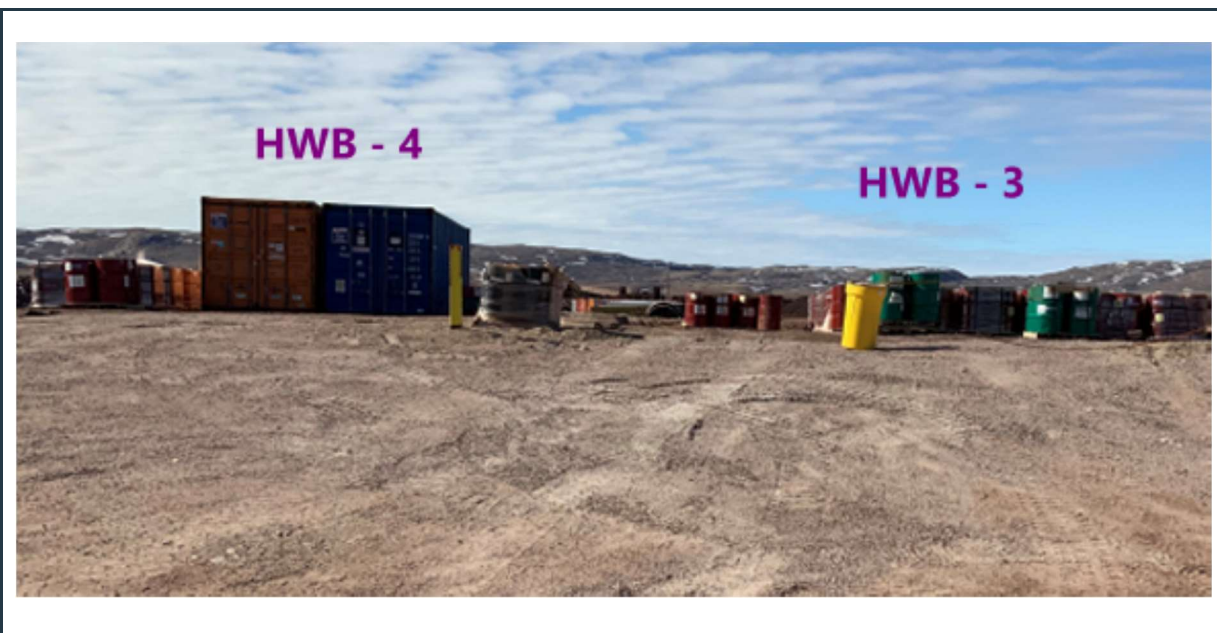
Figure 44: View of the HWB-3 and HWB-4 cells, containing fuel barrels and two shipping containers.

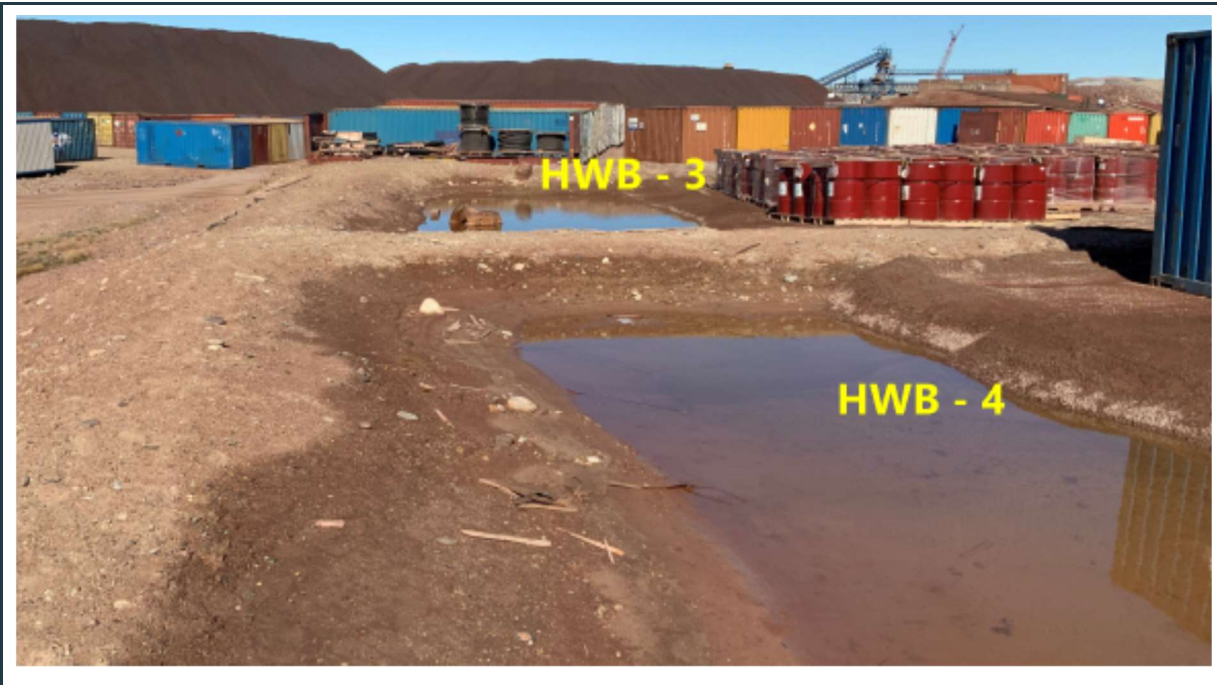
Figure 45: Stable berms around and ponding water within the HWB-3 and HWB-4 cells.

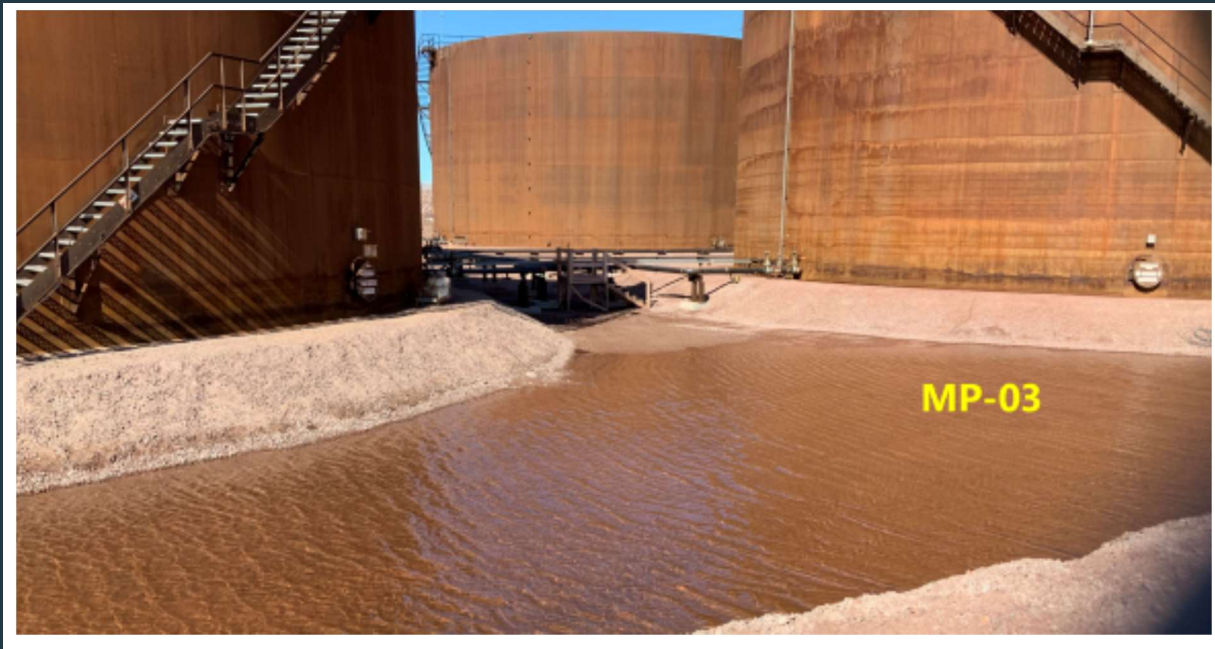
Figure 47: View of the well maintained MP-03 fuel tank farm (ponding melted snow at deep areas).

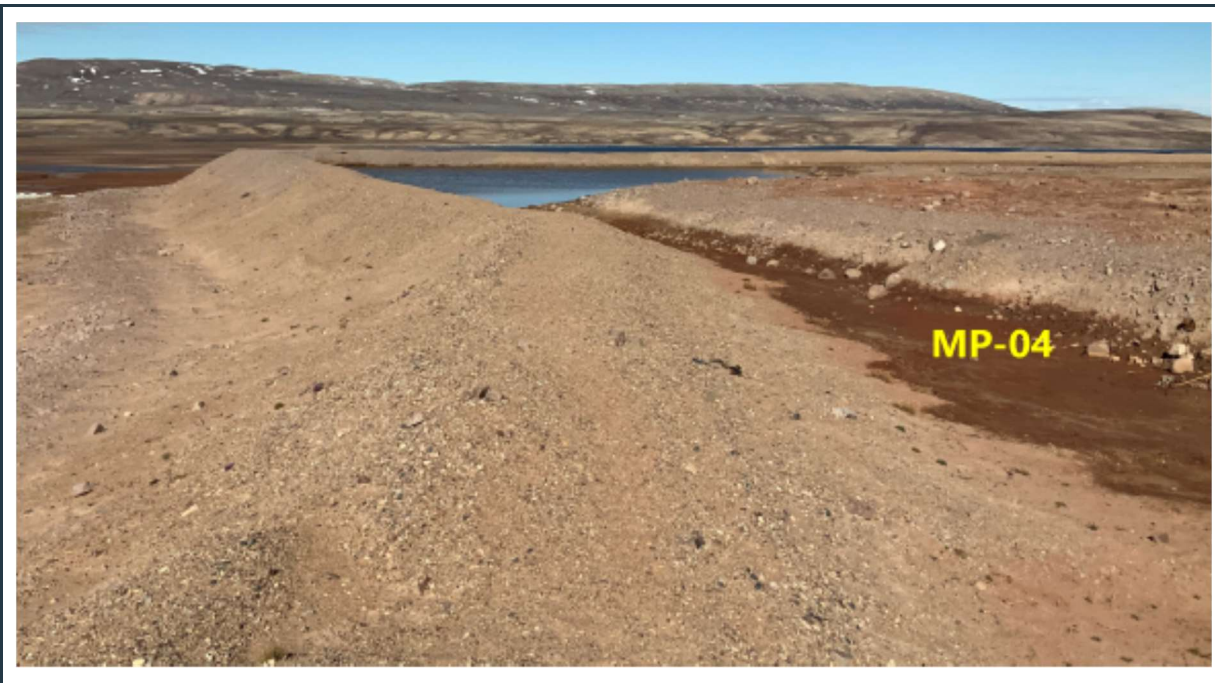
Figure 48: View of stable berm around the MP-04 landfarm. Note the ponding water and the stored waste, covered with soil fill within the cell.

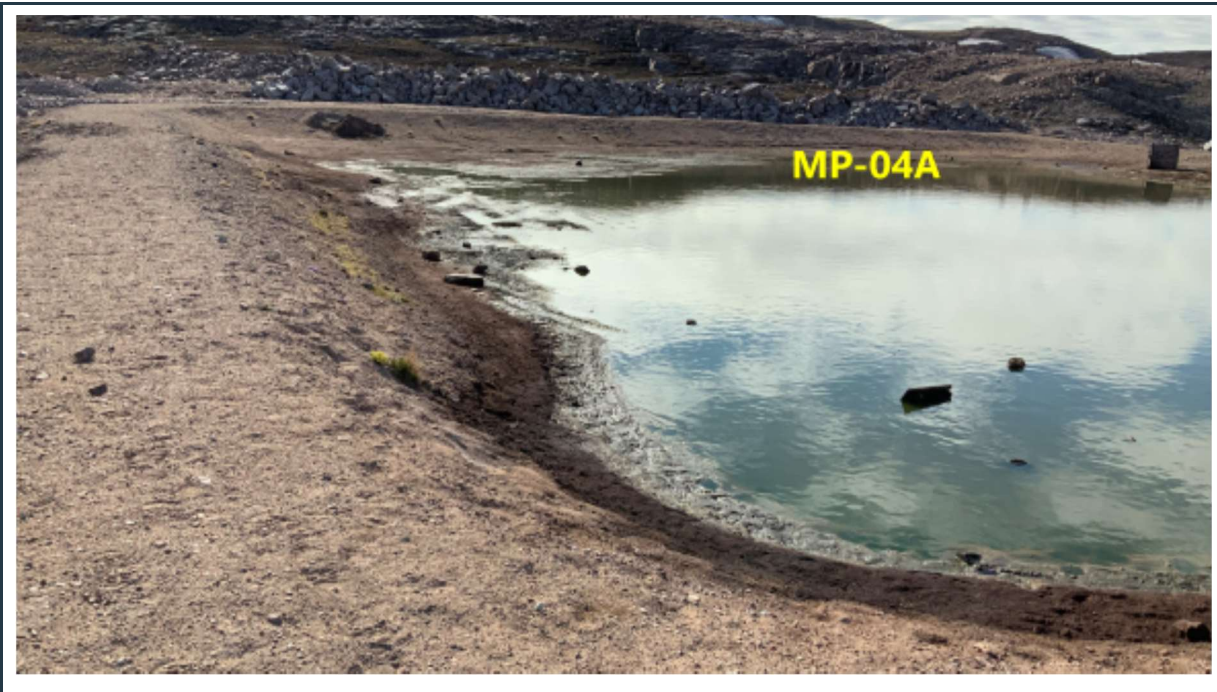
Figure 49: View of the MP-04A cell with stable berms and ponding melted snow.

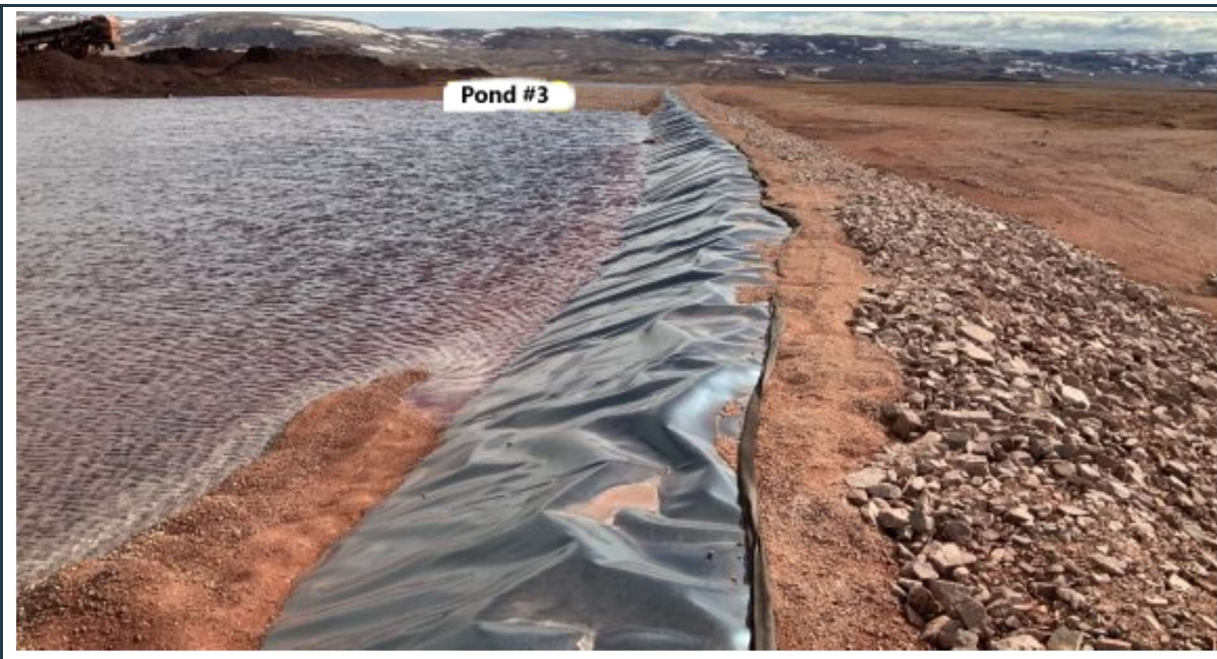
Figure 50: View of the lined, stable berm along the west side of settling pond #3.

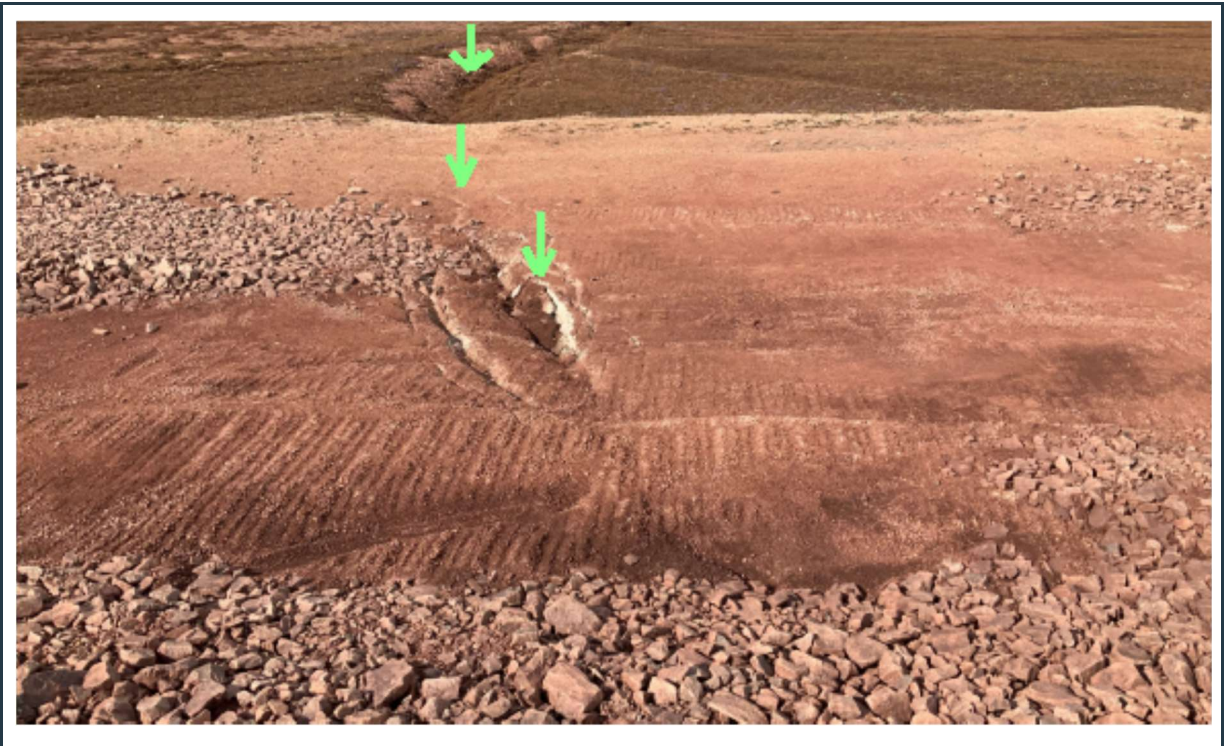
Figure 51: Cracking on the surface along a few historic depressions adjacent to the berm of pond #3.

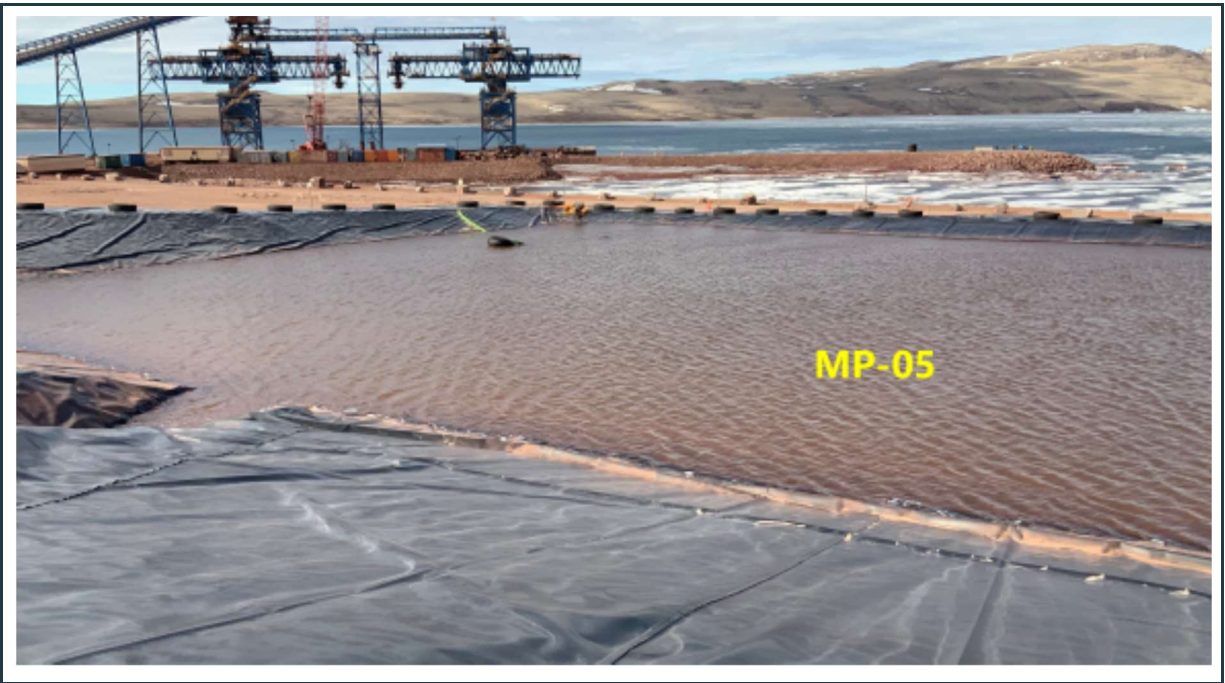
Figure 52: View of the stable berms and intact liner at the MP-05 settling pond (east of shiploader).

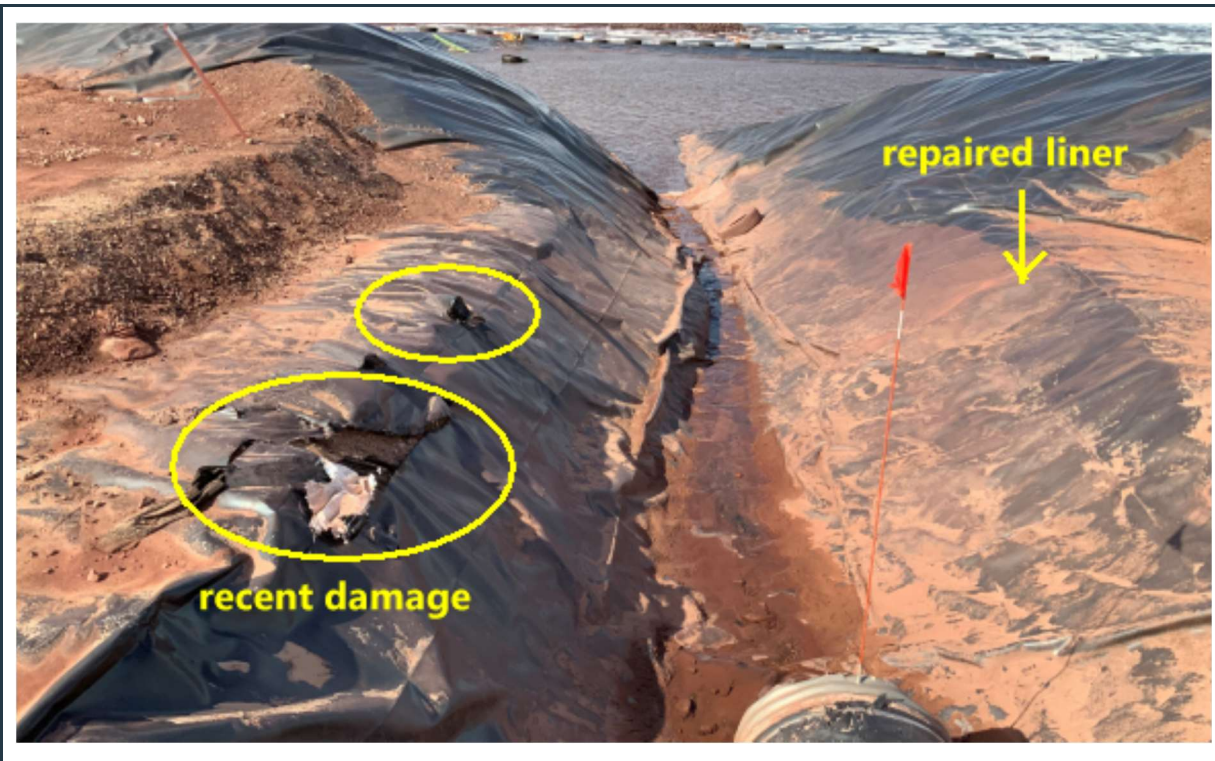
Figure 53: Some recent liner damage on the west slope of the southern intake channel.

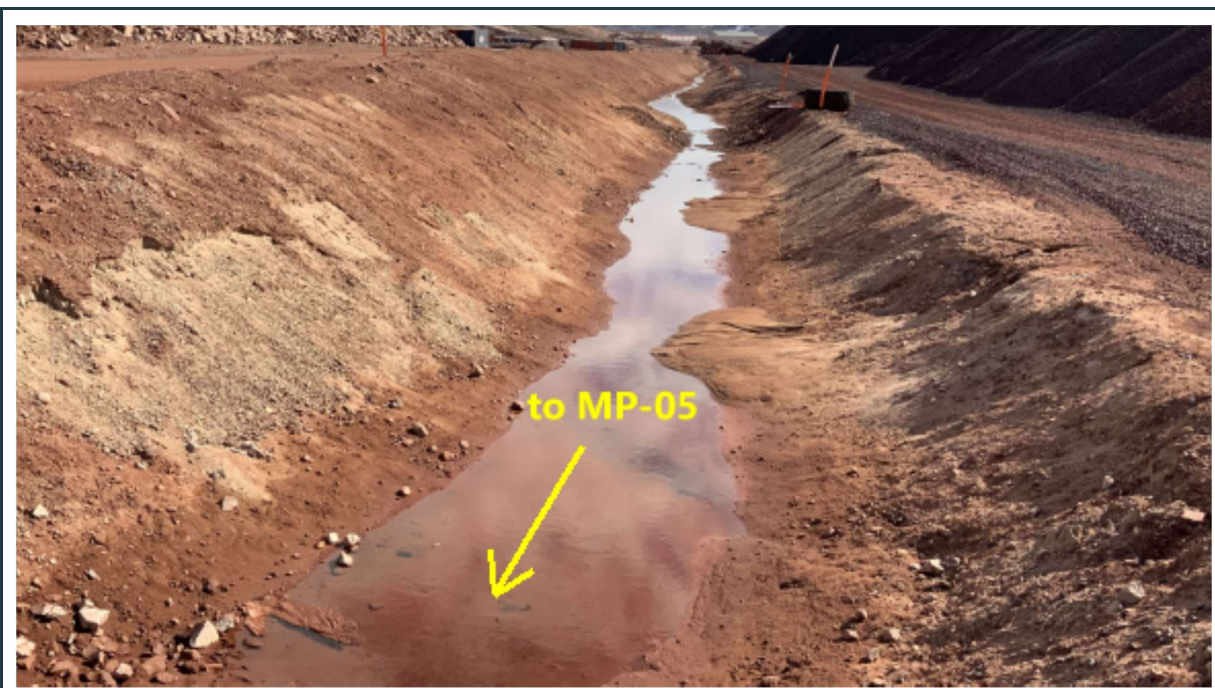
Figure 54: Surface water collection ditch adjacent (east) to the ore storage, draining to the MP-05 pond.

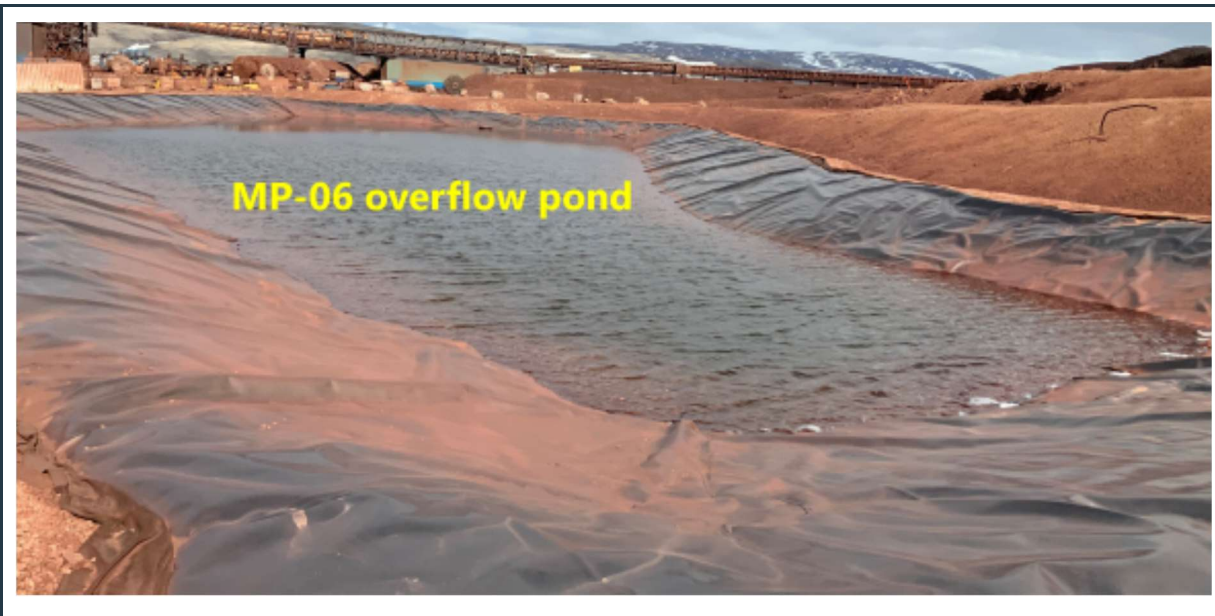
Figure 57: View of the lined MP-06 overflow pond, with stable berms.

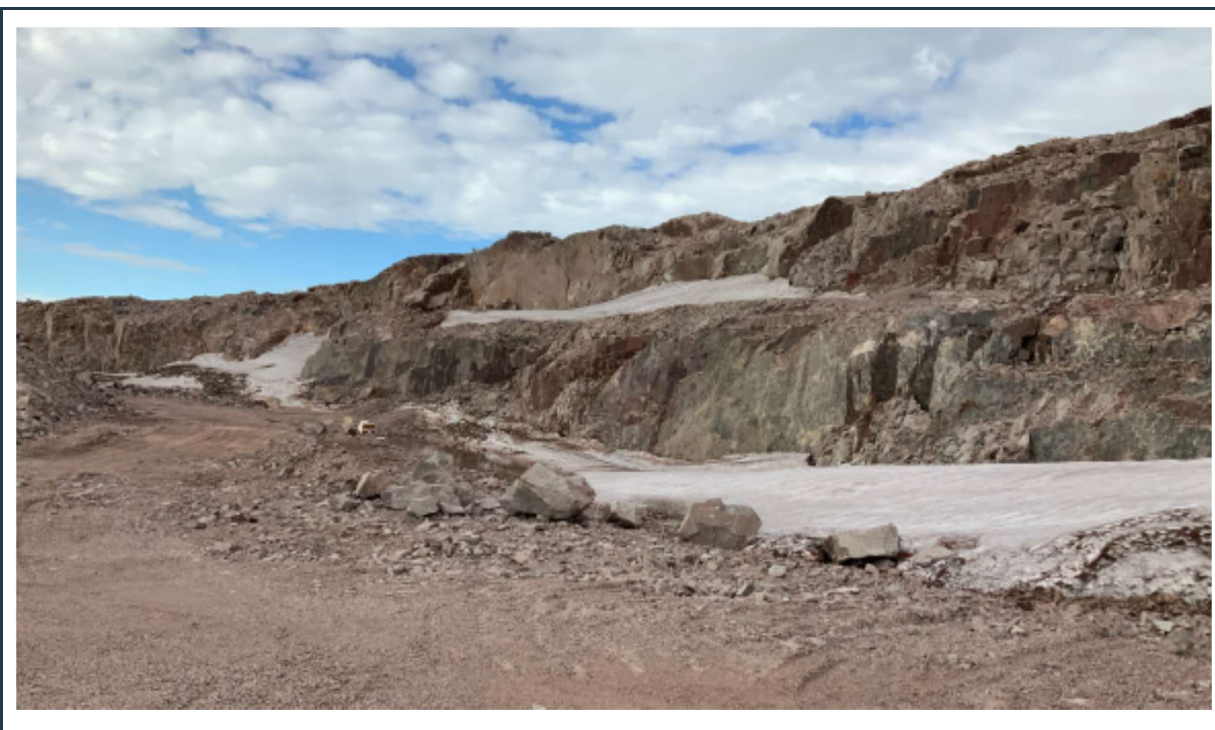
Figure 58: View of stable highwalls with minor weathering and bench erosion in the Q01 rock quarry.
Note the accumulated snow on the top of the benches.

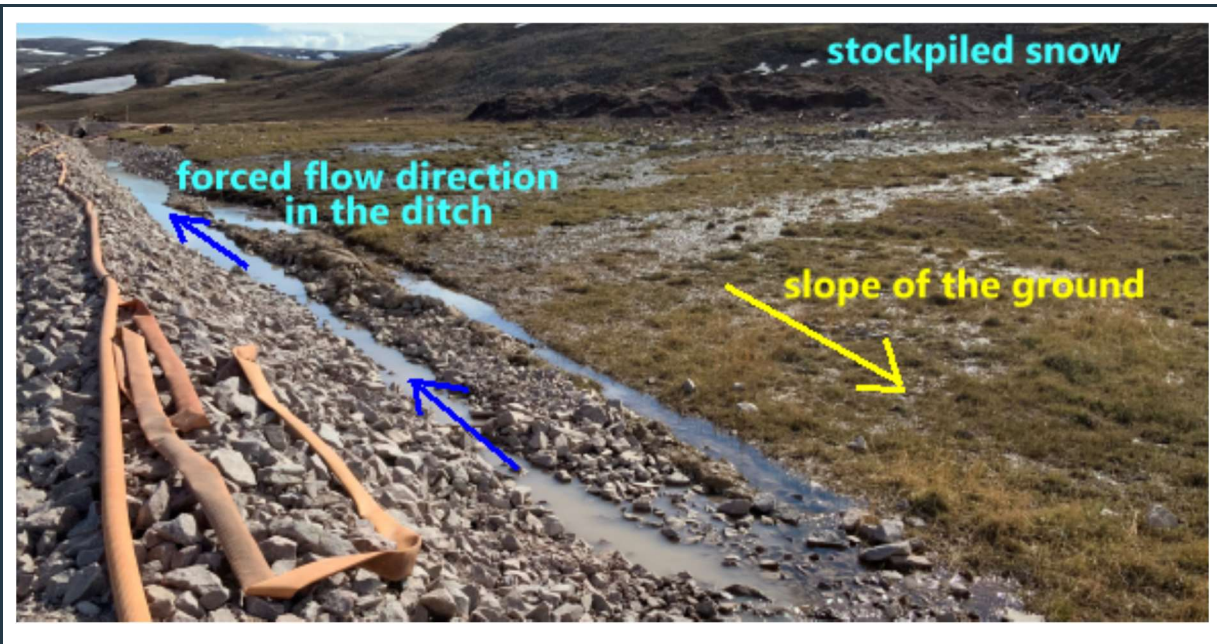
Figure 59: View of the "P-SWD-3 surface water collection ditch with failing side slope. The sloughing is caused by the uncontrolled water flow into the ditch along its alignment.

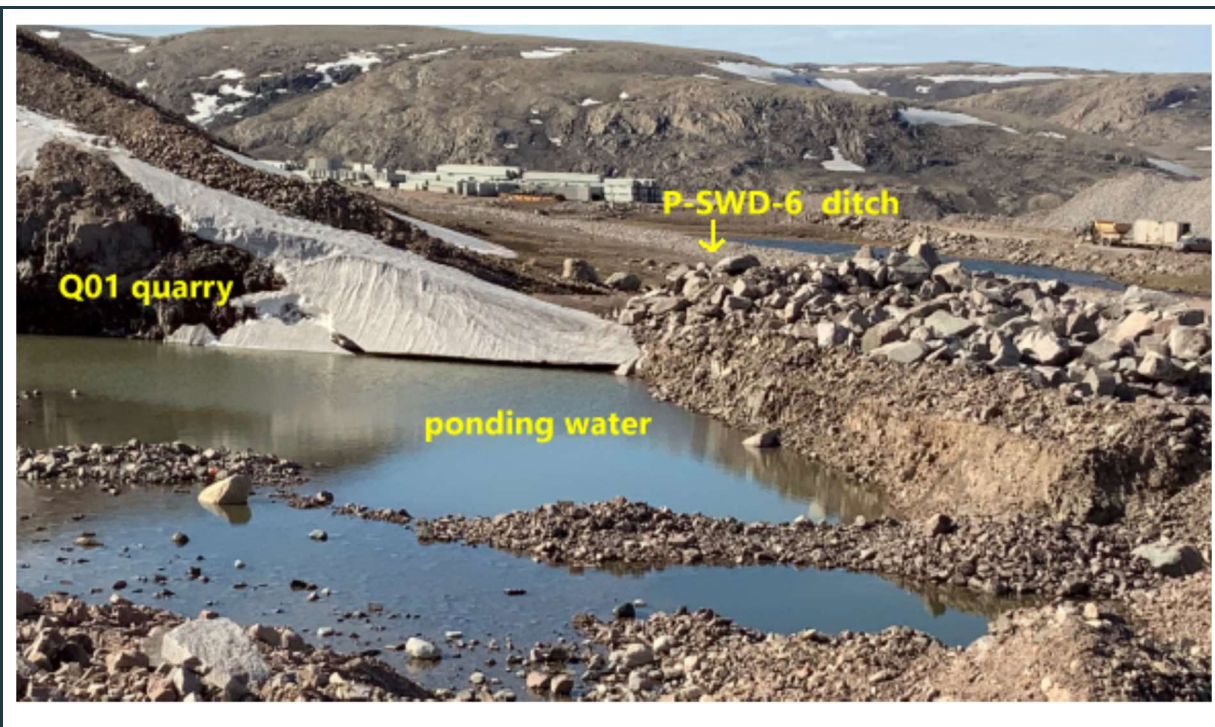
Figure 62: Ponding water next to the P-SWD-6 - “Q01 South” surface water collection ditch.

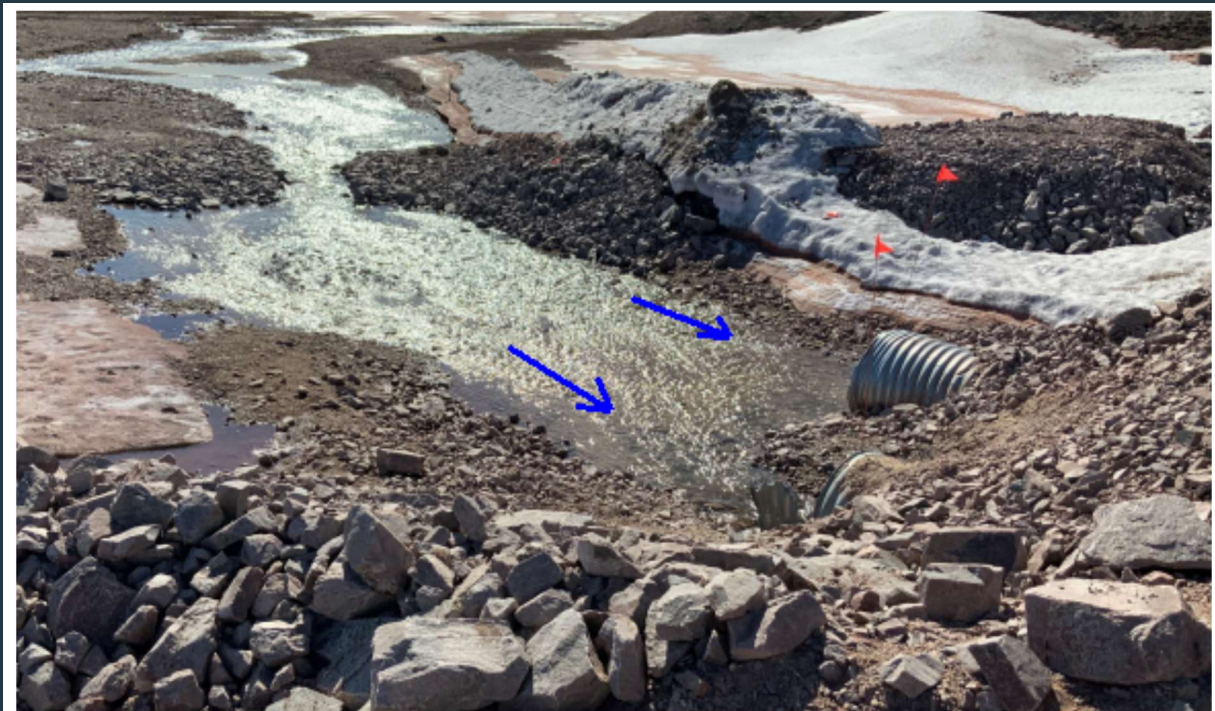
Figure 63: View of the P-SWD-7 surface water collection ditch and culverts (inlet).

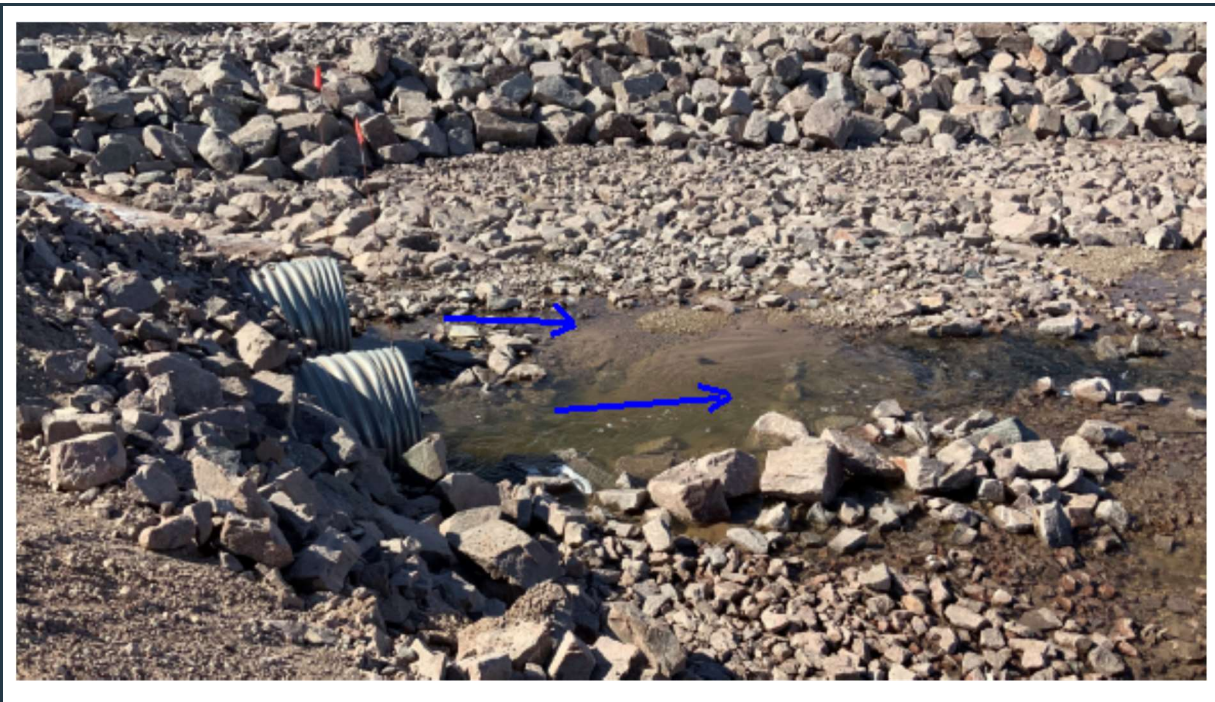
Figure 64: View of the P-SWD-7 surface water collection ditch and culverts (outlet).

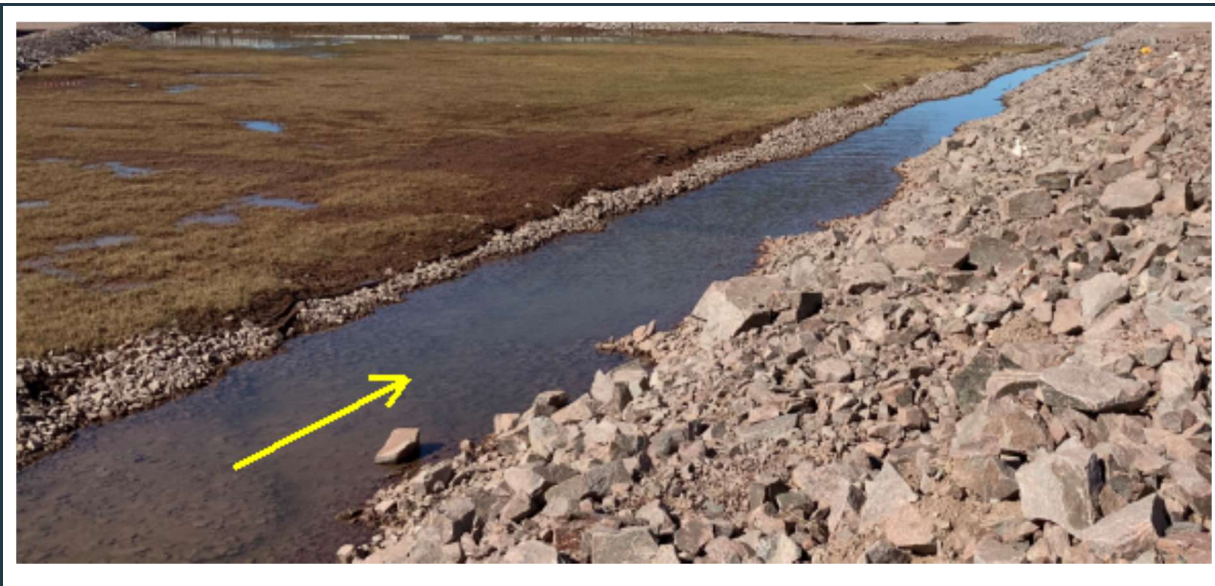
Figure 66: View of the south section of the 380 M surface water collection ditch.

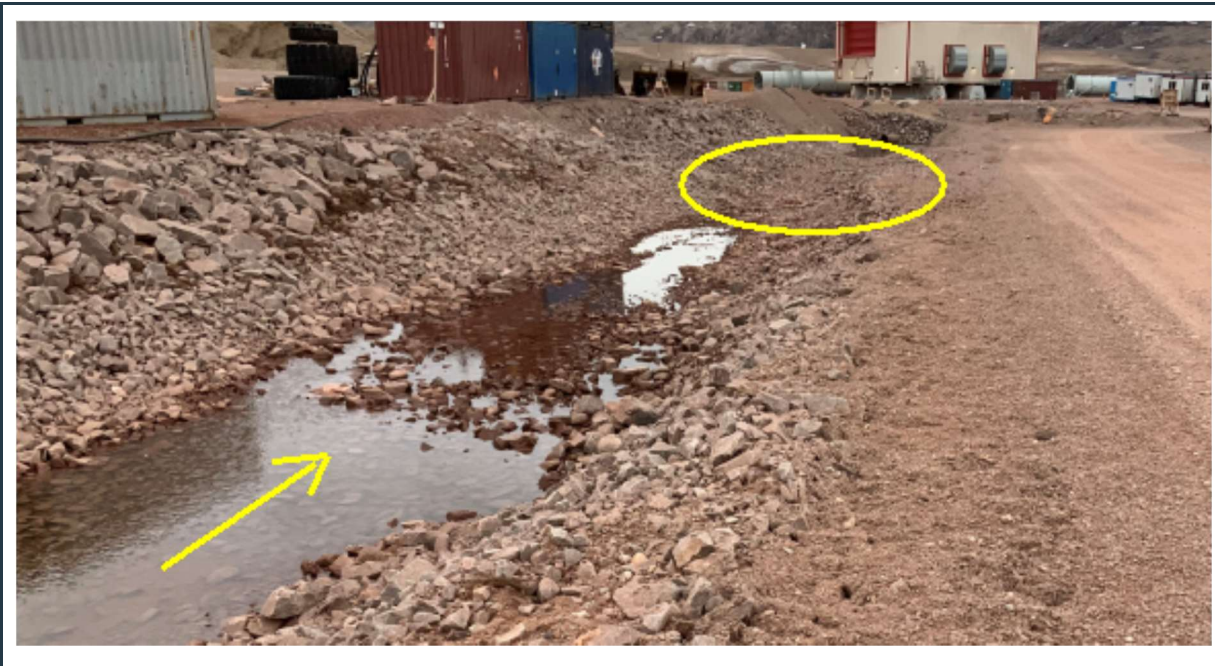
Figure 67: View of the east section of the 380 M surface water collection ditch.

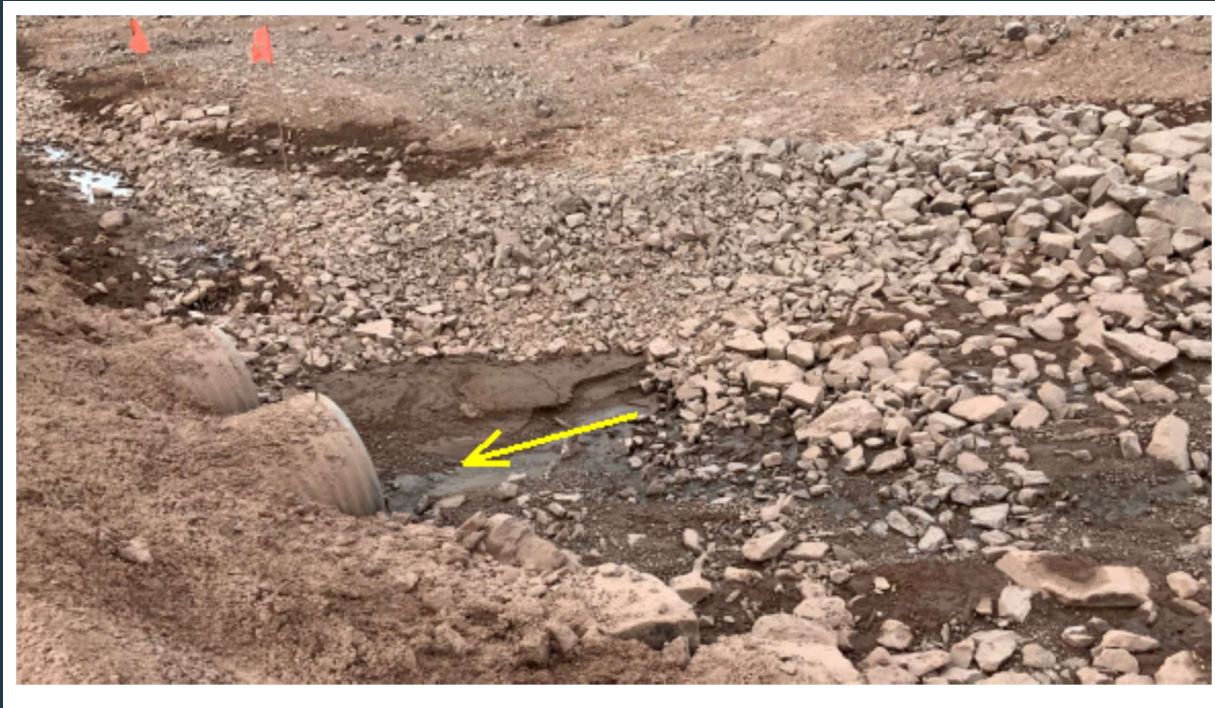
Figure 69: View of twin culverts, draining surface water from the quarry area under the tote road (inlet).

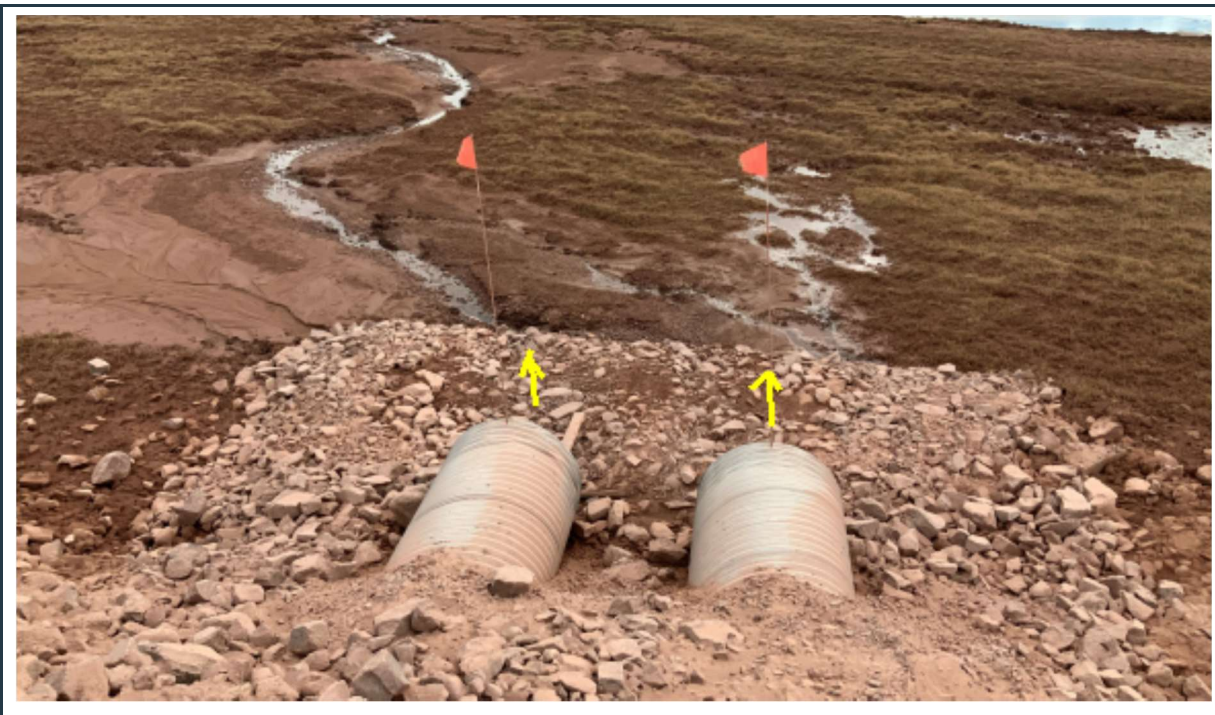
Figure 70: View of twin culverts, draining surface water from the quarry area (outlet).
