Baffinland Iron Mines Corporation

August 23, 2021
Project #: TC190307.2021

Annual Geotechnical Inspections – 2021 Report 1.

APPENDIX "C" – Tote/Haul Road - Photographs

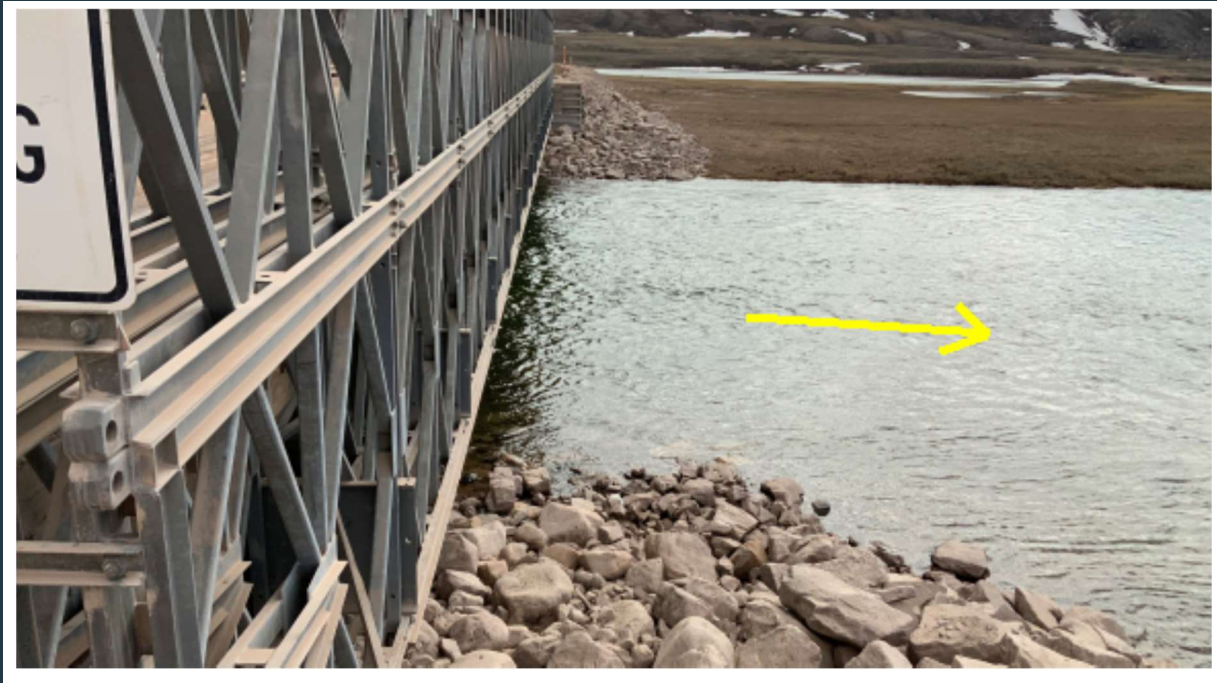
Figure 71: View of the north side of "bridge 17". Note the rip-rap scour protection at the abutments.

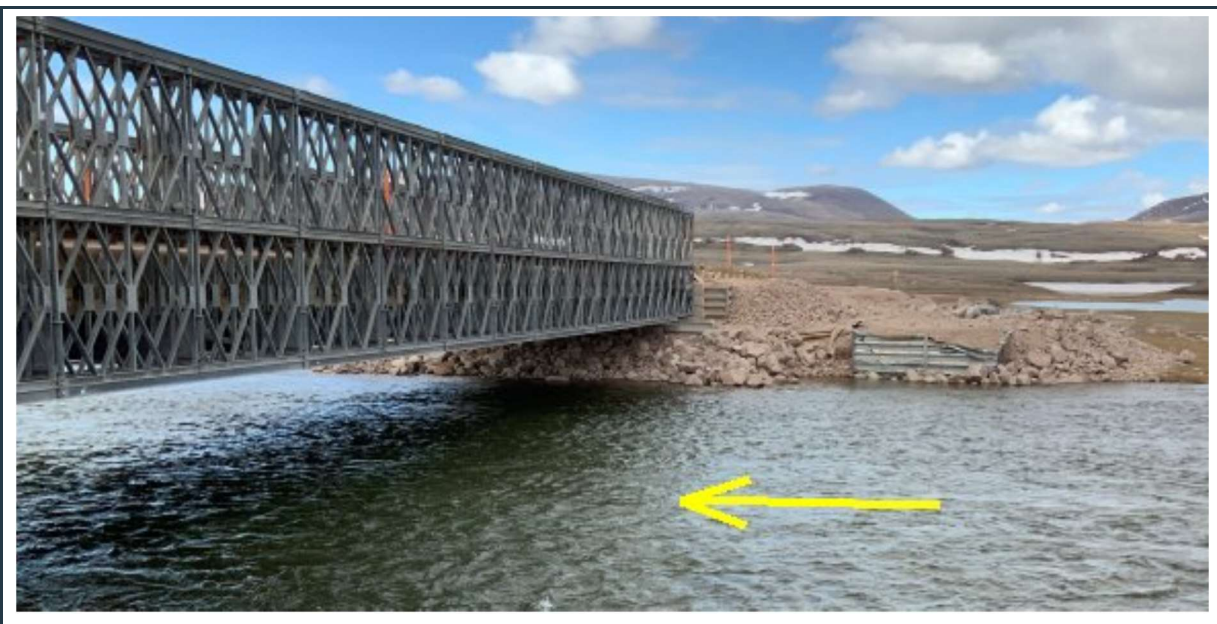
Figure 72: View of the south side of "bridge 17", with stable abutment and riprap scour protection.

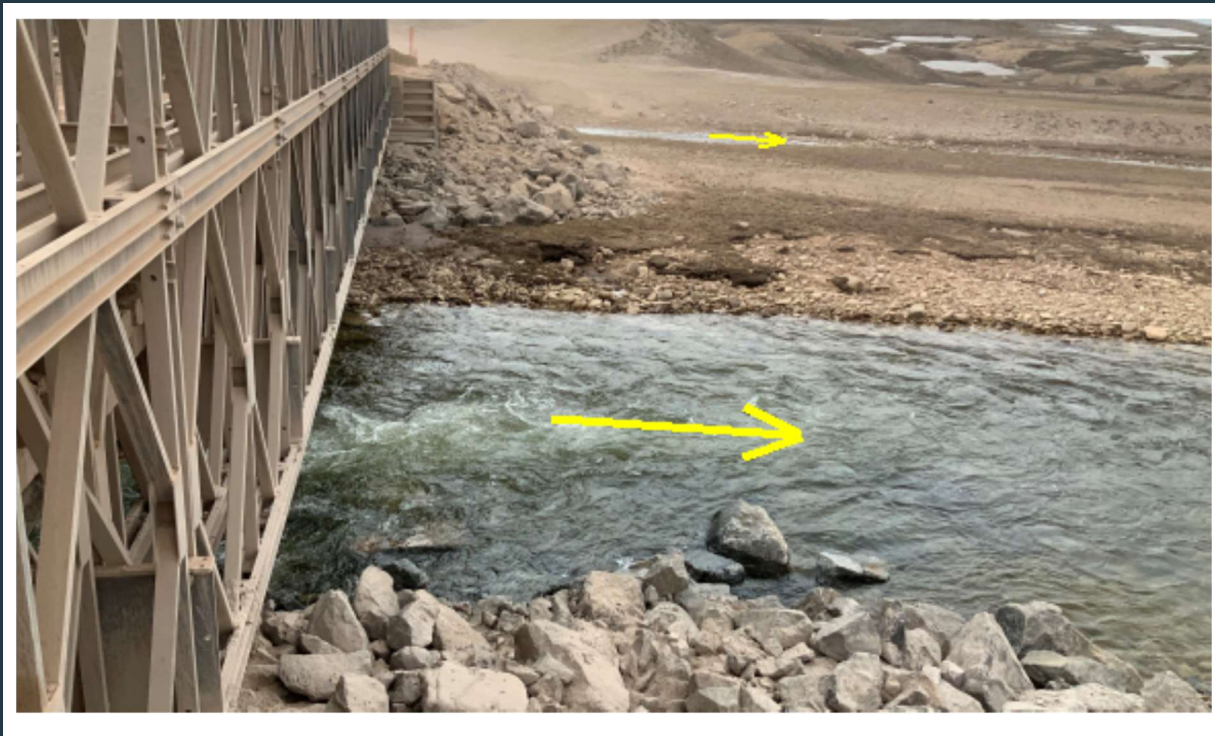
Figure 73: View of the west side of bridge 63. Note the flow through a nearby culvert as well.

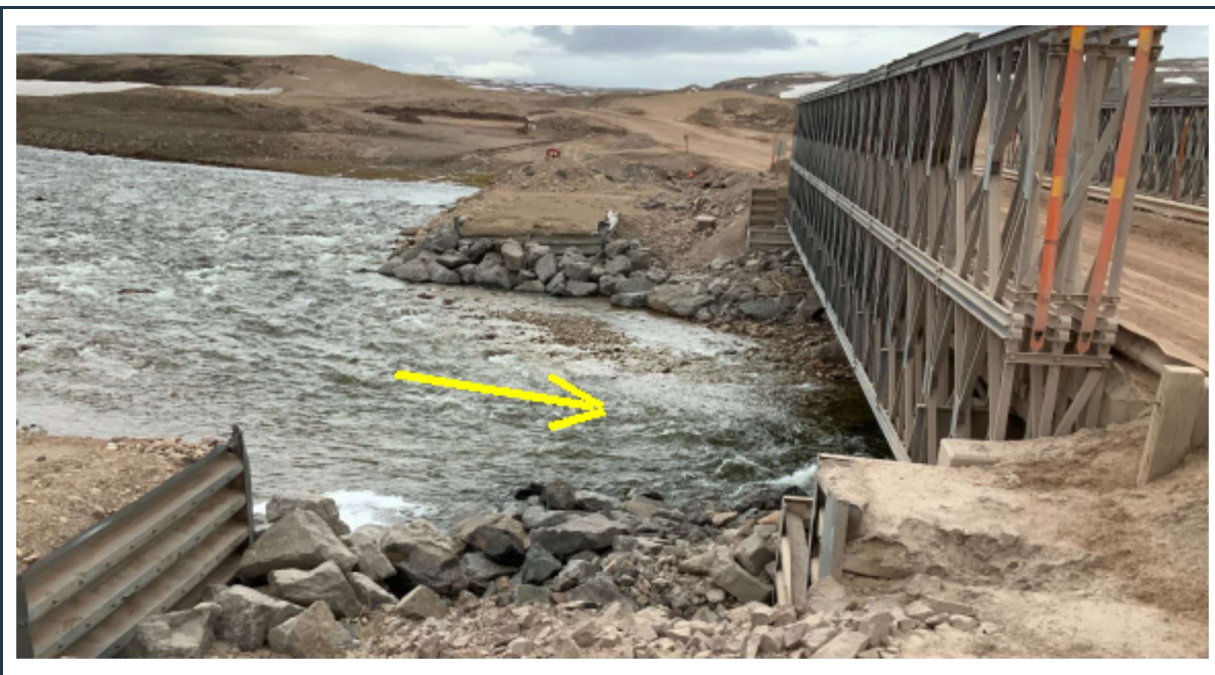
Figure 74: View of the east side of bridge 63, and the "old" abutments, looking south.

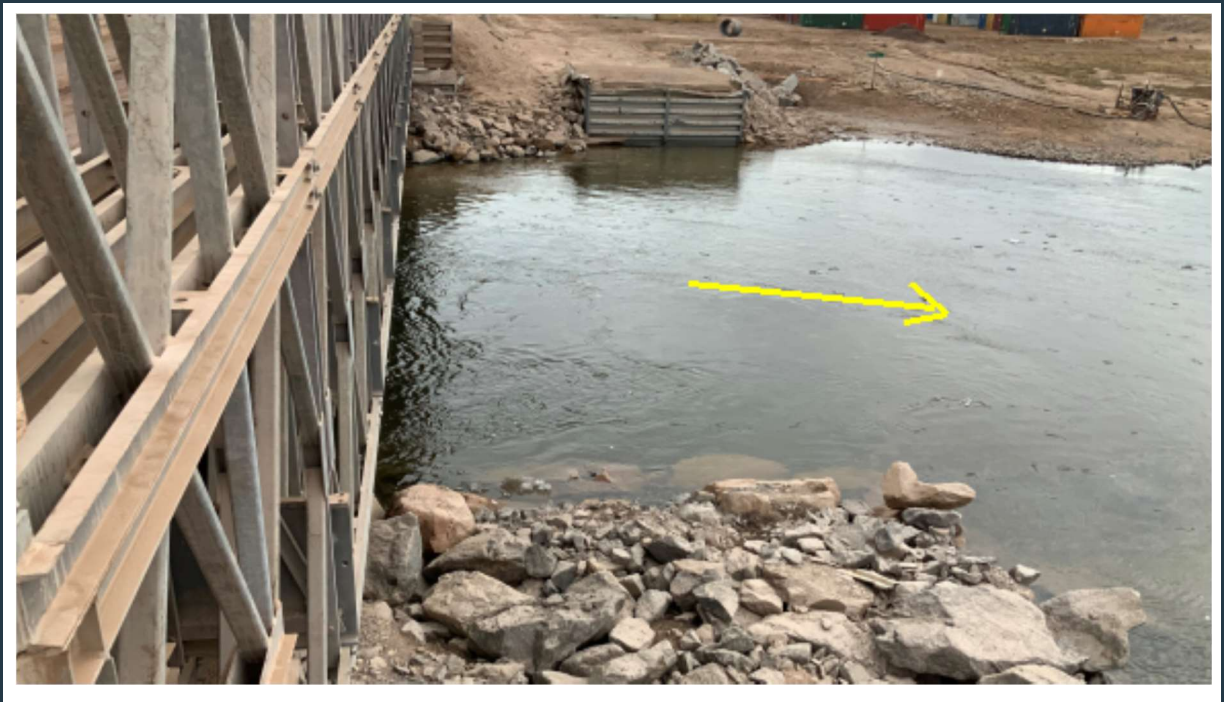
Figure 75: View of the west side of bridge 80, with the “old” abutment providing additional support.

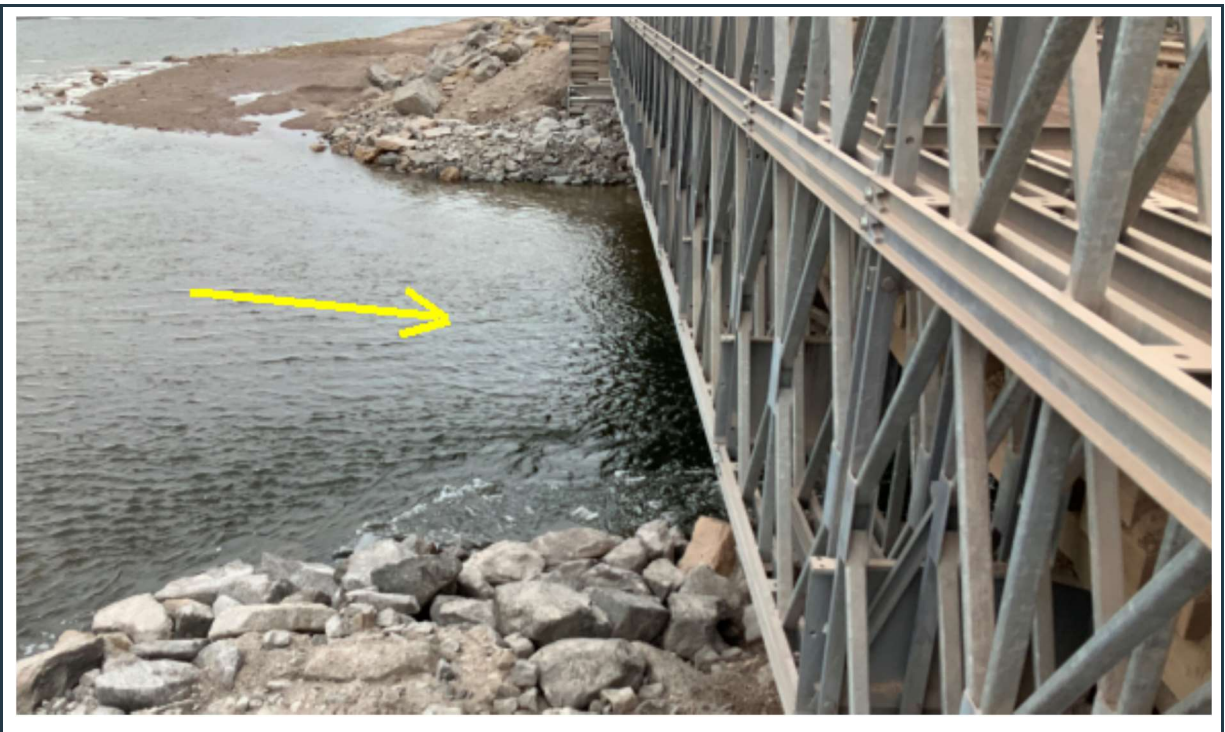
Figure 76: View of stable abutments at bridge 80, looking south.

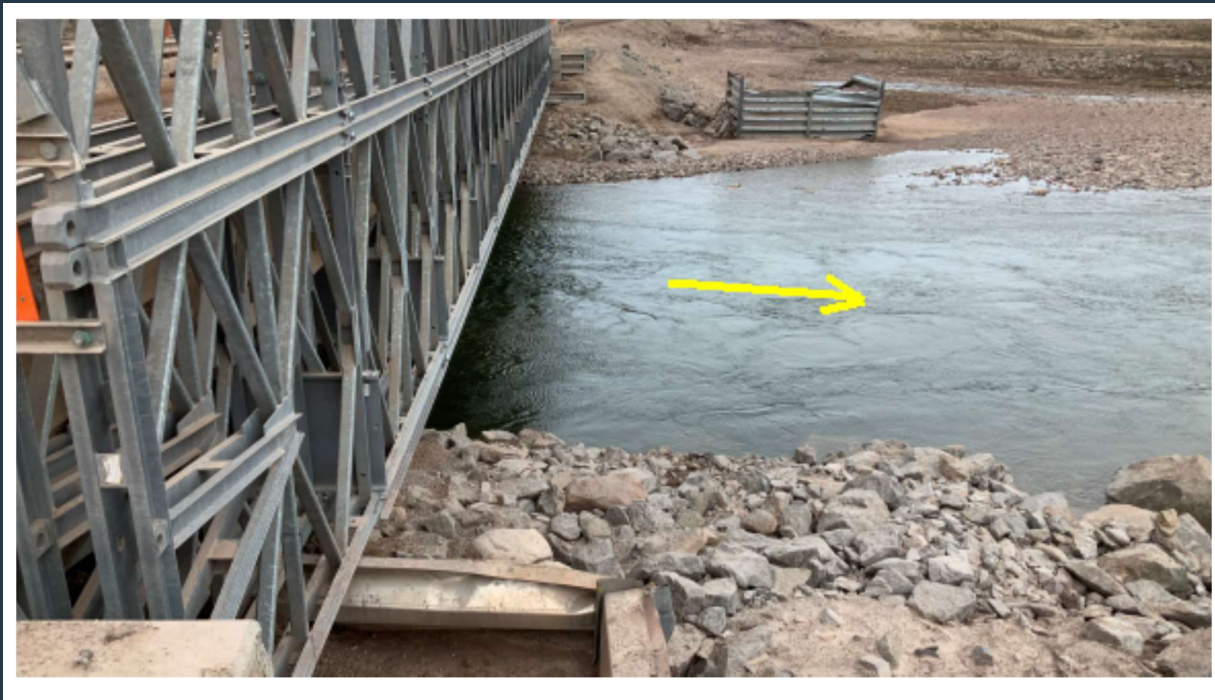
Figure 77: View of the west side of bridge 97, with one of the old abutments.

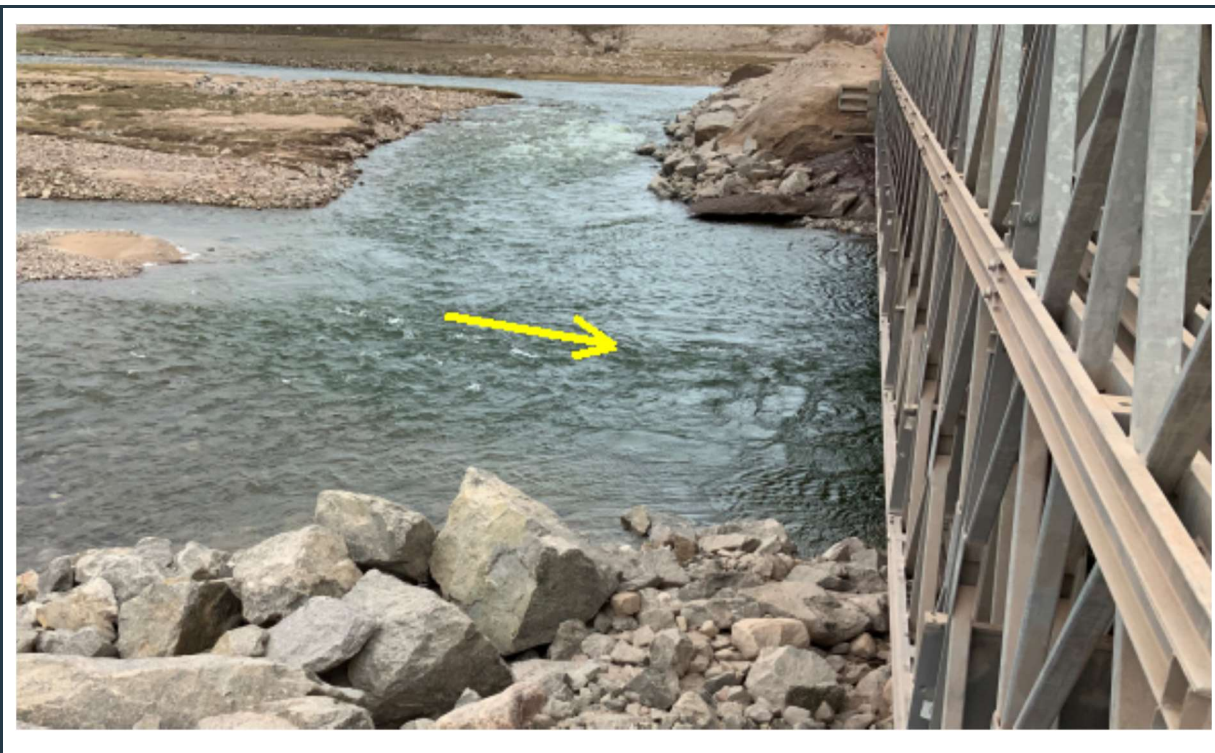
Figure 78: View of the two stable abutments and the east side of bridge 97.

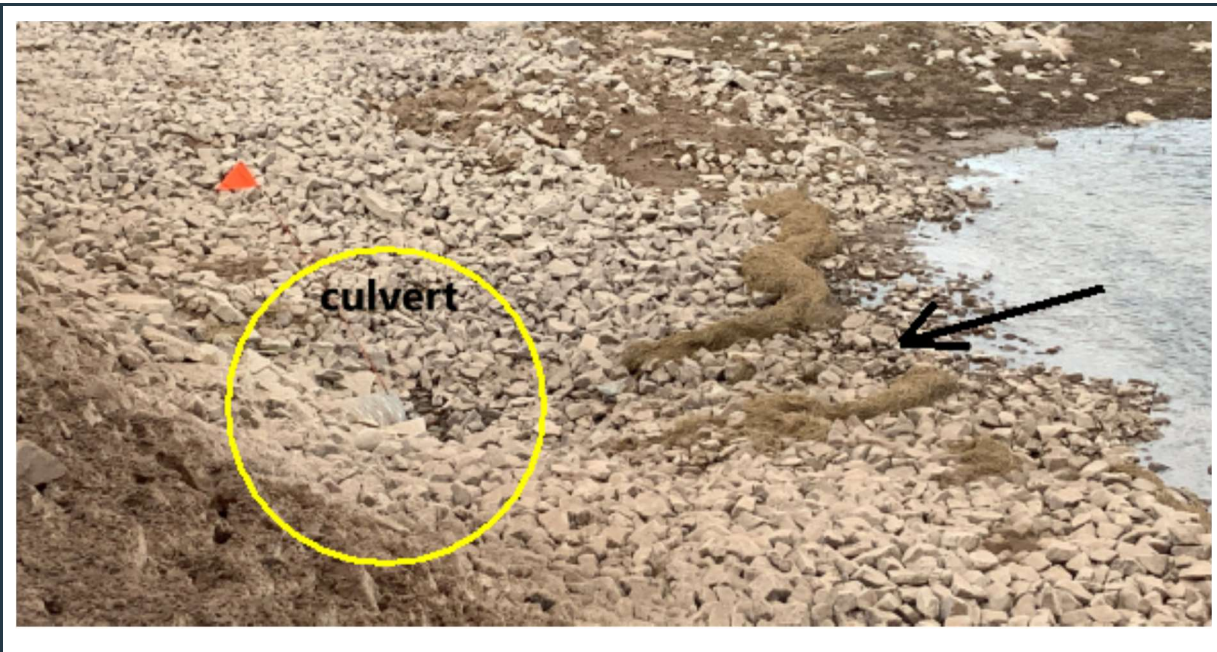
Figure 79: View of the inlet of culvert BG-033, with appropriate riprap erosion protection.

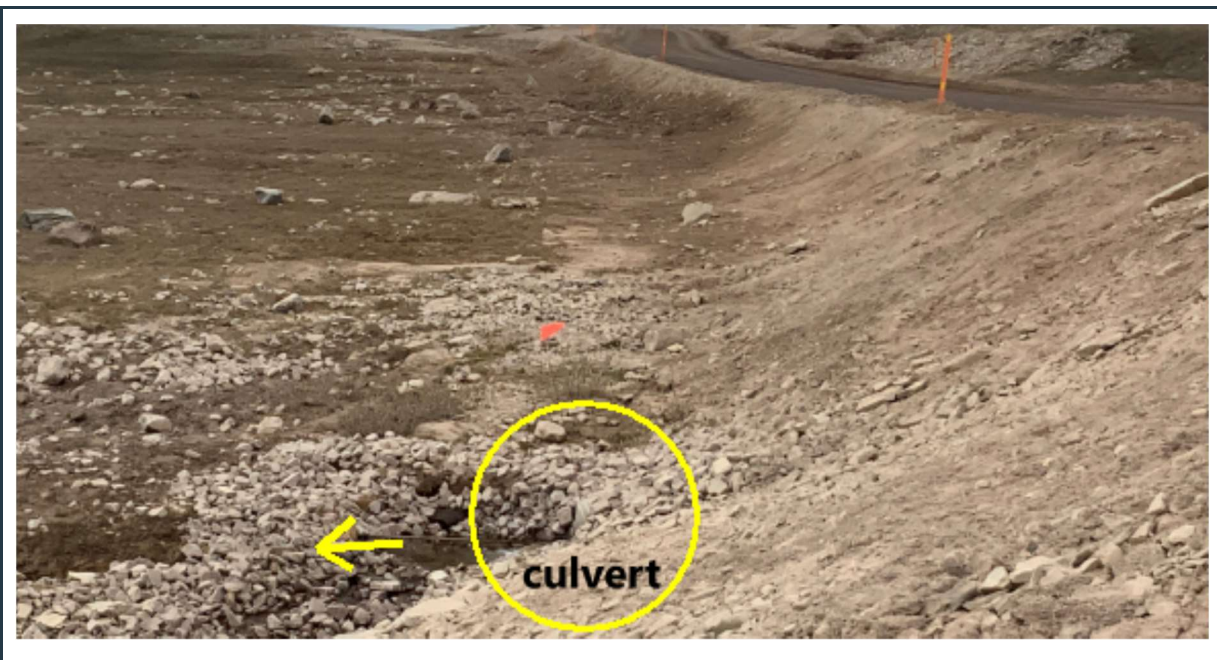
Figure 80: View of the outlet of culvert BG-033, with stable slope of the road embankment.

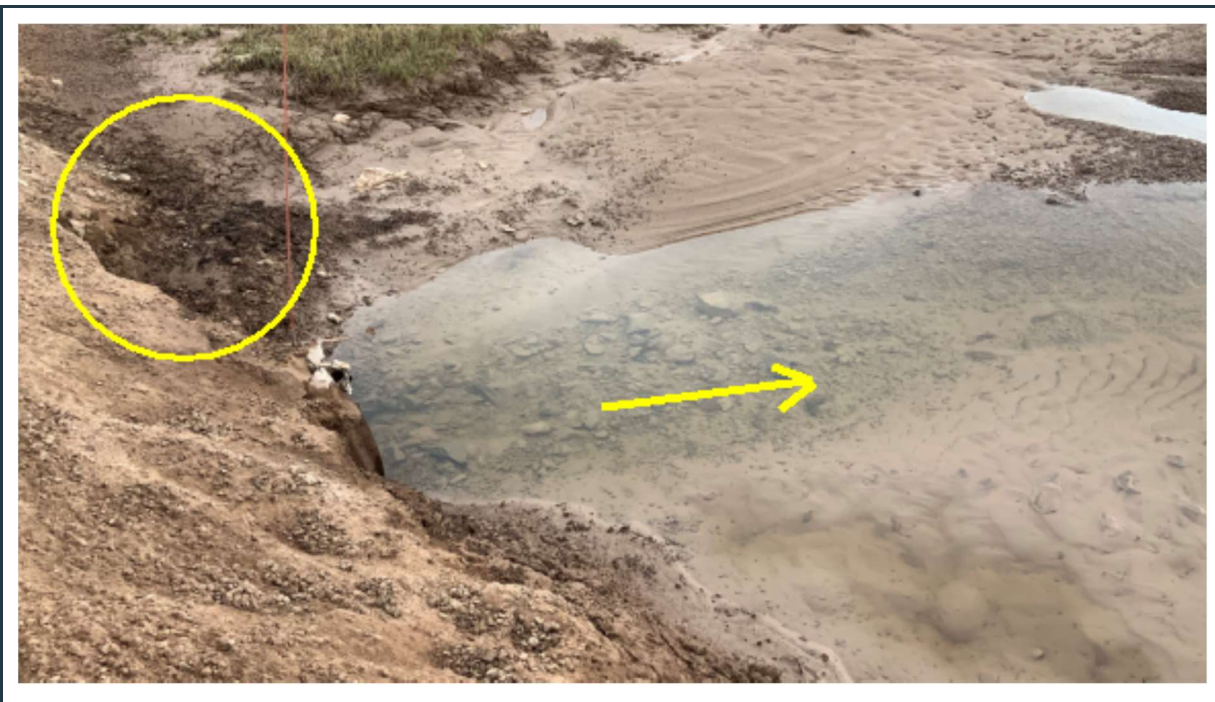
Figure 82: View of the outlet end of culverts 030A and B. Note that one of the pipes is clogged with soil.

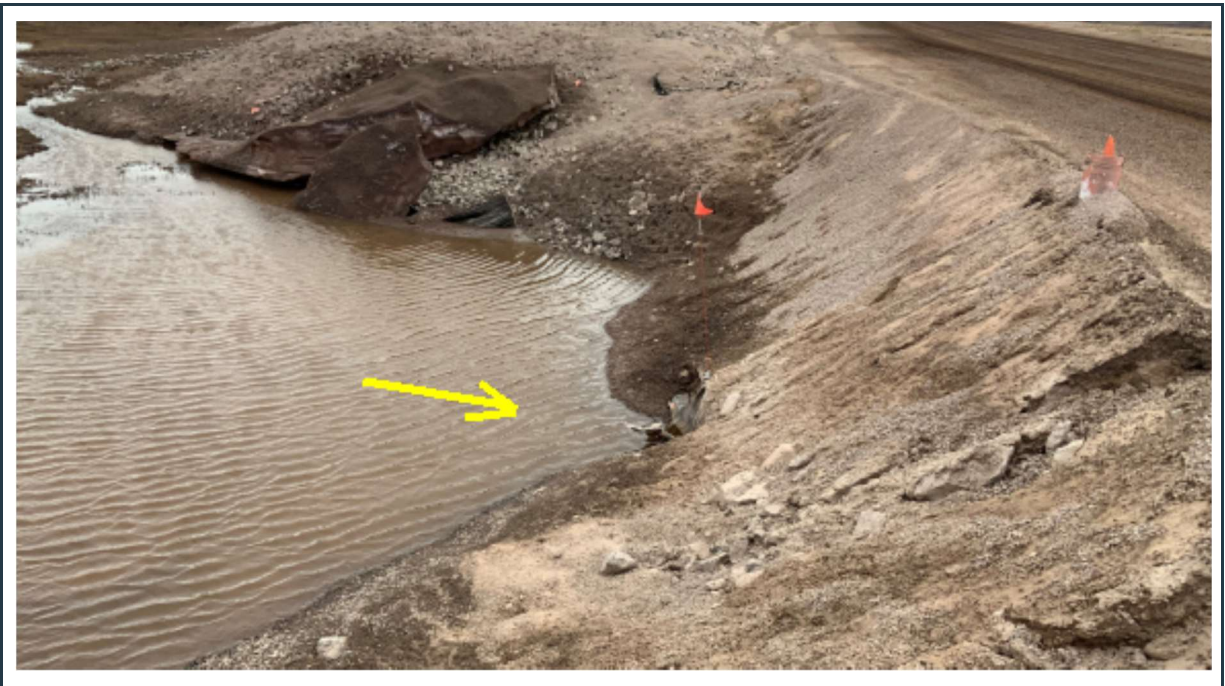
Figure 83: View of the inlet of culvert BG-038, with minor erosion on the slope of the road embankment.

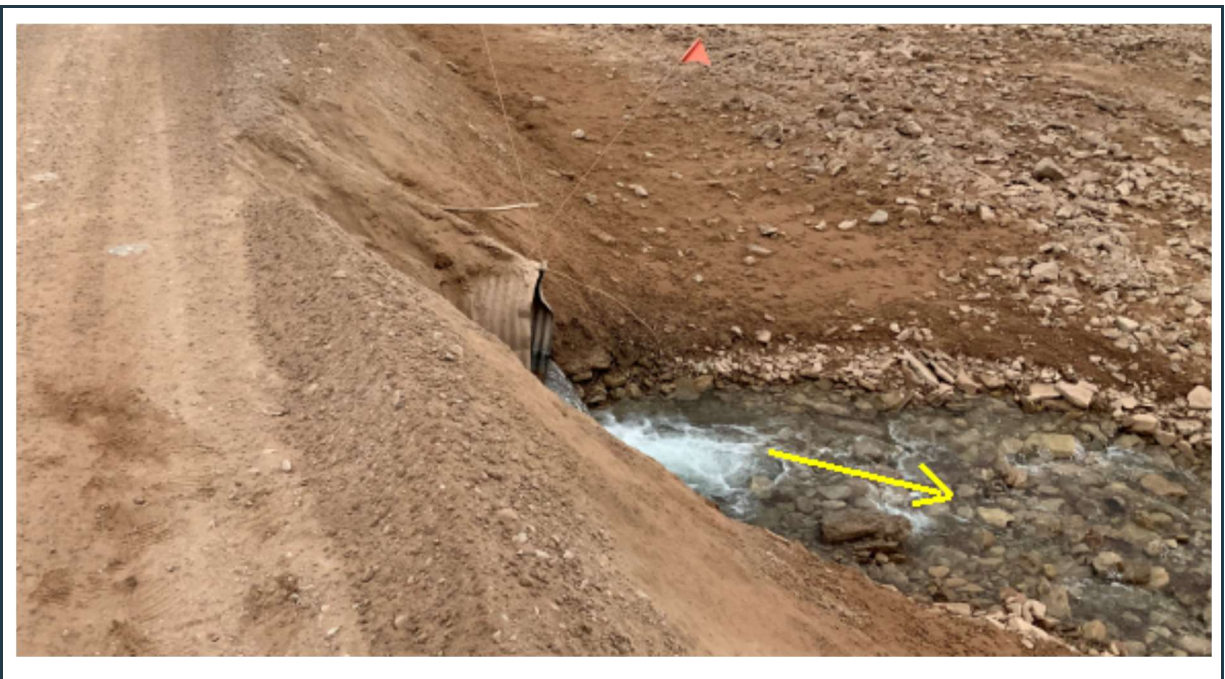
Figure 90: View of culvert 083 outlet, with erosion on the slope of the embankment around the culvert.

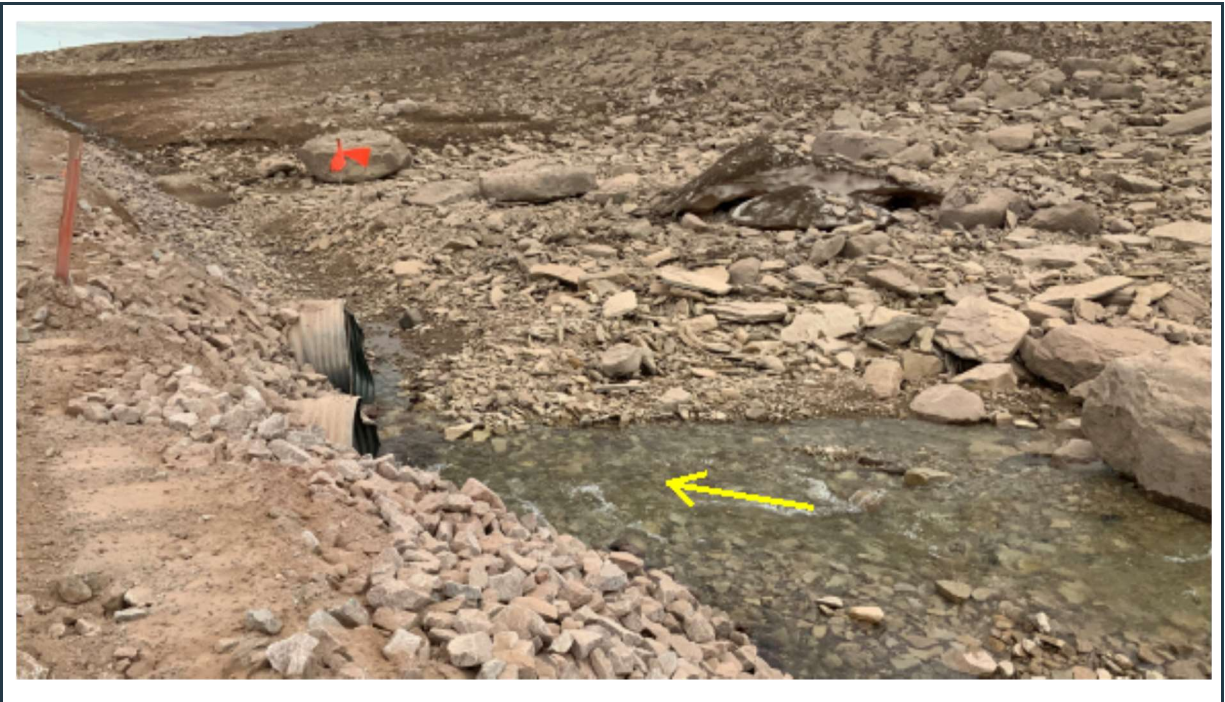
Figure 91: View of culvert(s) 094 inlet, in good condition (looking north).

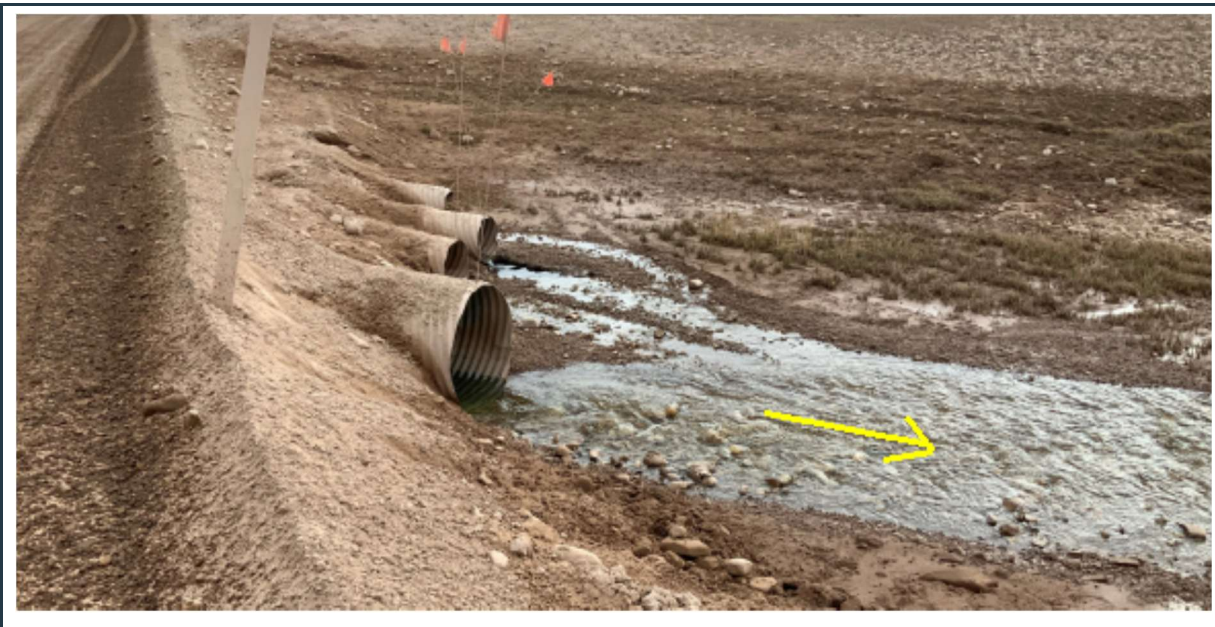
Figure 94: View of culvert(s) 102 outlets in good condition.

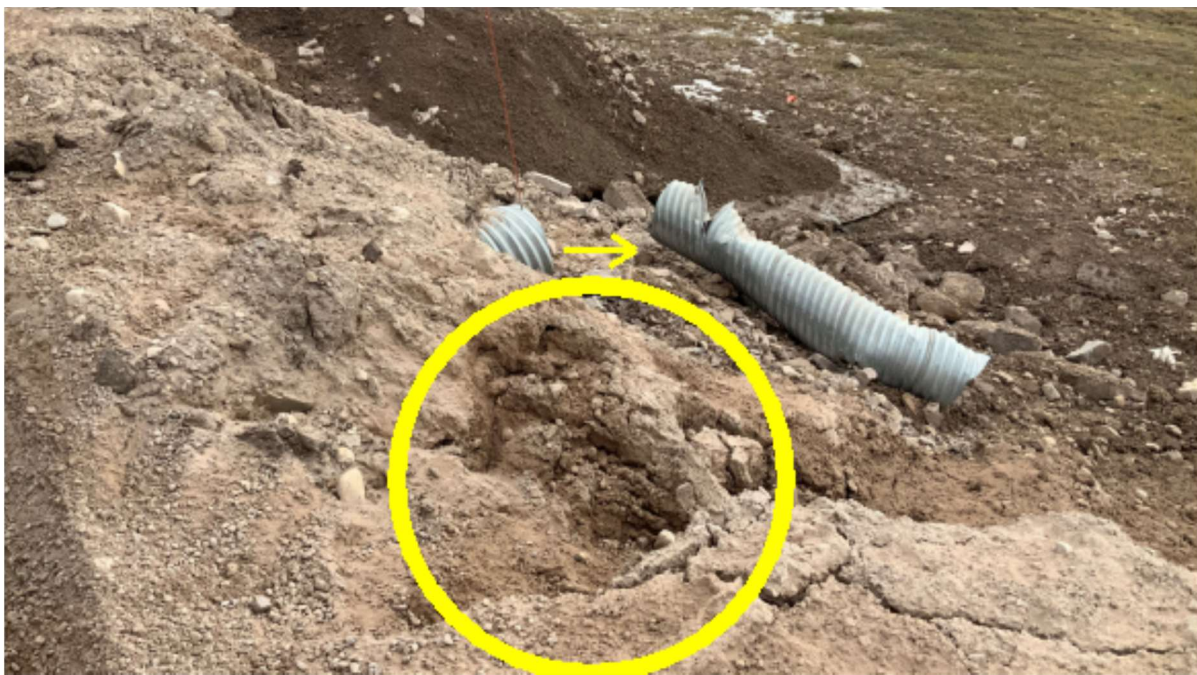
Figure 98: View of culvert 110A outlet. Note that a section of the pipe was cut off, and the erosion of the road embankment adjacent to the culvert (yellow circle).

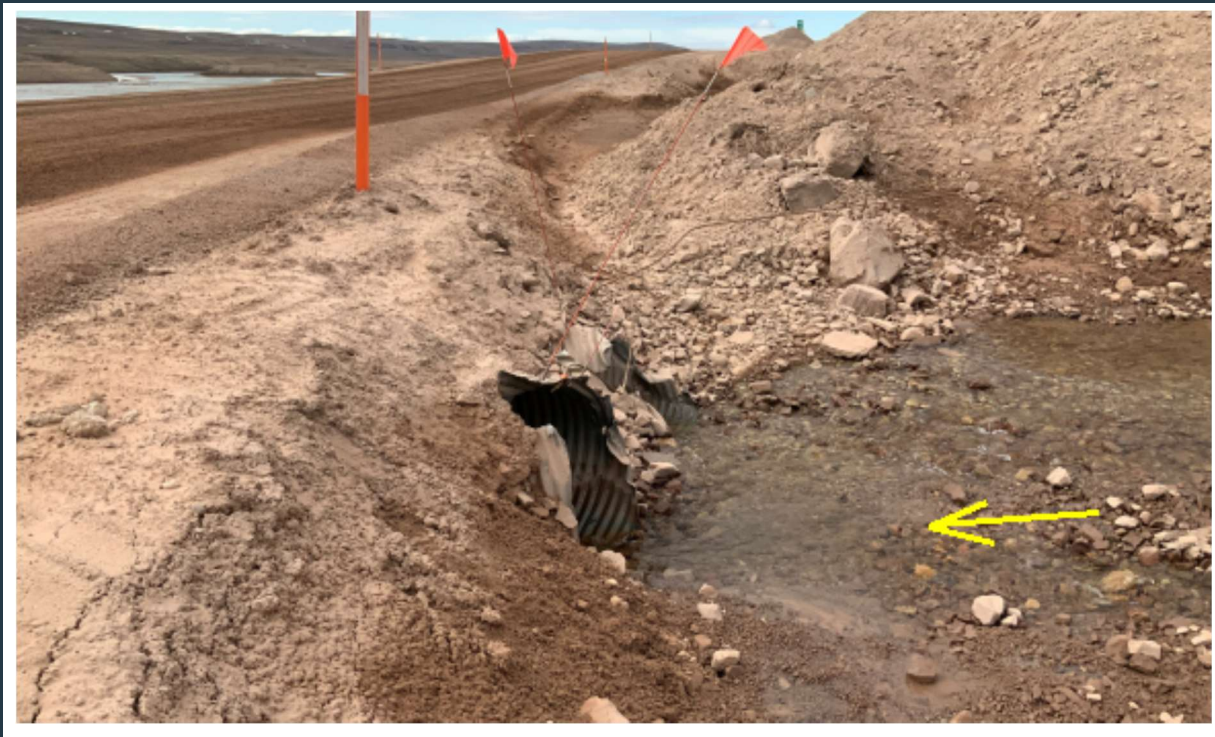
Figure 103: View of culvert(s) 114D inlets. Repair of both pipes is required.

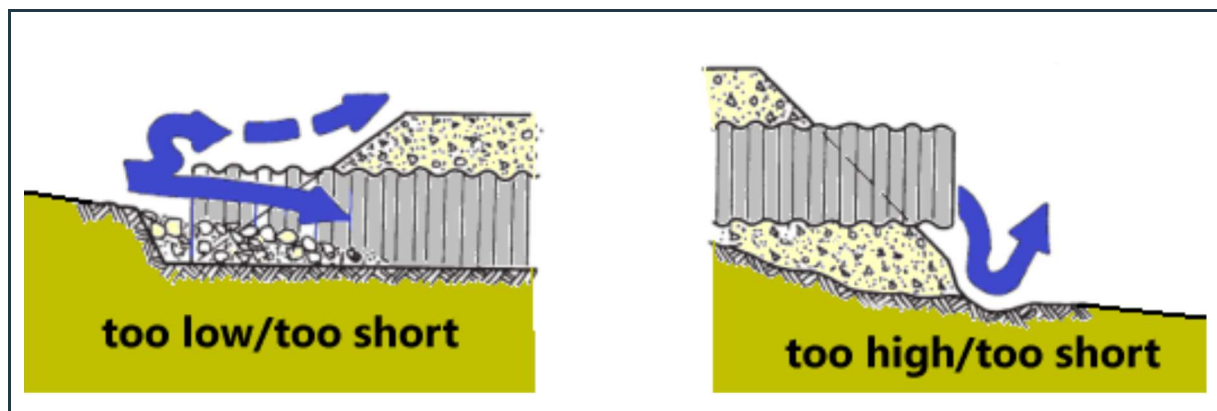
Figure 109: Typical installation problems/mistakes with culverts resulting in erosion and pipe clogging.
