Tote Road Fish Habitat Monitoring 2021 Annual Report December 2021

PHOTOGRAPHIC LOG OF HABITAT ASSESSMENTS AT TOTE ROAD CROSSINGS, SPRING 2021

Baffinland Iron Mines Mary River Project

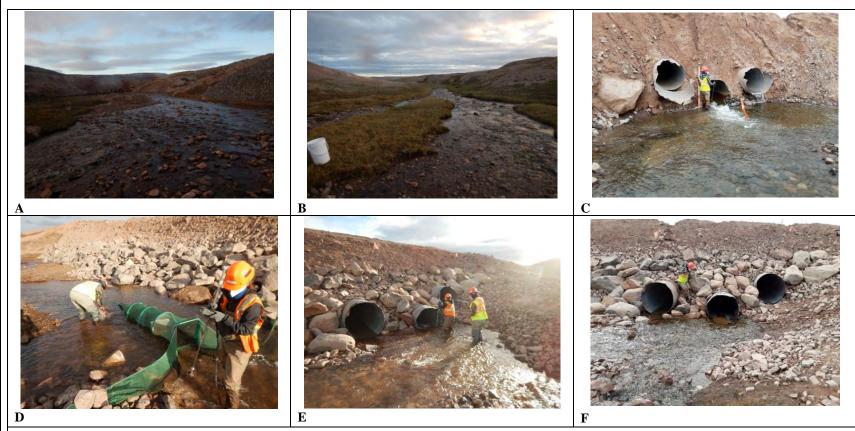
Summary: This stream provides summer rearing habitat for both species. Culvert outflow velocities may occasionally impede smaller fish.

Photos 1. Photographs downstream (top) and upstream (bottom) of the Tote Road crossing BG-01: (A,D) looking upstream during spring; (B,E) looking downstream during spring; and (C,F) looking at culverts during fall.

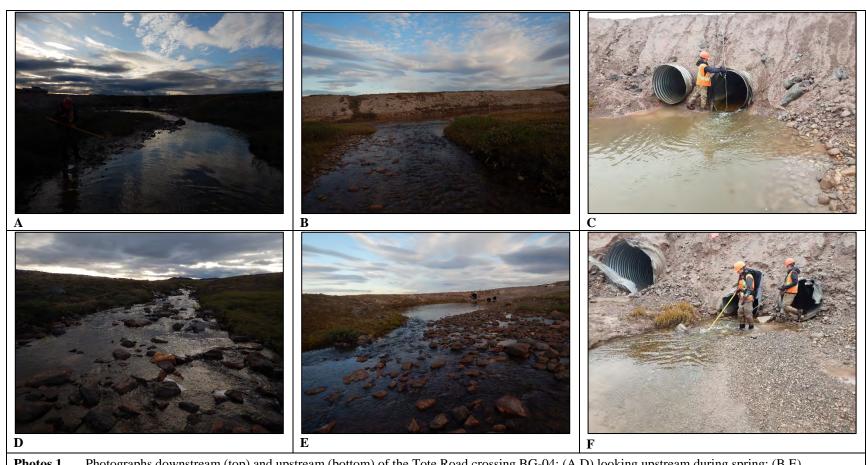
Summary: Site provides summer rearing habitat for both species. No fish passage issues in 2021.

Photos 1. Photographs downstream (top) and upstream (bottom) of the Tote Road crossing BG-04: (A,D) looking upstream during spring; (B,E) looking downstream during spring; and (C,F) looking at culverts during fall.

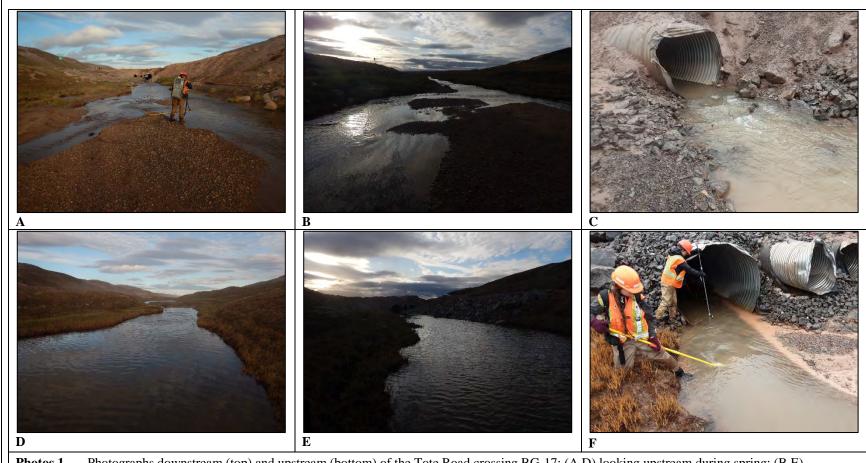
Summary: Site provides summer rearing habitat for both species. No fish passage issues in 2021.

Photos 1. Photographs downstream (top) and upstream (bottom) of the Tote Road crossing BG-17: (A,D) looking upstream during spring; (B,E) looking downstream during spring; and (C,F) looking at culverts during fall.

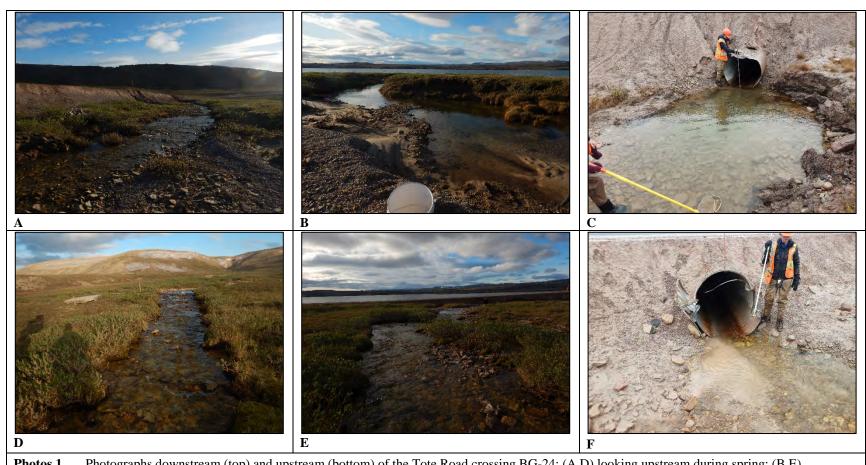
Summary: Site provides summer rearing habitat for juvenile Arctic Char. No fish passage issues in 2021.

Photos 1. Photographs downstream (top) and upstream (bottom) of the Tote Road crossing BG-24: (A,D) looking upstream during spring; (B,E) looking downstream during spring; and (C,F) looking at culverts during fall.

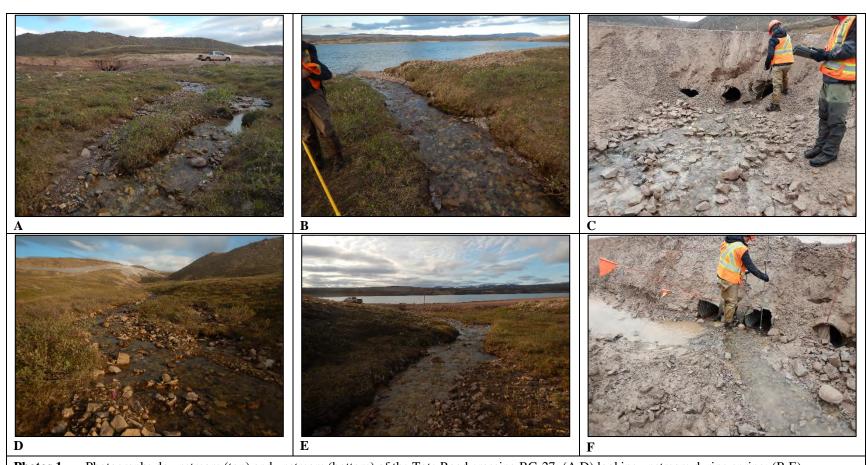
Summary: Site provides summer rearing habitat for juvenile Arctic Char. No fish passage issues in 2021.

Photos 1. Photographs downstream (top) and upstream (bottom) of the Tote Road crossing BG-27: (A,D) looking upstream during spring; (B,E) looking downstream during spring; and (C,F) looking at culverts during fall.

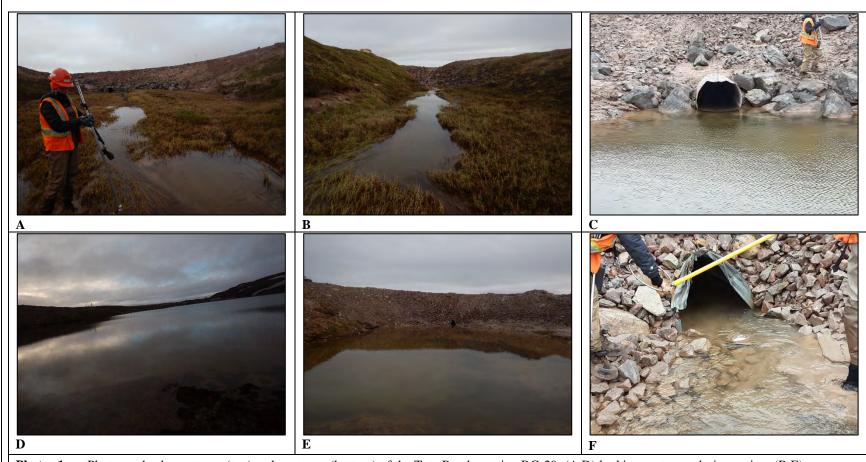
Summary: Stream provides abundant summer rearing habitat for both species. There were no fish access issues in 2021.

Photos 1. Photographs downstream (top) and upstream (bottom) of the Tote Road crossing BG-29: (A,D) looking upstream during spring; (B,E) looking downstream during spring; and (C,F) looking at culverts during fall.

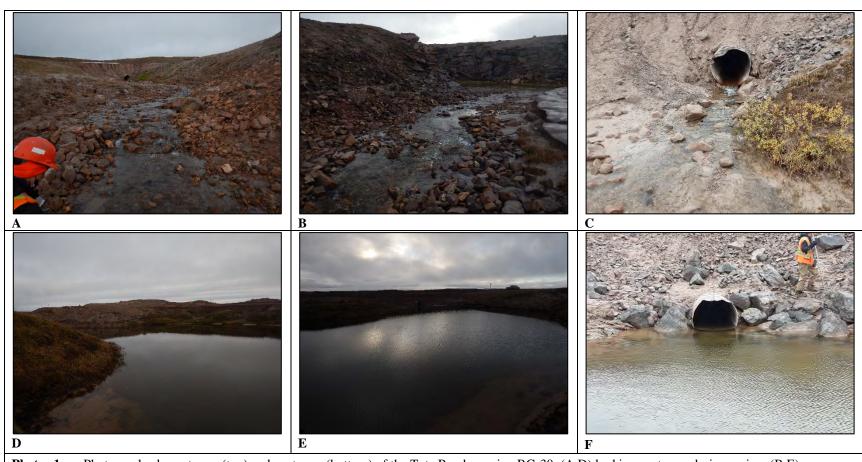
Summary: Stream provides abundant rearing habitat, particularly upstream of the road in a large pond. Access to the upstream pond was created with a rocky ramp as part of the Tote Road Compensation Plan. There were no fish access issues in 2021.

Photos 1. Photographs downstream (top) and upstream (bottom) of the Tote Road crossing BG-30: (A,D) looking upstream during spring; (B,E) looking downstream during spring; and (C,F) looking at culverts during fall.

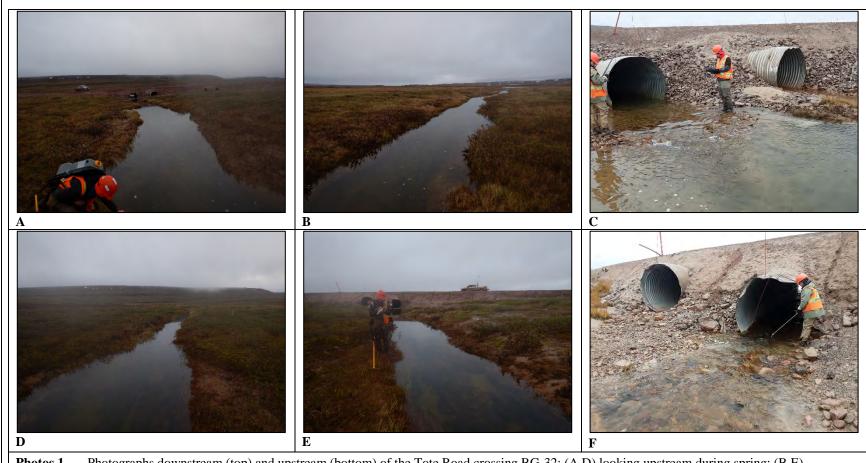
Summary: Consistently provides abundant, good quality rearing habitat for both species. No fish passage issues in 2021.

Photos 1. Photographs downstream (top) and upstream (bottom) of the Tote Road crossing BG-32: (A,D) looking upstream during spring; (B,E) looking downstream during spring; and (C,F) looking at culverts during fall.

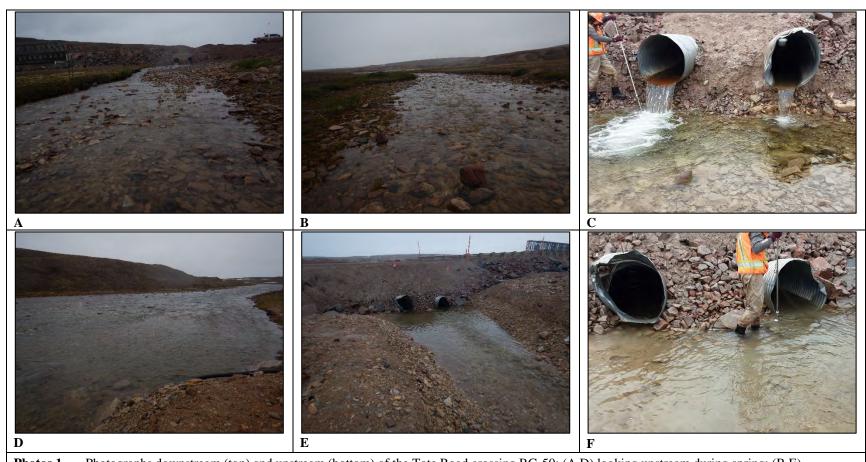
Summary: Large river with abundant habitat for both species. One channel is crossed by a bridge and the other with two culverts. Monitoring previously indicated culverts were perched, blocking fish movements, and remediation work was conducted in fall 2019. Remediation structures were destroyed by high flows during the 2020 freshet. Culverts remained highly perched in 2021. Alternative remediation will be discussed with the DFO.

Photos 1. Photographs downstream (top) and upstream (bottom) of the Tote Road crossing BG-50: (A,D) looking upstream during spring; (B,E) looking downstream during spring; and (C,F) looking at culverts during fall.

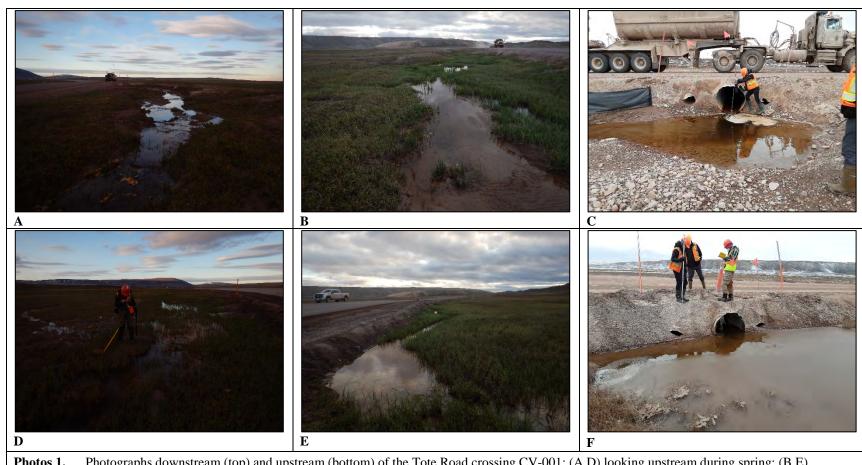
Summary: This stream typically provides summer rearing habitat for both species. There was a slight perch at the downstream end of the culvert during fall when water levels were lower, but it was not sufficient to prevent fish access upstream. No fish passage issues in 2021.

Photos 1. Photographs downstream (top) and upstream (bottom) of the Tote Road crossing CV-001: (A,D) looking upstream during spring; (B,E) looking downstream during spring; and (C,F) looking at culverts during fall.

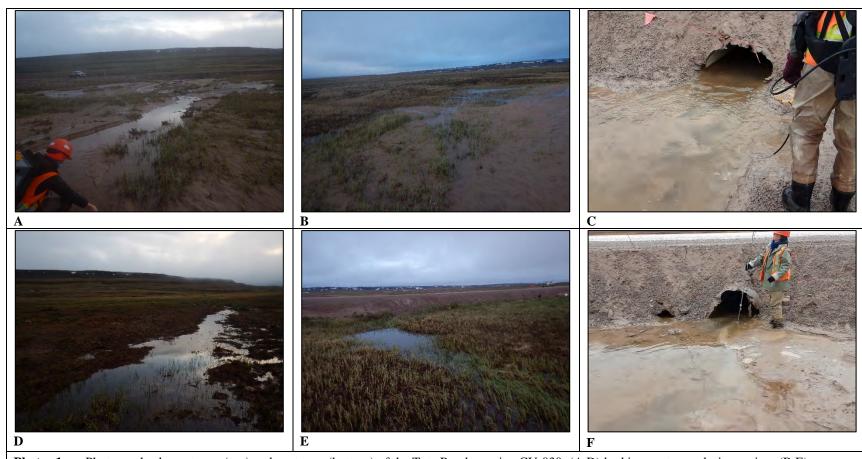
Summary: Arctic Char use of this stream is minimal due to consistently low water levels and lack of a defined channel, but Ninespine Stickleback are typically abundant. No culvert passage issues in 2021.

Photos 1. Photographs downstream (top) and upstream (bottom) of the Tote Road crossing CV-030: (A,D) looking upstream during spring; (B,E) looking downstream during spring; and (C,F) looking at culverts during fall.

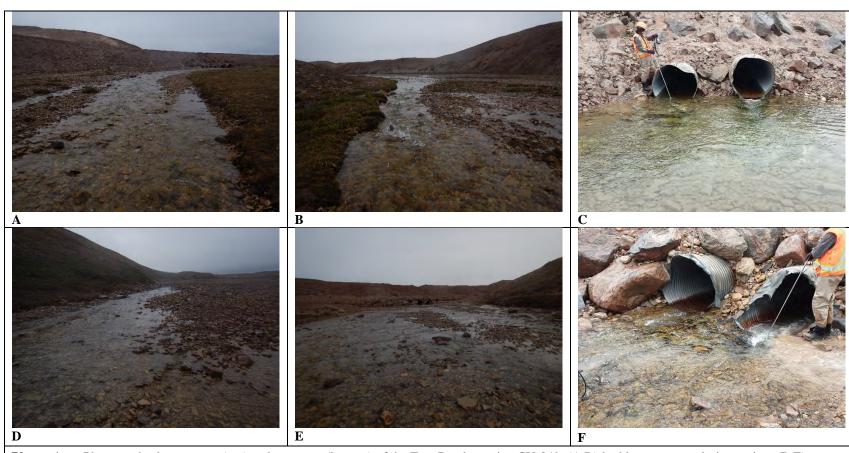
Summary: Site provides abundant summer rearing habitat for juvenile Arctic Char. There were no fish passage issues in 2021.

Photos 1. Photographs downstream (top) and upstream (bottom) of the Tote Road crossing CV-049: (A,D) looking upstream during spring; (B,E) looking downstream during spring; and (C,F) looking at culverts during fall.

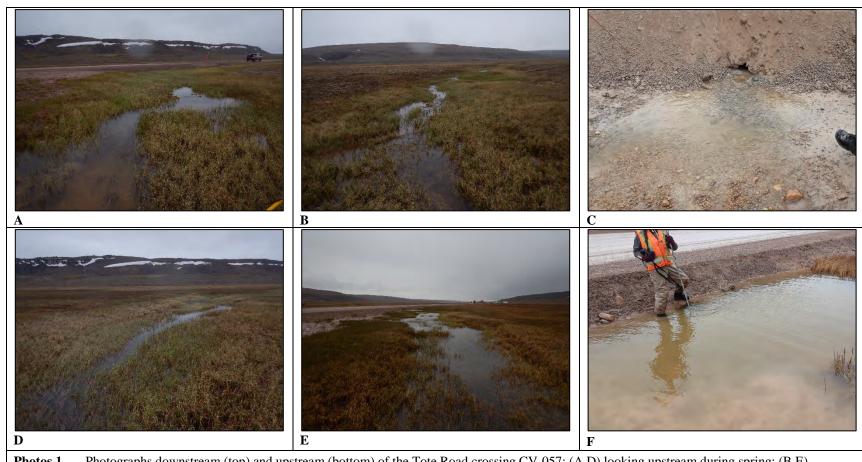
Summary: Site provides some summer rearing habitat for juvenile Arctic Char. There were no fish passage issues in 2021; however, culverts are becoming increasingly full of sediment and may soon create a blockage to fish movements if not remediated. Remediation recommended for winter months.

Photos 1. Photographs downstream (top) and upstream (bottom) of the Tote Road crossing CV-057: (A,D) looking upstream during spring; (B,E) looking downstream during spring; and (C,F) looking at culverts during fall.

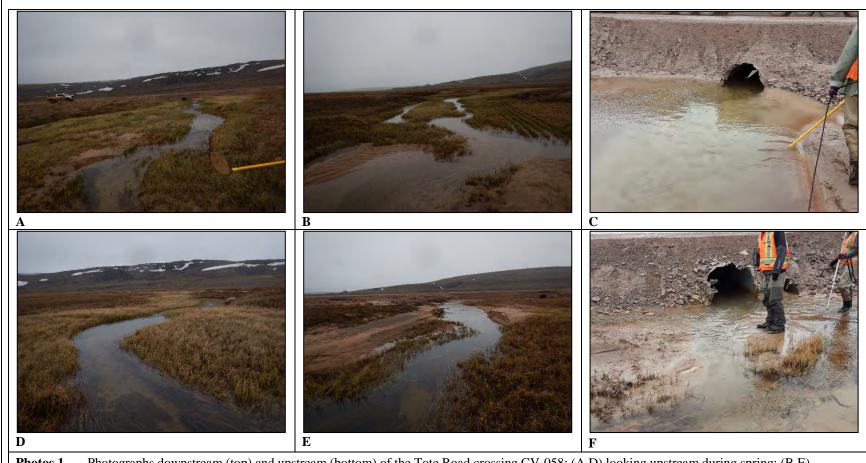
Summary: Site provides abundant summer rearing habitat for juvenile Arctic Char. There were no fish passage issues in 2021.

Photos 1. Photographs downstream (top) and upstream (bottom) of the Tote Road crossing CV-058: (A,D) looking upstream during spring; (B,E) looking downstream during spring; and (C,F) looking at culverts during fall.

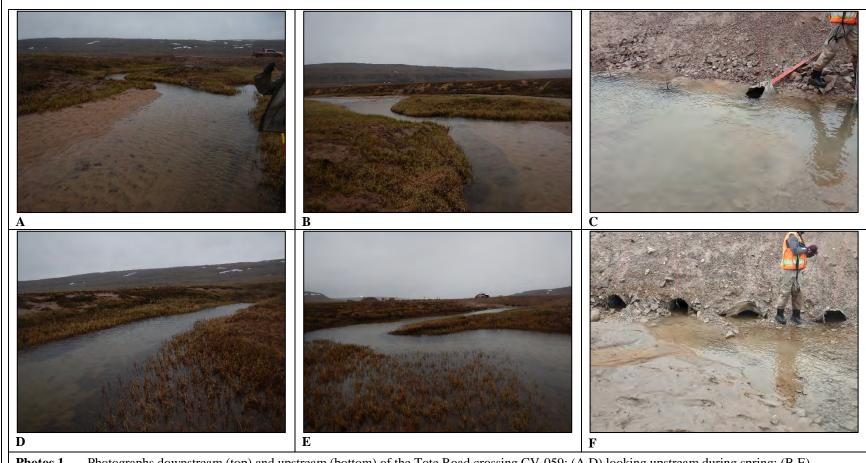
Summary: Site provides abundant summer rearing habitat for juvenile Arctic Char. There were no fish passage issues in 2021.

Photos 1. Photographs downstream (top) and upstream (bottom) of the Tote Road crossing CV-059: (A,D) looking upstream during spring; (B,E) looking downstream during spring; and (C,F) looking at culverts during fall.

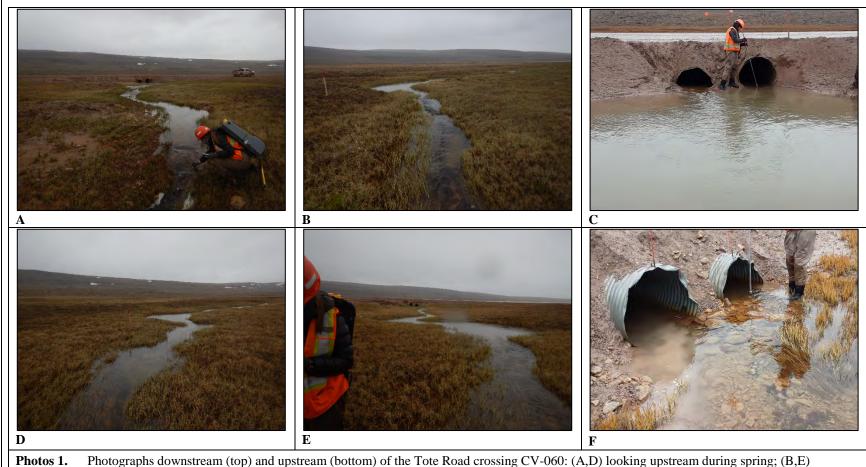
Summary: Site provides abundant summer rearing habitat for juvenile Arctic Char. There were no fish passage issues in 2021.

Photos 1. Photographs downstream (top) and upstream (bottom) of the Tote Road crossing CV-060: (A,D) looking upstream during spring; (B,E looking downstream during spring; and (C,F) looking at culverts during fall.

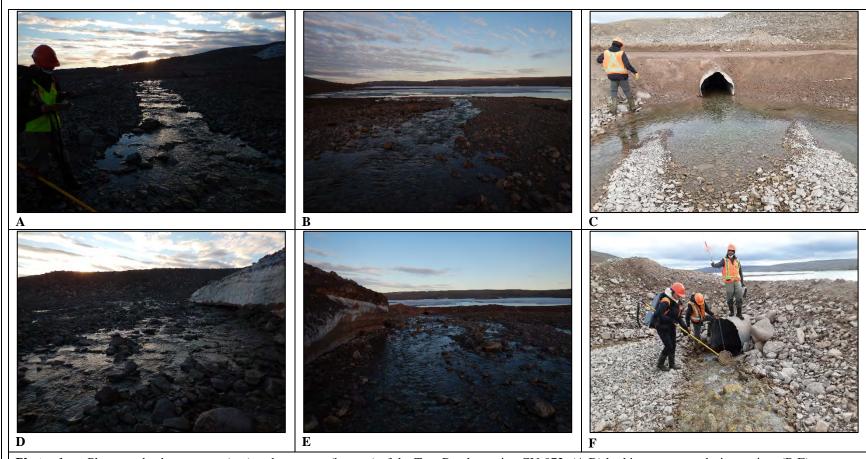
Summary: Site provides abundant summer rearing habitat for juvenile Arctic Char. There were no fish passage issues in 2021.

Photos 1. Photographs downstream (top) and upstream (bottom) of the Tote Road crossing CV-072: (A,D) looking upstream during spring; (B,E) looking downstream during spring; and (C,F) looking at culverts during fall.

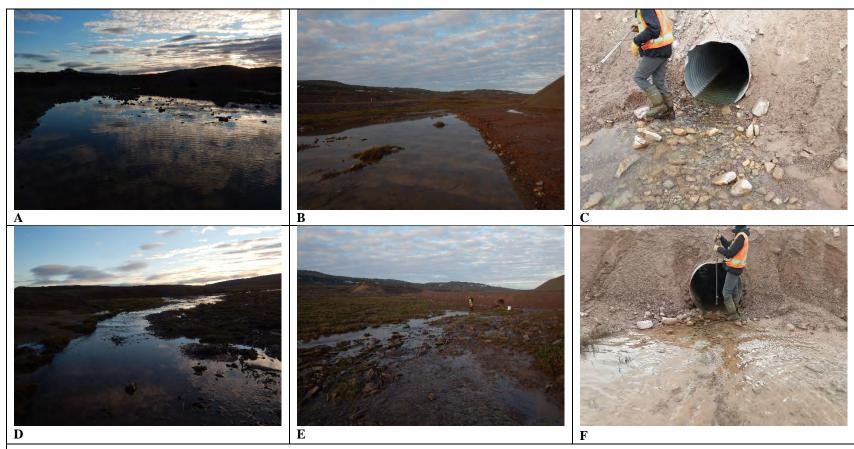
Summary: Small stream providing summer rearing habitat for juvenile Arctic Char. There were no issues affecting fish passage in 2021.

Photos 1. Photographs downstream (top) and upstream (bottom) of the Tote Road crossing CV-076: (A,D) looking upstream during spring; (B,E) looking downstream during spring; and (C,F) looking at culverts during fall.

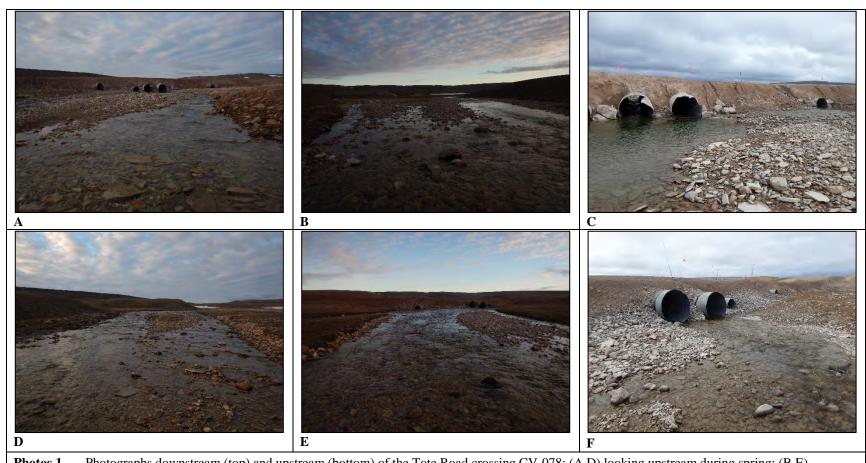
Summary: Site provides abundant summer rearing habitat for juvenile Arctic Char. There were no fish passage issues in 2021.

Photos 1. Photographs downstream (top) and upstream (bottom) of the Tote Road crossing CV-078: (A,D) looking upstream during spring; (B,E) looking downstream during spring; and (C,F) looking at culverts during fall.

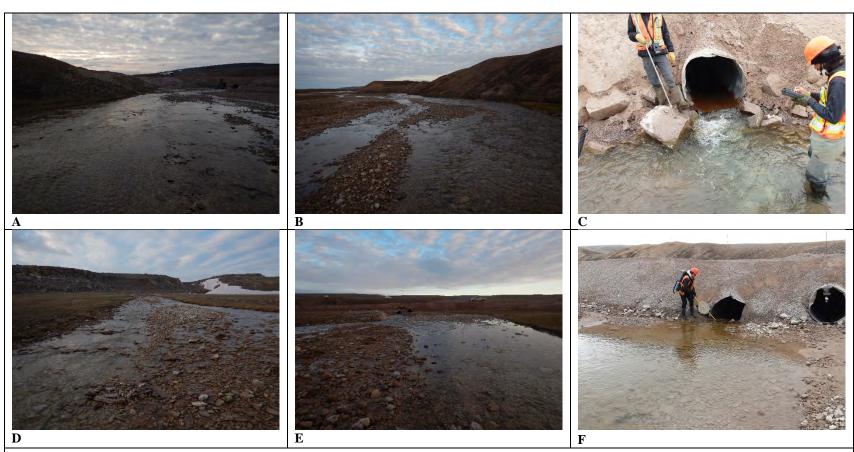
Summary: Site provides abundant summer rearing habitat for juvenile Arctic Char. There were no fish passage issues in 2021.

Photos 1. Photographs downstream (top) and upstream (bottom) of the Tote Road crossing CV-079: (A,D) looking upstream during spring; (B,E) looking downstream during spring; and (C,F) looking at culverts during fall.

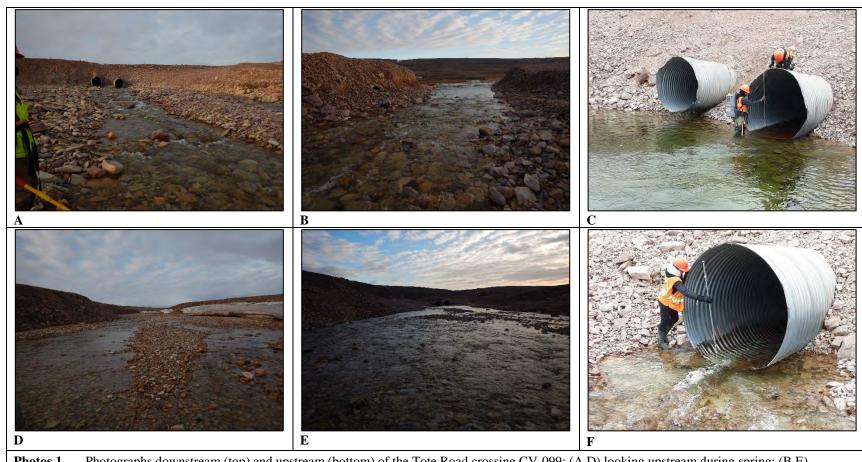
Summary: A large stream with abundant fish habitat. Water velocities in the culverts can be high enough to restrict upstream access to larger juveniles during periods of very high flows. There were no fish passage issues in 2021.

Photos 1. Photographs downstream (top) and upstream (bottom) of the Tote Road crossing CV-099: (A,D) looking upstream during spring; (B,E) looking downstream during spring; and (C,F) looking at culverts during fall.

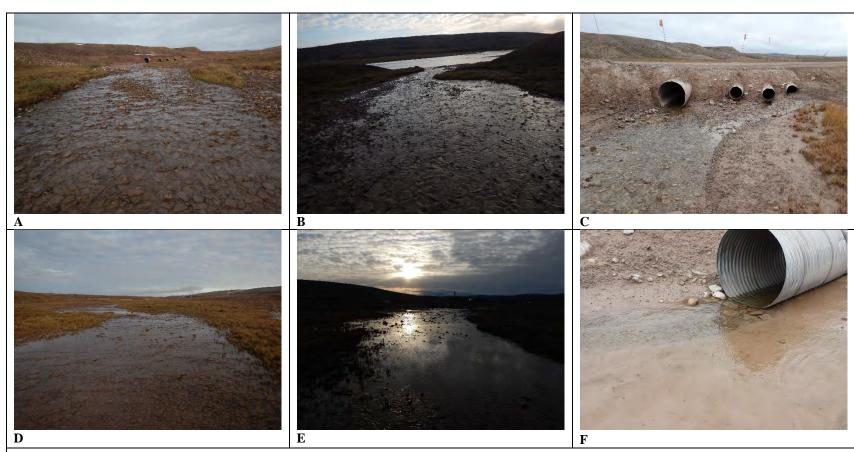
Summary: This stream typically provides summer rearing habitat for juvenile Arctic Char. There were no fish passage issues in 2021.

Photos 1. Photographs downstream (top) and upstream (bottom) of the Tote Road crossing CV-102: (A,D) looking upstream during spring; (B,E) looking downstream during spring; and (C,F) looking at culverts during fall.

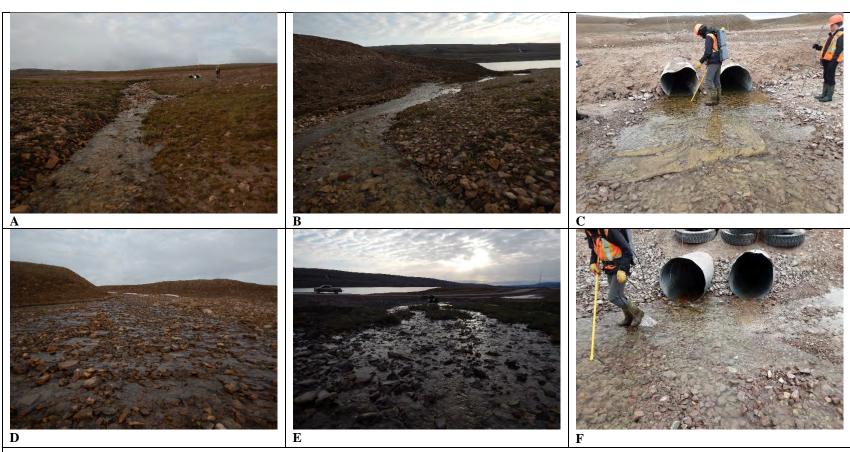
Summary: Though water levels are occasionally low (e.g., 2019), this stream typically provides summer rearing habitat for juvenile Arctic Char. There were no passage issues in 2021.

Photos 1. Photographs downstream (top) and upstream (bottom) of the Tote Road crossing CV-104: (A,D) looking upstream during spring; (B,E) looking downstream during spring; and (C,F) looking at culverts during fall.

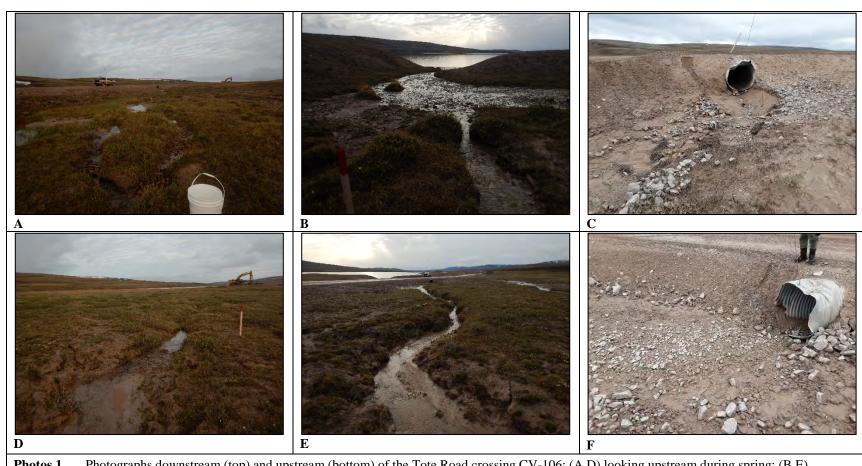
Summary: Stream provides summer rearing habitat for juvenile Arctic Char, though it frequently becomes dry following freshet without additional inputs of precipitation. An existing ramp (installed in 2018) designed to improve access received additional modifications in 2019 and 2020. Similar issues existed in 2021. Additional remediation may be required to improve the effectiveness of the ramp at providing fish passage during the periods of low water often experienced by this stream.

Photos 1. Photographs downstream (top) and upstream (bottom) of the Tote Road crossing CV-106: (A,D) looking upstream during spring; (B,E) looking downstream during spring; and (C,F) looking at culverts during fall.

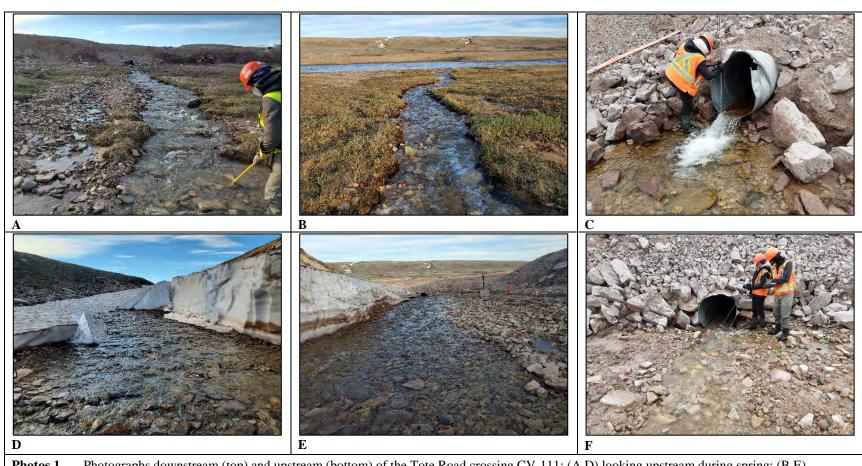
Summary: This stream provides summer rearing habitat for juvenile Arctic Char. Culvert was reinstalled during the winter of 2018/2019 with a high perch. Remediation measures in fall 2019 were insufficient to improve fish access and issues remained in 2021. Additional remediation required. See remediation Appendix for details.

Photos 1. Photographs downstream (top) and upstream (bottom) of the Tote Road crossing CV-111: (A,D) looking upstream during spring; (B,E) looking downstream during spring; and (C,F) looking at culverts during fall.

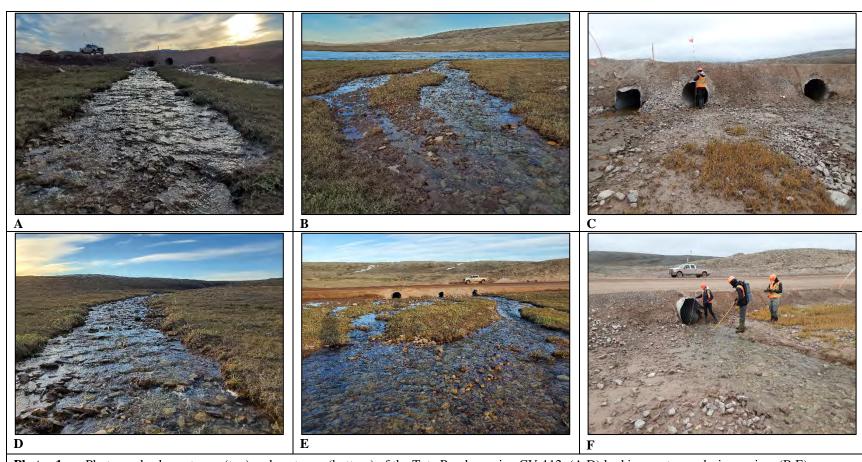
Summary: This stream provides summer rearing habitat for juvenile Arctic Char. There were no fish passage issues in 2021.

Photos 1. Photographs downstream (top) and upstream (bottom) of the Tote Road crossing CV-112: (A,D) looking upstream during spring; (B,E) looking downstream during spring; and (C,F) looking at culverts during fall (upstream photo includes only the left culvert).

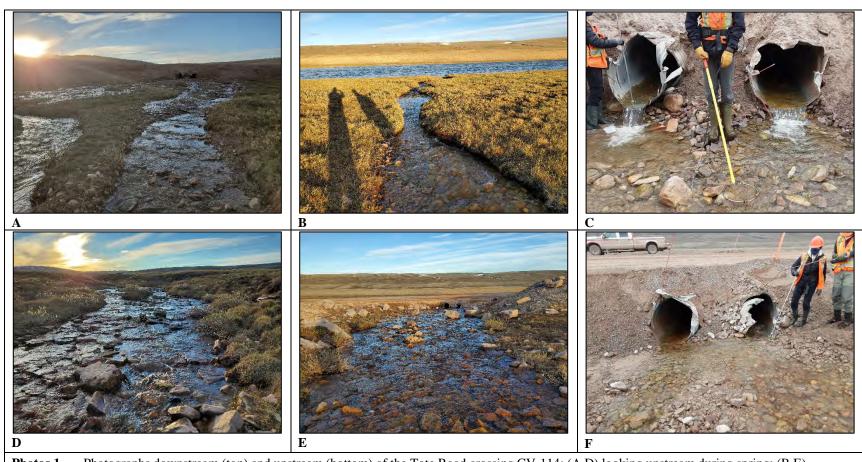
Summary: This stream provides habitat for juvenile Arctic Char. Perched culverts that may affect upstream access were remediated in fall 2019 and minor repairs to the works were completed in fall 2020. The remediation structure was destroyed during freshet and/or during snow clearing activities in 2021. New remediation measures will be required.

Photos 1. Photographs downstream (top) and upstream (bottom) of the Tote Road crossing CV-114: (A,D) looking upstream during spring; (B,E) looking downstream during spring; and (C,F) looking at culverts during fall.

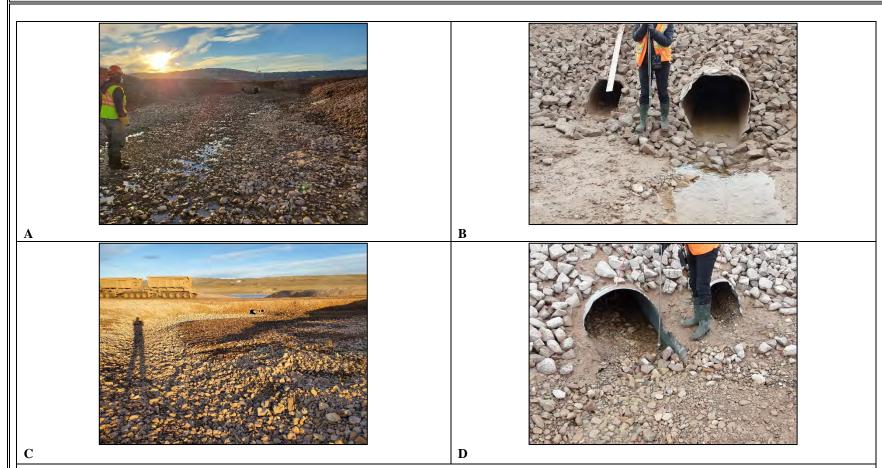
Summary: Stream has been regularly surveyed and is dry most years. The stream was nearly dry during both surveys in 2021 and no fish were present.

Photos 1. Photographs downstream (top) and upstream (bottom) of the Tote Road crossing CV-115: (A,C) looking upstream during spring; and (B,D) looking at the culvert during fall.

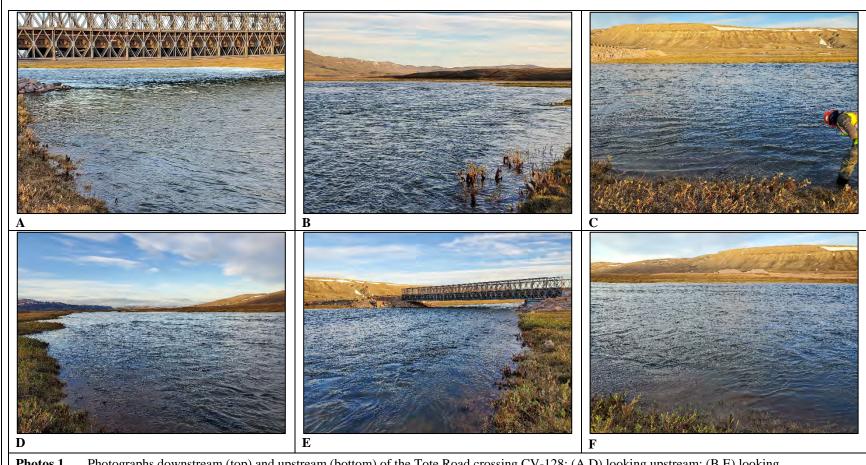
Summary: A bridge crossing of a major river that has consistently provided abundant fish habitat with no passage issues in 2021.

Photos 1. Photographs downstream (top) and upstream (bottom) of the Tote Road crossing CV-128: (A,D) looking upstream; (B,E) looking downstream; and (C,F) looking across during spring.

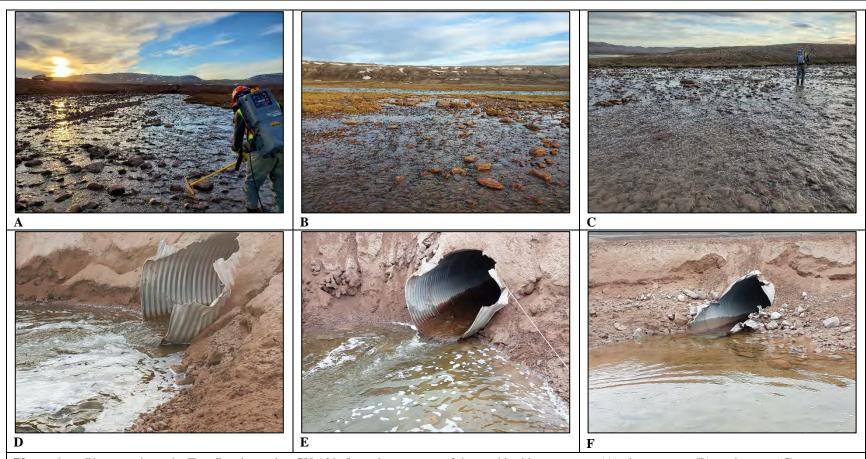
Summary: This site has consistently provided good quality summer rearing habitat for juvenile Arctic Char and is the first large tributary upstream of the impassable falls on Phillips Creek (i.e., fish use is restricted to land-locked Arctic Char). Small culvert perch was remediated in fall 2019 and minor repairs to the remediation works were conducted in fall 2020. The structure was damaged, and the perch reoccurred in 2021. Alternate remediation measures may be required. Upstream overwintering lake provides additional habitat.

Photos 1. Photographs at the Tote Road crossing CV-129: from downstream of the road looking upstream (A), downstream (B), and across (C) during spring; looking at the downstream end of the culvert during spring (D) and fall (E); and looking at the upstream end of the culvert during fall (F).

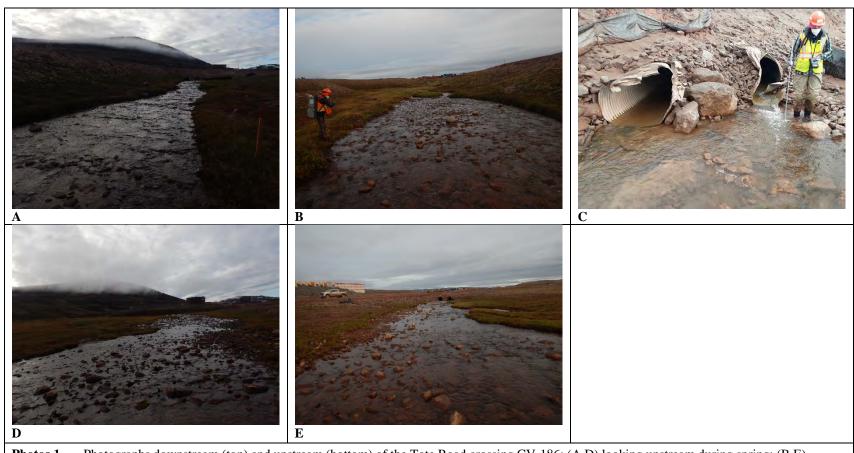
Summary: Site provides summer rearing habitat for both species. No fish passage issues in 2021.

Photos 1. Photographs downstream (top) and upstream (bottom) of the Tote Road crossing CV-186: (A,D) looking upstream during spring; (B,E) looking downstream during spring; and (C) looking at culverts during fall.

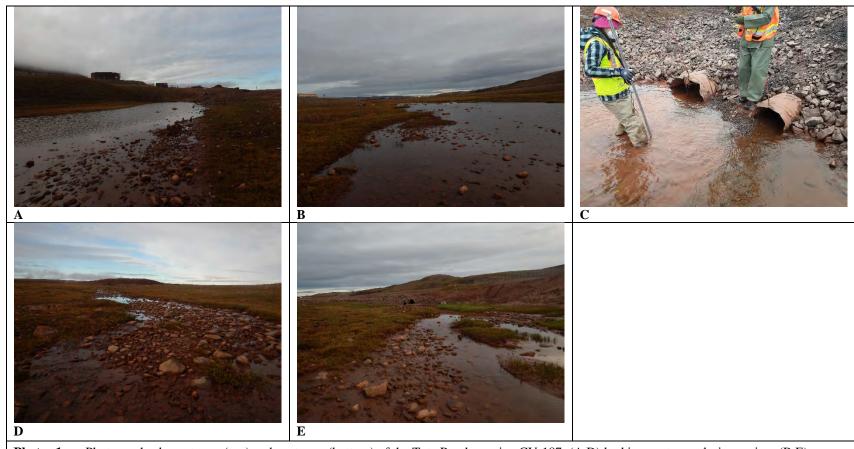
Summary: Site provides summer rearing habitat for both species, though upstream reaches become dry as water levels decrease. No fish passage issues in 2021.

Photos 1. Photographs downstream (top) and upstream (bottom) of the Tote Road crossing CV-187: (A,D) looking upstream during spring; (B,E) looking downstream during spring; and (C) looking at culverts during fall.

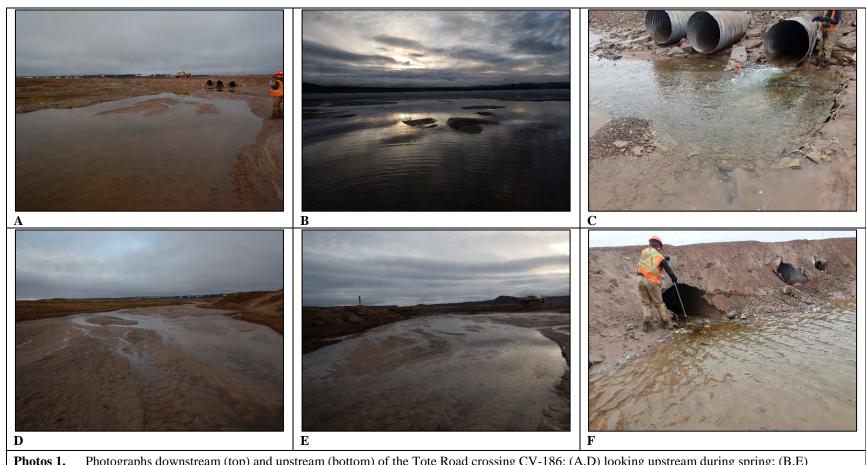
Summary: A small stream that provides habitat for Ninespine Stickleback and small juvenile Arctic Char (especially young-of-the-year from Muriel Lake). A slight perch was remediated in 2019 and small repairs to the structure were completed in fall 2020. The structure was damaged during freshet or snow clearing activities in early 2021. Alternative remediation may be required.

Photos 1. Photographs downstream (top) and upstream (bottom) of the Tote Road crossing CV-186: (A,D) looking upstream during spring; (B,E) looking downstream during spring; and (C,F) looking at culverts during fall.

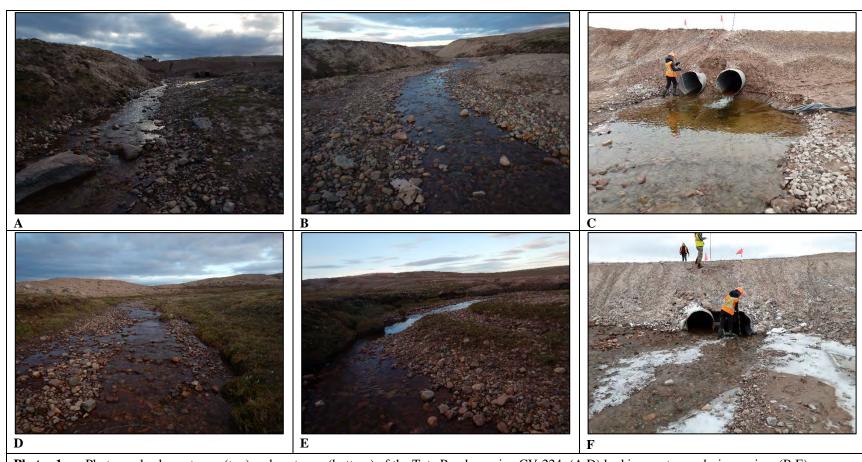
Summary: The site provides summer rearing habitat for both species. The fish passage culvert was still frozen after peak freshet at the time of the spring 2021 survey. No other fish passage issues were observed in 2021. Crossing should be monitored every spring for recurrence of ice damming.

Photos 1. Photographs downstream (top) and upstream (bottom) of the Tote Road crossing CV-224: (A,D) looking upstream during spring; (B,E) looking downstream during spring; and (C,F) looking at culverts during fall.

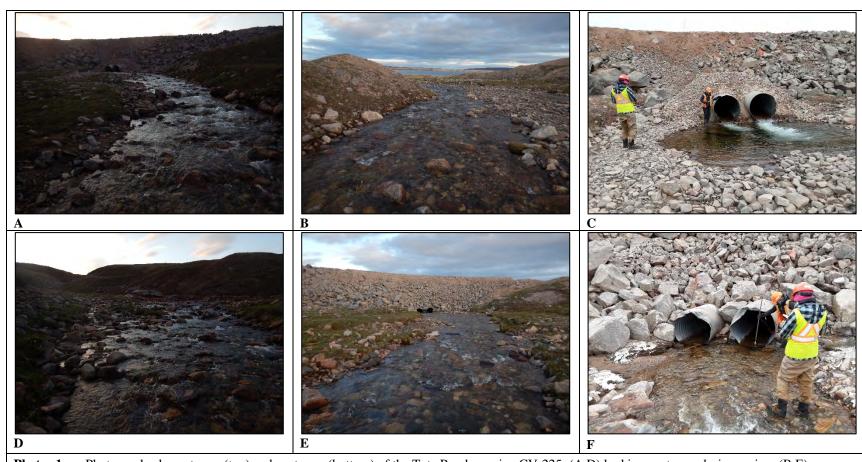
Summary: Site provides summer rearing habitat for both species. Remediation completed in early spring 2020 successfully reduced perching. However high culvert velocities remain a potential issue and spring ice damming inside the culverts is common. Continue monitoring of road and culverts going forward.

Photos 1. Photographs downstream (top) and upstream (bottom) of the Tote Road crossing CV-225: (A,D) looking upstream during spring; (B,E) looking downstream during spring; and (C,F) looking at culverts during fall.
