APPENDIX C.4

Tote Road Priority Action Schedule

Table C.4: Tote Road Priority Item Action Schedule

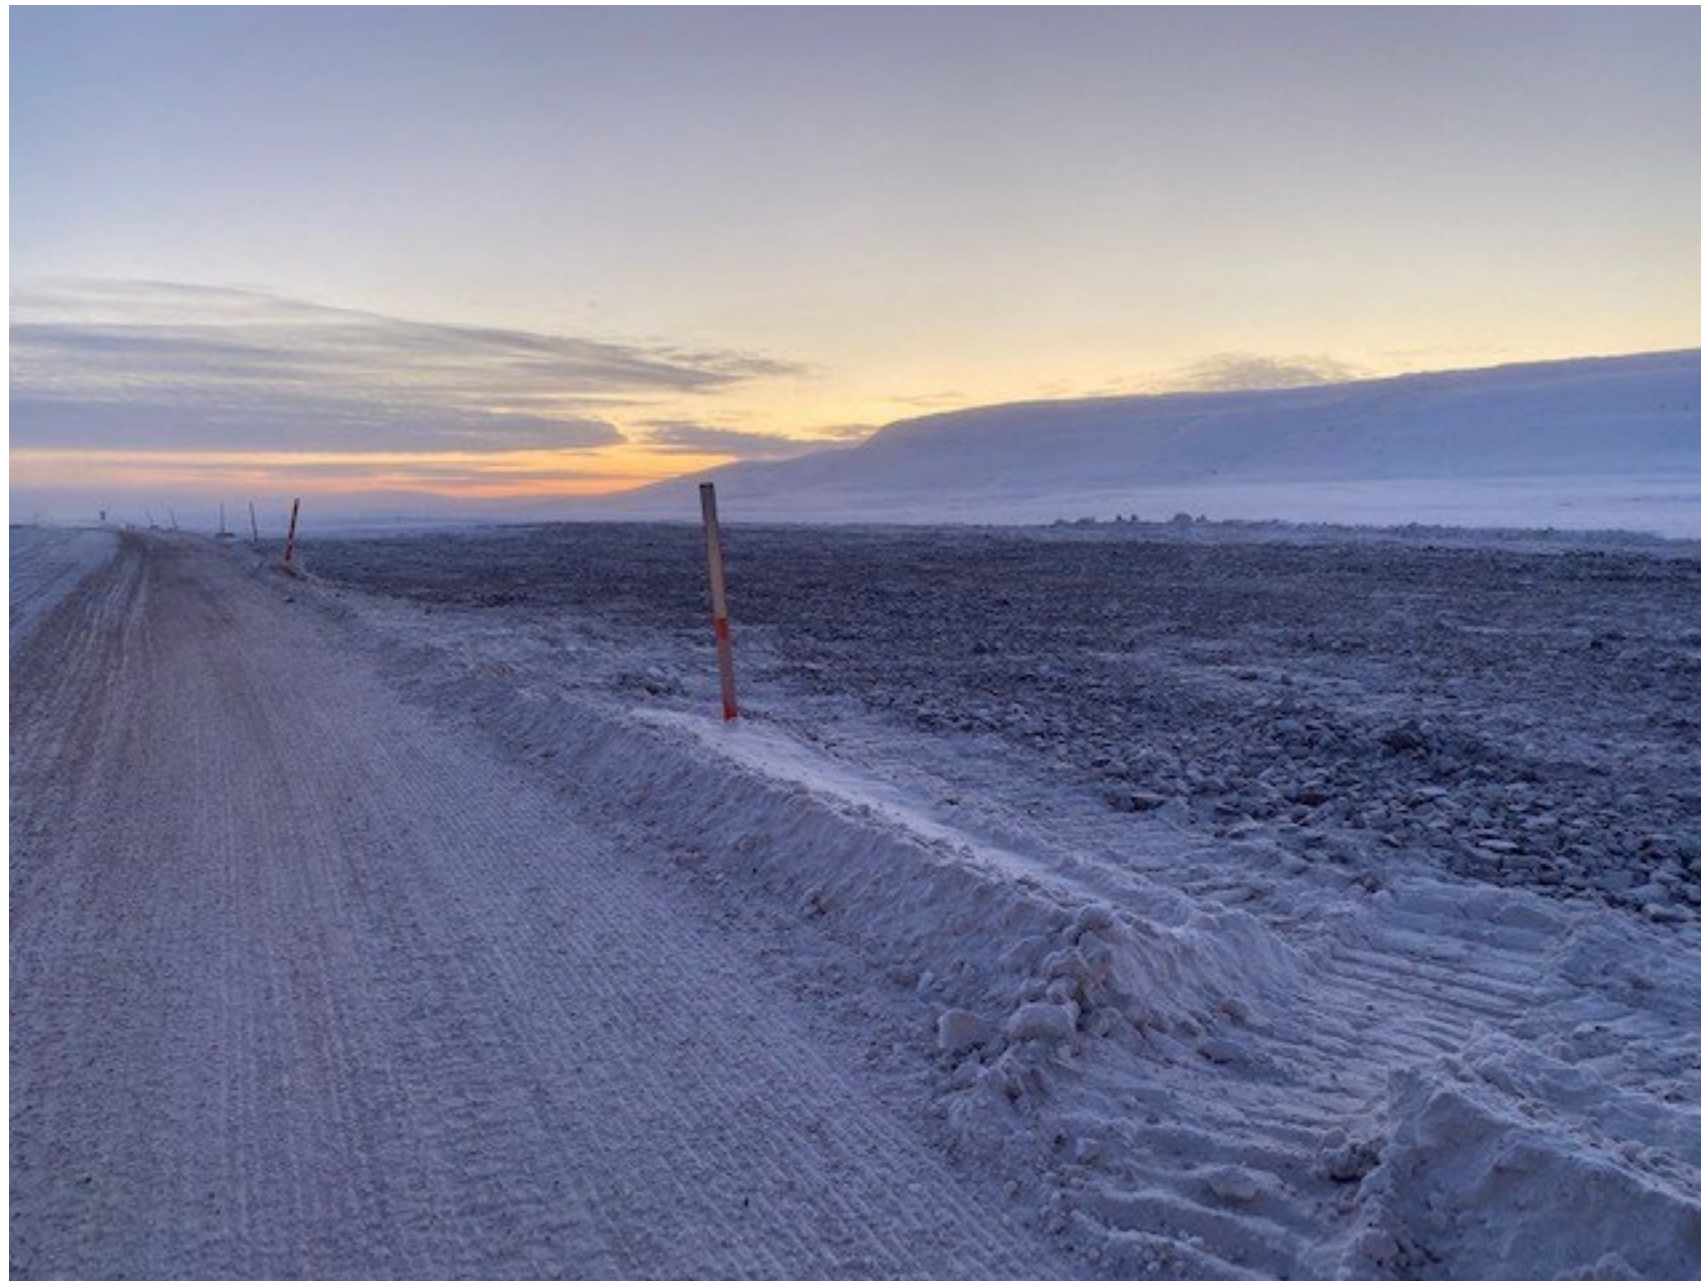
PHOTO 3 – KM 15, Nov 20 2021

75	15.0R	A	–	2574, 2586	More ponded water and there is a short section at the south end of the pit where there is a very steep side slope and considerable drop from the edge of the road down into the water. Pond should be drained and the area where water is ponding should be backfilled.	Planned for 2021- Material sourcing from Milne Inlet strippings, Q1 quarry, Km 13 road alignment leftover materials.	Work has been completed

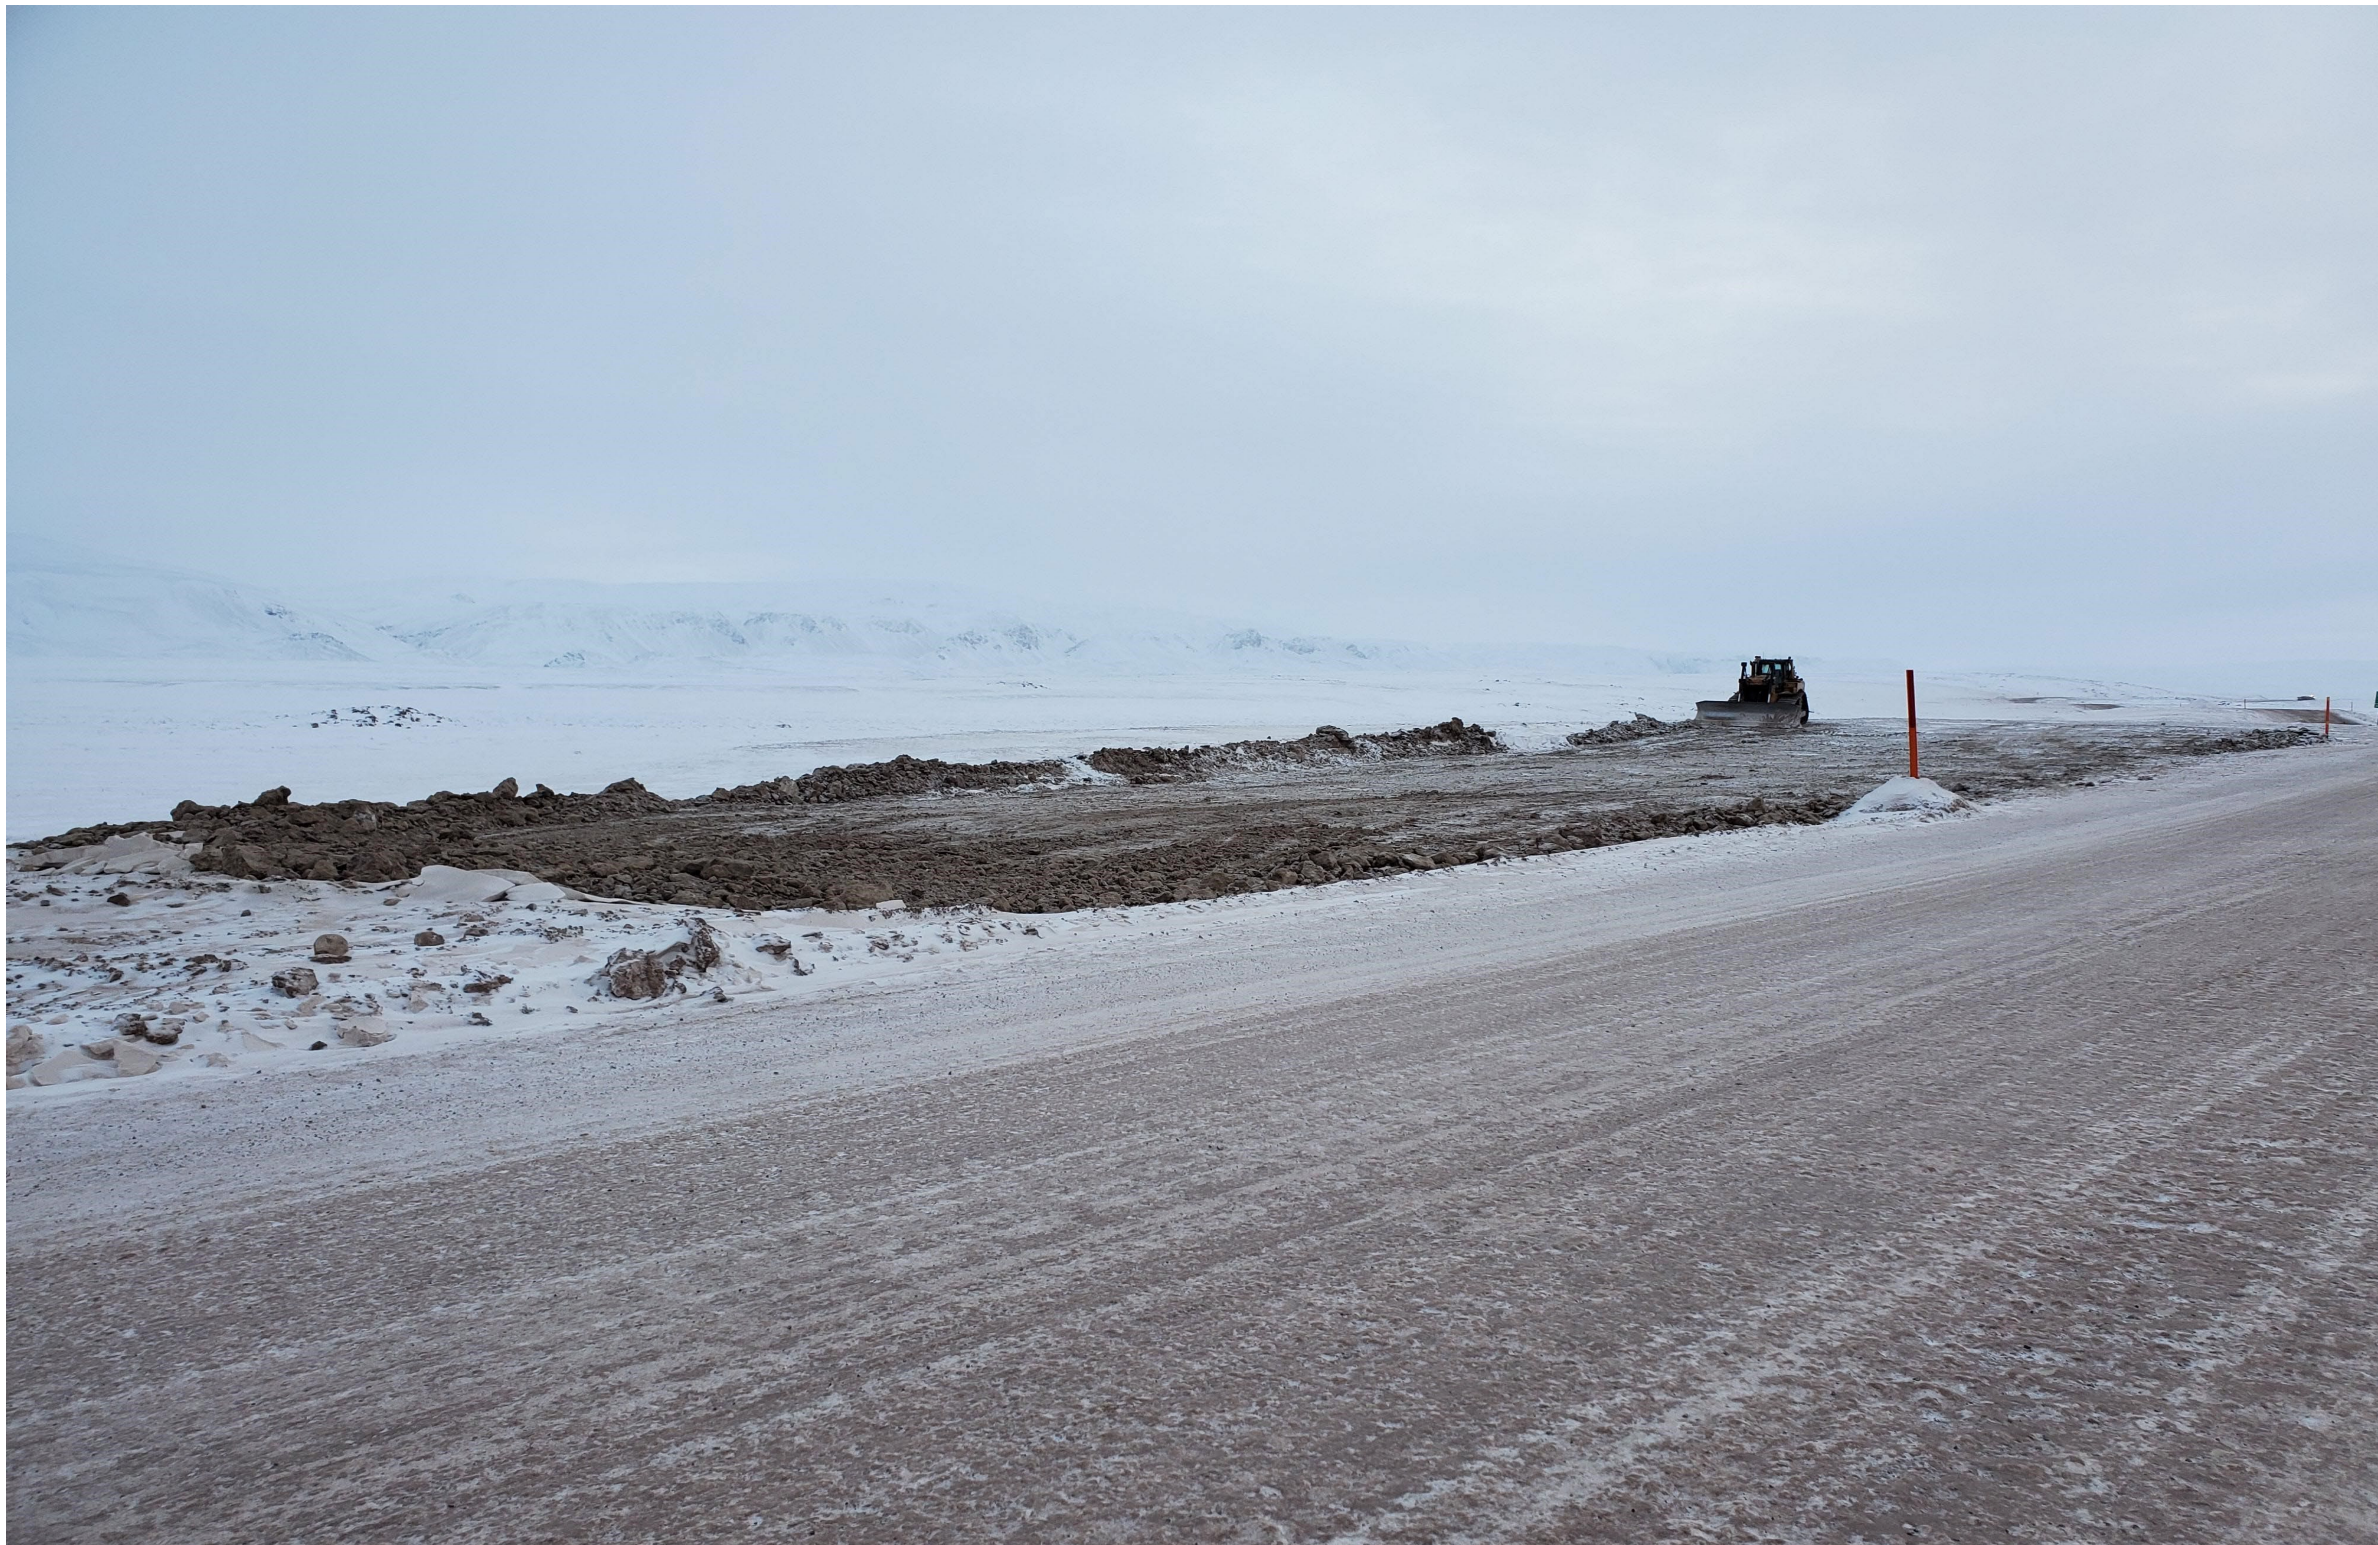
PHOTO 4 – KM 20.7, Nov 7 2021

71	20.7R	A++++	2543, 2544, 2545	2571	Pit remains similar to 2014 and settlement and instability of the road side slope is evident. Filling of the pit as soon as possible is still recommended to improve safety. See Section 4.0 for further detail	Planned Q3 2020, Material fill estimated at 3000 m3, planned to source from decommissioned road at km 23.5.	Work has been completed
72	19.8L	A++++	2540, 2541, 2542	2572, 2587	Photos 2541 and 2542 show instability on the side slopes and observed conditions and suggested stabilization measures remain as indicated in 2014. See Section 4.0 for further information.	Planned Q3 2020- Material fill estimated at 20,000 m3 - plan to source from decommissioned section of old road at km 23.5.	Work has been completed
74	16.9L&R	A	–	–	More water is ponding in the pits than noticed in 2014, and there is concern that rate of thaw will increase potentially leading to embankment instability but road currently appears stable. Determine if it is feasible to direct water from pit to reduce potential for increased thaw. Otherwise monitor closely to evaluate road stability.	Planned for 2021- Materials sourced from km 13 old road alignment construction stockpile.	Work has been completed
