**CIRNAC INSPECTION REPORTS  
AND BAFFINLAND RESPONSE**

**RE: Water Licence 2AM-MRY1325 September 2021 Inspection – Follow Up**

**2021-QIK-JKM012 2AM-MRY1325 Inspection Report**

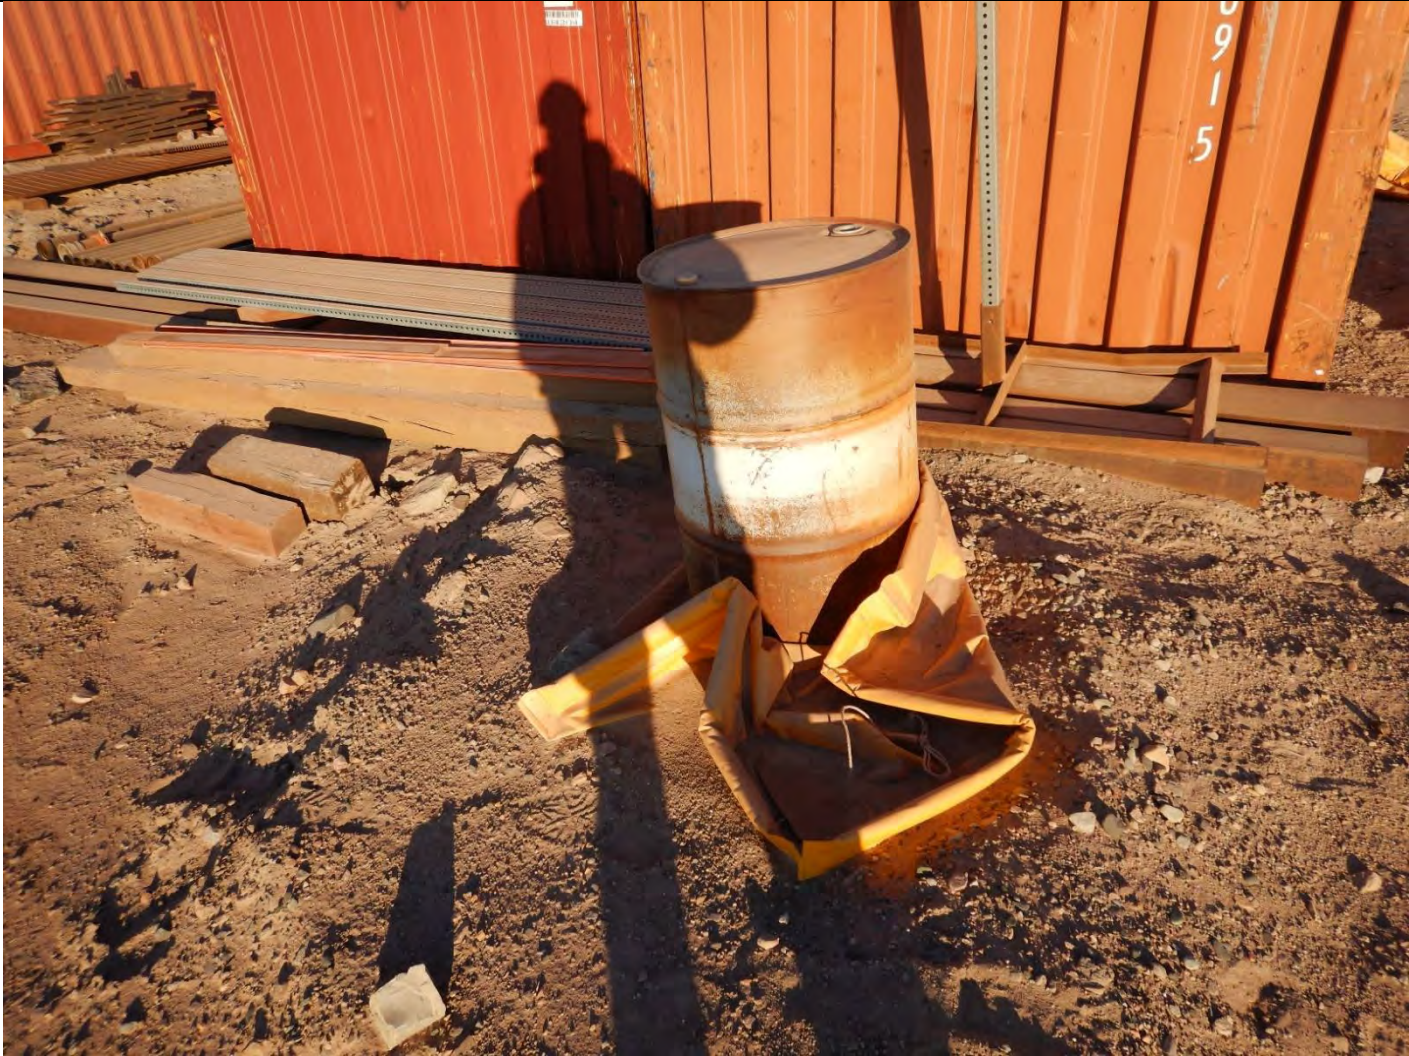
| Date | Camera | Inspector | Authorization |
|---|---|---|---|
| Description: damaged drip tray at km 97 | | | |

| Date | Camera | Inspector | Authorization |
|---|---|---|---|
| Description: damaged drip tray at km 97 | | | |

| | KM97 | Damaged drip trays were identified in CIRNAC inspection report supporting Photo 1 and Photo 2 beneath fuel drums at KM97. | The fuel drums at KM97 were removed from the area and placed in appropriate secondary containment. Photo 5 in Attachment 2 shows the area at KM97 with the fuel drums and damaged spill trays removed. |

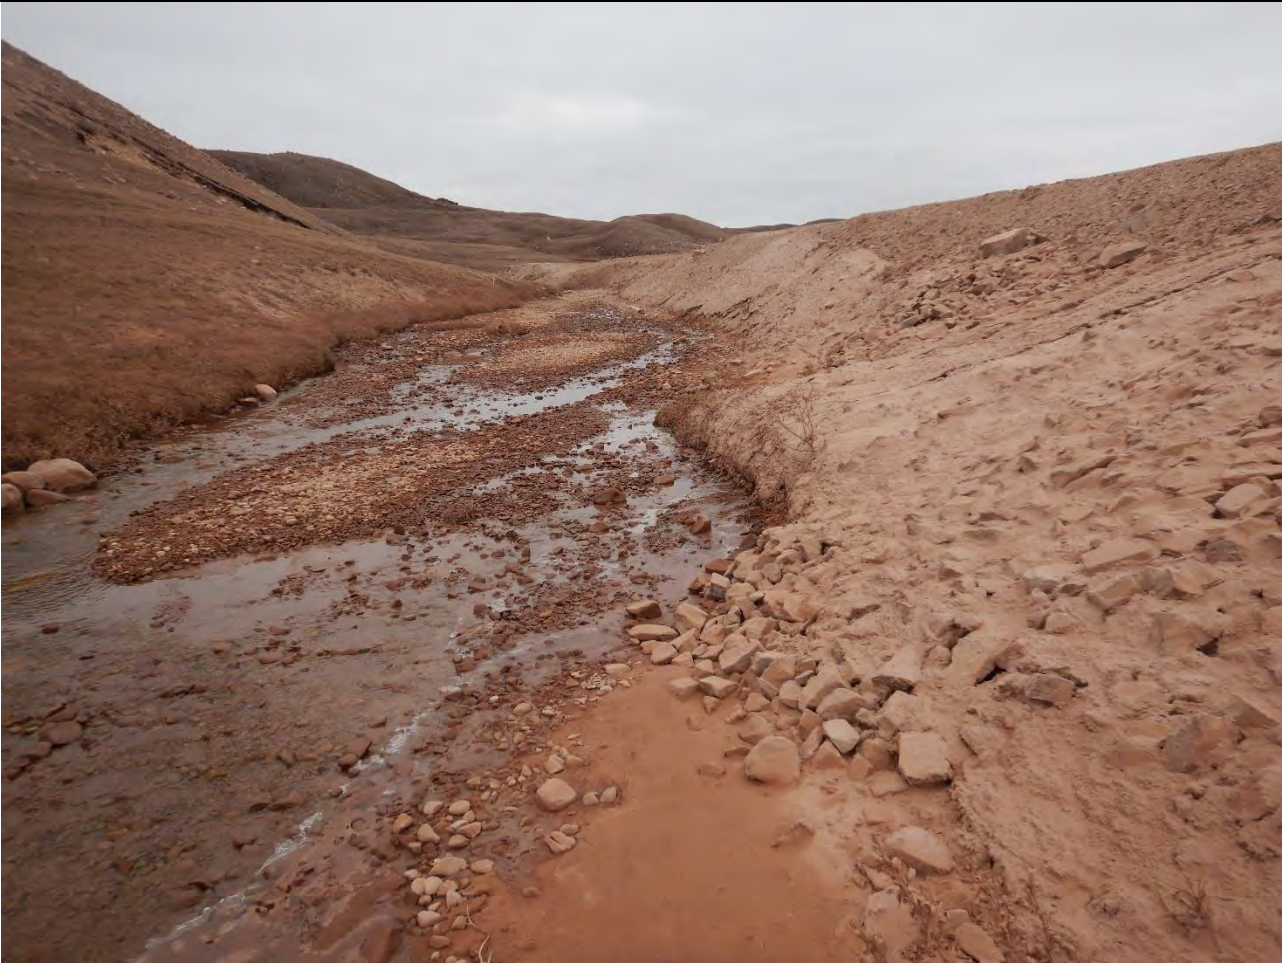
1-154A/ Spill 21247- there was visible erosion on the road near the culvert, upstream of the culvert and down stream of the culvert. See photos 4 &5 for erosion.

| Date | Camera | Inspector | Authorization |
|---|---|---|---|
| Description: Cv-154 erosion upstream | | | |

| Date | Camera | Inspector | Authorization |
|---|---|---|---|
| Description: Cv-154 erosion down stream. | | | |

| Number | Project Location | Description of Concern or Finding | Response |
|---|---|---|---|
| 2) | CV-154A | Spill 21247 - There was visible erosion on the road near the culvert, upstream of the culvert and down stream of the culvert. See photos 4 & 5 for erosion. The licensee is to install the appropriate erosion control measures to prevent continued erosion identified in comments A1-A7, C1 and C2. The licensee is to remediate all spills noted in this report. | Following the elevated TSS conditions at CV-154A on June 1, 2021, an assessment was completed to identify potential erosion and sediment control measures around the culvert crossing. During July 2021, check dams were constructed within the ditch and armouring of the ditch upstream of the culvert inlet was completed. Photo 2 in Attachment 2 shows the completed check dams. Additional work will be completed at this culvert crossing prior to freshet 2022, including removing excess sediment from the culvert inlet and outlet banks, reshaping and re-armouring of the embankment slopes, and routine maintenance of the check dams. |

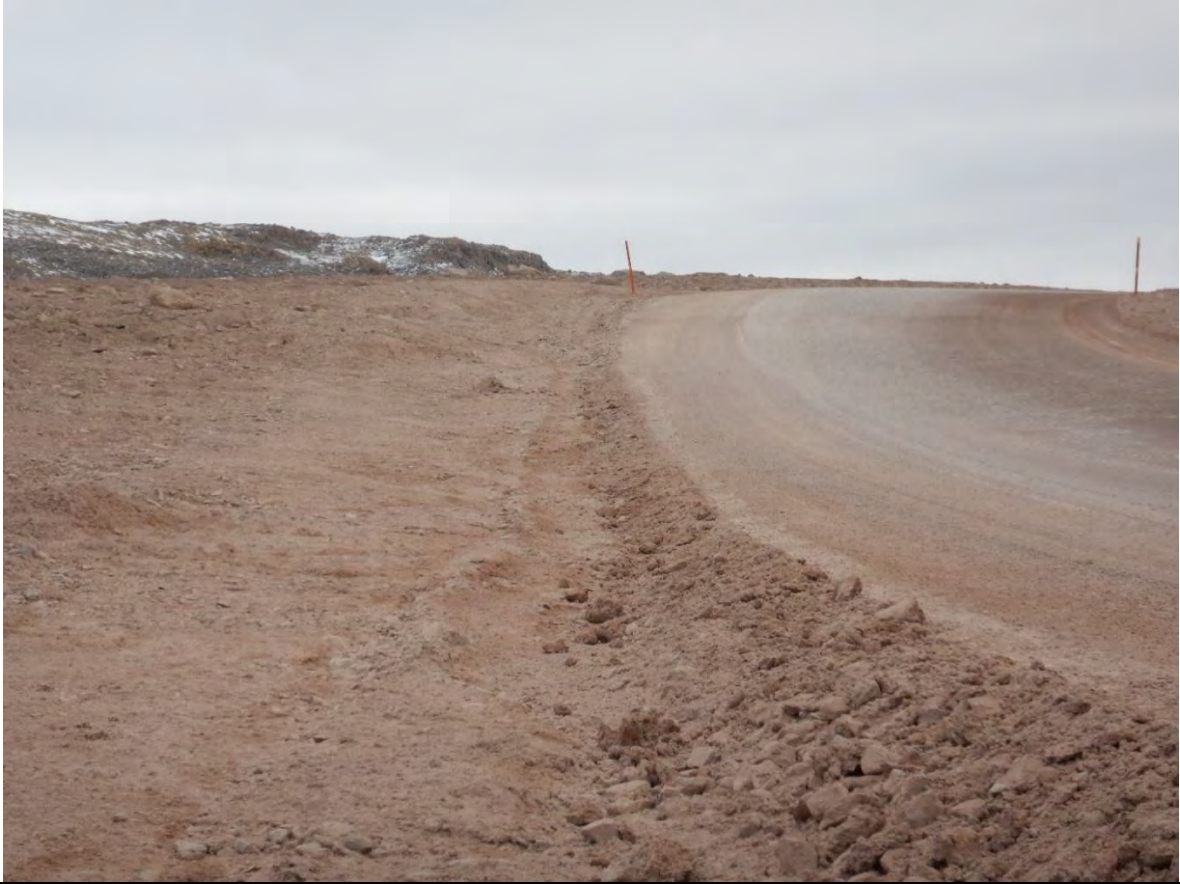
1-093/spill 21247- potentially non-engineered ditches upstream of the culvert could be causing increased TSS. See photo 6 for the potentially non-engineered ditches. See photo 7 for the potentially, non-engineered ditches.

| Date | Camera | Inspector | Authorization |
|---|---|---|---|
| Description: Cv-093, potential cause of TSS. | | | |

| 5) | CV-093 | Spill 21247- Potentially non-engineered ditches upstream of the culvert could be causing increased TSS. See photo of potentially non-engineered ditches. See photo 7 for the potentially, non-engineered ditches. The licensee is to install the appropriate erosion control measures to prevent continued erosion identified in comments A1-A7, C1 and C2. The licensee is to remediate all spills noted in this report. | Following the elevated TSS conditions at CV-093 on June 9, 2021, temporary ESC measures were installed and an assessment was completed to identify erosion and sediment control measures around the culvert crossing. During the summer 2021, rip rap was placed at the inlet and outlet of the culvert crossing embankments in accordance with the SWAEMP. Photo 4 in Attachment 2 shows the rip rap placed at the inlet of the culvert crossing. Additional work will be completed at this culvert crossing prior to freshet 2022, including the excavation of sediment build up from the ditch draining to the culvert inlet, and reshaping and armouring of the ditch as per the approved Civil Design Criteria for the Project. |

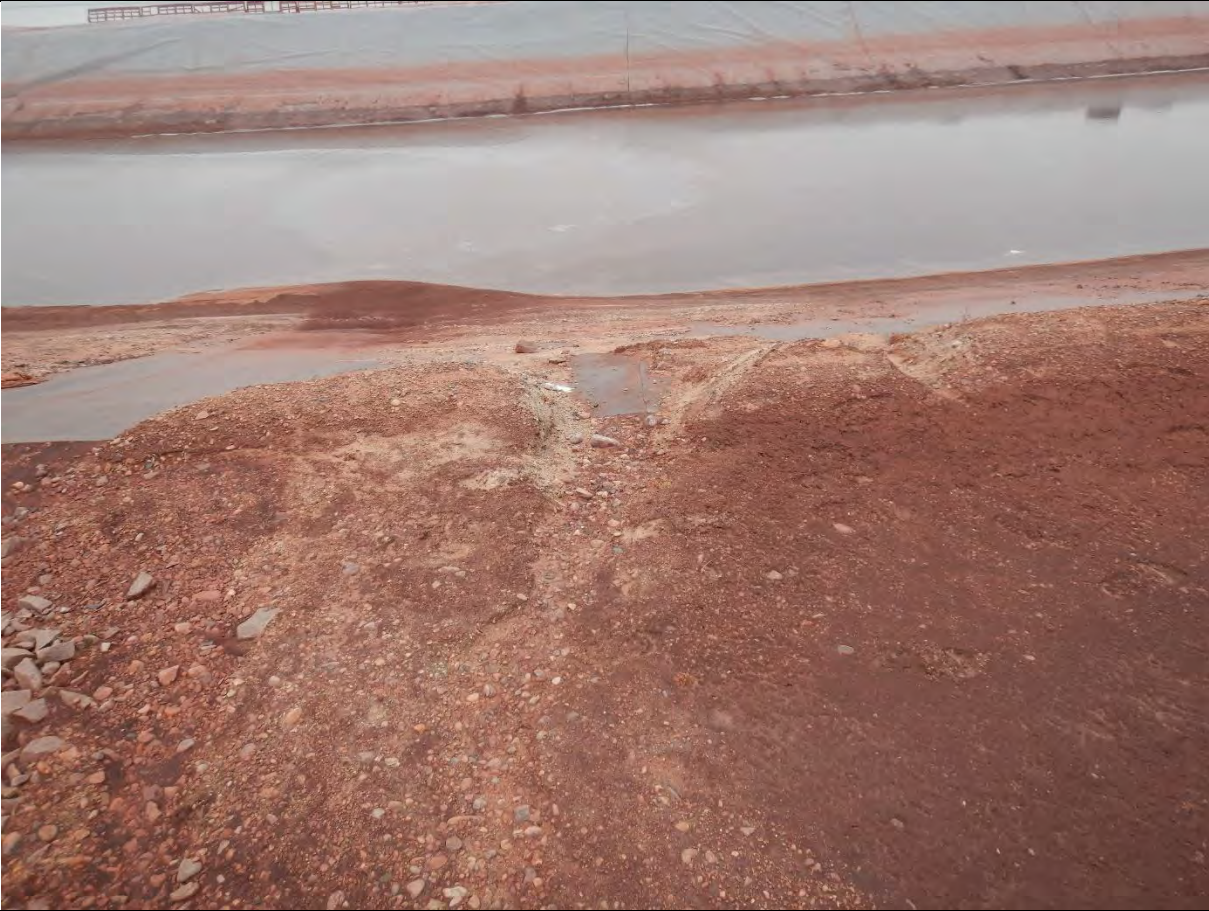
Description: erosion on the East inflow of MP-06

| 2) | MP-06 | There was erosion noted on the East inflow of the pond, the pond appeared appropriately pumped down. See photo 12 for the erosion noted. | Surface Water Management Pond MP-06 and associated ditches are routinely inspected as per Baffinland's Type A Water License. A geotechnical inspection of MP-06 was completed in September 2021, and the 2021 Geotechnical Report No. 2 noted that the pond was in excellent condition with stable, well-maintained berms and intact liner. To prevent the erosion observed during the September Water Licence inspection, a berm will be constructed to ensure runoff from the Ore pad enters the appropriate ditches for conveyance to MP-06. Baffinland will conduct routine monitoring and maintenance activities prior to Freshet 2022, which includes the regrading and stabilization of berm slopes and crests, and ensuring runoff from the ore pad enters the appropriate ditches. |

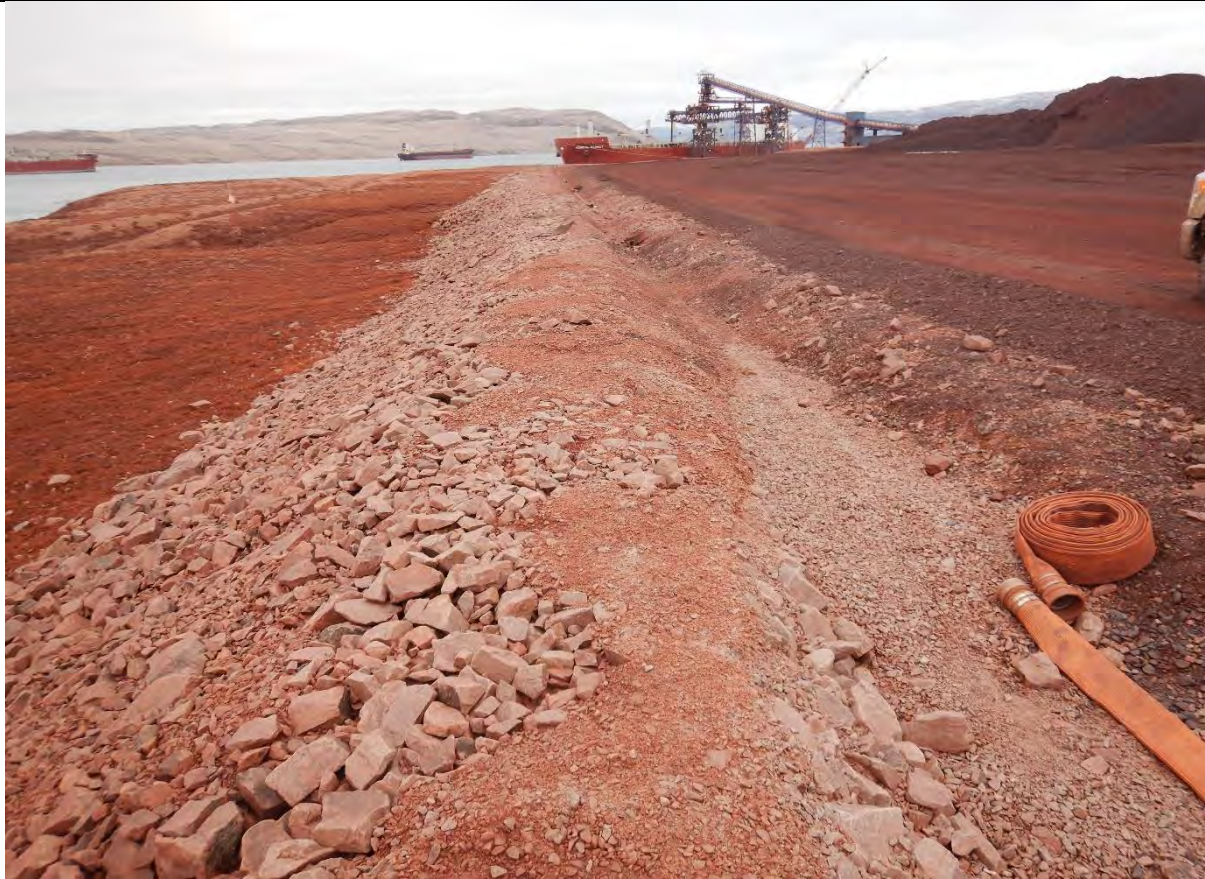
Description: hoses required for pumping and leaking area of the ditch.

| 3) | Pond 3 | Pond 3 is unable to passively drain into MP-06 and the ditch connecting the two ponds is leaking. The surface water on the South West side of the ore pad is unable to drain into Pond 3. See photo 13 for a picture of the hoses used to pump the water from pond 3 into mp-06 and the area leaking.<br>The licensee is to ensure the following waste/water management structures are operating as intended and consistent with the design in the plans approved by the Nunavut Water Board; Ore stockpile ditches and gradient, Crusher pad ditches, MP-07 ditches, Western Globe Fuel Module, HWB 03, HWB 04. | The west ore pad ditch normally collected a low volume of runoff water from the ore pad intermittently, however, a temporary diversion berm was constructed to prevent this runoff from reporting to the ditch until the ditch is repaired. In the interim, ore pad runoff water is being redirected to the surface water management ponds. The temporary diversion berm is inspected on a regular basis and is functioning as intended and diverting water away from the affected ditch and to the surface water management ponds. Pond 3 water is pumped directly into MP-06 whenever necessary. Corrective actions to address the seepage are under investigation and runoff water from the ore pad will continue to be diverted to the surface water management ponds via the interim measures until permanent corrective actions are identified and implemented. |

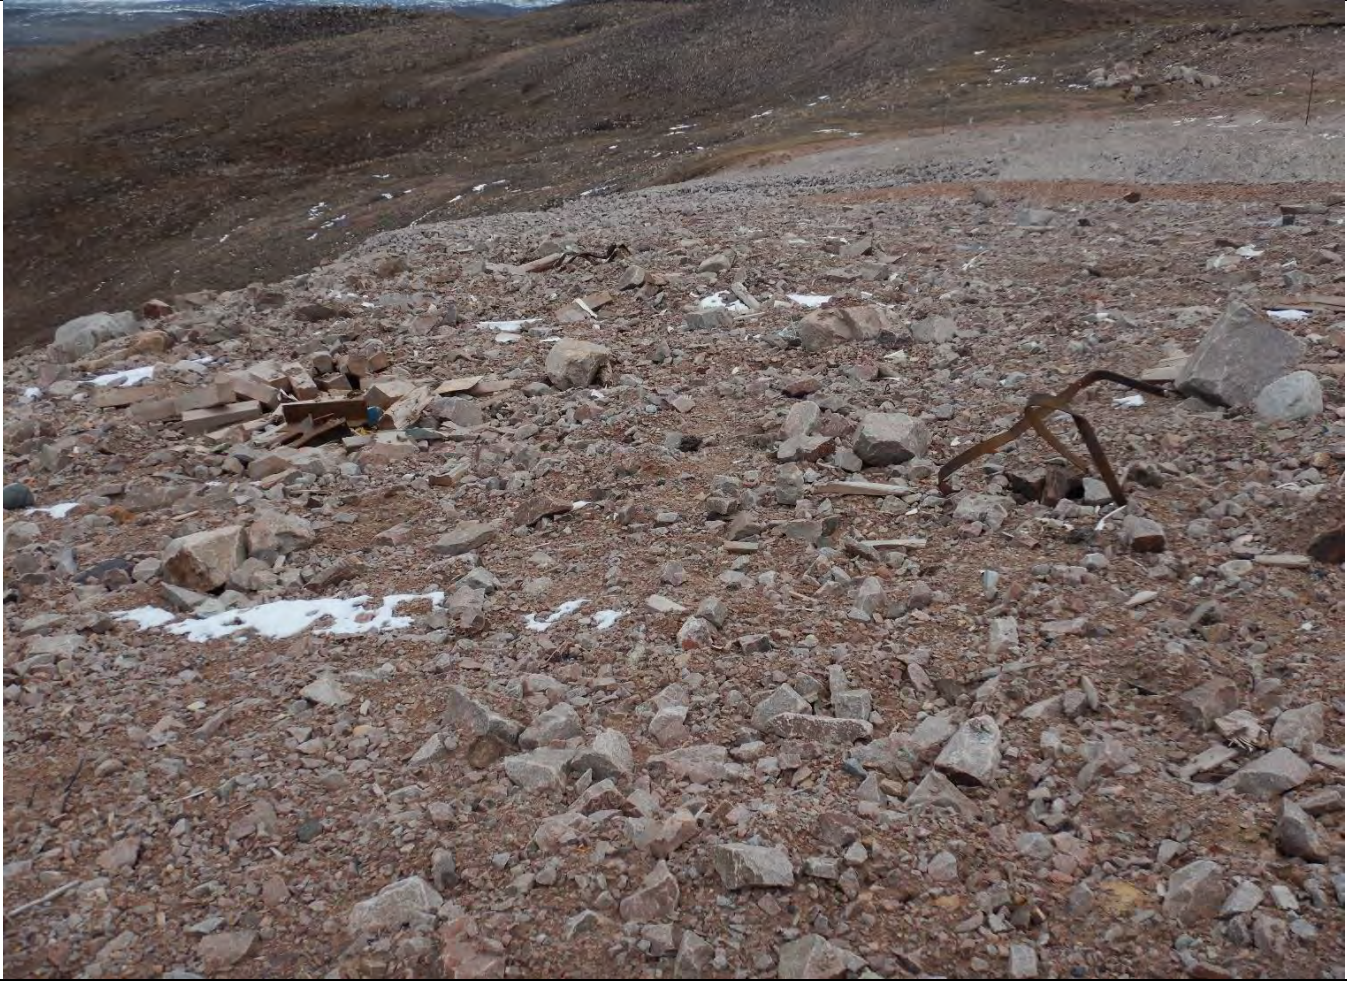
- 4)Snow dumps- The snow dumps appear to be contaminated with litter scooped up during the winter season. see photos 14 and 15 for waste in the snow dumps.

Description: current snow dump containing waste.

Description: previous snow dump still containing plastic, metal and wood waste

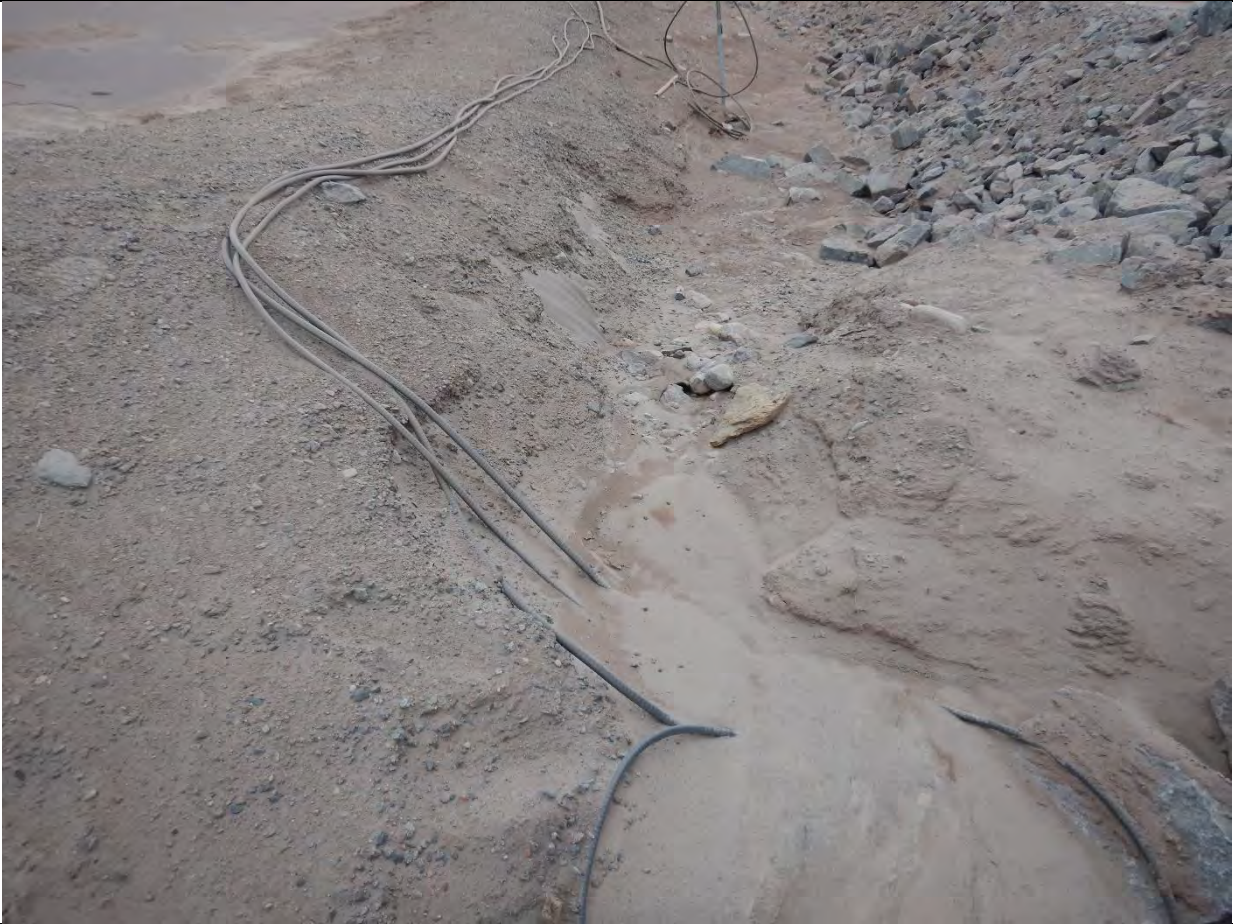
Description: Erosion on outside of aircraft fuel berm.

| 2) | Aircraft Fuel Berm | The inspector noted erosion on the outside of this berm. See photo 20 for the erosion noted. The licensee is to install the appropriate erosion control measures to prevent continued erosion identified in comments A1-A7, C1 and C2. | The Jet A Fuel Tank Berm, located at the aerodrome, is routinely inspected as per Baffinland's Type A Water License. A geotechnical inspection of the facility was completed in September 2021, and the 2021 Geotechnical Report No. 2 noted that the facility is surrounded by a stable perimeter berm and that a second berm, constructed from crushed rock fill, provides additional protection at two (2) sides (Tote Road and airport parking sides) of the facility. Baffinland will conduct routine maintenance activities prior to Freshet 2022 to address the minor berm erosion, including regrading of berm slopes and crests and runoff diversion away from the berm slopes to prevent future erosion. |

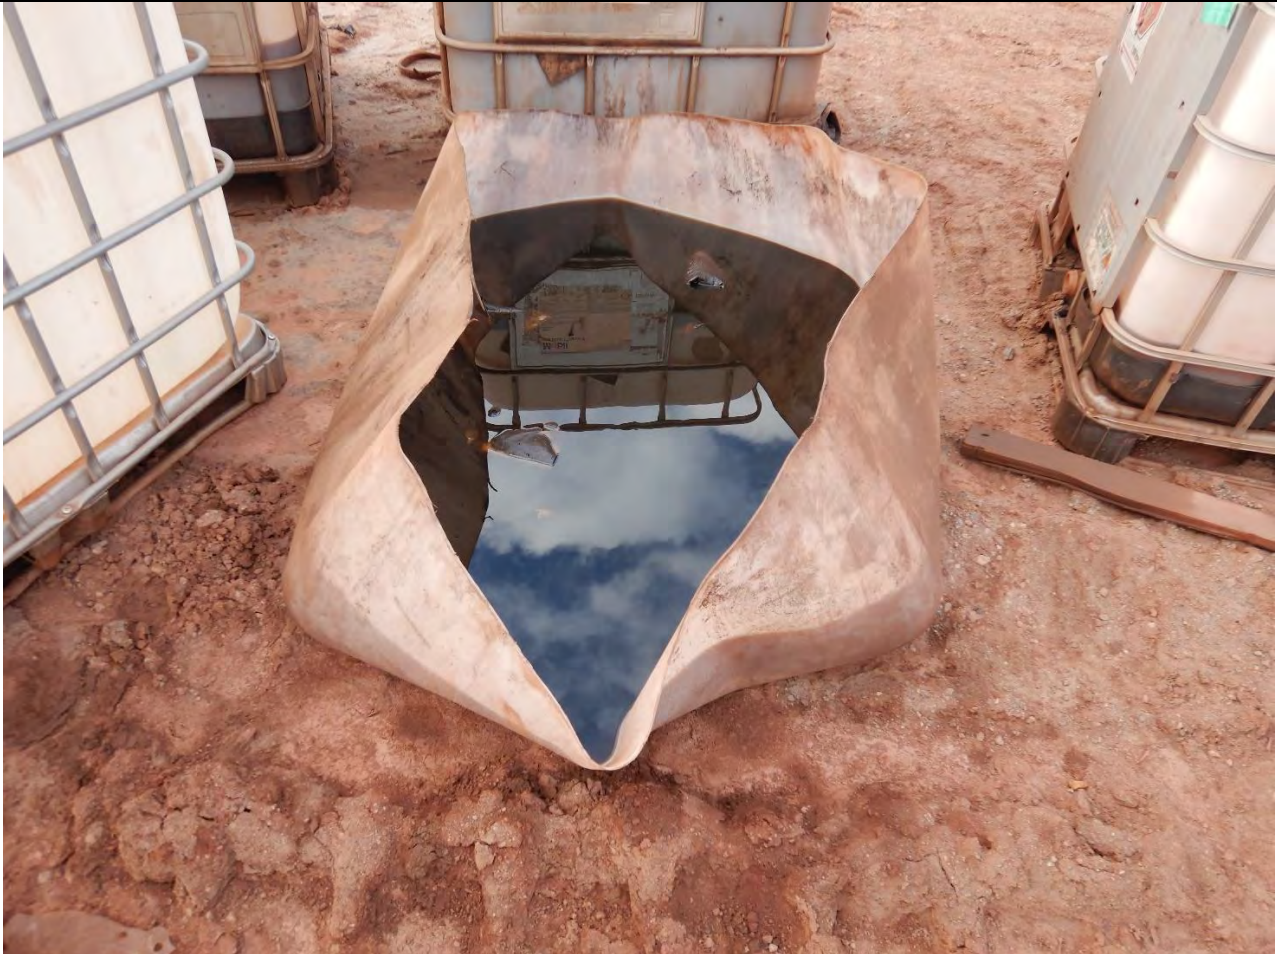
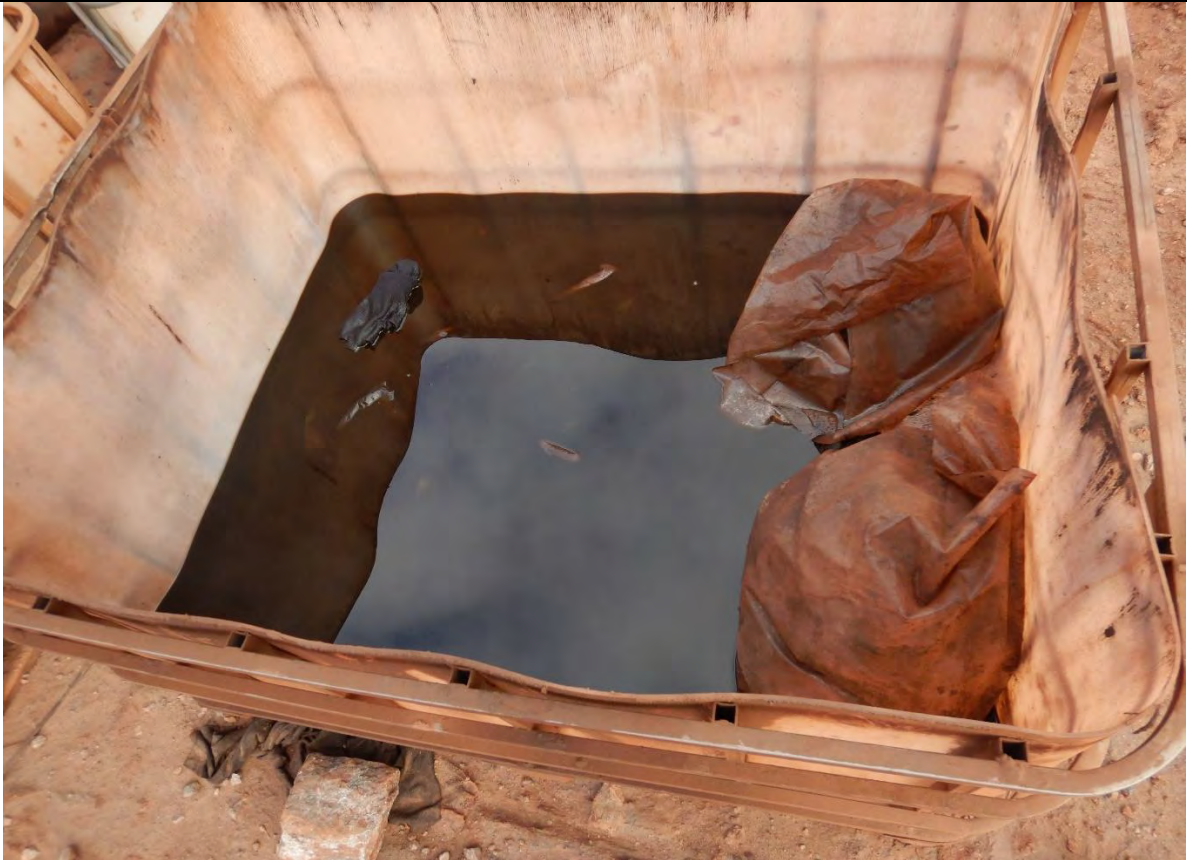
Description: dirty spill rags and unknown waste in open container outside of containment

| 7) | KM 104 Laydown | <p>During the inspection the inspector noted the following concerns at the 104 laydown:</p> <ul style="list-style-type: none"><li>• Lubricants and hazardous material outside of containment, in damaged containment and staining which smelled strongly of fuel. See photo 25 for the area with staining and hazardous material outside of containment.</li><li>• Open containers with dirty absorbent rags nearing capacity, see photo 26 and 27 for the containers.</li><li>• Heavy equipment actively leaking on the ground with no drip tray, see photos 28 and 29 for photos of fluid under heavy equipment at laydown 104.</li></ul> | <p>Containers that were observed to be located outside of secondary containment are in progress of being removed from the area and placed within appropriate secondary containment. Surficial staining observed beneath heavy equipment at the KM104 Laydown was cleaned up and placed in appropriate secondary containment. Spill trays were subsequently placed underneath dripping equipment and equipment in mid-term and long-term storage, in accordance with the EPP, to provide secondary containment to prevent spills due to product leaks. Photo 11 and Photo 12 in Attachment 2 show examples of these corrective actions. Baffinland is committed to ensuring that spill trays are placed beneath dripping equipment and equipment that is not being used for more than five (5) days, and beneath all stationary equipment that is regularly refueled. Operational areas are inspected for proper use of secondary containment during routine compliance inspections and any issues are addressed as they are identified.</p> |

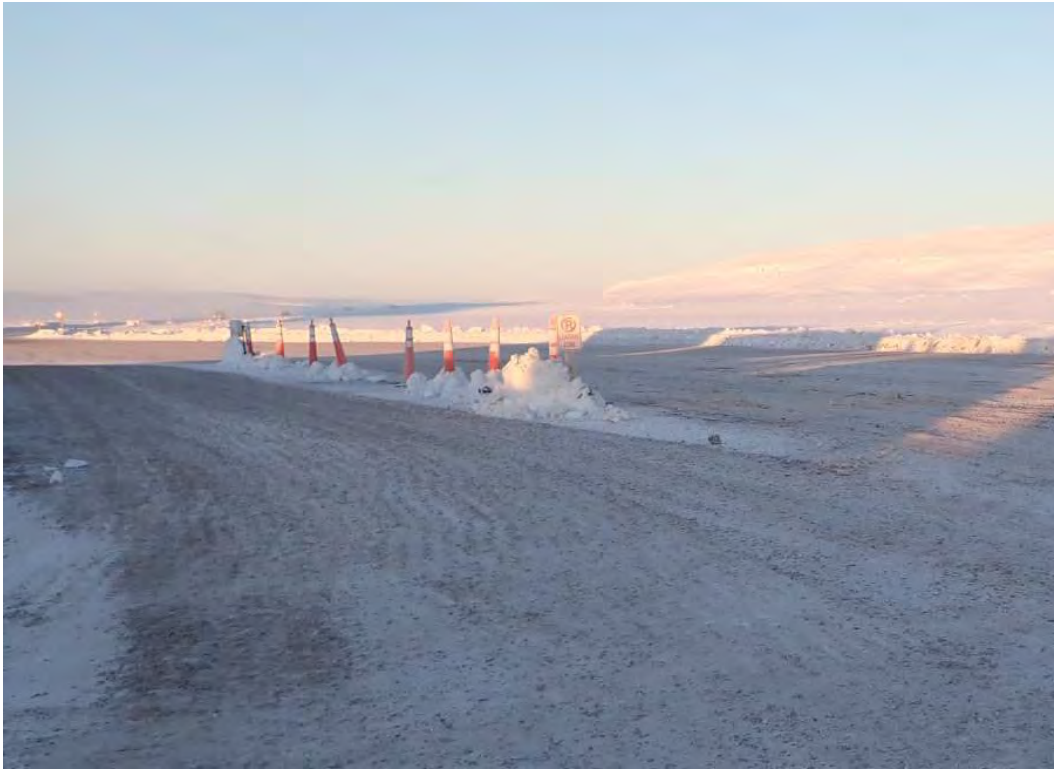
**Photo 1 – Current Status of the KM60 Laydown – November 2021**

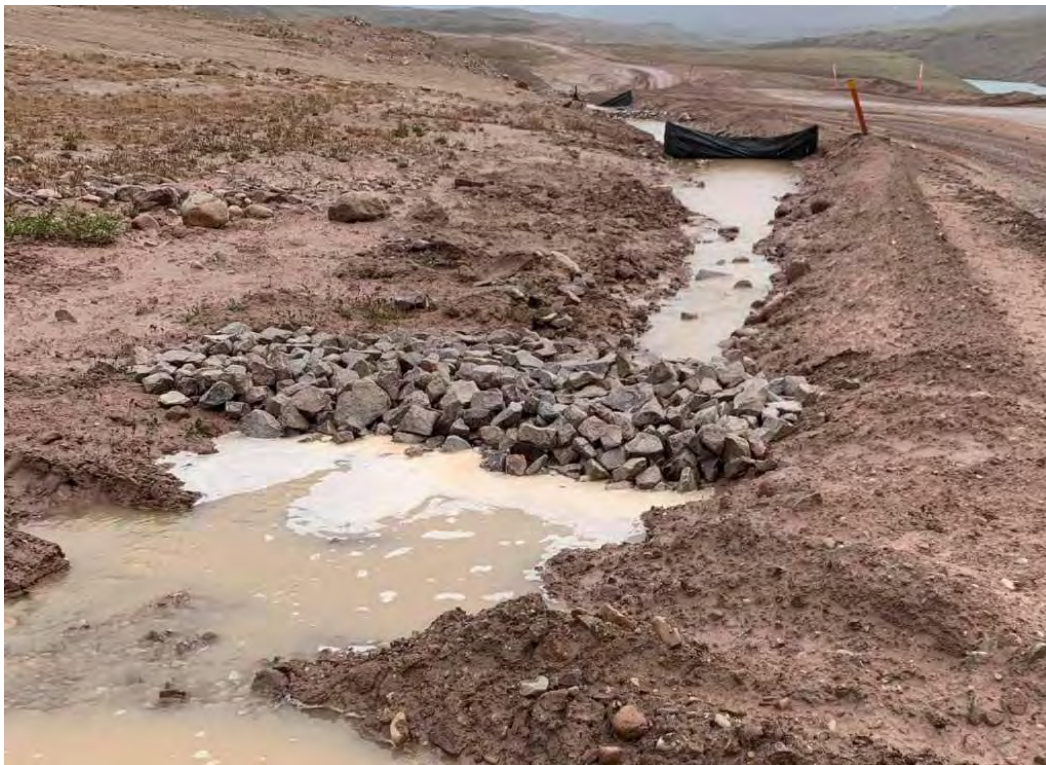
**Photo 2 – Check Dams Constructed in Ditch Upstream of Culvert CV-154A – August 2021**

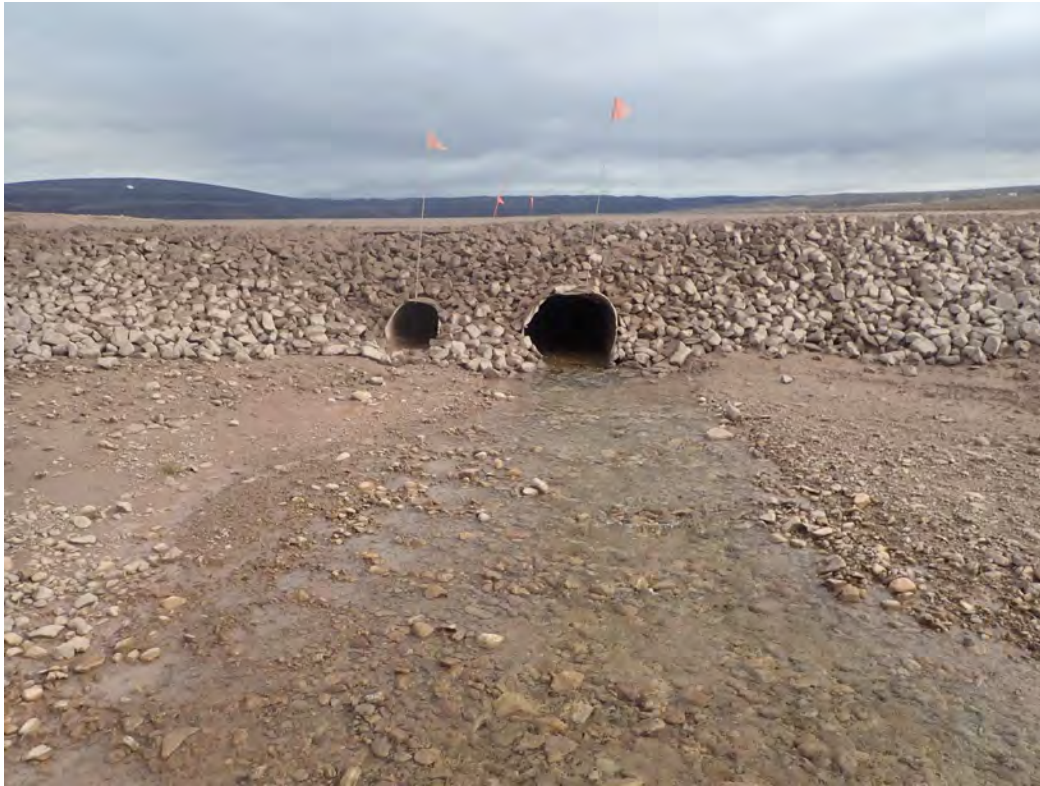
**Photo 3 – Rip Rap Placed at CV-115 Outlet to Stabilize Embankment – August 2021**

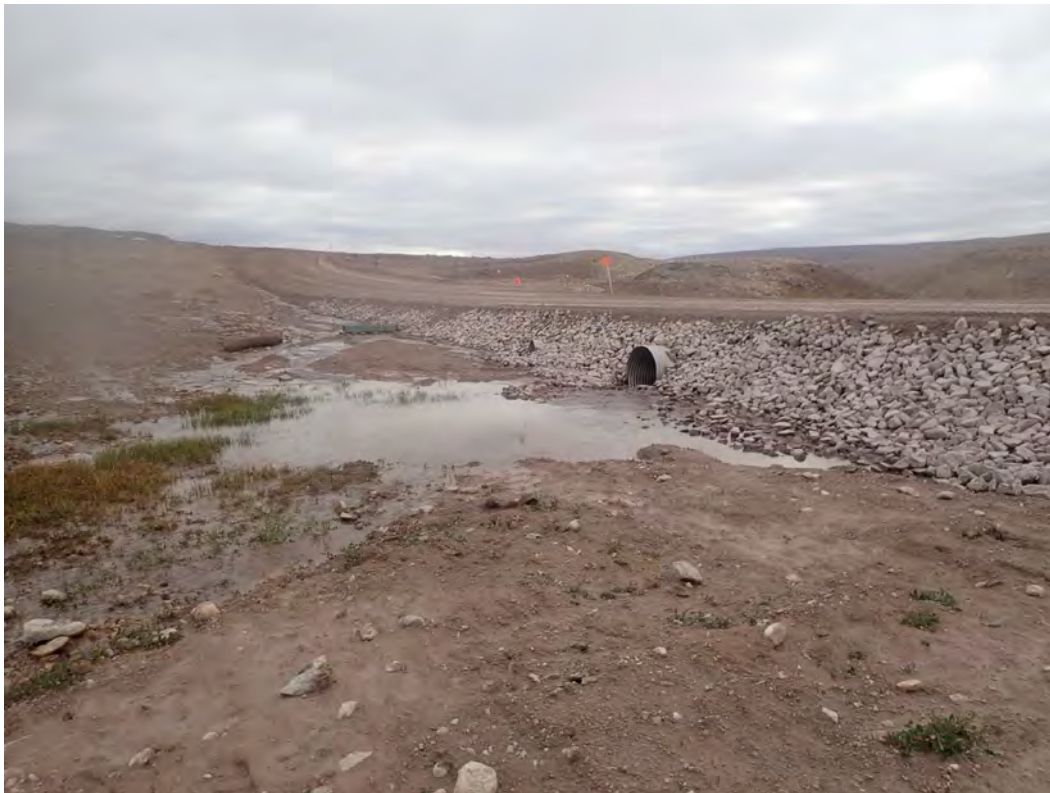
**Photo 4 – Rip Rap Placed at CV-093 Inlet to Stabilize Embankment – August 2021**

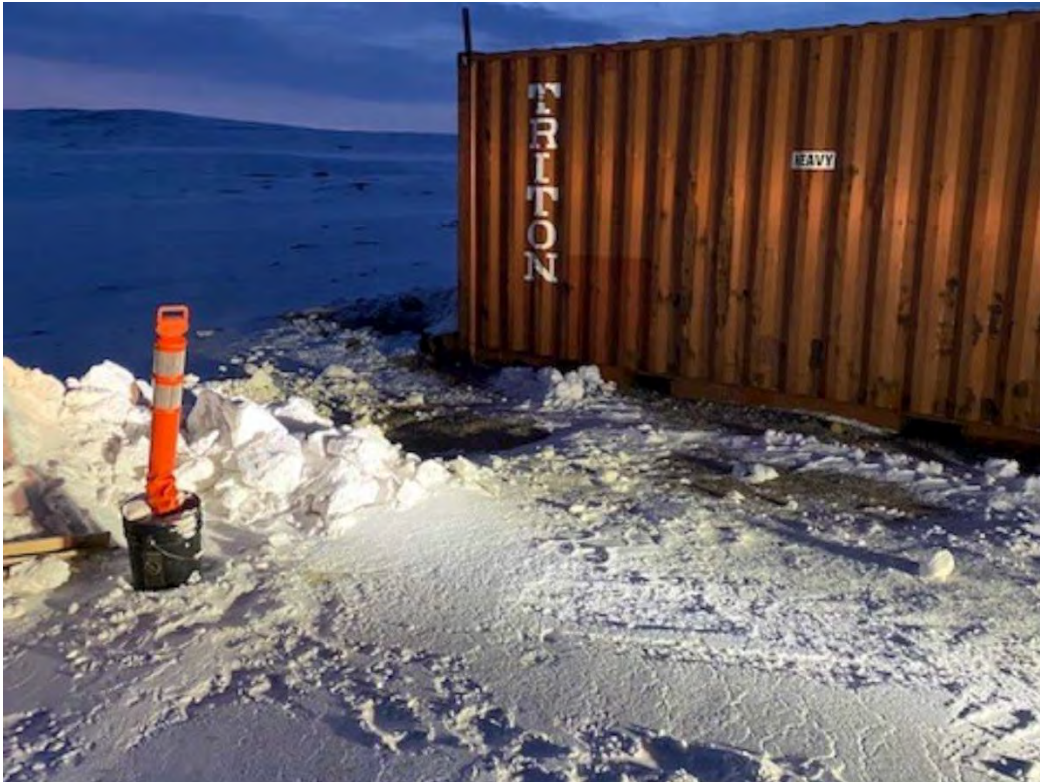
**Photo 5 – KM97 Following Removal of Fuel Drums –November 2021**

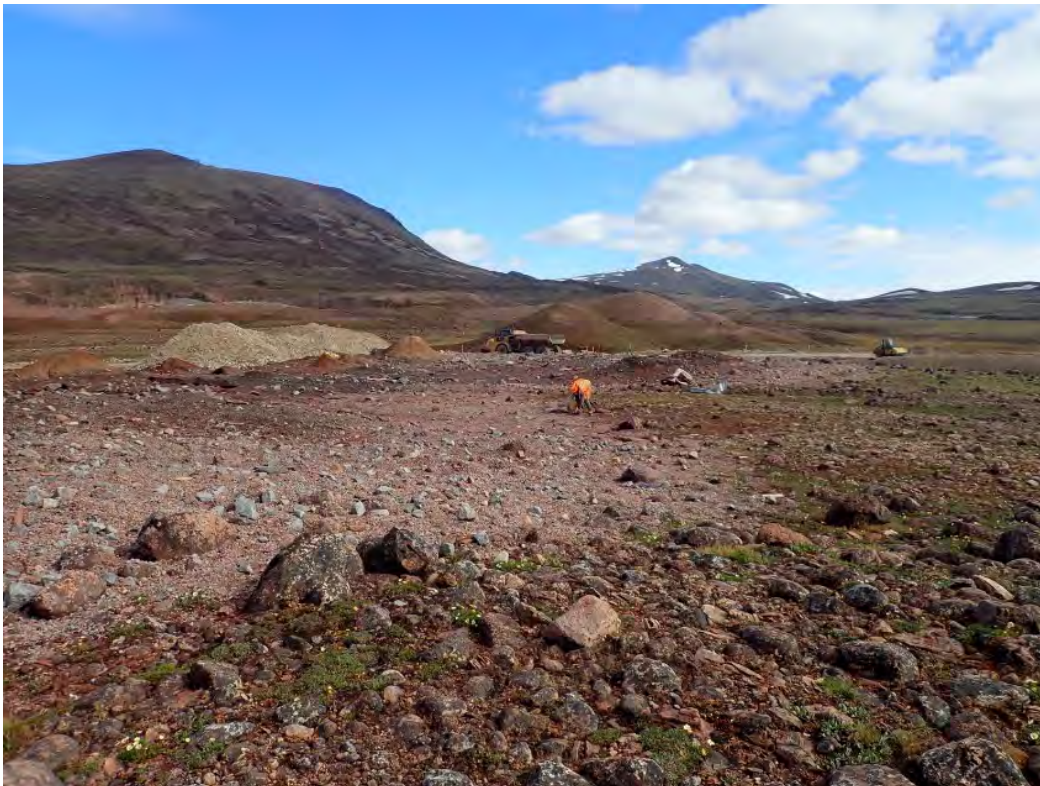
**Photo 6 – Snow Stockpile Clean Up Activities to Remove Debris – July 2021**

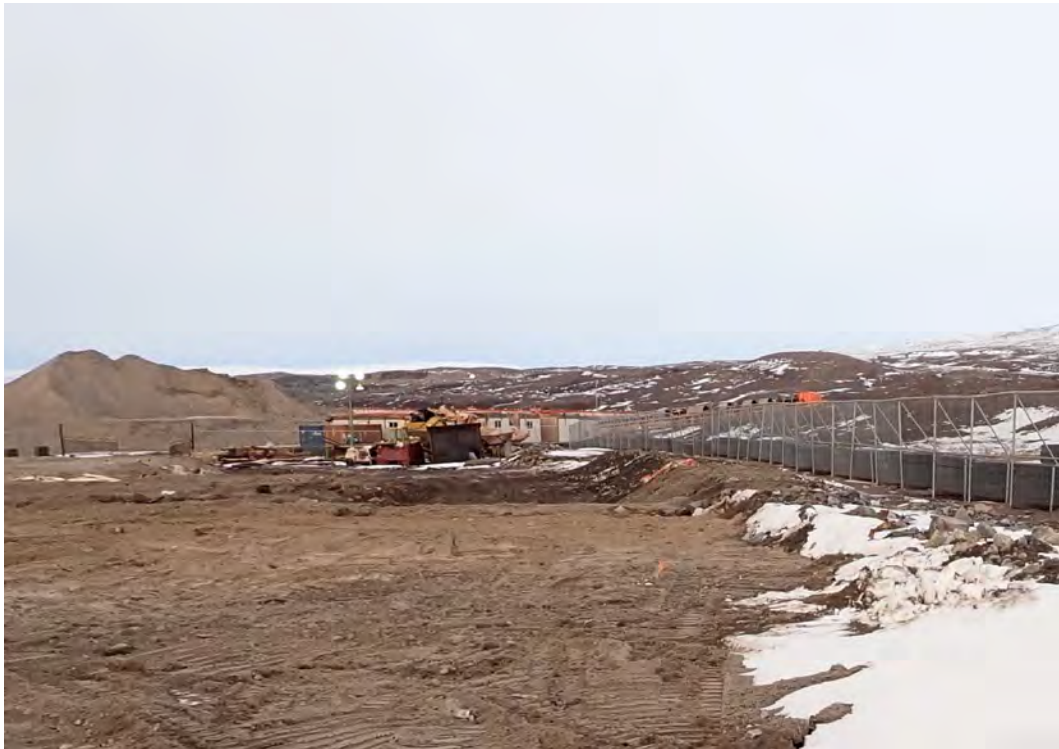
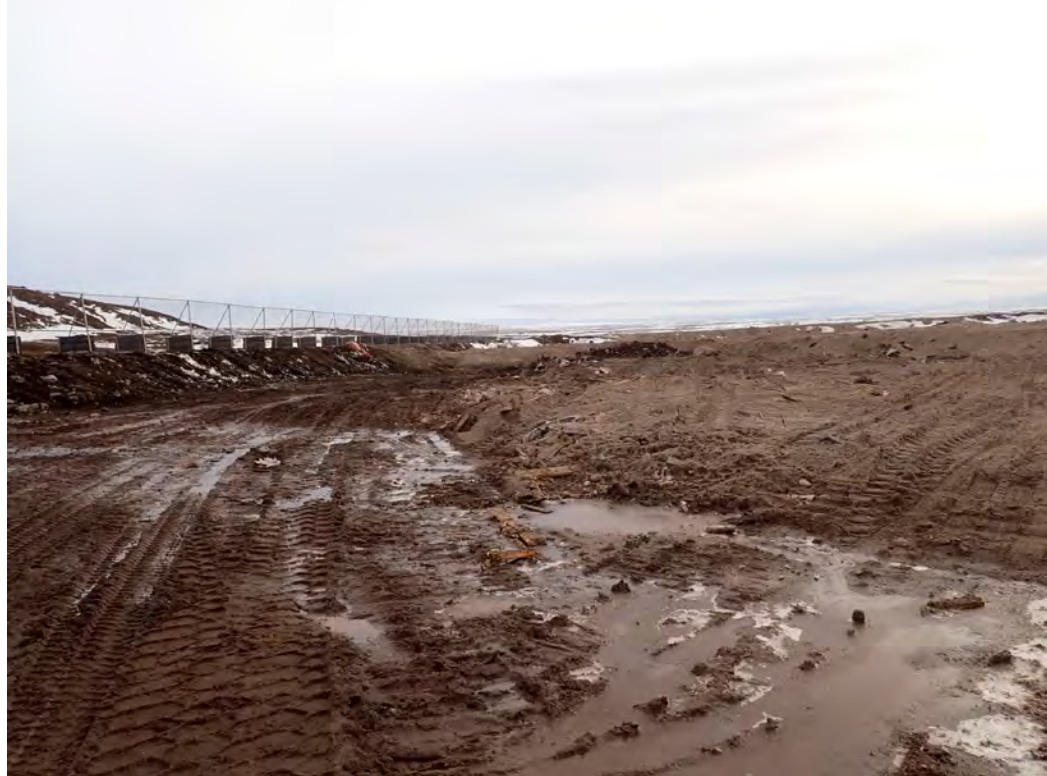
**Photo 7 – Mine Site Landfill Facility Following Debris Removal – October 2021**

**Photo 8 – Mine Site Landfill Facility Following Debris Removal – October 2021**

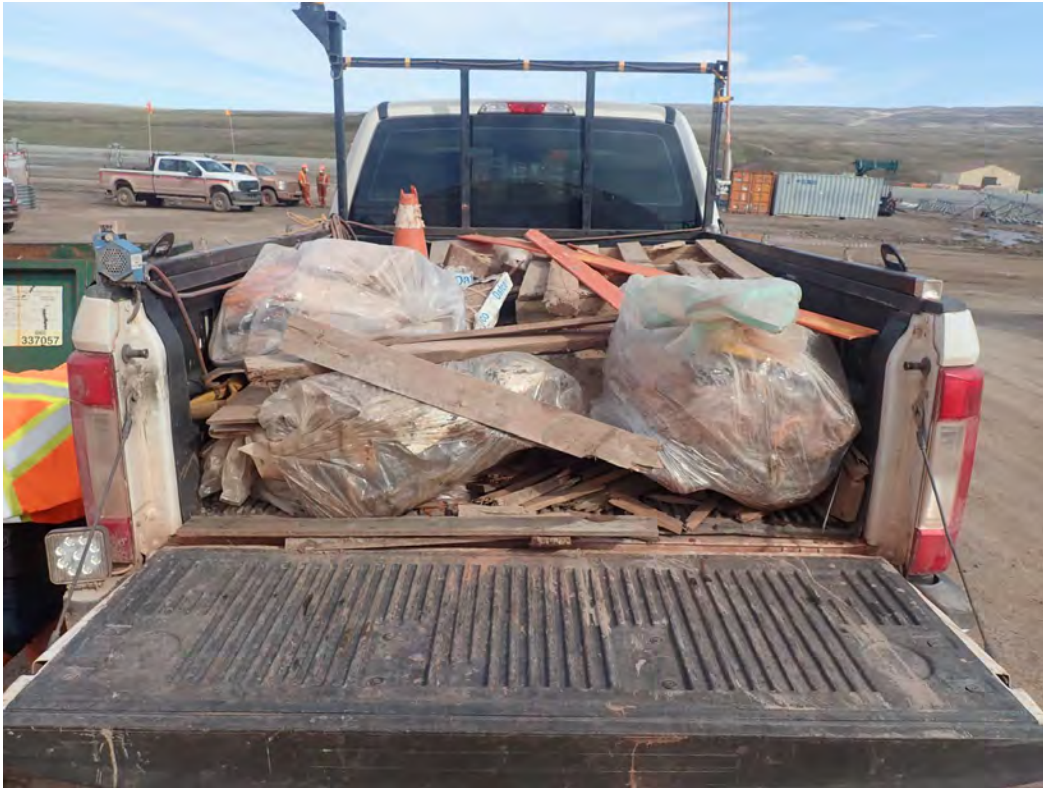
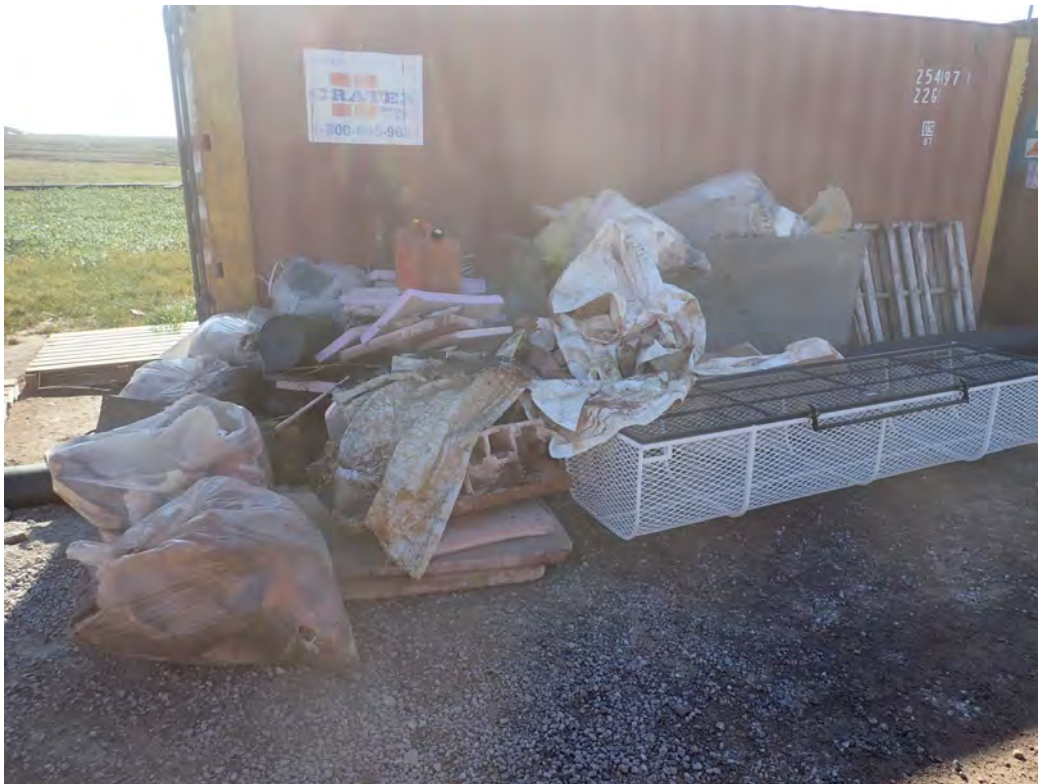
**Photo 9 – Site Waste Clean Up Activities – July 2021**

**Photo 10 – Site Waste Clean Up Activities – July 2021**
