**CIRNAC INSPECTION REPORTS  
AND BAFFINLAND RESPONSE**

**RE: Water Licence 2AM-MRY1325 September 2021 Inspection – Follow Up**

**2021-QIK-JKM012 2AM-MRY1325 Inspection Report**

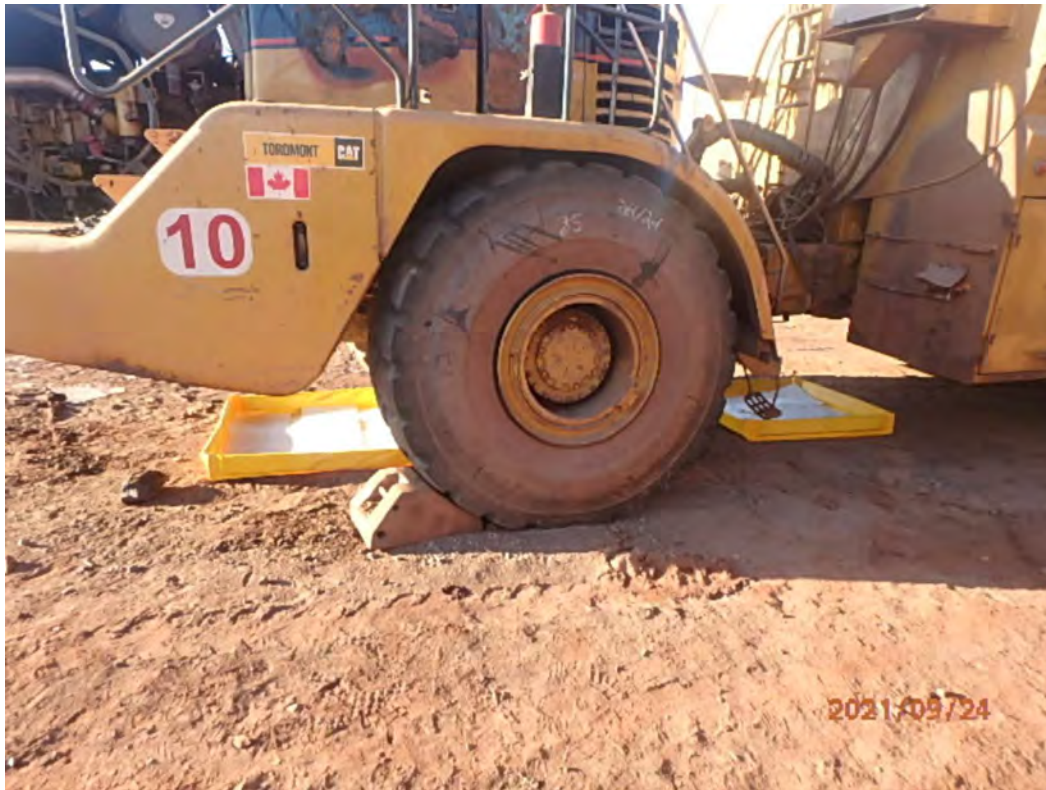
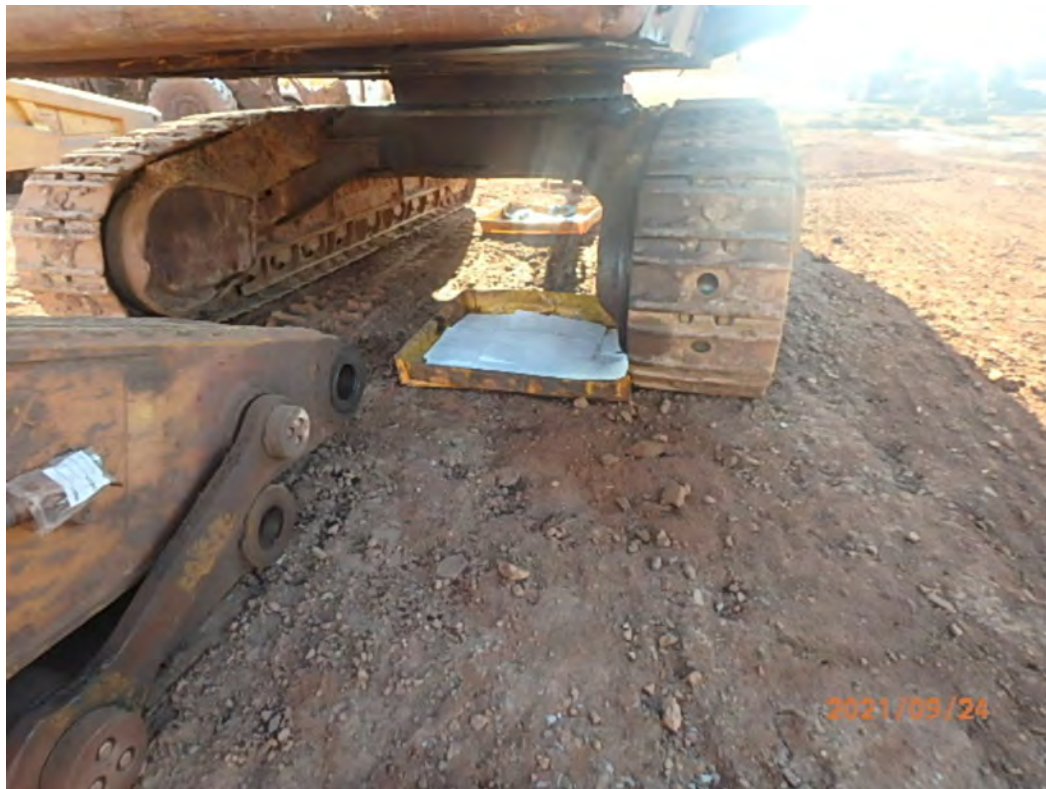
Photo 11 – Spill Trays beneath Heavy Equipment at the KM104 Laydown – September 2021

Photo 12 – Spill Trays beneath Heavy Equipment at the KM104 Laydown – September 2021
