APPENDIX E.8.2

QIA INSPECTION REPORTS AND BAFFINLAND RESPONSE

2021 July Environmental Inspection – Information Request

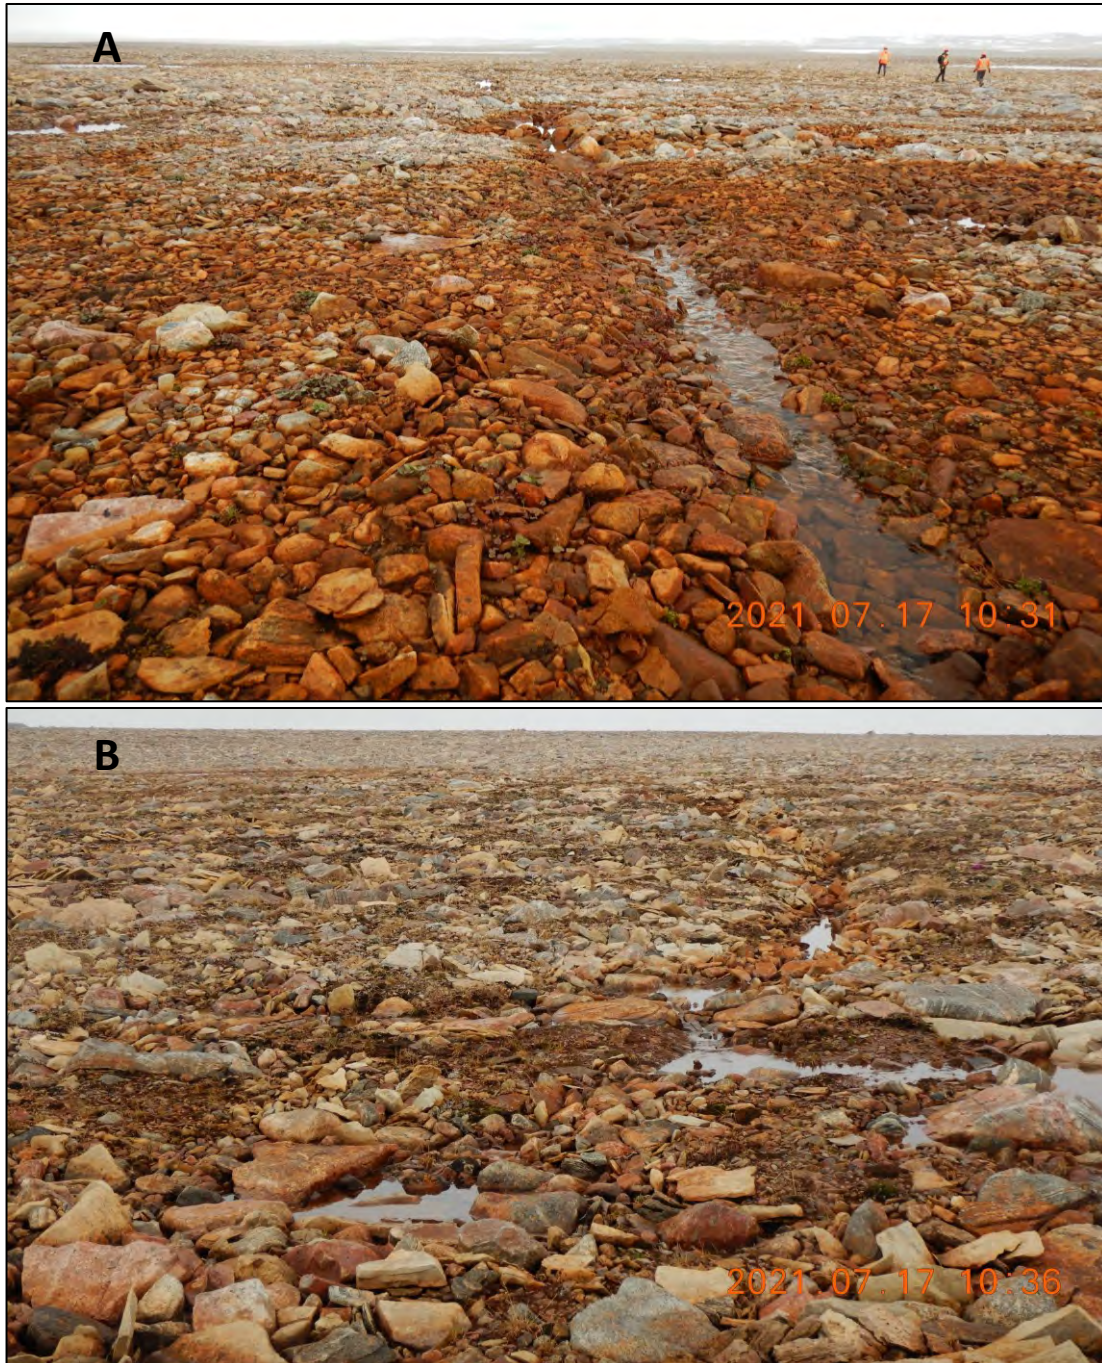
3.	Existing WRF FDP (Photo 3)	Apparent formation of a preferential flow path on the tundra as far as approximately 140 m downgradient of the existing WRF FDP. This is not an immediate concern as the discharges did not reach fish bearing habitat but does suggest	Baffinland to readjust the FDP such that it does not continue to degrade the tundra in the receiving environment, and submit a plan to the QIA, NIRB and NWB detailing how the impacts from ongoing discharges to the tundra will be reduced in the future Baffinland	Readjust FDP and submit FDP management plan to QIA prior to Freshet 2022. Edits to the ICRP and FDP

Photo 3. Formation of preferential flow path, degrading permafrost and iron staining downgradient of Waste Rock Facility Final Discharge Point approximately A) 30 m and B) 140 m down gradient.

#	Project Location	Description of Concern or Finding	Recommended Action	Completion Deadline
		discharges are impacting the tundra.	to further commit to scarifying or regrading the WRF FDP flow path at closure. This closure activity should be incorporated into the next iteration of the ICRP as well as the WRMP. If the WRF FDP is moved ahead of closure, the impacted area should be scarified as part of progressive reclamation.	management plan to be included as part of the next annual report (March 30, 2022).

#	Project Location	Description of Concern or Finding	Recommended Action	Completion Deadline	Baffinland Response
				report (March 30, 2022).	
3.	Existing WRF FDP (Photo 3)	Apparent formation of a preferential flow path on the tundra as far as approximately 140 m downgradient of the existing WRF FDP. This is not an immediate concern as the discharges did not reach fish bearing habitat but does suggest discharges are impacting the tundra.	Baffinland to readjust the FDP such that it does not continue to degrade the tundra in the receiving environment, and submit a plan to the QIA, NIRB and NWB detailing how the impacts from ongoing discharges to the tundra will be reduced in the future Baffinland to further commit to scarifying or regrading the WRF FDP flow path at closure. This closure activity should be incorporated into the next iteration of the ICRP as well as the WRMP. If the WRF FDP is moved ahead of closure, the impacted area should be scarified as part of progressive reclamation.	Re-adjust FDP and submit FDP management plan to QIA prior to Freshet 2022. Edits to the ICRP and FDP management plan to be included as part of the next annual report (March 30, 2022).	<p>The historical apparent preferential pathway for overland surface runoff prior to construction was selected as the outfall location of the WRF Pond discharge to ensure treated effluent was conveyed to the Mary River receiving environment. Photo 2 in Attachment 2 depicts this area in 2017 prior to a discharge commencing from the referenced Final Discharge Point (FDP).</p> <p>The Metal and Diamond Mining Effluent Regulations (MDMER) regulated FDP is the sample port located along the discharge line at the WRF WTP. Baffinland does not maintain an 'FDP management plan'. Discharges from the WRF Pond are conducted as per Baffinland's Fresh Water Supply and Sewage Water Management Plan (FWSSWMP).</p> <p>As stated in response to item #2, scarifying or regrading of this area is not warranted.</p>

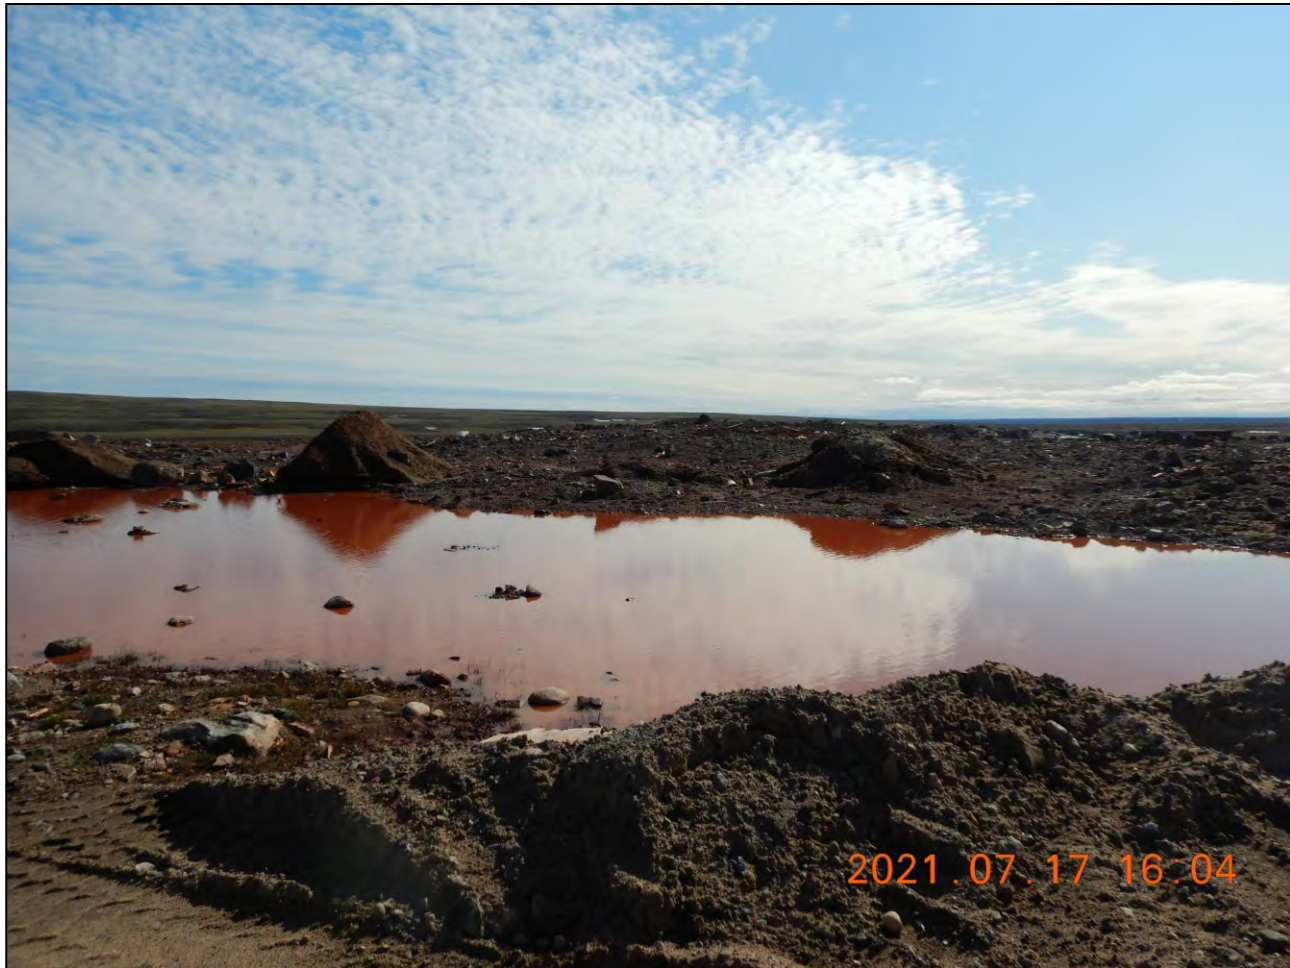
8.	East Dyno Snow Stockpile (Photo 10)	Ponded water observed with colouration indicating elevated iron and TSS.	Baffinland to clarify East Dyno Snow Stockpile is intended for contact or non-contact snow. If the water is intended as noncontact water, Baffinland to collect and submit water chemistry. Ponding water should be drawn down and	October 30, 2021.

Photo 10. East Dyno Snow Stockpile. Large body of pooling water with orange color.

#	Project Location	Description of Concern or Finding	Recommended Action	Completion Deadline
			disposed of as contact or non-contact water depending on results of water chemistry. Snow stockpile may require secondary containment if it was intended as contact snow stockpile or is determined as one based on water chemistry results.

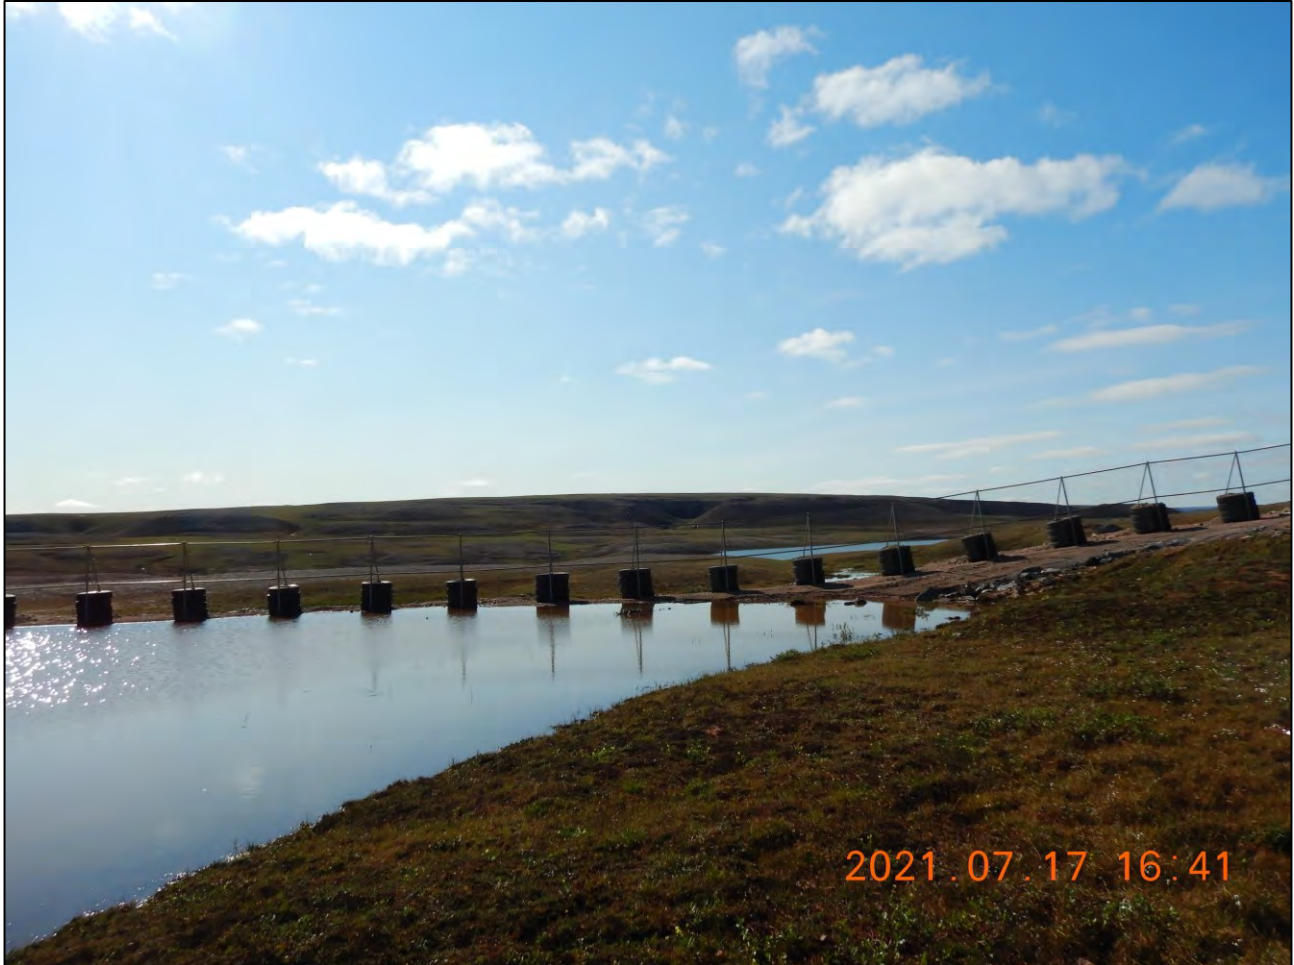
Photo 11. Landfill ponding water. Edge of ponding water appears to flow past barriers towards Sheardown Lake.

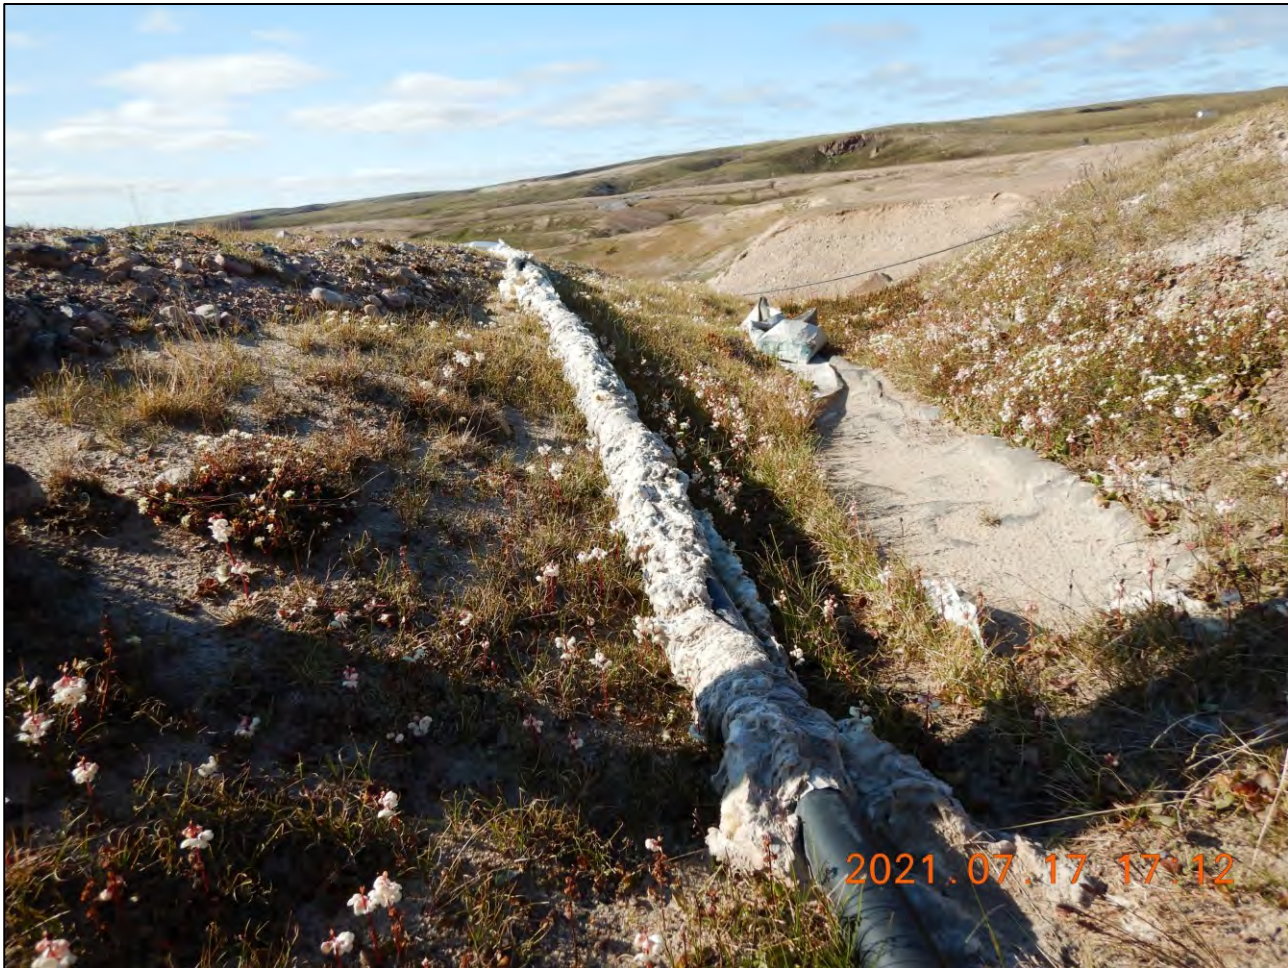
Photo 12. Old pipeline to Camp Lake Jetty. Insulation deteriorating and blowing on tundra.

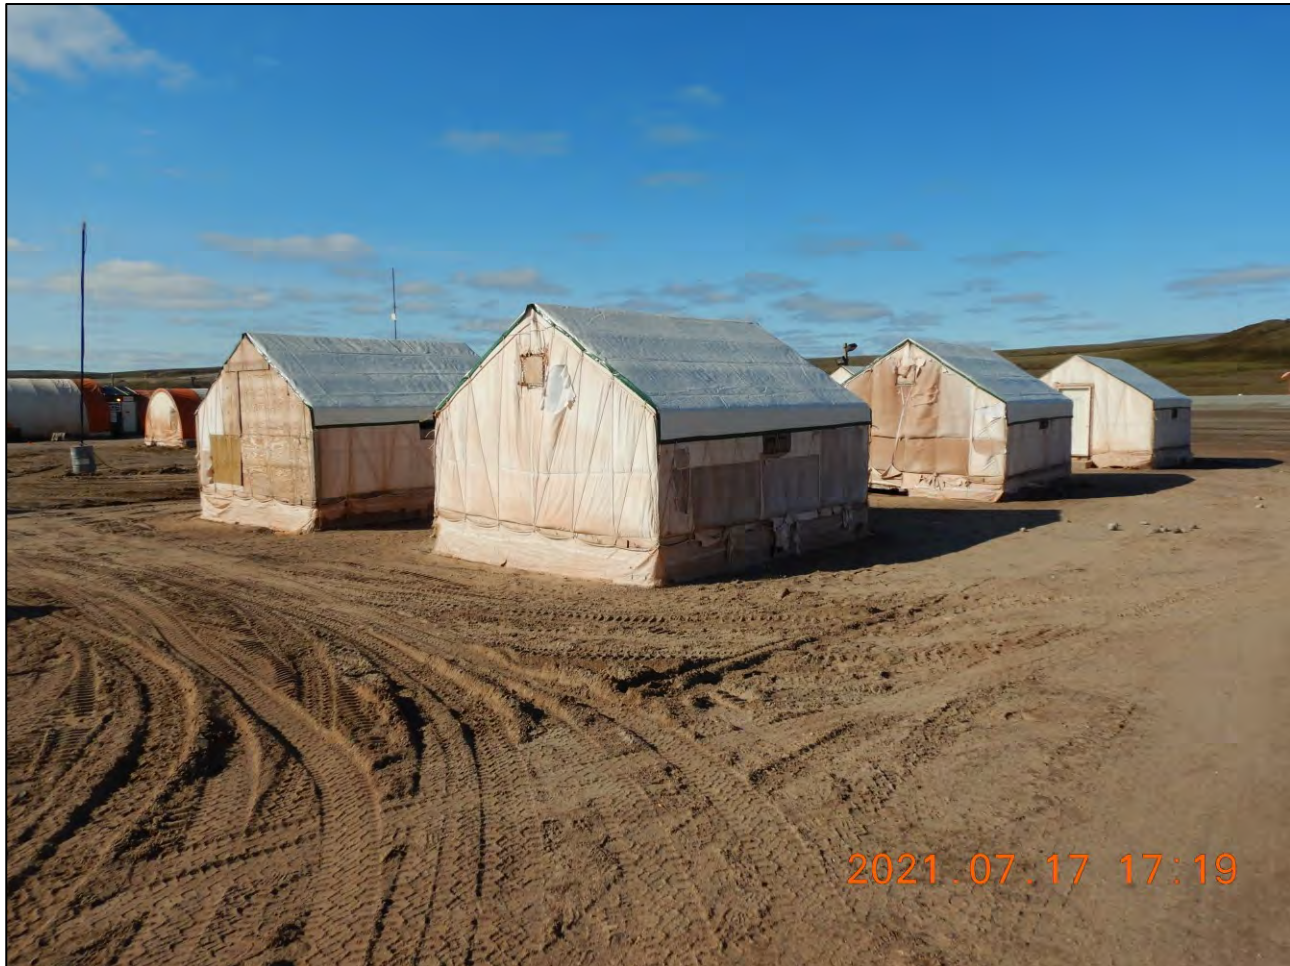
Photo 13. Deteriorating Weatherhaven facilities. Exposed insulation damaged by wind.

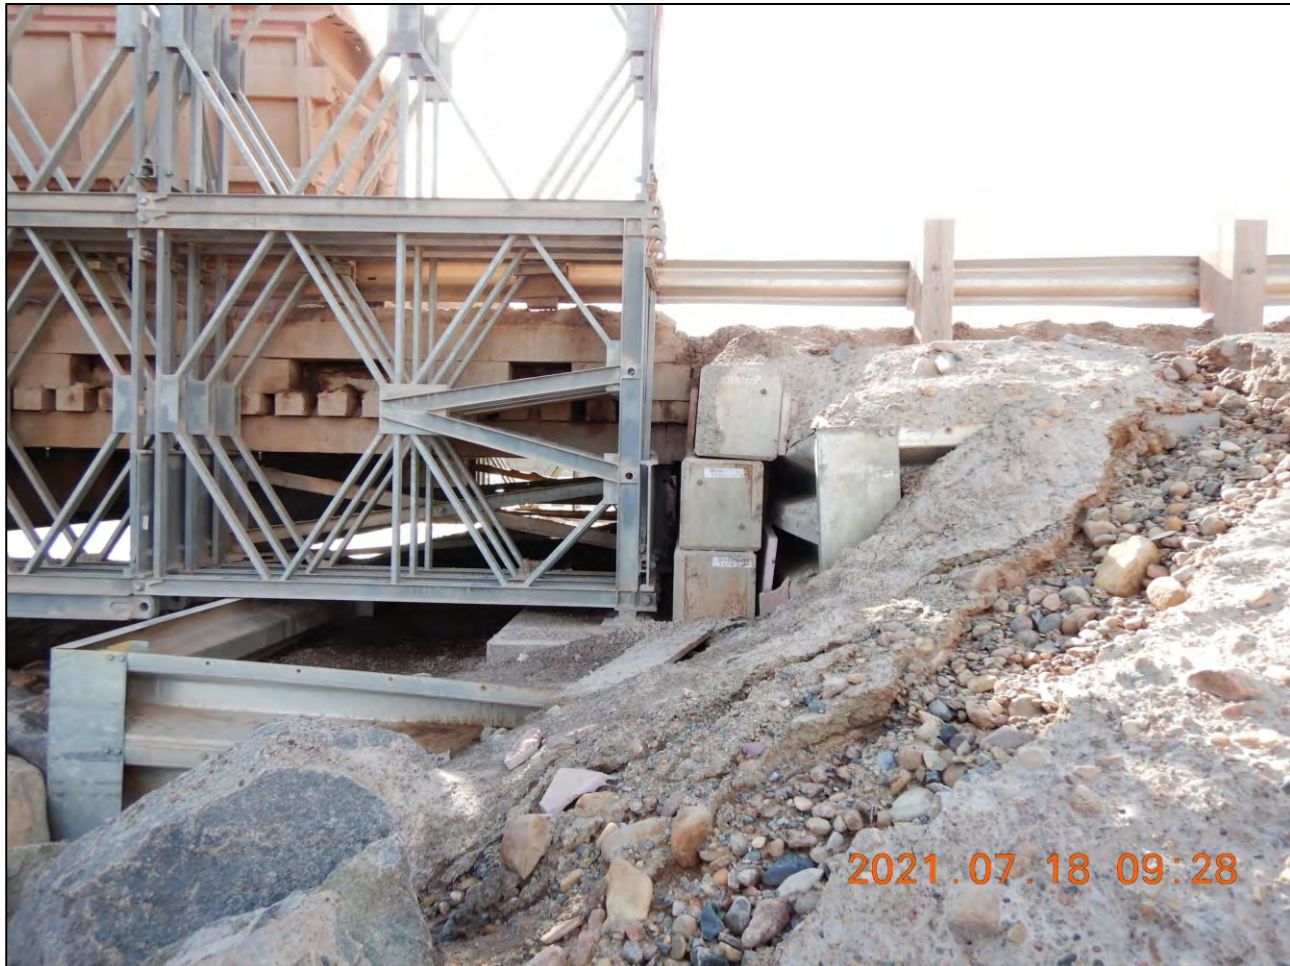
12.	West bank foundation of KM97 bridge (Photo 17)	Three stacked concrete blocks do not appear to have any backfill supporting them. The misalignment suggests longitudinal forces on the bridge are causing the blocks to shift over time increasing the longer-term potential for stability issues with this portion of the infrastructure.	While we understand Baffinland has employed an engineer to inspect the bridge and produce a summary report of their findings, we suggest a periodic inspection schedule to assess any developing stability issues. We recommend Baffinland employ an engineer to inspect the bridge and produce a new summary report every 2 years. The report is to include recommended mitigations and a timeline in which they must be implemented to prevent structural issues with the bridge.	New inspection to occur as soon as feasible if no inspection has occurred within 2 years, and every 2 years thereafter. Reports to be submitted as part of the Annual Reports following each inspection.

Photo 17. West bank foundation of KM97 bridge. Concrete blocks appear misaligned.

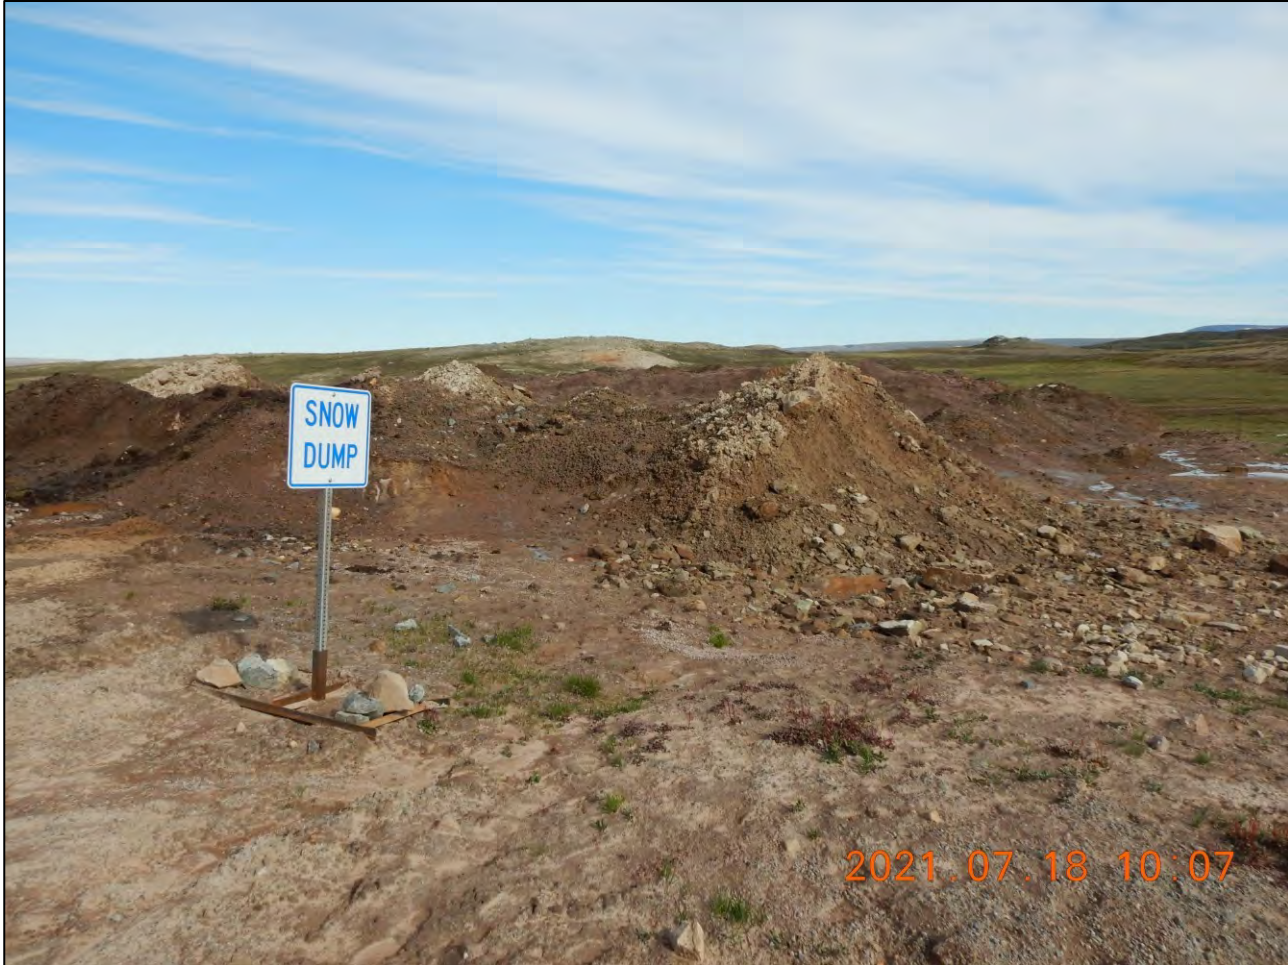
Photo 18. KM86 Snow stockpile without delineation markers.

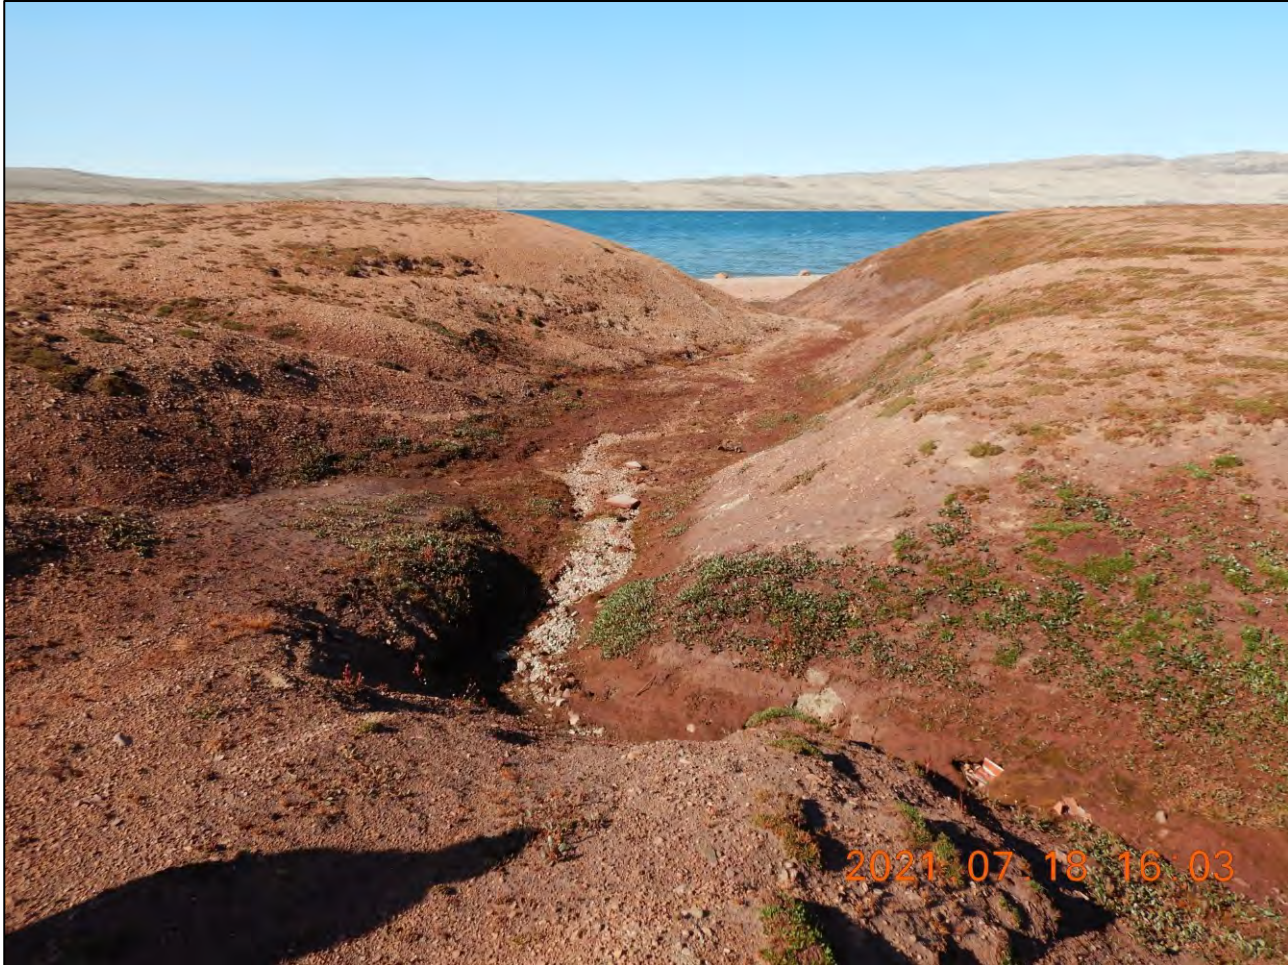
16.	Drainage downgradient of ore stockpile (Photo 22).	Iron staining visible in drainage pathway of recent (Spring 2021) berm failure and spill of contact water during transfer from MP-03 to MP-05. Pebble sized rocks visible in drainage pathway indicate ephemeral flows with sufficient energy to mobilize loose material. Fish bearing habitat visible in the background.	Baffinland to collect soil samples from the spillway and submit results to QIA for review. If elevated concentrations of metals are present in the upper 5 cm of soil, we recommend Baffinland a) install a silt fence at the end of the flow path to limit mobilization of materials as a result of precipitation and melting snow, and b) excavate the surface 10 cm of impacted soils prior to freshet 2022 to mitigate potential impacts to the receiving environment.	Soil sampling results to be submitted to QIA by October 30, 2021. Silt fence to be installed by and excavations completed, if necessary, prior to Freshet 2022.

Photo 22. Discoloration of tundra along natural drainage down gradient of ore stockpile berm failure spill (Spring 2021)

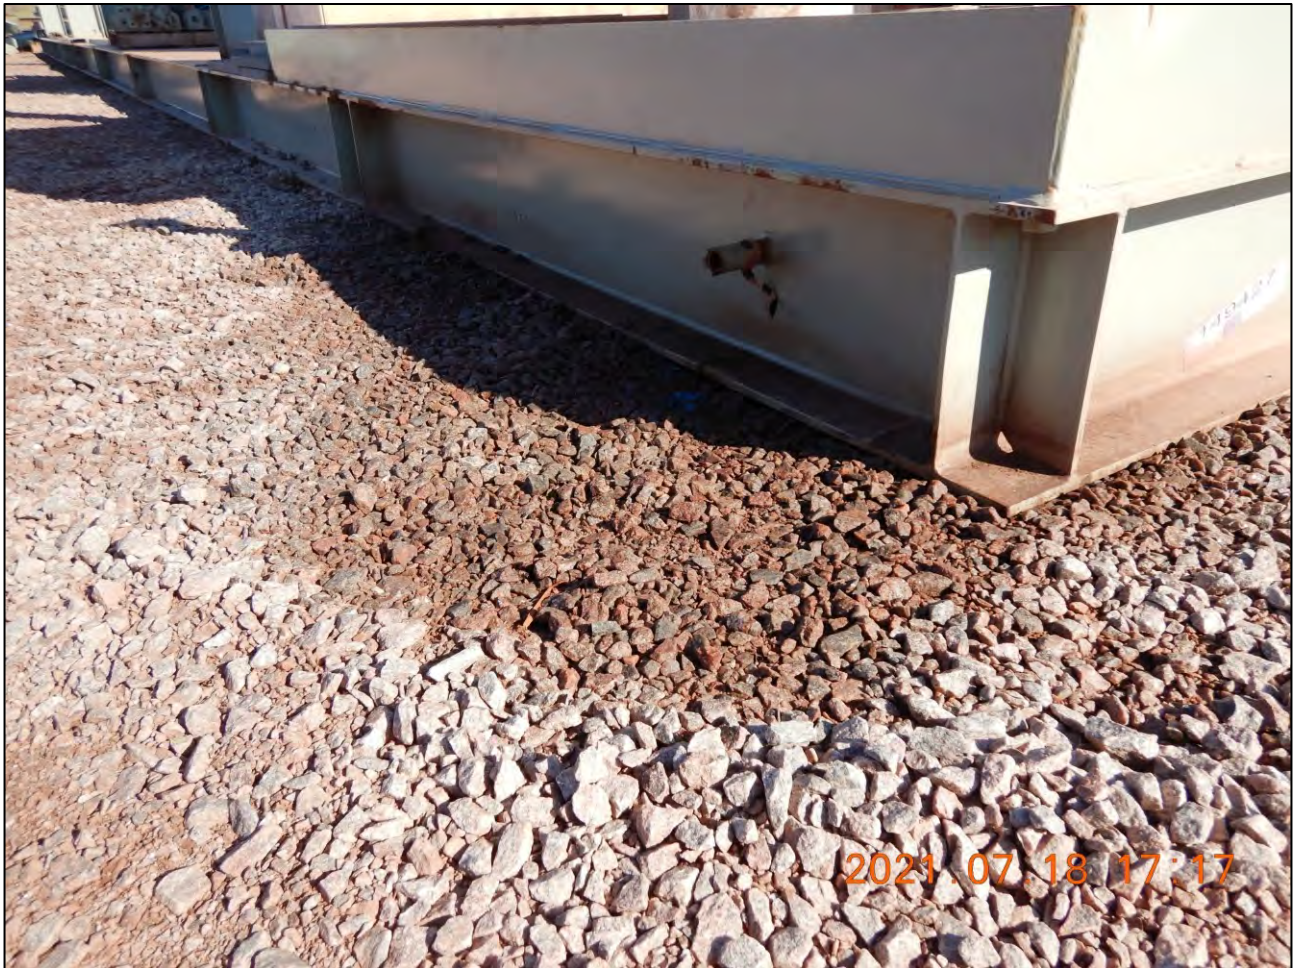
Photo 23. Potential oil spill at northwest corner of power generation station under construction.

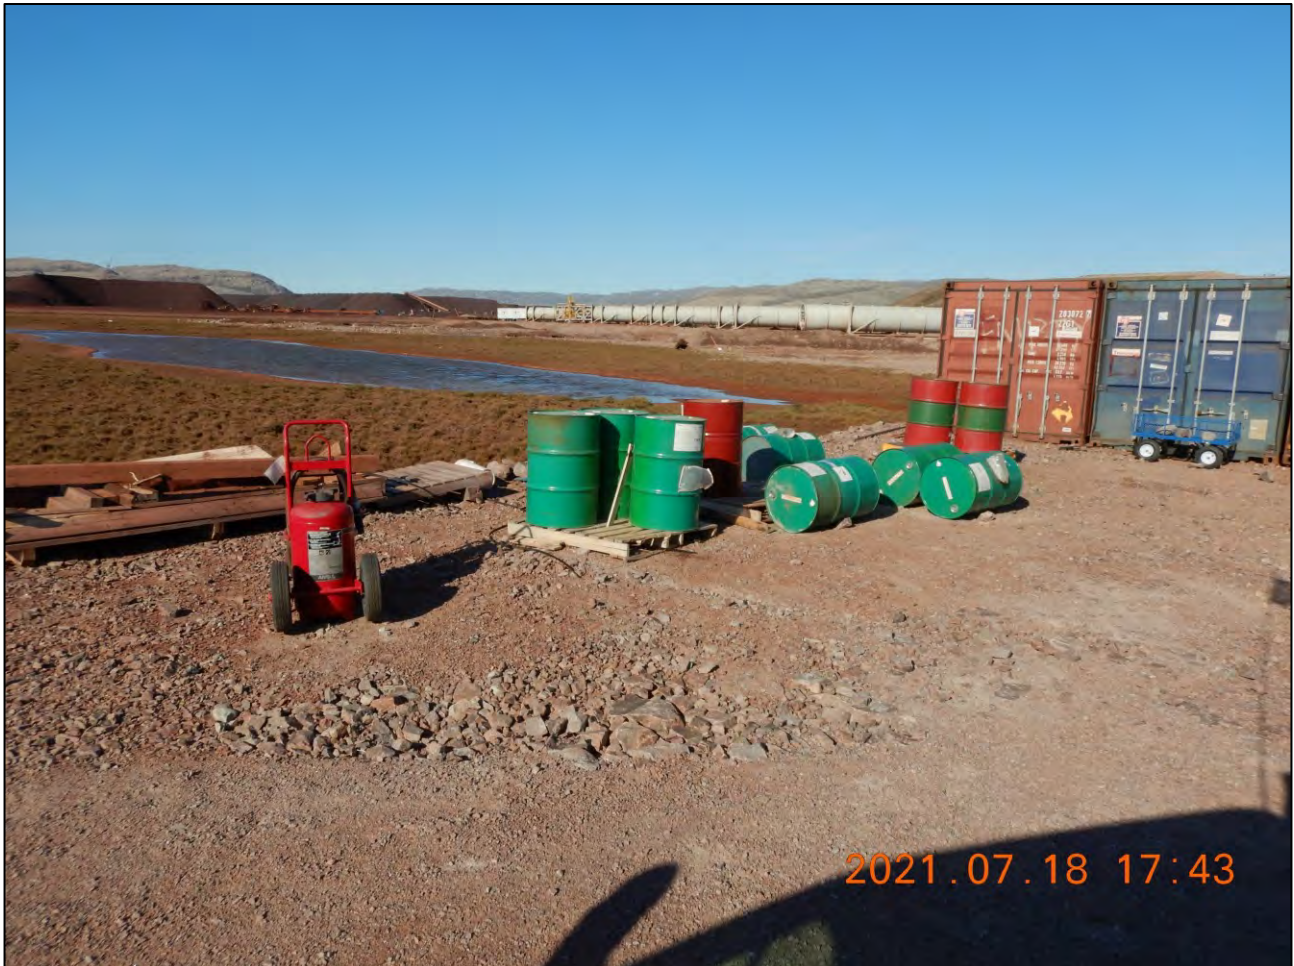
Photo 24. Fuel drums out of containment at LP3 helipad.

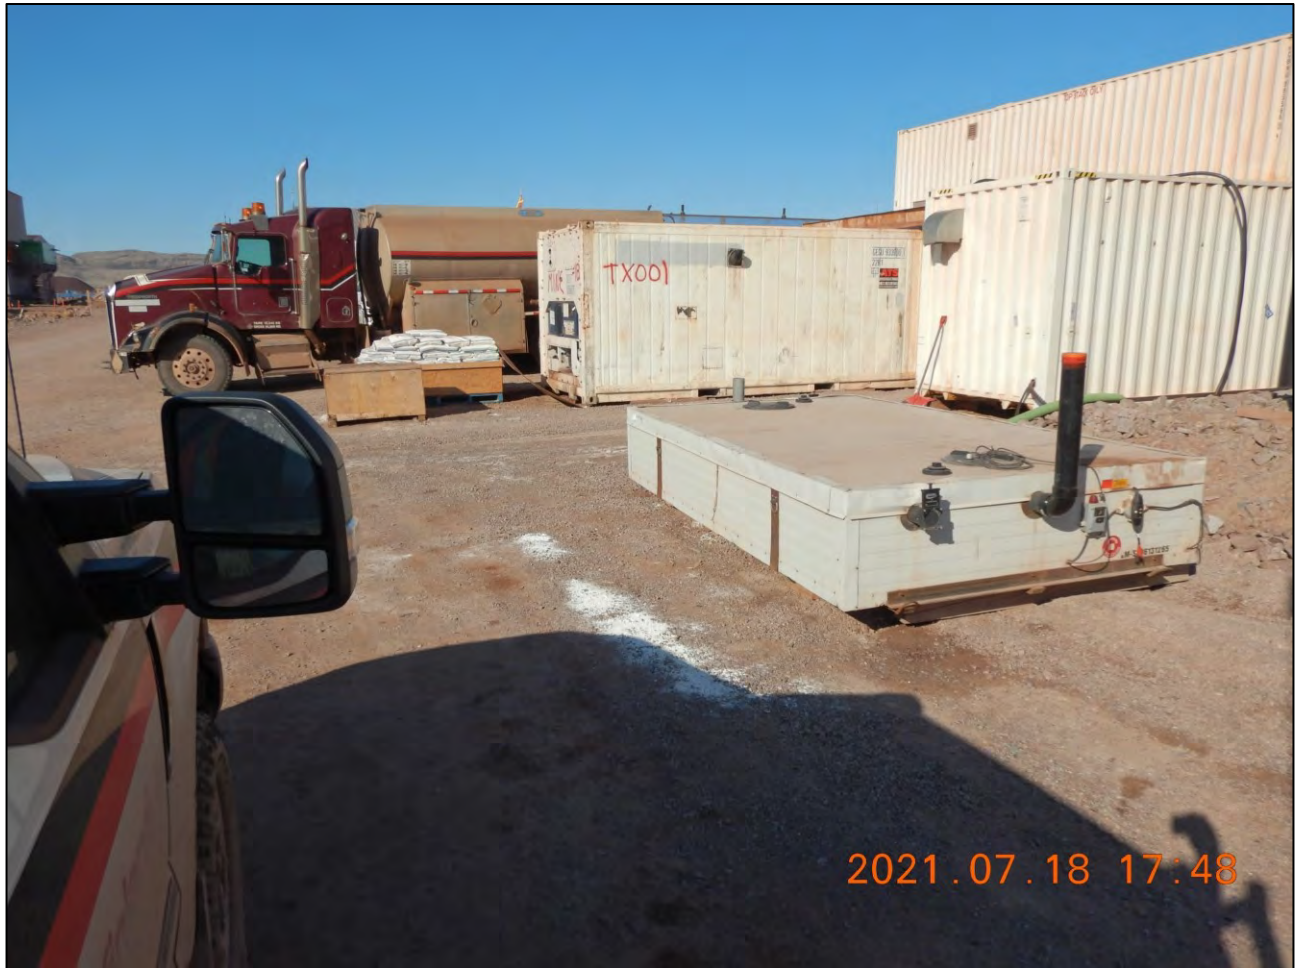
Photo 25. Soda Ash on ground near west side of 380-person camp.

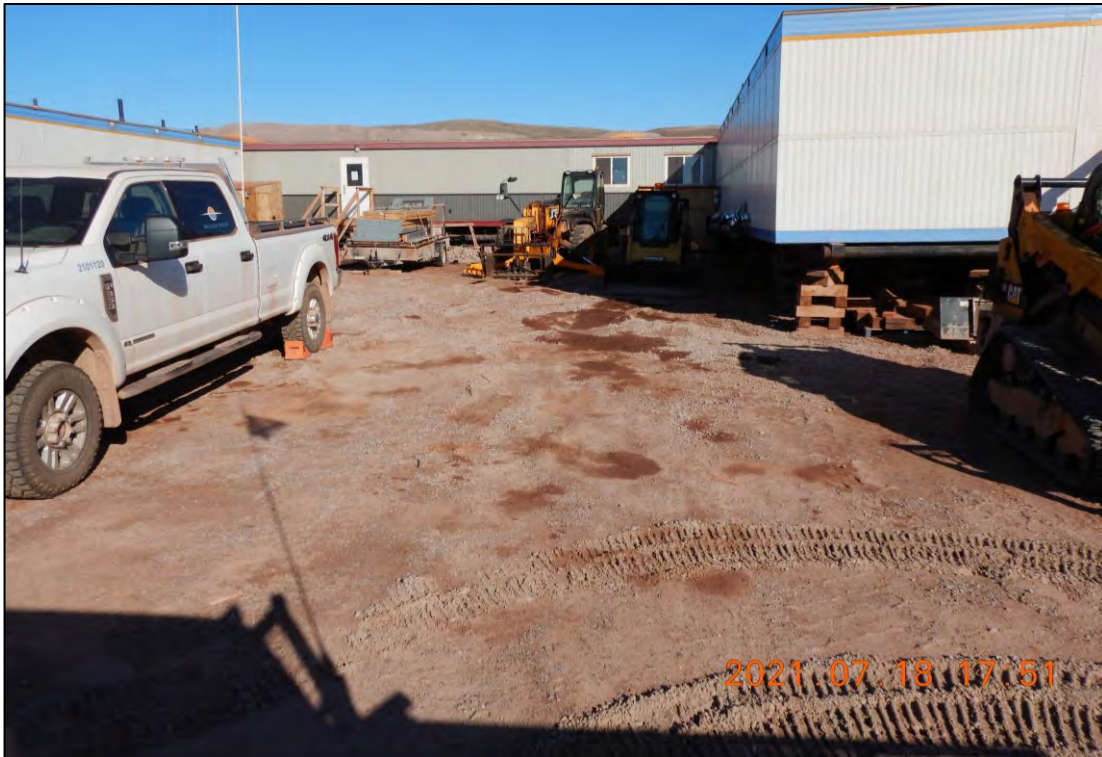
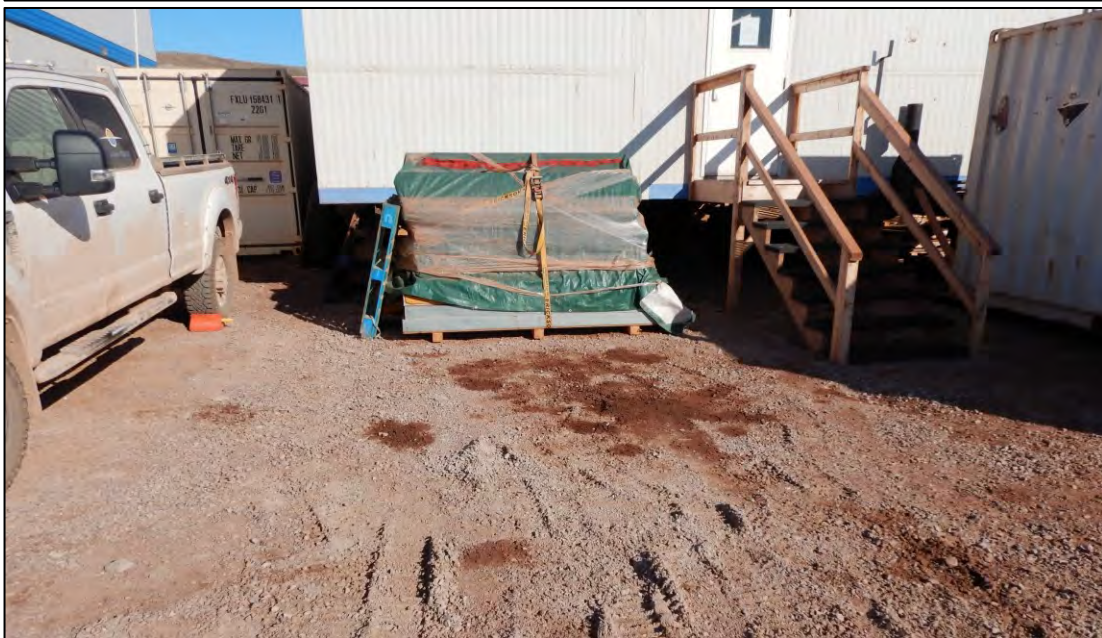
Photo 26. Potential spills from parked vehicles at 380-person camp parking lot.

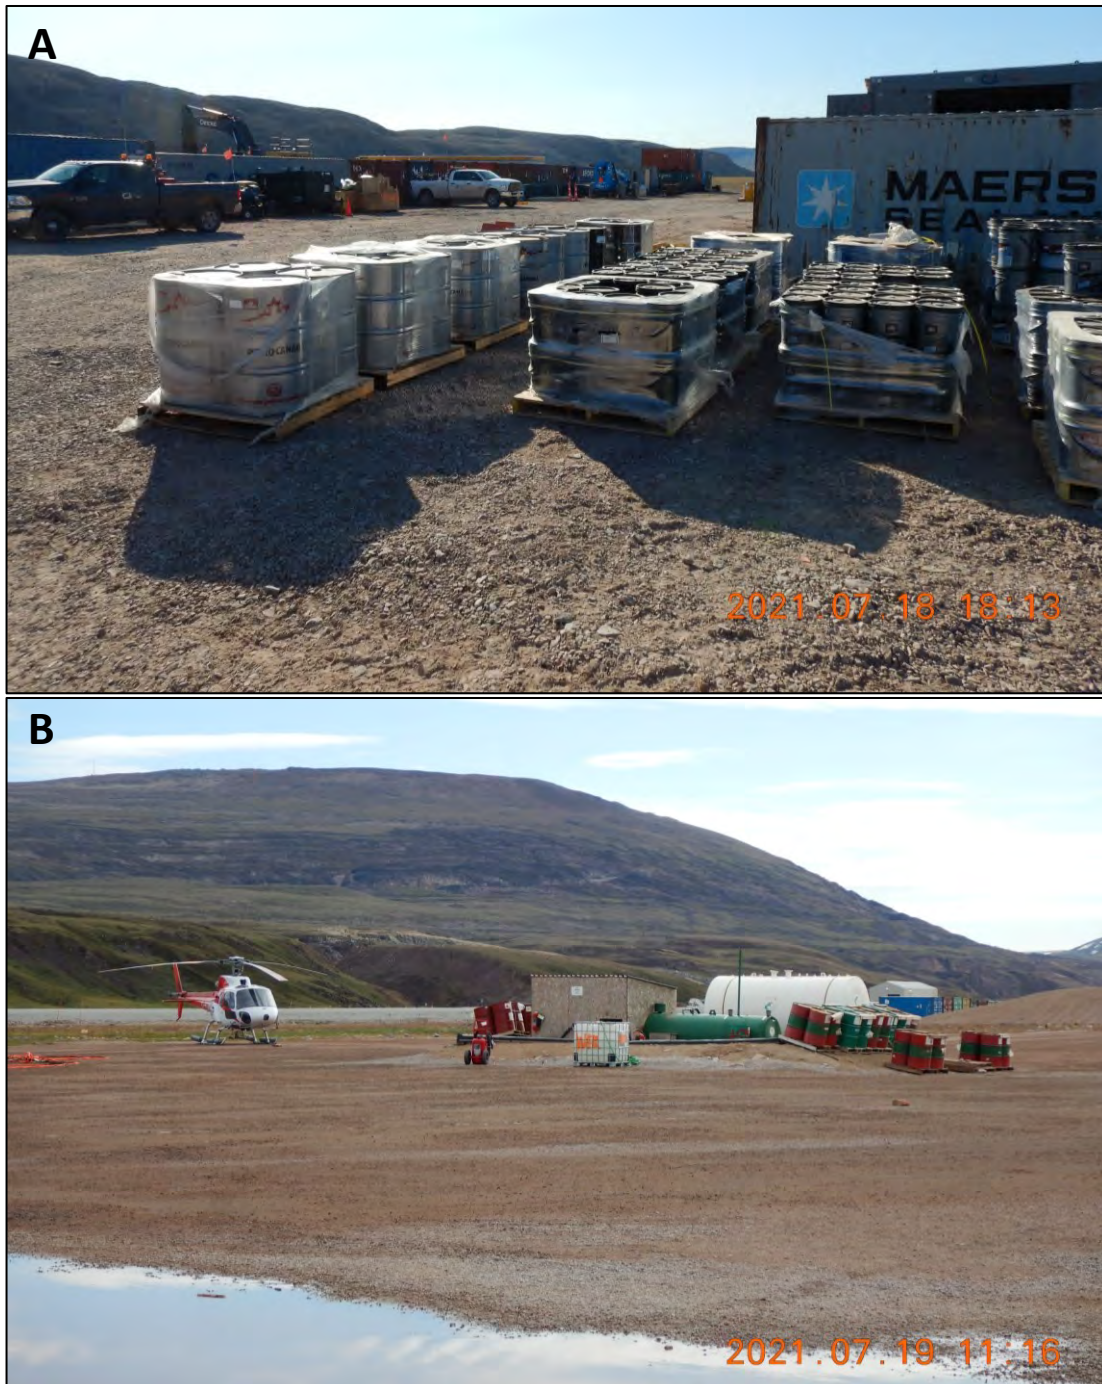
Photo 27. Fuel drums stored outside of containment at A) Qikiqtaaluk Sana laydown (KM 5) and B) Fuel drums stored outside of containment at the mine site helipad.

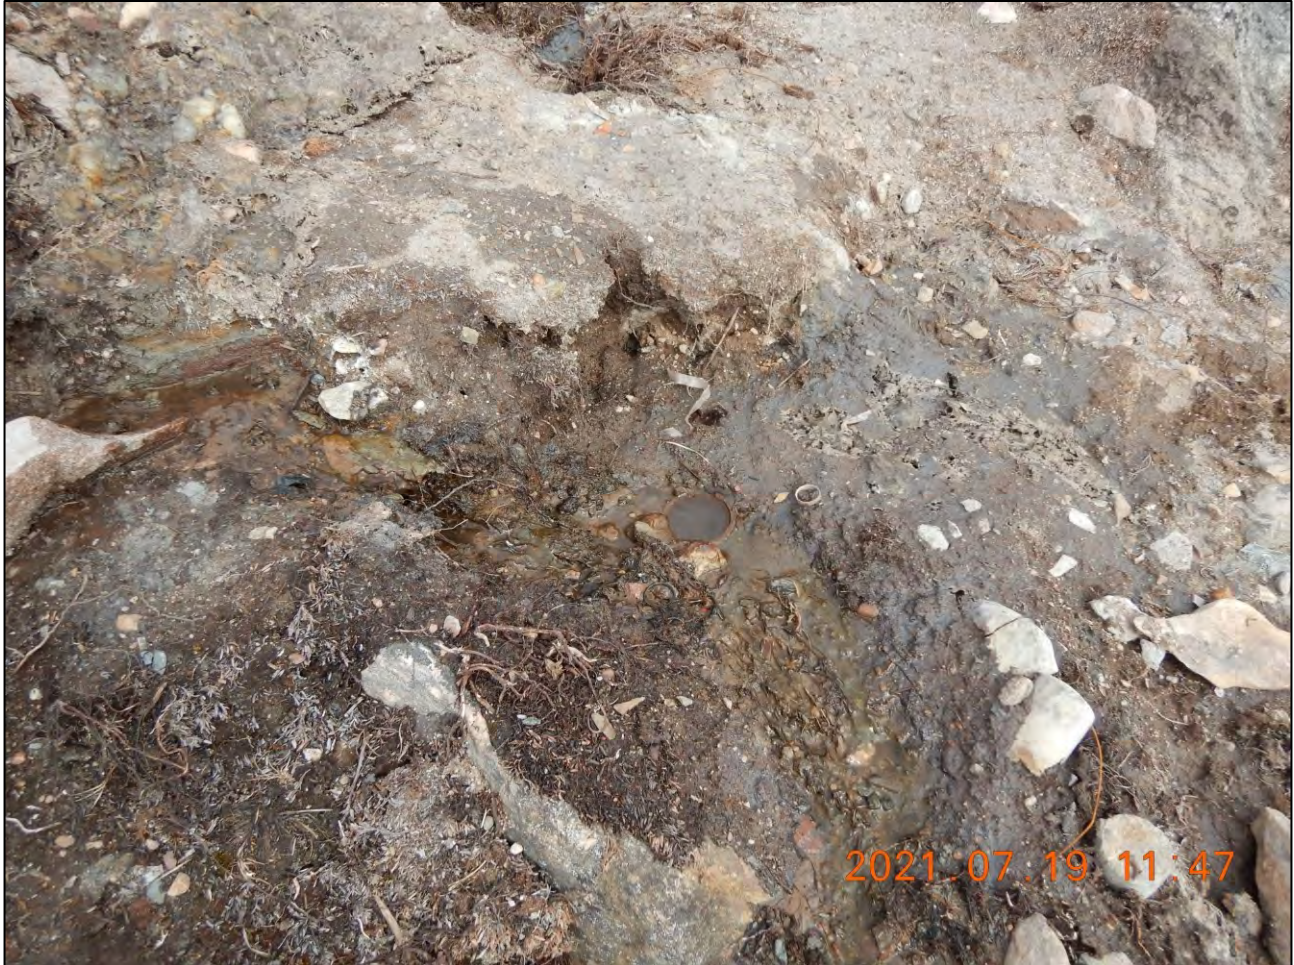
Photo 28. Uncapped drill hole on slope of Deposit 3

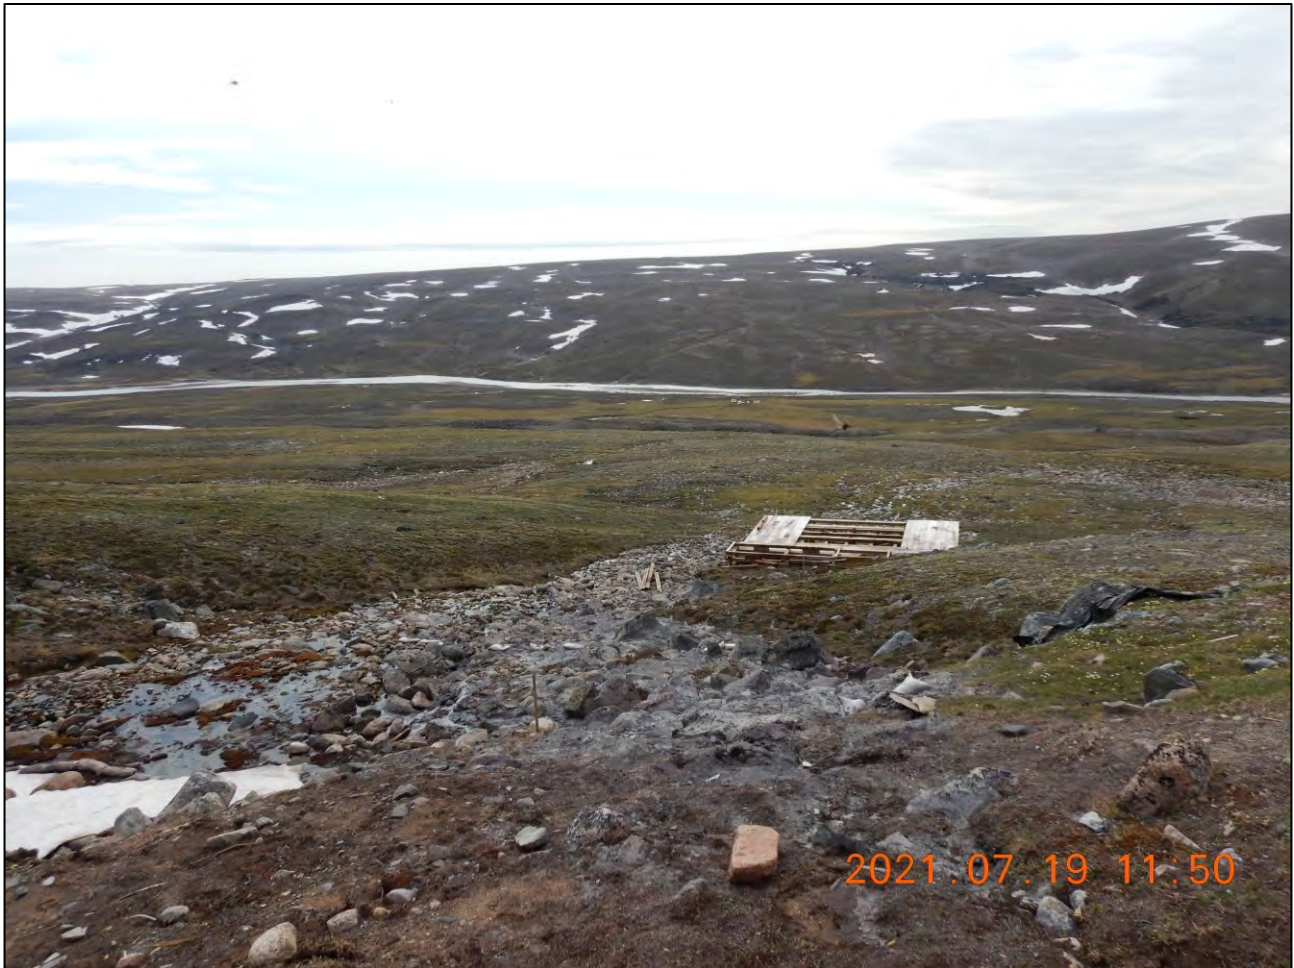
Photo 29. Residual drilling lubricant leading down the slope of Deposit 3 and old drilling platform.

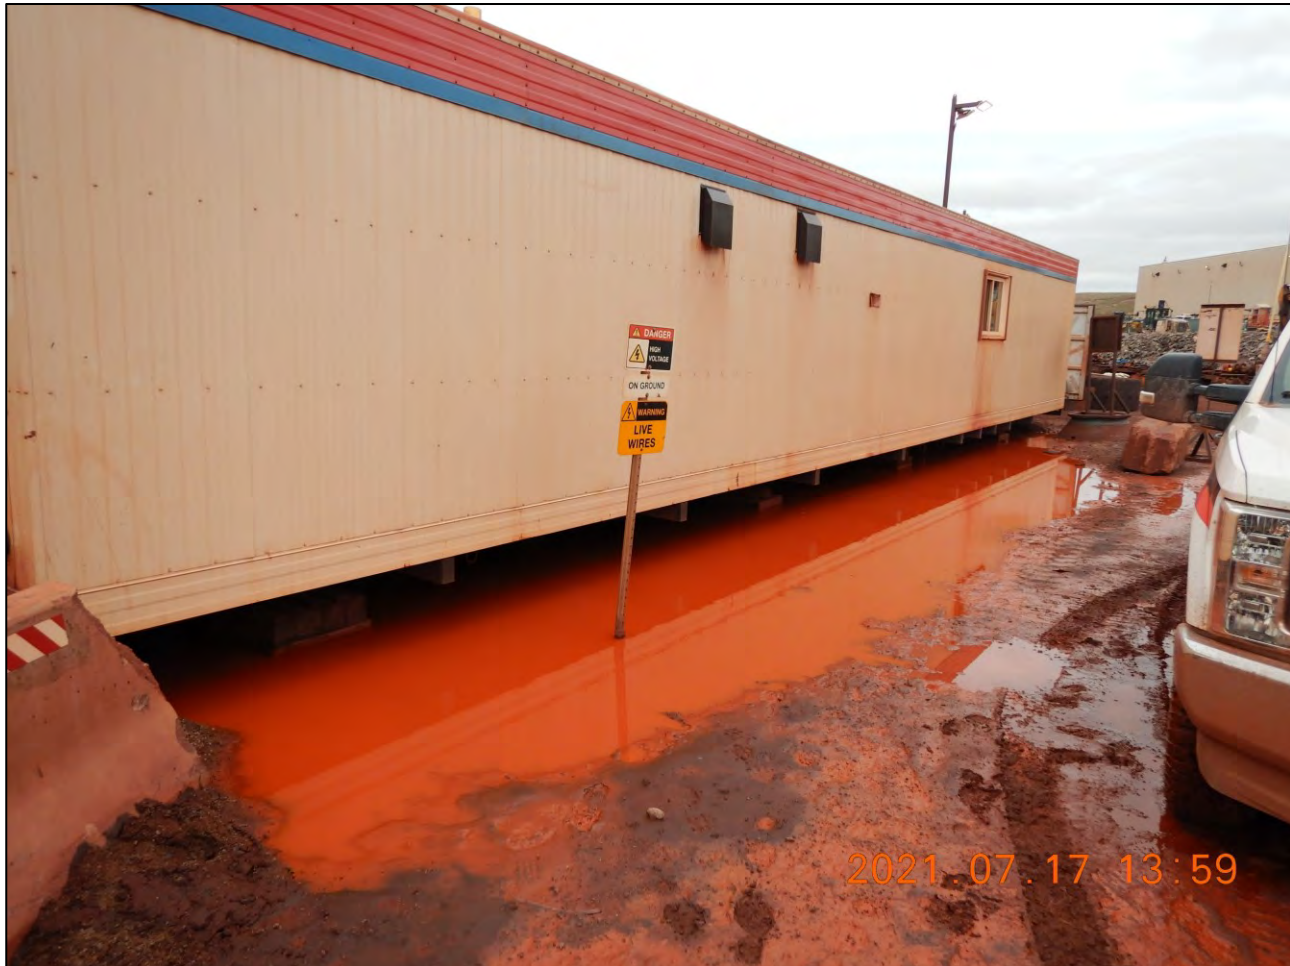
Photo 30. Muster station building inundated by contact water. Approximately 6in deep. Live wires running through contact water.
