APPENDIX E.8.2

QIA INSPECTION REPORTS AND BAFFINLAND RESPONSE

2021 July Environmental Inspection – Information Request

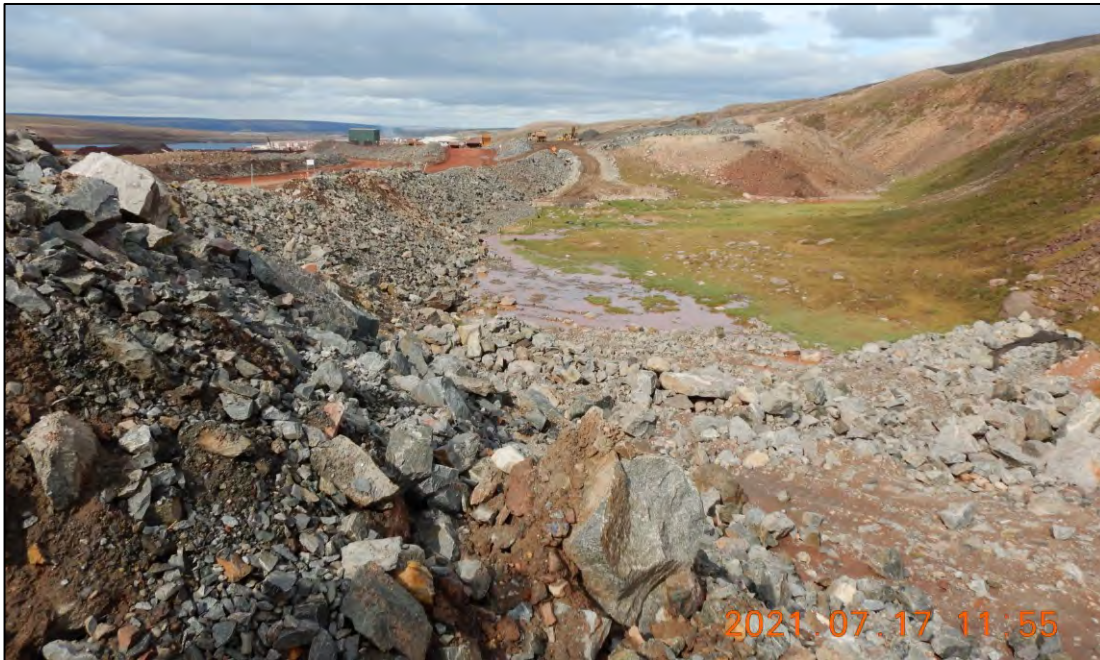
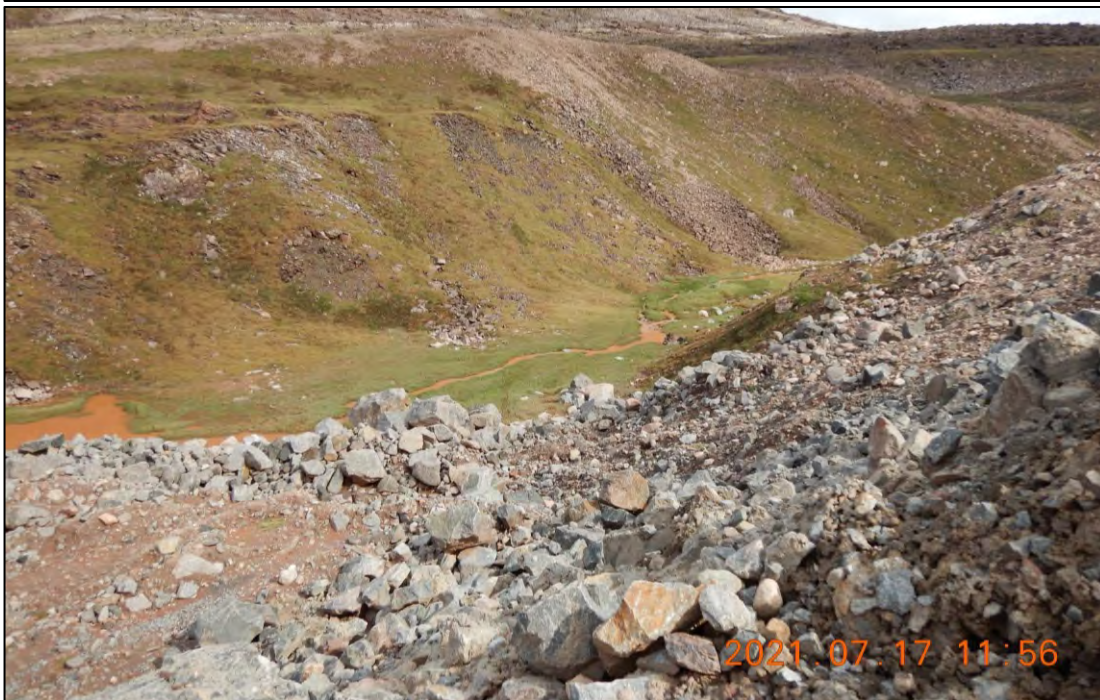
Photo 31. Site of the KM105 proposed sedimentation pond. Currently large quantity of pooling water with discoloration. No clear drainage path.

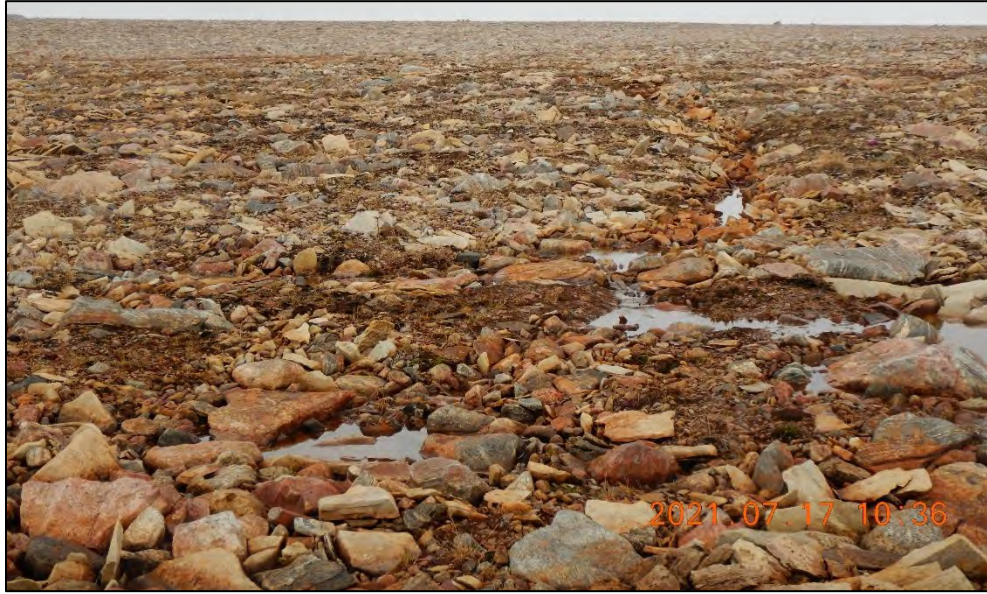
Some impact to the tundra is expected as a result of ongoing effluent discharges. However, efforts should be made to avoid degradation of the tundra and vegetation. As part of QIA's unscheduled investigation of the Mary River Site, inspectors walked the perimeter of the WRF and terrestrial receiving environment. Figure 4A highlights that 140 m downgradient of the final discharge point, scouring of the tundra was apparent along a preferential flow path. A comparison between Figure 3 and Figure 4 indicates that tundra vegetation has been damaged as a result of the ongoing discharges. Little to no vegetation is visible Figure 3 while a healthy tundra sedge environment is visible in Figure 4. While these environmental impacts need not be remediated at this stage of the project when as discharges are expected to persist for years to come, efforts can be made to minimize the interim effects and remediation required at closure. The current closure strategy for the WRF does not include any consideration of the terrestrial receiving environment⁵.

Figure 3. Impacted area 140 m down gradient of the final discharge point

5. **Discharge Approach.** Ongoing discharges to the receiving environment are permitted under the Project's Water Licence. However, damage to the permafrost and formation of preferential flow paths should be avoided. Baffinland should therefore revisit the discharge approach so that ongoing discharges via the final discharge point to the receiving environment no longer damages the tundra through the formation of preferential flow paths.
6. **Closure.** The current closure plan only considers the WRF itself and not the terrestrial receiving environment. The next iteration of the Waste Rock Management Plan (i.e., Version 4) and Interim Closure and Reclamation Plans should include provisions to address the impacts observed in the terrestrial receiving environment as a result of discharges from the WRF.
