APPENDIX E.8.3

Initial and Follow-Up Spill Reports

Re: Follow-Up to Spill #2021-021
Mary River Project - Water Licence No. 2AM-MRY1325

Re: Follow-up to Spill #2021-022
Mary River Project - Water Licence No. 2AM-MRY1325

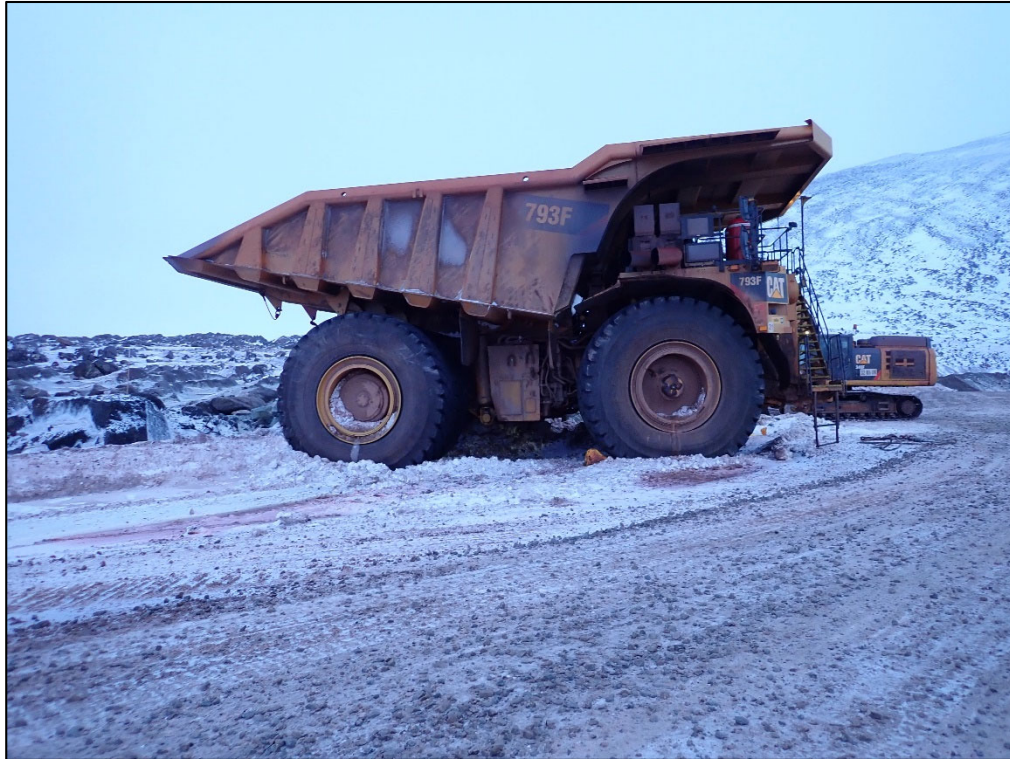
On January 22, 2021 at 16:12hrs, approximately 967 liters of glycol coolant and 247 liters of hydraulic oil spilled onto the surface of the Mine Haul Road (MHR) at KM105.4 from hoses on a Caterpillar 793F mine haul truck that failed when the truck temporarily lost control. The spilled coolant and hydraulic oil drained down the west edge of the MHR resulting in an affected area of approximately 300 m² that was 3 m wide by 100 m long. At the time of the event, the mine haul truck temporarily lost traction due to icy road conditions and came to rest partially off the MHR. The spill location is >100 m to the nearest fish bearing water body.

Photo 1. Location of Coolant and Hydraulic Oil Spill (Before Cleanup) – January 23, 2021

In response to the event, the braking system on the remainder of the 793 fleet was inspected to verify that all systems were operating properly prior to the trucks resuming haulage on the MHR. In addition, actions are being implemented to improve road maintenance on the MHR for haulage. These actions include smoothing out peak gradients at locations where the mine haul truck lost control, and implementing a scheduled road survey review to identify and remediate peak gradient variances along the MHR.

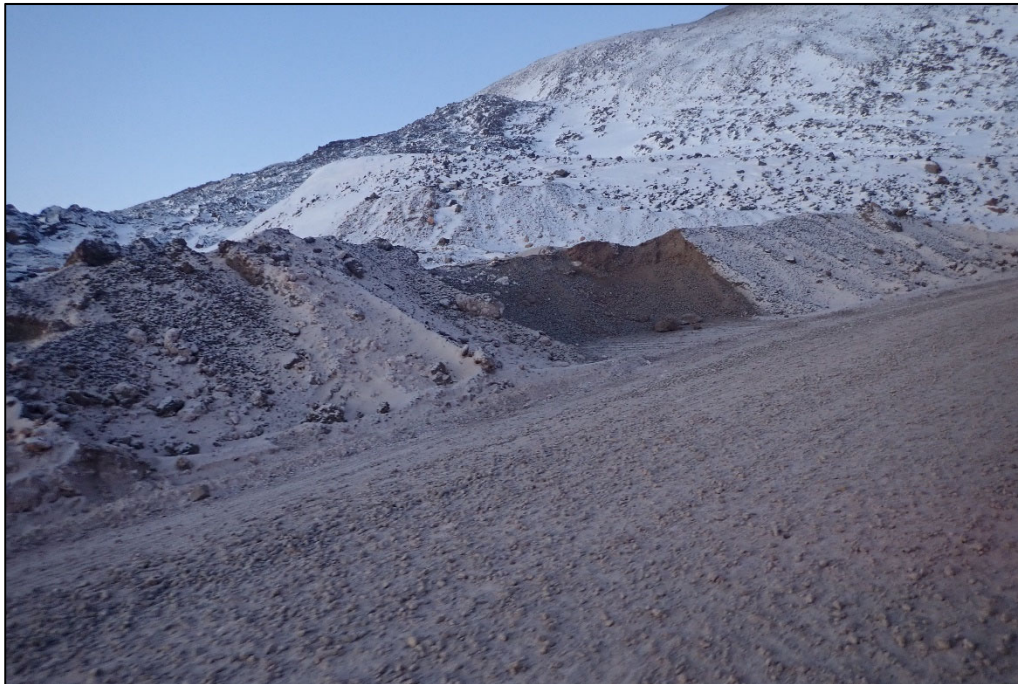
The affected area of the MHR was graded and resurfaced and the road is back in operation.

Photo 2. Location of Coolant and Hydraulic Oil (After Cleanup) – January 28, 2021

The scene of the incident was immediately secured to prevent additional product from being released from the mine haul truck. After the mine haul truck was safely removed from the spill location, mobile equipment scraped contaminated gravel and roadbed material from the affected area and placed it in sealed containers in the Hazardous Waste Berm (HWB) to be transported for offsite disposal.

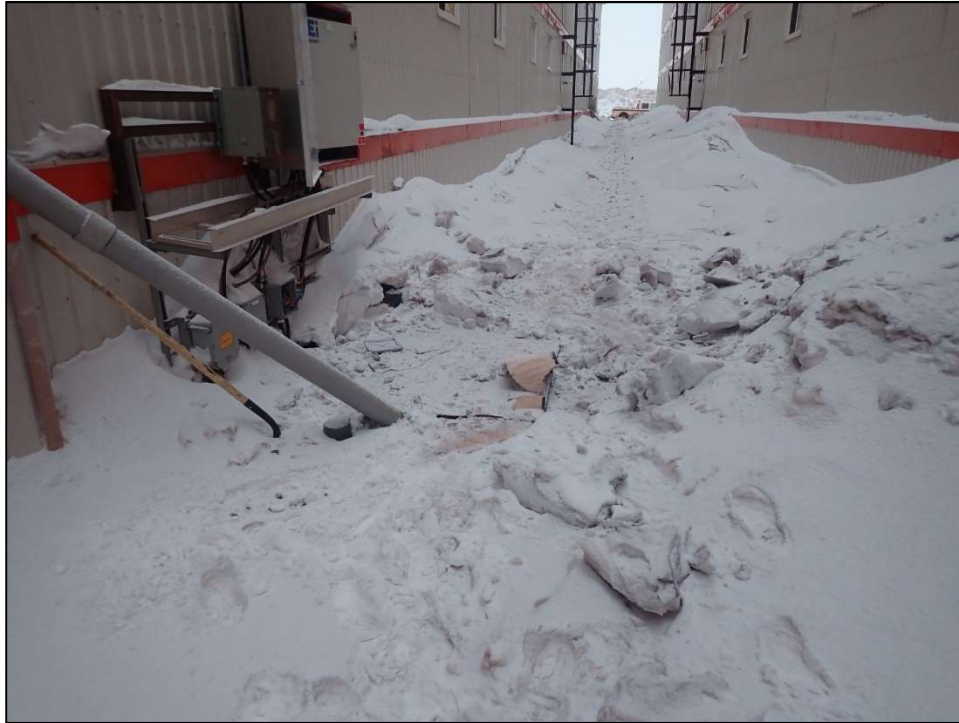
On January 23, 2021 at 06:30hrs, approximately 2,000 liters of raw sewage was spilled onto the frozen ground from the sewage lift station that services the E wing accommodations building at the Sailiivik Camp at the Mary River Mine Site. The lift station transfer pump was not operating at the time of the spill causing the underground holding tank for the lift station to overflow resulting in raw sewage overflowing onto the frozen ground. The spill affected an area of approximately 25 m² between E Wing and F Wing where the raw sewage soaked into snow and froze on the ground. The spill location is approximately 90 m to the nearest fish bearing water body, which is currently frozen due to winter conditions.

Photo 1. Location of Sewage Spill from Lift Station (Before Cleanup) – January 23, 2021

Immediate corrective actions included scheduling checks of all lift stations daily by Housing Maintainers, removing snow from lift station covers to provide access for inspections, and installing warning labels on all lift station electrical panels advising personnel not to open them without an electrician present. Additional corrective actions that Baffinland is taking to prevent similar spills from re-occurring include installing warning lights on the lift station electrical panels to indicate when power to the transfer pumps is on, completing an audit of lift station electrical panels throughout the Sailiivik Camp to identify and mitigate any potential issues, building structures over lift station inspection covers to prevent snow accumulation, and implementing a lift station and panel inspection checklist for daily and weekly inspections.

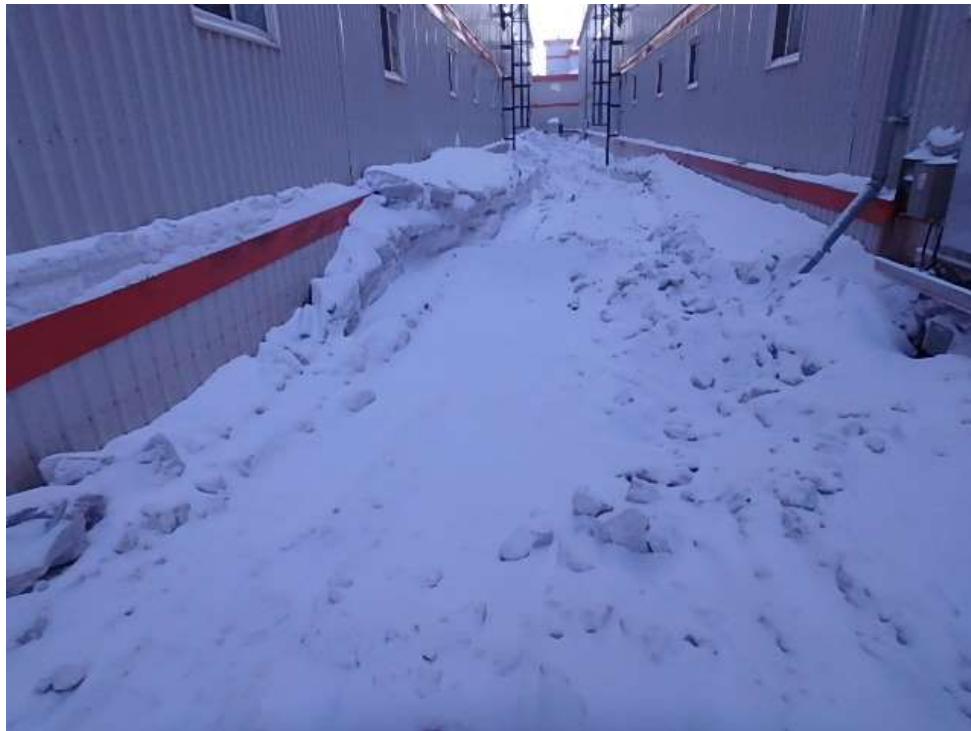
The switch that controls power for the lift station transfer pump was turned on and the lift station was returned to normal operation. Contaminated snow and ground was removed from the affected area and placed in sealed containment in the HWB for transport offsite for disposal. The affected area will be monitored as the ground thaws to ensure all affected ground was removed during clean up activities.

Photo 2. Location of Sewage Spill from Lift Station (After Cleanup) – January 31, 2021

Upon identifying the spill, the Site Services Housing Maintainer was immediately notified to request assistance. The Housing Maintainer inspected the electrical panel for the lift station and determined that the power switch for the transfer pump was in the off position. The power switch for the pump was turned on and the pump was returned to operation and pumped the holding tank down to the low-level pump shutoff setting. Additional inspections were performed to confirm that the pump was operating normally. Contaminated snow and ground was collected using a skid steer and shovels and placed in sealed containment in the Hazardous Waste Berm (HWB) to be transported for offsite disposal.

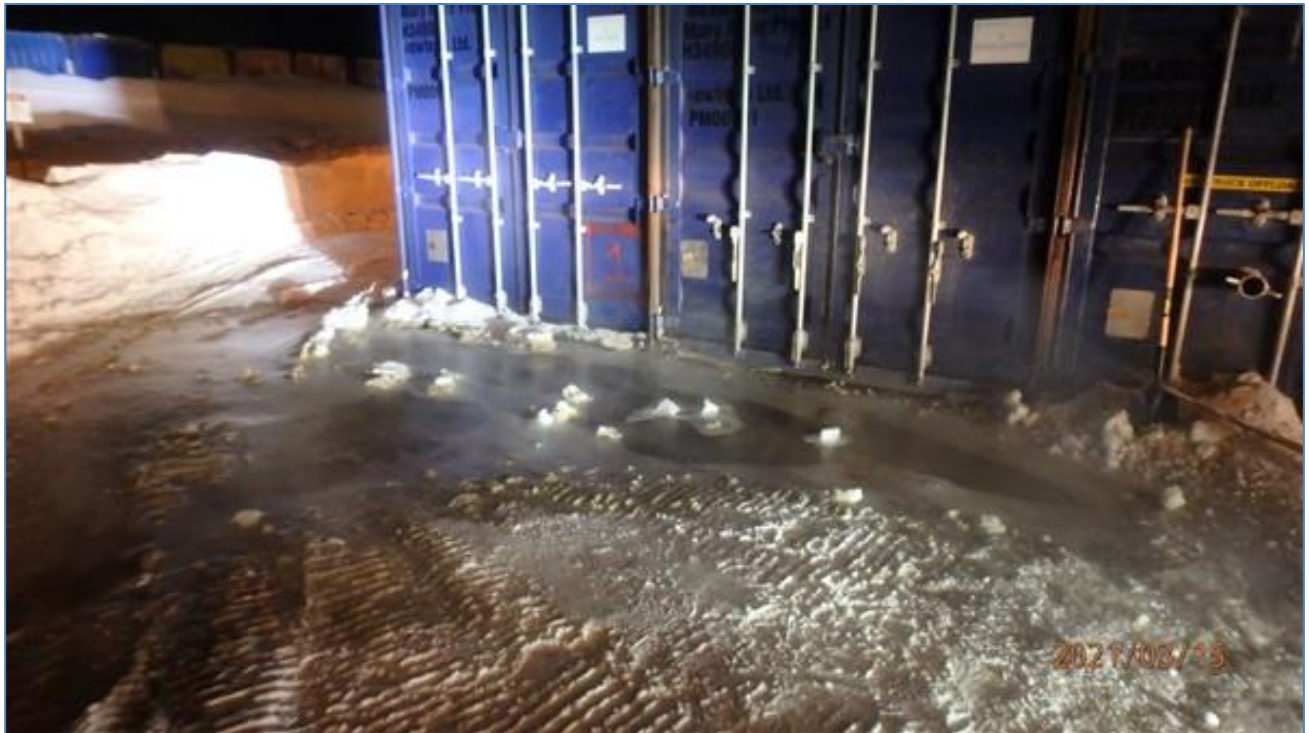
On March 16, 2021 at 00:10HRS, approximately 1000 liters of sewage was released to the frozen ground when the discharge hose disconnected from the Vacuum Truck discharge valve while sewage was being offloaded into the Sewage Treatment Plant (STP) that services the Port Site Complex (PSC) at Milne Port. The discharge hose disconnected during the sewage transfer because the fastening mechanism on the discharge hose was not properly locked into the fitting on the discharge valve. A factor which contributed to the release was that the Operator was not present at the discharge location to monitor the transfer hose and connection fittings during the offloading process because the Operator had remained in the cab of the Vacuum Truck after the sewage transfer was initiated. The area affected by the spill is farther than 100 m from the nearest water body, which is currently frozen.

Photo 1. Location of Sewage Spill from Vacuum Truck (Before Cleanup) – March 16, 2021

A Standard Operating Procedure (SOP) for Vacuum Truck operations, which instructs operators to remain at the discharge area and to continuously monitor hoses and fittings during sewage transfers was developed. All Site Services Vacuum Truck operators will be trained in the Vacuum Truck operating procedures described in the SOP.

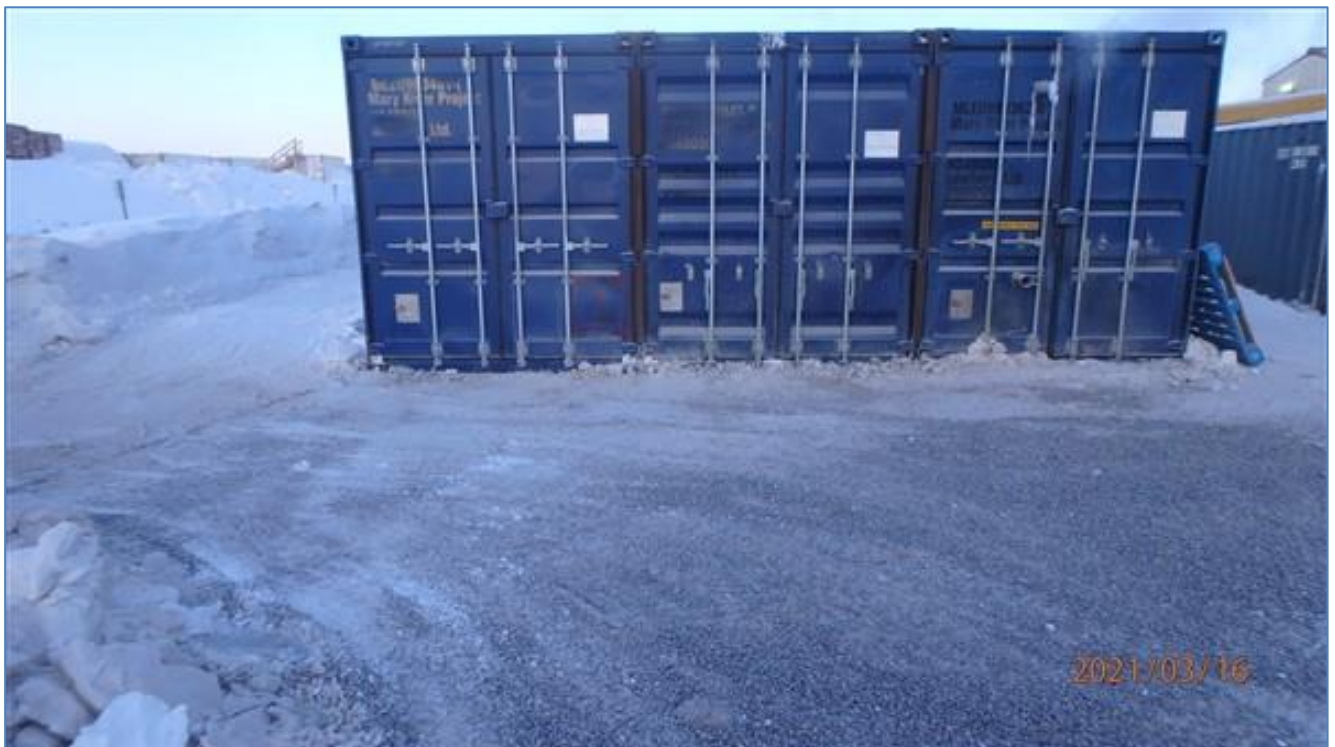
Frozen ground and released sewage was removed from the spill affected area with a skid-steer and placed in Quatrex bags in the hazardous waste berm. Vacuum truck operators have been instructed to remain at the discharge area and to continuously monitor hoses and fittings during sewage transfer operations. An SOP detailing this procedure was developed.

Photo 2. Location of Sewage Spill from Vacuum Truck (After Cleanup) – March 16, 2021

Upon identifying the spill, the Vacuum Truck Operator immediately disengaged the transfer pump and closed the discharge valve, preventing further release. A skid-steer was used to scrape the released sewage from the frozen ground and place it into Quatrex bags for storage in the hazardous waste berm. The fastening mechanisms on the Vacuum Truck were inspected to verify that they were functioning properly, and pins were subsequently installed on the fastening mechanisms of the Vacuum Truck as a secondary guard to prevent the primary locking mechanism from releasing.

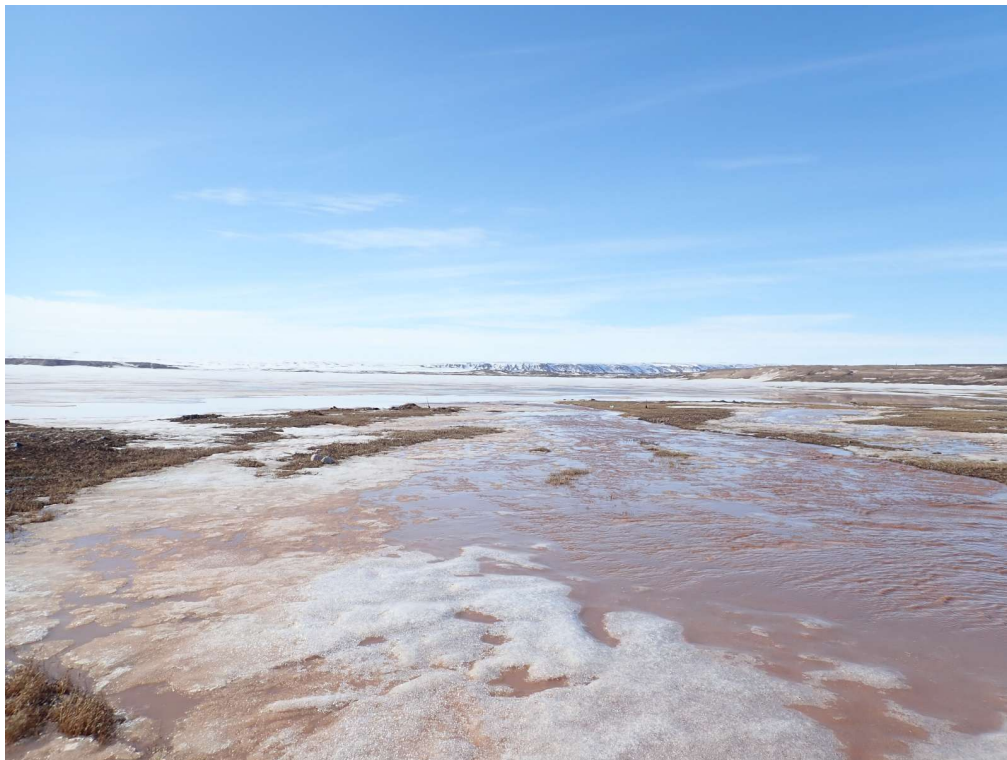
On May 2, 2021, warming temperatures at the Mary River Mine Site resulted in snowmelt runoff containing sediment-laden water, which was observed to be flowing at the Camp Lake Tributary 1 (CLT-OUT) and Sheardown Lake Tributary 1 (SDLT-OUT). On May 6, 2021, ongoing warm temperatures at the Mary River Mine Site resulted in snowmelt runoff containing sediment laden-water at the Sheardown Lake Landfill Gate Tributary (LDFG-OUT). The sediment-laden water at CLT-OUT and SDLT-OUT on May 2, 2021 was reported to the NT-NU Spills Reporting Line as Spill #2021-146 (Attachment 3) and the sediment-laden water observed at LDFG-OUT on May 6, 2021 was reported as Spill #2021-164 (Attachment 4). Details for the sample locations where sediment-laden water was observed at the Mary River Mine Site in May 2021 are presented in the following table:

Photo 2. CLT Outfall on May 2, 2021

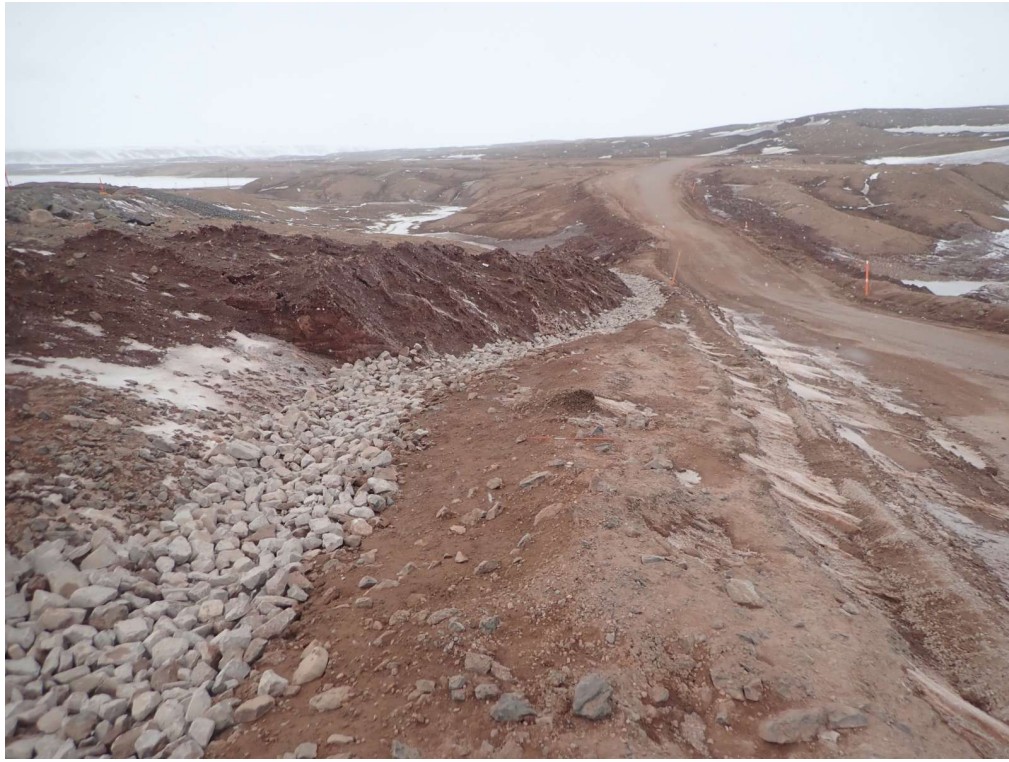
Photo 3. BG-01 Downstream Ditch Riprap Armouring (May 13, 2021)

In preparation for freshet 2021, permanent erosion and sediment control measures were reinforced and maintained as needed, including berm reinforcement upslope of the SDLT outfall and riprap armouring of the ditch at CLT upstream tributary BG-01, to stabilize the bank and reduce erosion.

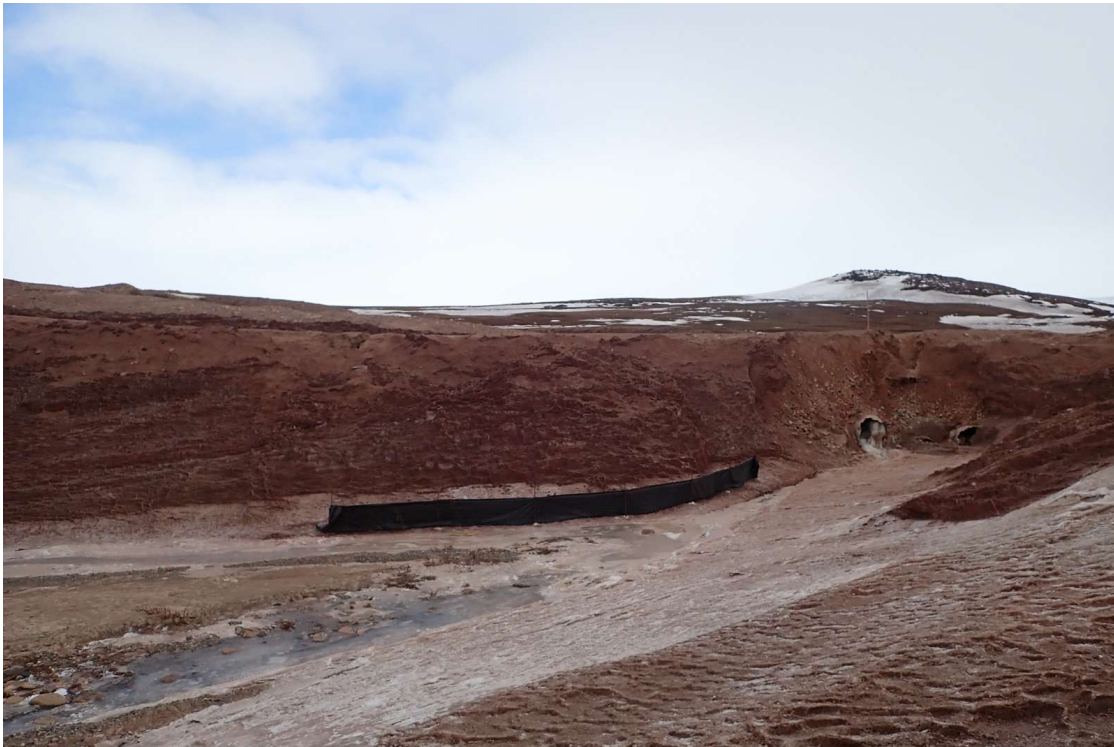
Photo 4. Silt Fencing at the Outlet of BG-01 (May 15, 2021)

Upon discovery of the elevated instream Total Suspended Solids (TSS) conditions at these drainages, personnel worked to install sedimentation mitigation measures, including silt fences, coir logs and sand bags, in areas around the CLT, SDLT and LDFG outfalls and upstream tributaries in accordance with Baffinland's Surface Water and Aquatic Ecosystem Management Plan, to slow the flow and settle sediments prior to the water entering the streams. Water diversion and pumping strategies were also implemented to reduce potential erosion and sedimentation. With freshet conditions present, daily monitoring of the water quality is ongoing. As per Baffinland's Freshet Monitoring Procedure, daily monitoring is conducted until seven (7) compliant sample results are obtained and, subsequently, the sampling frequency is reduced to weekly. The sampling frequency returns to a daily frequency if further non-compliant results are obtained.

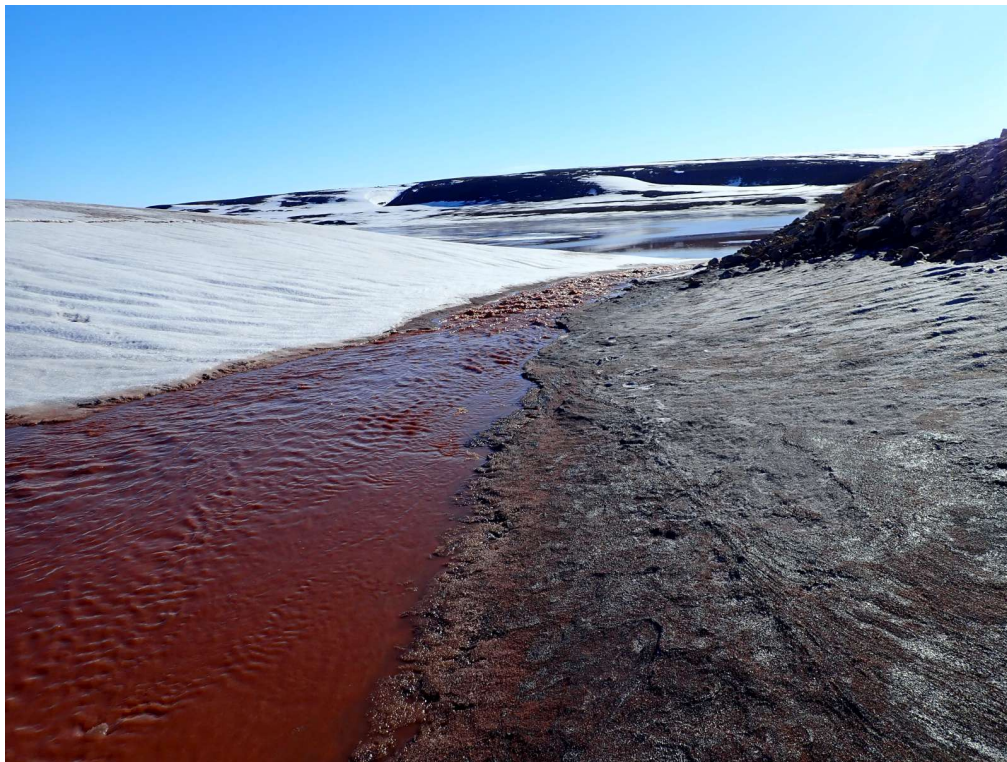
Photo 2. SDLT Outfall on May 2, 2021

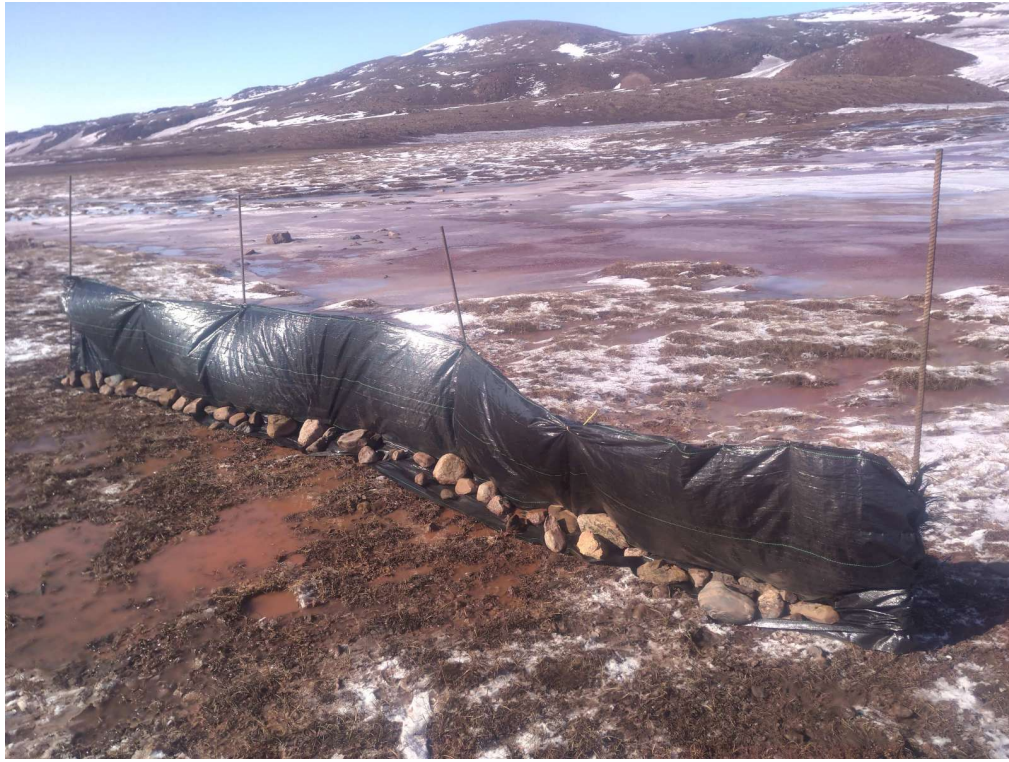
Photo 3. Erosion and Sediment Control at CV-186 Upstream of SDLT-OUT (May 12, 2021)

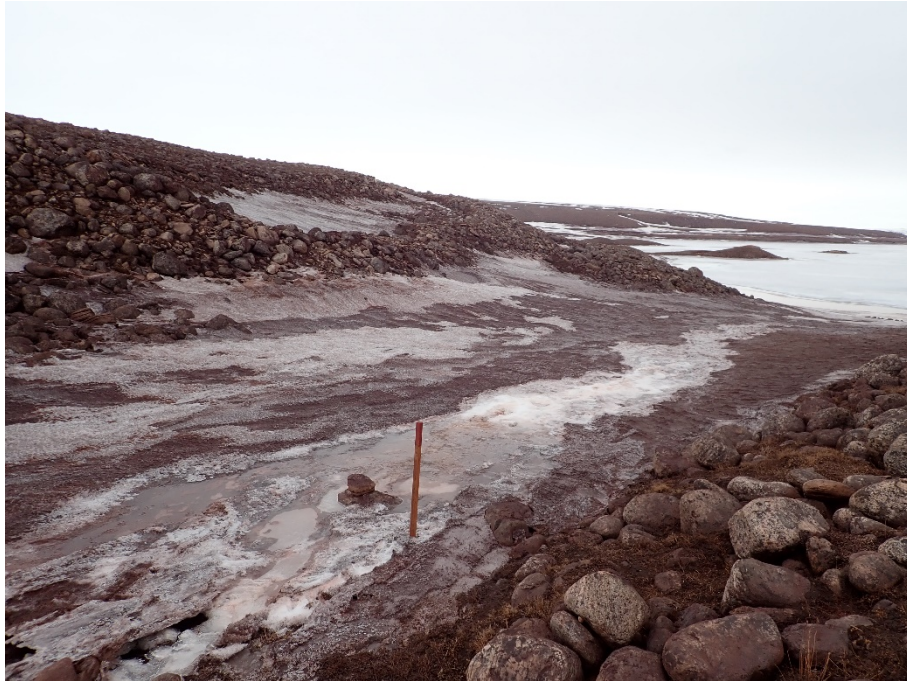
Photo 1. LDFG Outfall on May 6, 2021
