Spill Report Number:

21-247

Re: Follow-up to Spill #2021-247
Mary River Project - Water Licence No. 2AM-MRY1325

Photos

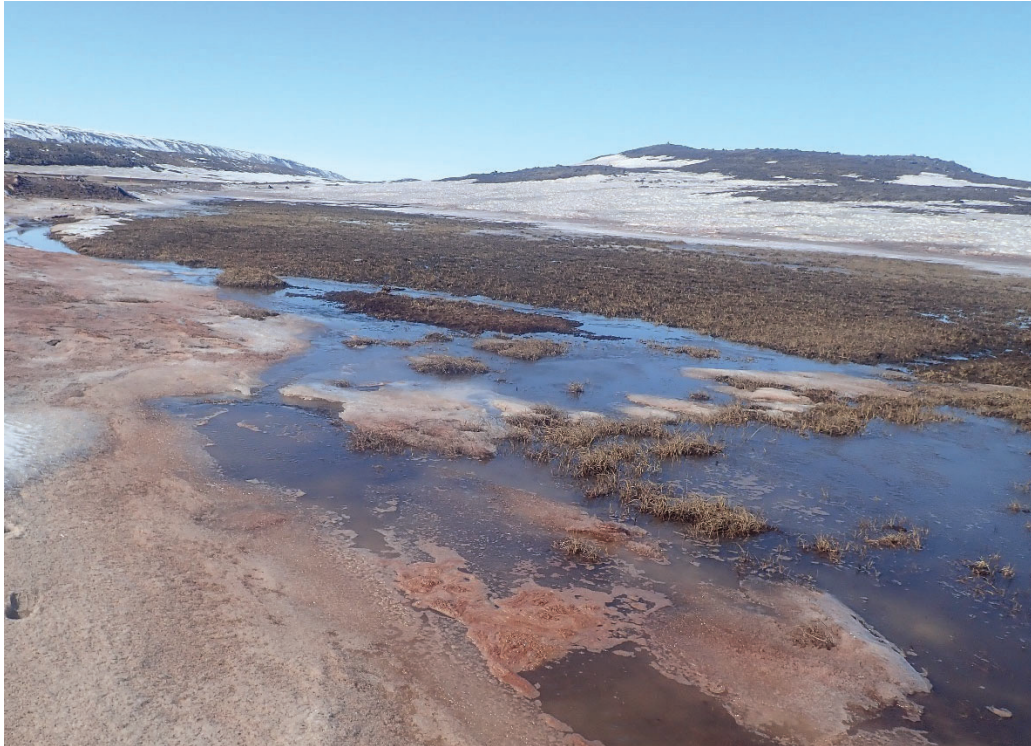
Photo 1. CV-001 Culvert Crossing Upstream on May 26, 2021

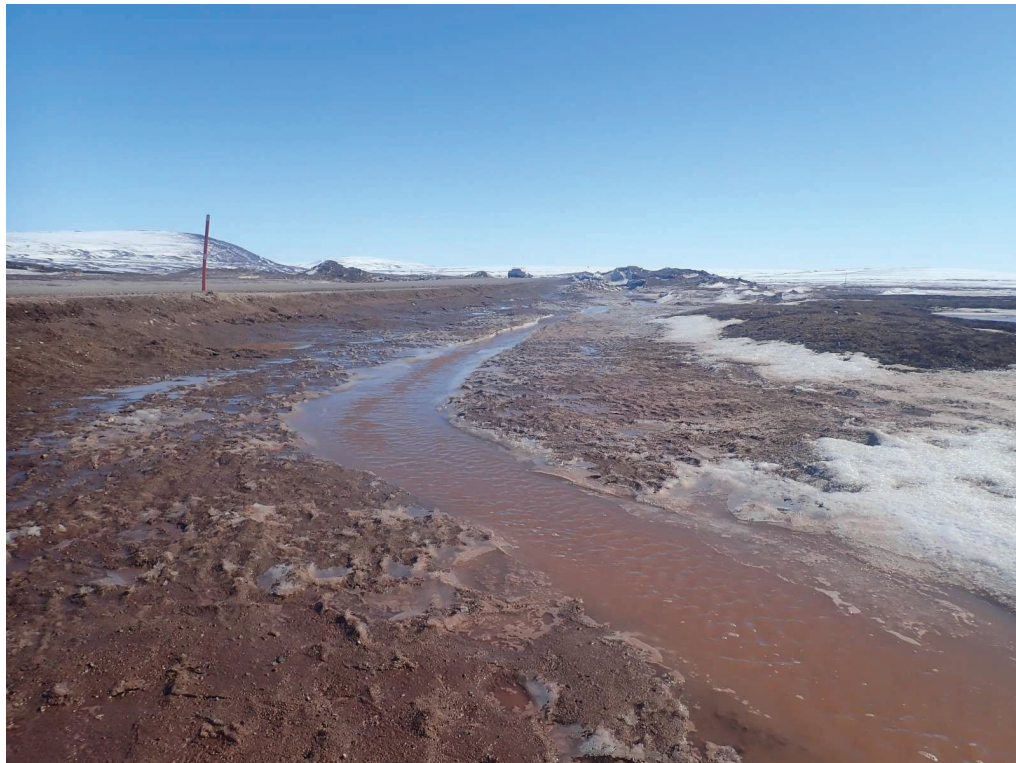
Photo 2. CV-001 Culvert Crossing Downstream on May 26, 2021

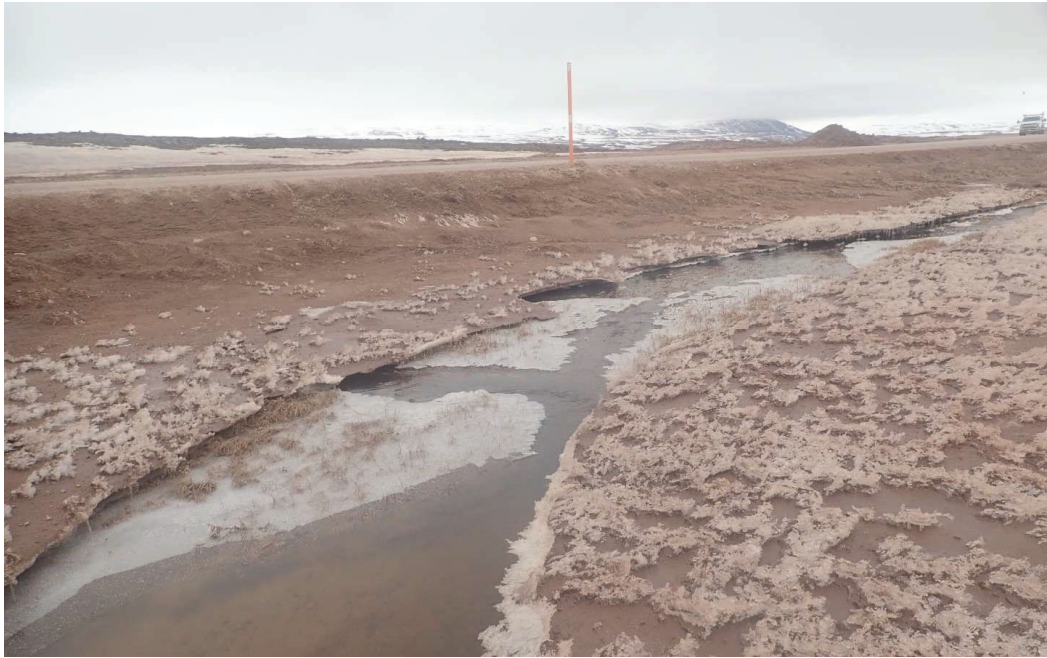
Photo 3. CV-001 Culvert Crossing Downstream on May 31, 2021

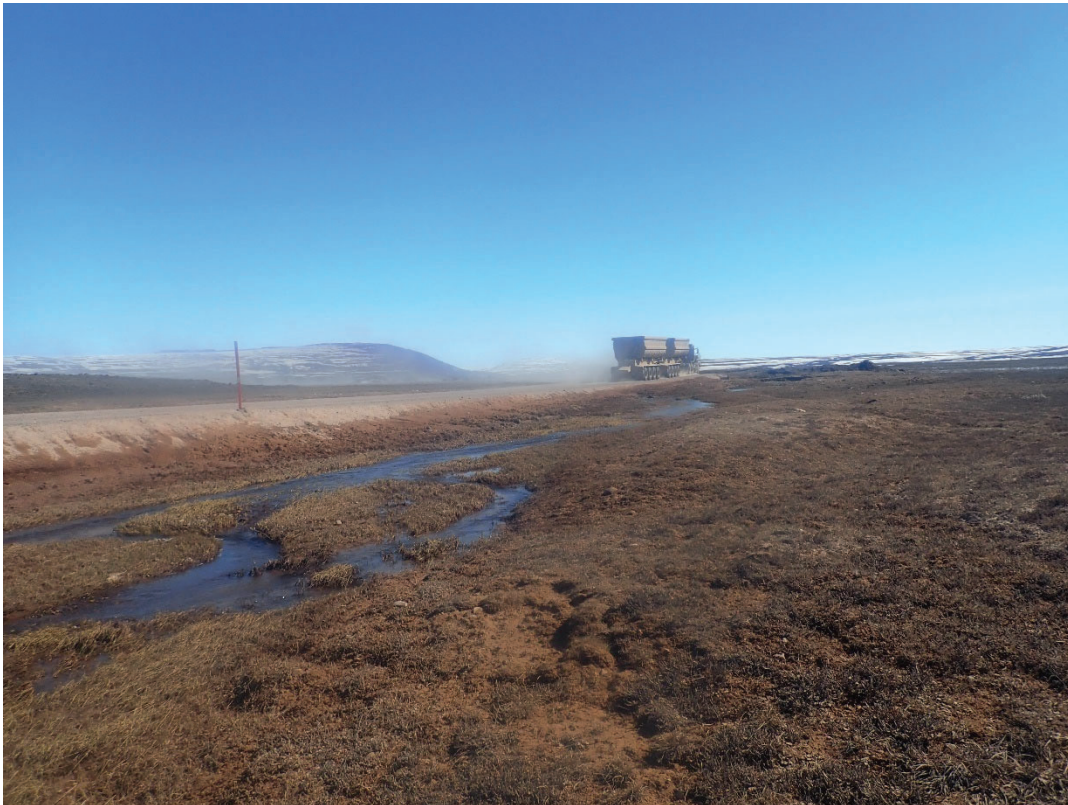
Photo 4. CV-001 Culvert Crossing Downstream on June 8, 2021

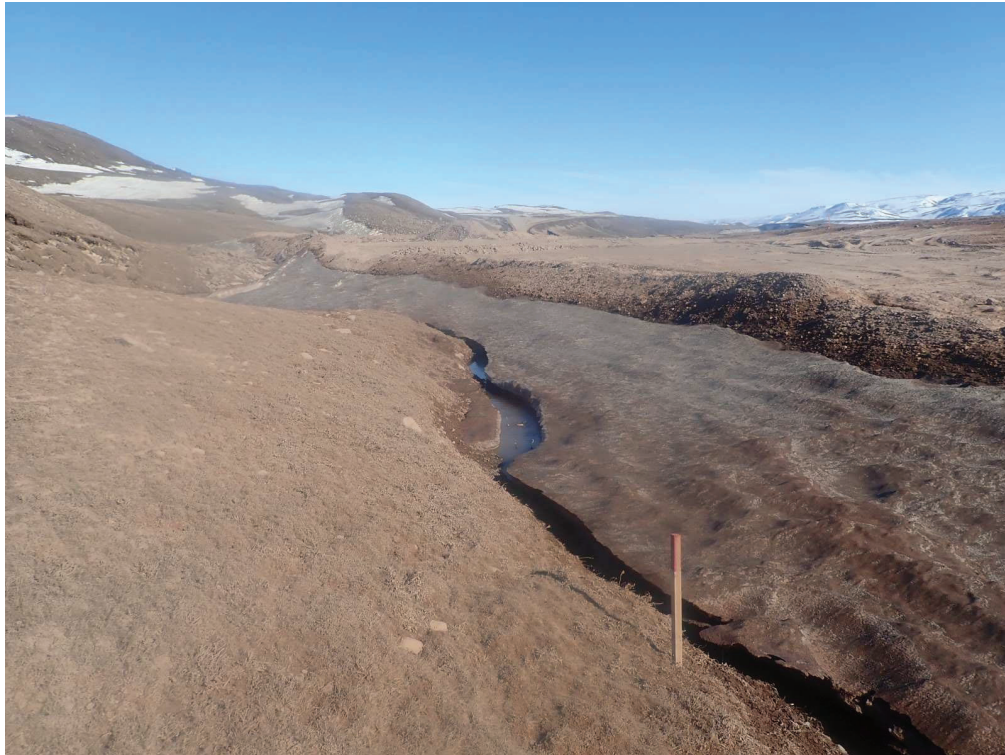
Photo 1. CV-154-A Culvert Crossing Upstream on June 1, 2021

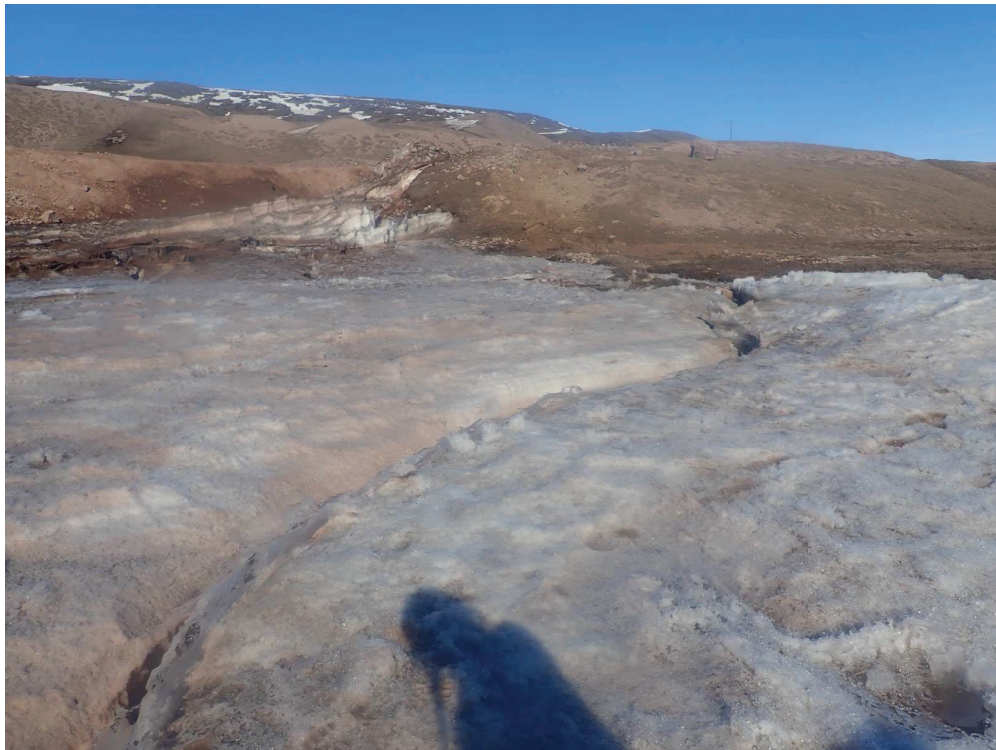
Photo 2. CV-154-A Culvert Crossing Downstream on June 1, 2021

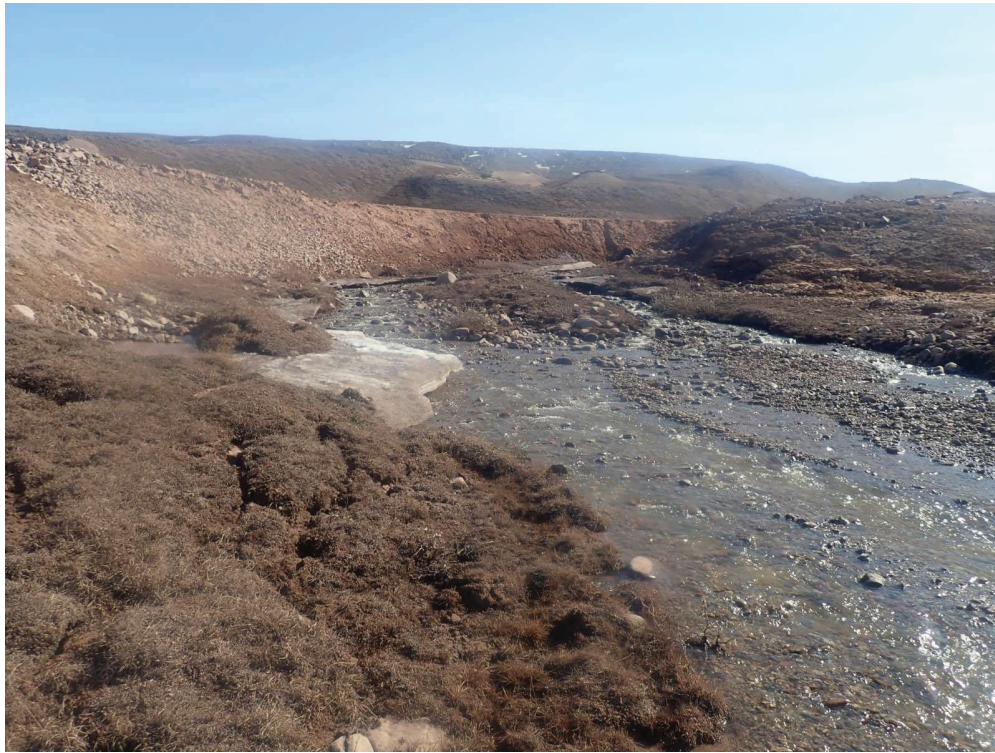
Photo 3. CV-154-A Culvert Crossing Downstream on June 10, 2021

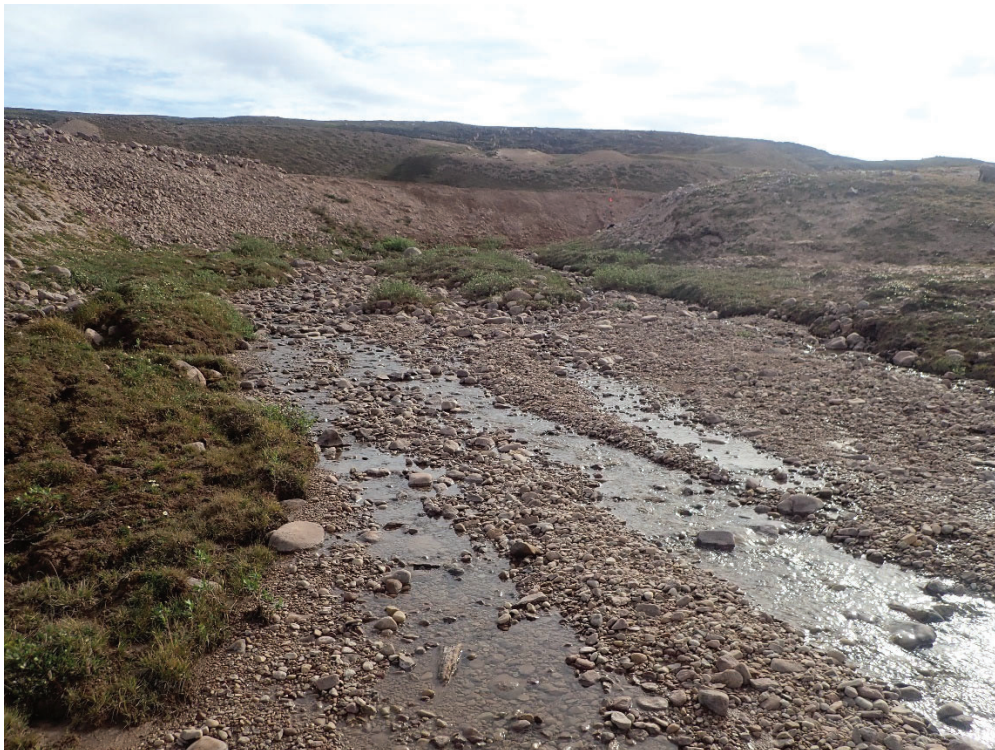
Photo 4. CV-154-A Culvert Crossing Downstream on July 11, 2021

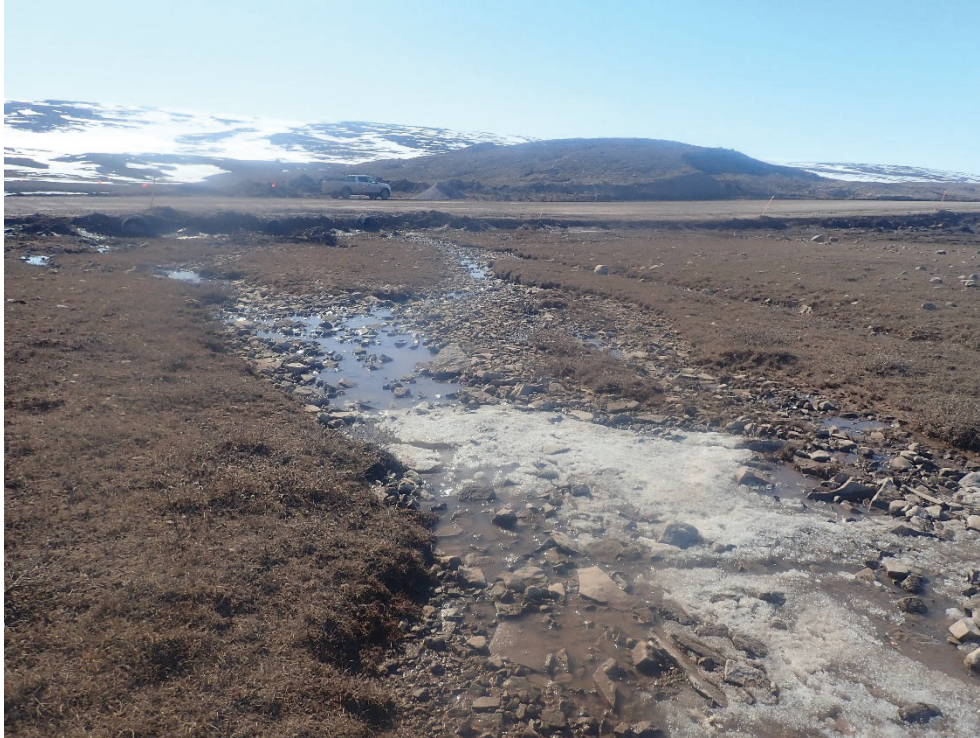
Photo 1. CV-112 Culvert Crossing Upstream on June 1, 2021

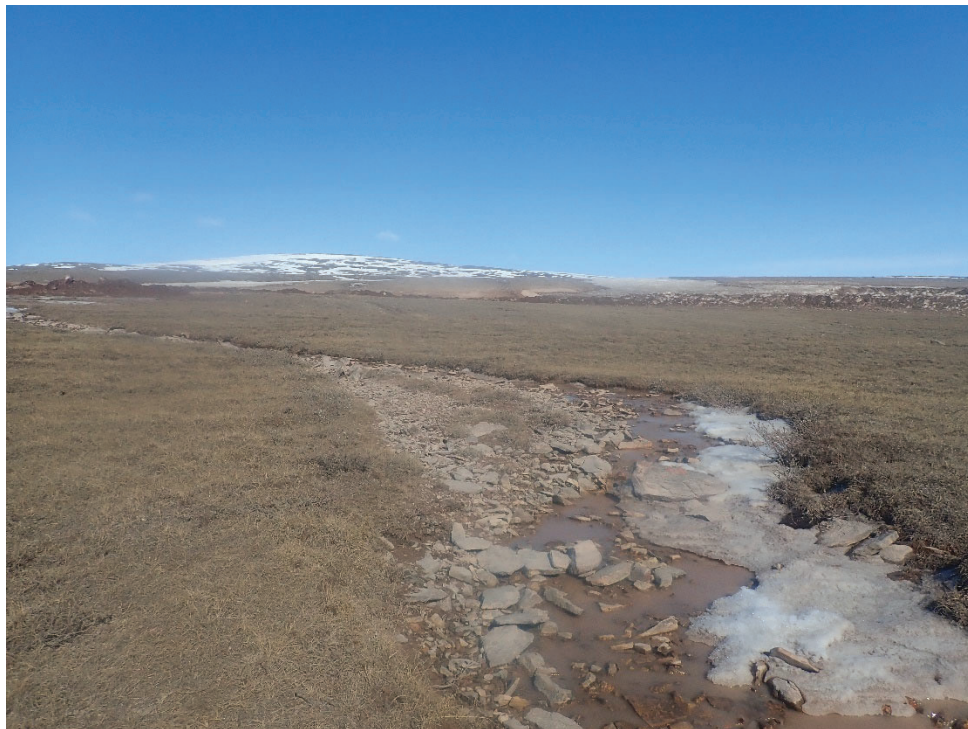
Photo 2. CV-112 Culvert Crossing Downstream on June 1, 2021

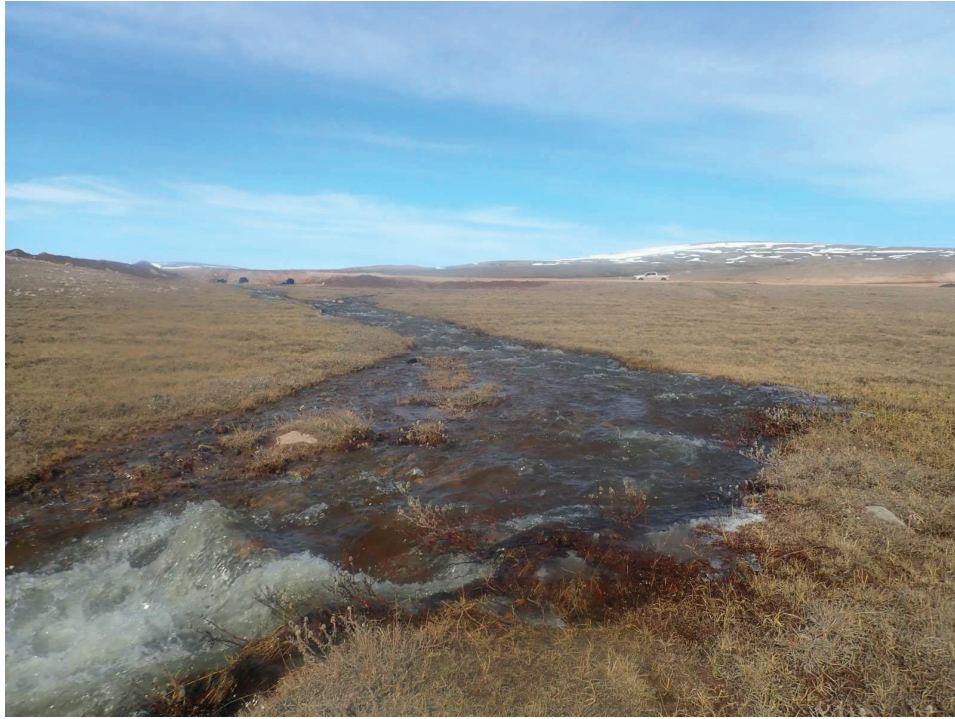
Photo 3. CV-112 Culvert Crossing Downstream on June 9, 2021

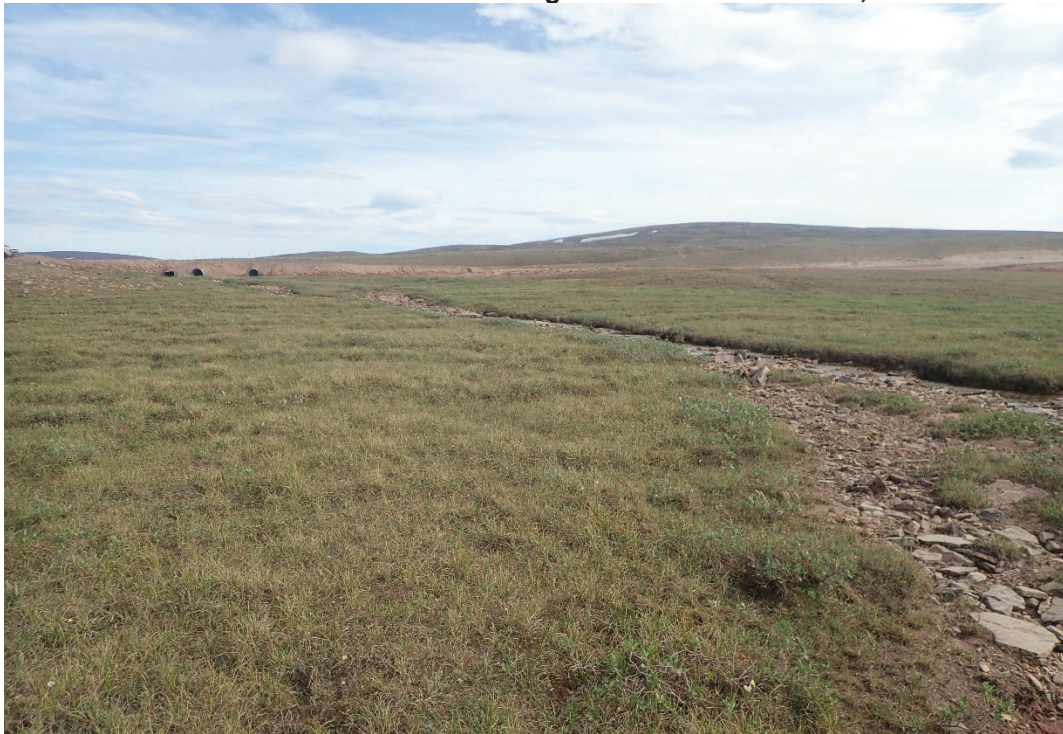
Photo 4. CV-112 Culvert Crossing Downstream on July 11, 2021

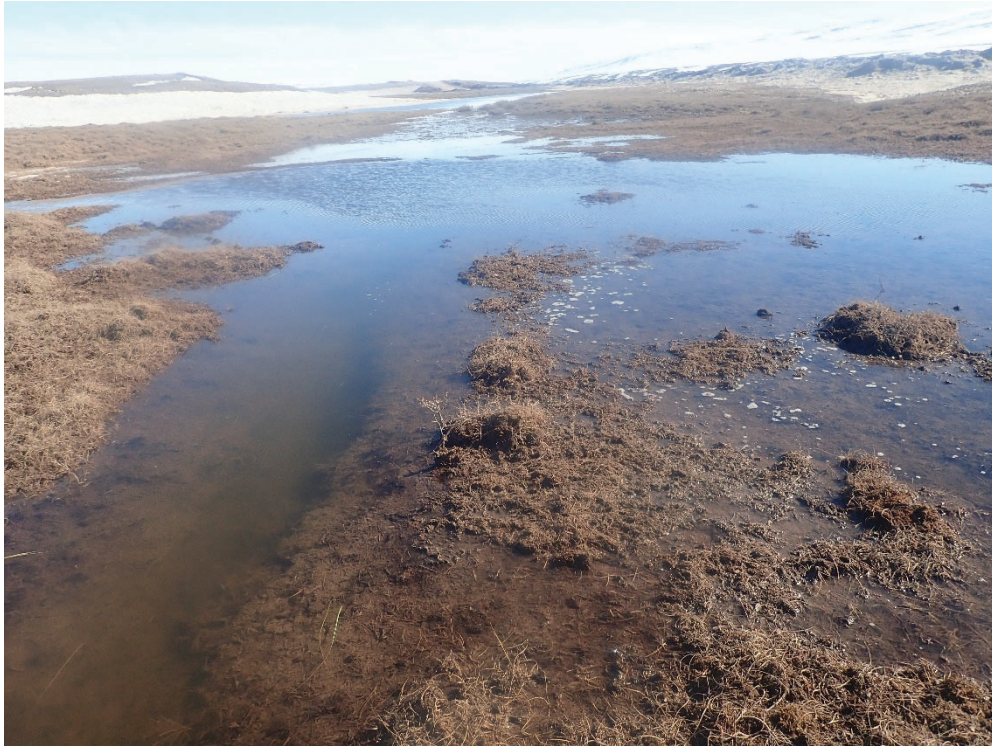
Photo 1. CV-115 Culvert Crossing Upstream on June 1, 2021

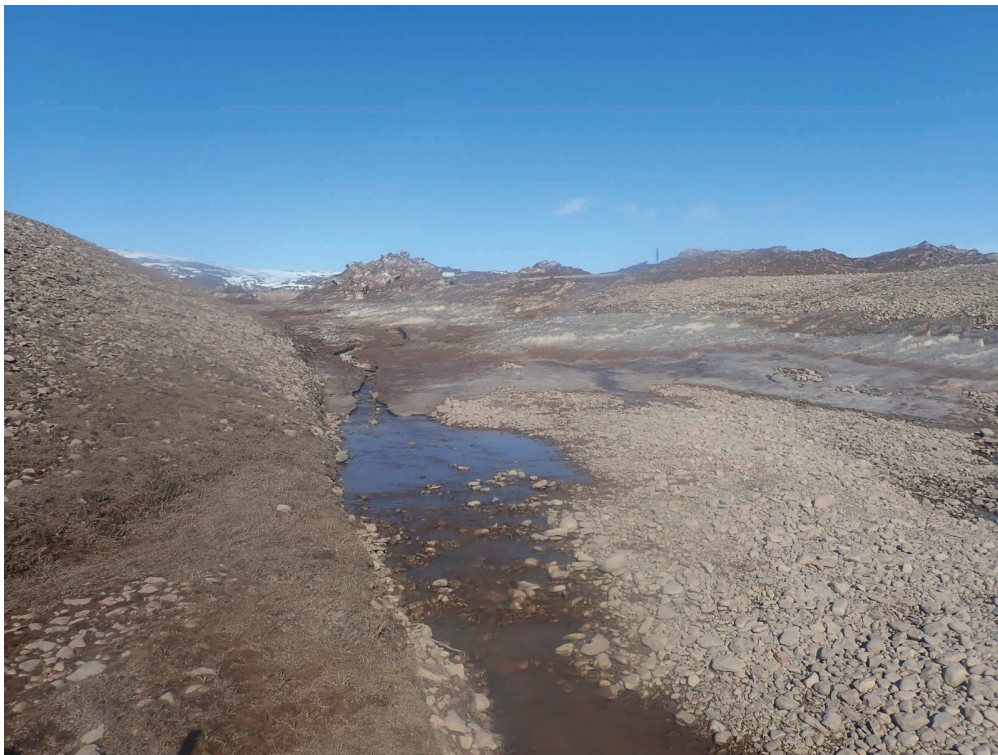
Photo 2. CV-115 Culvert Crossing Downstream on June 1, 2021

Upon discovery of the elevated instream TSS conditions at these downstream culvert crossing locations, field investigations of the affected culvert crossings were completed. Erosion and sediment control measures were subsequently implemented where possible. Culverts CV-115 and CV-093 have had riprap placed at the inlet and outlet culvert embankments in accordance with the Surface Water Aquatic Effects Management Plan to slow runoff water flow and settle sediments prior to the water entering the streams. Road maintenance will complete the armoring with riprap of the remaining culvert embankments as soon as resources become available.

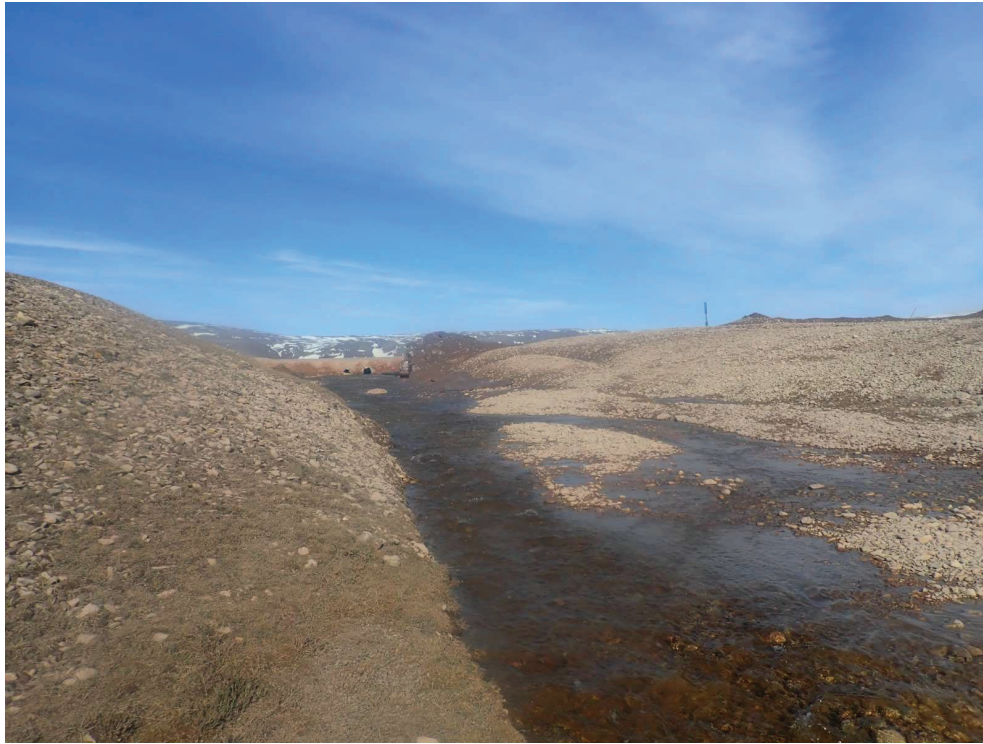
Photo 3. CV-115 Culvert Crossing Downstream on June 9, 2021

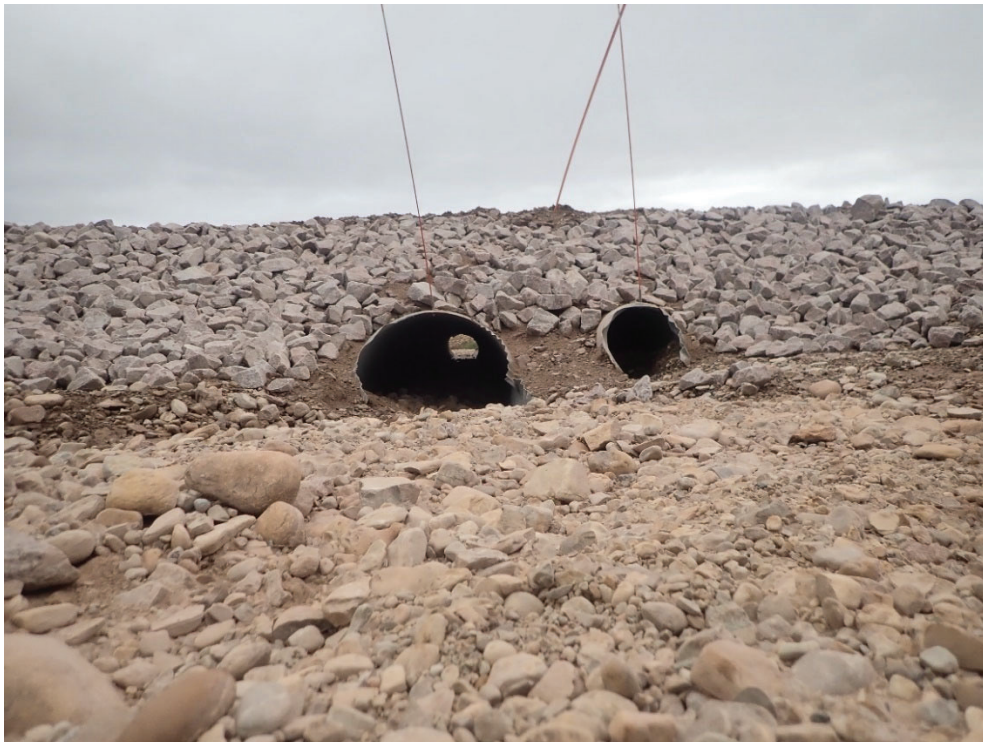
Photo 4. CV-115 Culvert Crossing Upstream July 9 2021

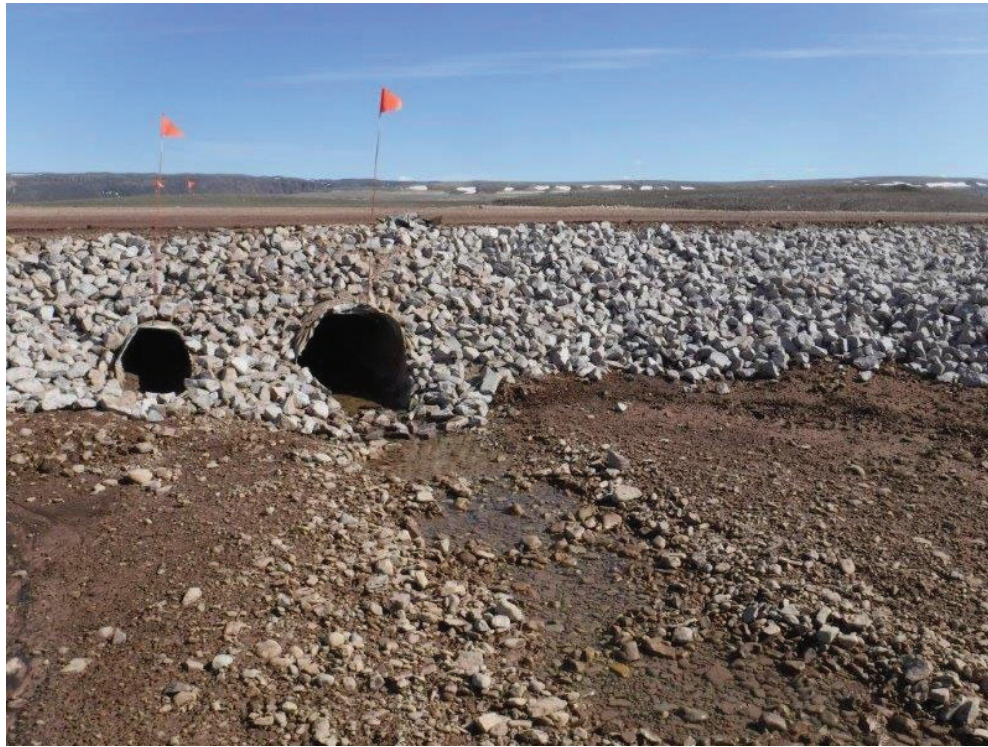
Photo 5. CV-115 Culvert Crossing Downstream July 9 2021

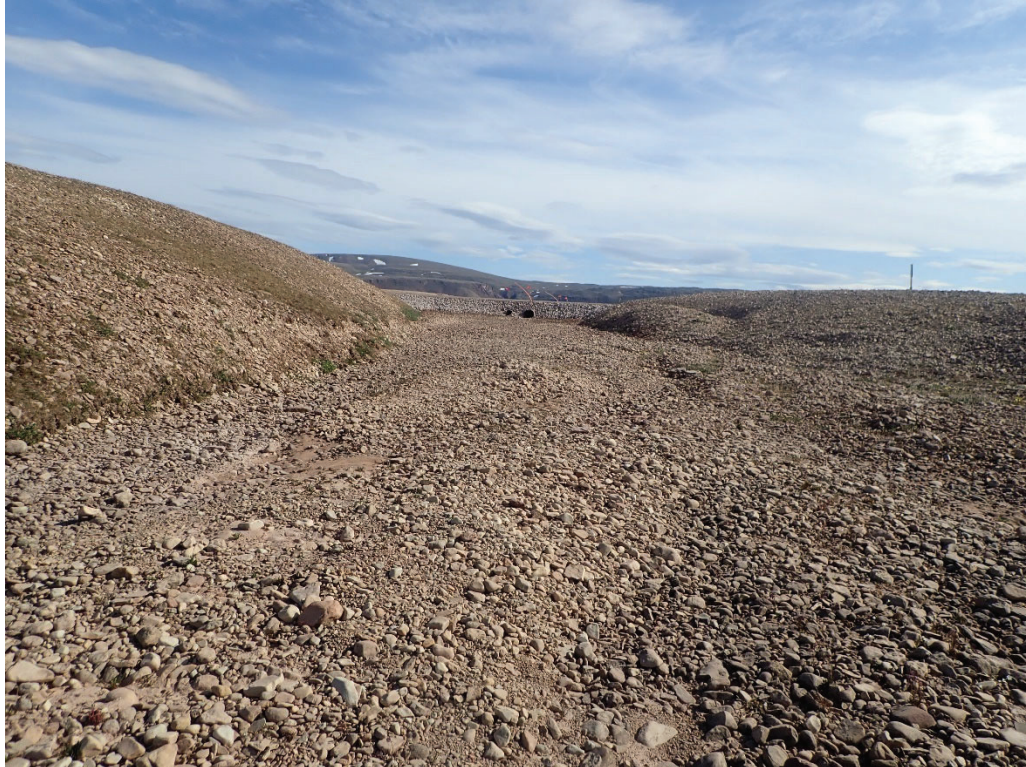
Photo 6. CV-115 Culvert Crossing Downstream July 11 2021
