## **APPENDIX C**

### **Construction Summary Letters**

## **RE: Construction Summary of BG-04 Remedial Measures**

## BG-04 AS-BUILT PHOTO LOG

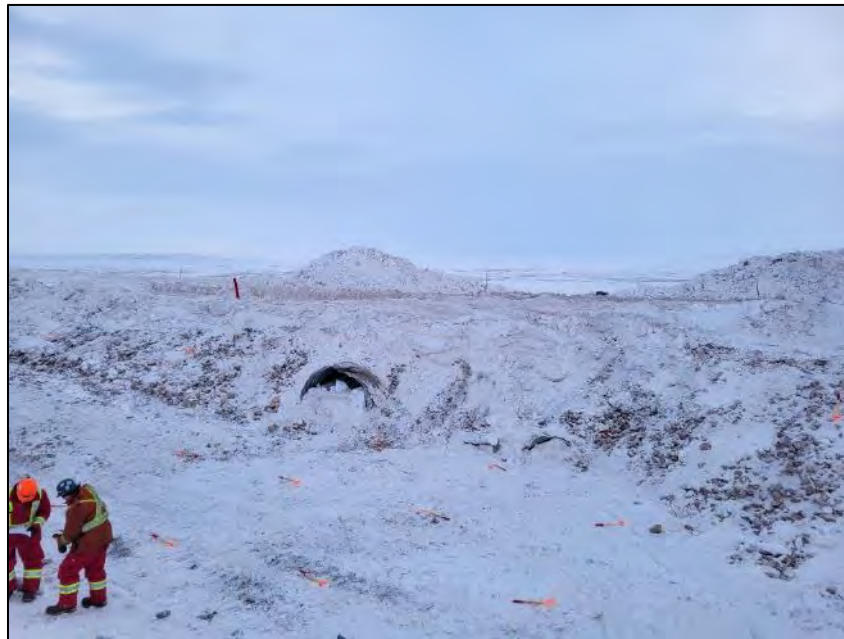
**PHOTO 2.** Prior to Construction - Vantage Point 1 - Upstream Inlet and Road Crossing - Looking North (March 01, 2024).

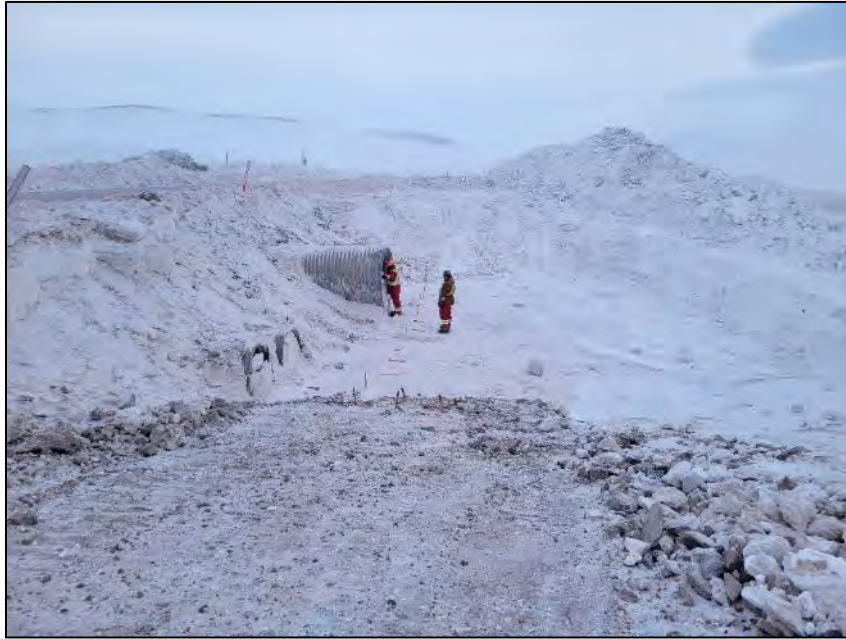
**PHOTO 3.** Prior to Construction - Vantage Point 2 - Upstream Inlet and Road Crossing - Looking West (March 01, 2024).

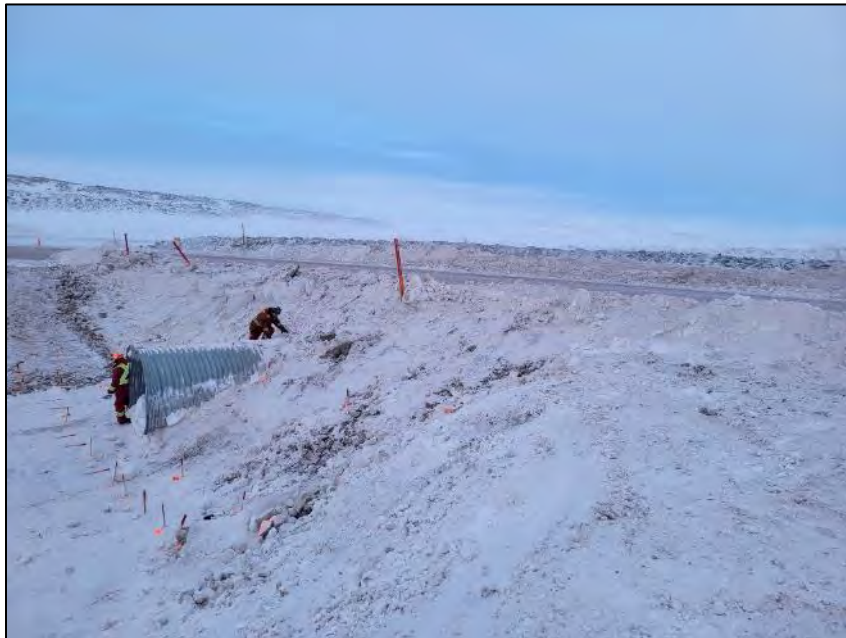
**PHOTO 4.** Prior to Construction - Vantage Point 3 - Downstream Outlet and Road Crossing - Looking Northwest (March 01, 2024).

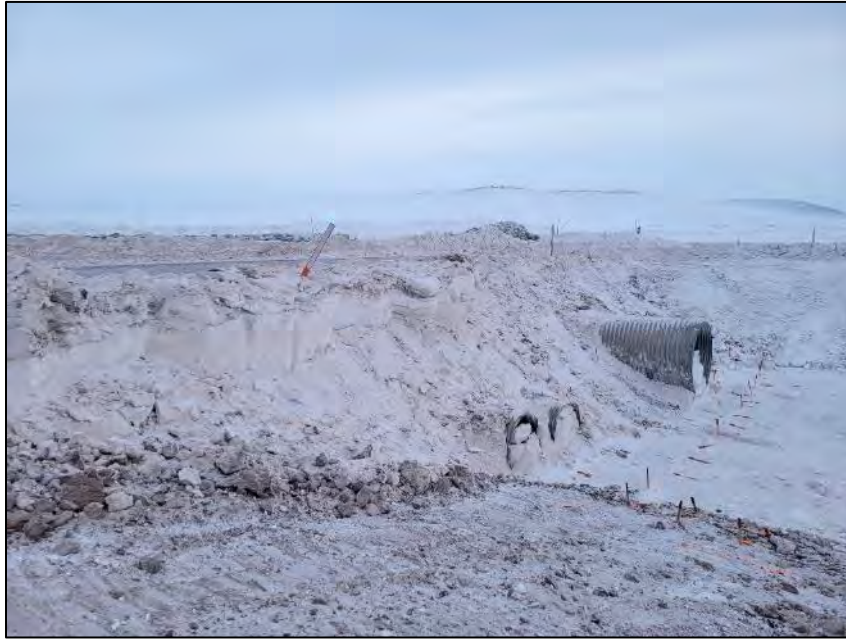
**PHOTO 5.** Prior to Construction - Vantage Point 4 - Downstream Outlet and Road Crossing - Looking East (March 01, 2024).

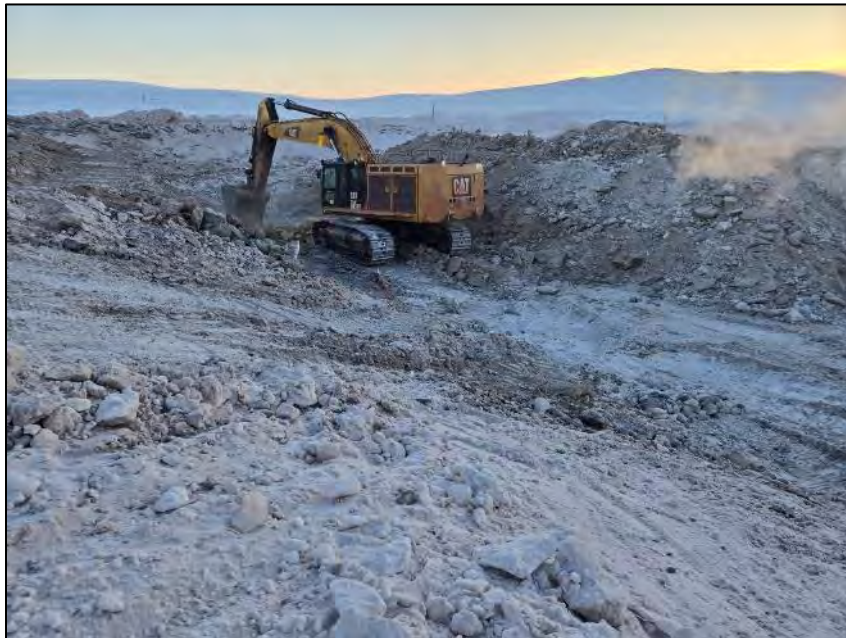
**PHOTO 6.** During Construction - Vantage Point 4 - Excavation of Blasted Material on Road Crossing - Looking Northeast (March 25, 2024).

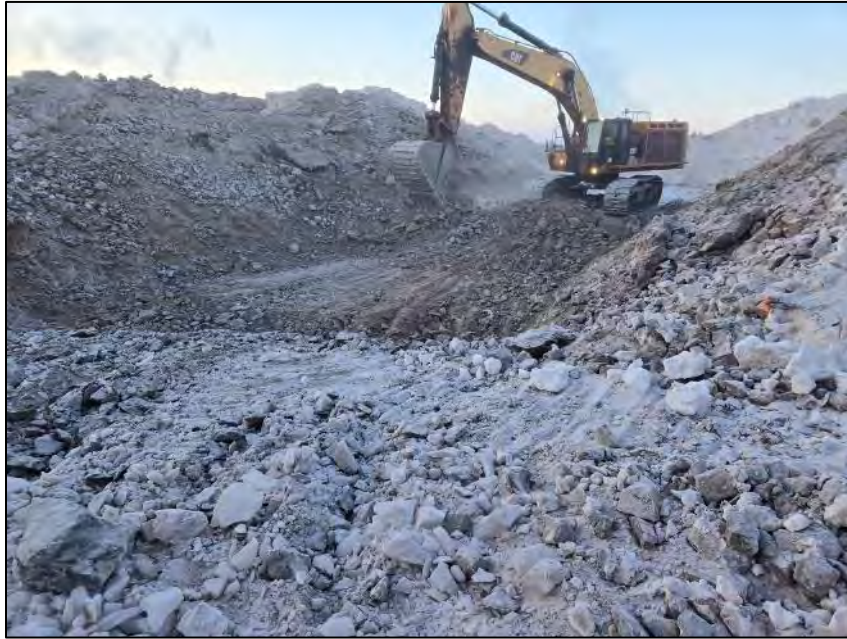
**PHOTO 7.** During Construction - Vantage Point 3 - Excavation of Blasted Material in Upstream Inlet and Road Crossing - Looking South (March 25, 2024).

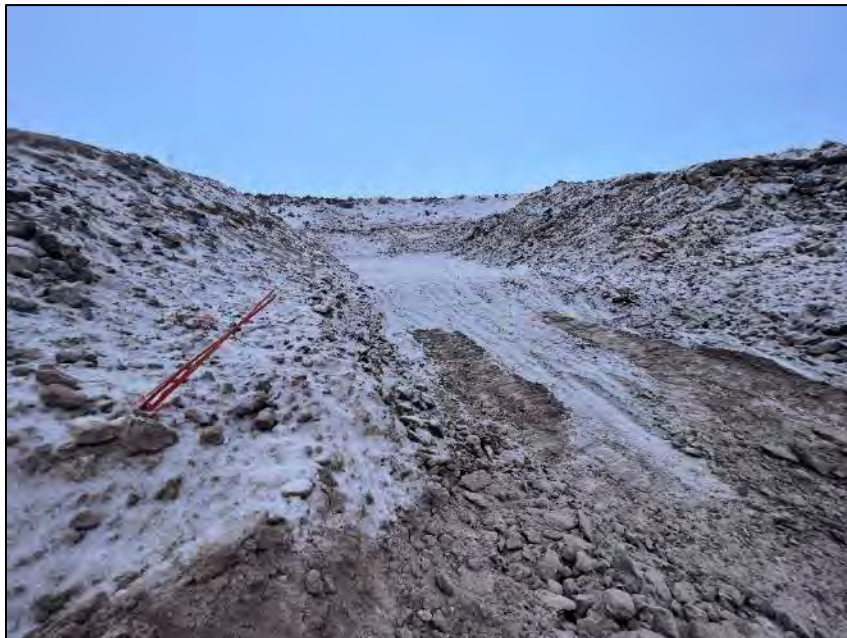
**PHOTO 8.** During Construction - Vantage Point 4 - Preparation of Foundation Surface Under Road Crossing and Upstream Inlet - Looking Northeast (March 27, 2024).

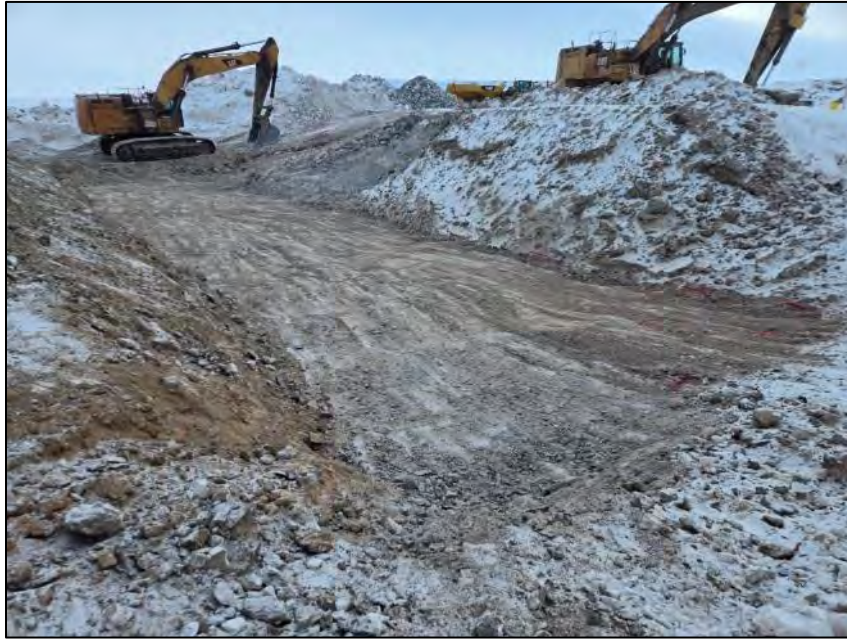
**PHOTO 9.** During Construction - Vantage Point 2 - Preparation of Foundation Surface Under Road Crossing and Inlet and Outlet - Looking Southwest (March 28, 2024).

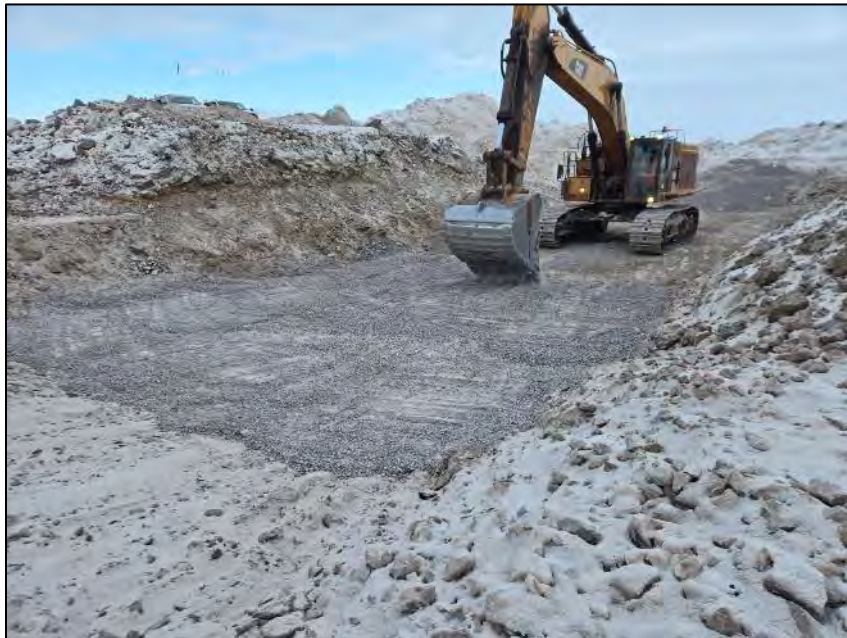
**PHOTO 10.** During Construction - Vantage Point 3 - Placement of Culvert Backfill Material Under Road Crossing and Downstream Outlet - Looking Northwest (March 28, 2024).

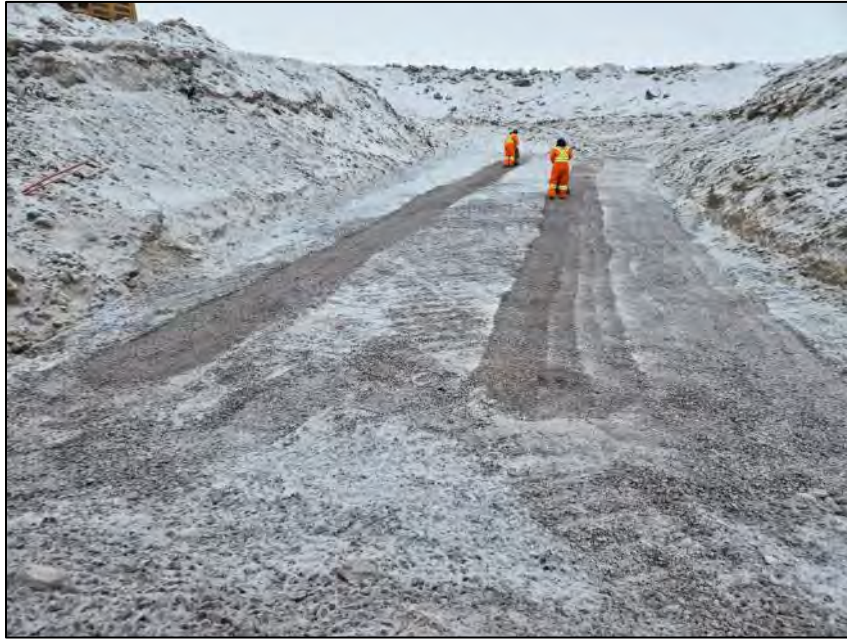
**PHOTO 11.** During Construction - Vantage Point 3 - Compaction of Culvert Backfill Material Under Road Crossing and Upstream Inlet - Looking North (March 29, 2024).

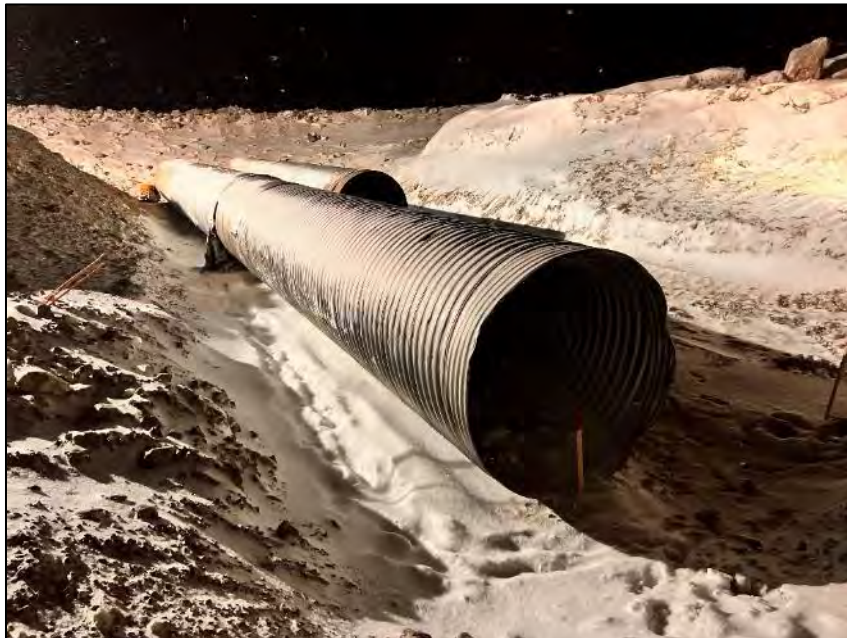
**PHOTO 12.** During Construction - Vantage Point 4 - Placement of 2.0 m Diameter Corrugated Steel Low Flow Culverts - Looking Northeast (March 30, 2024).

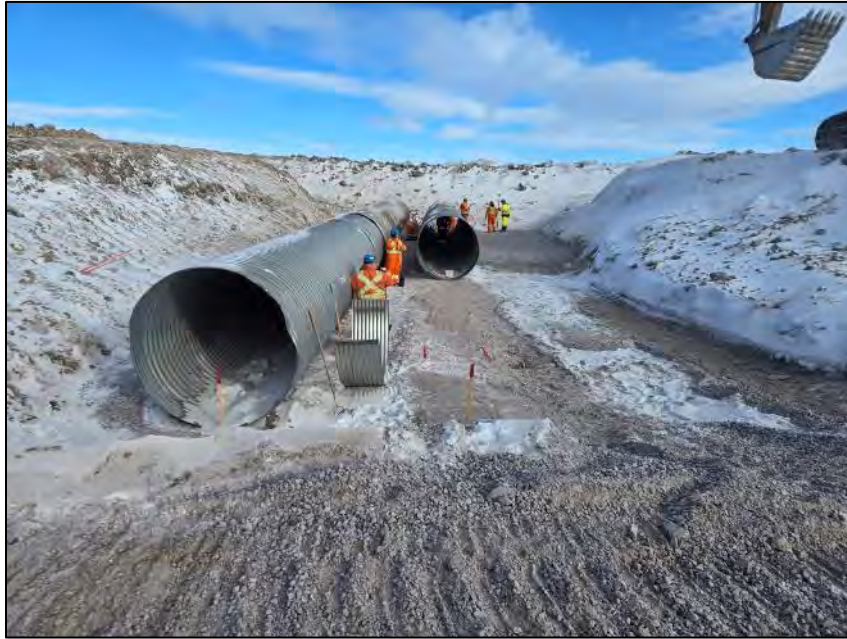
**PHOTO 13.** During Construction - Vantage Point 4 - Compaction of Culvert Backfill Under Road Crossing Around Low Flow Culverts - Looking North (March 31, 2024).

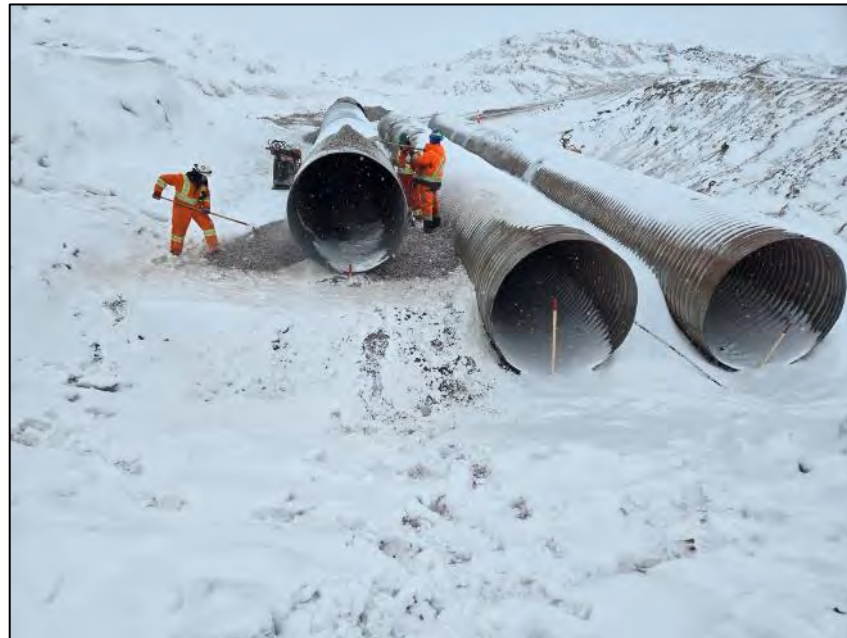
**PHOTO 14.** During Construction - Vantage Point 4 - Placement of 1.8 m Diameter Corrugated Steel High Flow Culvert - Looking South (April 01, 2024).

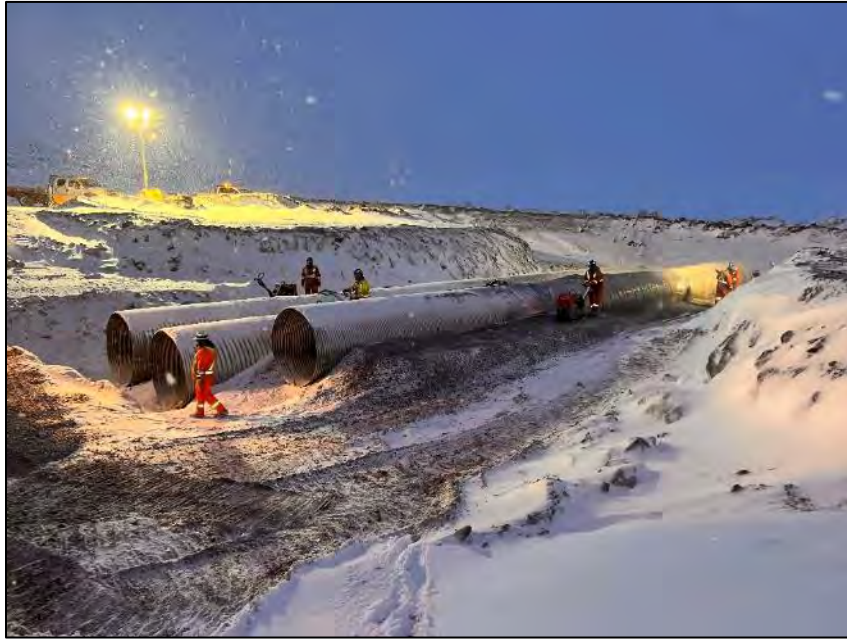
**PHOTO 15.** During Construction - Vantage Point 3 - Compaction of Culvert Backfill Material Around High Flow Culvert - Looking Northwest (April 01, 2024).

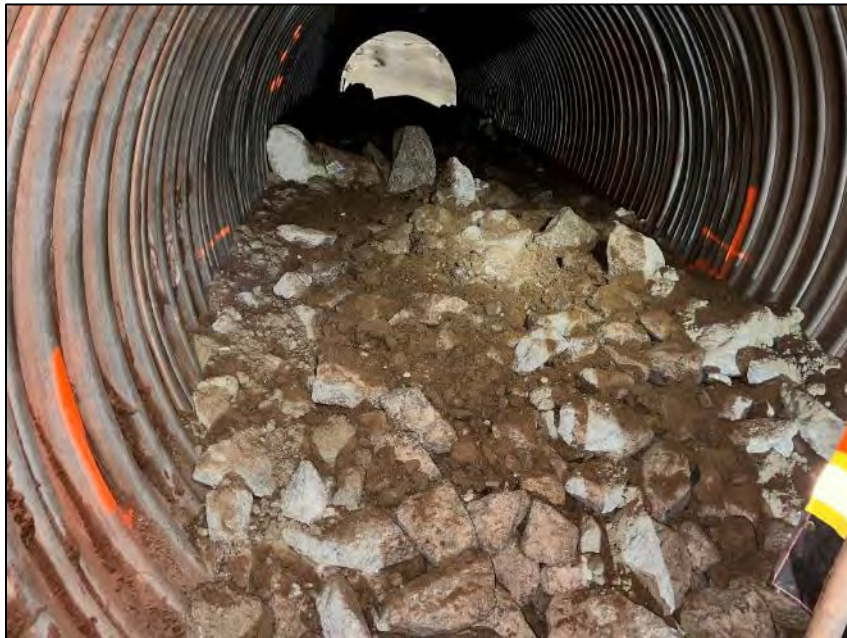
**PHOTO 16.** During Construction - Placement of Coarse Riprap and Stream Substrate Material in Low Flow Culverts - Looking North (April 03, 2024).

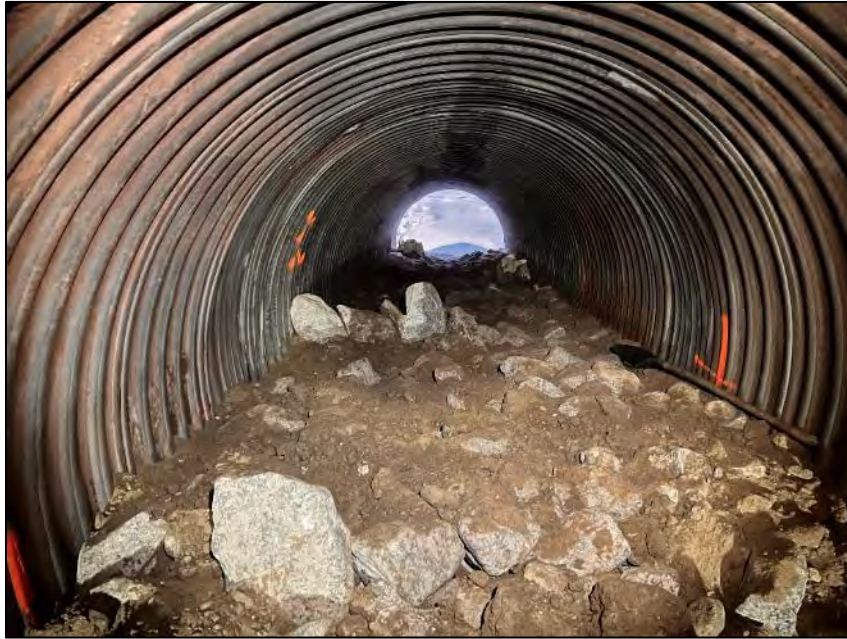
**PHOTO 17.** During Construction - Placement of Boulder Clusters in Low Flow Culverts - Looking North (April 03, 2024).

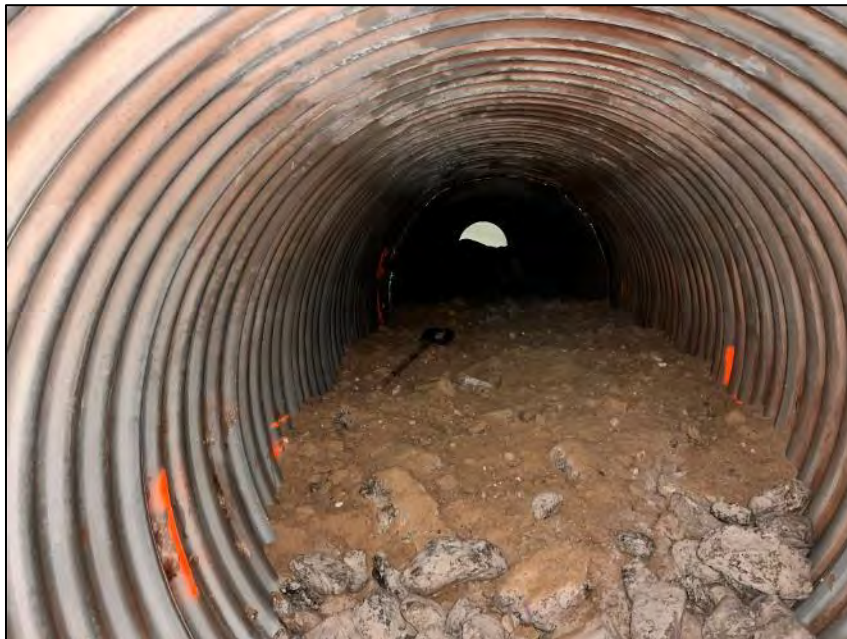
**PHOTO 18.** During Construction - Placement of Coarse Riprap and Stream Substrate Material in Low Flow Culverts - Looking North (April 06, 2024).

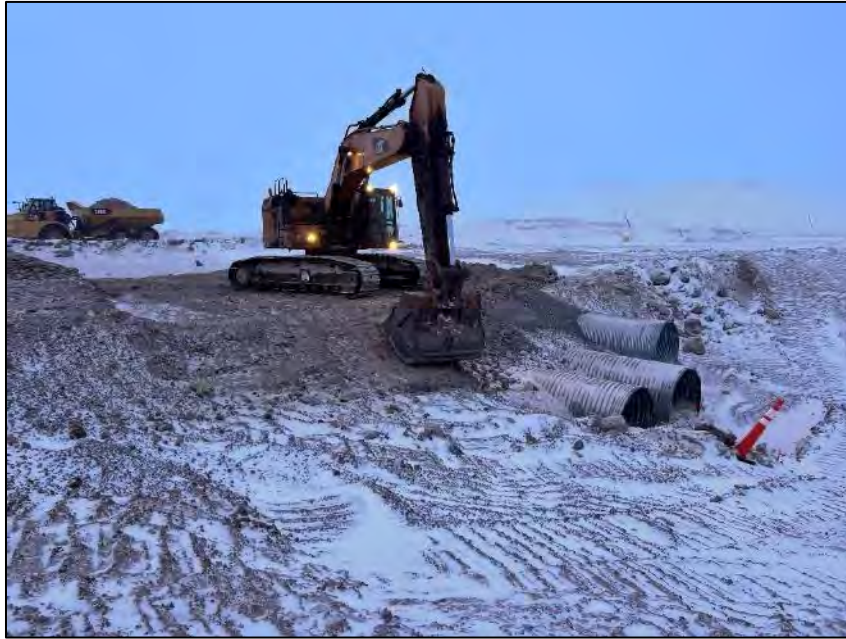
**PHOTO 19.** During Construction - Vantage Point 4 - Grading of Side Slopes - Looking Northeast (April 08, 2024).

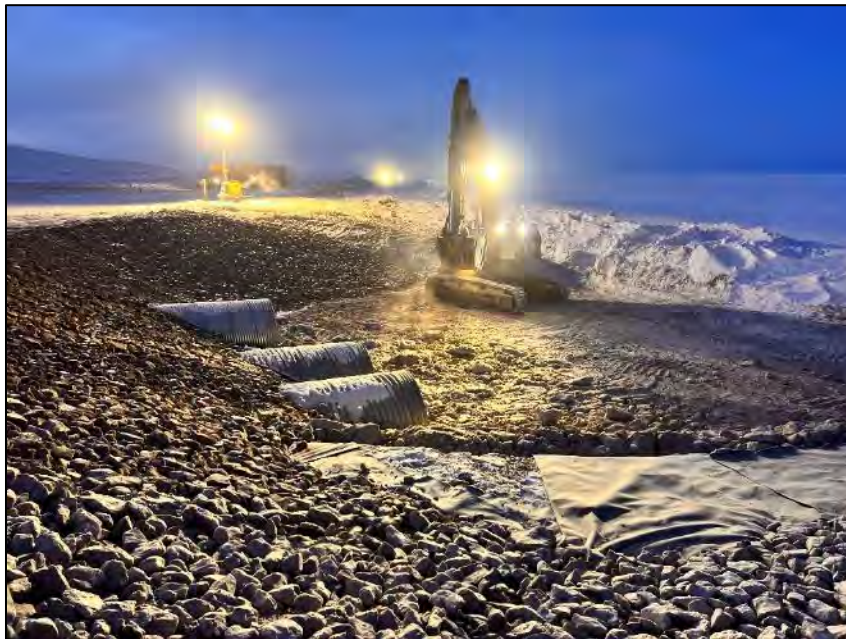
**PHOTO 20.** During Construction - Vantage Point 4 - Completed Downstream Outlet and Slope Stabilization - Looking Southeast (April 11, 2024).

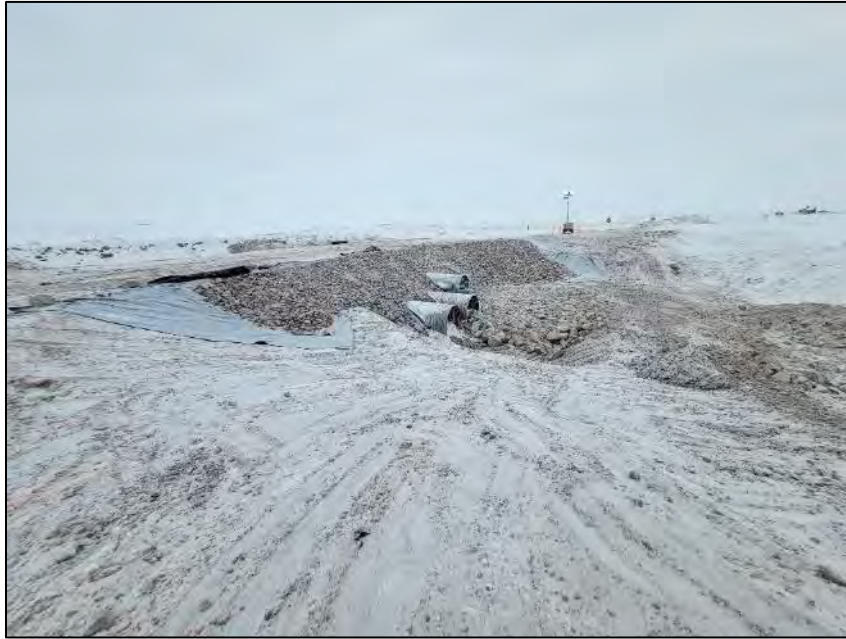
**PHOTO 21.** During Construction - Vantage Point 2 - Placement of Coarse Riprap and Stream Substrate Material in Upstream Inlet - Looking West (April 11, 2024).

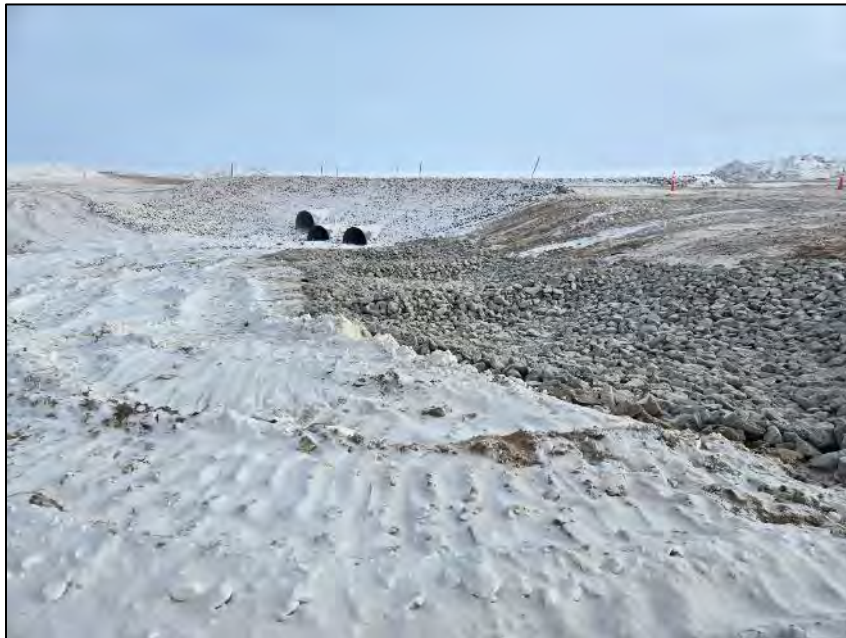
**PHOTO 22.** Following Construction - Vantage Point 1 - Upstream Inlet and Road Crossing - Looking Southeast (May 15, 2024).

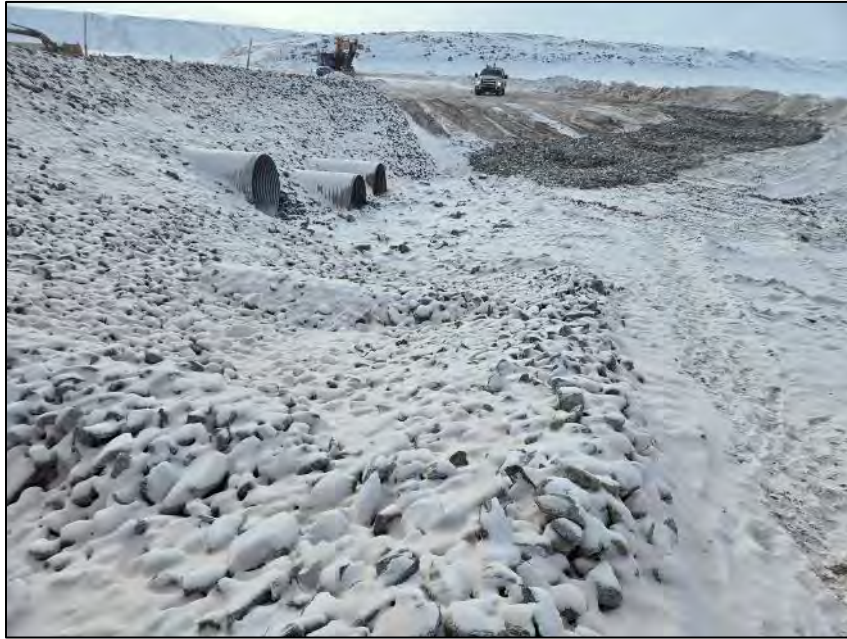
**PHOTO 23.** Following Construction - Vantage Point 2 - Upstream Inlet and Road Crossing - Looking West (May 15, 2024).

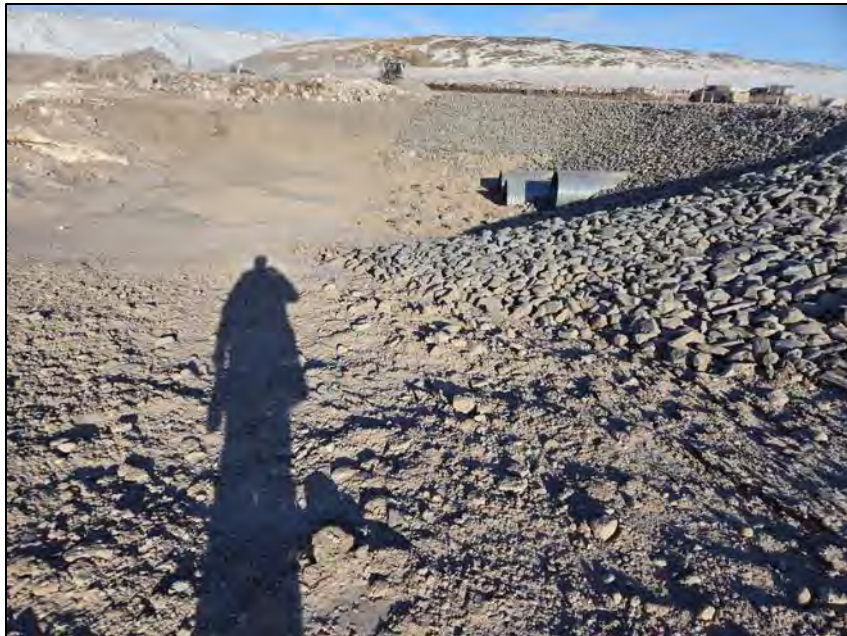
**PHOTO 24.** Following Construction - Vantage Point 3 - Downstream Outlet and Road Crossing - Looking West (May 15, 2024).

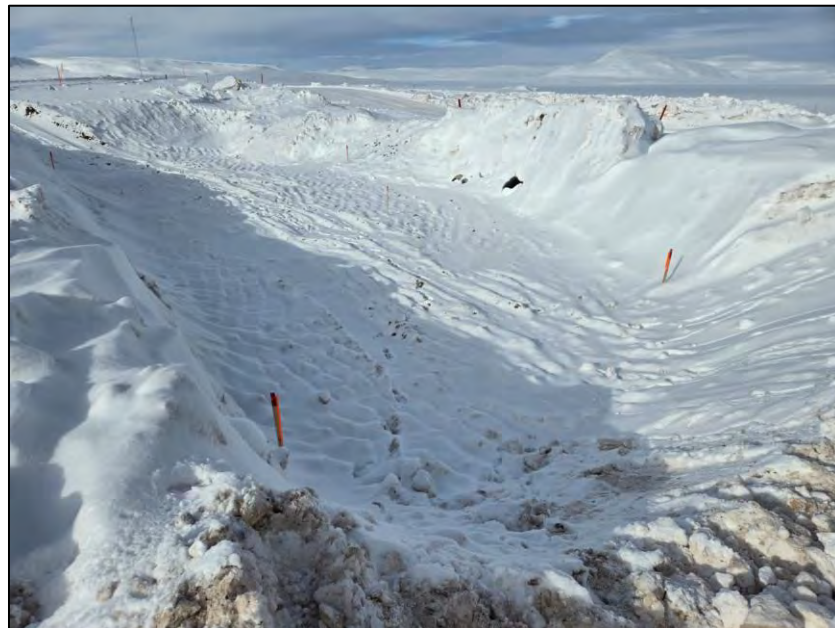
**PHOTO 2.** Prior to Construction - Vantage Point 1 - Downstream Side of Crossing - Looking South (April 03, 2024).

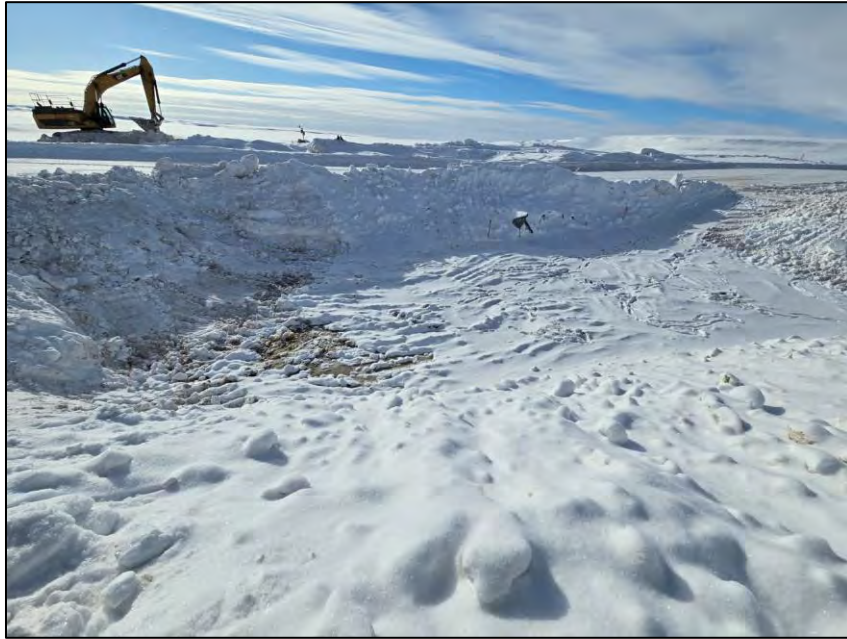
**PHOTO 3.** Prior to Construction - Vantage Point 2 - Downstream Side of Crossing - Looking West  
(April 03, 2024).

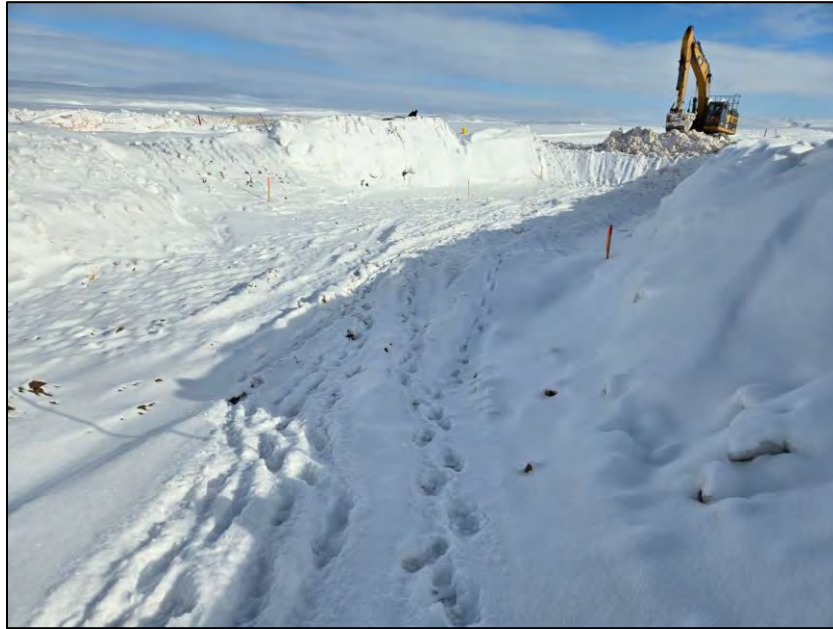
**PHOTO 5.** Prior to Construction - Vantage Point 4 - Upstream Side of Crossing - Looking East (April 03, 2024).

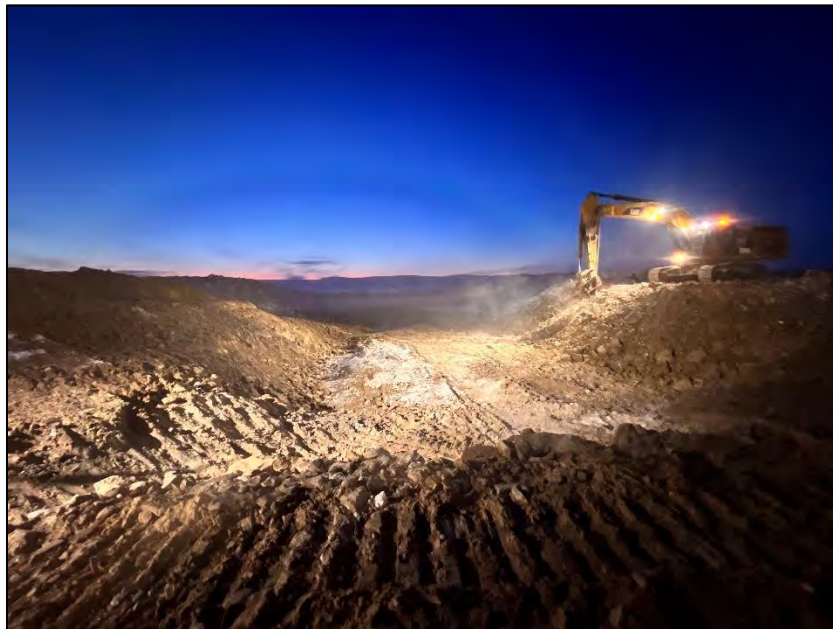
**PHOTO 6.** During Construction - Vantage Point 2 - Blasted Downstream Side of Crossing - Looking South (April 17, 2024).

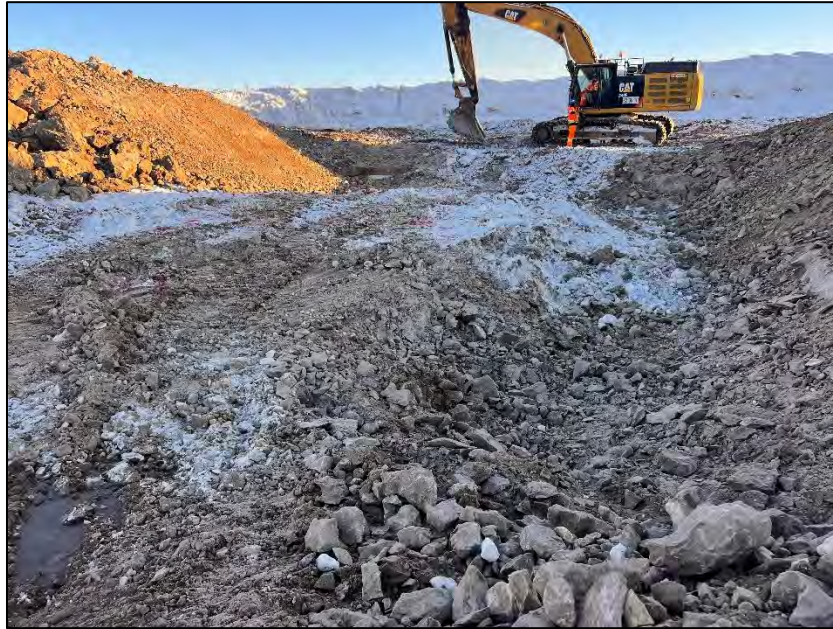
**PHOTO 7.** During Construction - Vantage Point 3 - Blast Excavation - Road Crossing and Downstream Outlet - Looking North (April 17, 2024).

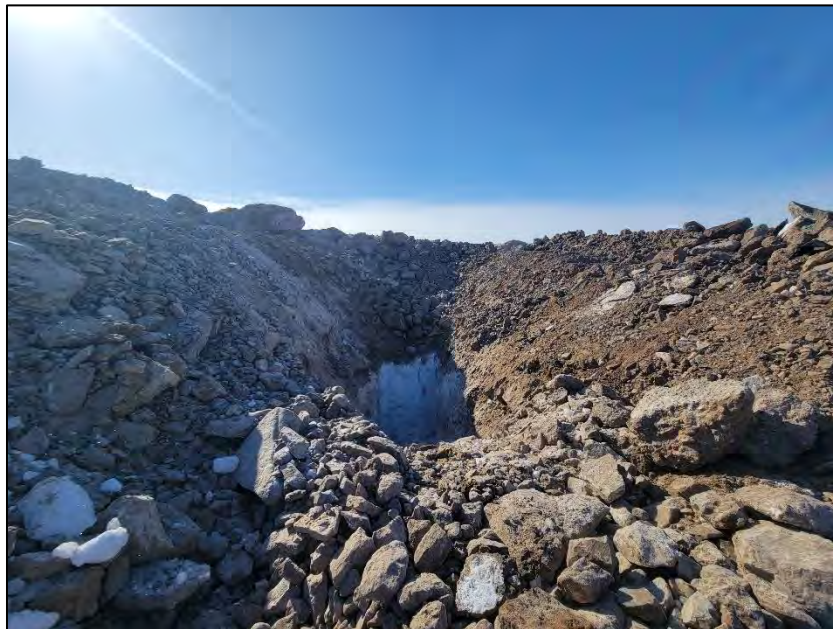
**PHOTO 8.** During Construction - Vantage Point 2 - Blast Excavation with Ice Present - Road Crossing - Looking South (April 12, 2024).

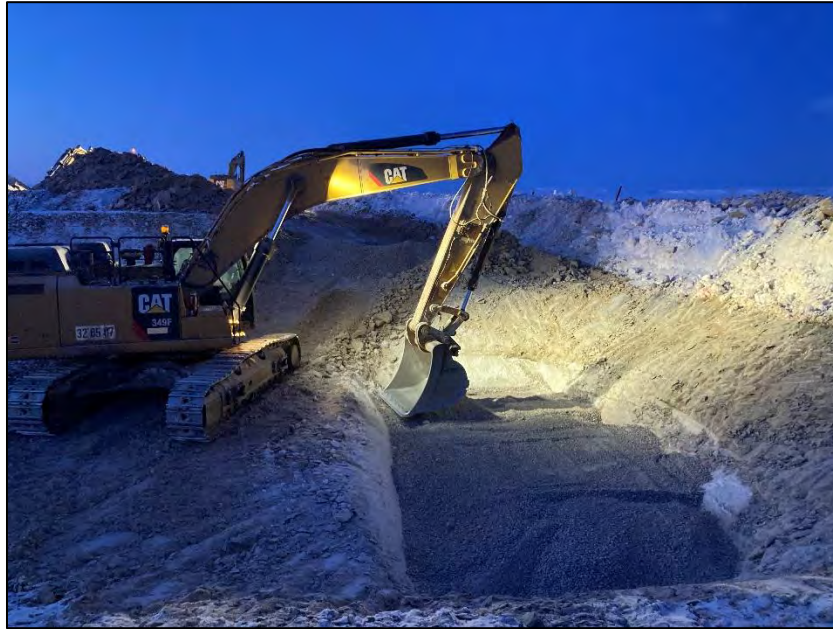
**PHOTO 9.** During Construction - Vantage Point 4 - Compaction of Culvert Backfill Material - Upstream inlet - Looking East (April 18, 2024).

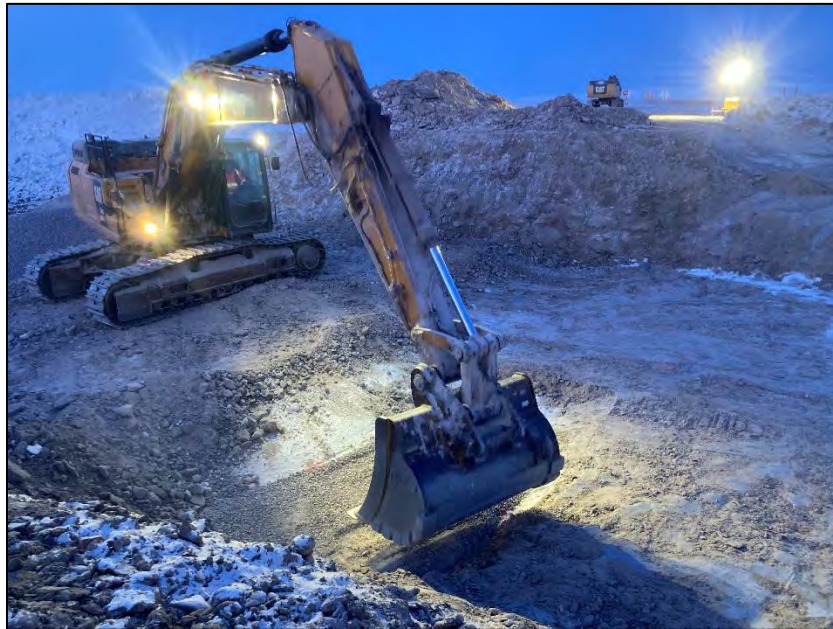
**PHOTO 11.** During Construction - Vantage Point 4 - Placement of Culvert Backfill Material - Road Crossing - Looking Northeast (April 19, 2024).

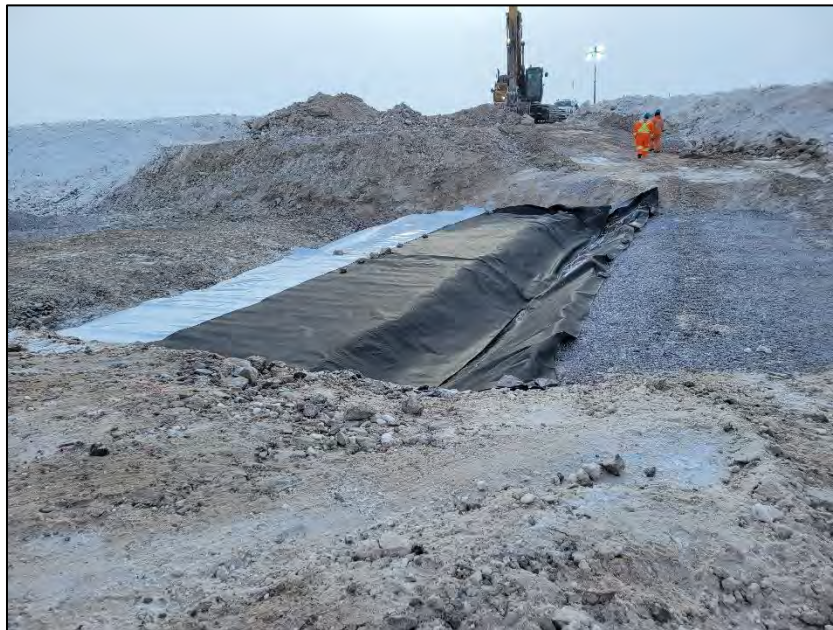
**PHOTO 12.** During Construction - Vantage Point 4 - Placement of Geomembrane and Geogrid Liner - Upstream Inlet - Looking Northeast (April 20, 2024).

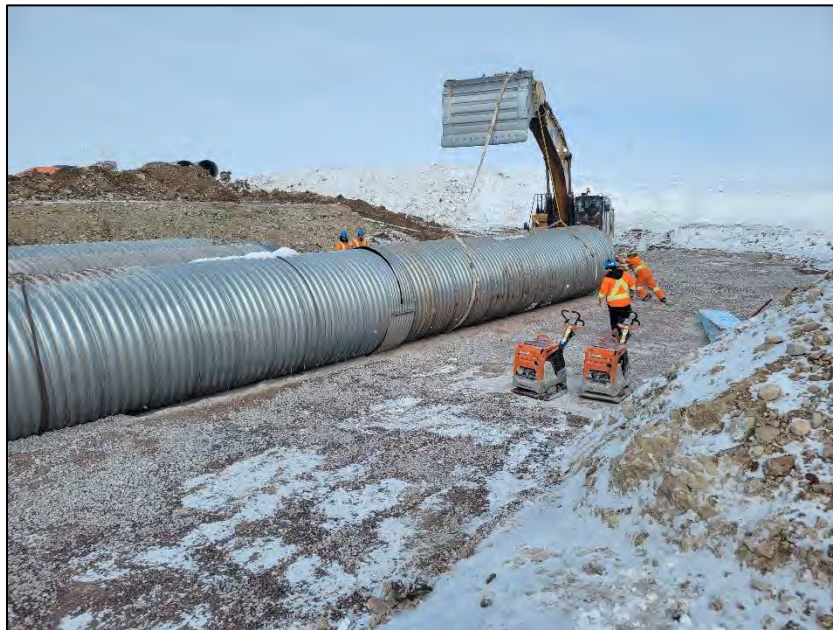
**PHOTO 14.** During Construction - Vantage Point 3 - Installation of 2.0 m diameter corrugated steel pipe low flow culvert - Looking North (April 23, 2024).

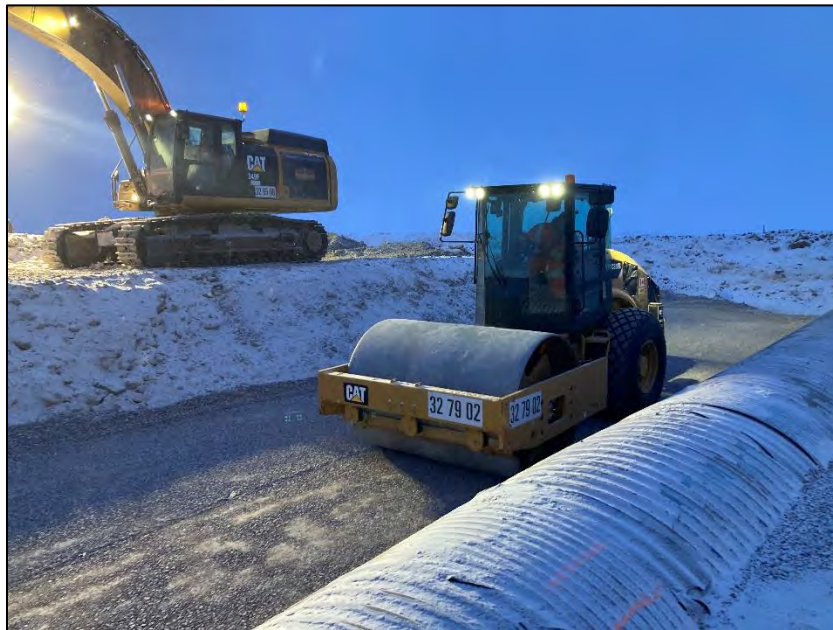
**PHOTO 16.** During Construction - Vantage Point 3 - Compaction of Culvert Backfill Material - Looking North (April 25, 2024).

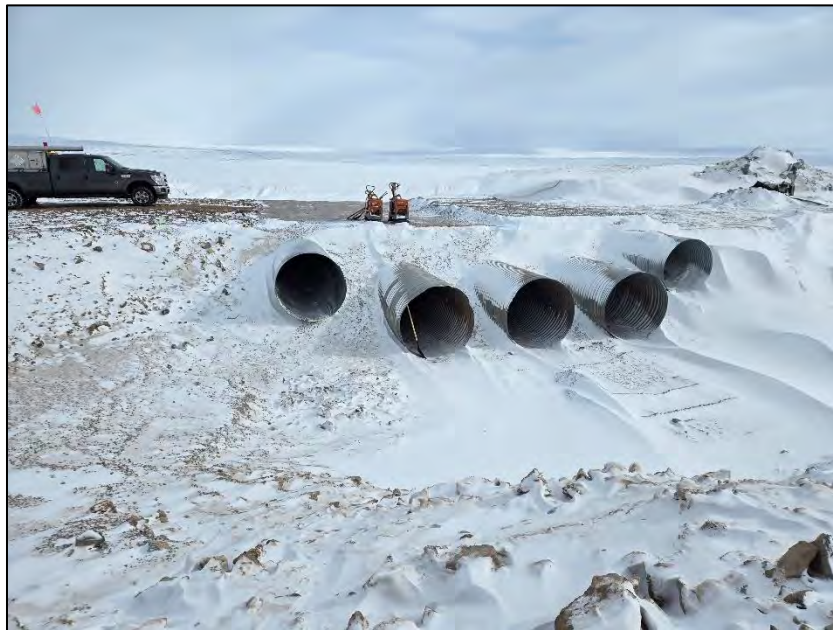
**PHOTO 18.** During Construction - Vantage Point 2 - Compaction of Culvert Backfill Material - Road Crossing - Looking Southwest (April 28, 2024).

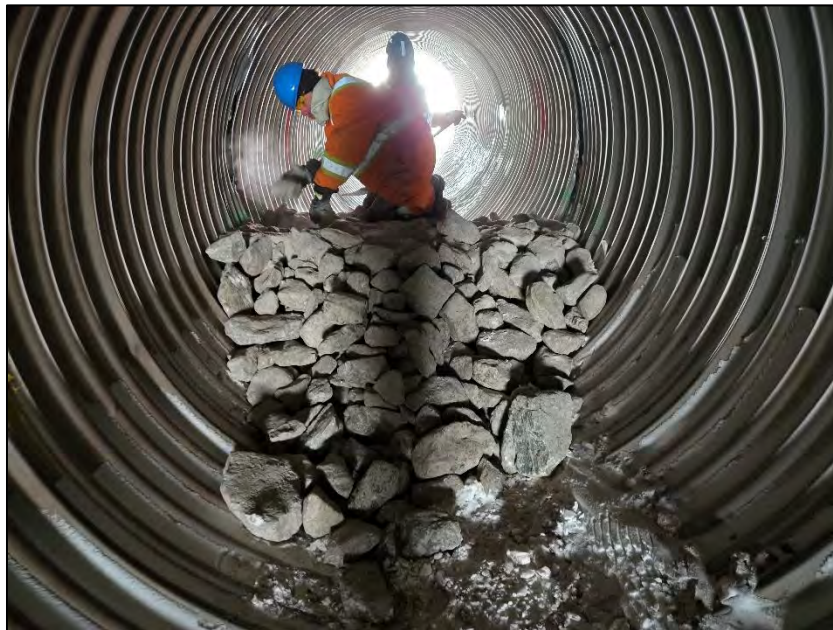
**PHOTO 20.** During Construction - Placement of Coarse Riprap and Stream Substrate Material in Low Flow Culvert - Looking South (May 02, 2024).

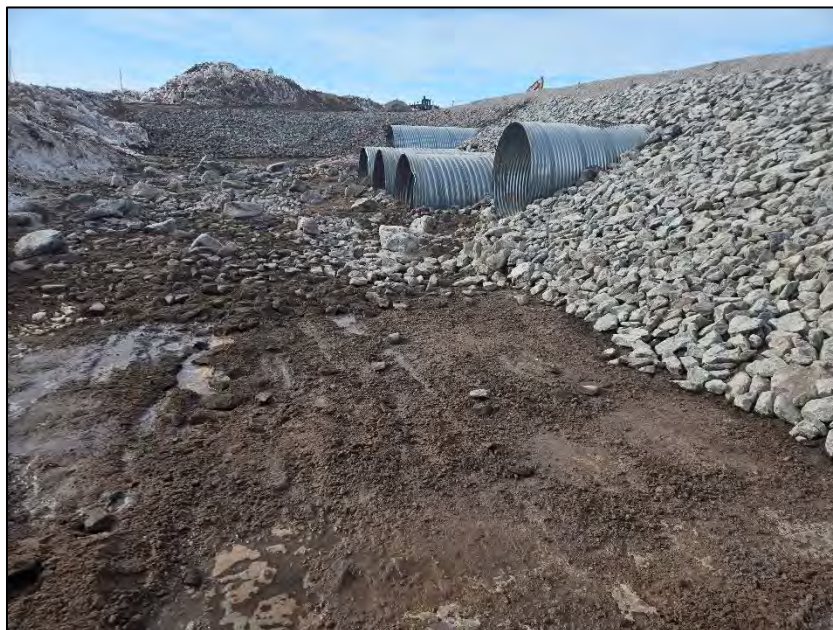
**PHOTO 24.** Following Construction - Vantage Point 3 - Completed Upstream Inlet Apron and Slope Stabilization -Upstream Inlet Area - Looking North (April 5, 2024).
