**August 28, 2024**

**Knight Piésold Ltd.**  
200-1164 Devonshire Avenue  
North Bay, Ontario P1B 6X7  
Canada  
T +1 705 476 2165  
E [northbay@knightpiesold.com](mailto:northbay@knightpiesold.com)  
[www.knightpiesold.com](http://www.knightpiesold.com)

## **RE: Construction Summary of CV-001 Remedial Measures**

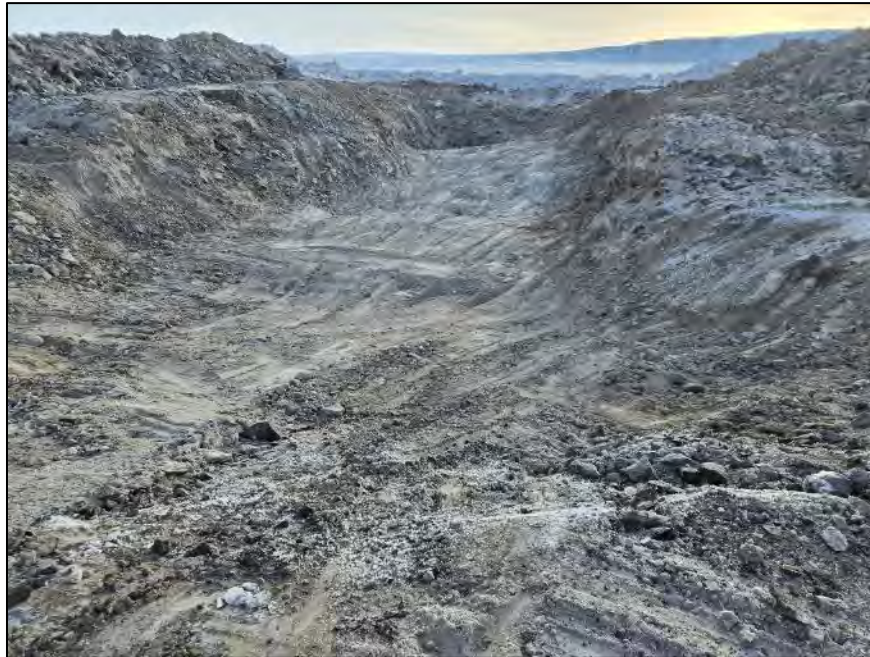
**PHOTO 2.** During Construction - Vantage Point 1 - Blast Excavation - Road crossing and upstream inlet - Looking South (March 26, 2024).

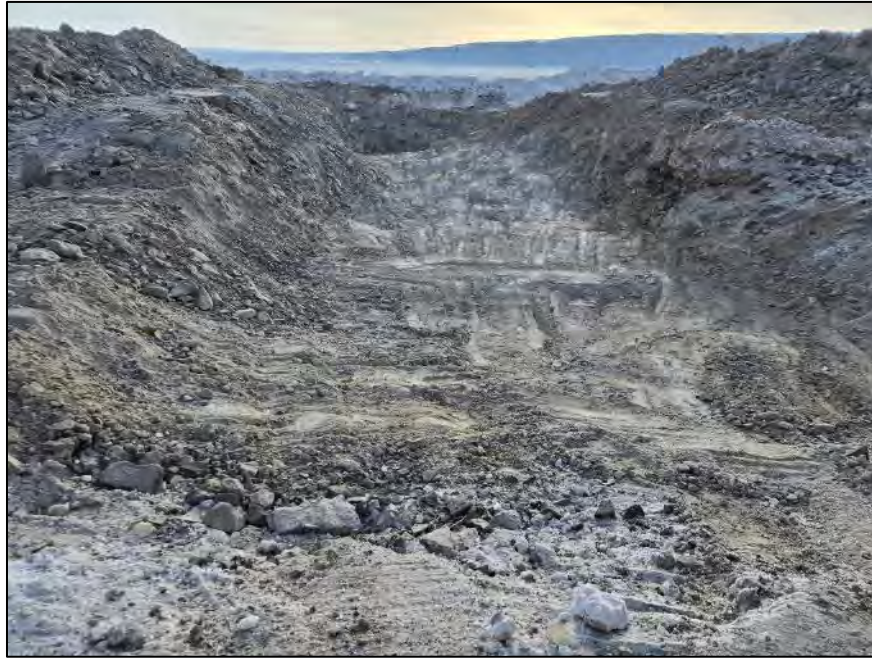
**PHOTO 3.** During Construction - Vantage Point 2 - Blast Excavation - Road crossing and upstream inlet - Looking Southwest (March 26, 2024).

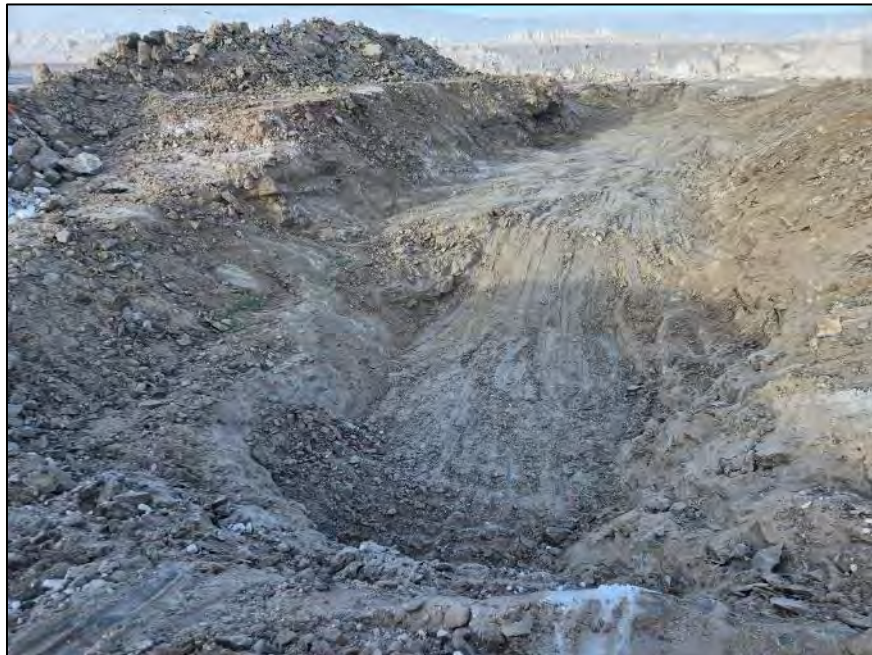
**PHOTO 4.** During Construction - Vantage Point 3 - Blast Excavation - Road crossing and downstream outlet - Looking North (March 26, 2024).

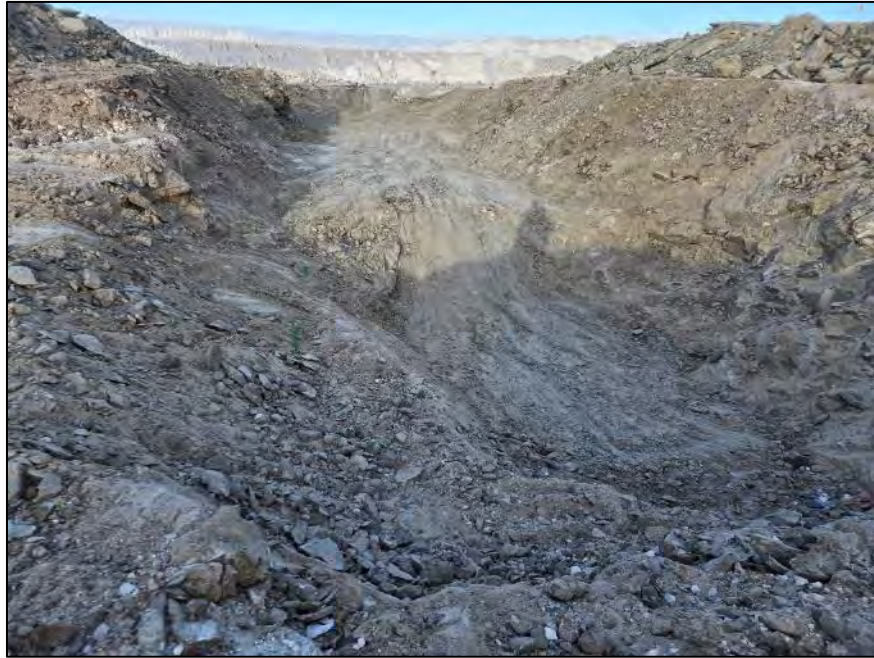
**PHOTO 5.** During Construction - Vantage Point 4 - Blast Excavation - Road crossing and downstream outlet - Looking Northeast (March 26, 2024).

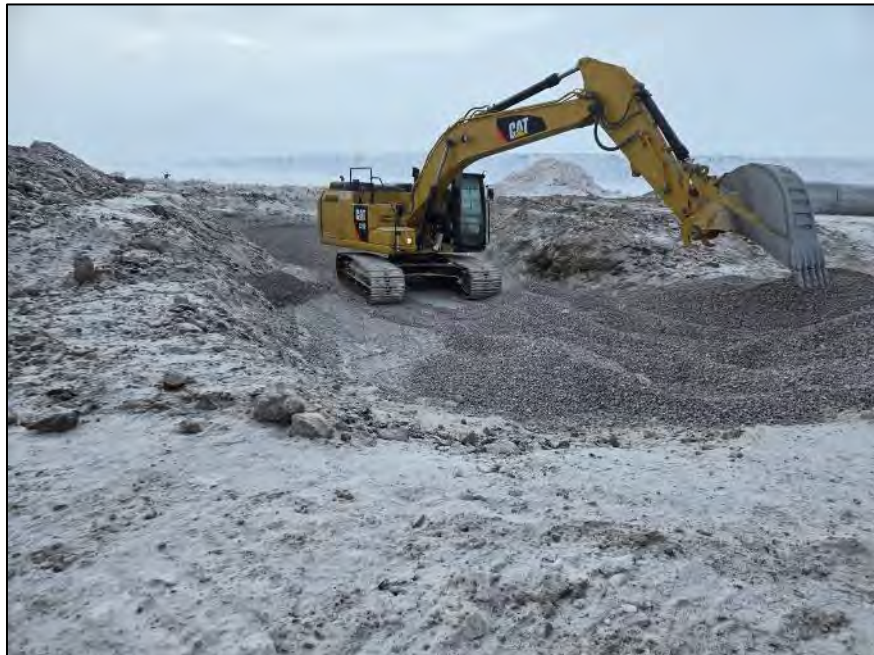
**PHOTO 6.** During Construction - Vantage Point 2 - Placement of culvert backfill - Road crossing and upstream inlet - Looking South (March 27, 2024).

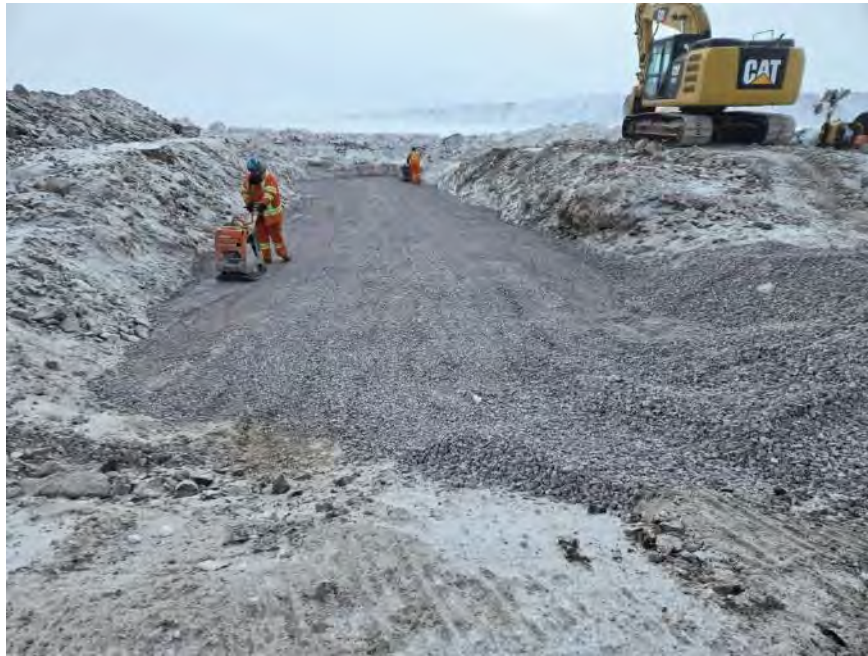
**PHOTO 7.** During Construction - Vantage Point 1 - Compaction of culvert backfill material - Road crossing and upstream inlet - Looking South (March 27, 2024).

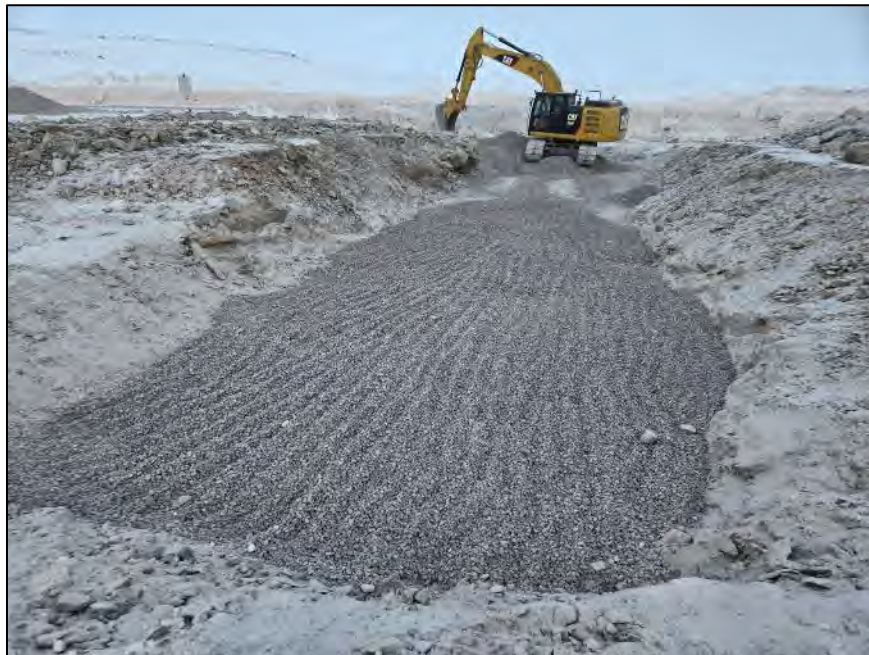
**PHOTO 8.** During Construction - Vantage Point 3 - Compaction of culvert backfill material - Road crossing and upstream inlet - Looking North (March 27, 2024).

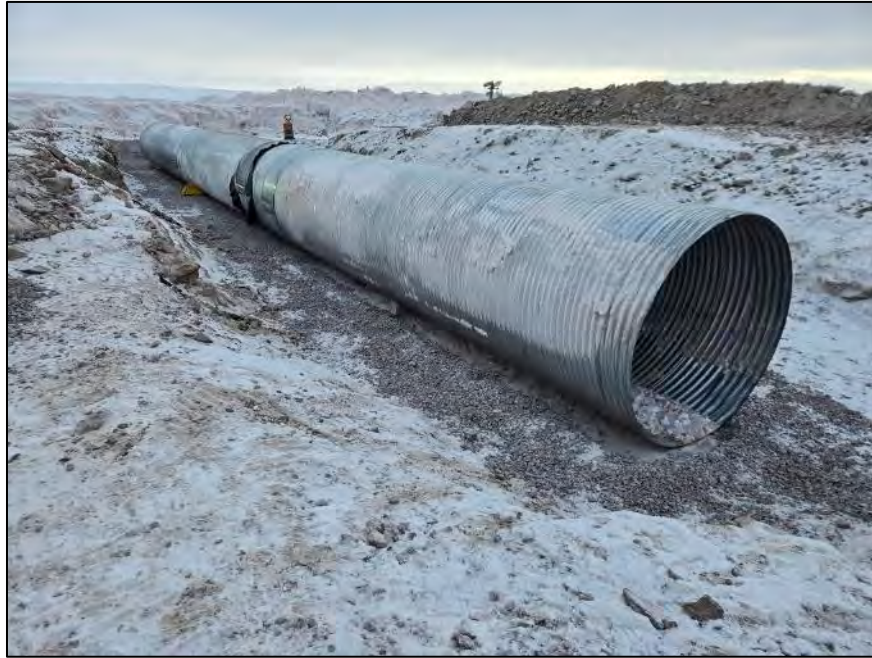
**PHOTO 9.** During Construction - Vantage Point 4 - Installation of 1.8 m diameter corrugated steel pipe low flow culvert - Road crossing and downstream outlet - Looking Northeast (March 28, 2024).

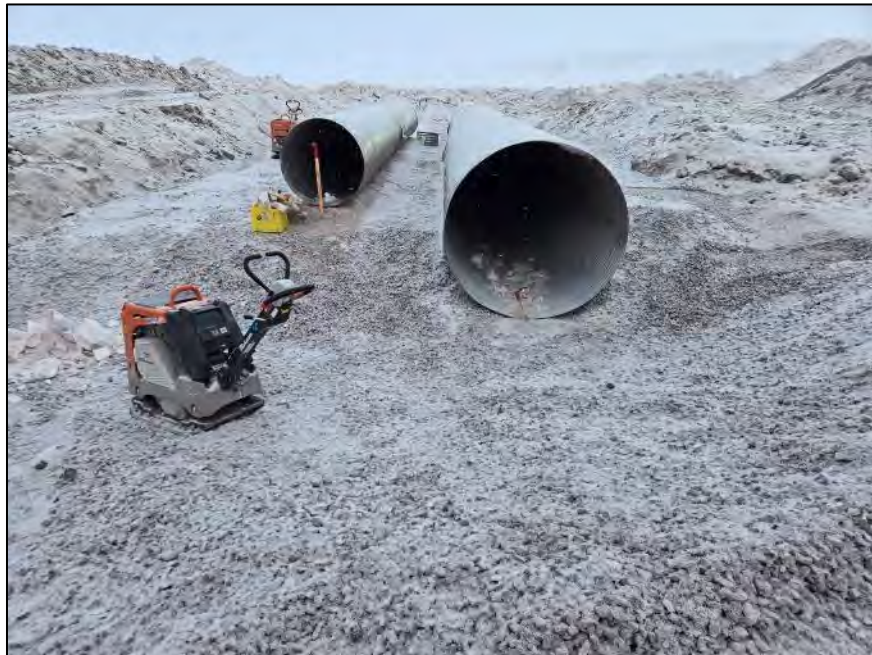
**PHOTO 10.** During Construction - Vantage Point 1 - Installation of 1.0 m diameter corrugated steel pipe high flow culvert - Road crossing and upstream inlet - Looking South (March 29, 2024).

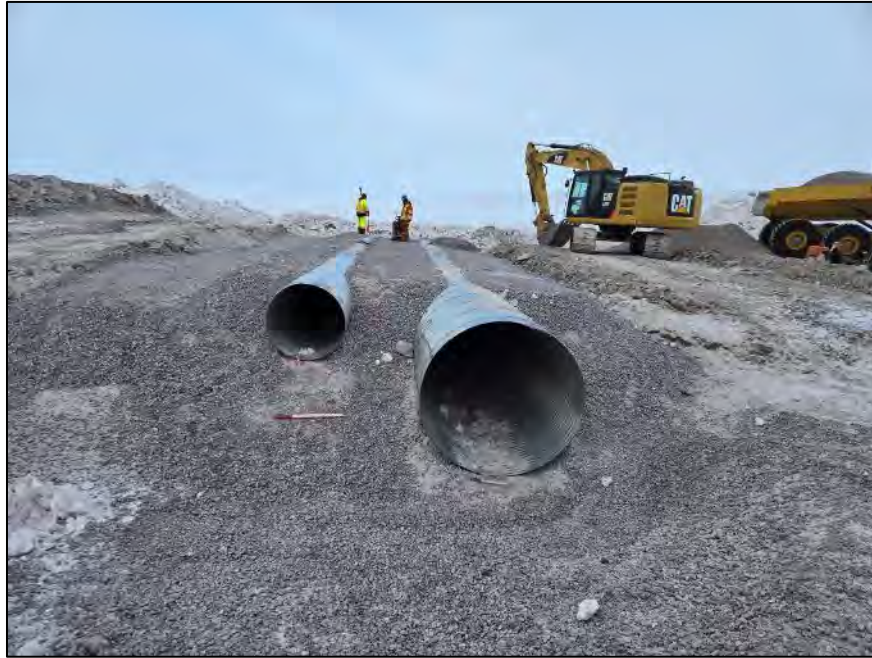
**PHOTO 11.** During Construction - Vantage Point 1 - Installation of 1.8 m diameter corrugated steel pipe low flow culvert and 1.0 m diameter corrugated steel pipe high flow culvert - Road crossing and upstream inlet - Looking South (March 30, 2024).

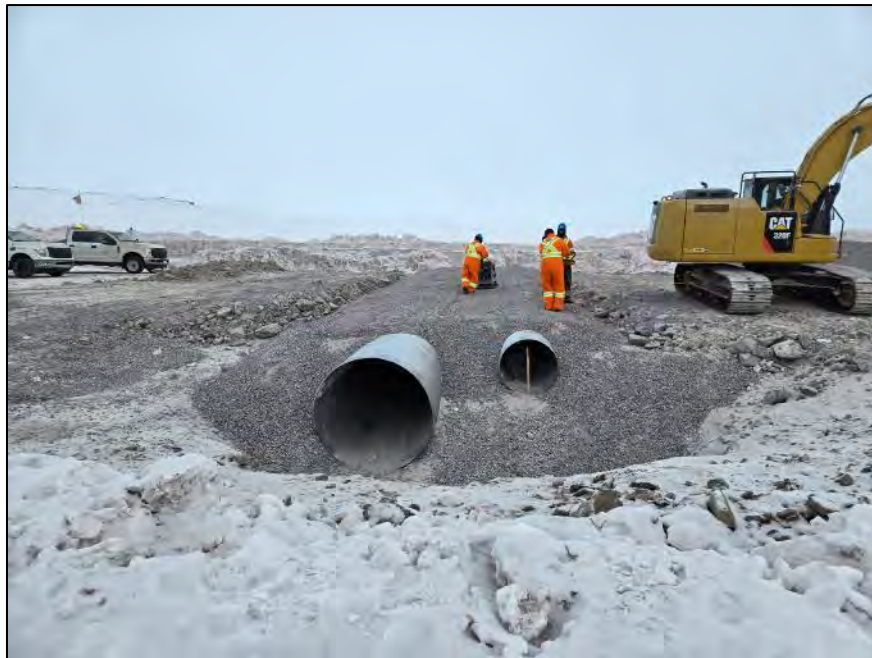
**PHOTO 12.** During Construction - Vantage Point 1 - Placement of culvert backfill material above the low and high flow CSP culverts - Road crossing and upstream inlet - Looking South (March 30, 2024).

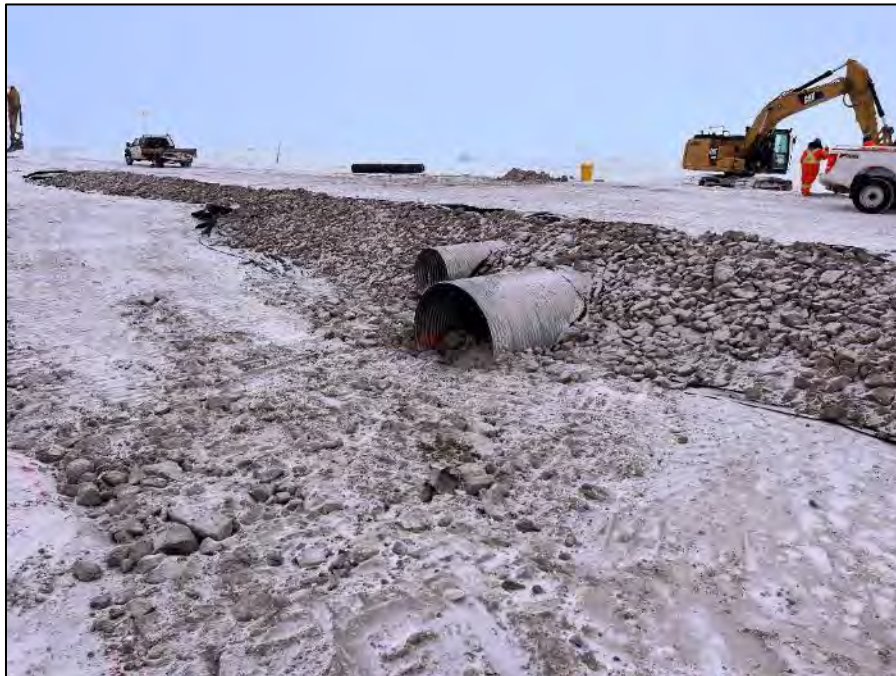
**PHOTO 14.** During Construction - Vantage Point 1 - Placement of geotextile and riprap on the north side slope at CV-001 - Road crossing and upstream inlet - Looking South (March 30, 2024).

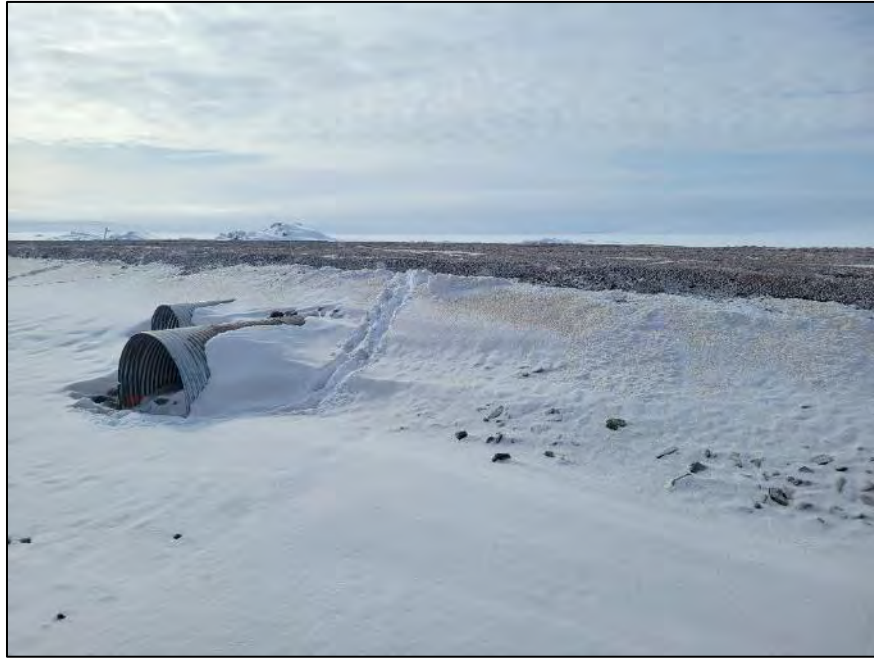
**PHOTO 15.** Following Construction - Vantage Point 1 - Road crossing and upstream inlet - Looking South (April 16, 2024).

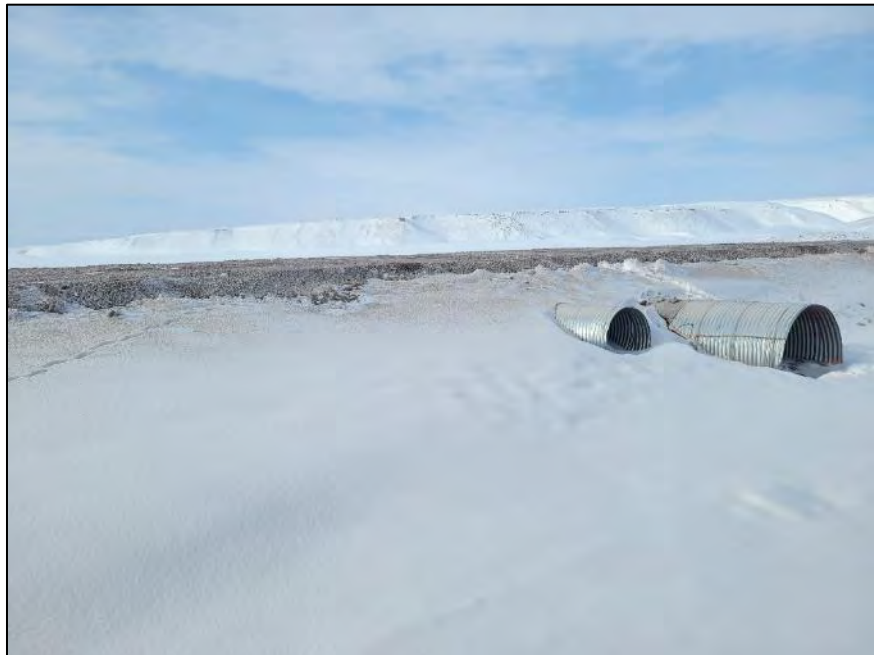
**PHOTO 16.** Following Construction - Vantage Point 2 - Road crossing and upstream inlet - Looking Southwest (April 16, 2024).

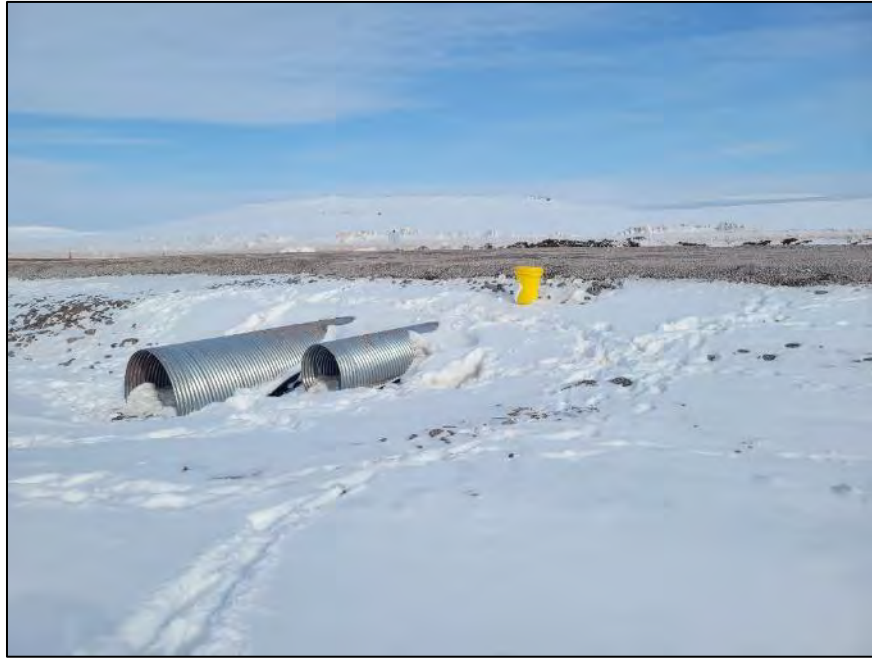
**PHOTO 17.** Following Construction - Vantage Point 3 - Road crossing and downstream outlet - Looking North (April 16, 2024).

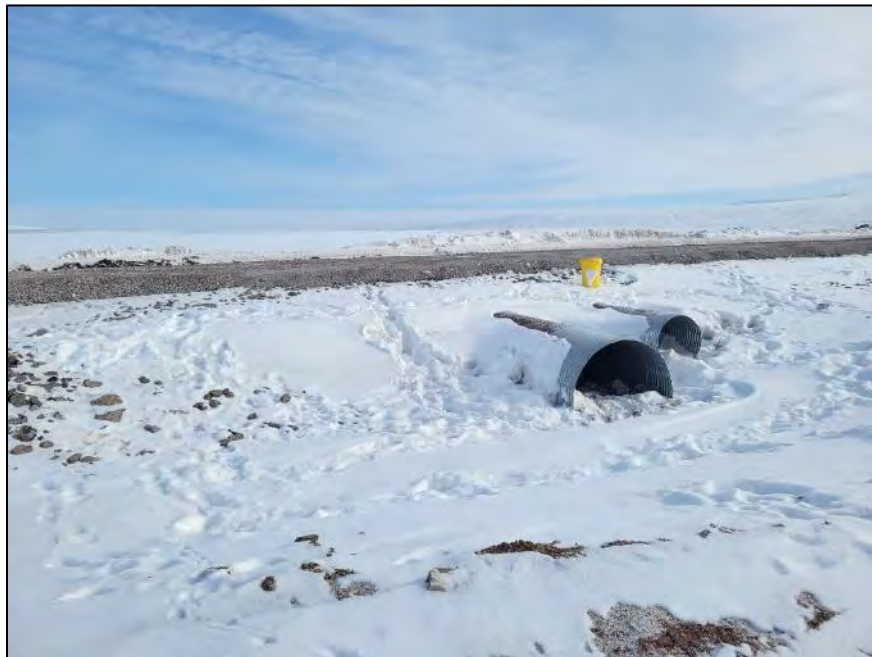
**PHOTO 18.** Following Construction - Vantage Point 4 - Blast Excavation - Road crossing and downstream outlet - Looking Northeast (April 16, 2024).

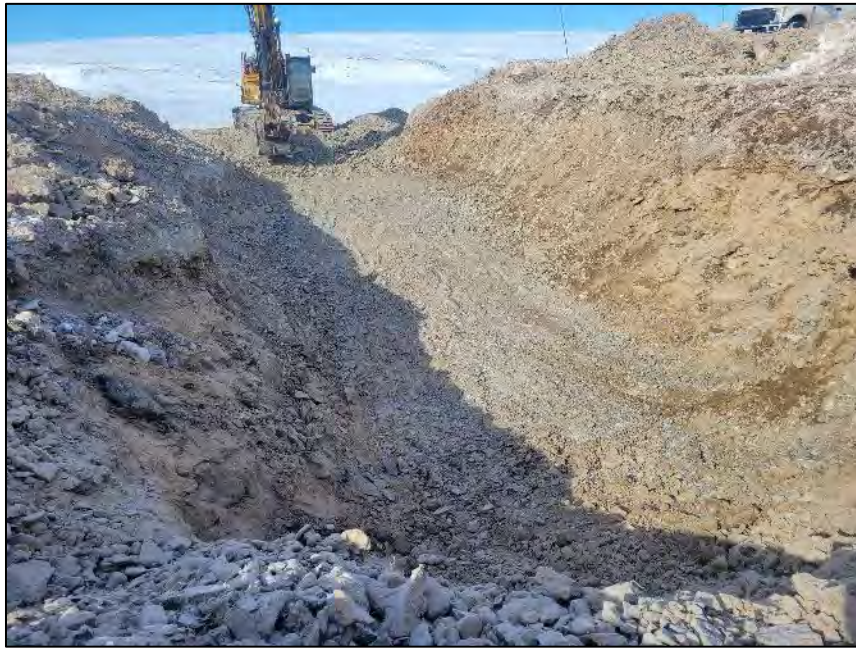
**PHOTO 7.** During Construction - Vantage Point 4 - Blast Excavation - Road Crossing and Upstream Inlet - Looking Northwest (April 24, 2024).

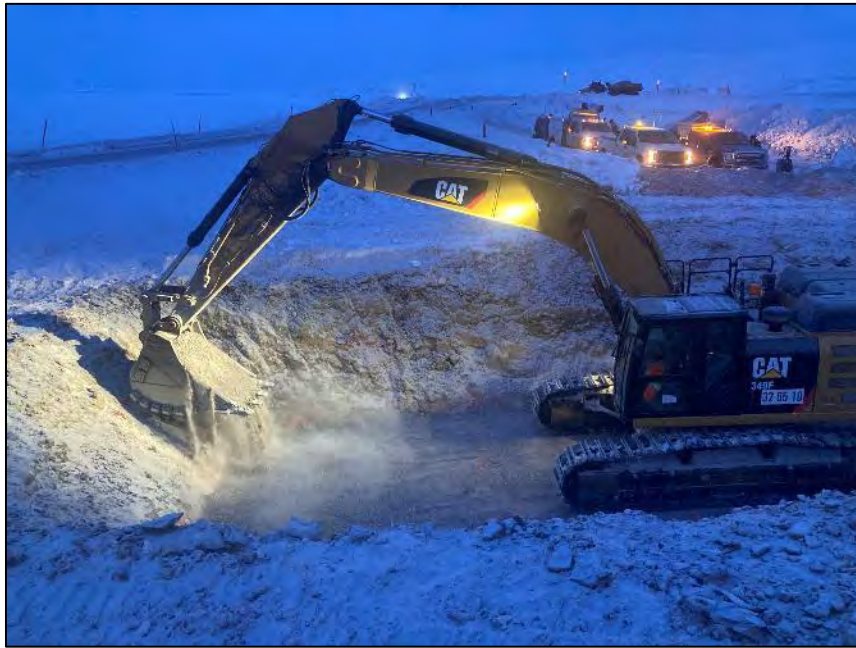
**PHOTO 9.** During Construction - Vantage Point 3 - Placement of Culvert Backfill Material - Upstream inlet - Looking North (April 24, 2024).

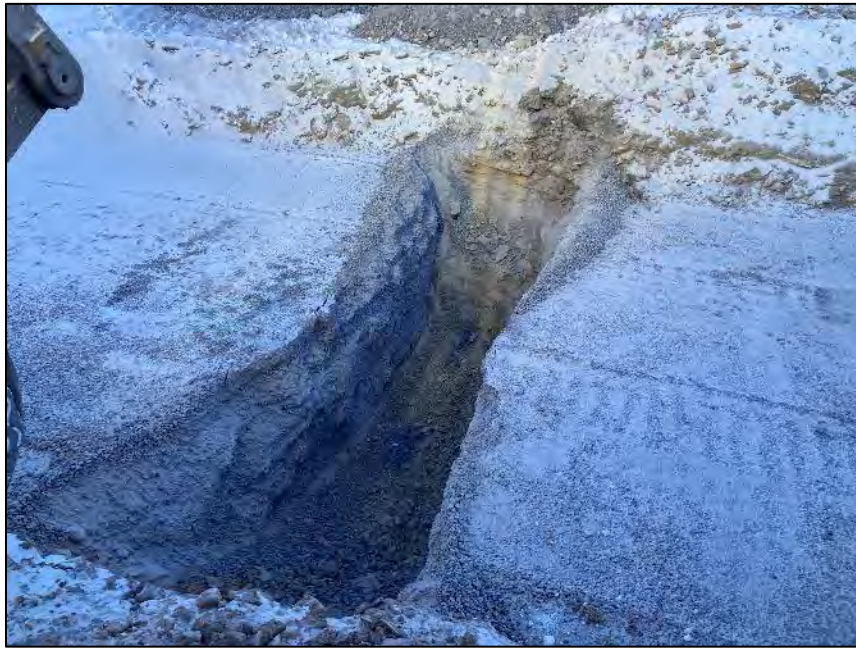
**PHOTO 11.** During Construction - Vantage Point 4 - Excavation of key-in trench in downstream end of crossing - Looking Southeast (April 25, 2024).

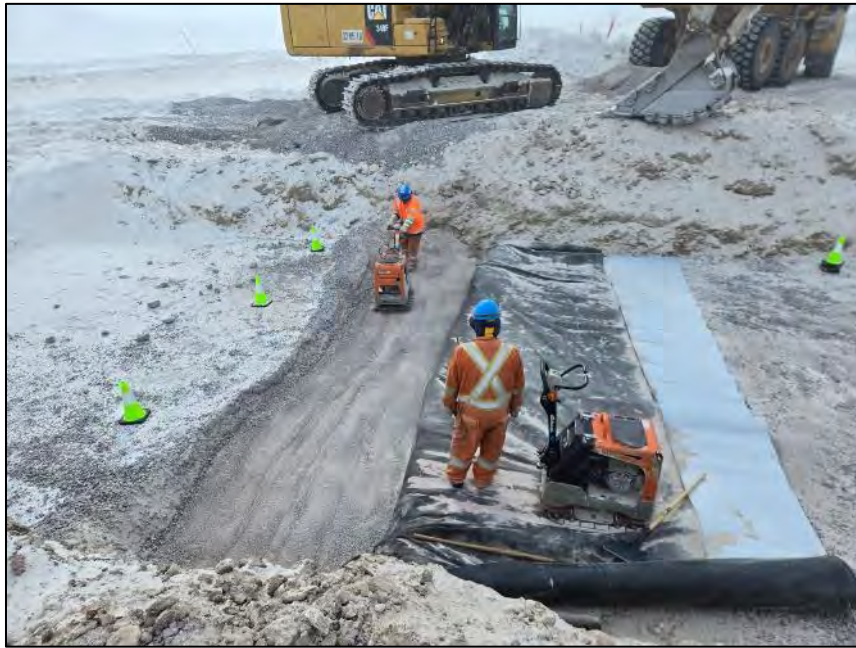
**PHOTO 13.** During Construction - Vantage Point 2 - Compaction of 3/4 inch minus Material in key-in trench in downstream end of crossing - Looking Northwest (April 26, 2024).

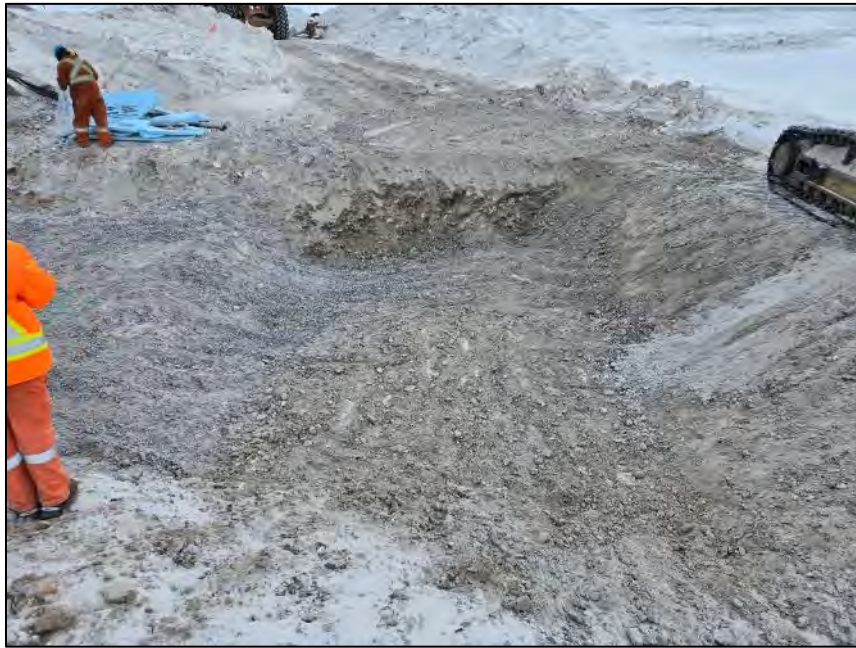
**PHOTO 15.** During Construction - Vantage Point 2 - Excavation of upstream inlet area - Looking Northwest (April 27, 2024).

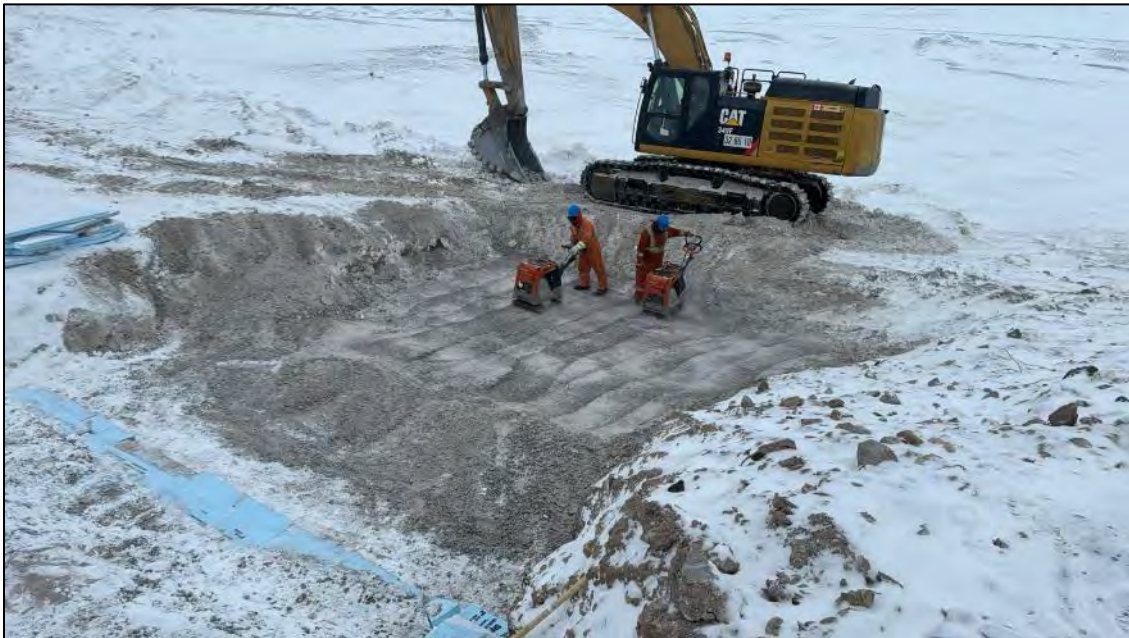
**PHOTO 16.** During Construction - Vantage Point 3 - Compaction of Culvert Backfill Material in upstream inlet area - Looking Northeast (April 29, 2024).

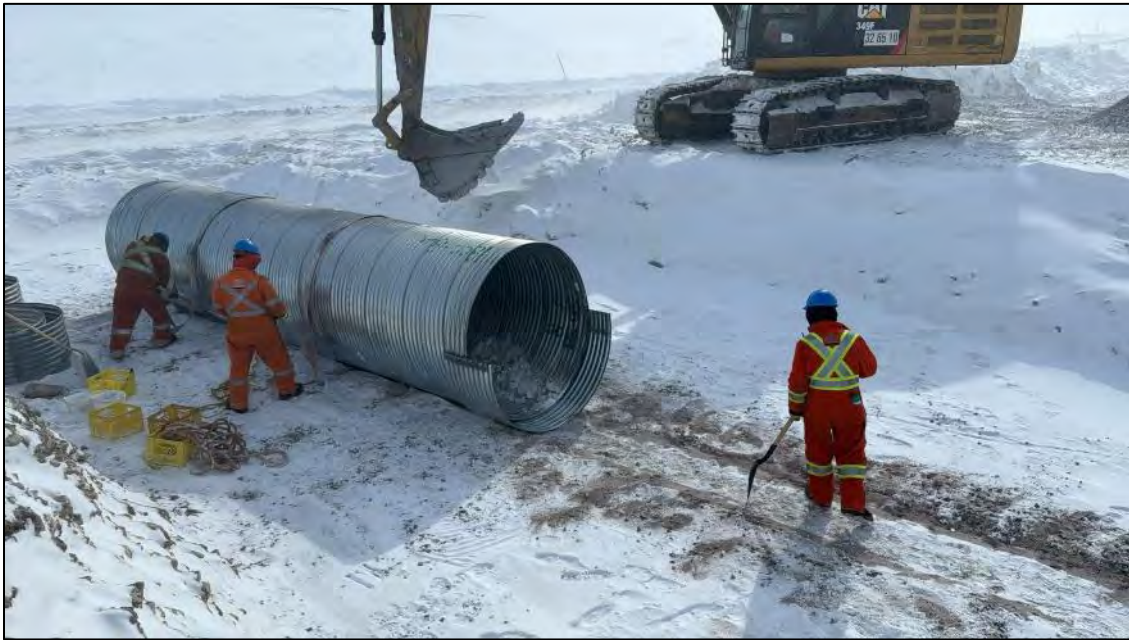
**PHOTO 17.** During Construction - Vantage Point 4 - Installation of 2.0 m diameter low flow culvert - Looking Southeast (April 29, 2024).

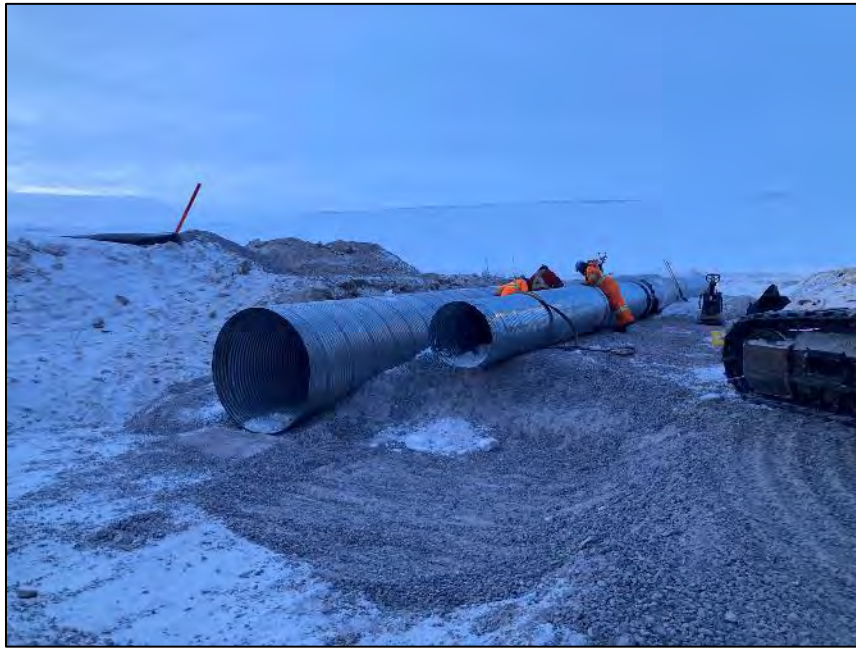
**PHOTO 21.** During Construction - Vantage Point 3 - Installation of high flow culvert - Looking Northeast (April 30, 2024).

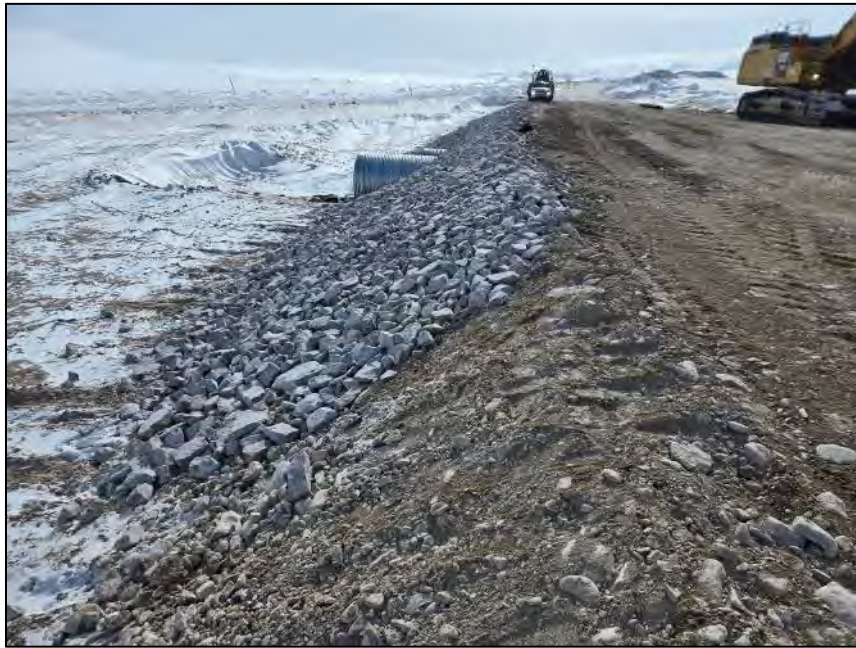
**PHOTO 23.** During Construction - Vantage Point 3 - Slope stabilization and riprap placement on inlet side of crossing - Looking South (May 04, 2024).

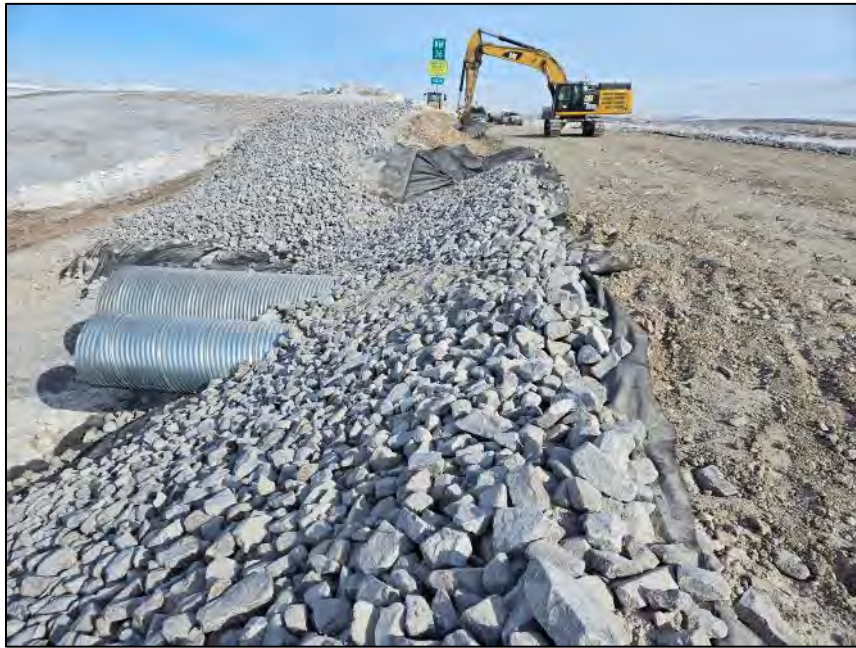
**PHOTO 25.** During Construction - Vantage Point 3 - Installation of geotextile and riprap placement on outlet side of crossing - Looking Northeast (May 05, 2024).

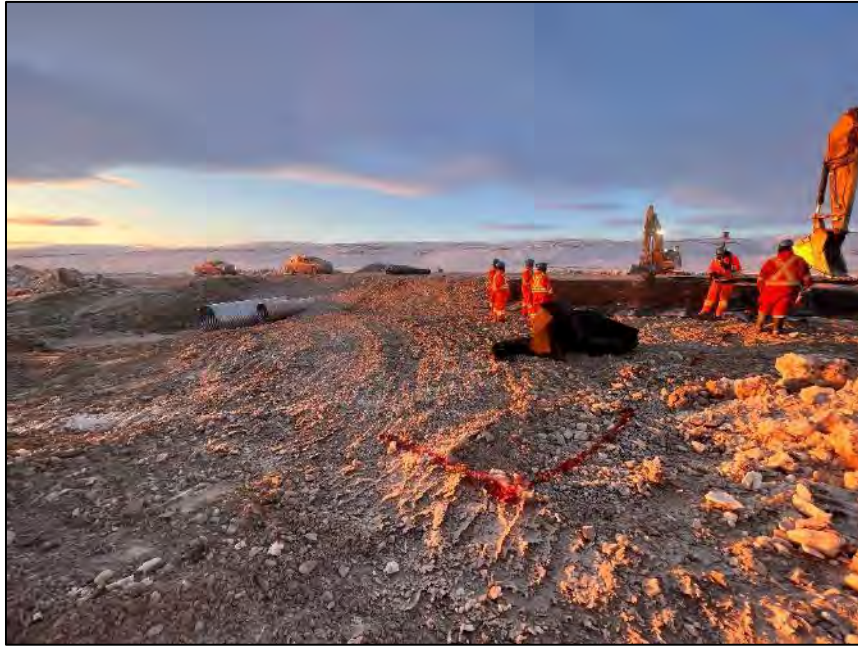
**PHOTO 25.** During Construction - Vantage Point 3 - Installation of Geotextile for Slope Stabilization - Looking Northeast (May 09, 2024).
