RE: Construction Summary of CV-059 Remedial Measures

CV-059 AS-BUILT PHOTO LOG

CV-057 AS-BUILT PHOTO LOG

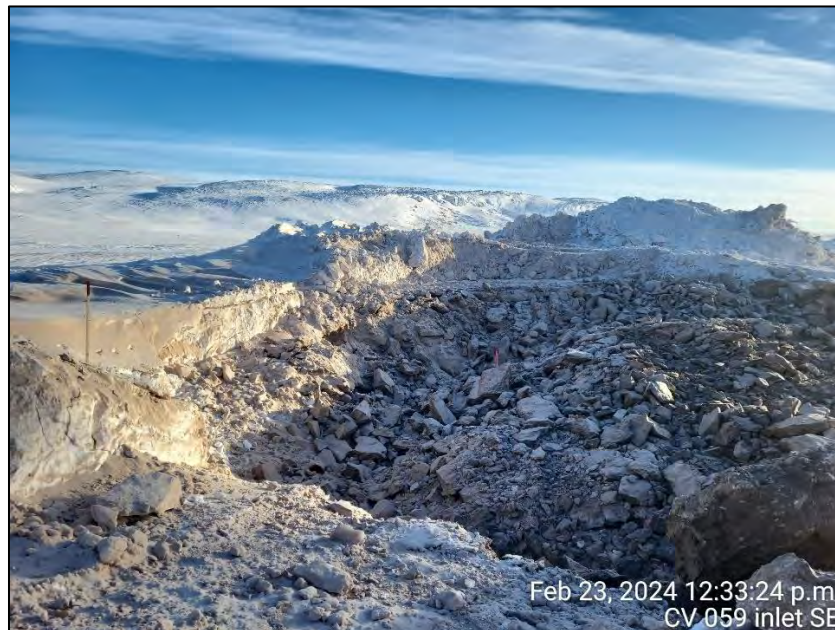
PHOTO 6. During Construction - Vantage Point 1 - Blasted upstream side of crossing - looking southeast (February 23, 2024).

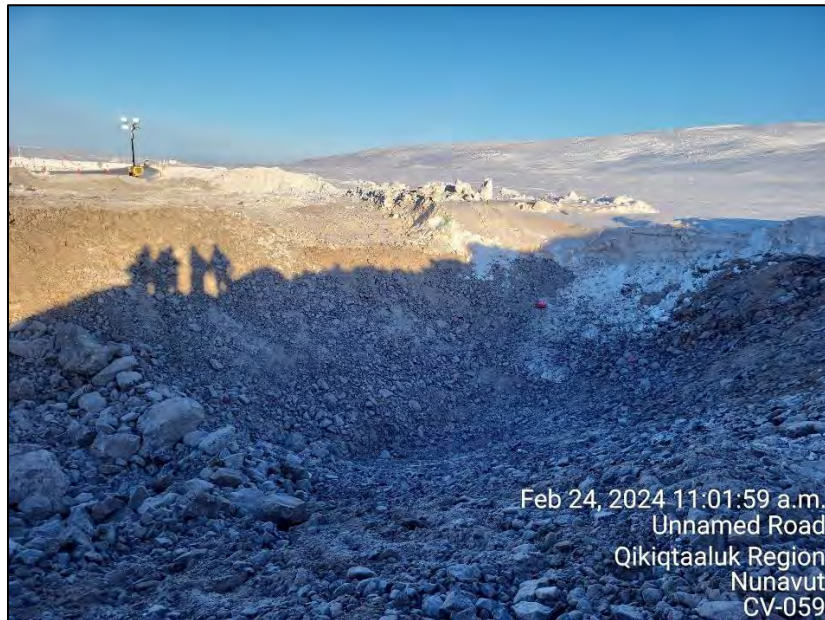
PHOTO 7. During Construction - Vantage Point 1 - Blast Excavation - Road crossing and upstream Inlet - looking south (February 24, 2024).

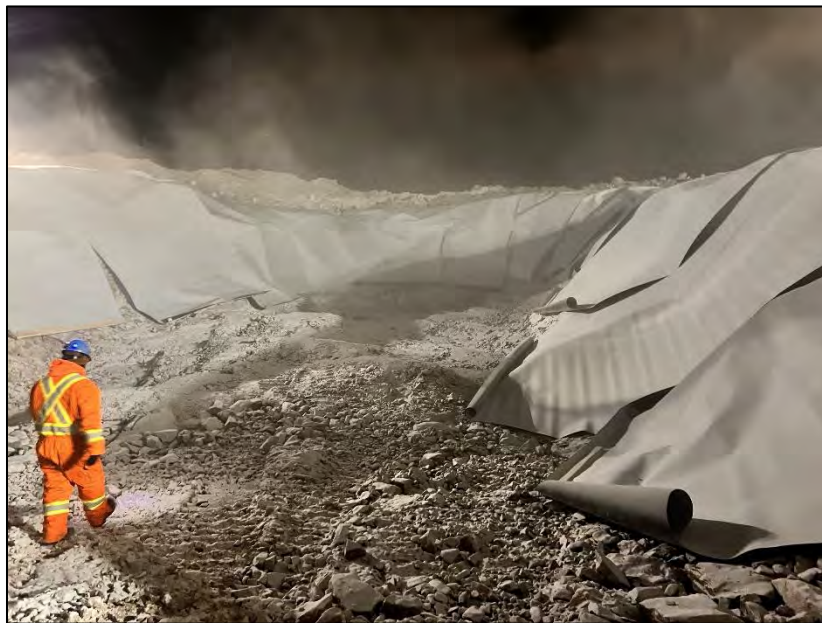
- 1. Over blast of the design excavation by approximately 2 m occurred during drilling and blasting at CV-059. In order to backfill the additional excavation depth, Culvert Backfill was extended at a 1H:1V slope from the culvert design elevation to the base of the excavation. Due to the over blasting, the final fill volume was significantly larger than the design volume.

PHOTO 8. During Construction - Vantage Point 3 - Completed blast excavation with slope stabilization - road crossing and upstream inlet - looking northeast (March 4, 2024).

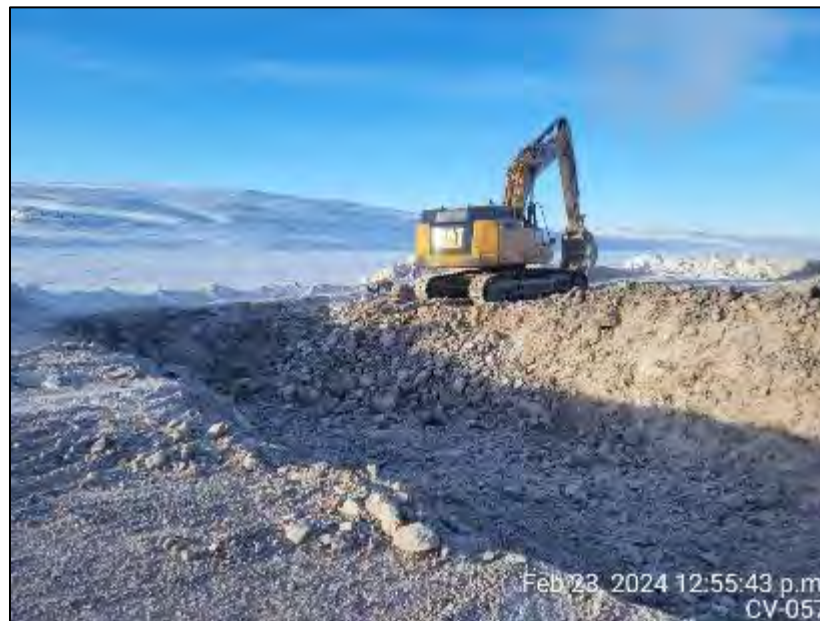
PHOTO 2. During - Vantage Point 4 - Blast excavation - Road crossing and upstream inlet - looking southeast (February 23, 2024).

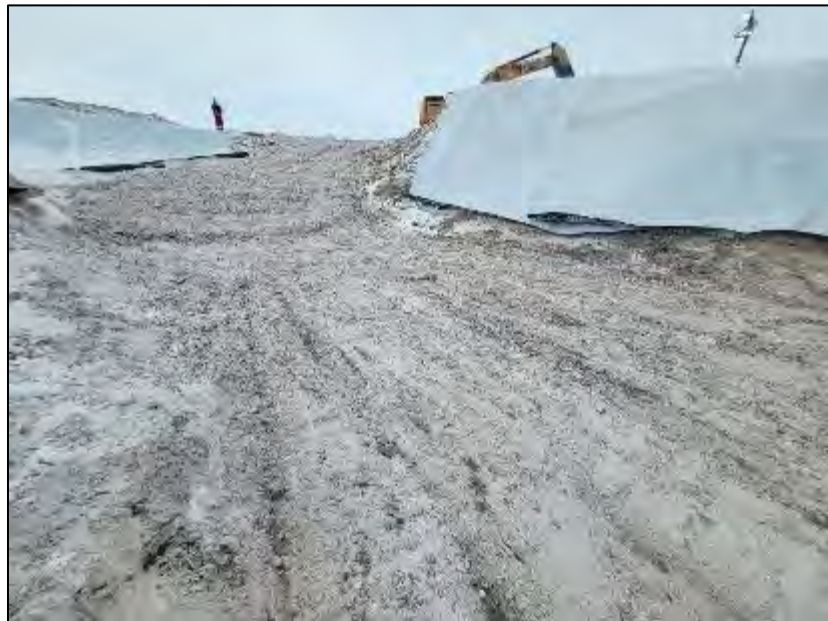
PHOTO 4. During - Vantage Point 4 - Completed blast excavation with slope stabilization - Road crossing and upstream inlet - looking east (March 11, 2024).
