MARY RIVER MINE

TOTE ROAD PERMANENT CROSSING PLAN - ROUND CSP CULVERT INSTALLATIONS

WEEKLY PROGRESS REPORT

WEEK 8 – March 31 to April 6, 2024

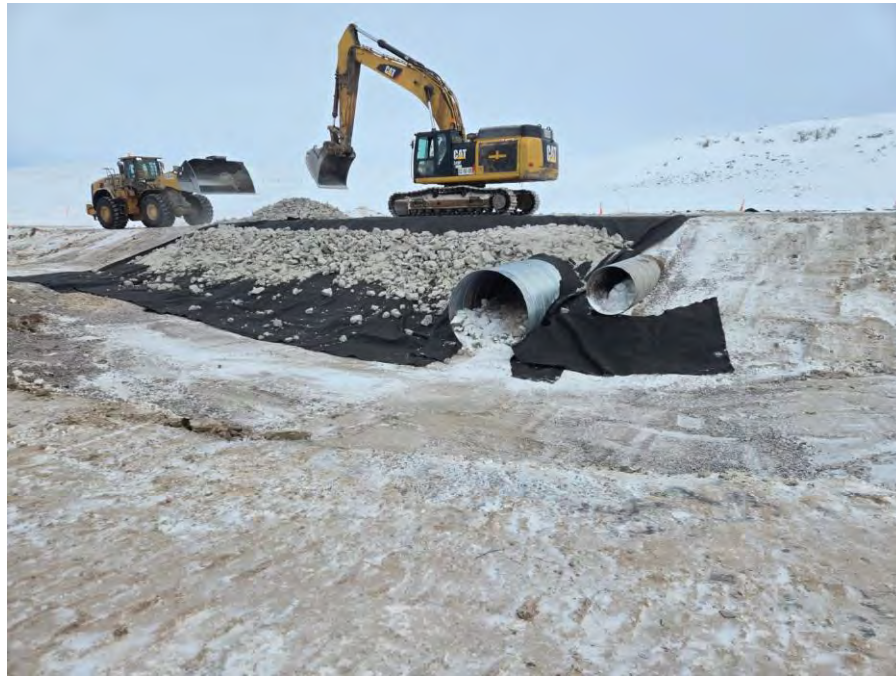
Photo 1 **Placing geotextile and fine riprap on the west 2H:1V side slope at CV-057. Photo taken March 31, 2024, facing east.**

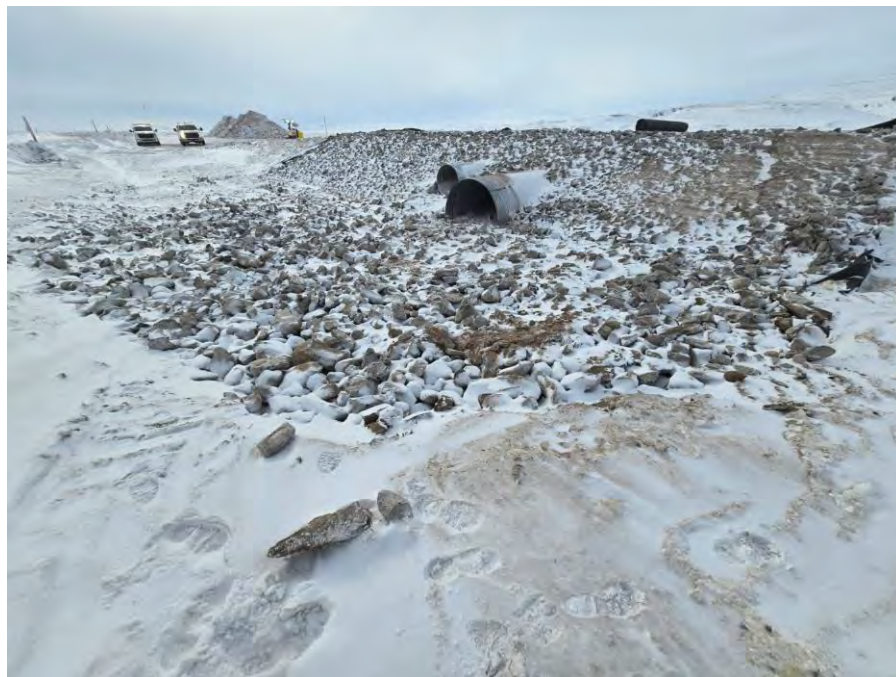
Photo 2 **East apron area complete with coarse riprap mixed with stream substrate material at CV-057. Photo taken March 31, 2024, facing south.**

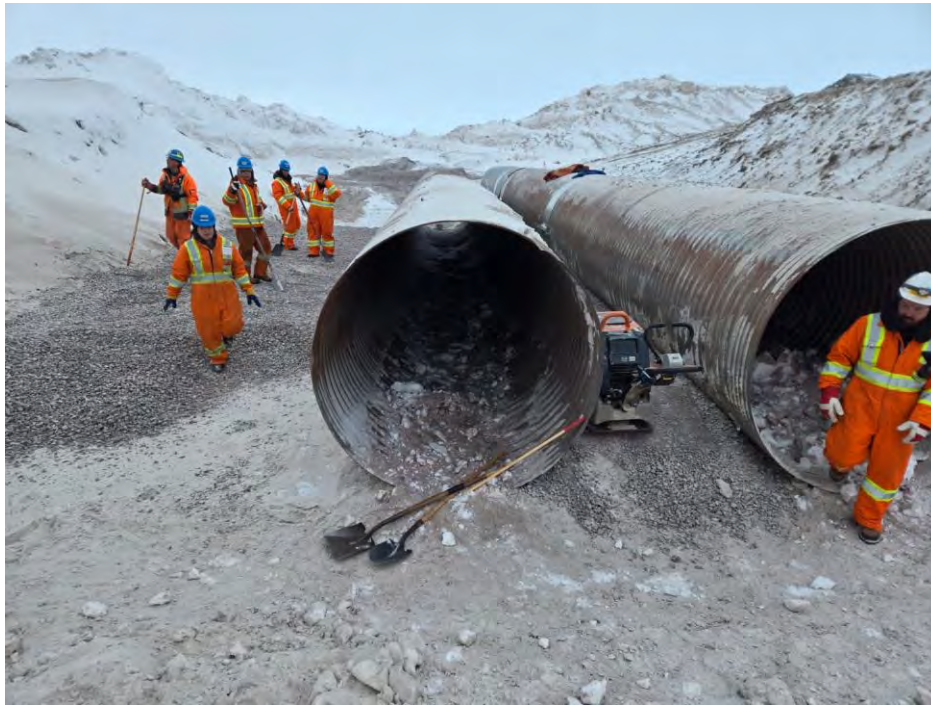
Photo 3 Placing and compacting 32 mm minus culvert backfill material at BG-04. Photo taken March 31, 2024, facing south.

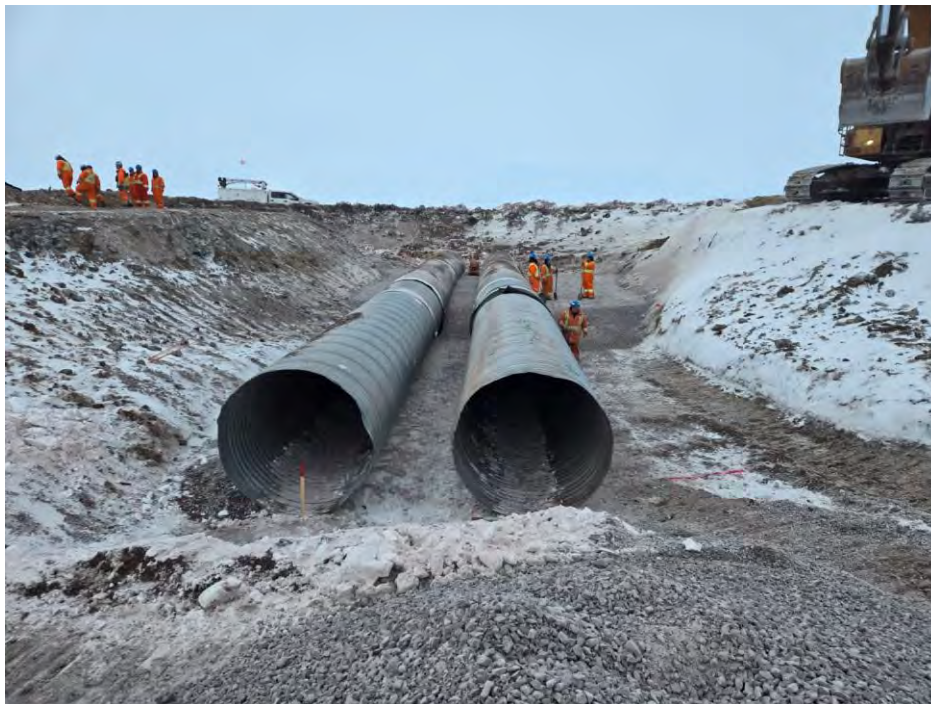
KP monitored the placement of the two (2) 2.0 m diameter low flow culverts and one (1) 1.8 m diameter high flow culvert at BG-04 and one (1) 1.0 m diameter high flow CSP culvert at CV-001. A GPS survey was conducted by Nuna to verify installation elevations and horizontal offsets; the elevations are within tolerances specified by KP.

Photo 4 2.0 m diameter low flow CSP culverts fully installed at BG-04. Photo taken March 31, 2024, facing north.

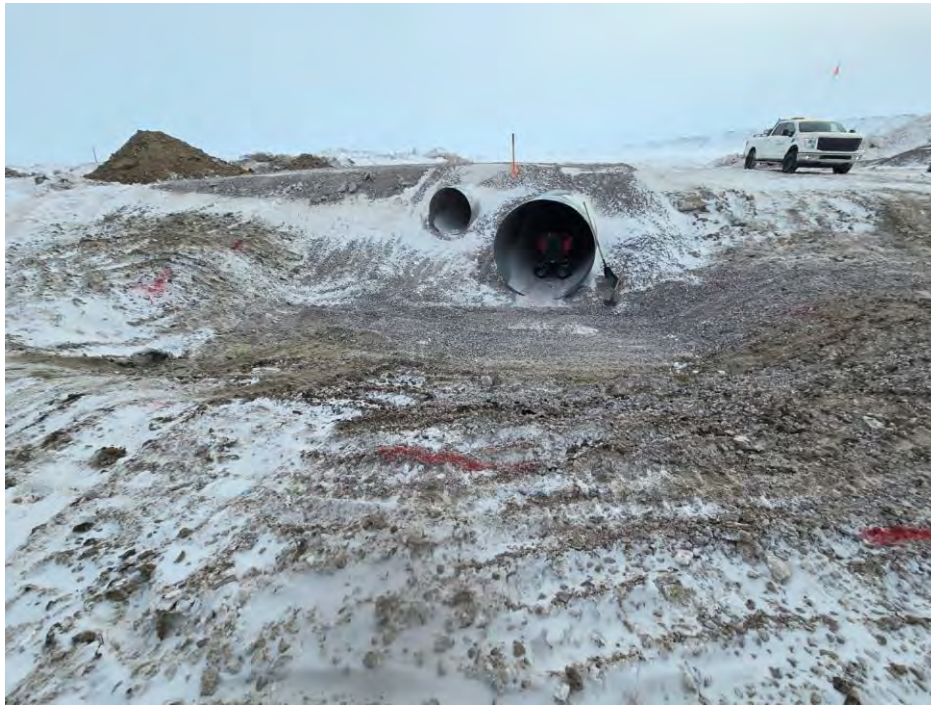
Photo 5 North apron area and prepared coarse riprap and stream substrate material for low flow CSP culvert infilling at CV-001. Photo taken March 31, 2024, facing south.

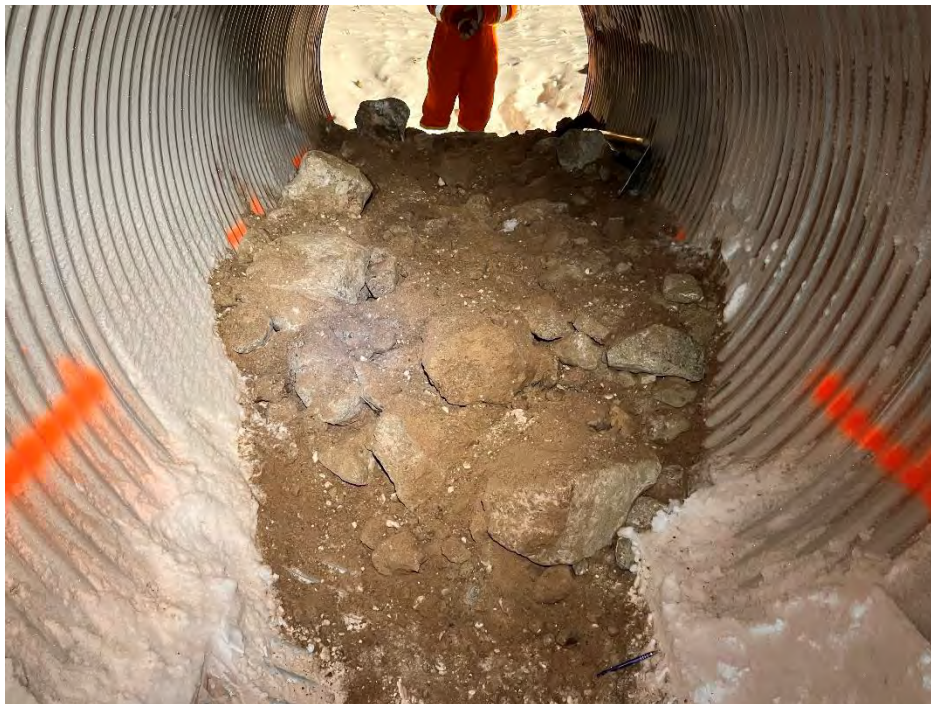
KP monitored the completion of infilling the interior of the low flow culvert at CV-001 with coarse riprap and stream substrate material. The level of infilling was verified to be at 40% (0.7 m) infilled using a measuring tape. In-culvert boulders were verified to be placed in a staggered arrangement with spacing of approximately 1 m from adjacent boulders. KP also monitored the grading, geotextile placement, and slope stabilization at CV-001.

Photo 6 South end (outlet) of CV-001 culvert infilling to 0.72 m above the base of the low flow culvert. Photo taken March 31, 2024, facing outlet.

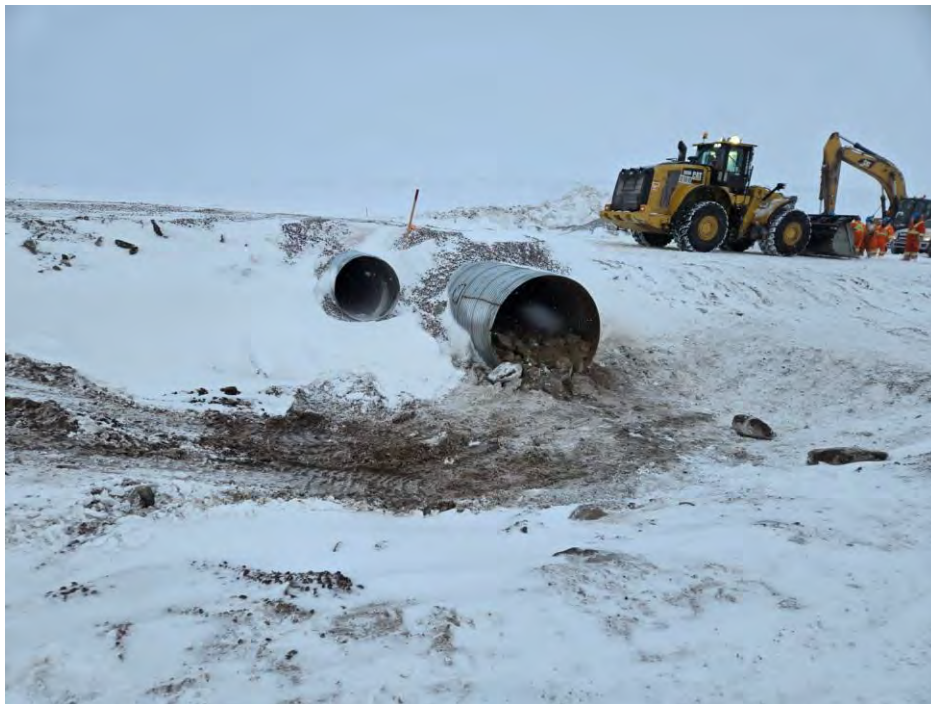
Photo 12 Low flow culvert at CV-001 completely infilled to 0.72 m above the base of the low flow culvert. Photo taken April 1, 2024, facing south.

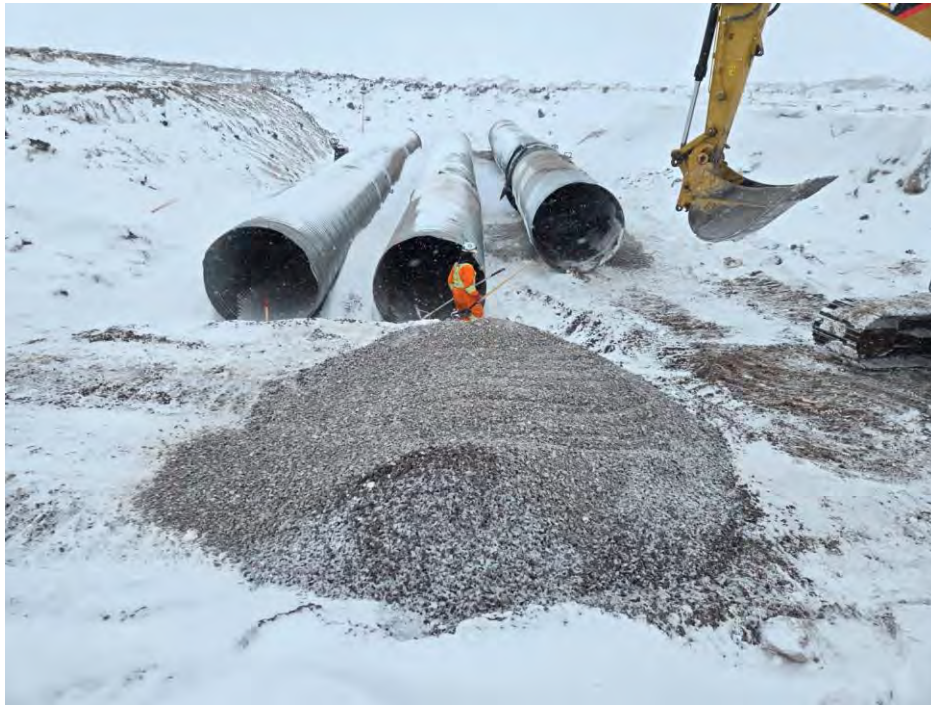
Photo 13

Placed 1.8 m diameter high flow CSP culvert at BG-04. Photo taken April 1, 2024, facing north.

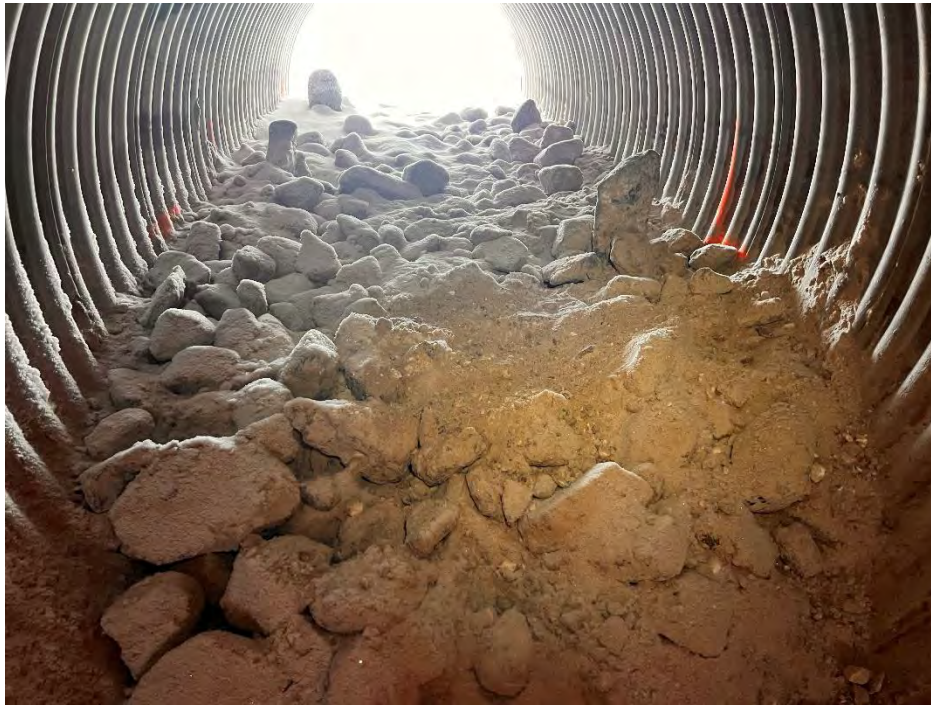
Photo 21

KP issued the surveillance form for BG-04 culvert infill material entrained with snow/ice.

The results of the sample of material similar to stream substrate material mixed with snow from BG-04 was collected. The 1.0 L sample of soil was placed in a graduated cylinder and allowed to melt/settle to determine the percent volume of snow entrained in the sample. The results indicate the sample contained greater than 50% snow/ice by volume.

- Mike Burns and Greg Johnstone discussed the snow within the culvert infill material. Greg informed Mike that the snow and ice within the culvert infill material may settle and cause fish passage issues within the culvert. Greg stated that it is recommended that the material is replaced with culvert infill material without snow and ice.

Snow mixed in with Culvert Infilling Material at BG-04 low flow culvert. Photo taken April 2, 2024, facing inlet.

- Don from Nuna stated that it would be very difficult to remove the culvert infill material.
- Abid from Baffinland stated that they will leave the material within the culvert, but ensure that material going forward will be without ice and snow.

- Greg stated that this is Baffinland's decision and KP will be providing a surveillance form documenting the non-complaint material.
- **April 4** – the following items were discussed:

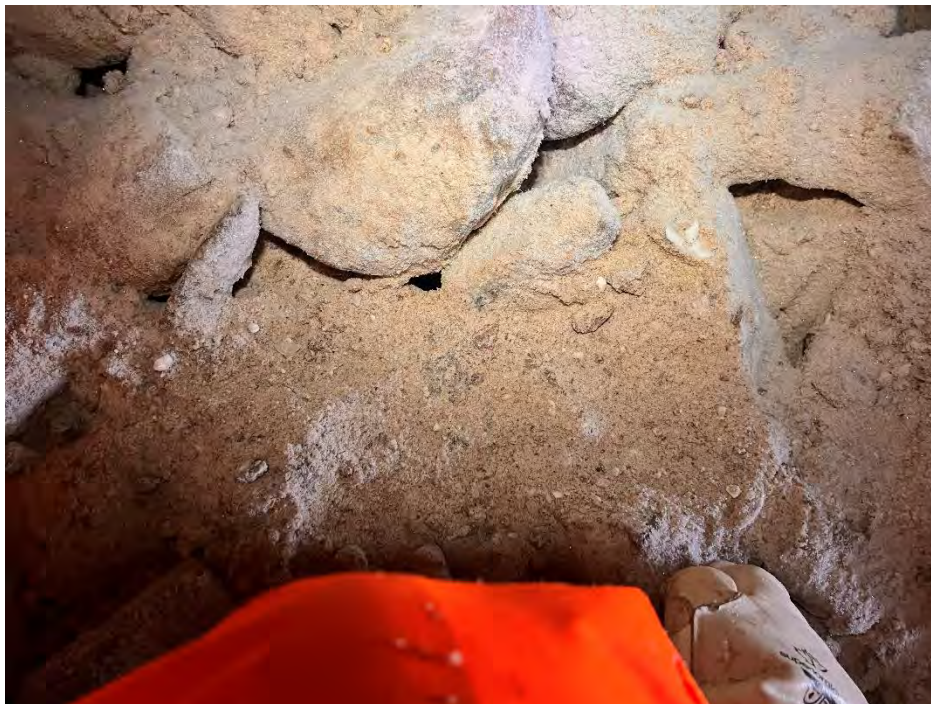
Photo 22

Close up of snow mixed in with Culvert Infilling Material at BG-04 low flow culvert. Photo taken April 2, 2024.

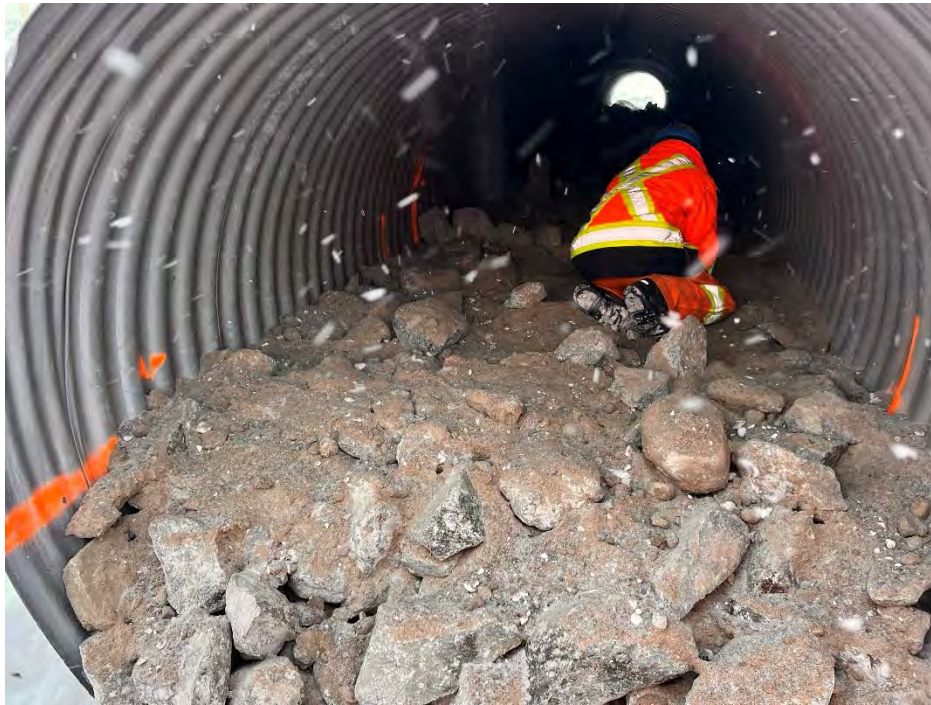
Photo 27 Stream substrate material being added to Riprap fill in voids throughout the 0.80 of riprap in West low flow culvert at the outlet side. Photo taken April 4, 2024, facing inlet.

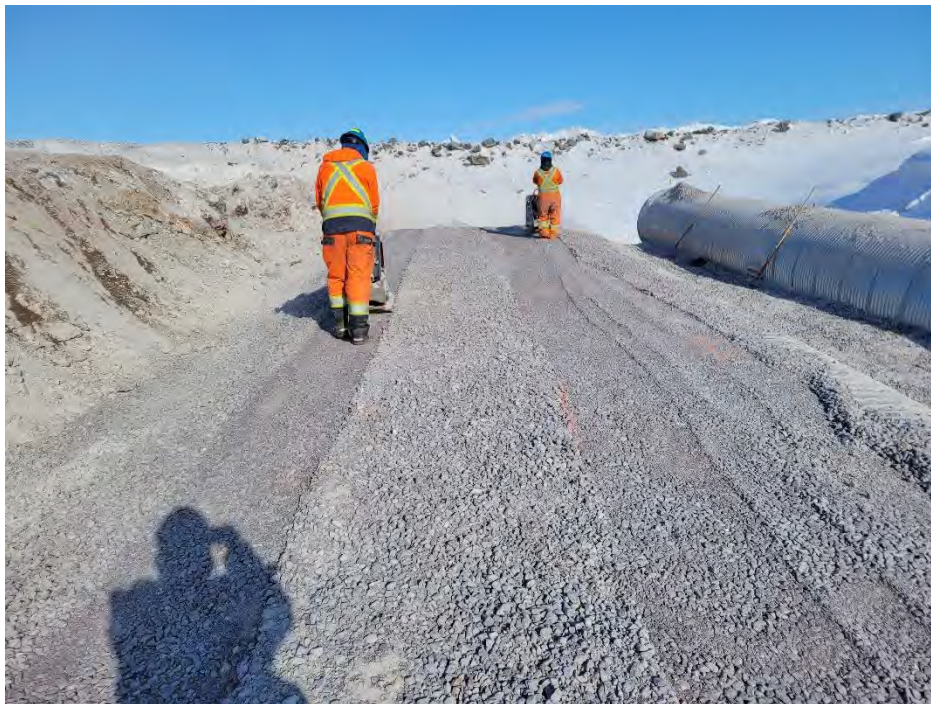
Photo 4 Uncompacted 15 cm (6 inch) layer of 32 mm minus material above the low flow culverts. Photo taken April 7, 2024, facing east.

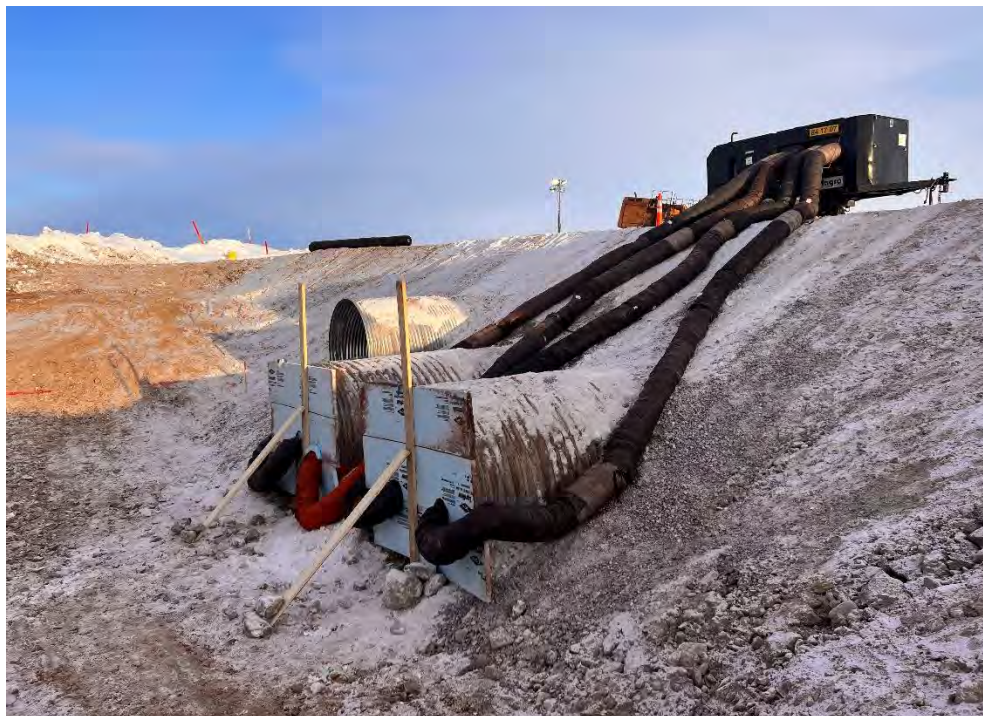
- Ice road construction is on-going at CV-102 and CV-106.
 - The 8.0 m of snow mixed with stream substrate material in the two low flow culverts at BG-04 is currently being heated with a frost fighter to melt the snow and ice. KP, Nuna and BIM will check on the progress today.

Photo 18 Frost fighters installed in the inlet end of the low flow culverts at BG-04. Photo taken April 11, 2024, facing east.

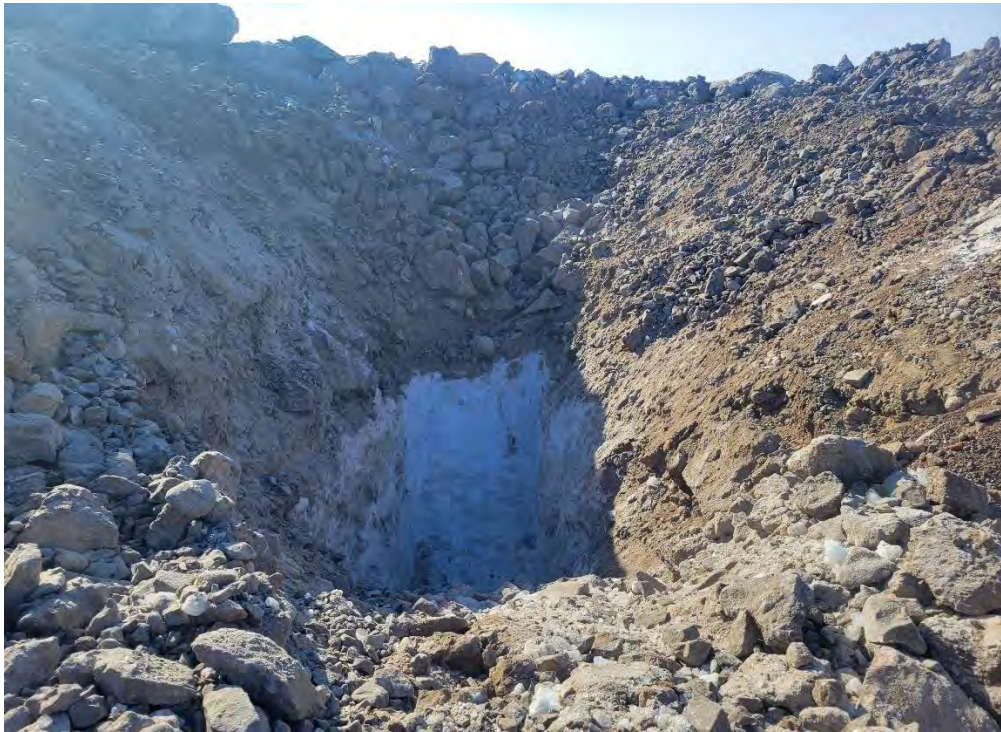
- Ice was encountered during the excavation of CV-216. A survey point found that the ice (at least 2 m thick) lies below the design culvert placement depth (see Photo 2).

Photo 19 Ice found below the blasted material at CV-216. Photo taken April 12, 2024.

- The following engineering items were discussed during the 3:00 pm Tote Road Culvert Update Meeting:
 - KP issued a figure yesterday afternoon showing proposed excavation, backfill and insulation installation to address the ice issue at CV-216. This figure was reviewed by KP's permafrost specialist. KP will issue revised drawing(s) for CV-216 based on this change next week. Richard noted that this coming week will already be very busy looking to issue the pipe arch culvert design letter to DFO, so it may be later in the week before the revised drawing(s) are issued.

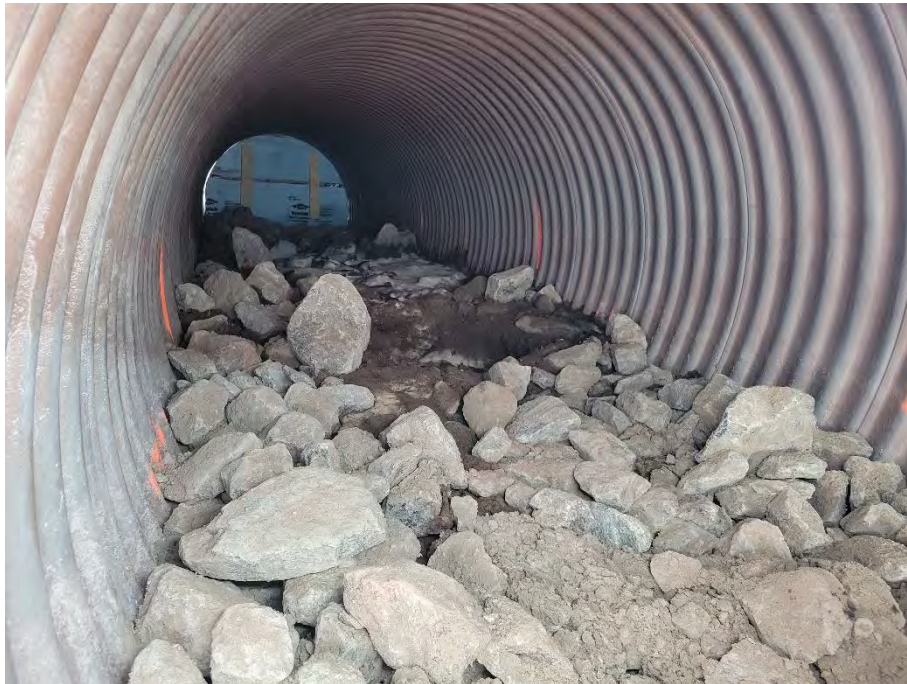
Photo 23

- Regarding the snow in the low flow culverts at BG-04 some melting of snow has occurred, in one culvert more than the other (a heater connection came loose on one culvert and a snowstorm shut down the road). The amount of settlement of the infill material from melting appears to be minor based on KP's photos. The heaters will be maintained for another day or two and we will reassess on Monday. KP asked if the fill in the culverts could be pushed to the side to expose more snow, but Nuna personnel cannot enter the culverts because the height in the backfilled culverts presents an ergonomic risk.

Heating progress inside of northwest culvert inlet at BG-04. Photo taken April 13, 2024, facing south.

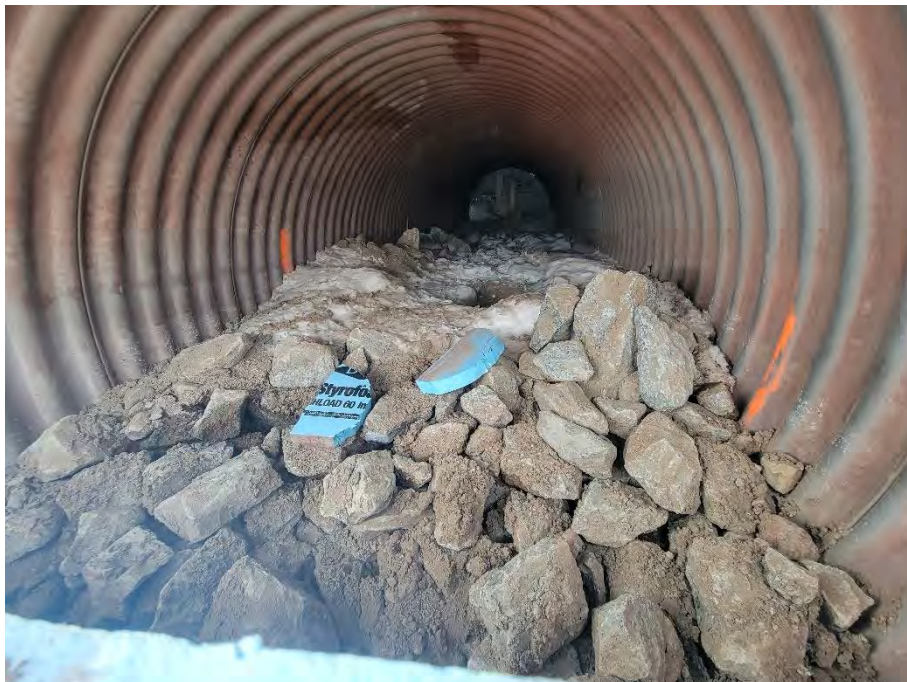
Photo 24

Heating progress inside of southeast culvert inlet at BG-04. Photo taken April 13, 2024, facing south.
