MARY RIVER MINE

TOTE ROAD PERMANENT CROSSING PLAN - ROUND CSP CULVERT INSTALLATIONS

WEEKLY PROGRESS REPORT

WEEK 10 – April 14 to April 20, 2024

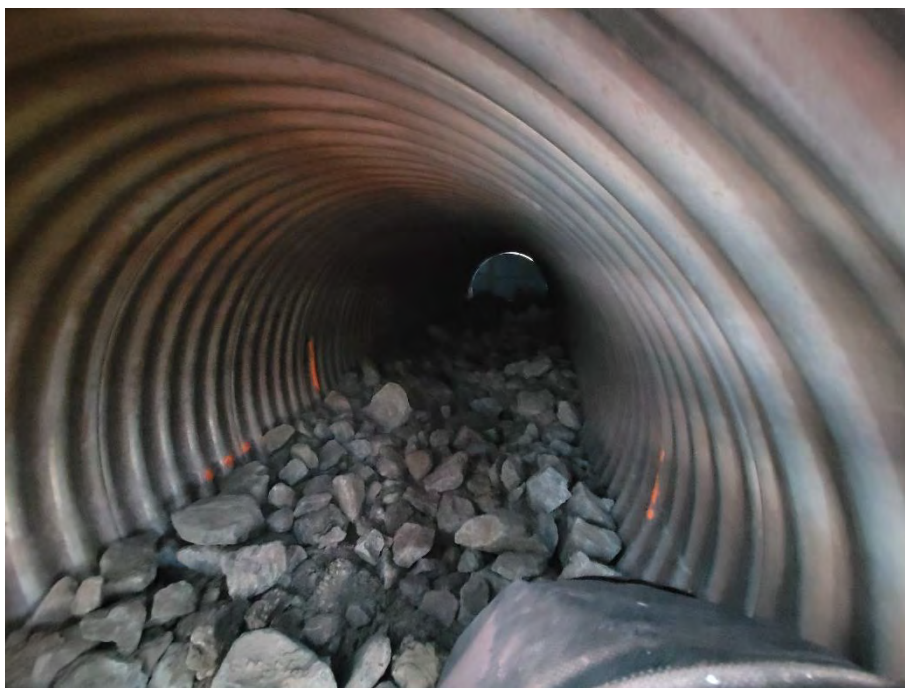
Photo 1

Heating progress inside of northwest culvert inlet at BG-04. Photo taken April 18, 2024, facing south.

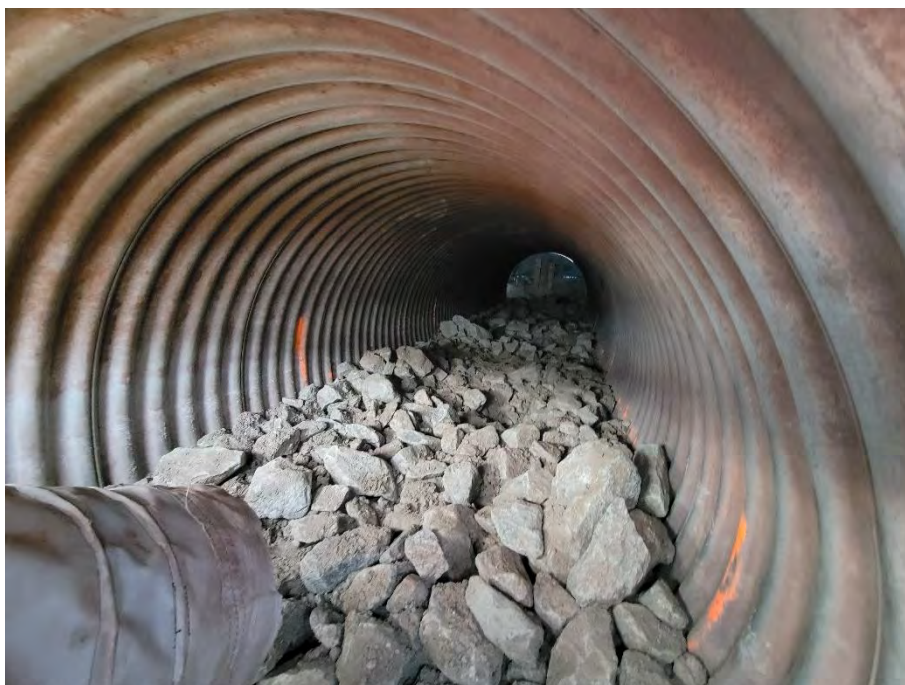
Photo 2

Heating progress inside of southeast culvert inlet at BG-04. Photo taken April 18, 2024, facing south.

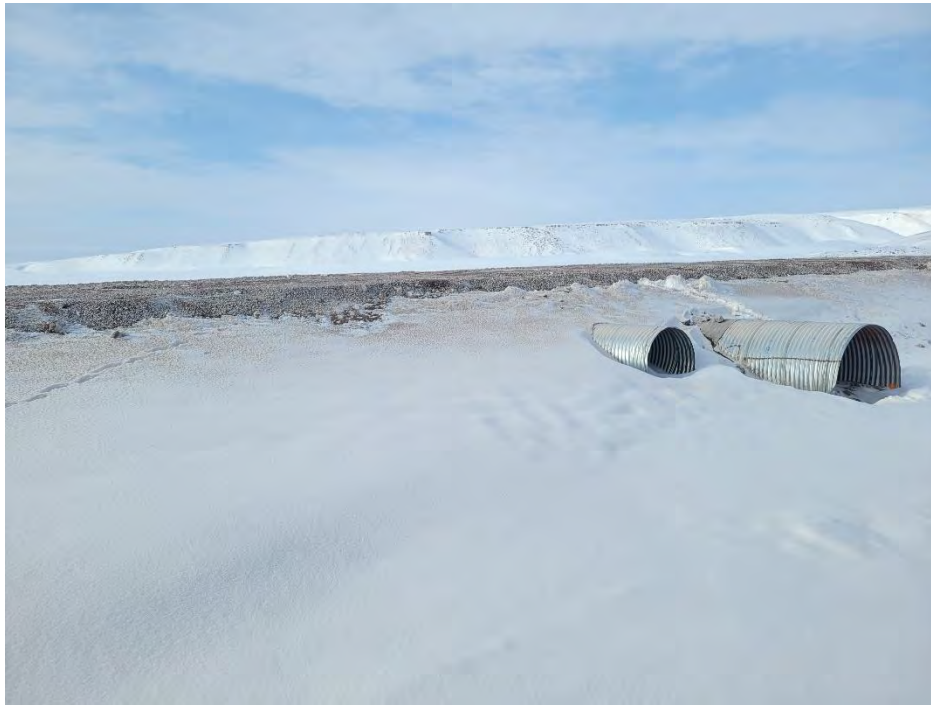
Photo 3 Road topping placed at CV-001. Photo taken April 16, 2024, facing west.

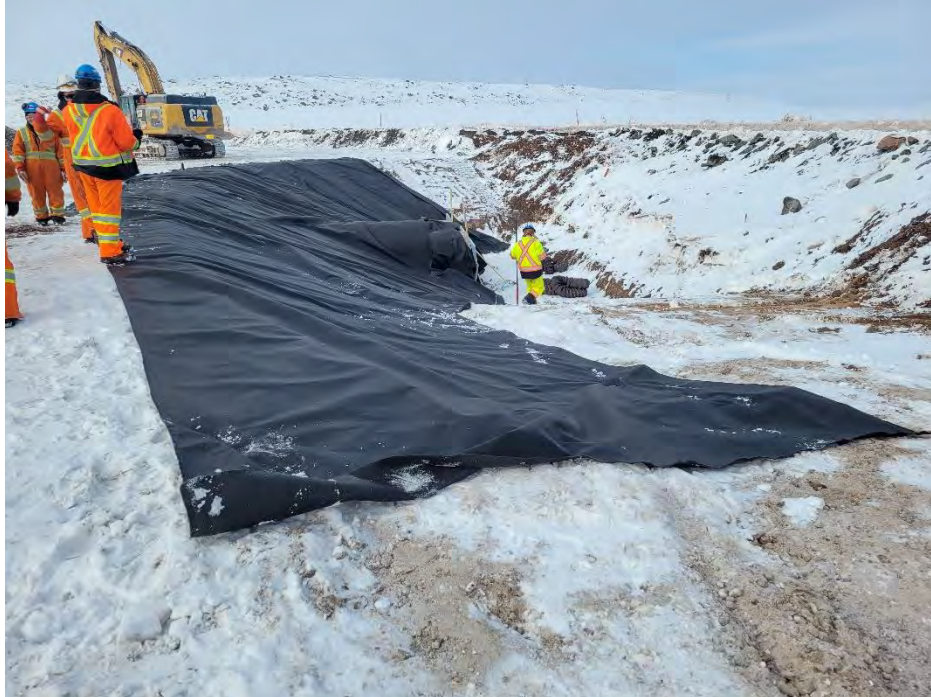
Photo 4 Placement of non-woven geotextile on the upstream slope of BG-04. Photo taken April 16, 2024, facing northwest.

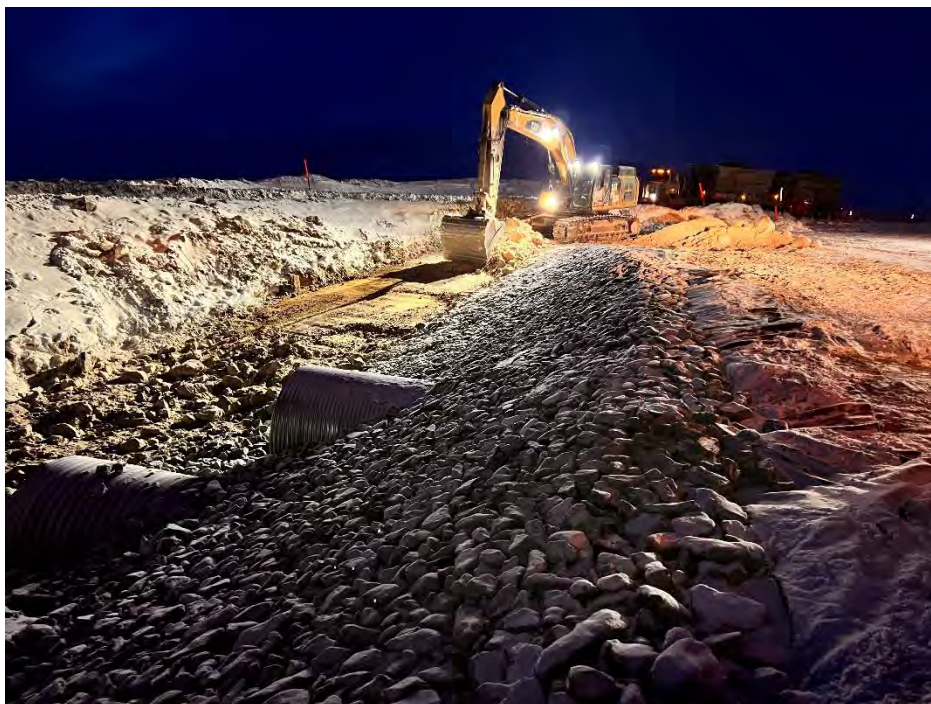
Photo 5

Final riprap placement on the inlet side slopes at BG-04. Photo taken April 16, 2024, facing east.

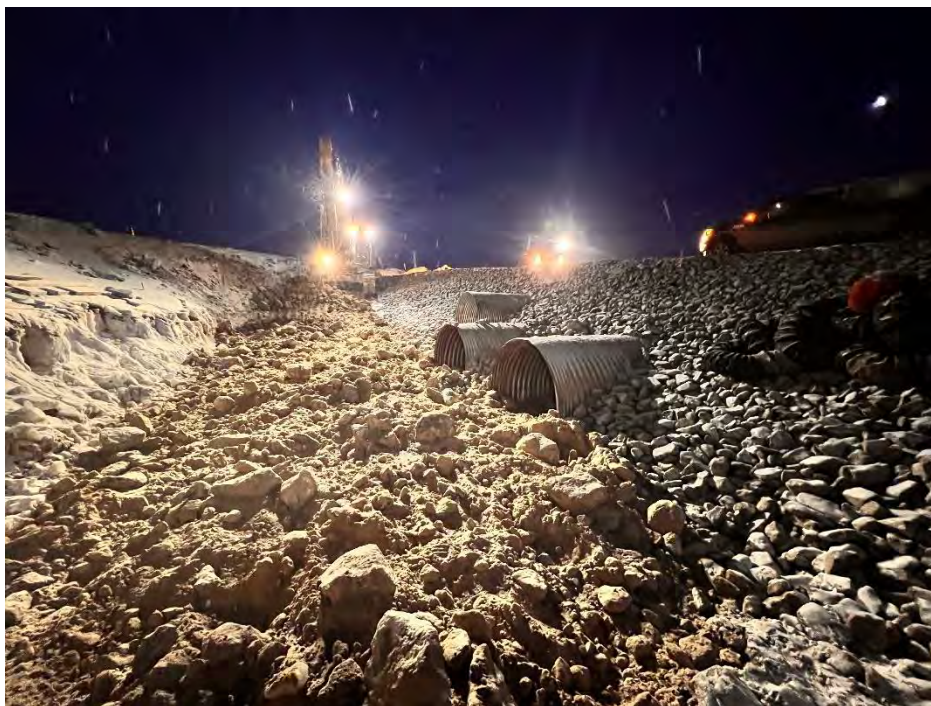
Photo 6

Completed culvert inlet apron at BG-04. Photo taken April 16, 2024, facing east.

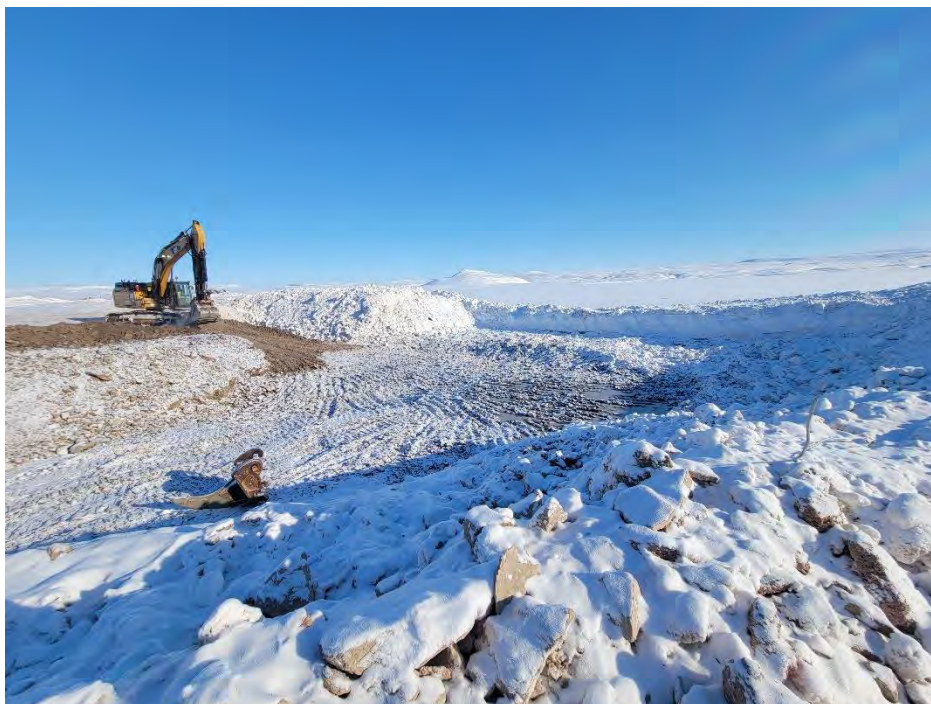
Photo 7 **Excavation of upstream inlet and road crossing at CV-216. Photo taken April 17, 2024, facing northeast.**

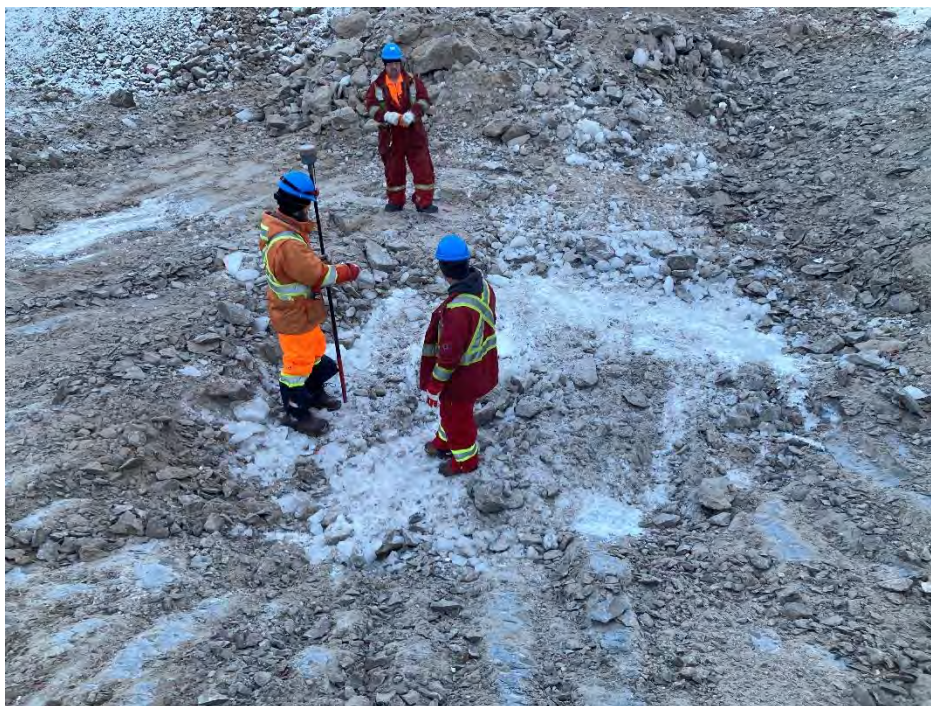
Photo 8 **Ice encountered in the inlet excavation area at CV-216. Photo taken April 18, 2024, facing southeast.**

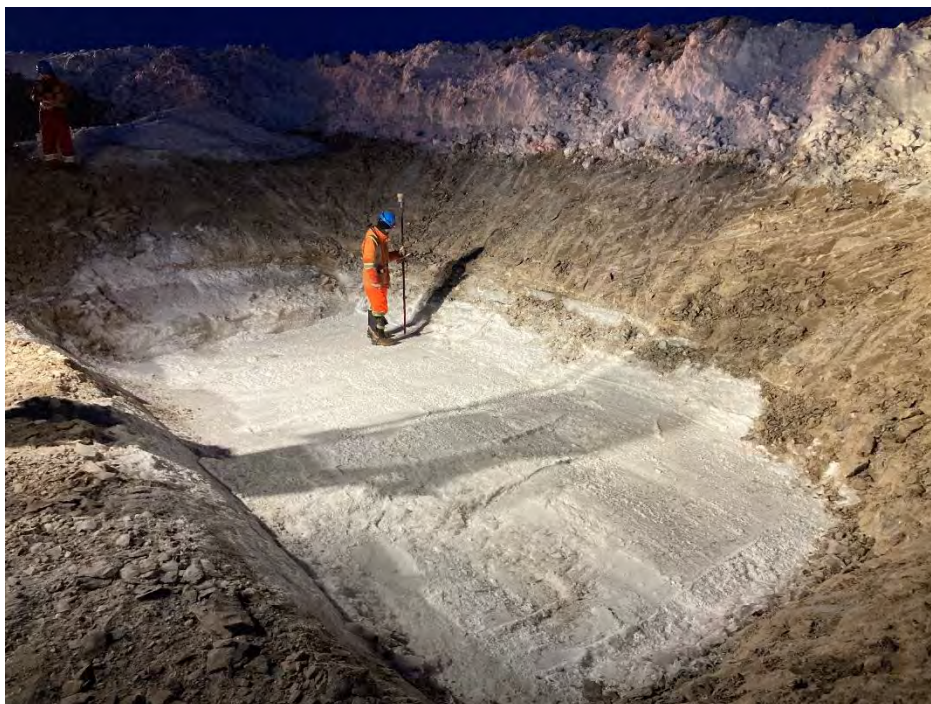
Photo 9 Approval foundation surface at the inlet apron at CV-216. Photo taken April 18, 2024, facing southeast.

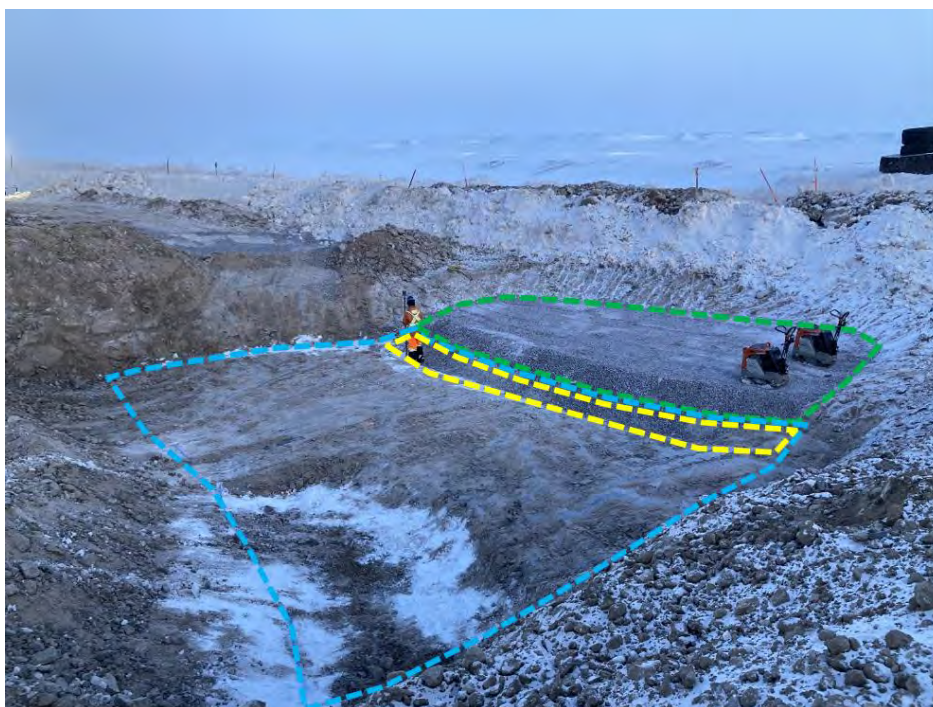
Photo 12 Approved foundation at CV-216 as of April 19, 2024. Photo taken April 19, 2024, facing southeast.

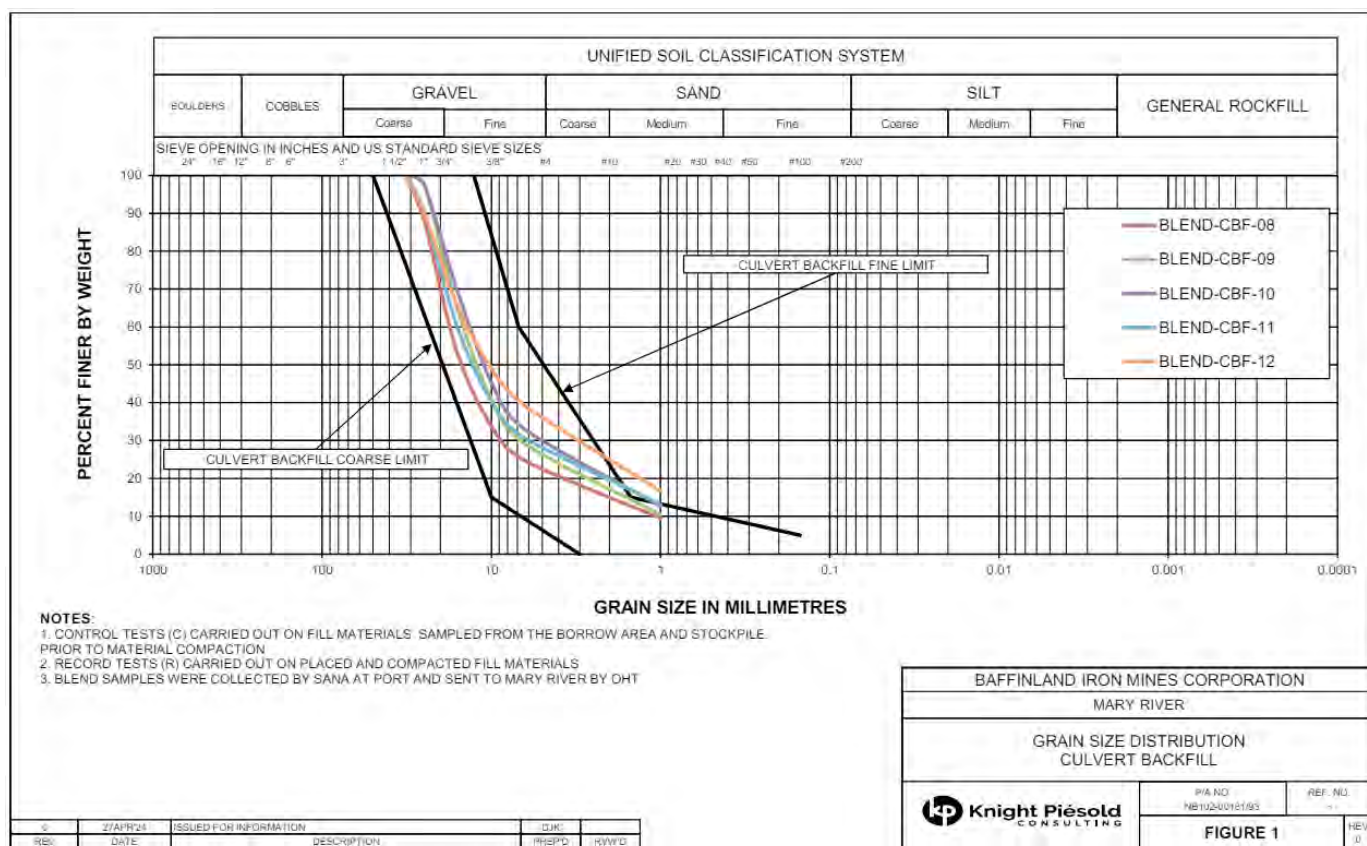
31.5	25	16	10	6.3	1	0.1
										%	%	%	%	%	%	%
CONTROL SAMPLES																
Blend -CBF-08	Blend -CBF-08	BLEND-CBF-08	N/A	Culvert Backfill Blend Sample 08	32mm minus culvert backfill	2024-04-20	2024-04-21	13.99	6.98	99.3	88.3	53.5	33.8	24.6	9.5	0.0
Blend -CBF-09	Blend -CBF-09	BLEND-CBF-09	N/A	Culvert Backfill Blend Sample 09	32mm minus culvert backfill	2024-04-20	2024-04-21	14.98	0.5	100.0	97.7	65.3	41.0	29.1	10.4	0.0
Blend -CBF-10	Blend -CBF-10	BLEND-CBF-10	N/A	Culvert Backfill Blend Sample 10	32mm minus culvert backfill	2024-04-20	2024-04-21	14.04	0.95	100.0	97.7	70.0	45.4	32.9	12.7	0.0
Blend -CBF-11	Blend -CBF-11	BLEND-CBF-11	N/A	Culvert Backfill Blend Sample 11	32mm minus culvert backfill	2024-04-20	2024-04-21	13.90	1.98	100.0	90.7	60.3	40.4	30.6	13.2	0.0
Blend -CBF-12	Blend -CBF-12	BLEND-CBF-12	N/A	Culvert Backfill Blend Sample 12	32mm minus culvert backfill	2024-04-20	2024-04-21	10.98	0.59	99.4	90.3	66.0	49.1	39.1	16.7	0.0

Figure 1: Grain Size Distribution - 32mm minus Culvert Backfill Samples from Sana Crusher

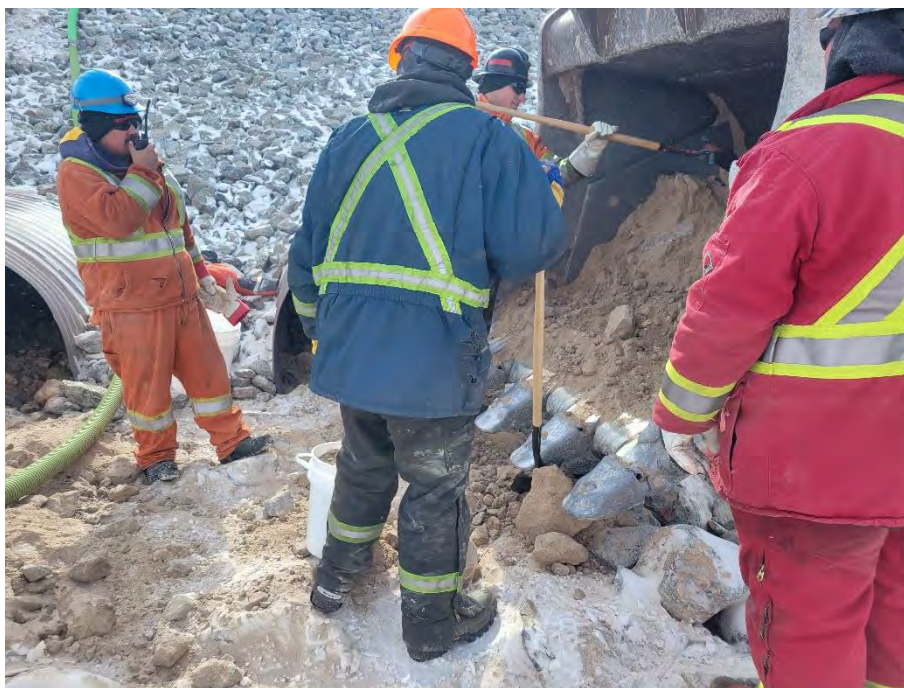
Photo 1 Placement of addition Stream Substrate Material in the low flow culverts at BG-04. Photo taken April 21, 2024, facing south.

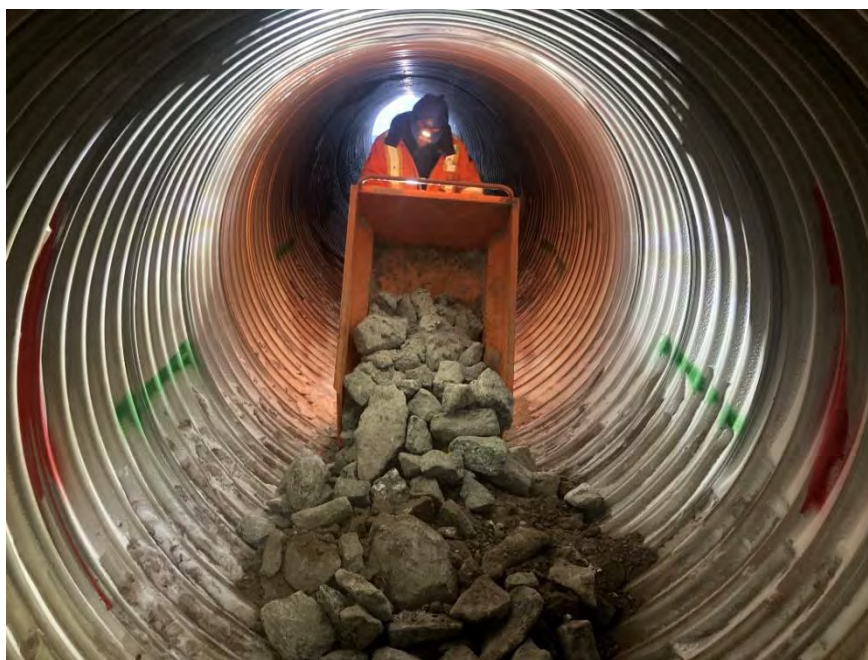
Photo 2

- It has been observed the culvert infilling material at CV-216 has contained a large amount of snow/ice. Alternative 3/16 inch culvert bedding material is to be used in-place of the stream substrate material to fill voids between coarse riprap when infilling the culverts going forwards.

Placement of riprap material within the western 2.0 m diameter low flow CSP culvert at CV-216. Photo taken April 28, 2024, facing south.

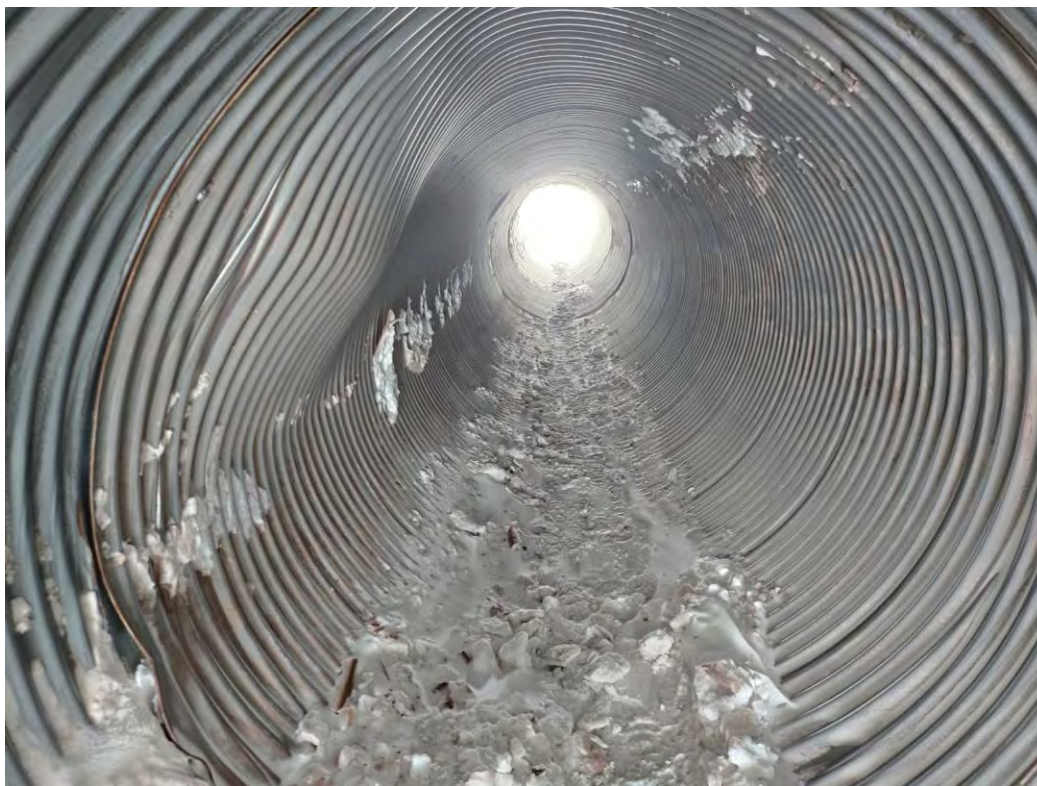
- **April 30** - The following engineering items were discussed during the 7:30 am Daily Coordination Meeting:
 - The dent in the northern high flow round CSP culvert at CV-216 was discussed. Greg Johnstone from KP recommended that Baffinland consult the culvert manufacturer Armttec to determine remedial measures. Baruck from Baffinland stated that they plan to excavate the material overlying the dent in the northern high flow CSP culvert at CV-216 and use hydraulic jack to pop out the dent. The culvert manufacturer will then be contacted after conducting the remedial measures to verify the pipe integrity is sufficient.

Photo 3 Dent in northern high flow CSP culvert at CV-216. Photo taken morning of April 29, 2024, facing northeast (outlet).

- **May 1** - The following engineering items were discussed during the 7:30 am Daily Coordination Meeting:
 - Baffinland stated that the dent in the culvert has been repaired and is not on the travel surface of the road. Greg informed Baffinland that they should discuss this with Armttec.

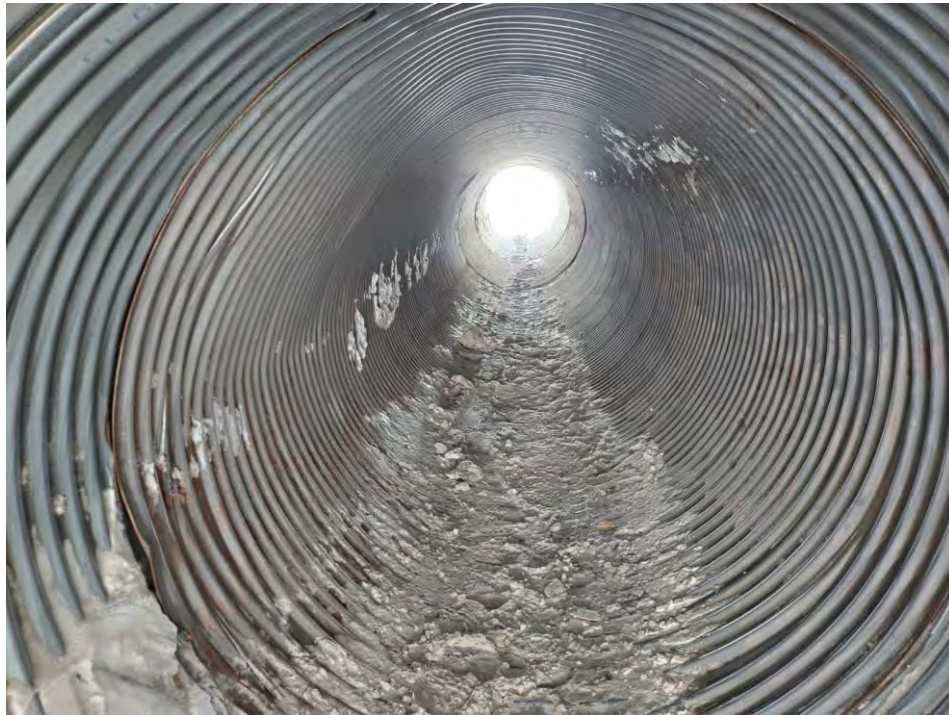
Photo 5 Pushed out dent in the northern high flow CSP culvert at CV-216. Photo taken April 30, 2024, facing downstream.

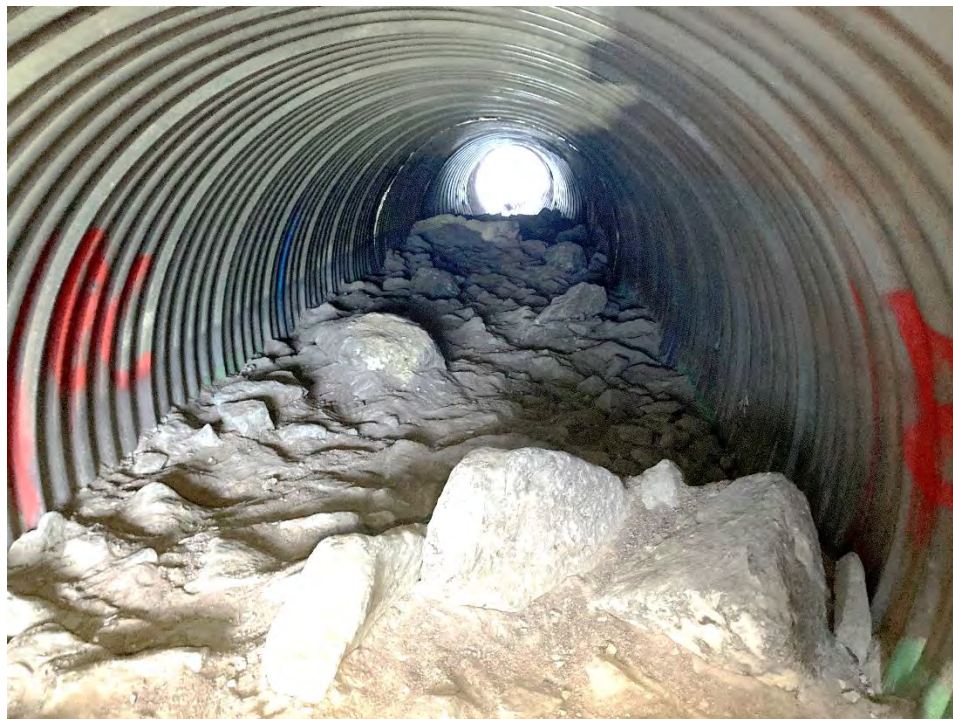
Photo 6 Boulder clusters installed at 6.5 m interval with embedded protruding boulders between clusters within the northern low flow culvert at CV-216. Photo taken April 30, 2024, facing upstream.

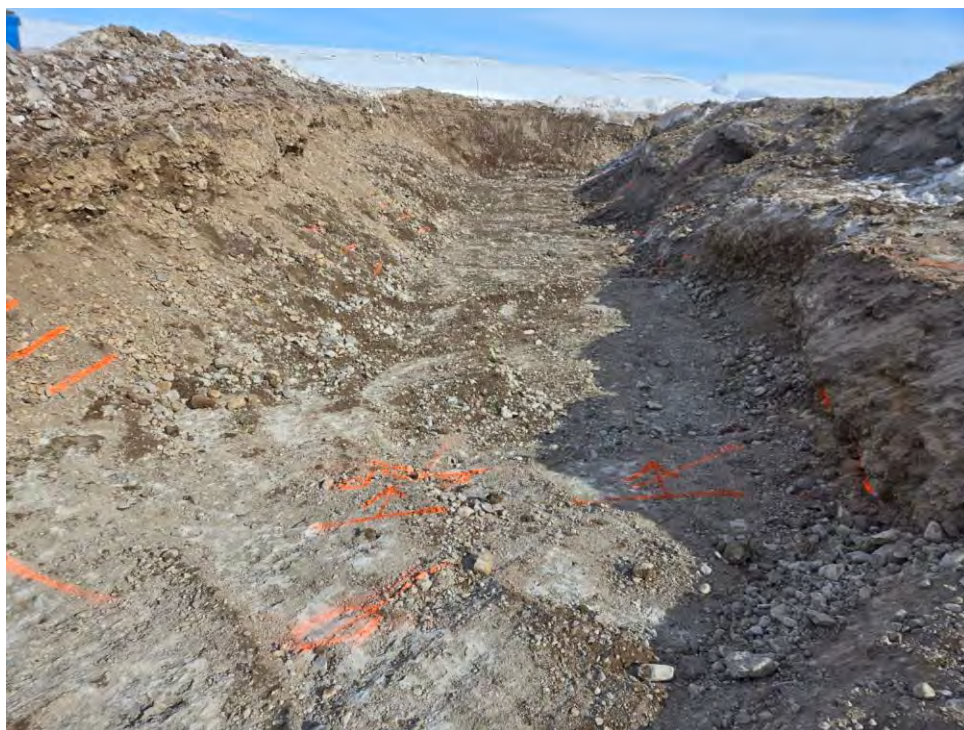
Photo 1 **Approved foundation surface of the road crossing area at CV-106. Photo taken May 5, 2024, facing east.**

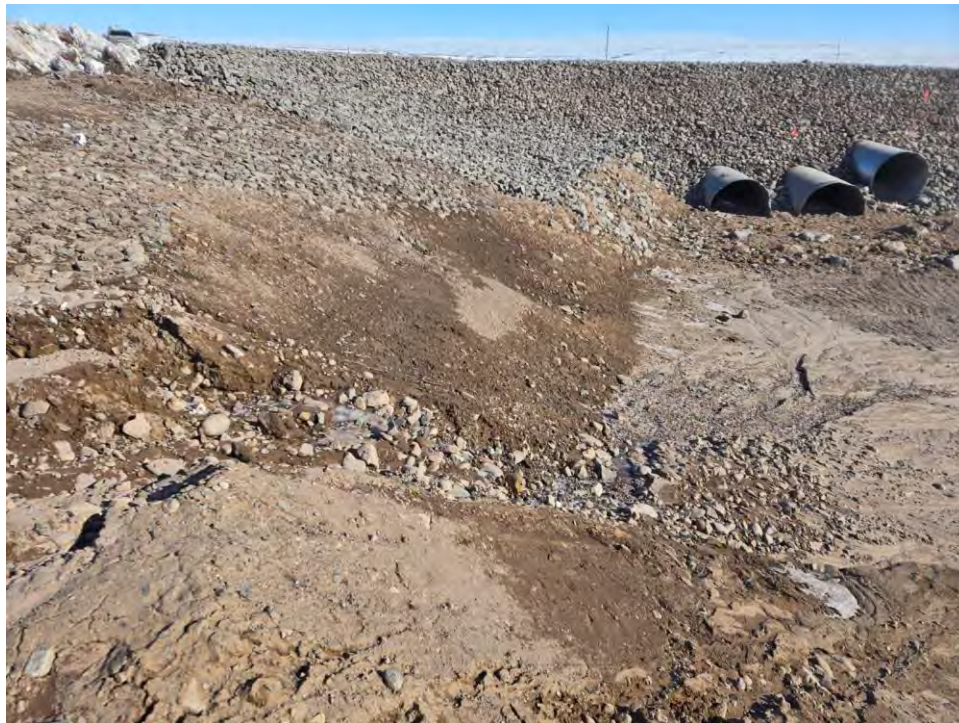
Photo 10 Rill erosion and sediment fan deposition in outflow environment on southwest side slopes at BG-04. Photo taken May 9, 2024, facing north.

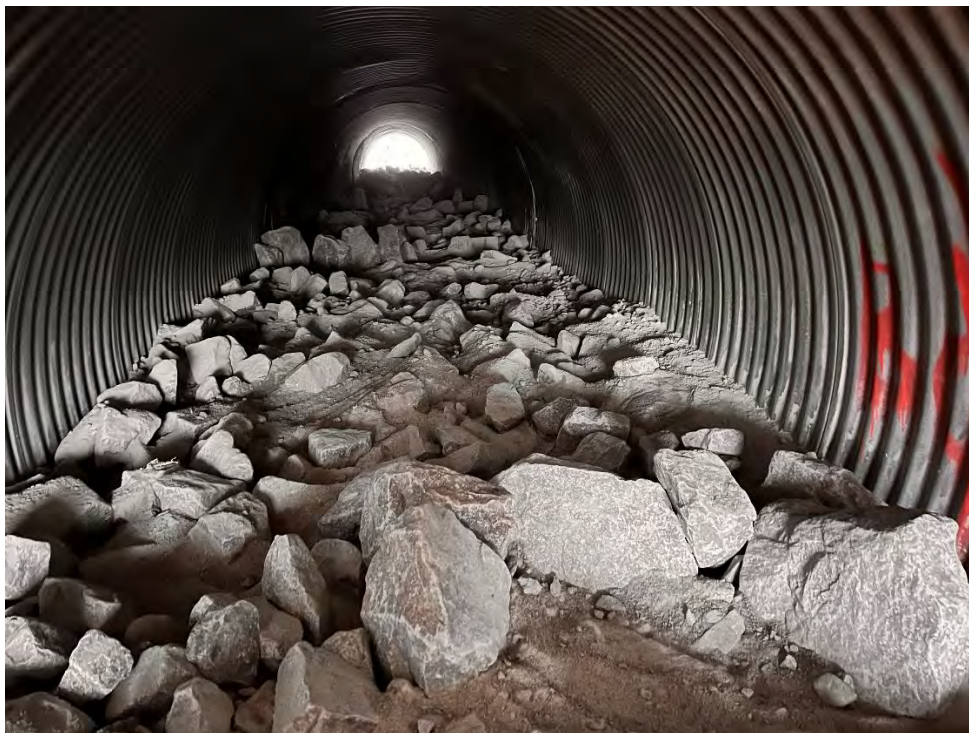
Photo 16 Infilled 1.8 m diameter low flow CSP culvert complete with boulder clusters at CV-106. Photo taken May 11, 2024, facing upstream.
