CONSTRUCTION SUMMARY REPORT ROUND CSP CULVERTS – FEBRUARY TO MAY 2024

APPENDIX E Design Change Forms

MARY RIVER - TOTE ROAD ROUND CSP CULVERTS

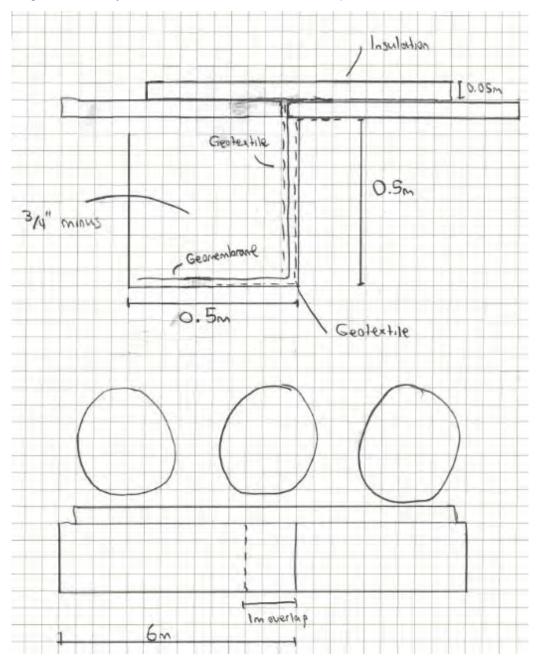
A large ice mass has been encountered in the foundation of culvert CV216 (see photo below). The ice mass in this location has prompted a potential design change by the Engineer for this culvert.

Figure 1 CV-216 Geomembrane Key-In Trench Design Change

KP provided a memorandum and figure to Baffinland on April 17 describing the design change details for the foundation at CV-216 (attached). Following the issuance of this memorandum Baruck Wile from Baffinland informed KP that there are not sufficient quantities of bentonite to construct the foundation per the design change. As such, KP has revised the design change to incorporate geomembrane with a key in trench in place of bentonite mixed with ¾" minus material. The proposed geomembrane key-in trench is shown on Figure 1. The key in trench is to be backfilled with compacted ¾" minus material.

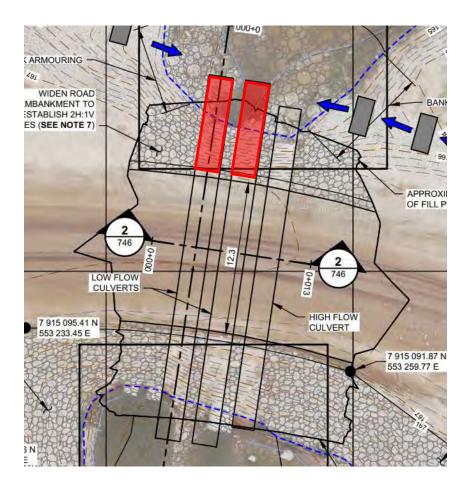
Figure 1 Approximate area of placed Culvert Infill Material containing snow at BG-04 Culvert shown in red (From Drawing 745 R2)

Removal of the placed Culvert Infill Material is the preferred option; however, this is recognized as being very difficult to complete due to the size of the material and difficulty using mechanization. In lieu of removing the material, additional natural stream substrate material should be placed on the surface of the 8 m section of each infilled culvert. It is recommended that this material consist of an approximately 10 cm thick lift of Stream Substrate Material only (no riprap). The expectation is that this additional material will assist in filling any voids that might be caused by the melting of the snow mixed with the Culvert Infill Material.

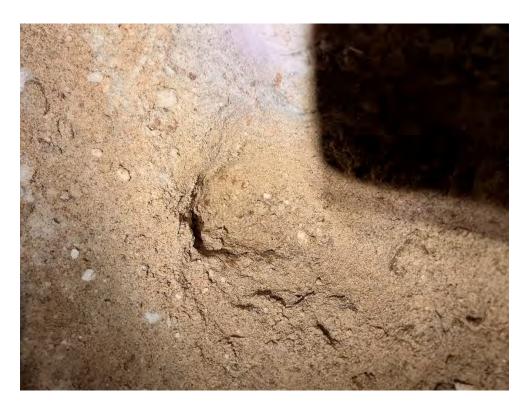
During the beginning of nightshift of April 2, 2024, it was observed that the Culvert Infill Material being placed by Nuna to backfill the inside of the two (2) low flow culverts at BG-04, for the first 8 m of fill on the inlet ends contained entrained snow (See Figure 1 and Figure 2). The Stream Substrate Material being used to mix with the Coarse Riprap, as well as the Coarse Riprap was observed to have snow mixed into the stockpiles which were then used for the culvert infilling.

Photo 3 Hole made to inspect the snow mixed in with Culvert Infill Material at BG-04

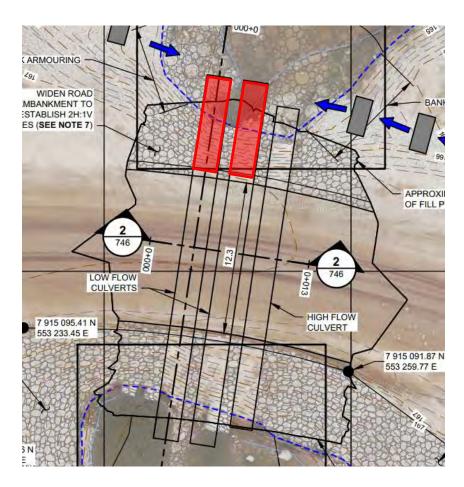
During the beginning of nightshift of April 2, 2024, it was observed that the Culvert Infill Material being placed by Nuna to backfill the inside of the two (2) low flow culverts at BG-04 contained entrained snow (See Figures 1 and 2). The material with snow was observed along the first 8 m from the inlet ends of both low flow culverts. Further review identified that the stockpiles of both the Stream Substrate Material and the Coarse Riprap had snow mixed into the stockpiled materials.

Figure 1 Approximate area of placed Culvert Infill Material containing snow at BG-04 Culverts shown in red (From Drawing 745 R2)

It is KP's official recommendation that the material in question be removed from the identified areas of the two low flow culverts at BG-04. This material should be replaced by more suitable Stream Substrate Material without an excess of snow and/or ice. This solution is considered lowest risk of non-compliance with DFO requirements.

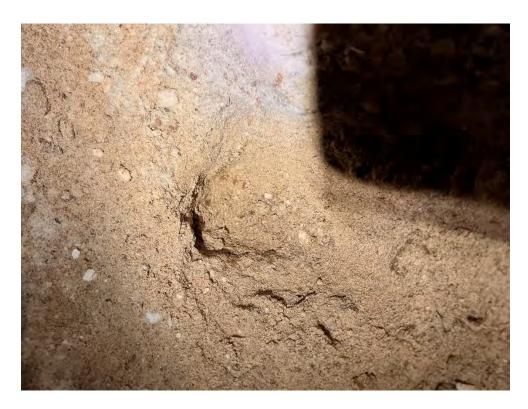
To confirm the observations and initial test results, an additional eight (8) samples were collected on April 9 from the identified non-conforming material in the two low flow culverts at BG-04. Four of the samples were delivered to the on-site ALS laboratory for moisture content testing, and four duplicate samples were retained by KP for comparison. The results of all eight samples indicate that approximately 80% of the volume of the natural stream substrate (finer portion of the matrix) samples consisted of snow and/or ice (See Photos 8 to 18).

Photo 3 Hole made to inspect the snow mixed in with Culvert Infill Material at BG-04.

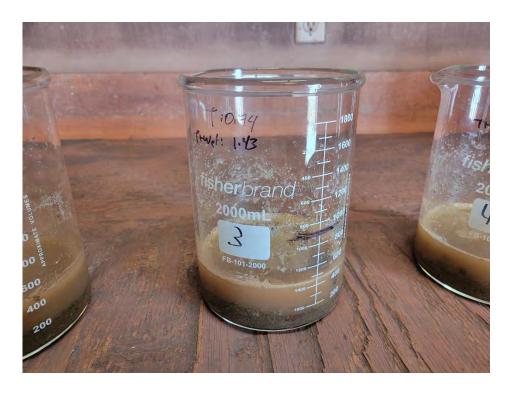
Photo 16 Sample 03 results after melting of snow and ice.

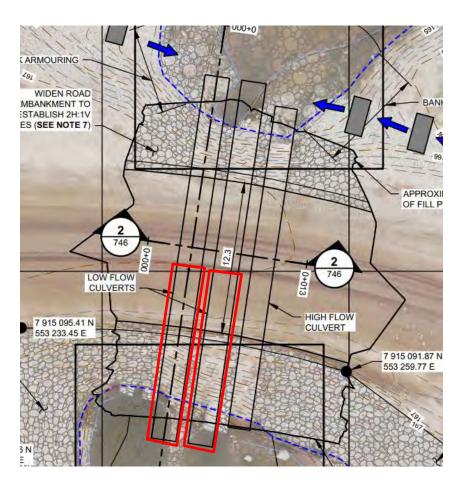
The infilling of the two low flow CSP culverts at BG-04 commenced on April 2, 2024, and was completed on April 7, 2024. Following the completion of infilling the culverts, it was observed that the required embedded Boulder Clusters and Protruding Boulders were not installed within the culverts as per the design.

Figure 1 Approximate area within the low flow culverts at BG-04 that lack the required Boulder Clusters and Protruding Boulders shown in red (From Drawing 745 R2)

KP recommends that the required Boulder Clusters and Protruding Boulders be installed within the southern half of the southeastern low flow culvert and that those present in the southern half of the northwestern low flow culvert be replaced at BG-04. As previously noted, this is required to comply with the DFO corrective measures order. It will be important to consider the safety concerns identified by Nuna in any remedial measures completed.

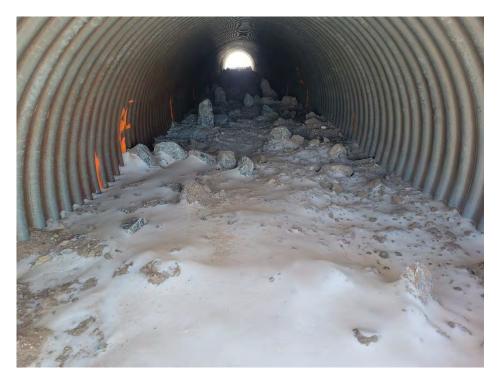
The Boulder Clusters that are present in the southern half of the northwestern low flow culvert require replacement as they are not installed as per the design specifications on Drawing No. 780 (See Photo 1). The boulders placed are too small and not properly imbedded to prevent movement during high flow conditions. There are no Boulder Clusters or Protruding Boulders currently present in the southern half of the southeastern low flow culvert (See Photo 2).

Photo 1 Boulder Clusters and Protruding Boulders (inadequately sized boulders) in the southern half of the low flow culverts at BG-04.

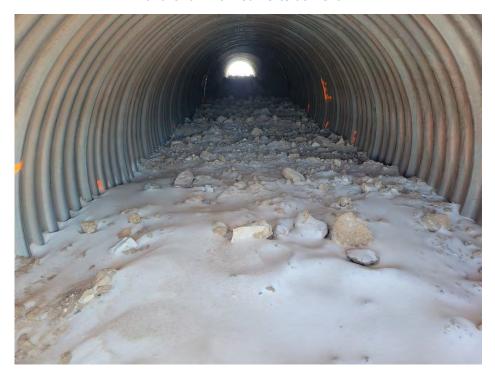
Photo 2 Lack of Boulder Clusters and Protruding Boulders in the southern half of the low flow culverts at BG-04.

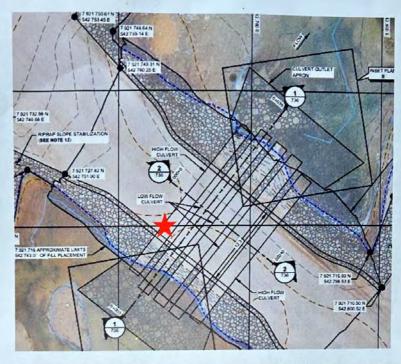
Damaged section of the northern high flow corrugated steel pipe (CSP) culvert at CV-216. See Figures 1 and 2 and Photos 1 to 4.

The location of the damage is located directly under the wheel loading area of the road surface.

Figure 1 Approximate location of damaged CSP culvert at CV-216 shown in red (From Drawing 735 R2)

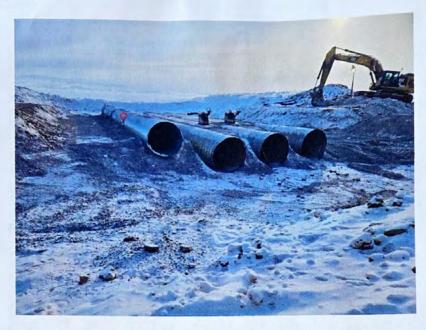
Photo 1 Northern high flow CSP culvert installed at CV-216, location of future damage approximated in red. Photo taken April 26, 2024, facing east.

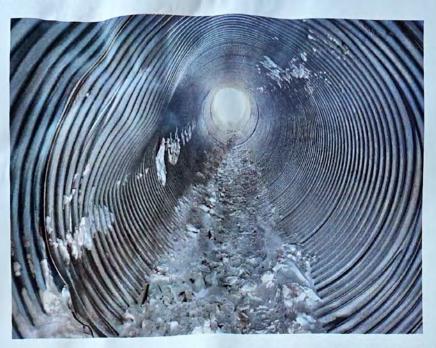
Photo 3 Northern high flow CSP culvert at CV-216, showing damaged section inside the culvert.

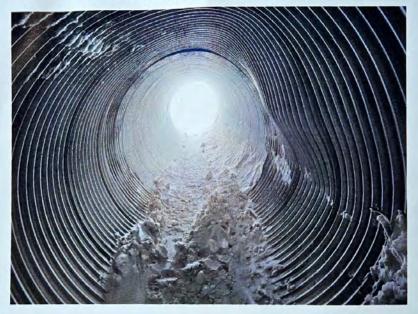
Photo 4 Northern high flow CSP culvert at CV-216, showing damaged section inside the culvert.

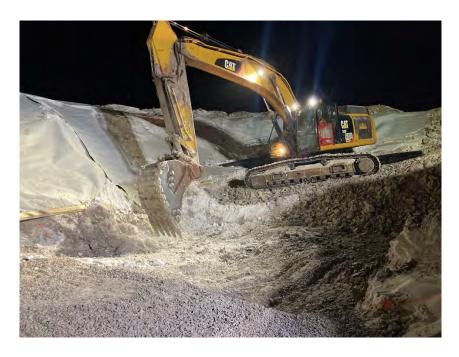
Photo 5: Excavating unsuitable materials within Section 2. Photo taken March 14, 2024.

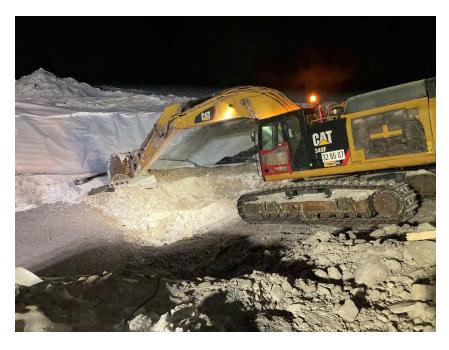
Photo 6: Excavating unsuitable materials within Section 3. Photo taken March 14, 2024.

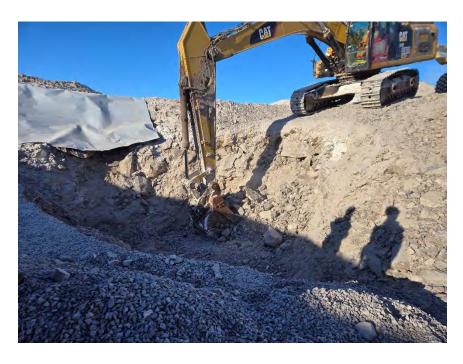
Photo 7: Excavating unsuitable materials within Section 4. Photo taken March 15, 2024.

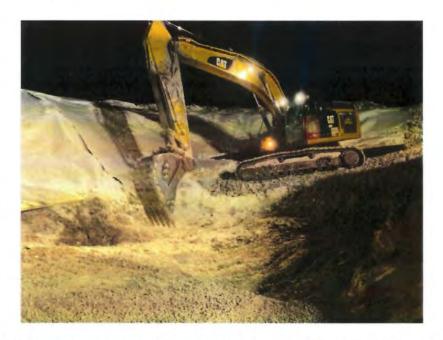
Photo 5: Excavating unsuitable materials within Section 2. Photo taken March 14, 2024.

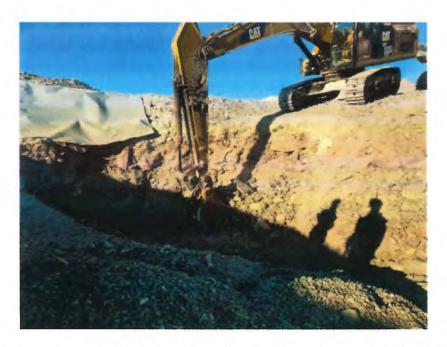
Photo 7: Excavating unsuitable materials within Section 4. Photo taken March 15, 2024.
