APPENDIX C.2  
Geotechnical Inspection Report

**Submission of Annual Geotechnical Inspection – 2024, Mary River Project – Nunavut, Project # CA0039374.4332**

WSP Canada Inc., has completed the required geotechnical field inspection of 2024 at the Mary River Project, which is a condition of the Type “A” Water Licence No: 2AM-MRY1325 – Amendment No.1 (“Water Licence”).

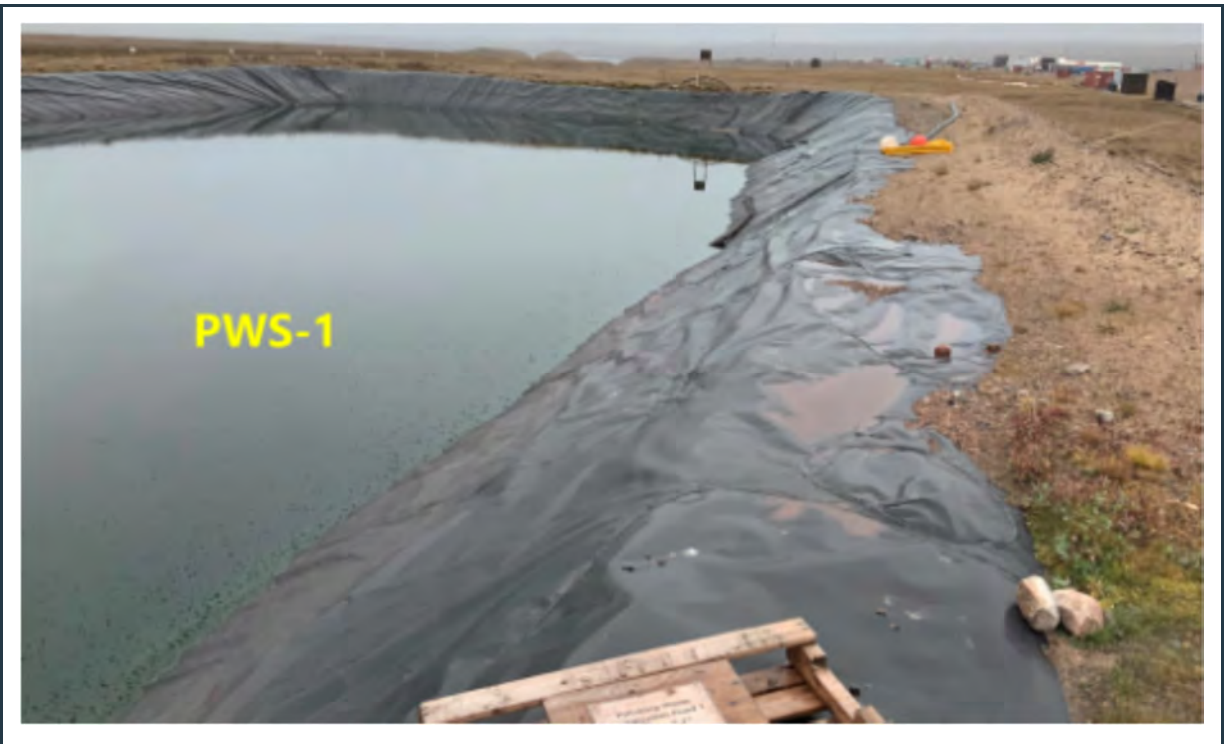
Figure 14: PWS pond #1. Well-maintained, stable perimeter berm and intact liner at the pond.

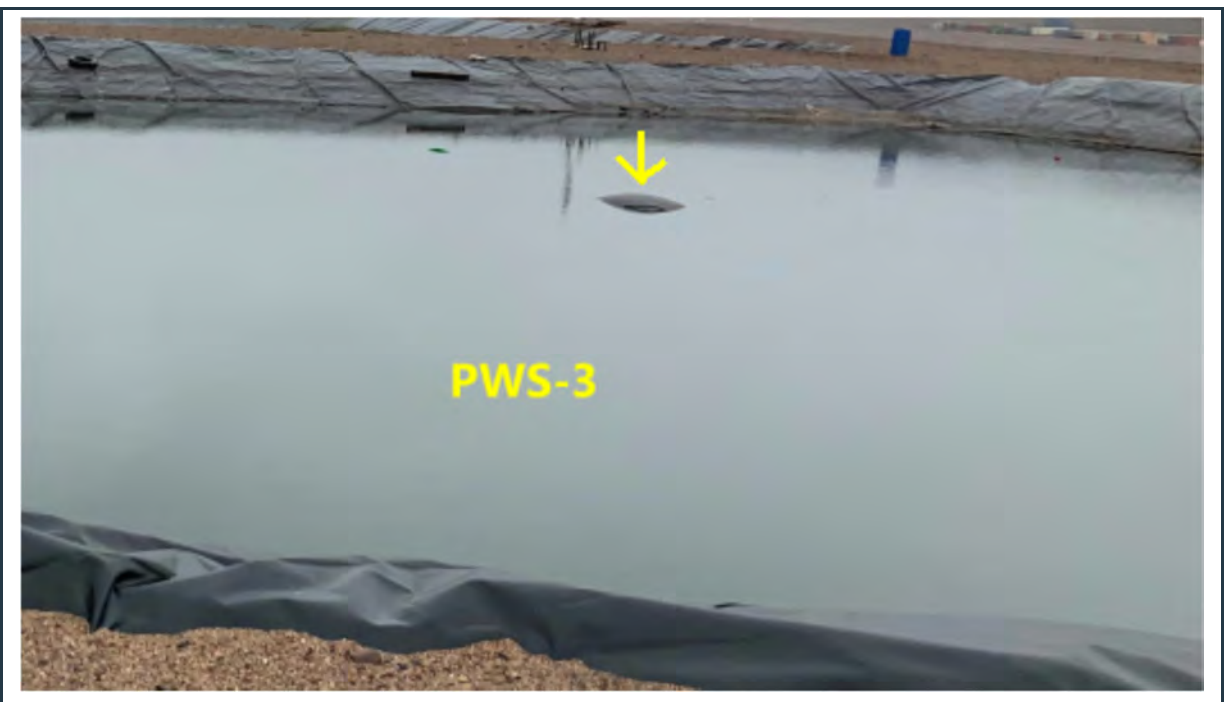
Figure 16: Robust, stable perimeter berms and intact liner at the PWS-3 pond. Note a “whale” in the pond, similar to the ones present in the neighbouring PWS-2 pond.

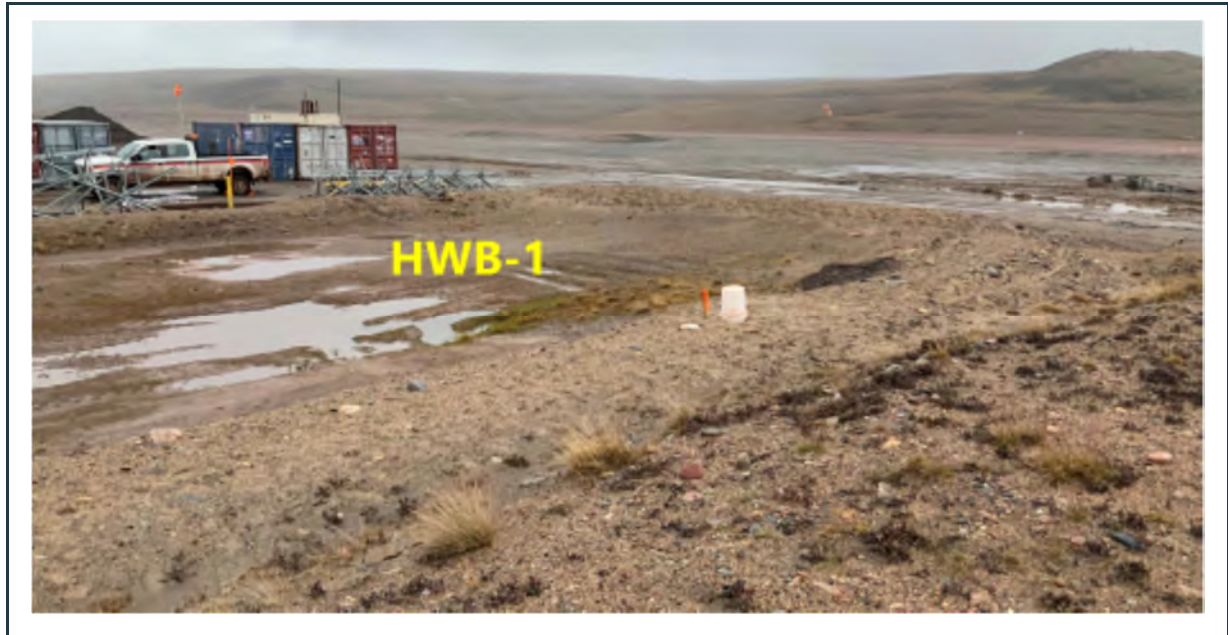
### a) HWB-1

Figure 17: View of the empty HWB-1 cell, which has not been in use for years.

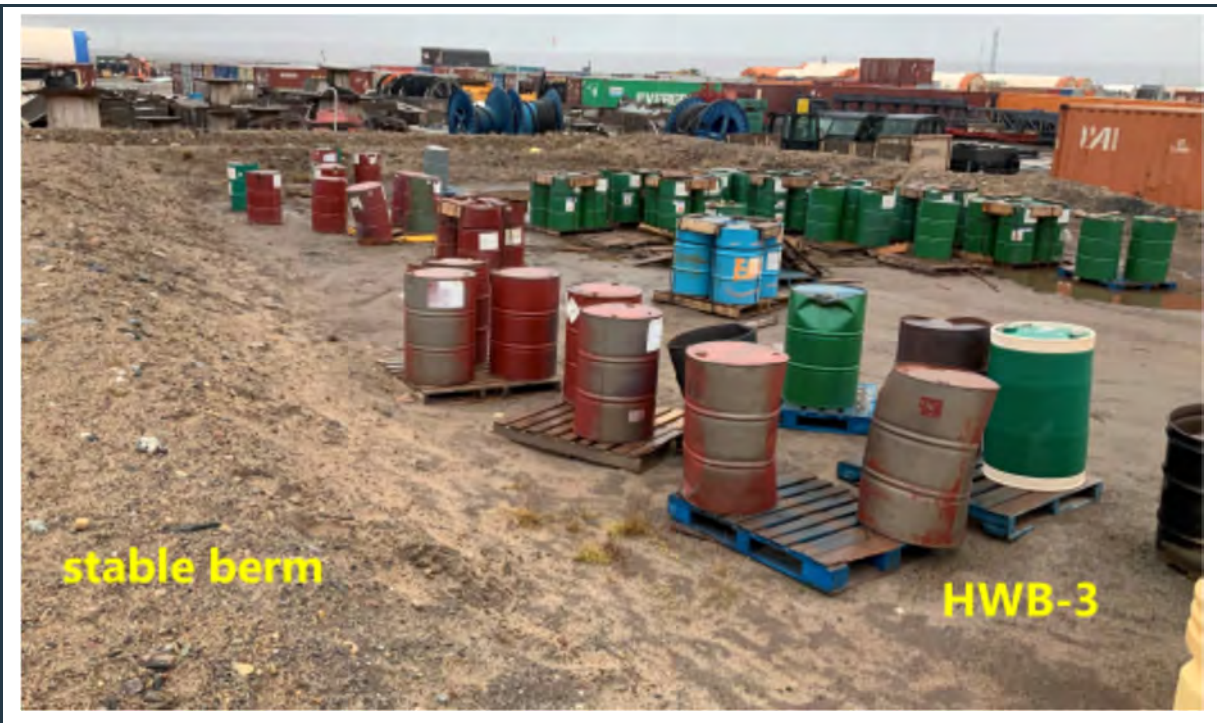
c) HWB-3 and HWB-4

Figure 19: View of stable perimeter berm and various fuel barrels in HWB-3.

*Recommendation: The debris, visible on the central berm between the two cells should be removed and disposed.*

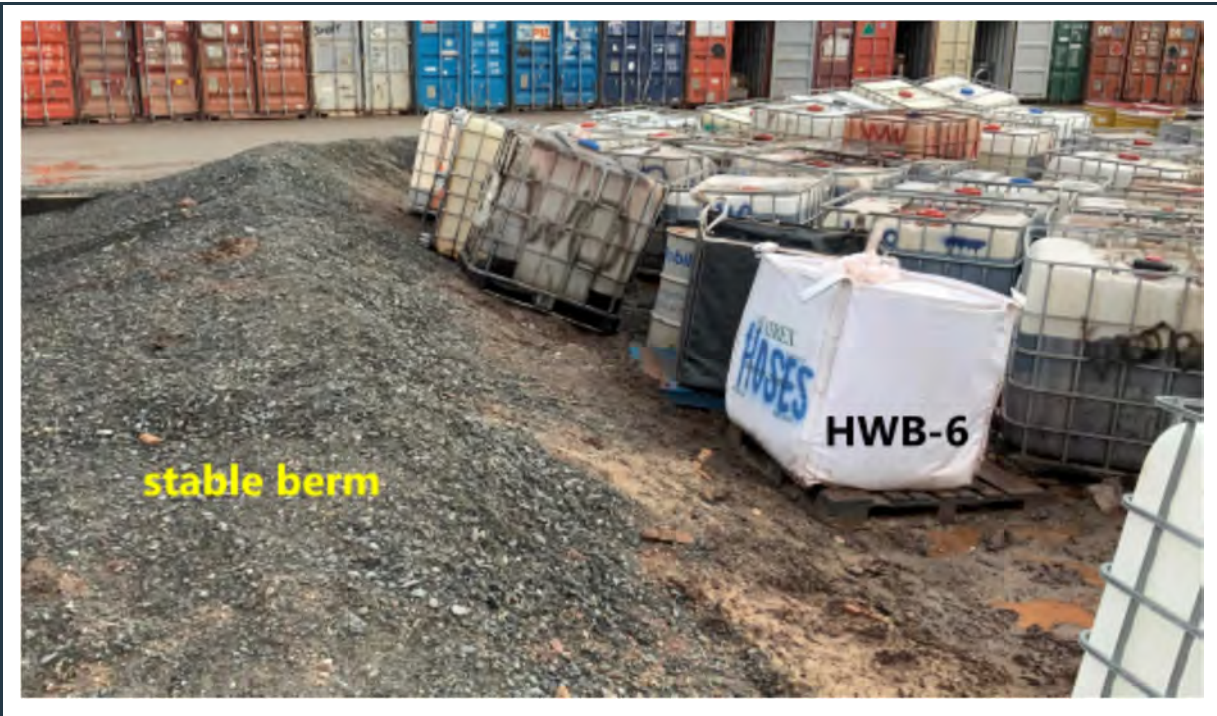
## e) HWB-6

Figure 22: View of the recently regraded stable berm at the HWB-6 cell. The presence of ponding water in the cell indicates good liner performance. This cell is almost always filled to its capacity.

*Recommendation: No material should be stored on the slopes or crest of the berms, therefore some of the stored materials in this cell should be rearranged.*

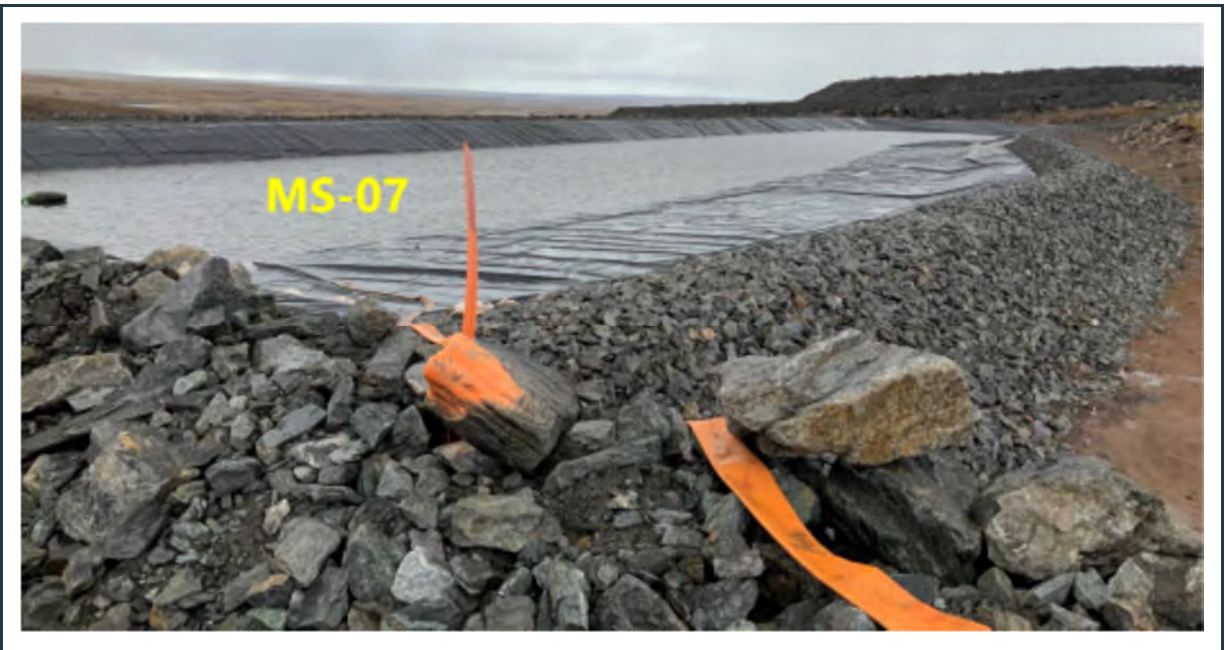
Figure 27: View of the robust, stable perimeter berm and intact liner at the MS-07 surface-water management pond at KM106.

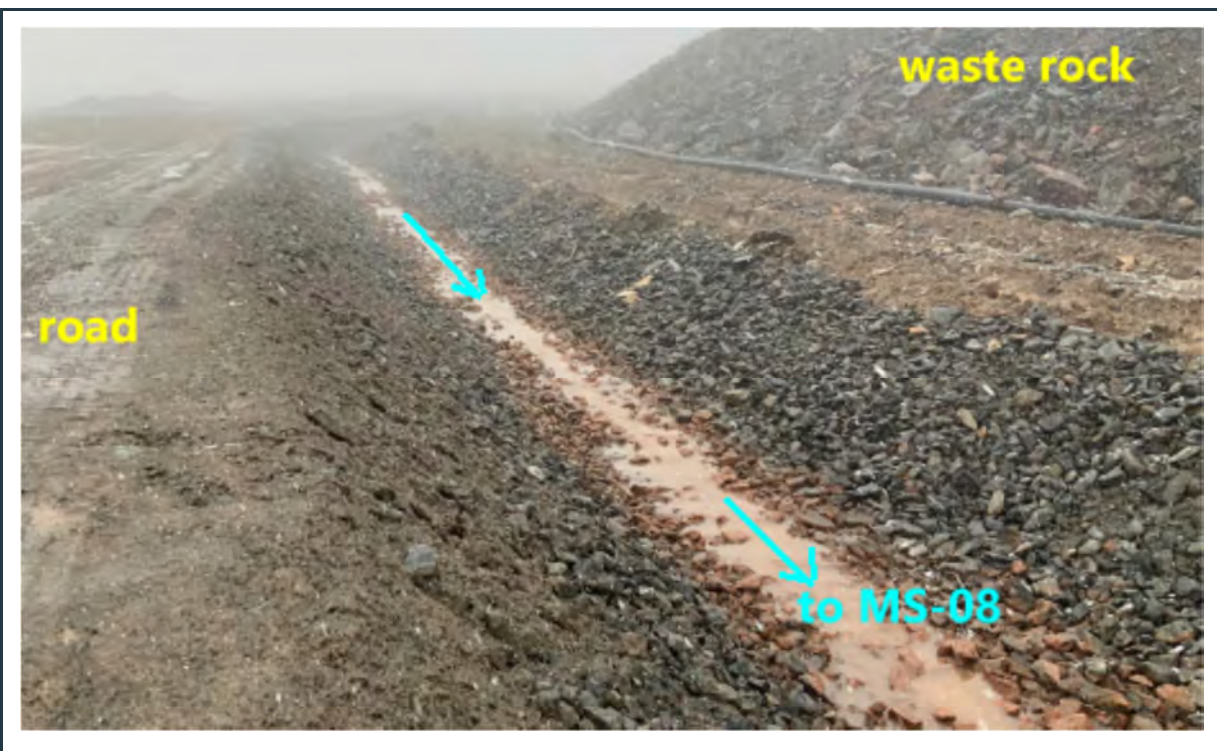
Figure 30: View of the well-maintained drainage ditch around the east side of the waste rock facility, leading to the MS-08 pond.

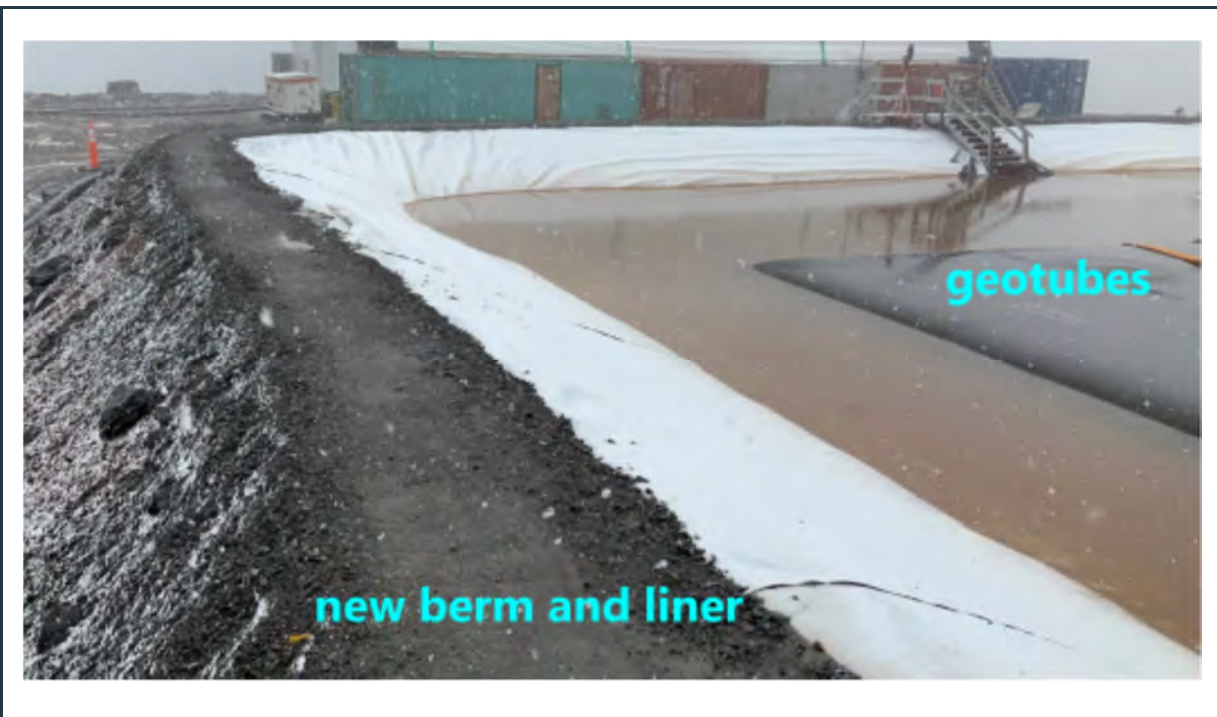
Figure 31: View of the completely refurbished perimeter berm and new liner at the geotube pond, located adjacent to the treatment plant.

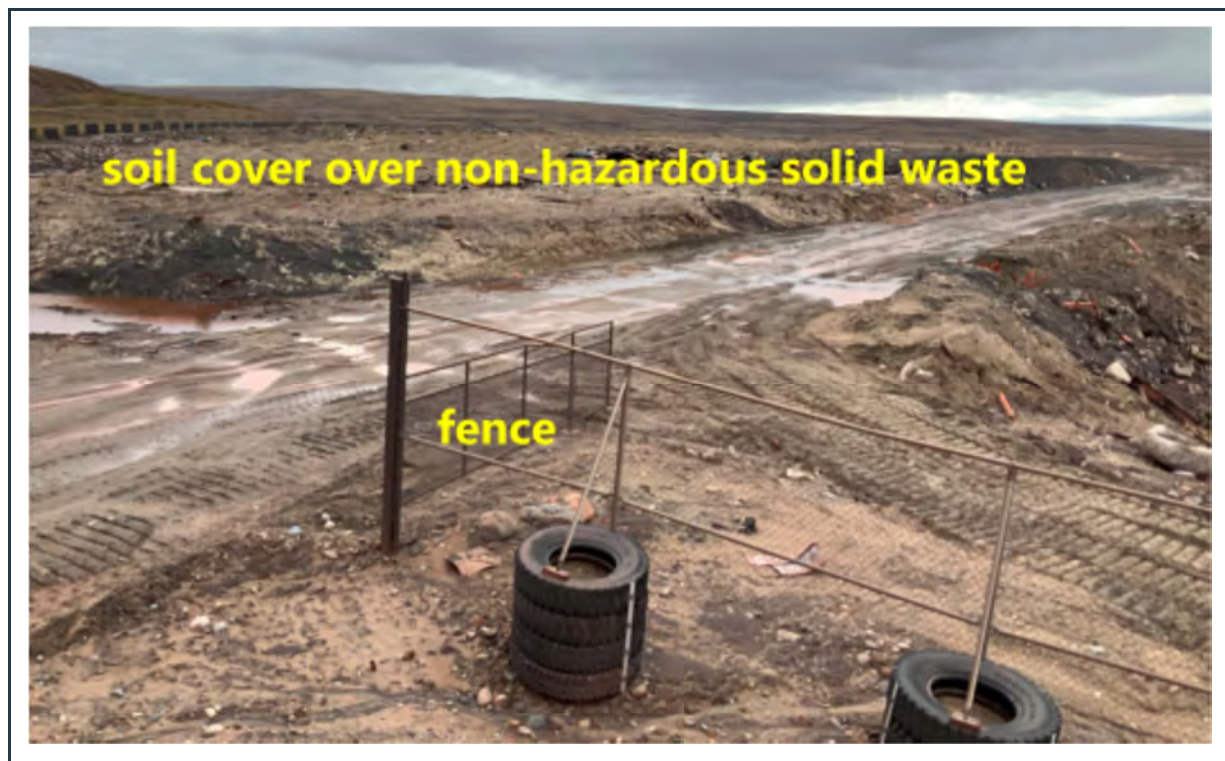
Figure 42: View of soil cover over non-hazardous solid waste in the fenced-in, gated landfill facility.

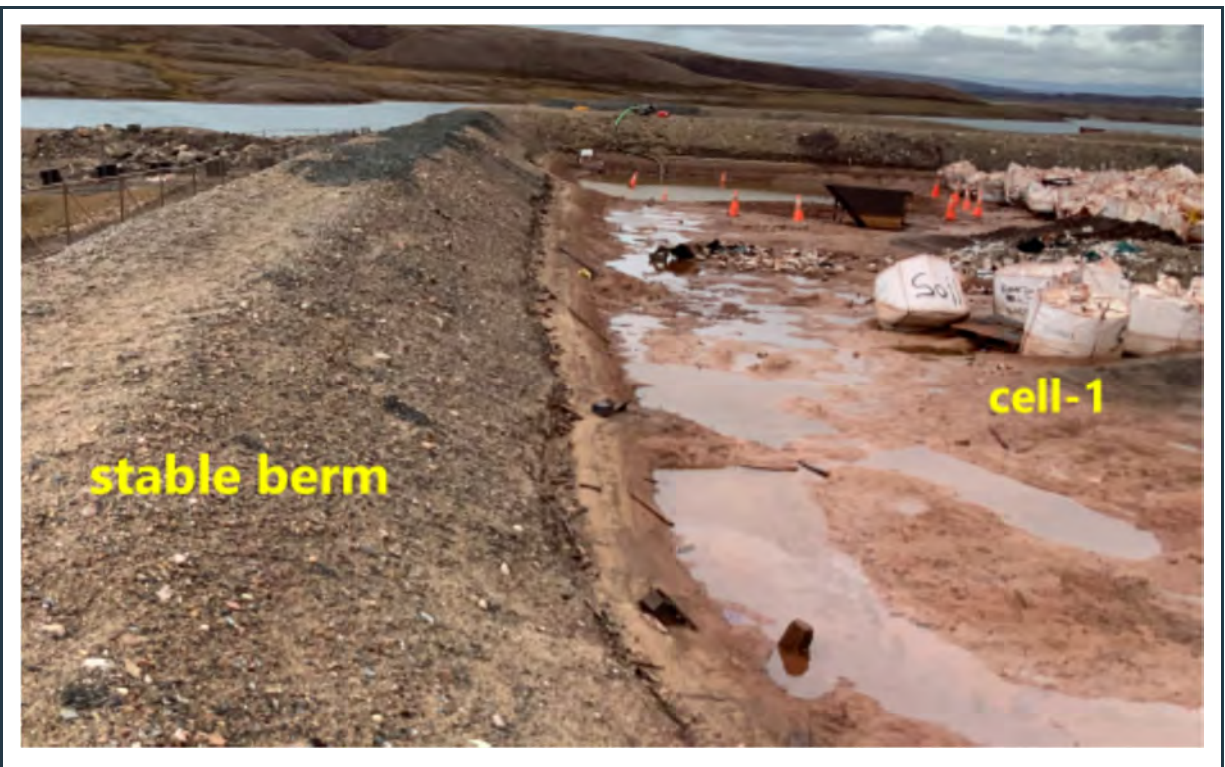
Figure 43: View of a section of the stable berm at the landfarm's Cell 1.

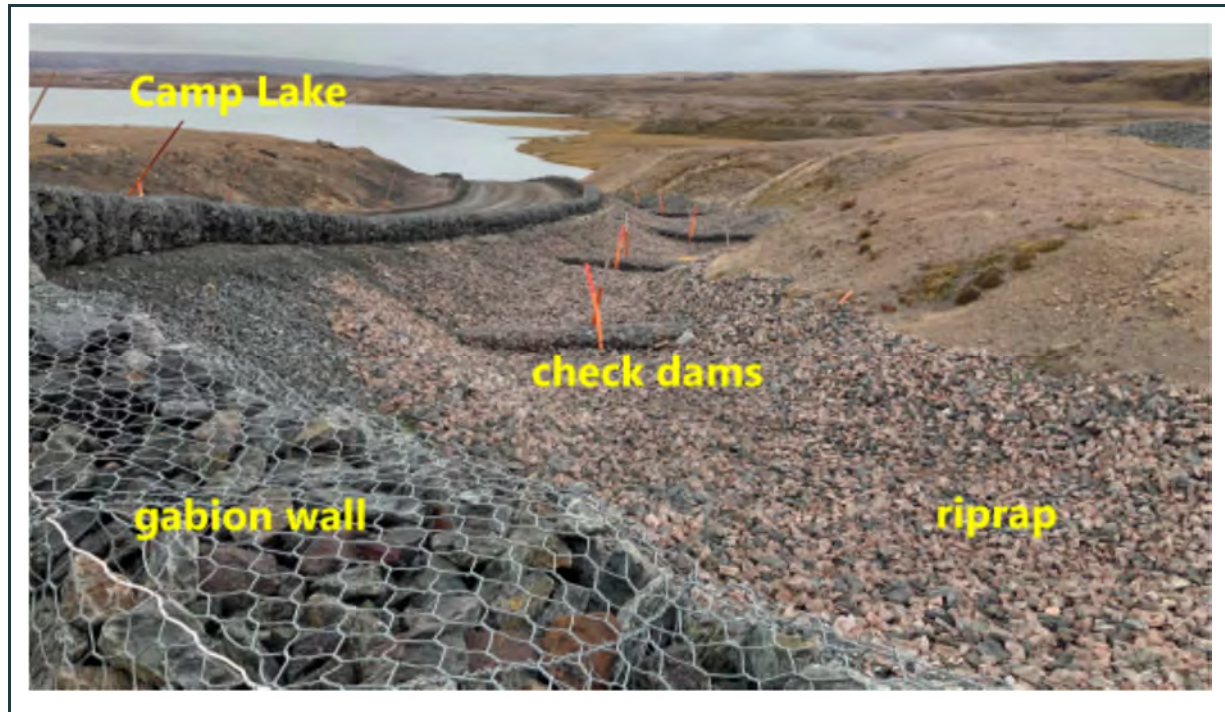
Figure 45: View of the upgraded Camp Lake check dams and new gabion wall in good conditions, constructed along the road to the lake.

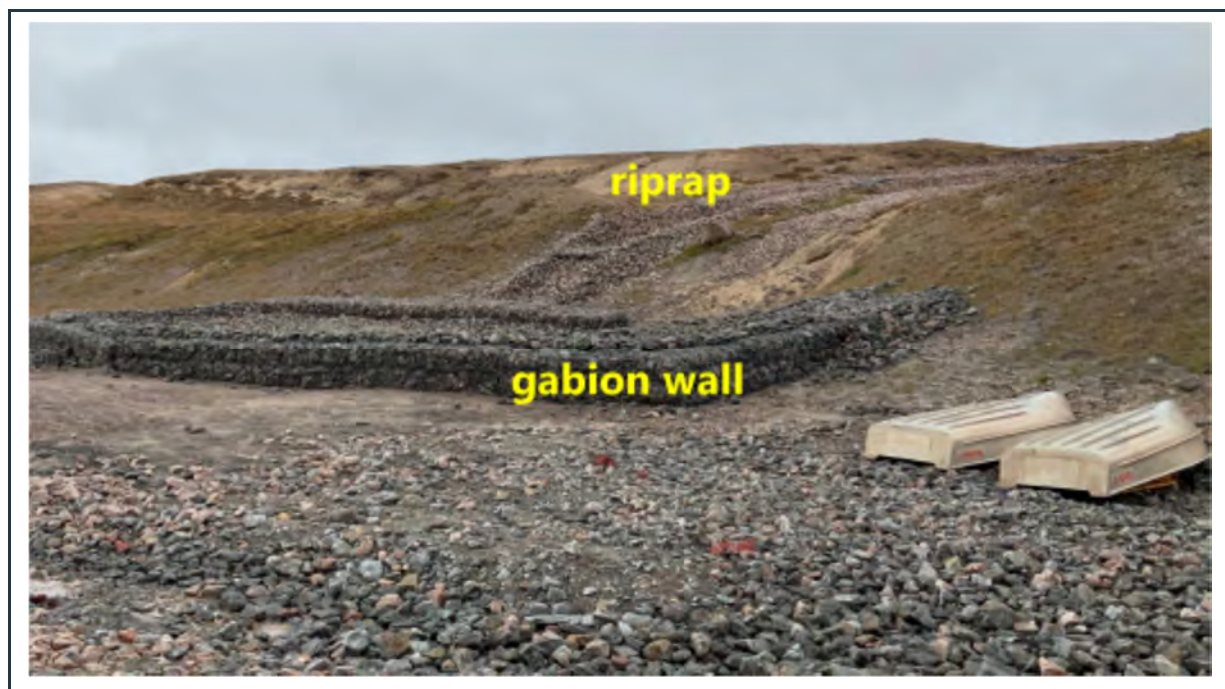
Figure 46: View of the new gabion wall and riprap adjacent to Camp Lake to capture suspended solids potentially eroding from the airfield area and to prevent siltation in the lake.

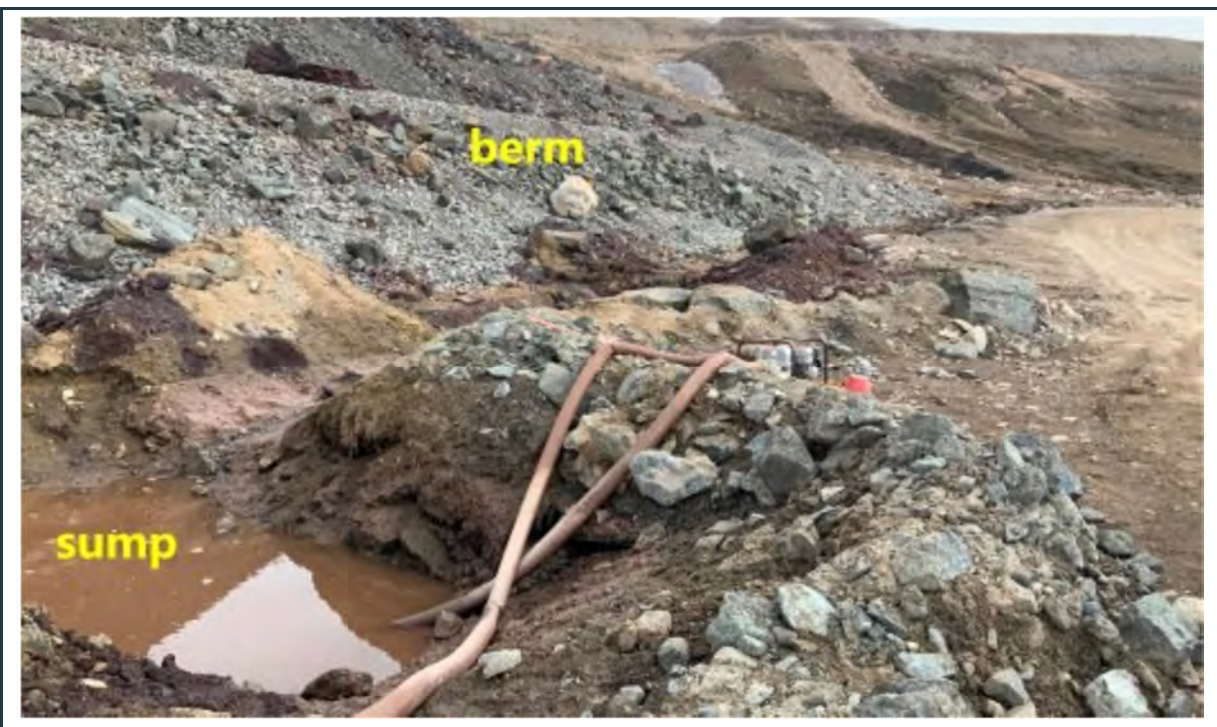
Figure 50: View of a historic image (2022) of the diversion berm, drainage ditch/swale and sump in poor conditions, south of the KM-106 ore stockpile area. See these recently upgraded infrastructure components in Figures 51 and 52 (next page).

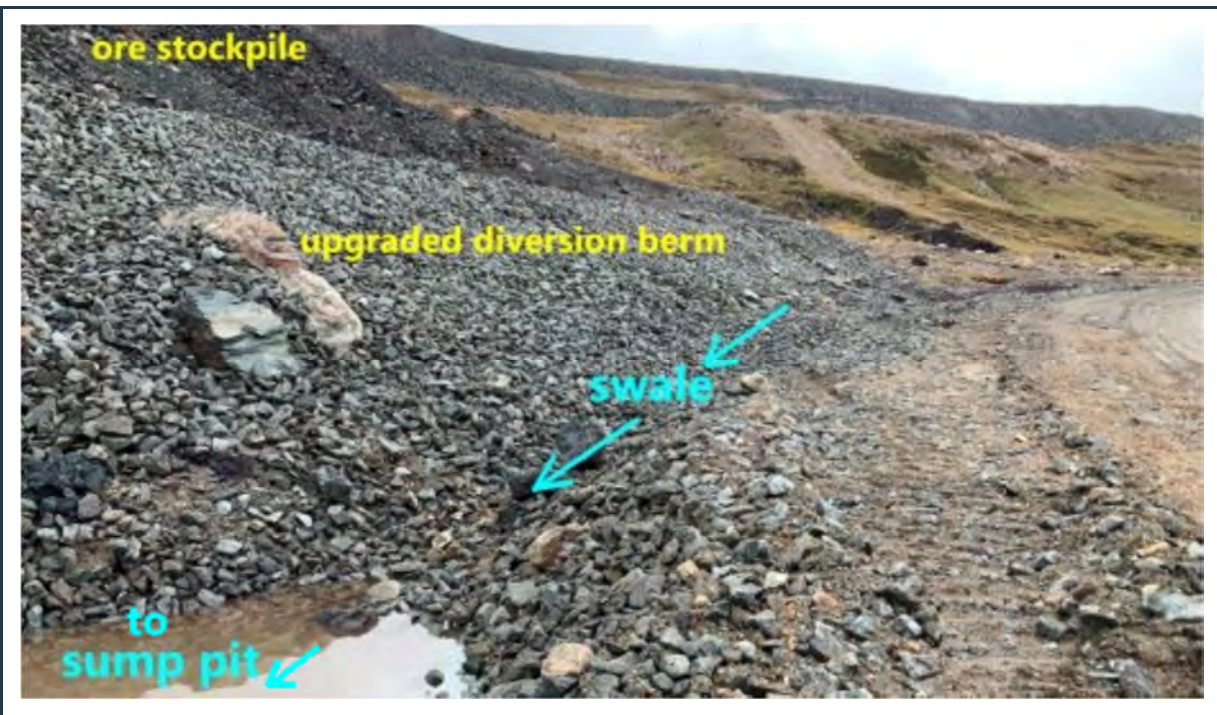
Figure 51: View of the new, recently upgraded diversion berm and drainage ditch/swale south of the ore stockpile area.

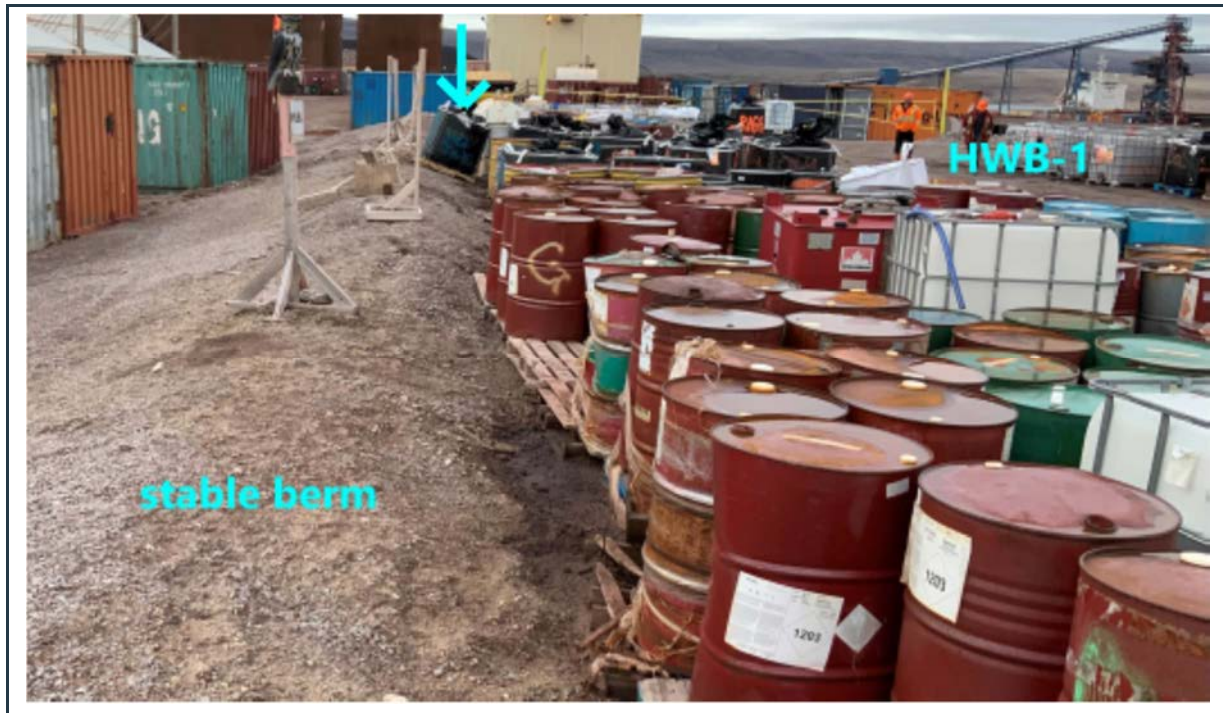
Figure 53: View of the stable perimeter berm around the lined HWB-1 cell with various materials and two shipping containers stored within the cell. Materials on pallets should be stored within the cell, not on the berms (note the container marked by the blue arrow).

*Recommendation: Materials on pallets should be stored within the cell, not on the berms.*

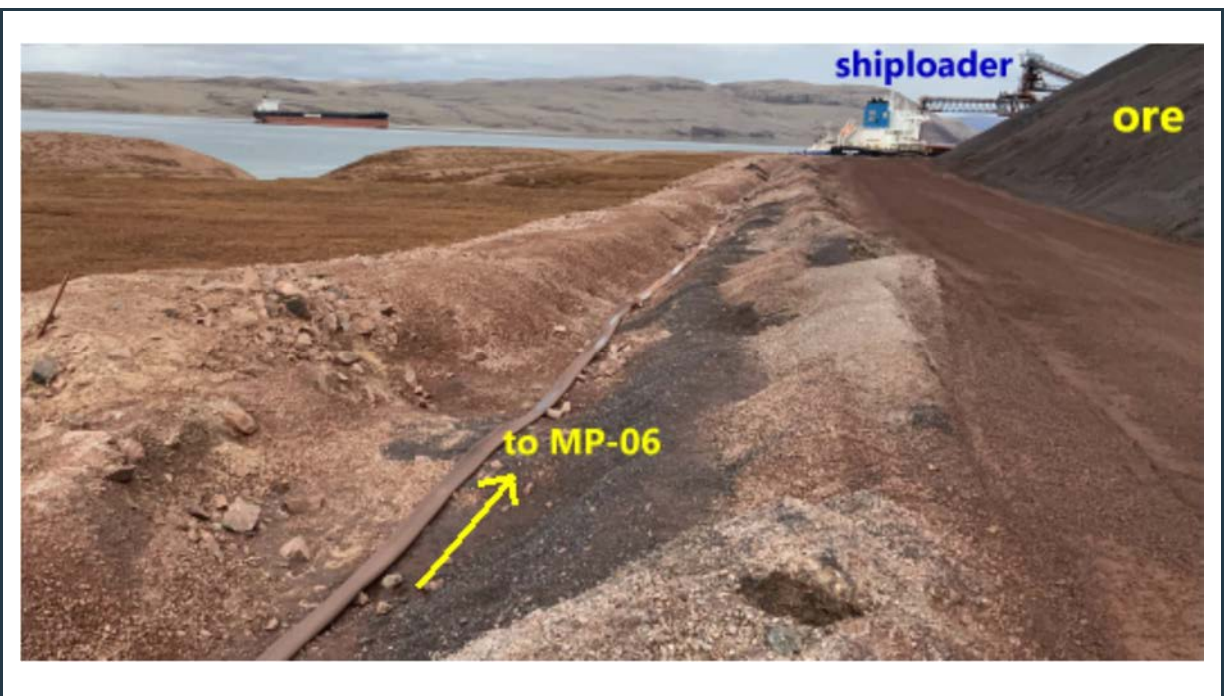
Figure 66: View of the 2023 condition of the “west” surface water collection ditch adjacent to the ore storage area, draining water from pond #3 to the MP-06 pond. This photograph was taken in 2023. Note the changes in ditch condition in Figure 67, which was taken in August 2024.

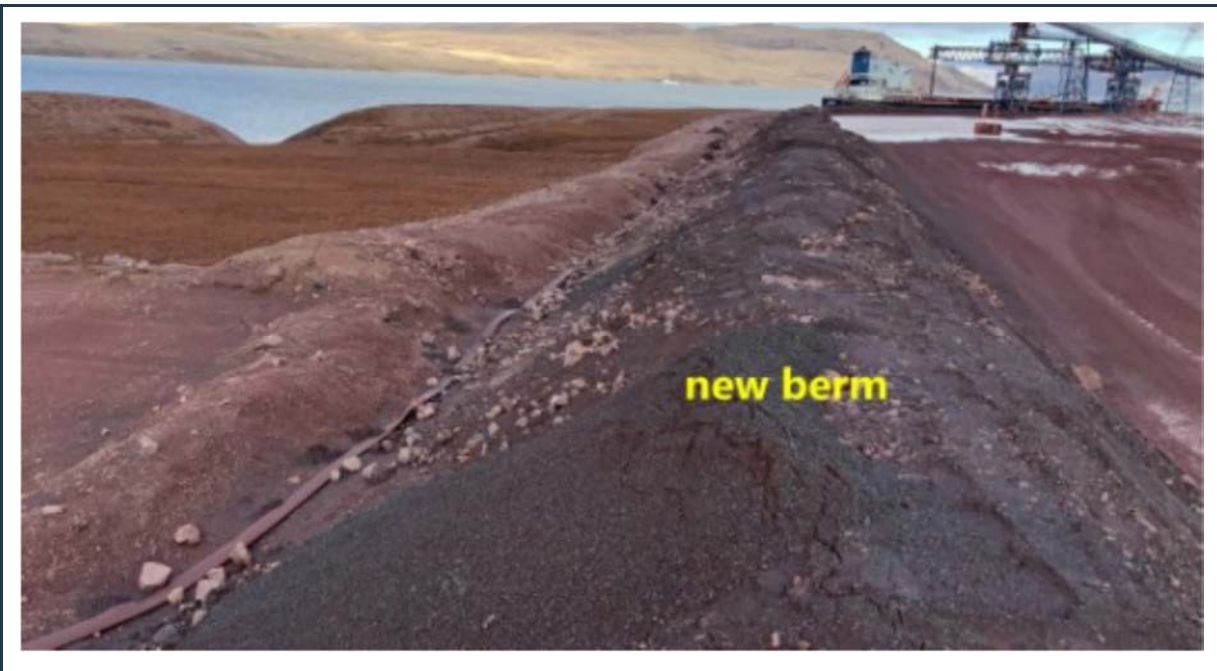
Figure 67: View of the 2024 condition of the “west” surface water collection ditch adjacent to the ore storage area. Note the new, widened berm along the ditch, partly constructed within the ditch.

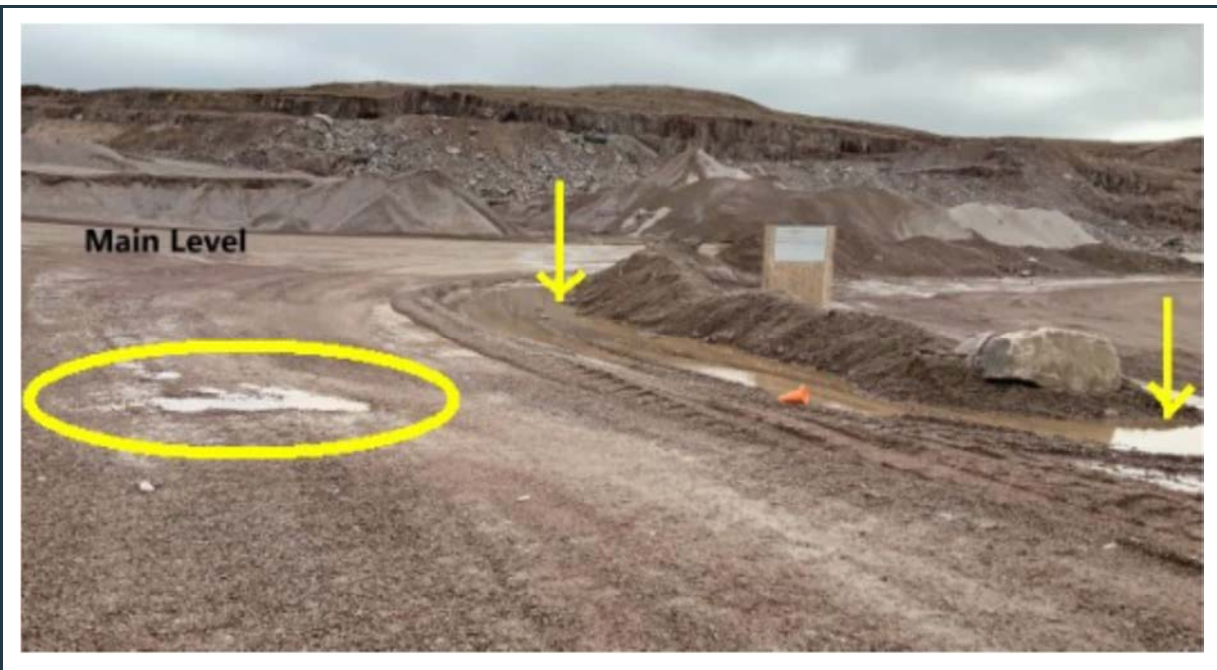
Figure 68: View of ponding and flowing water at may areas of the lower (main) level of the Q01 rock quarry. The drainage problem should be rectified prior to restarting the operation in the quarry.

**Recommendation:** *It is recommended that the somewhat finer soil, currently forming the side of the ditch, be removed to a depth/width of around 1 m and replaced with crushed rock fill. To minimize migration of fine soil particles from the quarry pad to the ditch, the crushed rock fill should be placed over a layer of geotextile fabric. The improvement of this section of the ditch shall be completed with the formation/excavation of additional drainage ditches, required to rectify the ponding water present in many parts of the lower (main) level of the quarry.*

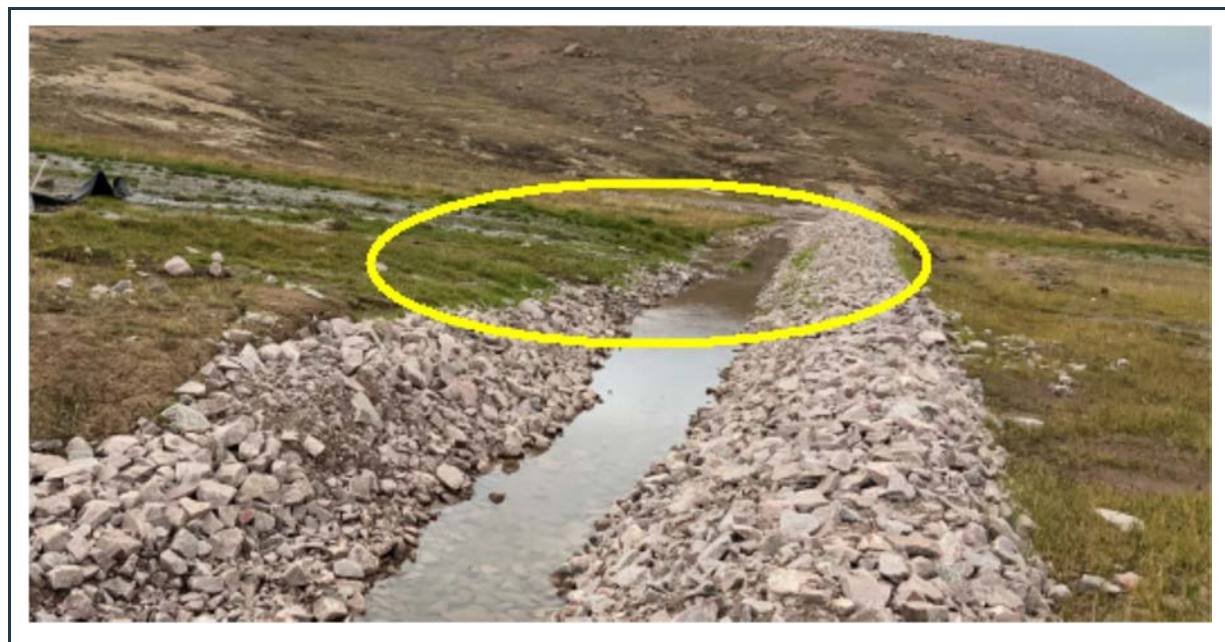
Figure 70: View of the southern section of the P-SWD-3 surface water collection ditch with failed slope sections and ponding water due to inadequate longitudinal channel slope.

**Recommendation:** *To improve the drainage capability of the P-SWD-3 ditch, it is recommended that it should be reconstructed to drain the large quantity of surface water from the snow-dump to the north-east. The culvert in the ditch beneath the access road to the snow-dump has also been damaged recently. This culvert should be replaced and installed to the correct invert level (to be specified during the redesign and reconstruction process). To prevent the migration of fine soil particles from the ditch to the environment, a rockfill check dam should be installed/constructed at the discharge point of the upgraded/reconstructed ditch. The culvert under the access road to the quarry in the P-SWD-3 ditch should be removed and replaced with a larger diameter pipe.*

**Baffinland Action:** Drainage improvement initiatives will be considered in 2025 with intent to improve the drainage capability of the P-SWD-3 ditch. Damaged or impacted culverts will be evaluated to consider if it still effectively passes water.

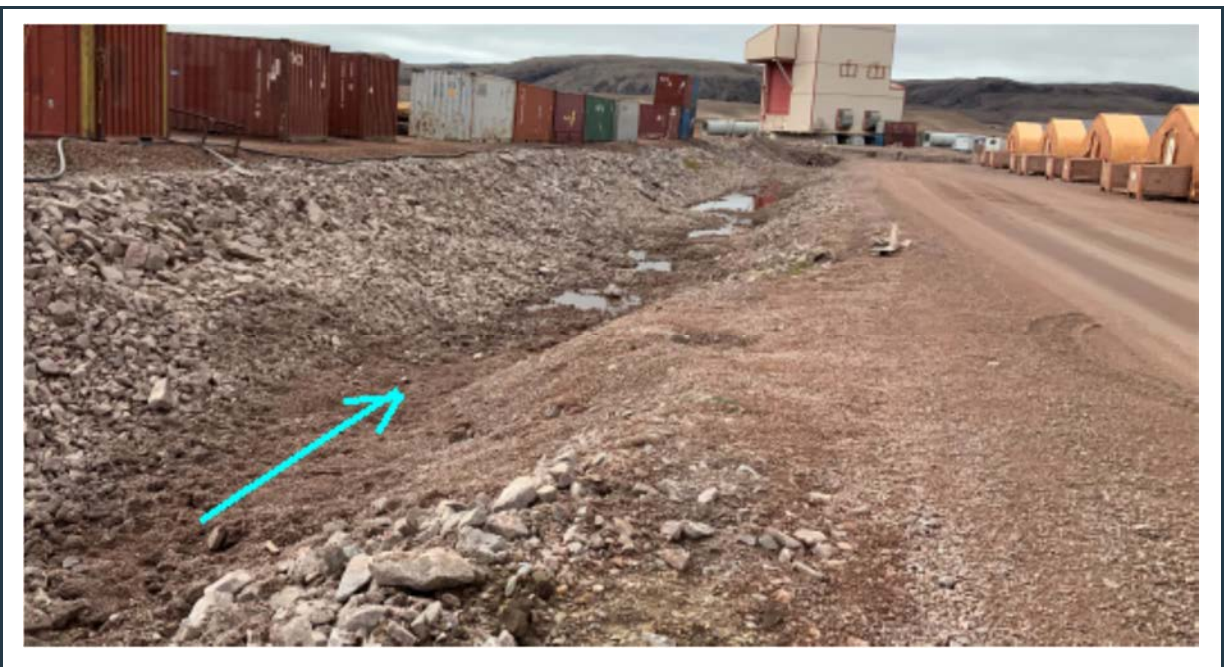
Figure 80: View of the east section of the 380-Person Camp surface water collection ditch in good condition.

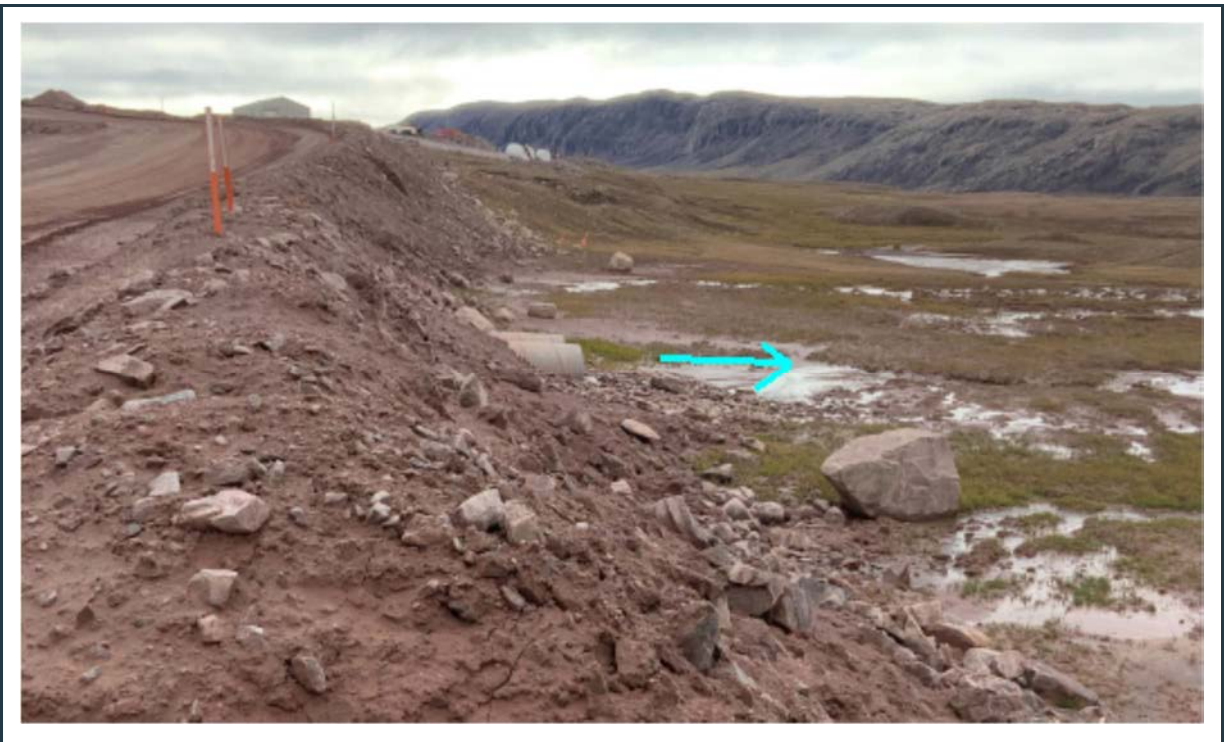
Figure 84: View of the outlet of the twin culverts, installed within the road embankment.

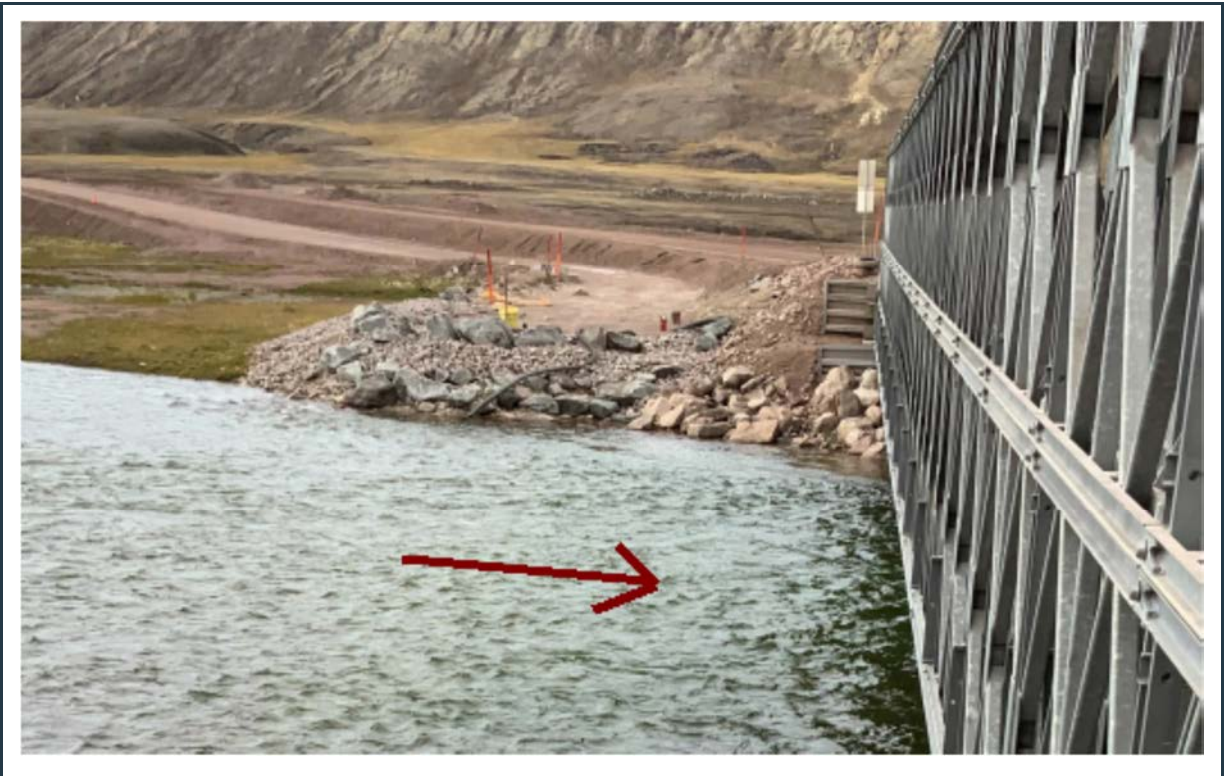
Figure 91: View of the west abutment, where the old metal crib has been removed and replaced with new riprap erosion protection at the south side of bridge KM17.

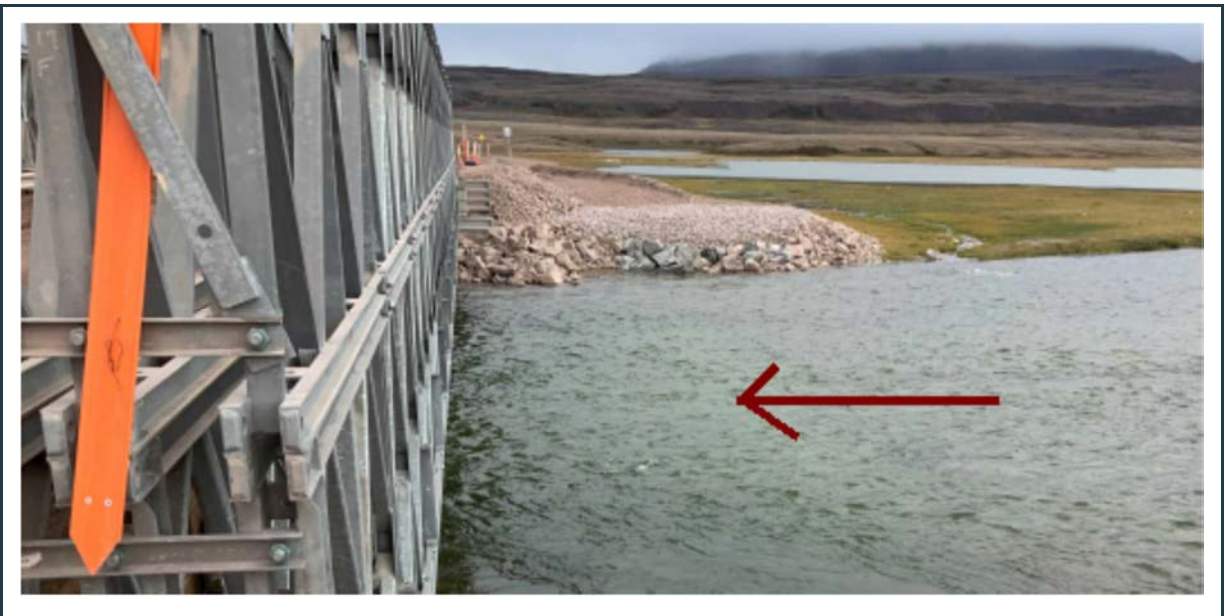
Figure 92: View of the east abutment, where the old metal crib has been removed and replaced with new riprap erosion protection at the south side of bridge KM17.

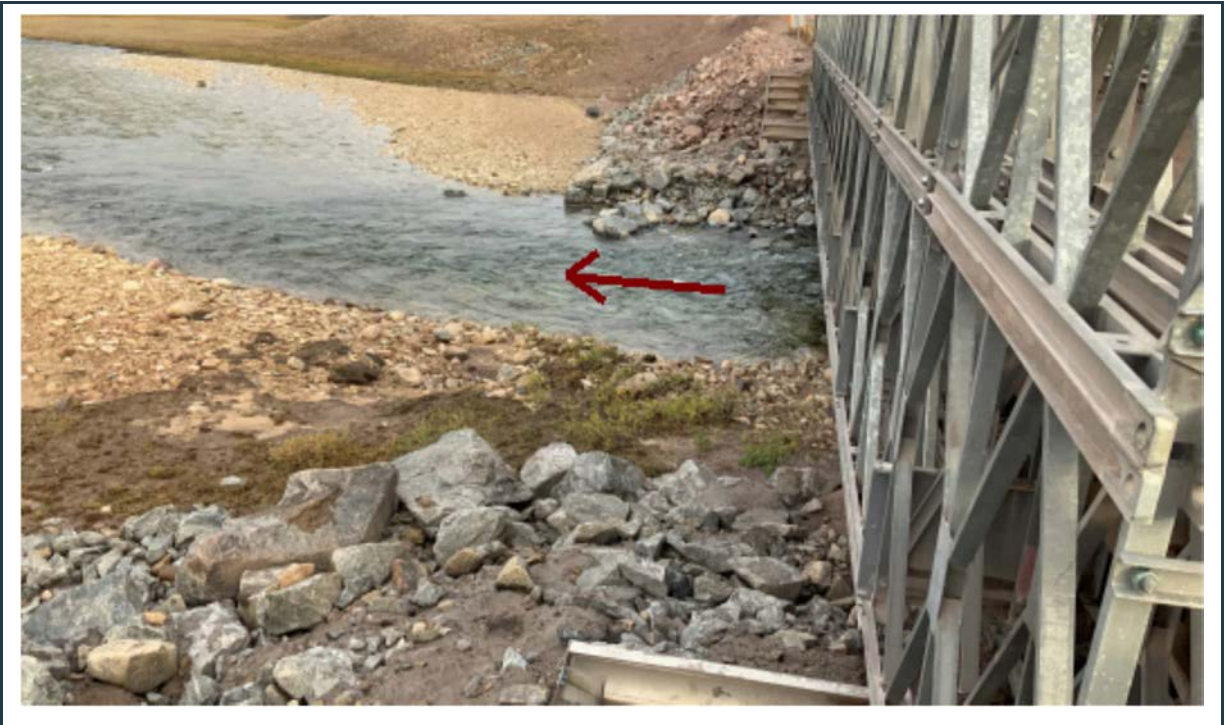
Figure 93: View of the west side of bridge 63, with stable abutments and riprap scour protection.

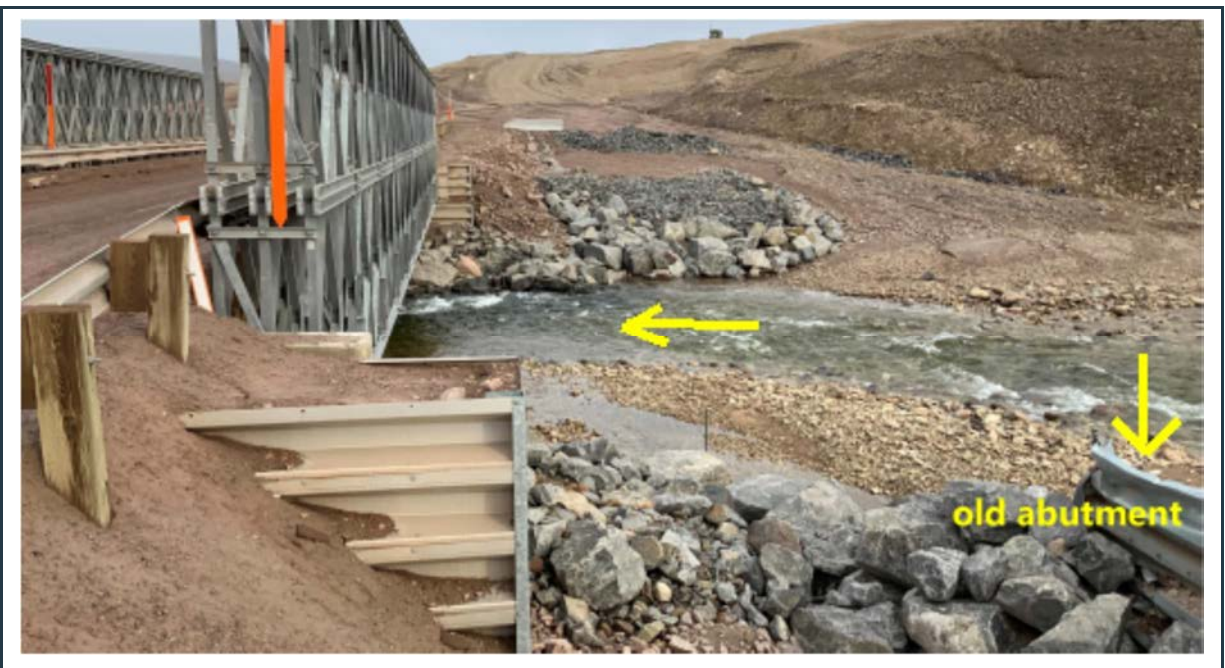
Figure 94: View of the stable abutments at the east side of bridge 63. Also note that one (south) of the two “old” crib abutments is still in place, while the north one has been removed and replaced with rock fill (cobbles and boulders).
