APPENDIX C.2  
Geotechnical Inspection Report

**Submission of Annual Geotechnical Inspection – 2024, Mary River Project – Nunavut, Project # CA0039374.4332**

WSP Canada Inc., has completed the required geotechnical field inspection of 2024 at the Mary River Project, which is a condition of the Type “A” Water Licence No: 2AM-MRY1325 – Amendment No.1 (“Water Licence”).

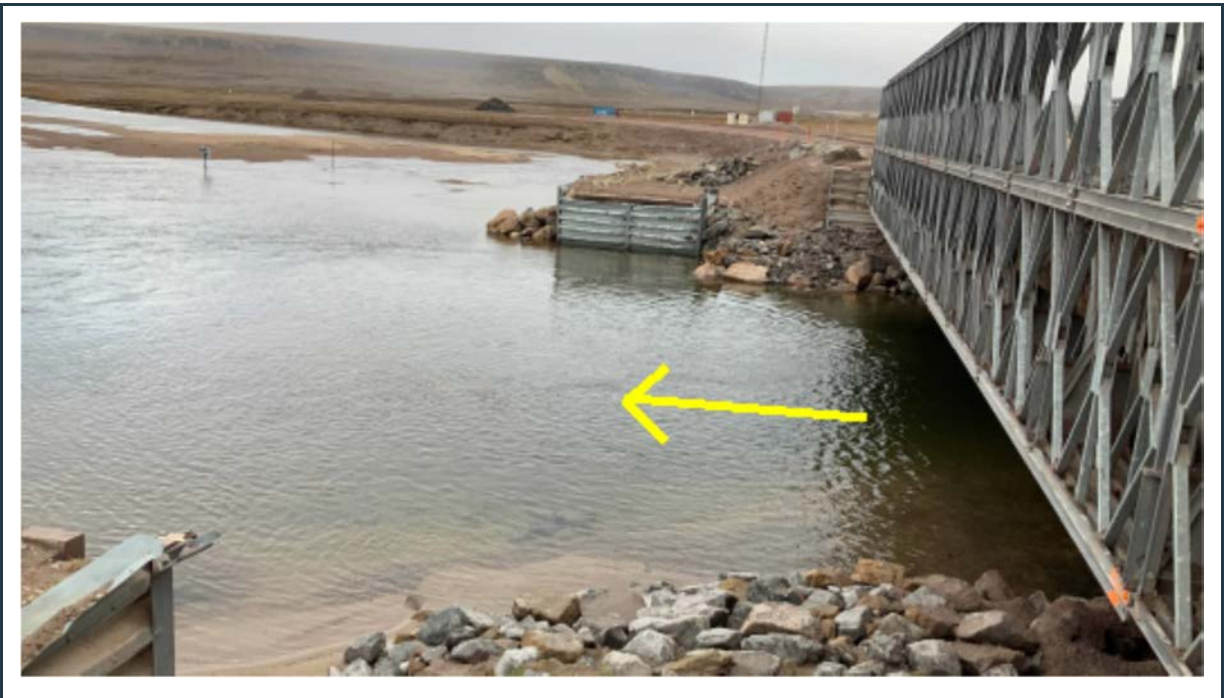
Figure 95: View of the west side of bridge 80, with riprap scour protection around the abutments.

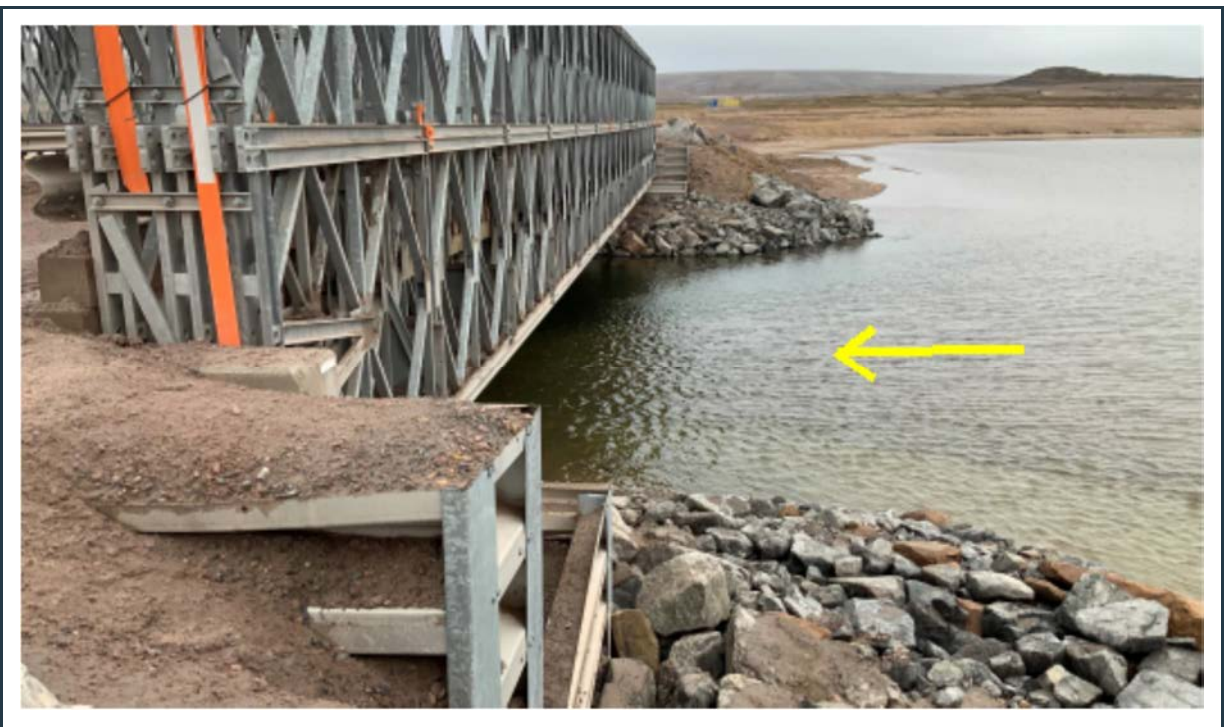
Figure 96: View of the abutments with riprap scour protection at the east side of bridge 80.

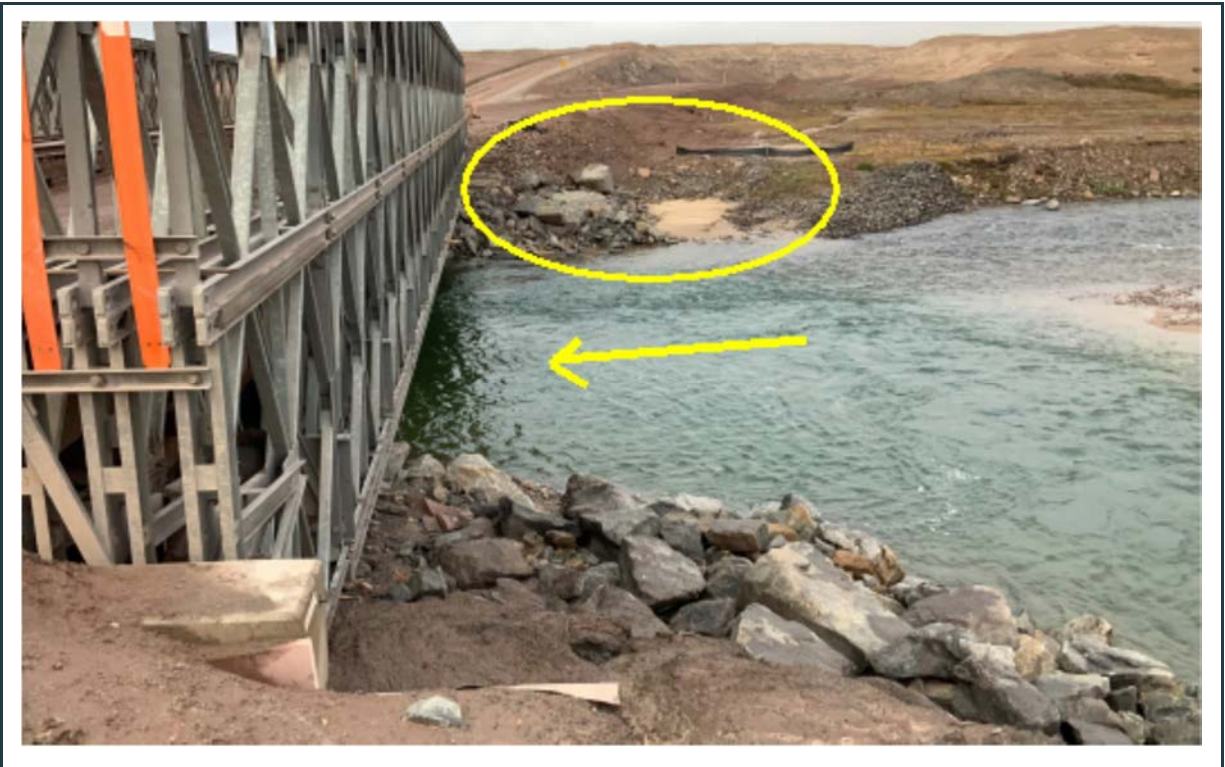
Figure 99: View of the stable abutments at the east side of bridge KM97. Note the area marked by the yellow circle where additional rock fill should be placed at the shore of the river and adjacent to the approach embankment to the bridge abutment, for erosion protection.

**Recommendation:** *There are areas at two locations where some additional rock fill should be placed over fine soils at the surface, to prevent erosion and migration of the finer material into the river.*

**Baffinland Action:** Erosion mitigation measures will be evaluated at the identified zones and implemented in snow free conditions.

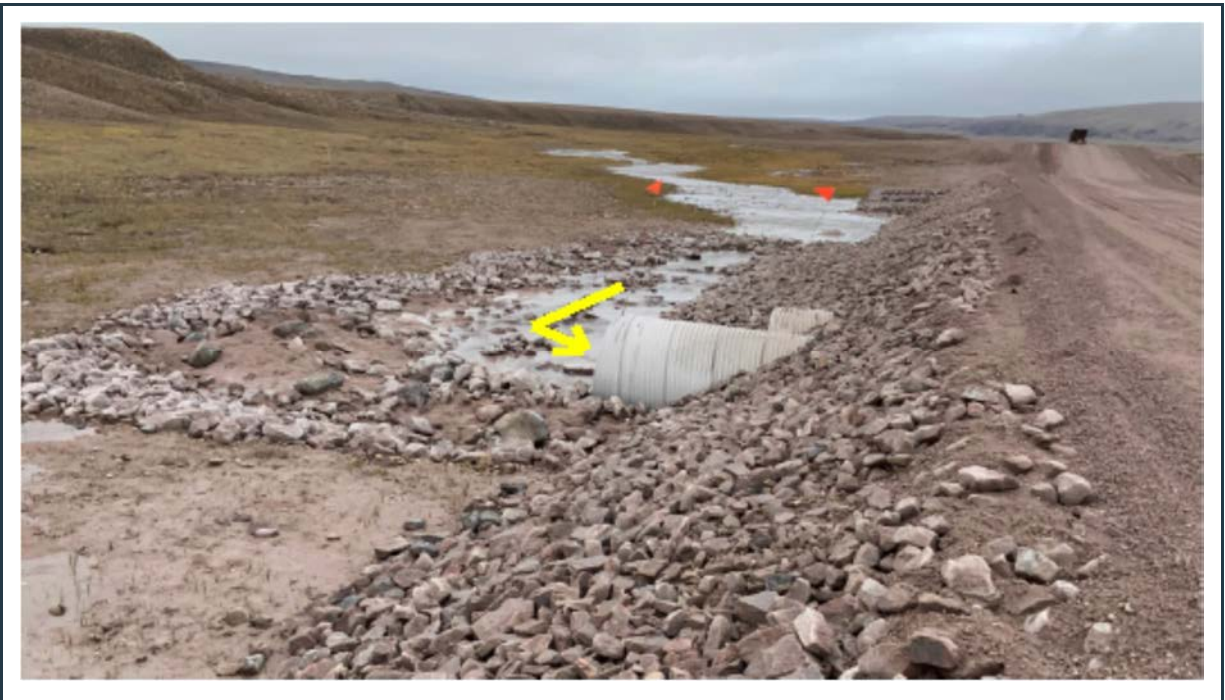
Figure 106: View of the inlet of the twin culverts at KM 36+000, in good condition.

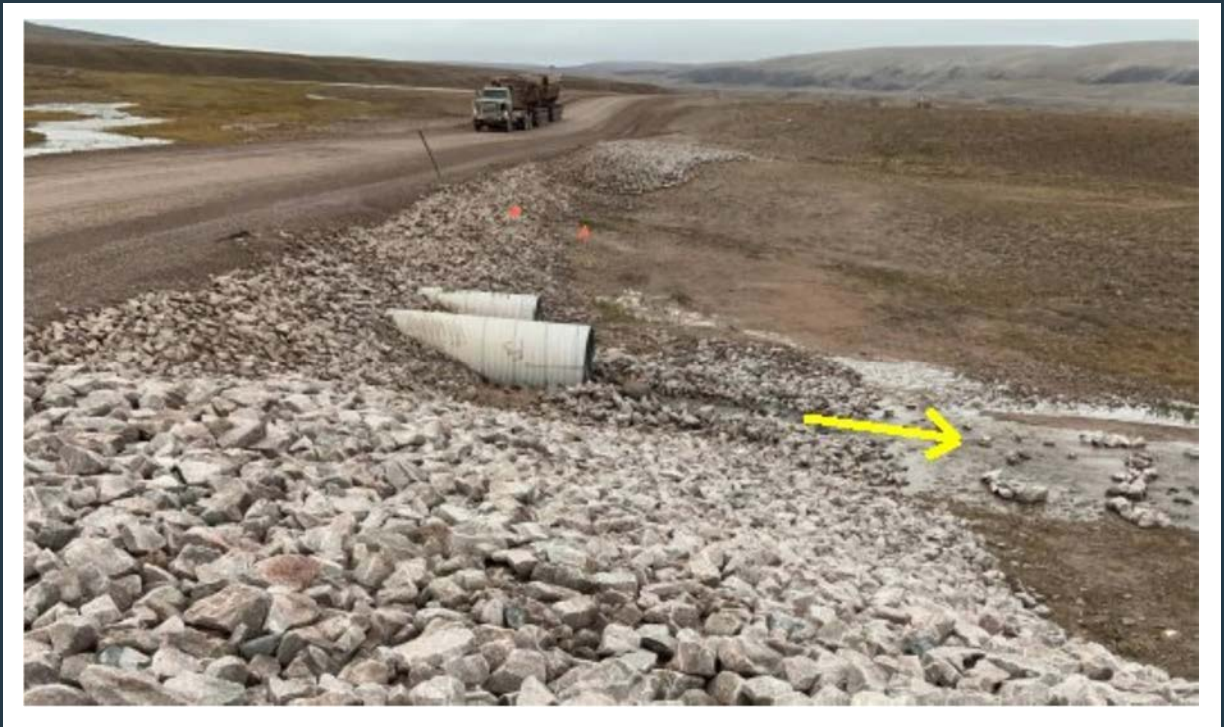
Figure 107: View of the outlet of the twin culverts at KM 36+000, in good condition.

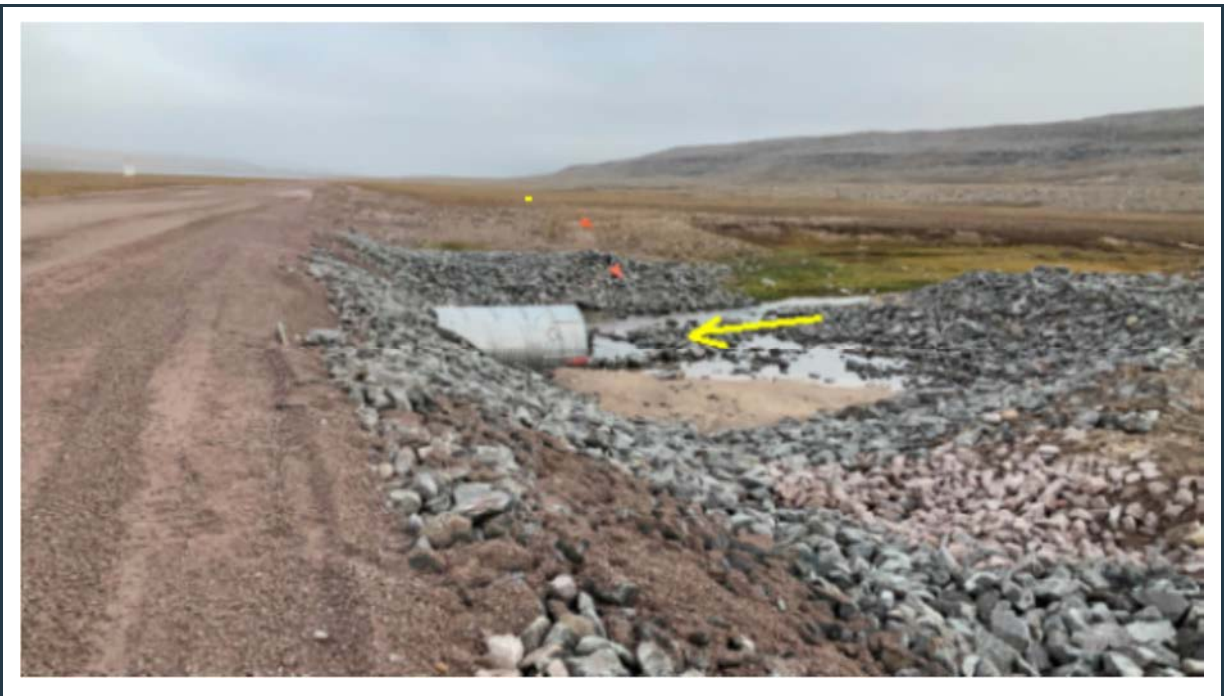
Figure 108: View of the inlet of the twin culverts at KM 59+800, in good condition.

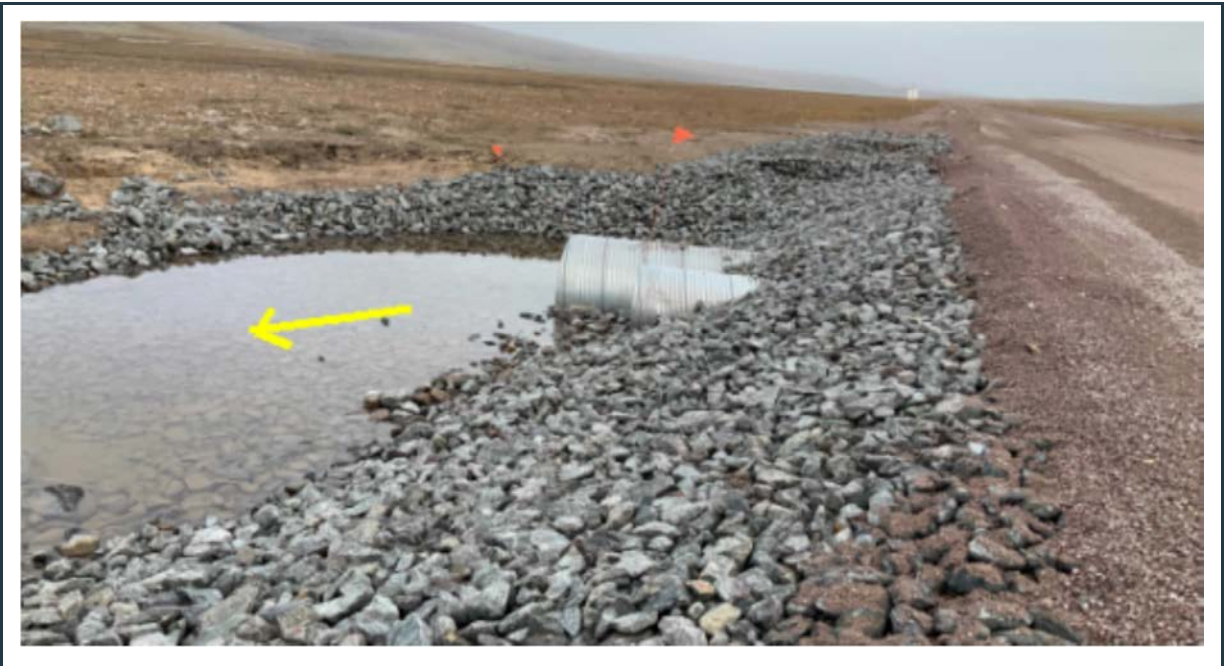
Figure 109: View of the outlet of the twin culverts at KM 59+800, in good condition.

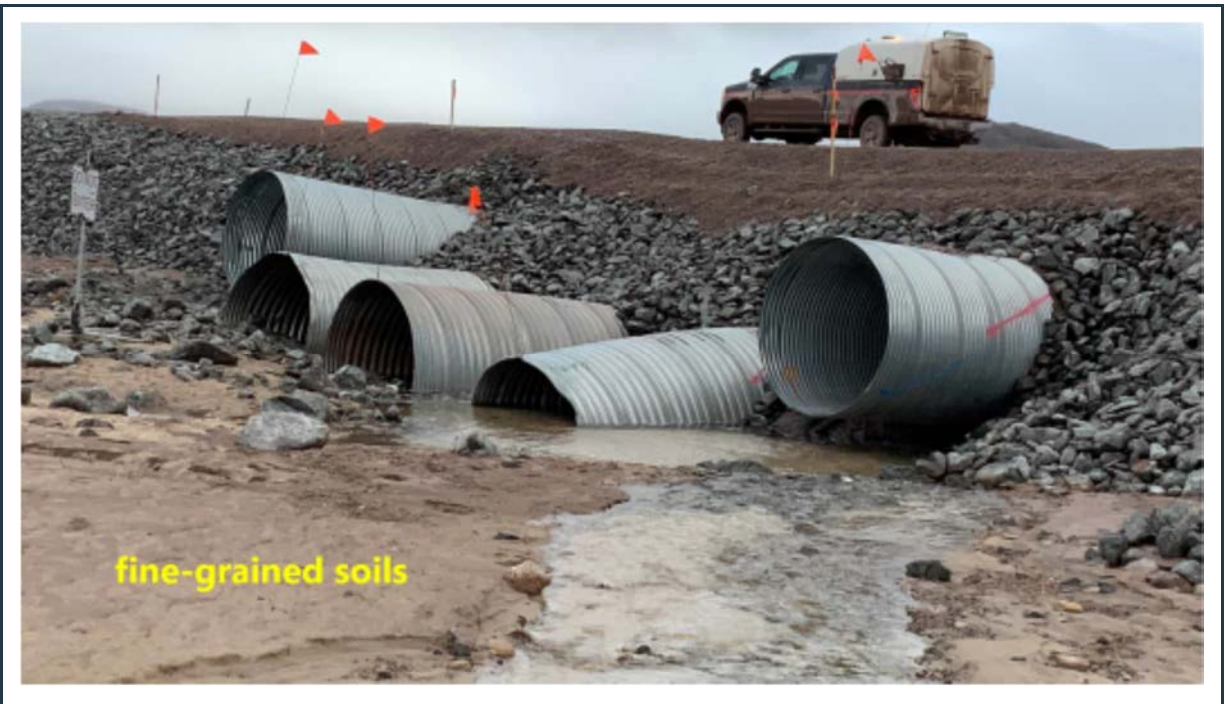
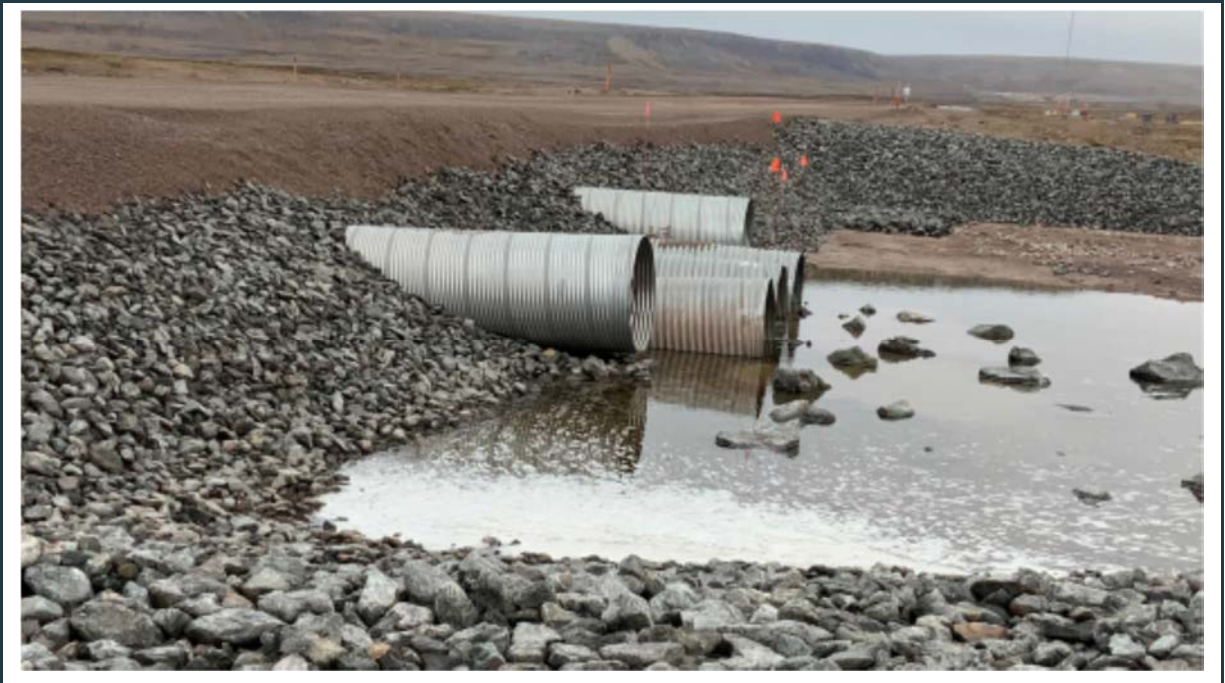
**Recommendation:** *The culverts were installed over poor soil subgrade which, after thawing, has lost its strength and bearing capacity, resulting in significant differential settlements of all pipes. To prevent similar settlement problems in the future, the thaw unstable, ice-rich soils will need to be removed from beneath the new culverts and replaced with thaw-stable, compacted granular materials to a depth of at least 1.5 m below the invert level of the pipes.*

Figure 110: View of the inlet of five culverts at KM 80+500. All five culverts suffered serious differential settlements (sagging) and all of them will need to be replaced as soon as practically possible.

Figure 111: View of the outlet of five culverts at KM 80+500. All five culverts suffered serious differential settlements (sagging) and all of them will need to be replaced as soon as practically possible.

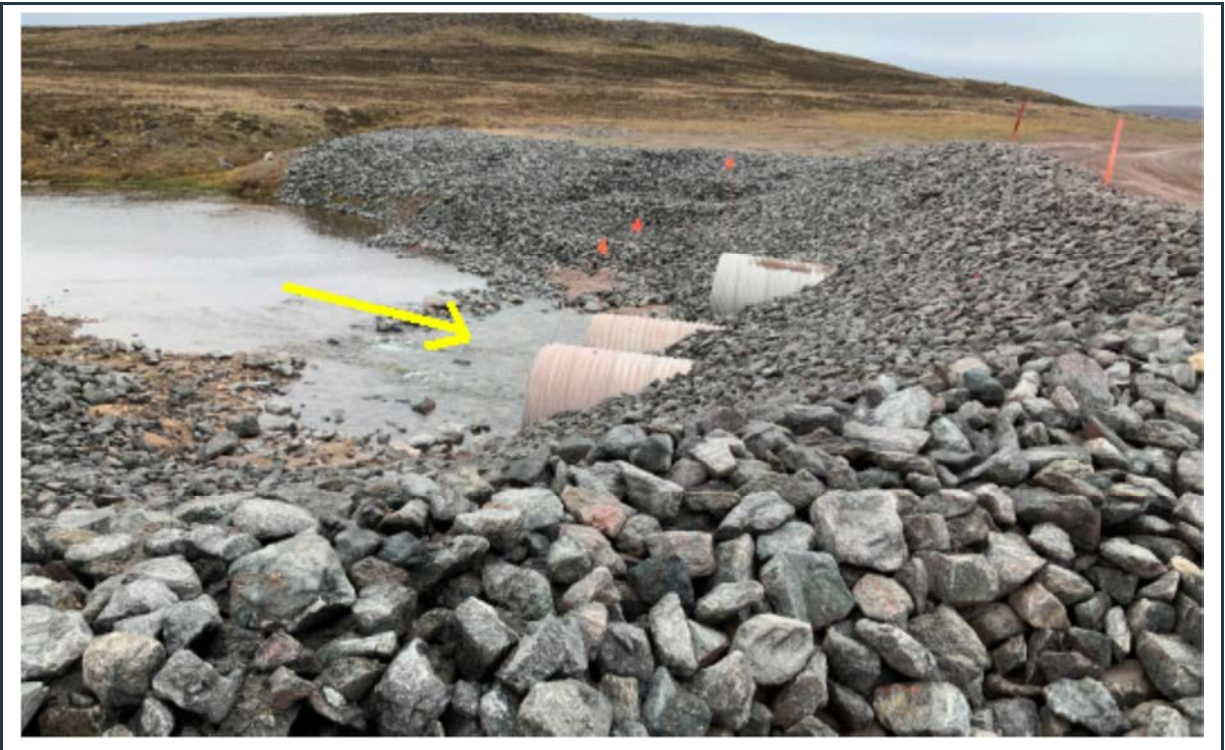
Figure 114: View of the inlet of three culverts at KM 94+060, in good condition.
