2024 Tote Road Priority Actions

APPENDIX C.3.1
2024 Tote Road Inspection Report

2023 Inspection of the Milne Inlet Tote Road and Associated Borrow Sources

AUGUST 2, 2024
ISSUED FOR REVIEW-REVISION 2
FILE: 704-ENG.EARC03209-12

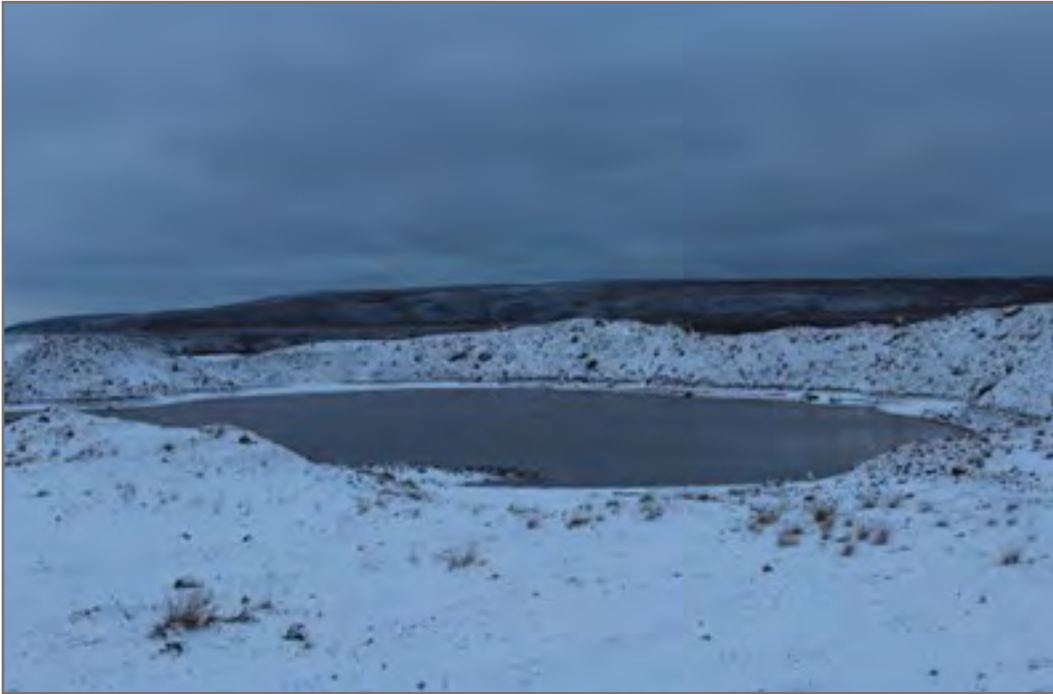
Photo 1 (Point 9-Priority B): Ponded water and continuing permafrost degradation

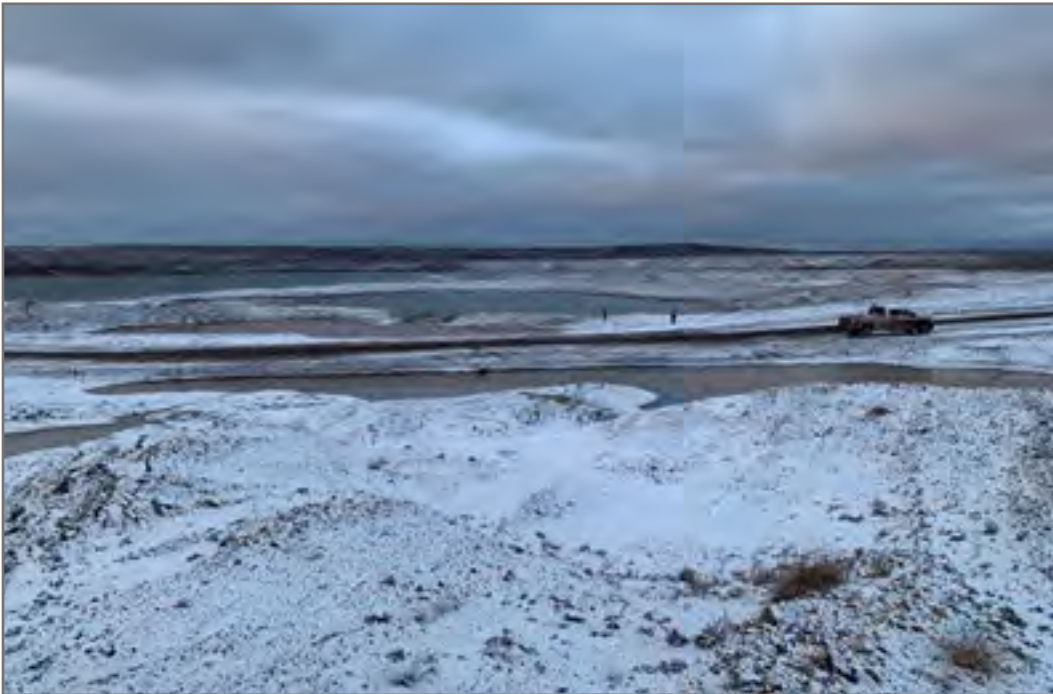
Photo 2 (Point 10-Priority B): Thaw settlement, excessive water pooling and dysfunctional drainage system

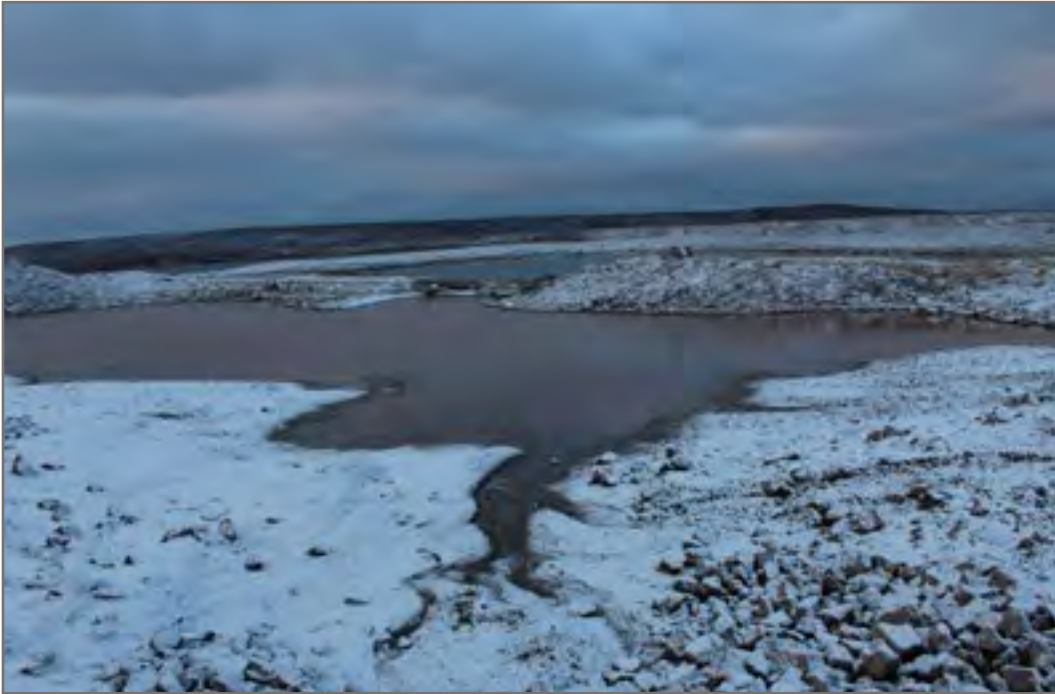
Photo 3: (Point 11-Priority B) Excessive water pooling and dysfunctional drainage

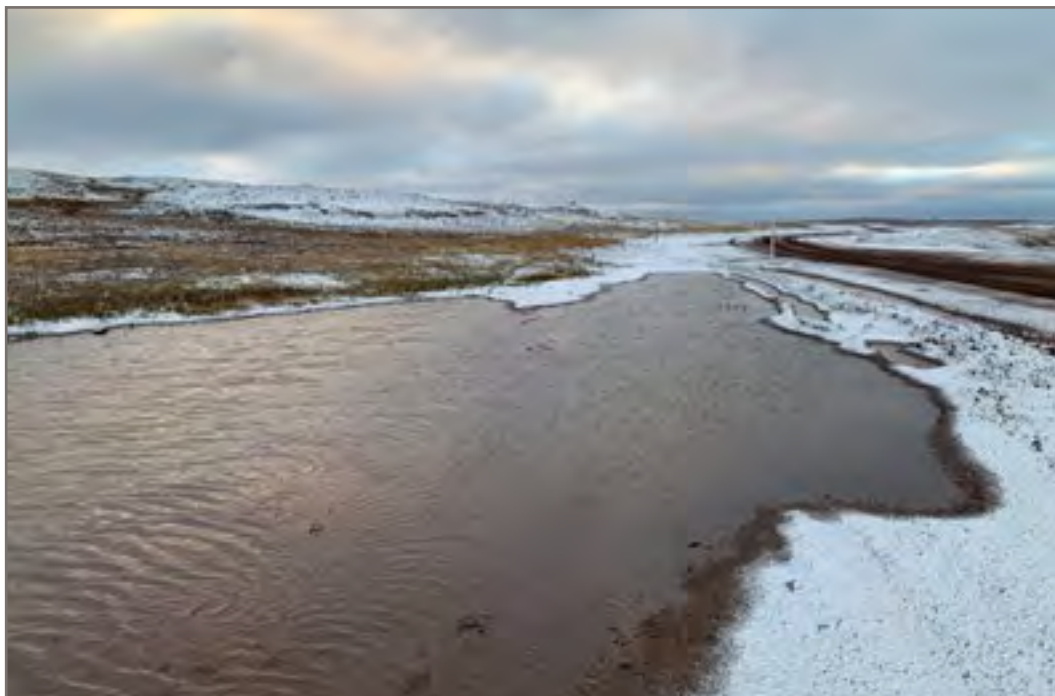
Photo 4 (Point 12A-Priority B): Water pooling adjacent to the north edge of the road

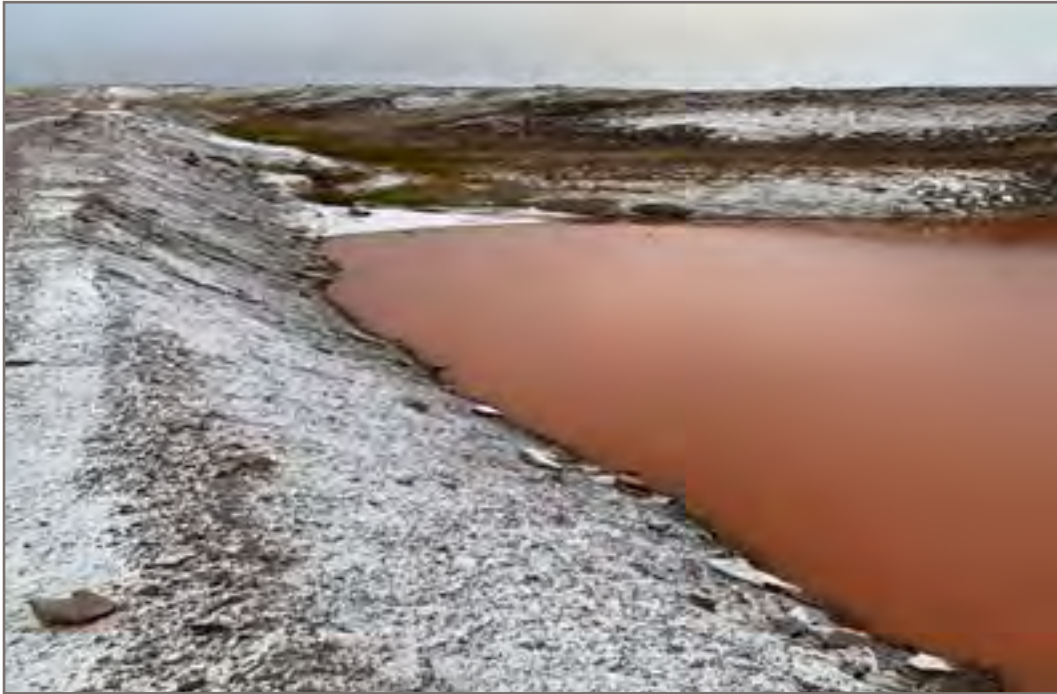
Photo 5 (Point-QIA-01): Water pooling at several locations along the north edge of the road

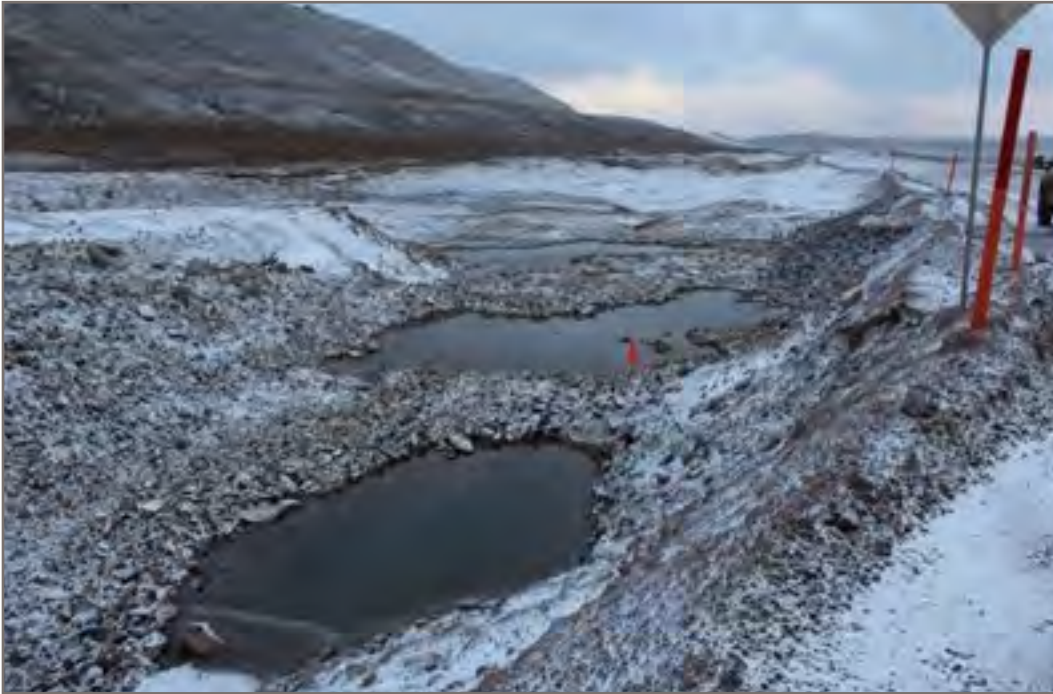
Photo 7 (Point 14 (QIA-02)-Priority A++++): Steep embankment, deep water pooling, and evidence of instability

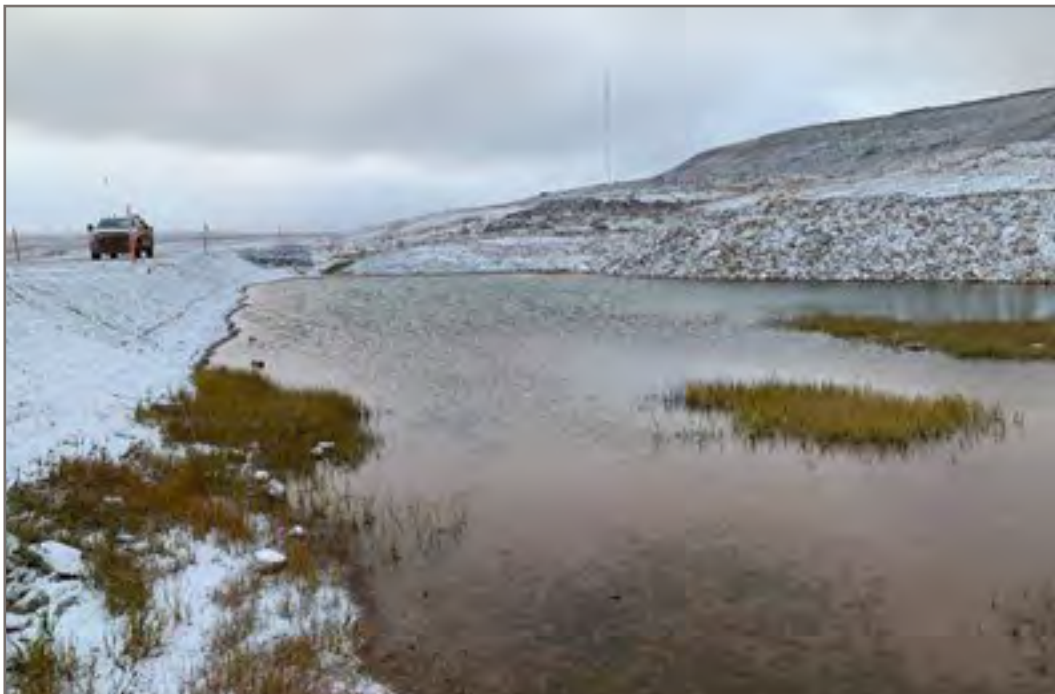
Photo 8 (Point 15-Priority B): Dysfunctional drainage system and water pooling at the toe of the embankment

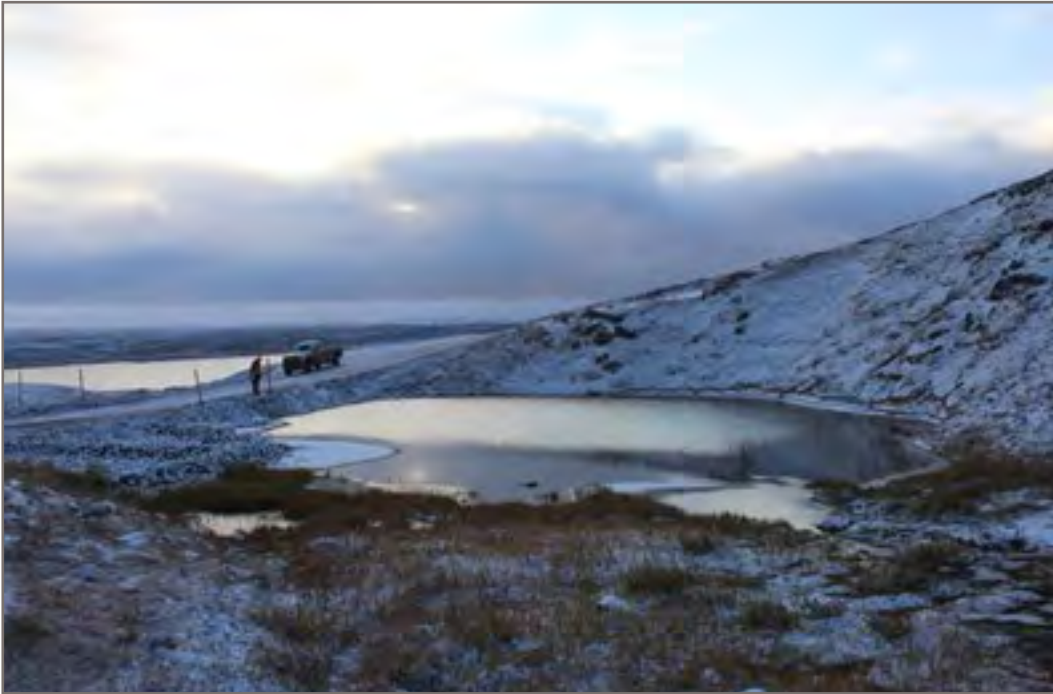
Photo 9 (Point 16-Priority B): Dysfunctional drainage system and water pooling at the toe of the embankment

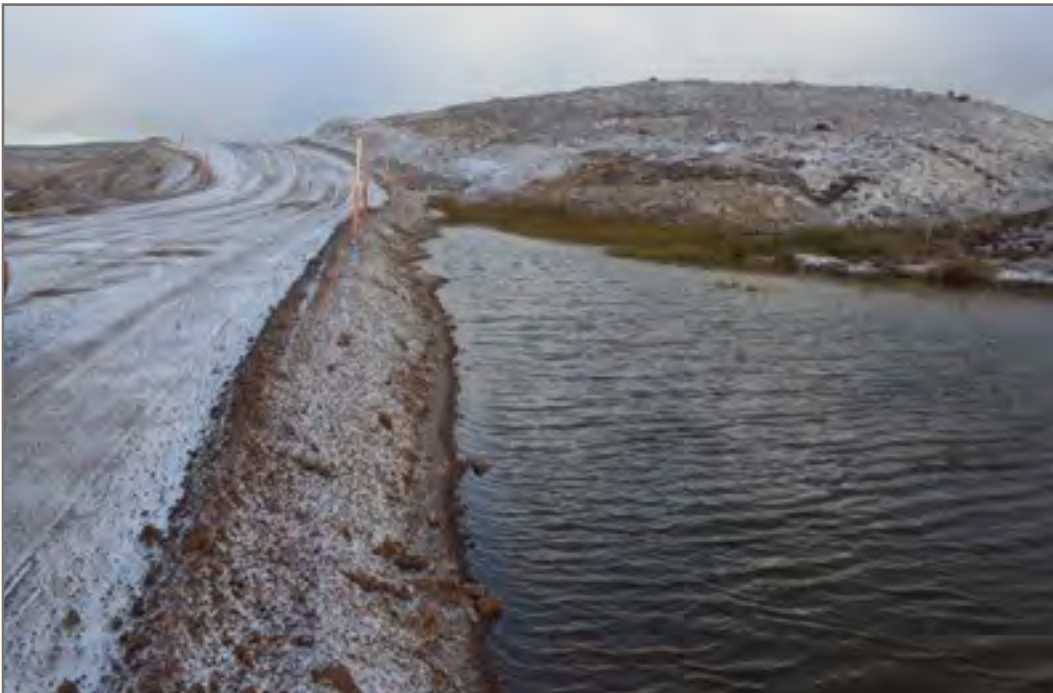
Photo 10 (Point 16.1-Priority C): Dysfunctional drainage system and water pooling at the toe of the embankment

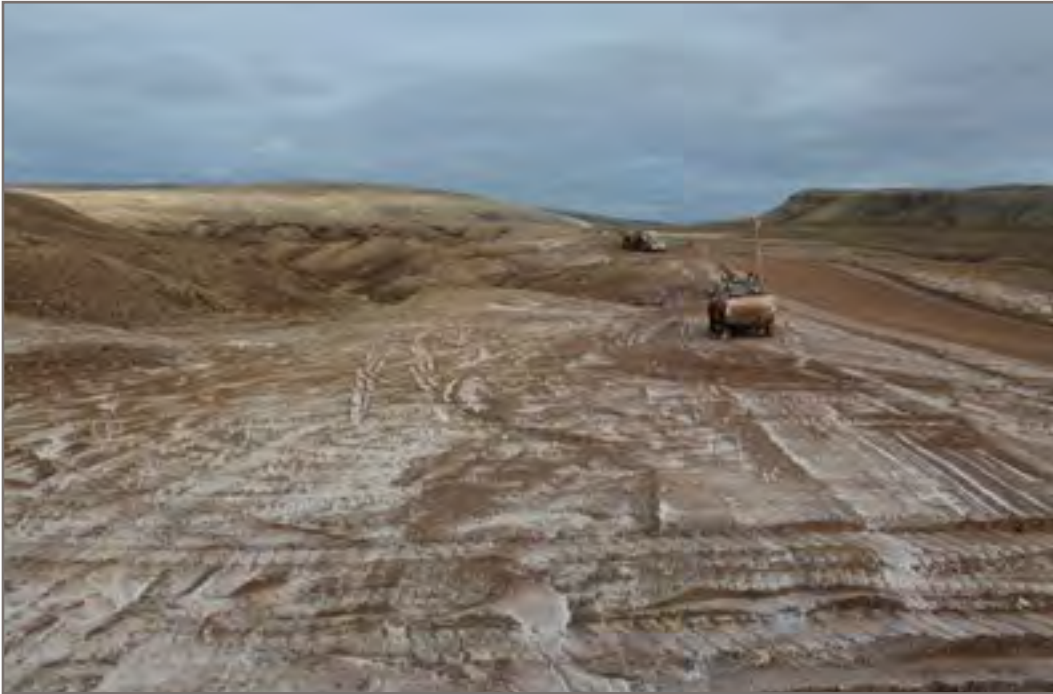
Photo 11 (Point 29-Priority B): Partially filled, need more filling, grading, and dressing

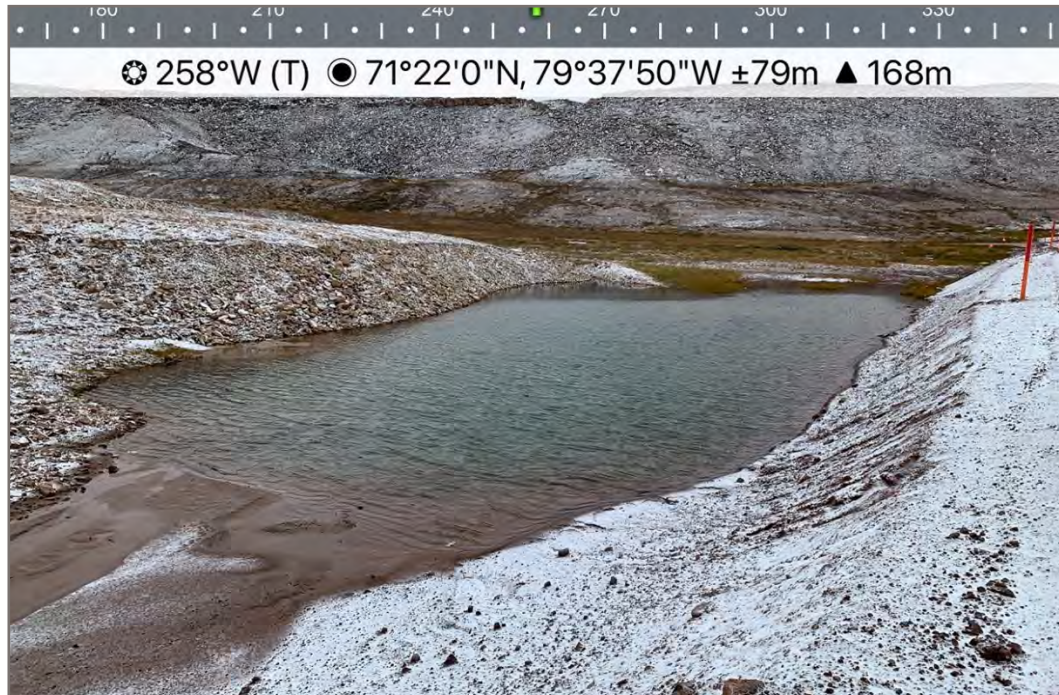
Photo 13 (Point 33- Priority A+++): Water pooling, ground settlement, dysfunctional drainage system

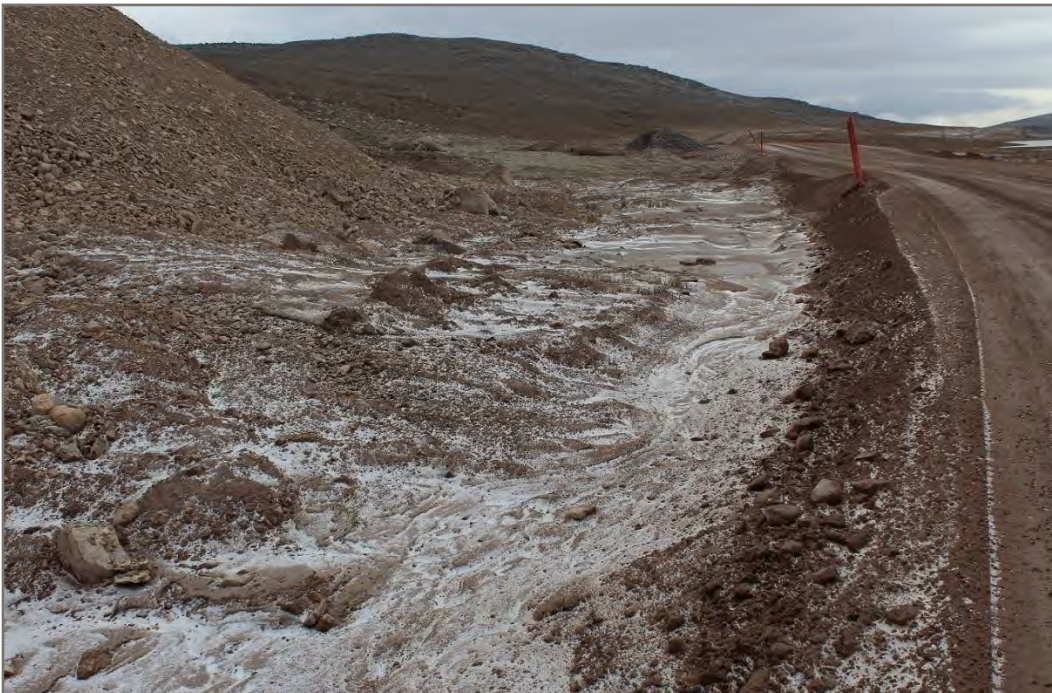
Photo 16 (Point 35A-Priority B): Dysfunctional drainage system and poor erosion protection measures

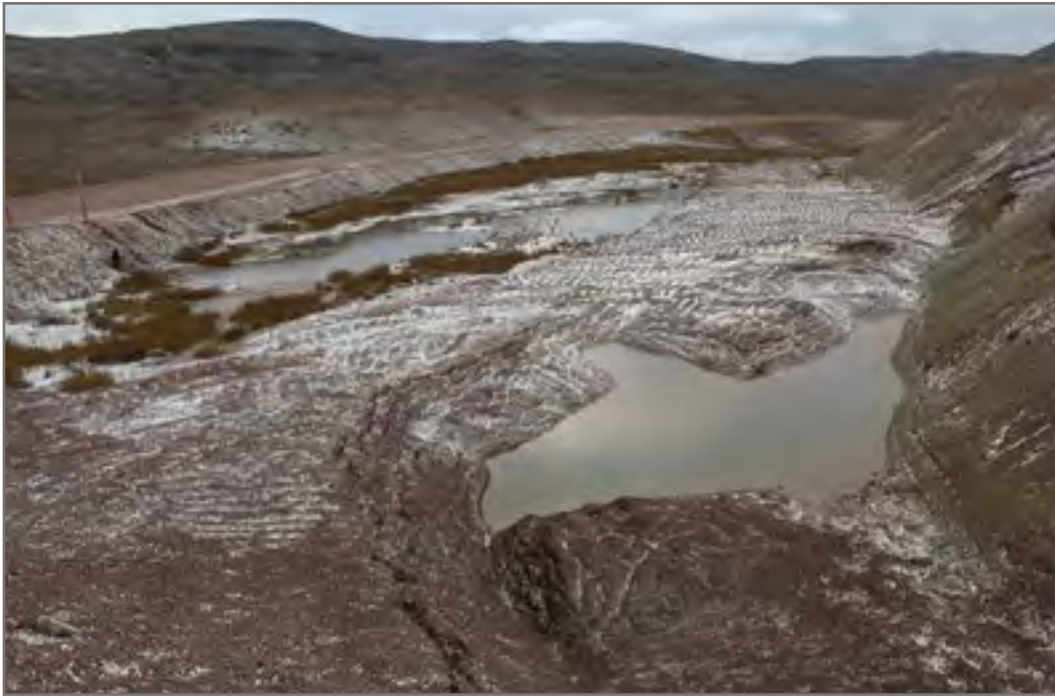
Photo 17 (Point 36-Priority B): Poor water management, ground settlement, and continuous permafrost degradation

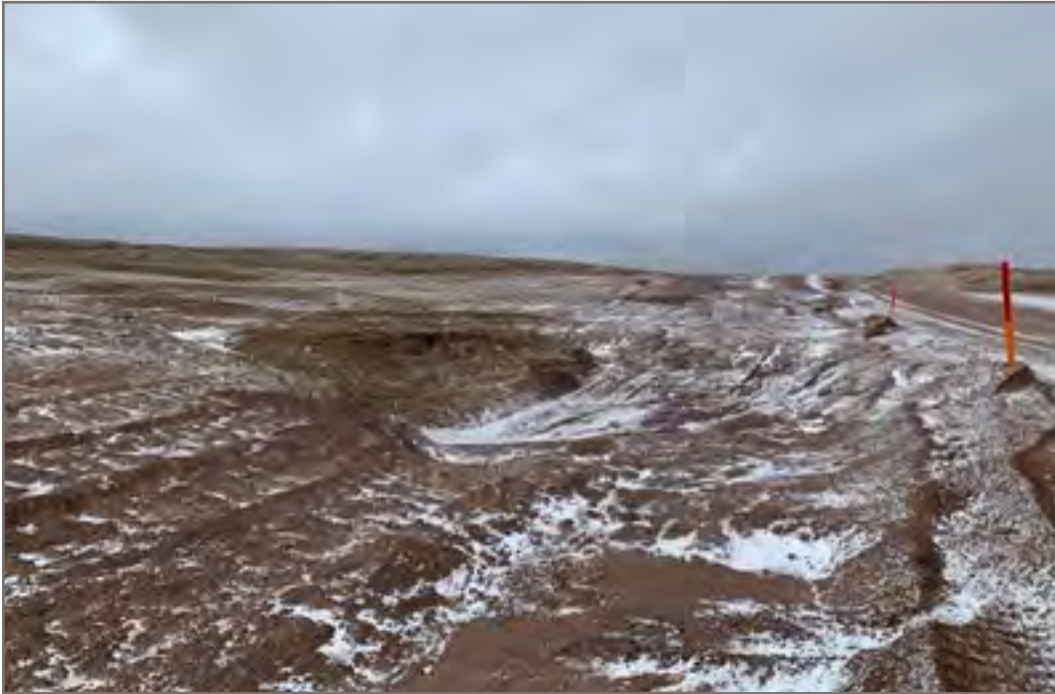
Photo 21 (Point 41-Priority A): Evidence of ground settlement and water pooling due to permafrost degradation

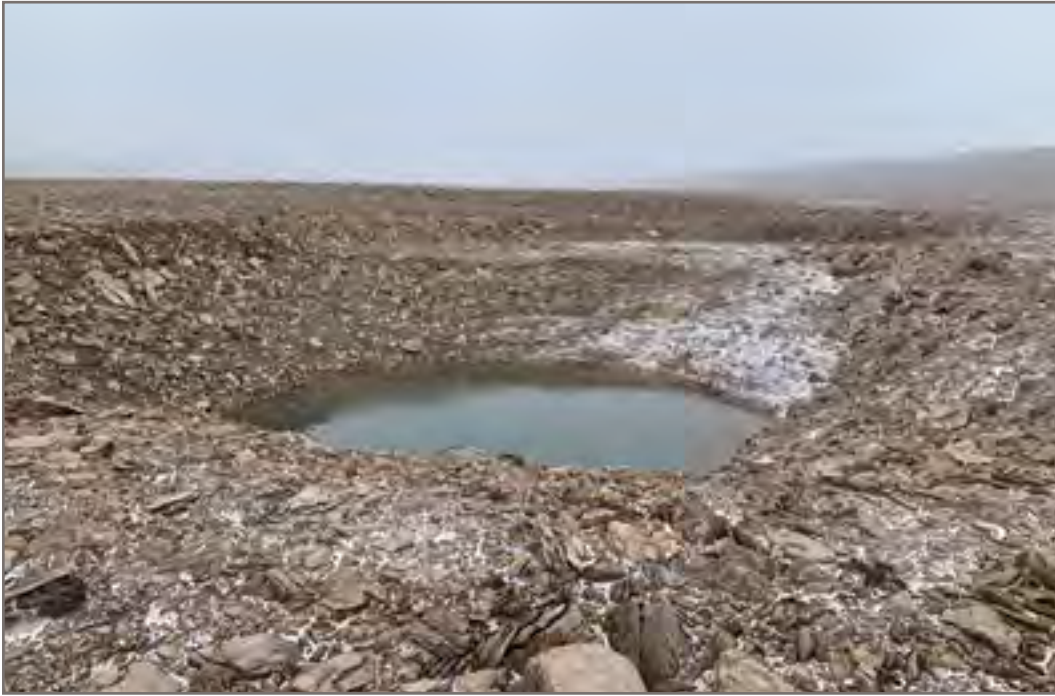
Photo 23 (Point 47-Priority B): Sinkhole (natural) has increased in size but is not yet affecting the road

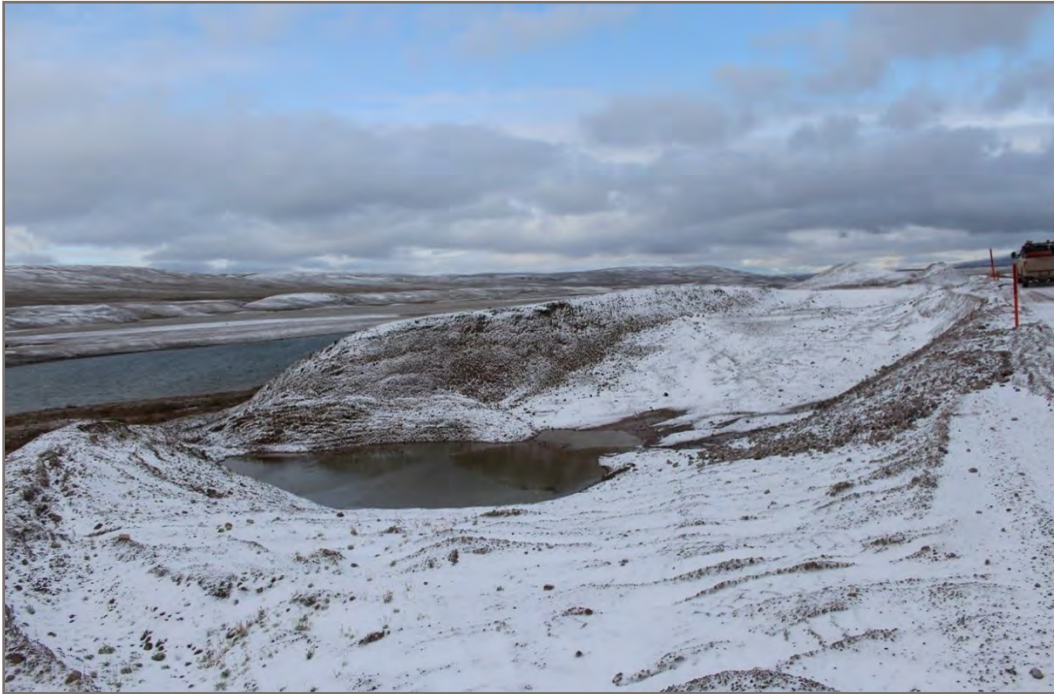
Photo 33 (Point 60 (NIRB-03)-Priority C): Stable, but drainage should be improved

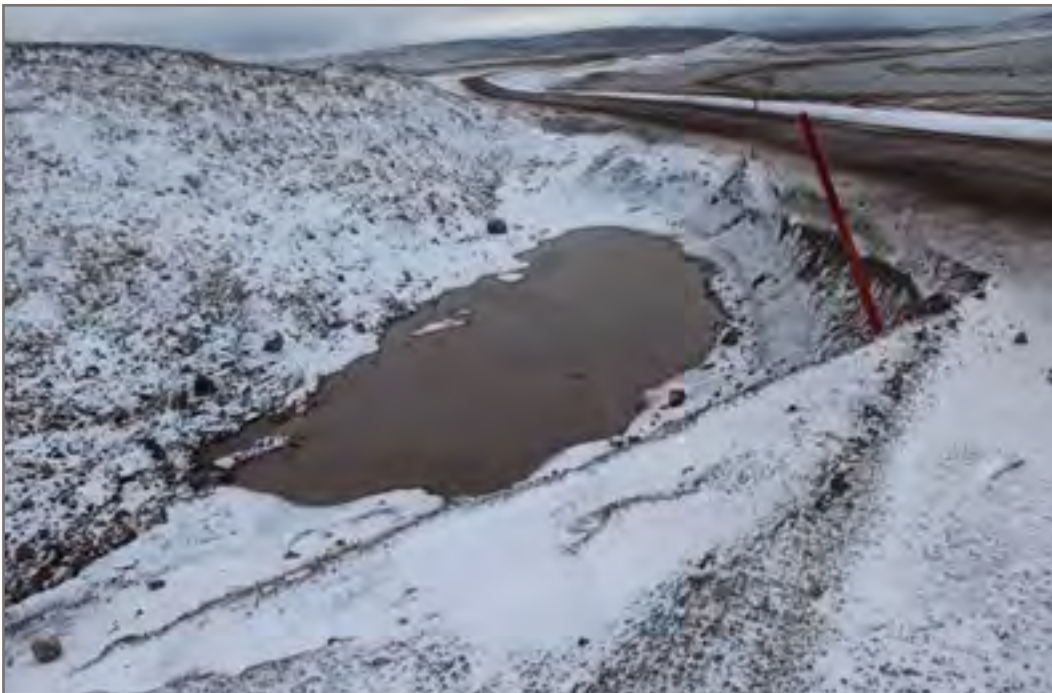
Photo 34 (Point 61B (QIA-09)-Priority A++++): Steep and high embankment, presence of water at the toe of the slope

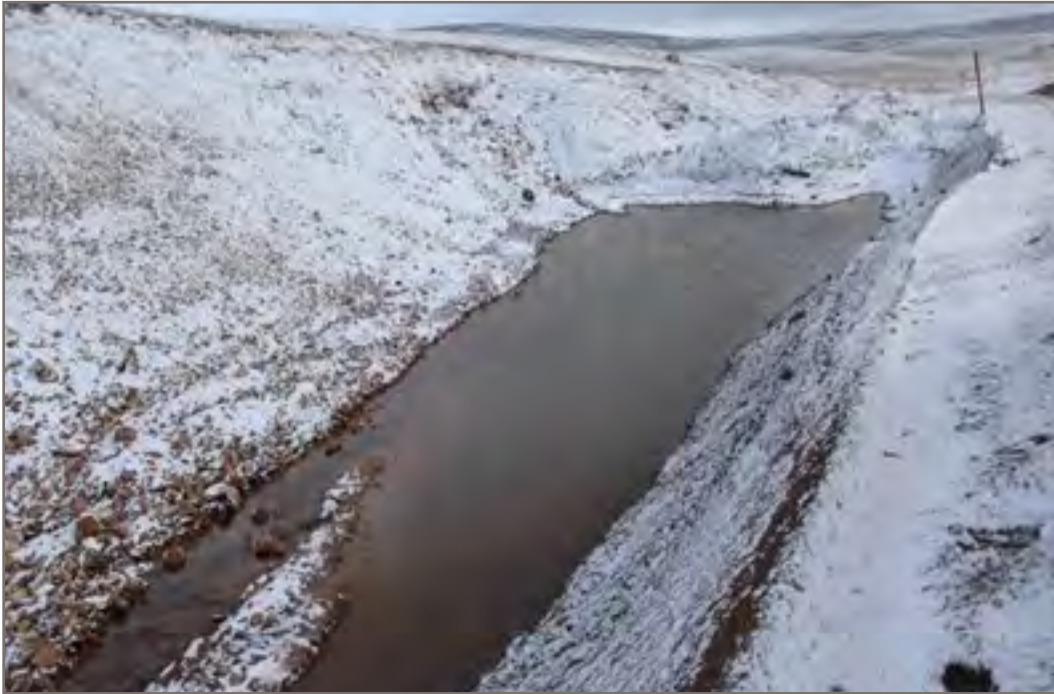
Photo 35 (Point 62-Priority B): Steep embankment and pooled water at the embankment

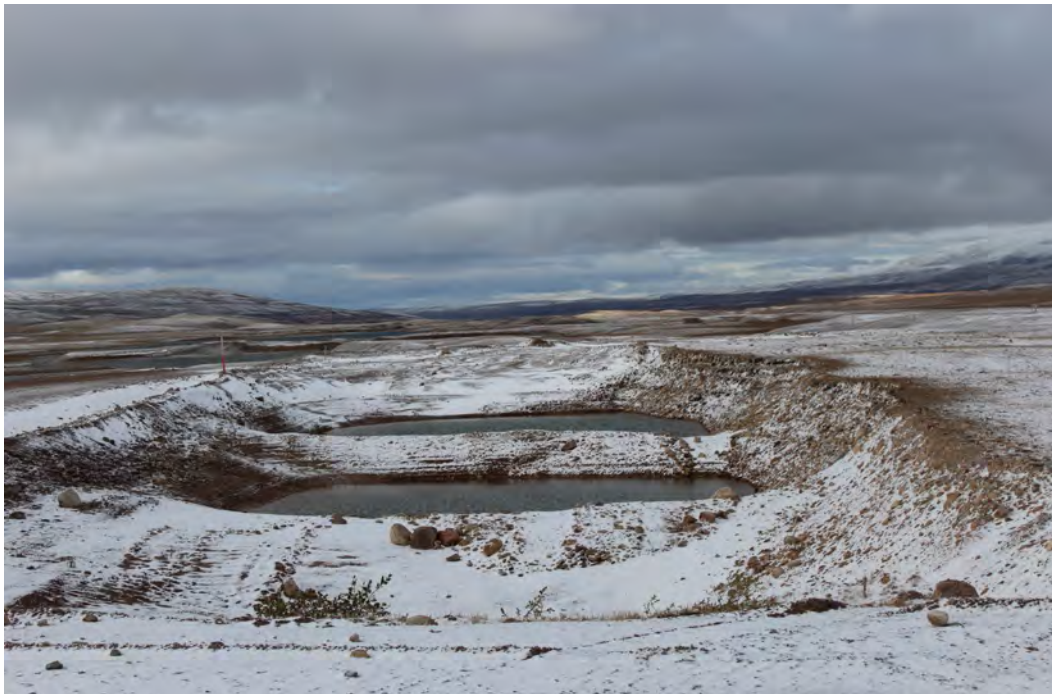
Photo 36 (Point 62A-Priority A+): Water pooling and evidence of permafrost degradation

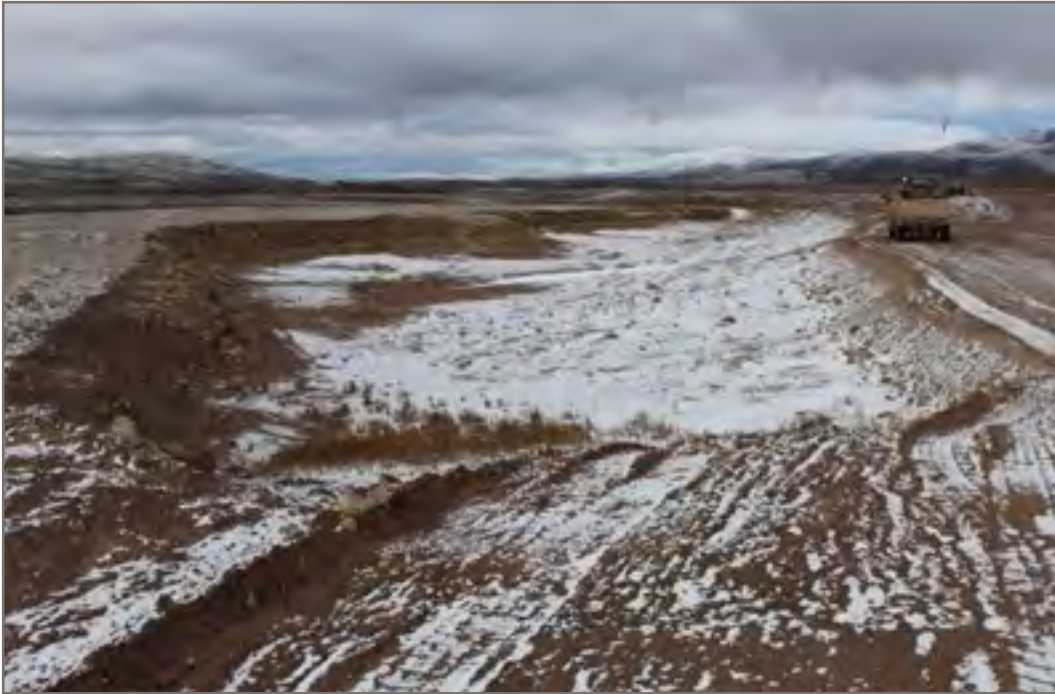
Photo 37 (Point 64-Priority B): Pit bottom appeared to be wet, but no presence of standing water

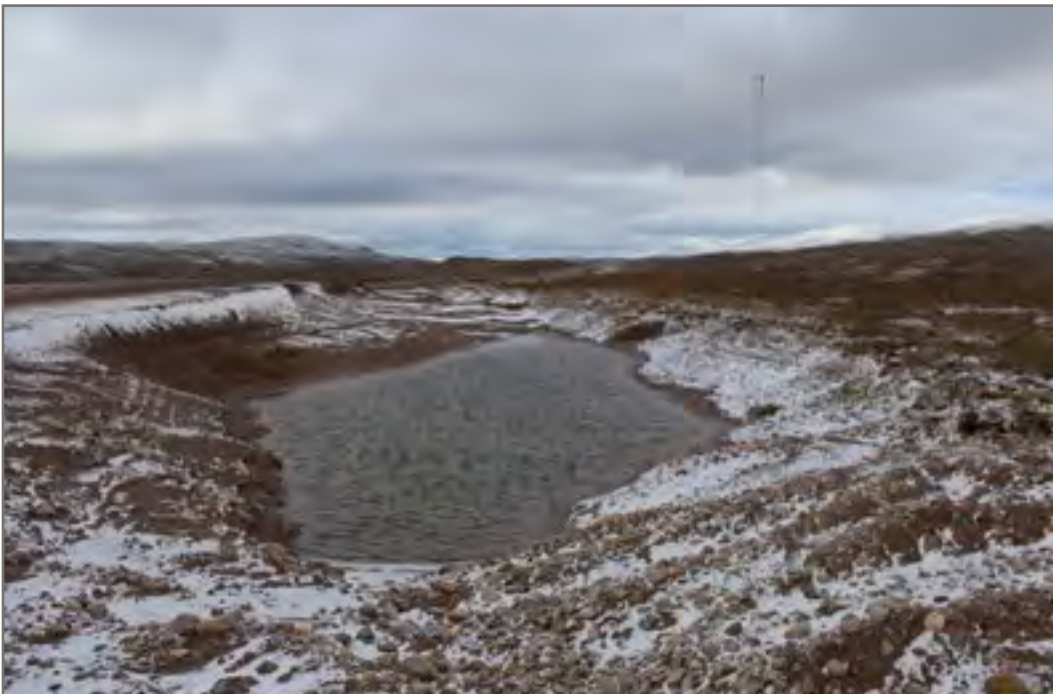
65	25.8 L&R	A+	Right borrow area appeared to be dry and stable. The left borrow areas (2 pits) were full of ponded water, and showed evidence of continuing permafrost degradation. Pooled water in the left borrow areas appeared to be deep, but the excavation walls were stable (at the time of the inspection).	Planned 2029 Remediation.	On 5-Year Plan for completion in 2029.
66	23.6 L&R	A+	Right borrow area appeared to be dry and stable. The left borrow was full of ponded water, and showed evidence of continuing permafrost degradation. Pooled water in the left borrow appeared to be deep and may affect the roadway embankment stability.	Planned 2029 Remediation.	On 5-Year Plan for completion in 2029.

Photo 38 (Point 65-Priority A+): Pooled water and evidence of permafrost degradation (left pit heading north)

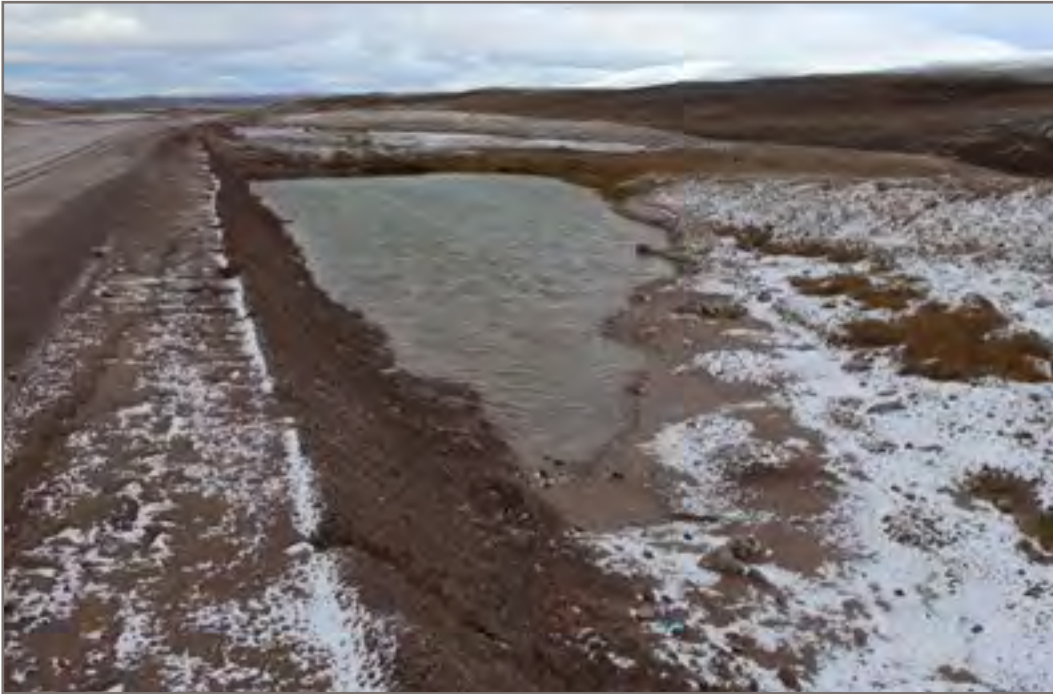
Photo 39 (Point 66-Priority A+): Pooled water and evidence of continuing permafrost degradation (left pit heading north)

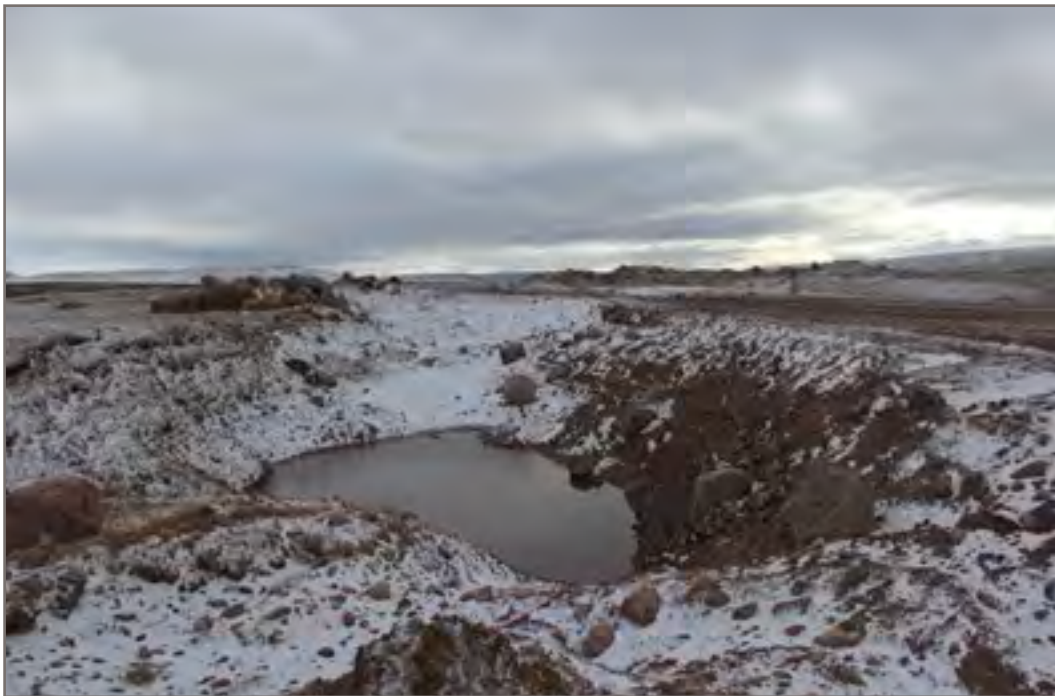
Photo 40 (Point 67-Priority B): Deep water and evidence of continuing permafrost degradation (north end of the pit)

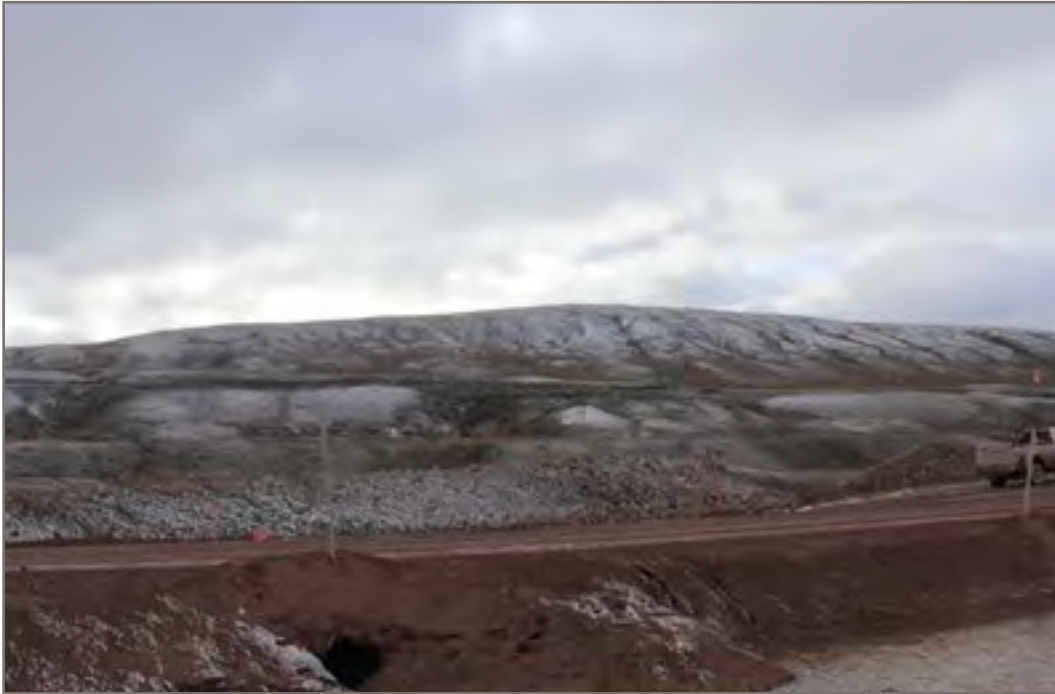
Photo 41 (Point 68 (QIA-10)- Priority A++++): Deep water pooling, evidence of continuing permafrost degradation, and the drainage system appeared to be dysfunctional

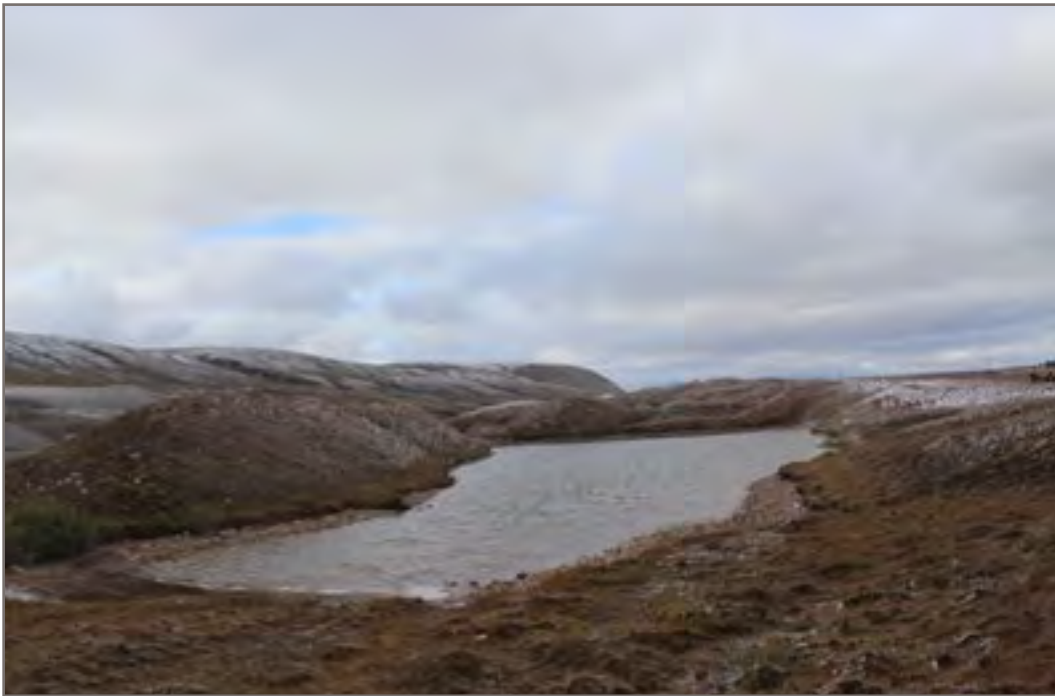
Photo 42 (Point 69-Priority C): Large water pooling and dysfunctional drainage system

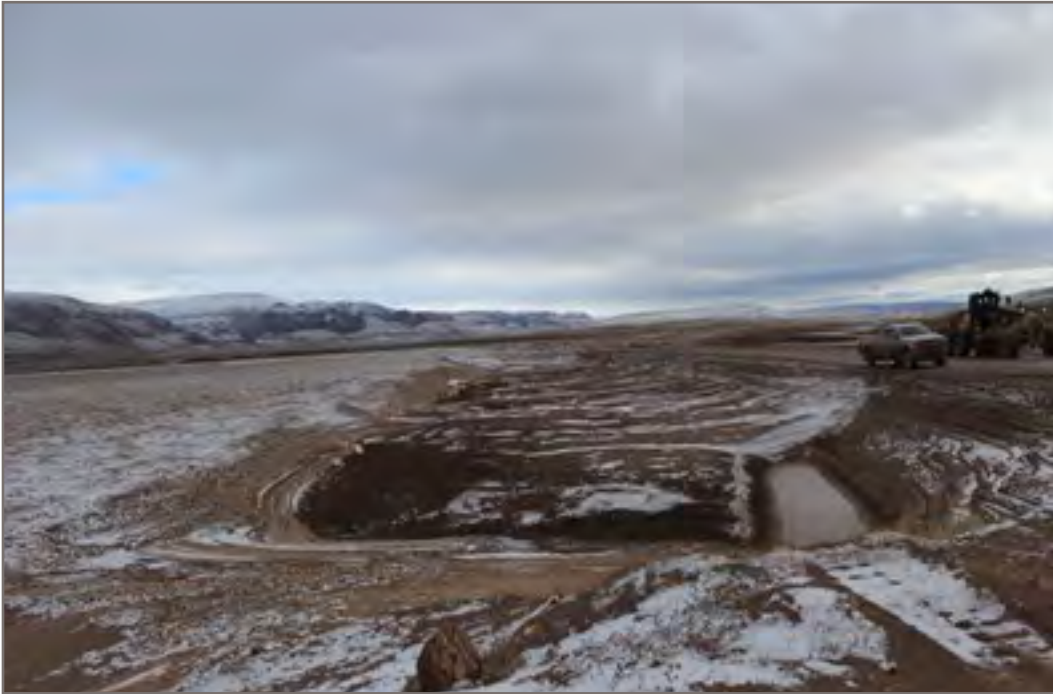
Photo 43 (Point 70-Priority B): Wet bottom, settlement, and evidence of continuing permafrost degradation

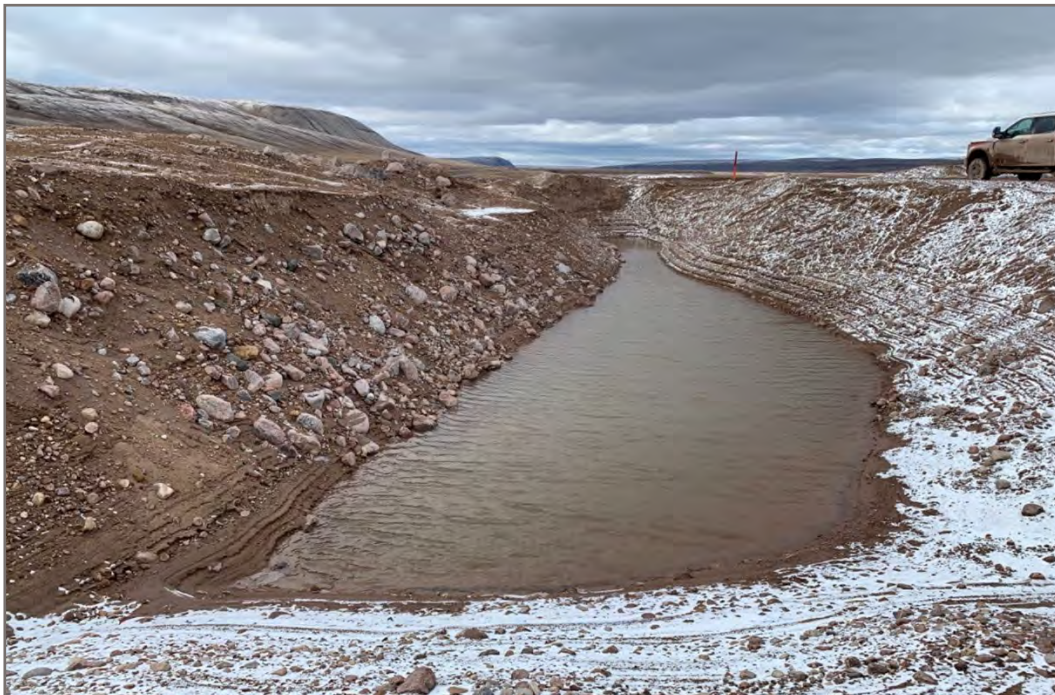
Site No.	KM Post	Priority	2023 Comments	Proposed Timeline for Completion ¹	2024 Update
71	20.7 R	A++++	Steep high roadway embankment. Presence of pooled water at the embankment toes. The pooled water may have resulted from poor surface water management and/or permafrost degradation. No signs of slope movement/instability.	Planned 2025 Remediation.	On 5-Year Plan for completion in 2025.
41	50.6 L	A+	Evidence of ground settlement, deep water pooling (due to permafrost degradation) and excessive erosion. This area needs to be graded (pushing pooled water, filling holes), in addition to improving the erosion protection system at the existing culvert outlet.	Planned 2025 Remediation.	On 5-Year Plan for completion in 2025.
62A	27.8	A+	Deep excavation full of water (high embankment). Granular fill placed over the embankment edge to flatten the steep slope, but this area needs to be drained from standing water, filling/grading, and dressing the surface to properly drain water.	Planned 2025 Remediation.	On 5-Year Plan for completion in 2025.

Photo 44 (Point 71-Priority A++++): Steep slope, deep water, and evidence of continuing permafrost degradation

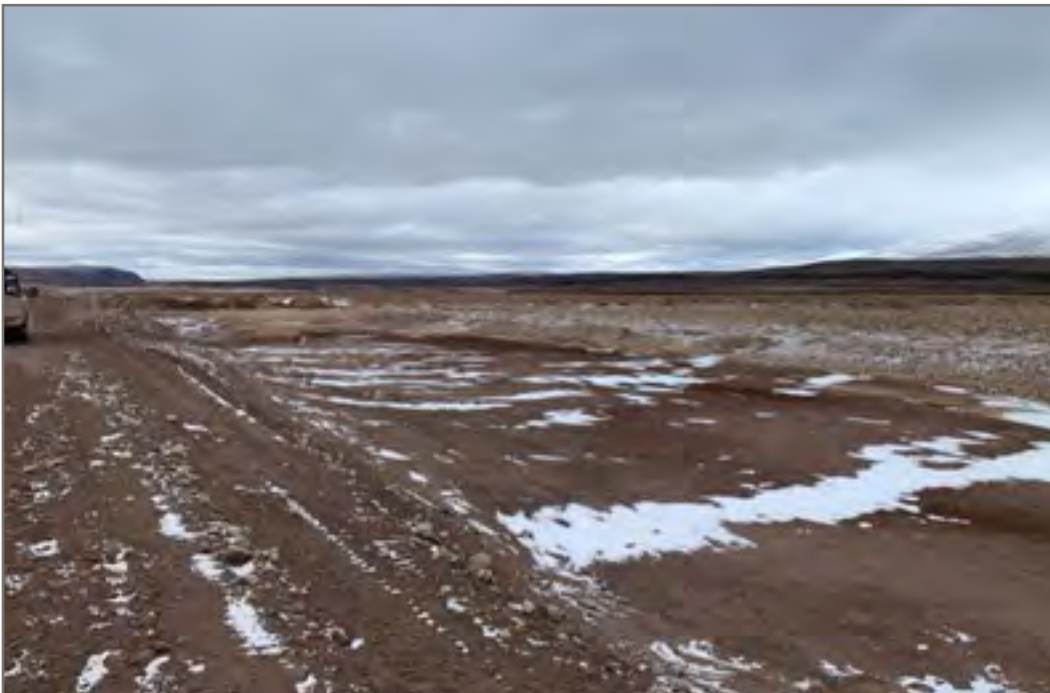
Photo 46 (Point 73-Priority B): Soft and wet pits bottom (left and right pits), but no presence of standing water

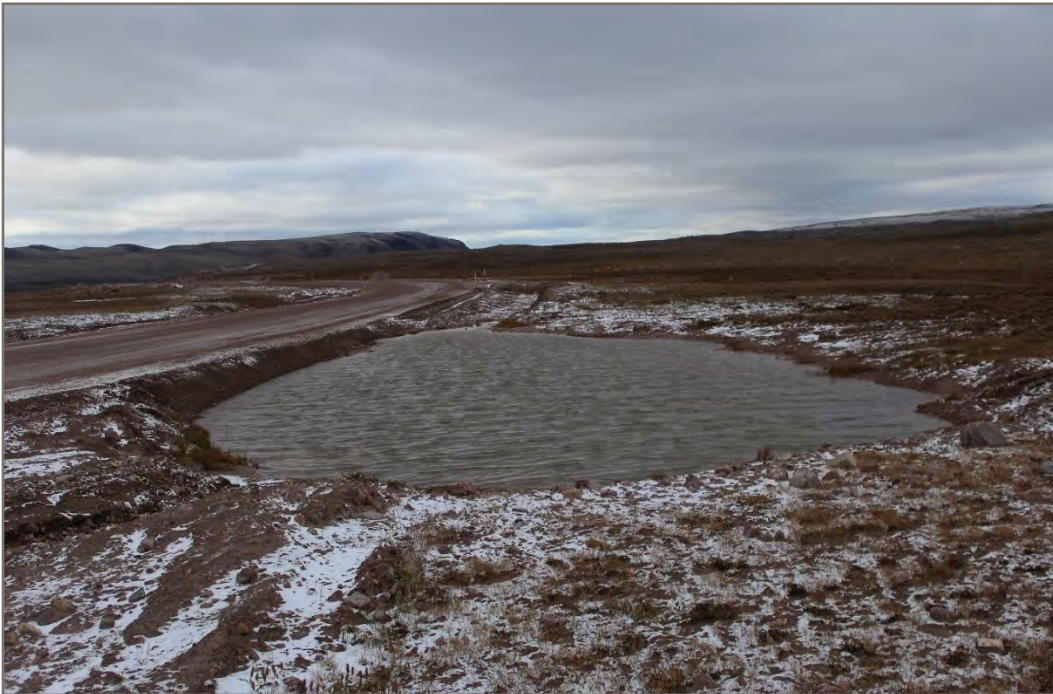
Photo 48 (Point 75-Priority A): Right (heading north) pit filled and graded. Deep pooled water in the left (heading north) pit
