2024 Tote Road Priority Actions

APPENDIX C.3.1
2024 Tote Road Inspection Report

2023 Inspection of the Milne Inlet Tote Road and Associated Borrow Sources

AUGUST 2, 2024
ISSUED FOR REVIEW-REVISION 2
FILE: 704-ENG.EARC03209-12

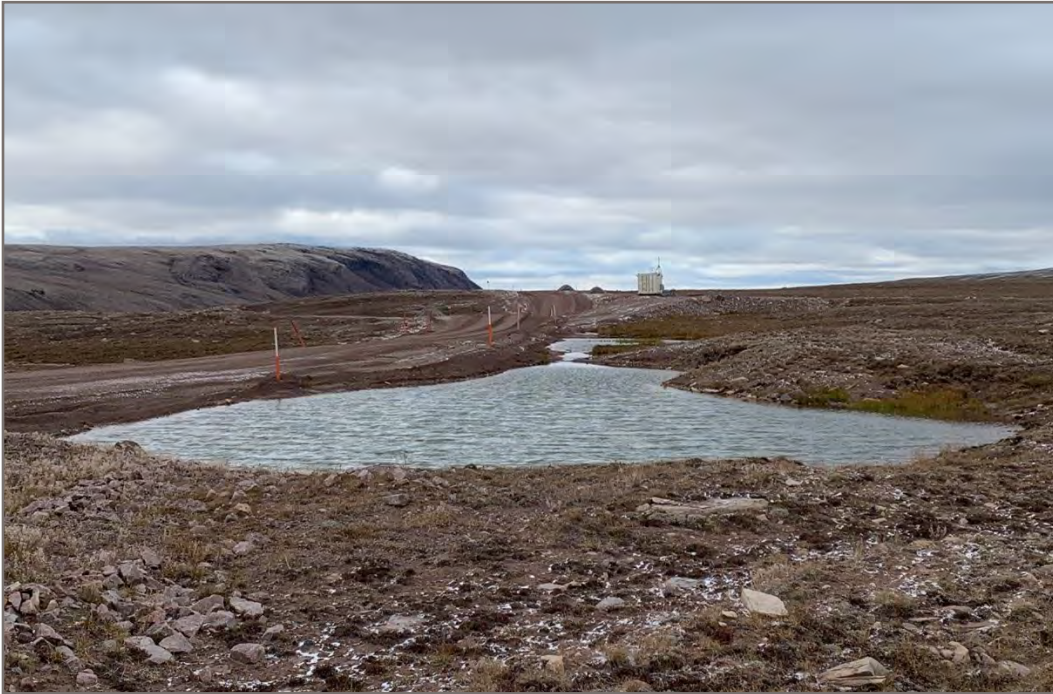
Photo 49 (Point 79-Priority A+): Large water pooling near the edge of the road

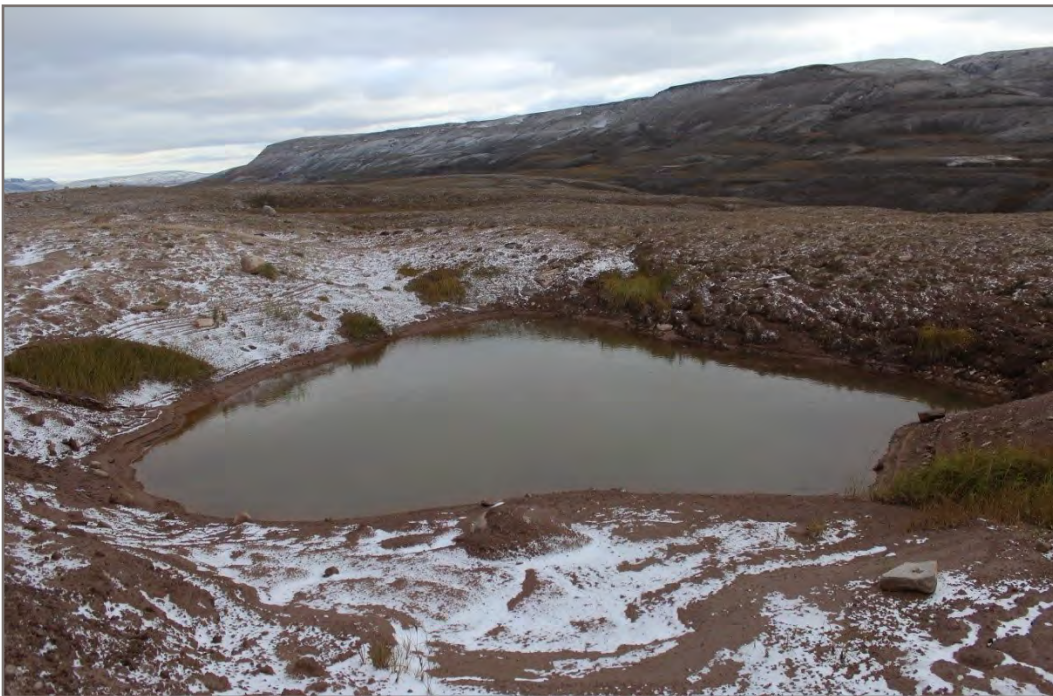
79.1	12.3 R	A	Large sinkhole filled by water near the right toe of the roadway embankment. The water in the sinkhole indicate the presence of continuing permafrost degradation. This sinkhole should be filled to prevent further expansion that may undermine the roadway embankment stability.	Planned 2026 Remediation.	On 5-Year Plan for completion in 2026.
75	15.0 L&R	A	The right side (heading north) borrow area was graded and filled before the 2023 site inspection, and no further action is required for this side. The left side (heading north) borrow area had ponded water and there is a short section at the south end of the pit where there is a very steep side slope and a considerable drop from the edge of the road down into the water. Ponded water must be drained, the area backfilled, and the surface dressed properly to improve drainage.	Planned 2027 Remediation.	On 5-Year Plan for completion in 2027.

Photo 50 (Point 79.1-Priority A): Large sinkhole filled by water near the right (heading north) toe of the roadway embankment

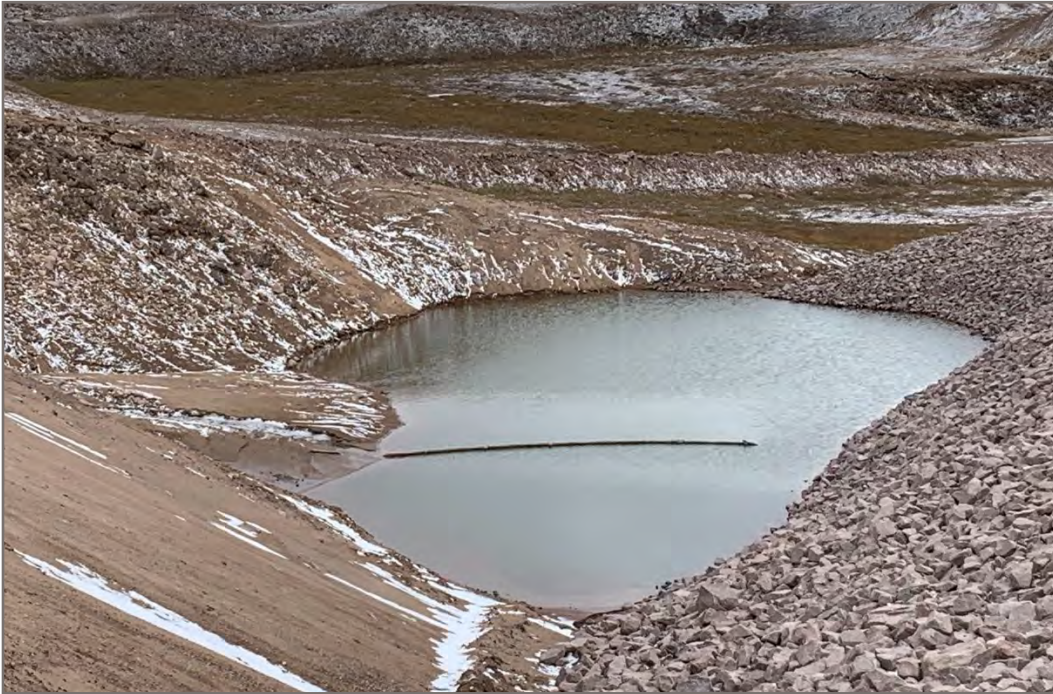
82A	8.8 L	A	embankment edge to flatten the steep slope, but this area needs to be drained from standing water, filling/grading, and dressing the surface to properly drain water.		
14	89.8	A++++	Instability is evident, water is very deep and the embankment side slope on the right side of the road is very steep and shows cracking on the shoulder and side slope.	Planned 2028 Remediation.	On 5-Year Plan for completion in 2028.
79	12.8 L&R	A++++	Large water pooling. Pooled water may have resulted from poor surface water management and/or permafrost degradation. The water level appeared to be close to the roadway surface and might affect the embankment stability and undermine the roadway structure.	Planned 2029 Remediation.	On 5-Year Plan for completion in 2029.
QIA-07	49	A+	No change from 2019 inspection. Embankment slope should be flattened, as such earthwork and filling activities will be required to push the pooled water away from the steep embankment toe.	Planned 2029 Remediation.	On 5-Year Plan for completion in 2029.

Photo 51 (Point 82A-Priority A): Old borrow area with deep standing water near the left edge of the embankment

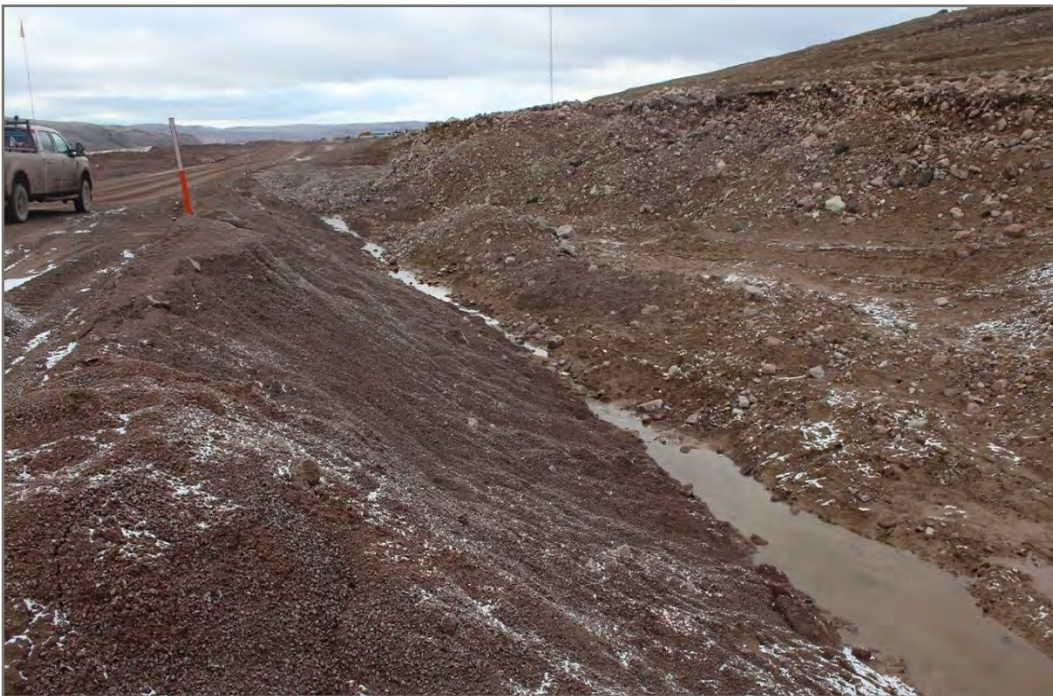
Photo 54 (Point 83A (QIA-11)-Priority B): Left borrow area was partially filled in 2021, needs more grading

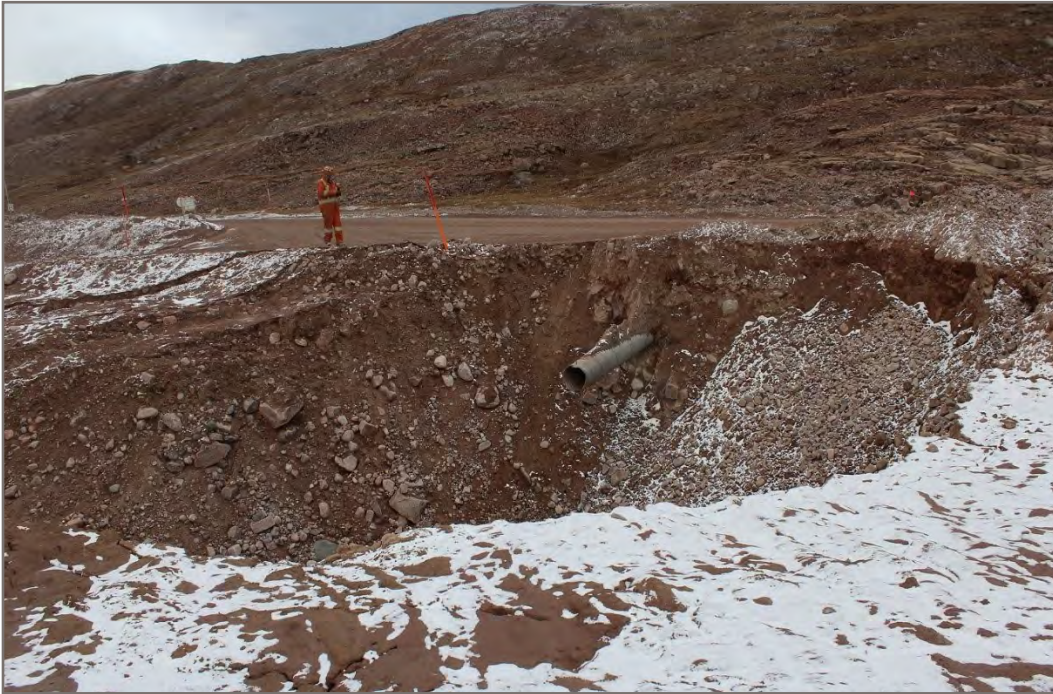
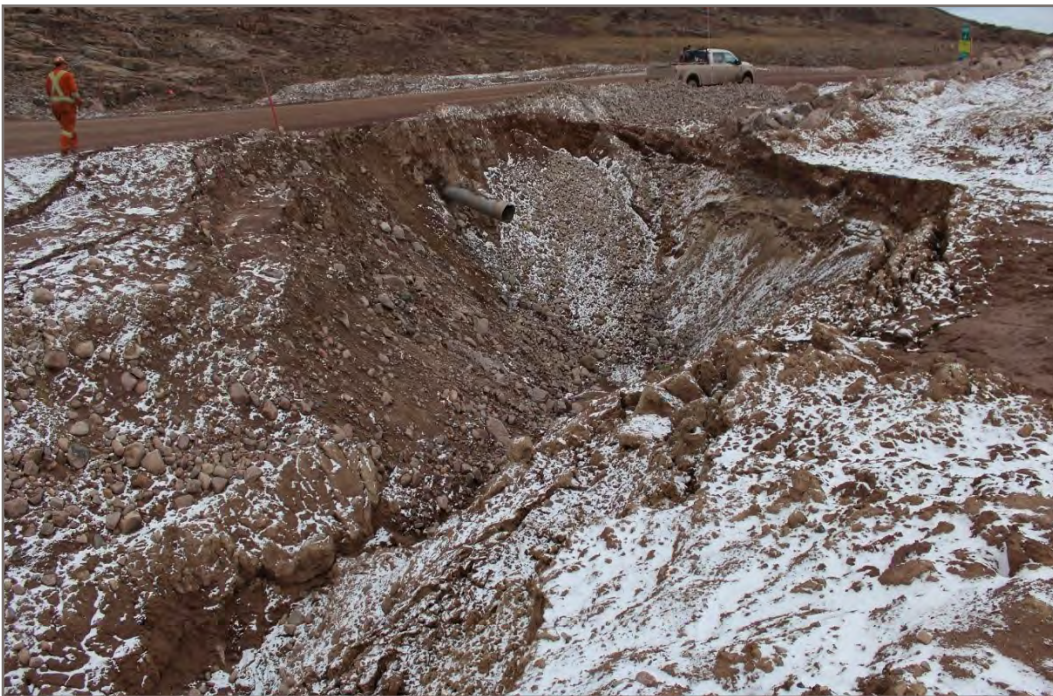
Photo 55 (Point 85-Priority A++++): Slope failure along the right (heading north) edge of the Tote Road

Photo 56 (Point 85-Priority A++++): Slope failure along the right (heading north) edge of the Tote Road
