APPENDIX E.8
Regulatory Correspondence

CIRNAC Inspection Report and Baffinland Responses

Water Licence Inspection Report

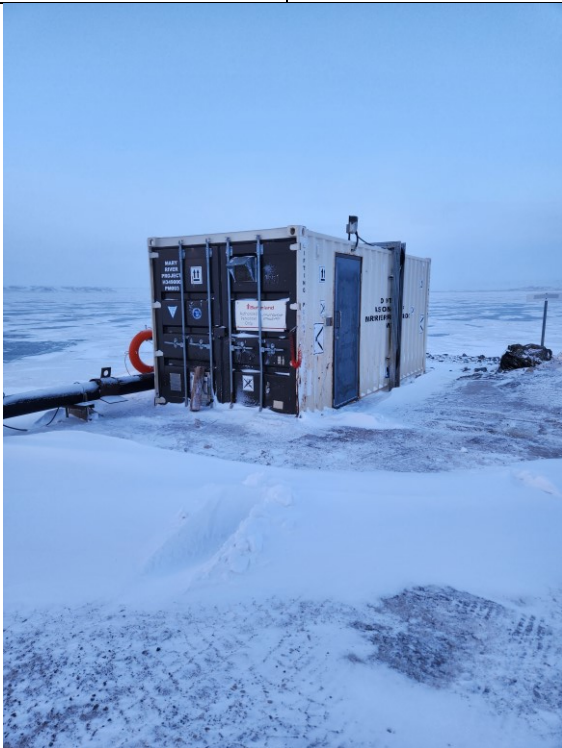
Photo No. 4	Lat/Long (DD.MM.SS.SS, NAD83)
Photo	71.19.666'N, 79.22.962'W

Description: Water Intake Station (Jetty). All systems observed were in proper working condition.

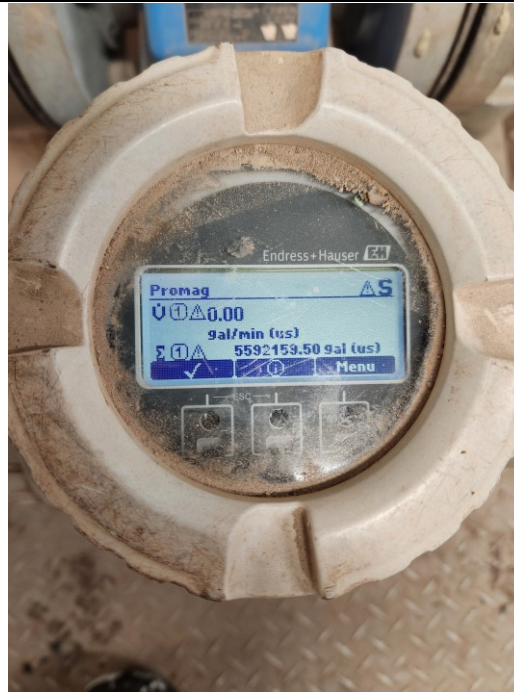
Photo No. 5

Flow intake meter inside the Water Intake Station.

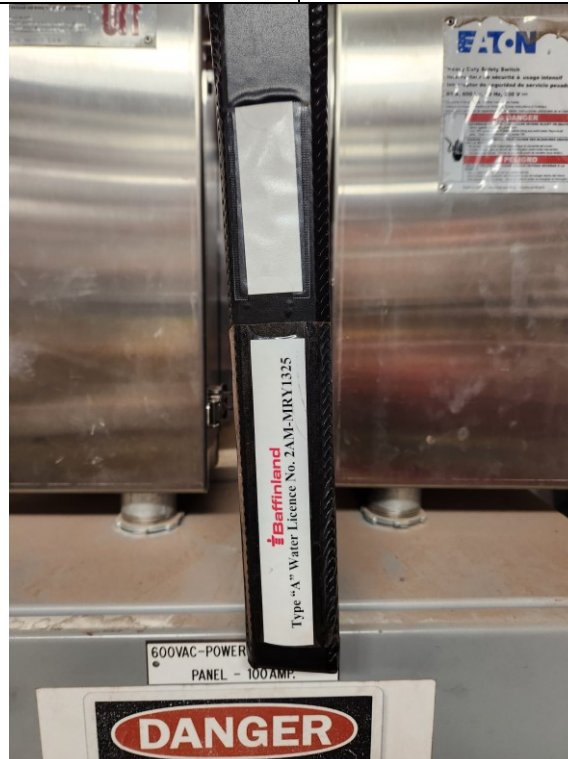
Paper copy of the Water License which was located inside the Water Intake Station.

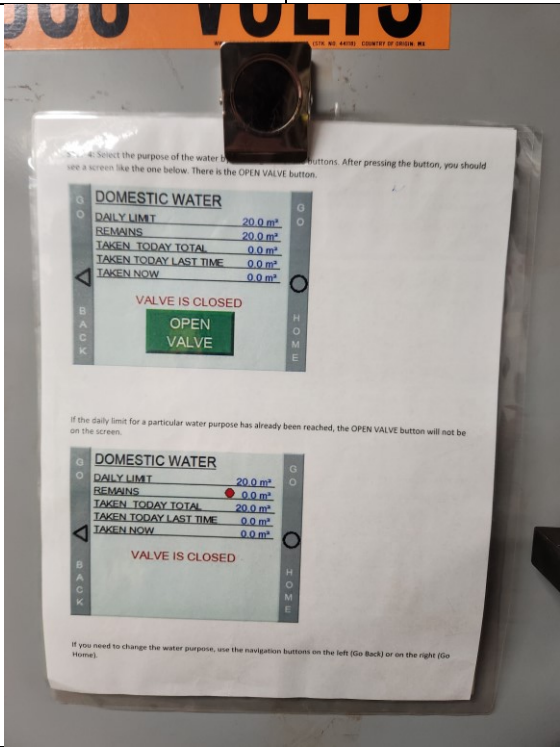
Photo No. 7		Lat/Long (DD.MM.SS.SS, NAD83)
Photo		71.19.666'N, 79.22.962'W

Description:
Computer program instructions. This program tracks and limits the use of water pumped from the station.

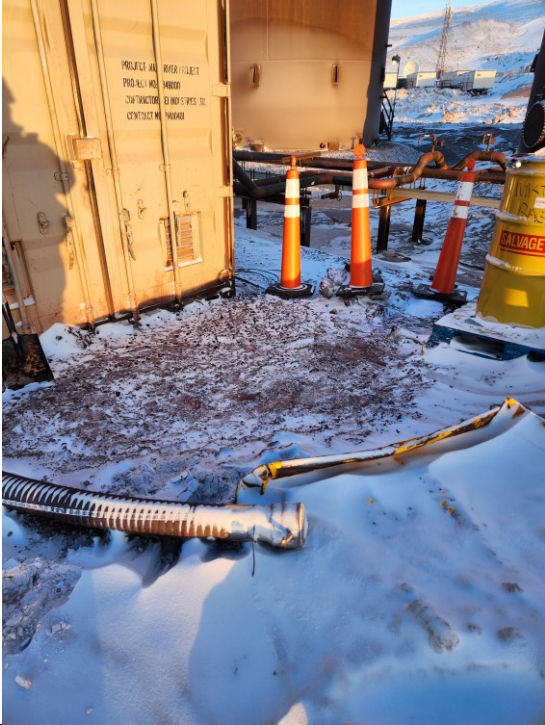
Photo No. 9	Lat/Long (DD.MM.SS.SS, NAD83)
Photo	71.18.837'N, 79.17.210'W

Description: Inspector Noble-Nowdluk observed stained soil at the Light Vehicle Refueling Station. A strong fuel odour was present at this location and has since been remediated. The Licensee is working towards spill prevention at these refueling sites.

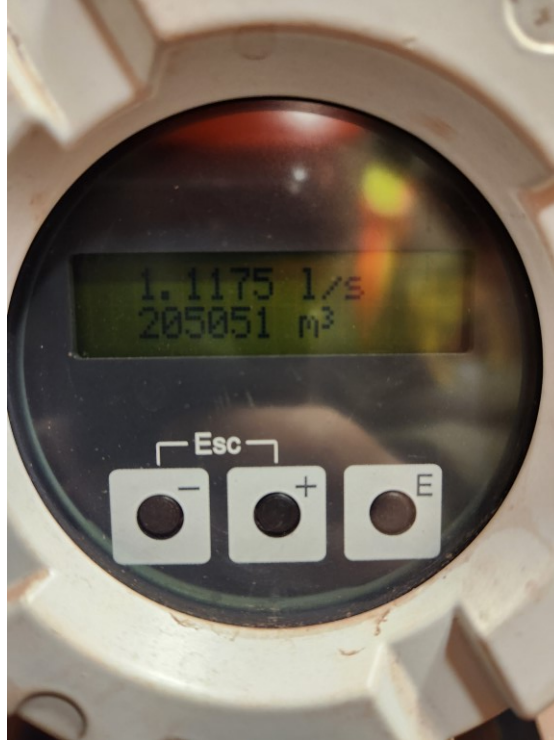
Sewage flow meter inside the Waste Water Treatment Plant.

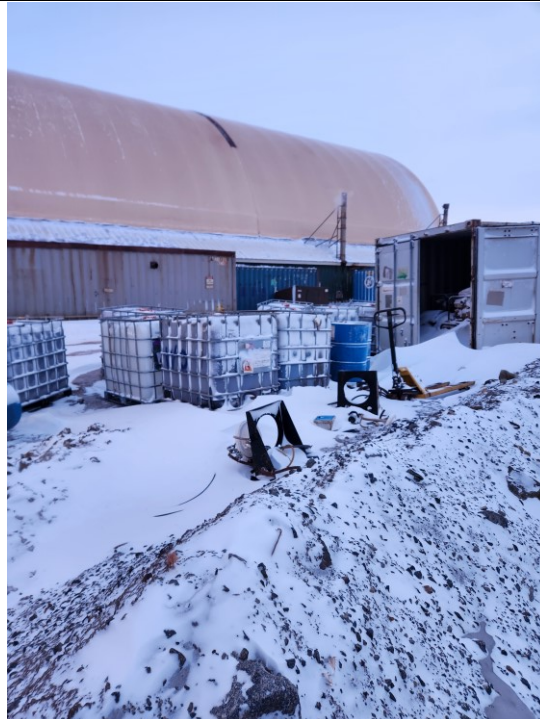
Photo No. 2	Lat/Long (DD.MM.SS.SS, NAD83)
Photo	71.18.779'N, 79.16.488'W

1. During the inspection, CIRNAC Inspector identified a number of totes filled with waste oil outside the Ore Haul Truck (OHT) Wash Bay. These totes were not situated within secondary containment and are in non-compliance with Part H – Section 3 of the Water License. Part H – Section 3 states “The Licensee shall provide secondary containment for fuel and chemical storage as required by applicable standards and acceptable industry practice.”.
2. At KM105, the Dam has been leaking causing sediment laden water to escape into the surrounding area. The Licensee has since put up mitigation measures to prevent the migration of the water.

Description:
Totes of hazardous waste not situated within secondary containment. Photo taken behind the OHT Wash Bay.

1. All totes or containers filled with hazardous material must be placed in a designated lined facility or secondary containment.
2. The KM105 Dam must be repaired to prevent future releases of sediment laden water.

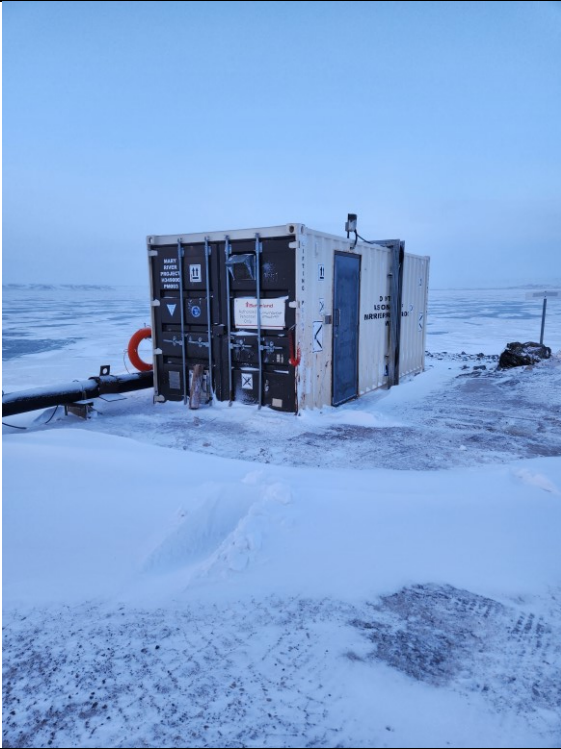
Photo No. 4	Lat/Long (DD.MM.SS.SS, NAD83)
Photo	71.19.666'N, 79.22.962'W

Description: Water Intake Station (Jetty). All systems observed were in proper working condition.

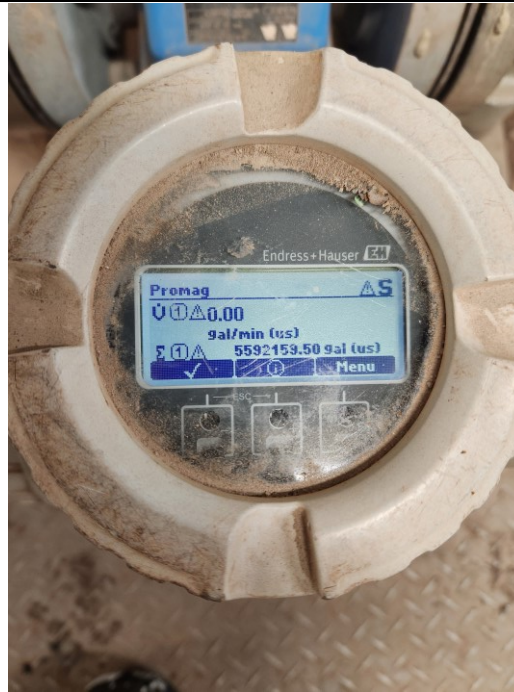
Flow intake meter inside the Water Intake Station.

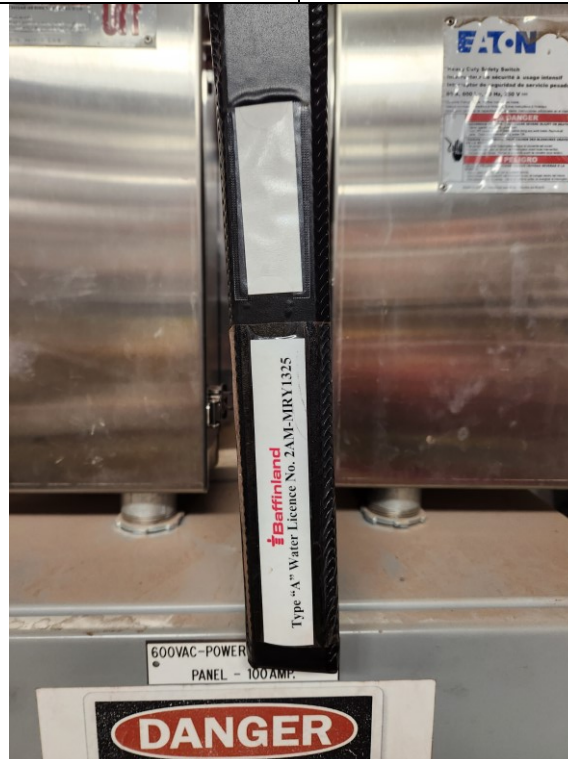
Paper copy of the Water License which was located inside the Water Intake Station.

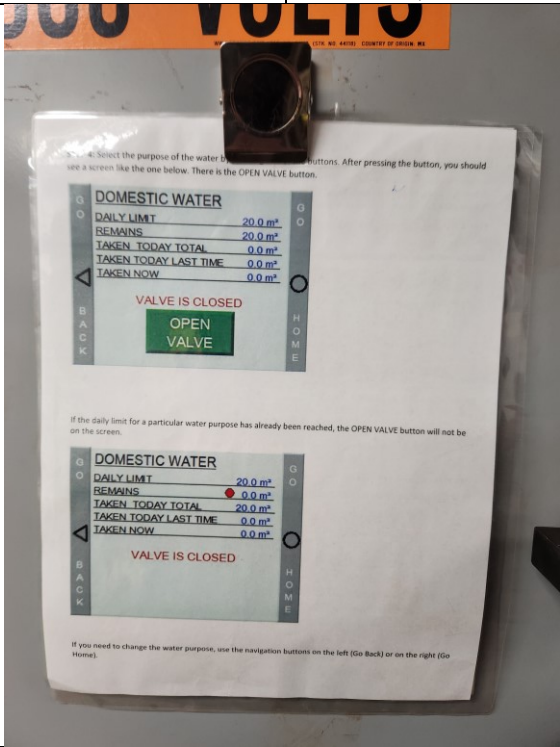
Photo No. 7		Lat/Long (DD.MM.SS.SS, NAD83)
Photo		71.19.666'N, 79.22.962'W

Description:
Computer program instructions. This program tracks and limits the use of water pumped from the station.

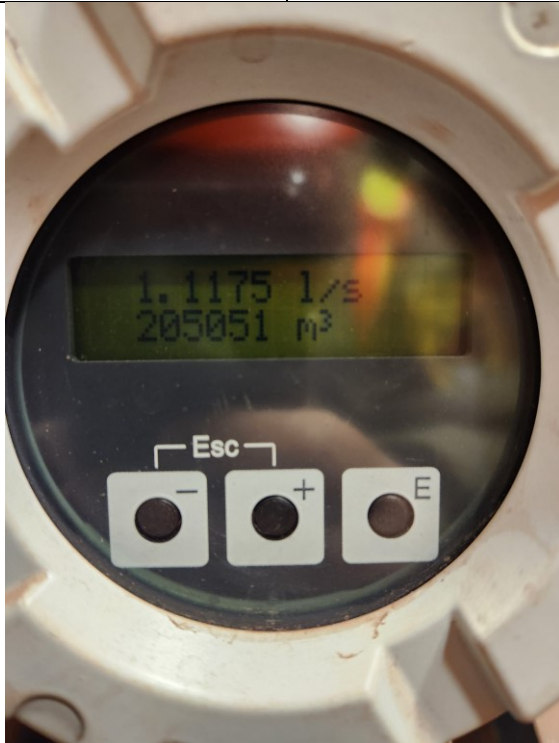
Photo No. 11	Lat/Long (DD.MM.SS.SS, NAD83)
Photo	71.18.850'N, 79.17.982'W

Description: Sewage flow meter inside the Waste Water Treatment Plant.

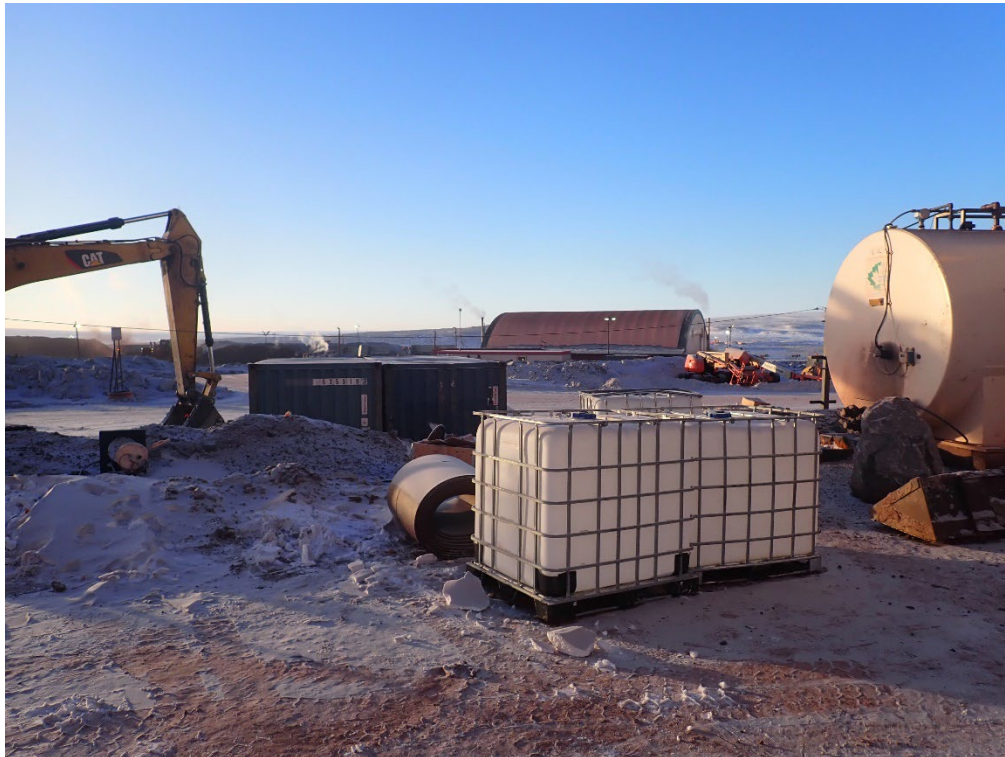
Photo 2. Totes with waste water and waste oil removed from OHT Wash Bay area. Totes pictured in photo are empty. February 18, 2024

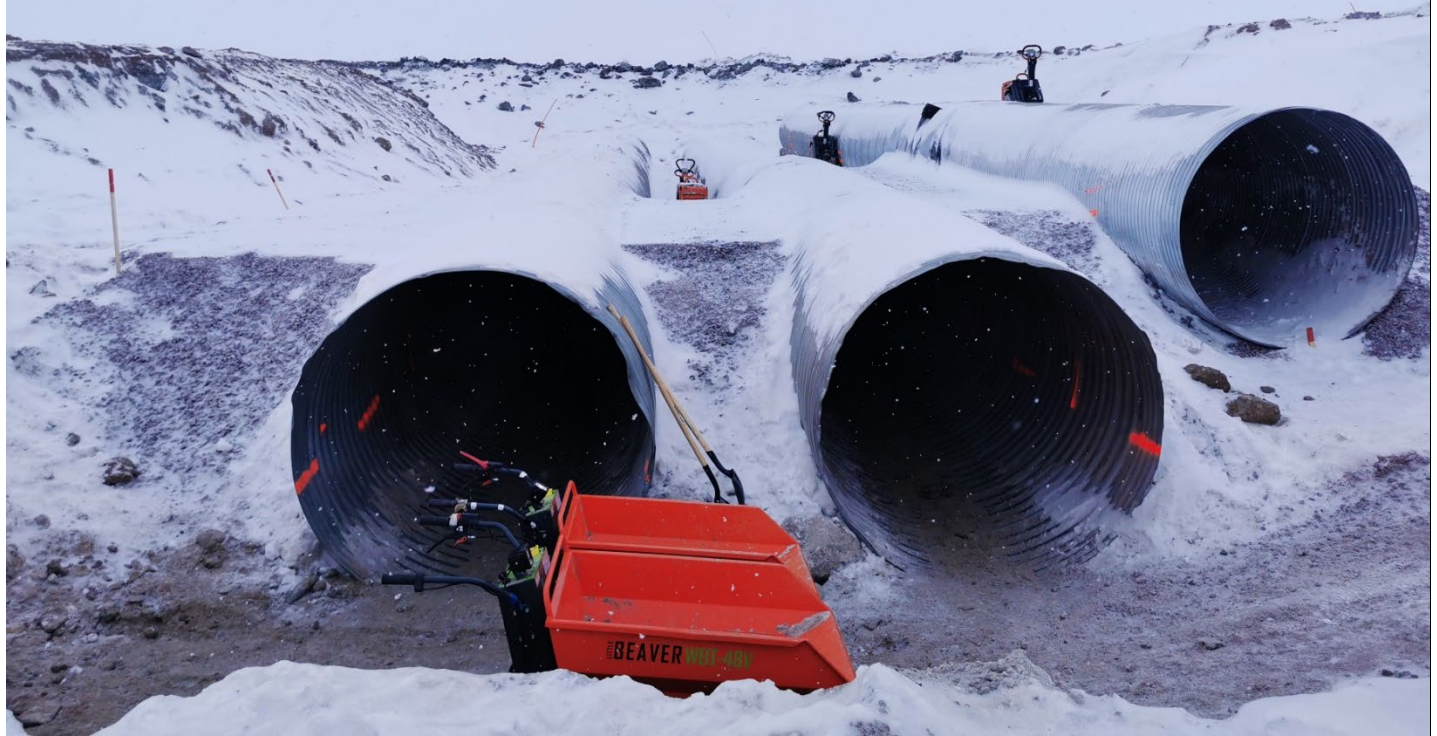
Culvert replacement at Tote Road – KM 95

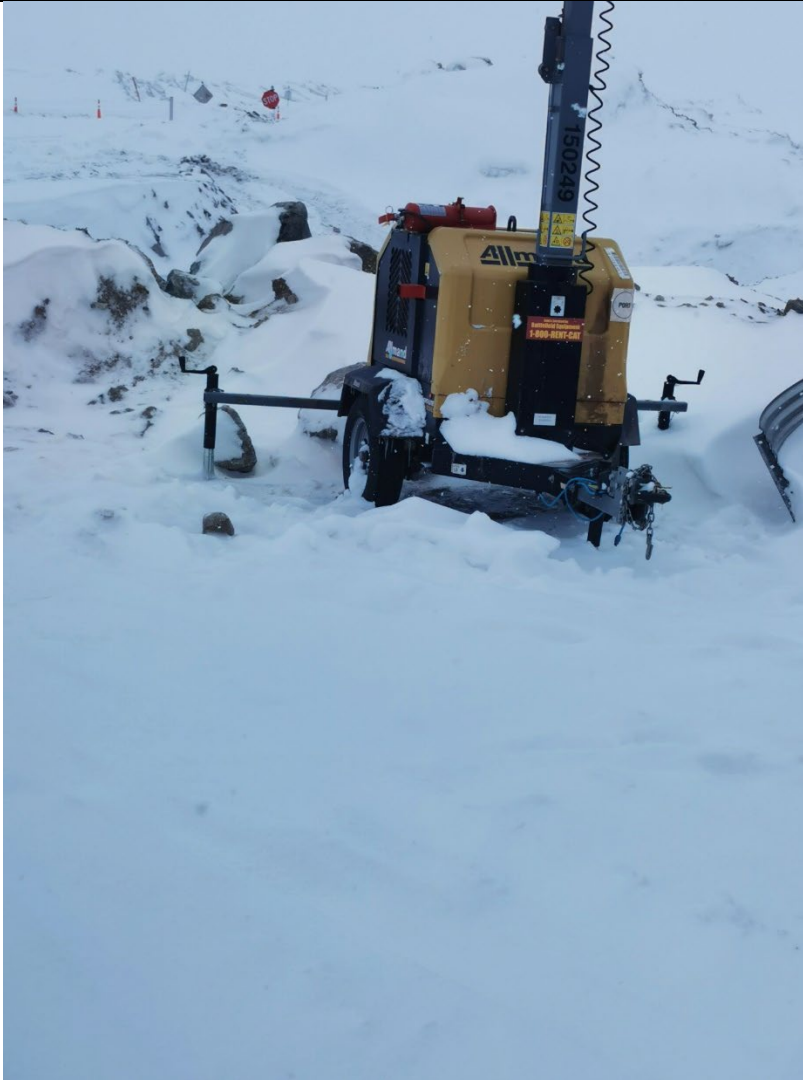
At the Tote Road, inspectors noted ongoing work at KM 95's location where culverts were being replaced by sub-contractor of Nuna Group of Companies, contracted by the Baffinland Iron Mine Corporation. The contractor, as requested by the Baffinland Iron Mine Corporation, was utilizing and placing rocks within the newly installed culverts in order to make the culvert appear more as the natural habitat for fish frequenting the streams through the culverts. Upon closer inspection of the location, the inspectors noted that no secondary containment was deployed under the generator used for lighting or nighttime work. Once photograph was taken, Mr. Deveraux was advised and stated the appropriate action of placing the secondary containment will be taken.

No secondary containment was deployed at KM 95.

- **Ensure that the fence has been repaired.**
- **Ensure secondary containments are deployed at the locations named in this report.**
- **Inspector requests photographs of required work completed no later than two weeks of the receipt of this report.**

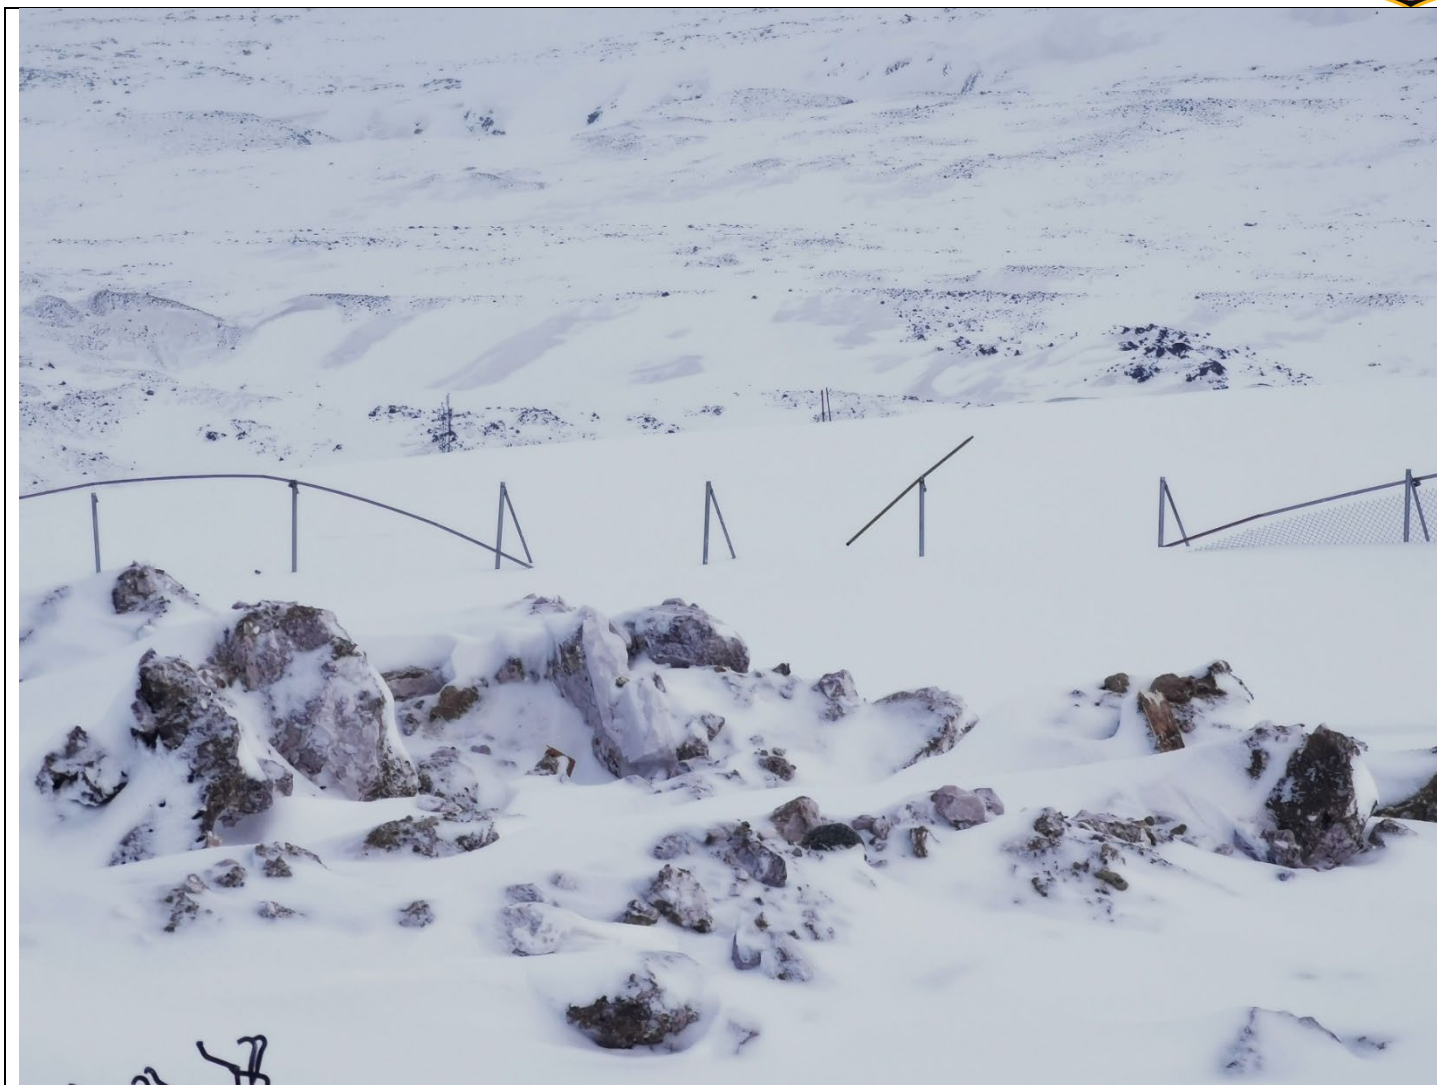
Once at the landfill area, the inspectors noted what appeared to be a significant fence damage. Photograph of the damage was taken and included with this report. Mr. Deveraux was made aware of the concern and stated that he will notify the appropriate site's personnel.

Demaged fence at landfill

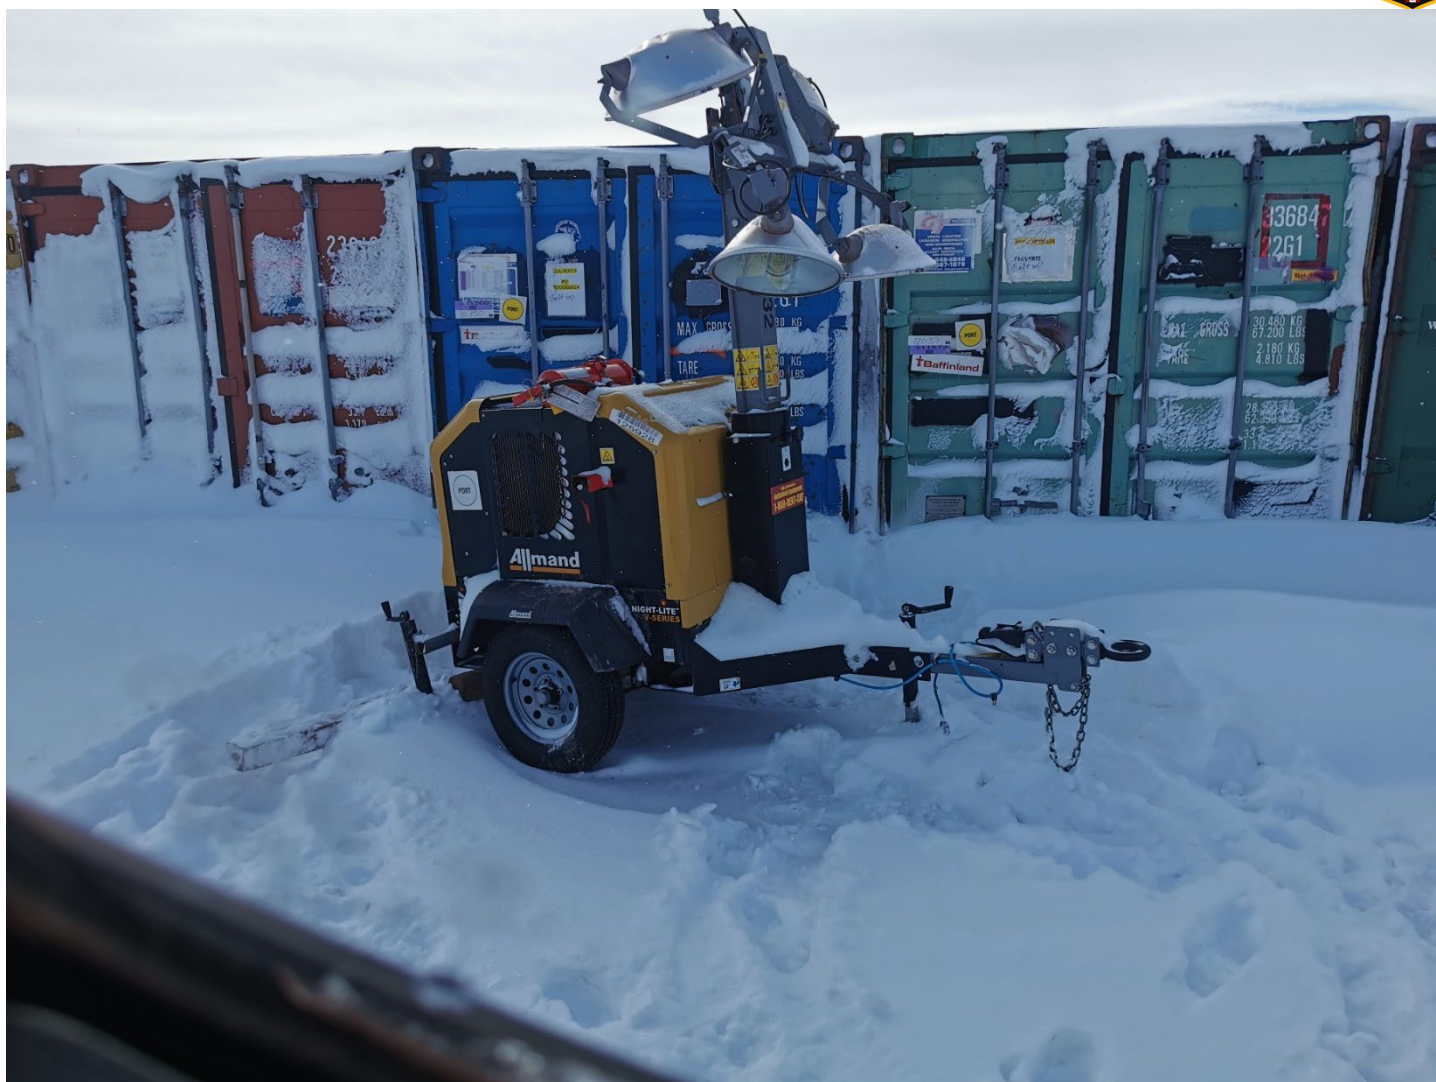
A generator was observed on the site near stacked sea cans with no secondary containment was deployed. Once the photograph was taken, Mr. Deveraux was advised at which time he stated the appropriate personnel will be advised.

No secondary containment deployed at Mary River site

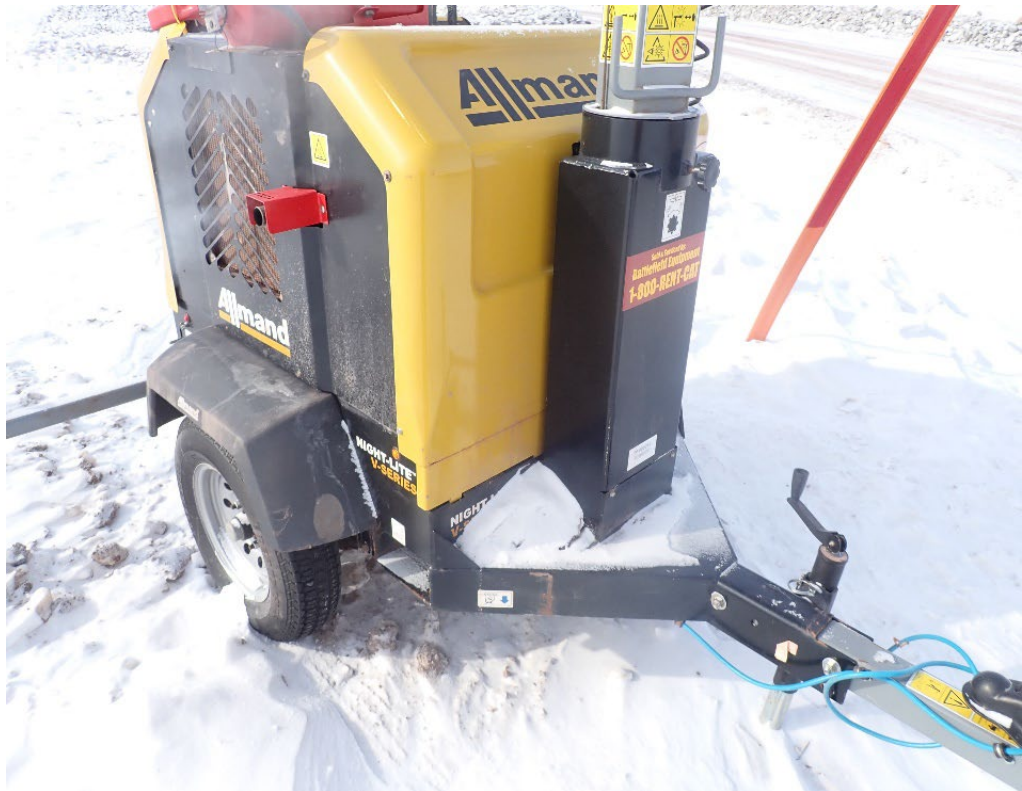
Photo 2: Generator/Light Plant at KM 97 indicating the make and model, April 20, 2024

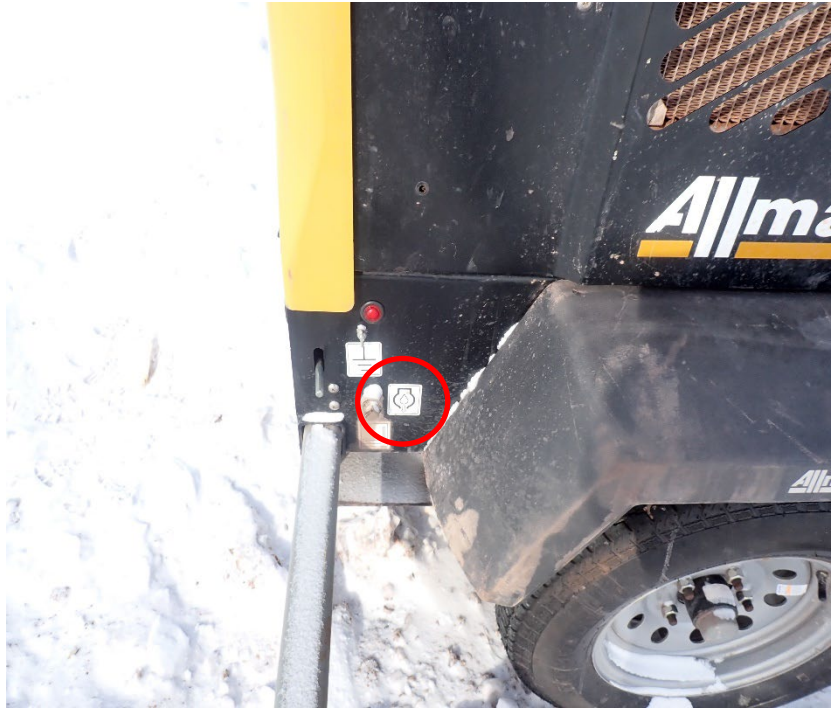
Photo 4: Location of fluid containment system drain plug on the Allmand Night-Lite V-Series located at KM 97, April 20, 2024.

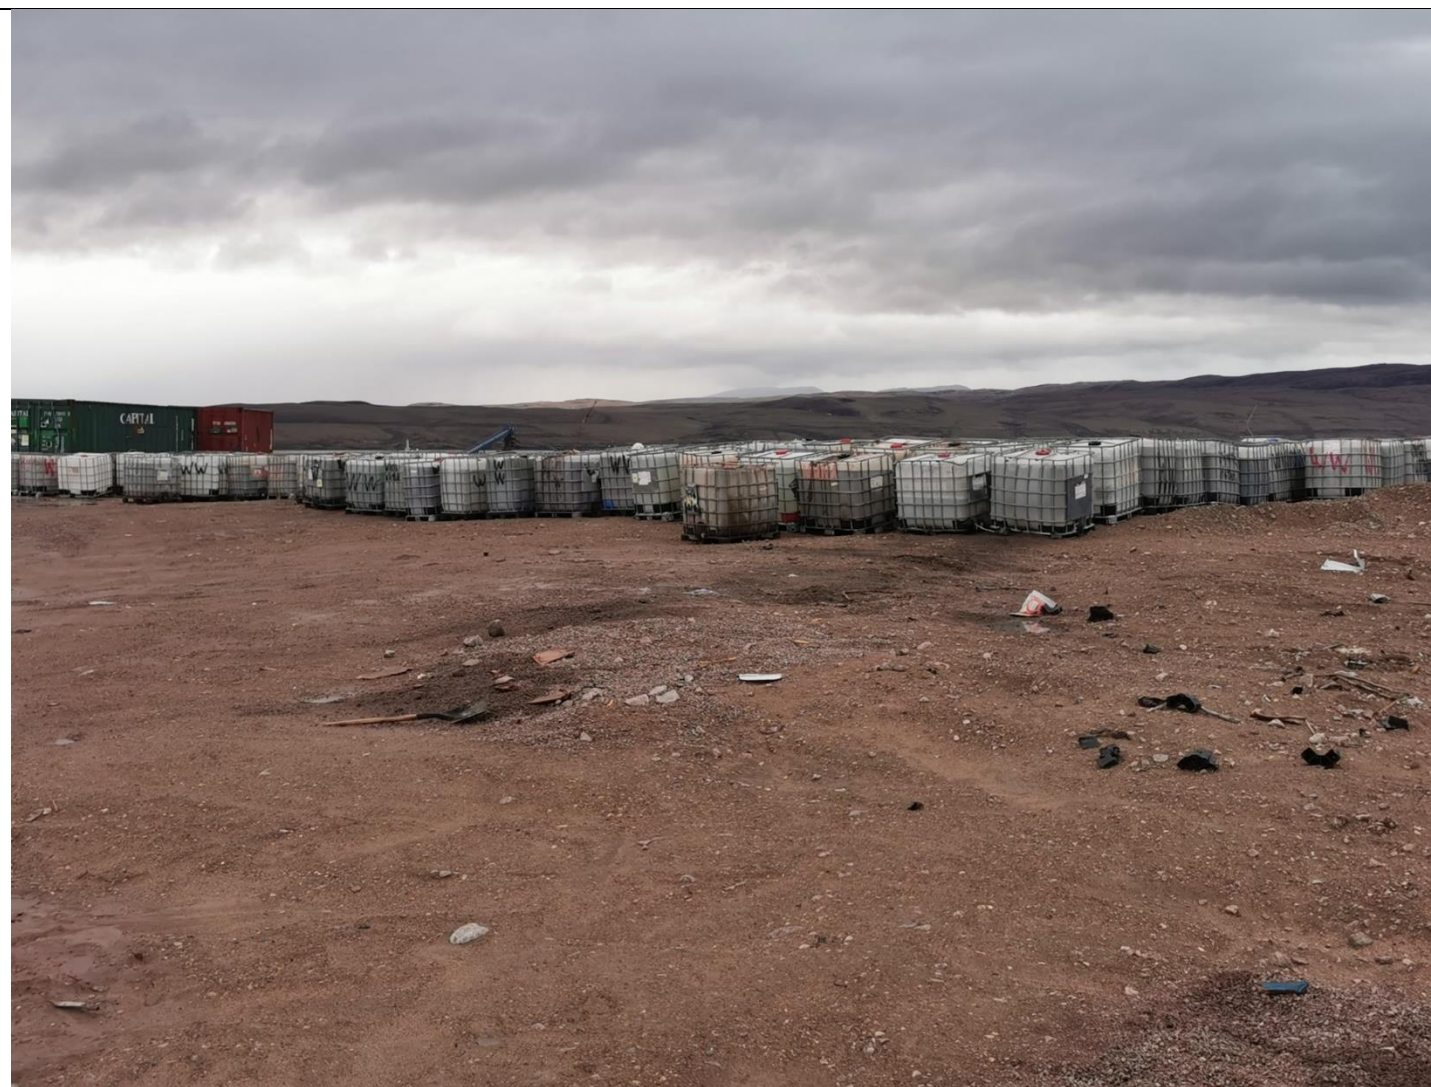
Land farm/Snow dump

- **Secure the loose objects/material within the grounds of the specified area.**

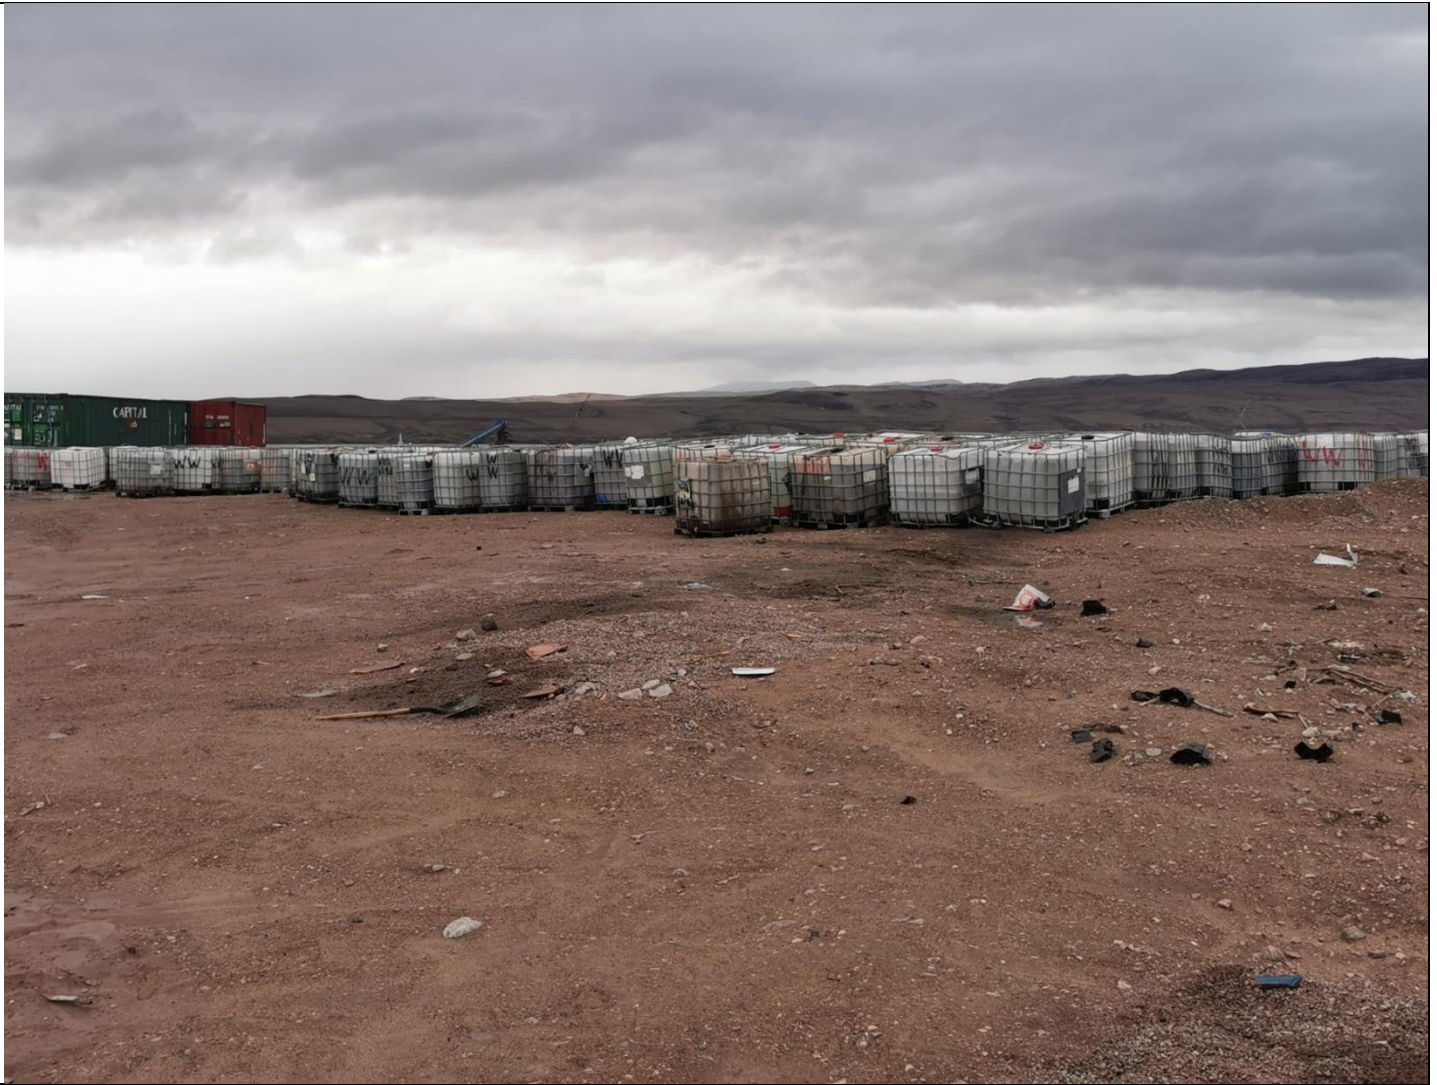
Land farm/Snow dump

- **Secure the loose objects/material within the grounds of the specified area.**

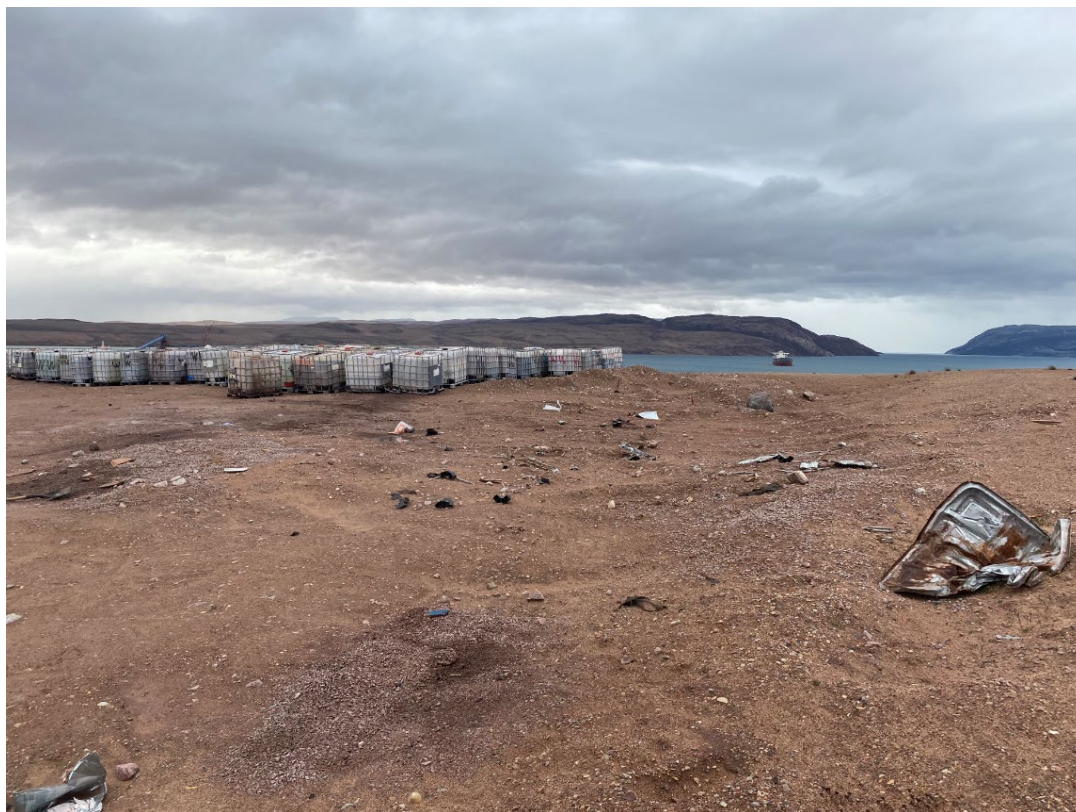
1) Debris at the Milne Port Landfarm – before clean up. July 31, 2024

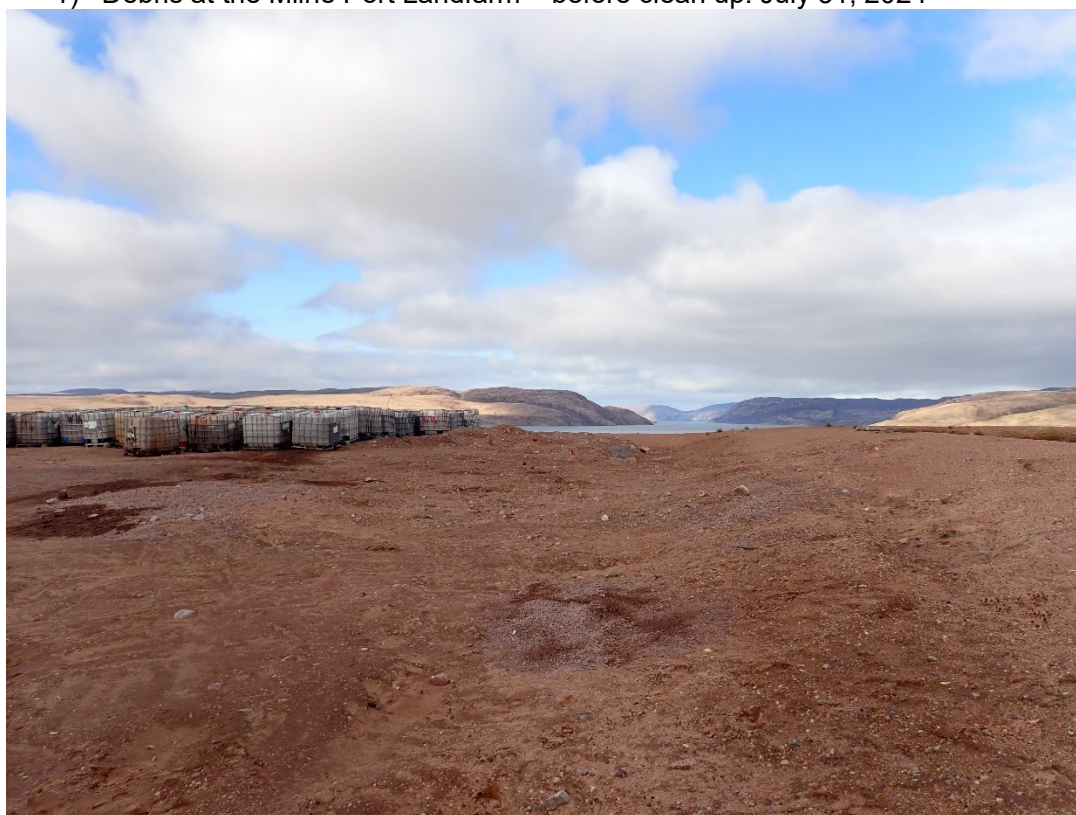
2) Debris at the Milne Port Landfarm – removed. August 2, 2024

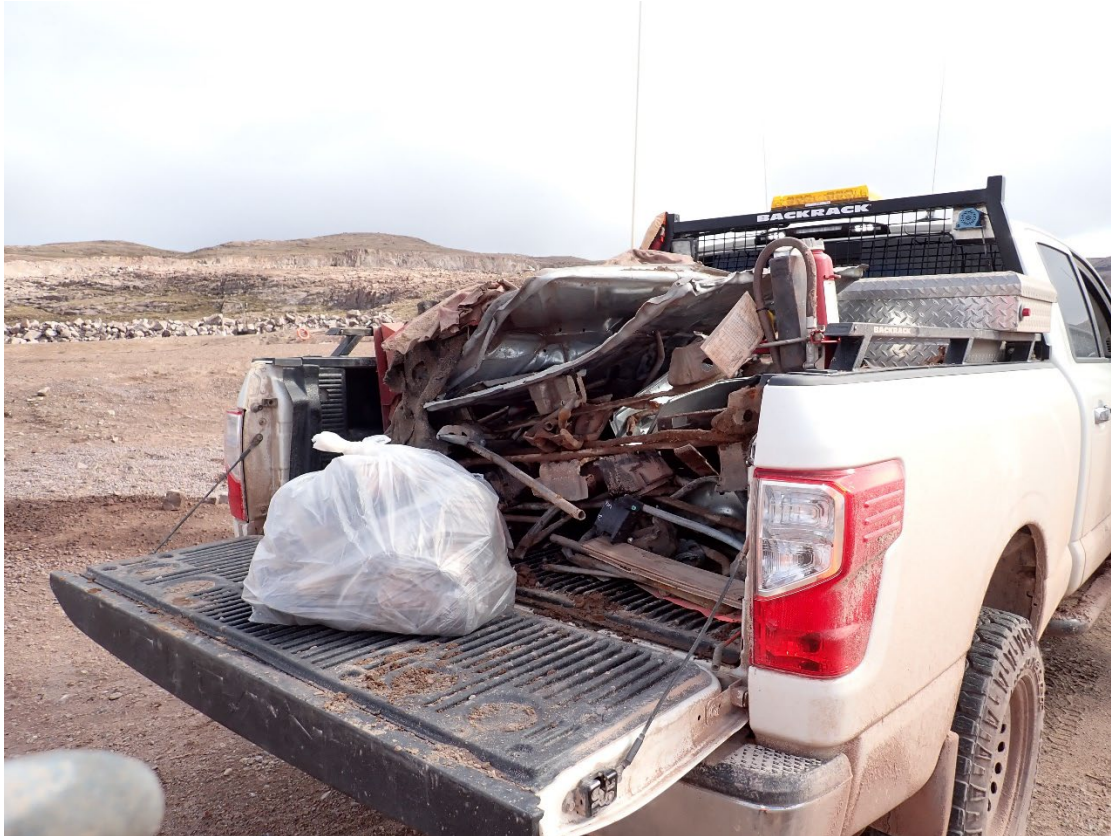
3) Debris removed from the Milne Port landfarm. August 2, 2024.

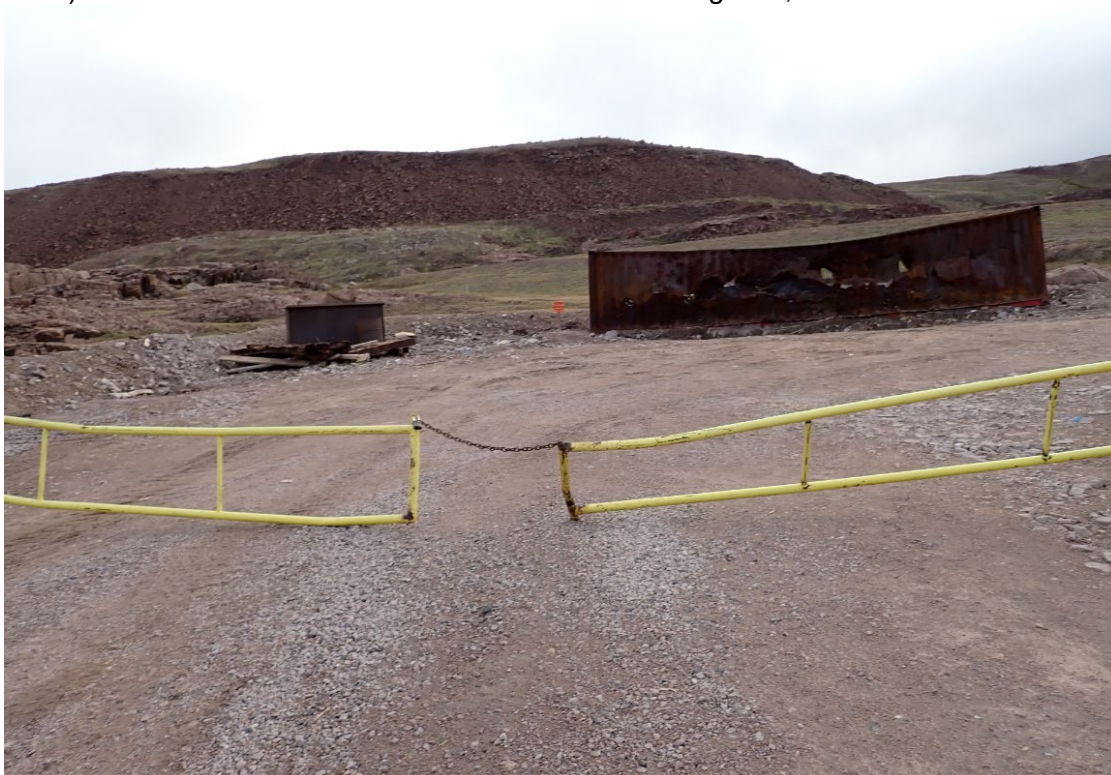
4) Milne Port Open Burn showing gates locked and good housekeeping – August 3, 2024.

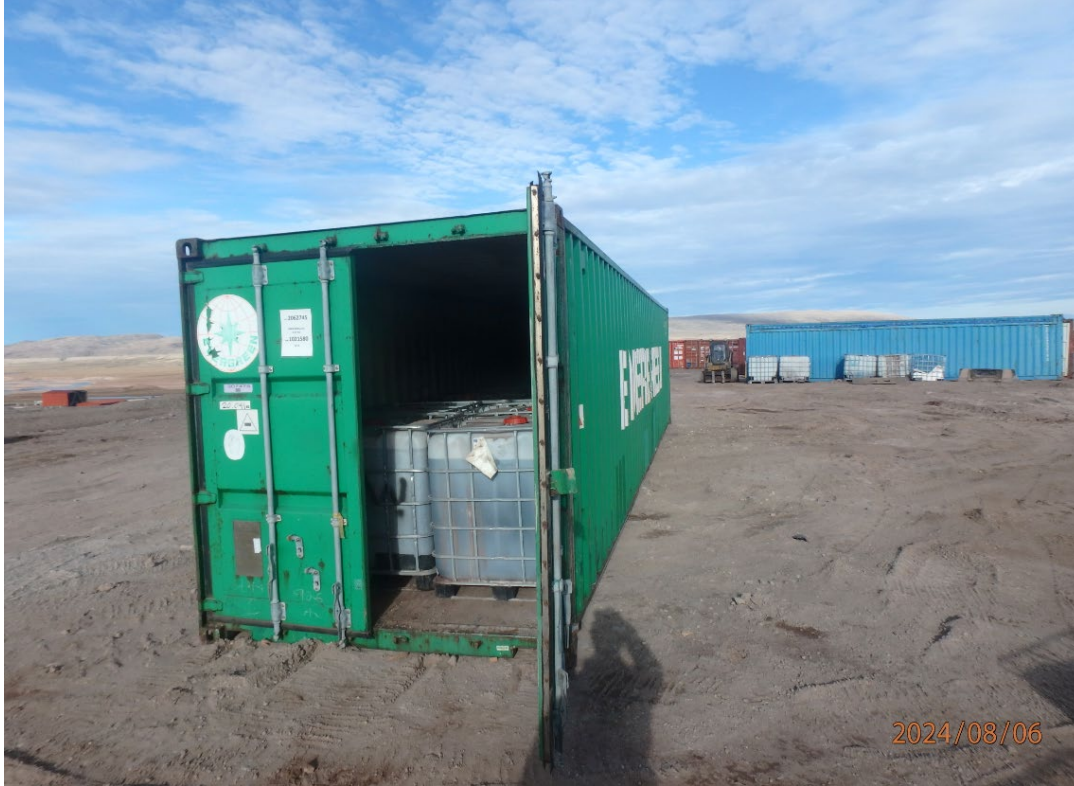
5) Waste water totes being loaded into sea cans at Mile Landfarm – August 6, 2024

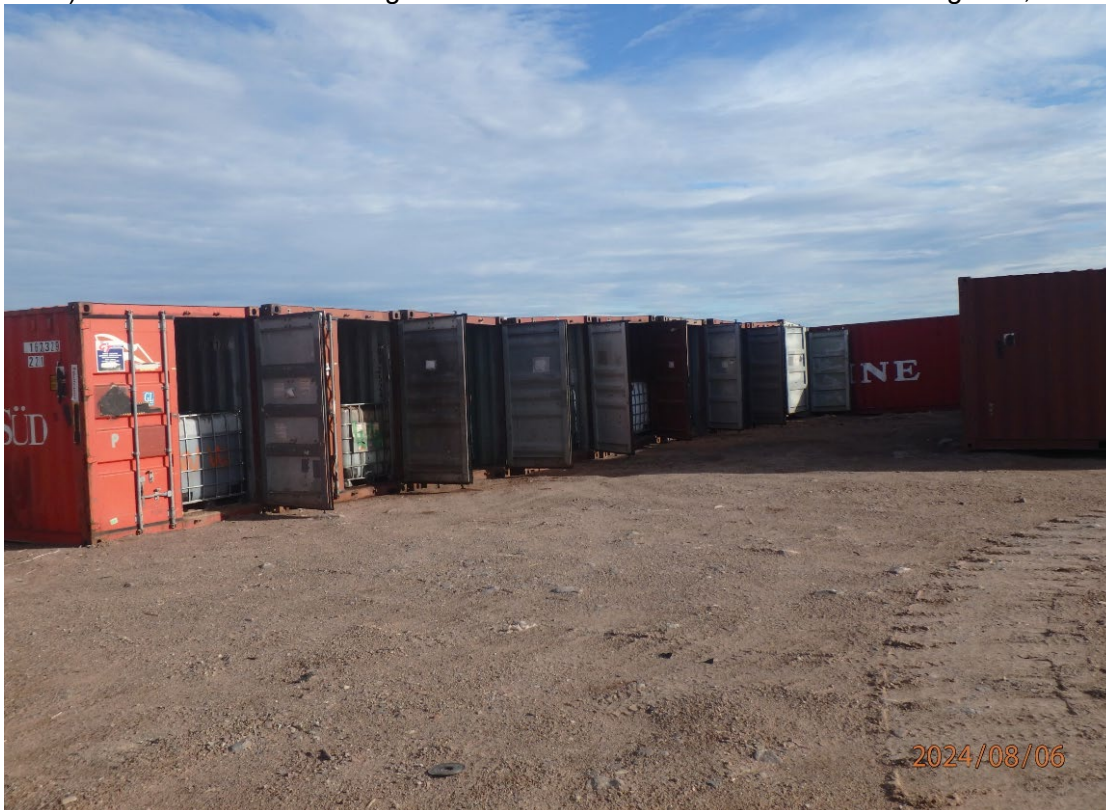
6) Seacans being staged for removal of waste water totes at Mile Landfarm – August 6, 2024

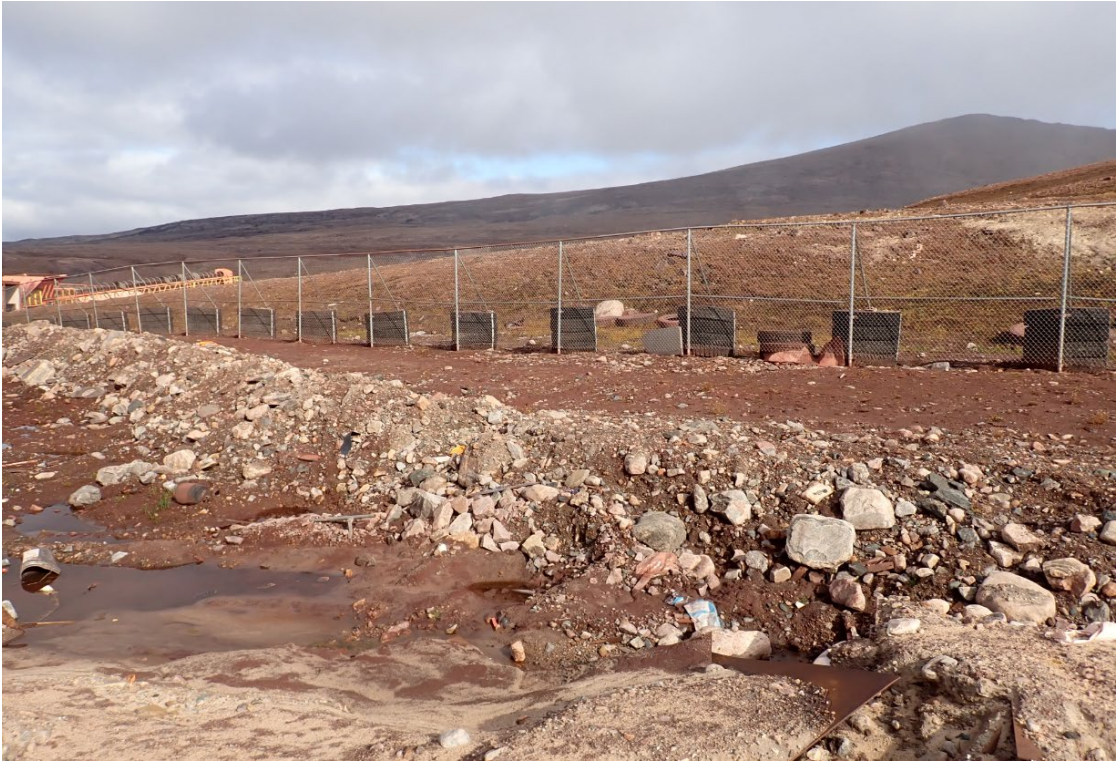
7) Landfill fence repairs completed (from April Inspection report)
