APPENDIX E.8
Regulatory Correspondence

CIRNAC Inspection Report and Baffinland Responses

Water Licence Inspection Report

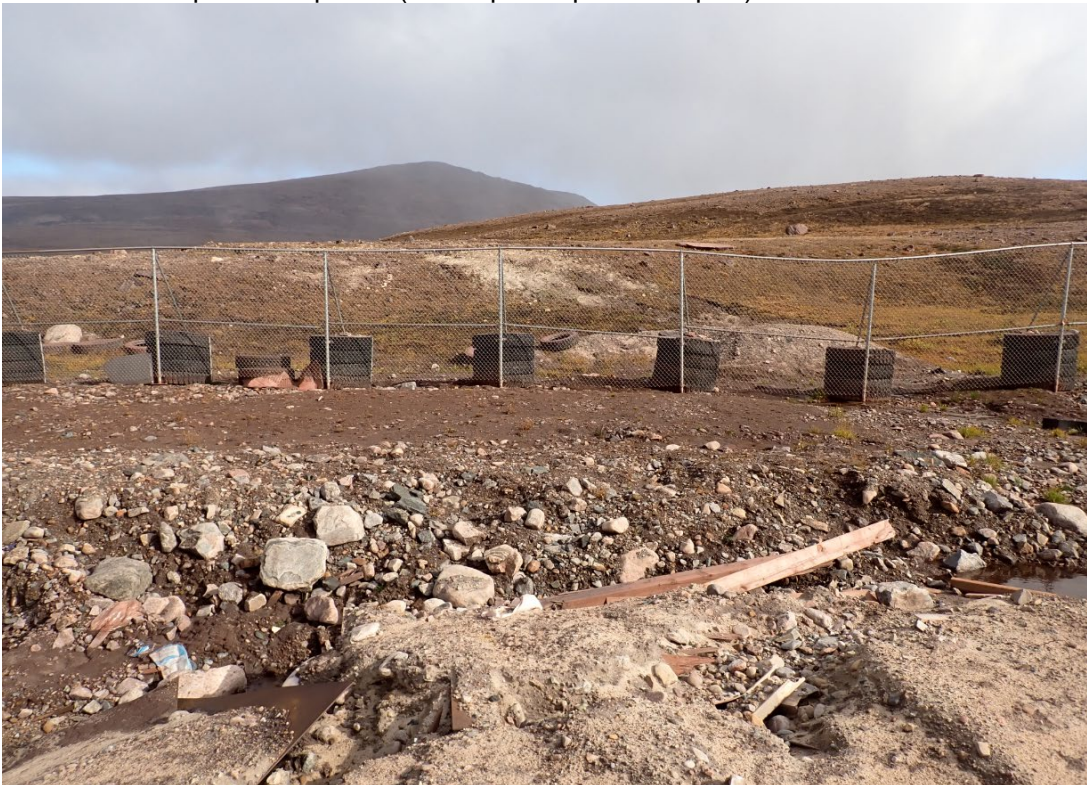
8) Landfill fence repairs completed (from April Inspection report)

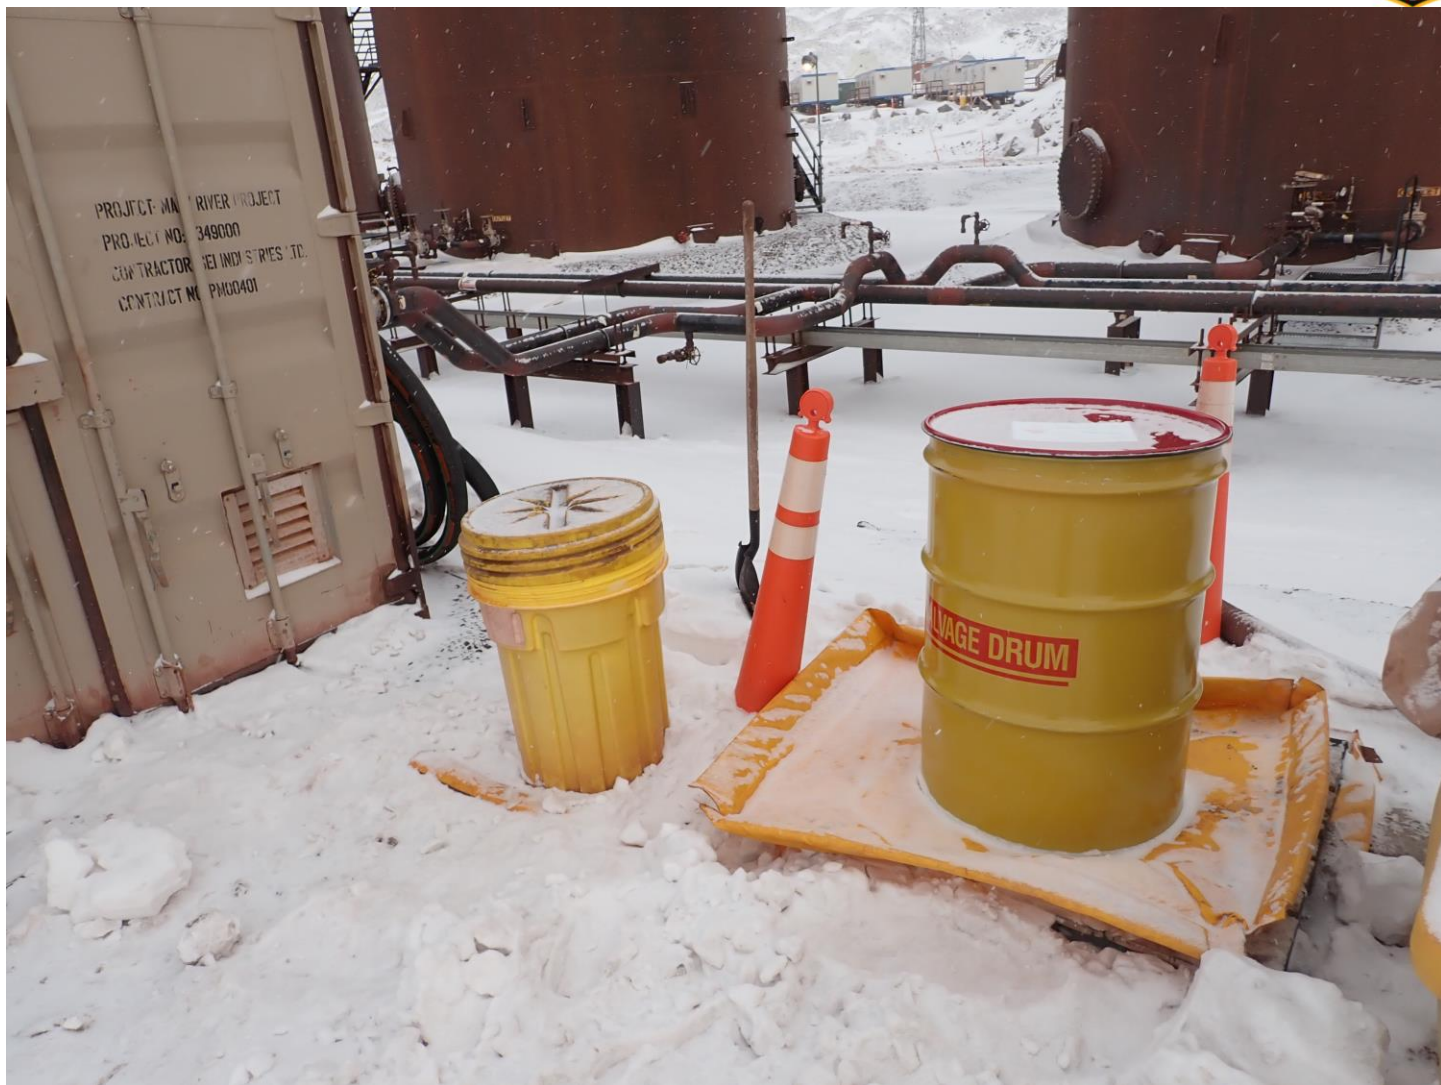
Picture showing clean-up completed at the location identified above in the report.

- We cleaned up the fuel mod area and removed the used absorbent hydrocarbon pads.
- We will remove the culverts downstream of the km 63.5 crossing when conditions have fully frozen and working around the high water mark with heavy equipment is safe to do so.

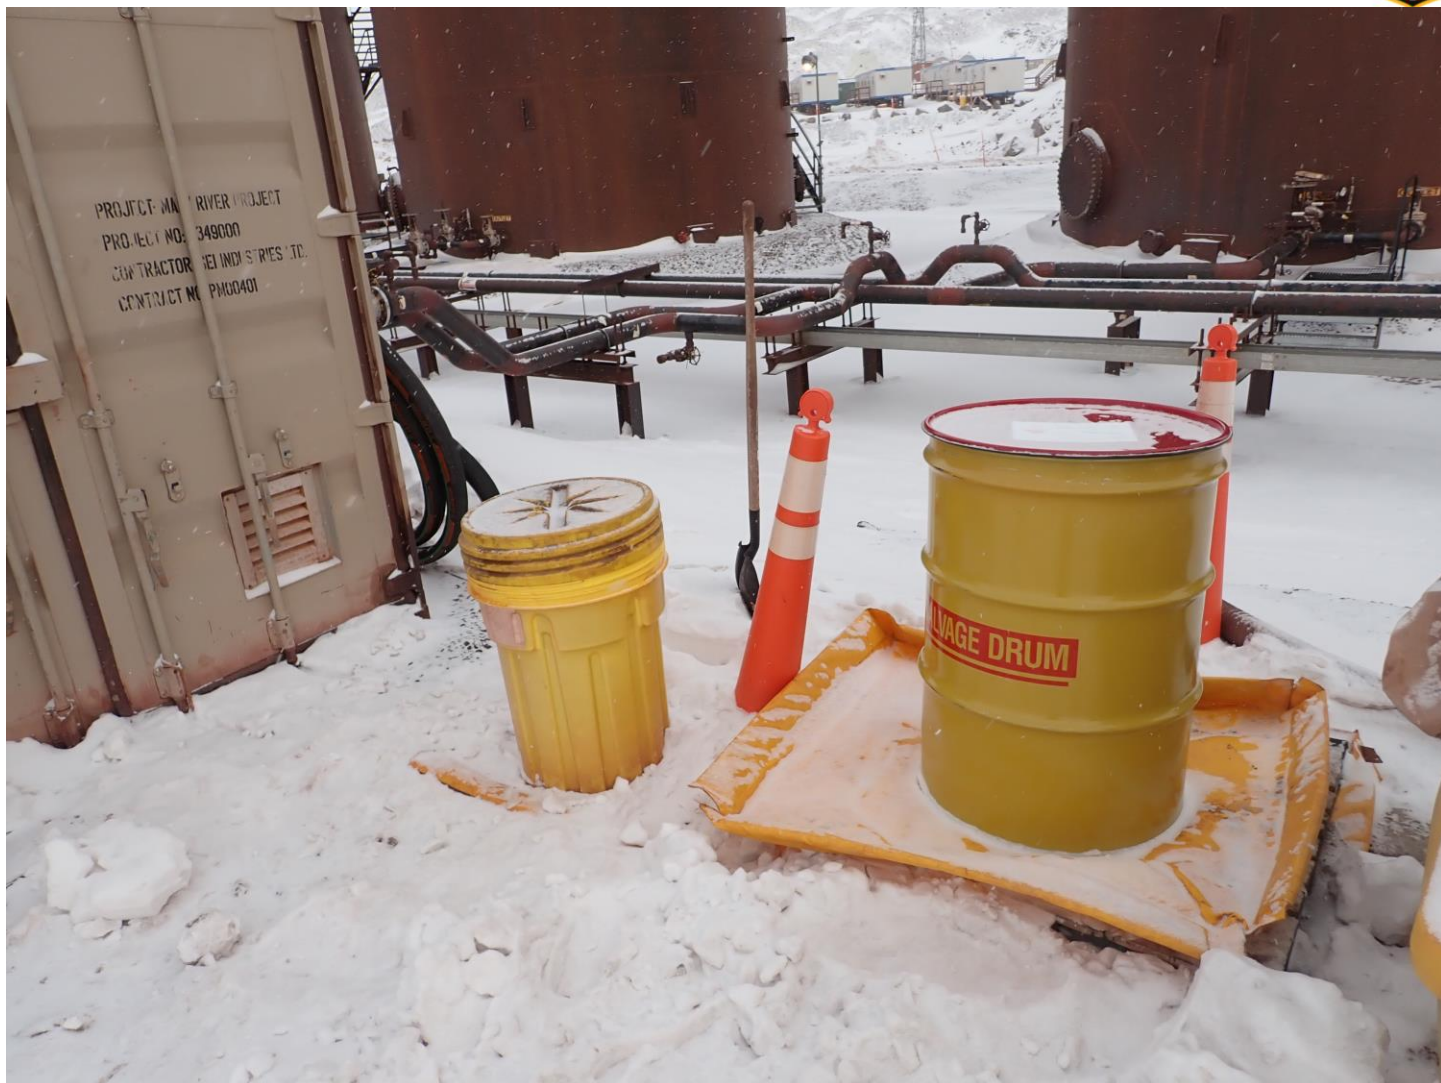
Picture showing clean-up completed at the location identified above in the report.
