June 10th – June 12th, 2024, Environmental Inspection

RE: Baffinland Iron Mines Corporation's Mary River Project – Qikiqtani Inuit Association September 2024 2nd Annual Site Inspection Findings and Recommendations

Baffinland Mine Site Investigations APPENDIX A - PHOTOGRAPHS

Baffinland Mine Site Unscheduled Environmental Investigation

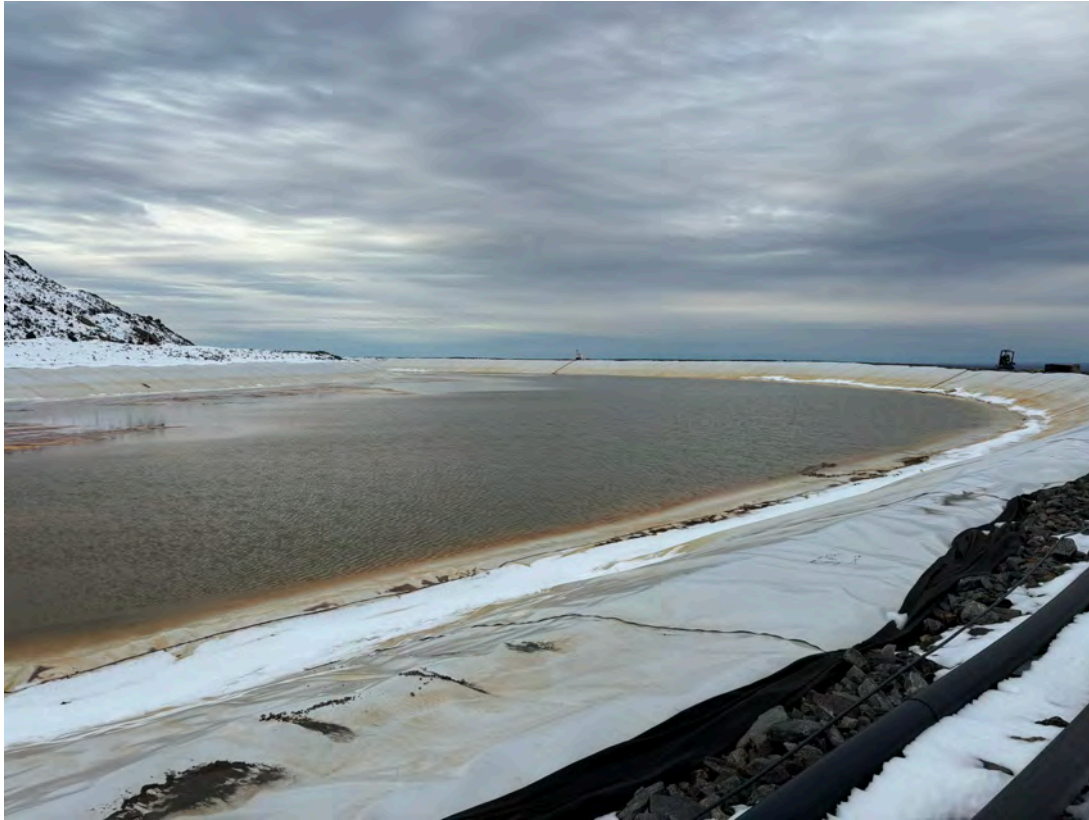
Photo 1 – Waste Rock Facility treatment pond (Sep 2024).

The liner at the Waste Rock Facility treatment pond remains untested by the supplier and therefore carries a risk of seepage of untreated water into the adjacent tundra. We recommend the liner be tested as soon as feasible (i.e. when the pond holds adequate volume), and repair, if necessary, to the liner take place to prevent future seepage.

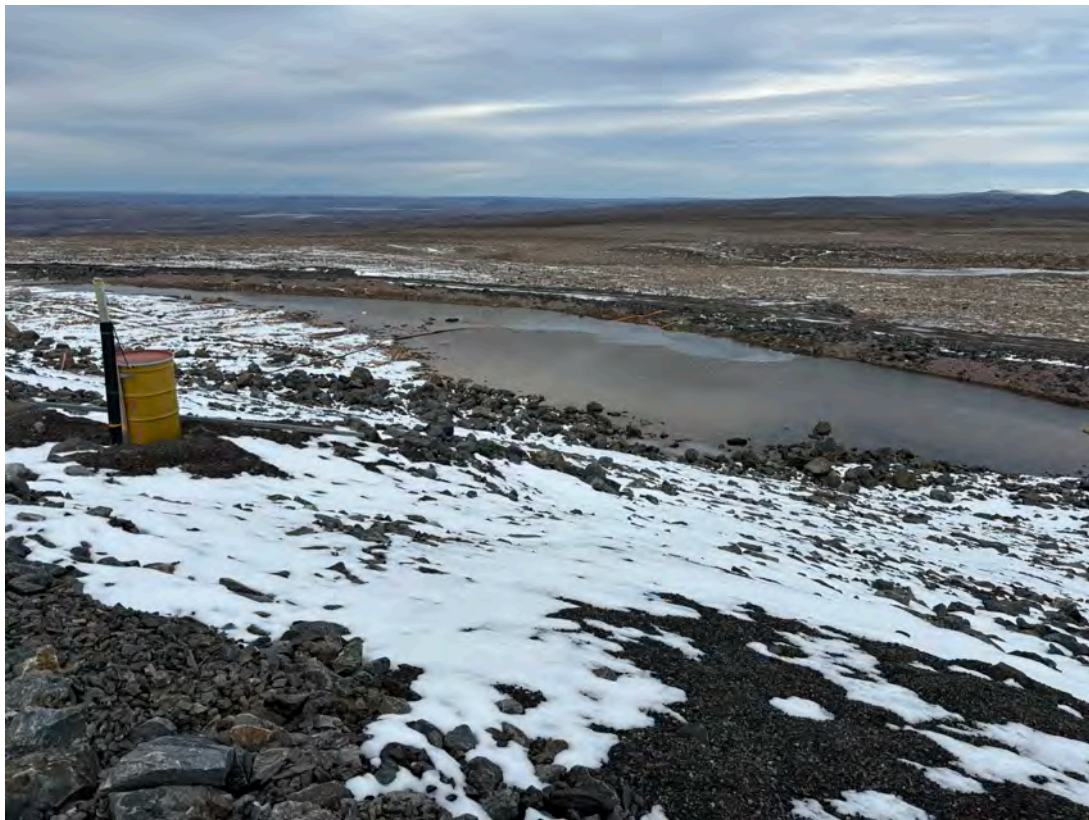
Photo 2 – Waste Rock Facility treatment pond – pooled water at base of berm (Sep 2024).

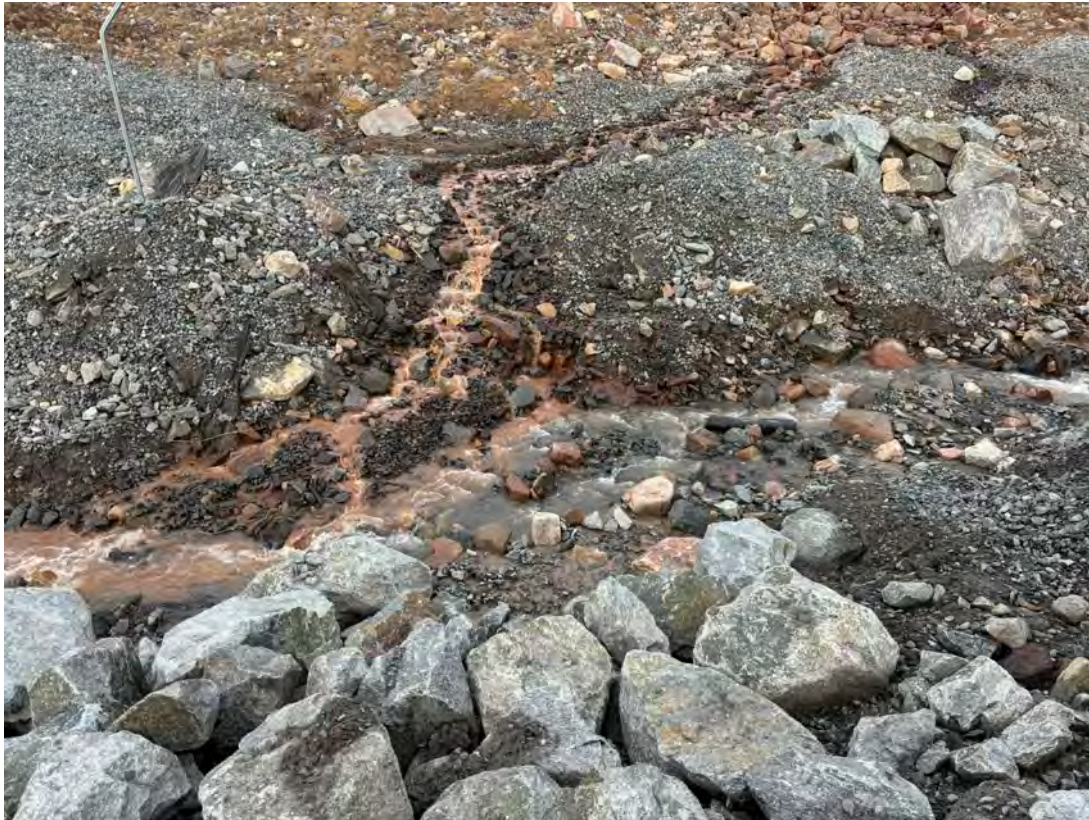
At approximately KM 106.5 the Inspectors noticed sediment-laden runoff originating from up-slope on the mountain and running into the north ditch of the haul road. The sediment laden water was visibly turbid. A noticeable increase in turbidity was observed when sediment laden water mixed with the relatively clear runoff from the haul road ditch. The Inspectors walked up slope for a short distance, but the source of the runoff was not determined. Katie Babin indicated that drone imagery could be taken and provided to determine the source and cause of the turbidity.

Photo 3 – Sediment laden runoff from upslope at KM106.5 (Sep 2024).

The source of the sediment-laden runoff observed at approximately KM 106.5 should be assessed and remediated to prevent further sedimentation into the Haul Road ditch. We have learned since the Inspection, the source is likely from a fracture in the bedrock that is receiving sediment laden water from somewhere in the active mining area. High-level drone imagery was provided of the area, but did not provide a clear image of the source of the sediment laden water. We recommend

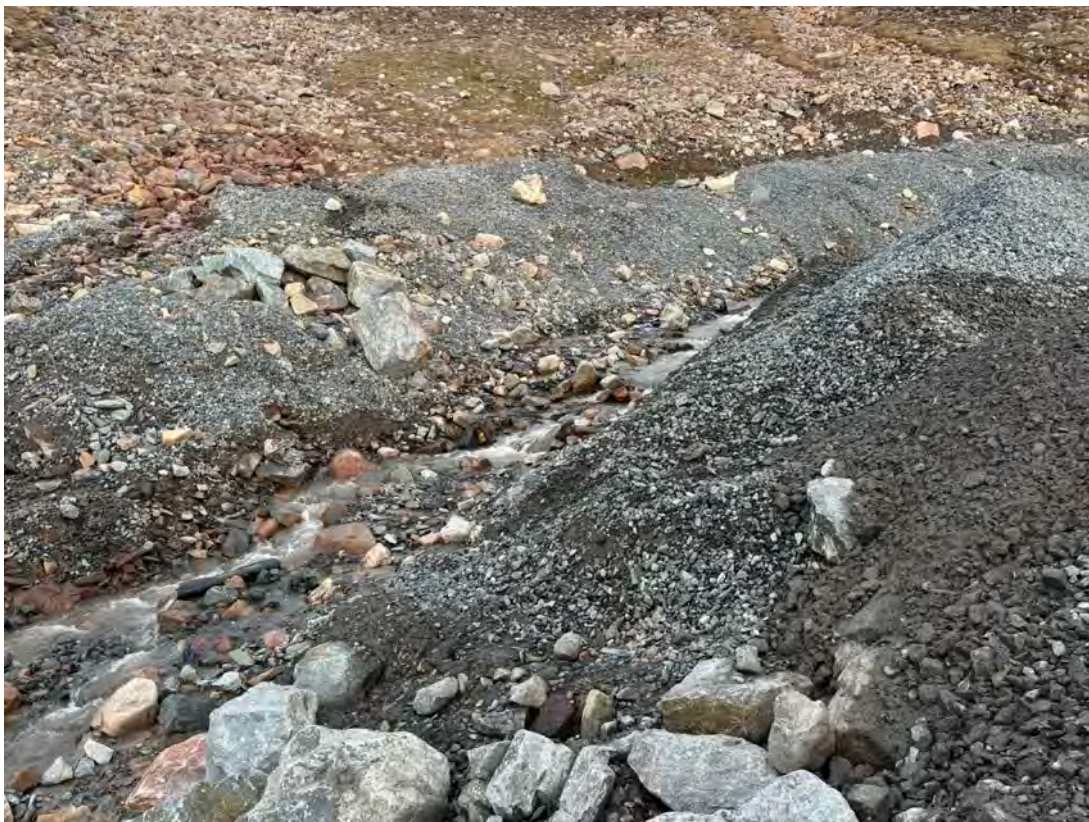
Photo 4 – Upstream of sediment laden runoff from upslope at KM106.5 (Sep 2024).

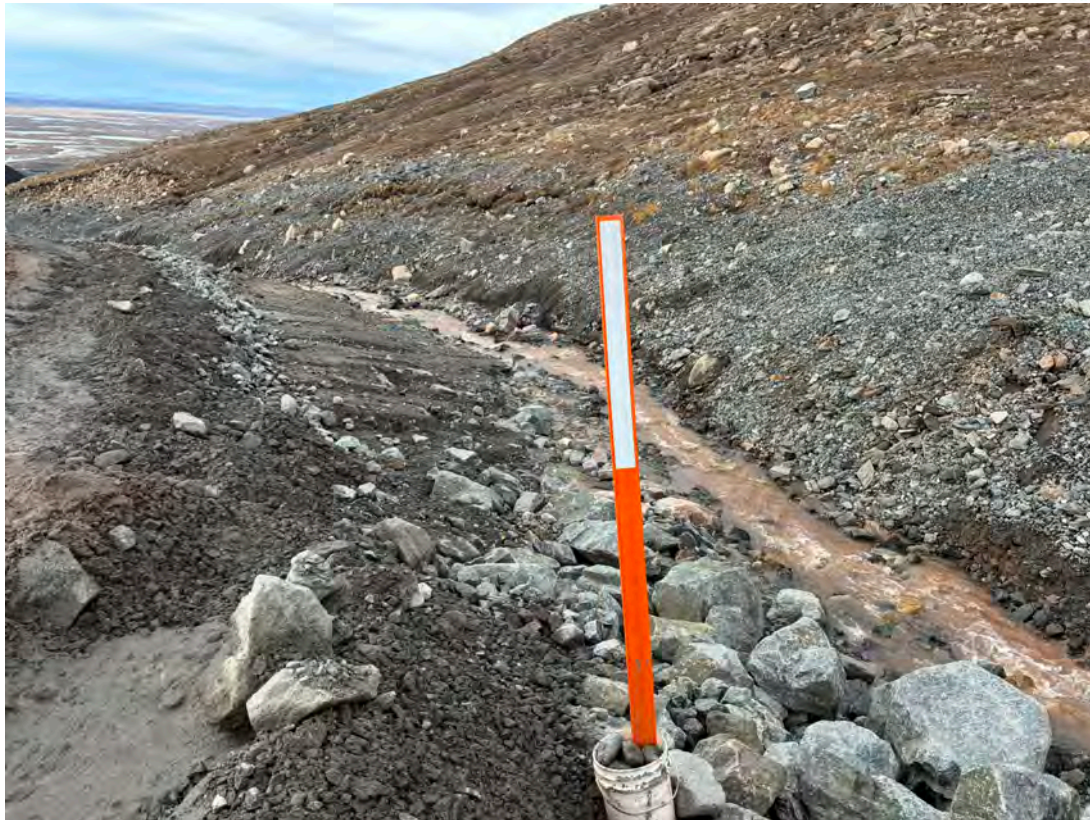
Photo 5 – Downstream of sediment laden runoff from upslope at KM106.5 (Sep 2024).

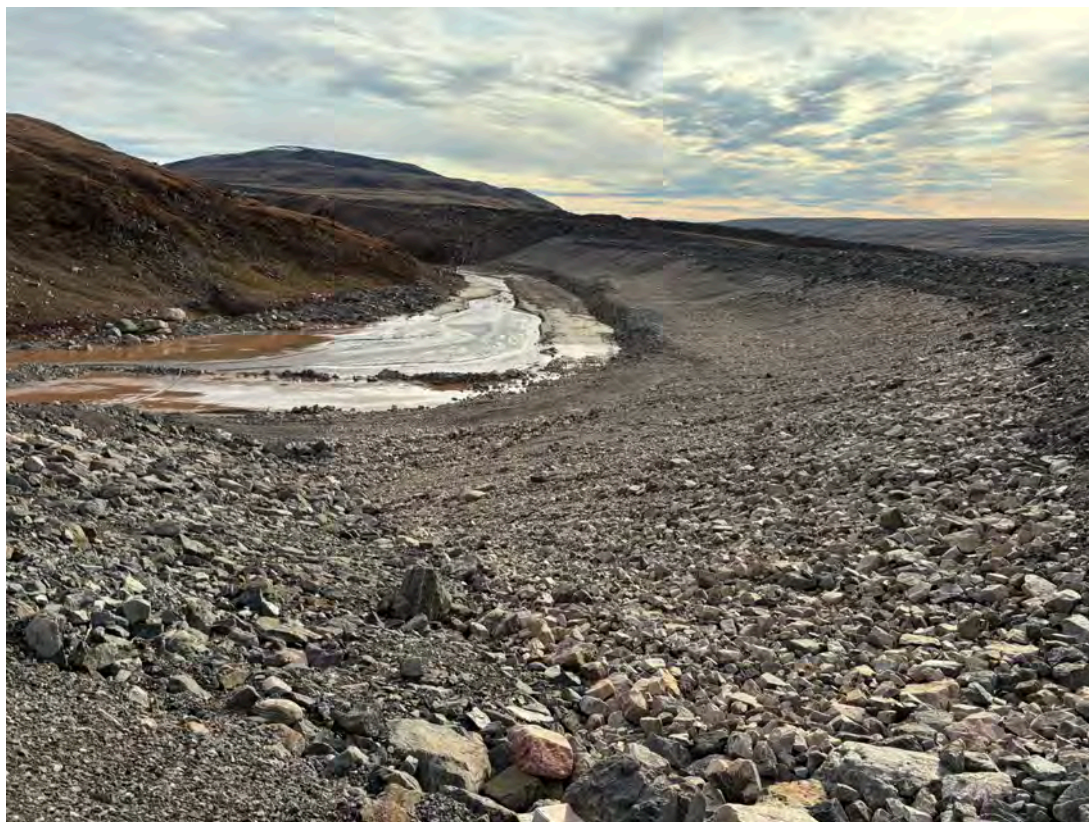
The Environmental Inspectors evaluated pond KM 105 and the new water treatment system. The treatment system was not functional as it was in winter shutdown condition. It was clarified to the Inspectors that the treatment system was functional only when the dam was holding sufficient water in the upstream holding area. We understood that the water treatment system was not functional for the majority of the time from the end of the June Inspector visit to the winter shutdown. The water held in the area downstream of the dam (seepage water) contained visibly high levels of turbidity, which was conveyed to the natural tundra area downstream of the dam. This area appeared to be inundated with turbid water, indicating much of the sediment dropped out of suspension in this area, creating a sink for fine sediments. No notable efforts since the previous June visit were made to repair the dam seepage issue. It should be noted that the flows from the Sheardown Tributary at the Mine Road were relatively clear with no visible turbidity, indicating sediments are dropping from suspension between the dam and road.

Photo 6 – Upstream of KM105 pond with SW Embankment visible on the right side (Sep 2024).

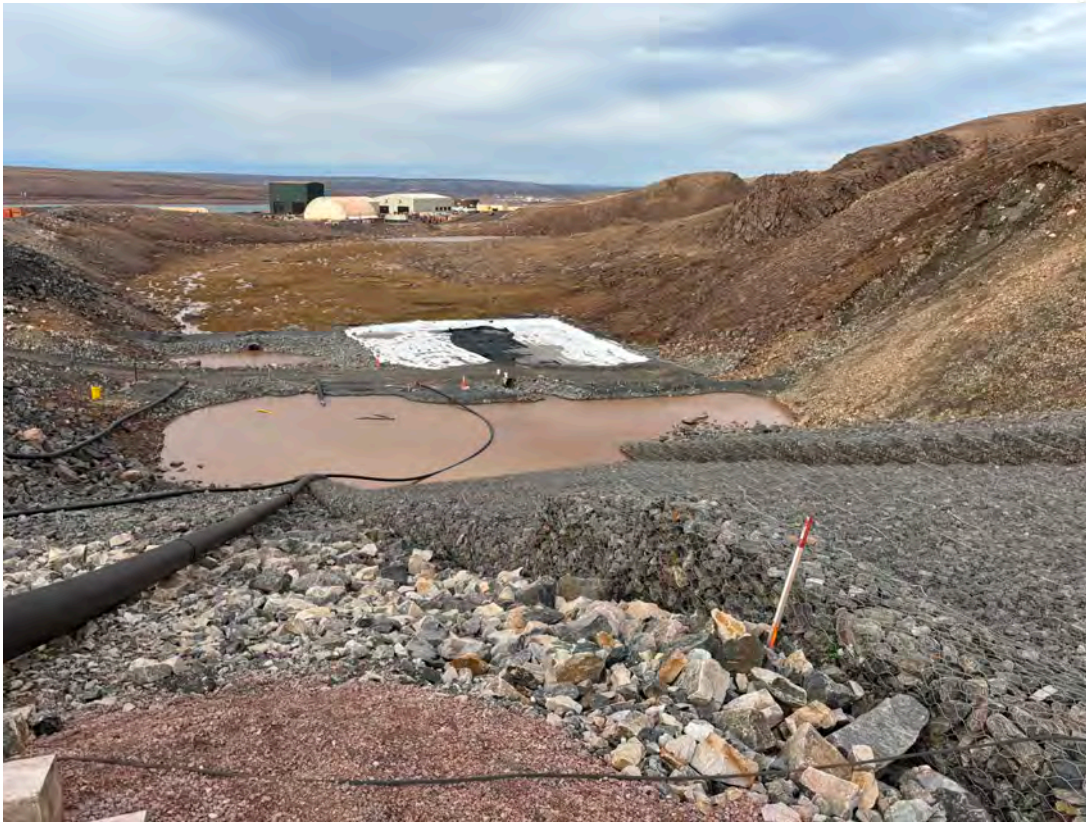
Photo 7 – Downstream of KM105 Dam (Sep 2024).

As described to the Inspectors, the water treatment system at KM 105 is not functional while the dam is not able to hold back water. The water treatment system would, therefore, appear to not be a viable form of water treatment until dam repairs are completed. QIA is of the opinion a clear plan is required for the repair of the KM 105 dam, or an effective alternative should be presented. The treatment of runoff from the active mining area and haul roads, remains the utmost of importance to QIA. The long-term effects to all areas downstream of the dam and to Sheardown Lake are at risk. It is our professional opinion that some of the concerns, namely the exceedances of TSS and the sustained high concentrations of high levels of TSS could be in contravention of section 34(1) *deleterious substance* of the federal *Fisheries Act*. Areas a few hundred metres downstream of KM 105 pond directly support fish and fish habitat, and as such, increased priority should be placed on preventing sediments from entering these waters. Control of the source of sediments is crucial and the fundamental principal in sediment and erosion control. As with the previous inspections, the extent of sediment loading into Sheardown Lake is unacceptable and effective measures should be taken to rectify all sediment transport conditions

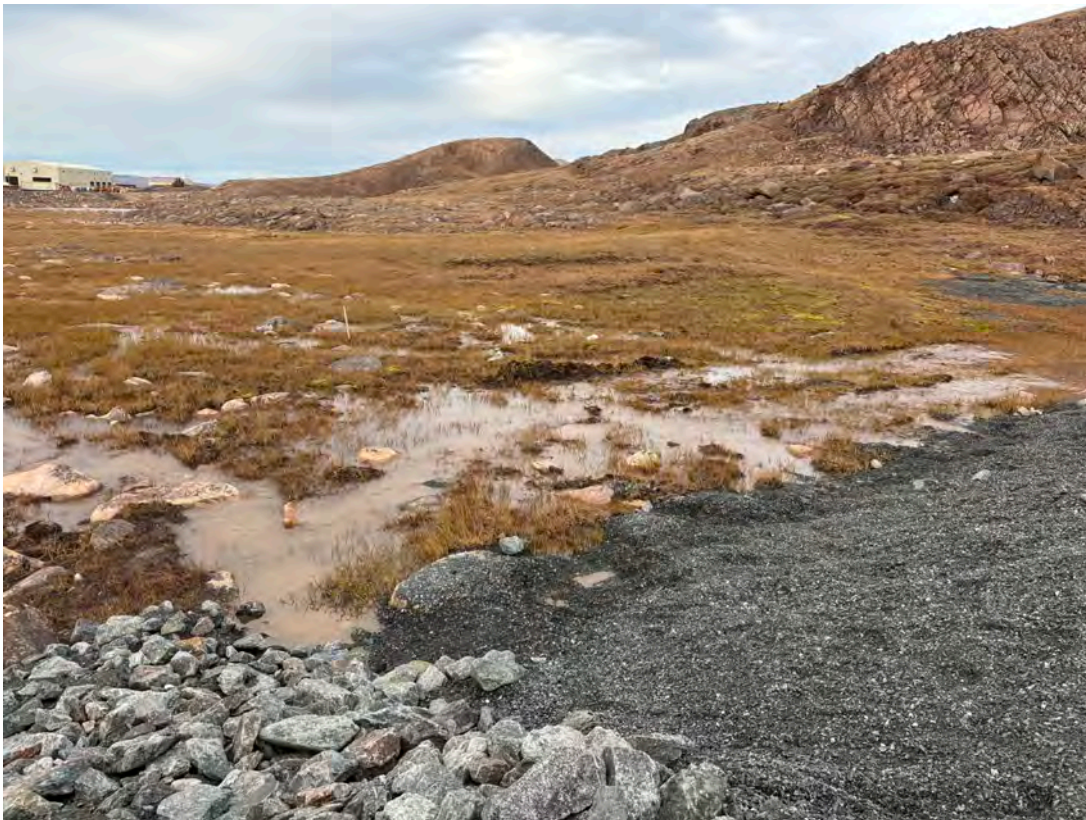
Photo 8 – Downstream of KM105 Dam looking at sediment laden runoff on the tundra (Sep 2024).

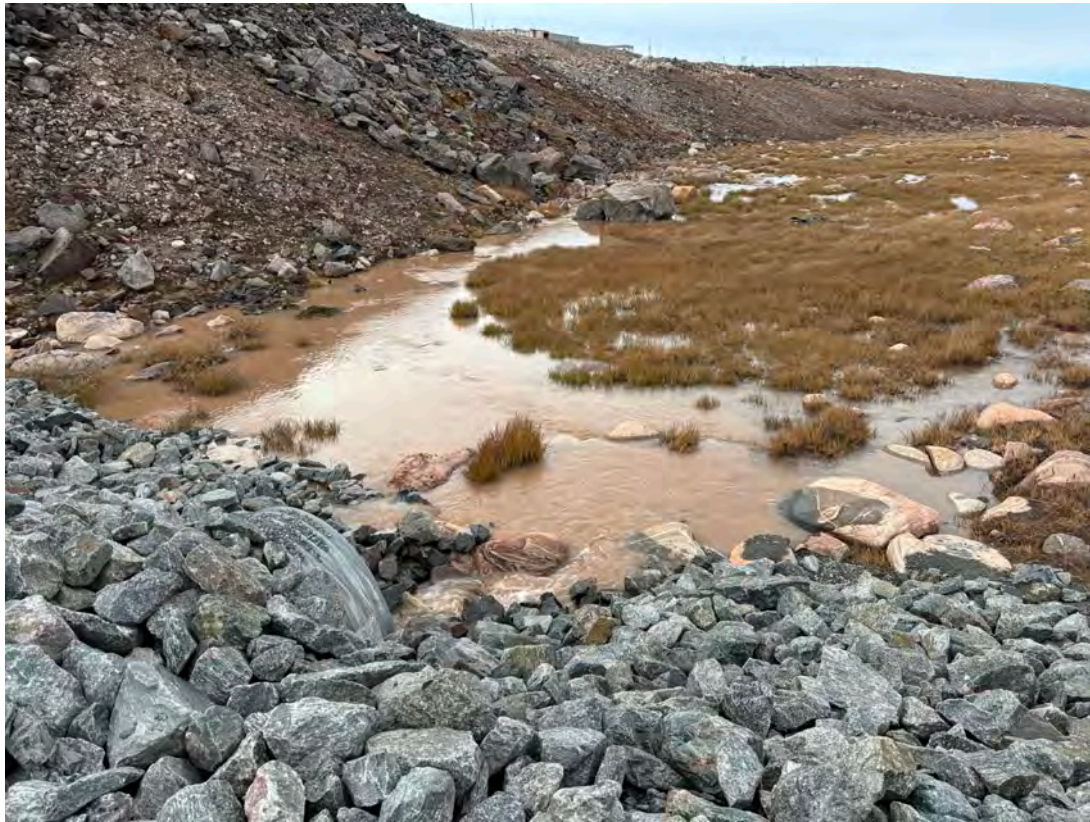
Photo 9 – Downstream of KM105 Dam looking at sediment laden runoff on the tundra (Sep 2024).

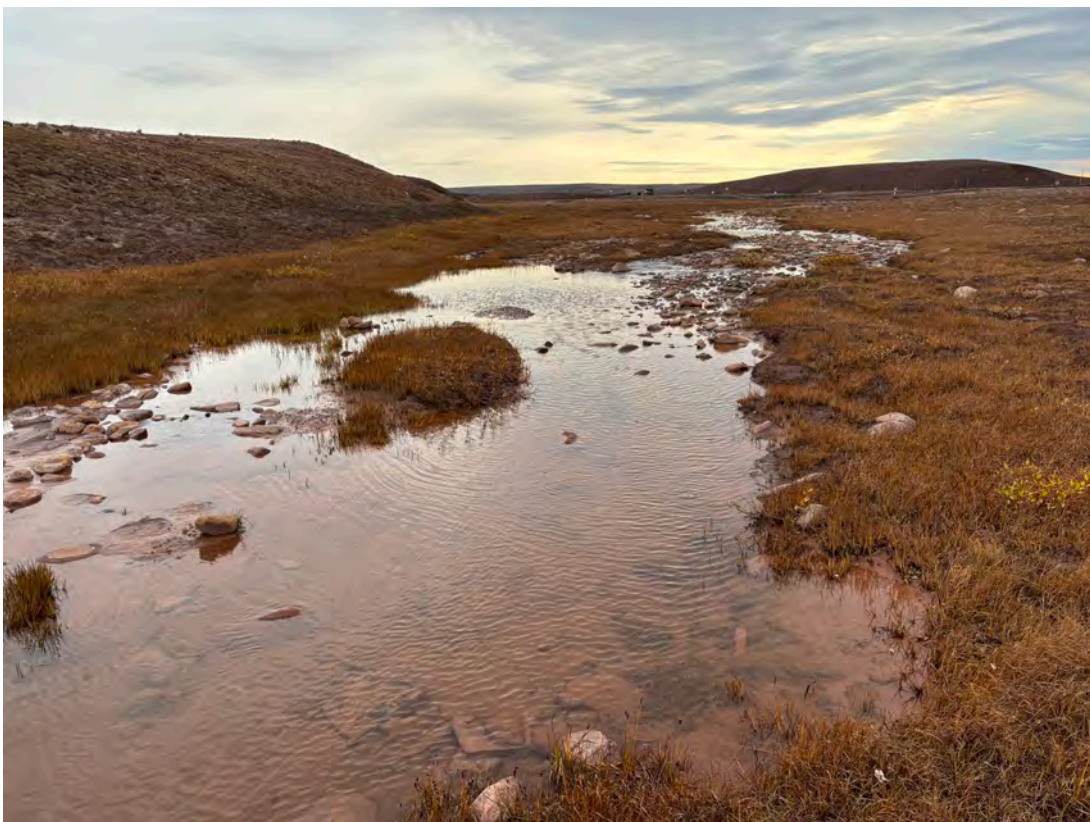
The Inspectors inspected the two Sheardown Lake Tributaries on the mine site and the two road-culvert crossings. There was less turbidity than observed previously during the June Inspection although there were visible accumulations of fine sediment along the streambed. A conversation during the June visit occurred where we were informed a new surface water treatment pond was being proposed east of Sailiivik Camp on the south side of the road in the area of the Sheardown Tributary. No follow up on the proposal was provided, although we understand this treatment facility is no longer being advanced. The Sheardown Lake tributary was observed along the mine road where no major issues were noted, other than what appeared to be the presence of coarse sand/gravel deposits in the mid-channel where snow dumping was observed during the June visit.

Photo 10 – Fine sediment accumulation on rocks – Sheardown Tributary east of Sailiivik Camp (Sep 2024).

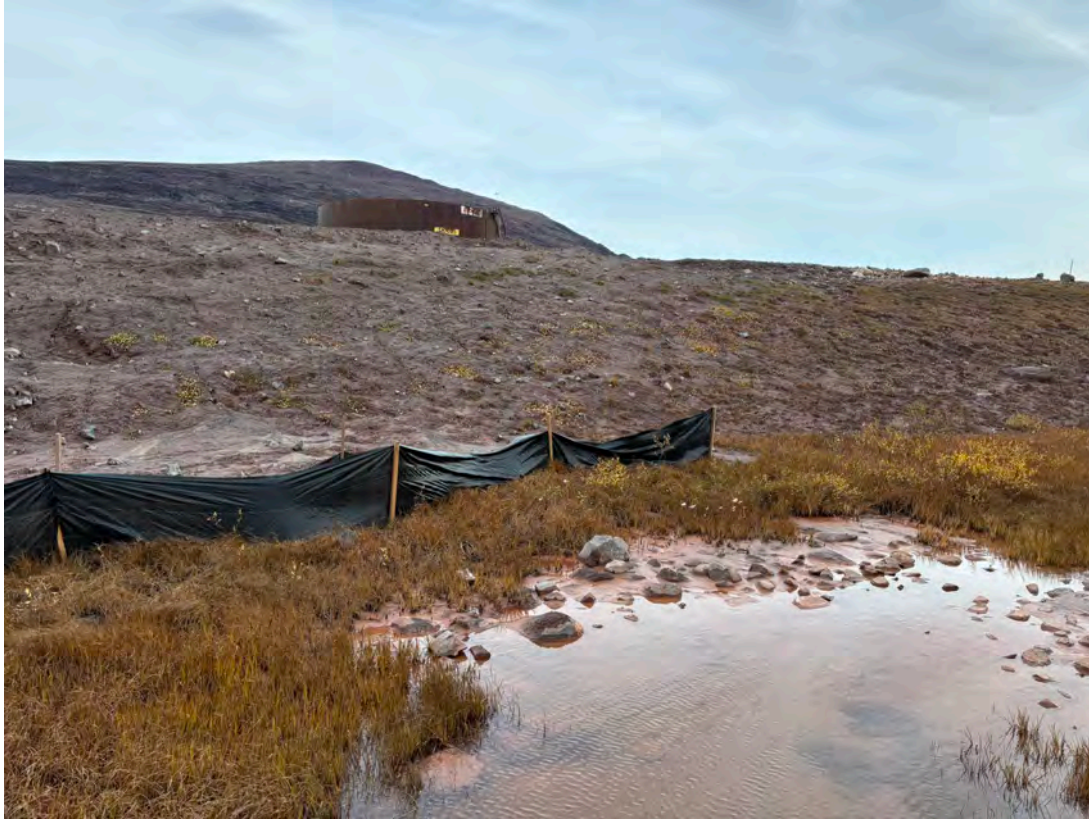
Photo 11 – Fine sediment accumulation on rocks – Sheardown Tributary east of Sailiivik Camp. Example of location where use of coir logs could be implemented (Sep 2024).

We continue to recommend a more robust implementation of erosion and sediment control (ESC) and other mitigation measures when concerns are noted. Part of this process is the immediate identification of issues with the potential to impact waterbodies or other sensitive environmental areas, prior to them occurring. This should be followed by clear plans and implementation of measures that are demonstrably effective. We suggest stockpiles of ESC controls such as coir logs be kept on site and ready for use as needed as these have shown to be effective for controlling runoff in this environment.

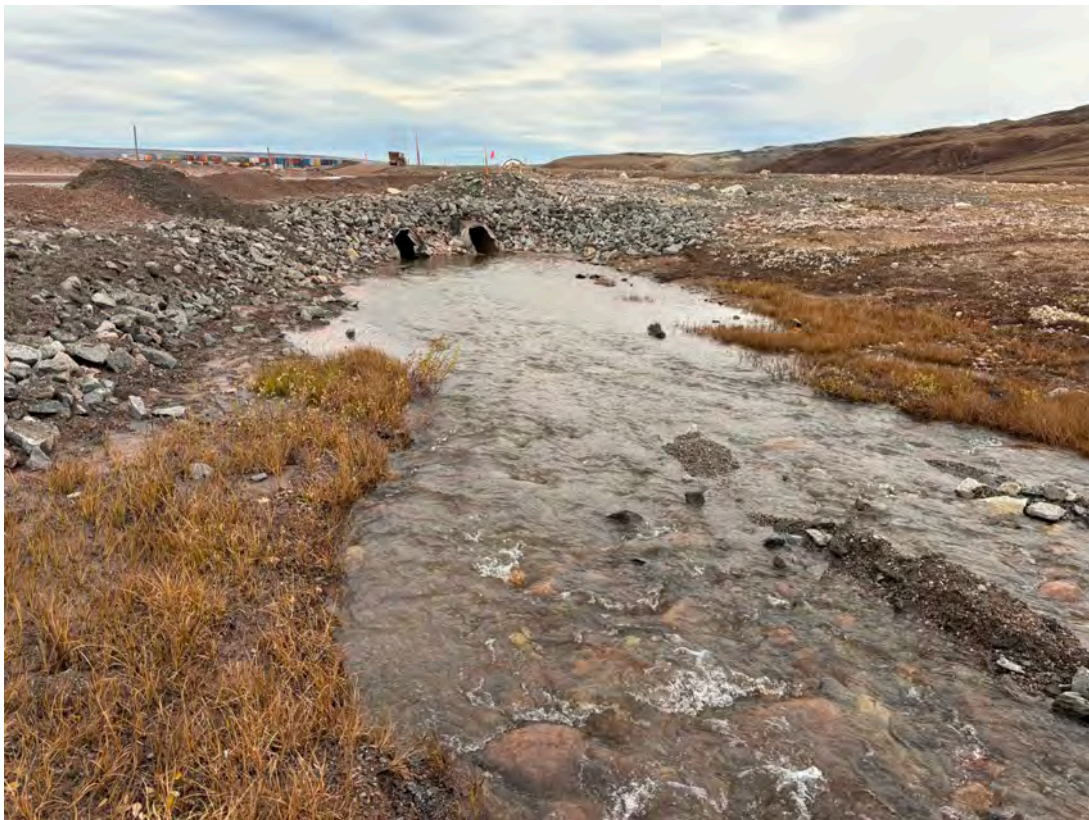
Photo 12 – Sheardown Tributary north of Sailiivik Camp where snow management is required (Sep 2024).

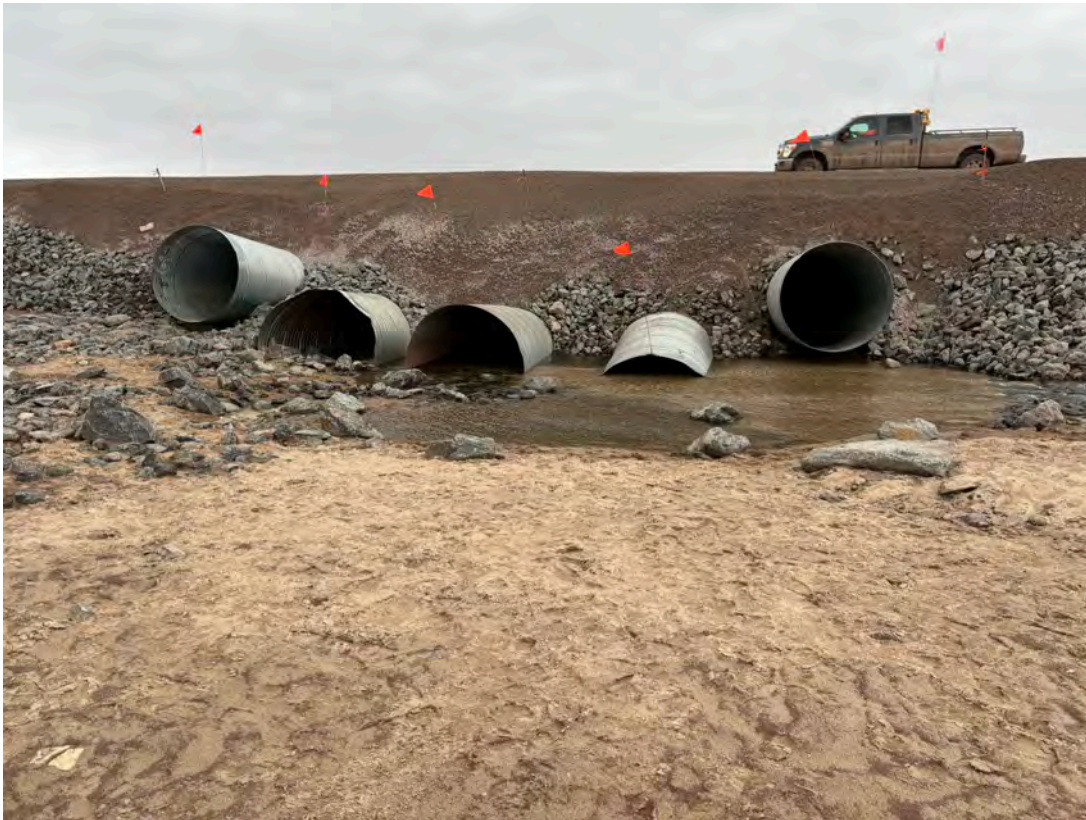
At the KM 81 stream crossing, a failure of the road materials caused the Tote Road to be closed days prior to the inspection visit. The road was re-opened during our inspection and we were able to observe the repairs to the road and the culverts. Five CSP culverts at various elevations have been installed at the location of this small, permanently flowing stream that flows into Muriel Lake a short distance downstream. It is unknown how much of the road granular material had washed into Muriel Lake, but observations immediately upstream of the lake did suggest some accumulation of material, particularly fine materials appearing to be fine sand, silt and possibly clay. Some mid-channel accumulations of material were observed, but it is unknown if this was a result of the road failure. We suggest the amount of fine materials in the short section of channel downstream of the culverts, and upstream of the lake, be monitored over time to ensure there have been no impacts to fish habitat in Muriel Lake. It is possible that fine materials from the road have covered important habitat for Arctic Char in Muriel Lake.

Photo 13 – KM81 watercourse crossing where road has washed out – downstream side (Sep 2024).

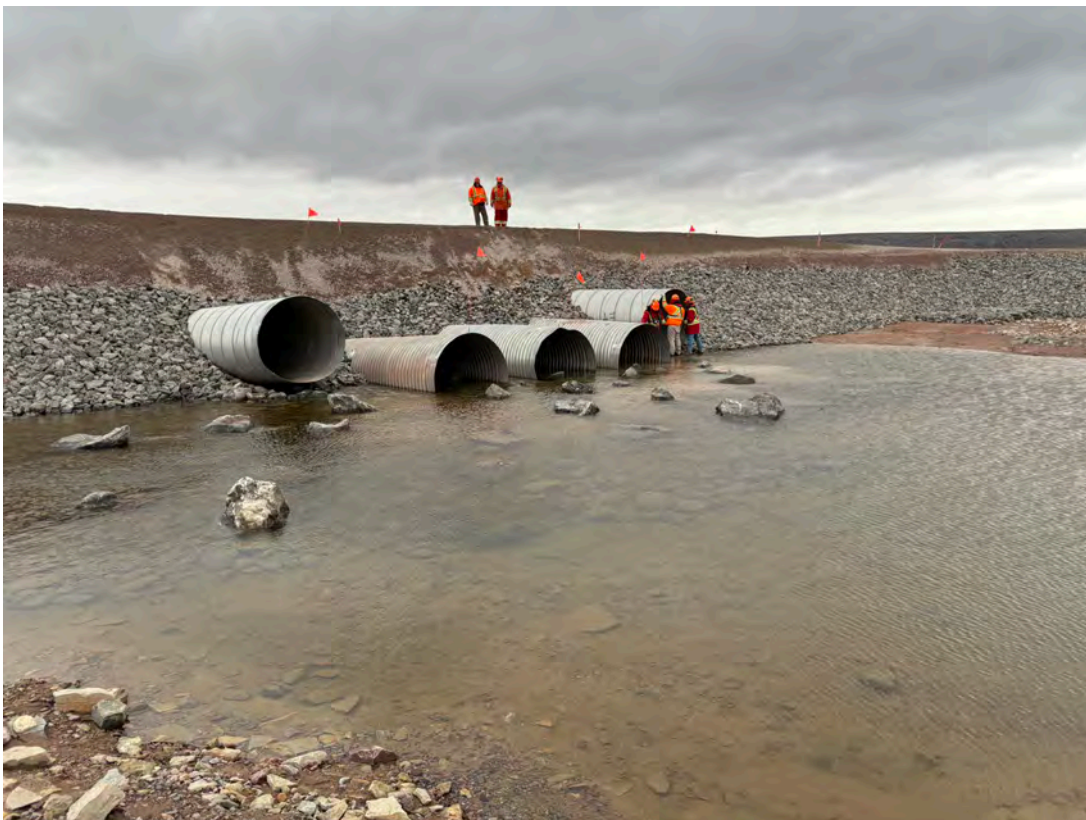
Photo 14 – KM81 watercourse crossing where road has washed out – upstream side (Sep 2024).

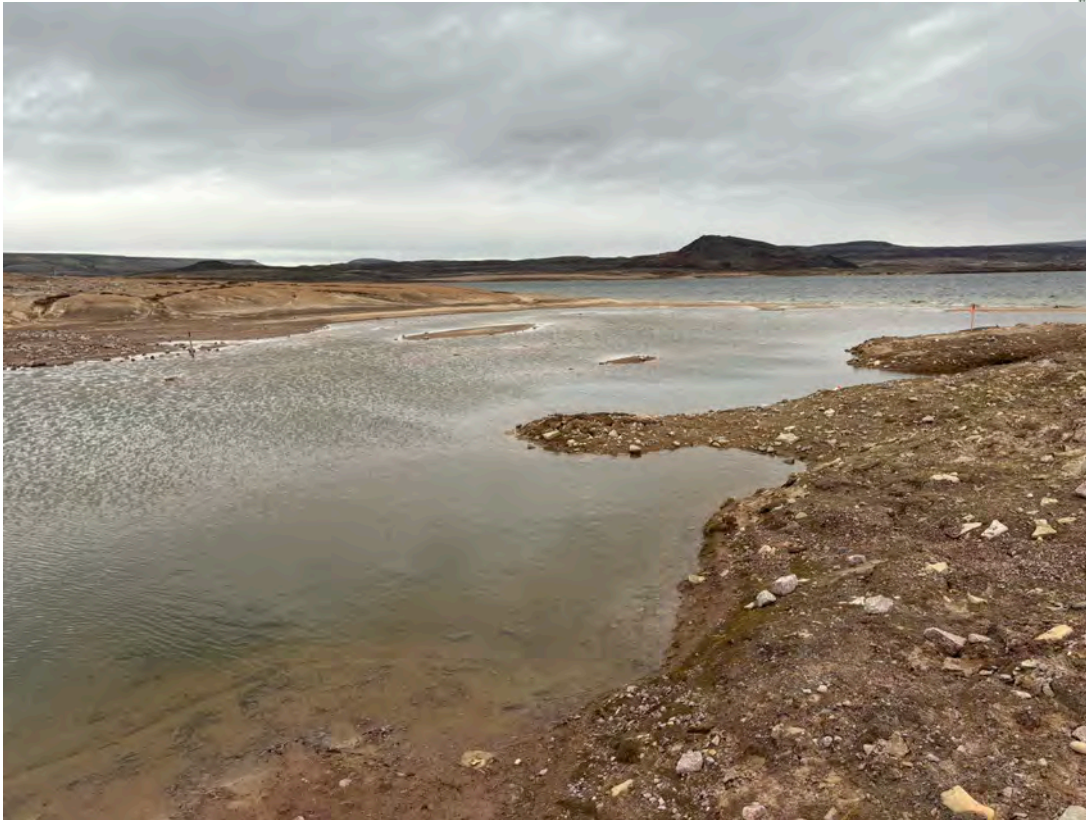
Photo 15 – KM81 watercourse crossing where road has washed out – area of possible deposition of road materials with Muriel lake in background (Sep 2024).

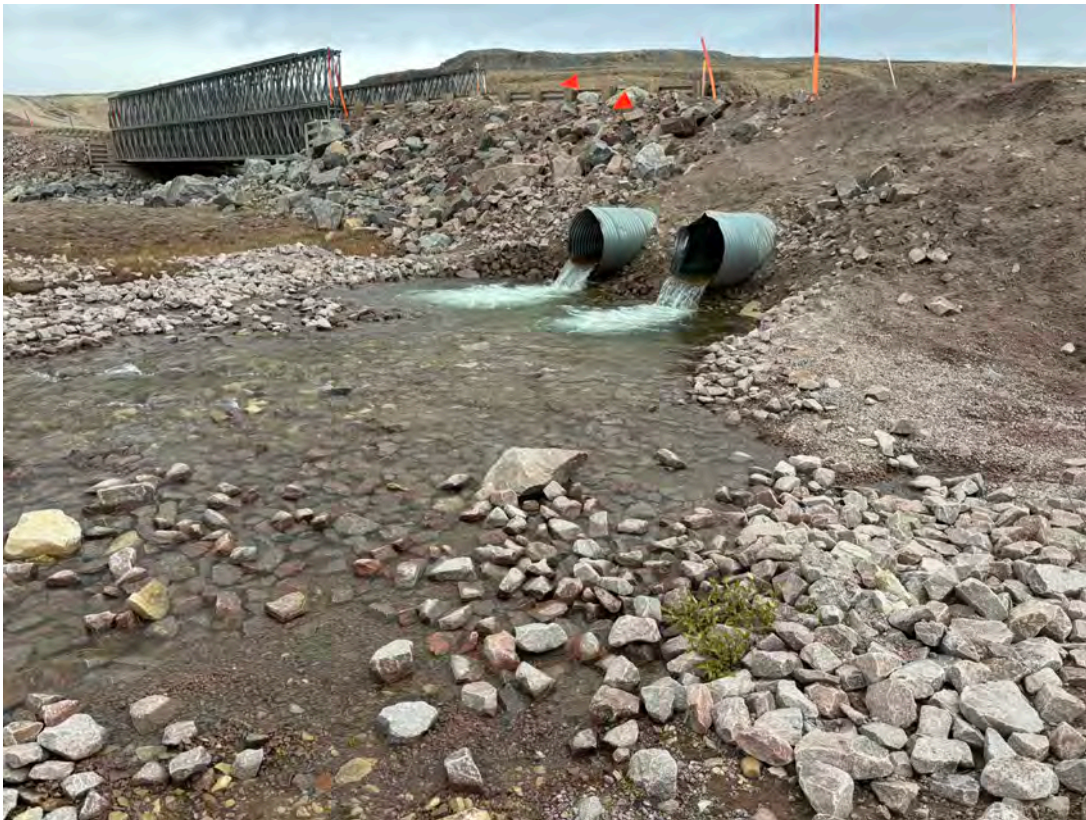
The stream crossing at KM 63 was observed where the two CSP culverts located south of the bridge are perched and causing some minor bank erosion downstream. Previously reported since 2022, these two culverts convey flows for a side channel of this stream but are creating a fish barrier for any upstream migration. At KM 33 the stream crossing was repaired recently where two new CSP culverts were installed with rock treatment along the streambed and banks. The channel was noted as dry with no recent evidence of flows upstream of the culvert and to an area approximately 10 m downstream. It appears there are flows under the new rock substrate, but it does not emerge until it proceeds to a previously undisturbed section of streambed. The crossing at KM 17 was inspected and no issues were noted.

The two CSPs located south of the bridge at the KM 63 stream crossing have been addressed previously in past inspection reports. The structures remain perched above the channel they convey, creating a barrier to fish passage within this side channel of the stream. Streambank erosion has also been noted downstream, likely resulting from turbulent flows caused by the CSP's. We understand DFO has observed this location and has not provided any mitigative advice.

Photo 16 – KM63 watercourse crossing – perched CSP culverts (Sep 2024).

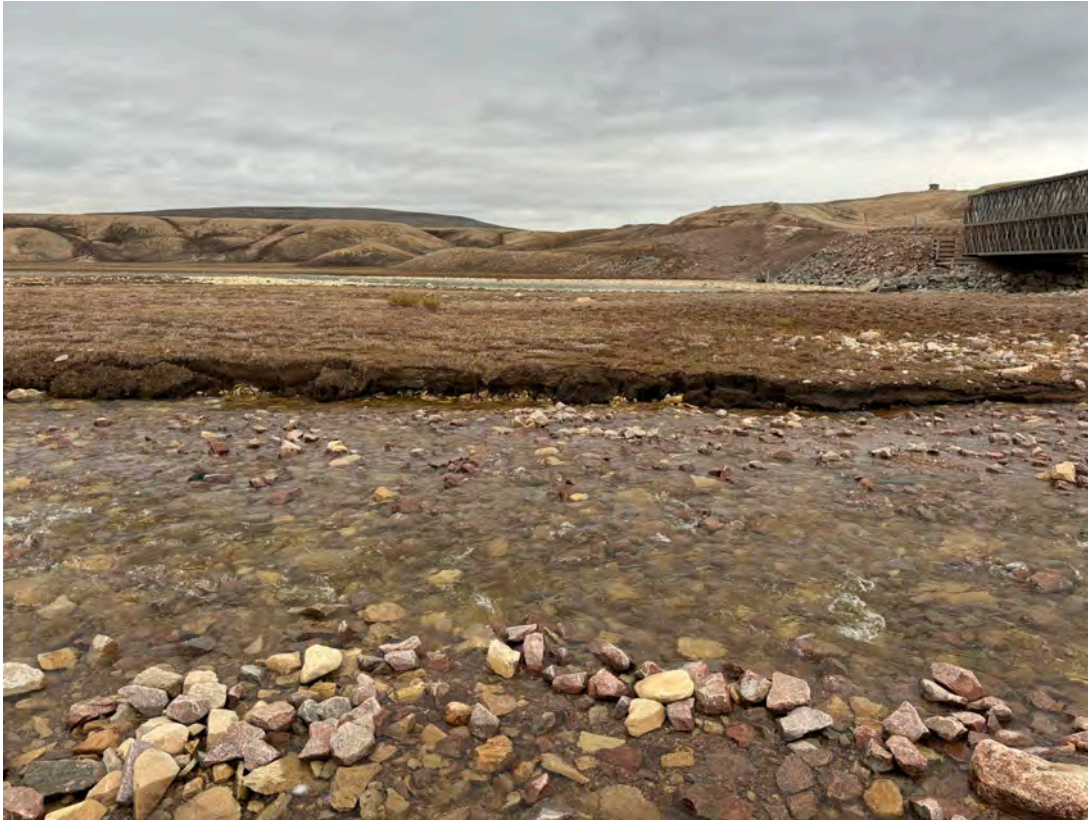
Photo 17 – KM63 watercourse crossing – streambank erosion downstream of perched CSP culverts (Sep 2024).

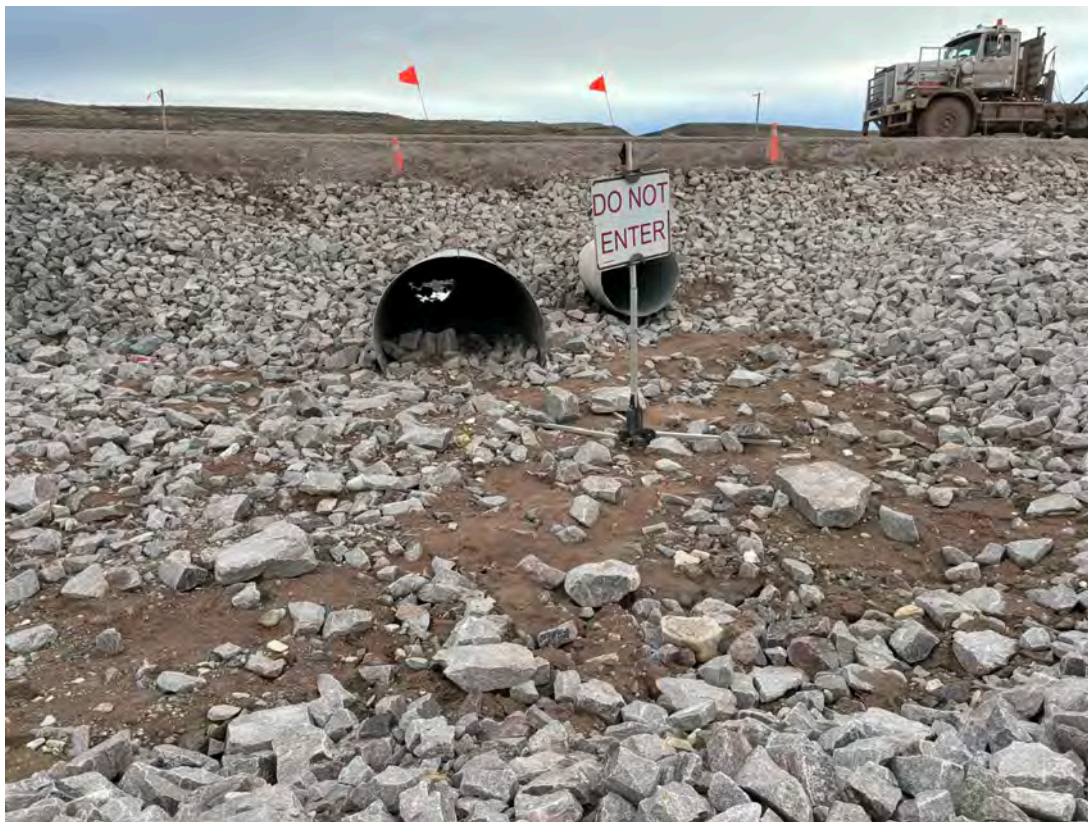
At KM 33 the stream crossing recent rock revetment work was completed. Water flow was not observed upstream, or at the culvert and for the length (approx. 10 m) of the revetment work downstream. However, flows were observed from under the rocks placed for the revetment work and into the channel. The voids in the recently placed rock material are allowing flow to proceed under the material, which does not allow for fish passage into and upstream of the culvert. Finer materials should have been mixed into the rocks to prevent this situation. This area should be observed over time to determine whether fine materials will accumulate to a degree enough to encourage surface flows.

Photo 18 – KM33 watercourse crossing – flow under recently placed rocks (Sep 2024).

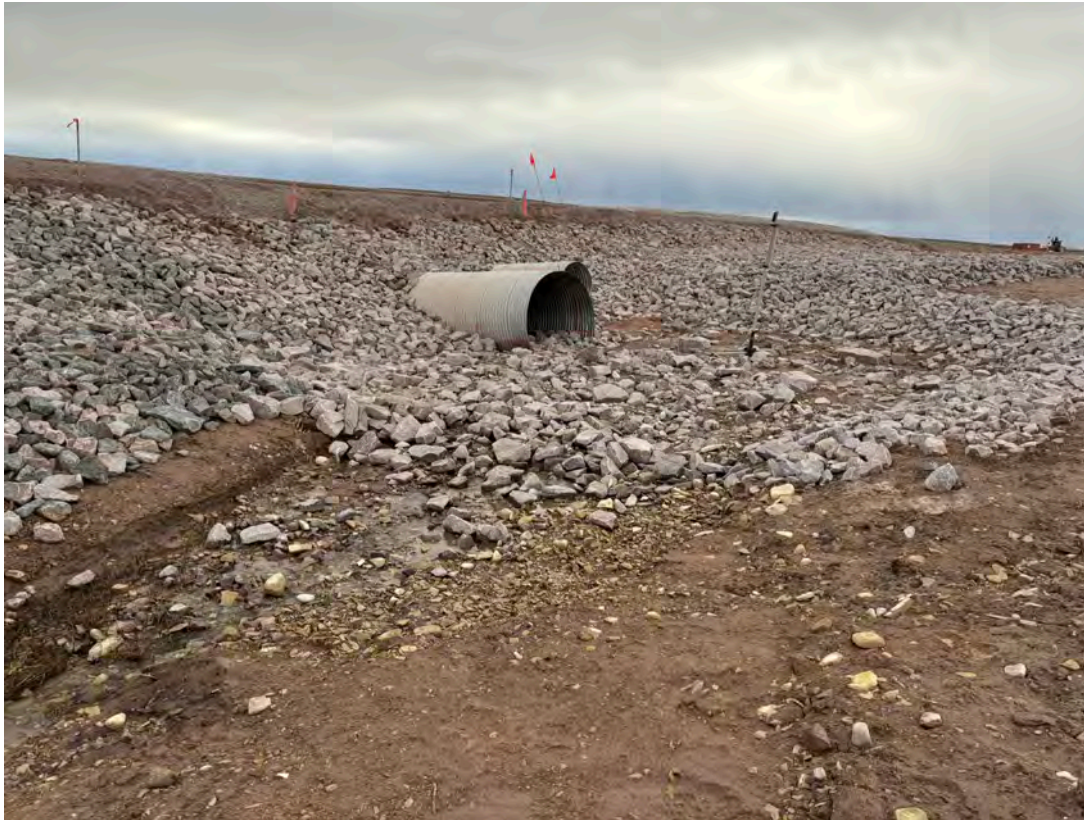
Photo 19 – KM33 watercourse crossing – flow emerging from under recently placed rocks visible (Sep 2024).

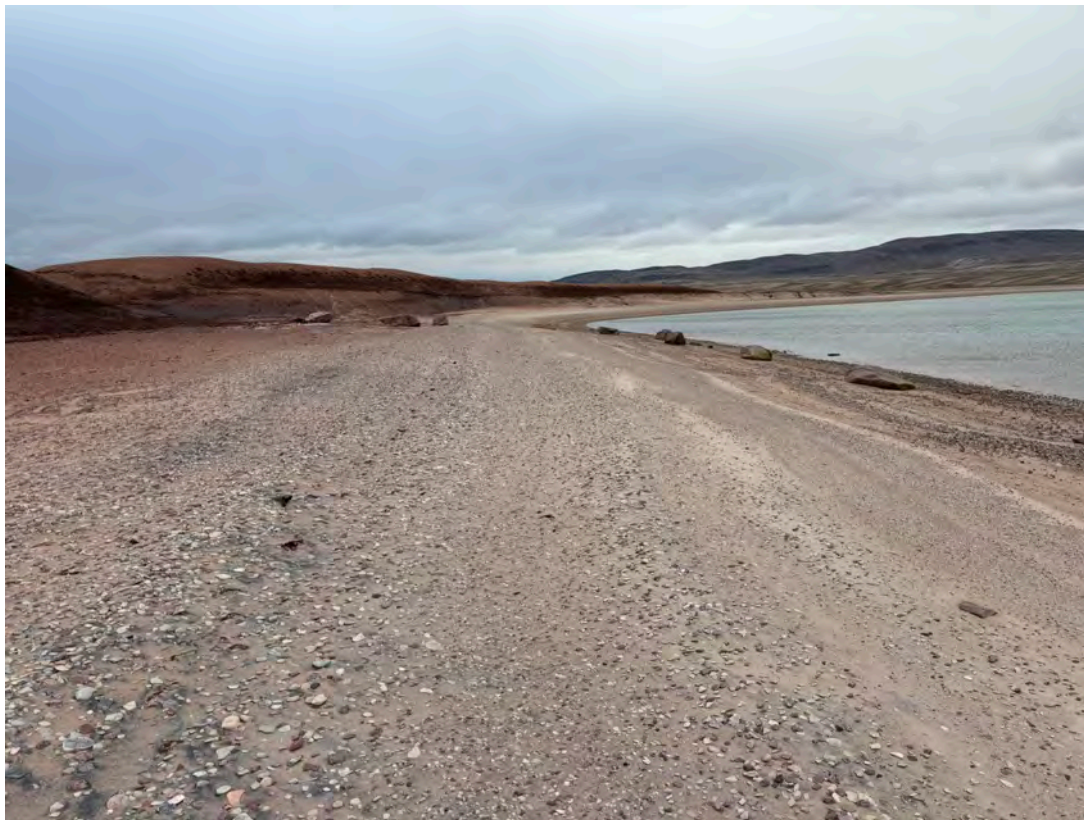
The dark coloured sediments at Milne Port we believe are a result of wind and water borne accumulations of iron-ore from nearby stockpiles. The geochemical analysis presented in this report indicated the samples contained an elevated level of iron (4x the level of the earth's crust). While iron is not acutely toxic to aquatic, terrestrial or marine life, accumulations could cause unknown results over the long-term. The proximity of the iron rich sediments to the marine environment of Milne Inlet presents an unknown risk of this material entering the water and the food chain. This presents an unknown risk to sensitive marine species, many of which the Inuit rely on for subsistence. A plan to prevent these sediments from entering the nearshore area and ultimately the marine environment should be developed and implemented.

Photo 20 – Milne Port beach with dark coloured iron-ore rich sand visible to the left (Sep 2024).

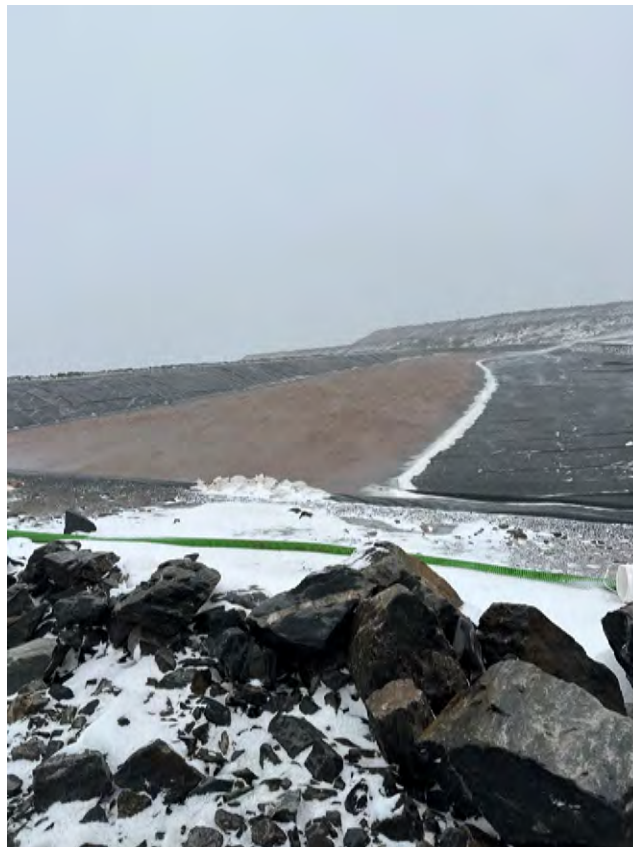
Photo 2 – KM106 Pond after the rain event (Oct 2nd, 2024).

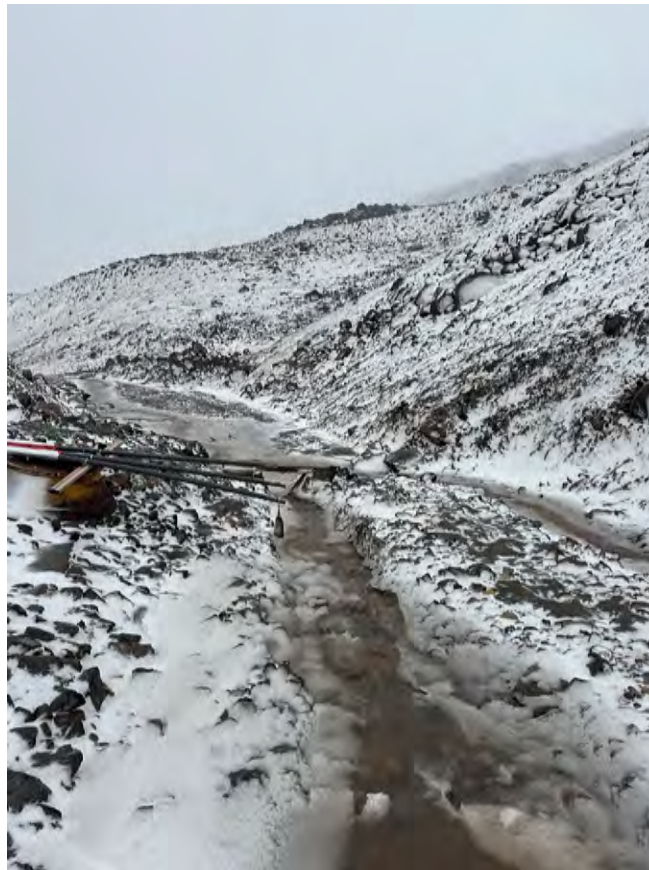
Photo 4 – Downstream view of the dosing facility upstream of KM105 infrastructure. Note the new channel by passing the dosing facility (Oct 2nd, 2024).

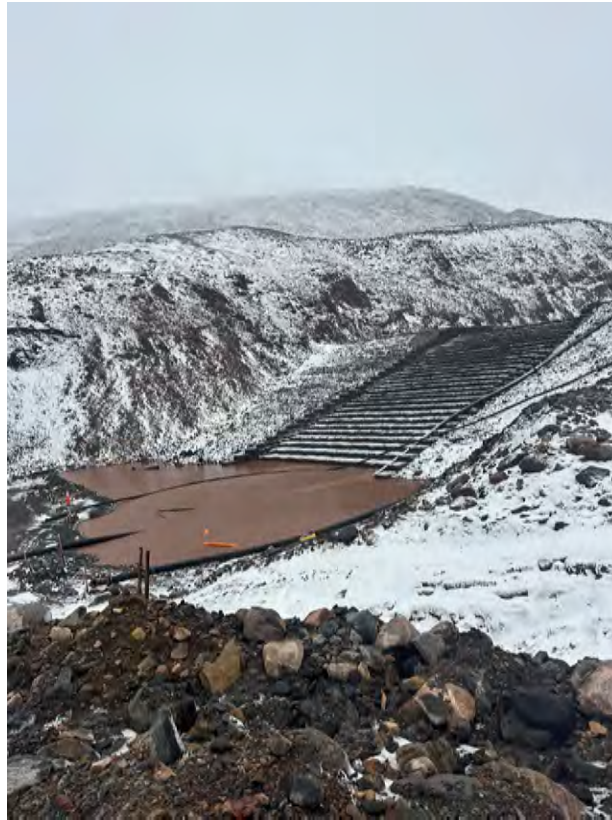
Photo 9 – Water pooling below the KM105 Dam, noticeable turbid (Oct 2nd, 2024).
