June 10th – June 12th, 2024, Environmental Inspection

RE: Baffinland Iron Mines Corporation's Mary River Project – Qikiqtani Inuit Association September 2024 2nd Annual Site Inspection Findings and Recommendations

Baffinland Mine Site Investigations APPENDIX A - PHOTOGRAPHS

Baffinland Mine Site Unscheduled Environmental Investigation

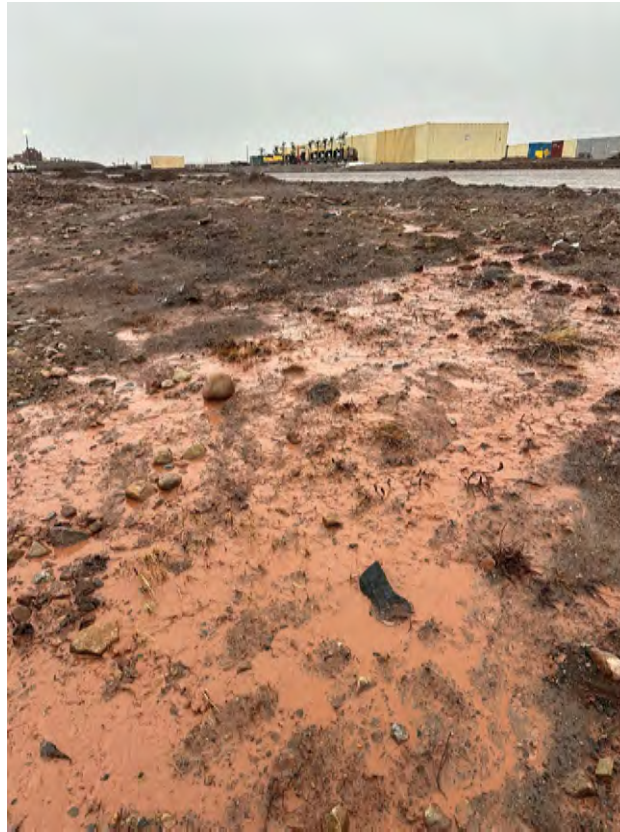
Photo 15 – Source of run off from the road. Water is noticeably turbid (Oct 2nd, 2024).

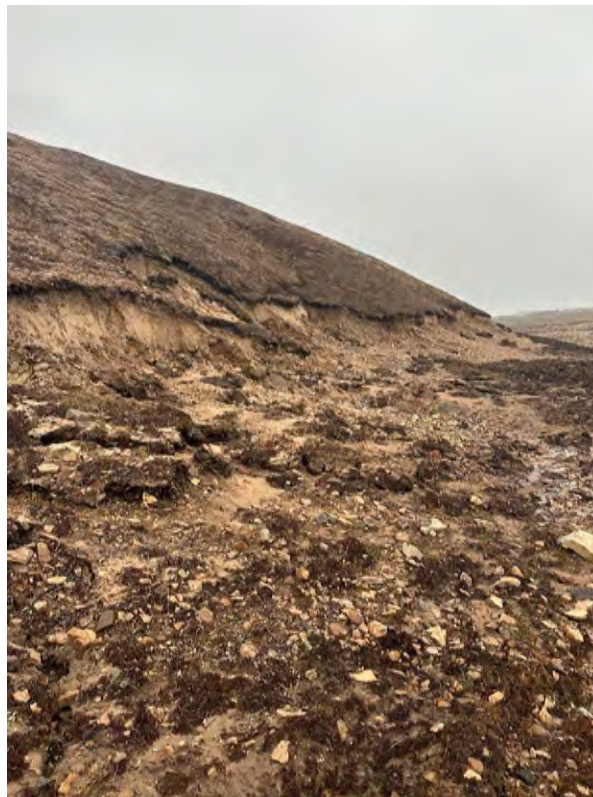
Photo 18 – Sediment erosion due to the unprecedented rain event (~KM63.5; Oct 2nd, 2024).

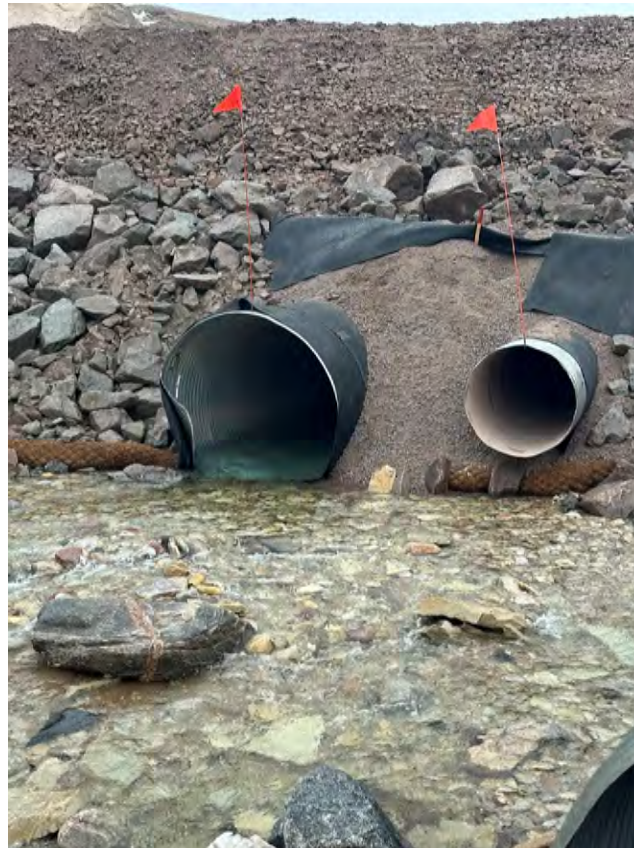
Photo 20 – Culvert replacement at KM63.5 from the opposite side of the Tote Road as Photo 17 (Oct 2nd, 2024).

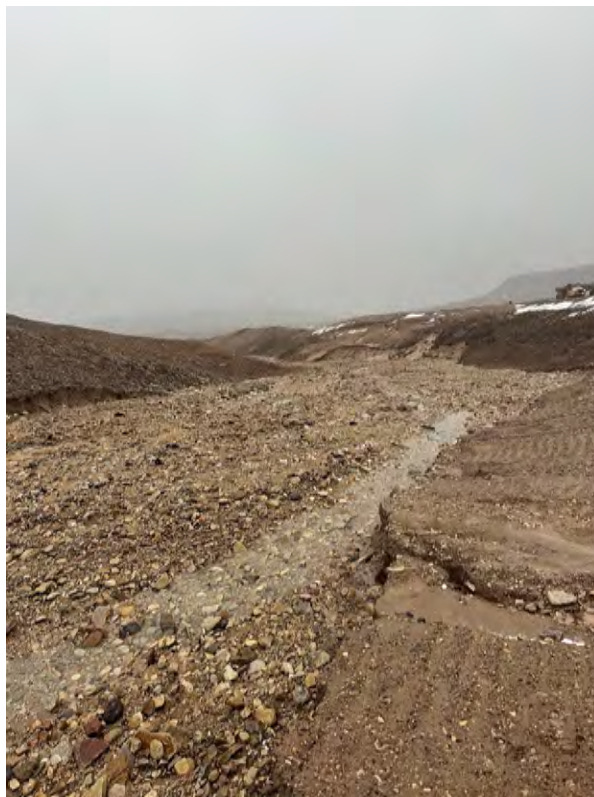
Photo 21 – Example of sediment erosion adjacent to the Tote Road (Oct 2nd, 2024).

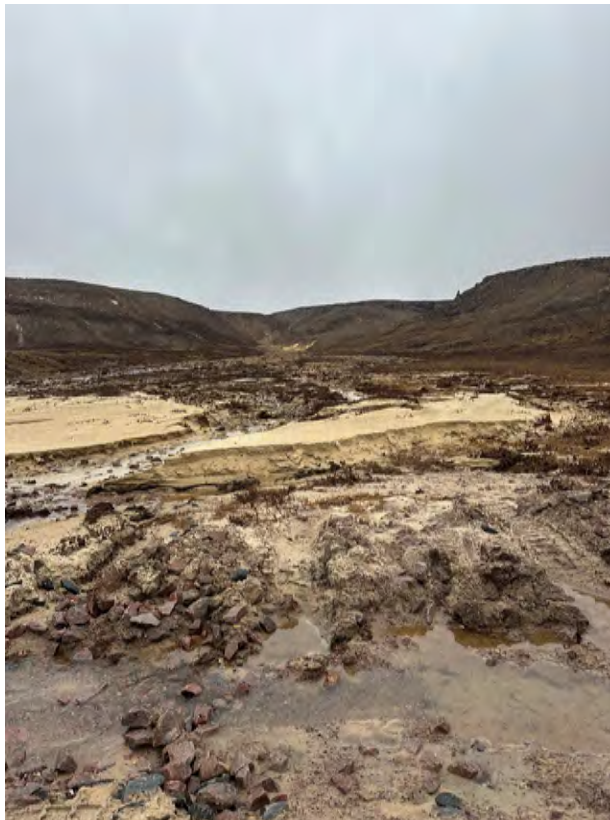
Photo 24 – Quantity of sand deposited at KM86 washout (Oct 2nd, 2024).

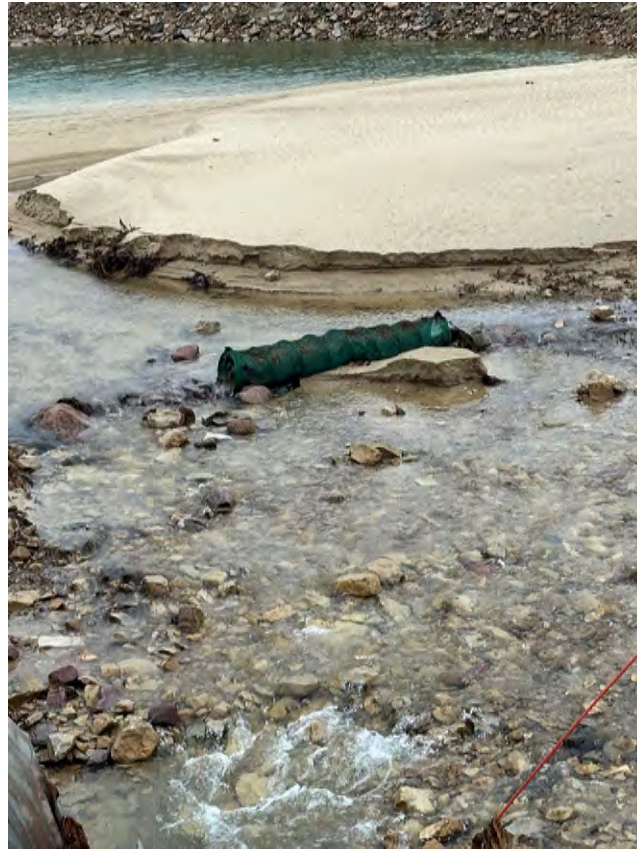
Photo 25 – Extent of erosion and increased channel size compared to erosion trap (Oct 2nd, 2024).

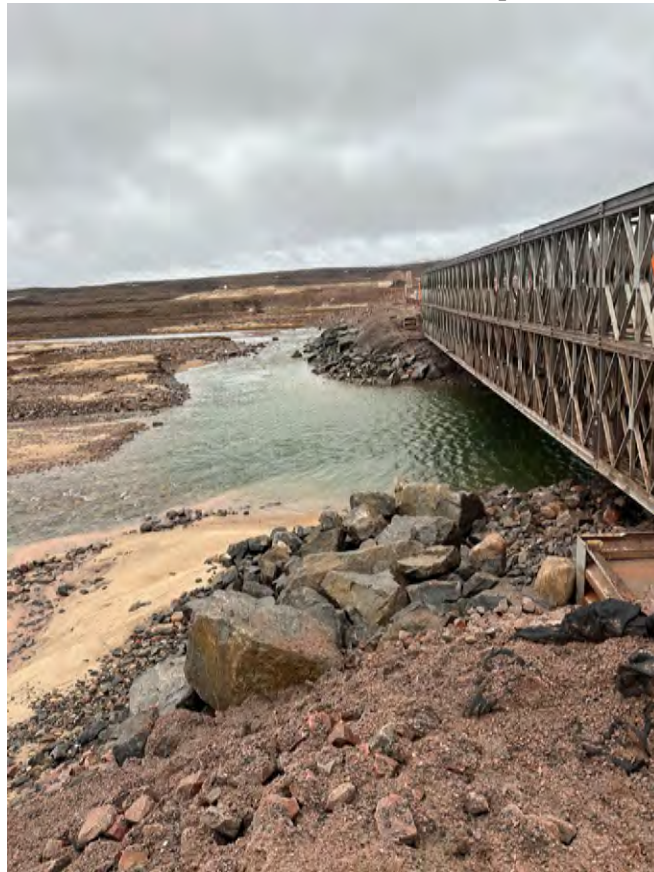
Photo 26 – Bridge close to Sailiivik Camp and sediment deposited due to erosion (Oct 2nd, 2024)

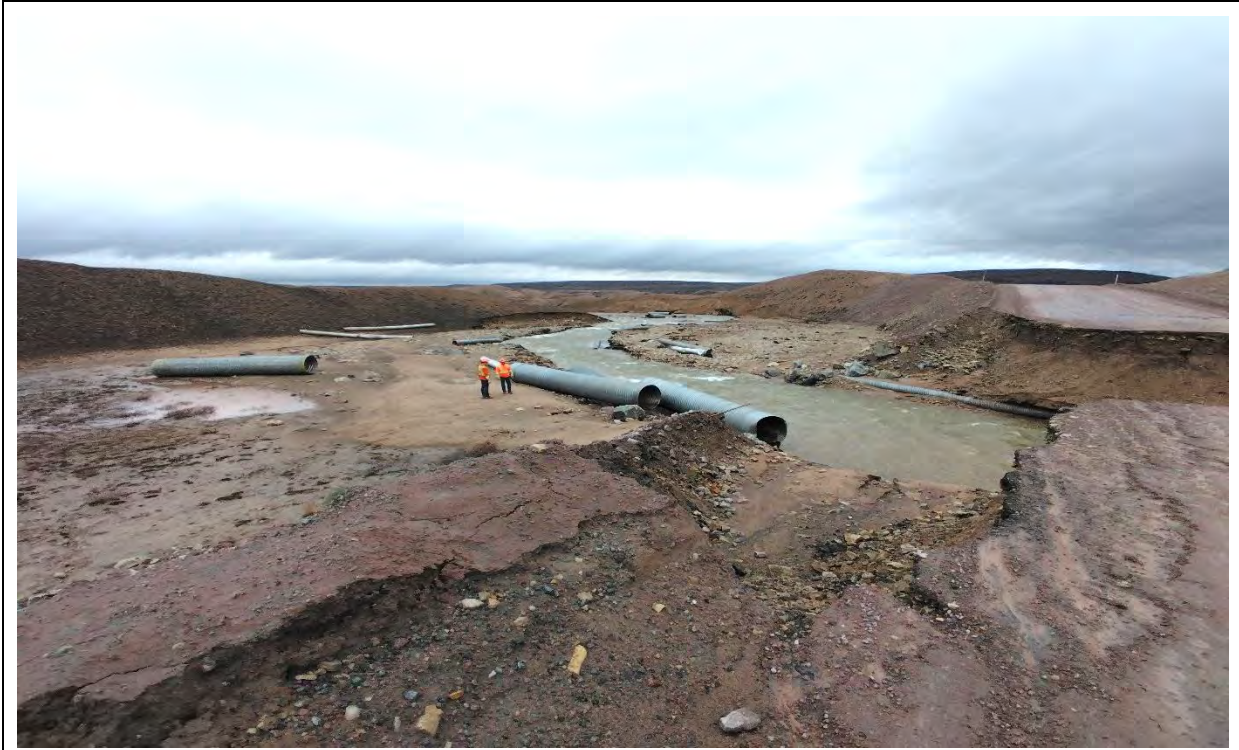
Photo 1. KM 63.5 Culverts deposited downstream from Tote Road crossing during September rain event, 2024-09-22

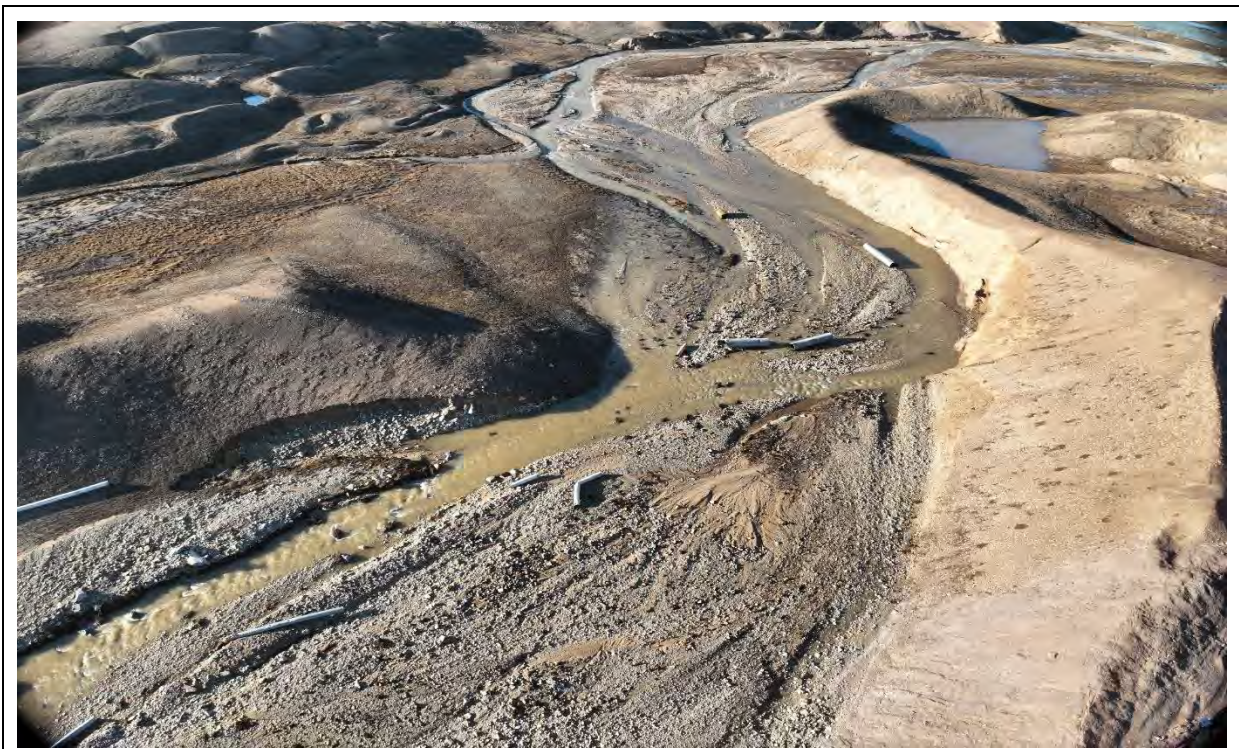
Photo 2. KM 63.5, Culverts deposited downstream from Tote Road crossing during September rain event, 2024-09-22
