APPENDIX E.8.3

Initial and Follow-up Spill Reports

Re: Follow-Up to Spill #2024-041
Mary River Project - Water Licence No. 2AM-MRY1325

Re: Follow-Up to Spill #2024-058
Mary River Project - Water Licence No. 2AM-MRY1325

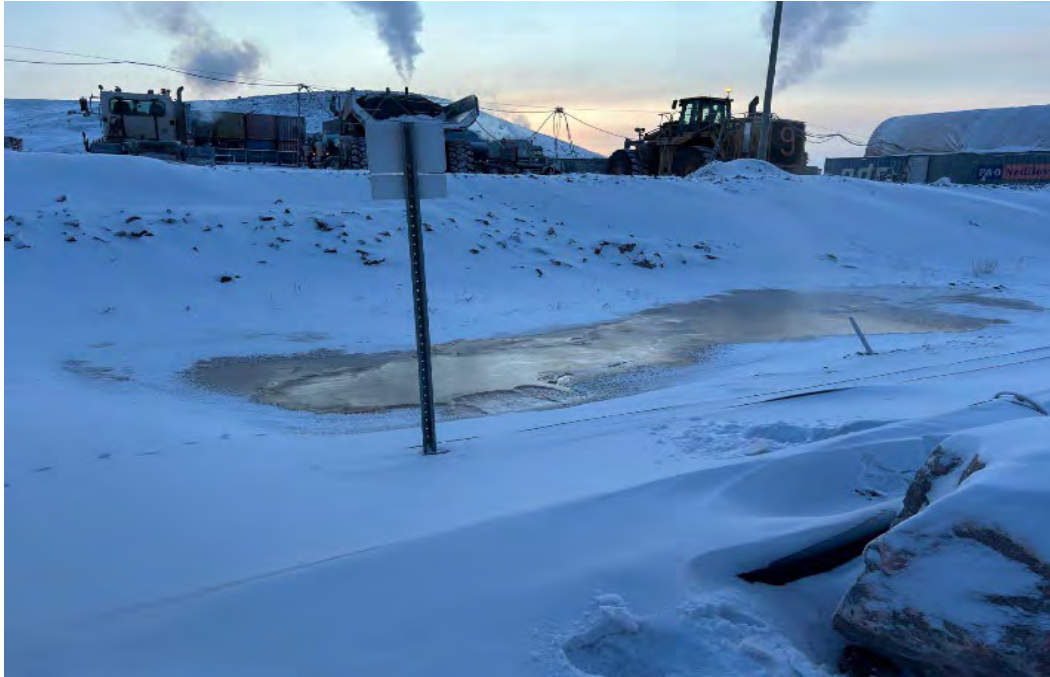
On February 4, 2024, approximately 1500 L of untreated sewage was observed leaking from a lift station pipe into a drainage ditch, located immediately south of the Port Site Complex (WWTP), during a routine inspection. On further investigation, the release was found to be originating from the PSC raw sewage influent line; where the influent line, located between the PSC WWTP and drainage ditch, is re-directed north via a 90° elbow fitting. The spill was contained to the immediate area adjacent to the WWTP, and did not migrate. The spill location is approximately 370 m to the Milne Inlet; the nearest fish bearing water.

Photo 1. Untreated Sewage Release – February 4, 2024

PSC lift station pumps were immediately disengaged to prevent any further flow from the PSC influent line and lift station, and the area was isolated. A vacuum truck was mobilized to empty the main PSC camp collection and discharge lift station that utilizes the effected piping, to prevent further release, and then deployed to the location of the failed fitting to capture any further sewage being released during draining of the line and preparation of the line for repair. Once the line was empty, the failed fitting was removed and a new fitting was installed. Following the repair, the influent line was placed back into service and inspected for further leaks as per routine start-up procedures. Additional clean up activities are scheduled to be initiated once thaw conditions occur if required. At that time, any remaining contaminated snow and ground material will be removed from the affected area.

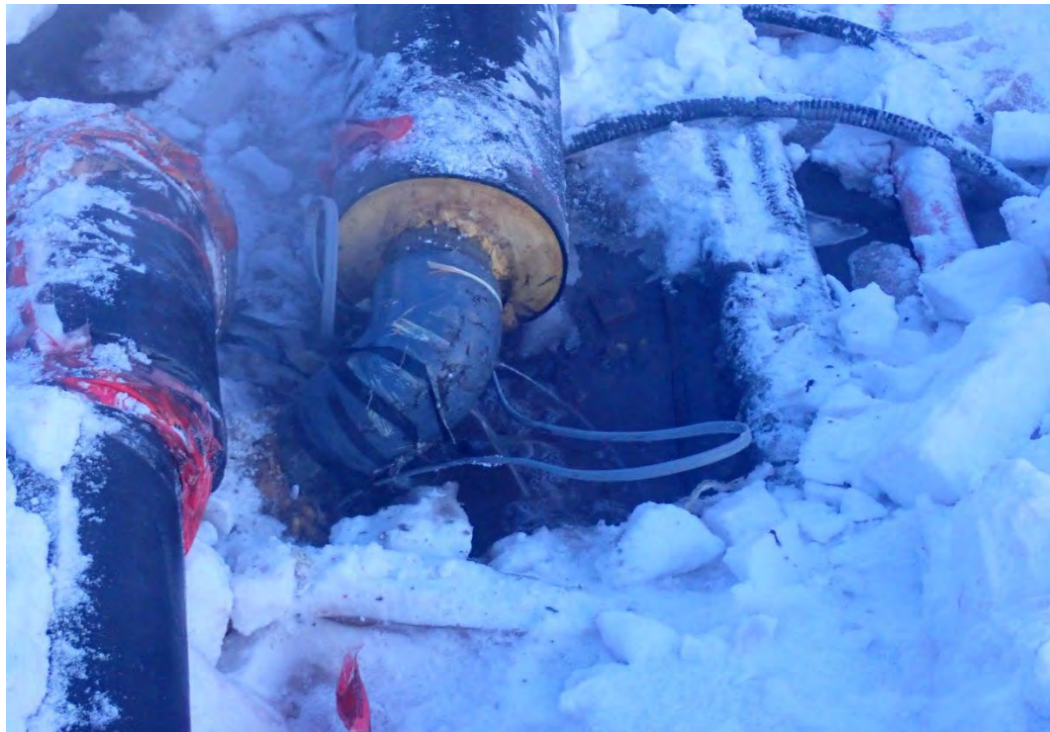
Photo 2. Influent Line (Before Repair) – February 4, 2024

The long-term corrective action to prevent a similar reoccurrence is removal of the repaired 90° elbow fitting and replacement with two 45° fittings and a short length of pipe to reduce mechanical stress on the connection to the PSC WWTP. The PSC WWTP influent line and the repaired connection will be inspected daily until the long-term corrective measures are implemented.

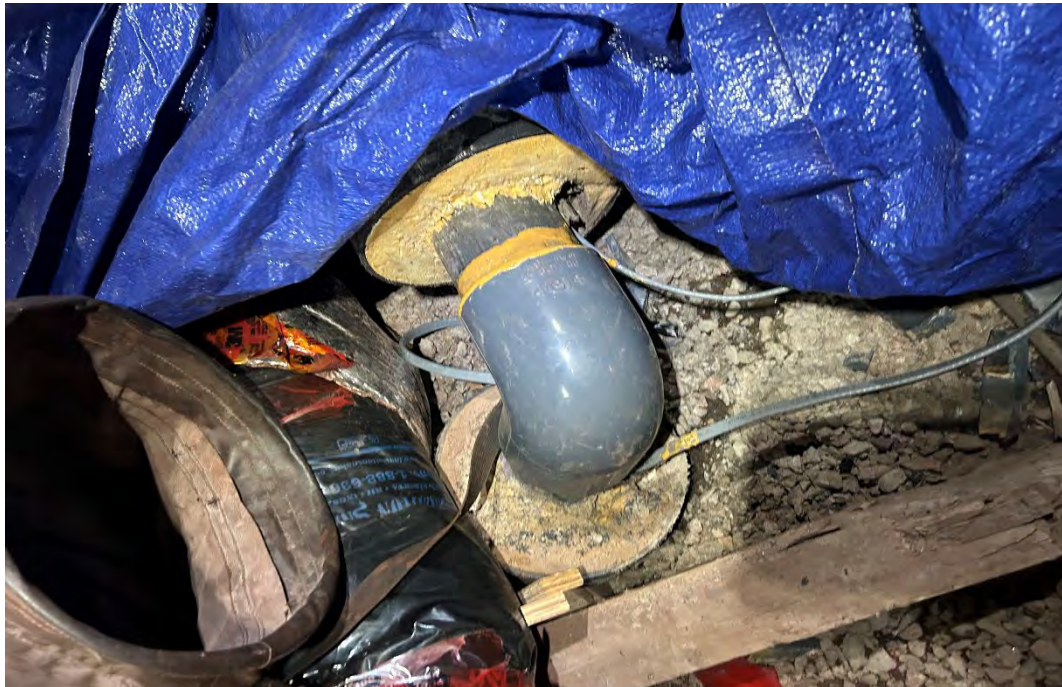
The failed fitting has been replaced and the PSC WWTP influent line put back into service. The area will be monitored in the spring and additional clean up activities will be conducted as necessary.

Photo 3. Influent Line (After Repair) – February 4, 2024

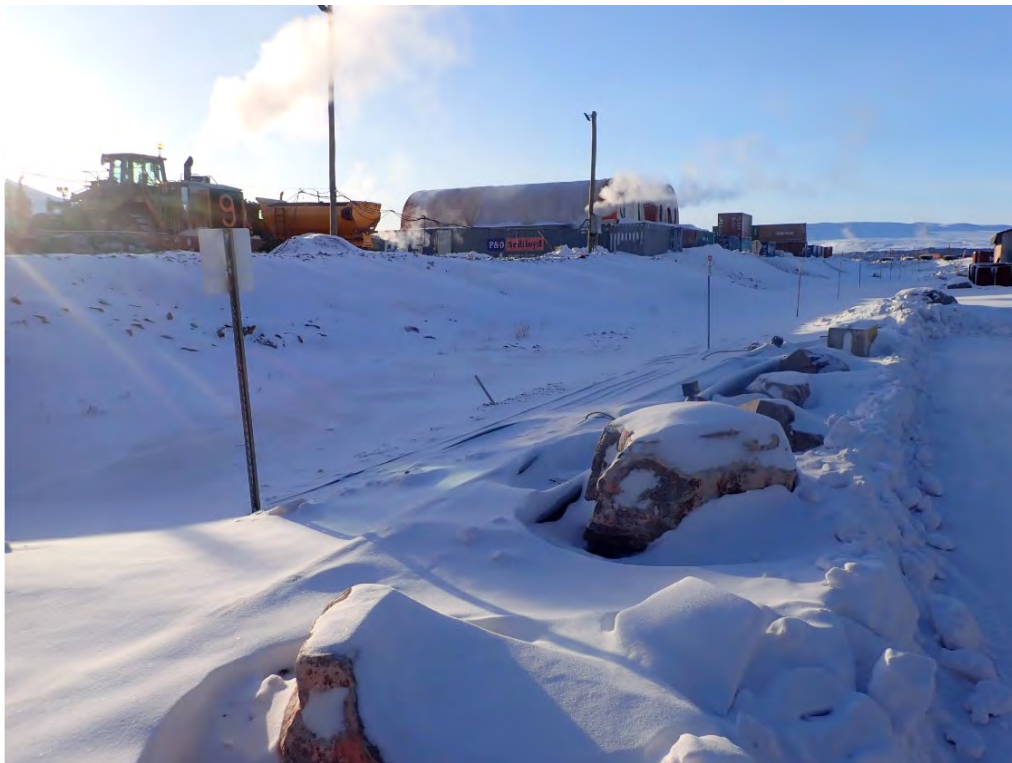
Photo 4. Untreated Sewage Release After Clean-up) – February 26, 2024

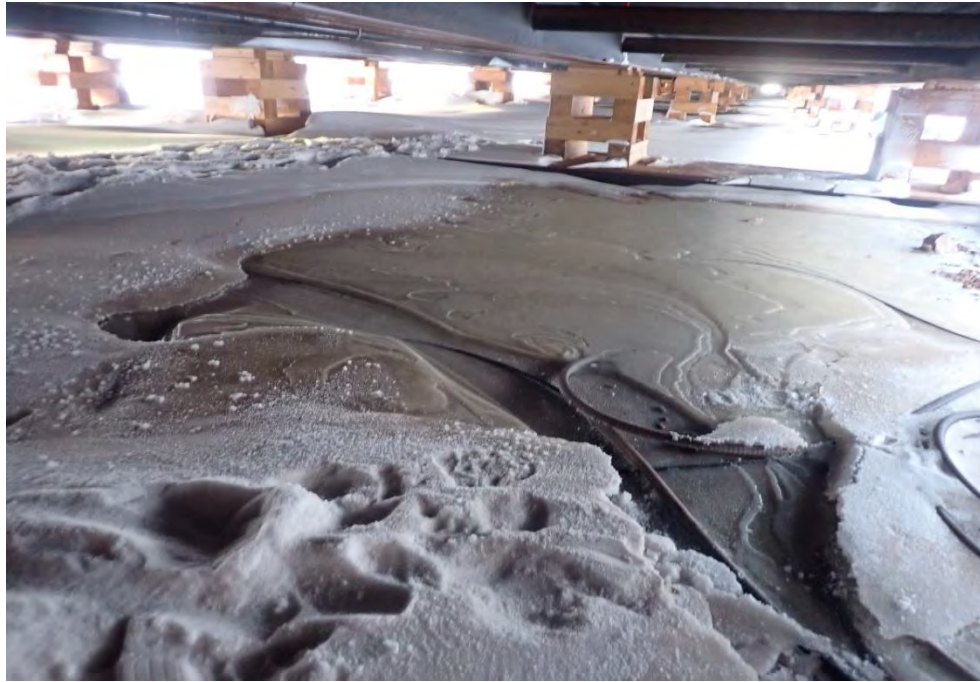
During daily sewer inspections on February 29, 2024, it was discovered that the BD South Lift Station discharge elbow had cracked causing the joint to fail resulting in a spill of approximately 400 L of untreated sewage onto the ground. The lift tank was manually cleaned out using a vacuum truck to prevent any further spillage. The spill was frozen and contained to the immediate area underneath the PSC building area. The spill location is approximately 350 m to the Milne Inlet; the nearest fish bearing water.

Photo 1. Untreated Sewage Release – February 29, 2024

PSC lift station pumps were immediately disengaged to prevent any further flow from the PSC influent line and lift station, and the area was isolated. A vacuum truck was mobilized to empty the lift stations that utilizes the affected piping, to prevent further release. The failed elbow and joint was removed and replaced. Following the repair, the influent line was placed back into service and inspected for further leaks as per routine start-up procedures. Accessible contaminated material was scraped up and disposed of in the Polishing Waste Settling Pond (PWSP). Additional clean up activities are scheduled to be initiated once thaw conditions occur if required. At that time, any remaining contaminated snow and ground material will be removed from the affected area.

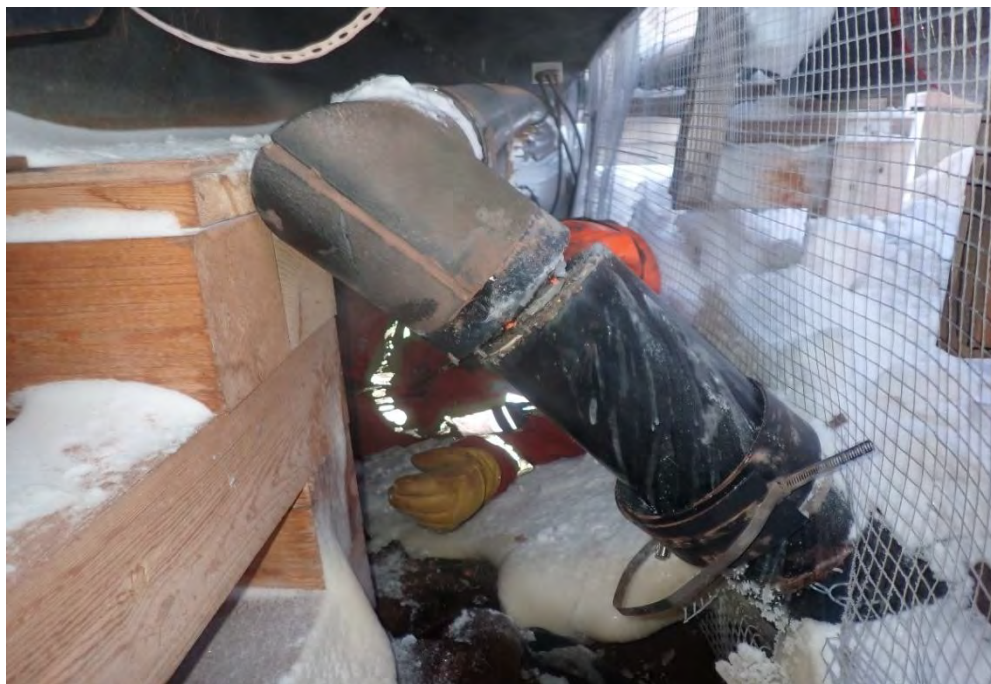
Photo 2. Influent Line (Before Repair) – February 29, 2024

The corrective actions implemented as a result of this spill include implementing an increased frequency of bump tests for sewage lift stations, include visual inspections of all feed and discharge piping during the daily inspections, and scheduling yearly inspections where the insulation is removed and an in depth integrity inspection is completed of the outdoor sewage piping systems

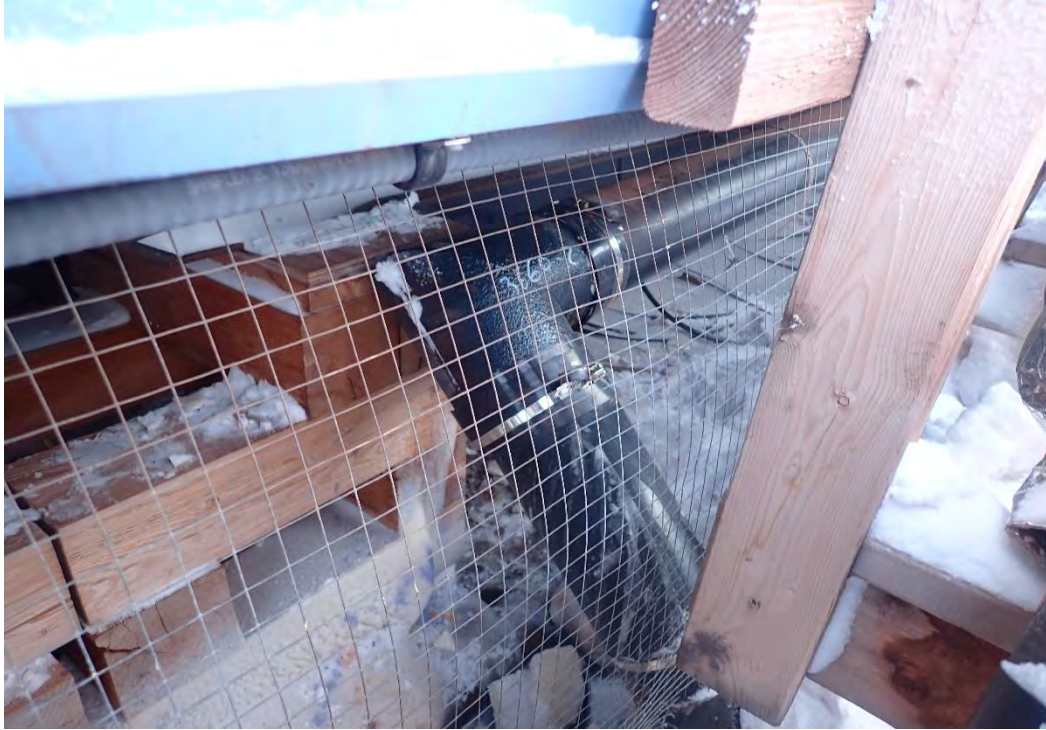
The failed elbow and joint have been replaced and the PSC BD lift stations were put back into service. The area will be monitored in the spring and additional clean up activities will be conducted as necessary.

Photo 3. Influent Line (After Repair) – February 29, 2024

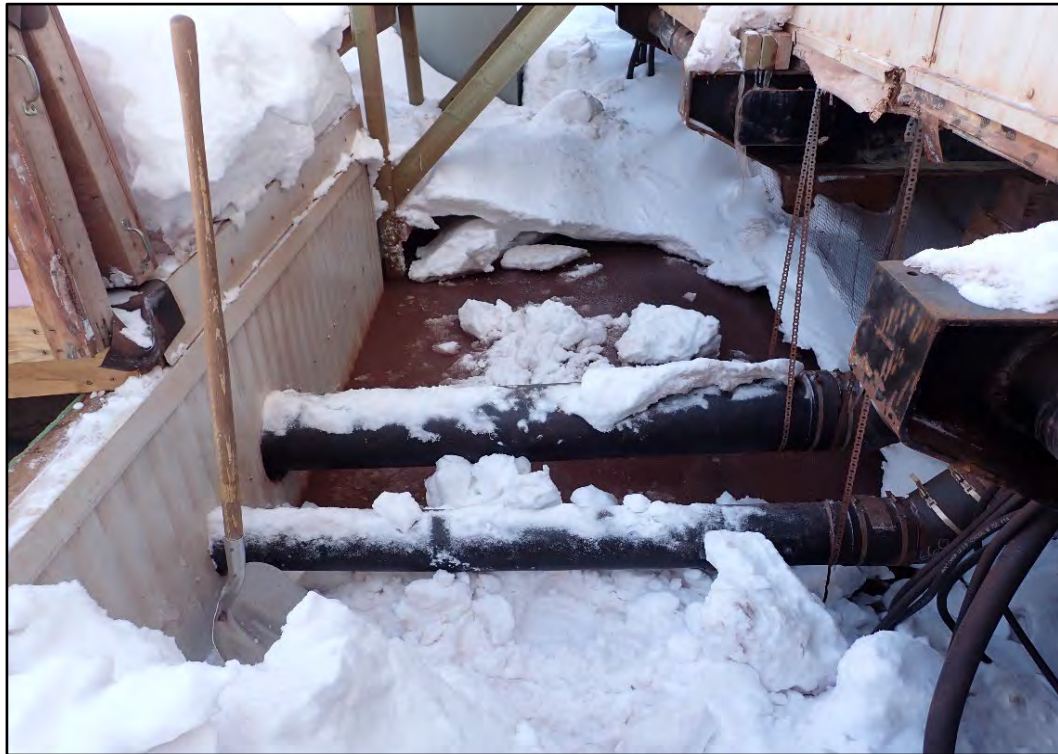
On April 19, 2024, approximately 116 L of untreated sewage was released onto the ground when the industrial laundry room lift station at the Port Site Complex (PSC) overflowed. On investigation, sewage sludge was observed to have accumulated around the float inside the lift station, which prevented the lift station pumps from engaging when the high level was reached as per the design. The released sewage was contained to the immediate area adjacent to the lift station and did not migrate beyond the area of release. The location of the sewage release is approximately 318 m from the Milne Inlet, the nearest fish-bearing water, which is currently frozen.

Photo 1. Untreated Sewage Release – April 20, 2024

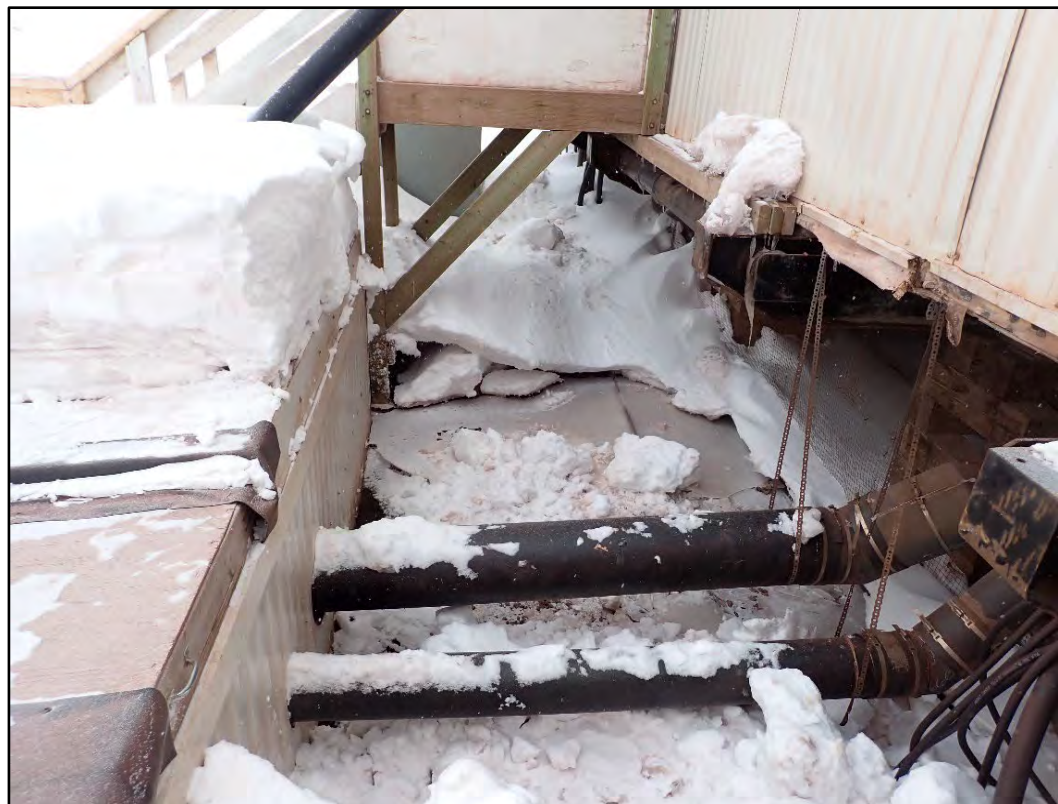
Photo 2. Untreated Sewage Release Following Clean Up – April 20, 2024

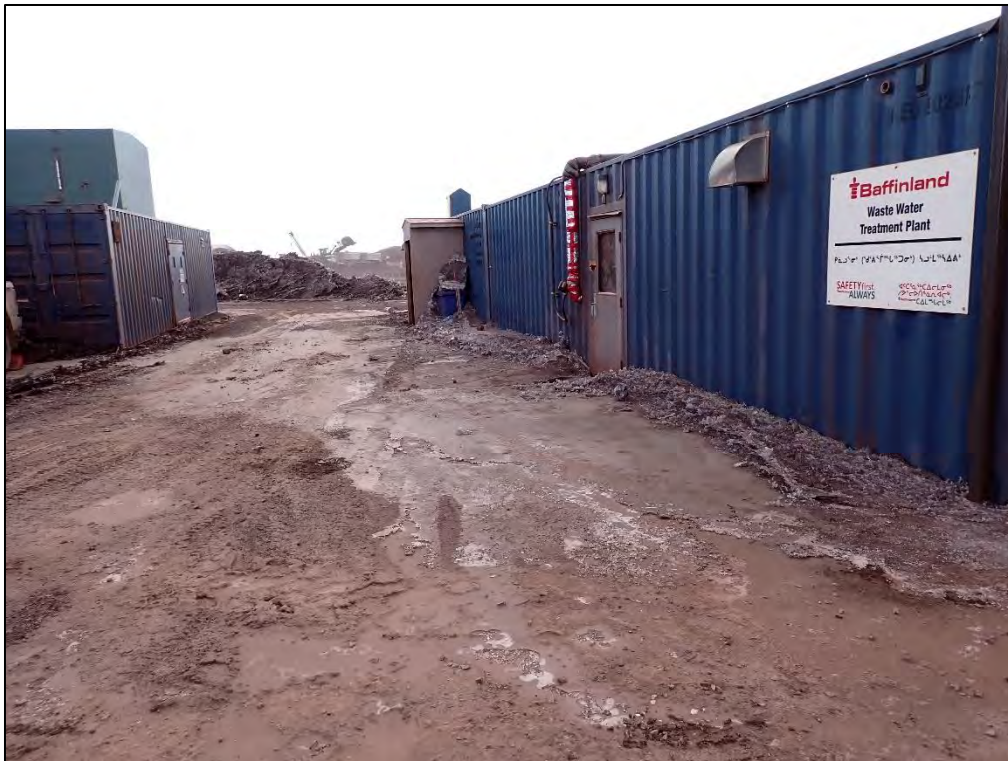
Upon discovery of the release by the operator, the MSC WWTP was immediately shut down and the release contained. It was determined that the high-level float was not placed at the correct height and thus did not function as expected resulting in the overtopping of the tank and subsequent release. The high-level float was set at the correct height and the plant resumed operations. Recovery of any accessible product was completed but was limited due to frozen conditions.

Photo 1: Origin of discharge from MSC WWTP. May 9, 2024

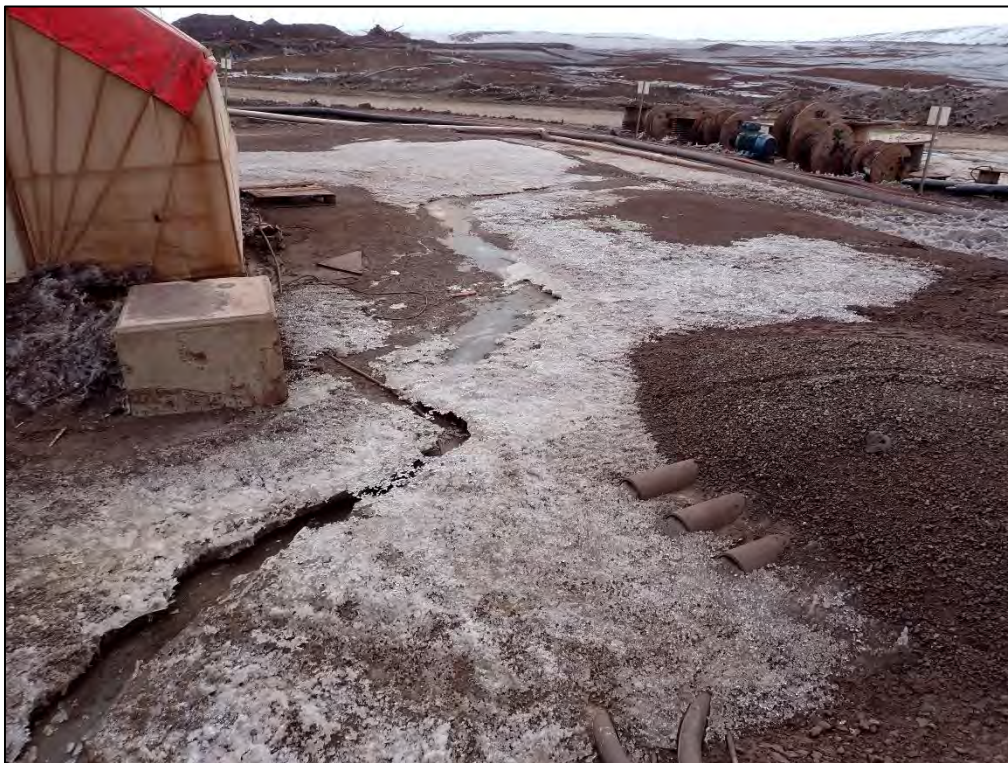
Photo 2: Flow path of spill over frozen ground. May 9, 2024

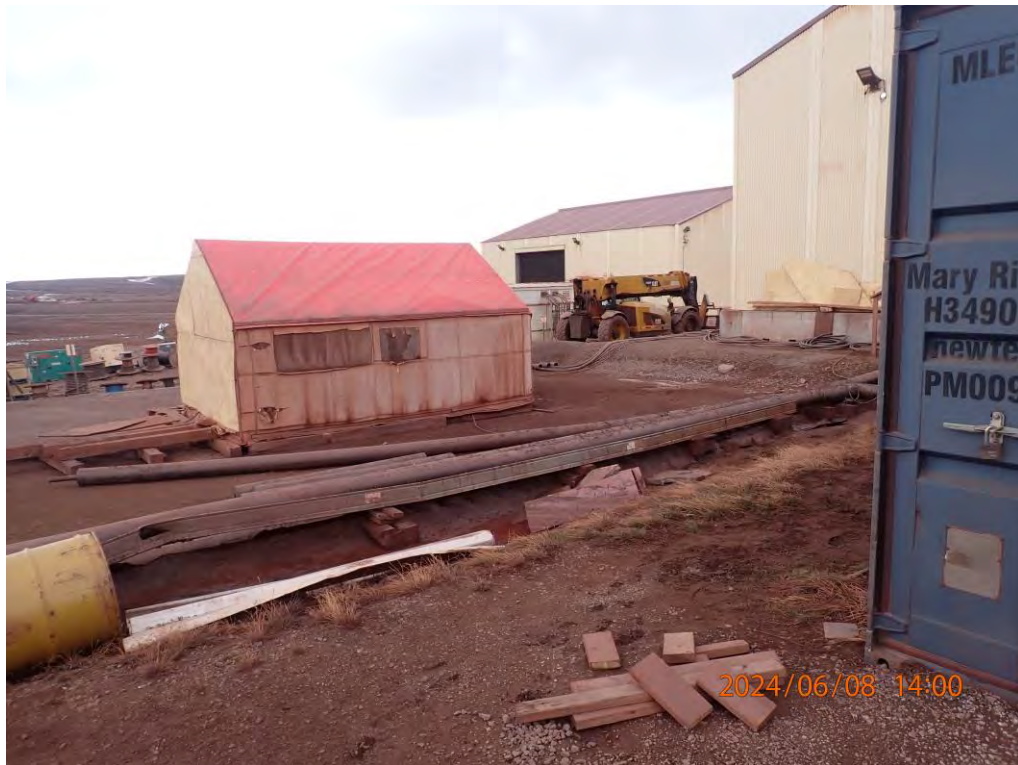
Photo 3: Area of discharge after snow melt. June 8, 2024

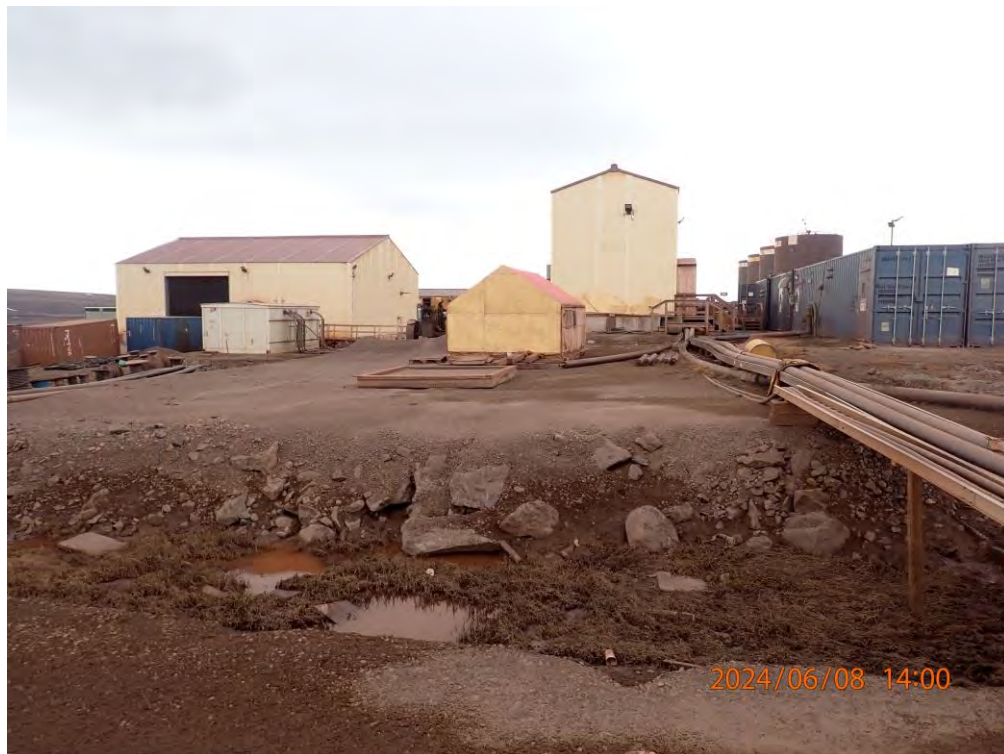
Photo 4: Area further down slope of the discharge. June 8, 2024

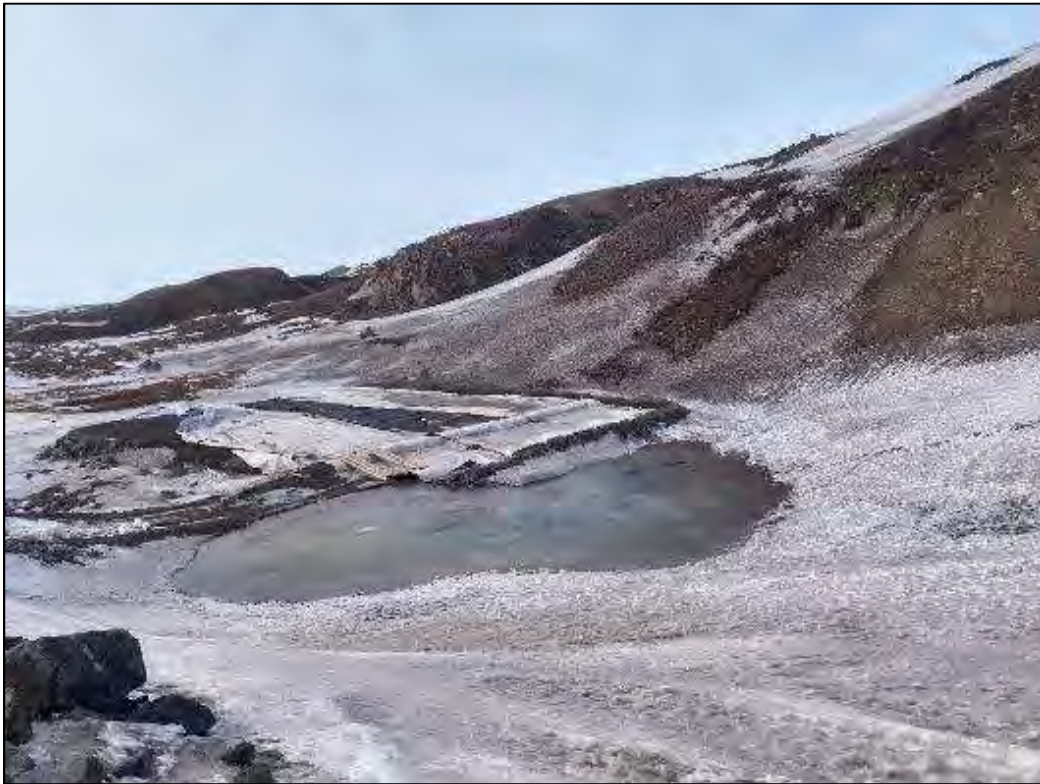
On May 10, 2024, an uncontrolled release from the KM105 Surface Water Management Pond (KM105 Pond) was confirmed through testing and observations conducted in response to observed flowing water at the downstream toe of the dam (see Attachment 2; Photograph 1). Visual inspections confirmed seepage from upstream of the northwest embankment in a discrete location from the seepage reported in 2022 and 2023. Initial field readings of the release indicated elevated levels of pH at 11.8 in the immediate vicinity of the release. Subsequent water quality samples were collected from a newly established water quality monitoring station (KM105-SWMP-SEEP-03) at the seepage location and submitted to an external laboratory to characterize the water quality of the seepage (see Attachment 3; KM105-SWMP-SEEP-03 Water Quality Results). The downstream receiving environment was frozen at the time of the release. This prevented the seepage from migrating to the receiving environment and was observed to be pooling approximately 60m downstream of the toe of the northwest embankment.

Photograph 1. Seepage from Toe of KM105 Dam on May 11, 2024

In response to the observed seepage, Baffinland engaged a third-party design consultant to evaluate potential remediation measures. Based on their analysis of site investigations and available data, the consultant determined that the seepage likely originated from the area immediately upstream of the northwest embankment geomembrane tie-in trench, where the trench transitions from the upstream embankment to the abutment slope.

Baffinland is currently reviewing the potential remedial options for permanent repair of the water management structure at the KM 105 Sedimentation Pond and continues to engage a third-party design consultant and Engineer of Record to determine appropriate corrective actions. Water quality monitoring will continue as scheduled at the new sample location, KM105-SWMP-SEEP-03 until permanent corrective actions are implemented.

The remediation plan recommended by the third-party consultant included the installation of a cut-off trench, with trench soils augmented by a bentonite mixture. This approach was designed to improve the existing anchor trenches at the toe and on the abutments by increasing the depth where no permafrost was present and/or extending their width, thereby decreasing the permeability of the fill material. In addition, an insulation cover was recommended to protect the permafrost during the melting season.

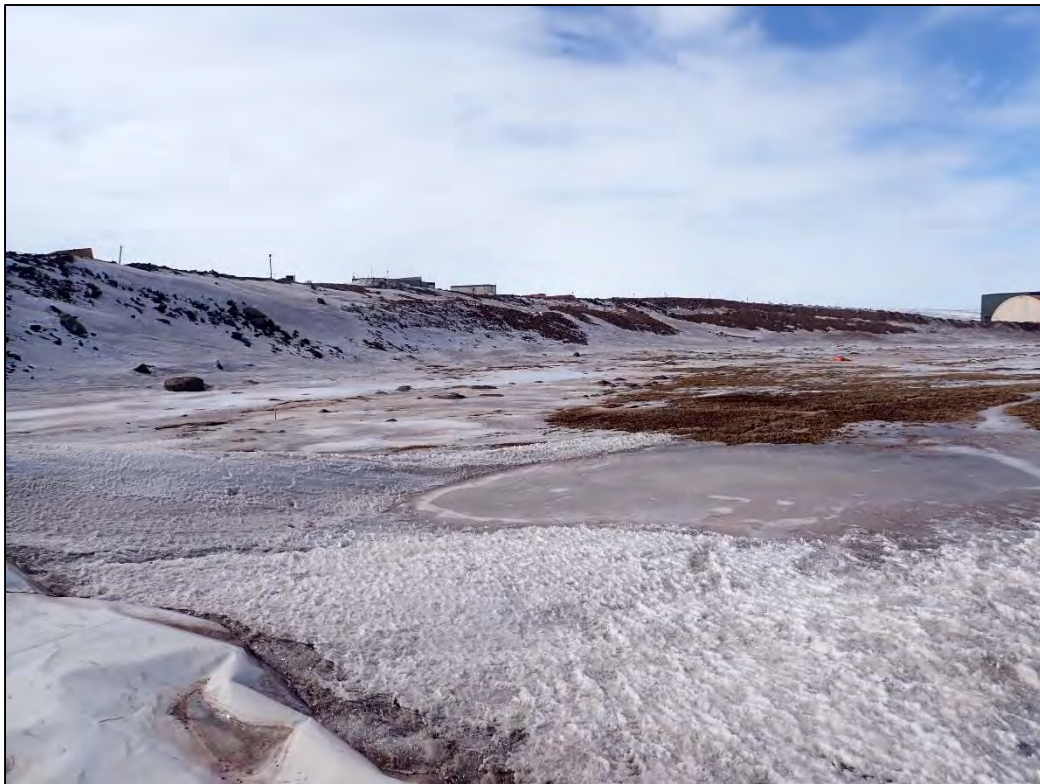
Photograph 2. Downstream showing no seepage from toe of dam to receiving environment, May 11, 2024

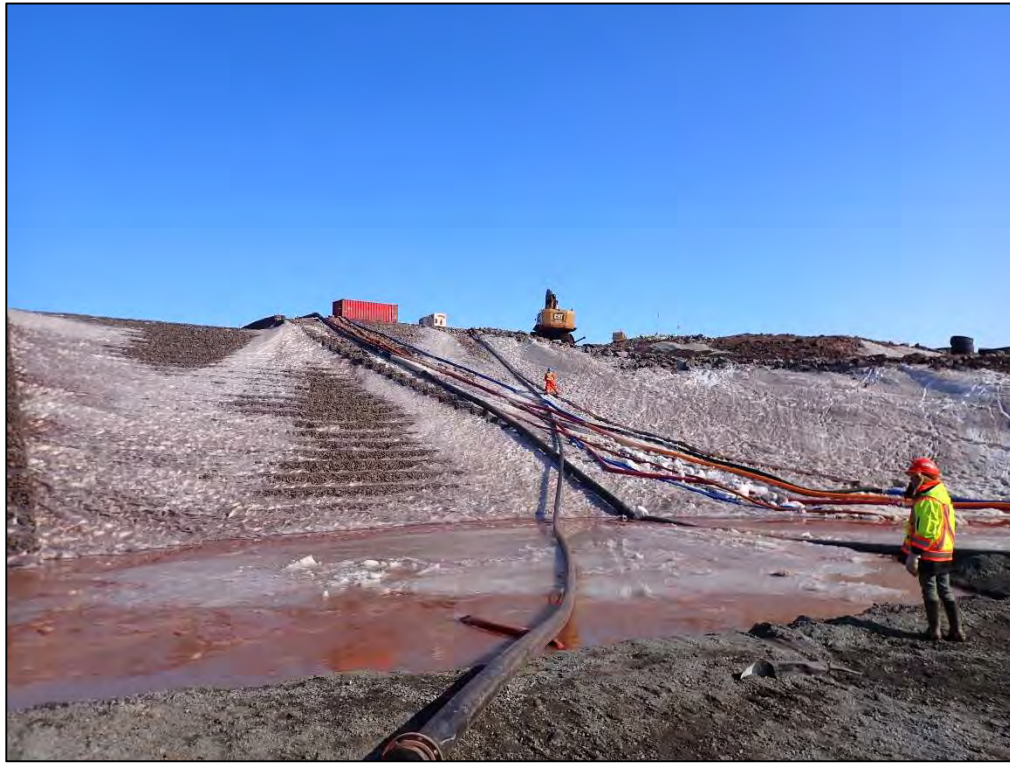
Photograph 3. Seepage collection pond (within containment) on May 19, 2024

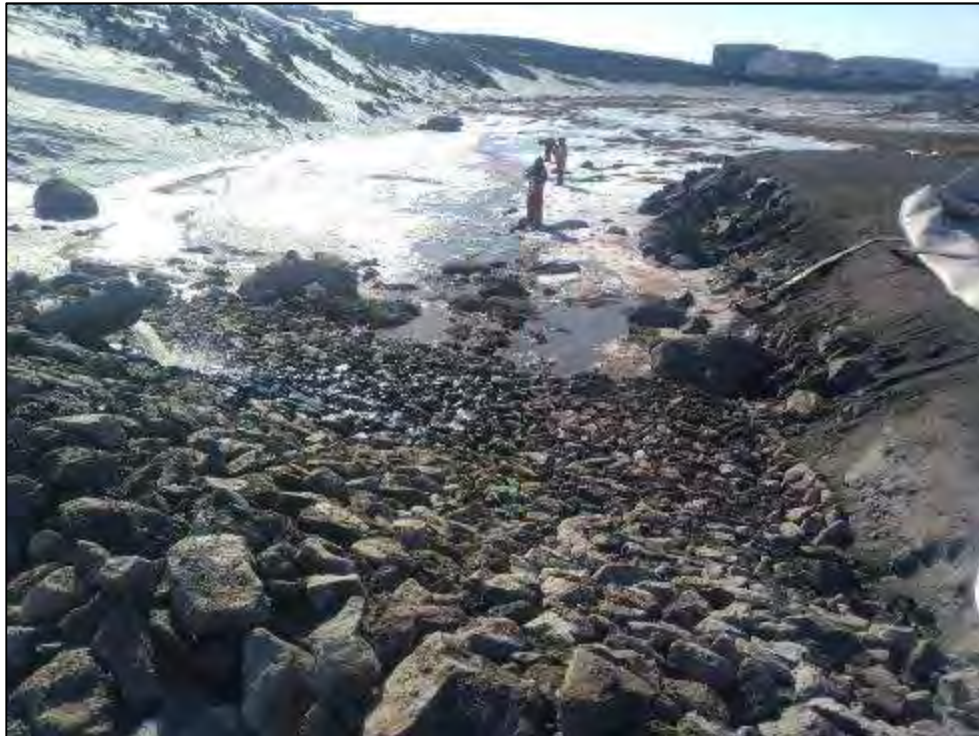
Photograph 4. Downstream Receiving Environment on May 20, 2024

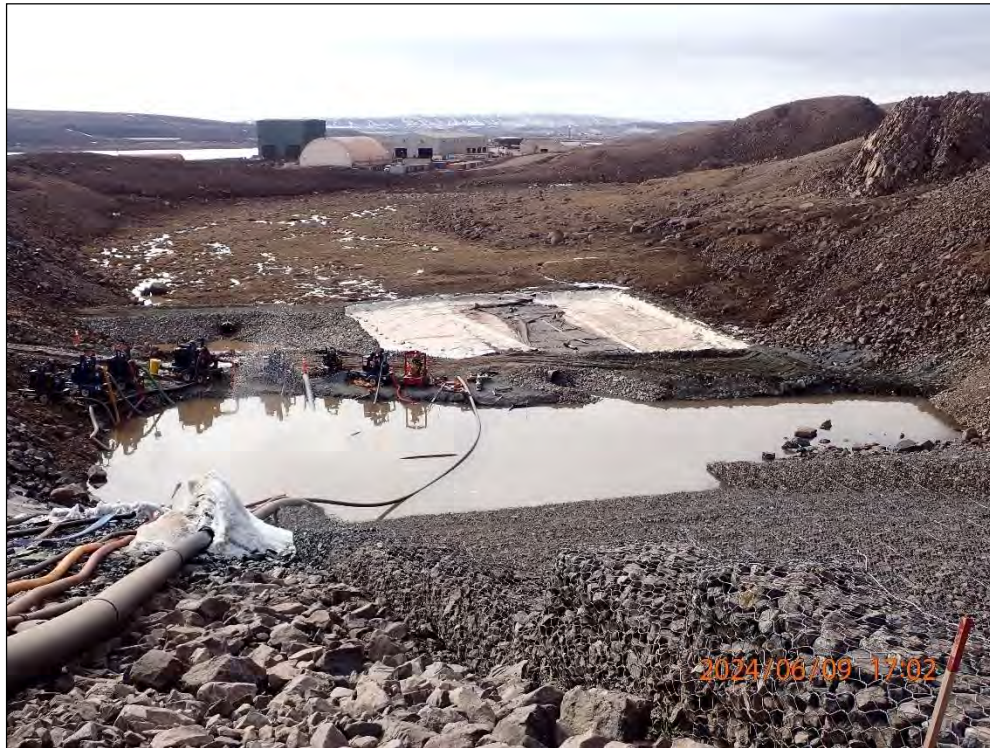
Photograph 5. Seep Collection Area on June 9, 2024

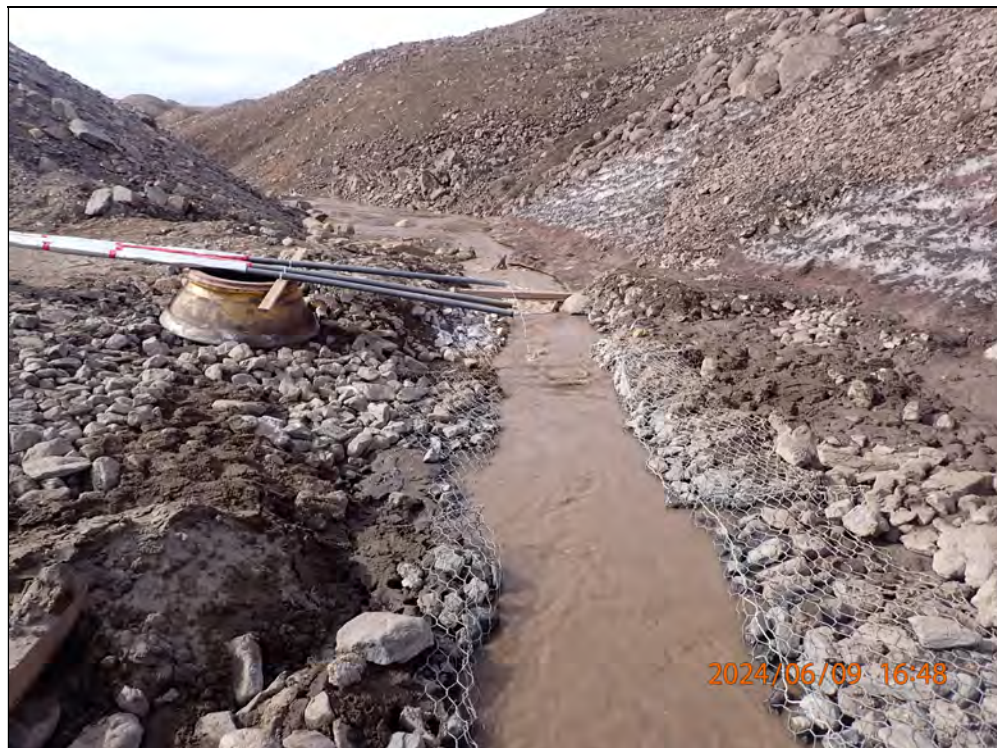
Photograph 6. Pre-dosing station on June 9, 2024

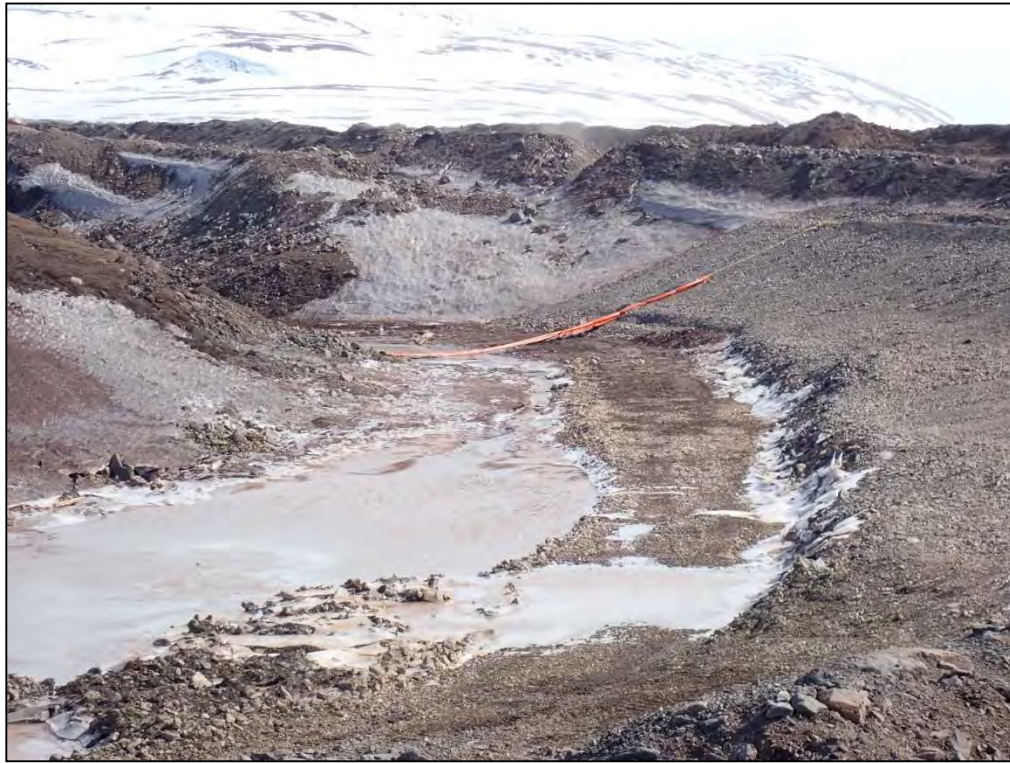
Photograph 7: Silt curtain installation

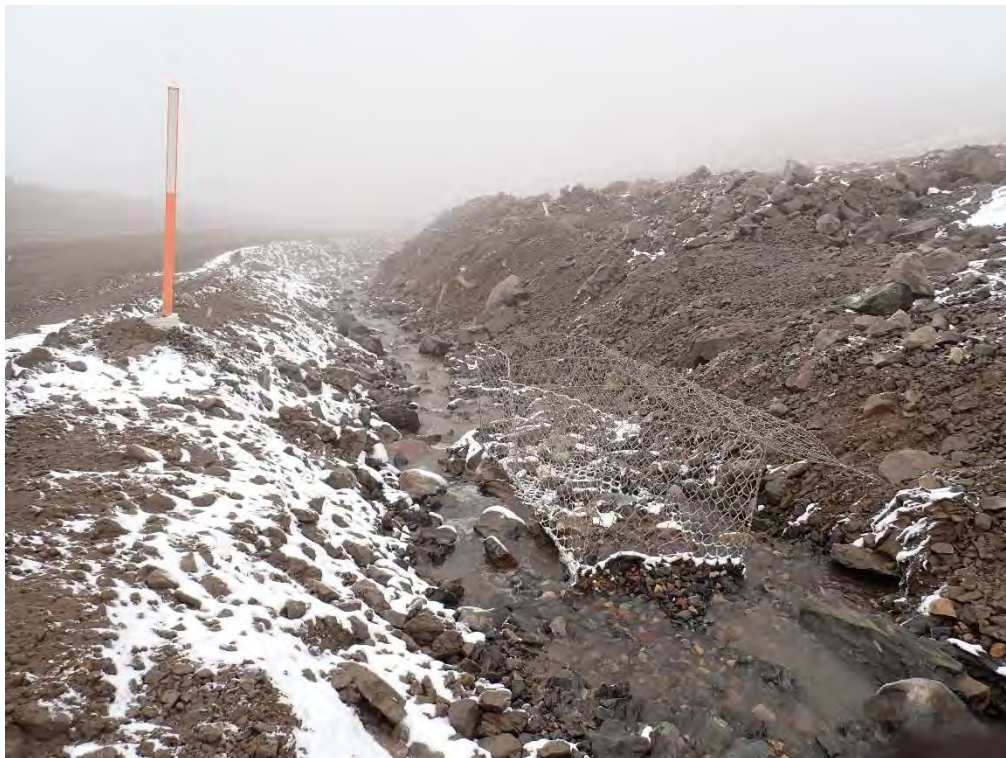
Photograph 8: Placement of Floc Blocs in drainage ditch of inflow to KM105 Pond

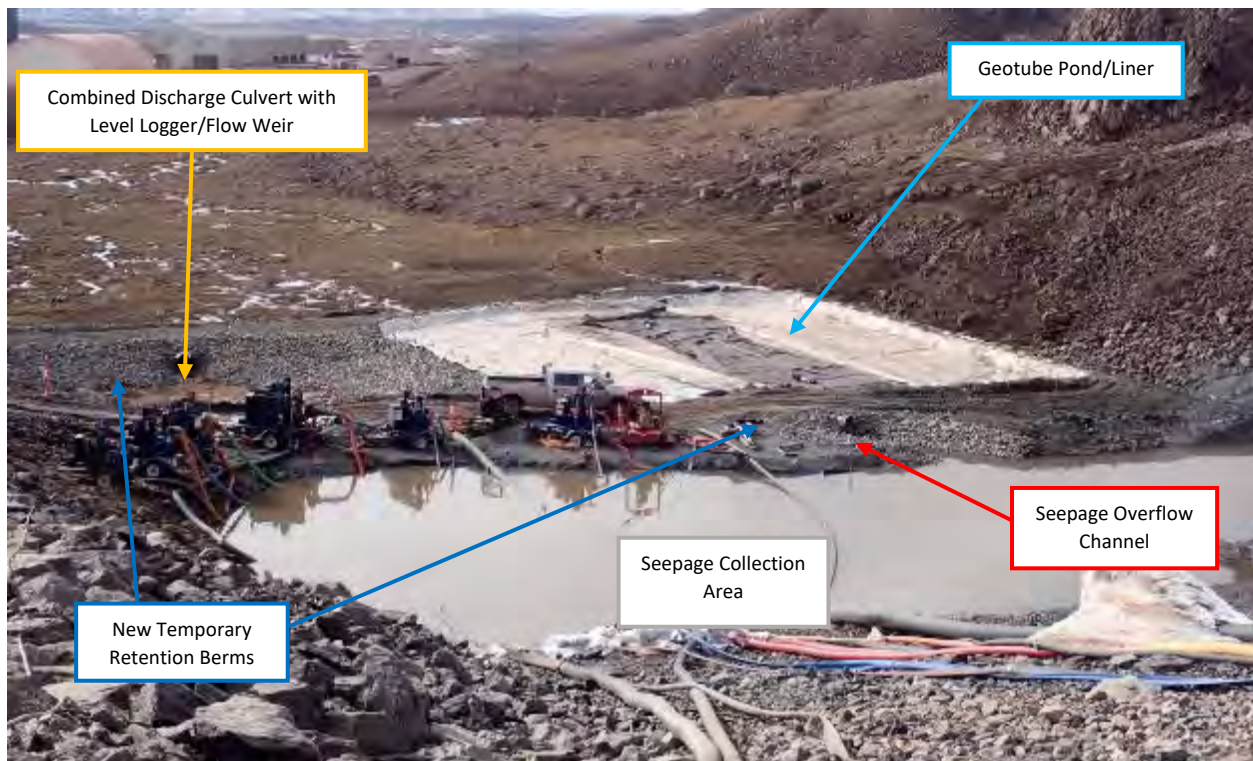
Figure 1: Temporary Retention Structures and Associated Water Management Features

In the seepage collection area an overflow culvert was installed through the temporary retention structure, as shown in Figure 1.

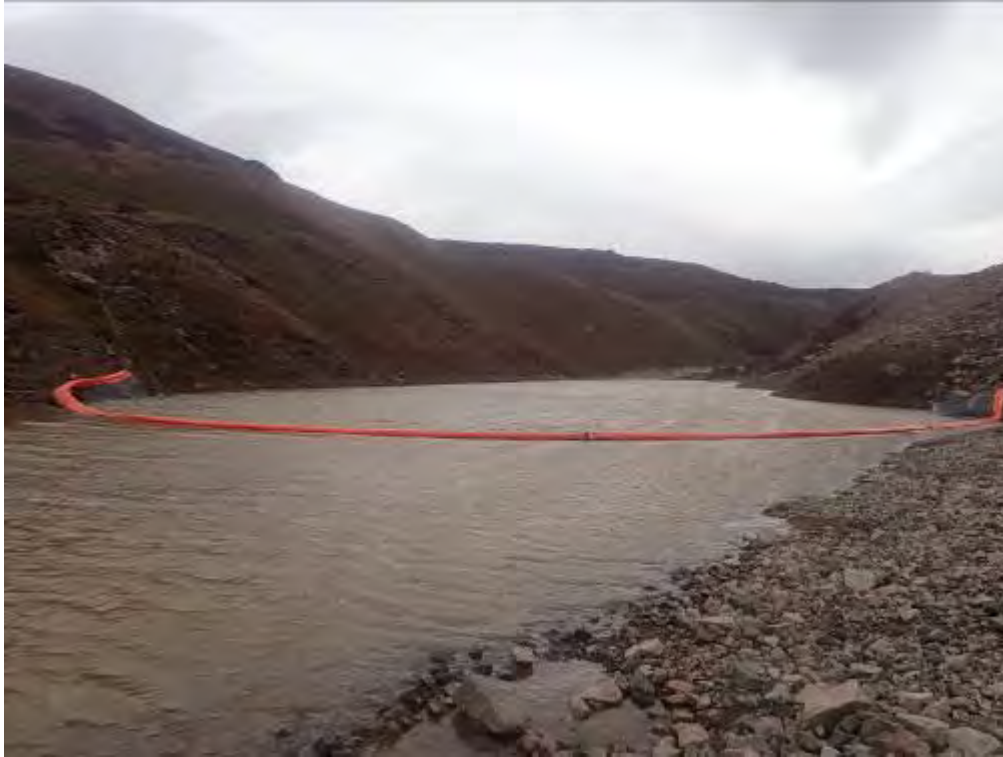
Photo 2: Remedial construction completed in September 2022 to patch seepage location

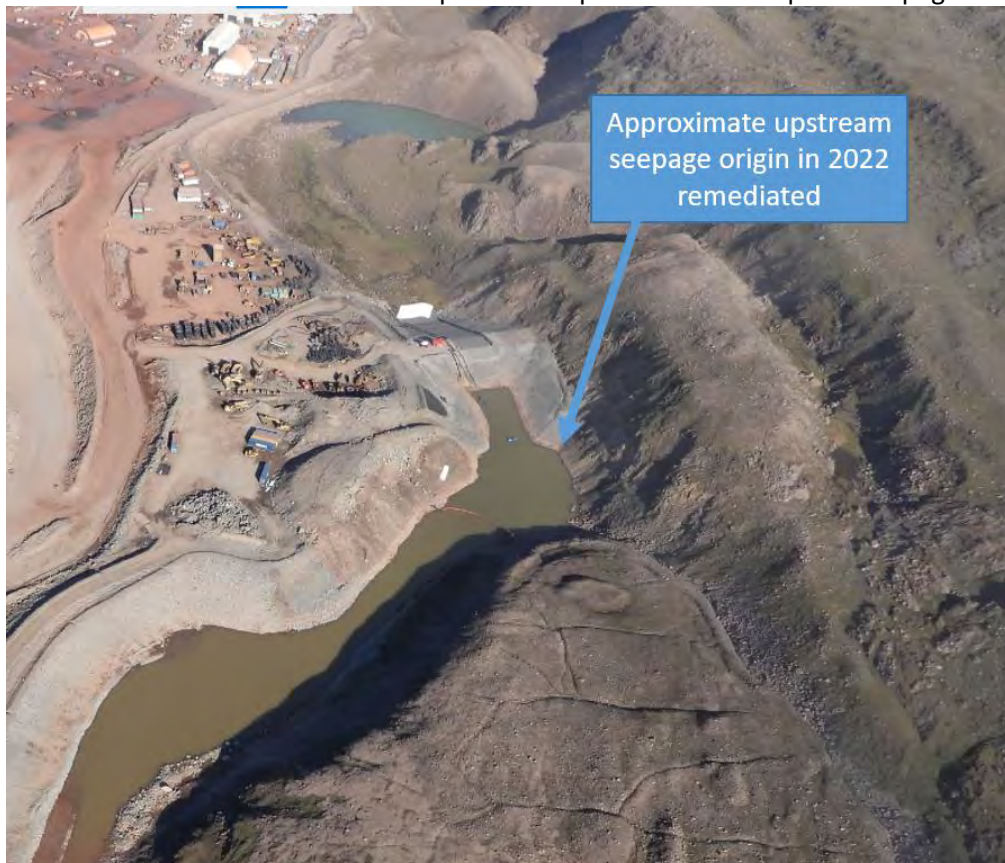
Photo 3: Attempt at sealing new seepage location utilizing bentonite plugs, 2023

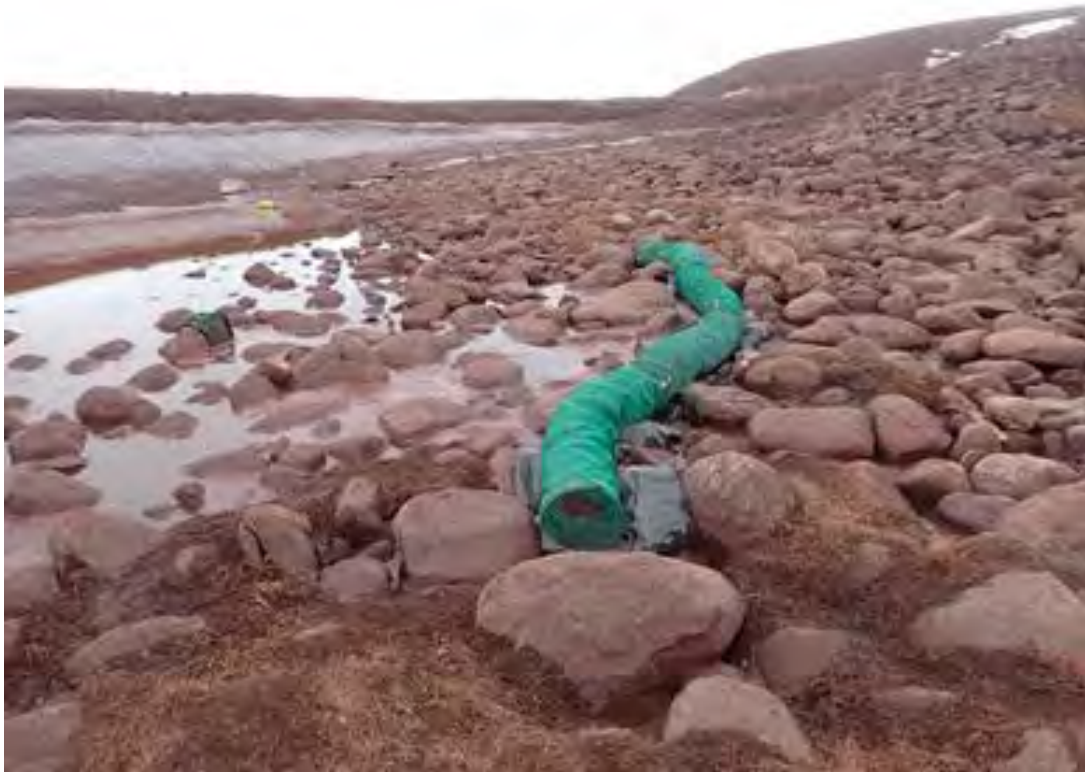
Photo 9: LDFG-OUT ESC Measures (Spring Berm/Floc Bloc) June 3, 2024

Erosion and Sediment Control (ESC) measures were assessed and installed where applicable, in accordance with Baffinland's Surface Water Aquatic Effects Management Plan (SWAEMP), and maintained and adjusted as required. At LDFG, a spring berm was installed across the stream to help alleviate the amount of sediment flowing into the watercourse. Additionally, floc blocs implemented in 2023 continued to be utilized to promote settling of solids prior to the water entering Sheardown Lake (see photo in Attachment 1). Ground conditions will continue to be monitored for feasibility and suitability of additional ESC measures.

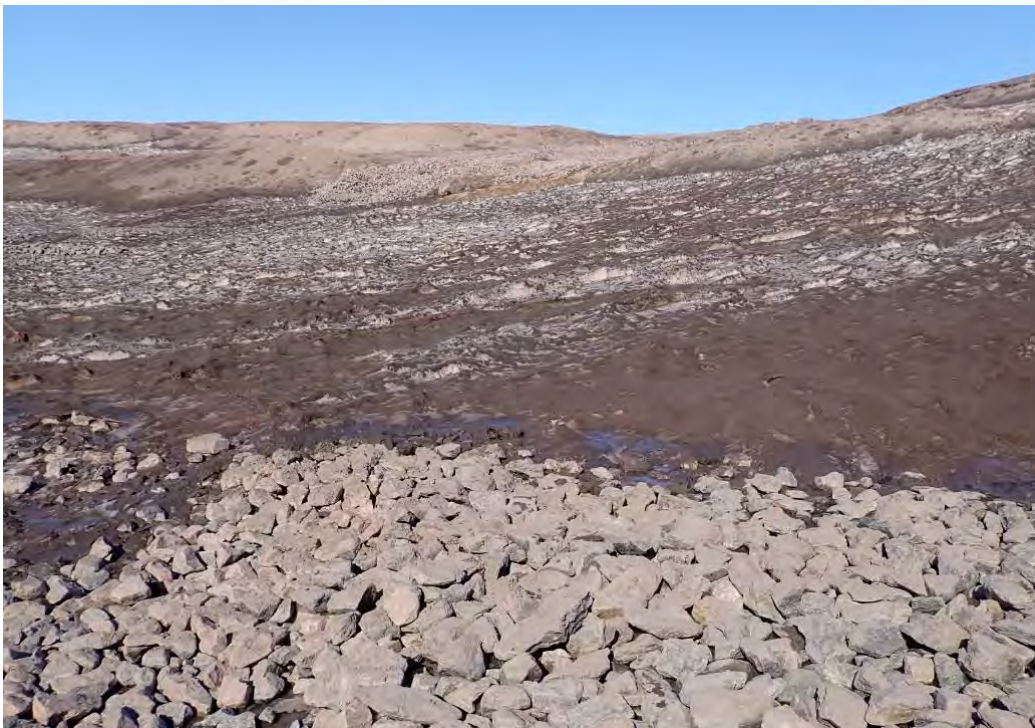
Photo 15: CLSP Melting Snow Resulting in Spill June 3, 2024
