MARY RIVER PROJECT

NT-NU SPILL REPORT

Re: Follow-Up to Spill #2024-193
Mary River Project - Water Licence No. 2AM-MRY1325

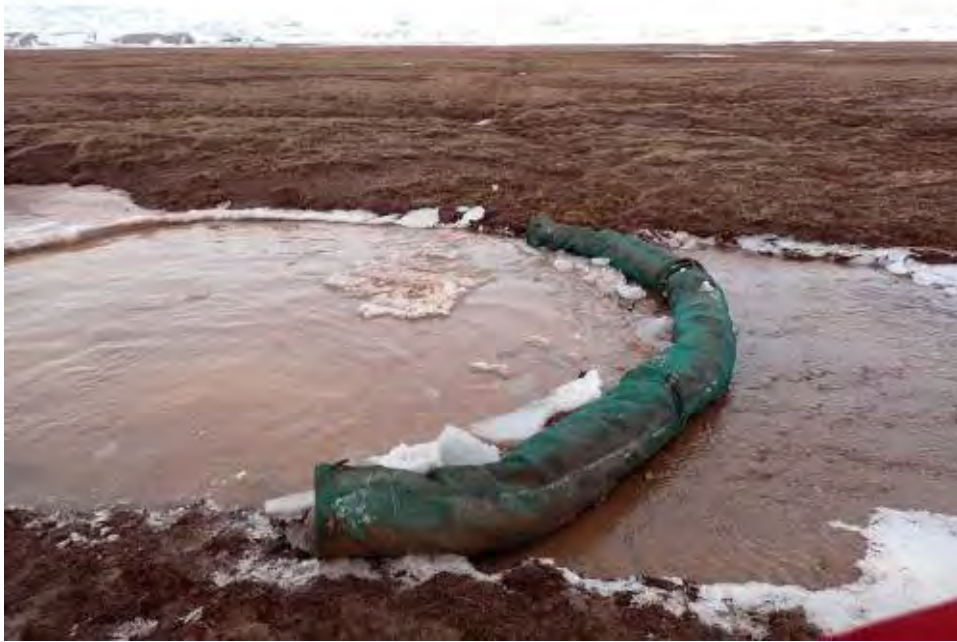
Photo 1: MP-C-B Freshet Site Upstream with ESC (Spring Berm) Installed on May 22, 2024

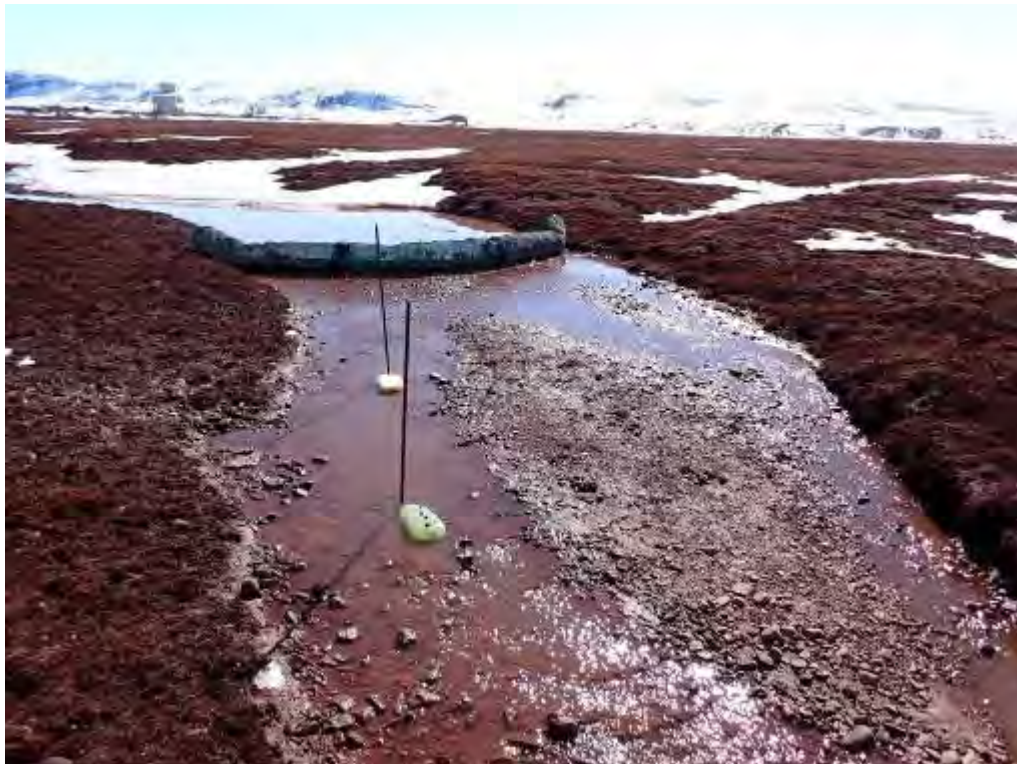
**Photo 2: MP-C-B Freshet Monitoring Site with ESC (Spring Berm and Floc Blocs)
Installed on May 26, 2024**

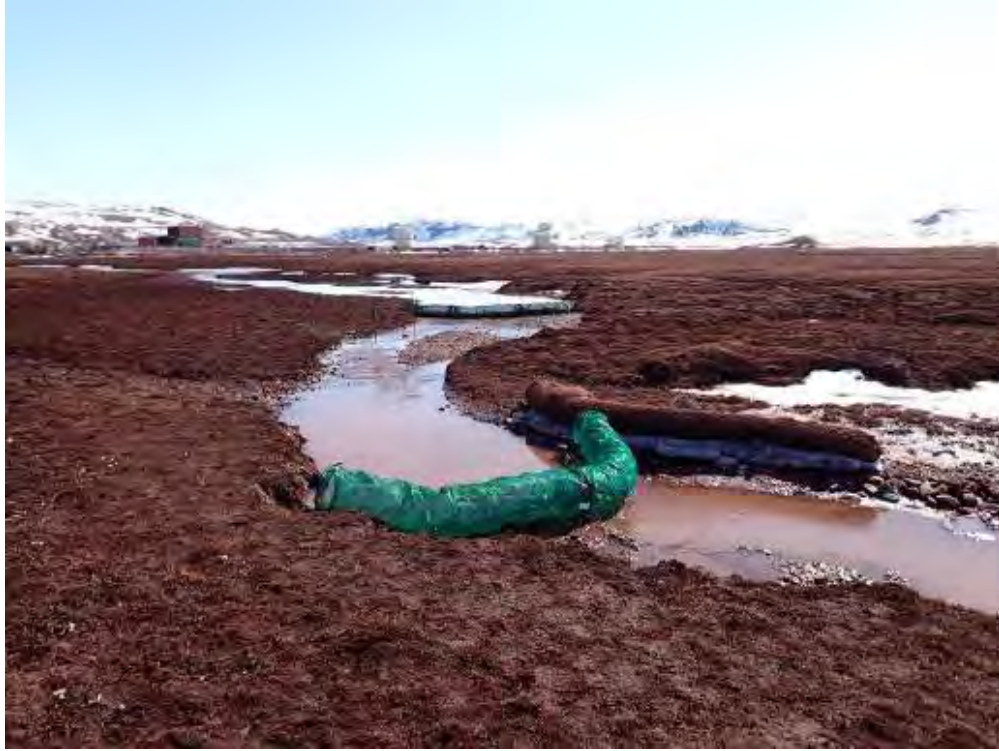
Photo 3: MP-C-B Freshet Monitoring Site with ESC (Additional Spring Berm) Installed on May 29, 2024

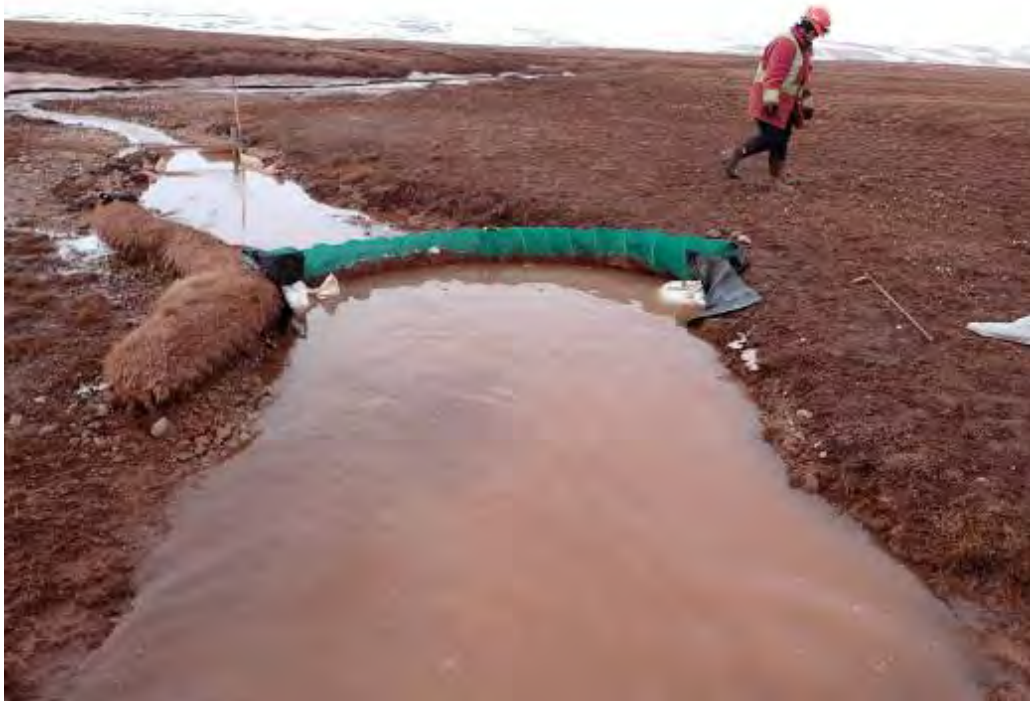
Photo 4: MP-C-B Freshet Monitoring Site with ESC (Reinforced Spring Berm) on May 30, 2024

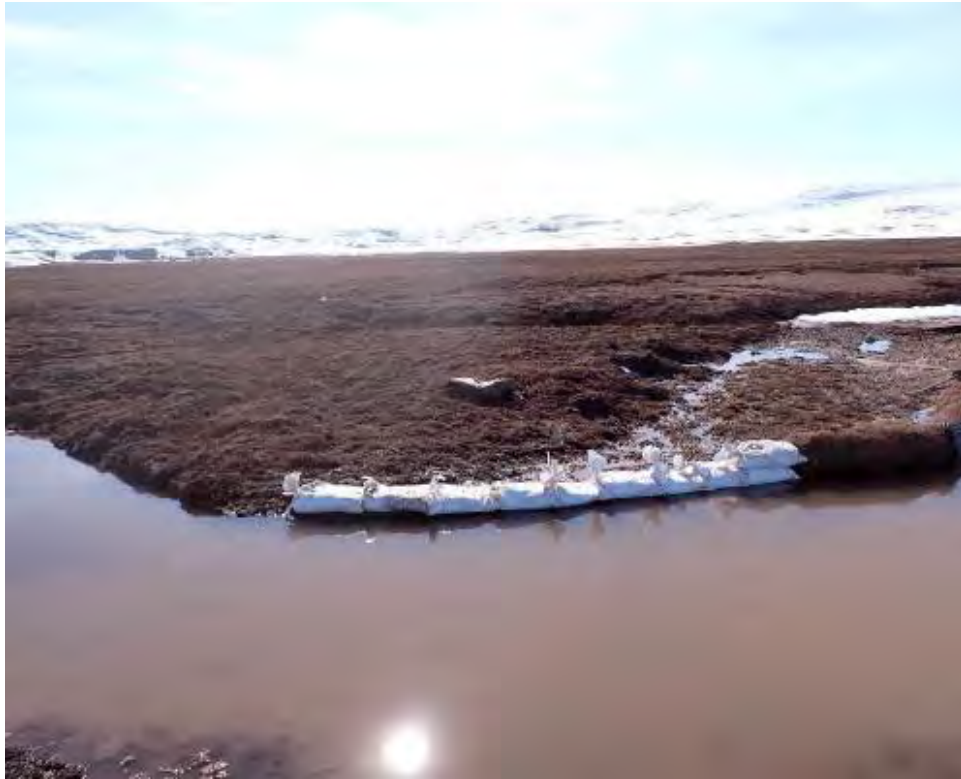
Photo 5: MP-C-B Freshet Monitoring Site with ESC (Sandbags) Installed on June 1, 2024

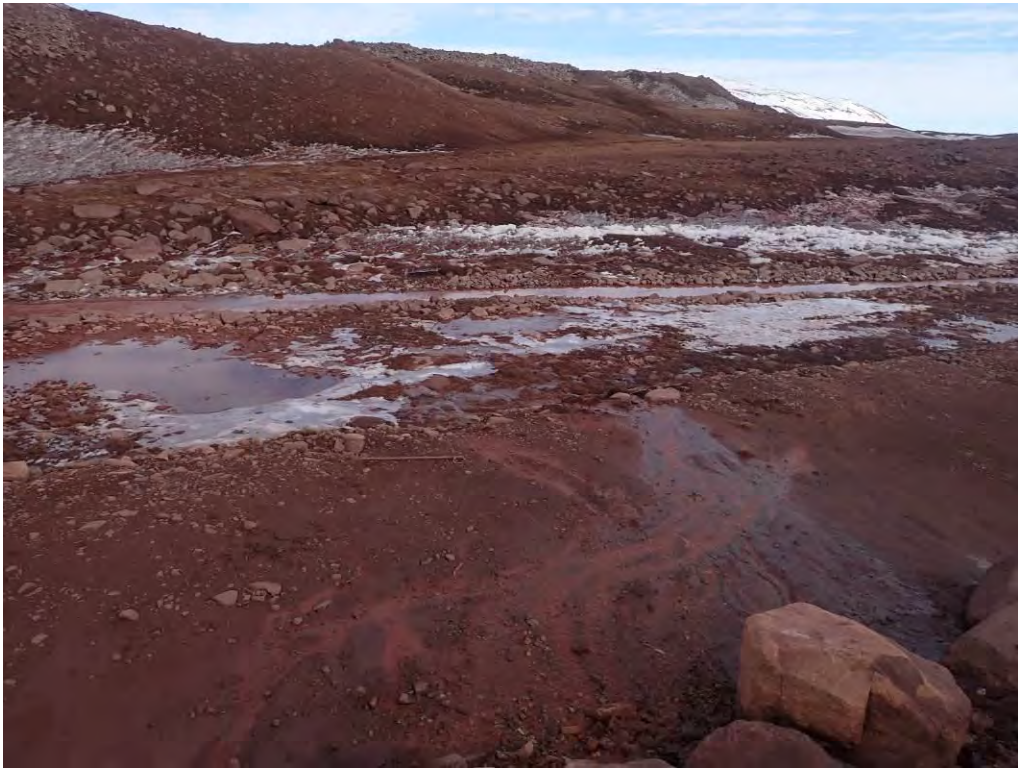
On May 27, 2024, seepage was observed entering the crusher pad perimeter ditch through the embankment berm at the northeast corner of the Crusher Facility and releasing onto the tundra. The embankment berm was installed in 2020 to capture contact water runoff and isolate the perimeter ditch from Crusher Facility water management infrastructure following the identification of integrity issues with the perimeter ditch network in 2020. Water management at the Crusher Facility has subsequently involved the use of active pumping of contact water from the pad directly to the MS-06 Pond. In preparation for freshet 2024, actions were implemented, including additional embankment berm maintenance and drainage improvements, to prevent runoff water from entering the perimeter ditch. Upon completion of the plan, water was successfully diverted directly to the MS-06 Pond when thawing conditions occurred, as planned, via a temporary sump and pumping system. However, some water entered the perimeter ditch beneath the embankment berm in a localized area and was subsequently released onto the tundra.

Photo 1: Crusher Seepage Location - May 27, 2024

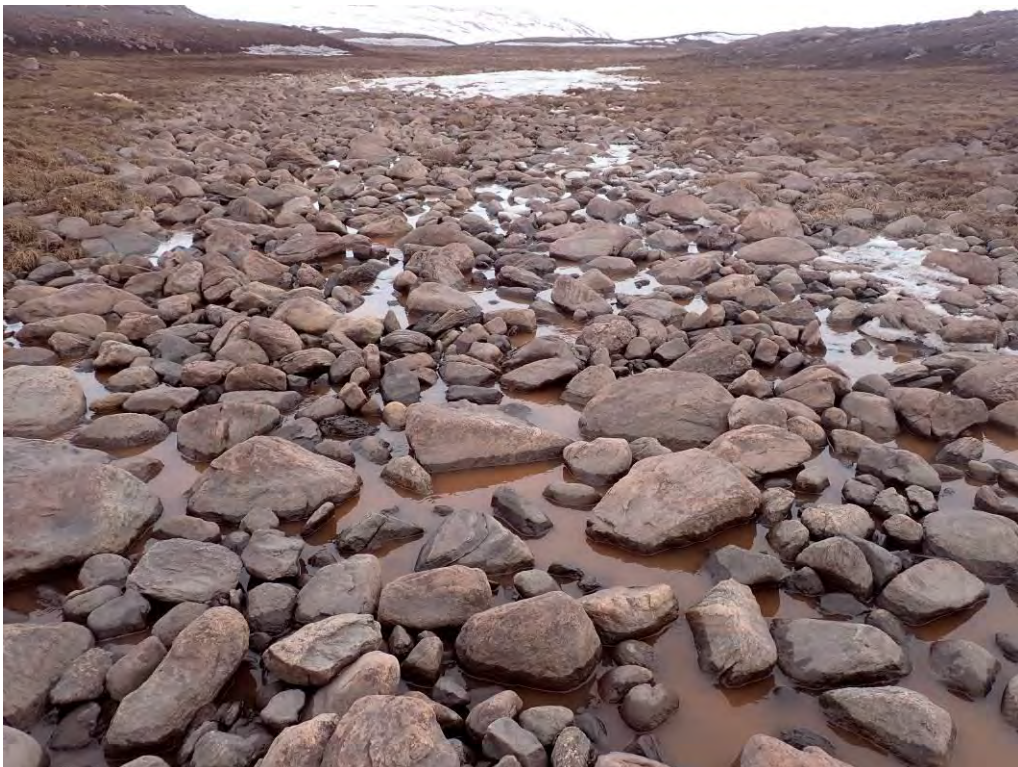
Photo 2: Crusher Seepage onto Tundra - May 28, 2024

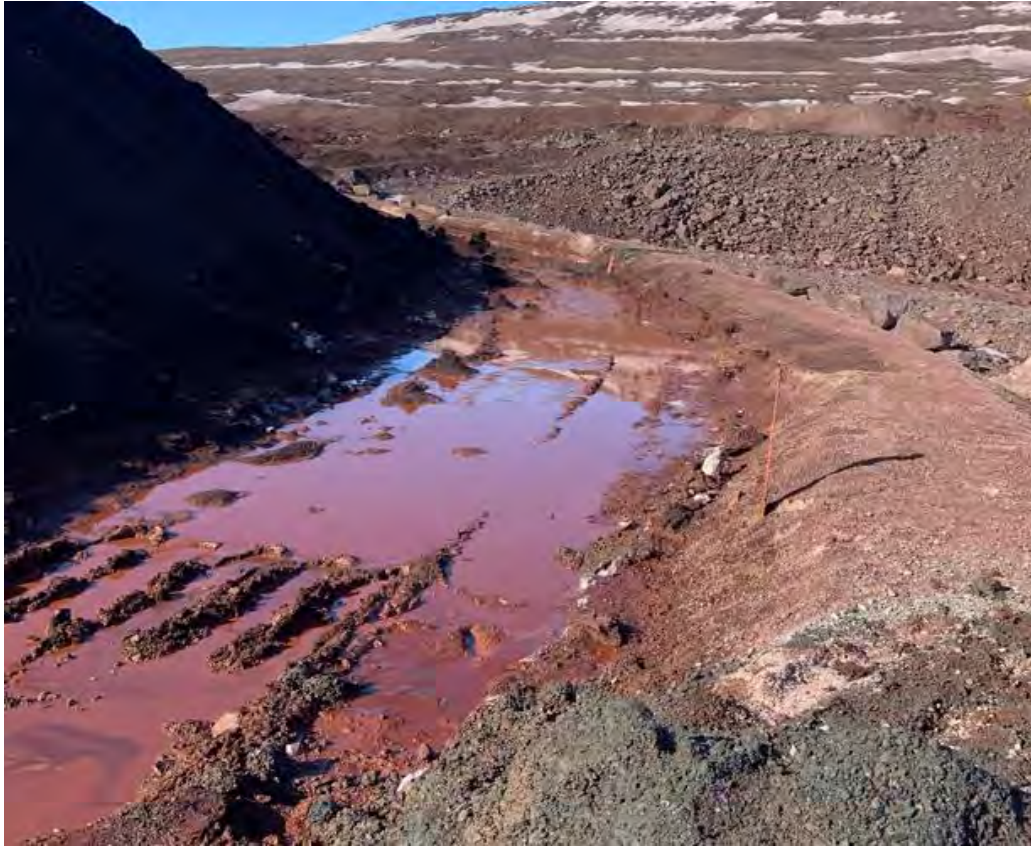
Photo 3: Embankment Berm Where Seepage Entered Perimeter Ditch – May 27, 2024

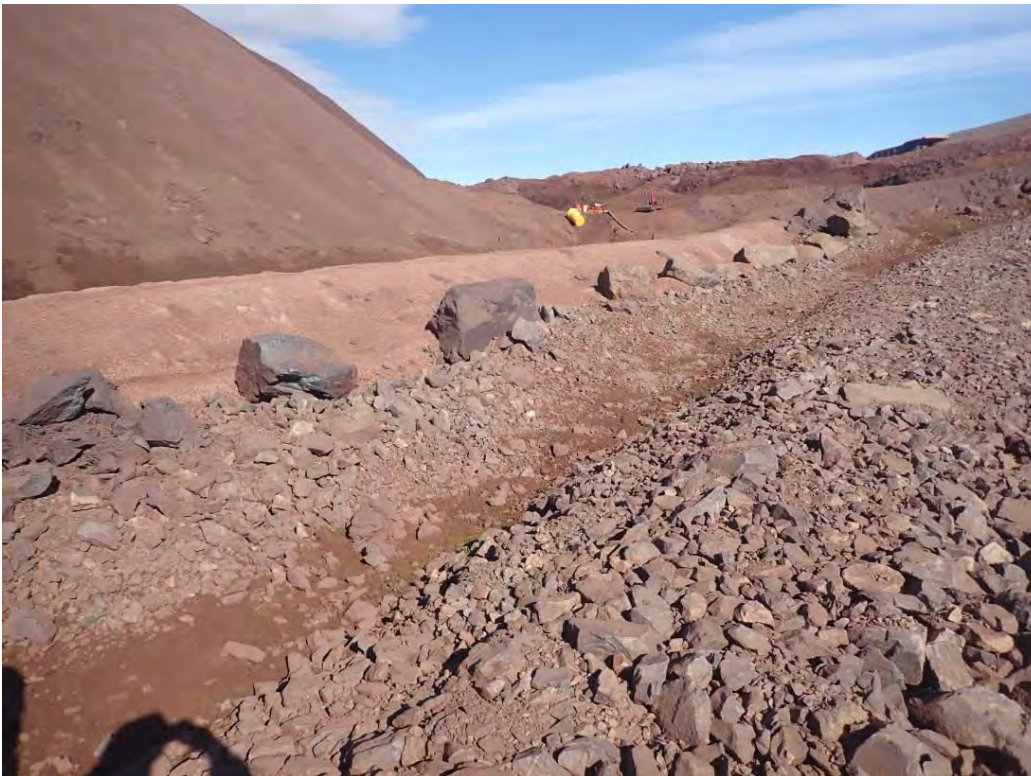
Photo 4: Reinforced Embankment Berm to Ensure Water Flows to MS-06 - June 24, 2024

Snow in the vicinity of Crusher Facility drainage infrastructure was removed to reduce the presence of melting water in the area. Water inputs were contained at the Crusher Facility through the construction of a berm and subsequently transferred by pump directly to the MS-06 Pond, in accordance with Baffinland's MDMER Emergency Response Plan (BAF-PH1-830-P16-0047). The embankment berm was repaired, re-isolating the perimeter ditch from additional water inputs and preventing further seepage to the tundra.

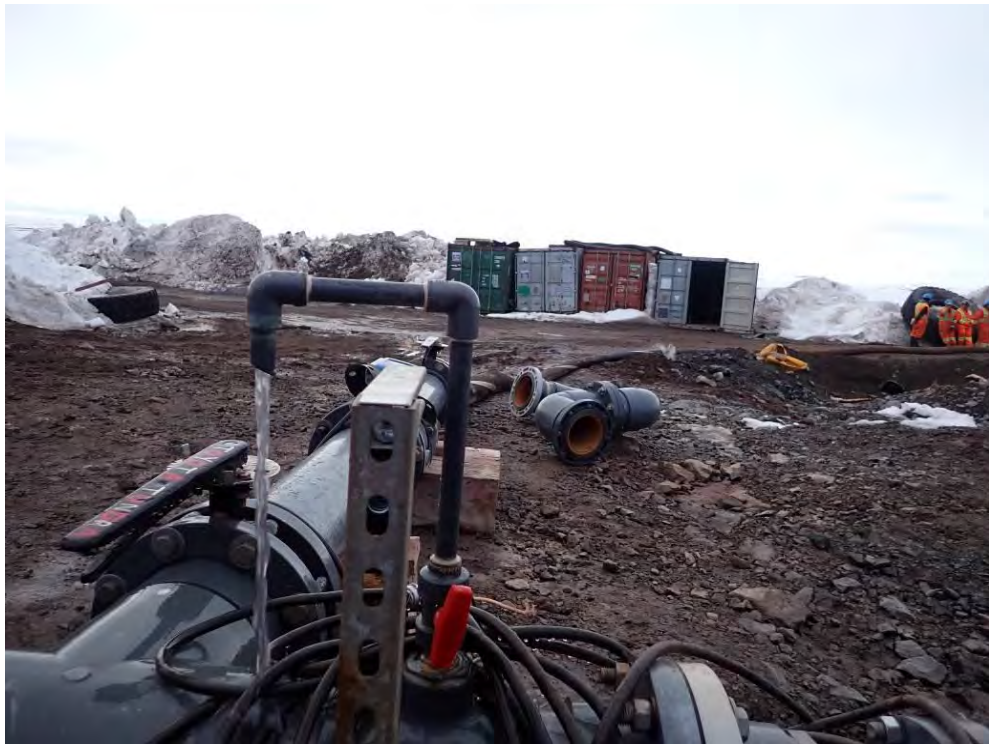
Photo 1: Sample port during discharge occurring through MS-08 FDP. June 21, 2024

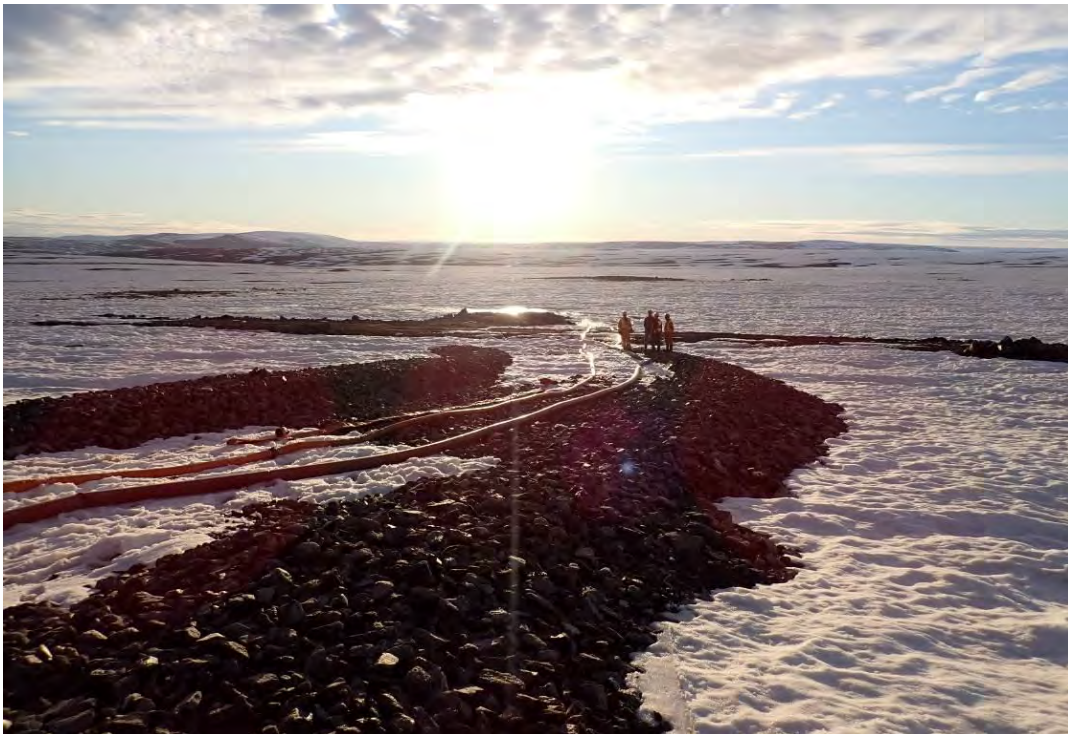
Photo 2: Discharge occurring over spill way onto frozen ground. June 24, 2024

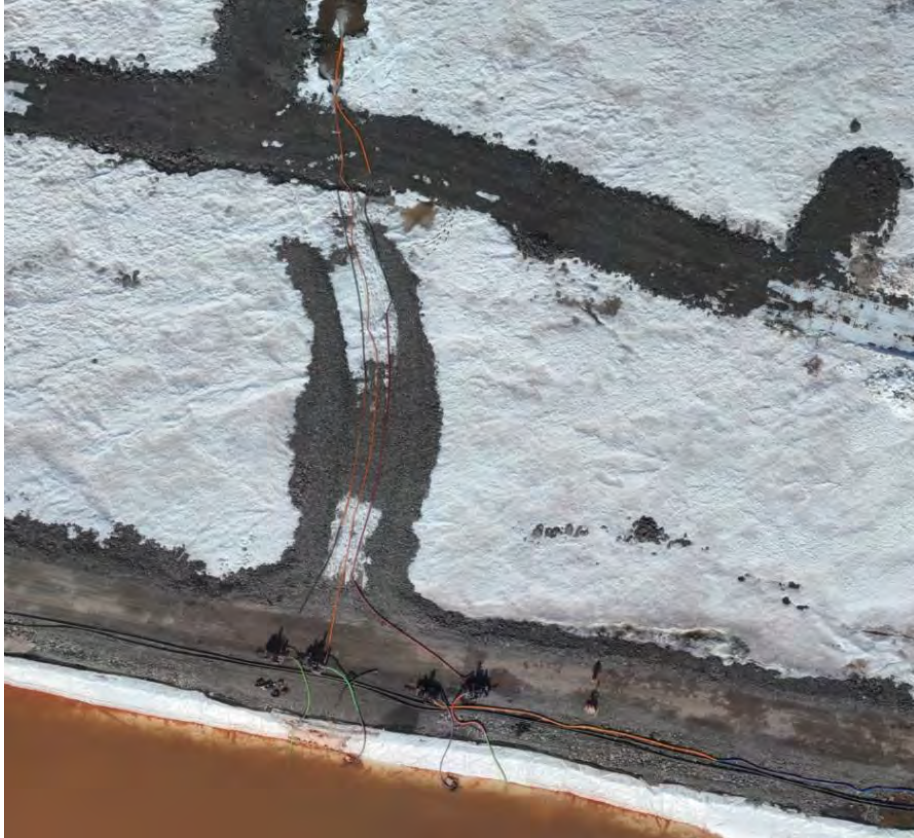
Photo 3: Additional pumps set up and discharging to lower water level in WRF Pond. June 24, 2024

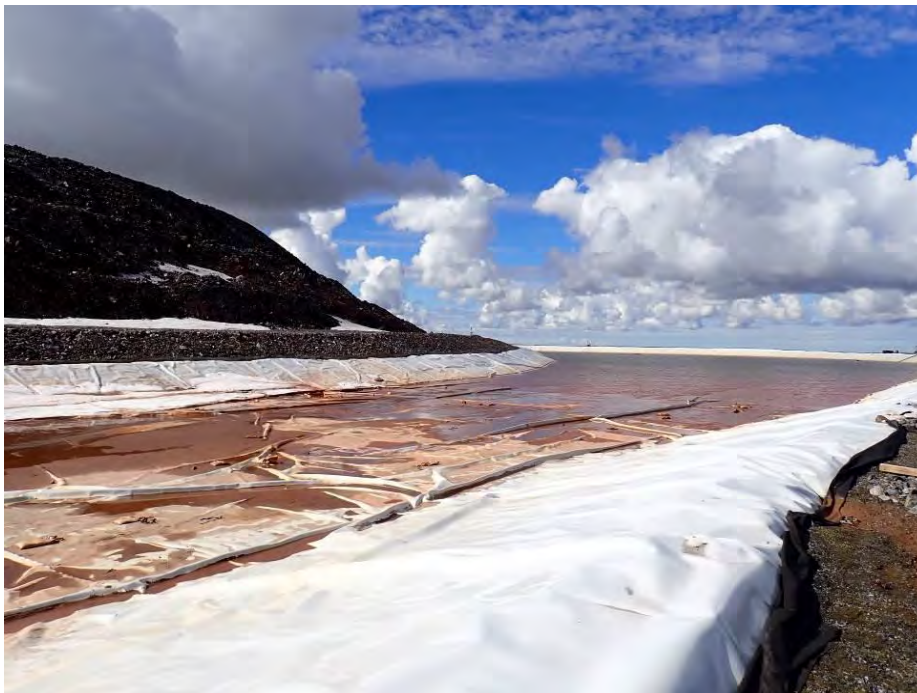
Photo 4: Low water levels in WRF Pond. July 9, 2024

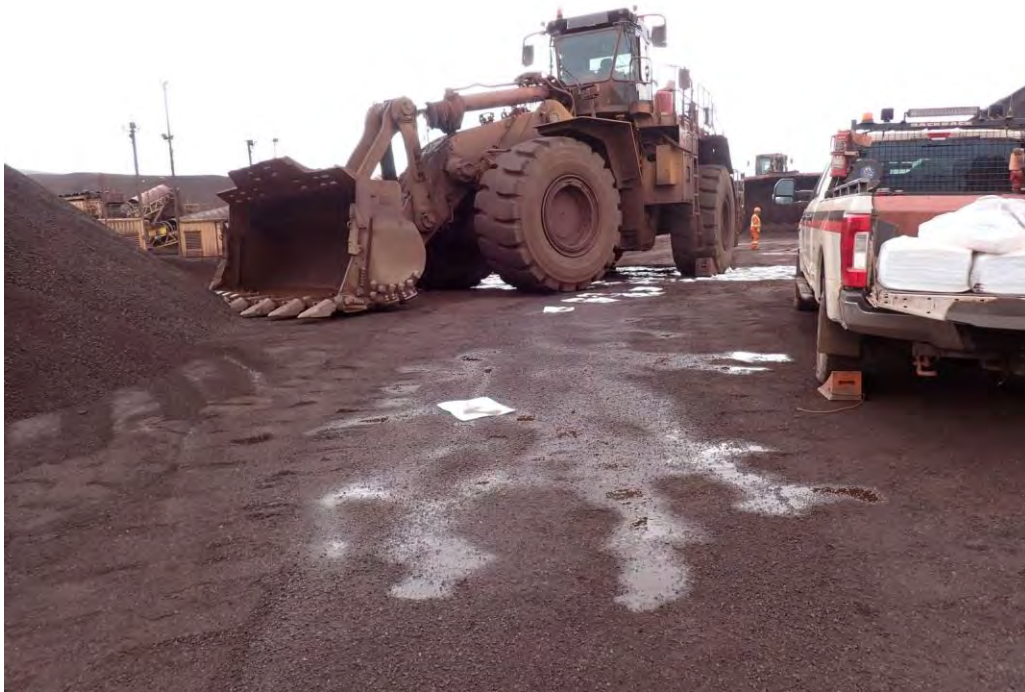
On July 11, 2024, a hydraulic hose on a K992 loader failed during routine operations, resulting in a release of approximately 280 liters of hydraulic fluid onto the ore pad within the Crusher Facility, near Crusher B. The impacted area was estimated to be approximately 20 m². An investigation of the hydraulic hose indicated that a hose fitting was the main component failure resulting in the release. The hose fitting failed as a result of stress from contact with another hose. The incident occurred on IOL located greater than 500 m from Sheardown Lake tributary, the nearest fish bearing waters. A figure showing the spill location and photos of the incident are provided in Attachment 1 and Attachment 2, respectively. The spill was reported to the NT-NU Spill Reporting Line on July 12, 2024. The NT-NU Spill Report (#2024-266) is included as Attachment 3.

Photo 1: Release of Hydraulic Fluid on Ore Pad within the Crusher Facility on July 11

The failed hydraulic hose was replaced, and positioned to ensure no risk of stress contact with other hoses or components. A post installation inspection was completed to verify hydraulic hose condition and ensure quality control of hose routing and separation.

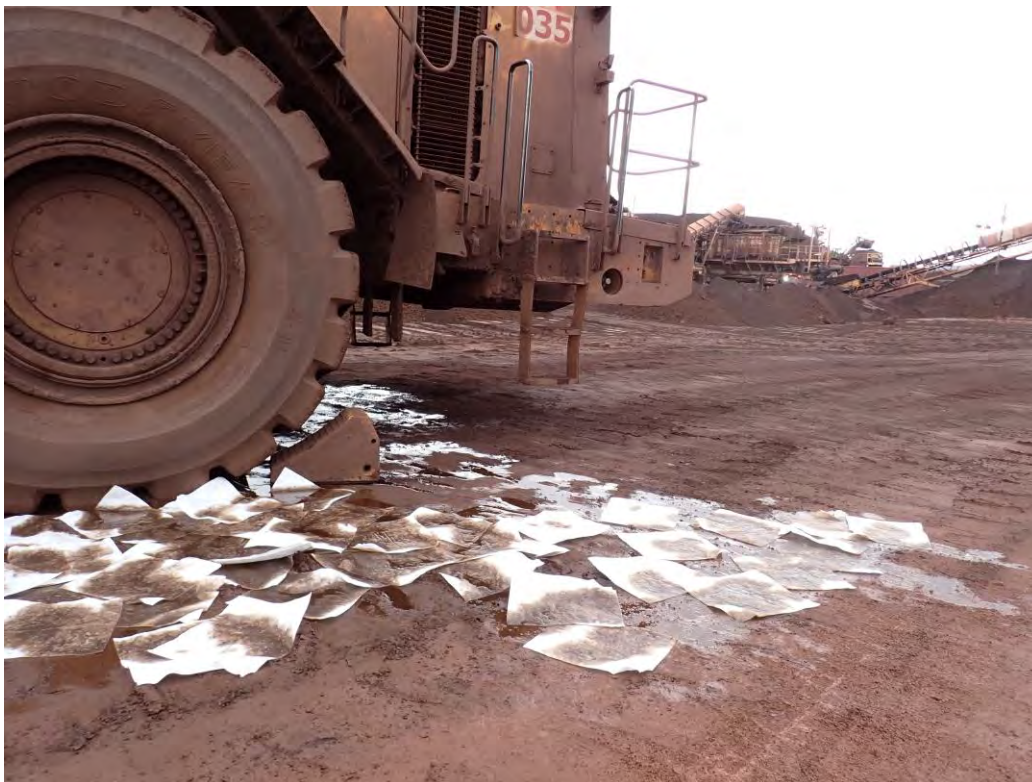
Photo 2: Absorbent Pads Placed on the Impacted Area on July 11

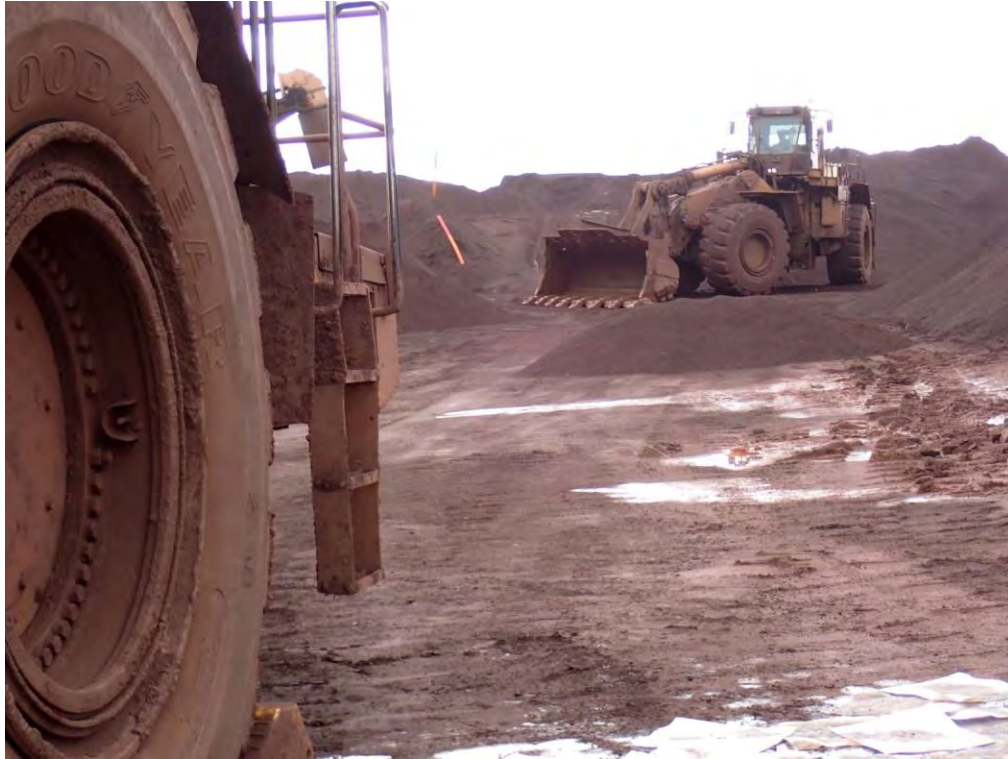
Photo 3: Berm Constructed to Prevent Migration of Release from Immediate Area on July 11

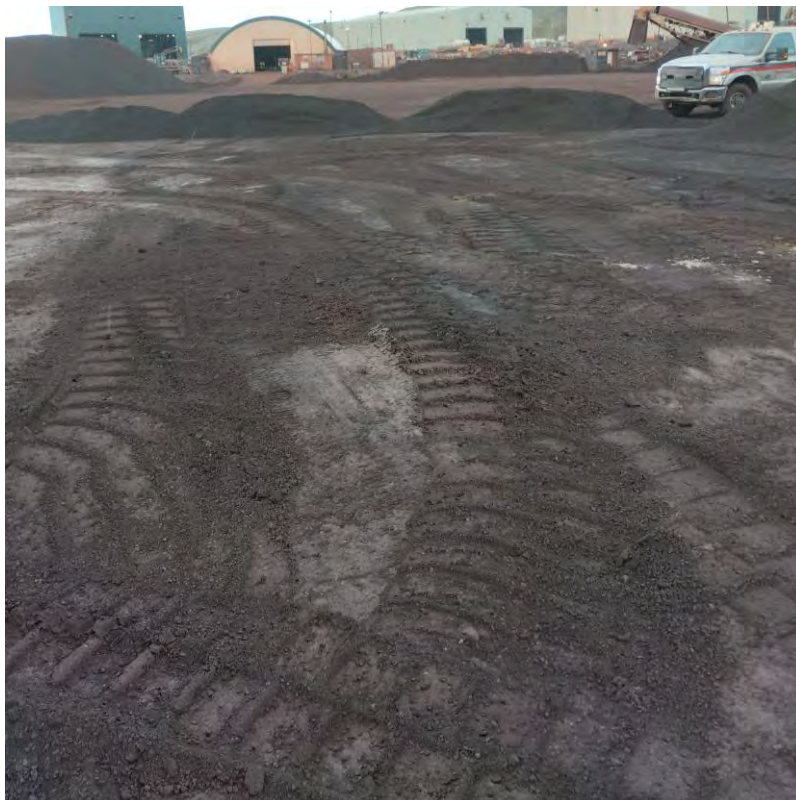
Photo 4: Location of Spill after Clean-up on July 11

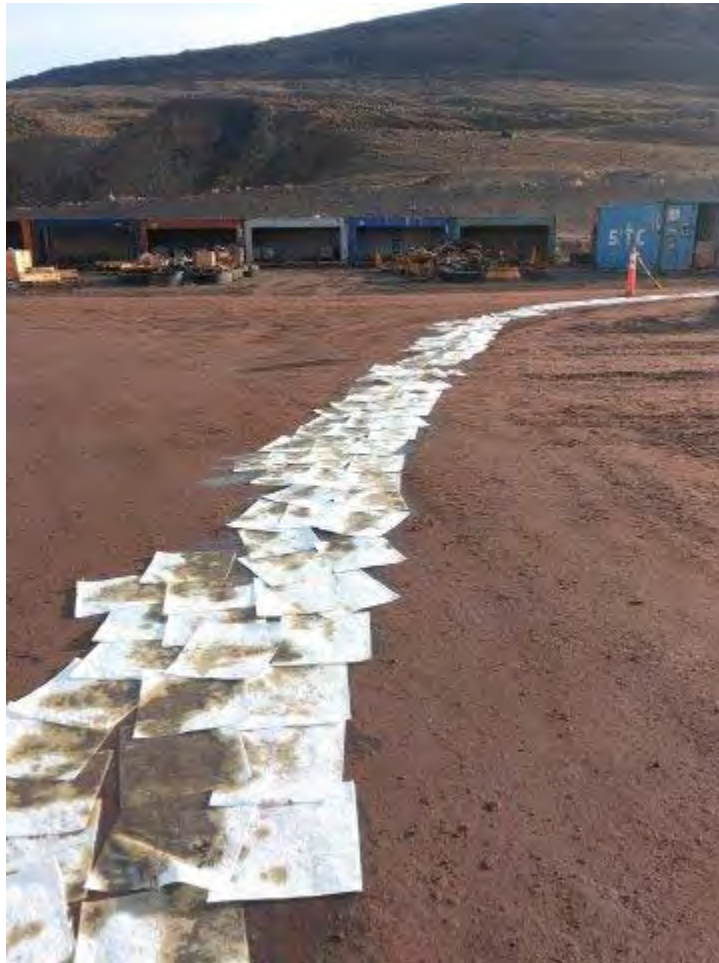
The technician noted that the valve on the tote had opened slightly during transportation. The Technician immediately closed the valve to stop the leak and the area workers placed spill pads to contain the release. The Supervisor was immediately contacted, and the Environment department was notified. This resulted in a release of approximately 250 liters of hydraulic oil onto the ground, to an area approximately 0.5 to 1.5 meters wide by approximately 130 meters long.

Photo 1: Release of Hydraulic Oil onto ground near OHT Mobile Maintenance Shop – August 31, 2024

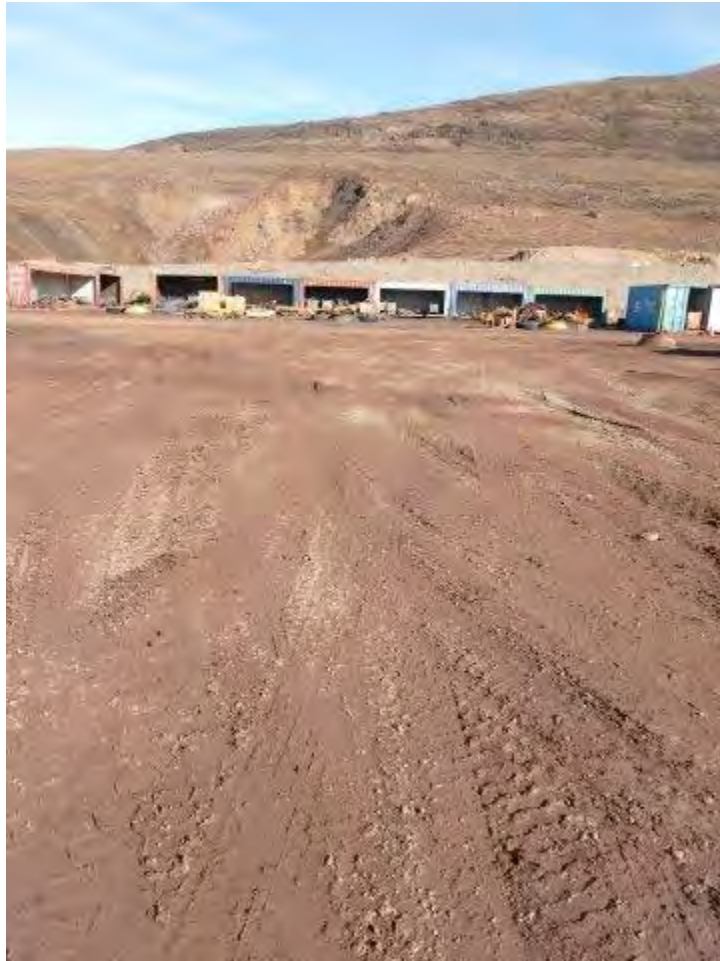
Photo 2: Location of spill after cleanup – August 31, 2024

Following the release, spill pads were immediately placed on the ground. The spill was contained, and impacted material was excavated, and disposed of as per Baffinland's Hazardous Materials and Hazardous Waste Management Plan.

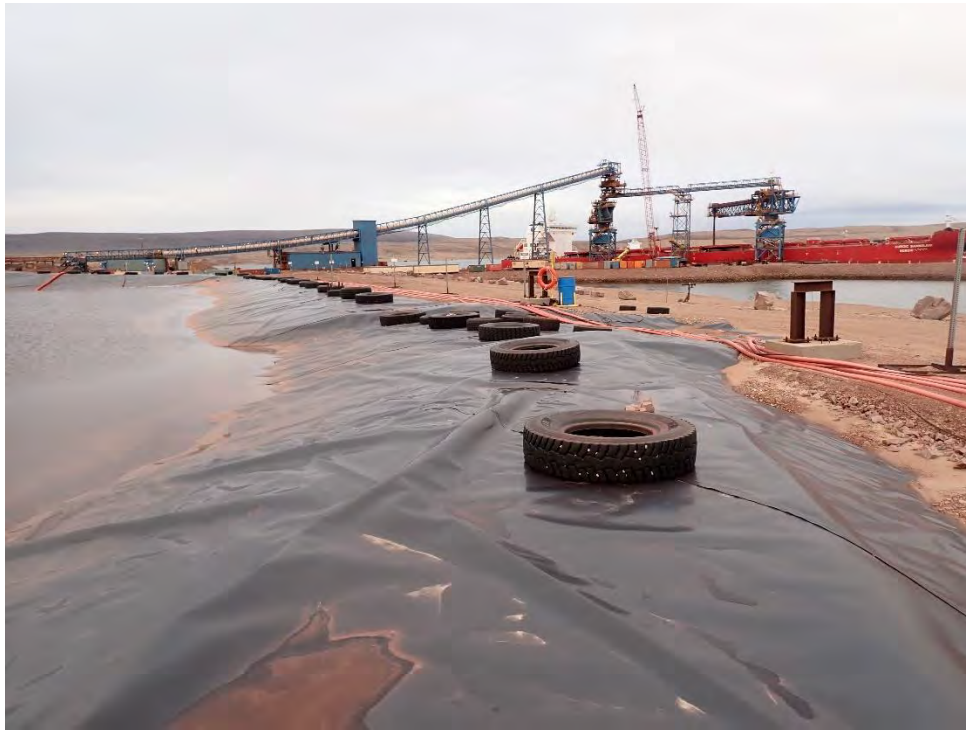
Photo 1: MP-05 spill way showing low water levels during inspection prior to precipitation event - September 20, 2024

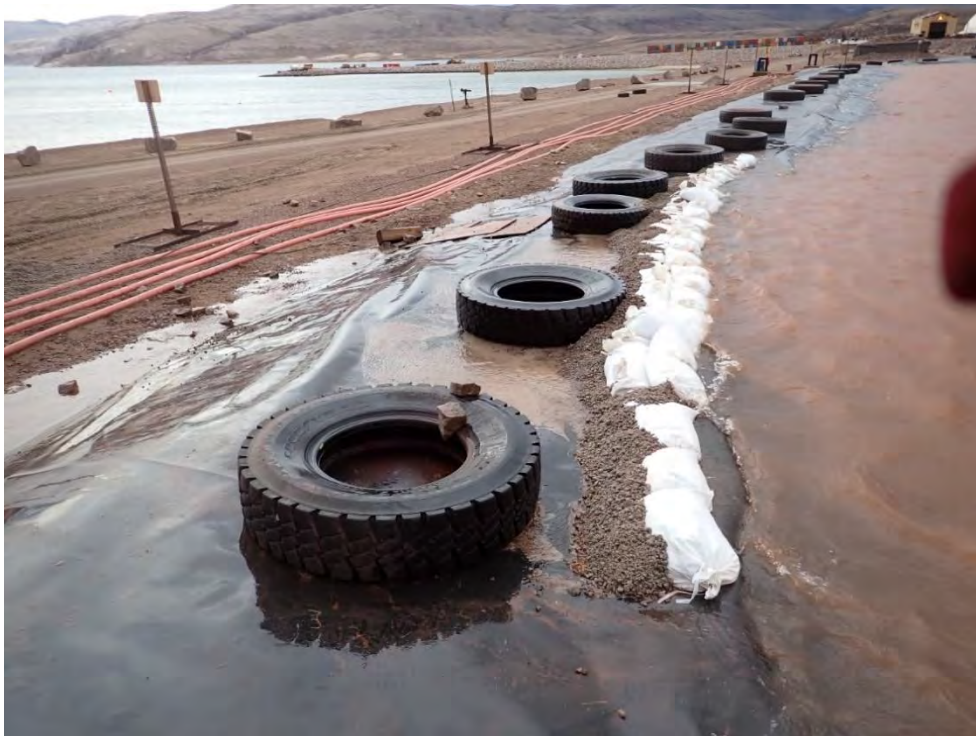
The Milne Port Ore Stockpile Sedimentation Pond (East) (MP-05) on September 22, 2024 experienced an uncontrolled release of surface water stored within the water management infrastructure. The overtopping event was minor in nature and was observed to occur from September 22 08:00 to 16:00. The sedimentation pond experienced the release of water at the Northwest corner of the pond berm as well as the engineered spillway. Due to the nature of the event, the volume of surface water that overtopped MP-05 was not able to be quantified.

Photo 2: Sandbags Placed to Stop Uncontrolled Release at MP-05 Northwest Corner - September 22, 2024

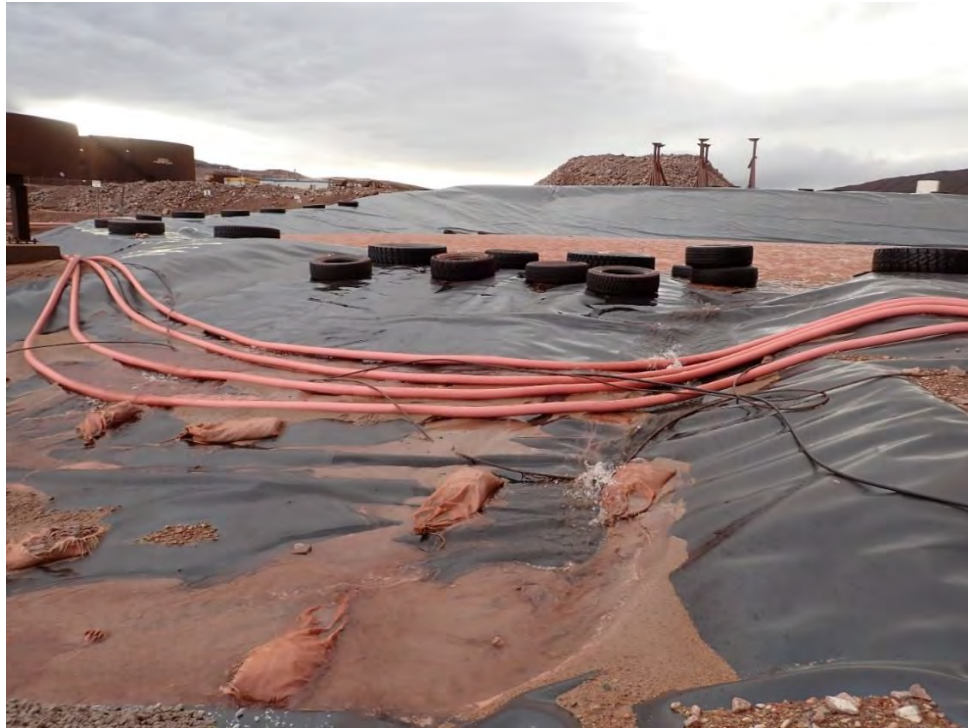
Photo 3: Discharge from Engineered Spillway – September 22, 2024

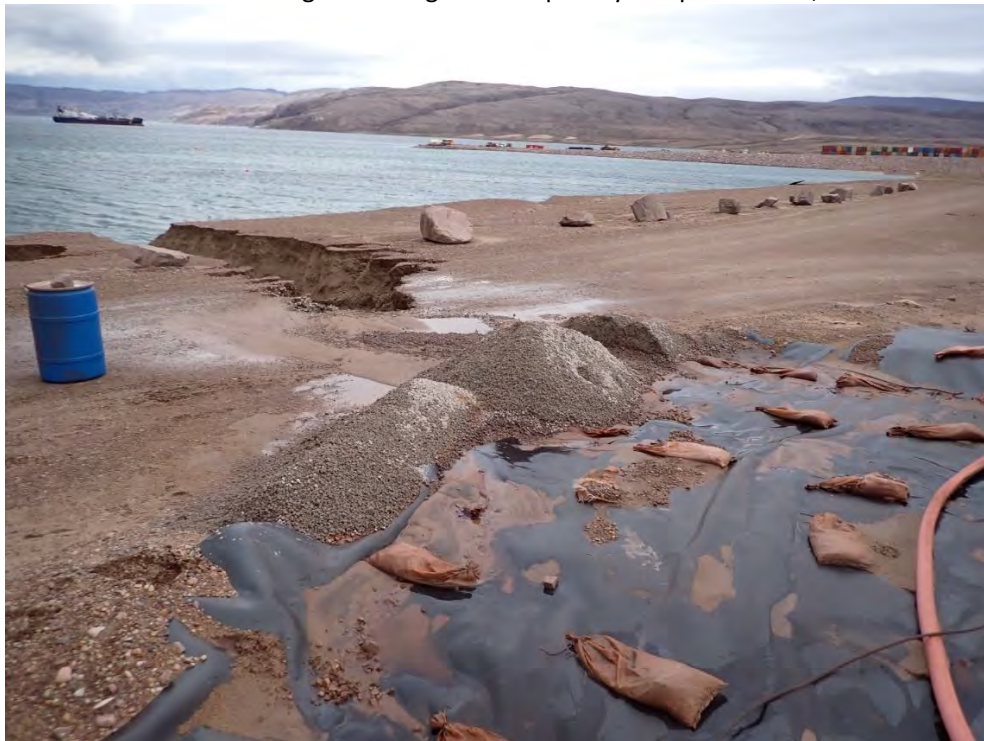
Erosion and Sediment Control (ESC) measures were assessed, in accordance with Baffinland's Surface Water Aquatic Effects Management Plan (SWAEMP). Erosion down-gradient of the Northwest corner of the pond was limited and was repaired shortly following the release. Flows from the engineered spillway caused erosion of the area down-gradient of the pond below the engineered spillway. Remediation efforts commenced and will continue to monitor this area during next open water season. Photos of the erosion and remediation are provided in Attachment 1.

Photo 4: Erosion Down-Gradient of Engineered Spillway – September 22, 2024

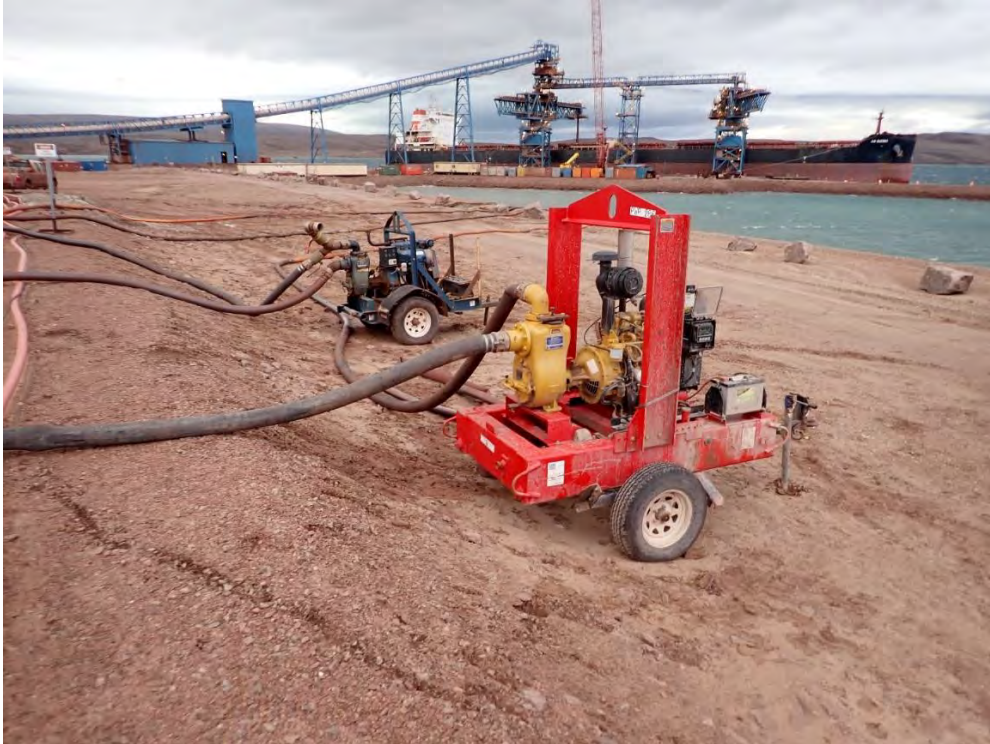
Photo 5: Controlled Discharge via Pumps Directly to Milne Inlet – September 22, 2024

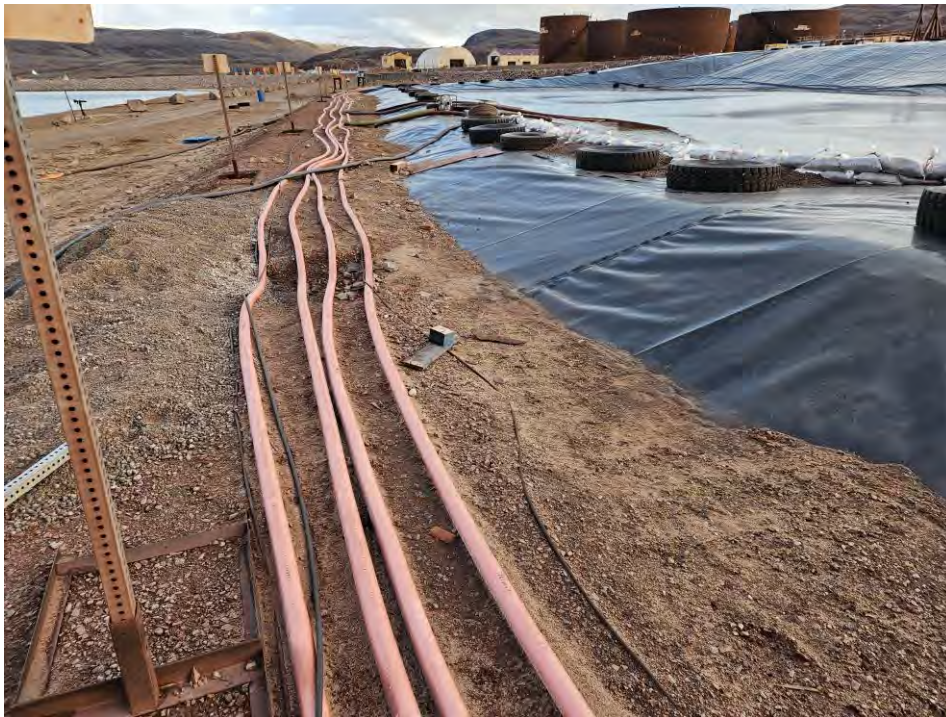
Photo 6: MP-05 Northwest Corner following Remediation of Erosion – October 10, 2024

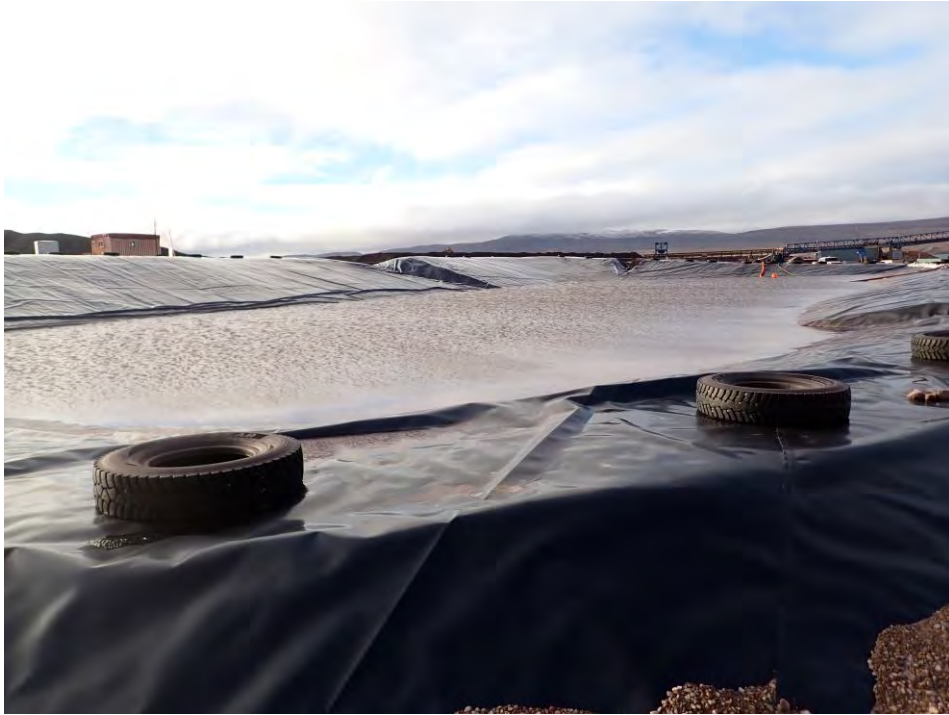
Photo 7: Low Water levels at MP-05 prior to Winter Conditions– October 10, 2024

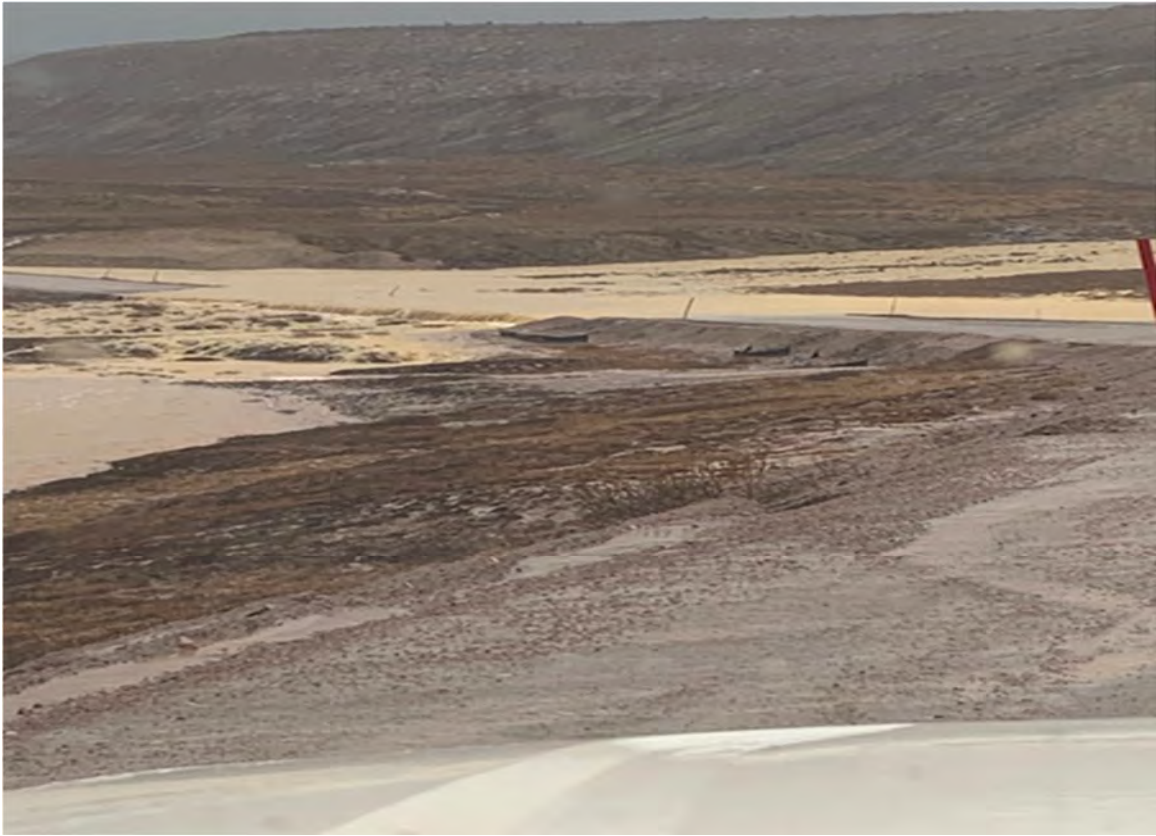
Photo 1: KM 87 Tote Road Completely Flooded – September 22, 2024

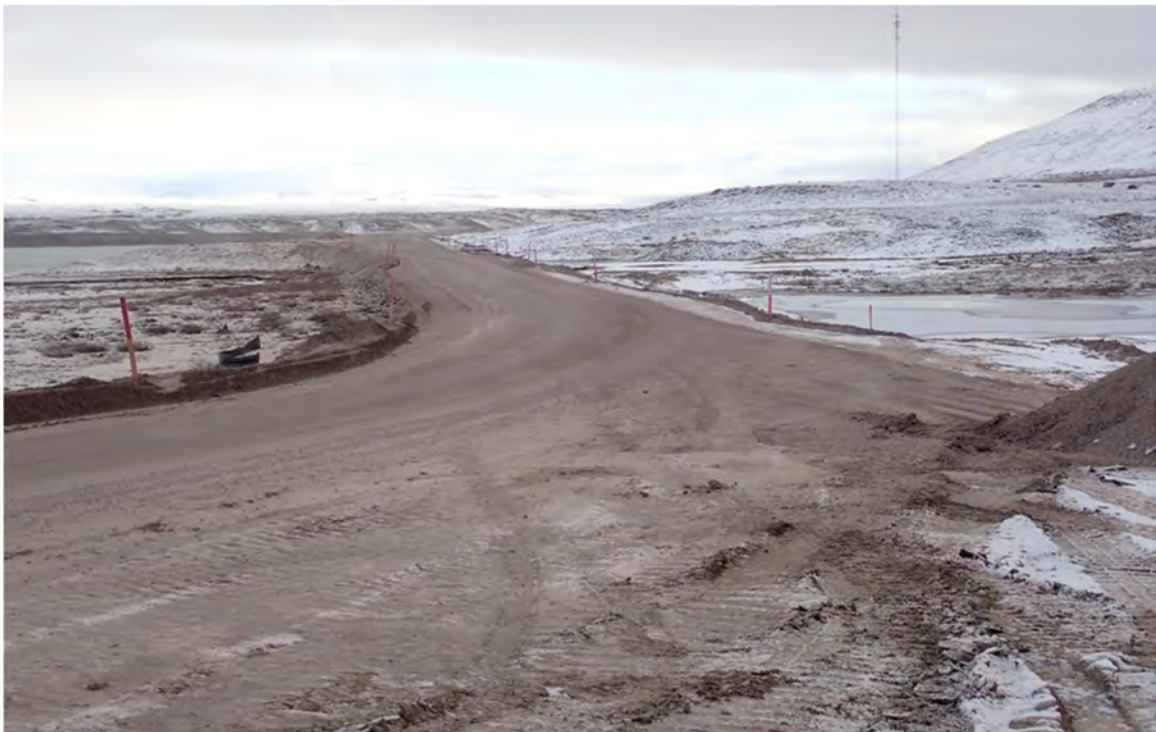
Photo 2: KM 87 Tote Road Remediated, Sand and Debris Cleared from Flood– October 9, 2024
