MARY RIVER PROJECT

NT-NU SPILL REPORT

Re: Follow-Up to Spill #2024-193
Mary River Project - Water Licence No. 2AM-MRY1325

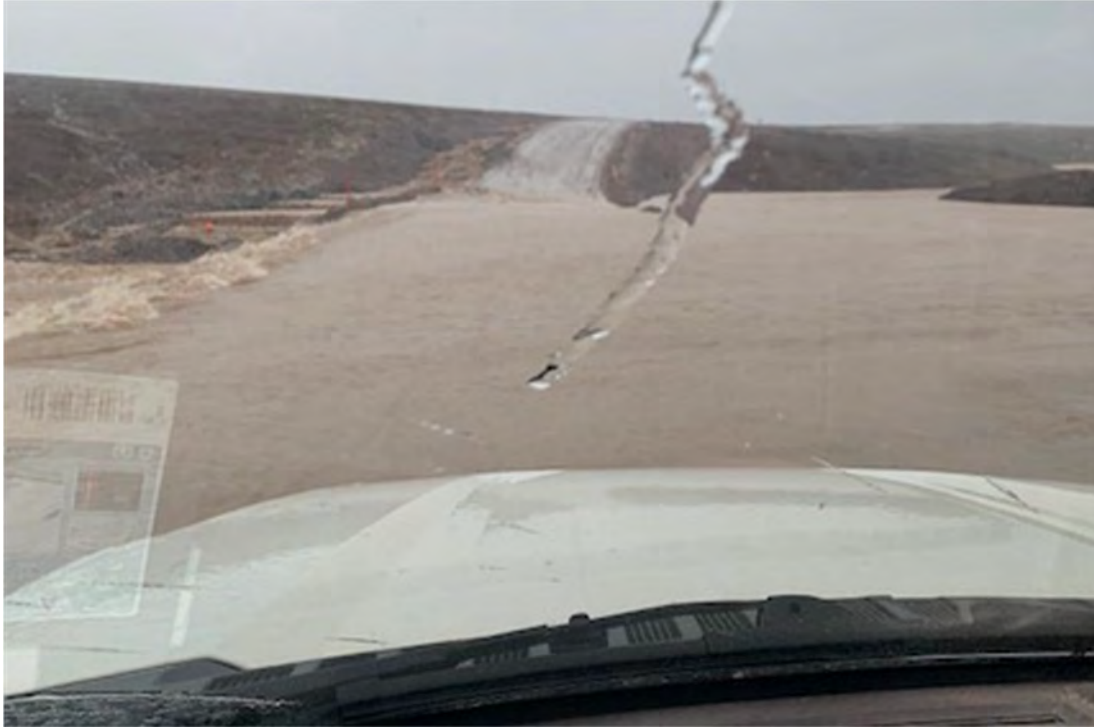
Photo 3: The KM 72 Dip Tote Road Completely Flooded and Severe Road Degradation – September 22, 2024

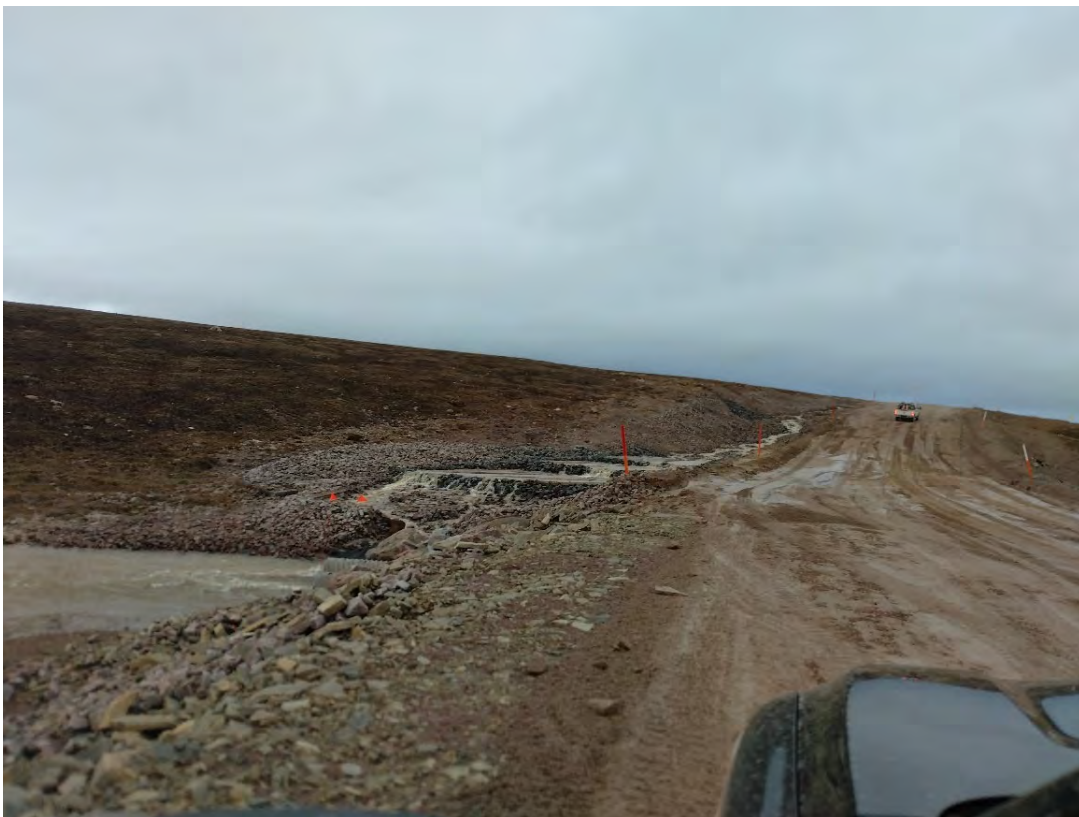
Photo 4: The KM 72 Dip Tote Road Following Road Resurfacing. Check Dams Adjacent to Road Operating as Designed – September 22, 2024

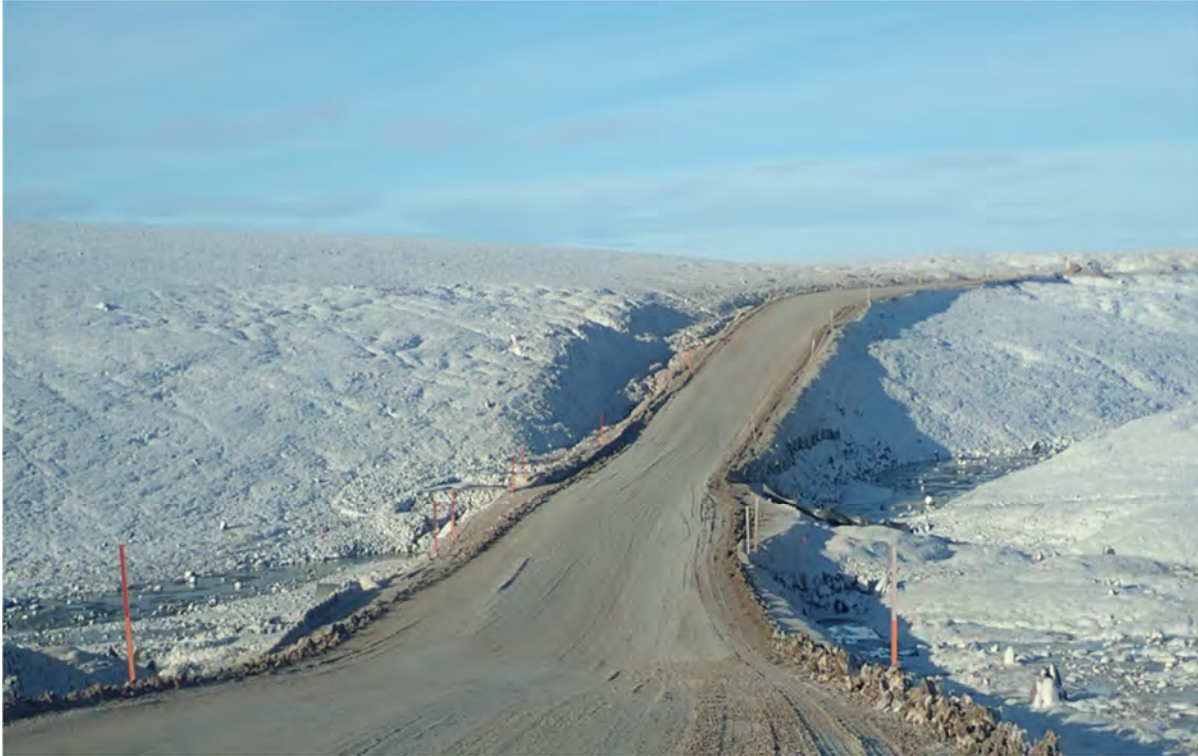
Photo 5: The KM 72 Dip Flood Debris Cleared and Repairs Complete – October 9, 2024

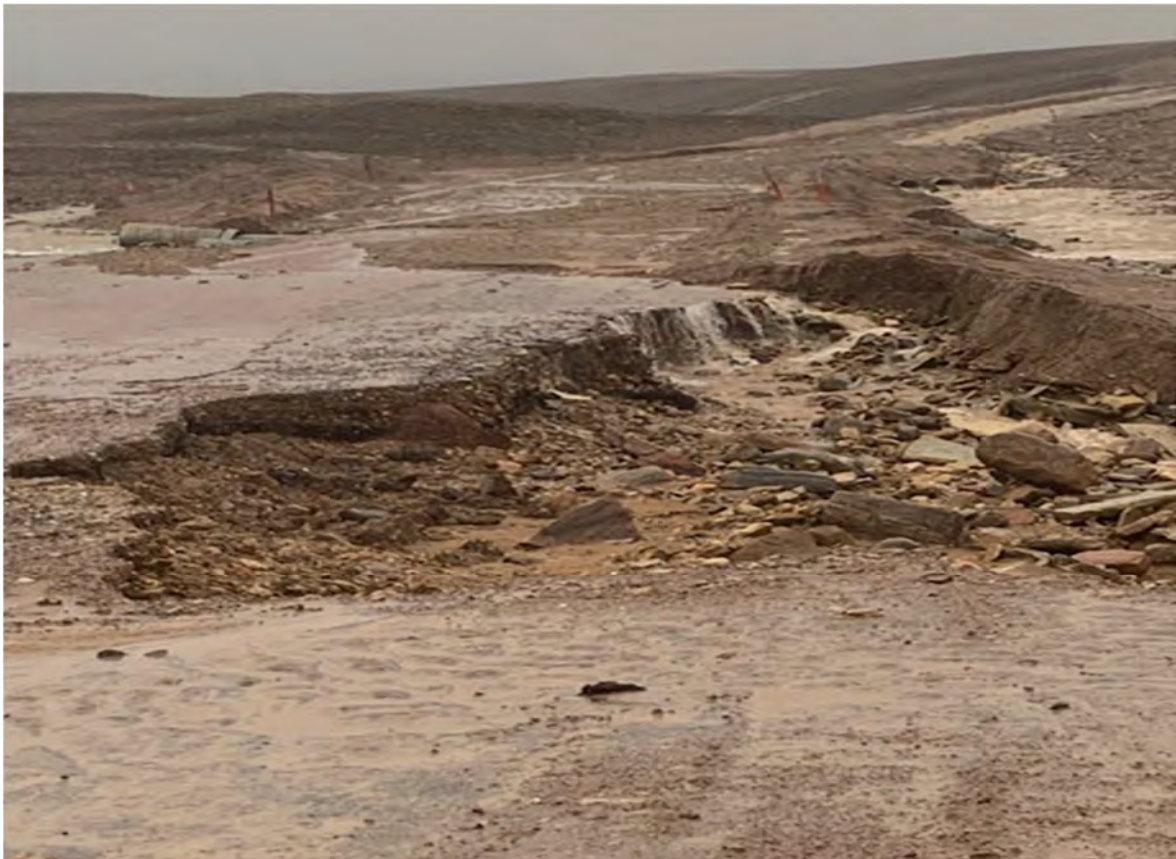
Photo 6: The Tote Road at KM 67 Hill Partially Washed Out – September 22, 2024

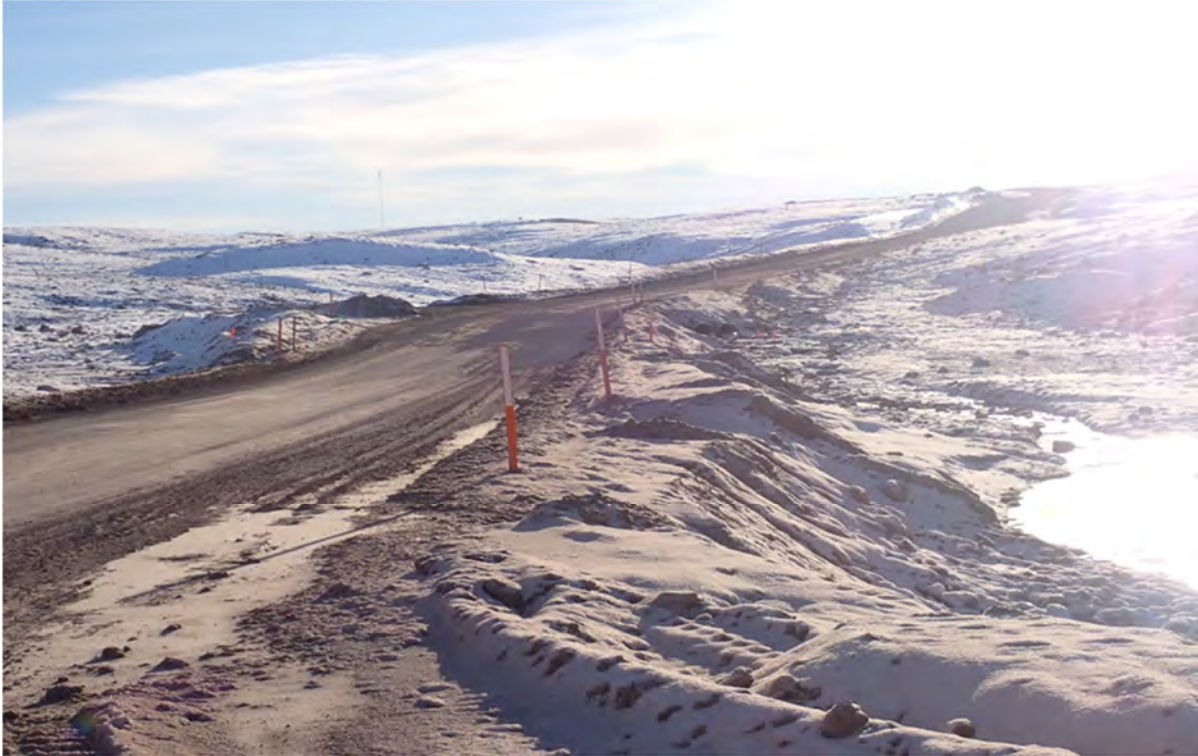
Photo 7: The KM 67 Hill Remediated – October 9, 2024

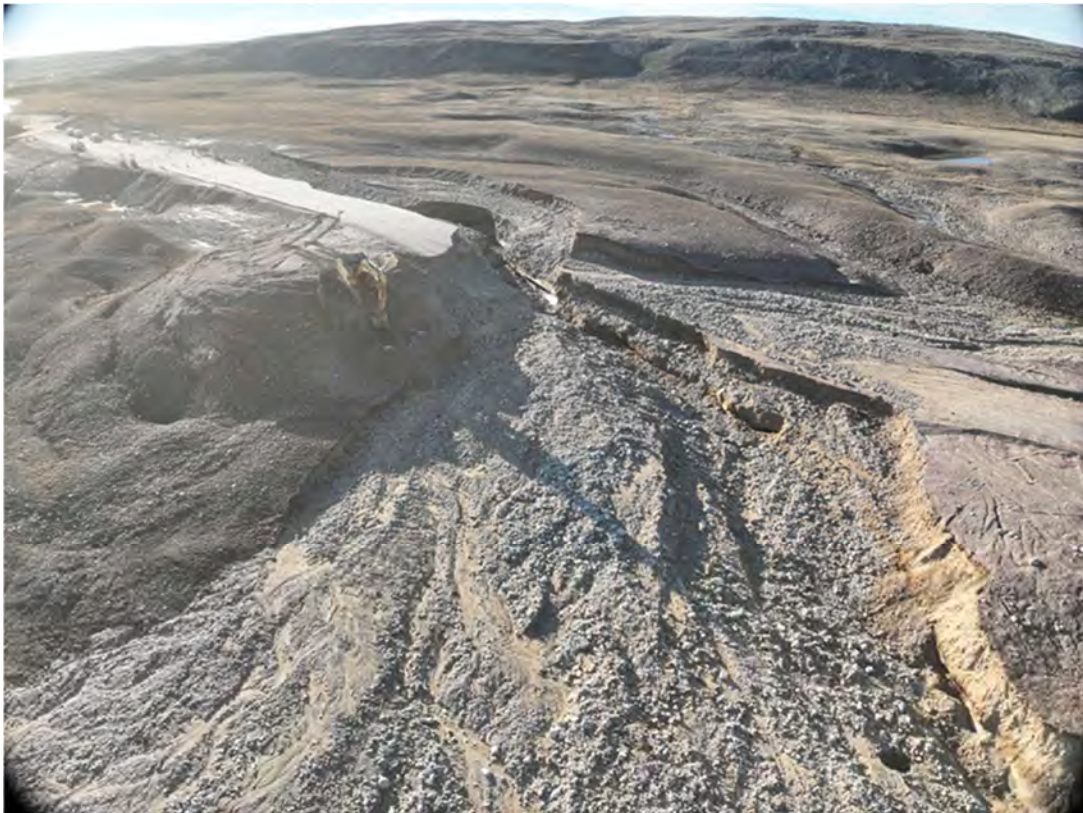
Photo 8: KM 64 Tote Road Completely Washed Out - Aerial View – September 23, 2024

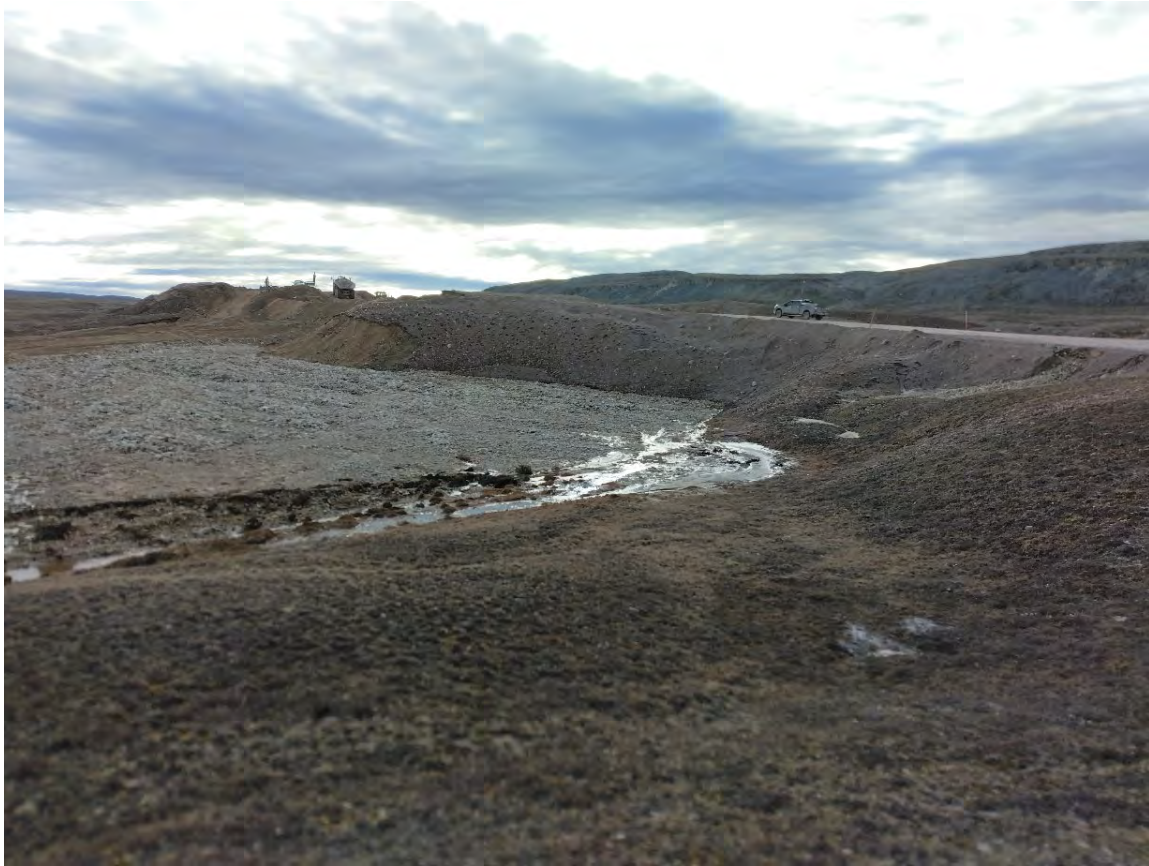
Photo 9: KM 64 Tote Road Active Road Replacement Occurring– September 24, 2024

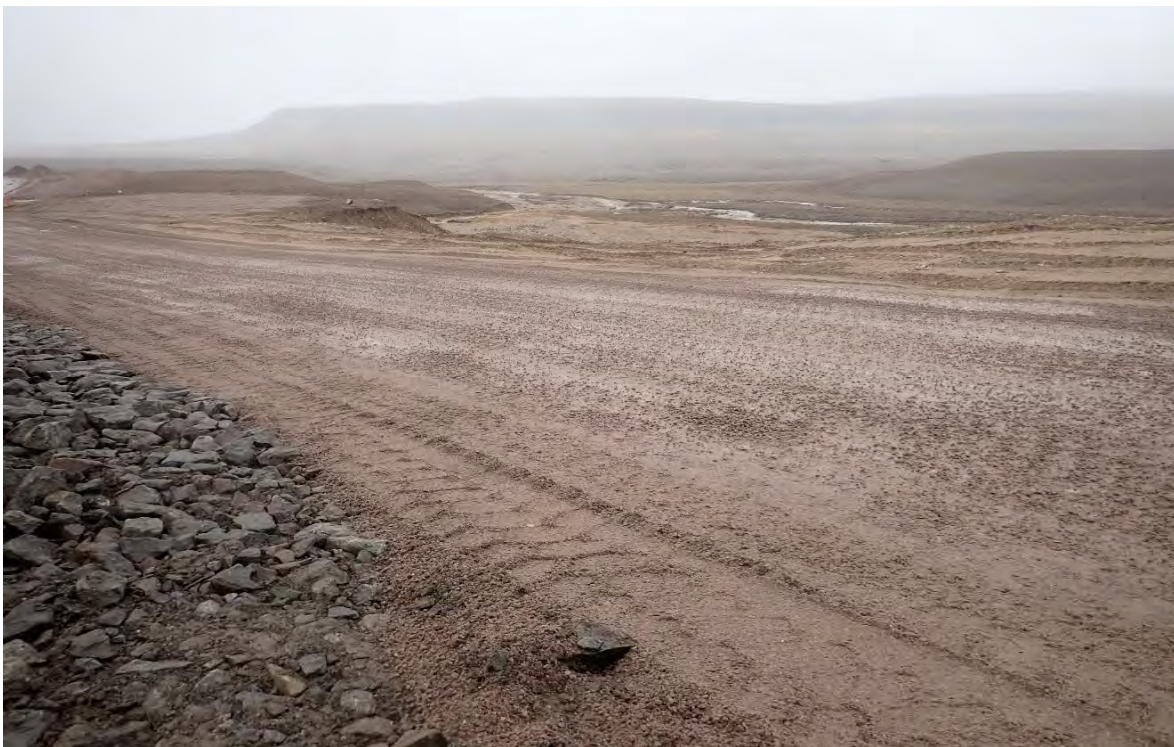
Photo 10: KM 64 Reconstructed – September 27, 2024

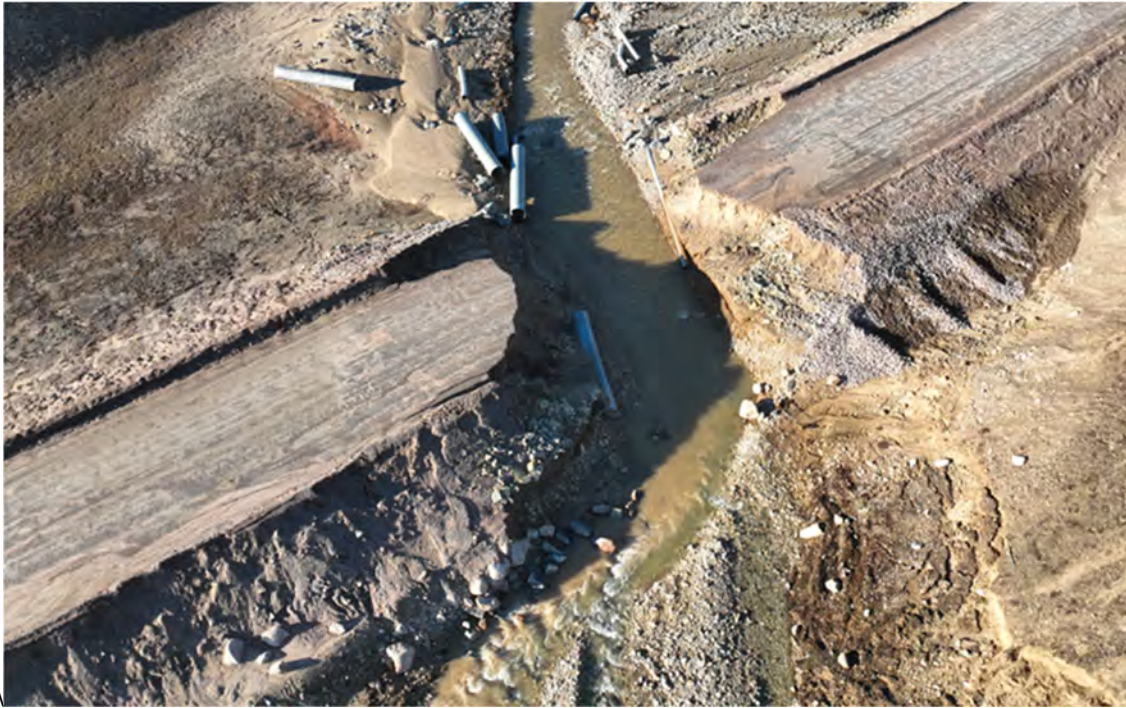
Photo 11: KM 63.5 and CV-049 Tote Road and Culverts Completely Washed Out – September 23, 2024

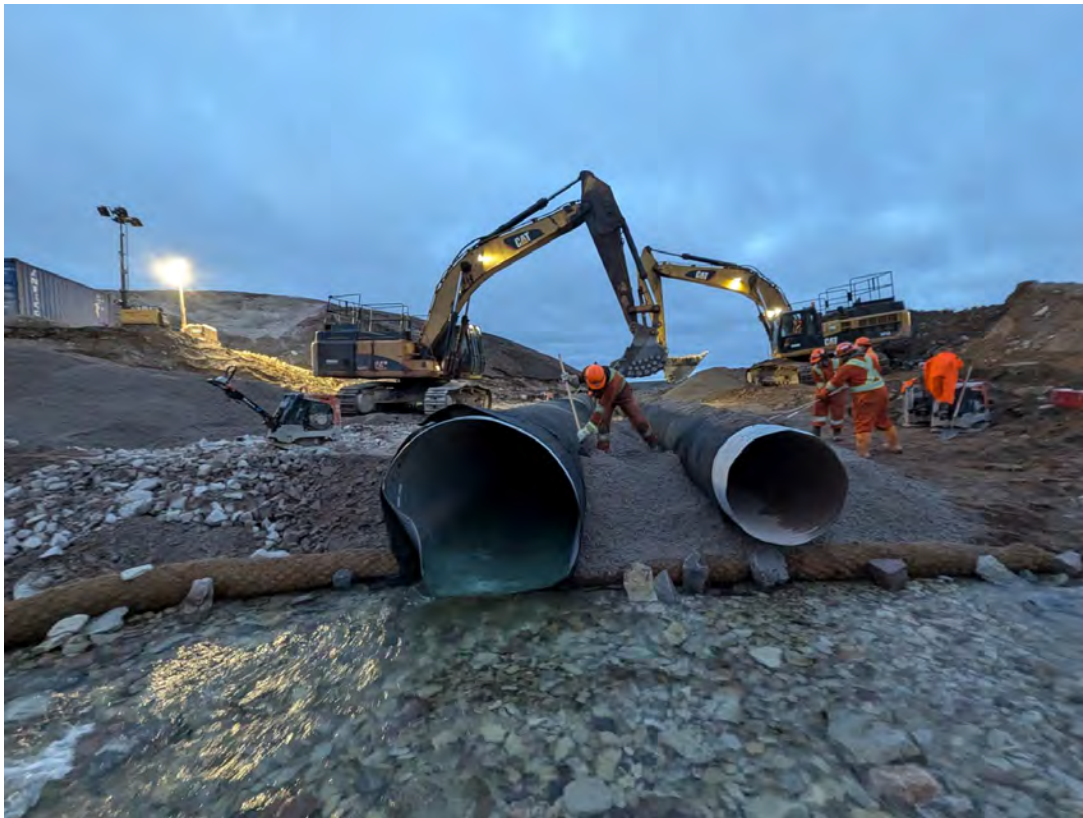
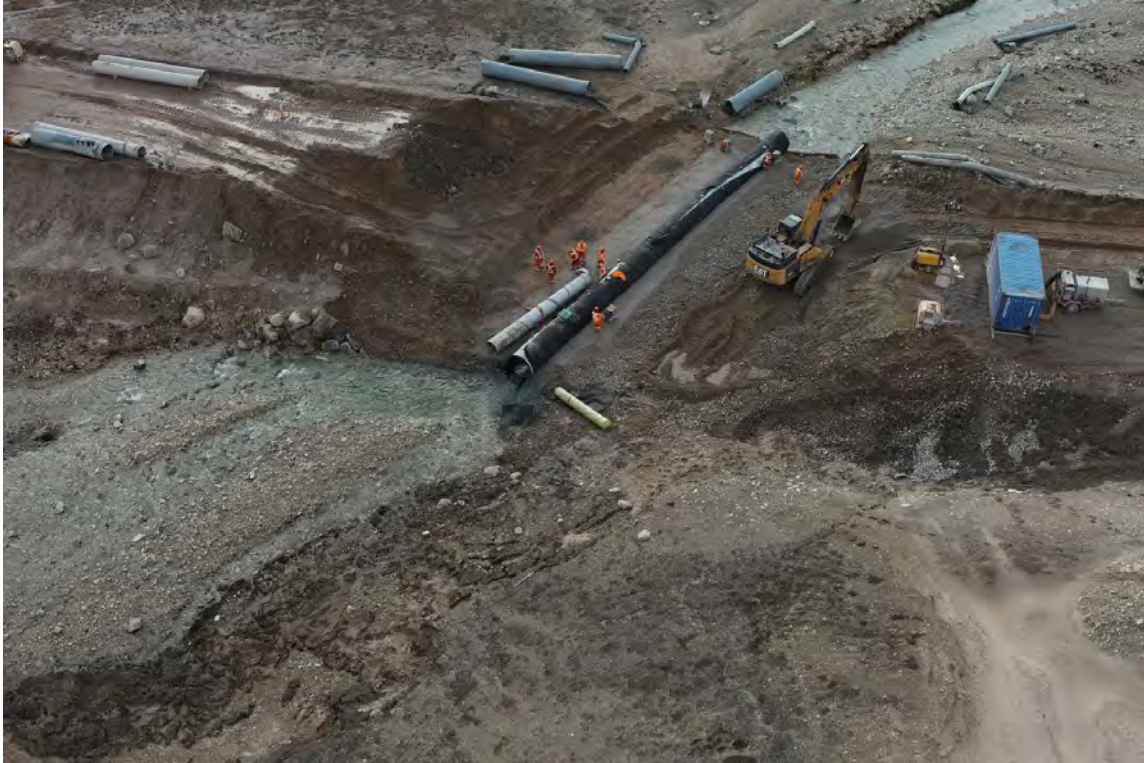
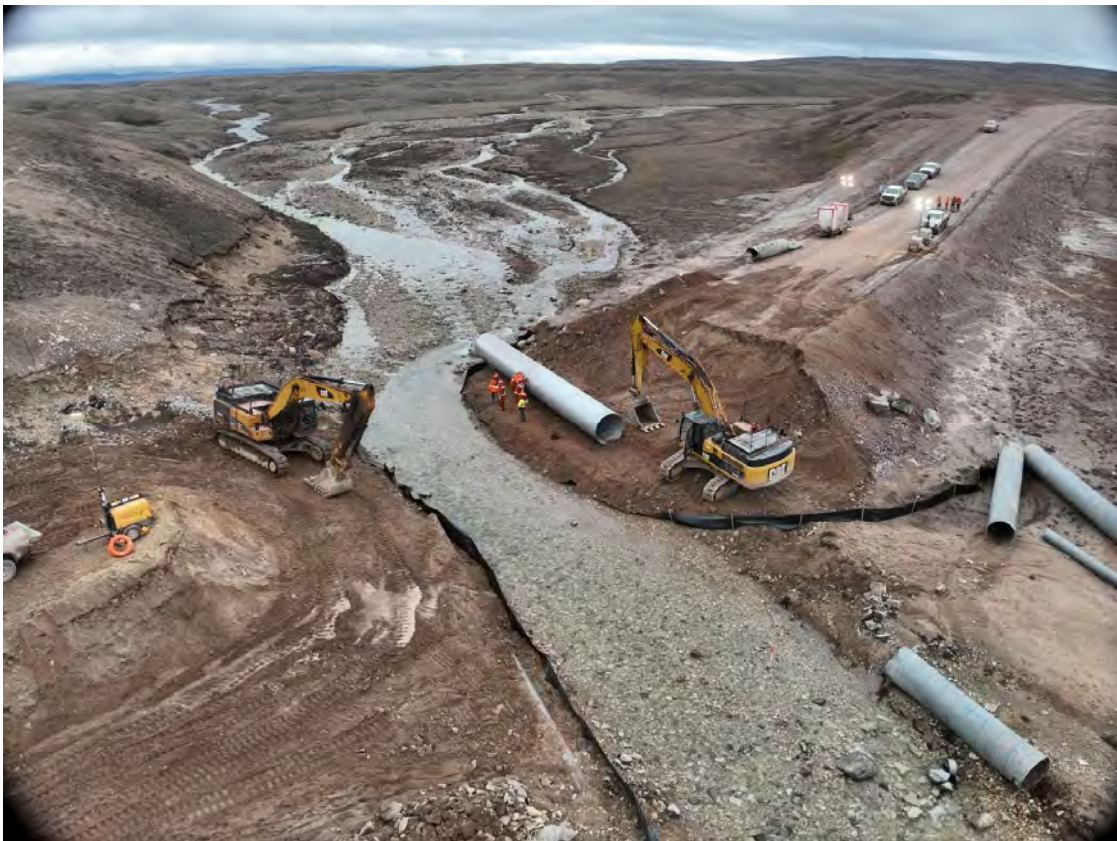
Photo 12: KM 63.5 and CV-049 Culvert Remediation – September 27, 2024

Photo 13: KM 63.5 and CV-049 Culvert Remediation - September 27, 2024

Photo 14: KM 63.5 and CV-049 Culvert Remediation - September 27, 2024

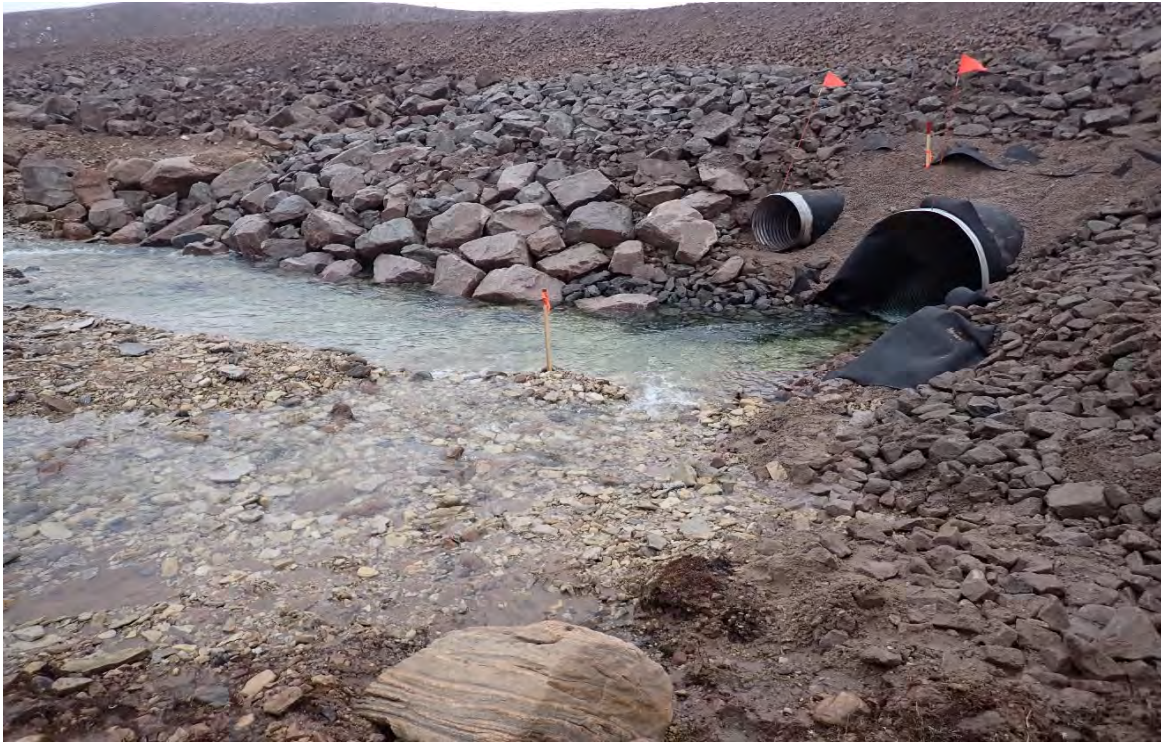
Photo 15: KM 63.5, upstream culvert inlet, looking south west, 2024-10-02

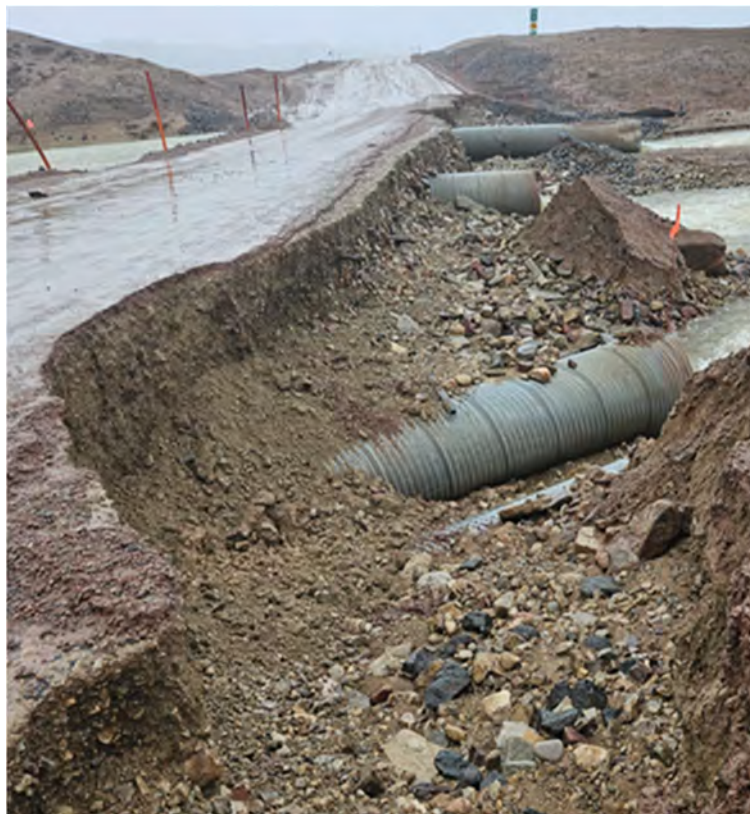
The northbound lane at Km 51, (CV-078, fish-bearing) was washed out, while the southbound lane remained largely intact. Repairs commenced September 28, and included:

Photo 16: KM 51 Severe Road Degradation and Partial Washout – September 21, 2024

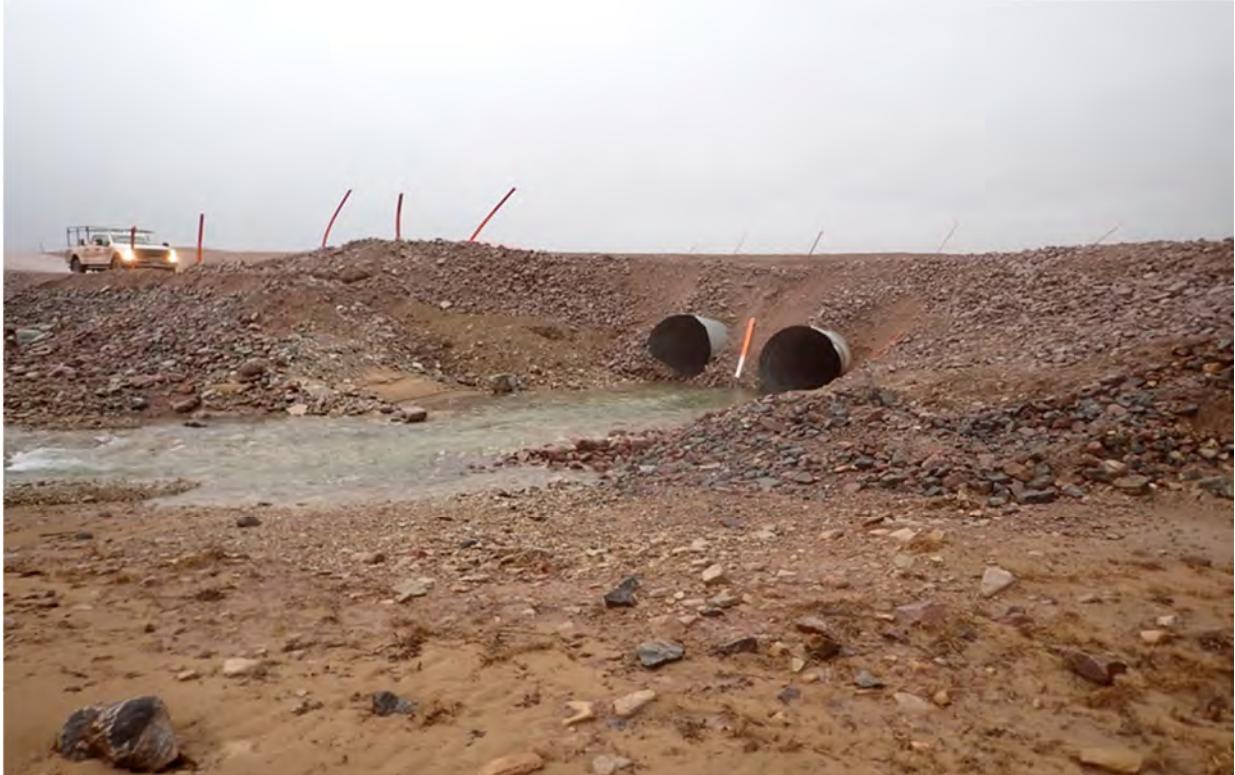
Photo 17: KM 51 Tote Road and Culverts remediation near Completion – September 28, 2024

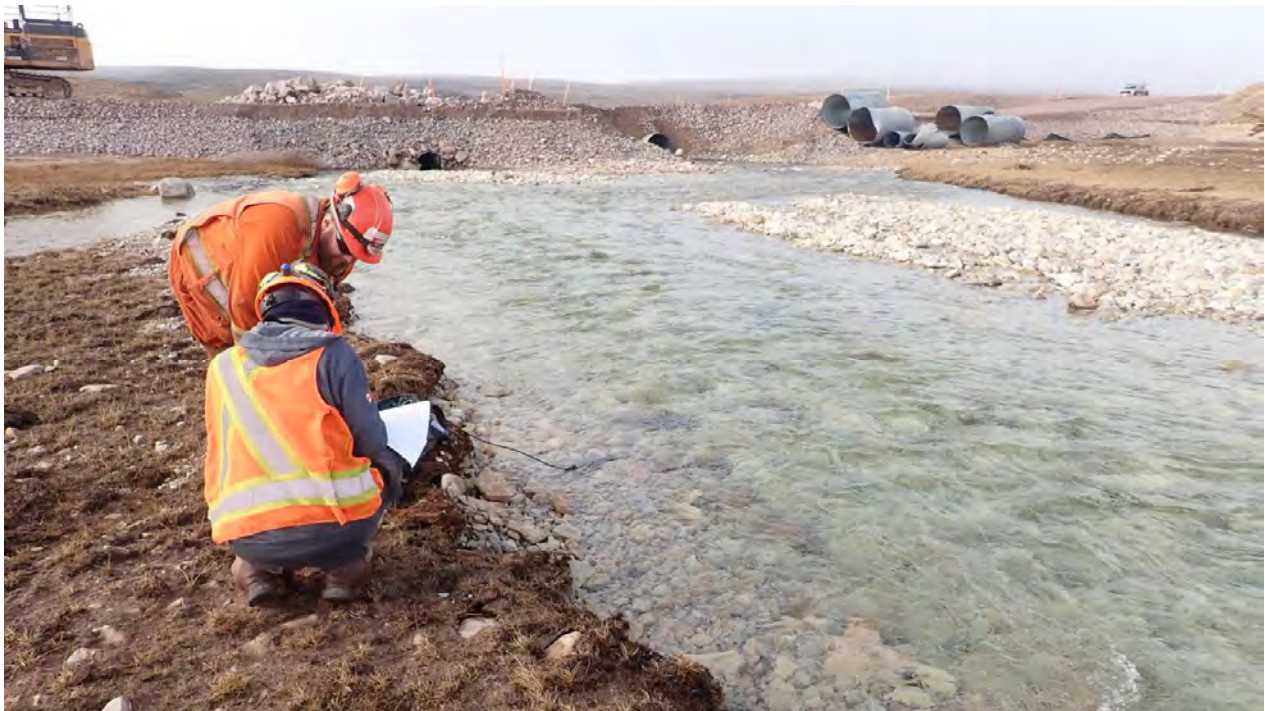
Photo 18: Rip-rap Placed along the Upstream Side of KM 51 Crossing – September 29, 2024
