MARY RIVER PROJECT

Spill #2024-367 – Follow Up Report – elevated TSS locations

**Re: Unprecedented Rainfall Event – September 21**  
**Mary River Project - Water Licence No. 2AM-MRY1325**

**Re:** Summary of Tote Road Conditions Following Unprecedented Rainfall Event

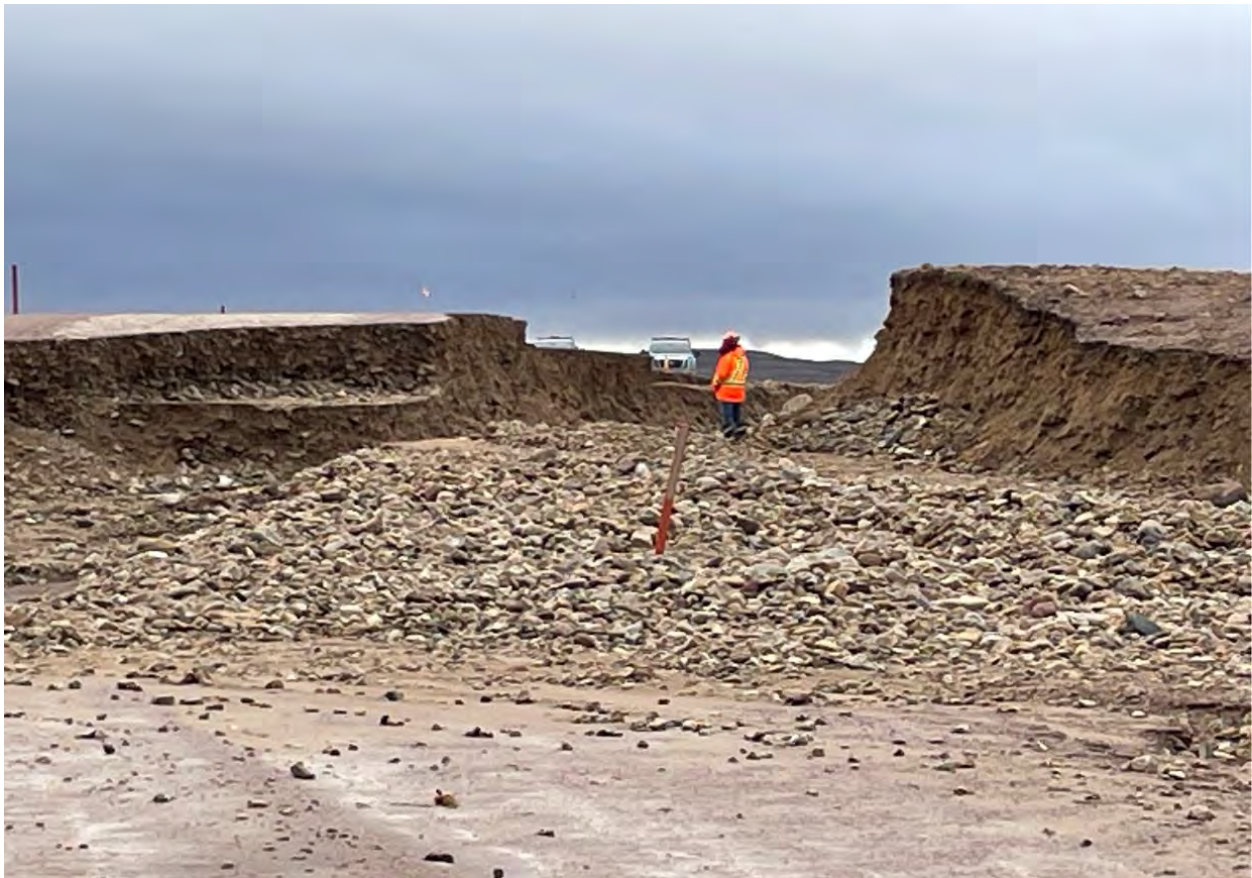
Photo 1: Complete loss of roadway at KM 63.5

Note that this is not a culverted crossing, but a washout created by overland flow away from natural water crossing locations.

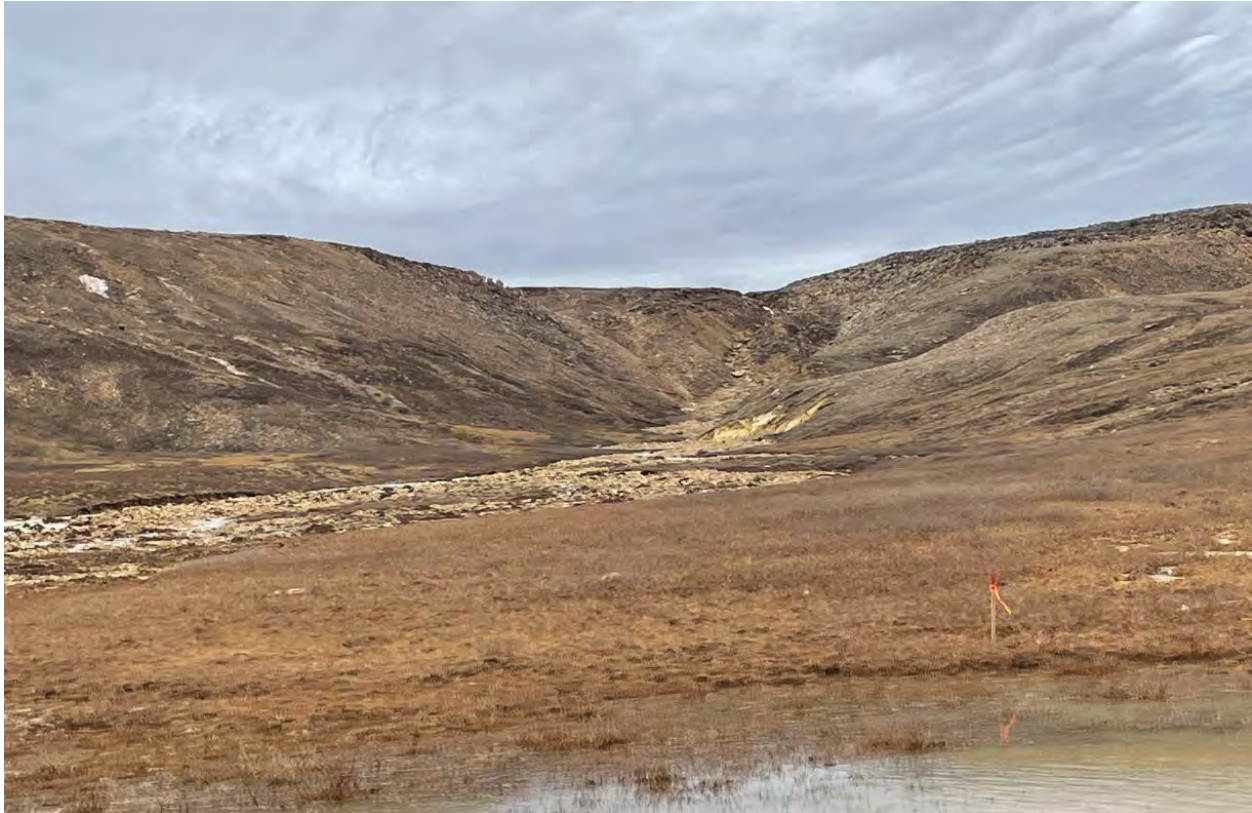
Photo 2: Natural erosion of surface sediments from high flows at KM 88. There may be other examples of natural erosion not visible from the Tote Road.

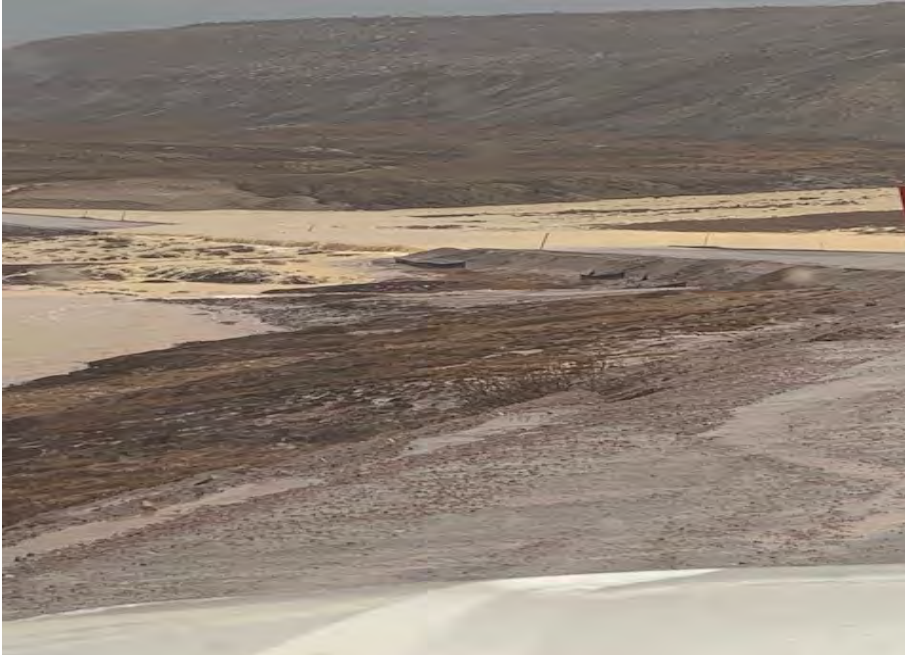
## **Km 87**

- Minor surface capping removed
- Road passable via single lane
- Remediation started and ongoing

**Photo 1:** km 87 - Rainfall Event September 21-22 (highly sediment laden water source is natural upstream of Tote Road)

1. Emergency remediation plans for km 87 (BG-24), km 72 Dip (CV-040), km 67 Hill , and km 51/51.5 (CV-079, CV-078) include:
  - a. Replacement and re-compaction of any stripped road bed material above the ordinary high water mark
  - b. Placement of sufficient capping material to establish safe travel for equipment to access further areas).
  - c. Ongoing remediation of disturbed materials above the ordinary high water mark.
  - d. Longer term construction to return road to full functionality will take place during winter.

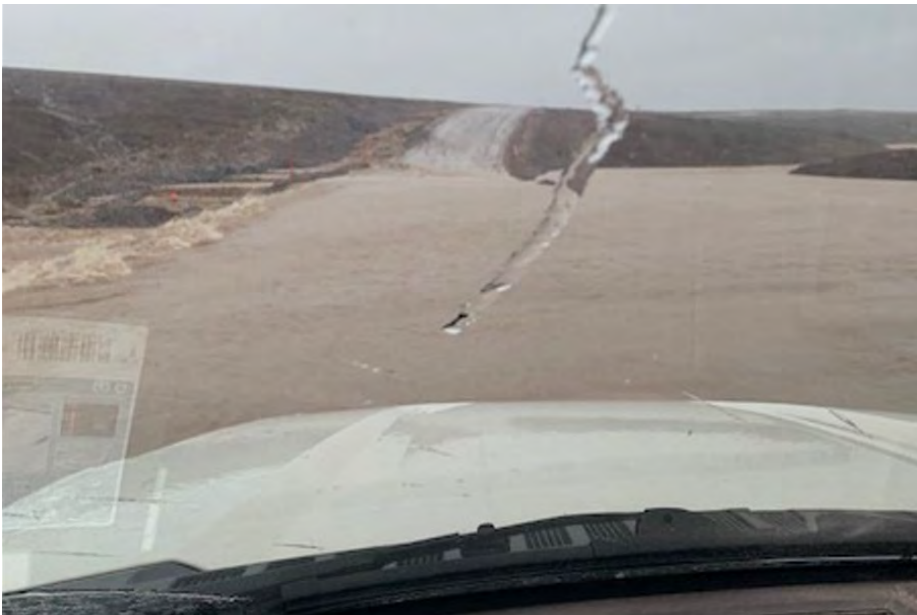
**Km 72 Dip**

- Loss of capping and severe degradation of roadway
- Road passable via single lane
- Remediation started and ongoing

**Photo 2:** km 72 Dip - Rainfall Event on September 21-22

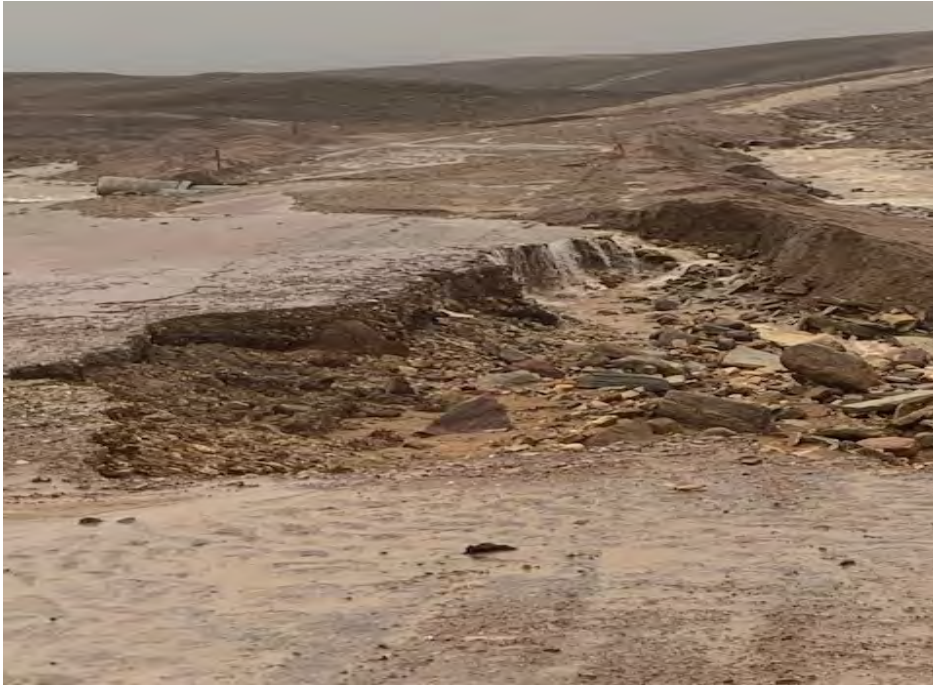
**Km 67 Hill**

- Loss of capping and severe degradation of roadway
- Road passable via single lane

**Photo 3:** km 67 Hill - Rainfall Event on September 21-22  
**Km 64 and 63.5**

- Remediation started and ongoing

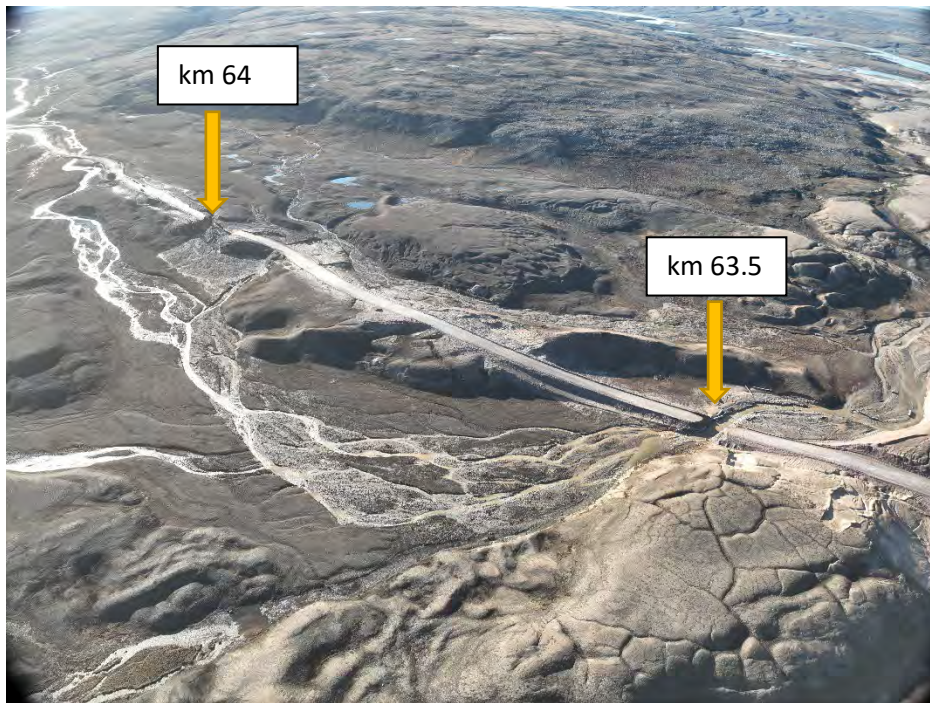
- Complete loss of roadway in two separate locations
- Emergency remediation started and ongoing

**Photo 4:** km 64/63.5 Aerial Photo Showing Damage to Roadway following Rainfall Event (September 23)

2. Remediation plans for km 64 area include; (Note this is > 100 m away from closest watercourse)
  - a. Creation of a berm at km 64.2 to ensure water flows thru the two existing culverts.
  - b. Straightening out of upstream ditch near km 64.2 to ensure water flows thru the two existing culverts (CV-048A, CV-048B).
  - c. Protecting the exposed permafrost at km 64 with sand and water.
  - d. Returning the washed out road subgrade to km 64 area and packing it.
3. Remediation plans for km 63.5 (CV-049). Sketch of proposed ESC measures for this specific area is depicted in Figure 2.
  - a. Cutting access ramps down to the stream level at CV-049
  - b. Installing 2 x 1.8m dia. culverts into the stream area at km 63.5.
  - c. Backfilling and packing around the culverts.
  - d. Armouring the inlet and outlet areas of the culverts.
  - e. Capping the road.

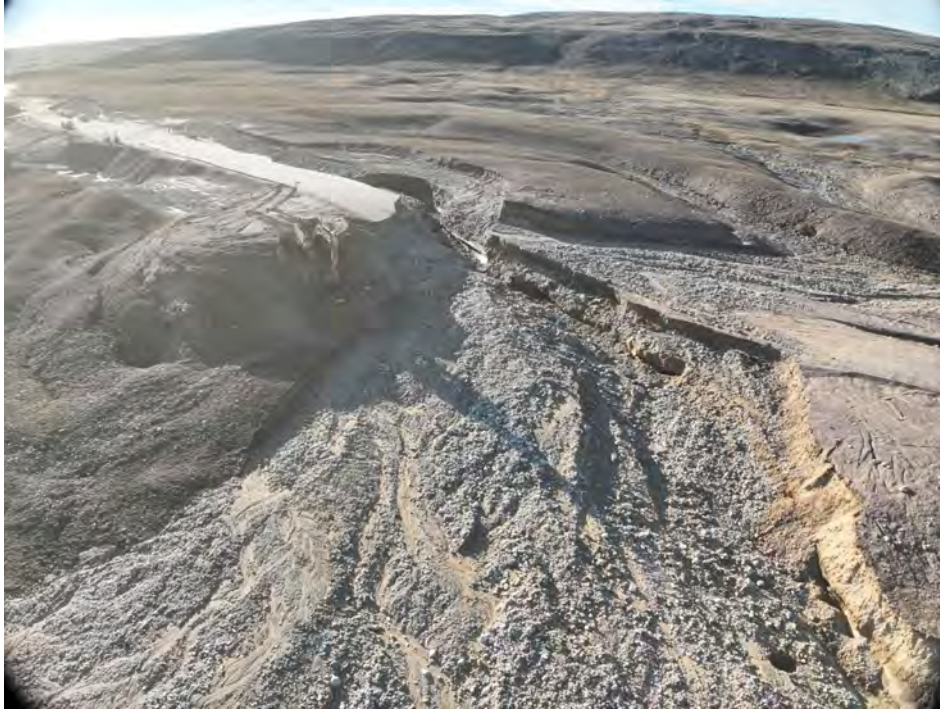
**Photo 5:** km 64 Aerial Photo Showing Damage to Roadway following Rainfall Event (September 23)

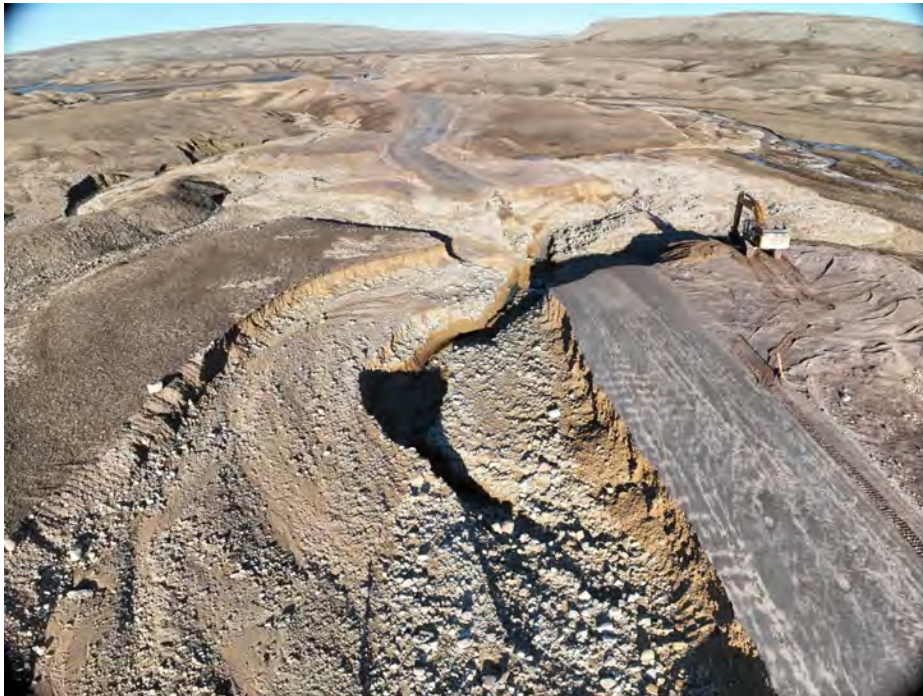
**Km 64/63.5**

- Complete loss of roadway in two locations
- Emergency remediation started and ongoing

**Photo 6:** km 64 Aerial Photo Showing Damage to Roadway following Rainfall Event (September 23)

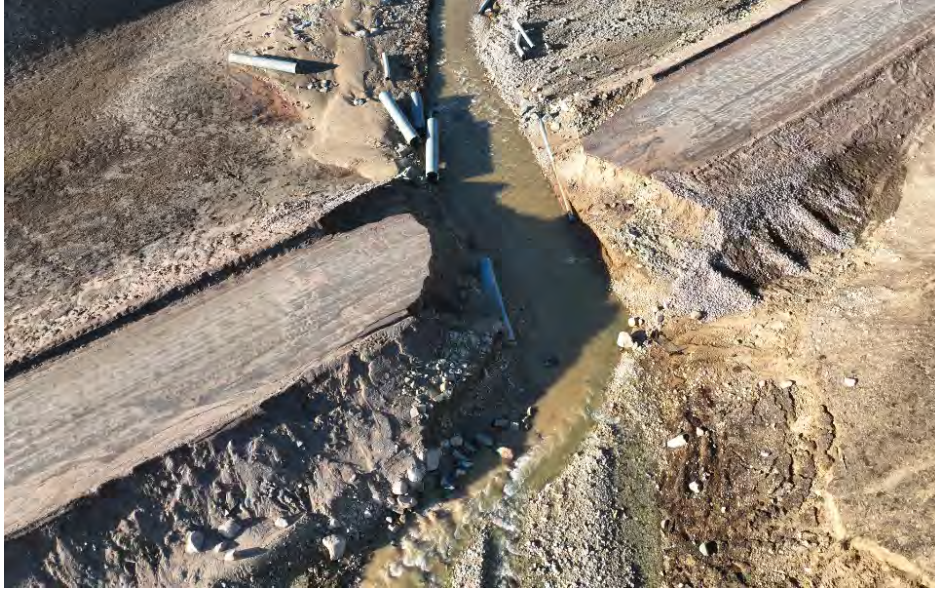
**Photo 7:** km 63.5 (CV-48) Aerial Photo Showing Damage to Roadway following Rainfall Event (September 23)

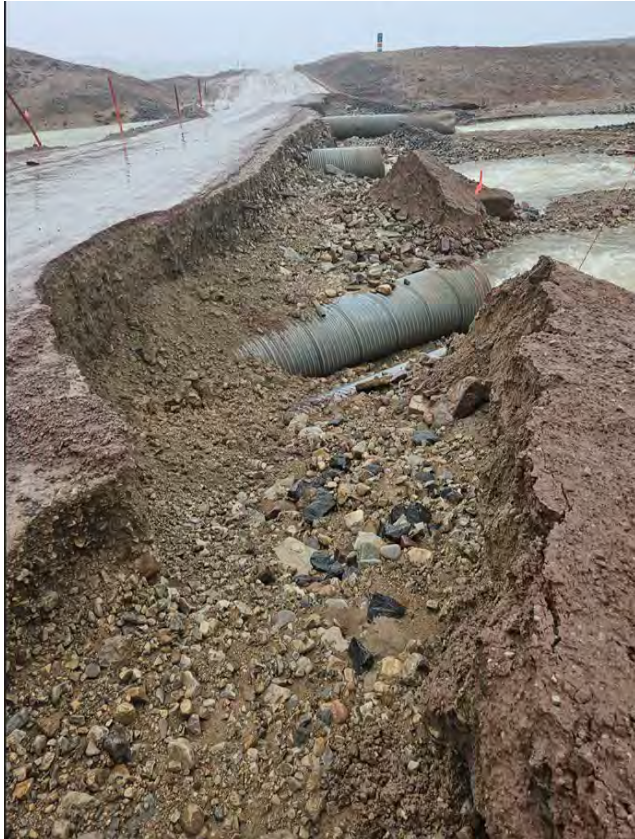
#### **Km 51/km 51.5**

- Severe degradation of roadway
- Road passable via single lane
- Emergency remediation started and ongoing

**Photo 8:** km 51/51.5 - Rainfall Event on September 21-22

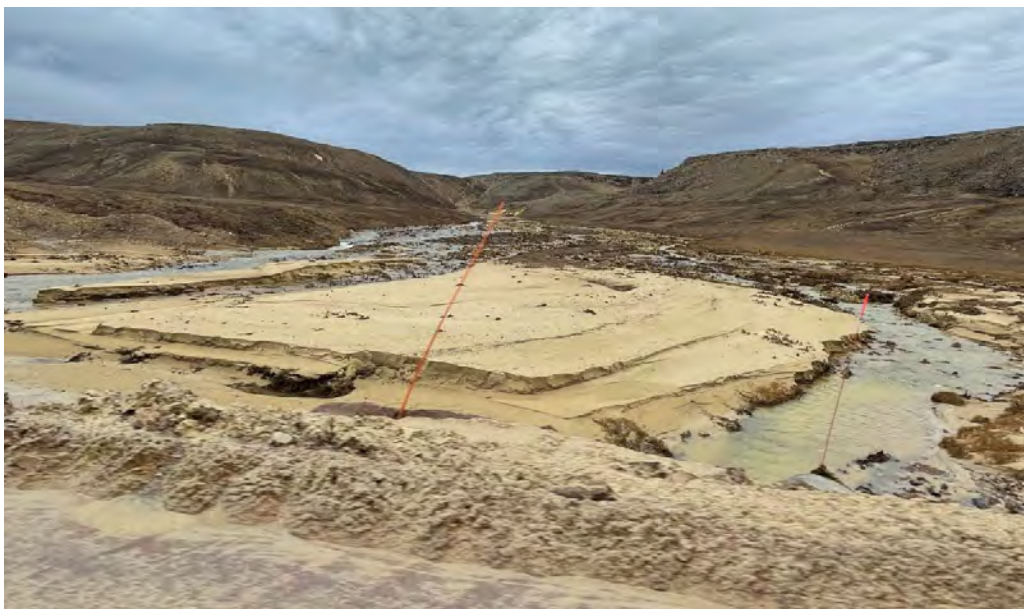
It is important to highlight that this was an unprecedented rainfall event, and that there is evidence of natural landform washouts that are not associated with Project infrastructure, that have greatly contributed to the overall impacts to the receiving environment, such as the below example washout from the hillside adjacent to km 88.

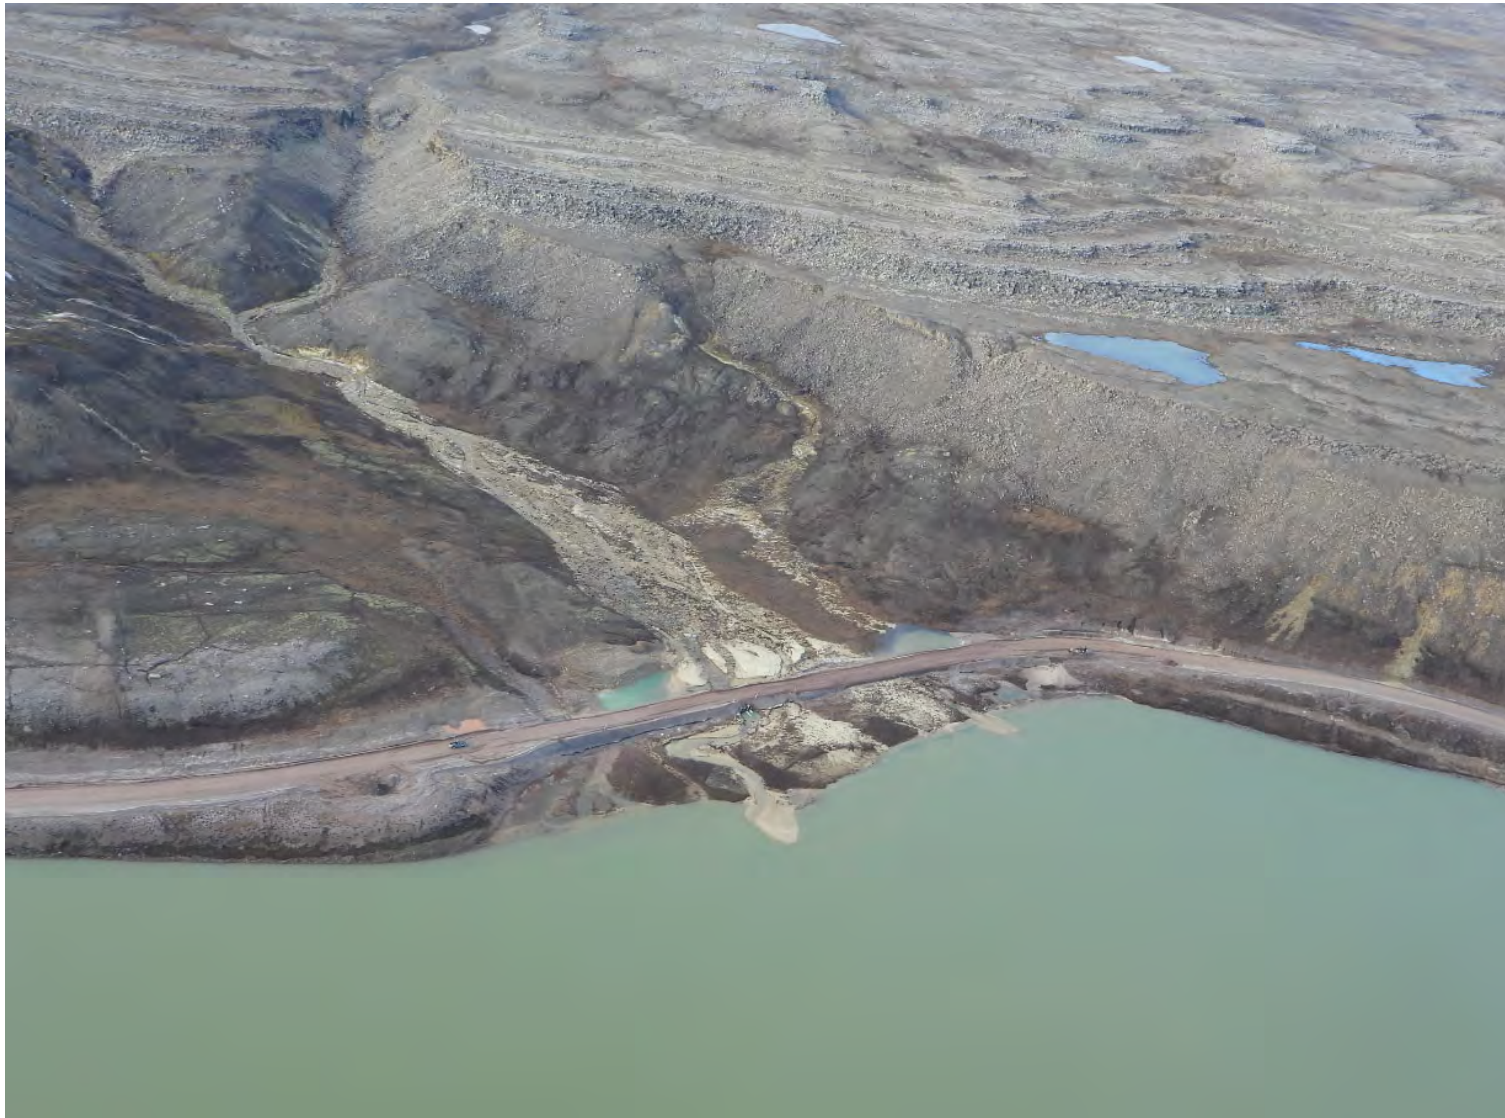
**Photo 1:** Significant natural slope failure near David Lake, resulting in sediments entering stream and lake. Not related to Project infrastructure, 2024-09-24.

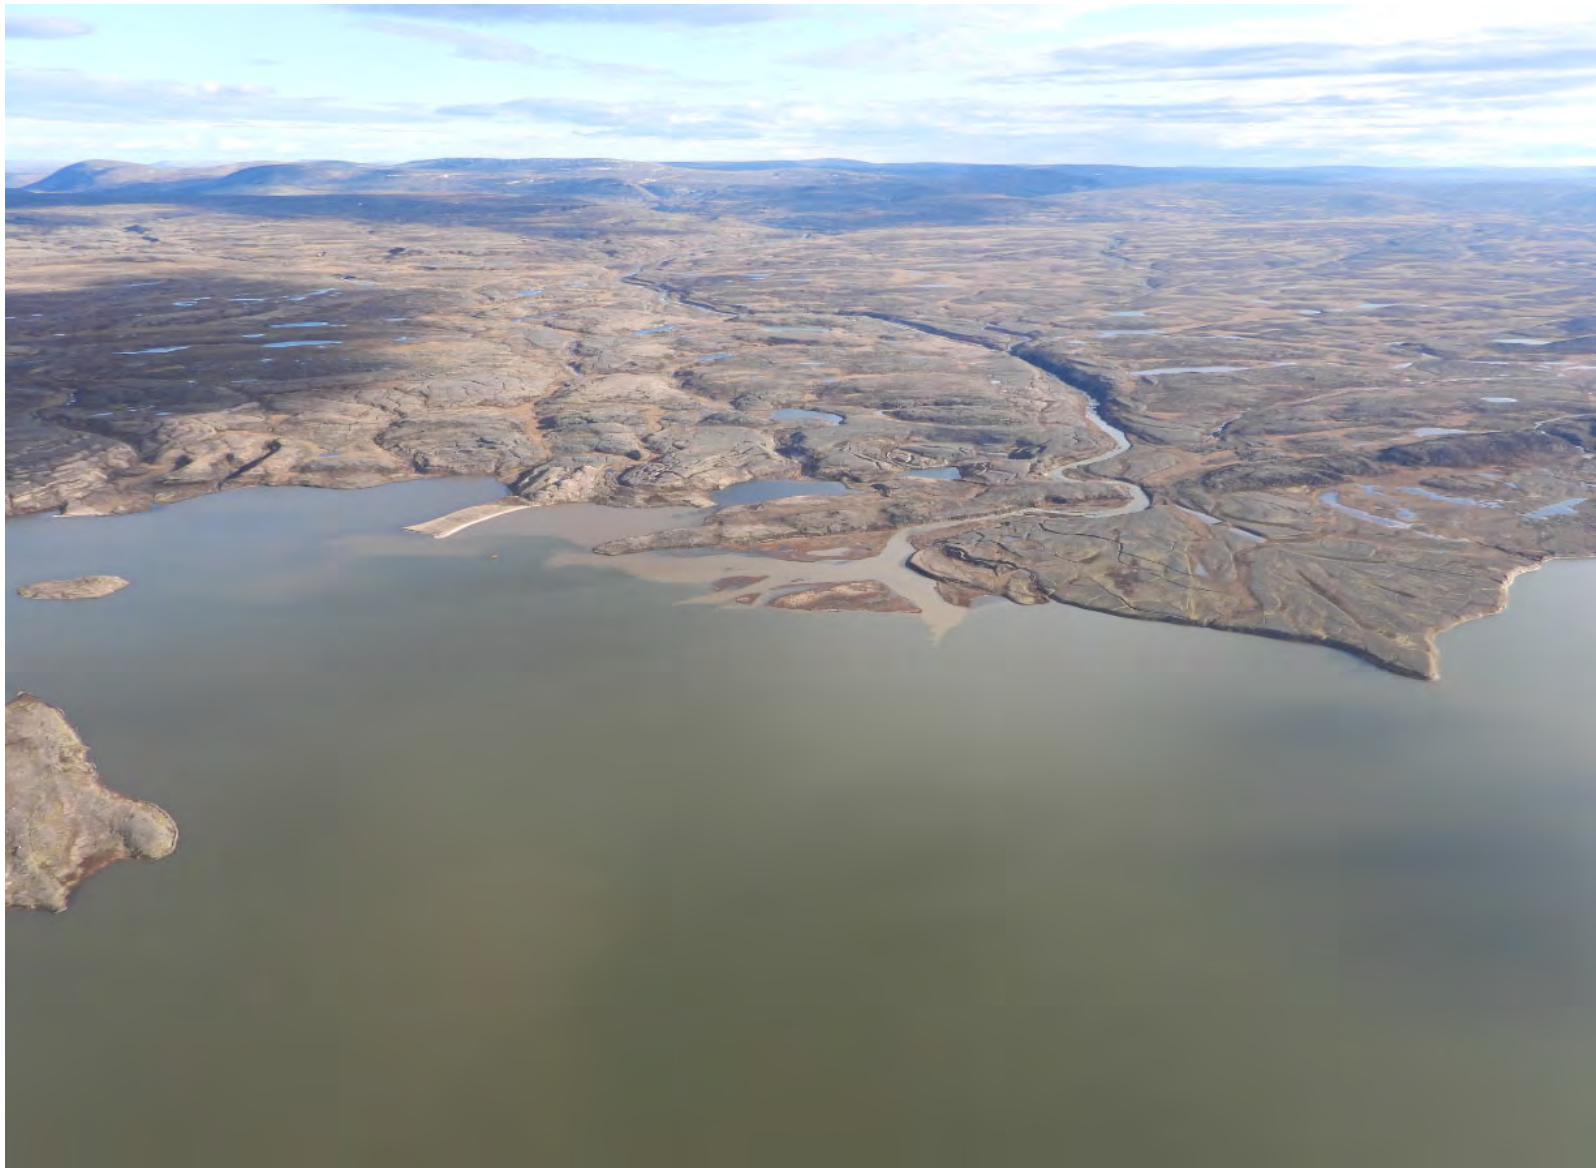
**Photo 2:** Natural sedimentation event upstream of Muriel Lake resulted in significant deposition of TSS into lake. Not related to Project infrastructure, 2024-09-24.

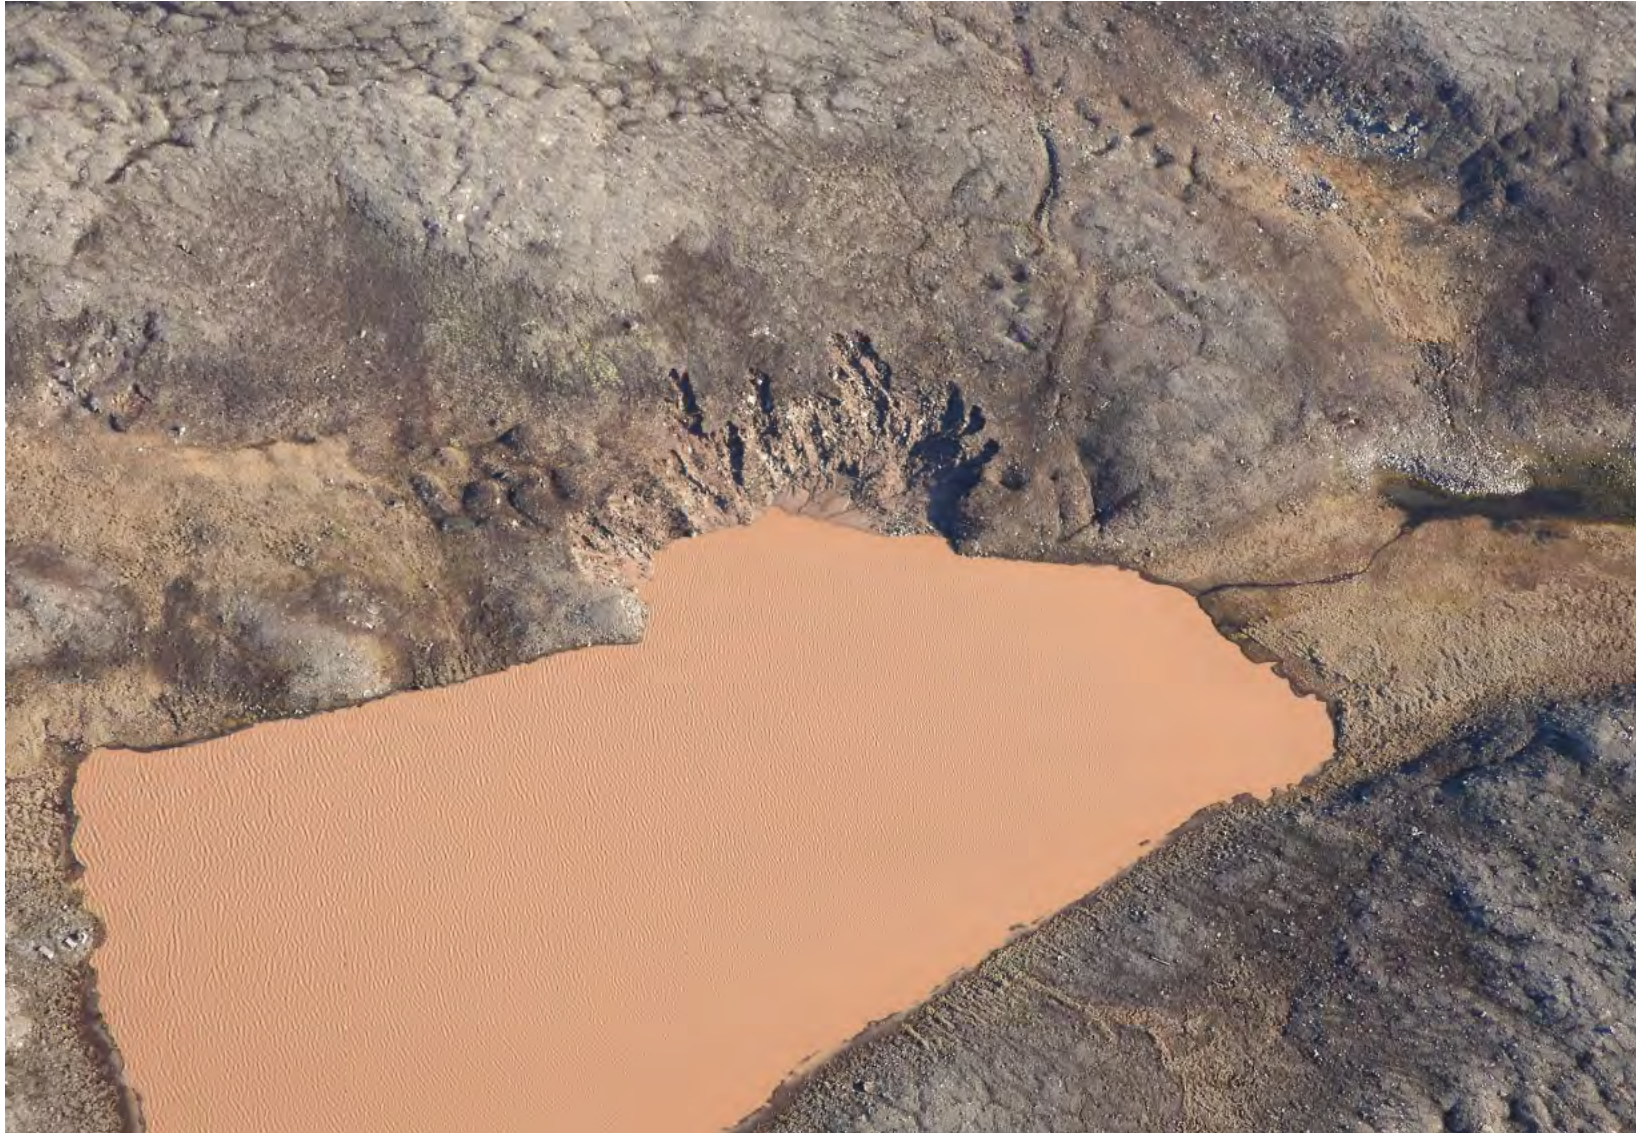
**Photo 3:** Slope failure into unnamed lake, resulting in apparent iron-rich TSS loadings to lake 9 km NW of Project, 2024-09-24.

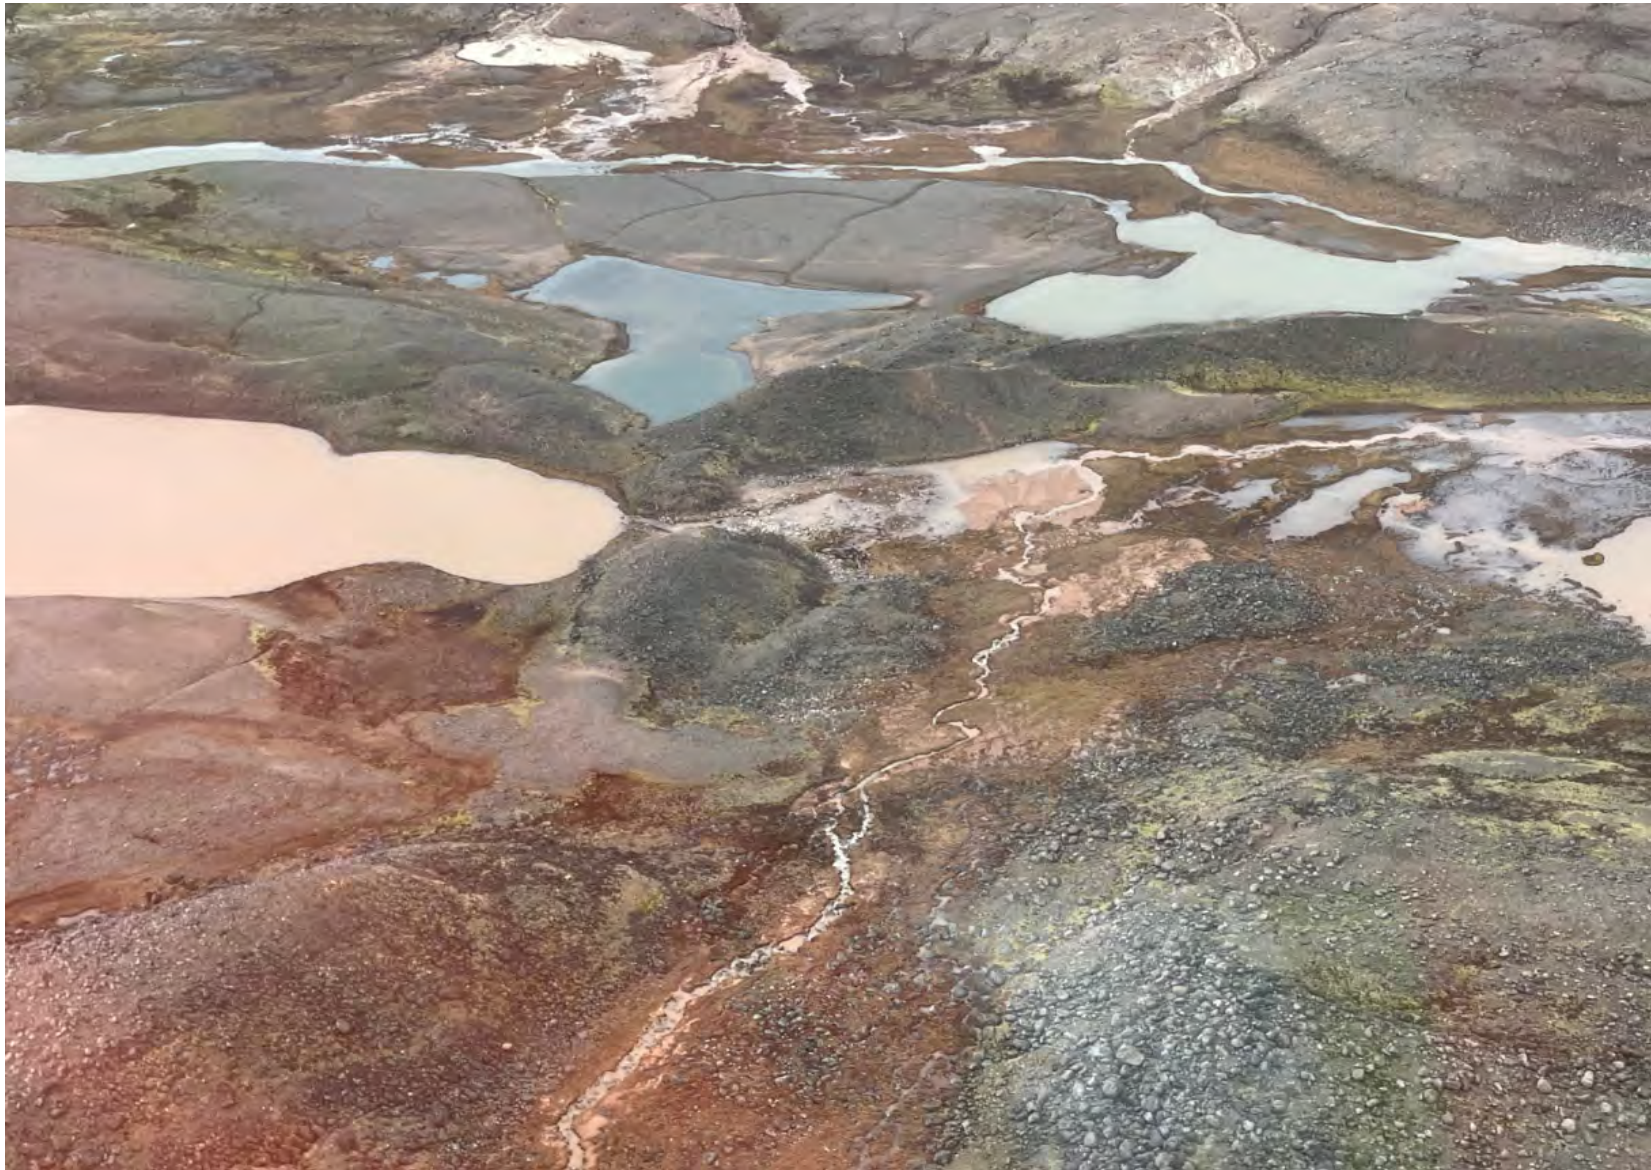
**Photo 4:** Multiple sedimentation events resulting in new delta creation and TSS loadings to unnamed lakes and stream, 27 km SE of Project (different catchment basin), 2024-09-27.

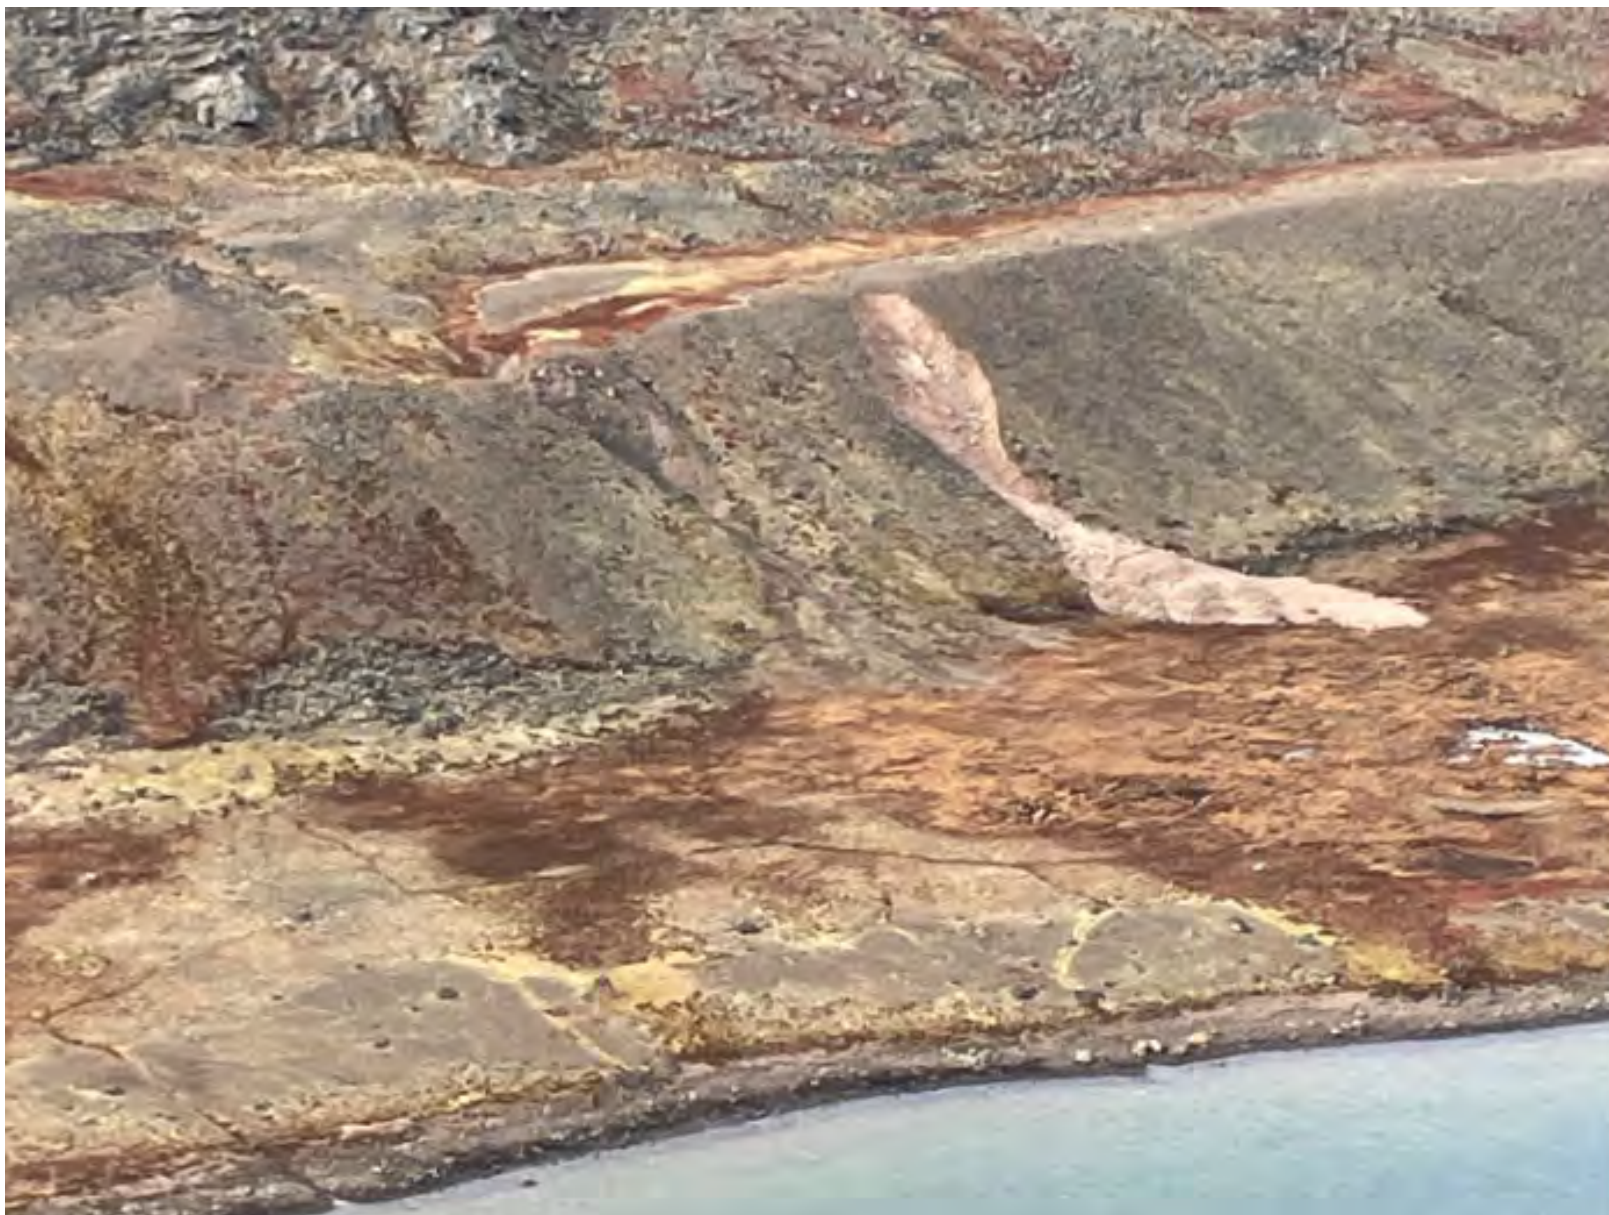
**Photo 5:** Hillside slope washout 101 km SE of Project, 2024-09-27.

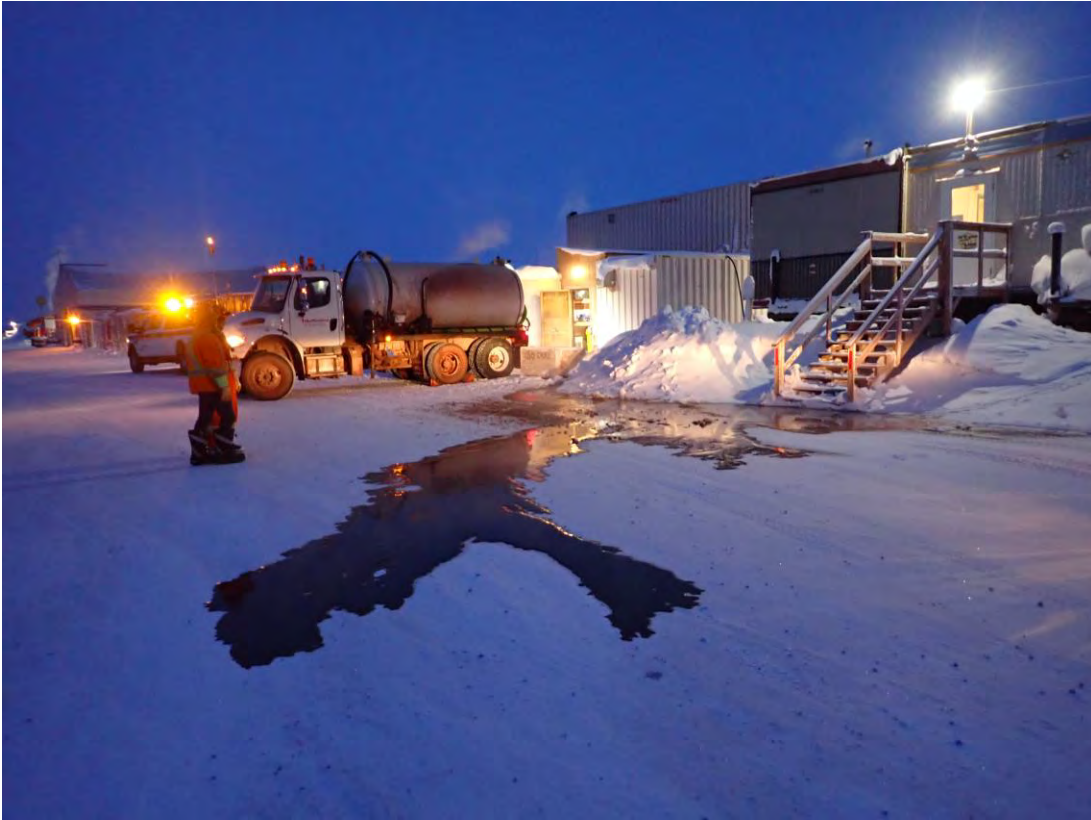
The sludge then migrated outside onto frozen ground adjacent to the WWTP, contaminating roughly 30 square meters. An investigation concluded that a siphon effect occurred between the aeration tank and the tote due to the transfer line still being submerged. The nearest water body is located 350m away from the WWTP and is currently frozen.

Photo 1: Aerobic sewage that migrated outside of the Milne Port 380 WWT - December 12, 2024

Following this, cleanup was initiated utilizing a vac truck to vacuum up the impacted area, which was then deposited into the Milne Port Polishing Waste Stabilization Pond. Further, a loader was utilized to scrape up impacted snow. Monitoring of the area will occur once thawing conditions prevail to ensure cleanup activities were effective.

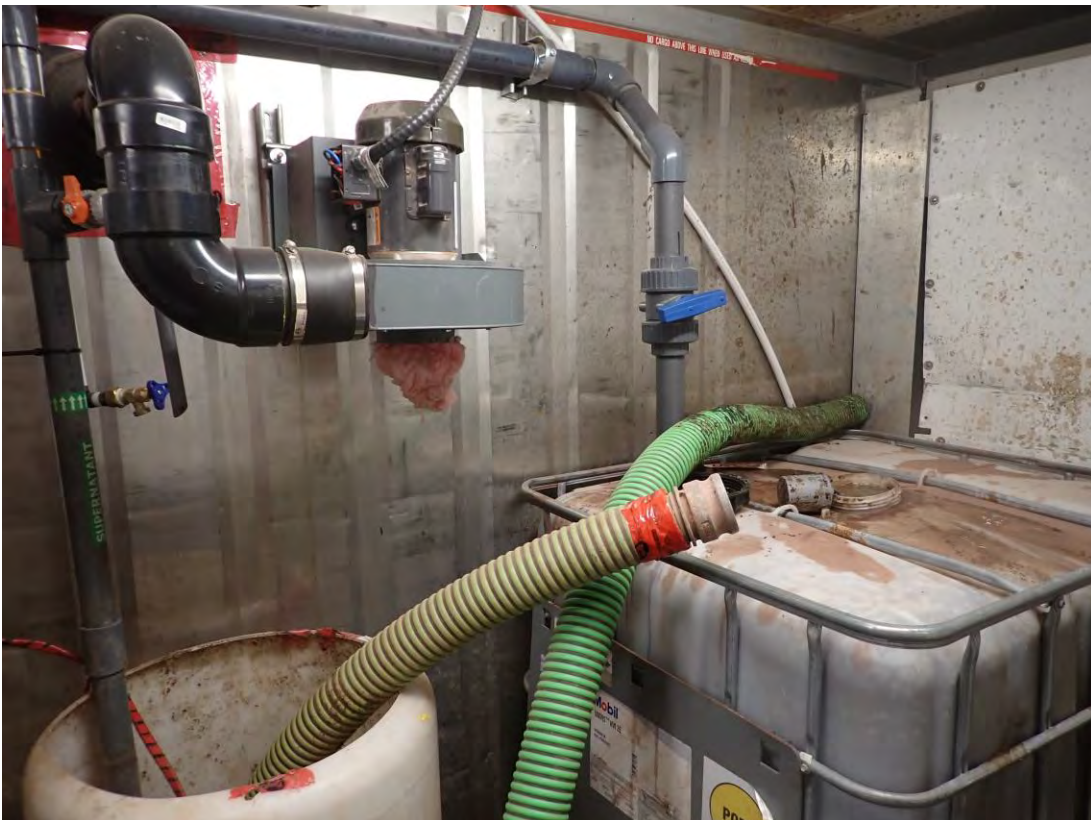
On December 12, 2024, at approximately 10:45, an estimated 600 litres of treated sewage was released to the environment immediately outside the Milne Port 380 Camp Waste Water Treatment Plant (WWTP). As part of the operations of the WWTP, aerobic sludge is transferred from an aeration tank to a tote using a waste-activated sludge (WAS) transfer pump. The tote was filled approximately halfway, and the WAS transfer pump was shut off. At approximately 11:30, a Supervisor noticed liquid outside the plant building. Upon inspection, it was discovered that the tote had overflowed, releasing the sludge onto the floor of the building.

Photo 2: Tote inside Milne Port 380 WWTP that overflowed, resulting in release – December 12, 2024

Corrective actions implemented as a result of the incident include creating a Safe Work Instruction (SWI) for transferring from the aeration tank to a tote, which indicates the requirement to close the valve on the line filling the tote. This will ensure the siphoning effect between the aeration tank, and the tote does not reoccur. An intrinsically safe shut-off switch for the WAS transfer pump will also be installed closer to the pump.

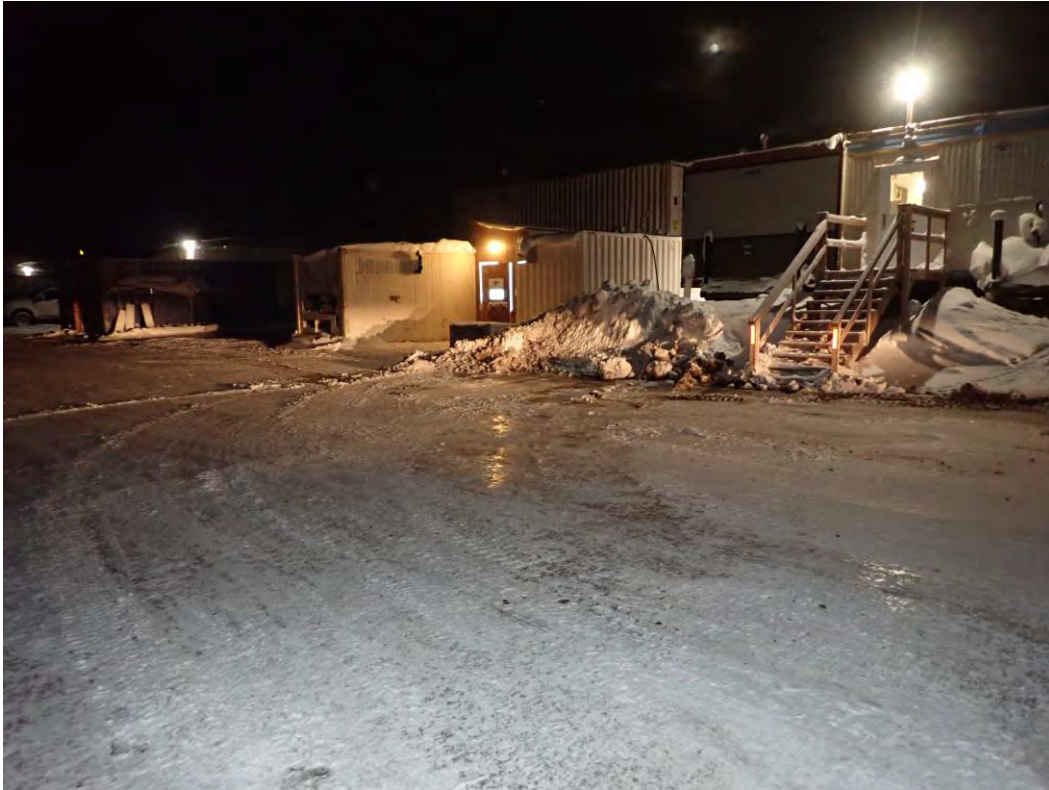
Photo 3: Post release of aerobic sewage adjacent to Milne Port 380 WWTP following first clean up – December 12, 2024

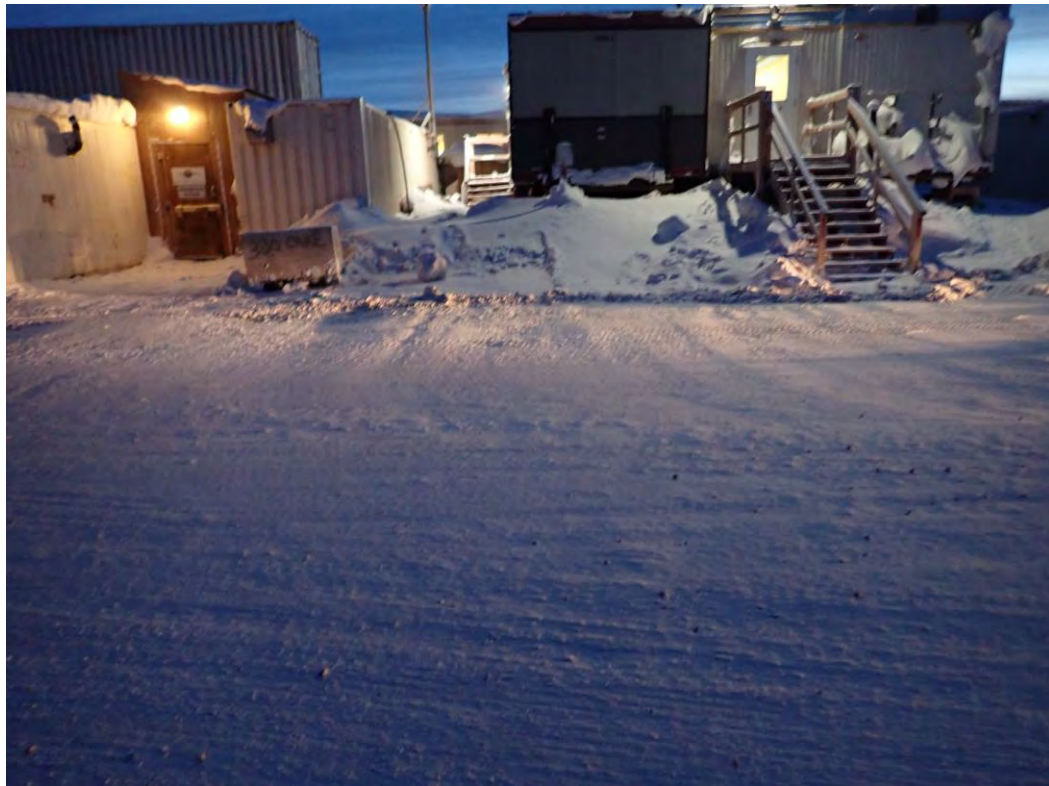
Photo 4: Location of aerobic sewage release at Milne Port 380 WWTP following second clean up – January 5, 2024
