Mary River Project
2025 Borrow Pit Reclamation Report

Baffinland Iron Mines Corporation
Mary River Project

Issue Date: October 28, 2025

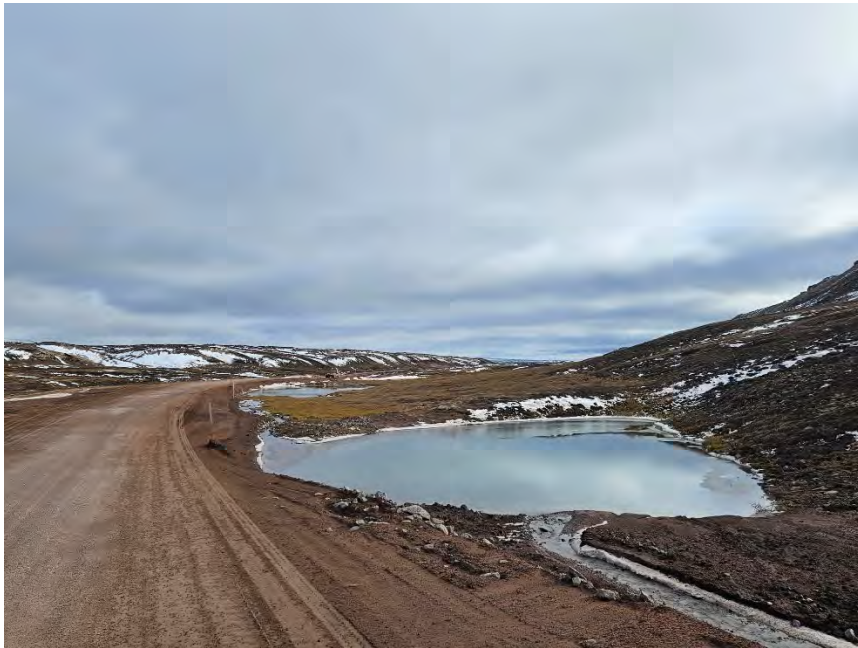
Figure B1. Site 14A during freshet, July 2025

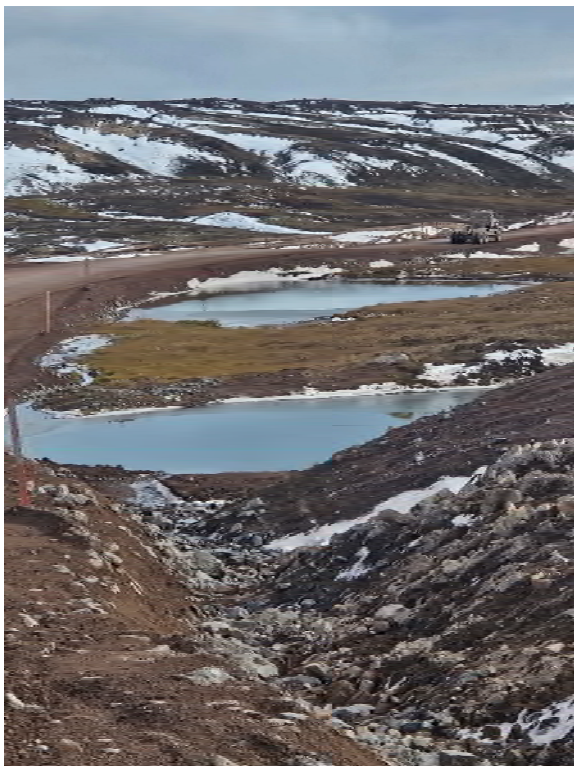
Figure B2. Site 14A during freshet, July 2025

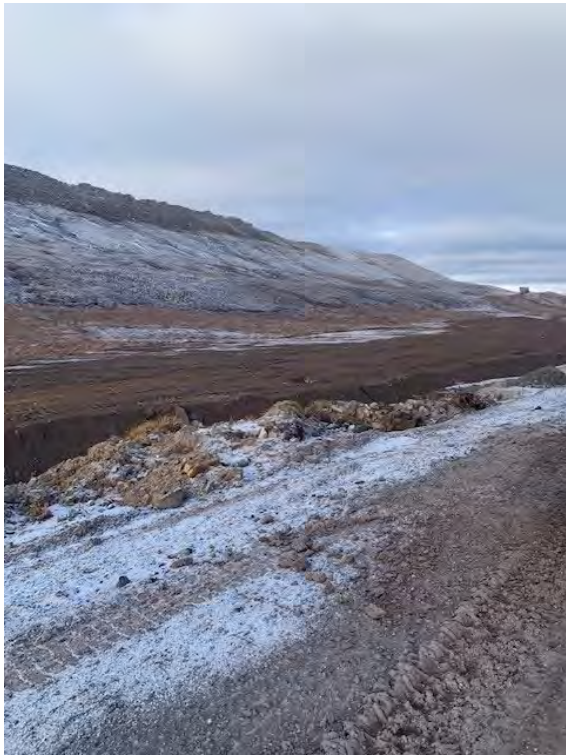
Figure B3. Site 14 and Site 14A after Reclamation Work, September 2025

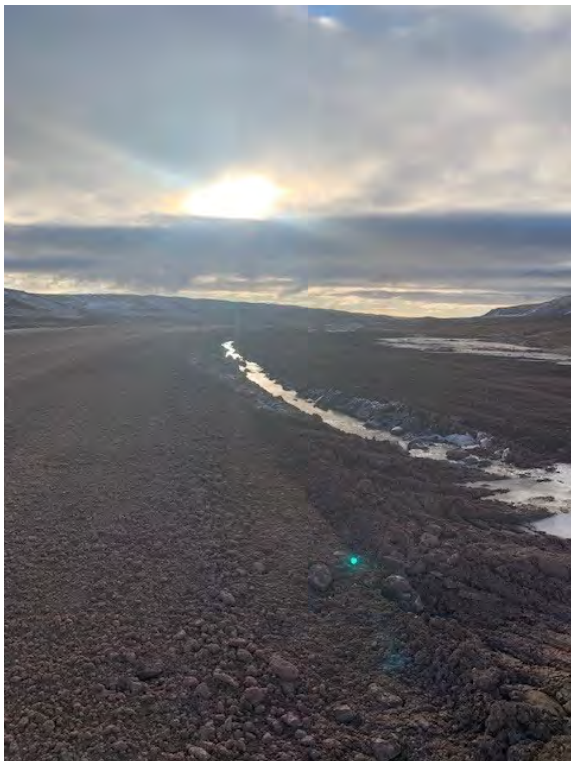
Figure B4. Site 14 and Site 14A after Reclamation Work, September 2025

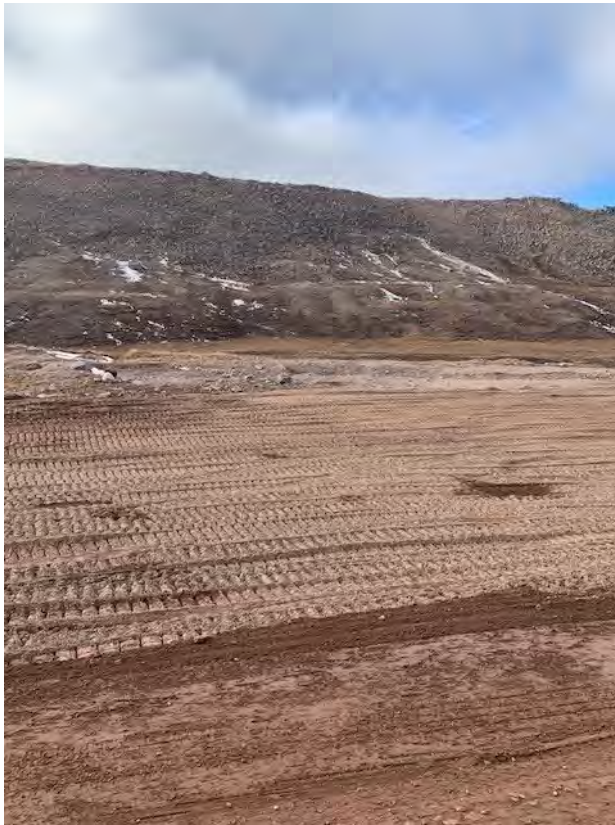
Figure B5. Site 14 and Site 14A after Reclamation Work, September 2025

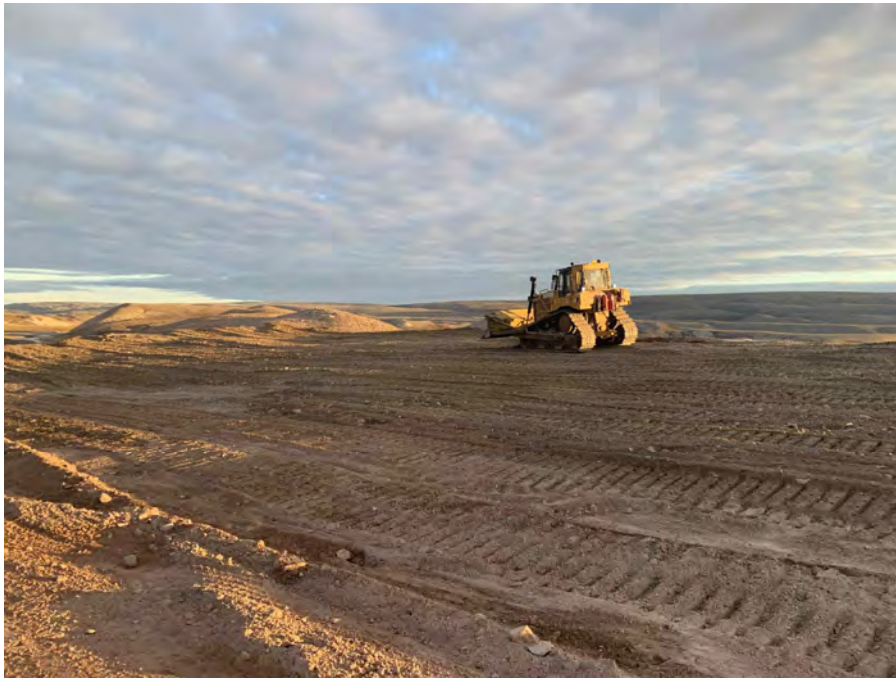
Figure C1. Regrading of Borrow Pit 41 using a CAT D6 dozer, August 2025

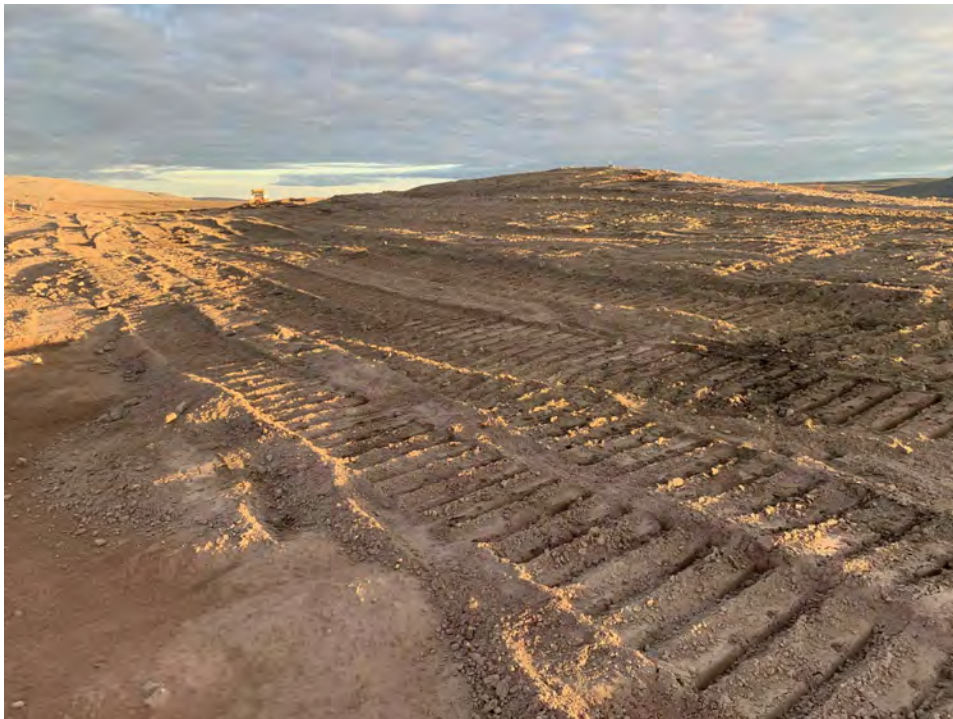
Figure C2. Post-reclamation site, surface grading, August 2025

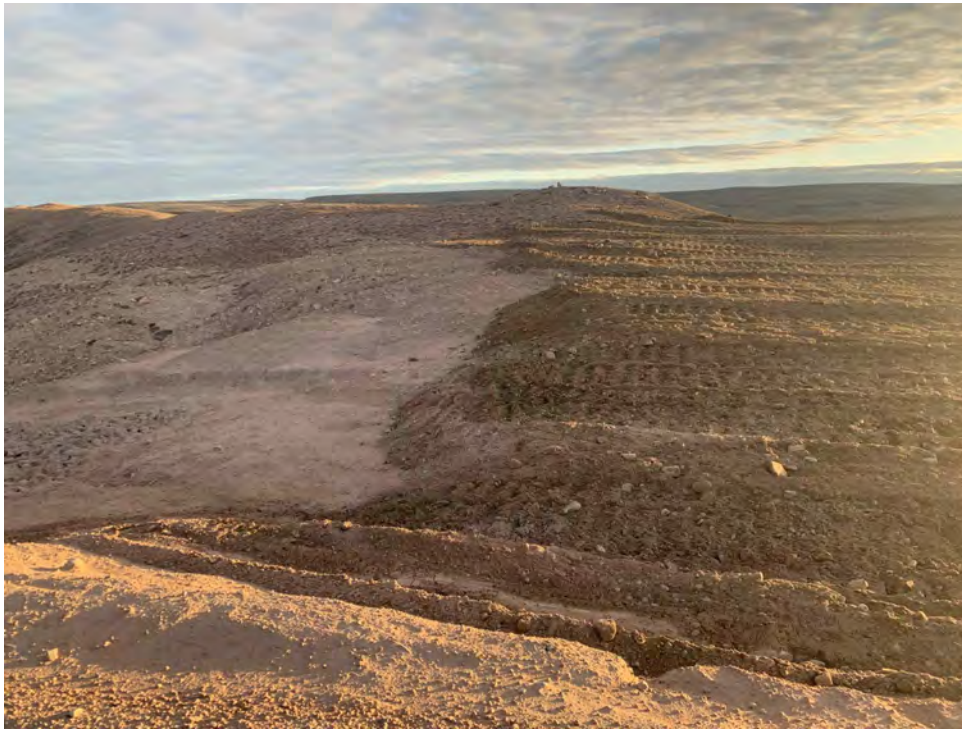
Figure C3. Post-reclamation site, surface grading, August 2025

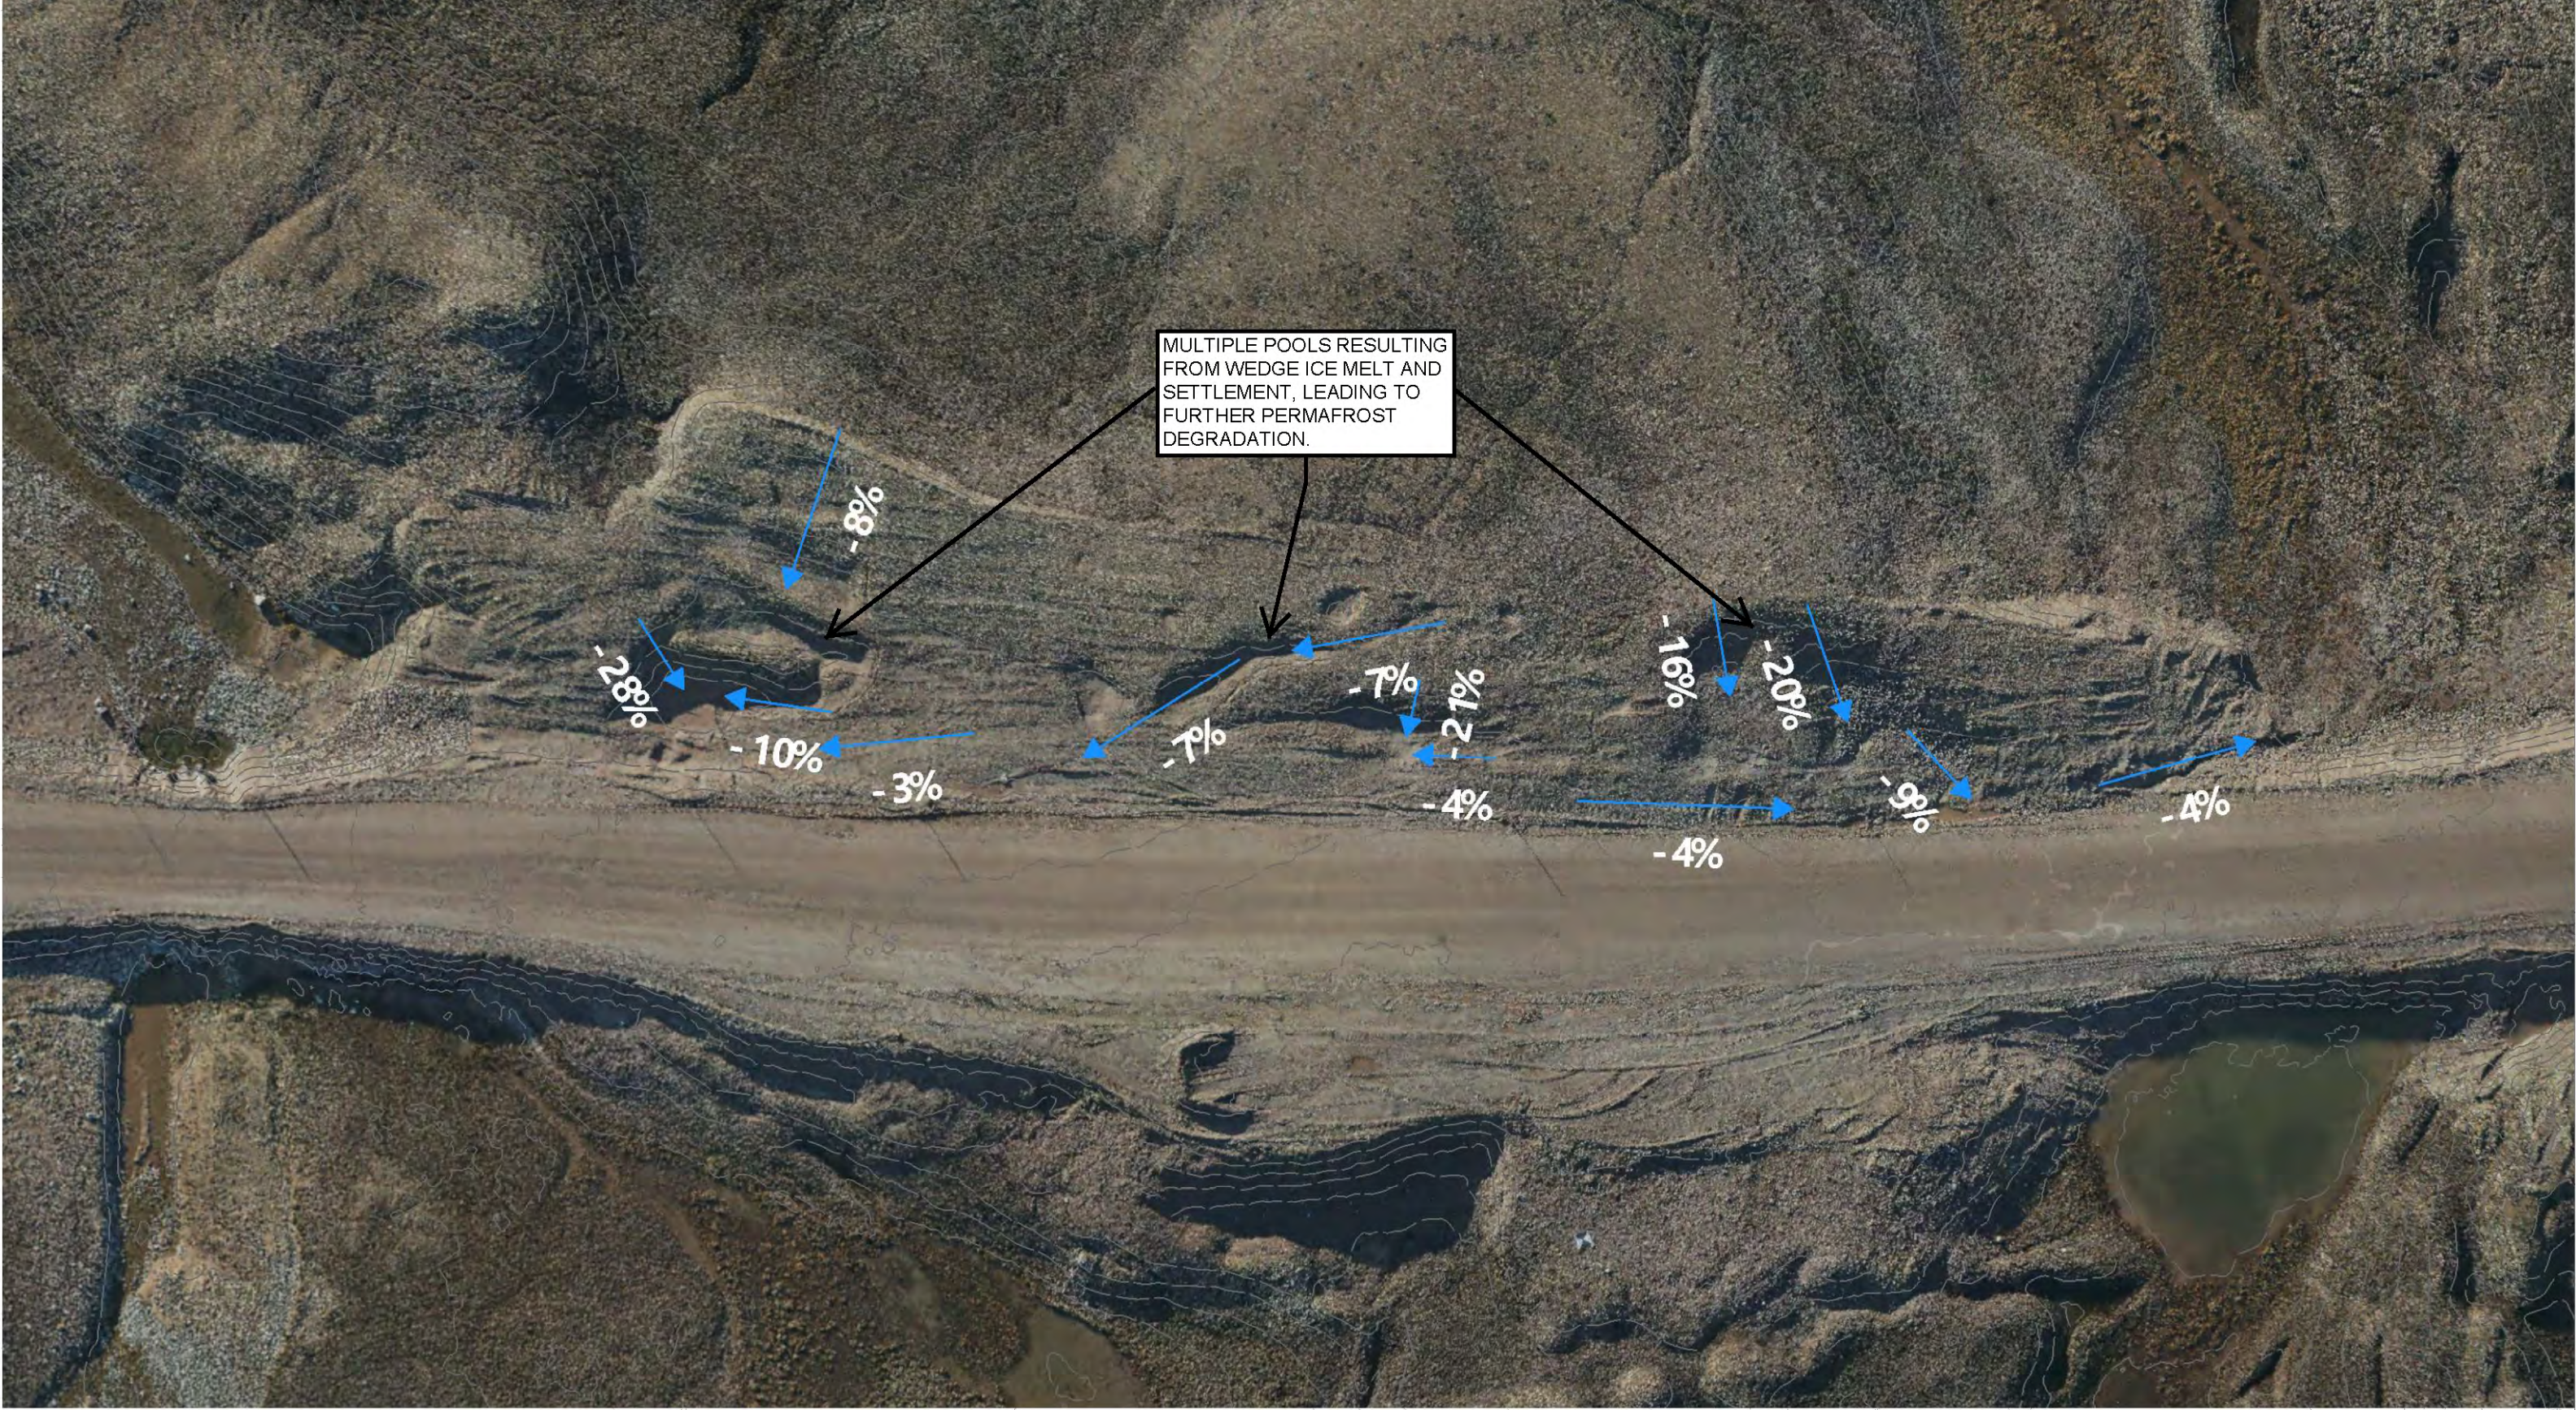
NOTES: SEPTEMBER 2024 BEFORE REMEDIATION

MULTIPLE POOLS RESULTING FROM WEDGE ICE MELT AND SETTLEMENT, LEADING TO FURTHER PERMAFROST DEGRADATION.

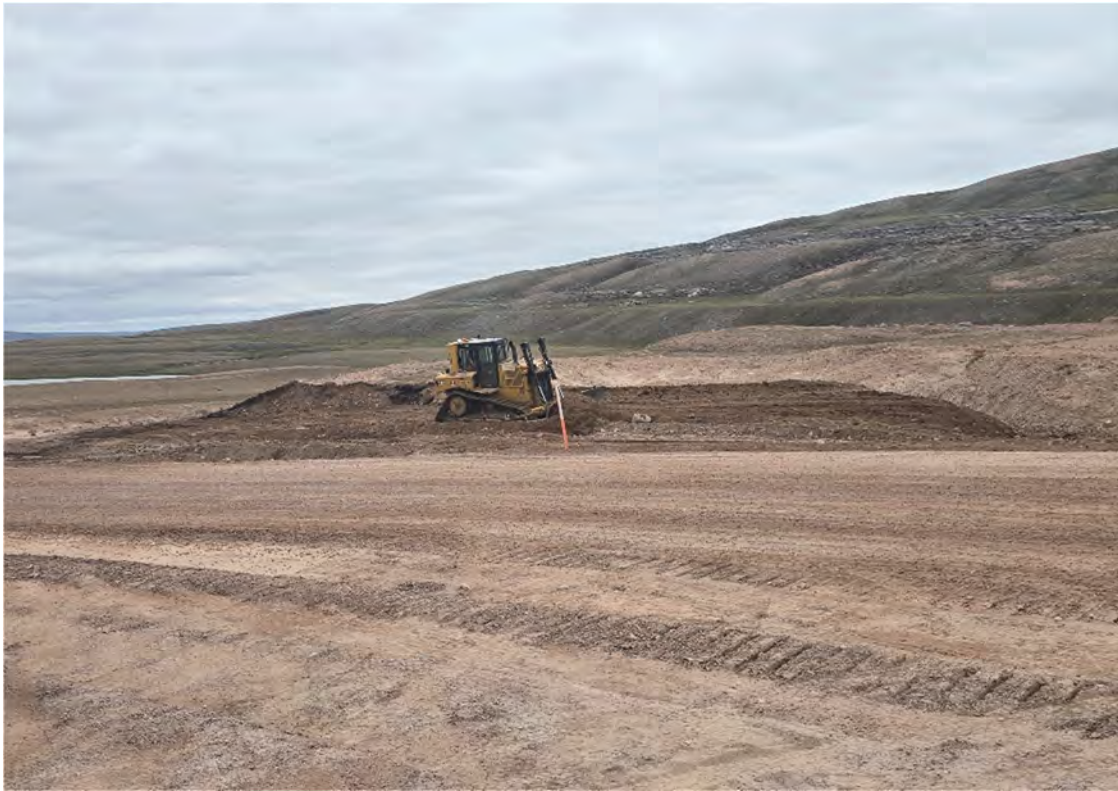
Figure D1. Regrading of Borrow Pit 71 using a CAT D6 dozer, July 2025

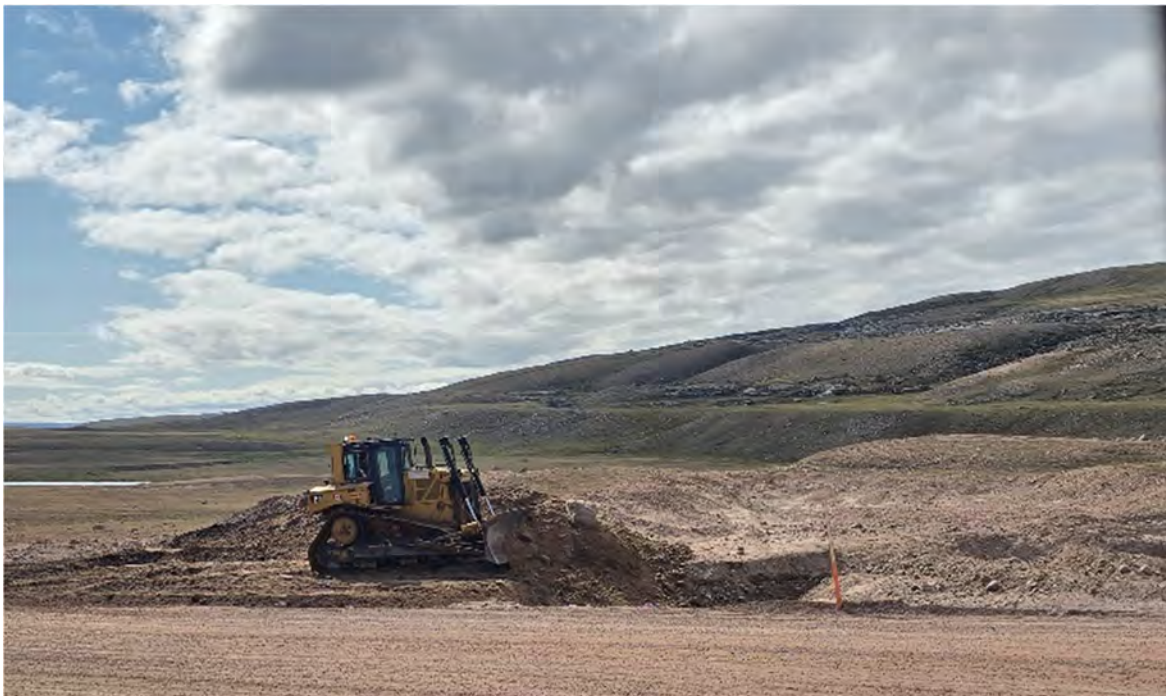
Figure D2. Regrading of Borrow Pit 71 using a CAT D6 dozer, July 2025

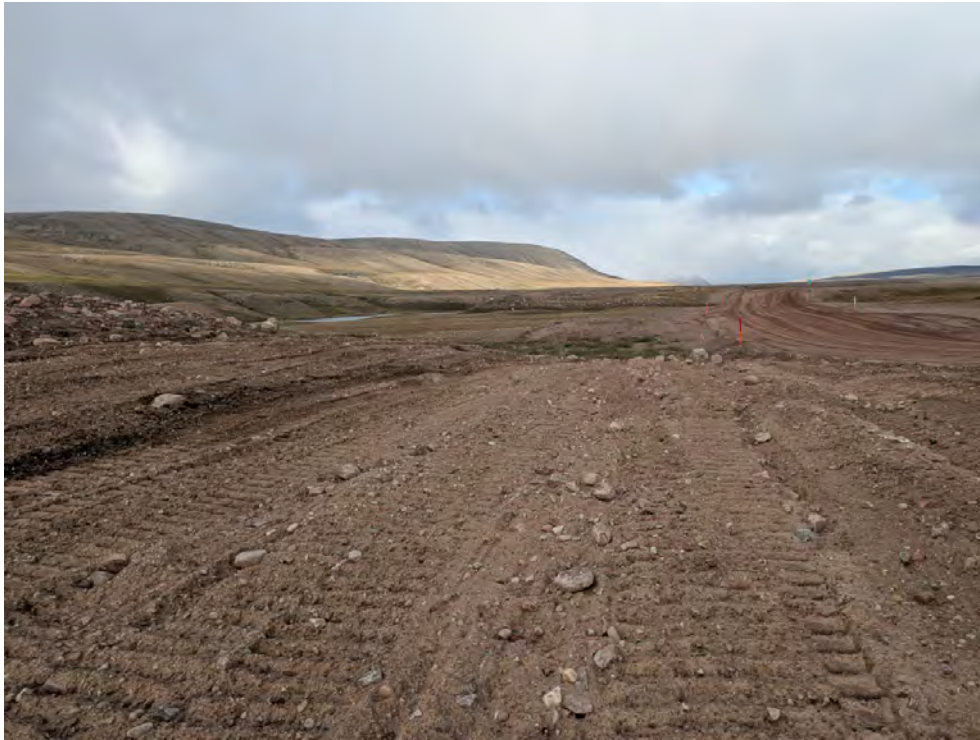
Figure D3. Post-reclamation site, surface grading, August, 2025

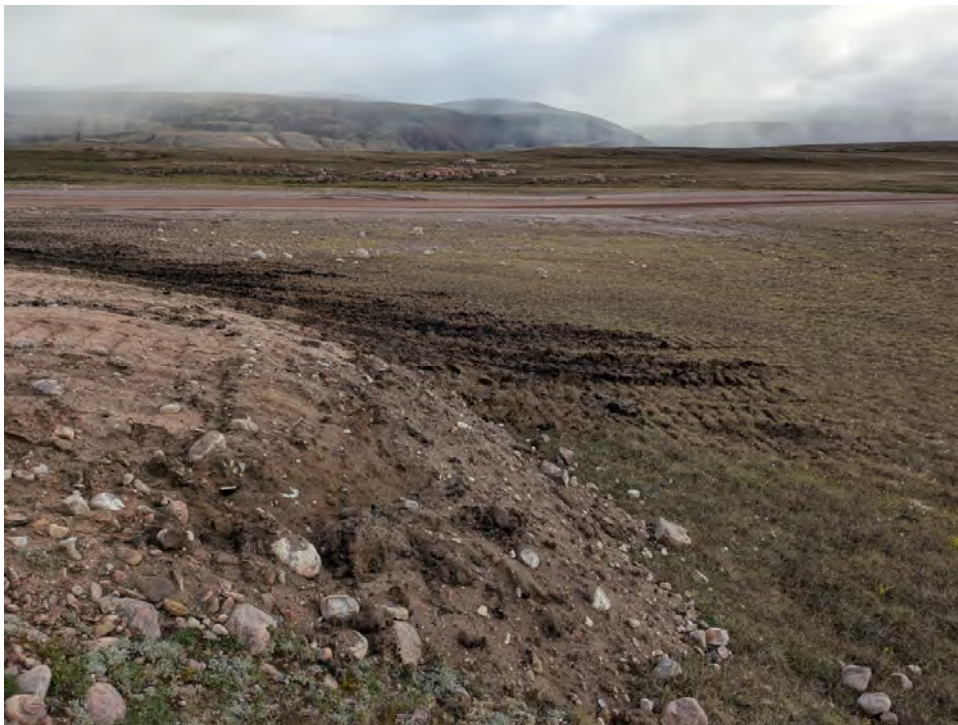
Figure D4. Post-reclamation site, side slope, August, 2025

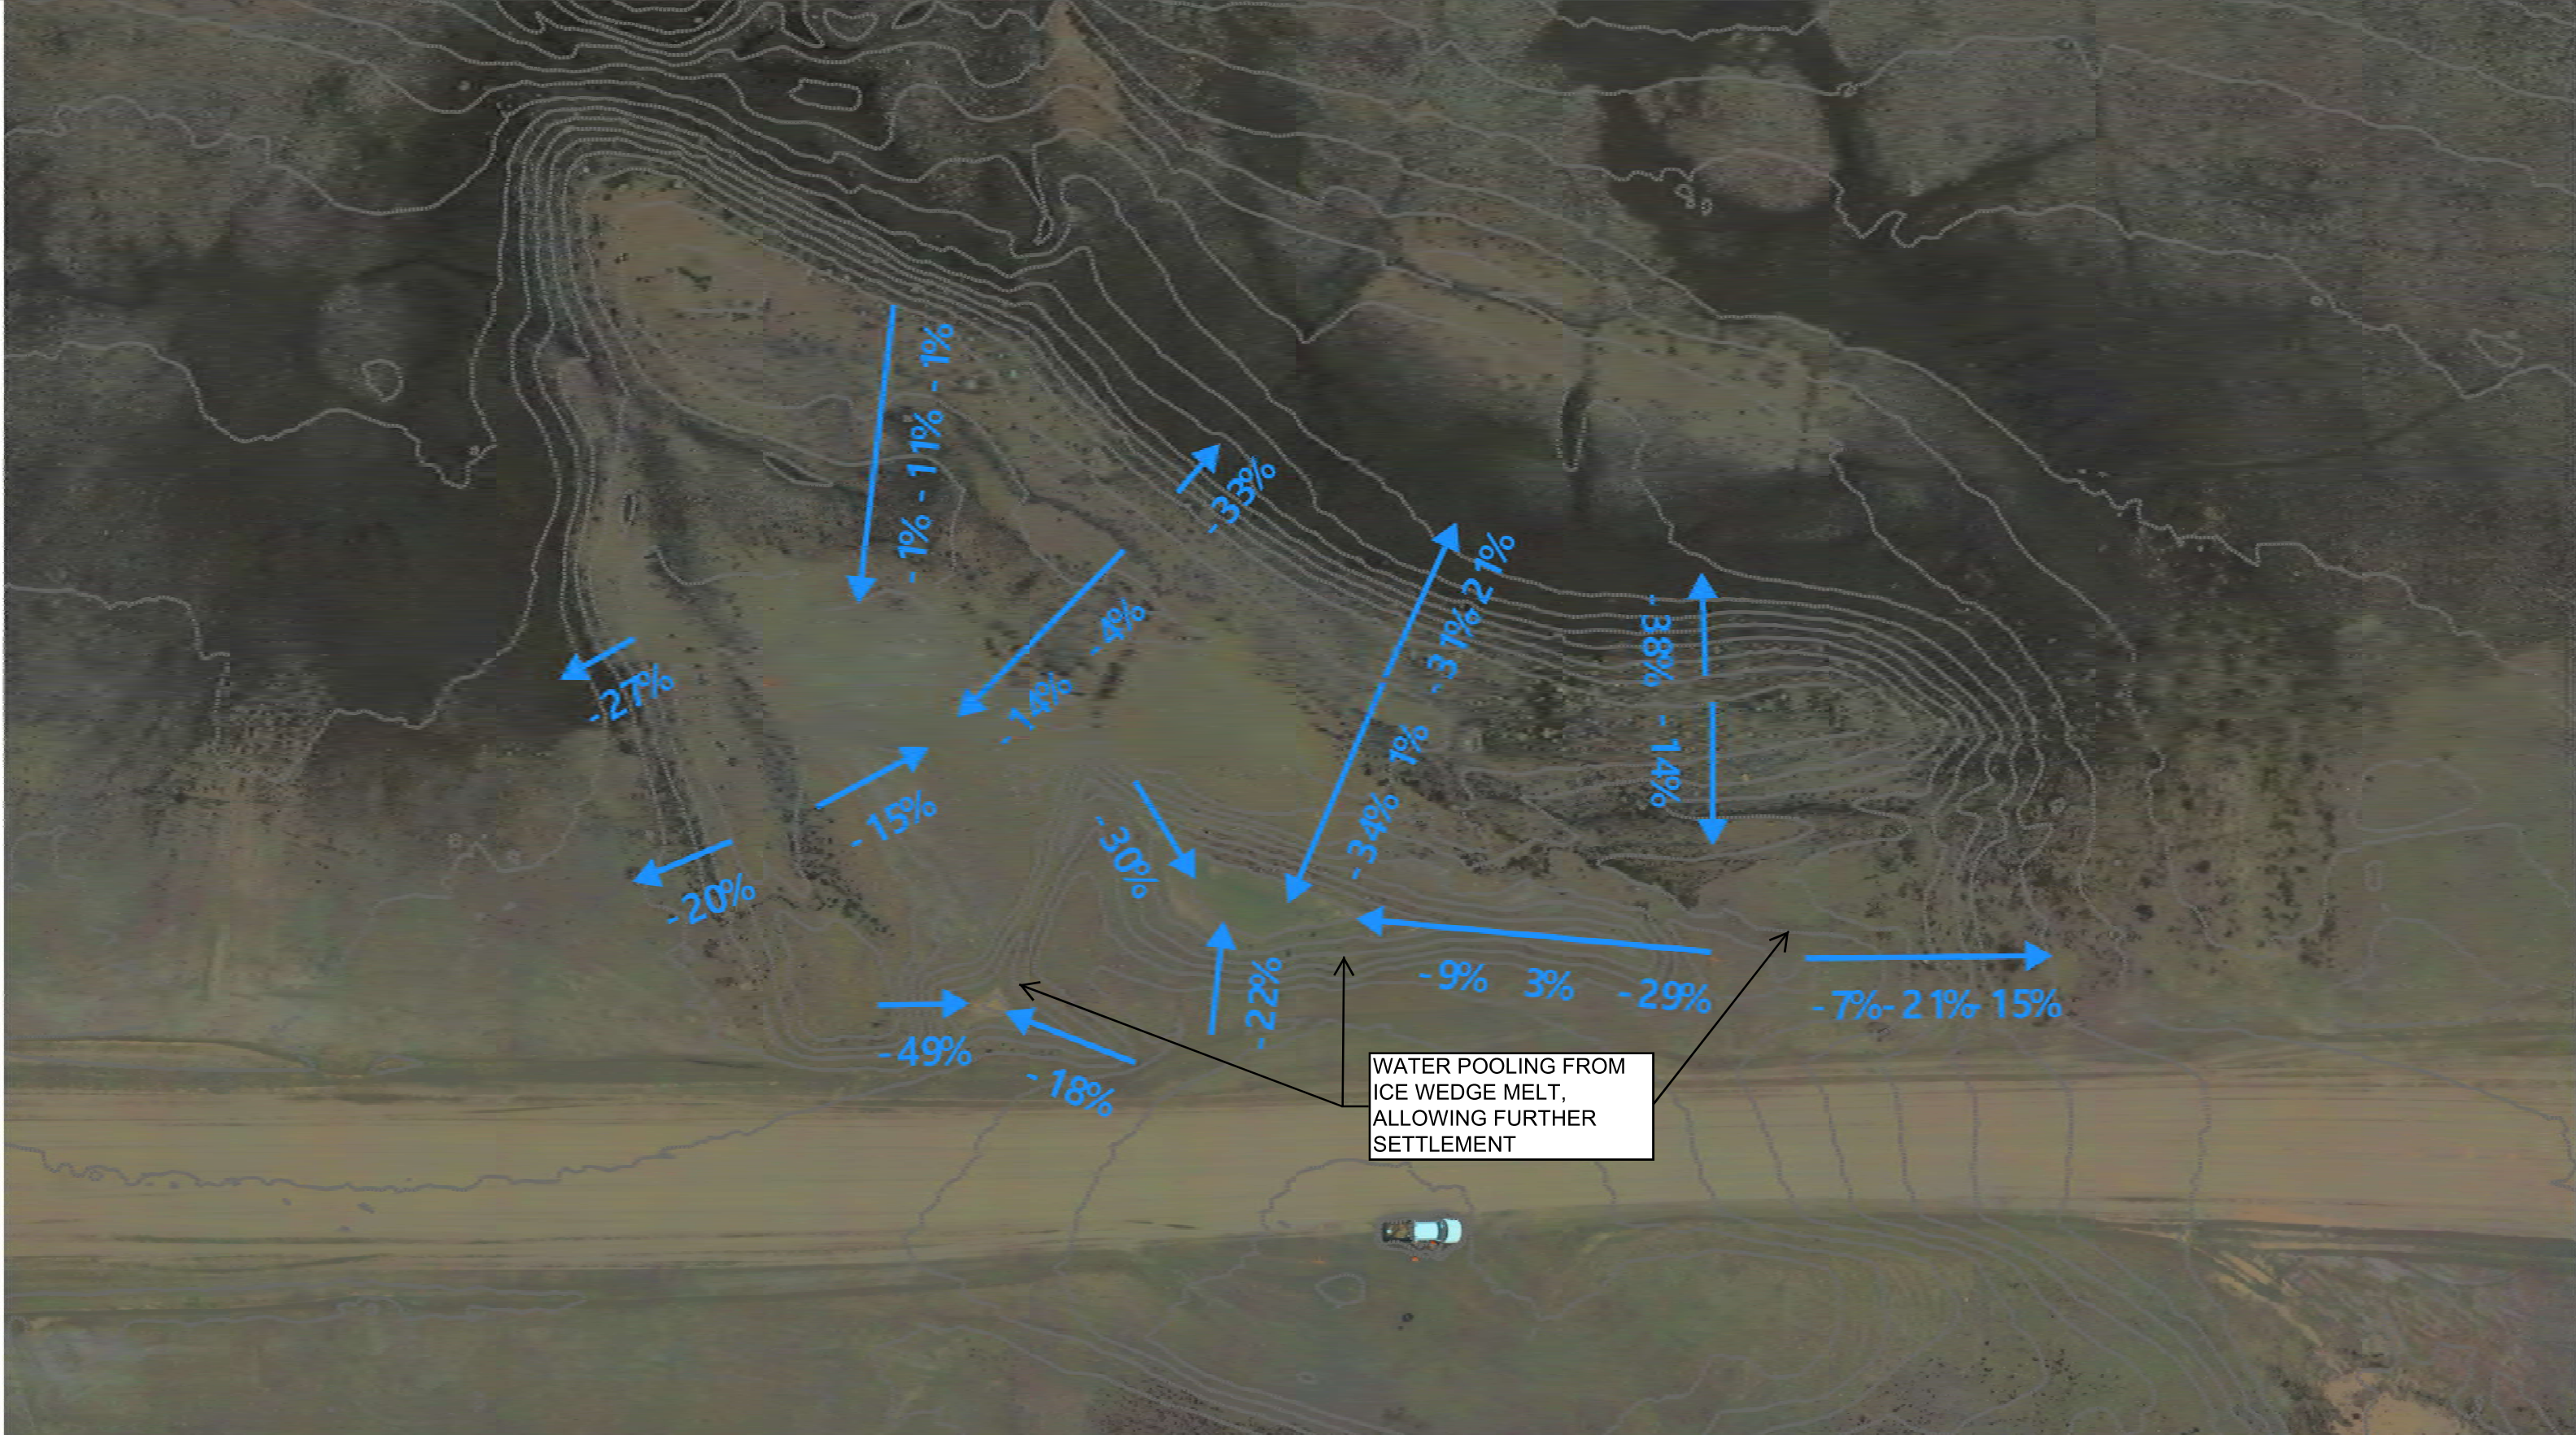
WATER POOLING FROM
ICE WEDGE MELT,
ALLOWING FURTHER
SETTLEMENT
