As-Built Report

Tote Road Bridges Approach Remediation

Tote Road Bridge Abutment Maintenance – 2025

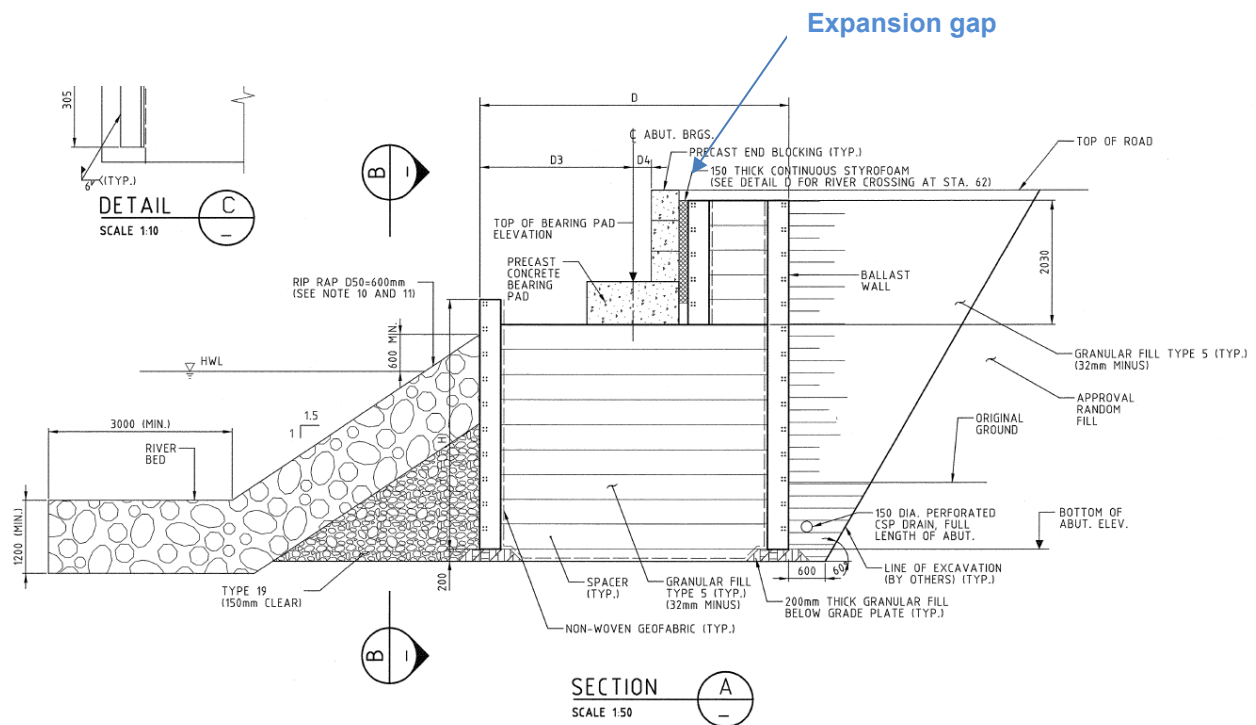
Section of Original Bridges Abutment and Approach

Four Acrow bridges and abutments were installed in the winter of 2014 during the construction phase of the Mary River Project. After installation, settlement occurred limiting the expansion gap, adding axial pressure to the fixed end, and twisting the bridge from the differential settlement of the bearing pads.

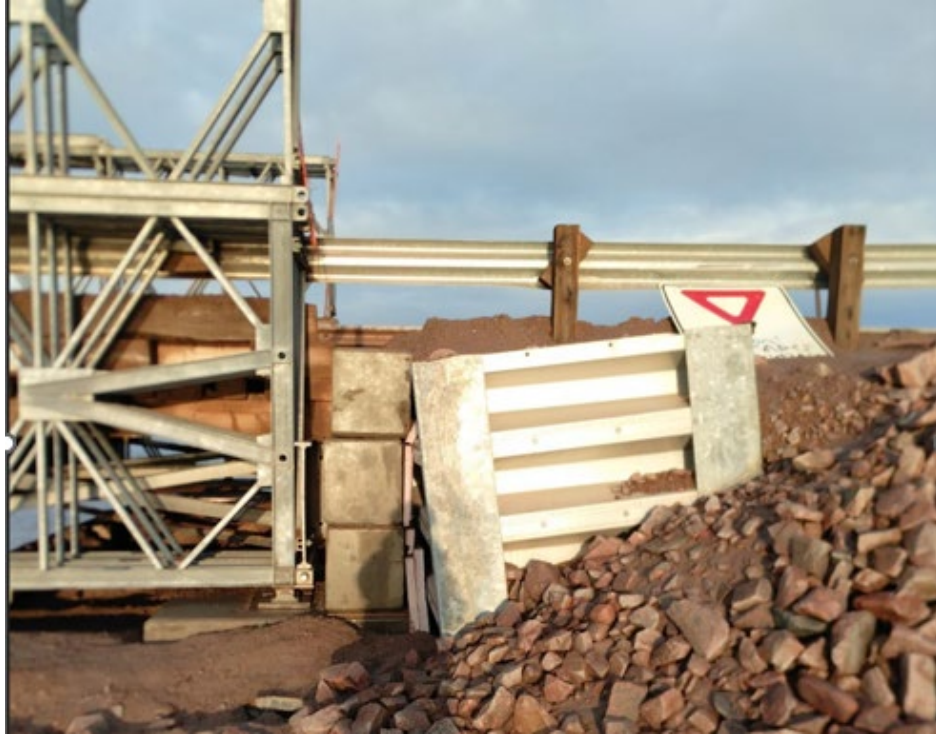
Photo 1. Pre-construction condition of bridge sliding end (typical)

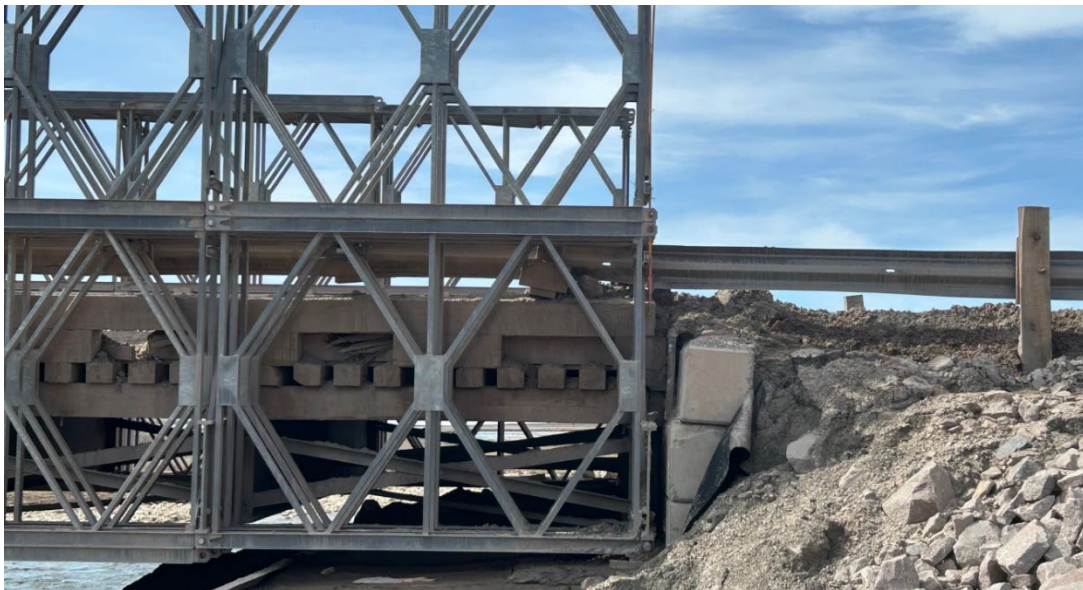
Photo 8. Post-construction condition of bridge sliding end
