APPENDIX C.2
Geotechnical Inspection Report

October 29, 2025

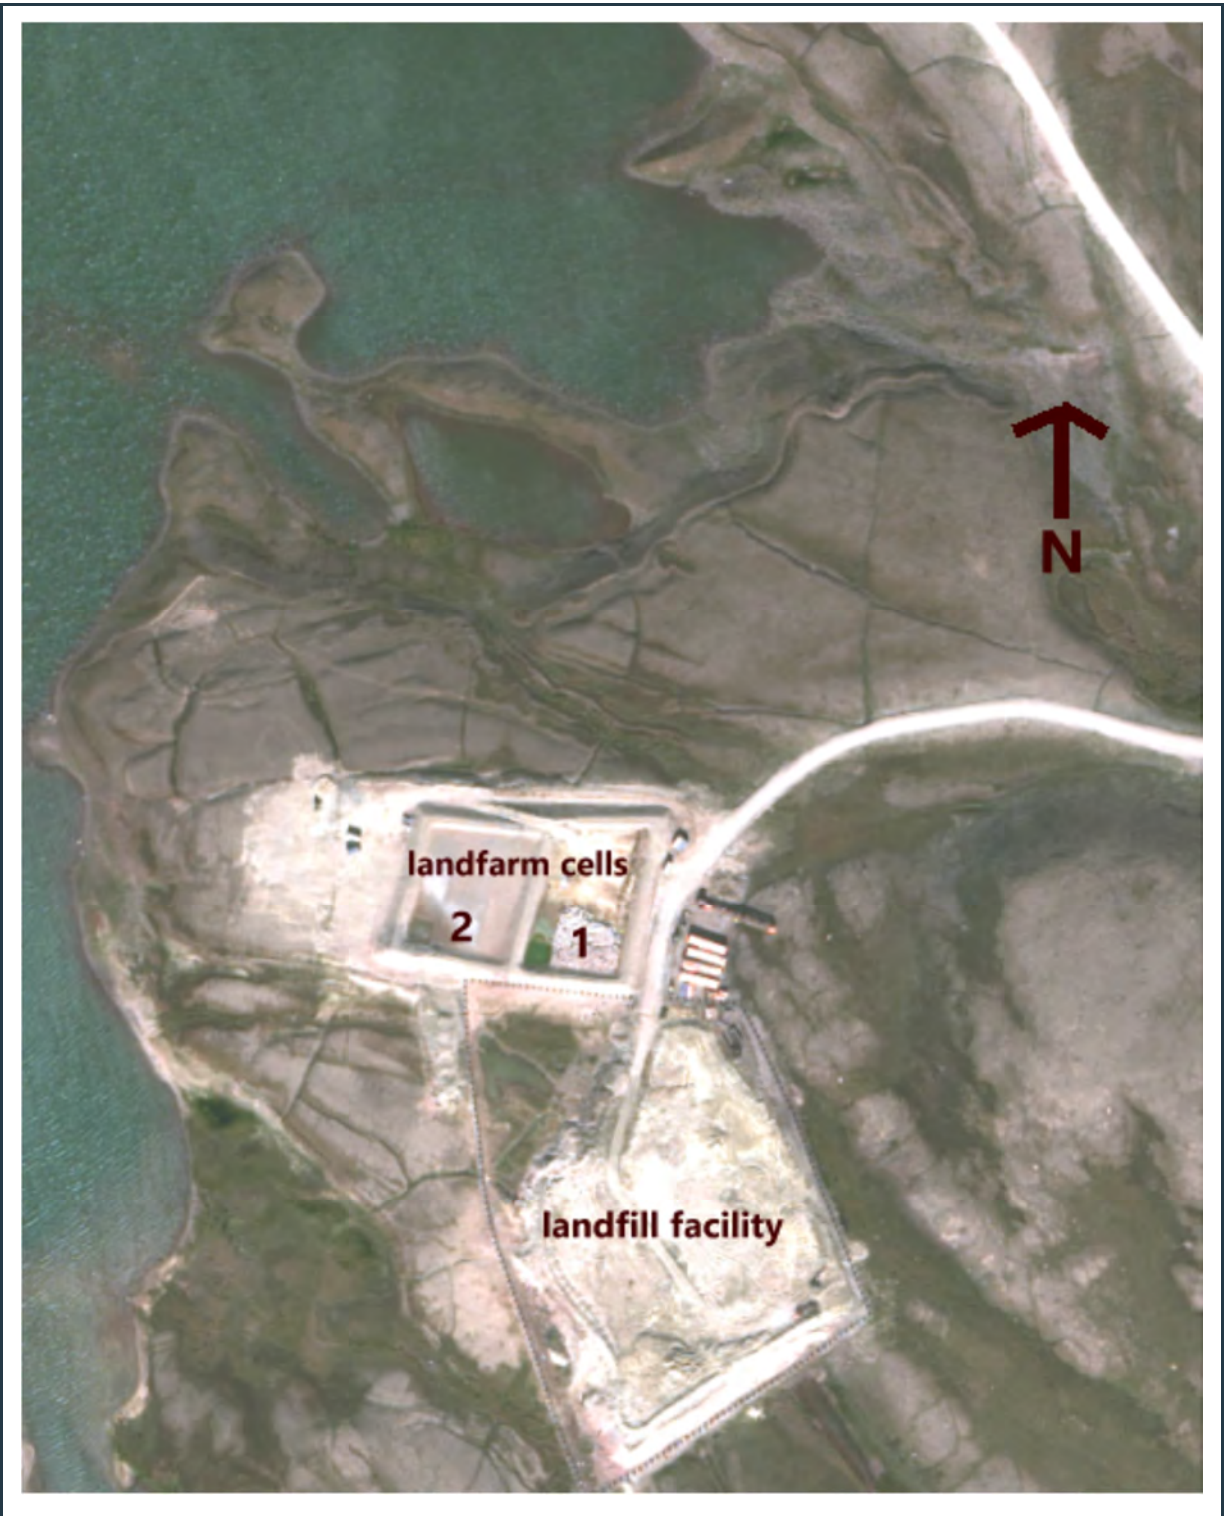
Figure 7: Mary River Mine Site – Layout Map – Southern Zone – Non-hazardous waste landfill facility and two adjacent, lined landfarm cells - © 2023 Digital Globe, Inc.

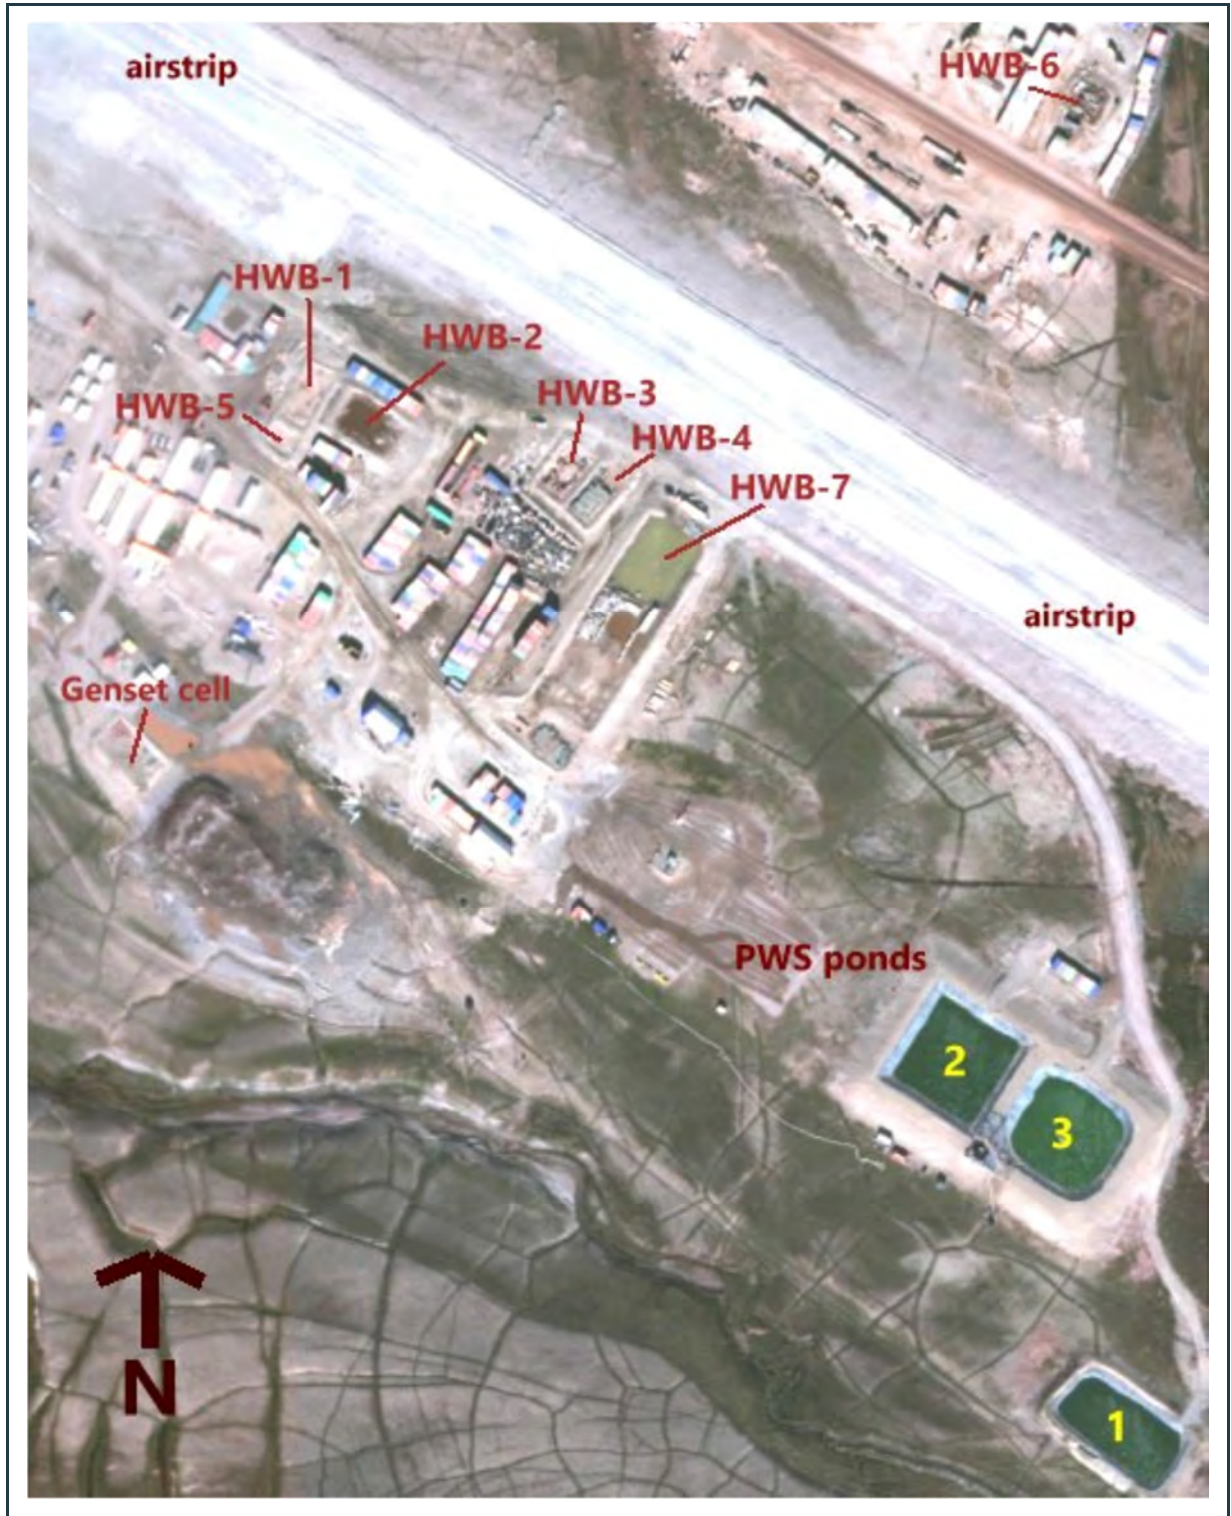
Figure 8: Mary River Mine Site – Layout Map - Western Zone – Polishing Waste Stabilization Ponds (1-3), Hazardous waste storage cells (HWB 1-7), and Genset cell - © 2023 Digital Globe, Inc.

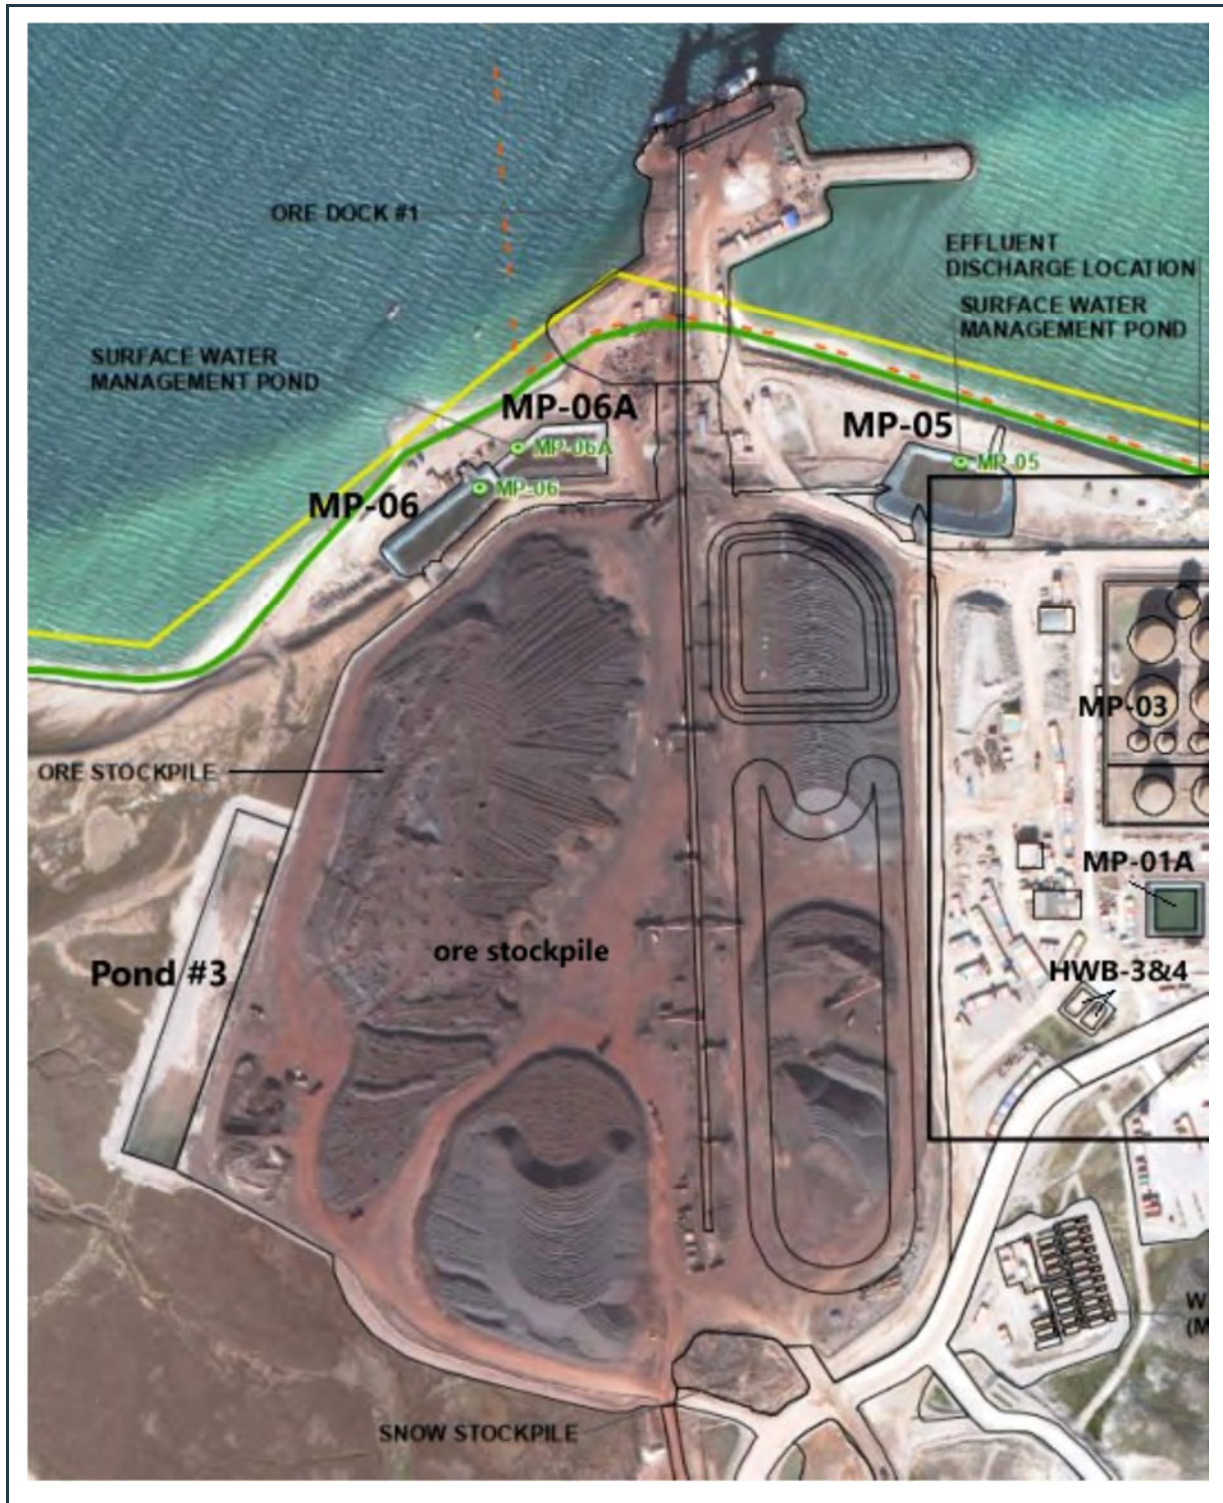
Figure 9: Milne Inlet Port Site – Layout Map -- North-Western Zone - © 2023 Digital Globe, Inc.

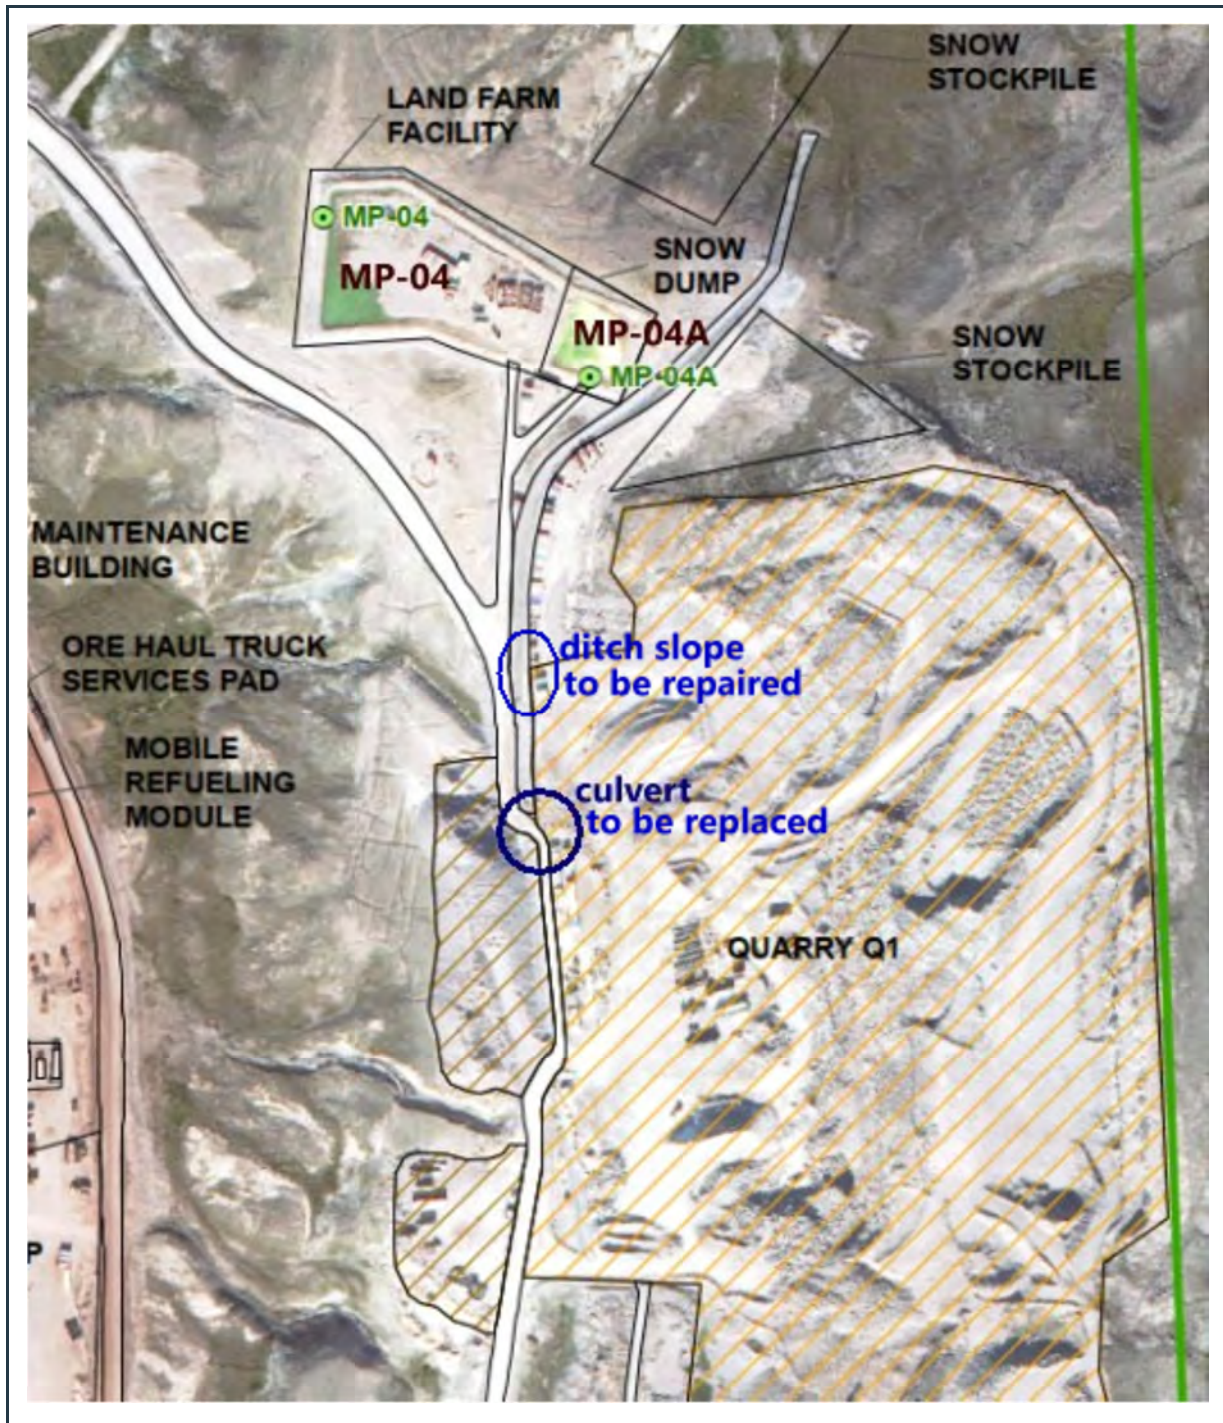
Figure 11: Site layout – Milne Inlet Port – South-Eastern Zone – Quarry Q1 - © 2023 Digital Globe, Inc.

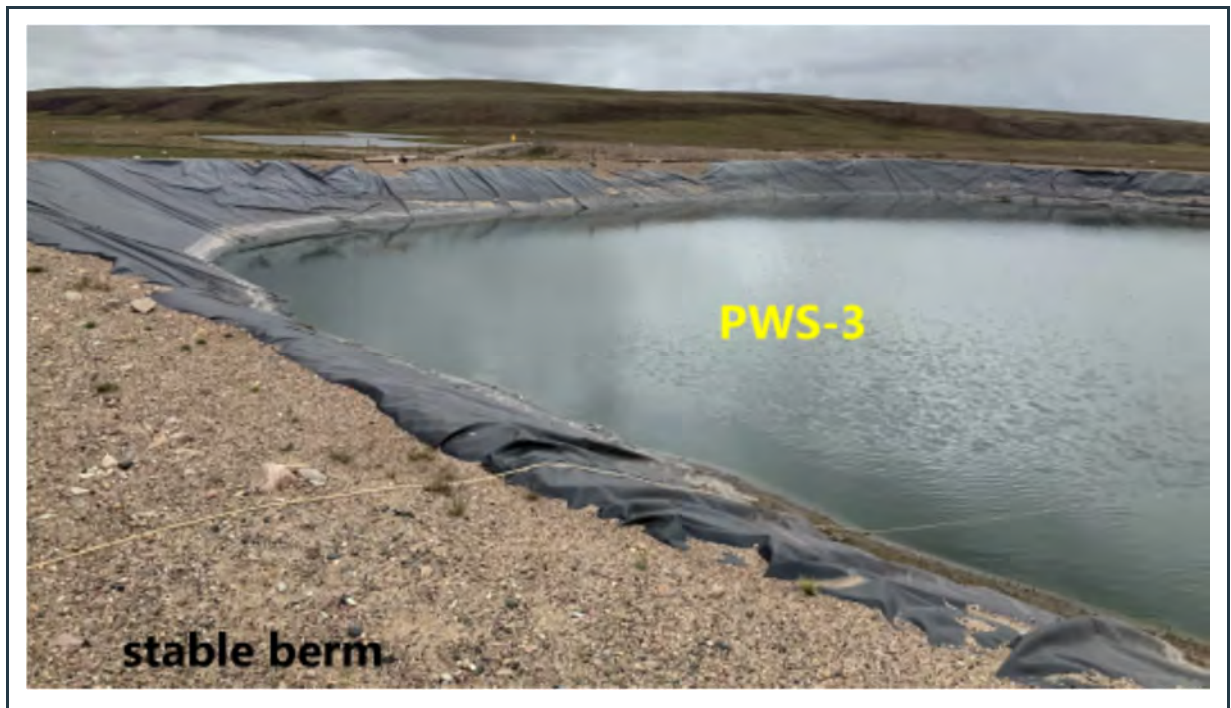
Figure 15: Robust, stable perimeter berms and intact liner at the PWS-3 pond.

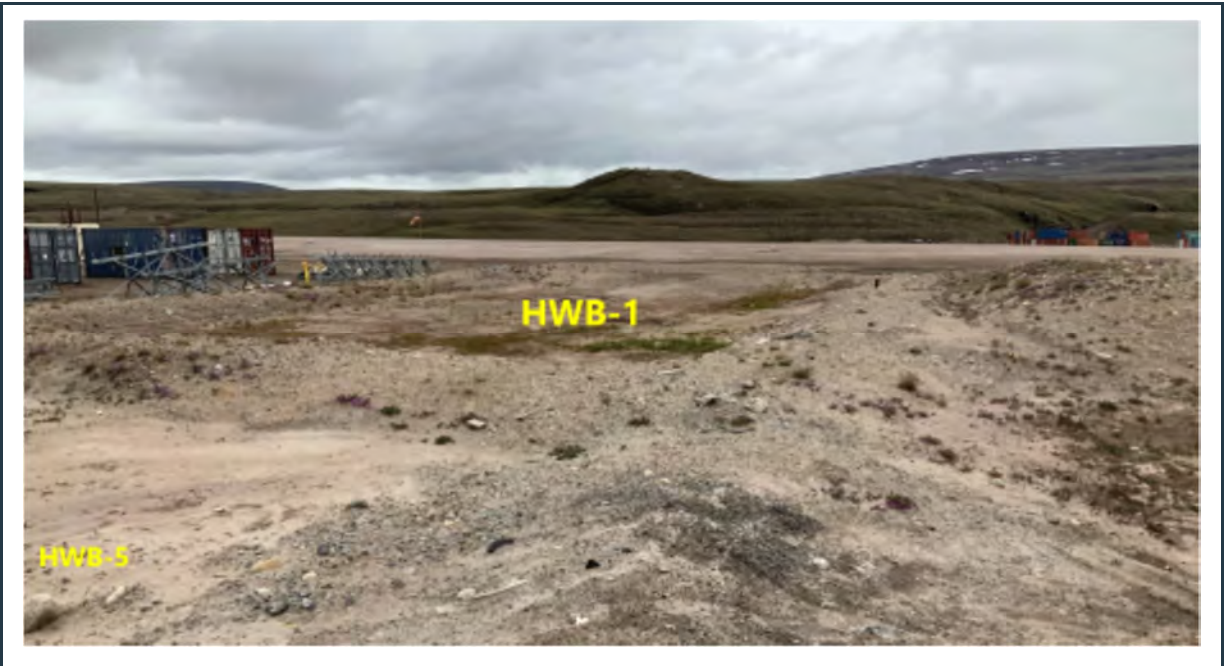
Figure 16: View of the berms around the empty HWB-1 cell, which has not been in use for years.

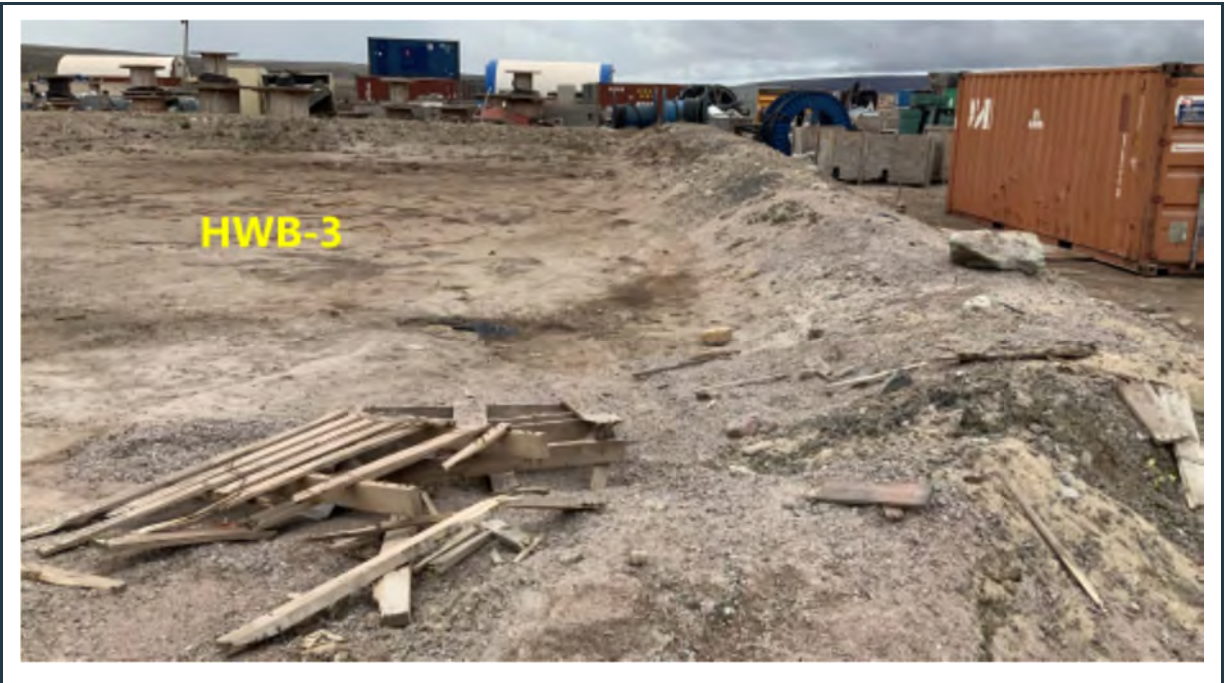
Figure 18: View of stable berms around HWB-3. The broken wooden pallets and other debris should be removed from the cell and from the berms.

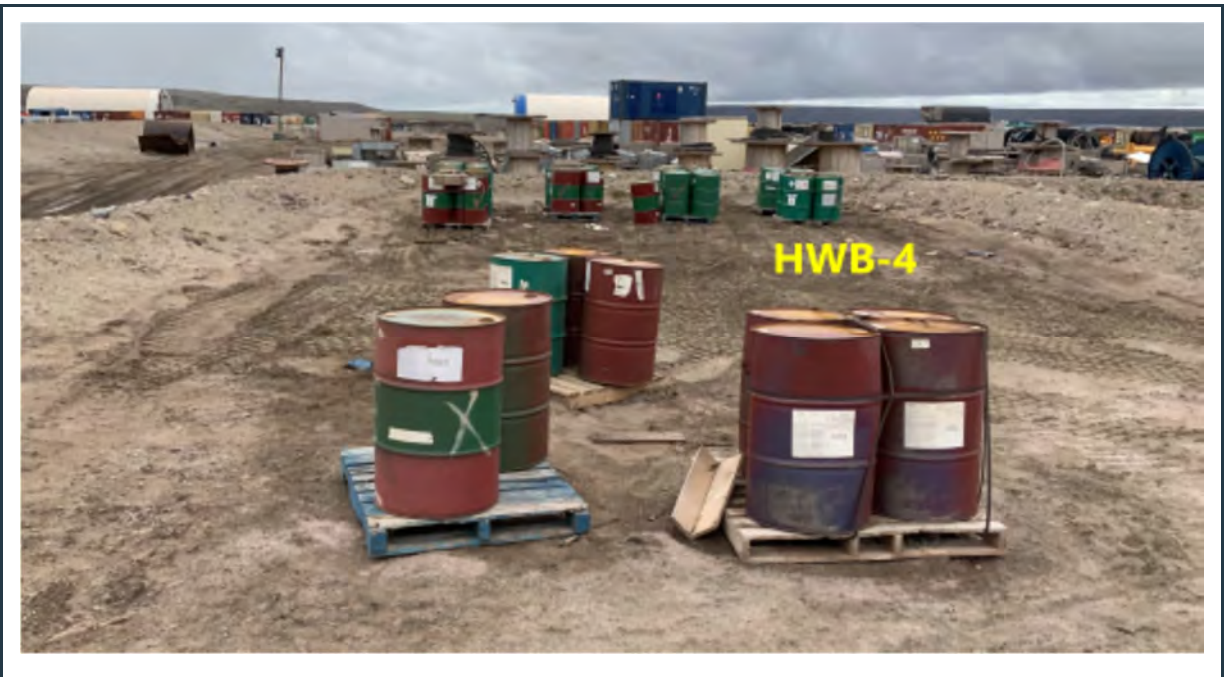
Figure 19: View of the stable berms around the HWB-4 cell, with a few fuel barrels stored on wooden pallets in the cell. The debris, visible in the cell should be removed.

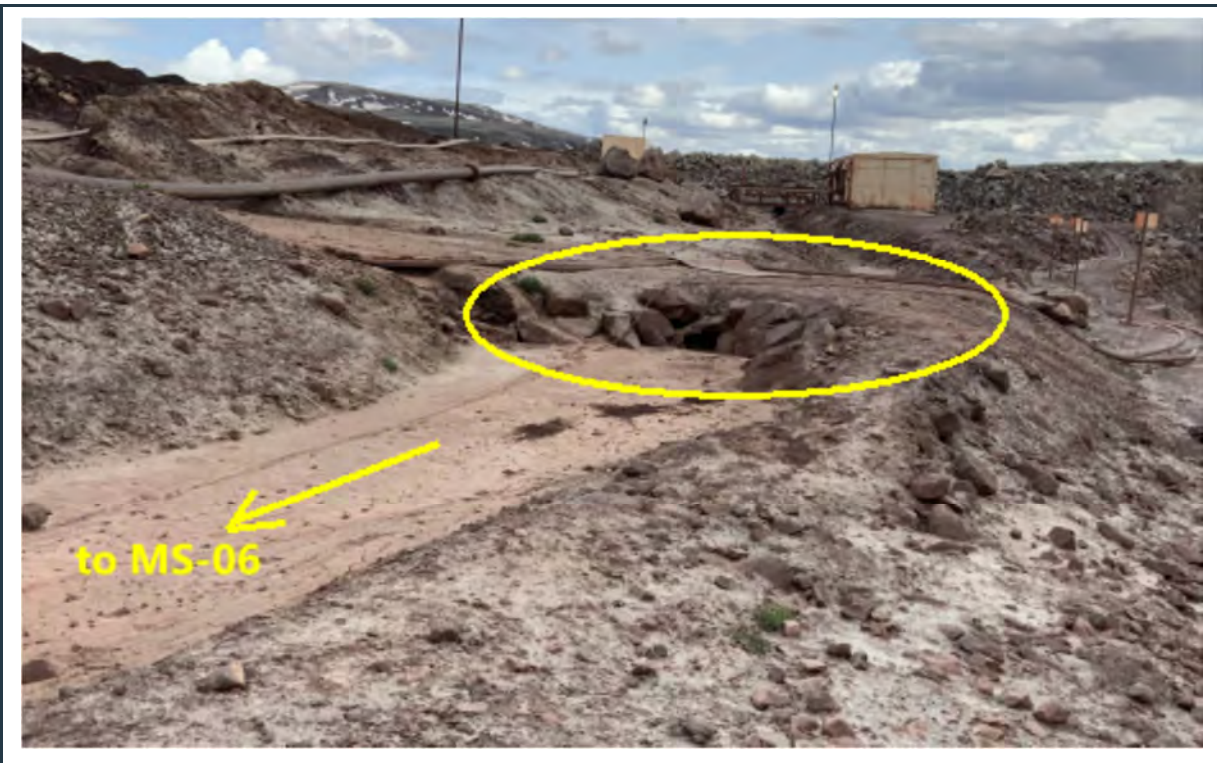
Figure 27: View of one of the side-ditches and a culvert leading to the MS-06 pond. As shown by the yellow circle, the culvert is damaged and clogged and should be replaced. Alternatively, the culvert could be removed permanently and the ditch opened for easy flow. See culvert B in Figure 2 for location.

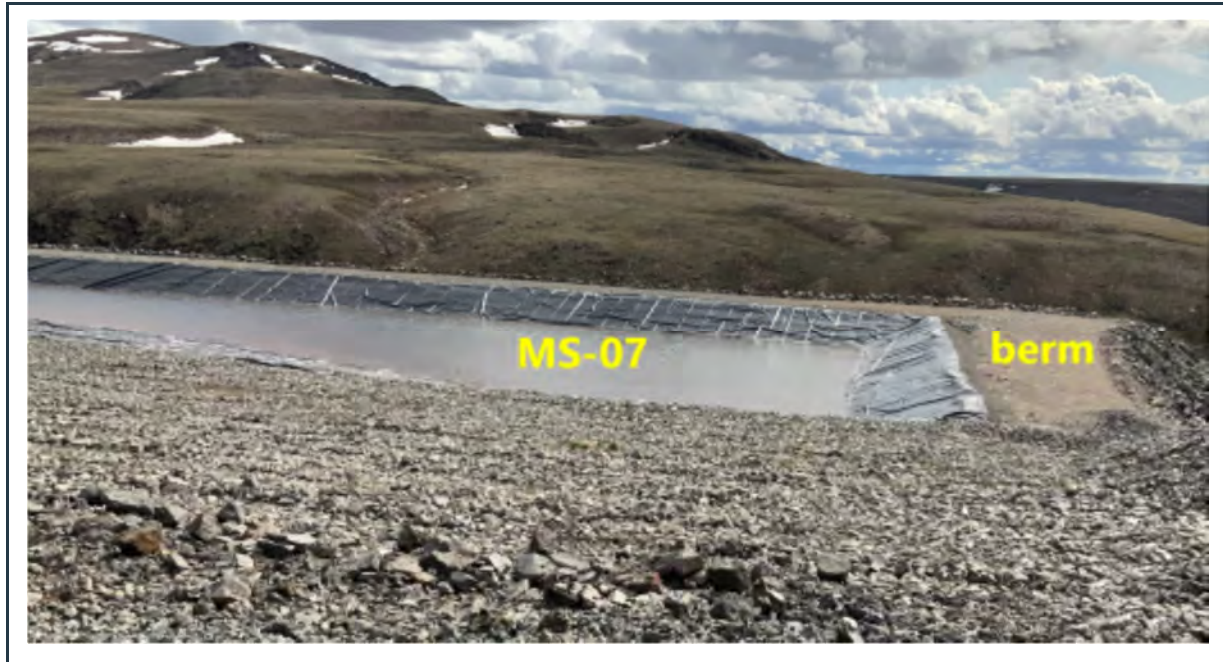
Figure 28: View of the robust, stable perimeter berm and intact liner at the MS-07 surface-water management pond at KM106.

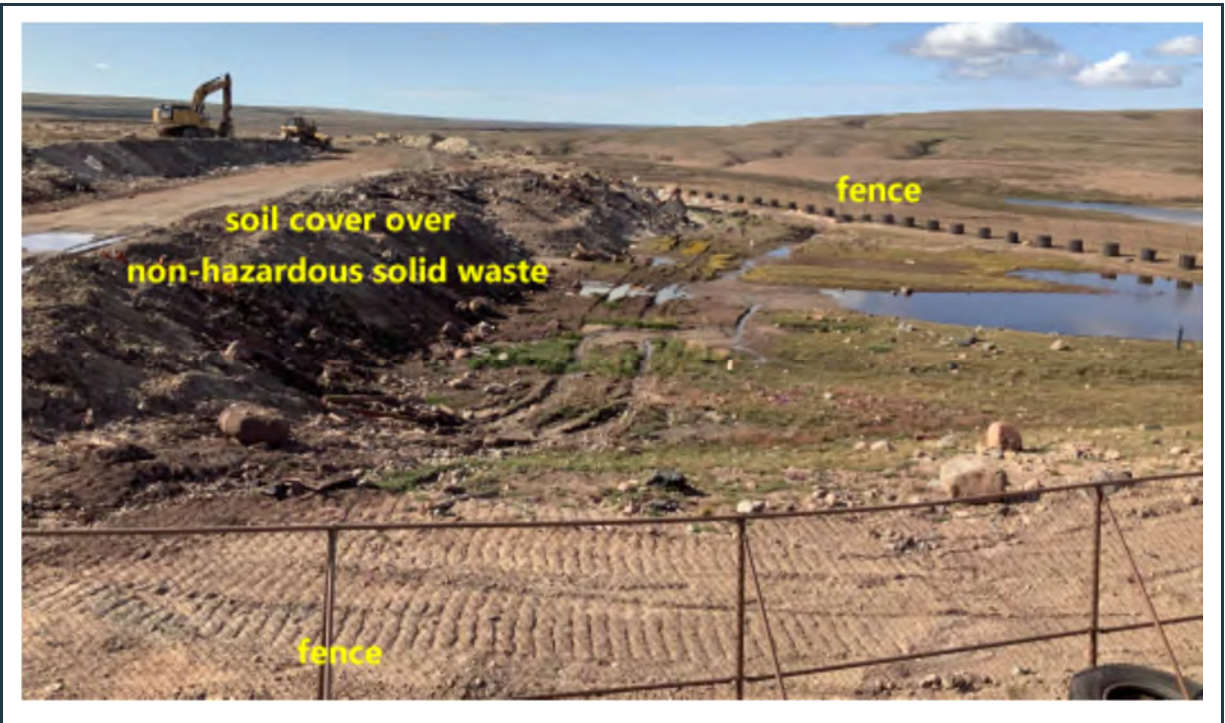
Figure 42: View of soil cover over non-hazardous solid waste in the fenced-in, gated landfill facility.

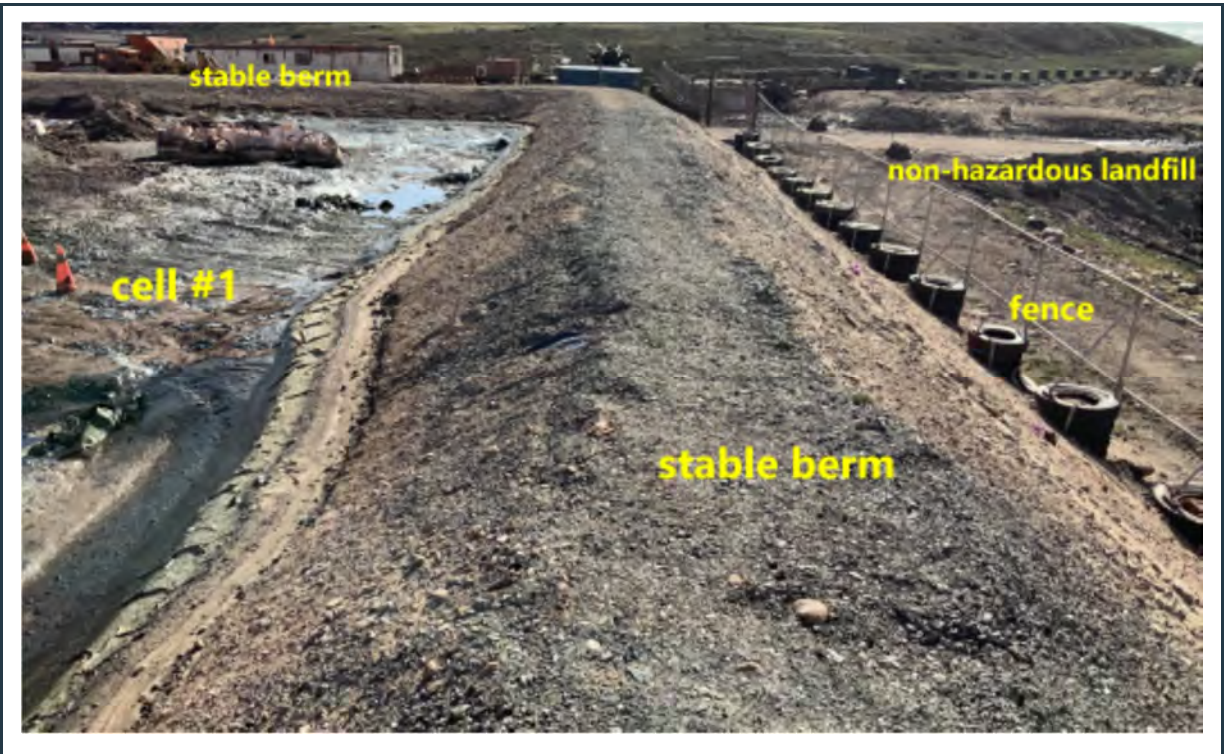
Figure 43: View of a section of the stable berm at the lined landfarm's cell #1.

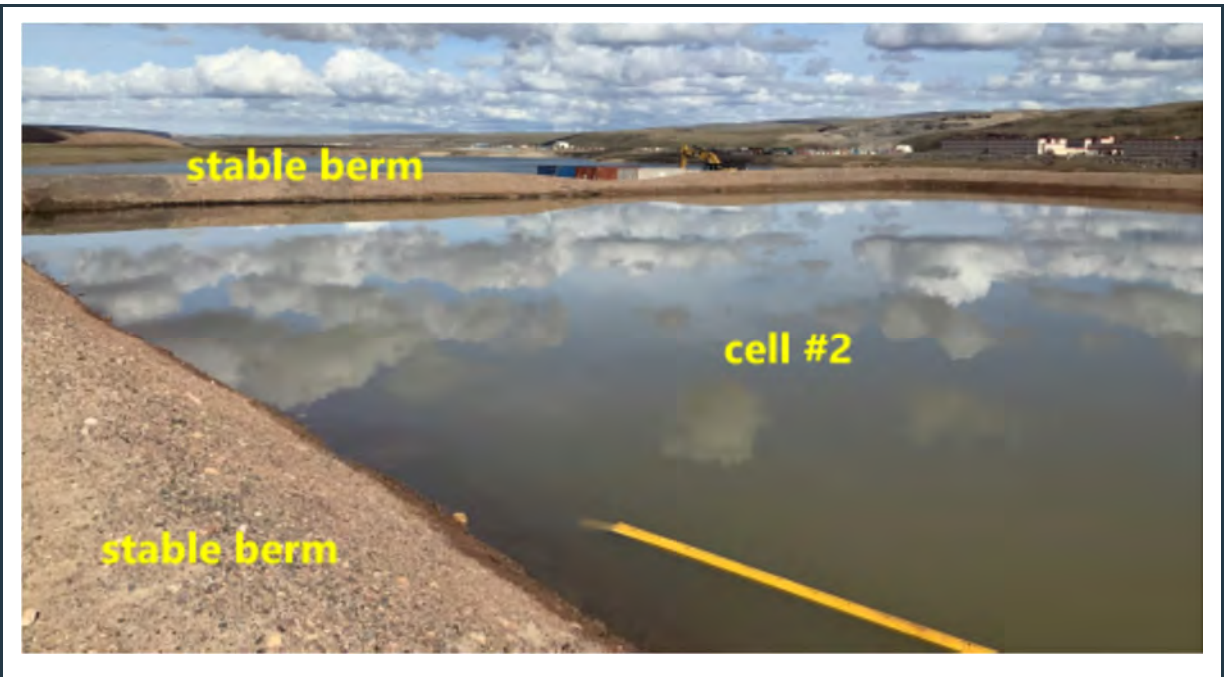
Figure 44: View of the stable berm around the currently empty, flooded cell #2 of the landfarm. The ponding water indicates good liner performance.

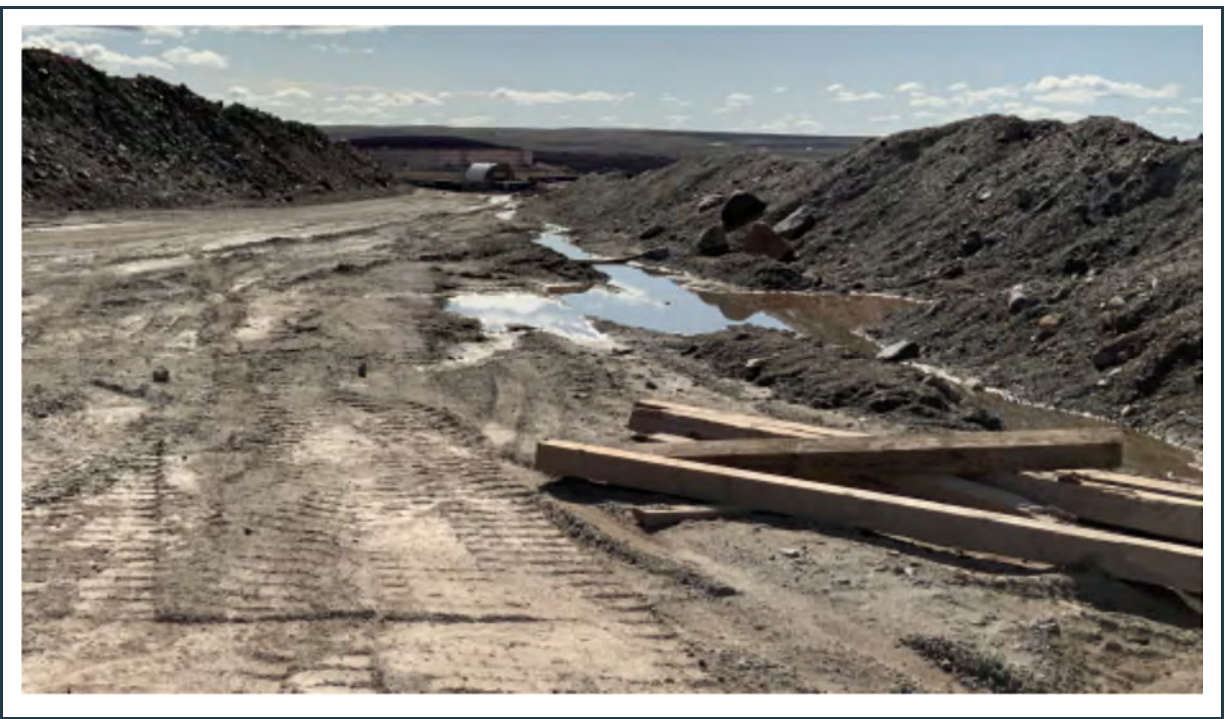
Figure 45: Drainage problems still exist at the first quarry level. Surface drainage shall be rectified.

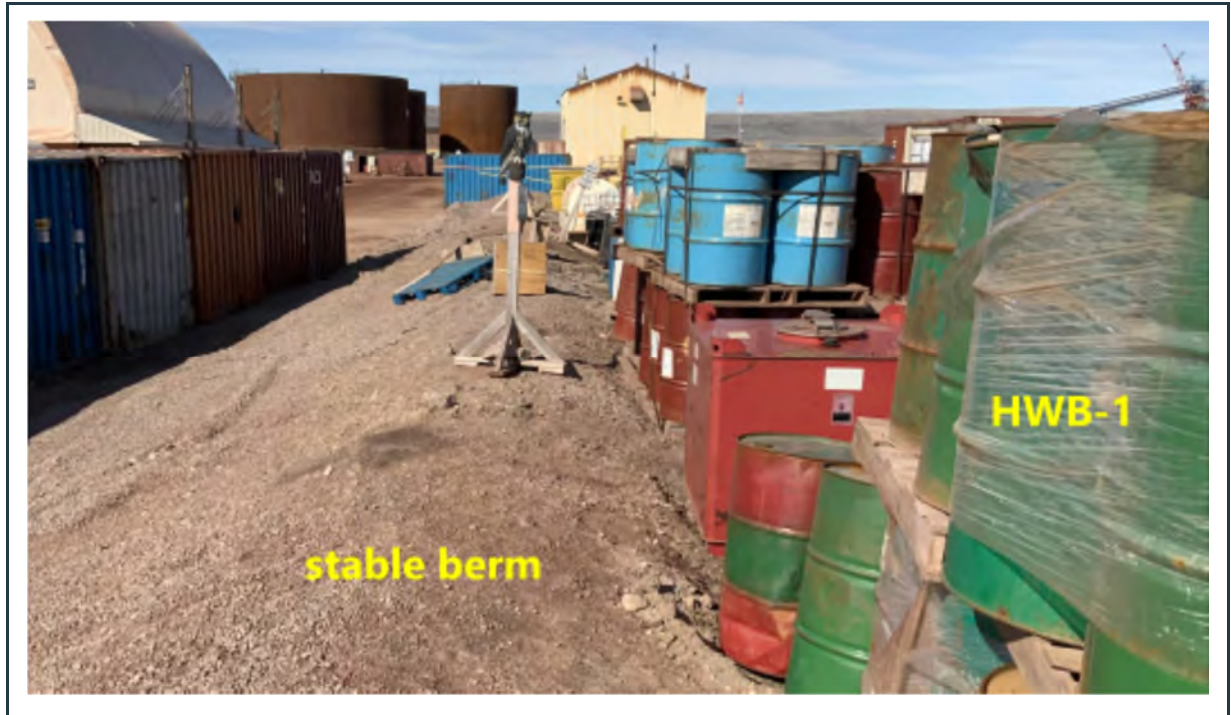
Figure 48: View of the stable perimeter berm around the lined HWB-1 cell with various materials and seven shipping containers stored within the cell. Materials on pallets should be stored within the cell, not on the berms.

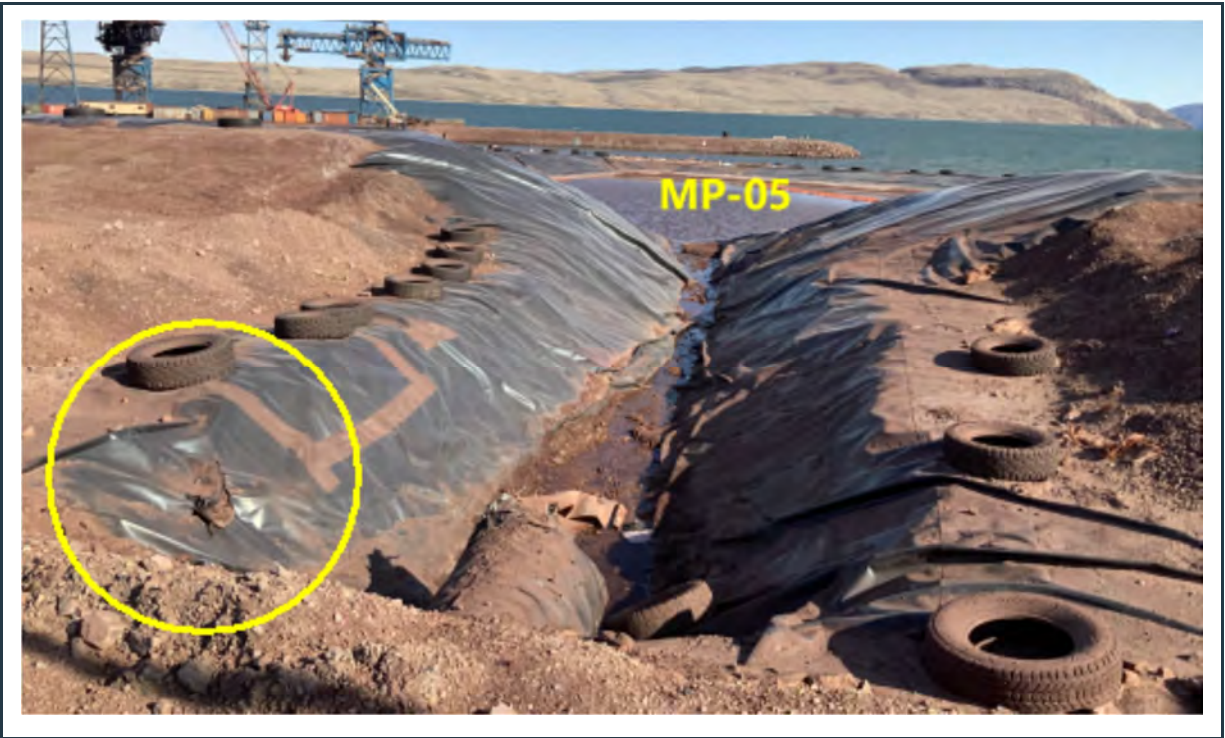
Figure 58: View of the slightly damaged liner (yellow circle) at the intake channel to the MP-05 pond.

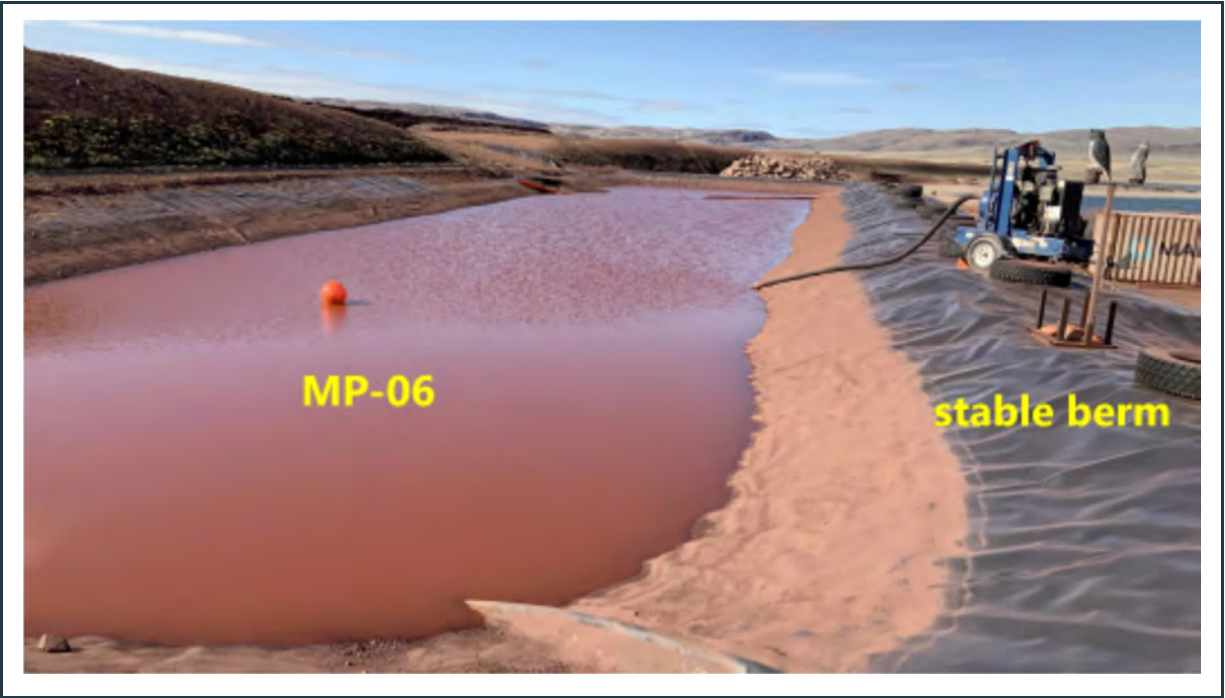
Figure 59: View of the lined MP-06 pond with robust, stable berm.

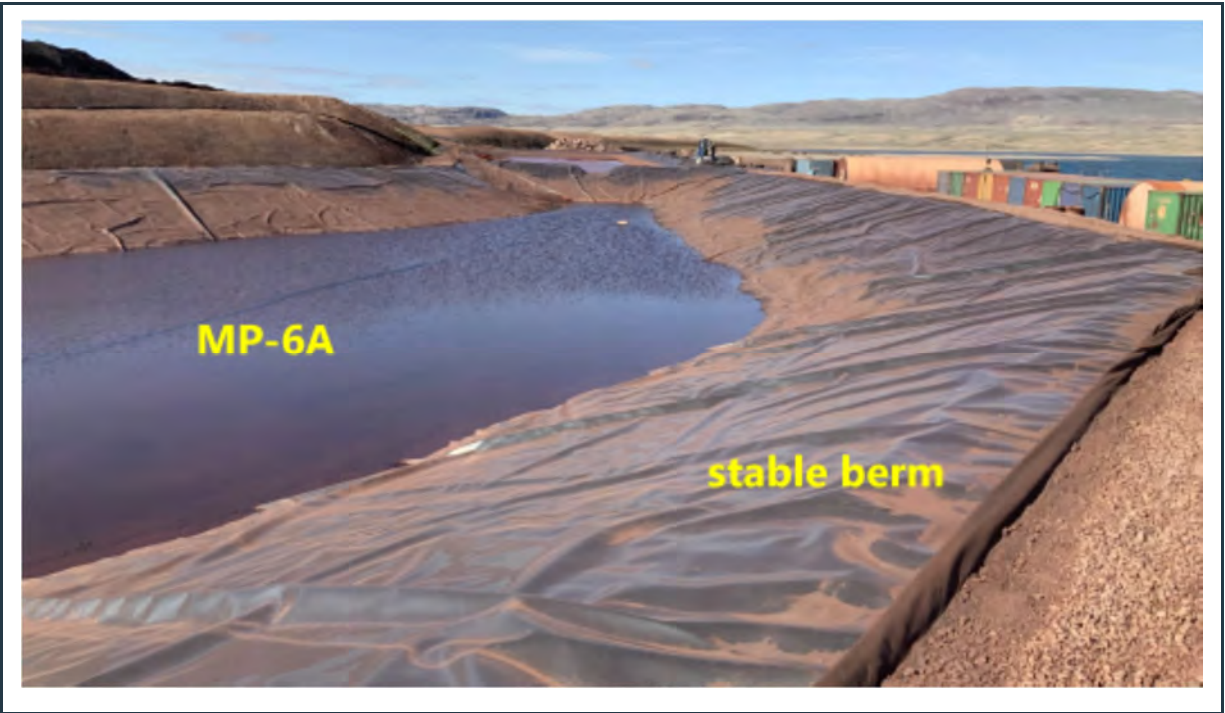
Figure 60: View of the lined MP-06A overflow pond with robust stable berms.

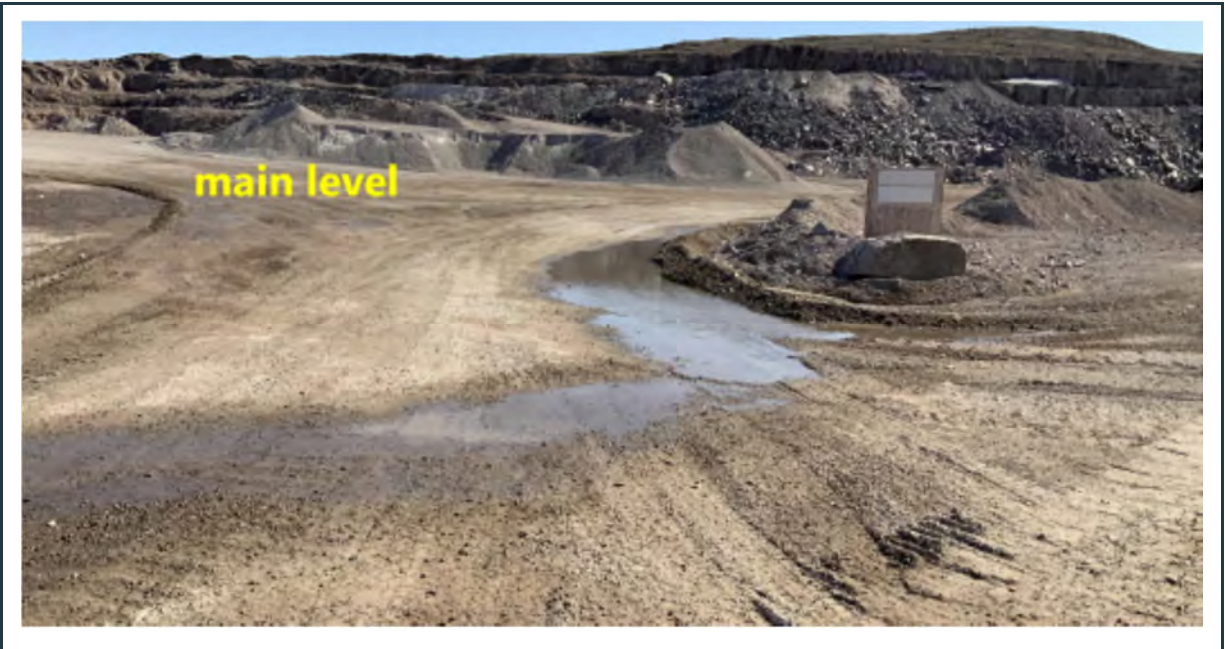
Figure 61: View of ponding and flowing water in many areas of the lower (main) level of the Q01 rock quarry. The drainage problem should be rectified prior to restarting the operation in the quarry.

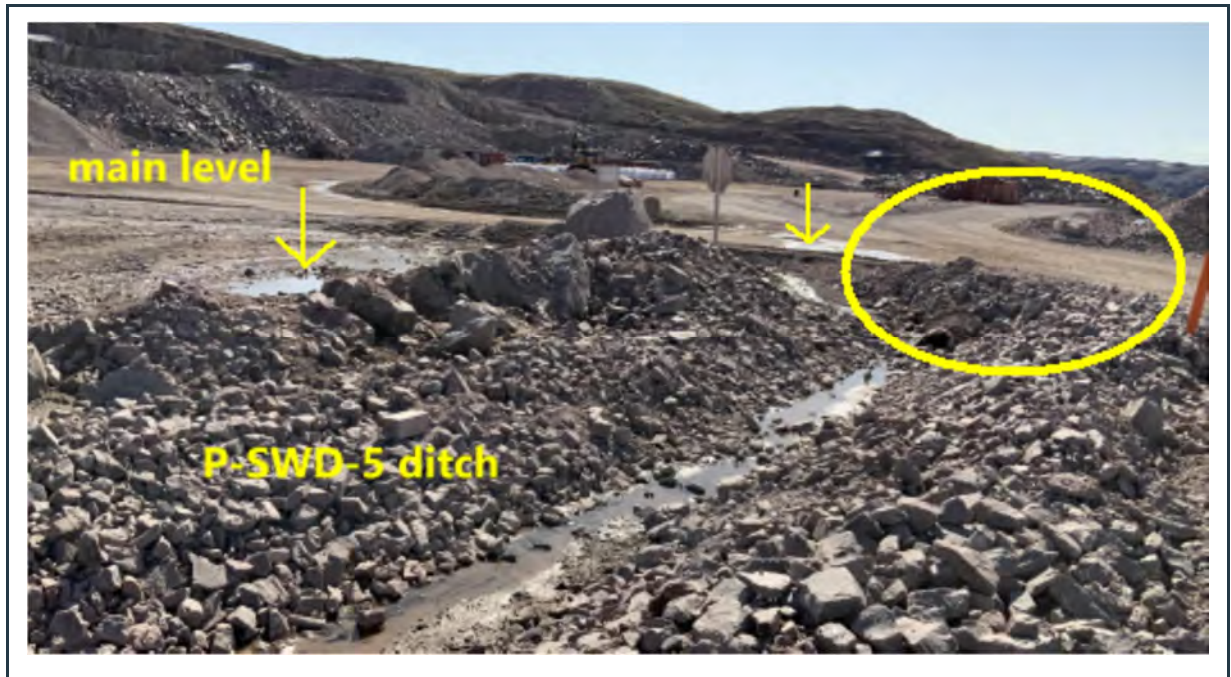
Figure 62: Poor surface water control in many areas of the lower (main) level of the Q01 rock quarry. The culvert at the entrance to the quarry (yellow circle) must be replaced.

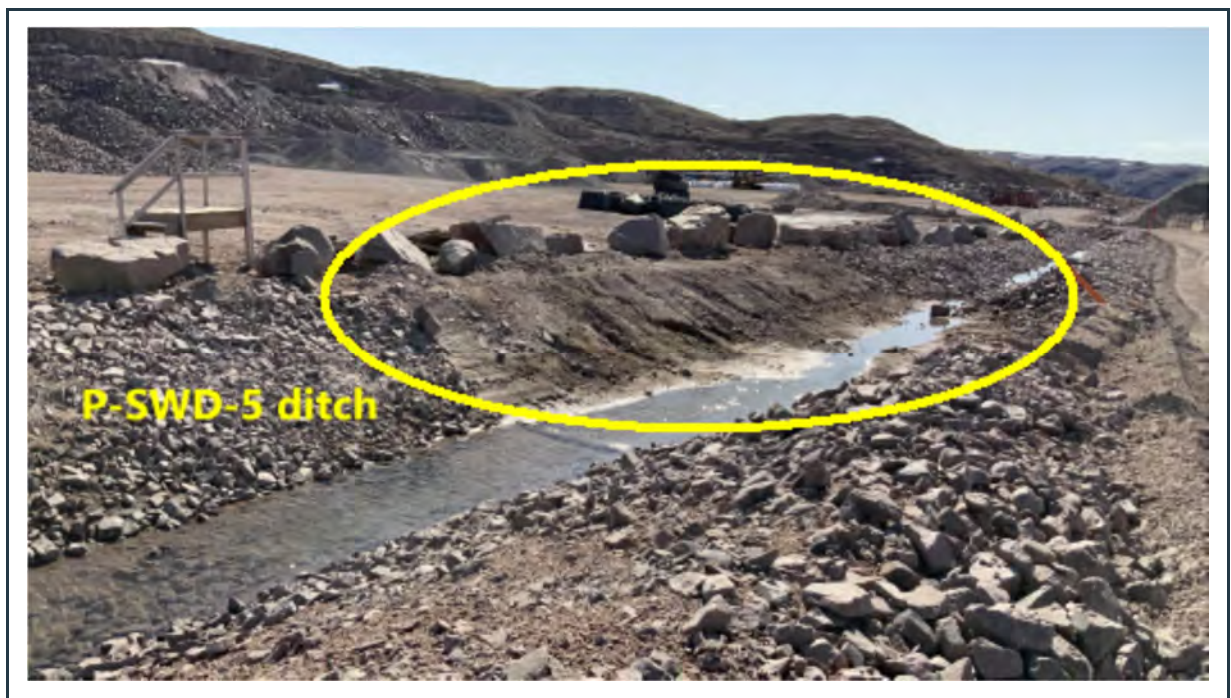
Figure 63: P-SWD-5 – “Q01-North” surface water collection ditch with missing riprap at one section of the ditch. Note the continuous seepage from the granular fill pad of the quarry’s lower (main) level.
