Water Licence Inspection Report

Authorization	Representative
Baffinland Iron Mines	William Bowden/Scott Klingmann
Authorization No. / Expiry	Representative's Title
2AM-MRY1325 June 10, 2025	Sr. Environnemental Superintendent/Mine Manager
Inspection Date: January 8, 2025	Inspector: Omer Pasalic
Activities Inspected	
<input type="checkbox"/> Camp, Commercial <input type="checkbox"/> Drilling <input type="checkbox"/> Mining <input type="checkbox"/> Construction <input type="checkbox"/> Reclamation <input type="checkbox"/> Fuel Storage <input type="checkbox"/> Roads/Hauling <input type="checkbox"/> Winter Hauling <input type="checkbox"/> Camp, Private <input checked="" type="checkbox"/> Other Waste Rock Facility/Follow up on the items of concern identified during October 23, 2024 inspection

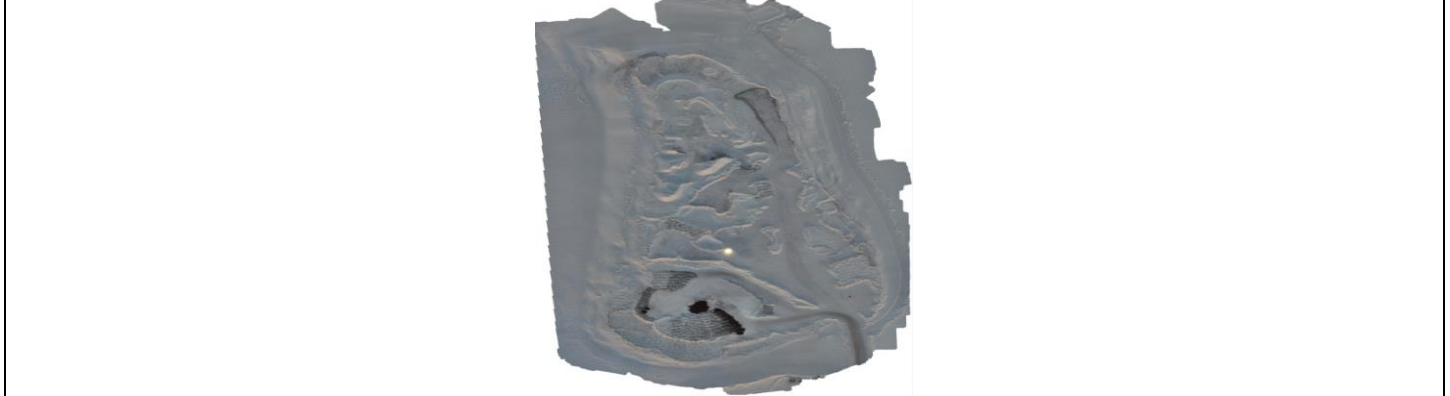
Photo No. 1	Lat/Long (DD.MM.SS.SS, NAD83)
Waste Rock Facility	MRY-WRF

Description:
Aerial photograph of the Waste Rock Facility

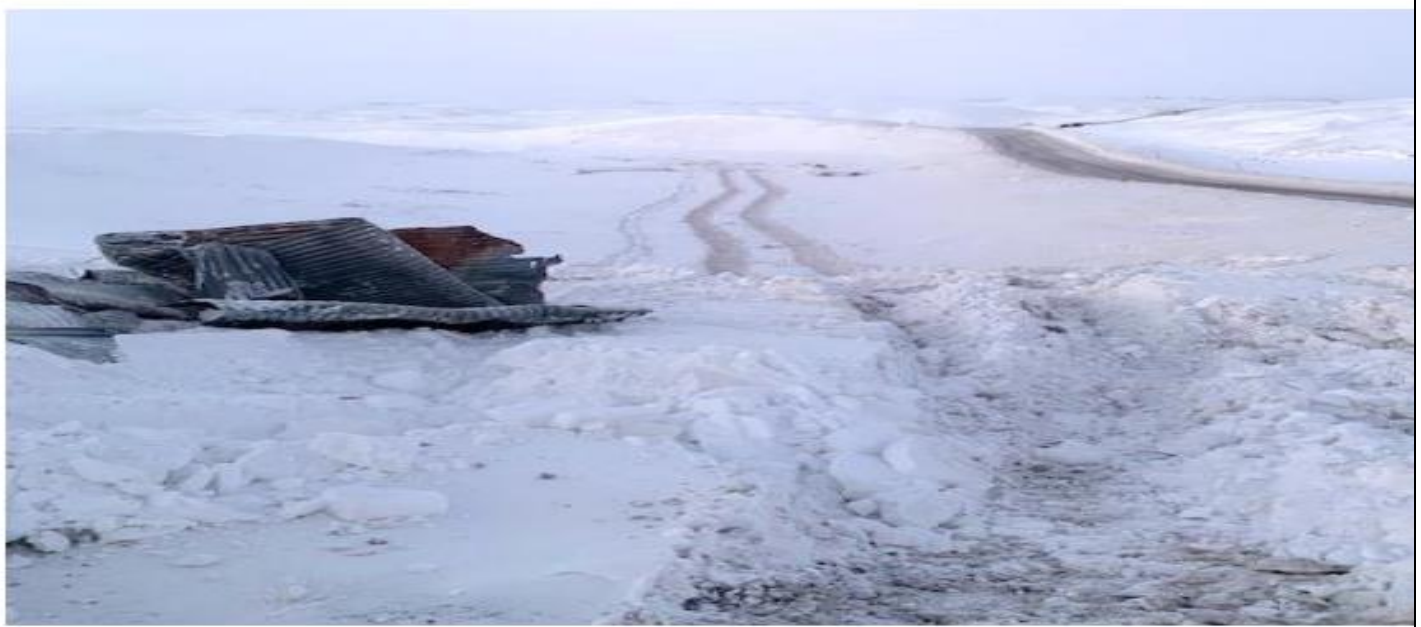
Photo No. 4

Photo 4. KM 63.5, Culverts retrieved from watercourse, staged next to Tote Road for pick final disposal, 2024-11-28

Culverts staging area before removal

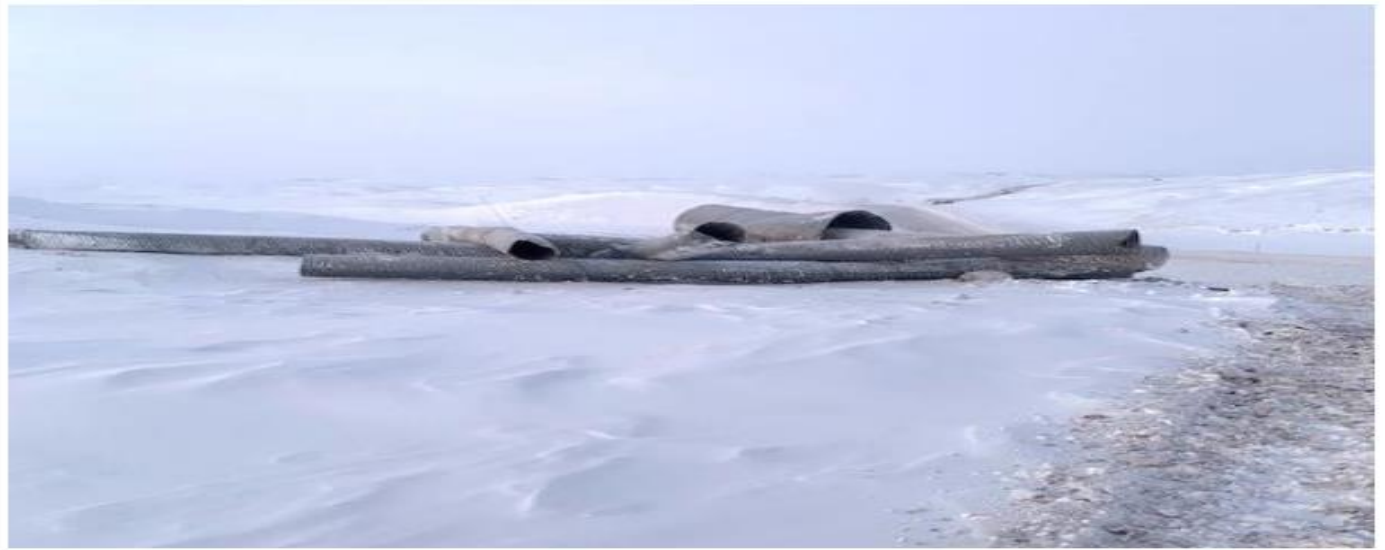
Photo No. 5

Photo 5. KM 63.5, Culverts retrieved from watercourse, staged next to Tote Road for pick-up and final disposal, 2024-11-28

Culverts staging area before removal

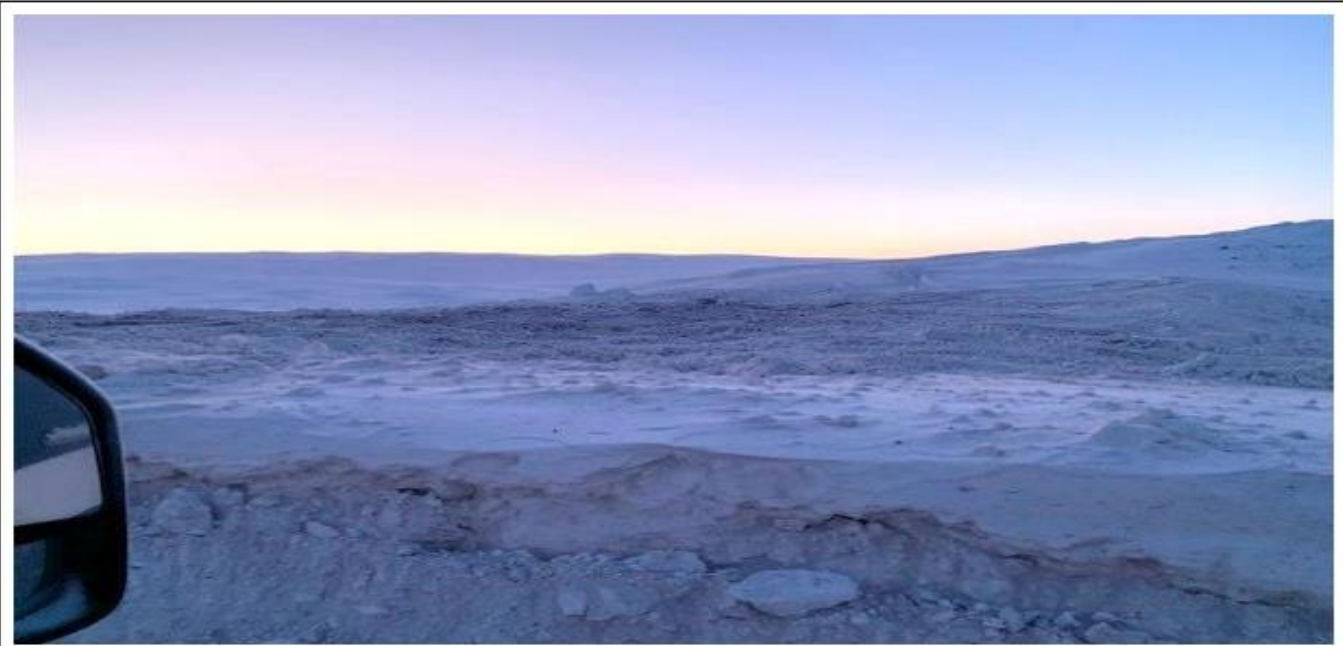
Photo No. 6

Photo 7. KM 63.5, Culvert staging area empty, after transporting culvert debris for disposal, 2024-11-29

Culverts removed. Staging area clear.

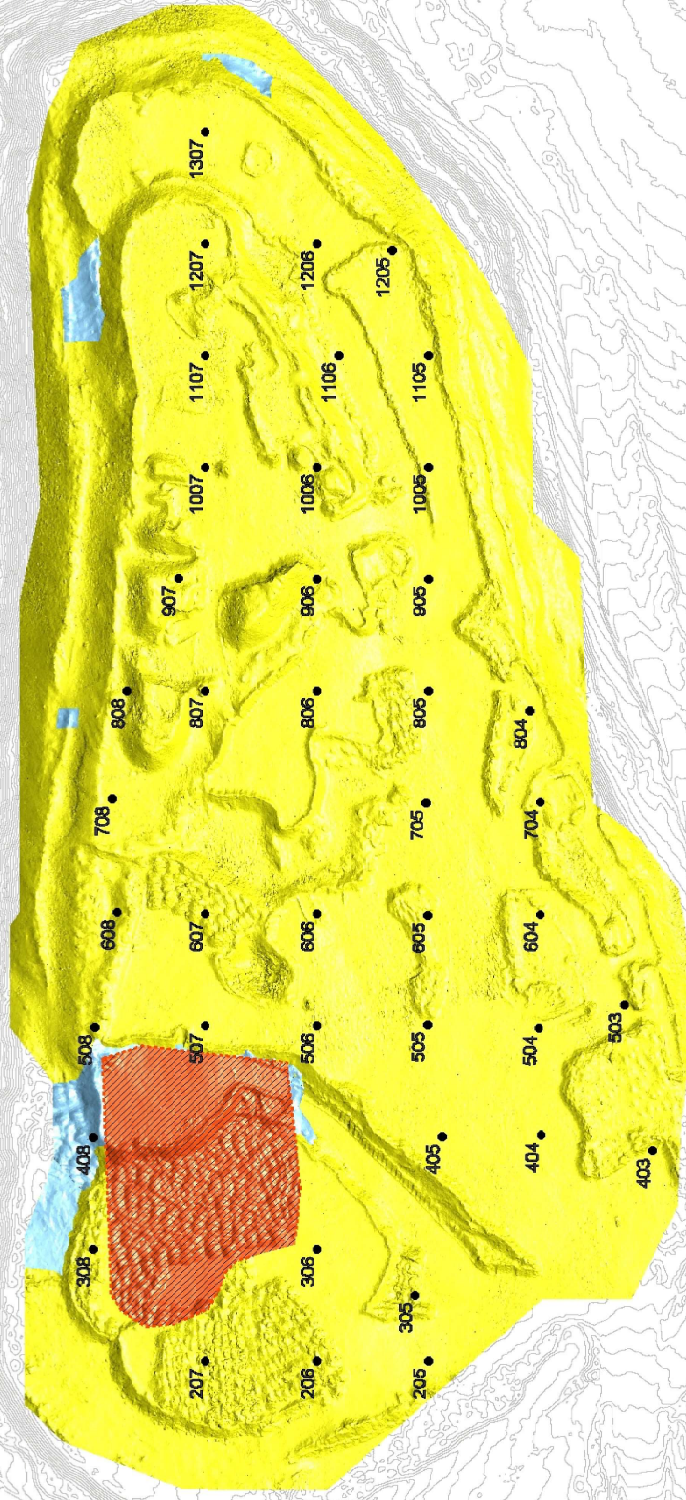
WRF 4m COVER - PROGRESS REPORT

2024 WRF Cover Progress

Q1	Q2	Q3	Q4
Final 4m Cover m2	388,233			
Actual 4m Cover m2	59,584	141,647	194,509	357,321
Actual % Covered	15%	36%	50%	92%
Quarterly Cover % Target	15%	34%	50%	85%

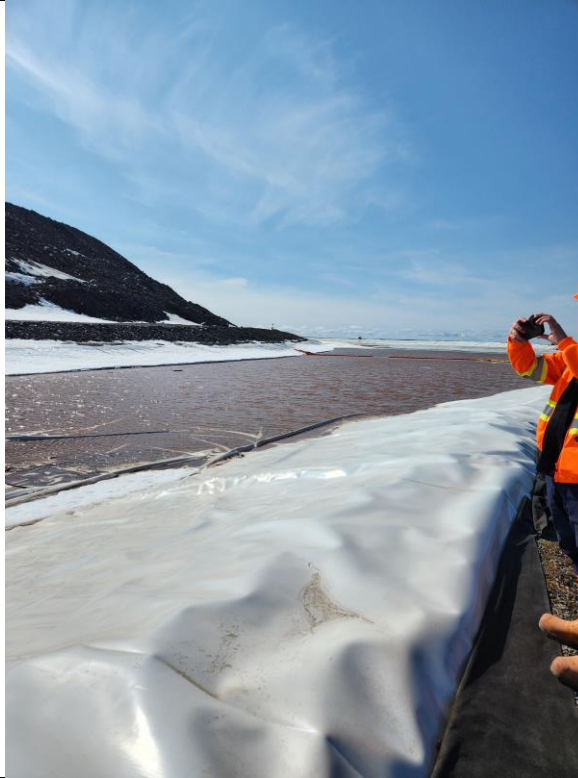
View of Waste Rock Facility's Surface Water Management Pond. Once the surface water reaches here it is treated prior to being discharged.

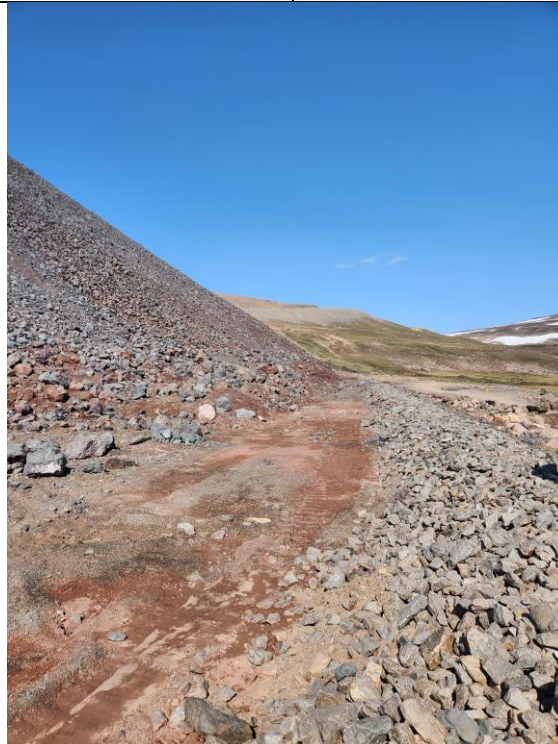
A breach in the drainage system during freshet had caused untreated water to escape the facility. The spill has then been managed and spill file has been closed.

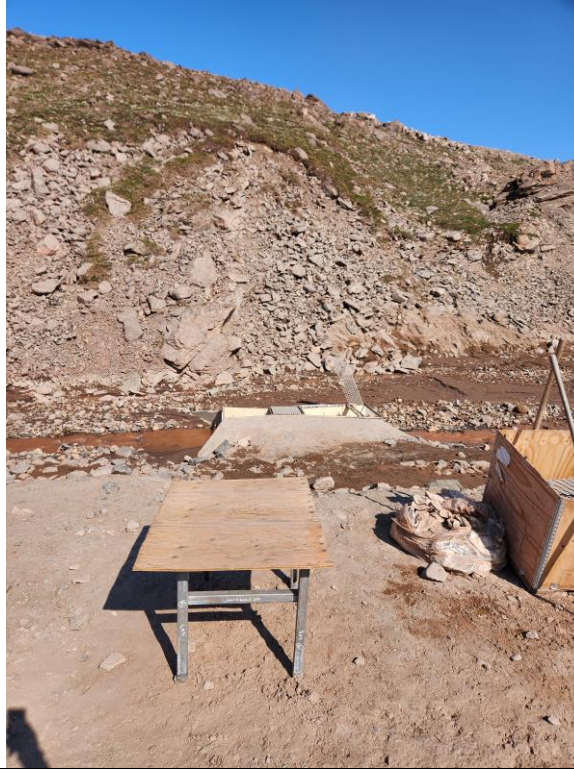
Check dams have been put in place in order to further treat/settle the sediments before reaching the dam.

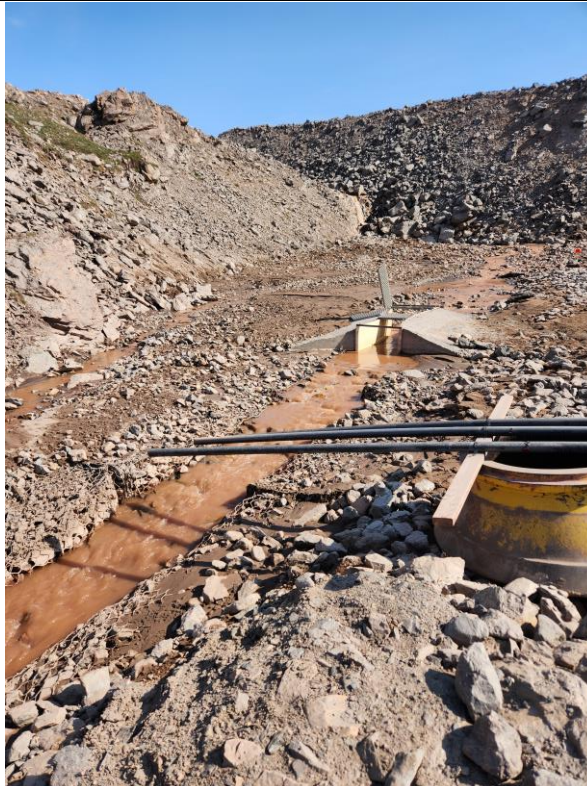
A solution is being deposited into the drainage system to help with the dispersion of sediment into the stream.

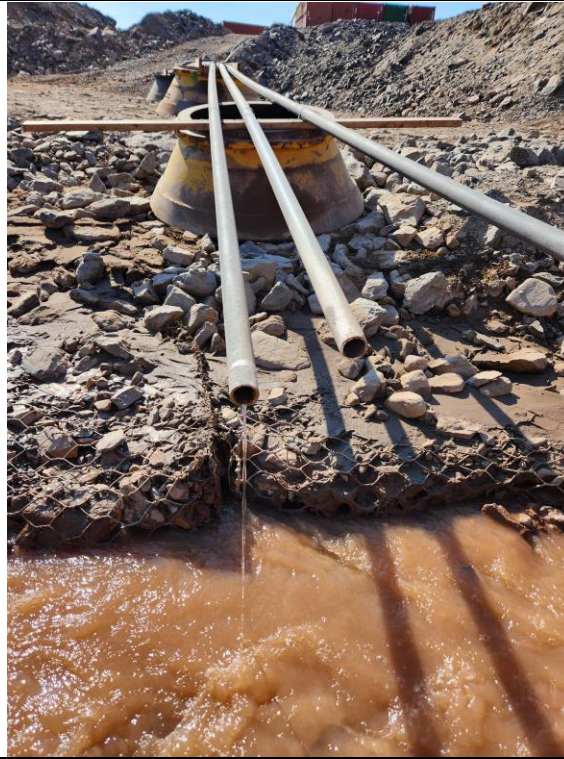
A solution is being deposited into the drainage system to help with the dispersion of sediment into the stream.

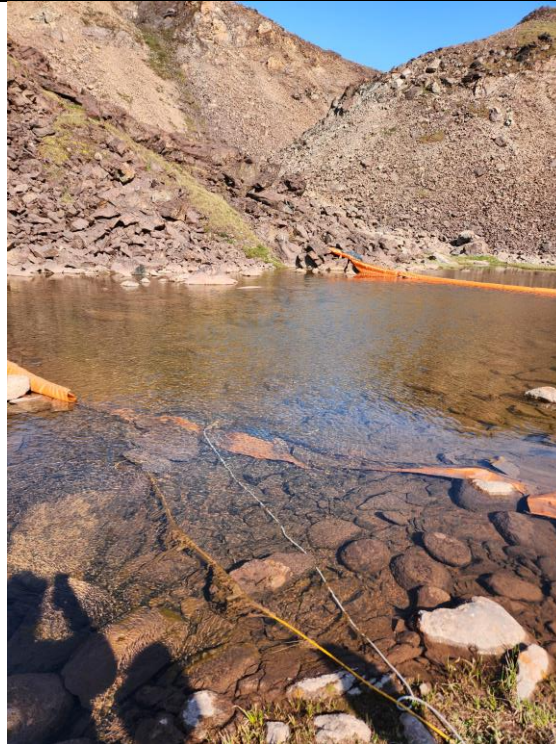
Final water monitoring station of the KM105 facility before it is discharged into the environment. The water was clear and no signs of elevated TSS was observed.

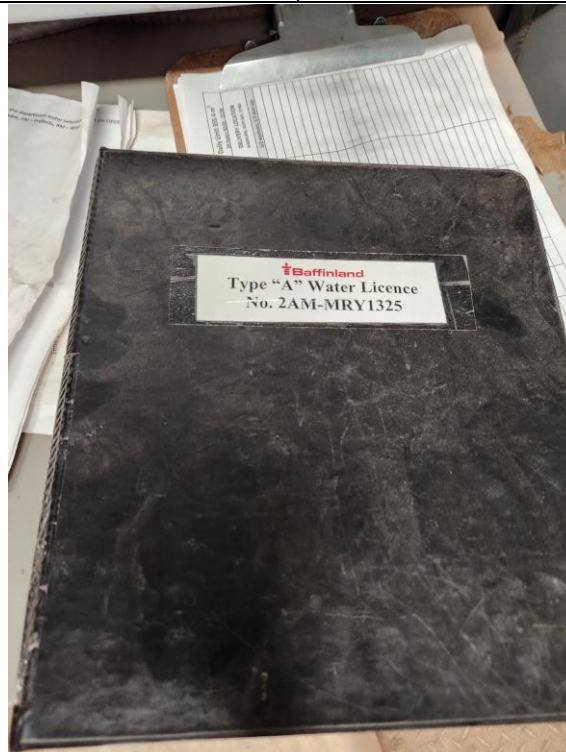
A copy of the Water License was observed within the pump station. This will need to be replaced with the new version of the Water License.

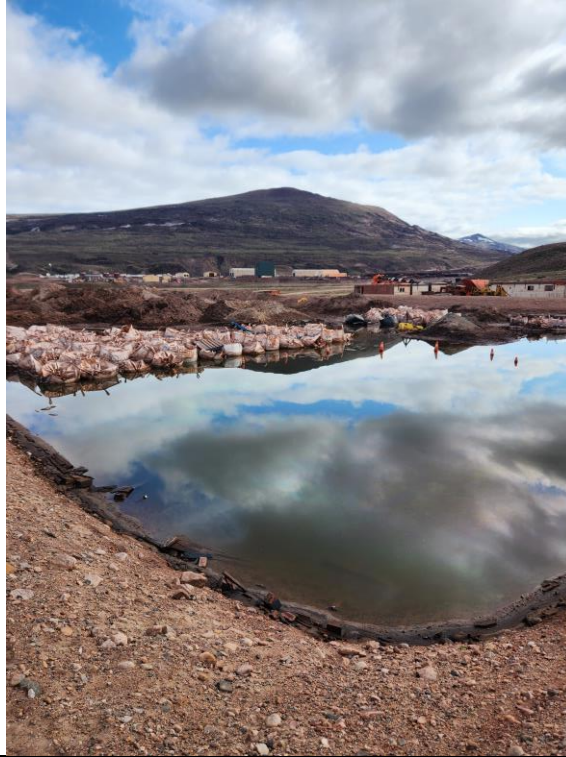
Photo of the Hazardous Waste Disposal Facility. Baffinland team stated work will begin to treat/discharge the water contained within the berm.

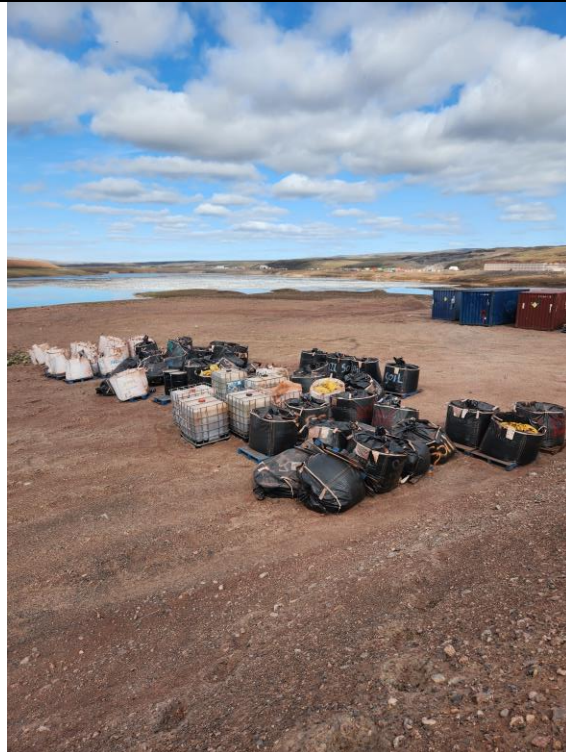
1. Numerous quatrex bags filled with previously contaminated soil were discovered outside a designated lined/berm facility.

Hazardous Waste was observed outside a lined berm. CIRNAC inspectors had instructed the Baffinland team to have these moved to a lined berm.

- 1. Hazardous Waste must be placed into a designated lined facility.
- 2. Drums of hazardous materials must be placed within secondary containment.
- 3. All fuel spills must be reported and remediated to the satisfaction of the Inspector.

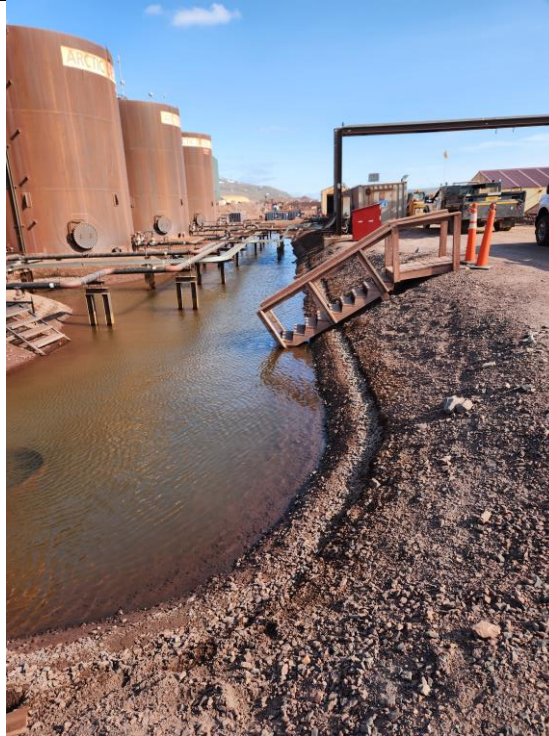
Photo of Mary River tank farm and refuelling station. No sheening was observed within the berm.

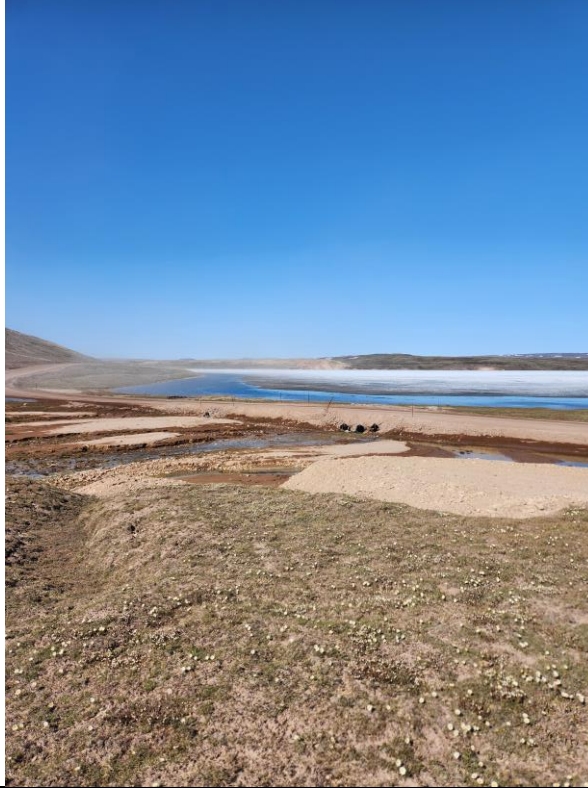
This section of the tote road had a washout during the 2024 severe rain event. Culverts were replaced and the road was repaired.

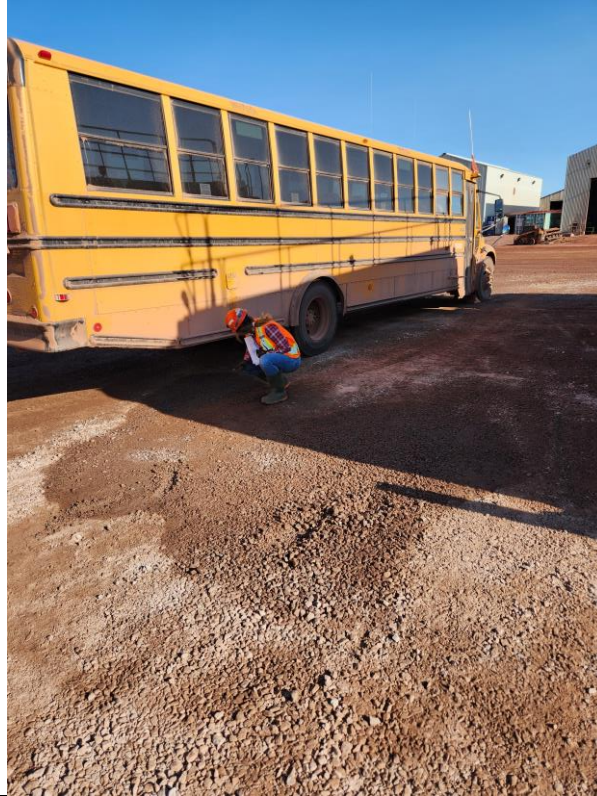
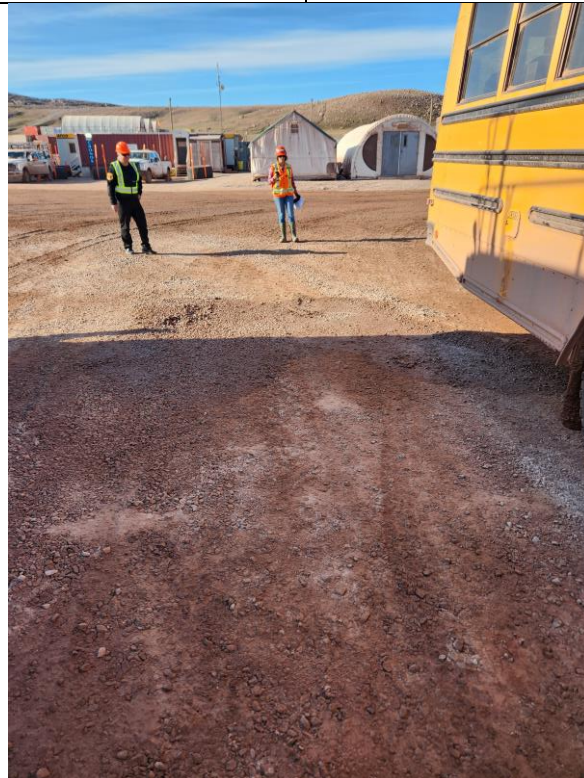
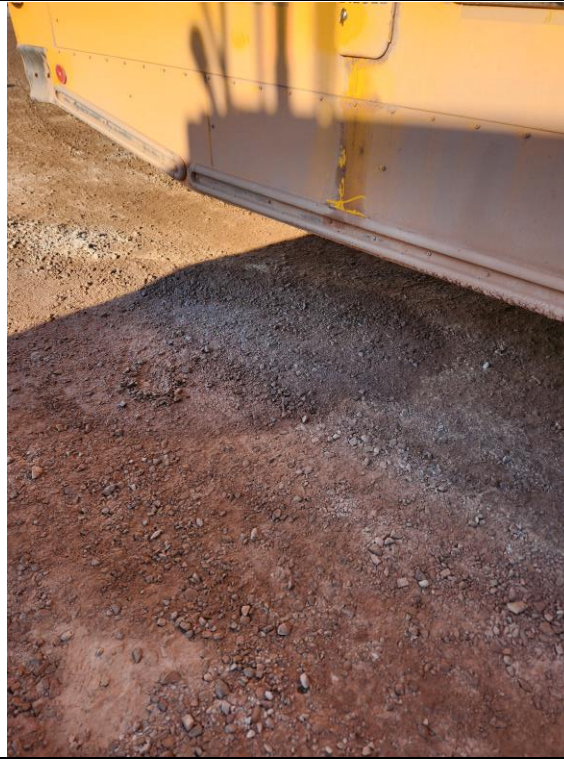
A fuel spill had been observed at the Milne Port Site. The Baffinland team had started the remediation shortly after the inspection.

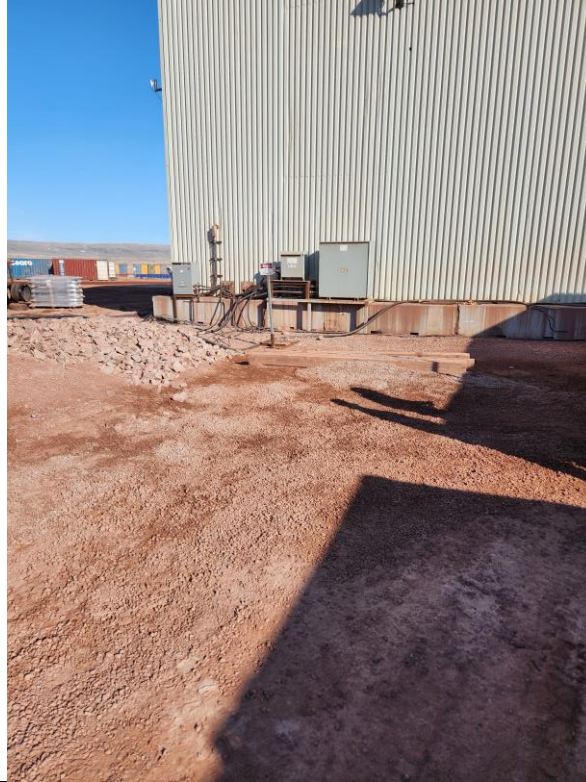
During the inspection, a follow-up had occurred on one of the sewage spills that occurred during the winter. Remediation had been conducted.

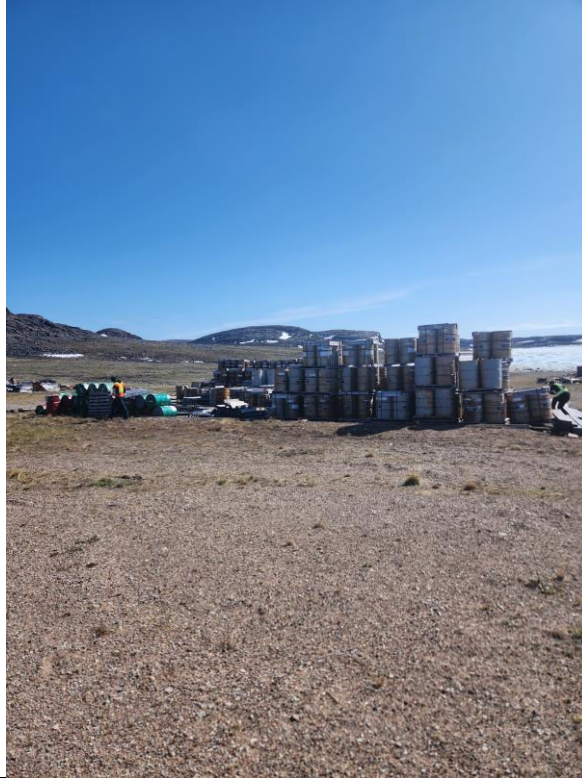
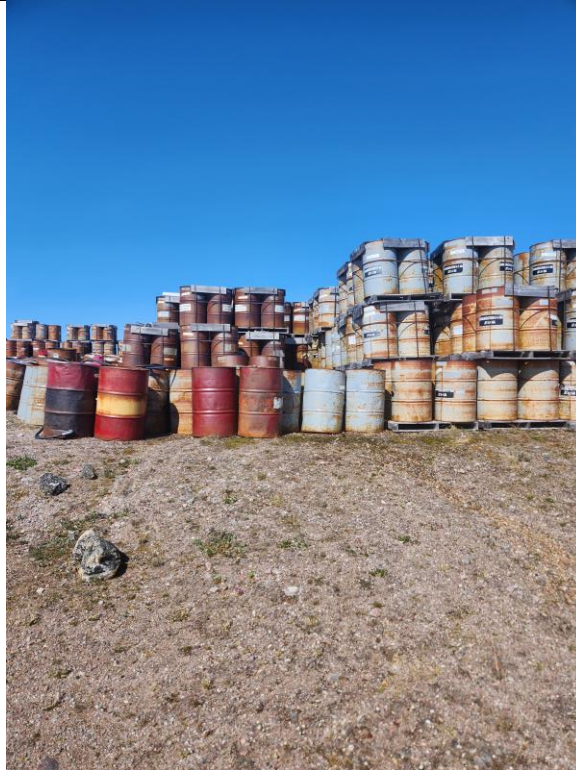
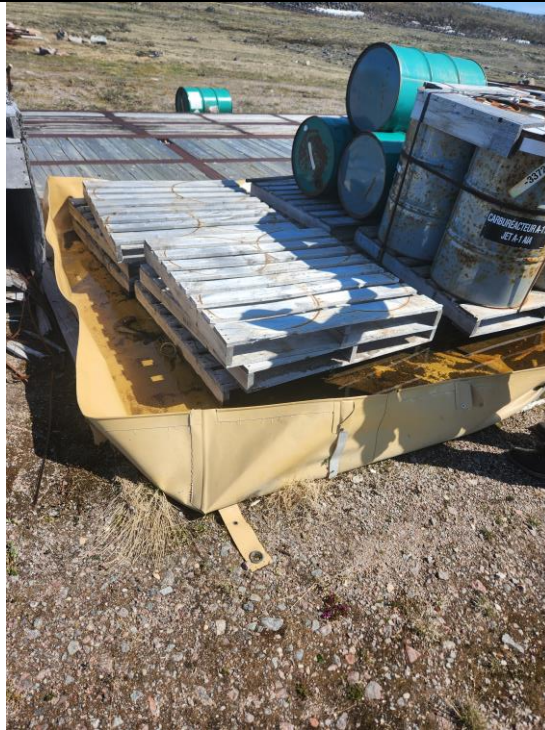
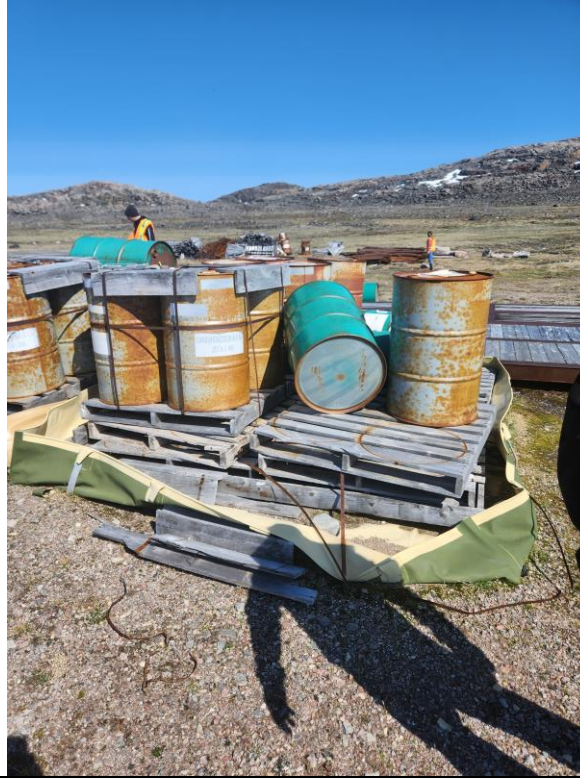
Numerous fuel drums were observed at the Steensby Inlet site. Baffinland stated that work will start to remove old equipment and structures.

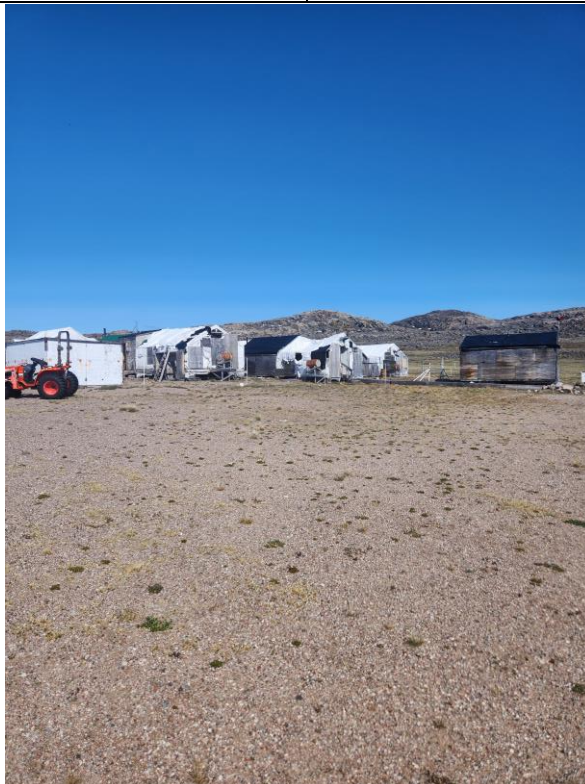
Old tents and cabins were observed at the Steensby Inlet site. Baffinland stated that work will start to remove old equipment and structures.

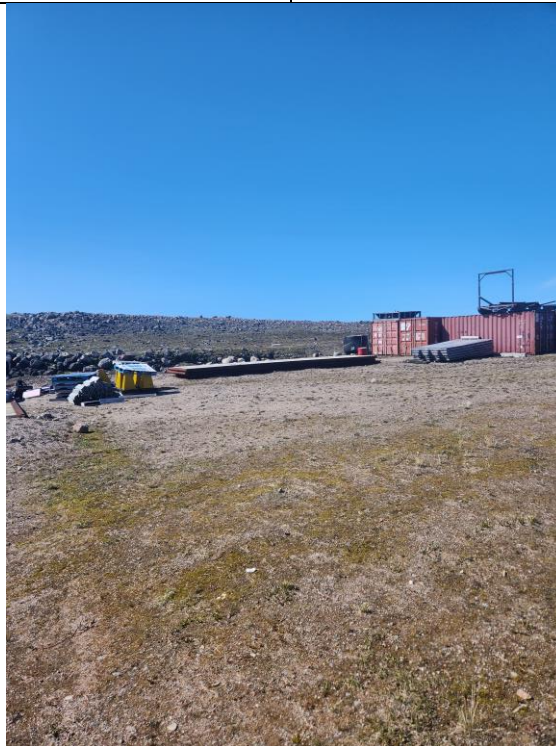
Sea-cans and miscellaneous equipment were observed at the Steensby Inlet site. Baffinland stated that work will start to remove old equipment and structures.

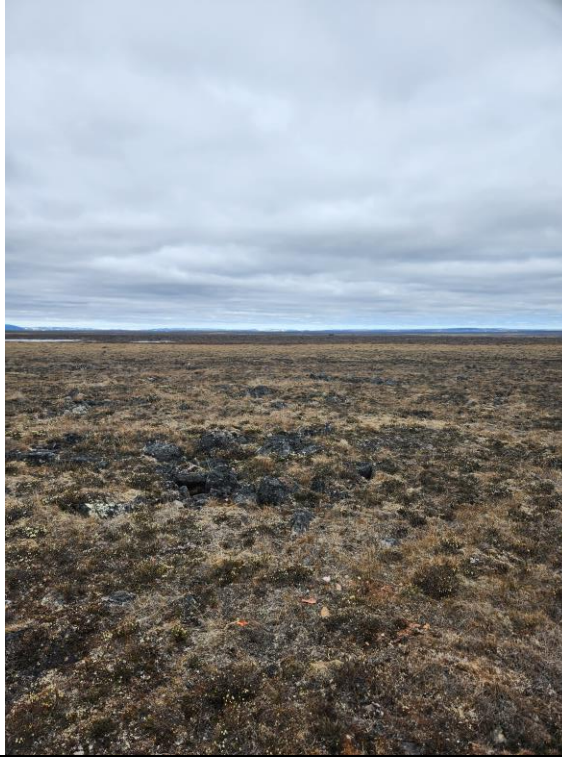
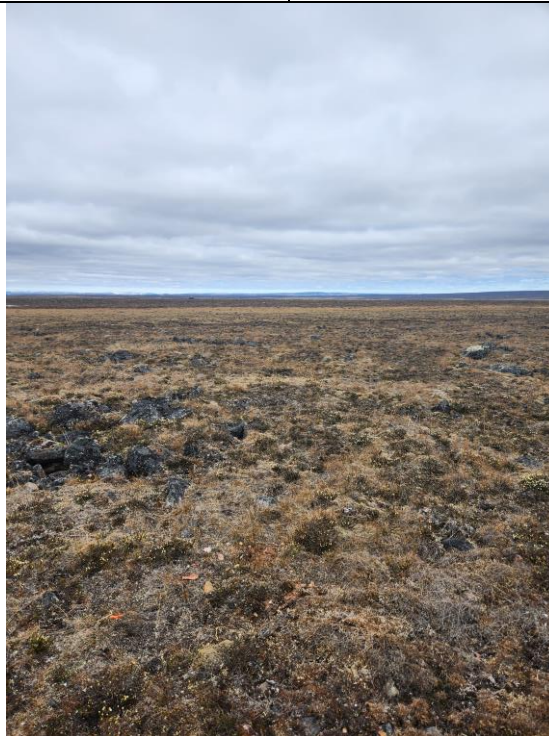
No debris was observed at the helicopter crash site. Stakes were observed confirming the location of the site.

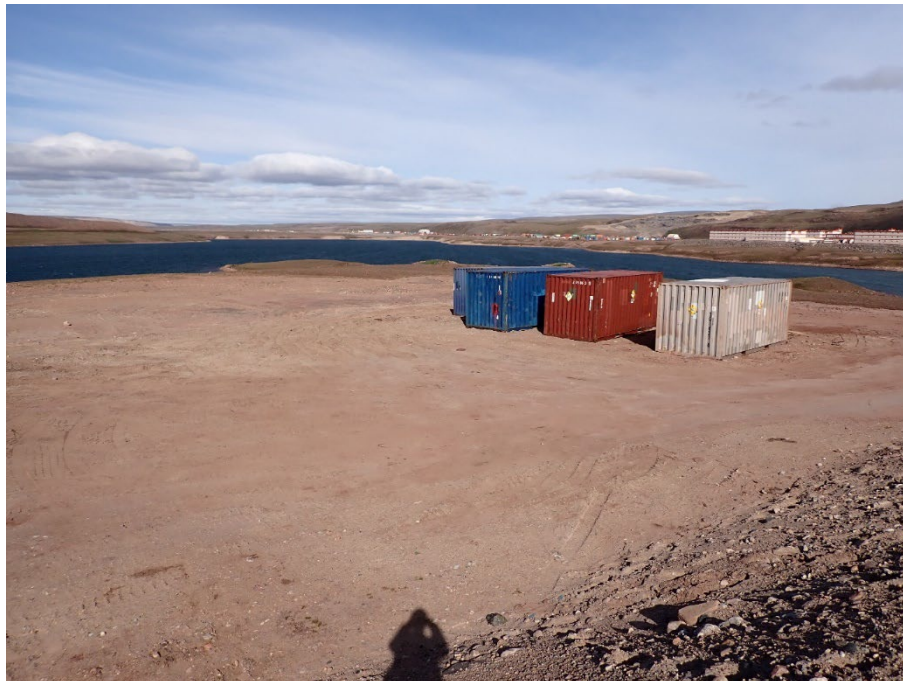
Photo 1. Landfarm cleared of hazardous materials – August 3, 2025

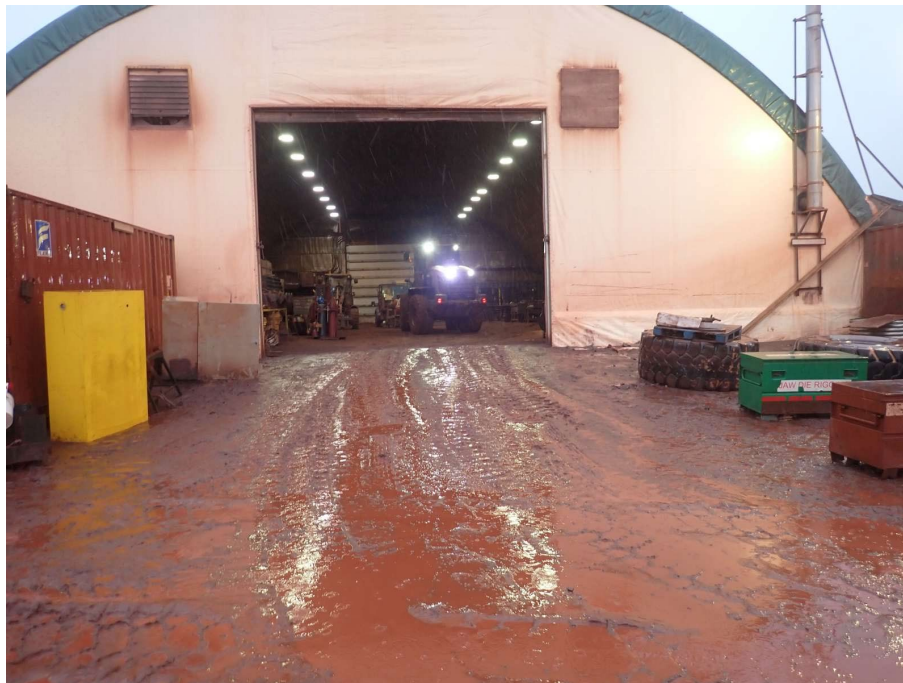
Photo 2. Materials removed from in front of Crusher Shop – September 23, 2025

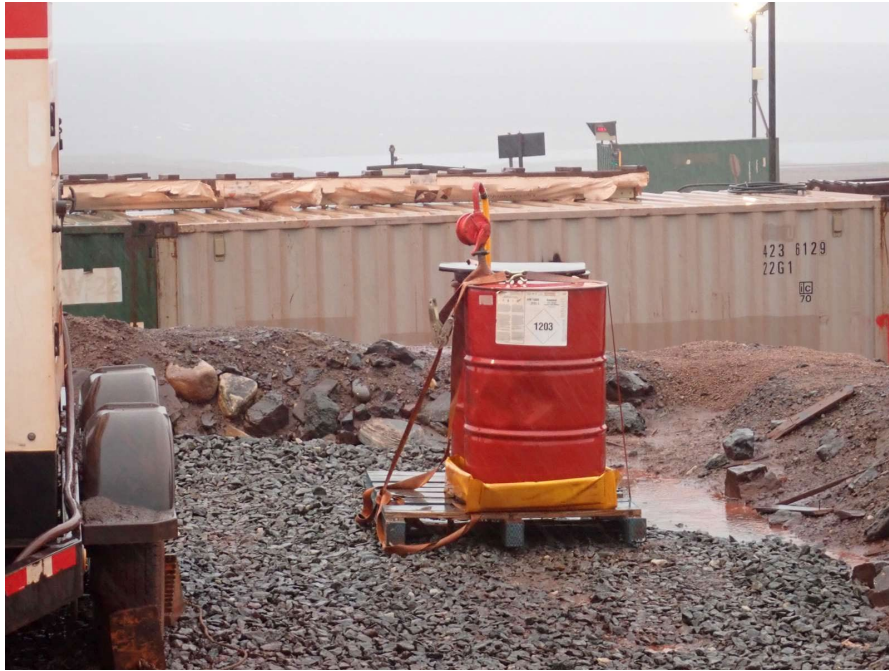
Photo 3. Drums placed within secondary containment – September 23, 2025

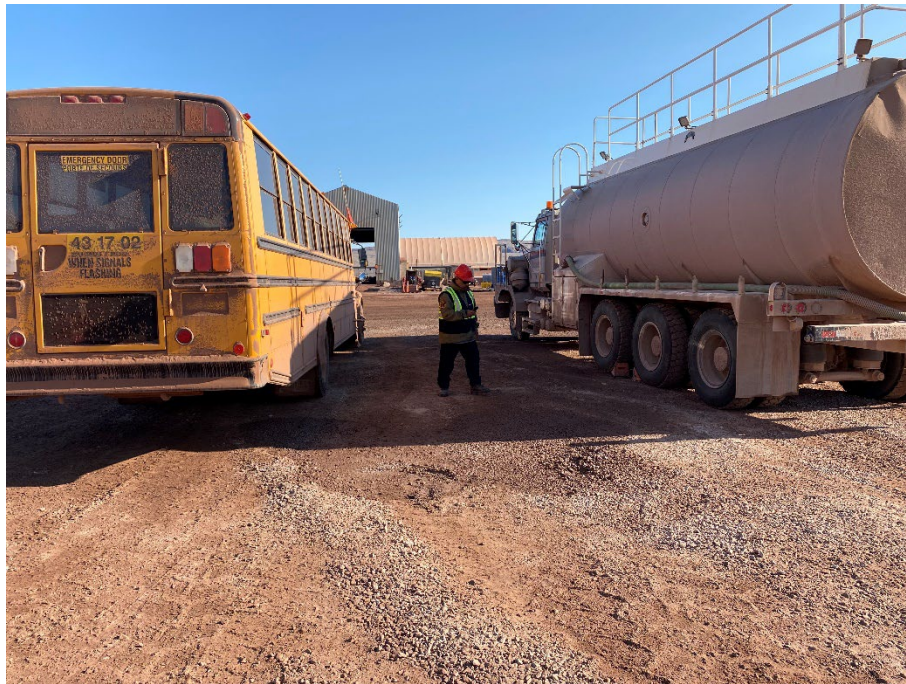
Photo 4: Water Truck parked directly adjacent to stained soils – June 27, 2025

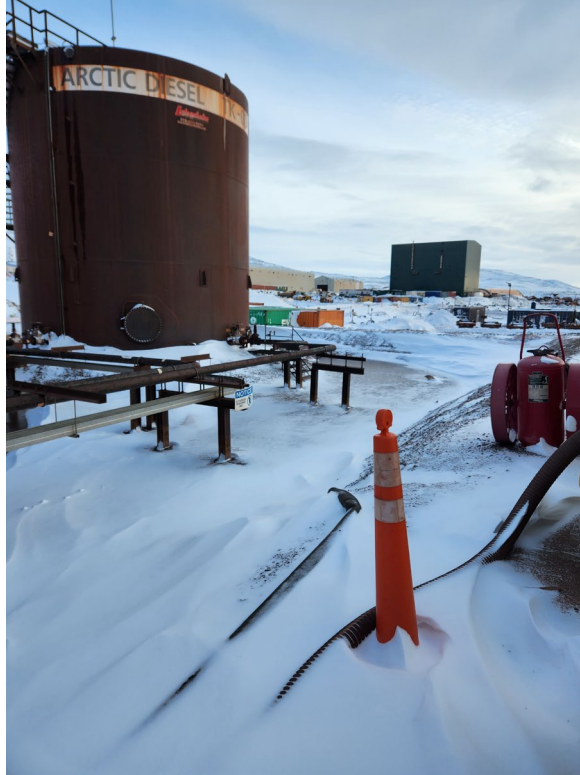
Photo showing snow and ice conditions within the tank farm.

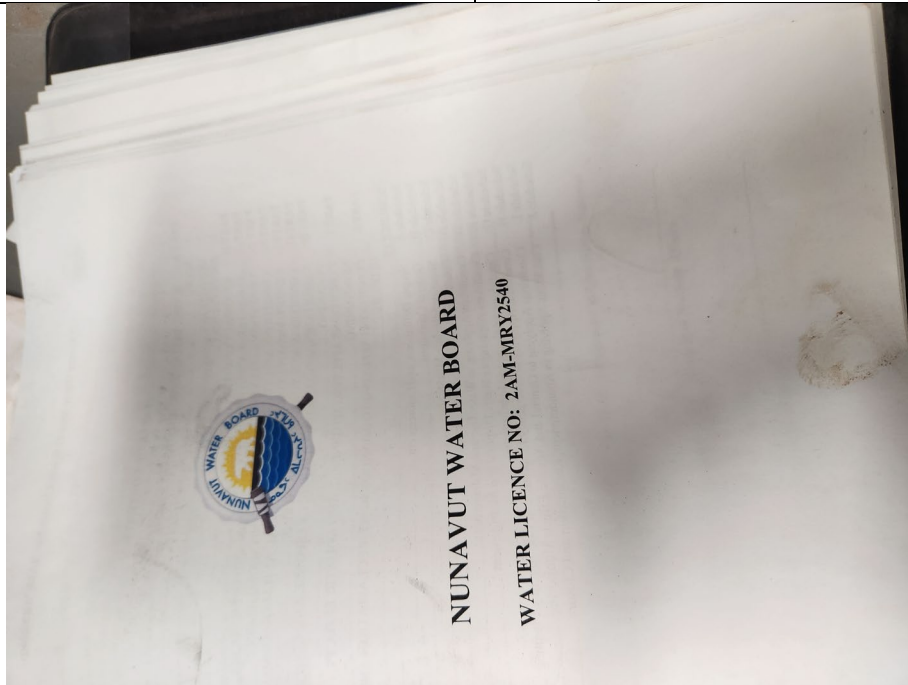
Photo of the updated water license located inside the water intake station.

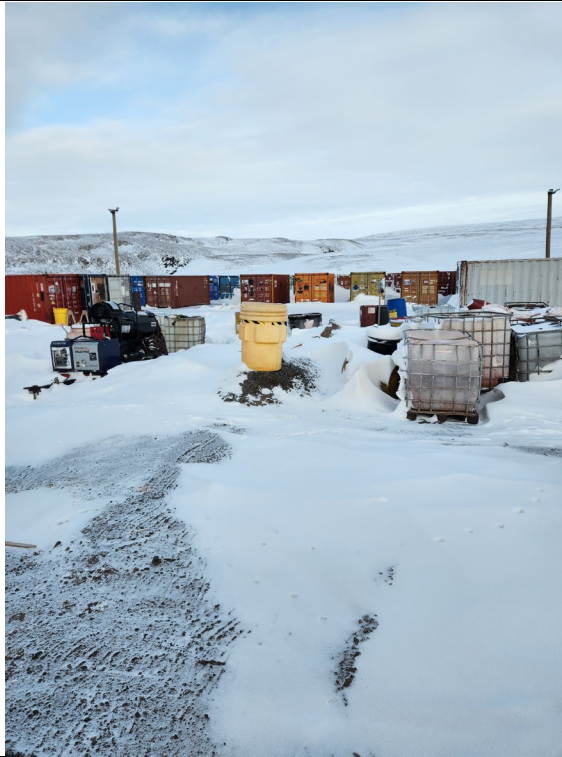
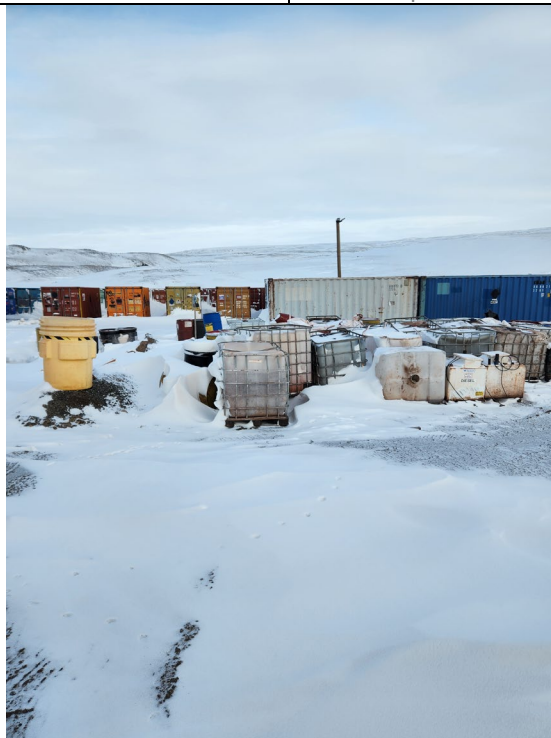
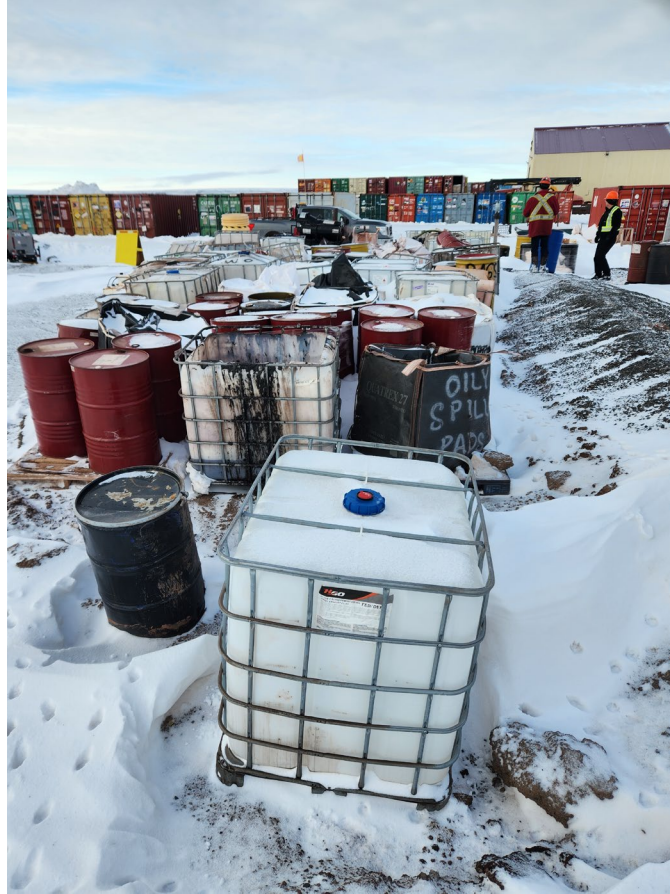
During the inspection, hazardous waste was observed out of secondary containment due to snow build up. The issue was resolved the following day and the hazardous waste was placed within secondary containment. The inspection of the tote road was not done due to weather and road conditions during this time.

Hazardous waste was found sitting outside the designated storage location out of the berm.

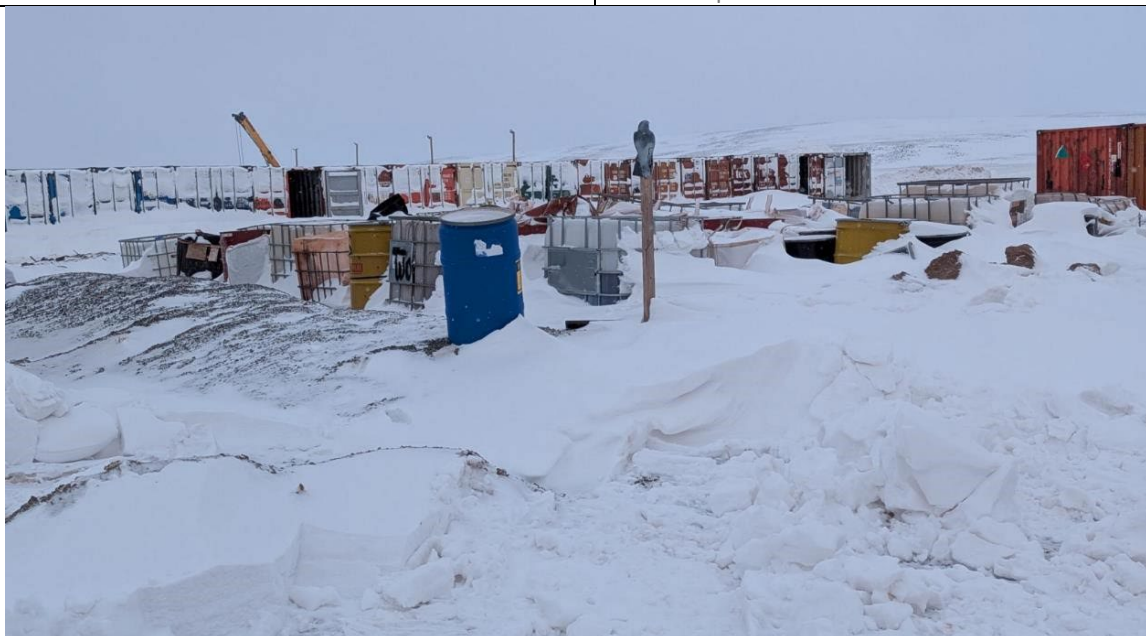
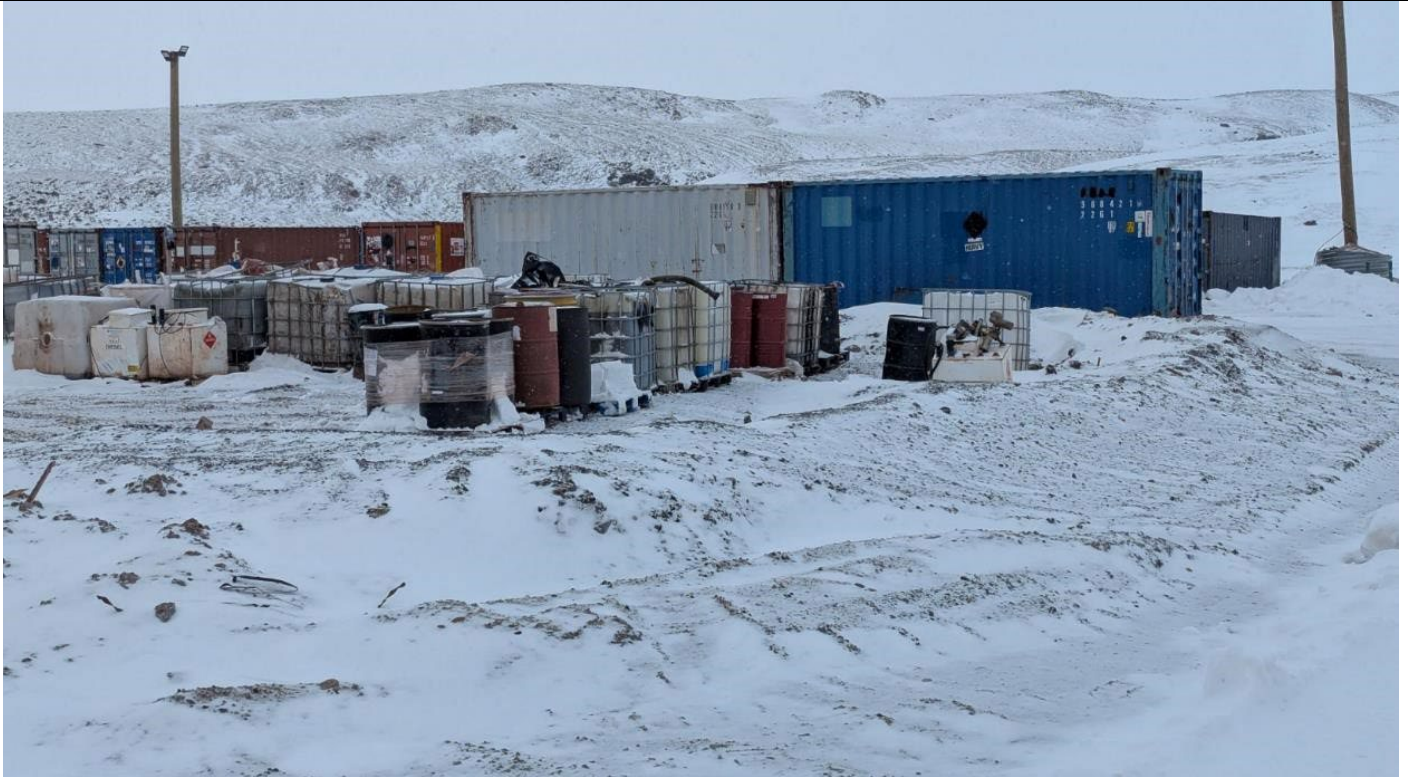
The hazardous waste was placed inside the berm within secondary containment the following day.
