Water Licence Inspection Report

Authorization	Representative
Baffinland Iron Mines	William Bowden/Scott Klingmann
Authorization No. / Expiry	Representative's Title
2AM-MRY1325 June 10, 2025	Sr. Environnemental Superintendent/Mine Manager
Inspection Date: January 8, 2025	Inspector: Omer Pasalic
Activities Inspected	
<input type="checkbox"/> Camp, Commercial <input type="checkbox"/> Drilling <input type="checkbox"/> Mining <input type="checkbox"/> Construction <input type="checkbox"/> Reclamation <input type="checkbox"/> Fuel Storage <input type="checkbox"/> Roads/Hauling <input type="checkbox"/> Winter Hauling <input type="checkbox"/> Camp, Private <input checked="" type="checkbox"/> Other Waste Rock Facility/Follow up on the items of concern identified during October 23, 2024 inspection

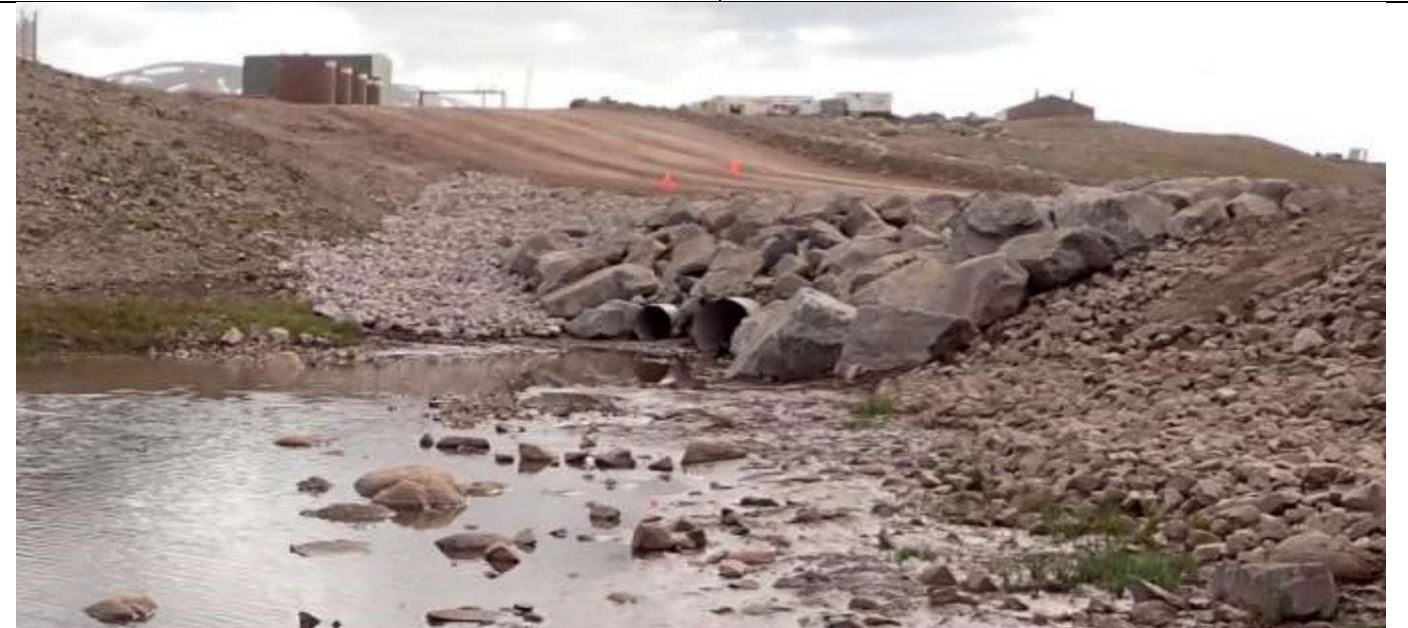
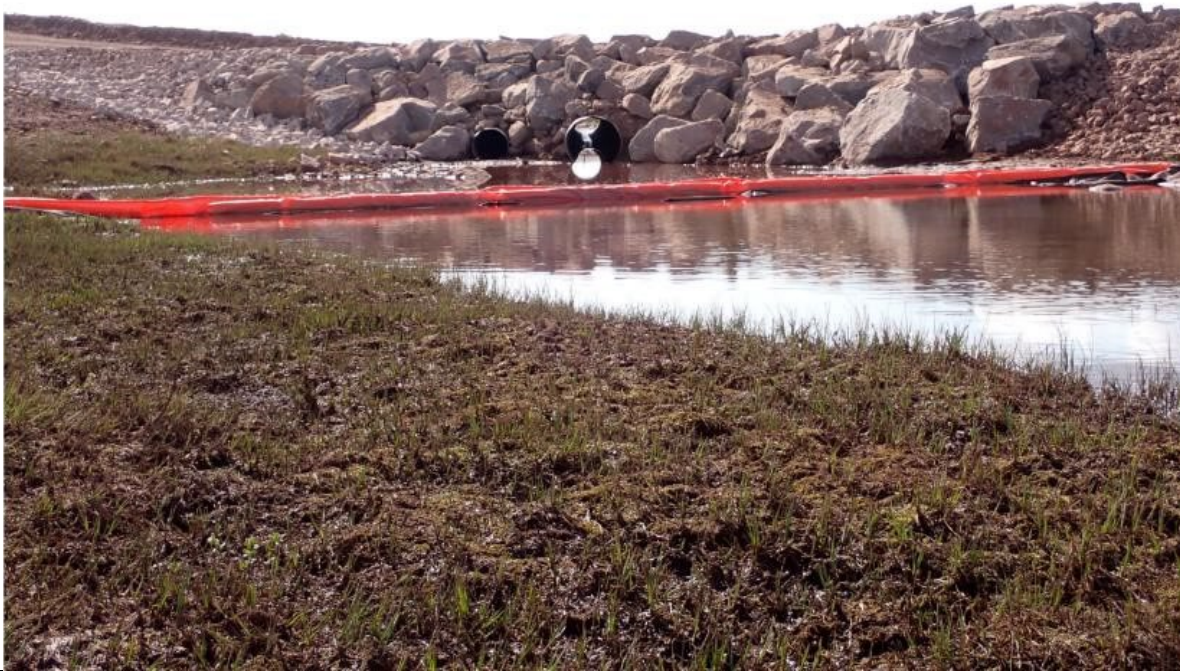
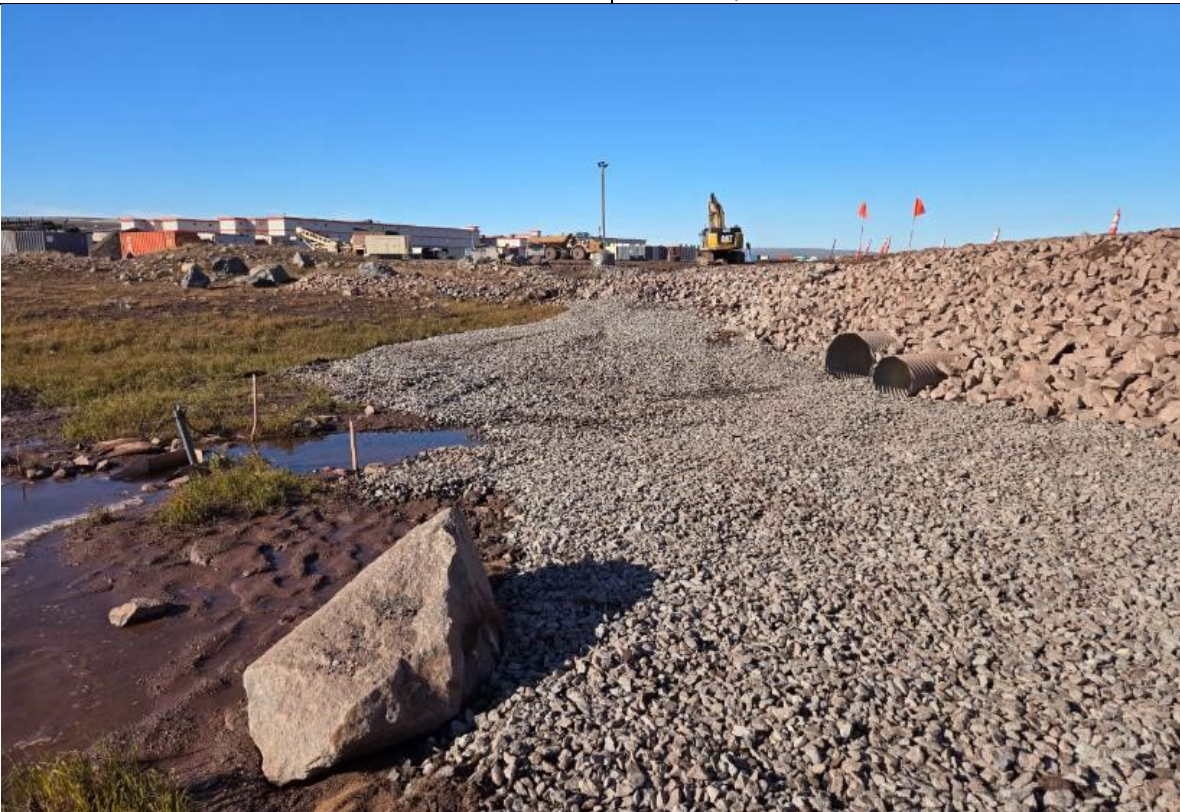
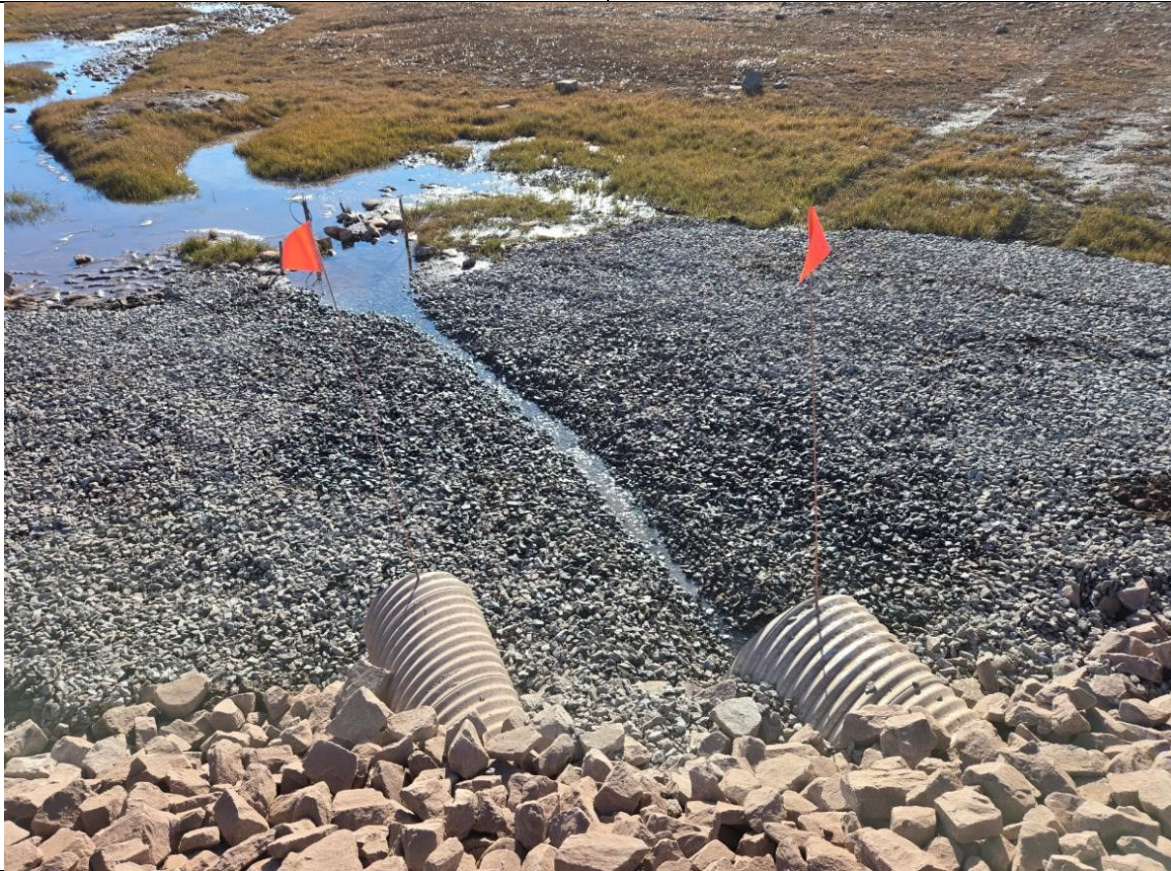
Road/culvert work was completed during the summer of 2025 at the Mary River site down grade from the tank farm. This was done to repair the road washout and prevent this incident from happening again. Photos of the job can be seen in the photo log below.

Photo showing culvert/road work that was completed downgrade of the tank farm to repair and prevent a washout happening again.
