APPENDIX E.8.2
QIA Inspection Reports and Responses

September 9, 2025

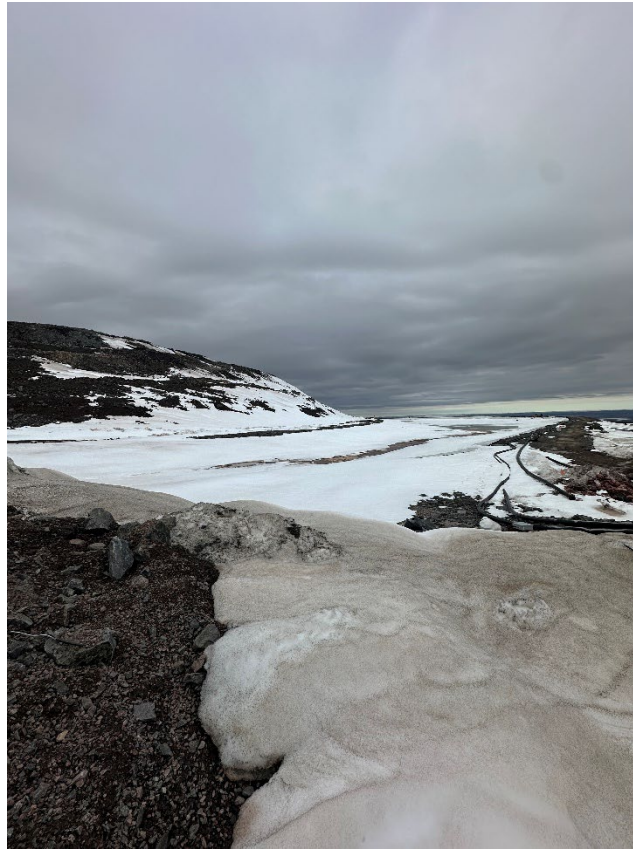
Photo 1 –Waste Rock Facility Pond still frozen and covered in snow (June 18th, 2025).

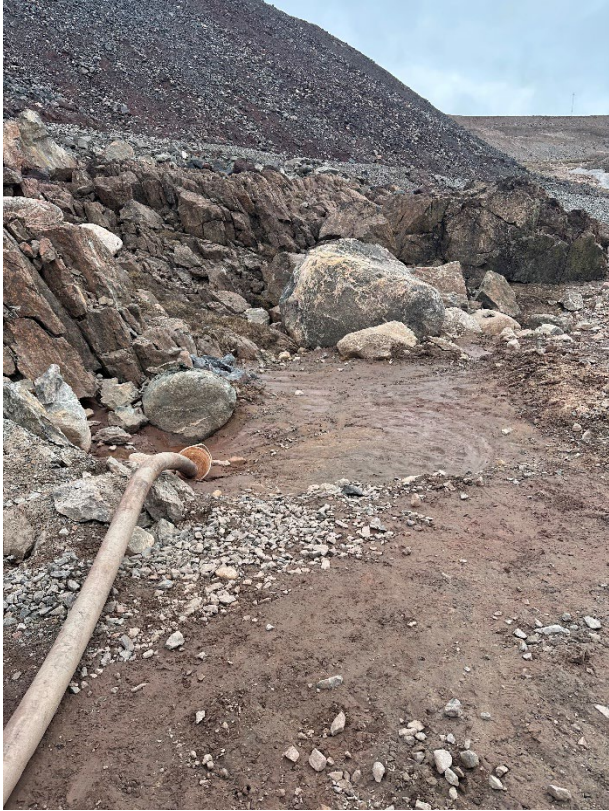
Photo 5 – Pooling location caused by the KM106 spill (June 18th, 2025).

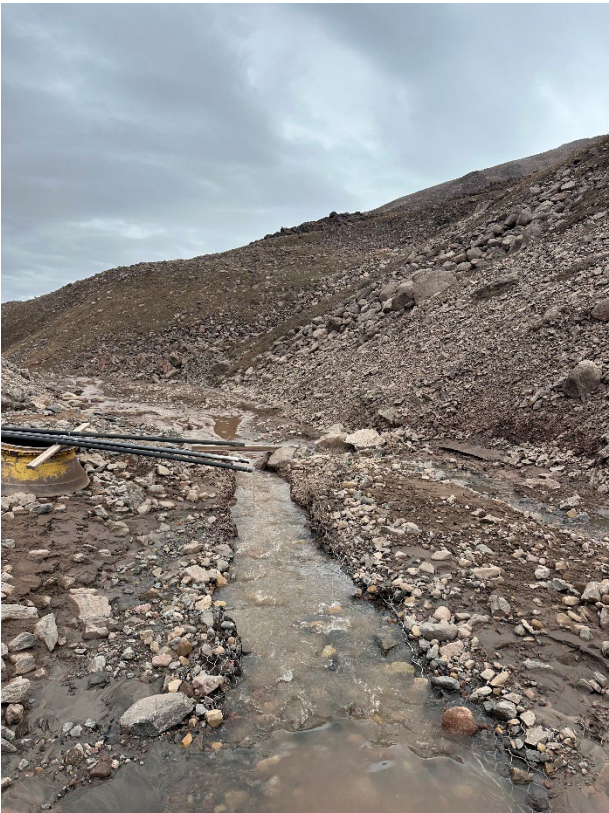
Photo 6 – Dosing facility upstream of the KM105 infrastructure. Note the secondary flow path (June 10, 2024).

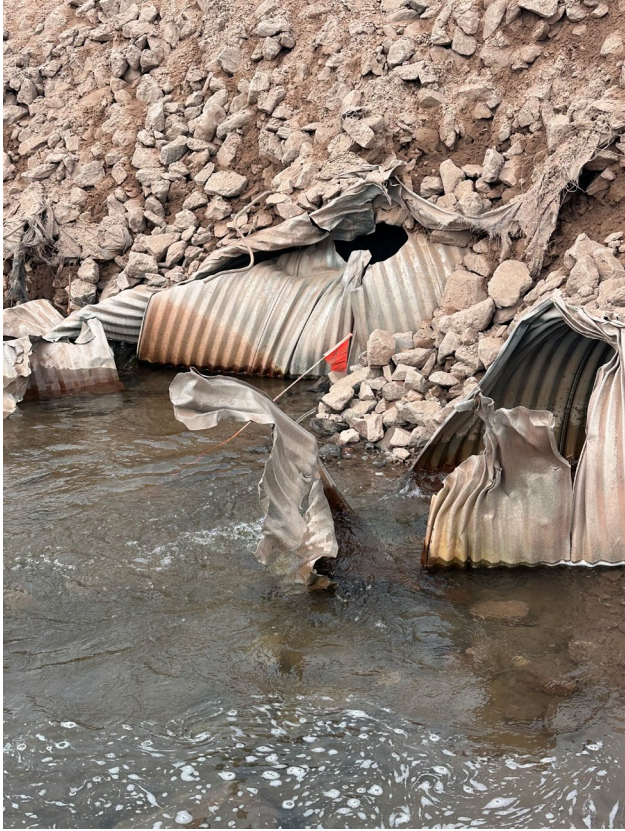
Photo 15 – Damaged culverts behind Sailiivik Camp (June 18th, 2025).

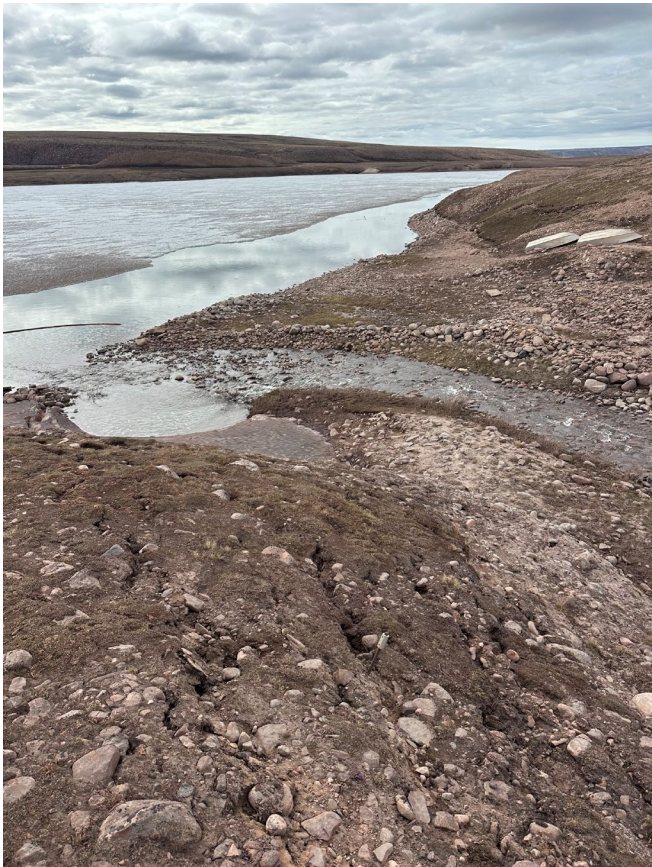
Photo 16 – Sheardown Tributary entering Sheardown Lake (June 18th, 2025)

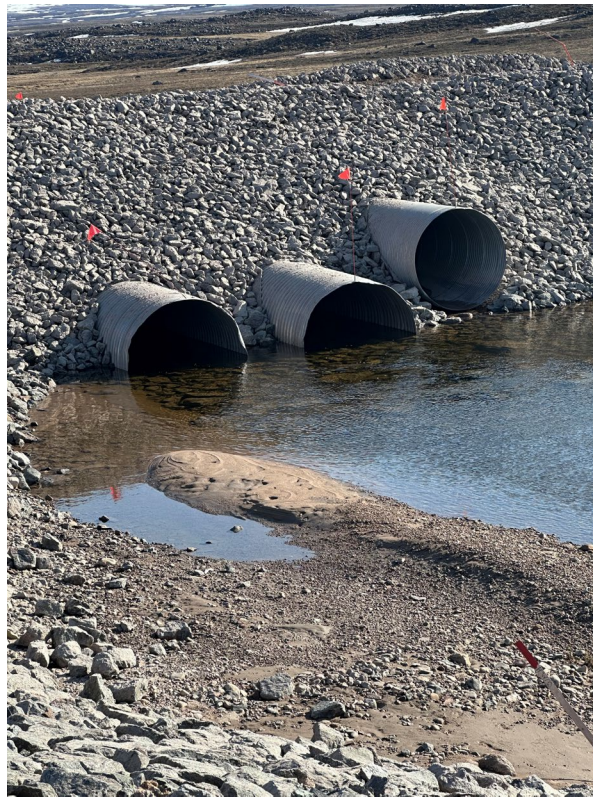
Photo 21 – Culvert replacement on the Tote Road (June 19th, 2025).

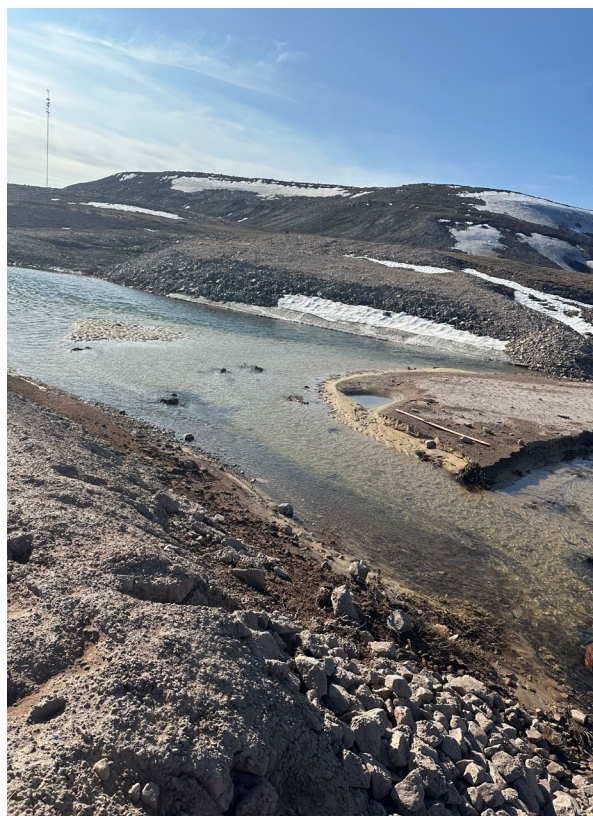
Photo 22 – Potentially isolated pool at KM87.5 (June 19th, 2025).

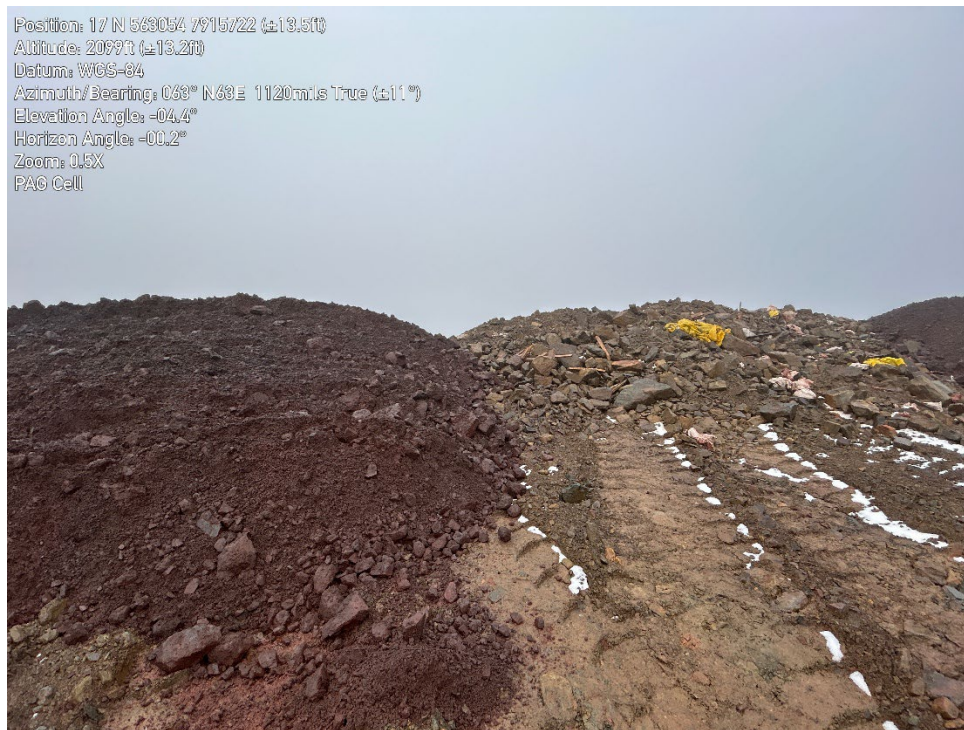
Figure 3.1: Variability in texture on WRF (finer-grained on left, coarser-grained on right)

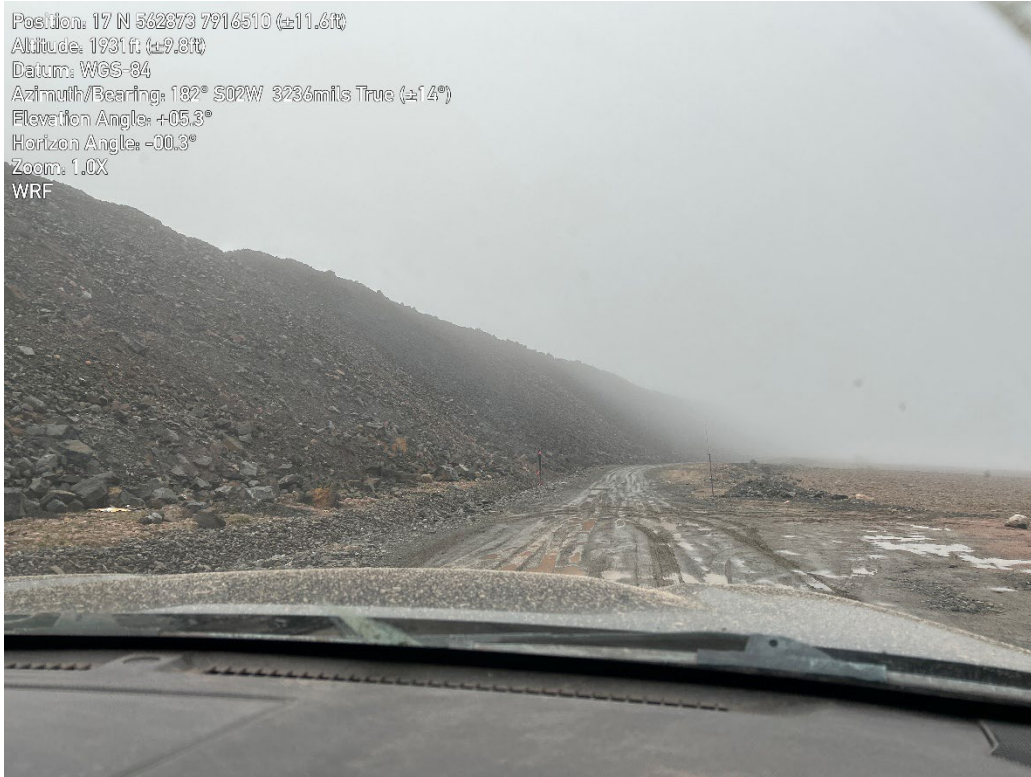
Figure 3.2: Eastern slope of WRF. No erosional or stability concerns noted.

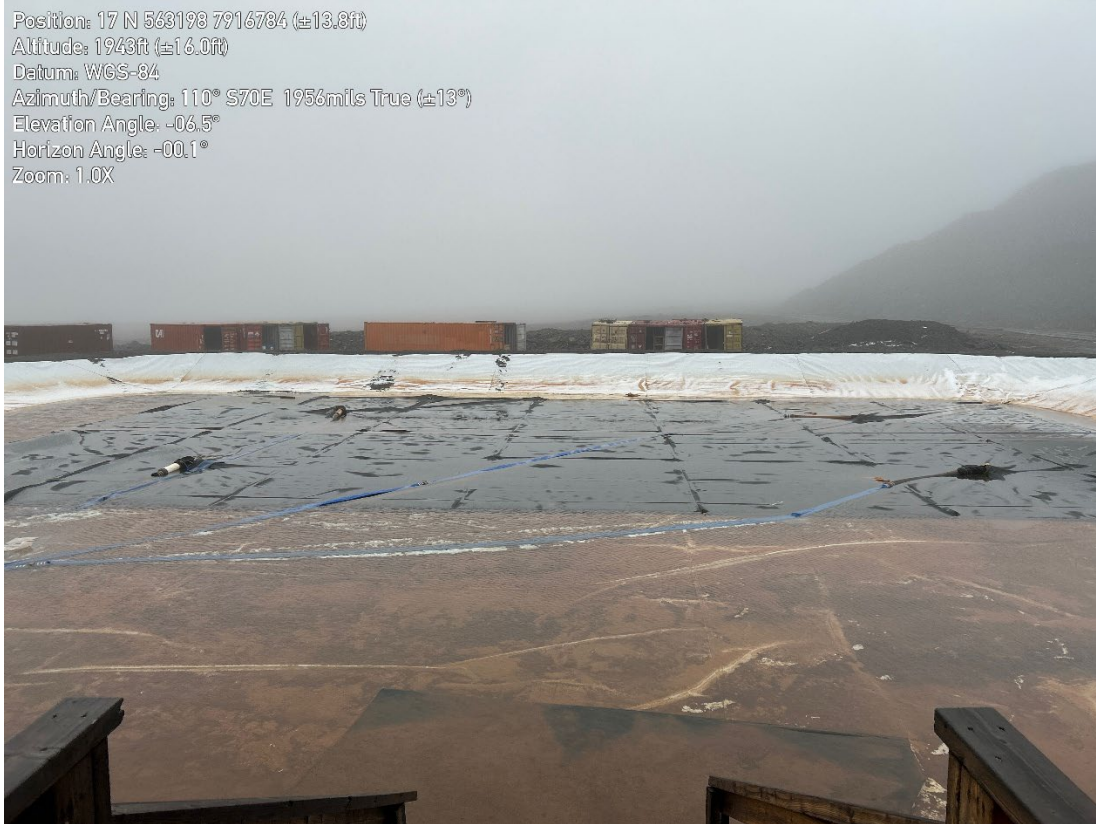
Figure 3.3: Geobags at water treatment plant (installed in 2024)

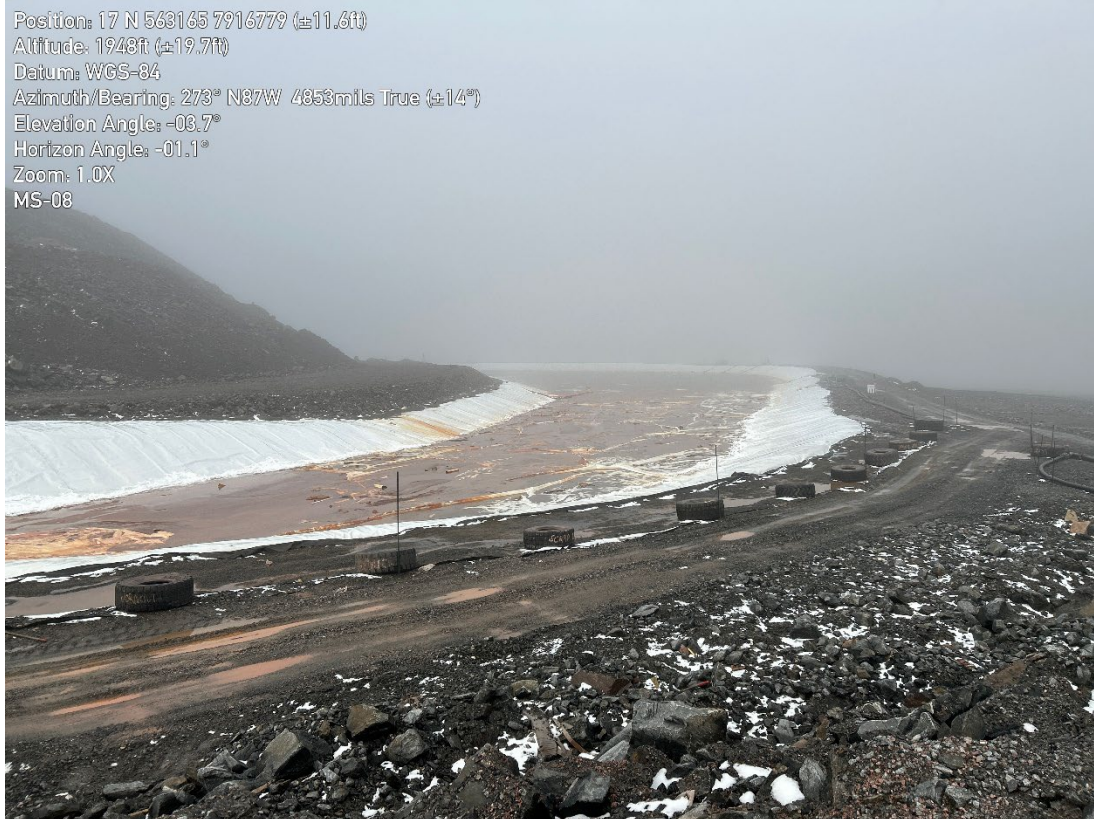
- It was noted that the water levels in MS-08 were low and liner appeared to be intact (Figure 3.5).
- A relatively large volume of water was present in secondary containment pond to the north of MS-08 (Figure 3.6) indicating either seepage is occurring from MS-08 or seepage from the WRF is bypassing the MS-08 seepage collection system.
- Discussions with the Environmental Manager indicated that High precipitation events in the past year have lead to concerns with the storage capacity of MS-08, however, ongoing studies being conducted to better understand the water balance of the MRS area as it relates to the capacity of MS-08.

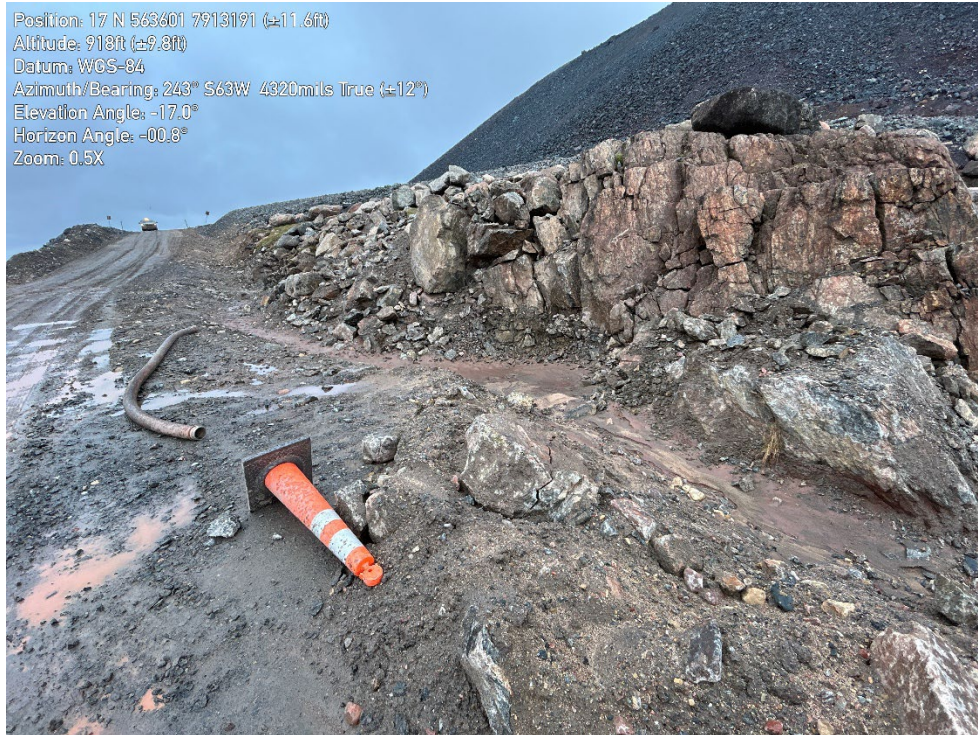
Figure 3.7: Uncontrolled seepage from KM 106 pumped to MS-07 sediment pond.

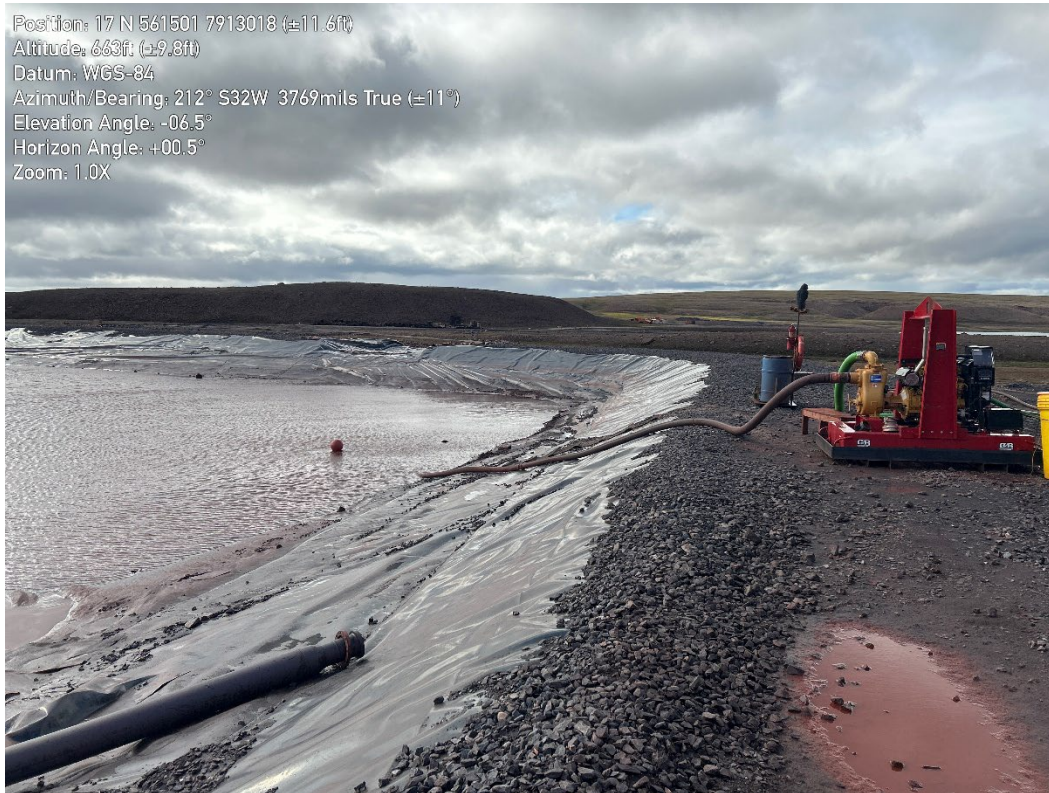
- Conversations on site with BIM personnel indicate that investigations into the source of uncontrolled seepage were inconclusive but based on water quality sampling the seepage is not coming from the ore crusher pad itself.
- No concerns with the additional quarried rock placed West of the ore crusher pad as a laydown/improved access in the area.

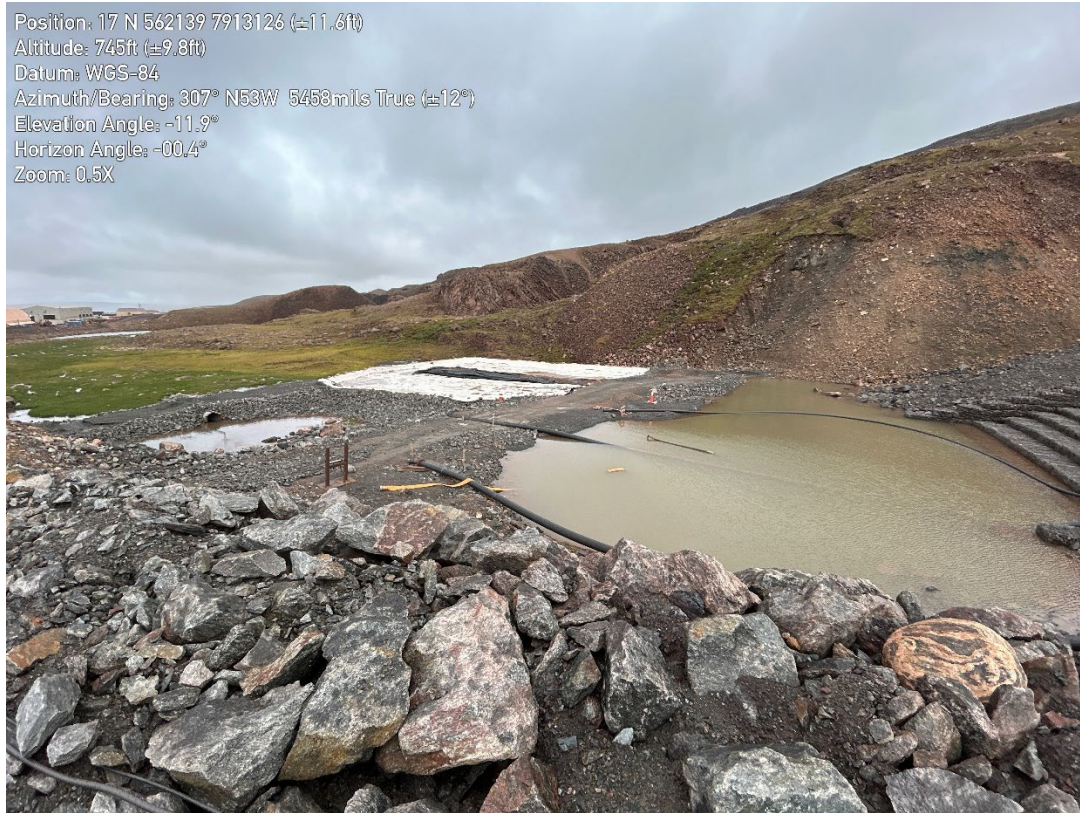
Figure 3.11: Downstream check dam and water treatment area downstream of KM 105 embankment

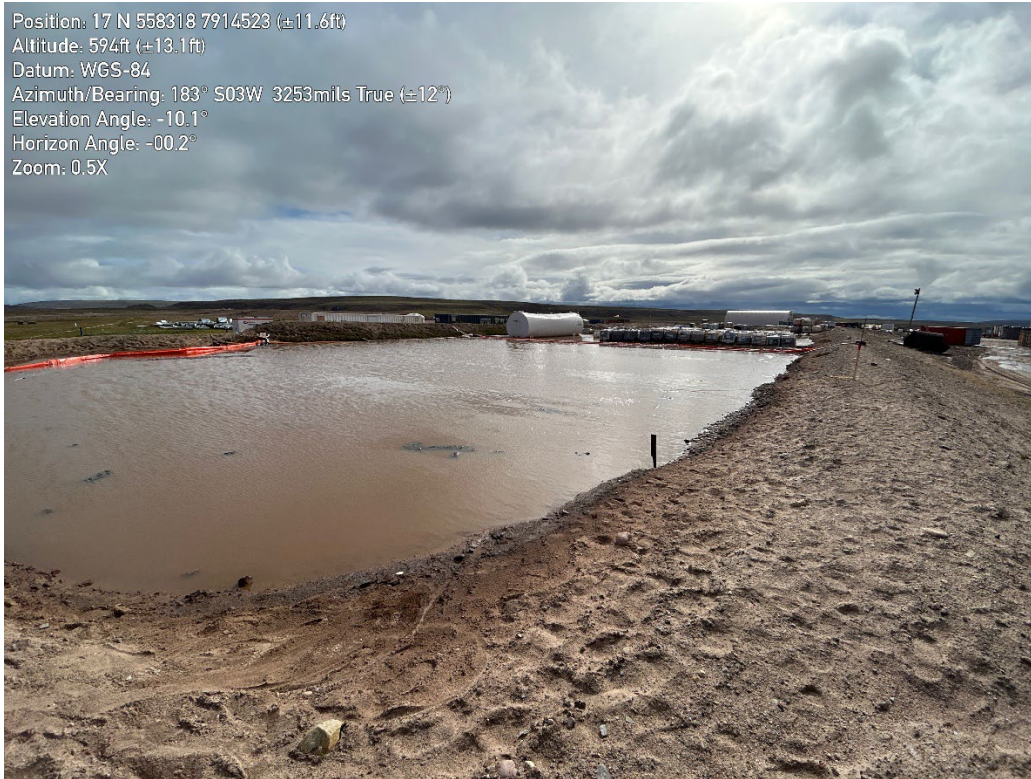
Figure 3.12: Hazardous Waste storage area

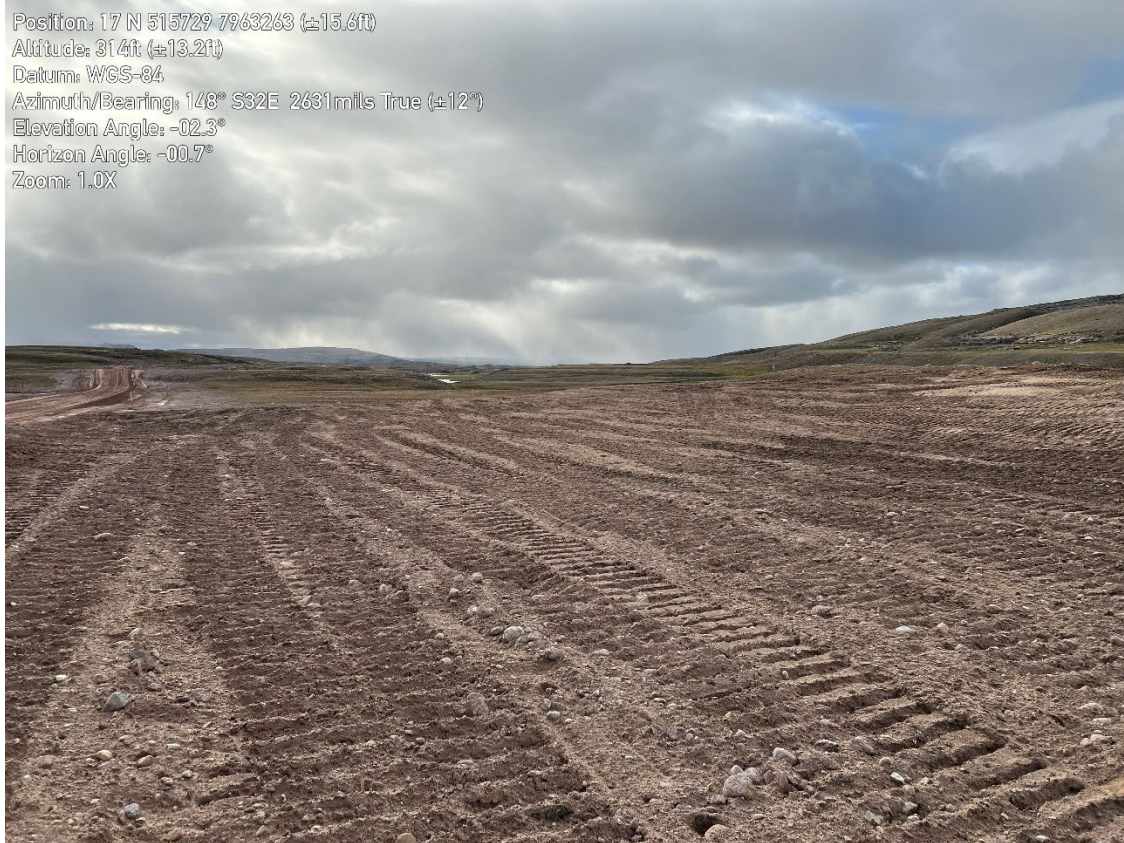
Figure 3.13: Reclaimed borrow area adjacent to Tote Road at KM 37

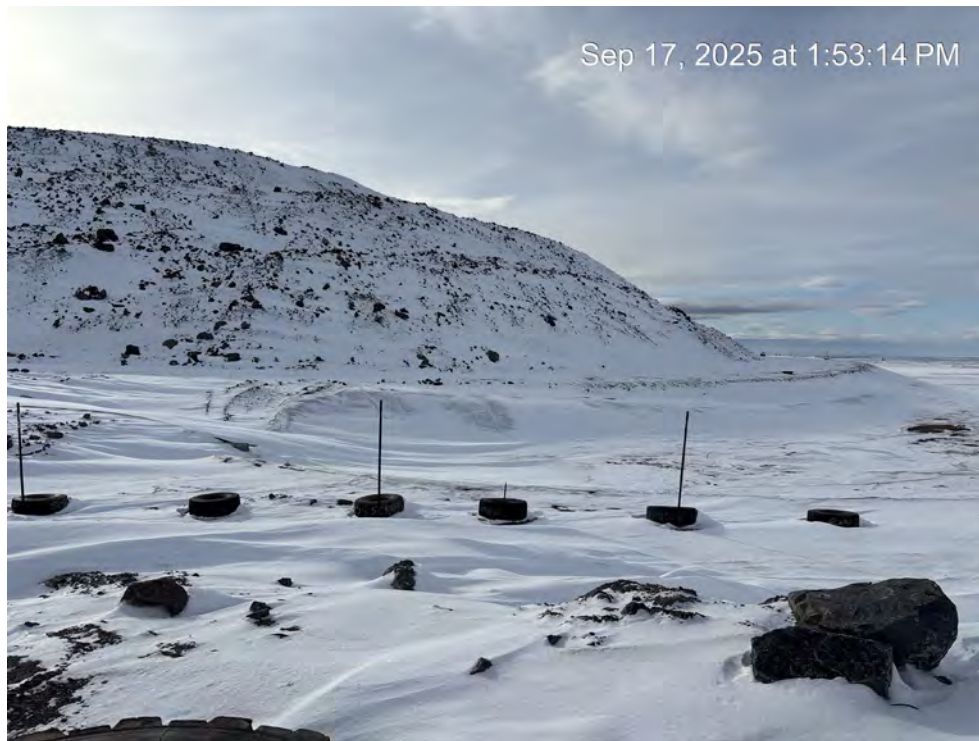
Photo 1 –Waste Rock Facility Pond still frozen and covered in snow (September 17, 2025).

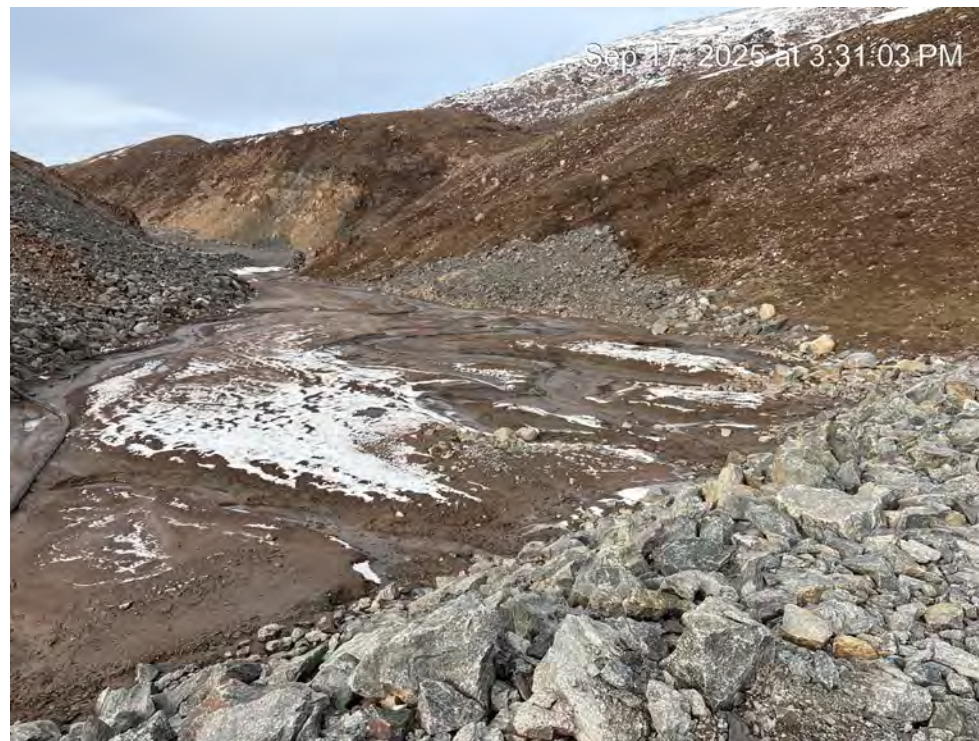
Photo 6 – Accumulation of sediment downstream of second filter berm at KM105 pond (September 17, 2025).

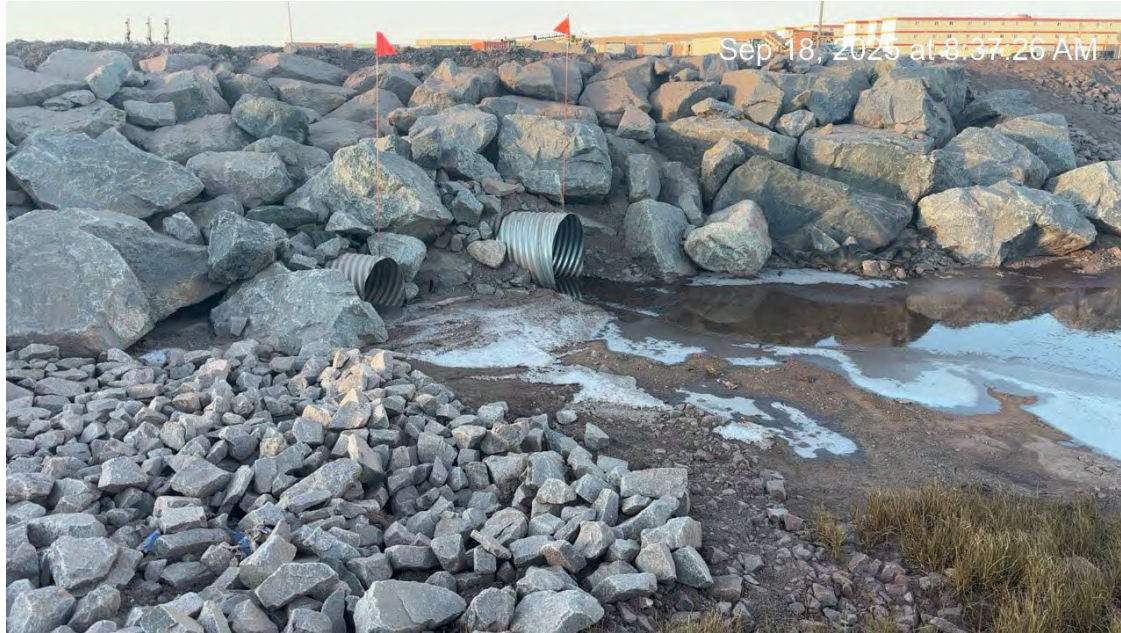
Photo 19 – CV187 replaced in June 2025 (September 18, 2025).

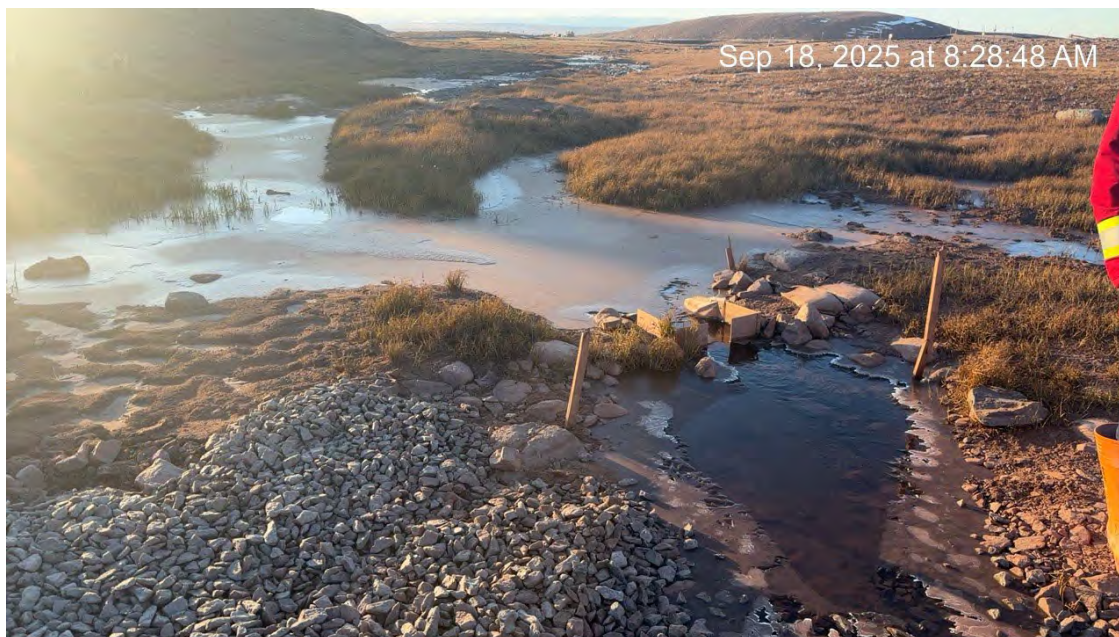
Photo 20 – Area of proposed rail infrastructure southeast of CV187 (September 18, 2025).

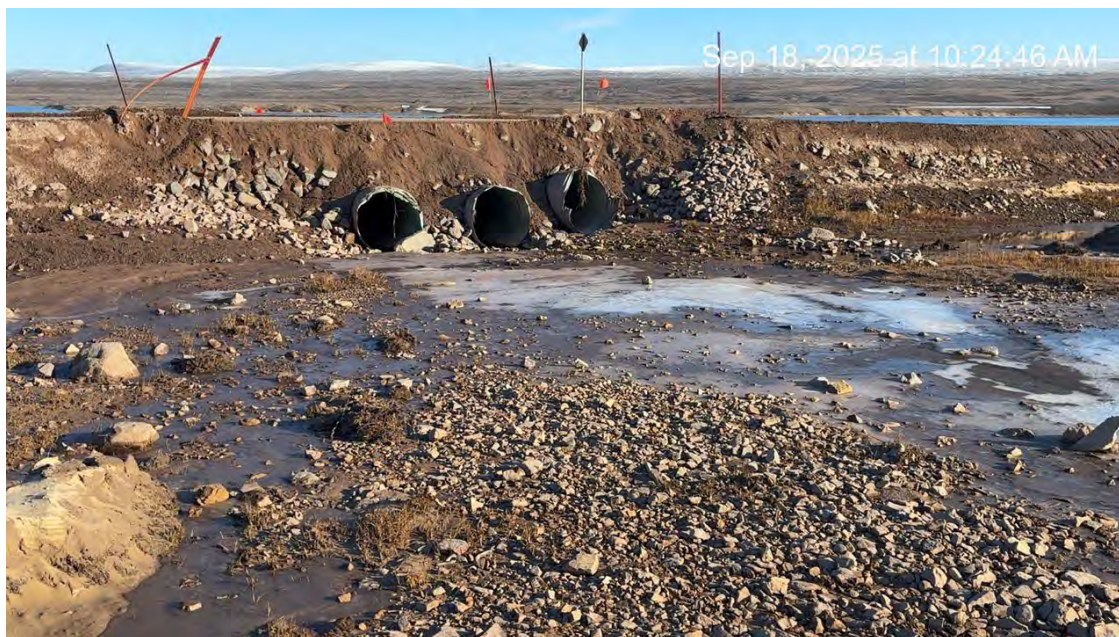
Photo 34 – Culverts to be replaced at KM87.5 (September 18, 2025).

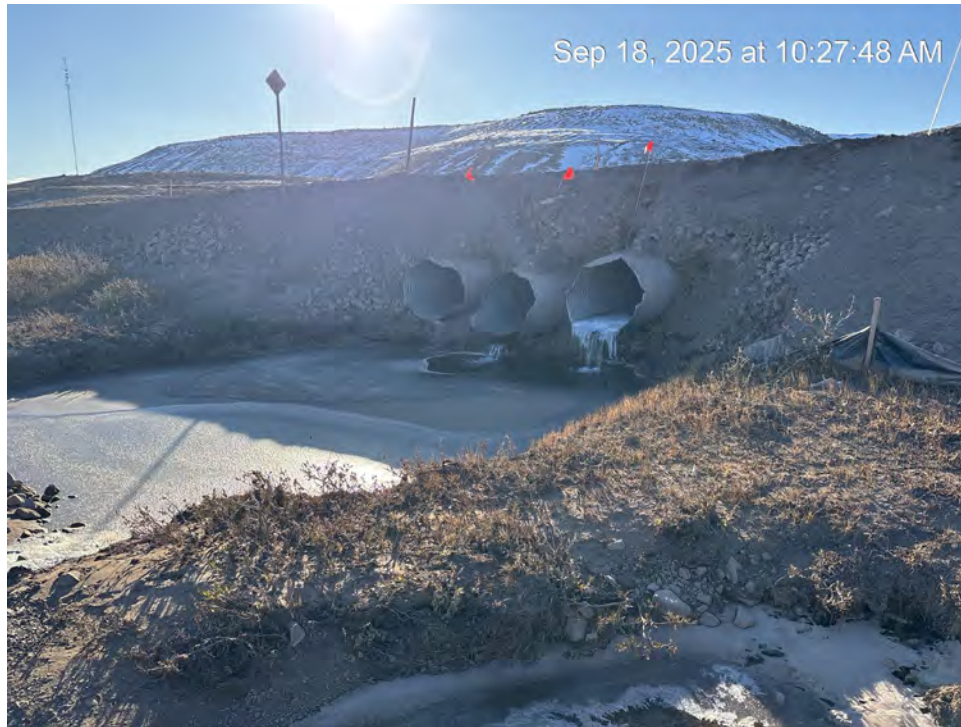
Photo 35 – Perched culverts and erosion on embankment at KM87.5 (September 18, 2025).
