## APPENDIX E.8.3

### 2025 Initial and Follow-up Spill reports

**Re: Follow-Up to Spill #2025-091**  
**Mary River Project - Water Licence No. 2AM-MRY1325**

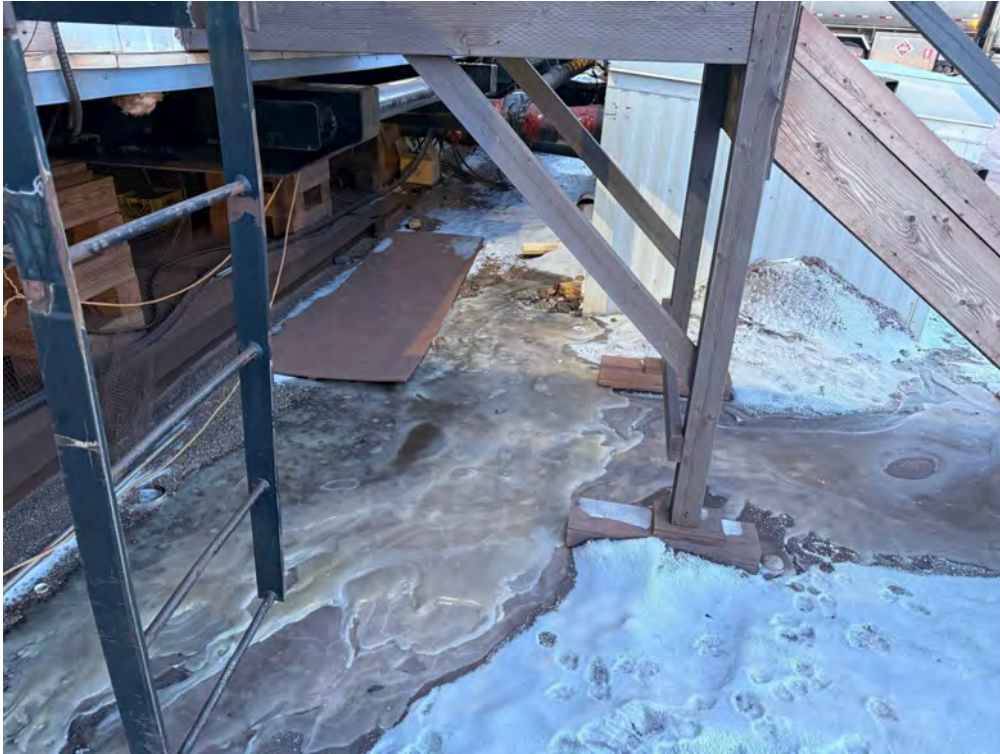
While conducting scheduled inspections on March 29, a housing maintainer observed a flashing warning light signaling for the lift station at the Mine Site Complex (MSC) laundry room. Upon further investigation he discovered that the amperage overload breaker for the low-level pump had tripped, rendering the pump non-operational. The high-level pump was also found to be inactive, though it was noted that the fluid level was insufficient to trigger the high-level pump float. Following this, the maintainer observed frozen untreated sewage near the lift station, estimated to be 195 liters in volume. The maintainer activated both pumps to reduce the fluid level in the tank to prevent the potential for a similar occurrence. The spill was contained to an area approximately 12.2m<sup>2</sup>, and was located approximately 550 meters away from the nearest water body, Sheardown Lake, which is currently frozen.

**Photo 1:** Mine Site Complex Laundry Lift Station Spill Location – Spilled Sewage Frozen on Ground - March 29, 2025

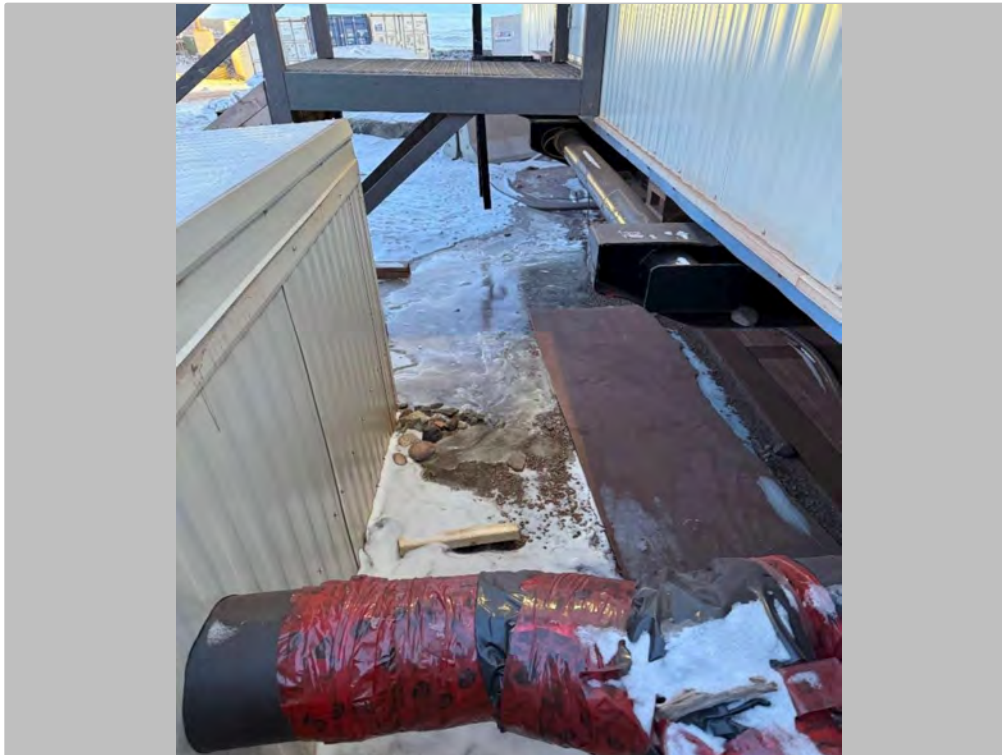
**Photo 2:** Mine Site Complex Laundry Lift Station Spill Location – Spilled Sewage Frozen on Ground - March 29, 2025

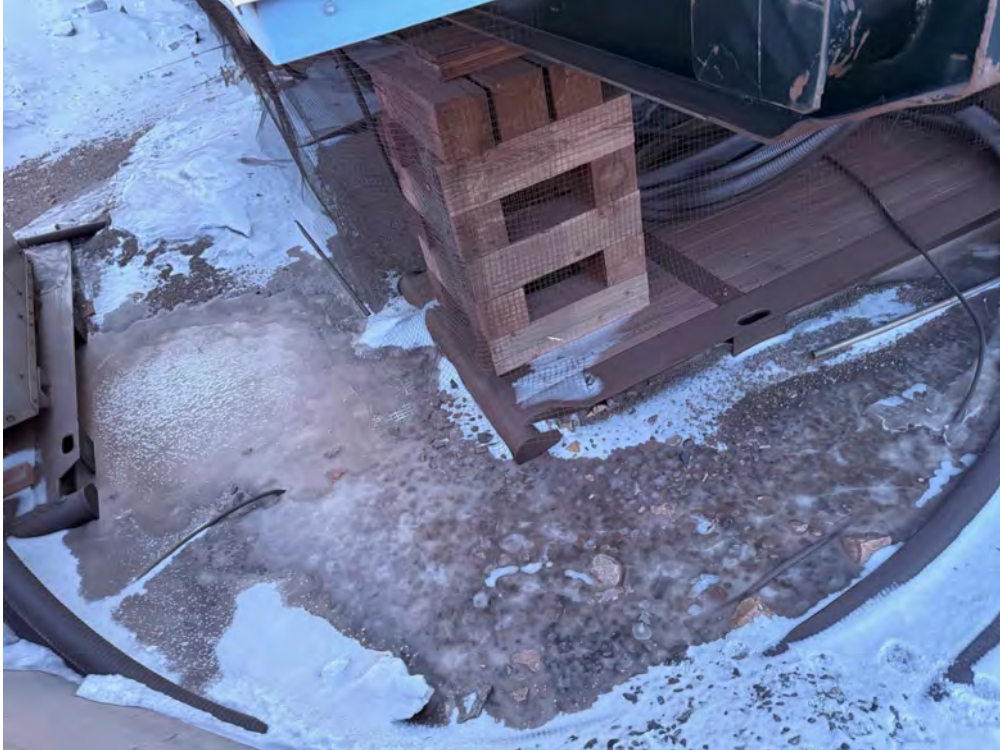
**Photo 3:** Mine Site Complex Laundry Lift Station Spill Location – Spilled Sewage Frozen on Ground Near Transformer - March 29, 2025

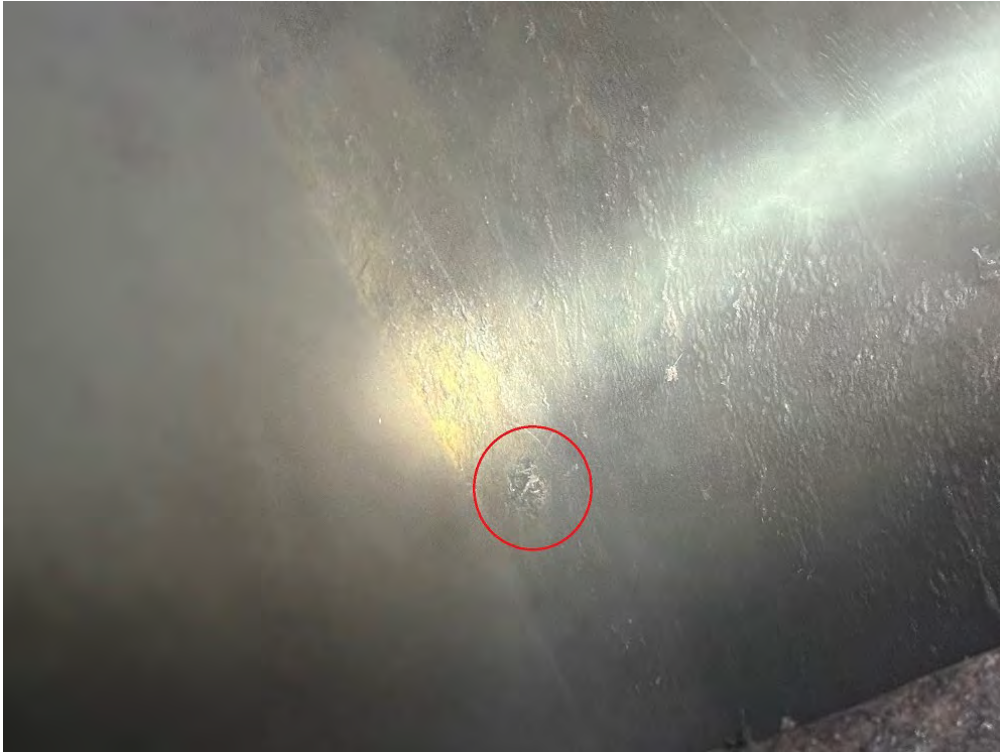
Following discovery of the release, the station was emptied and cleaned to prevent further release. Further investigation revealed a crack in the lift station tank, which had been previously concealed by an accumulation of sediment and debris, explaining its failure to be detected during previous inspections. The sediment build-up resulted from the tank's design, which does not allow for the debris and material to be removed without entering the tank.

**Photo 5:** Mine Site Complex Laundry Lift Station – Crack in the tank - March 29, 2025

The immediate corrective actions implemented following the spill included cleaning and reactivating the pumps, as well as relocating the pump floats to a lower level to prevent fluid from rising to the height of the crack in the tank.

Long-term corrective actions implemented to address the root cause of the incident include the replacement of the damaged lift station with a new unit featuring an access port for a vacuum truck operator to remove silt and debris. This debris removal will be conducted on a bi-weekly basis for all lift station tanks across the Mine and Port sites. Additionally, the current weekly lift station inspections will be elevated to a daily task. Finally, a plan will be implemented to replace all lift station tanks that were originally installed in 2013 and 2014 respectively, by January 2026.

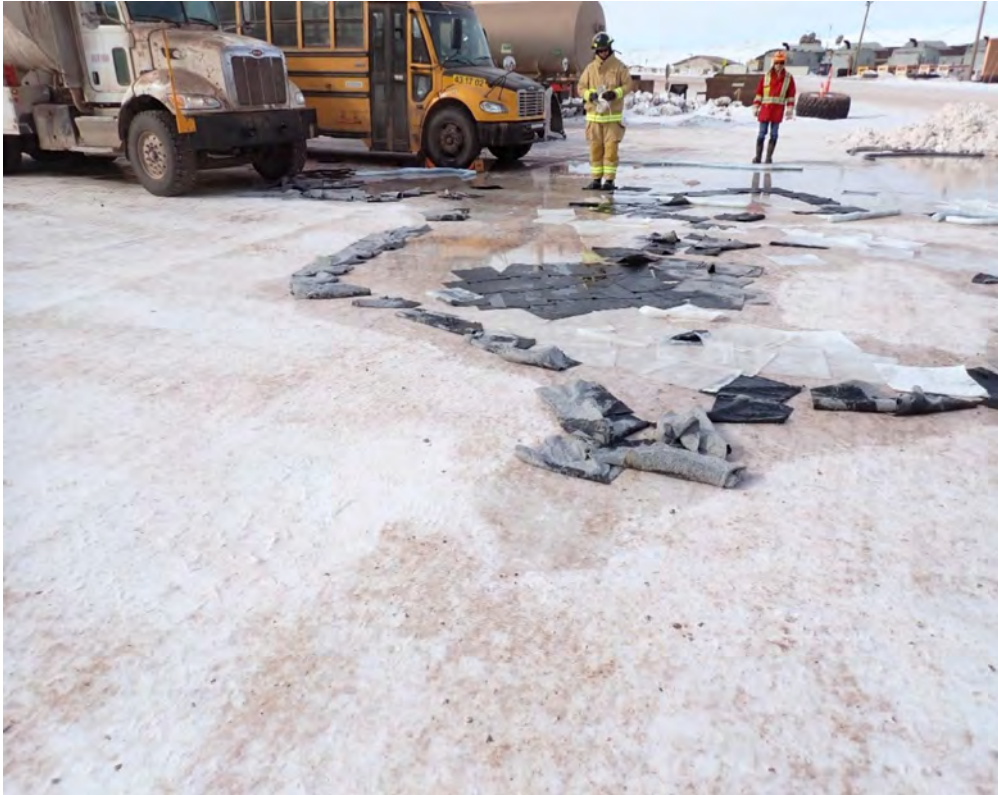
Upon discovery of the release, the fuel truck operator promptly closed the emergency shut-off valve, stopping further release. Due to the volume of the release, the Emergency Response Team (ERT) was immediately notified and spill response equipment was deployed to the site. Spill pads and sorbent socks were used to absorb as much free product as possible, and a portable spill containment berm was placed beneath FLT020 to catch any residual spillage from the fuel hose and fuel storage tank. Contaminated response materials were collected in quatrex bags and transported to the hazardous waste berm facility for staging and eventual offsite disposal. The affected area was delineated, contaminated snow and ice was removed, and an excavator ripper tool was used to excavate frozen surface soil to a maximum depth of 12 inches. Affected snow & ice and approximately 60 m<sup>3</sup> of impacted soil was transported to the Mary River landfarm for disposal.

**Photo 1: Initial Spill Response; Visible Diesel on Ground Being Absorbed By the Pads – May 4, 2025**

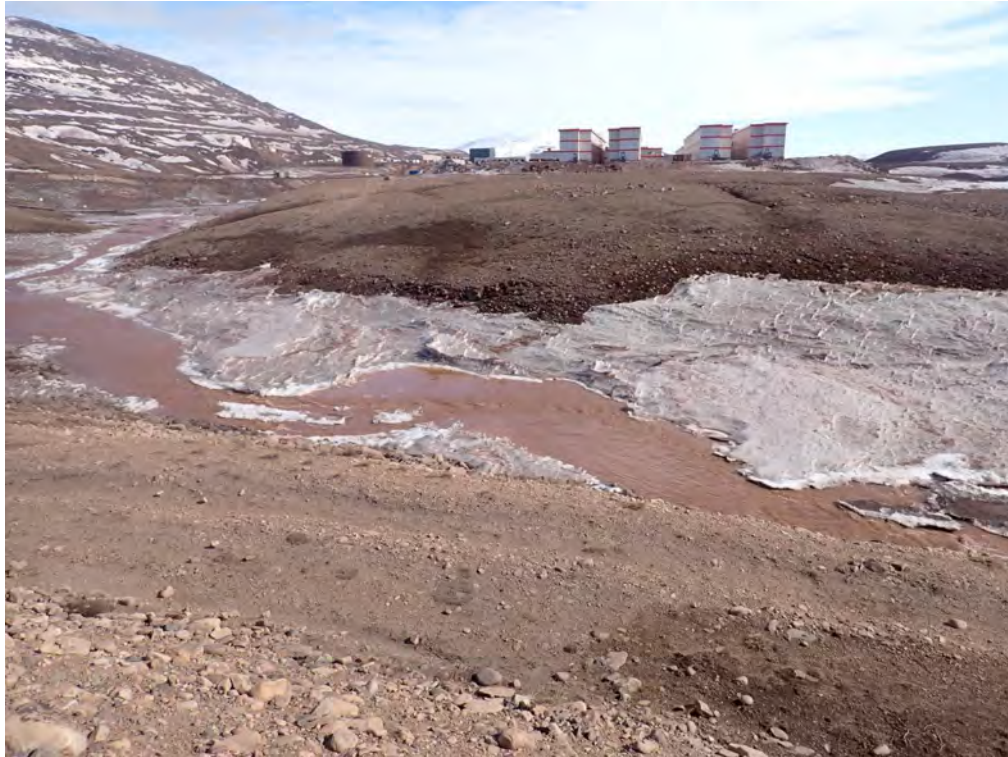
**Photo 1: SDLT-OUT Sample Location - May 23, 2025**

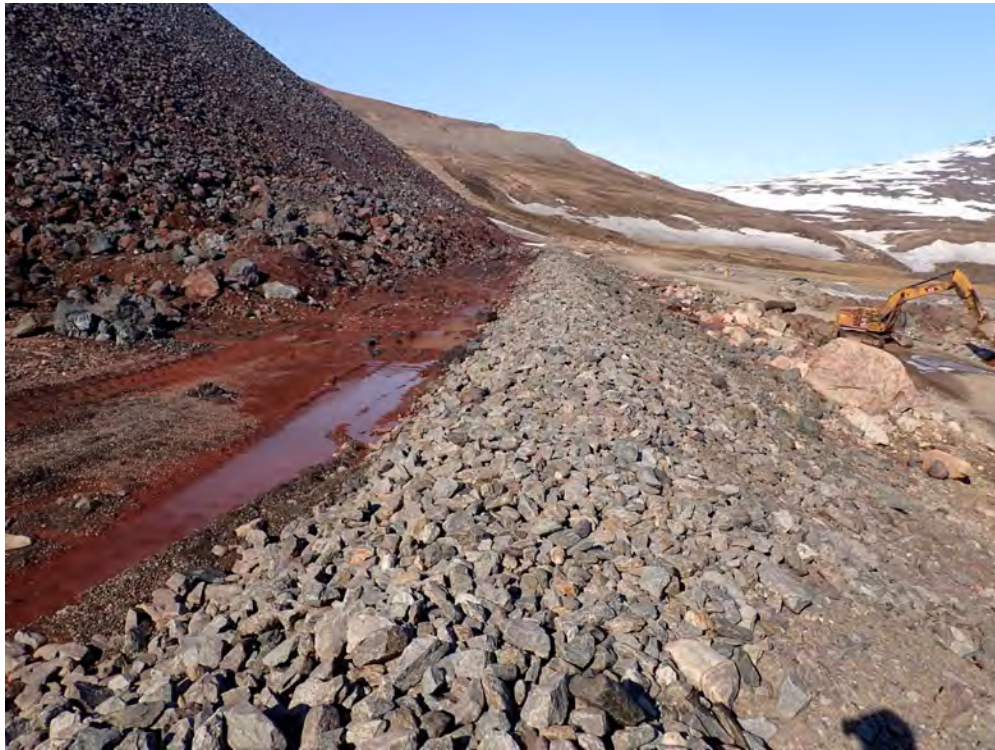
MS-106OS-07

On June 6, 2025, personnel conducting routine monitoring observed water from the Km 106 Ore Stockpile bypassing the diversion berm and seeping onto the facility road in between the Pond and Stockpile. Minor amounts of pooling water remainder from freshet flows and thawing ground was observed to result in saturated diversion berm conditions. Uneven gradient along the diversion berm resultant of thawing conditions allowed water to pool near the diversion berm, which contributed to the event. The seepage was not observed to migrate outside of the facility road in between the Pond and Stockpile and was characterised as shallow laminar flow. The flow was captured or redirected to the seepage collection swale/ditch and sump previously installed, and did not enter the receiving environment. Initial field readings of the release indicated elevated levels of Total Suspended Solids (TSS), however the low flow conditions and substrate of the road at the sample location resulted in poor sampling conditions and elevated TSS measurements from disturbance of the substrate during sampling that could not be mitigated by sampling technique. Nevertheless, water quality samples were collected on June 6 to characterize the water quality and potential lethality of the seepage, and were submitted to an external laboratory for analysis.

**Photo 1:** Water Pooling on the Upgradient Side of the Diversion Berm – June 6, 2025

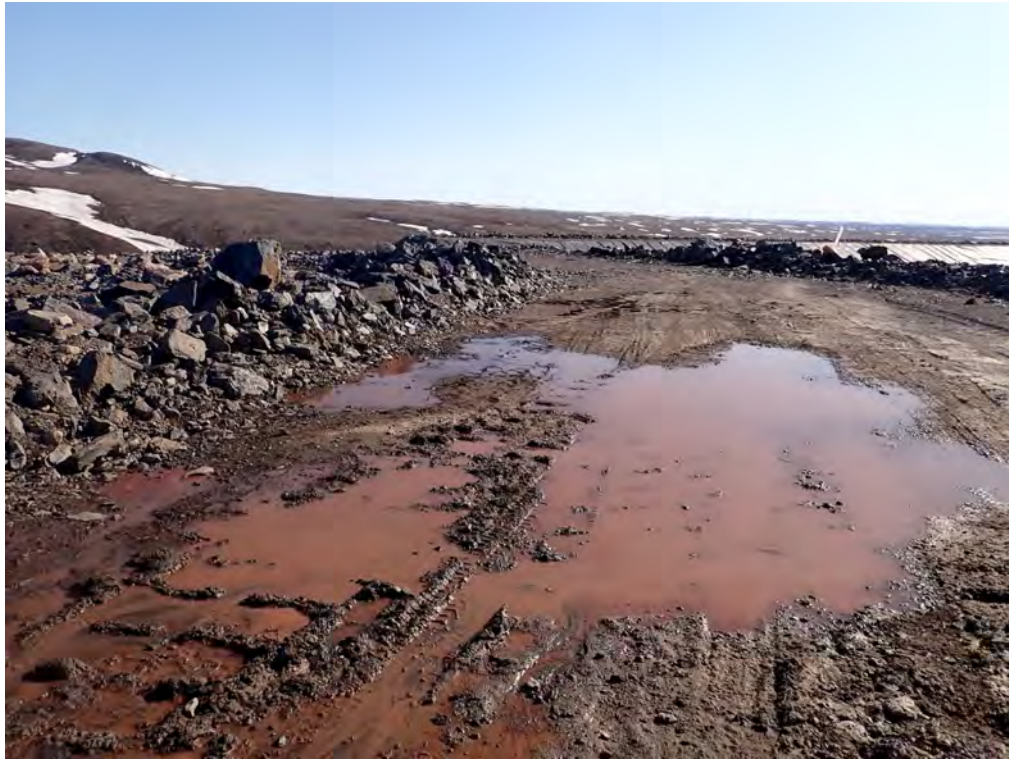
**Photo 3:** End of Observed Flow of Seepage Water, Downgradient of MS-106OS-07 – June 6, 2025

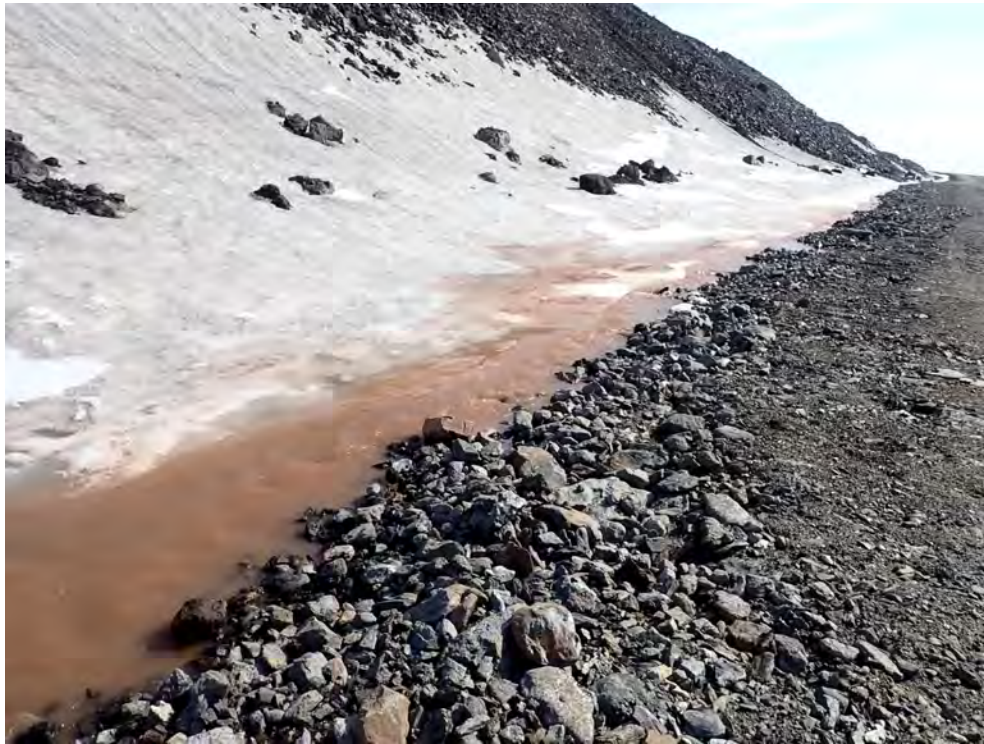
MS-WRF-WEST-DITCH

**Photo 1:** Snow and High Water Level Conditions in WRF West Perimeter Ditch, June 20, 2025

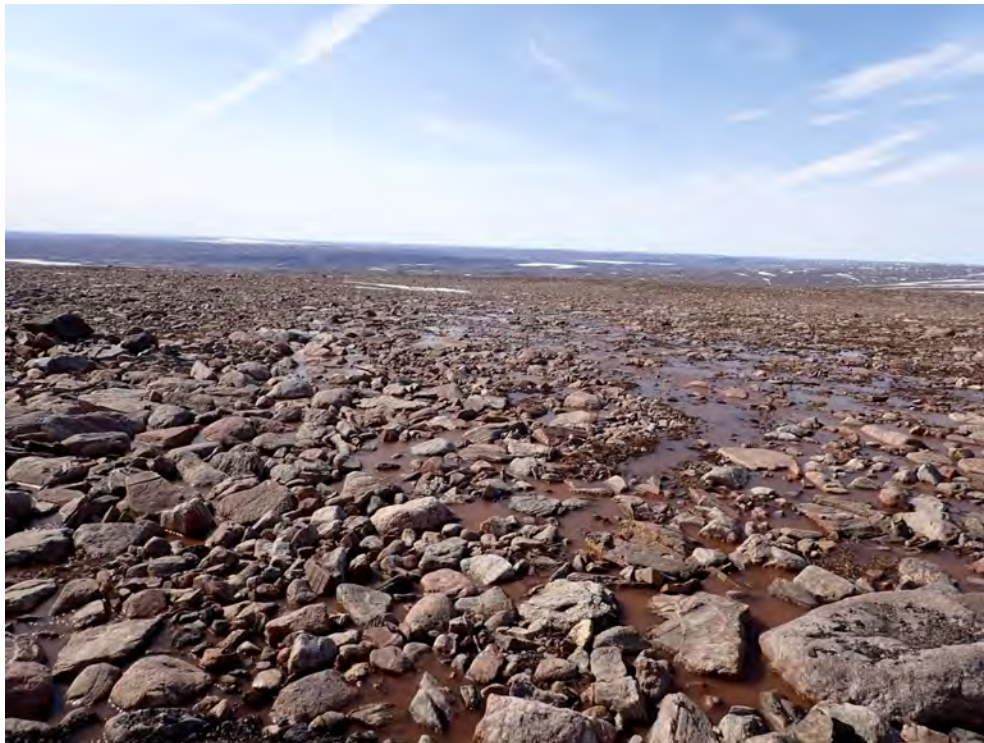
**Photo 2:** Seepage Location, Adjacent to the WRF West Perimeter Ditch, June 20, 2025

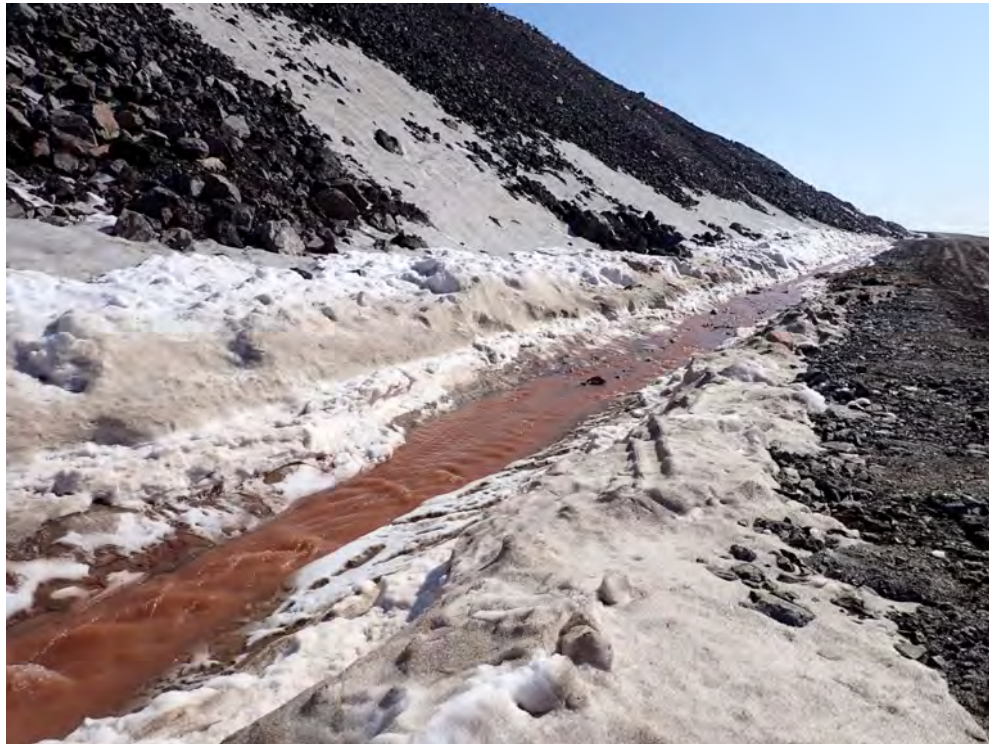
**Photo 4:** Snow Cleared from West Perimeter Ditch Restoring Proper Ditch Gradient and Improving Water Flow, June 21, 2025

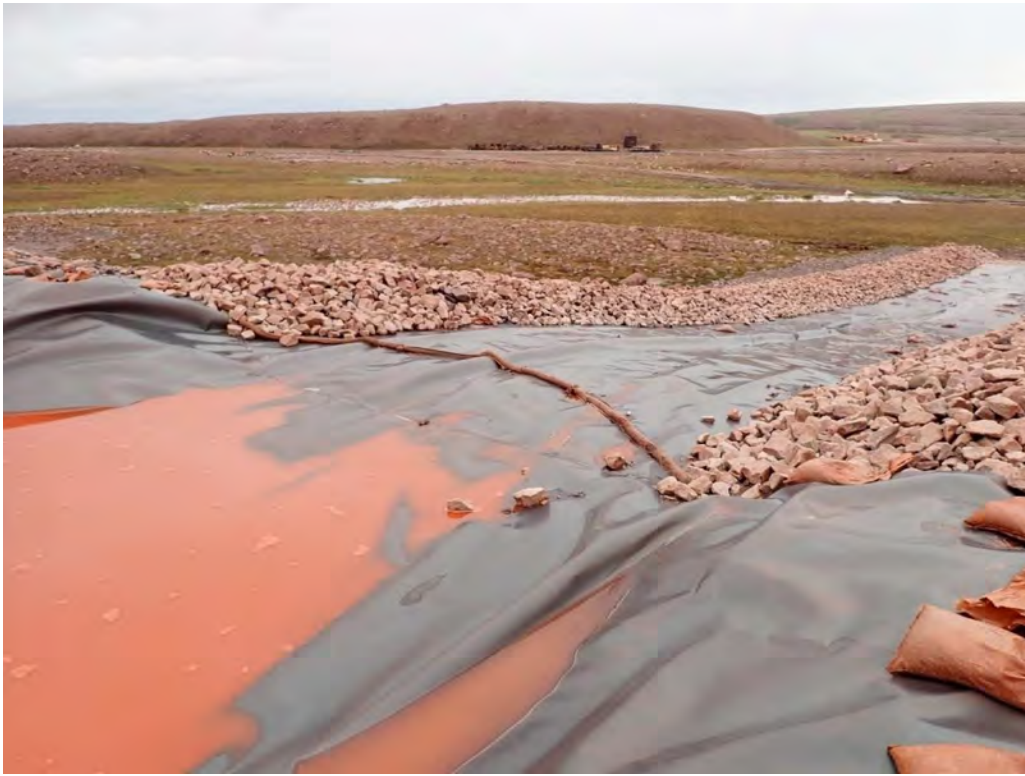
**Photo 1:** Effluent Emerging onto Emergency Spillway of MS-06 Pond at 19:30hrs – July 16, 2025

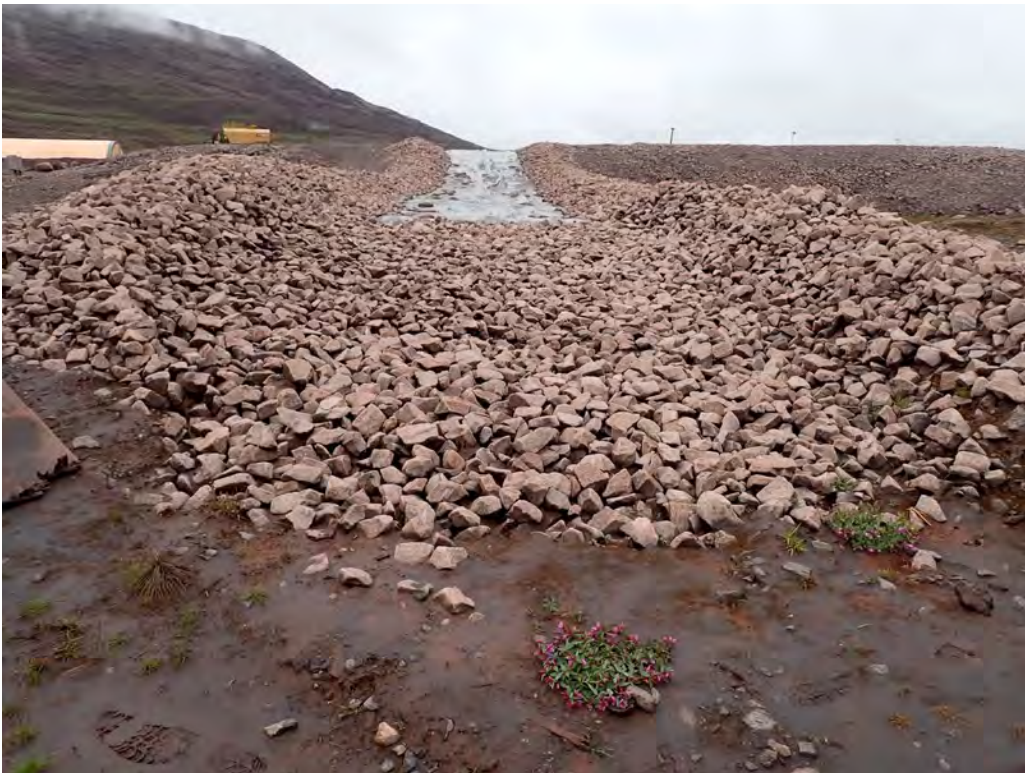
**Photo 2:** Tundra View of Slow Release into Rip Rap below the Emergency Spillway – July 16, 2025

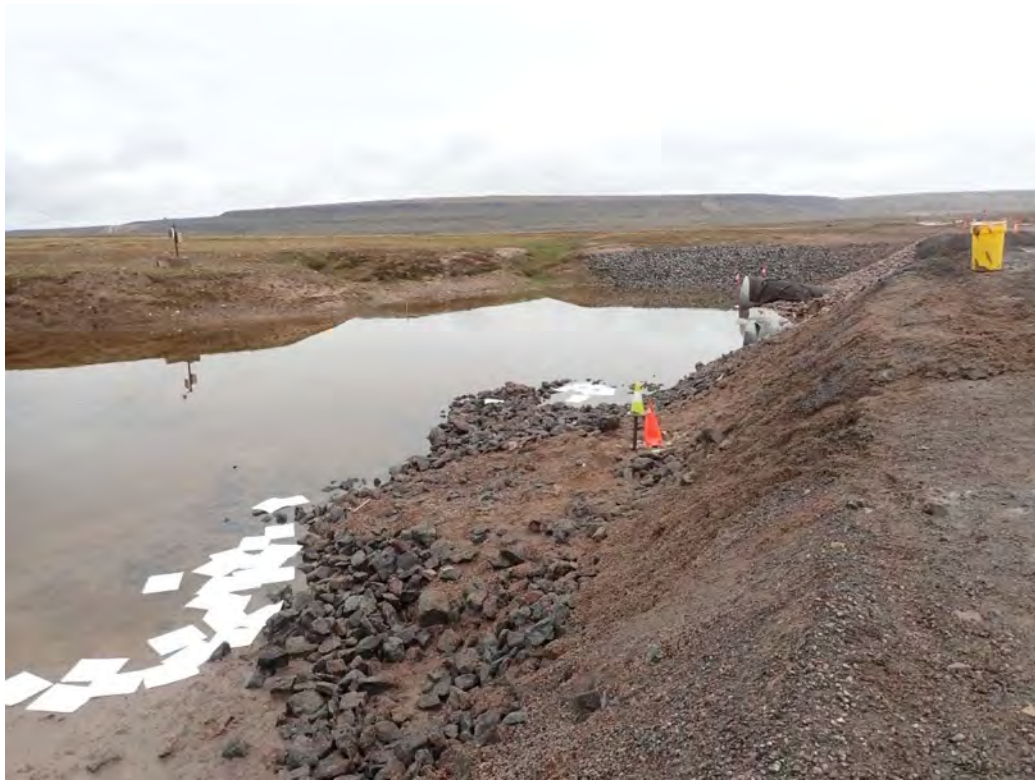
**Photo 1:** Spill Pads Placed on Contaminated Soil and Surface of the Water Upstream of CV-216 – July 16, 2025

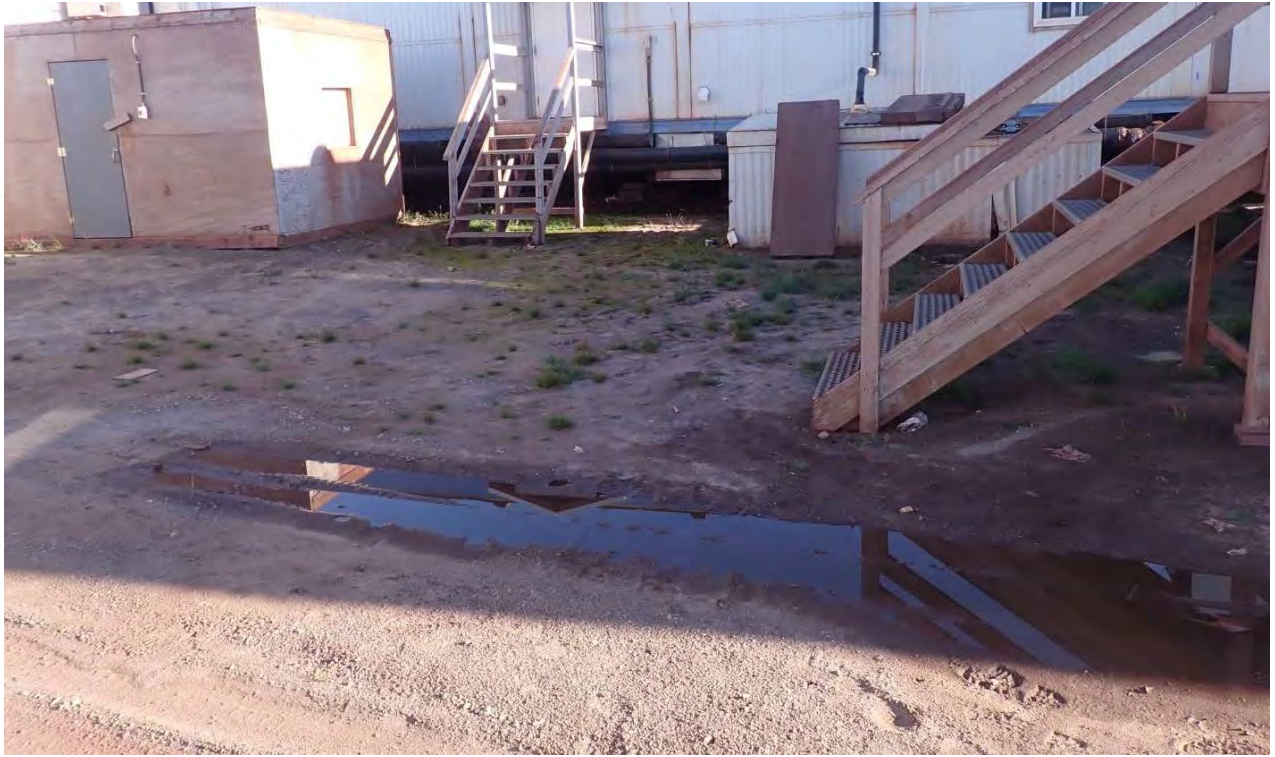
**Photo 1:** MSC Lift Station Release – July 30, 2025

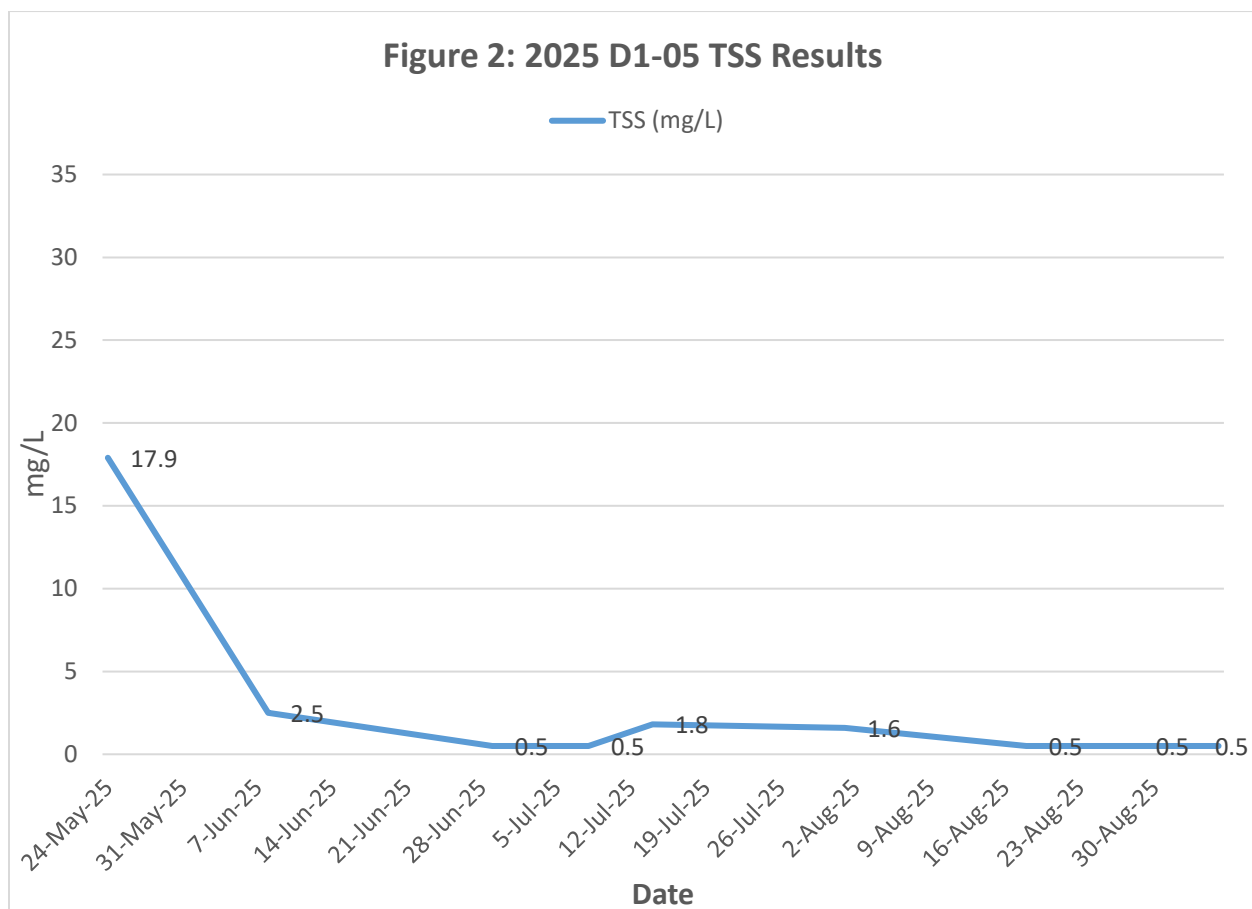
**Figure 2 – TSS Concentrations in Water Quality Samples at D1-05 in 2025**

**Downstream Receiving Environment (D1-05):** Follow-up monitoring was completed at receiving environment monitoring station D1-05 on May 24, 2025, including the full suite of MDMER parameters and acute lethality testing. D1-05 is located approximately 300 m downstream of MS-11 on SLDT-1 and represents the nearest fish-bearing waters. All parameters analyzed at D1-05 were below applicable criteria. Figure 2 shows the results of TSS concentrations in water samples collected at D1-05 in 2025.

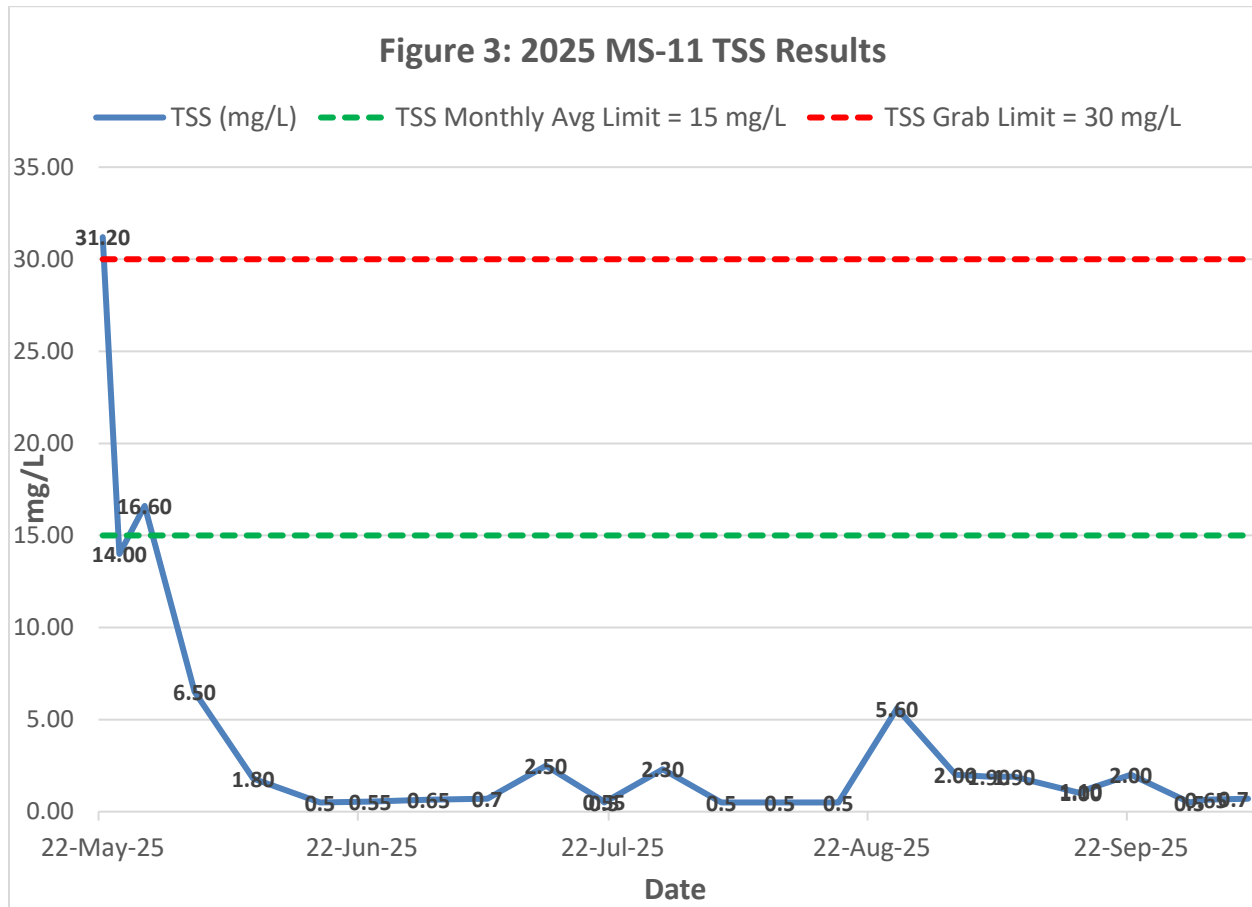
**Figure 3 – TSS Concentrations in Water Quality Samples at MS-11 in 2025**

**TSS Monthly Mean (MS-11):** The May monthly mean TSS at MS-11 was 20.6 mg/L, which exceeded the Water Licence monthly mean maximum concentration of 15 mg/L. The May monthly mean is based on three (3) samples, including one non-permitted follow-up spill sample.

Effluent quality at MS-11 remained compliant for the remainder of the open-water season and through the end of the year when flow was present. Figure 3 shows the results of TSS concentrations in water samples collected at MS-11 in 2025.
