MARY RIVER TOTE ROAD QUARRY RECLAMATION  
MARY RIVER, BAFFIN ISLAND

PLAN - PHOTO LOCATIONS  
SHEET 1 OF 14

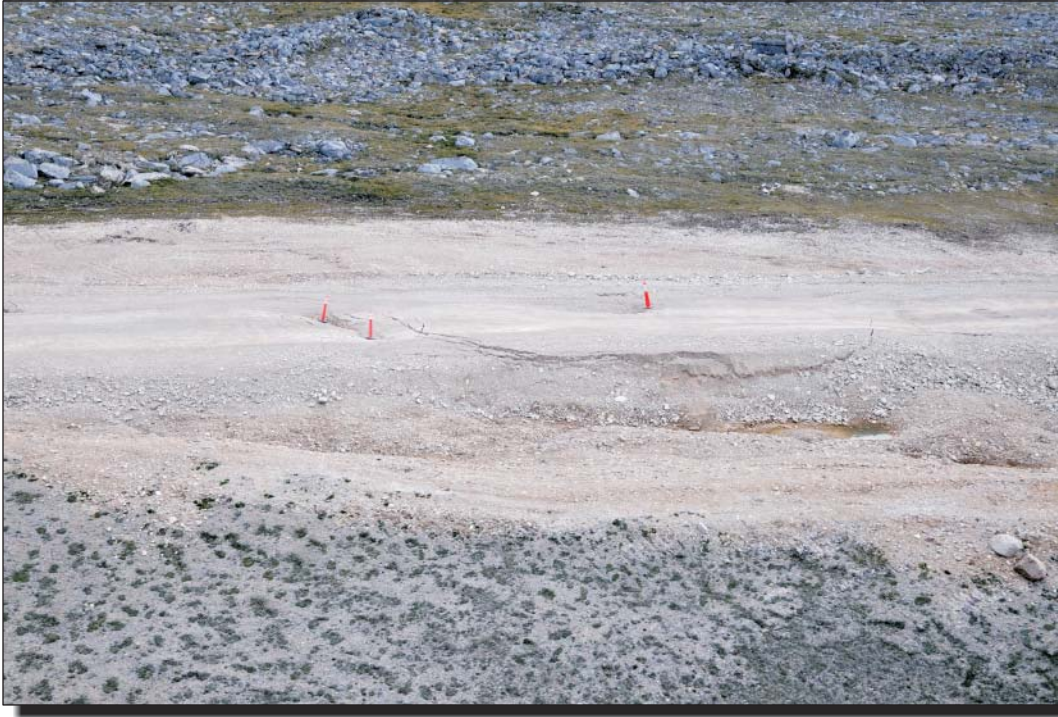
**Photo 3 (DWH 596)**

Road collapse at km 55.4 (WP 35) initiated by thermal erosion from water running through ice wedge exposed in adjacent pit.

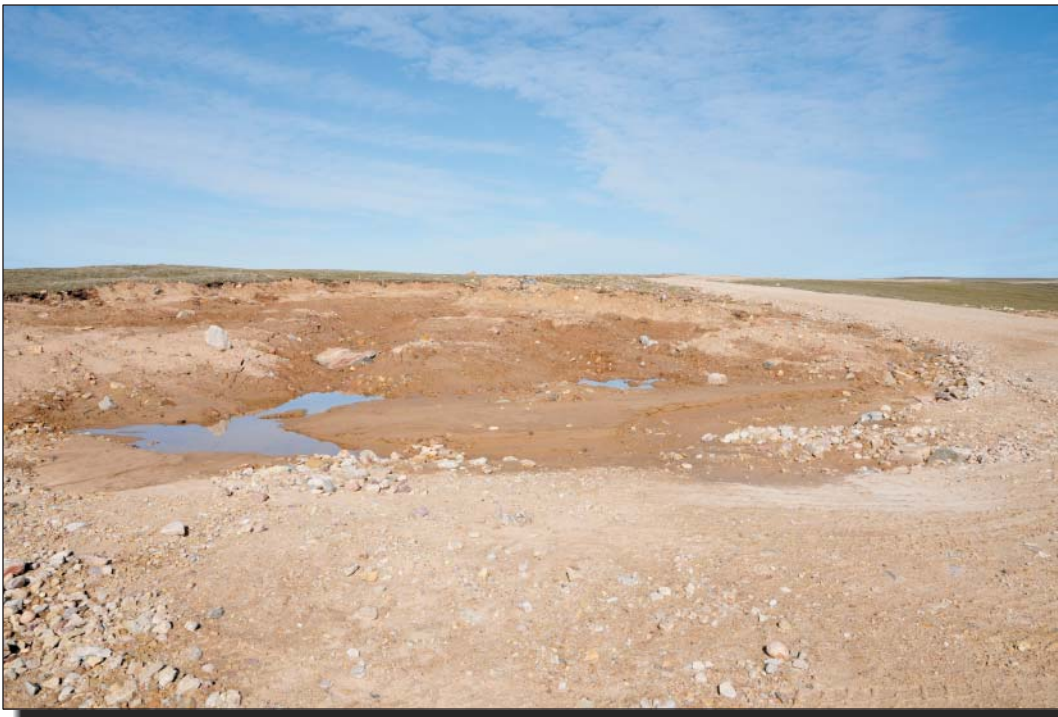
**Photo 4 (DWH 691)**

Pit at km 71.8 (WP 23) typical sinkholes in pit bottom from thaw of segregated ice common in fine-grained lacustrine soils.

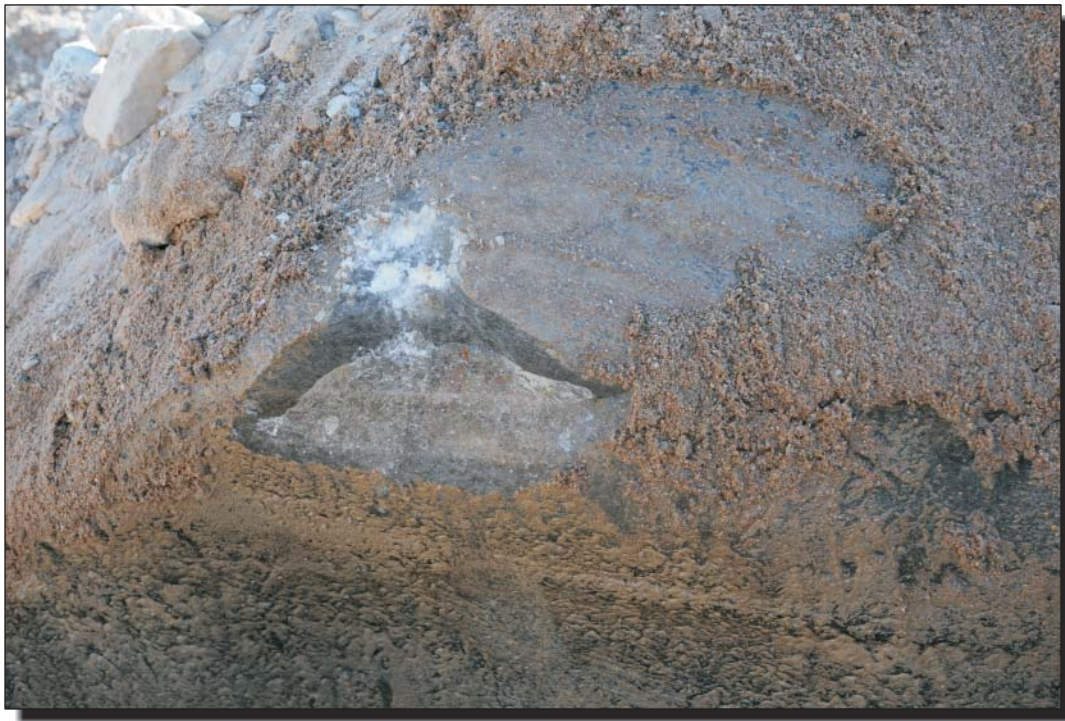
**Photo 5 (DWH 697)**

Pit at km 63.7 (WP 29) exposure of massive ice remaining in pit wall.

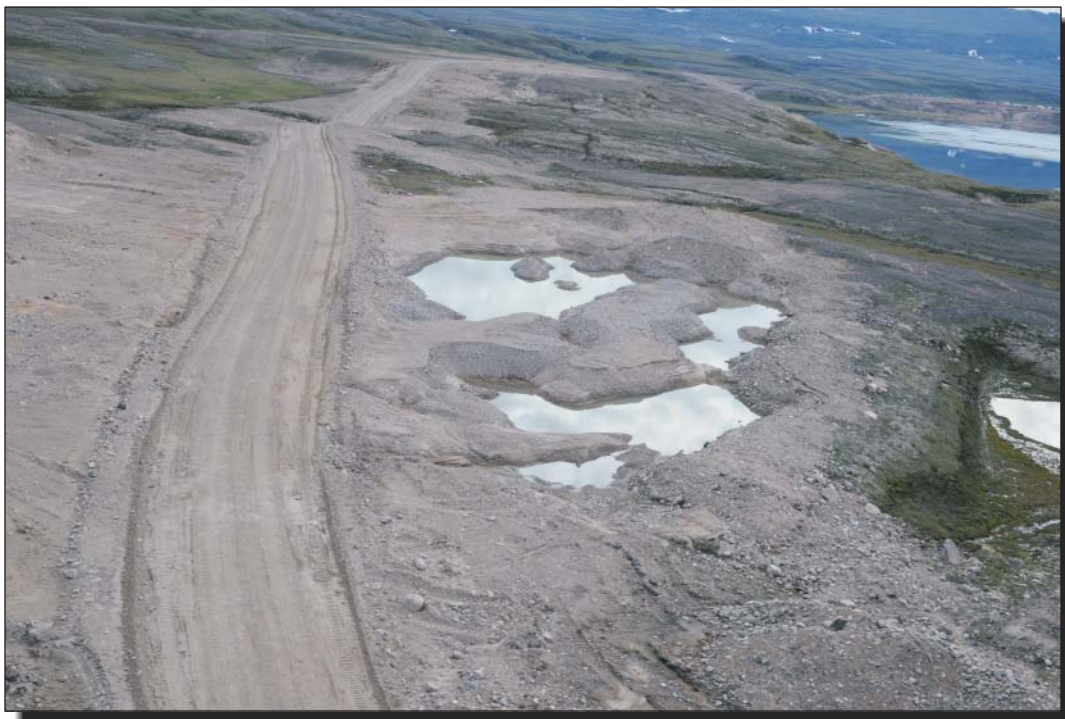
**Photo 6 (DWH 561)**

Pit at km 97.5 (WP 10) typical sinkhole formation from thaw of massive ice.

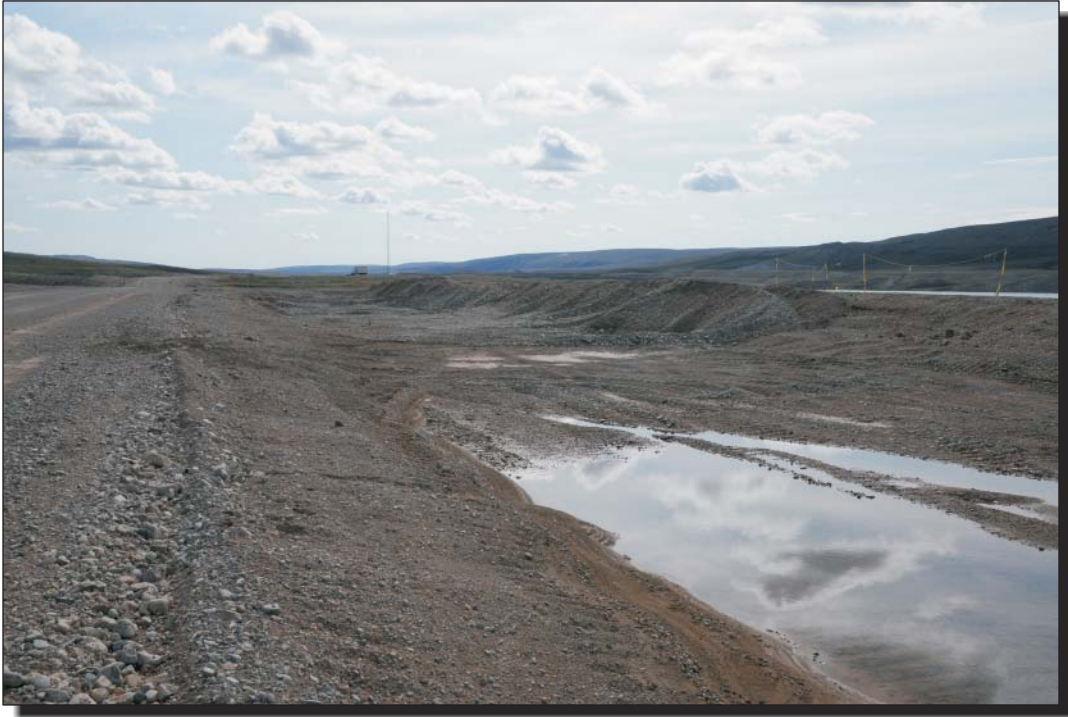
**Photo 7 (DWH 721)**

Pit at km 32.4 (WP 58) typical Priority C pit in thaw stable soils that only requires regrading.

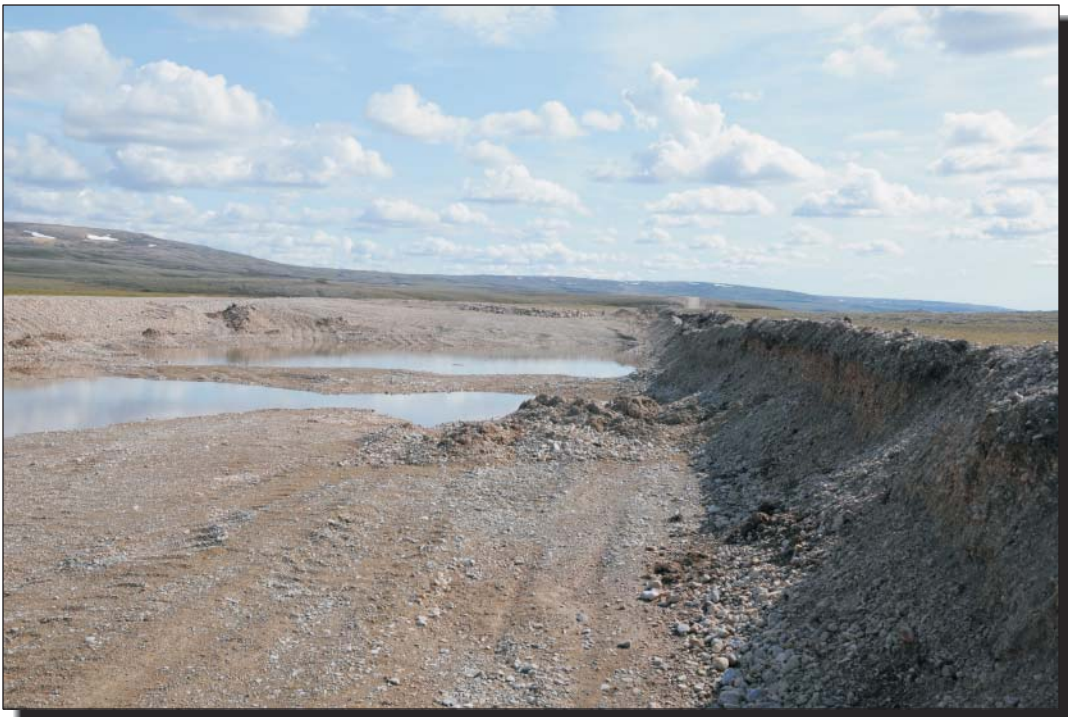
**Photo 8 (DWH 722)**

Pit at km 27.5 (WP 63) vertical cut slope 2 to 3 m high. The thaw-stable soils at this site are stable at this slope. The slope can be graded back to 3:1 by cut and fill.
