3.03 Generator Fuel Storage Containment

This report is the 7th annual Geotechnical Inspection at Mary River and Milne Inlet completed by this author on behalf of Baffinland Iron Mines Corporation and the first report covering two inspections in one shipping season.

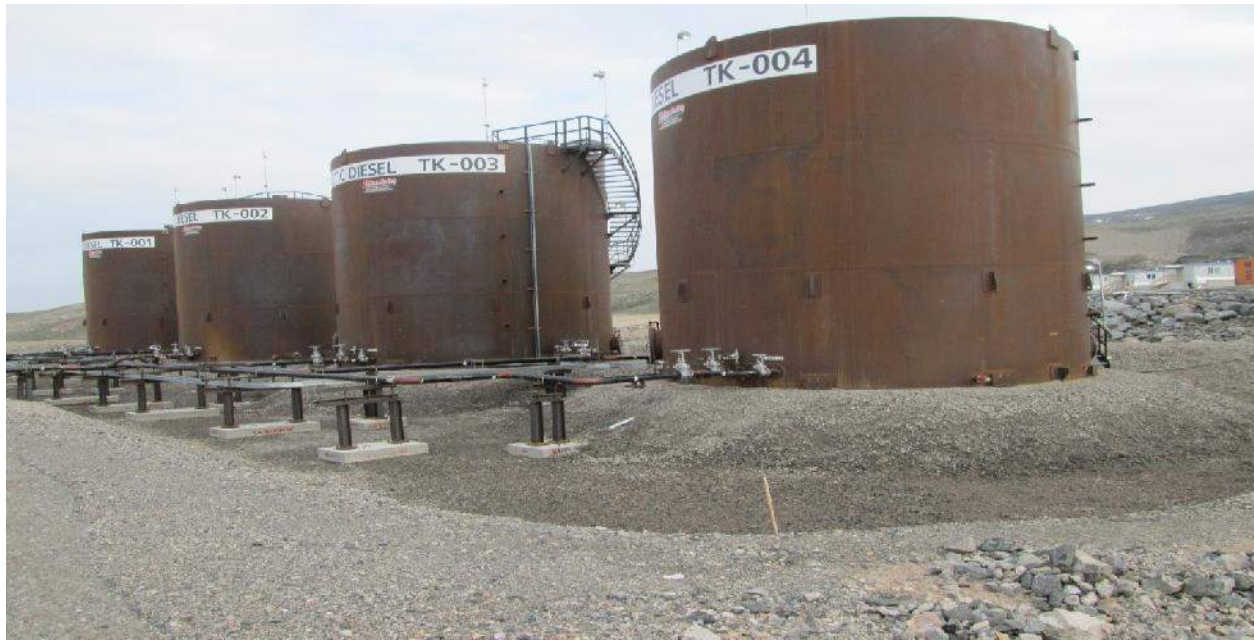
Minesite Steel Fuel Tank Farm Containment

All work appears to be complete excepting the installation of the sump pits that are on site awaiting installation and which shall be utilized to facilitate the removal of water that collects from precipitation.

All work appears to have been completed in accordance with drawings and we have no concerns with the stability of this containment structure.

We have no recommendations to make with respect to this containment once the sump is installed.

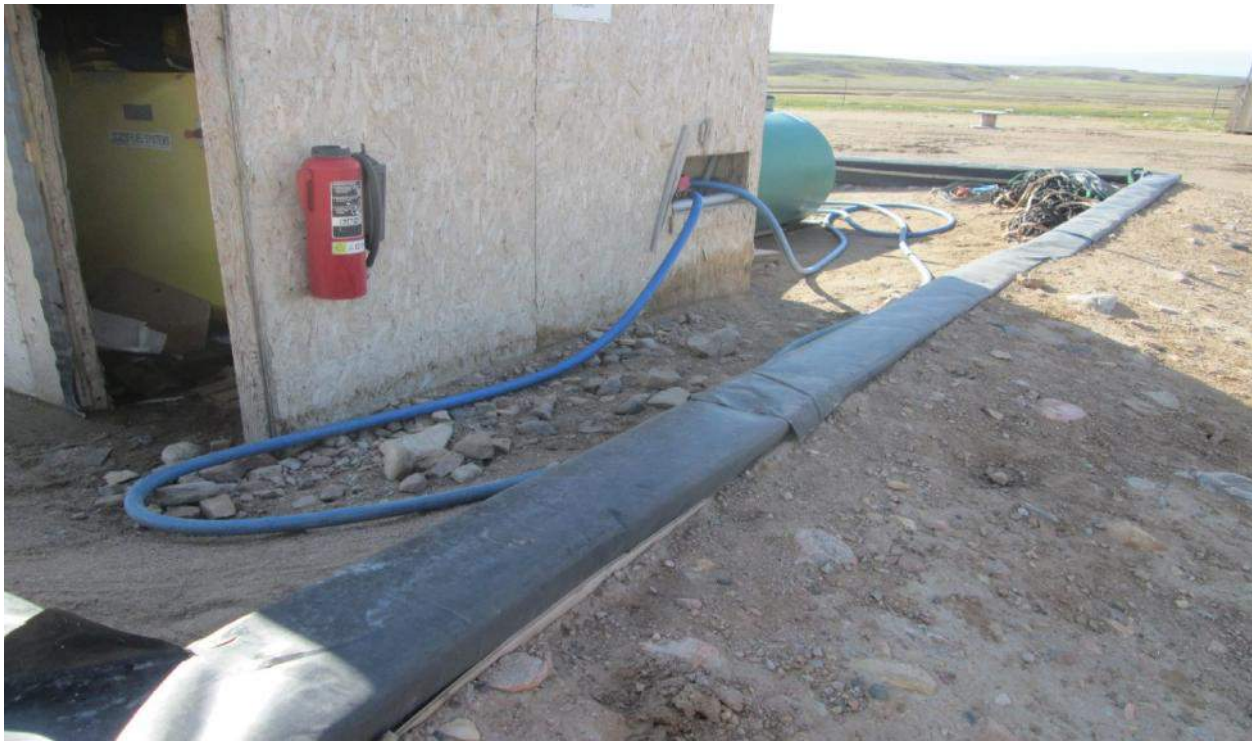
Helicopter Fuel Tank Containment.

Our review of the area around the pond at the base of the slopes showed no sign of seepage. There is a minor amount of water ponding in the bottom of the containment indicating the integrity of the liner.

A review of the exterior and the top of the berms showed no sign of cracking or settlement which would indicate stress within the structure.

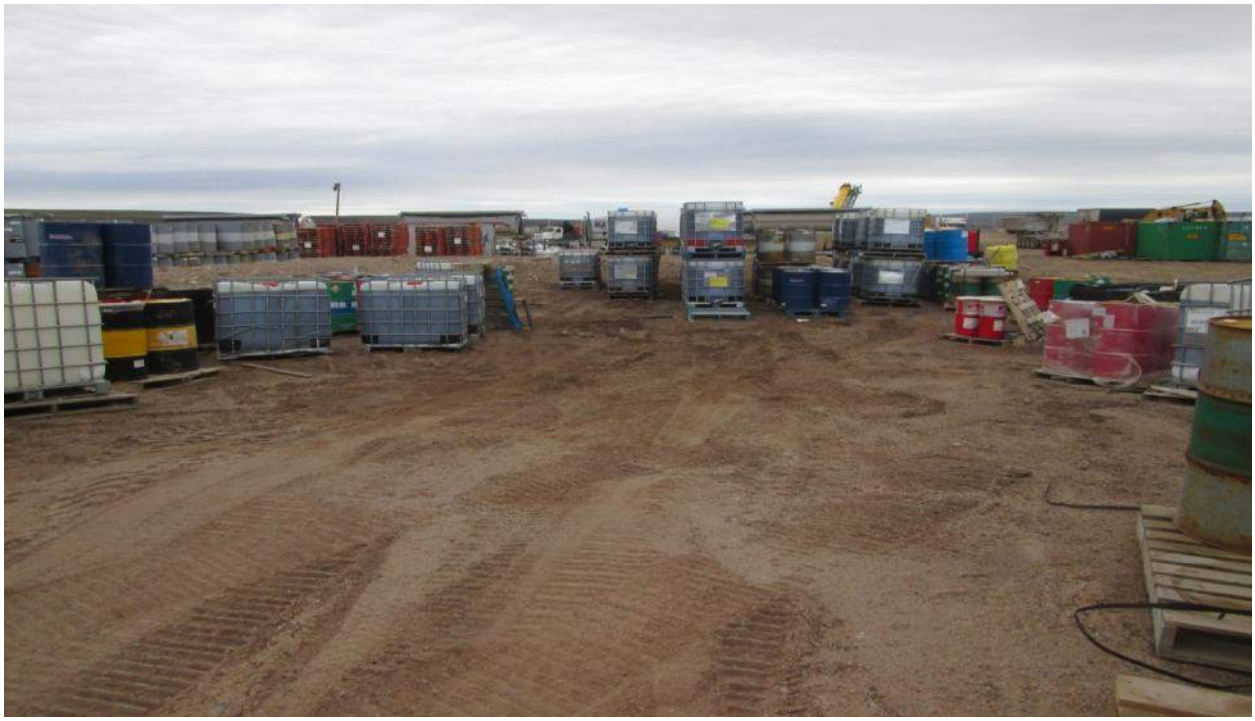
Barrel Fuel Containment.

Our review of the area around this containment structure showed no sign of seepage. This shows that there is reasonably little chance of tearing or rupture of the membrane having taken place.

A review of the exterior and top of the dyke showed no sign of cracking or settlement which would indicate stresses within the structure.

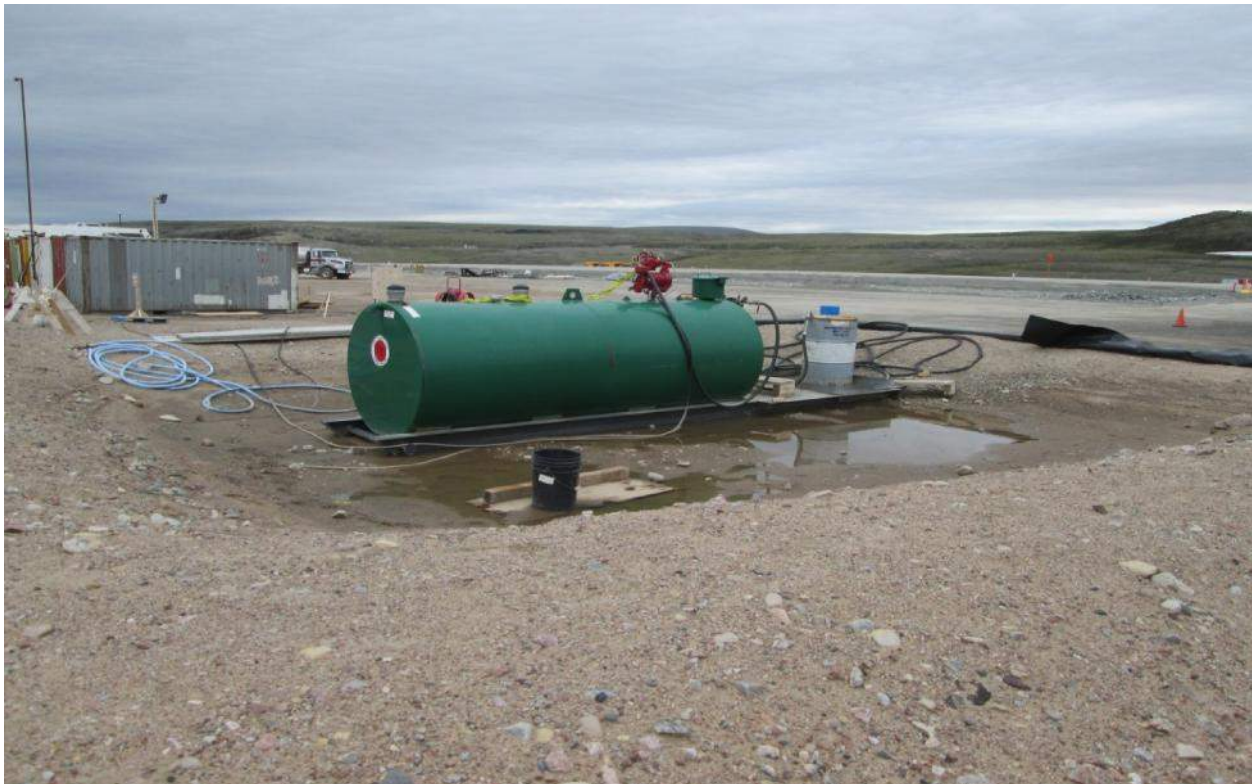
Jet Fuel Containment.

The construction appears proper and the structure is in good condition.

Minor water ponding confirms the integrity of the liner.

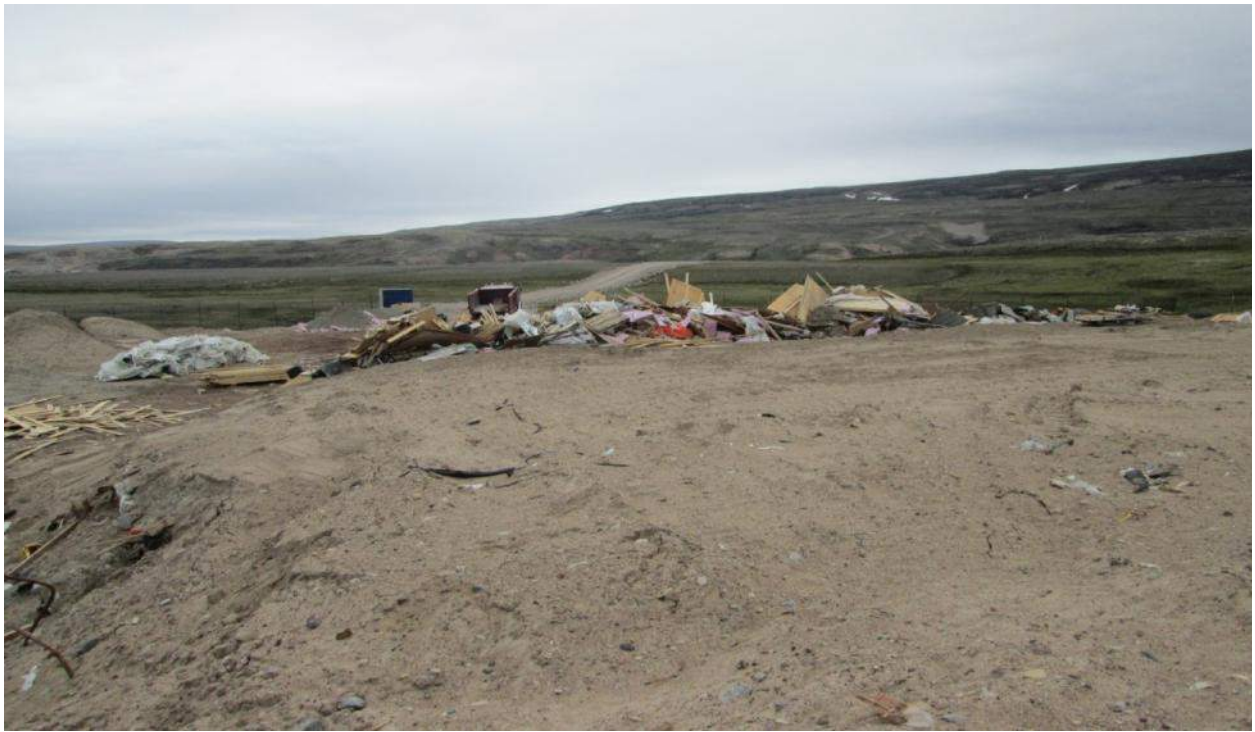
Solid Waste Disposal Site.

Berms appear stable and no erosion appears to have taken place on the back and both sides of the site.

Solid waste was being placed at the front edge of the site and was awaiting salvage of wood and lumber prior to the placing of cover at the time of our first site review in August. There was considerably more waste covered during the time of our second review on September 25th.

The current footprint as established by the existing covered material and the “blow control” fence at the front of the immediate site shall soon be filled and the site footprint shall have to be expanded within the plans and guidelines set out for this solid waste disposal site.

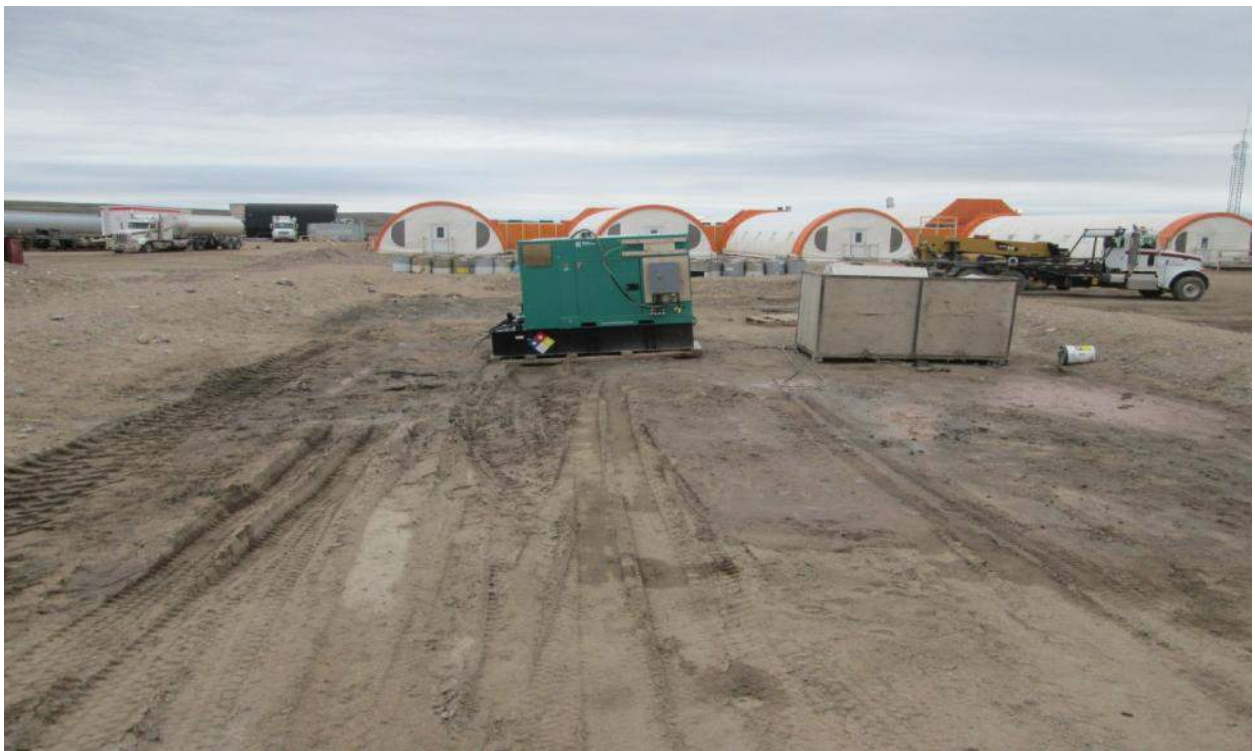
Enviro Tank Storage

There was concern for the integrity of this cell as the cell was dry and the geotextile is exposed from heavy traffic during our initial inspection. During our second inspection, the cell was holding a small amount of water confirming the integrity of the liner.

We recommend that the geotextile over the liner and the granular cover be made good prior to continuing use of this cell as a wash down cell.

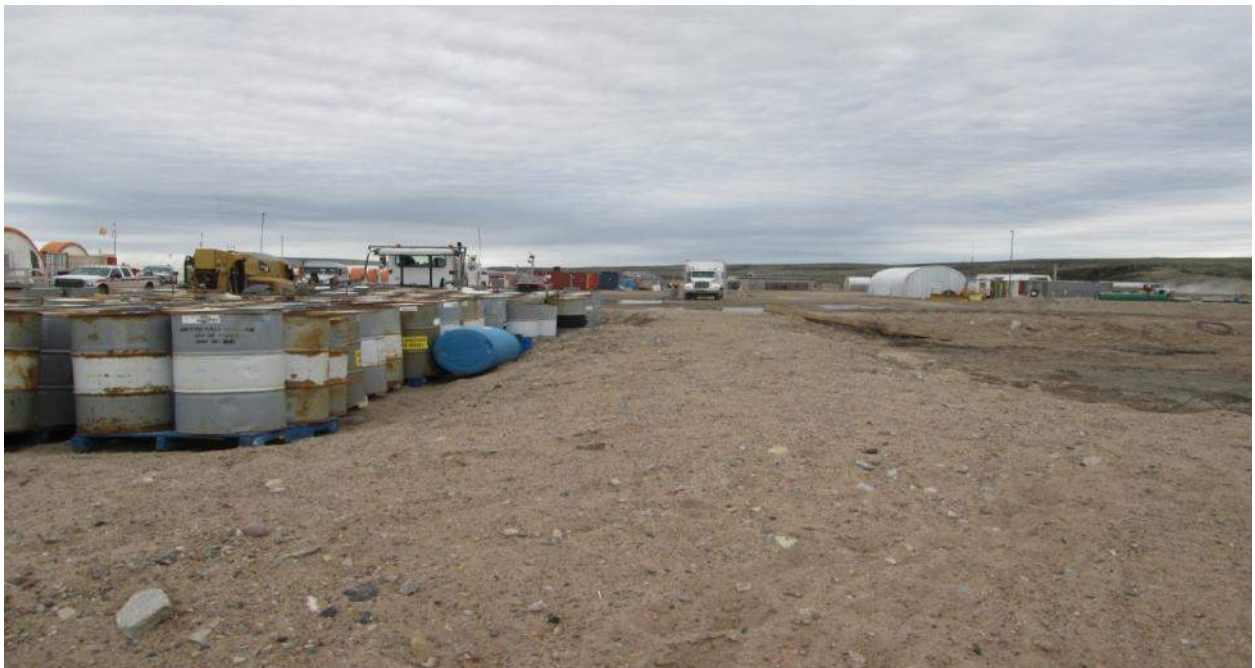
Stove Oil Storage.

Our review of the area around the containment structure shows no sign of seepage. This shows that there is reasonably little chance of tearing or rupture of the membrane having taken place.

A review of the exterior and the top of the dyke showed no sign of cracking or settlement which would indicate stresses with the structure.
