SNC • LAVALIN	Technical Report		Revision	
	Geotechnical Site Inspection		#	Date
	Report No.: 640120-0000-000-4GER-0001		0	2016-09-22
				Page 1 of 26

CLIENT: Indigenous and Northern Affairs Canada (INAC) PROJECT: Mary River Project – Annual Geotechnical Site Inspection (2016)
--	---

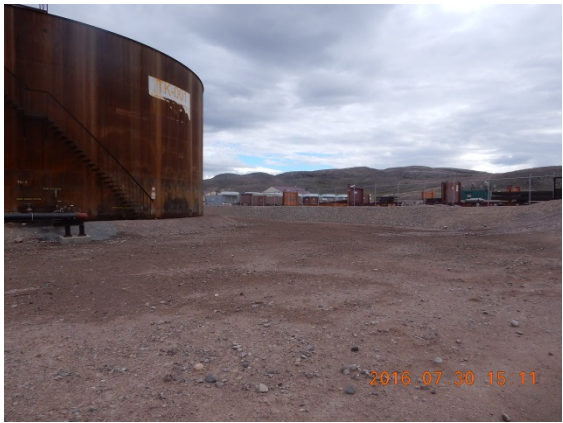
Figures 2 to 5 describe the general situation with respect to earthwork and its long term performance and performance during an annual rainfall event. All of the liquid and solid hazardous waste containments at the site are lined with geo-membrane. The material used in the construction of these embankments or berms or dikes are from local granular borrows. These granular materials hold less water and are less prone to degradation on freeze-thaw cycles. These materials have full gradation sizes from gravel to fine size and compact reasonably well with tracked or other appropriate machinery. The embankment or the berms, as a structural unit, are performing satisfactorily. The embankment or berm slope profiles, and the earthworks profile at the subgrade level are straight and smooth,

<p>Figure 2: A View of the Port Site Bulk Fuel Tank Farm Secondary Containment Dike Earthworks</p>	<p>Figure 3: A View of the Mine Site PWSP Pond Liner, Embankment Earthworks and its Immediate Vicinity</p>

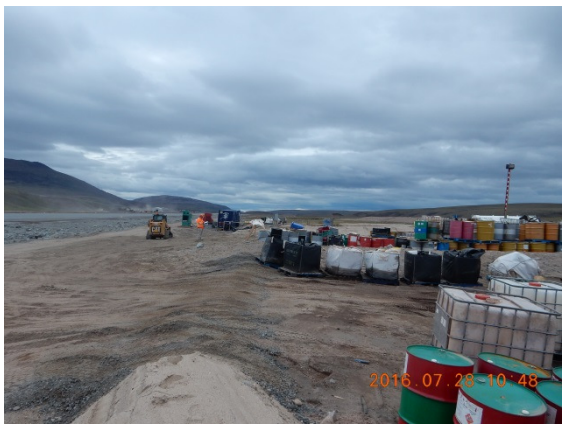
<p>Figure 4: A View of the Mine Site Hazardous Waste Containment Dike Earthworks, Access Arrangements and General Vicinity</p>	<p>Figure 5: A View of the Mine Haul Road Surface Conditions and Side Drainage Arrangements During an Annual Rainfall Event</p>

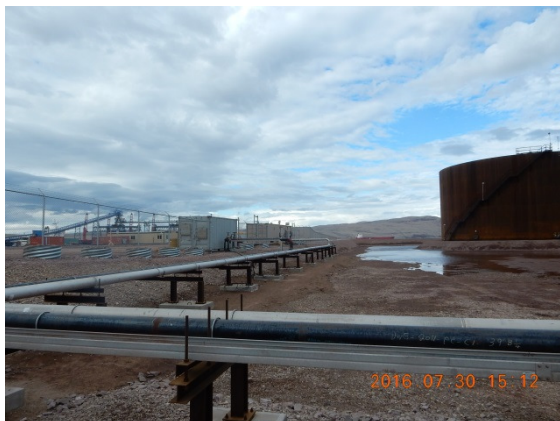
The re-fuelling module, at the Port Site was not operational during this visit but may be grouped under this heading during the next inspection. Figures 6 and 7 show the secondary containment details such as: containment floors, containment dikes, tank foundations, interior pipelines and other operational ancillaries, and fence where applicable. The secondary containment is made up of, primarily, geo-membrane liner both on the containment floor up to and extending over the dikes. The dikes and the cover on the geo-membrane are constructed with sand and gravel and with granular fill as slope protection or wind/rain erosion protection. There were no penetrations through the containment dike systems, it appears all the piping, cables and other related service gear is mounted over the containment dikes. Both the mine site facilities are open facilities while the facility at Milne Inlet Port Site is fenced and locked. Each of these three facilities are located on an isolated spot with no outside catchment draining into these secondary containment areas, therefore servicing exclusively as its own catchment. Further, the three facilities are not located along any drainage paths; hence there is little potential for washouts during any significant runoff events.

Figure 6: A View of the Milne Inlet Port Site Bulk Fuel Storage Tank Farm

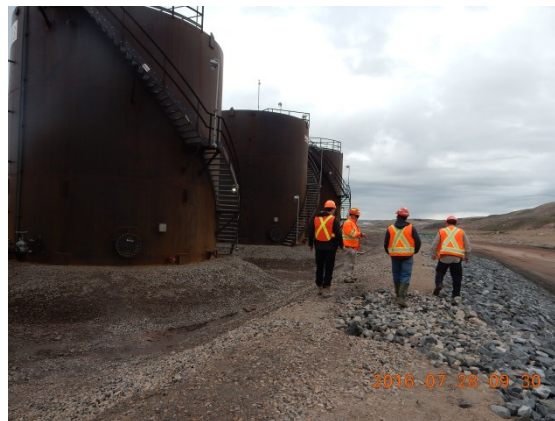
Figure 7: A View of the Mine Site Bulk Fuel Storage Tank Farm

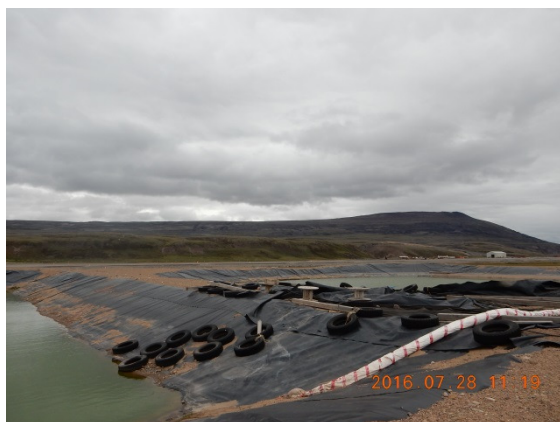
Figure 8: A View of the PWSP Ponds 2 and 3 at Mine Site

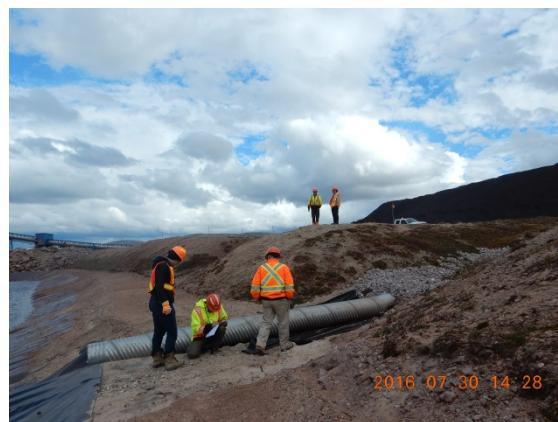
Figure 9: A View of the Crushed Ore Stockpile Pond at Milne Inlet Port Site

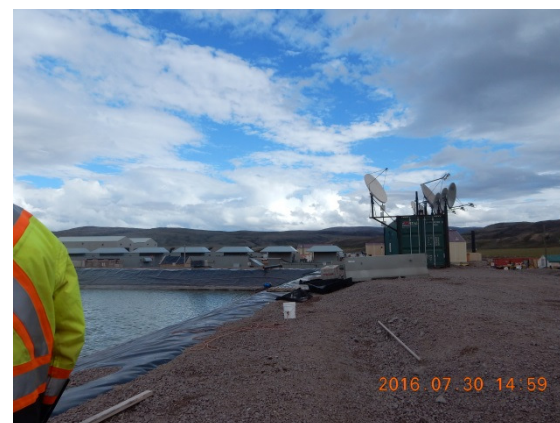
Figure 10: A View of the PWSP Pond at Port Site

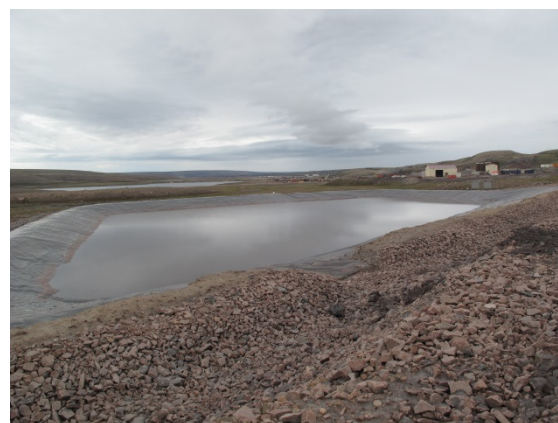
Figure 11: A View of the Ore Crushing Settling Pond at Mine Site

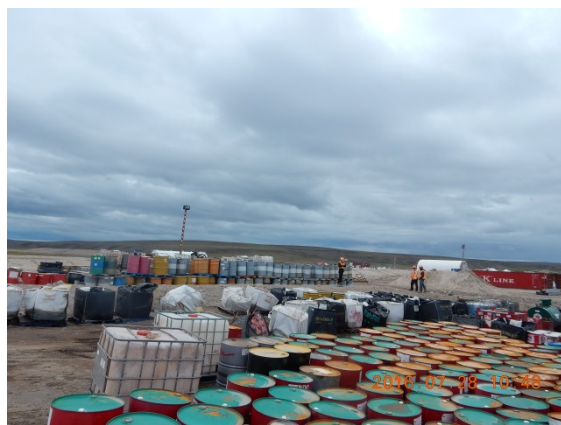
There are several hazardous waste and environmental containment systems at the project site and some have been operational since the early exploration phase. Figures 12 and 13 show some typical containment details. These are all geo-membrane lined facilities, with the liner both on the base, up to and extending over the crest of the perimeter dikes. The dikes and the cover on the geo-membrane are constructed with sand and gravel fill. Many of these facilities are drive-through facilities, allowing loaded vehicles to enter the containment to place the waste. Drive-through access is allowed from one of the dikes which has a lower crest for the drive-through section and a ramp on either side. There are no penetrations (i.e., for pipelines or cables or other services) through any of these facilities, these services are typically run over the crest of the dikes. All of these facilities are open facilities with no fence or access control. Access control is mainly through signs posted at some facilities, though several signs had fallen over. All of these facilities are located on relatively level platforms with no outside catchment draining into these containments.

Figure 12: A View of the Hazardous/Environmental Waste Containment at Mine Site

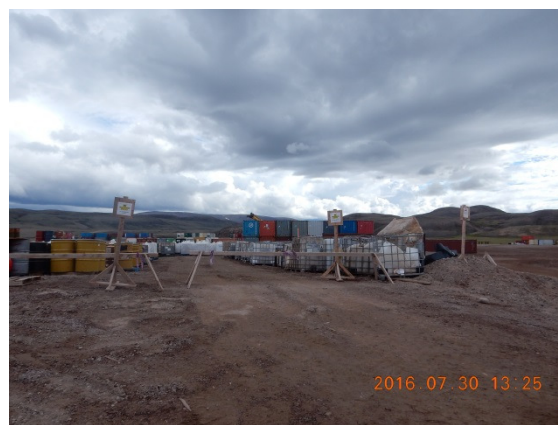
Figure 13: A View of the Hazardous/Environmental Waste Containment at Milne Inlet Port Site

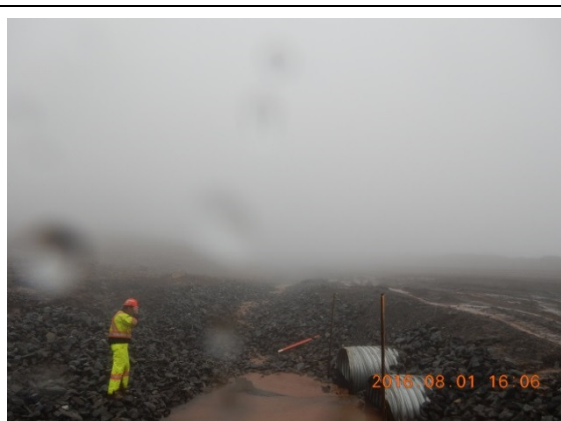
In general the ditches, culverts, check dams and runoff collection/ sedimentation control ponds, silt fences along the disturbed drainage areas and mine hill side slopes all along the Mine Haul Road appeared functional (See Figures 14 and 15). However, there are limited sections of the Haul Road where soil conditions are prone to excessive sediment load, particularly the upper reach areas where the flow was laden with clay/silt (red colouration). Some drainage sections were not functional resulting in flows over the Haul Road, deterioration of the road surface, and disruption to hauling operations.

Figure 14: A View of the Drainage and Culvert Along a Section of the Haul Road

It is recommended that a senior geotechnical engineer should do a walk-over survey of the Mine Haul Road and map the geology of the area and identify areas which are more prone to silt loading and where a closely-spaced series of check dams and sedimentation ponds may be required to prevent silt load flowing over the mountain slopes. A hydraulic engineer should check the adequacy of drainage measures along the Haul Road so that water does not accumulate and saturate the berms or slopes and result in sloughing. This will also prevent disruptions to the hauling operations. Both these experts should also ensure that Haul Road profile and drainage profiles are maintained to the design grades to ensure smooth runoff.

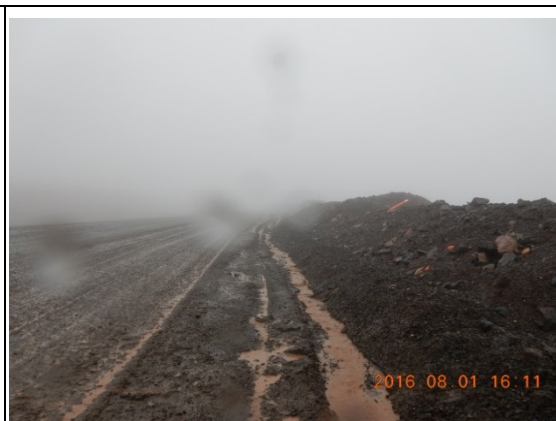
Figure 15: A View of the Drainage Along the Berm Side of Mine Haul Road

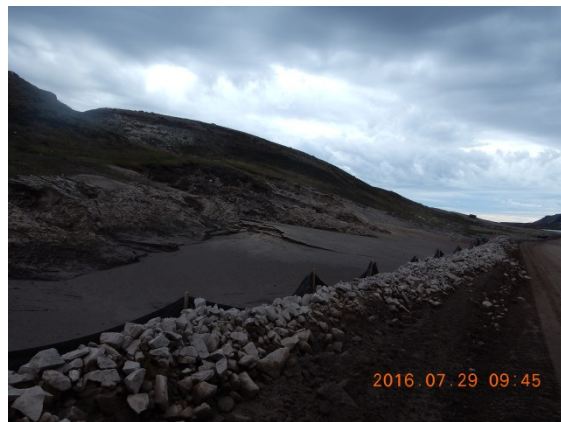
During this inspection of Tote Road prior to the rainfall event, the generation of road dust appeared to be under control with application of water, and/or calcium chloride (salt) on the road surface. In general the road surfaces, ditches, culverts and sedimentation control ponds, silt fences along the disturbed drainage areas and the side slopes all along the road appear relatively functional (See Figures 16 and 17). At KM 90.5, there is a localised instability of the hill slope (See Figure 16).

Figure 16: A View of a Problematic Section of the Tote Road. Ground sloughing – Sand/Silt Deposit with Steep Slopes

The material at KM 90.5 there appeared be sandy deposits which soften on saturation and result in instability. However, no major siltation issues were identified at this location. There are some localised sections along the road where perhaps soil conditions are prone to sloughing on excessive wetness and could result in silt loading to drainages; these would need more attention than other areas both for maintenance and engineering for a permanent solution.

It is recommended that a senior geotechnical engineer should do a walk-over survey of the Tote Road and map the geology of the area and identify areas which are more prone to sloughing and silt loading and provide a closely spaced series of check dams; reinforcement of side slopes and upgraded surface water management.

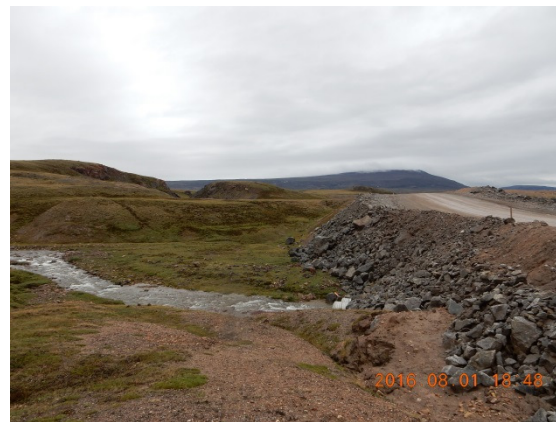
Figure 17: A View of a Typical Drainage Crossing Along the Tote Road (Soon After a Rainfall Event)
