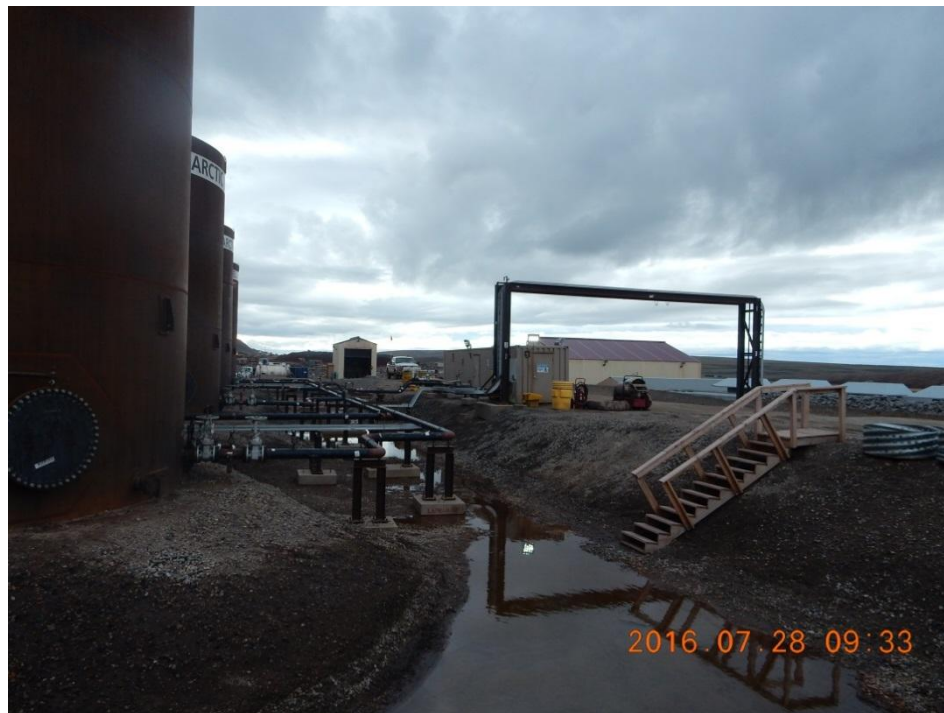
**Photo 1: Bulk Fuel Storage Tank Farm Mine Site - Secondary Containment Dike**

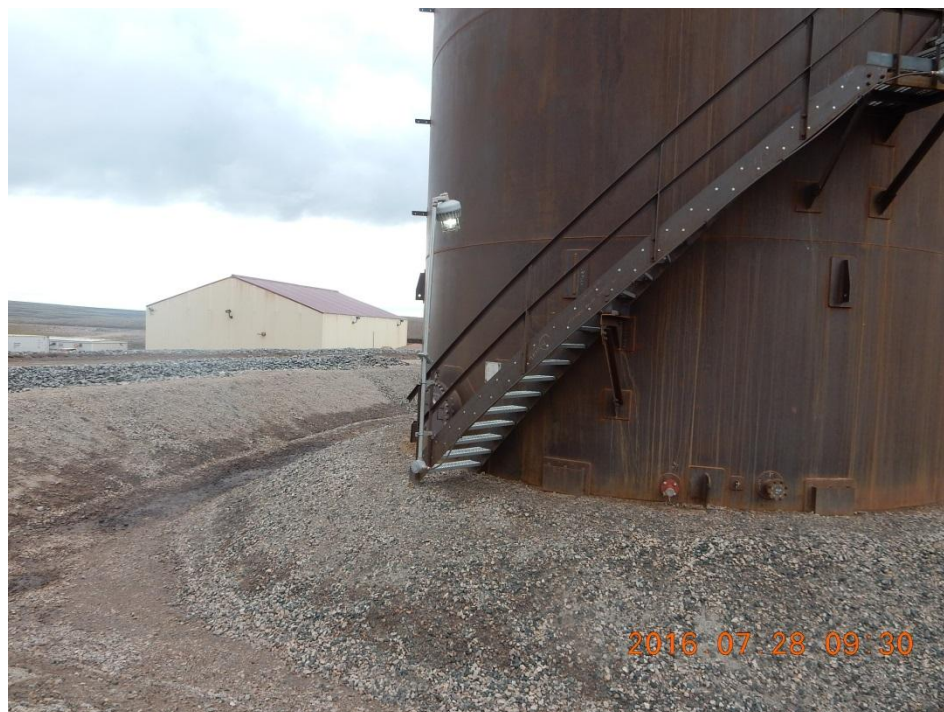
**Photo 2: Typical Conditions of the Secondary Containment Base and the Dike**

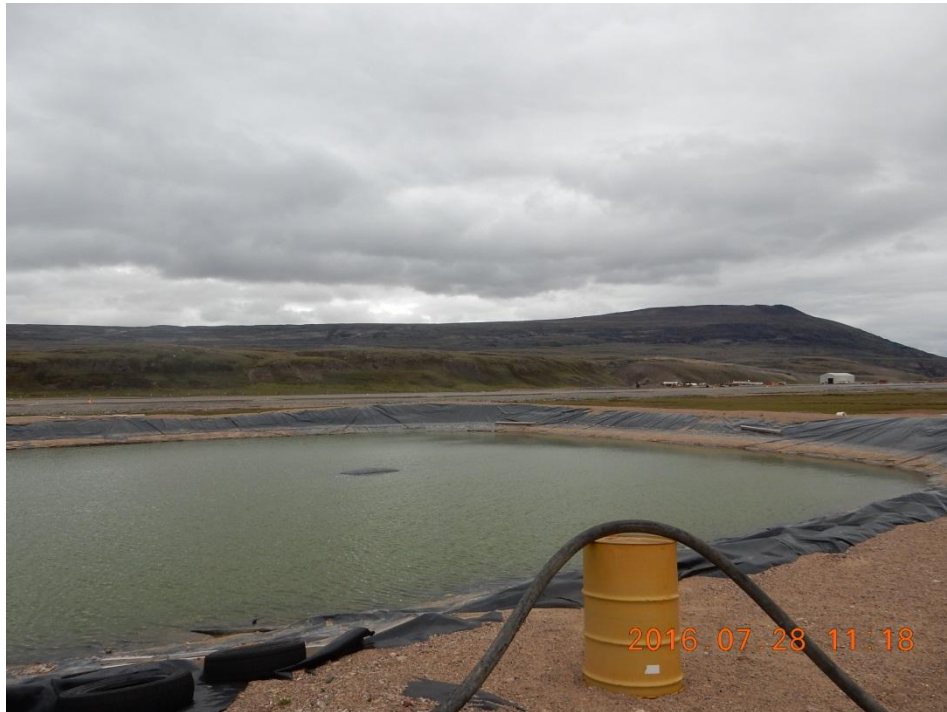
**Photo 8: PWSP Pond 3 – Basin and Its Dikes**

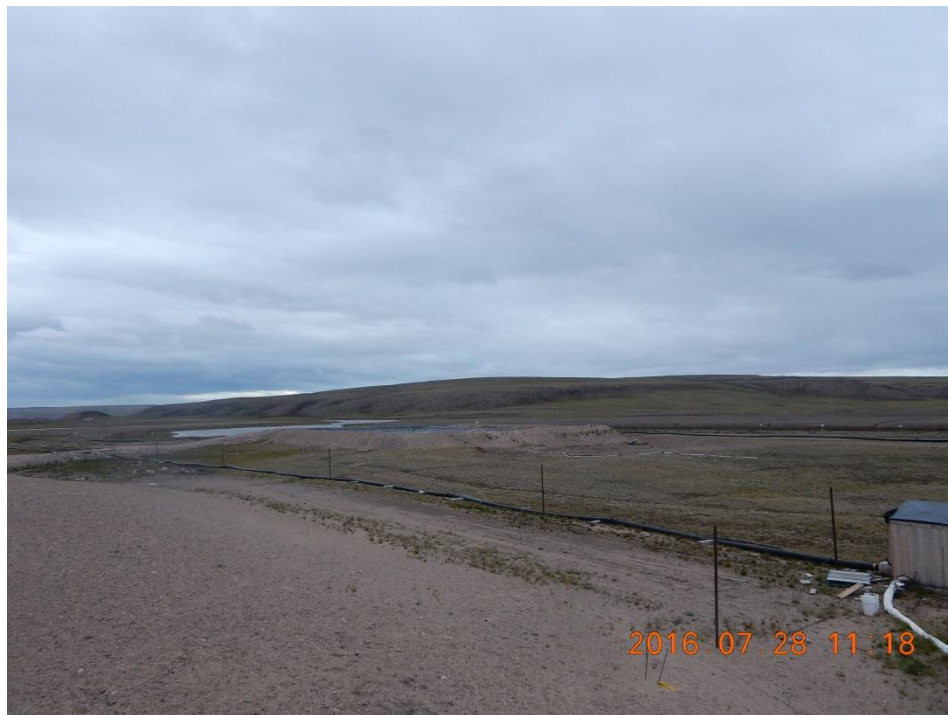
**Photo 9: PWSP Pond 3 - Typical Conditions of the Dike, its Outside Slope and Vicinity**

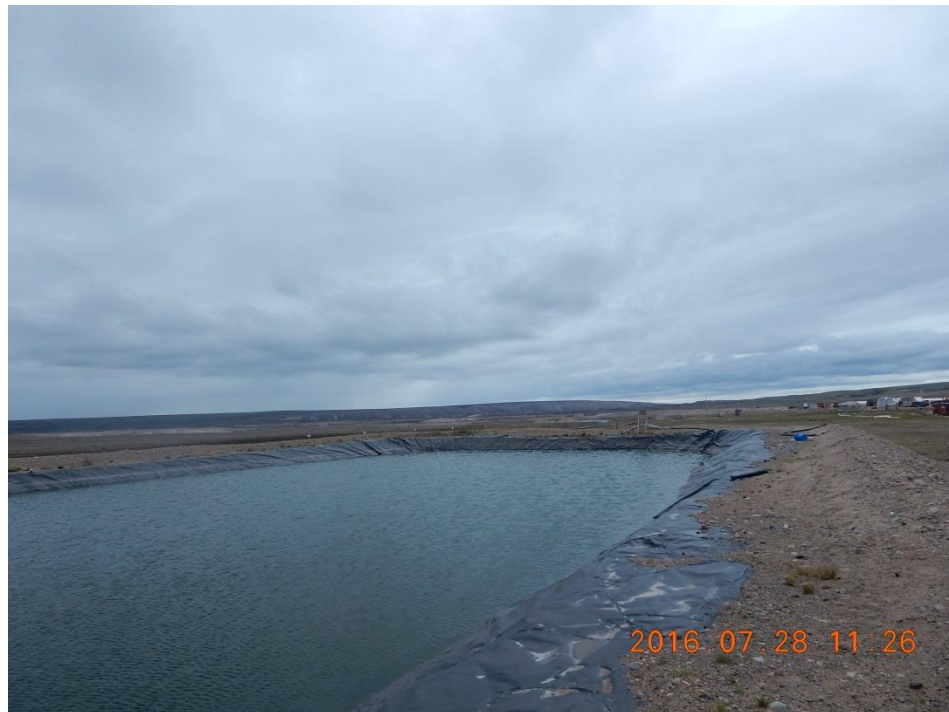
**Photo 10: A View of PWSP Pond 2 (Facing North) and a View of its East Dike**

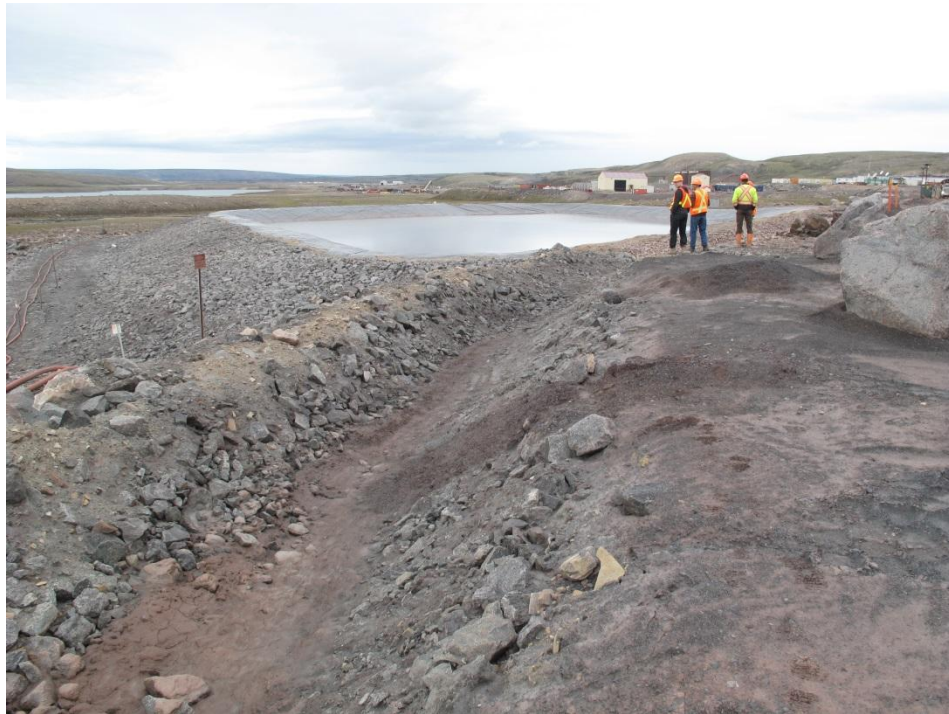
**Photo 16: A View of Sedimentation Pond Crusher Pad Area at Mine Site**

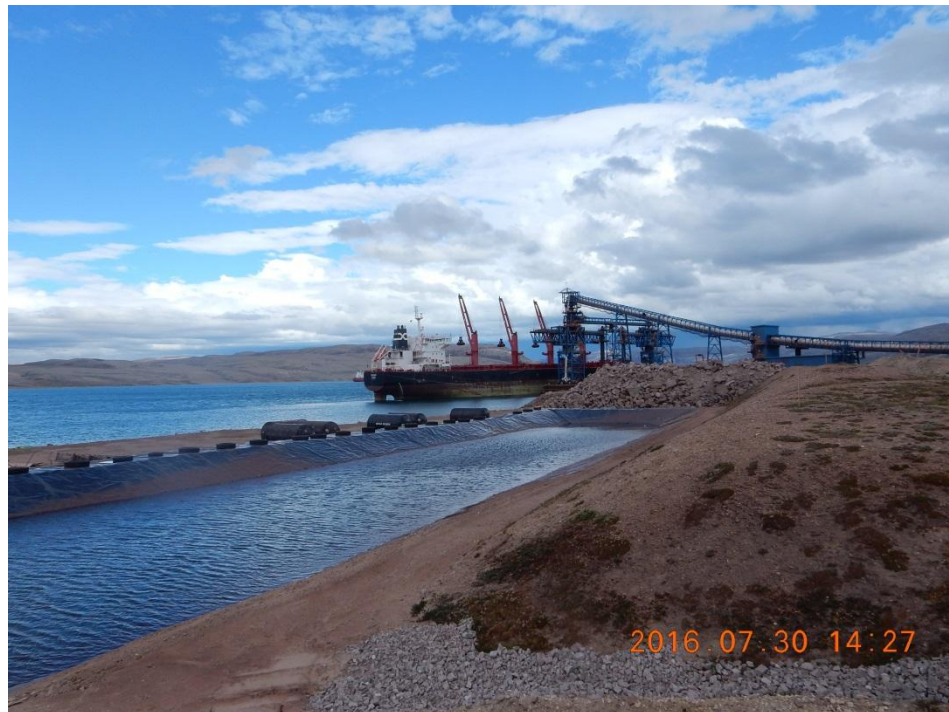
**Photo 20: A View of Sedimentation Pond (West) Port Area**

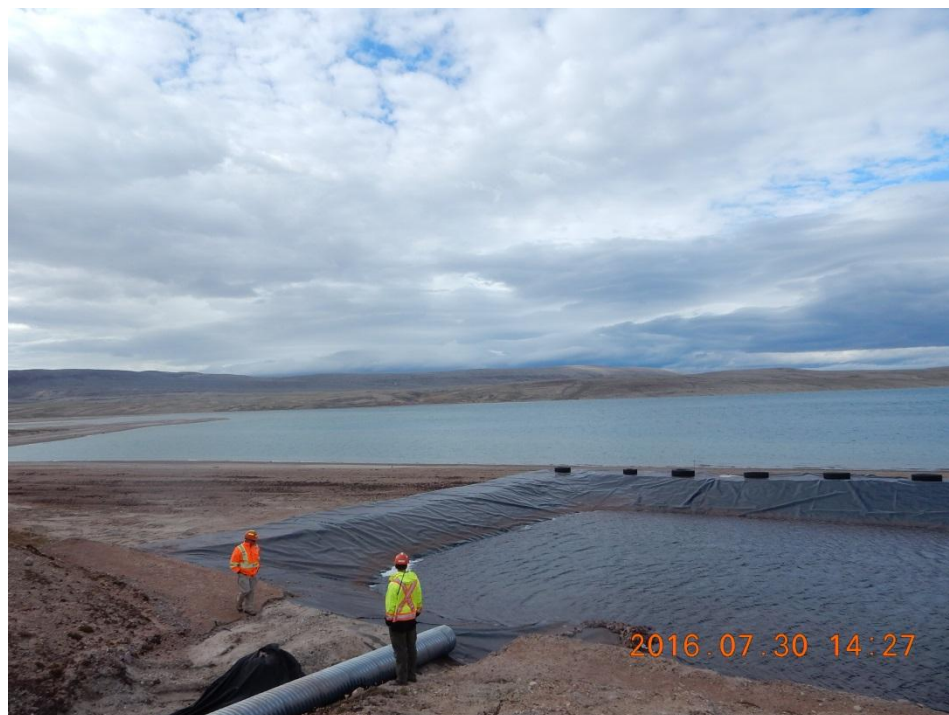
**Photo 21: A close-up of Inlet to Sedimentation Pond (West) Port Area**

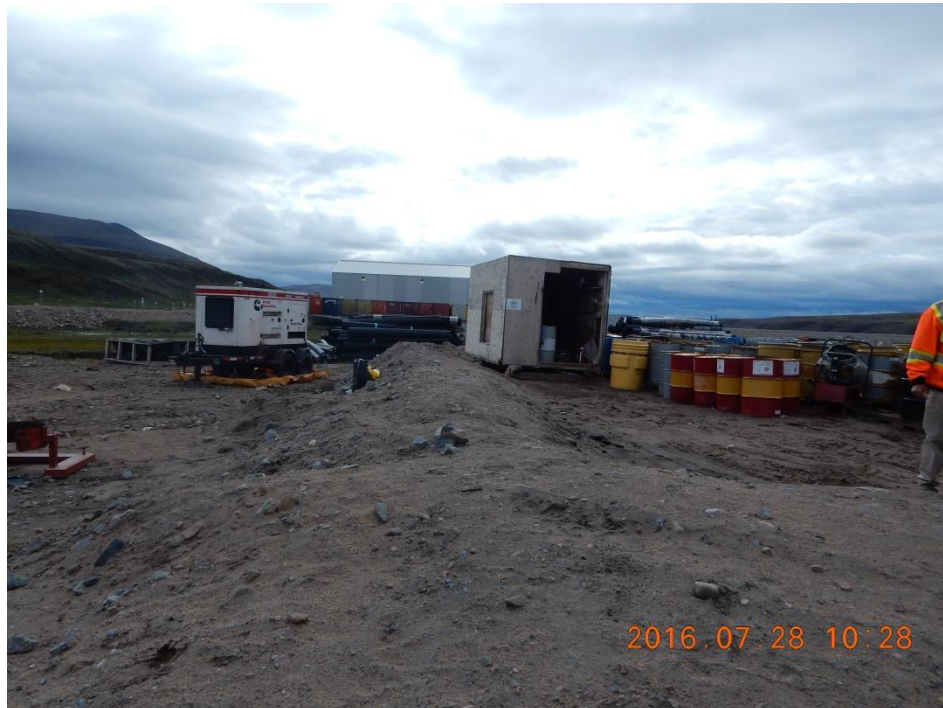
**Photo 24: Mine Site Hazardous Waste Storage – its Contents and Dike**

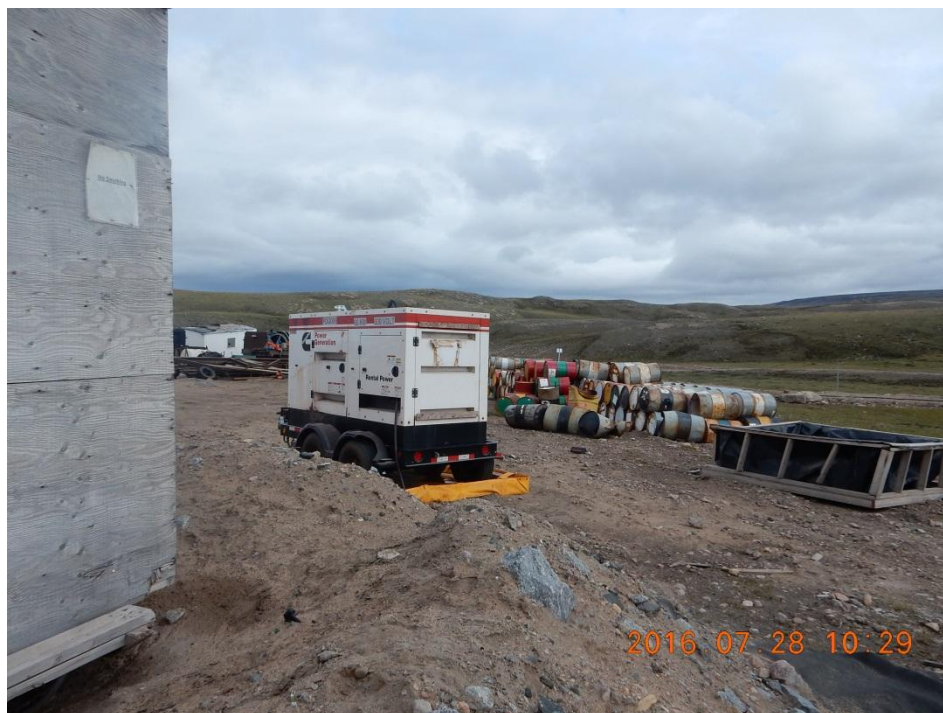
**Photo 25: Mine Site Hazardous Waste Storage – its Dike and Vicinity**

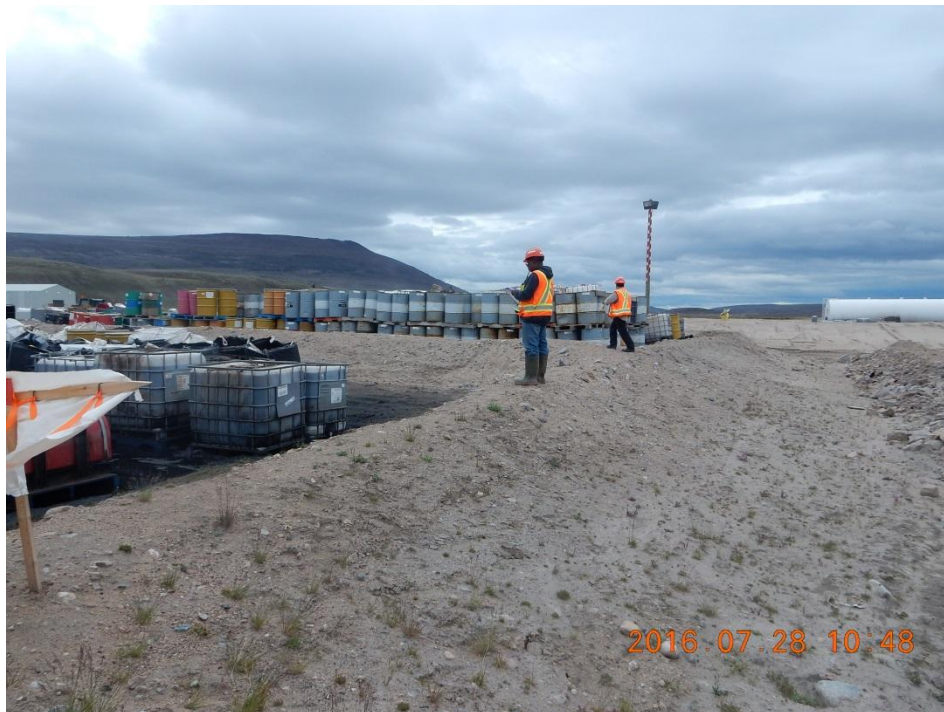
**Photo 26: Mine Site Environmental Storage – General View of its Dike and Vicinity**

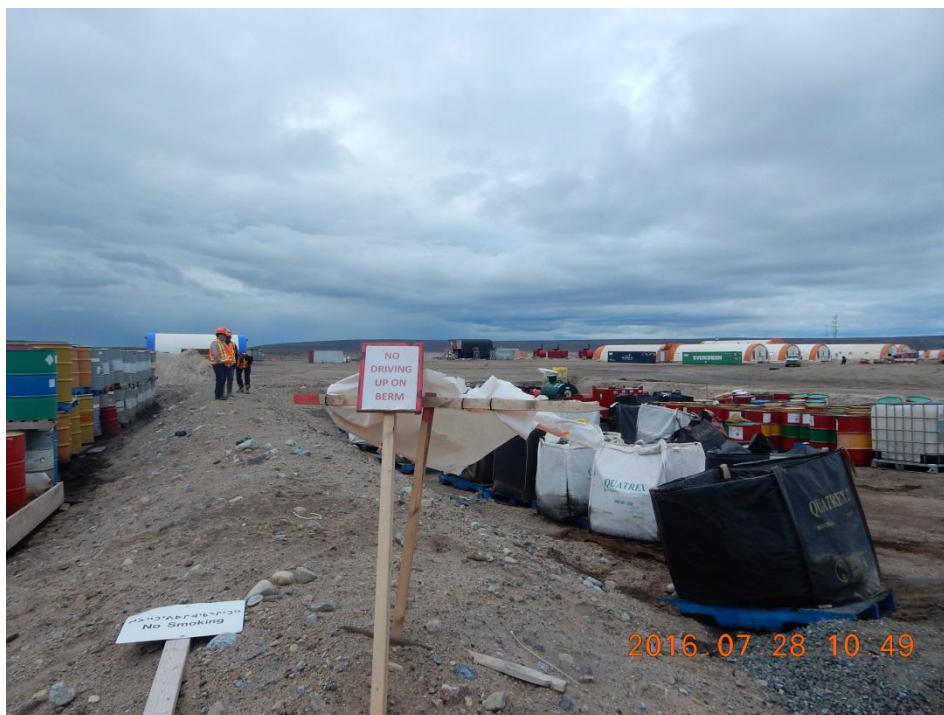
**Photo 27: Mine Site Environmental Storage – its Dike Details**

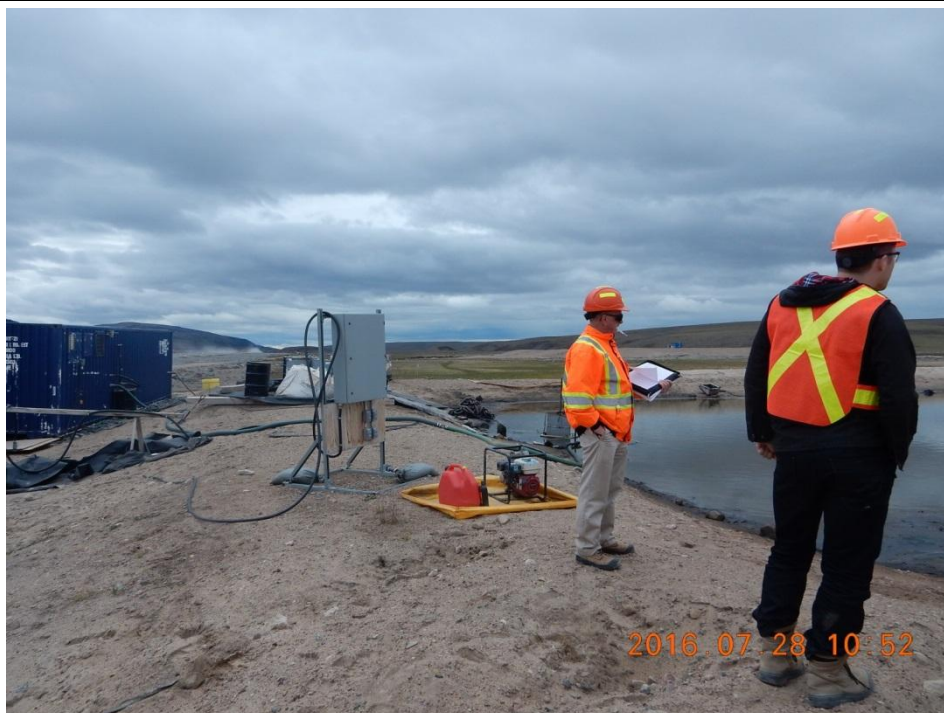
**Photo 28: Environmental Storage Containment at Mine Site – Oily Water and Treatment Plant**

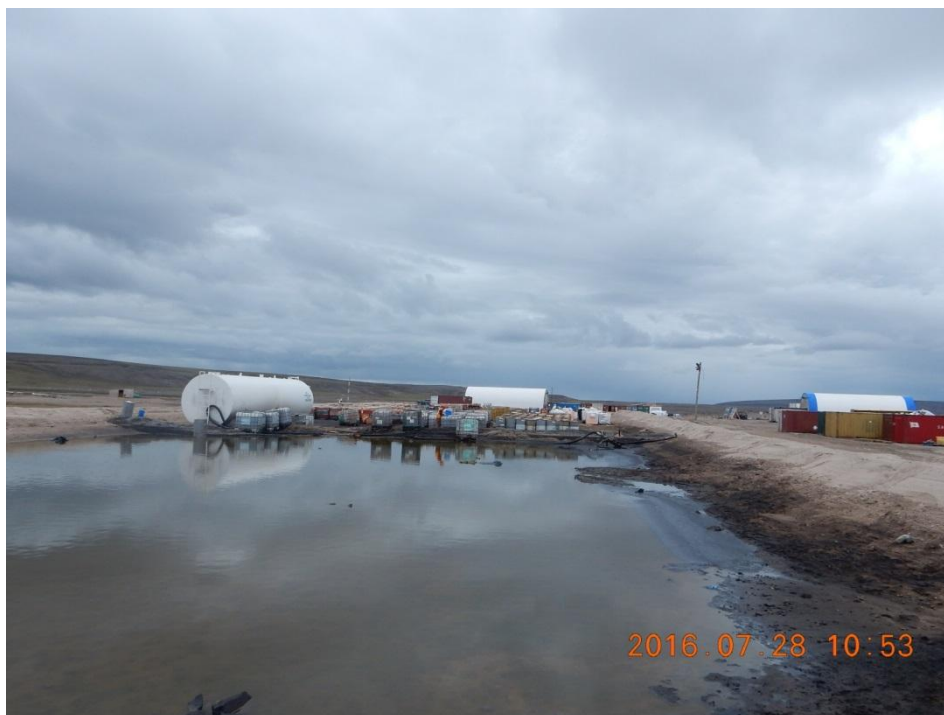
**Photo 29: Environmental Containment at Mine Site – its Dike and Contents**

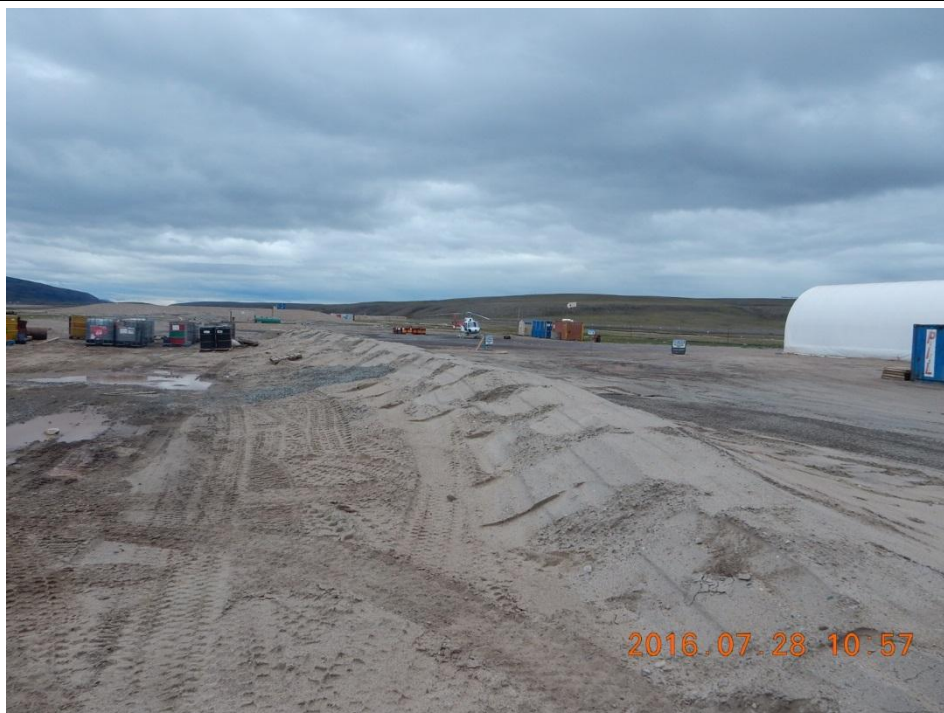
**Photo 30: Mine Site – Environmental Storage Containment - its Dike and Vicinity**

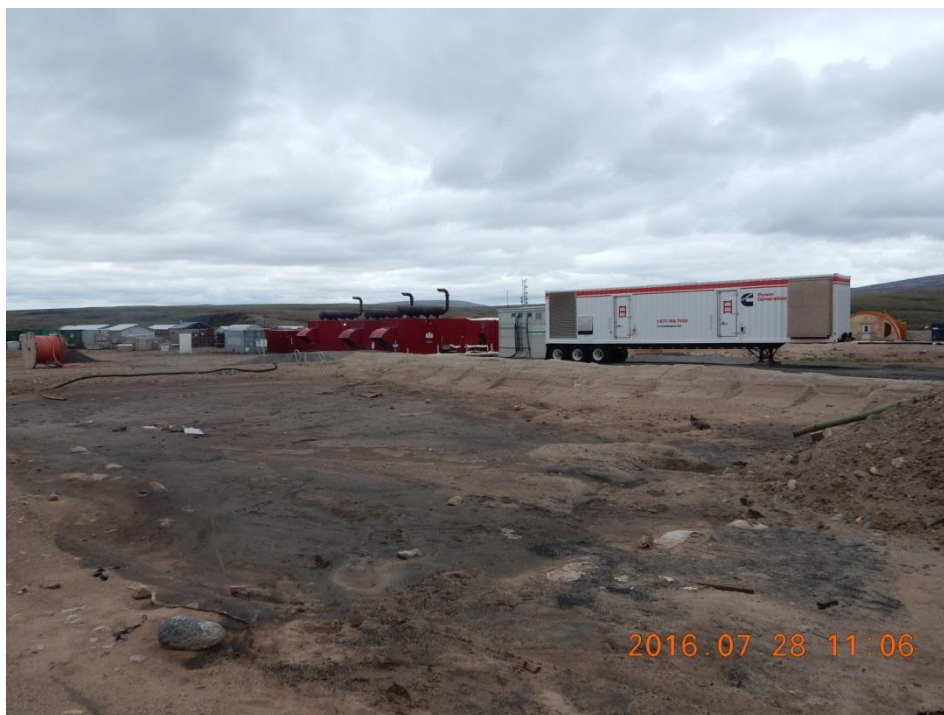
**Photo 31: Mine Site – Environmental Storage Containment Dike (Generator Overflow)**

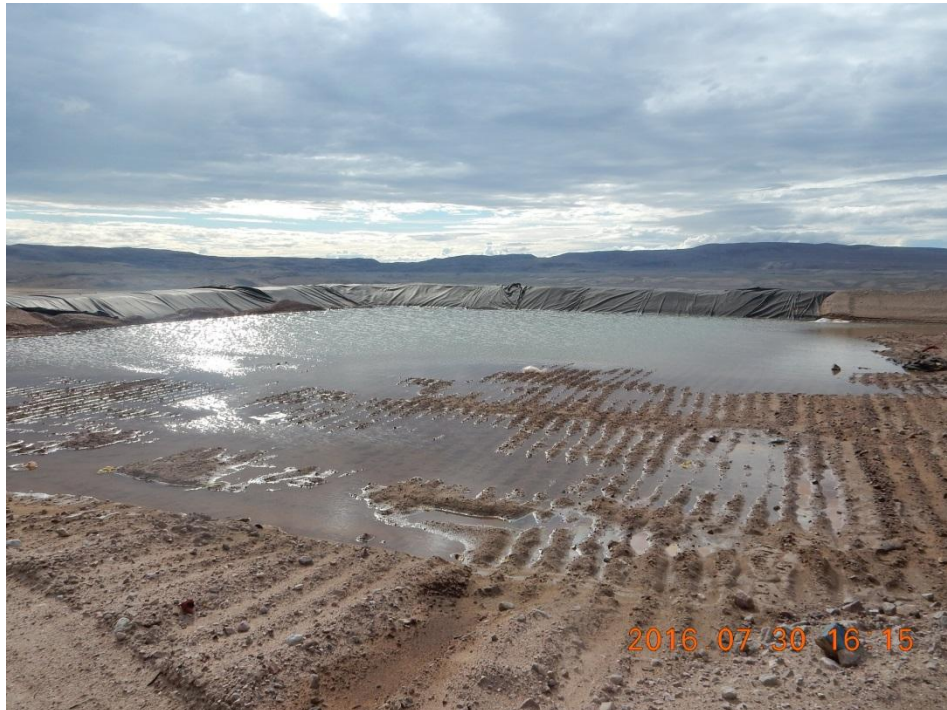
**Photo 36: Port Area – Land Farm (Water Collection at the Lowest Level)**

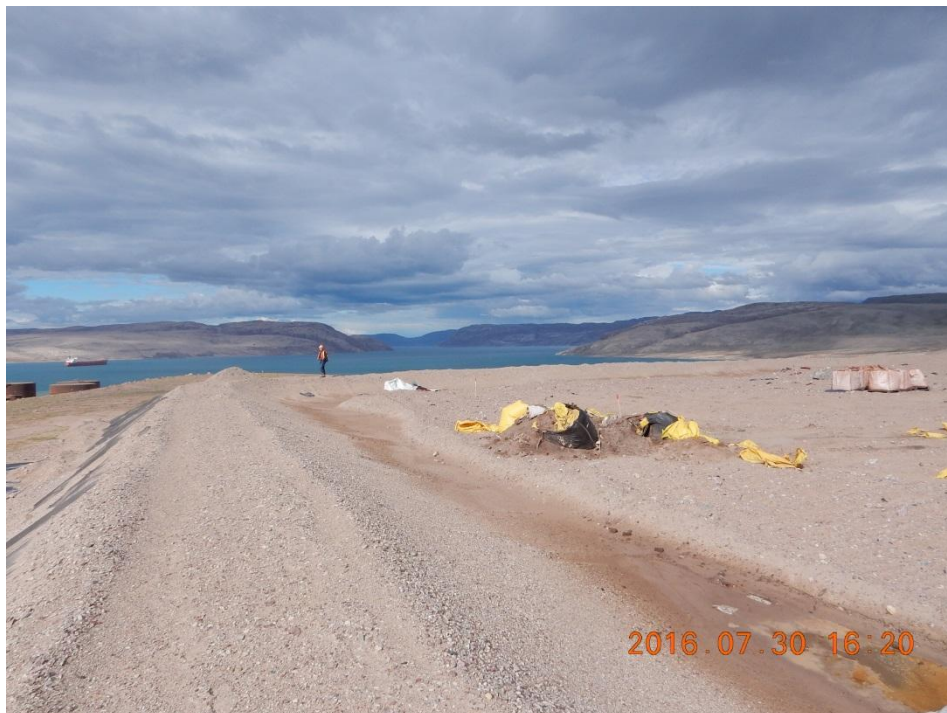
**Photo 37: Port Area – Land Farm Dike Details and Contents**

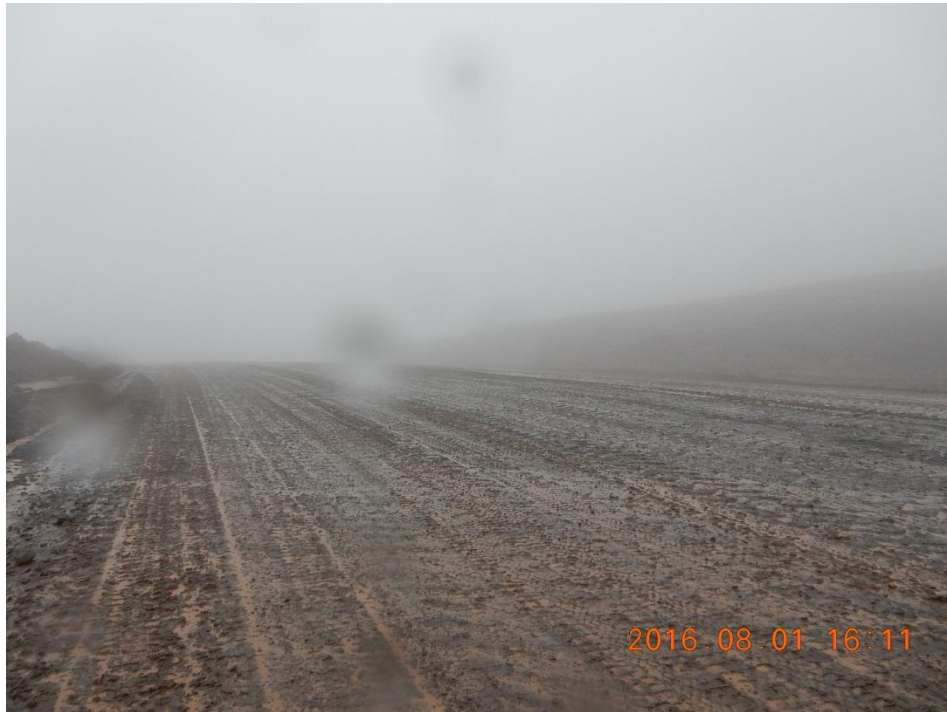
**Photo 38: Mine Haul Road – During Rainfall Event**

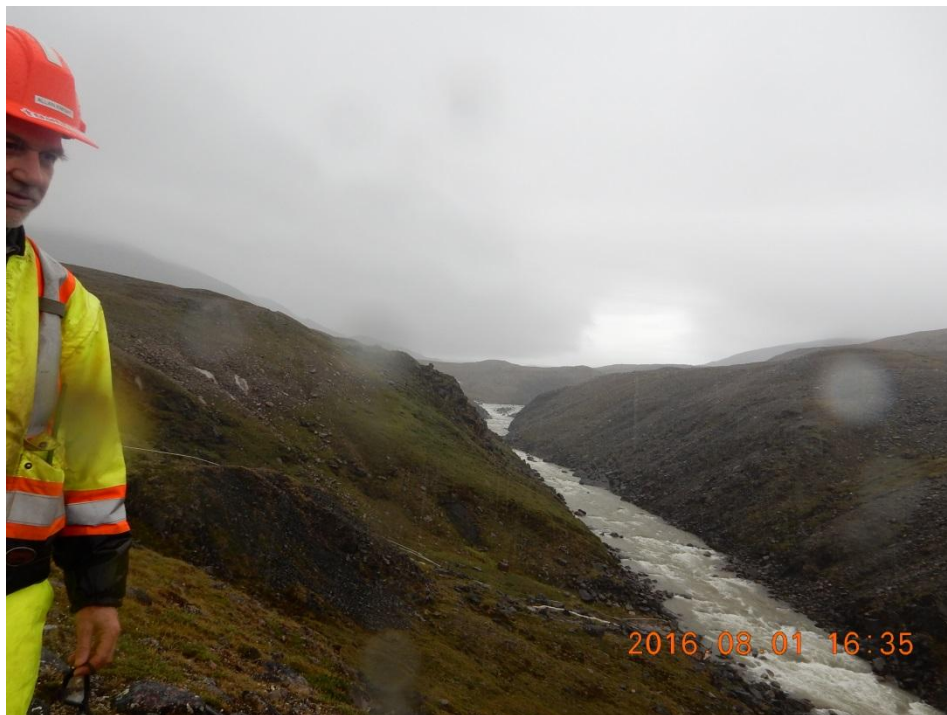
**Photo 39: Mine Haul Road - Larger Drainage Area Reporting to a Tributary to Mary River**
