GEOTECHNICAL INSPECTIONS

Mary River Mine, Nunavut

October 31, 2017

702751

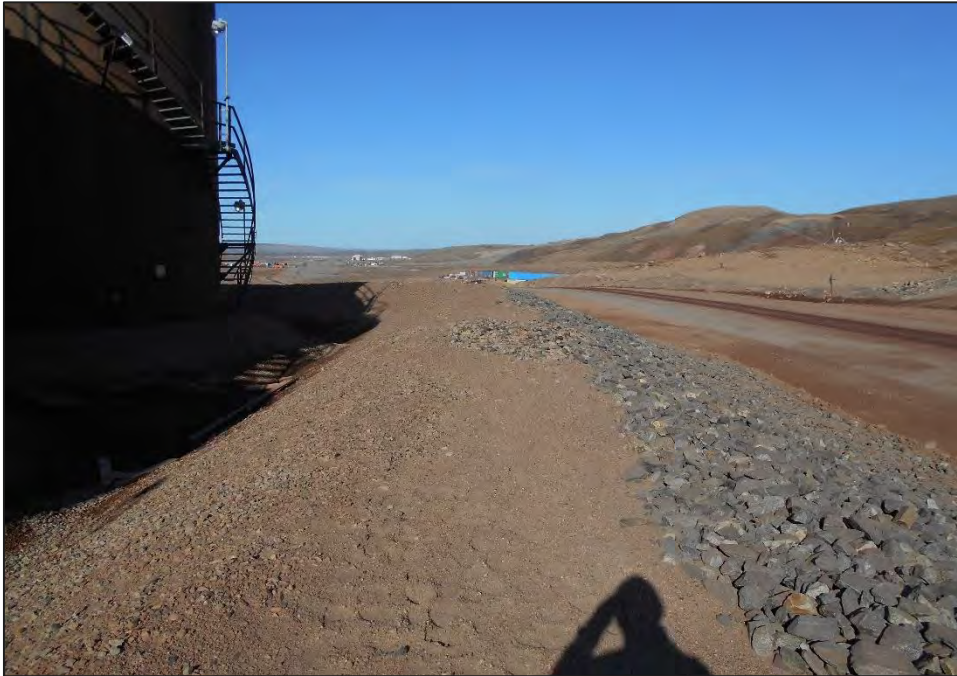
Photo: 3

Bulk Fuel Diesel ASTs – looking west along north berm. Note slope protection and an area where repairs made to berm.

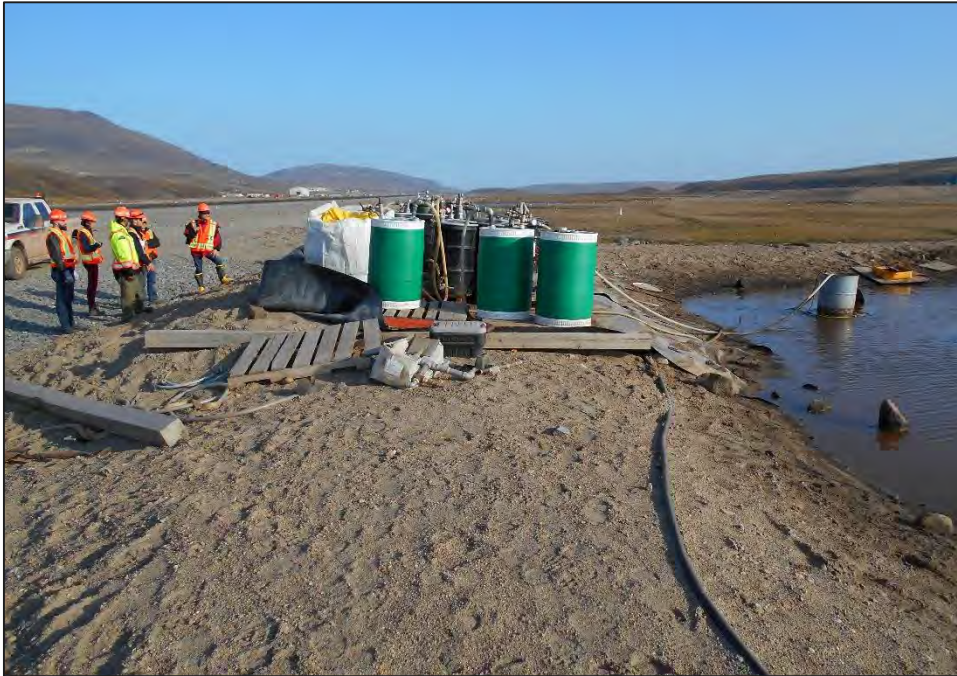
Photo: 1

Hazardous Waste Berm #7 – view of set up for treating standing water in contained area.

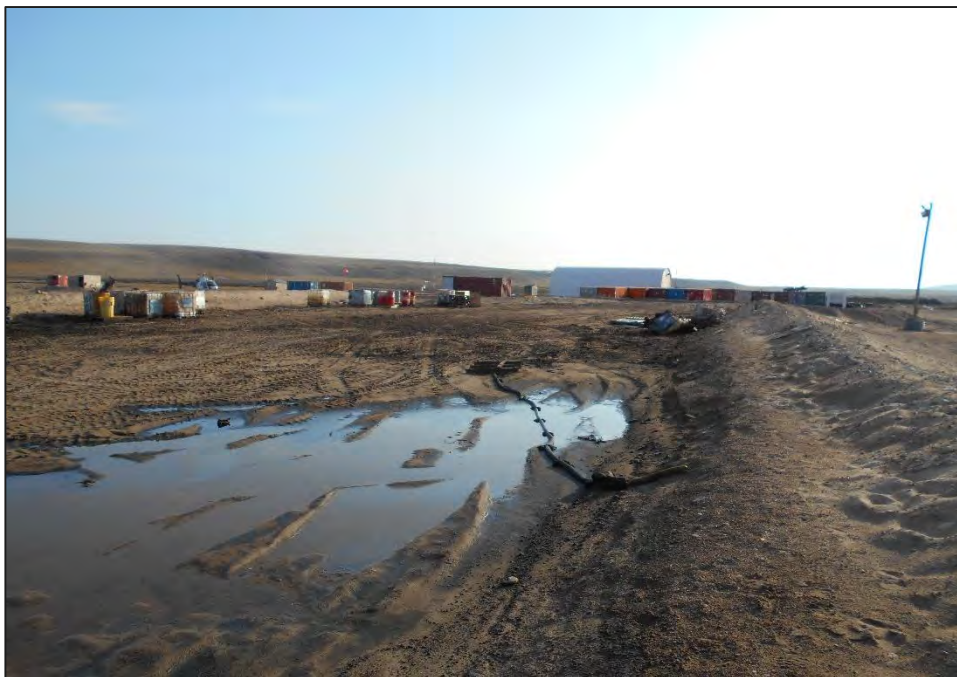
Photo: 2

Hazardous Waste Berm #7 – general view. Note very little waste.

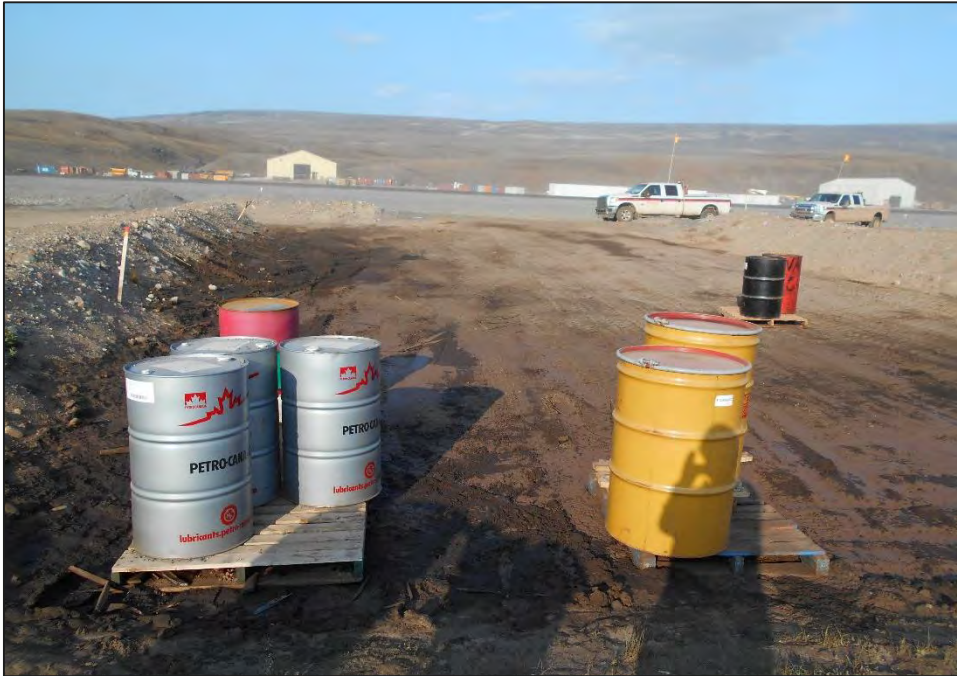
Photo: 3

Hazardous Waste Berm #4 – view of drums of Waste Jet A fuel.

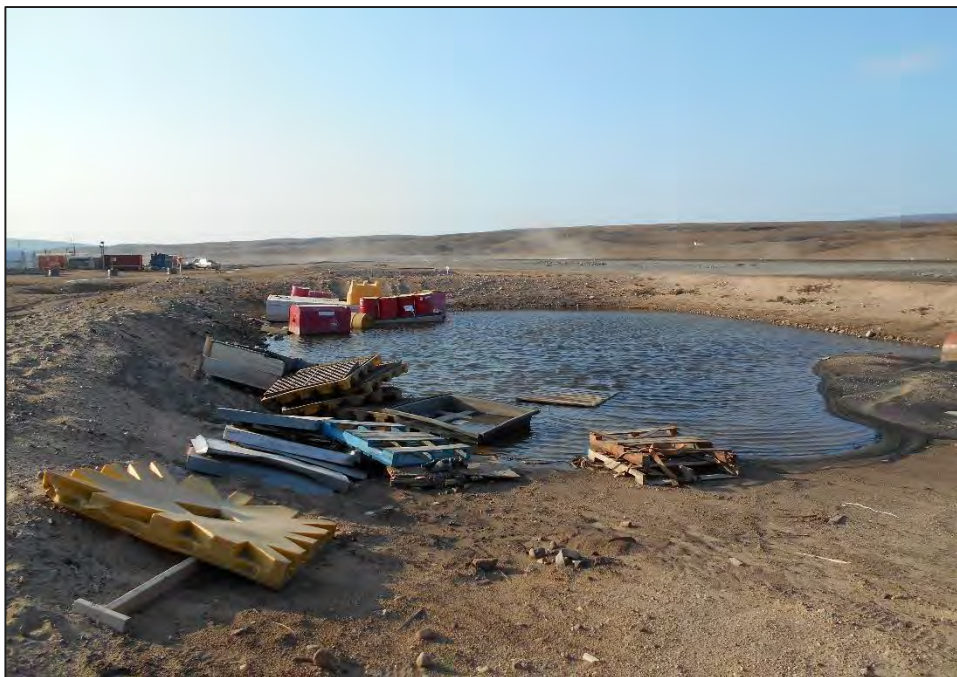
Photo: 4

Hazardous Waste Berm #5 – note standing water and debris.

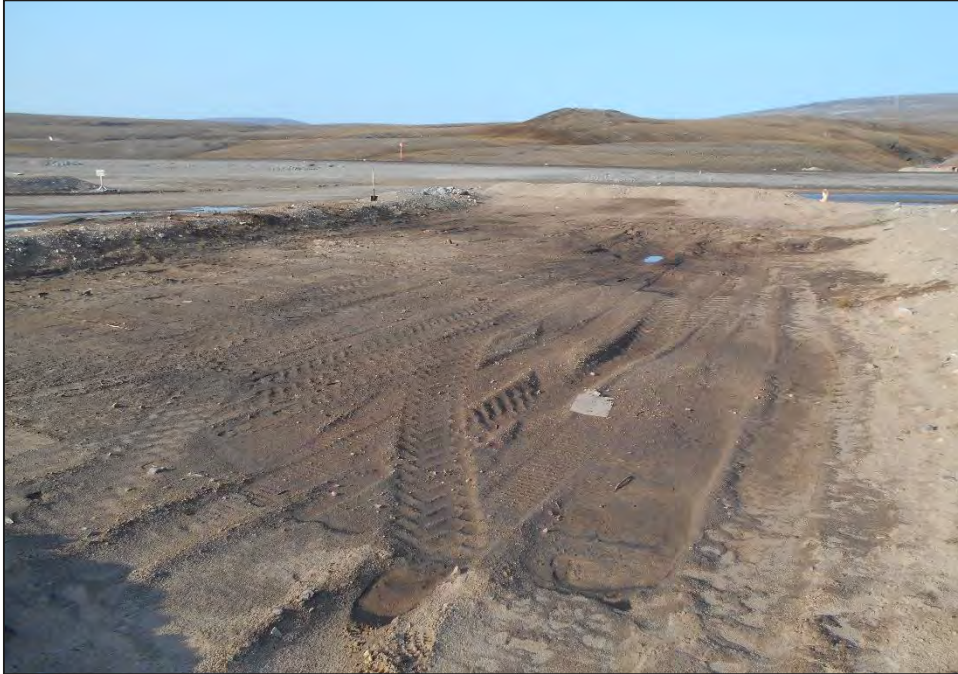
Photo: 5

were noted to be relatively free of waste materials, and to contain standing water. Hazardous waste area #3 was empty, as BIMC had determined that the area did not retain water (i.e it leaked) and so no material was being stored in this area. The berms were observed to be stable, with no evidence of tension cracking or crest subsidence.

Hazardous Berm #3 – area is not used due to leakage.

If Hazardous Waste Area #3 is to be put back into service, the geomembrane liner on the floor and berms will need to be exposed and the discontinuities responsible for the leakage repaired. No other remedial work on the other hazardous waste areas is believed warranted.

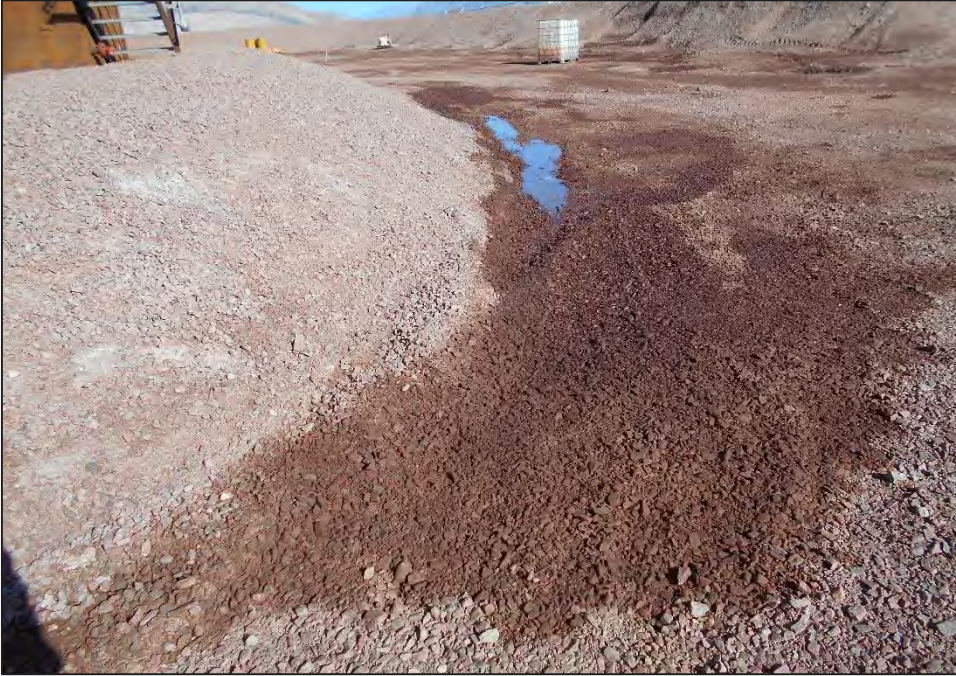
Photo: 3

Stained area within contained area.

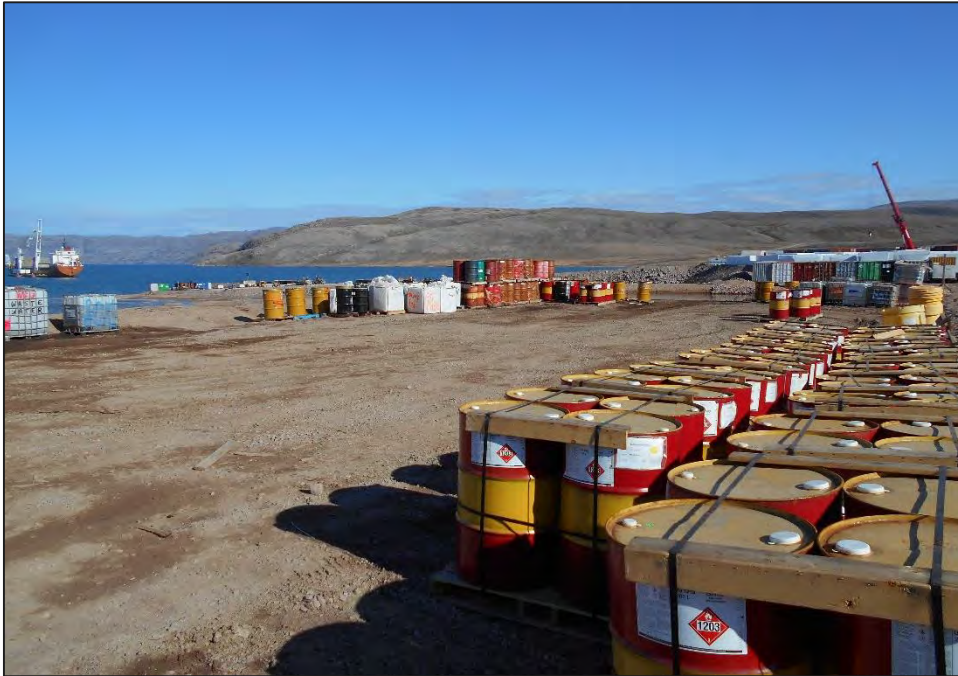
Photo: 1

Hazardous Waste Storage
Area – general view.

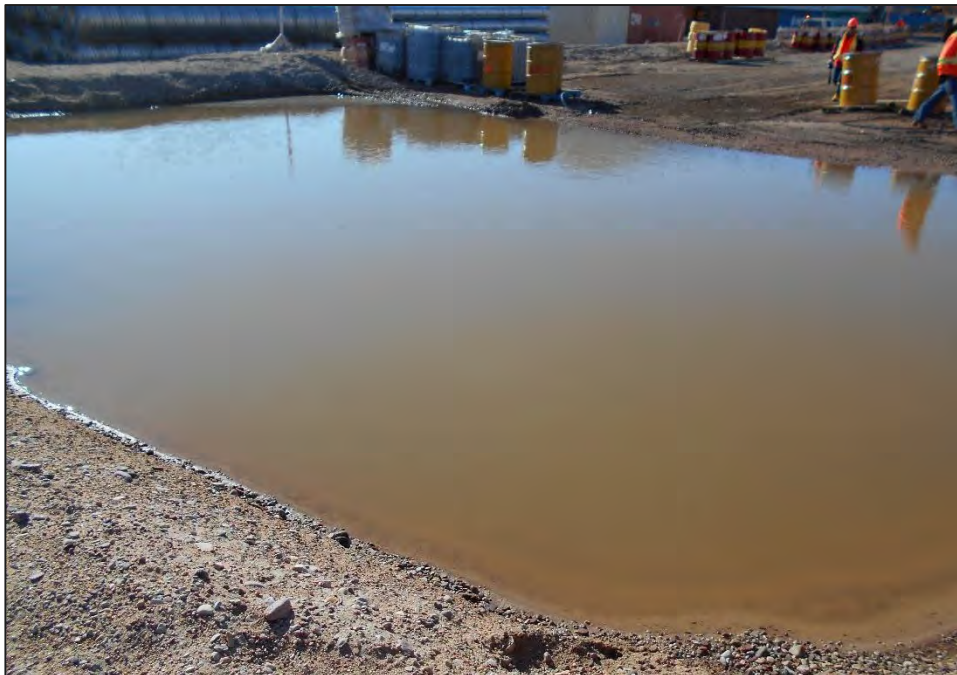
Photo: 2

Hazardous Waste Storage
Area – note exposed
geomembrane and ponded
water.

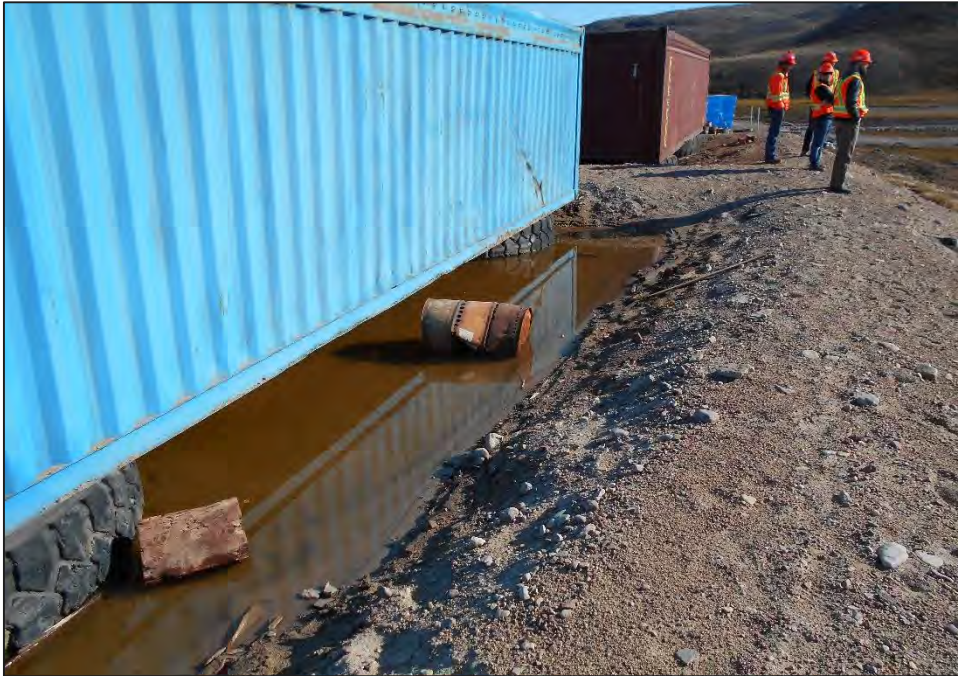
Photo: 3

Hazardous Waste Areas 4 & 5
– note partially covered
geomembrane.

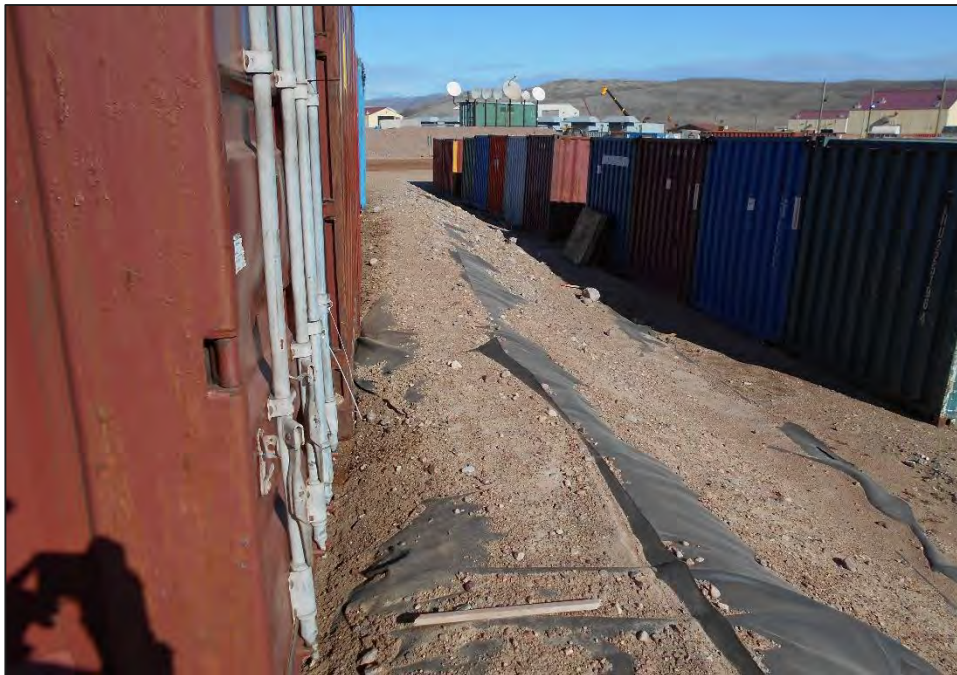
Photo: 4

Hazardous Waste Area 4 & 5
– note stable berm and
exposed geomembrane.
