SNC • LAVALIN	Technical Report Geotechnical Site Inspections	Revision		
		#	Date	Page
	Report No.: 658342-0000-000-4GER-0001	01	2018-10-31	1 of 26

CLIENT: Crown-Indigenous Relations and Northern Affairs Canada (CIRNAC)
	PROJECT: Mary River Project – Annual Geotechnical Site Inspections (2018)

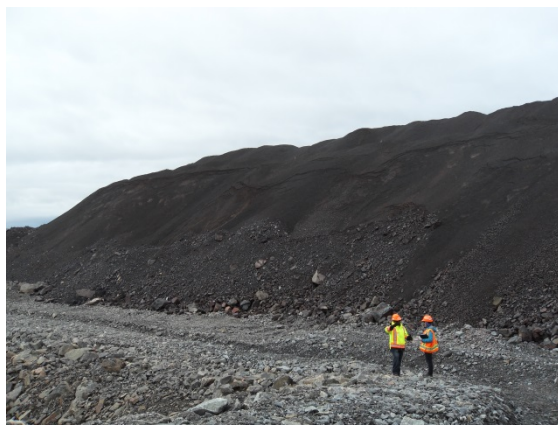
Figure 1: A view of the Crusher Pad and Ore Stockpile Expansion at Mine Site

The crusher pad, expanded crushed ore (products) storage, surface runoff drainage ditches/channels and its associated sediment control pond with its intake channel, emergency spillway were included in these inspections. Figure 1 shows a view of the crusher pad area, crushed ore stockpile, and its associated toe ditch/drain. Photo B1 - 1 shows the conditions associated with the base of pad post a recent rainfall event; Photo B1-2 shows its expansion in the vicinity of the existing natural drainage channel; Photos B1 - 3 & 4 show the expansion of the crushed ore stockpile and its associated toe ditch/drain; and Photos B1 - 5 & 6 show crusher pad area sedimentation/settling pond and its dam raising in progress. The following observations were noted:

- The pond dam raising was in progress at the time of the 2018 inspections– dam raising with granular material, liner extension was to follow.
- The visit coincided with rainfall season, local accumulation of mud or muddy surfaces were visible on the crusher pad (see Photo B1 - 1). A better material handling system is required or some local sumps on the pad should be considered to avoid the accumulation mud or muddy surfaces on the pad.

- A natural drainage channel runs along the crusher pad. The crusher pad expansion that is currently under way may be reaching the limits of the natural drainage channel. It is recommended that the natural drainage channel in this area be clearly demarcated so that encroachment, either through unplanned expansion or ore spillage, could be prevented.

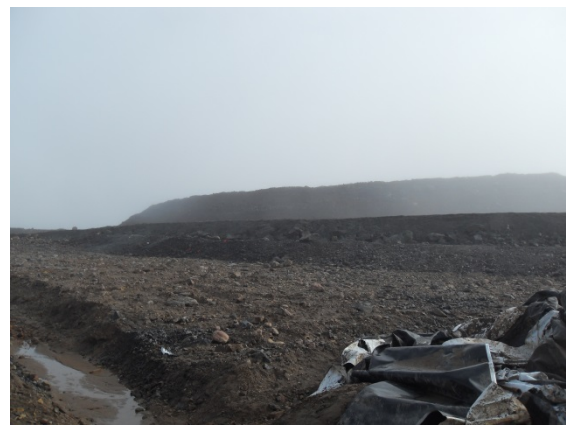
Figure 2: A view of the Mine Waste Rock Storage Facility at Mine Site and its associated Water Management Facilities

in these inspections. Figure 2 shows a view of the Mine Waste Rock Storage Facility and its associated water management. Photos B1 - 15 & 16 show the conditions of the settling pond; Photos B1 - 17 & 18 show new water treatment facility; and Photos B1 - 19 & 20 show the polishing pond berm, liner and solids settling arrangement detail. The following observations were noted:

- Toe and downstream leakages were noted during the inspection in 2017 (Arcadis) which was noted to be an indication of poor performance of the lined pond. At the time of the 2018 inspection, pond level was maintained at low level. Some temporary secondary containment and pump back arrangements have also been installed here, however, we were not able to verify the quantities or the secondary containment and pump back details.

- The engineer of record for this facility should be engaged to update geochemistry, water quality and leakage challenges in this area and provide some practical long-term sustainable measures for routing, storing and treating contact water.
