Technical Report Geotechnical Site Inspections	Revision		
	#	Date	Page
Report No.: 630212-0000-000-4GER-0001	00	2015-09-10	B-1

Appendix B – PHOTO COLLAGE OF THE INSPECTIONS (selected photos)

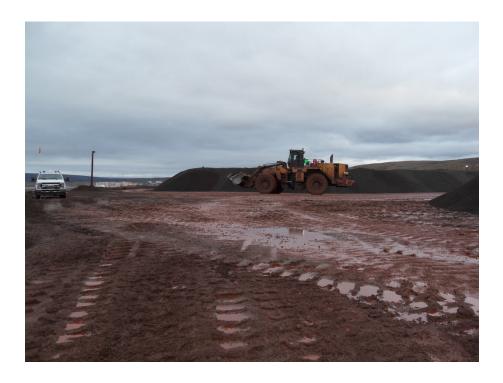
Photo 1: A view of the Crusher Pad base post a rainfall event (muddy surface)

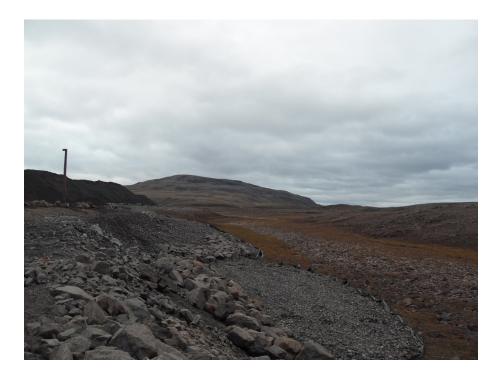
Photo 2: A view of the Crusher Pad expansion adjacent to an existing natrual water course (potential for interferences with water course during an extreme flood)

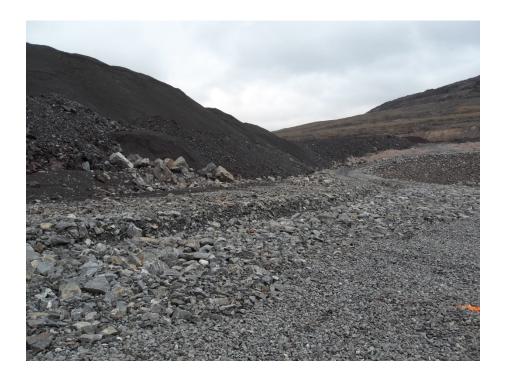
Photo 3: A view of the Crusher Pad expansion and its associated surface runoff drain

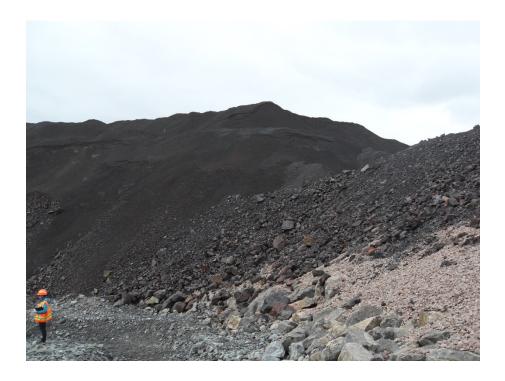
Photo 4: A view of the Crusher Ore Stocpile expansion and its toe drain

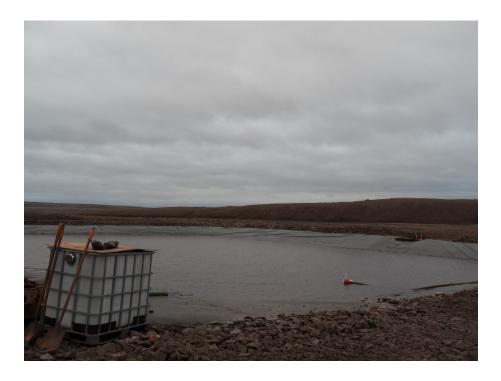
Photo 5: A view of the Sedimentation Pond associated with the Crusher Pad area at Mine Site

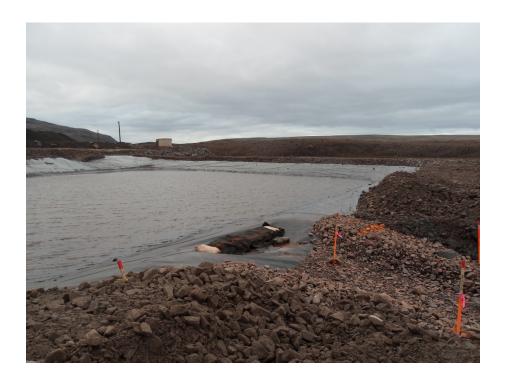
Photo 6: A view of the Emergency Spillway, Intake Channel to Sedimentation Pond and perimeter dam raising in progress associated with the Crusher Pad Area at Mine Site

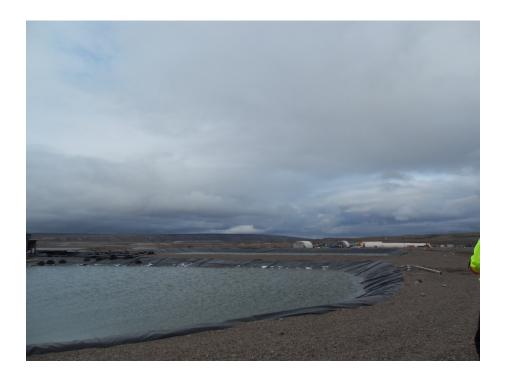
Photo 7: A view of the exposed liner on PSPW ponds at Mine Site

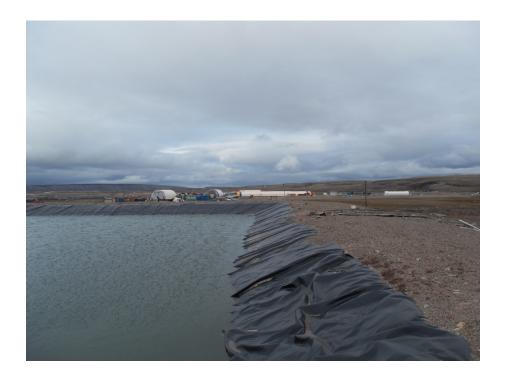
Photo 8: A close-up view of the exposed liner and embankment conditions of PSPW ponds at Mine Site

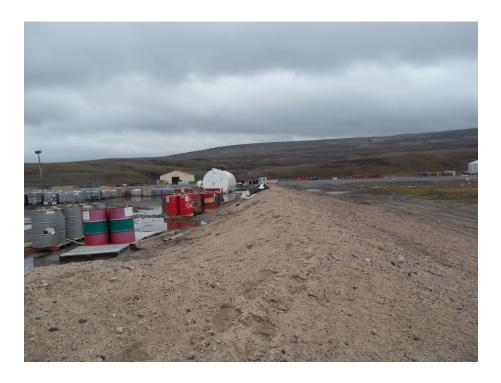
Photo 9: A view of the mine Hazardous Waste and Environment Containment Systems and its Embankment/Berm at Mine Site (typical)

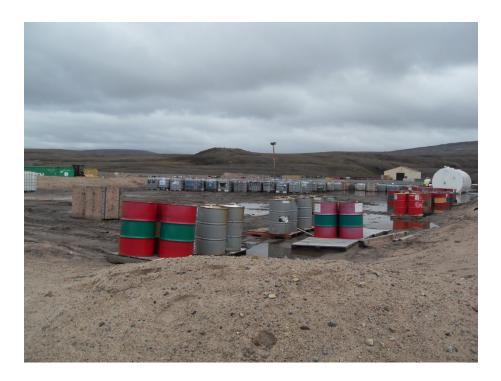
Photo 10: A view of the Mine Hazardous Waste and Environmental Containment systems (typical) at Mine Site

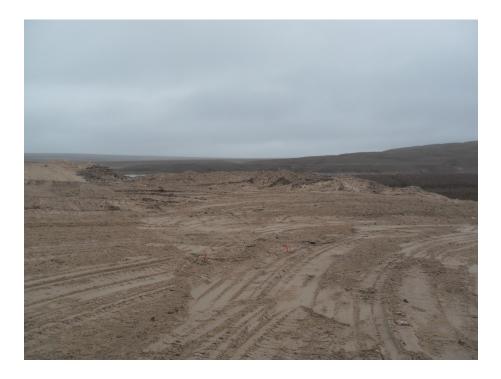
Photo 11: A view of the mine site Landfill site - progressive cover placement

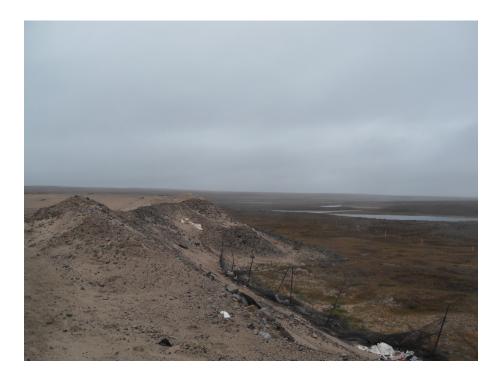
Photo 12: A view of the mine site Landfill side slope and vicinity (typical) and the planned fencing layout in the background (flag posts)

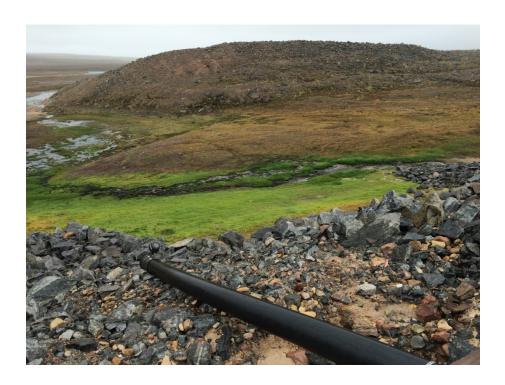
Photo 13: A view of the mine site Sewage Effluent Discharge Point station

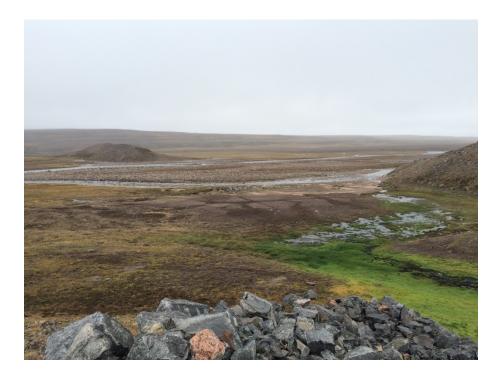
Photo 14: A view of the mine site Sewage Effluent Discharge Area meeting with the Mary River

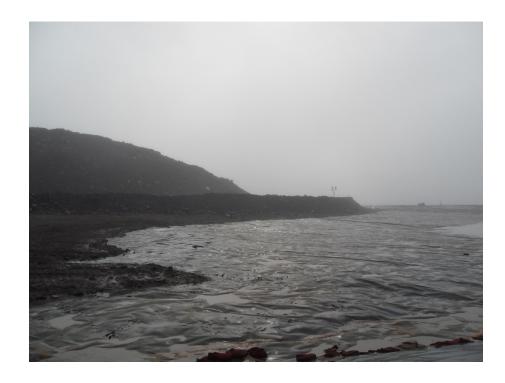
Photo 15: A view of the Mine Waste Rock Storage Facility and its associated runoff collection pond

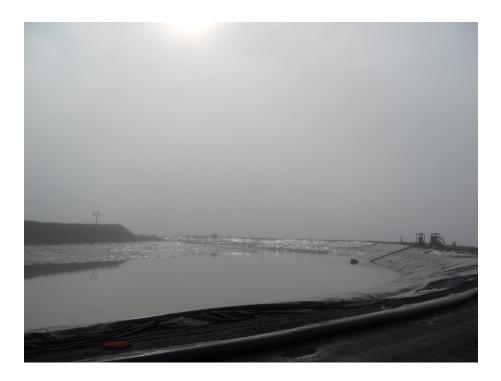
Photo 16: A view of the Mine Waste Rock Storage Facility collection pond liner and embankment/berm

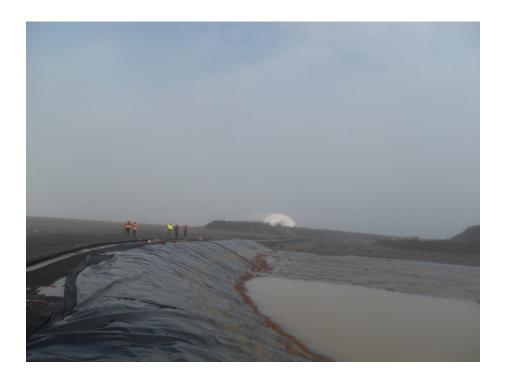
Photo 17: A view of the Mine Waste Rock Storage Facility Pond and Water Treatment Facility (dome in the background)

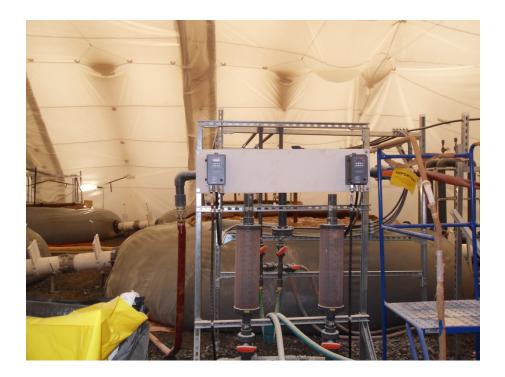
Photo 18: A view of the Mine Waste Rock Storage associated Water Treatment Facility

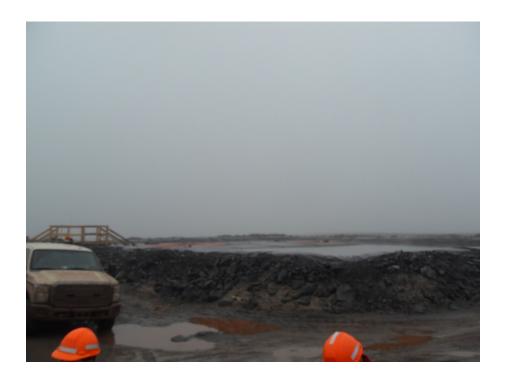
Photo 19: A view of the Mine Waste Rock Storage Facility's Post Water Treatment Settling/Polishing Pond Embankment/Berm

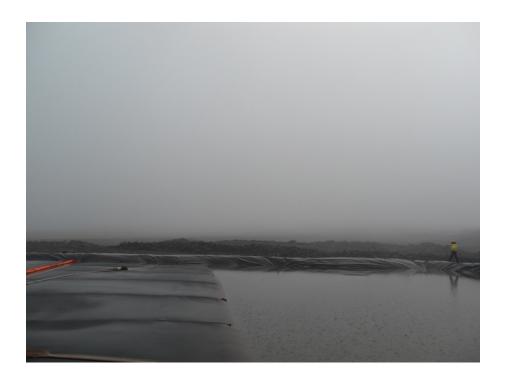
Photo 20: A view of the Mine Waste Rock Storage Facility's Post Water Treatment Sedimentation Arrangements and Pond

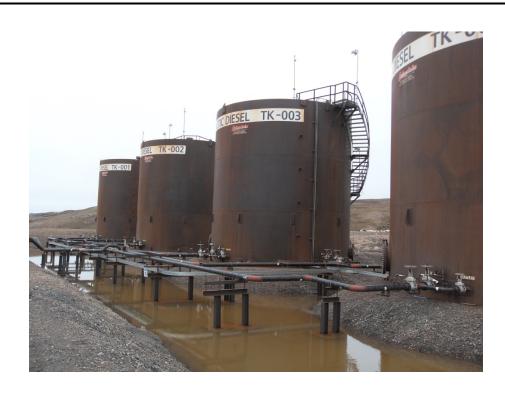
Photo 21: A view of the mine site Bulk Fuel Storage Facility - Base

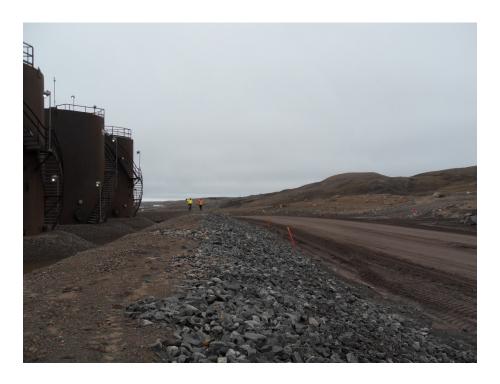
Photo 22: A view of the mine site Bulk Fuel Storage Facility – Perimeter Embankment
