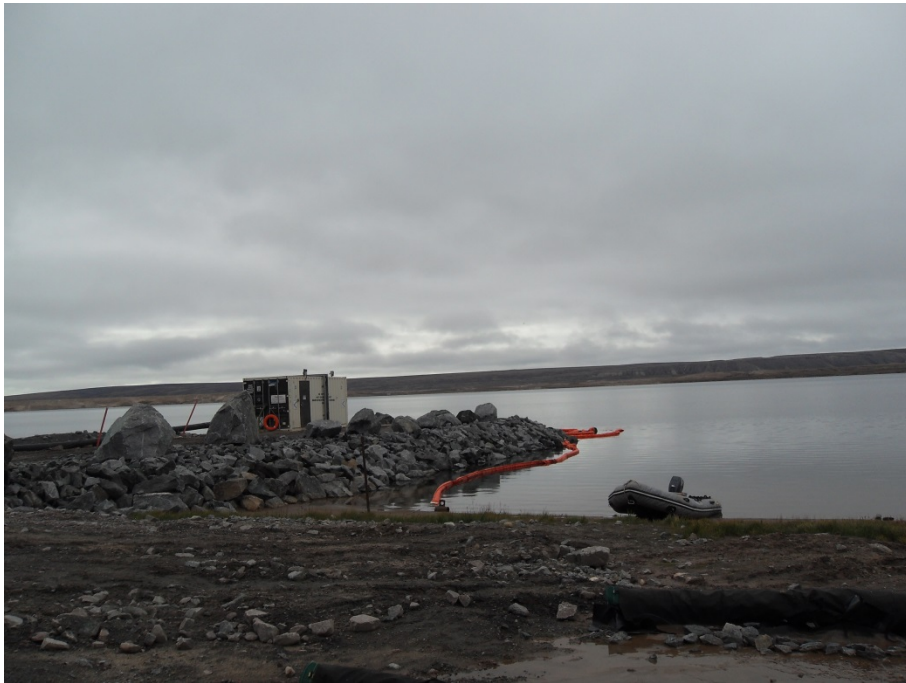
**Photo 23: A view of the mine site water intake jetty**

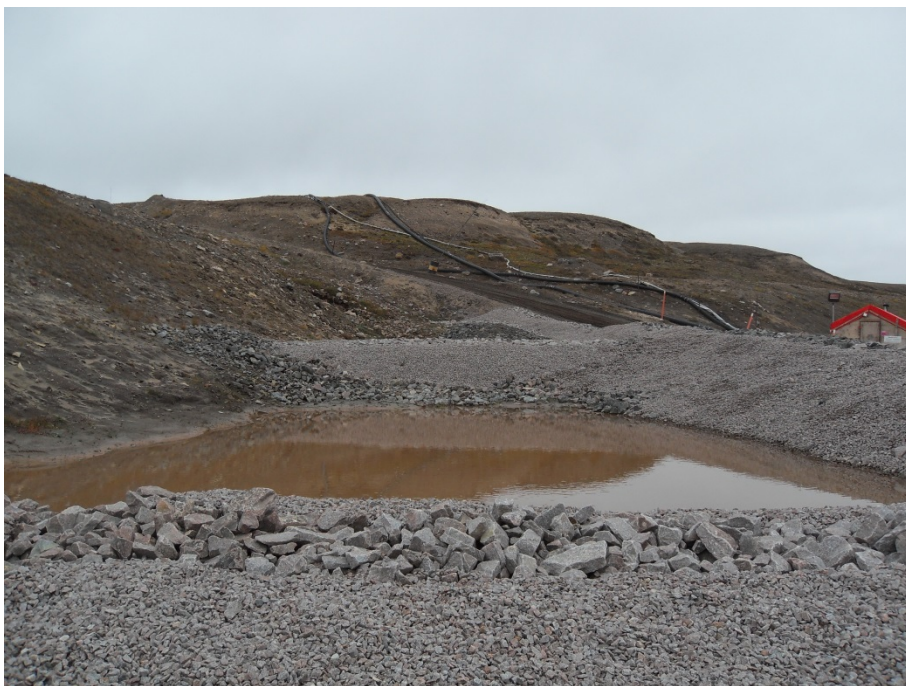
**Photo 24: A view of the mine site series of check dams near intake jetty**

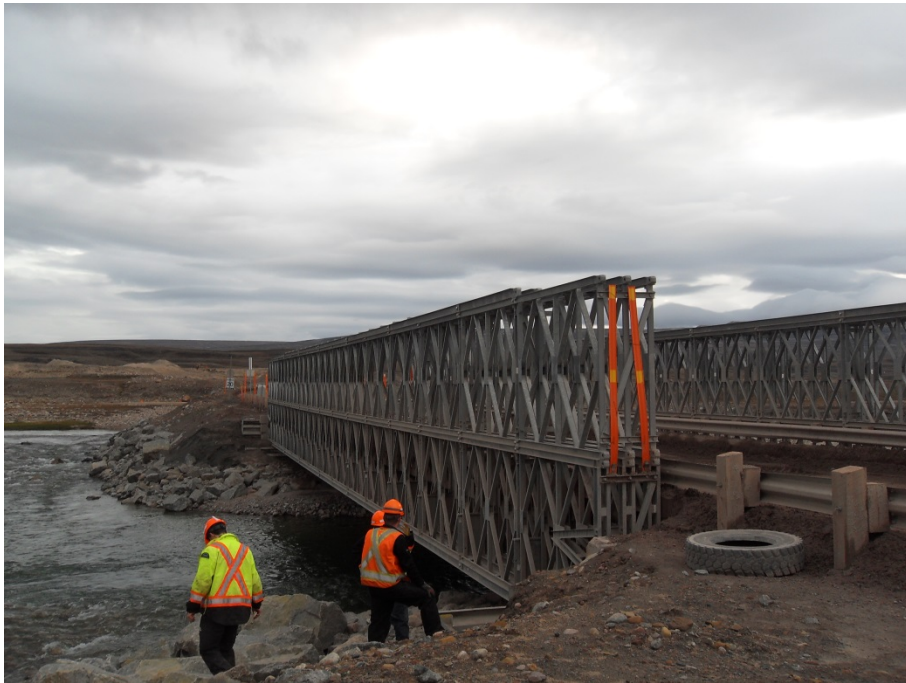
**Photo 25: A view of the bridge on Tote Toad at KM 97 (u/s)**

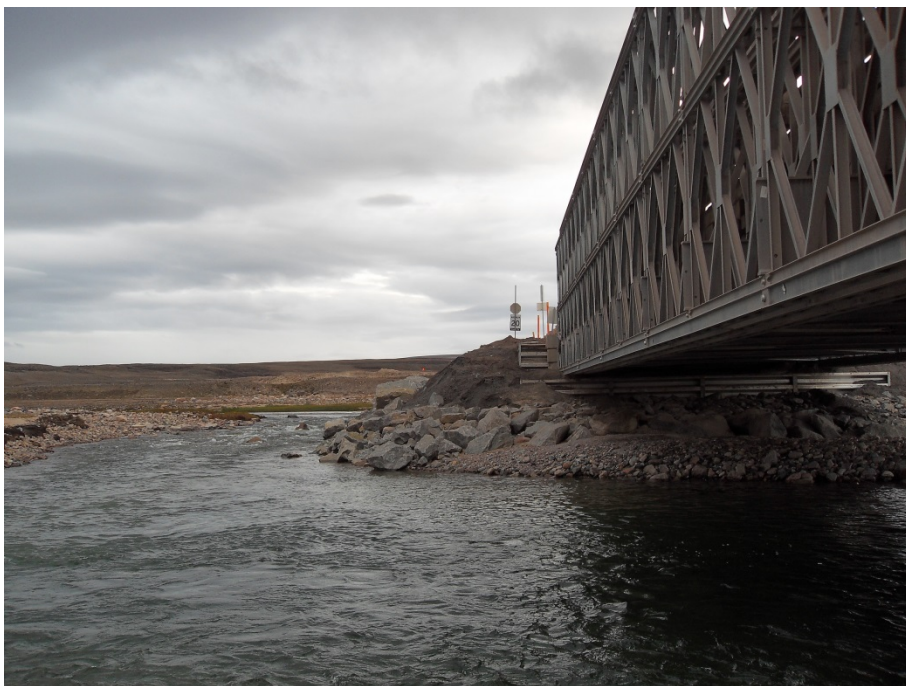
**Photo 26: A view of the bridge abutment and approaching flow**

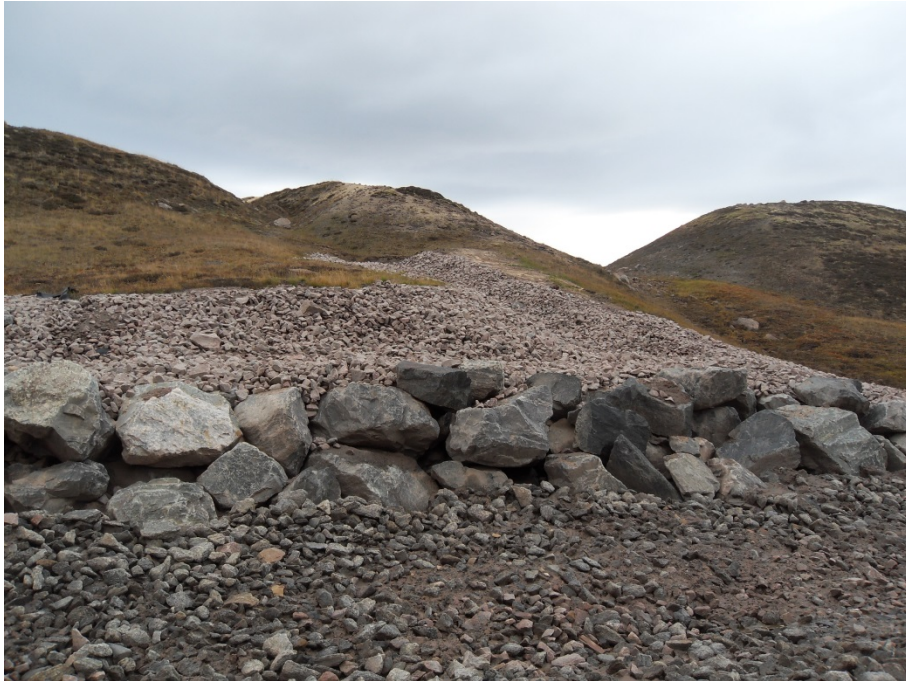
**Photo 27: A view of the tote road slope improvement (Rockfill buttress)**

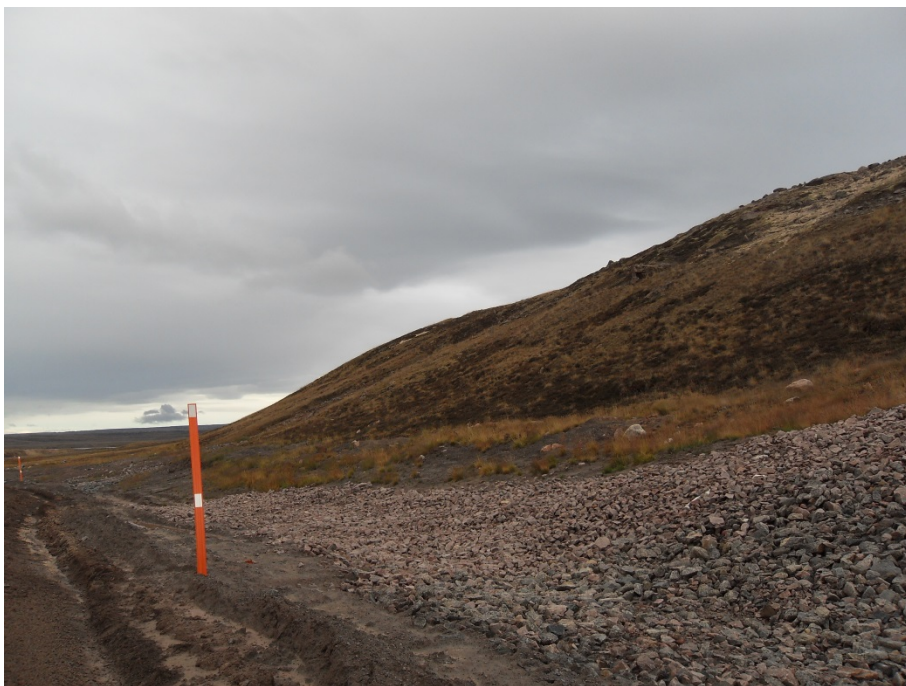
**Photo 28: A view of the tote road slope improvement (granular fill slope protection)**

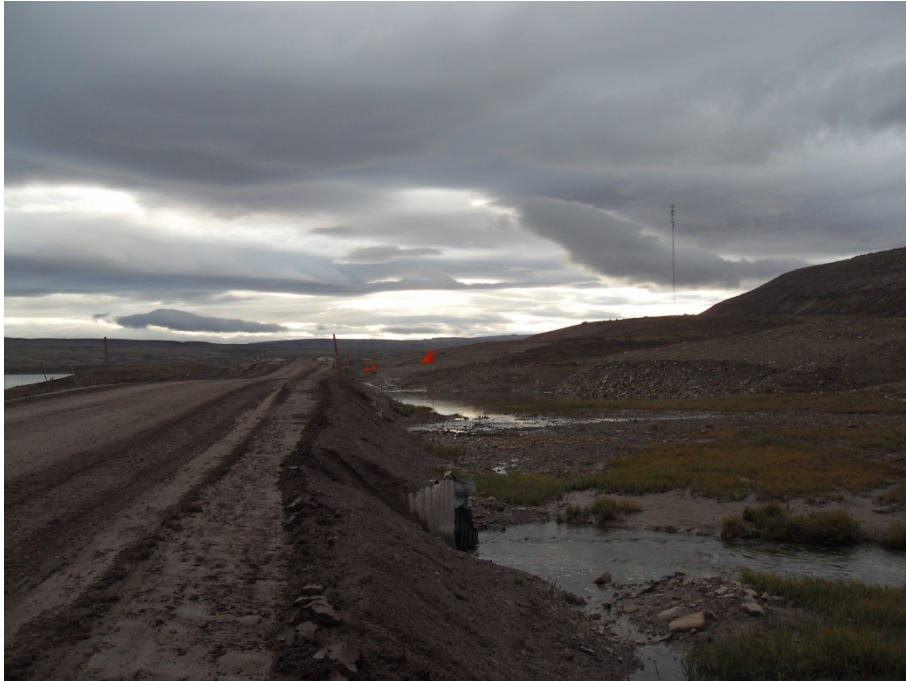
**Photo 29: A view of the Tote Road surface and a culvert U/S**

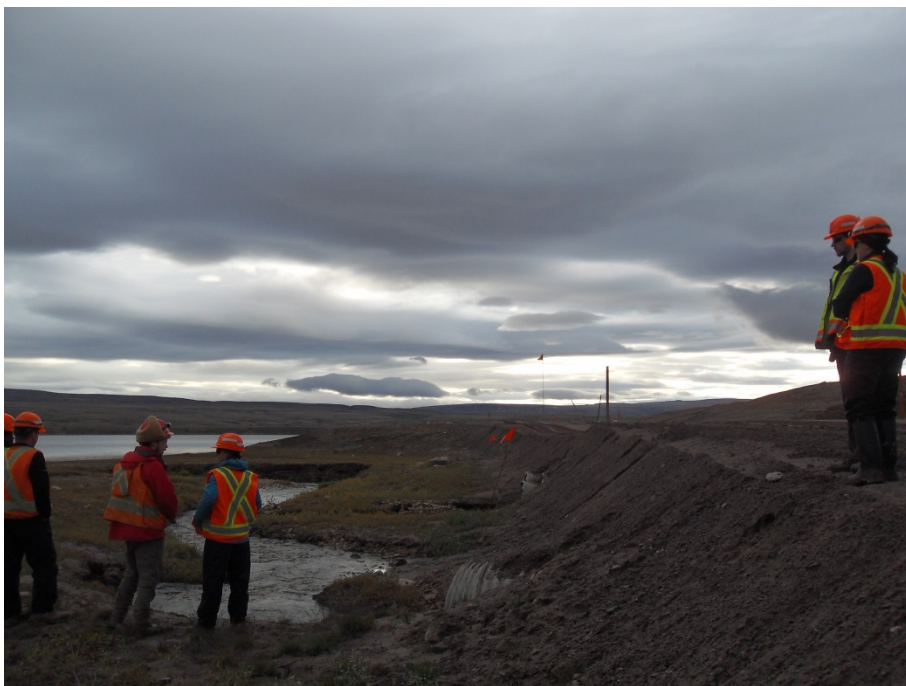
**Photo 30: A view of the Tote Road culvert d/s**

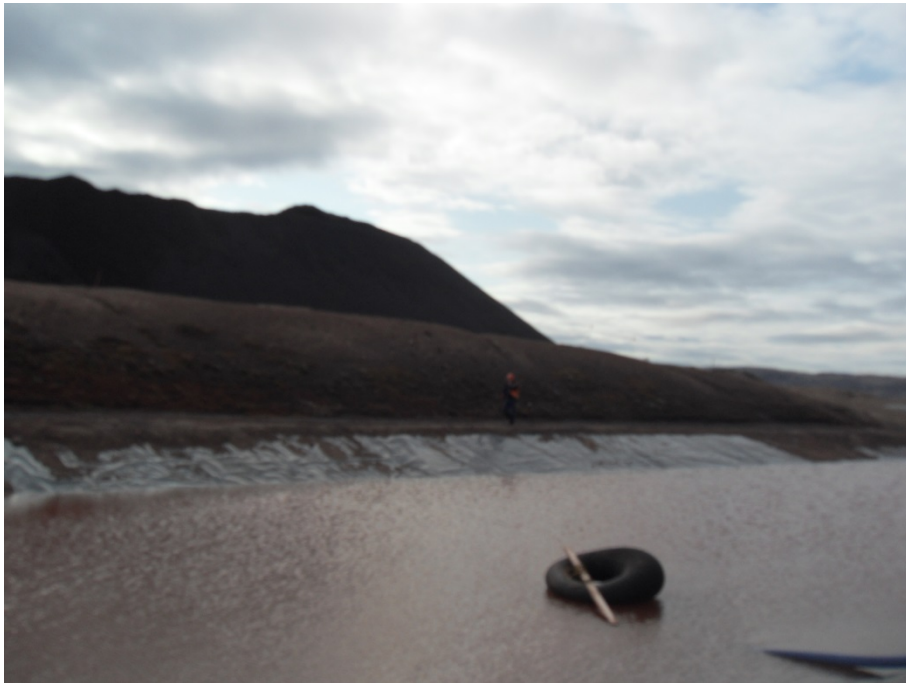
**Photo 31: A view of the ore stockpile pond (West) showing condition of the liner and intake**

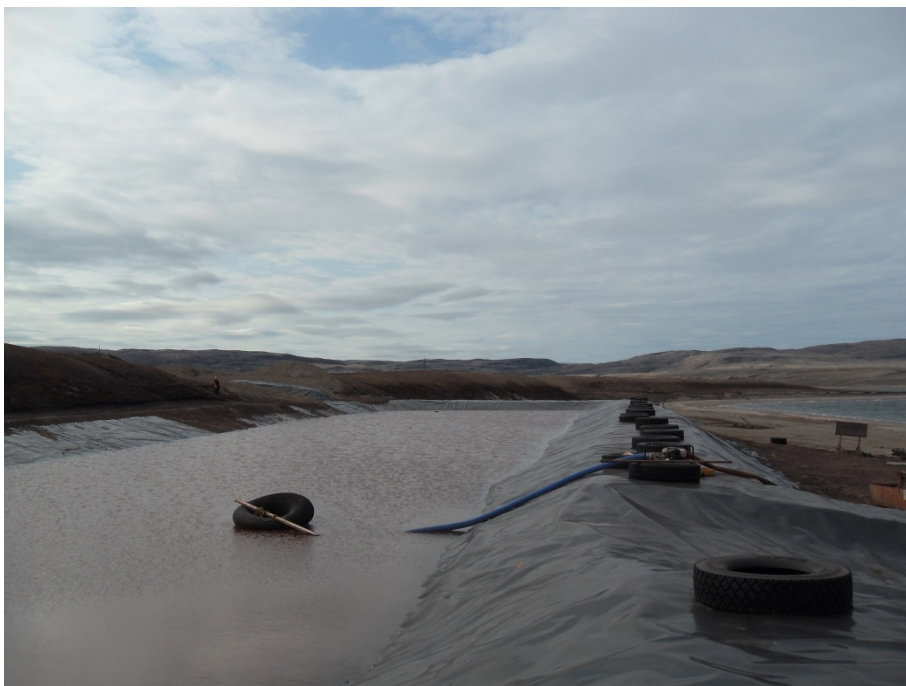
**Photo 32: A view of the ore stockpile pond (West) – depressed section on right corner is emergency spillway**

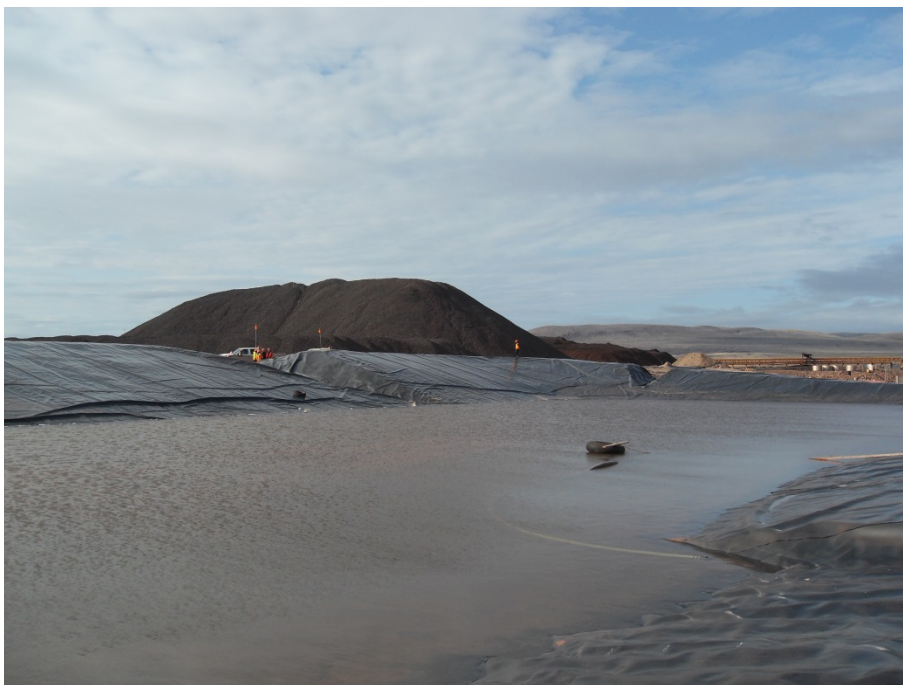
**Photo 33: A view of the ore stockpile sedimentation pond (East Pond) showing liner conditions, water level and intake arrangements**

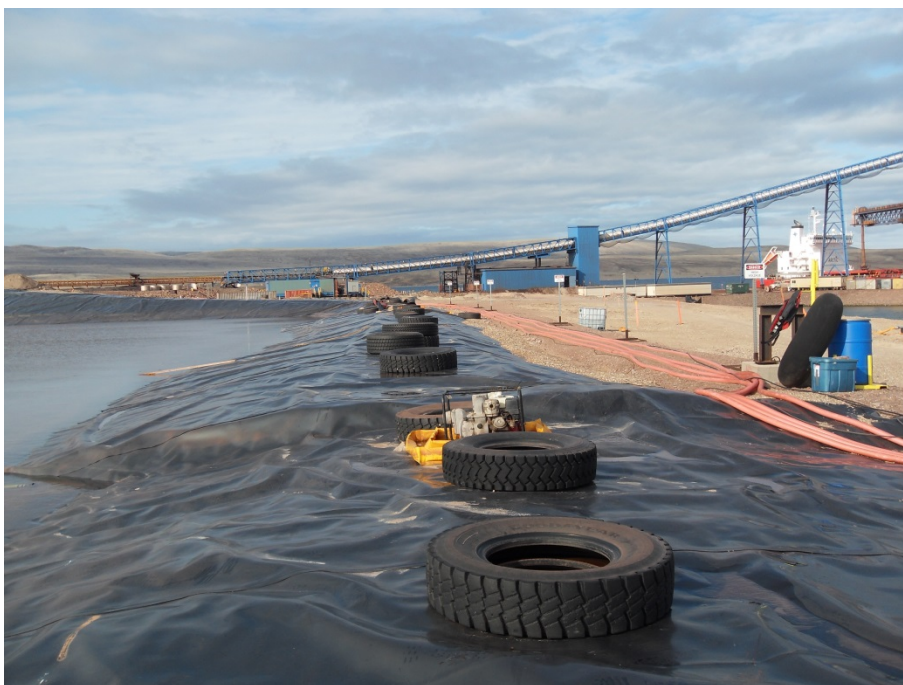
**Photo 34: A view of the ore stockpile sedimentation pond (Esat Pond) showing emergency spillway section**

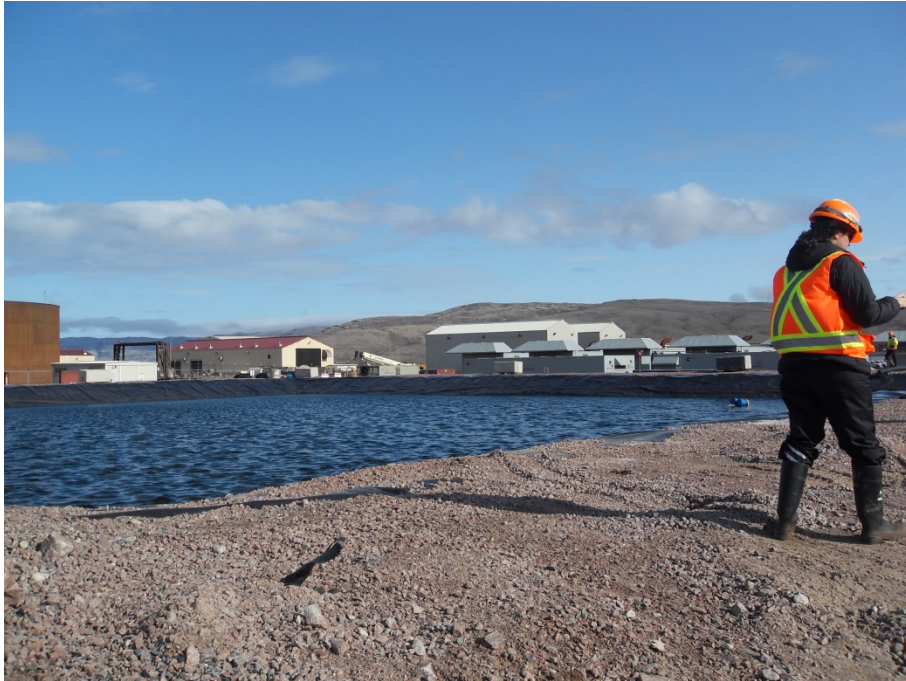
**Photo 35: A view of the PWSP at port site (Embankment Conditions)**

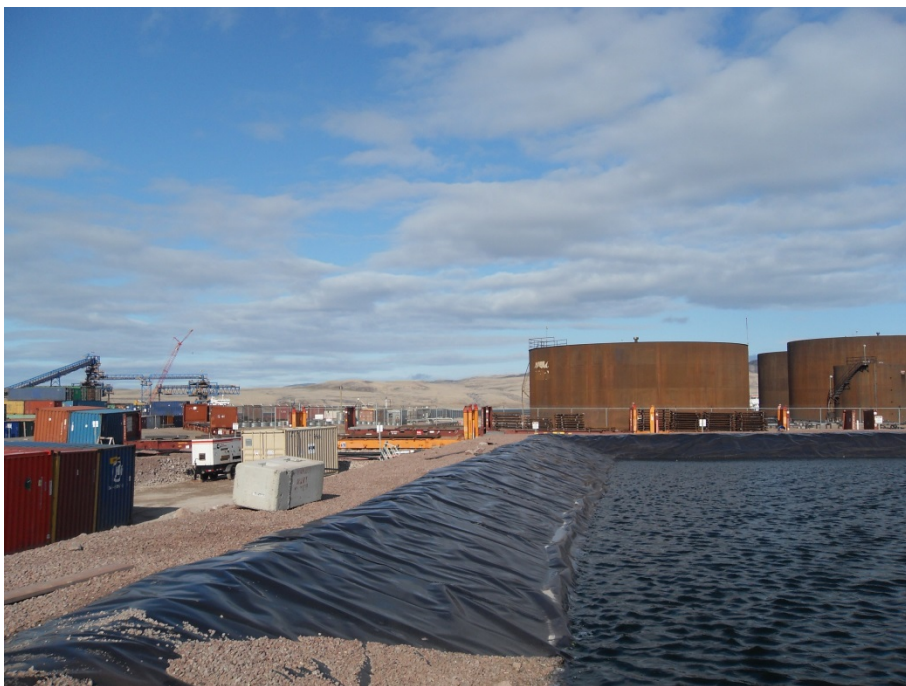
**Photo 36: A view of the PWSP at port site (Liner Conditions)**

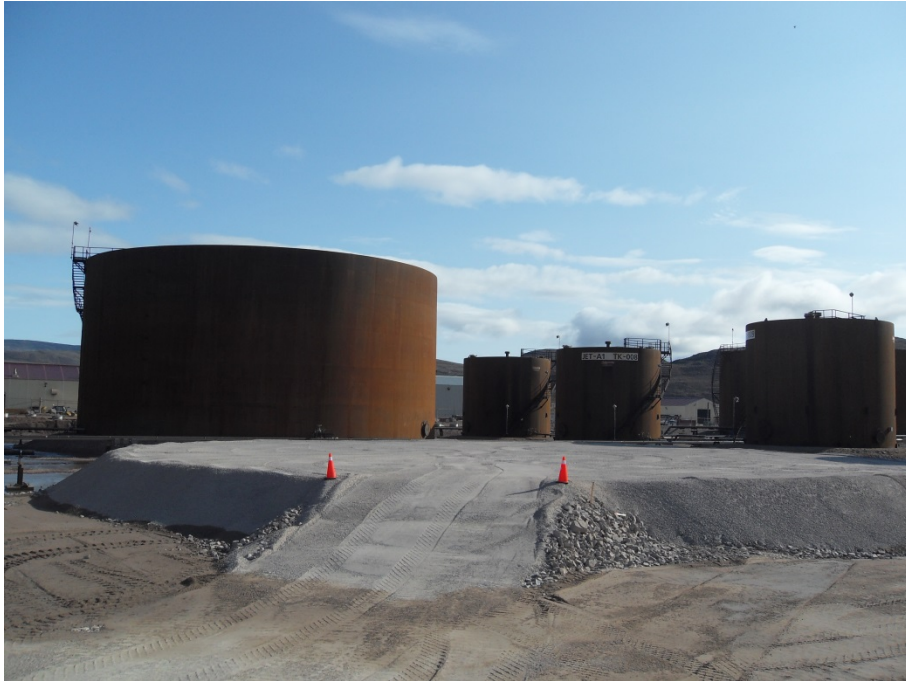
**Photo 37: A view of the bulk fuel storage at port site – additional tank pad being constructed**

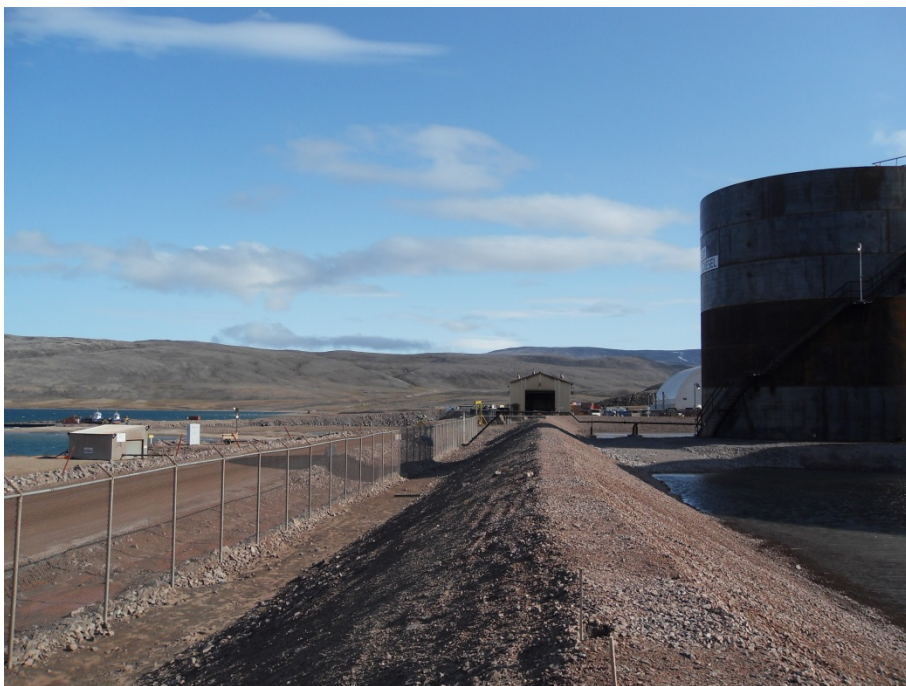
**Photo 38: A view of the bulk fuel storage facility at port site – embankment/vicinity conditions**

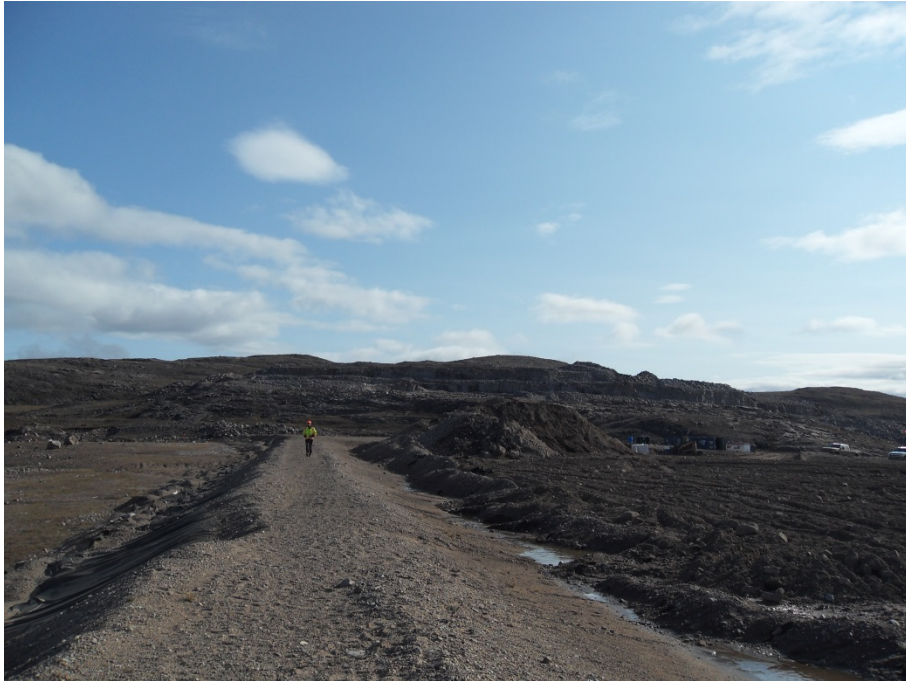
**Photo 39: A view of land farm at port site – its contents and perimeter embankment**

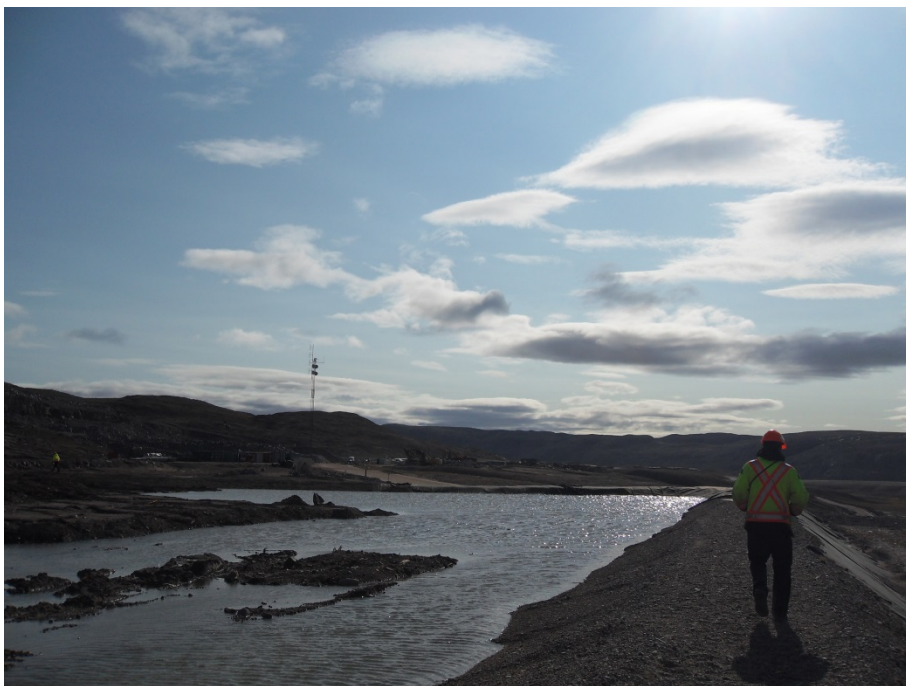
**Photo 40: A view of the view of land farm at port site – its associated pond area**

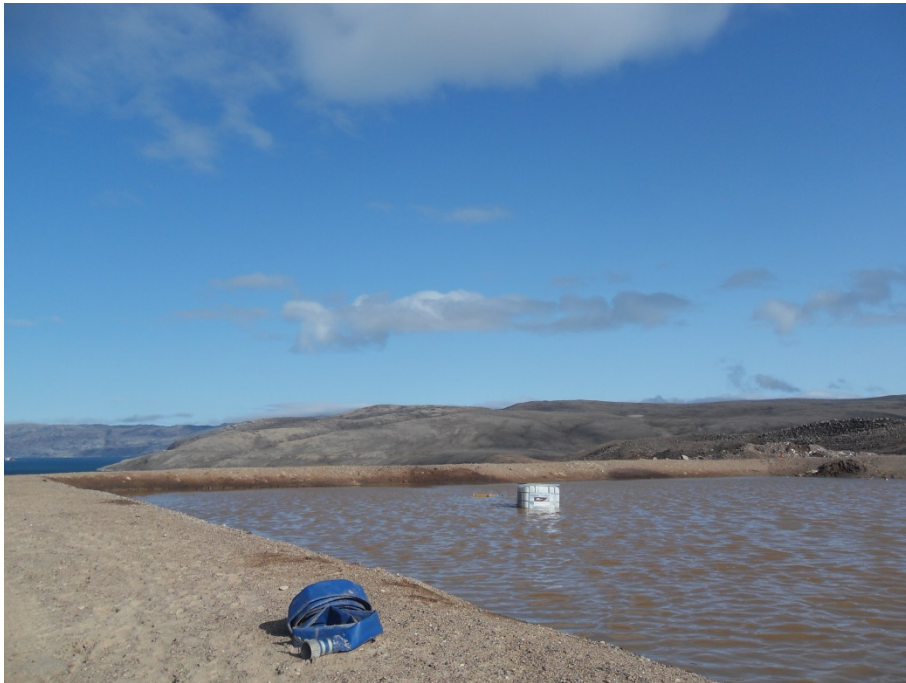
**Photo 41: A view of contaminated water pond at port site**

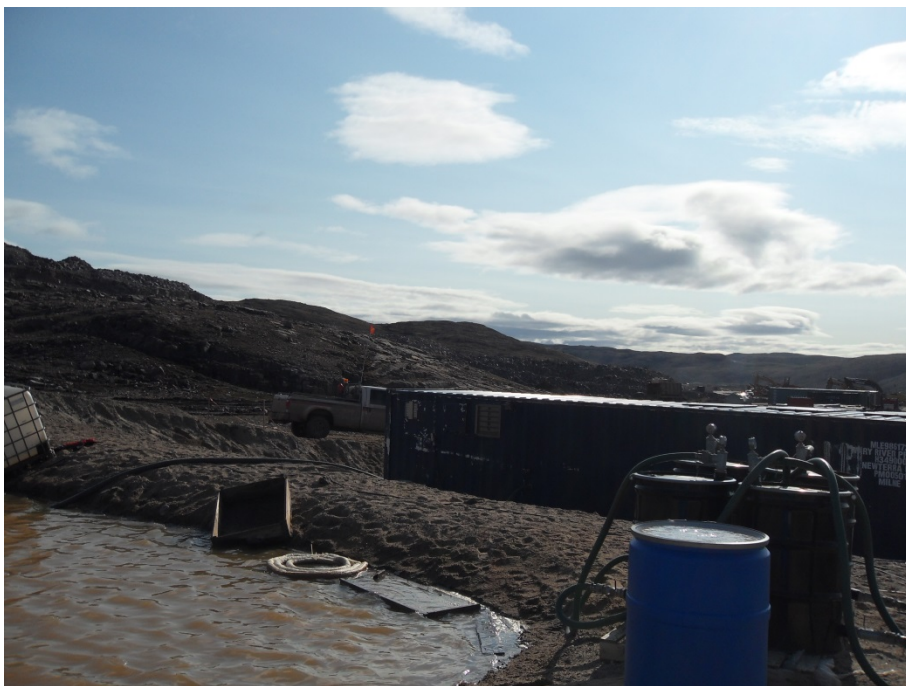
**Photo 42: A view of the water treatment facility associated with contaminated water pond**

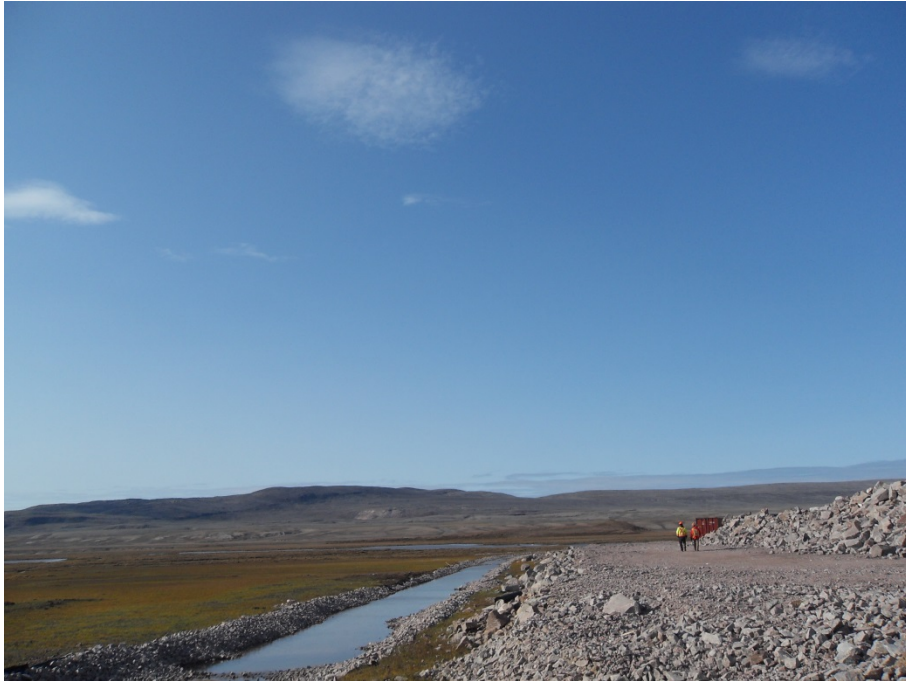
**Photo 43: A view of the drainage around laydown area at port site – drainage line vicinity**

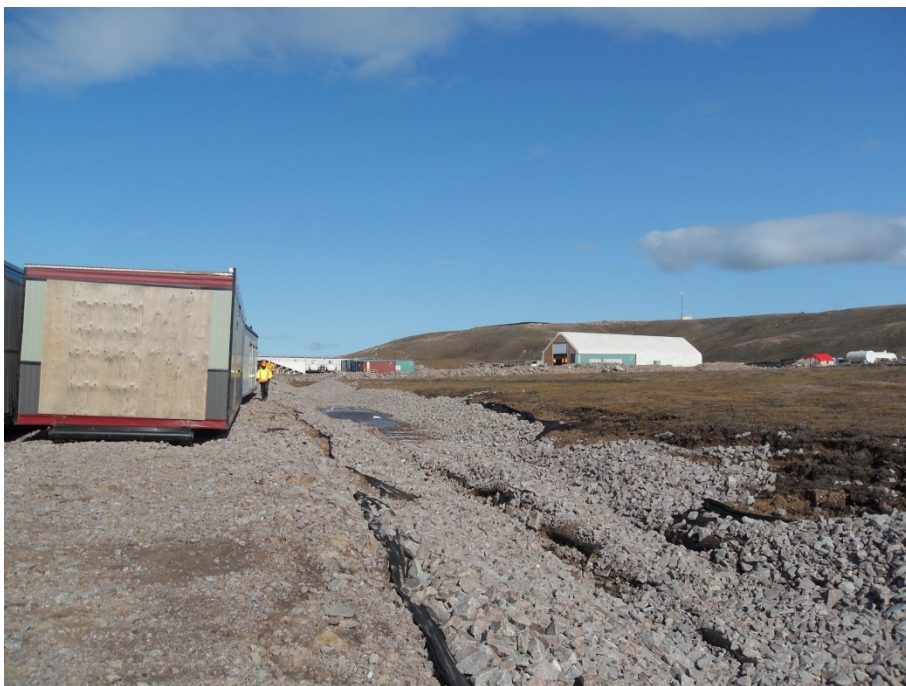
**Photo 44: A view of the diversion drain at port site laydown area – local slogging**
