BAFFINLAND IRON MINES CORPORATION MARY RIVER PROJECT

Mine Haul Road Drainage Improvement Project Phase 1 Construction As-Built Report

Report Number: 1649295 (DOC008)

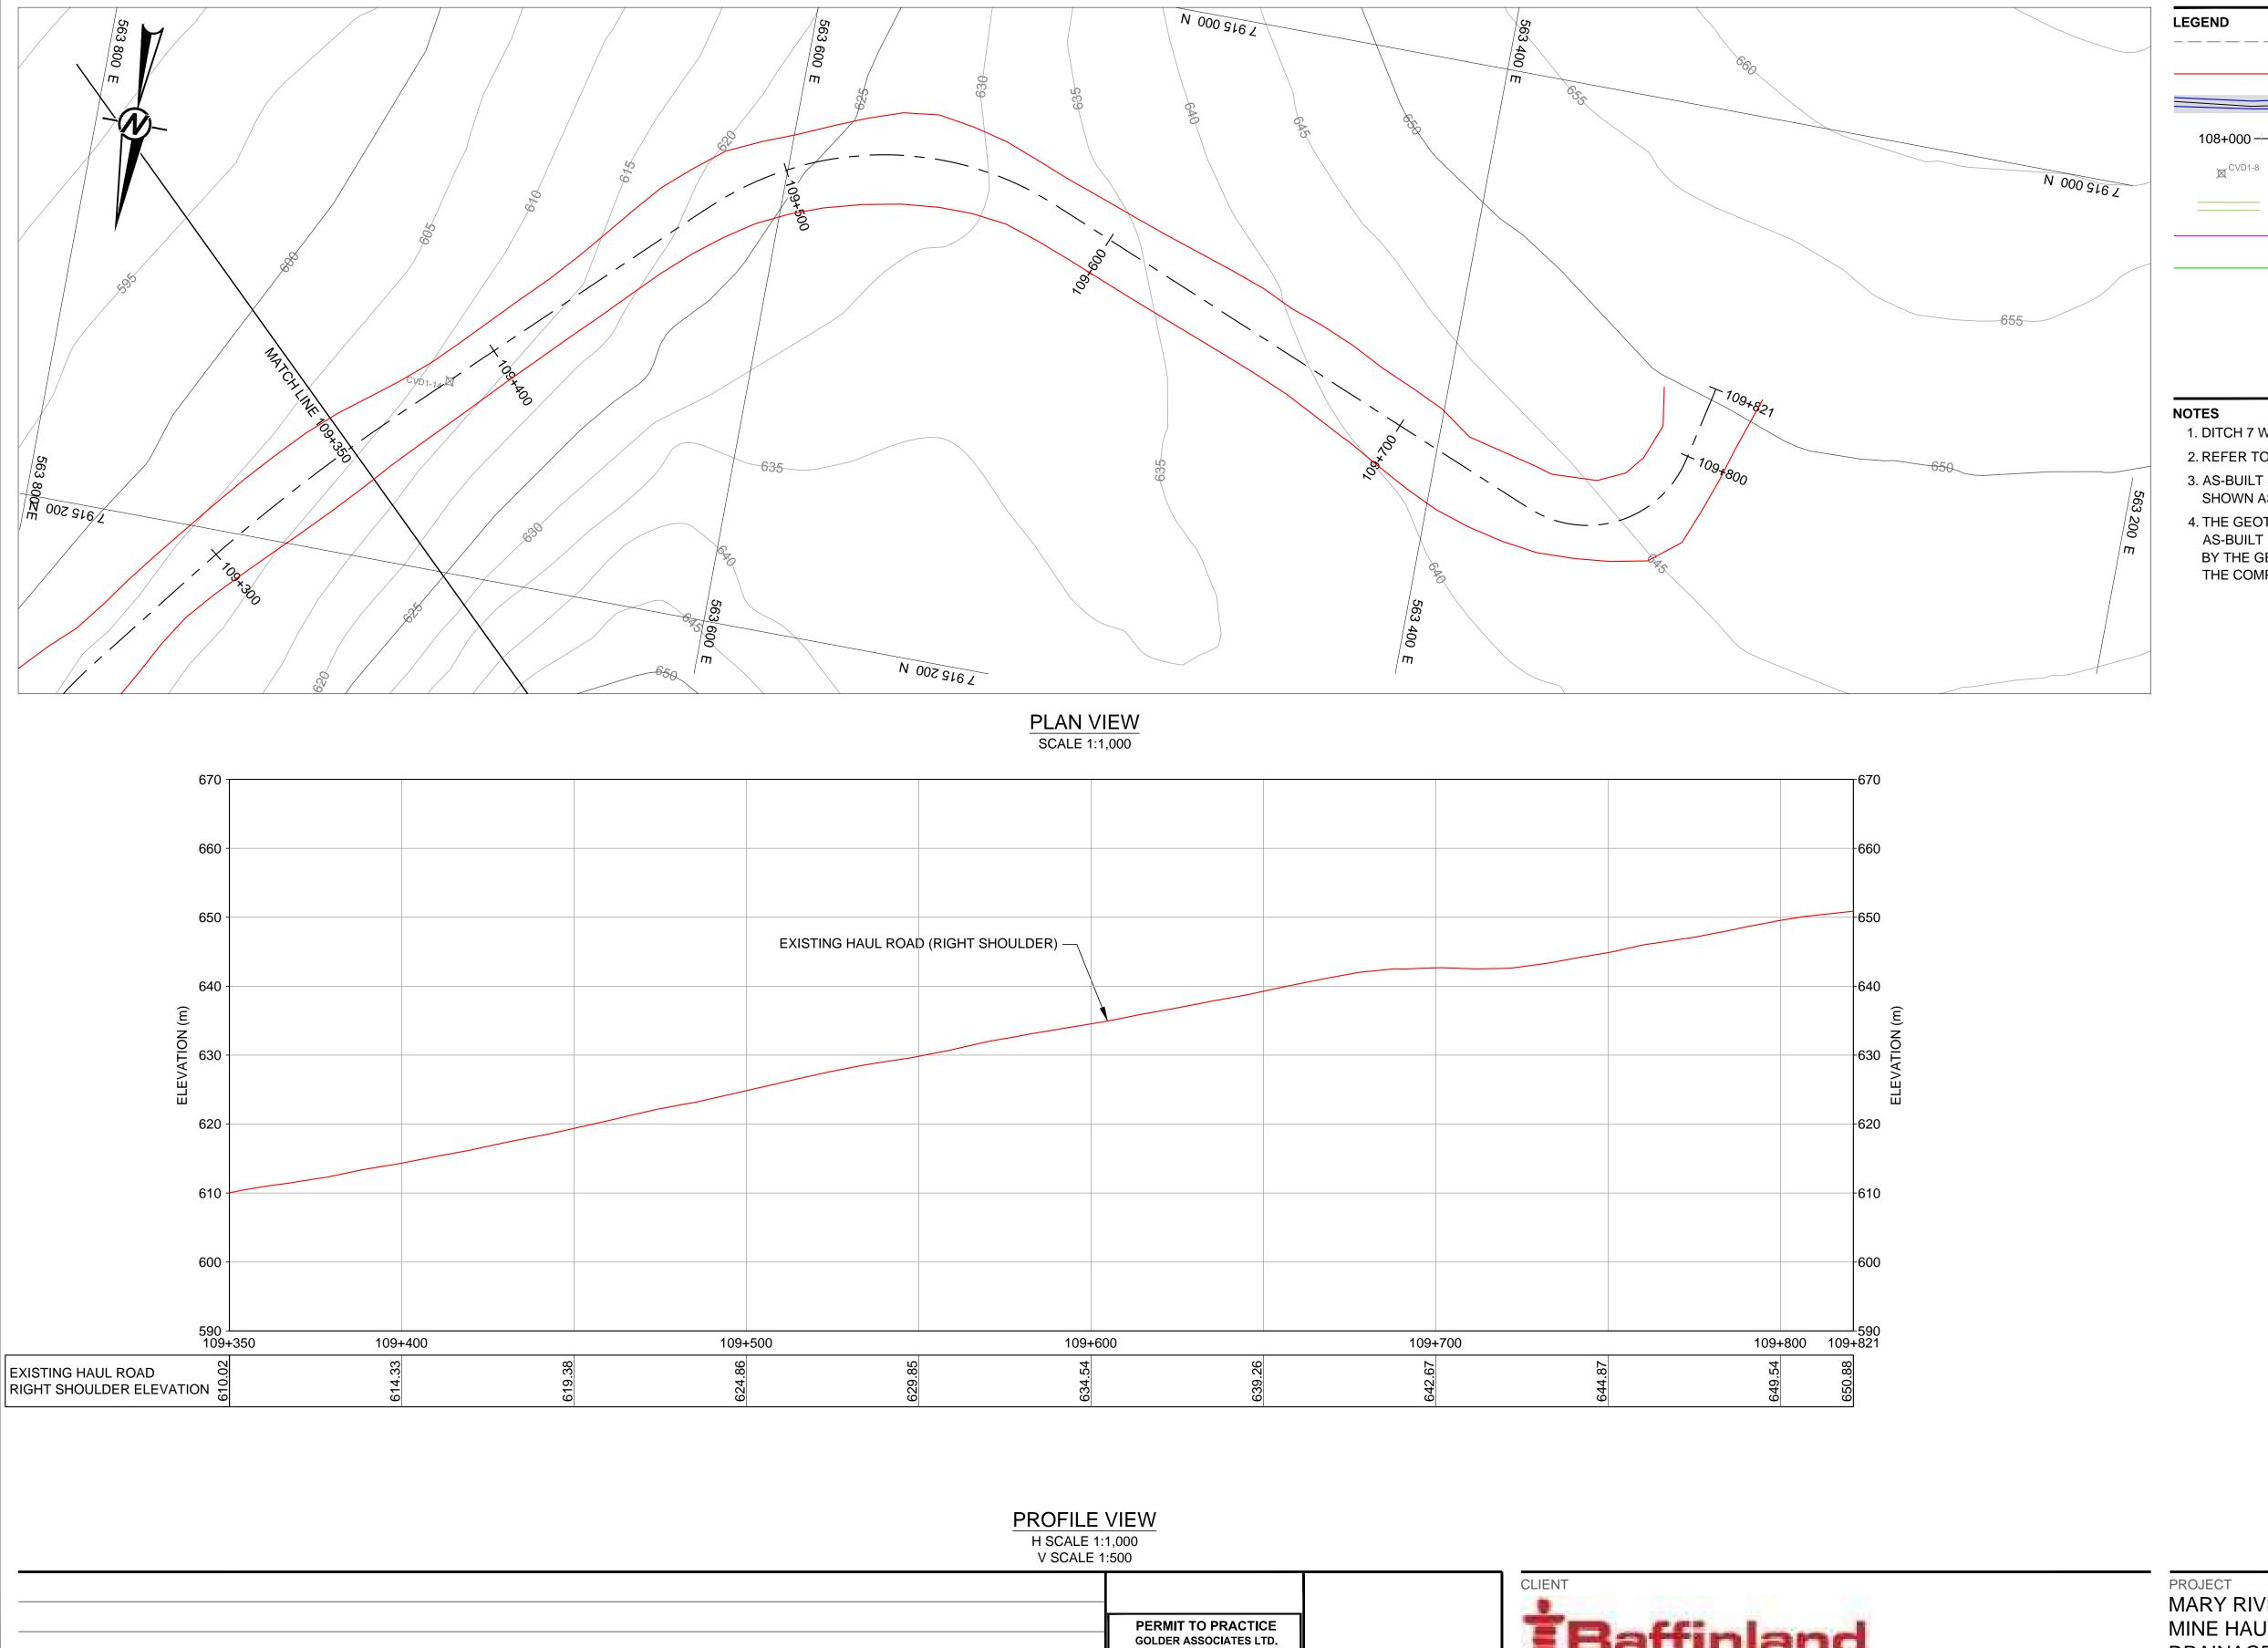
PROJECT NO. PHASE REV. 13 of 17 DRAWING 1649295 7000 2 013

- 1. DITCH 7 WAS NOT CONSTRUCTED.
- 2. REFER TO DWG. 002 FOR ADDITIONAL NOTES.
- 3. AS-BUILT SURVEY DATA WAS PROVIDED ON MAY 30, 2016 BY NUNA LOGISTICS AND IS SHOWN AS PROVIDED UNLESS OTHERWISE INDICATED.
- 4. THE GEOTECHNICAL ENGINEER'S SEAL ON THIS DRAWING VERIFIES THAT THE AS-BUILT INFORMATION PROVIDED BY OTHERS AND REVIEWED, BUT NOT INSPECTED BY THE GEOTECHNICAL ENGINEER, HAS NO MATERIAL EFFECT ON THE DESIGN OF THE COMPLETED WORK.

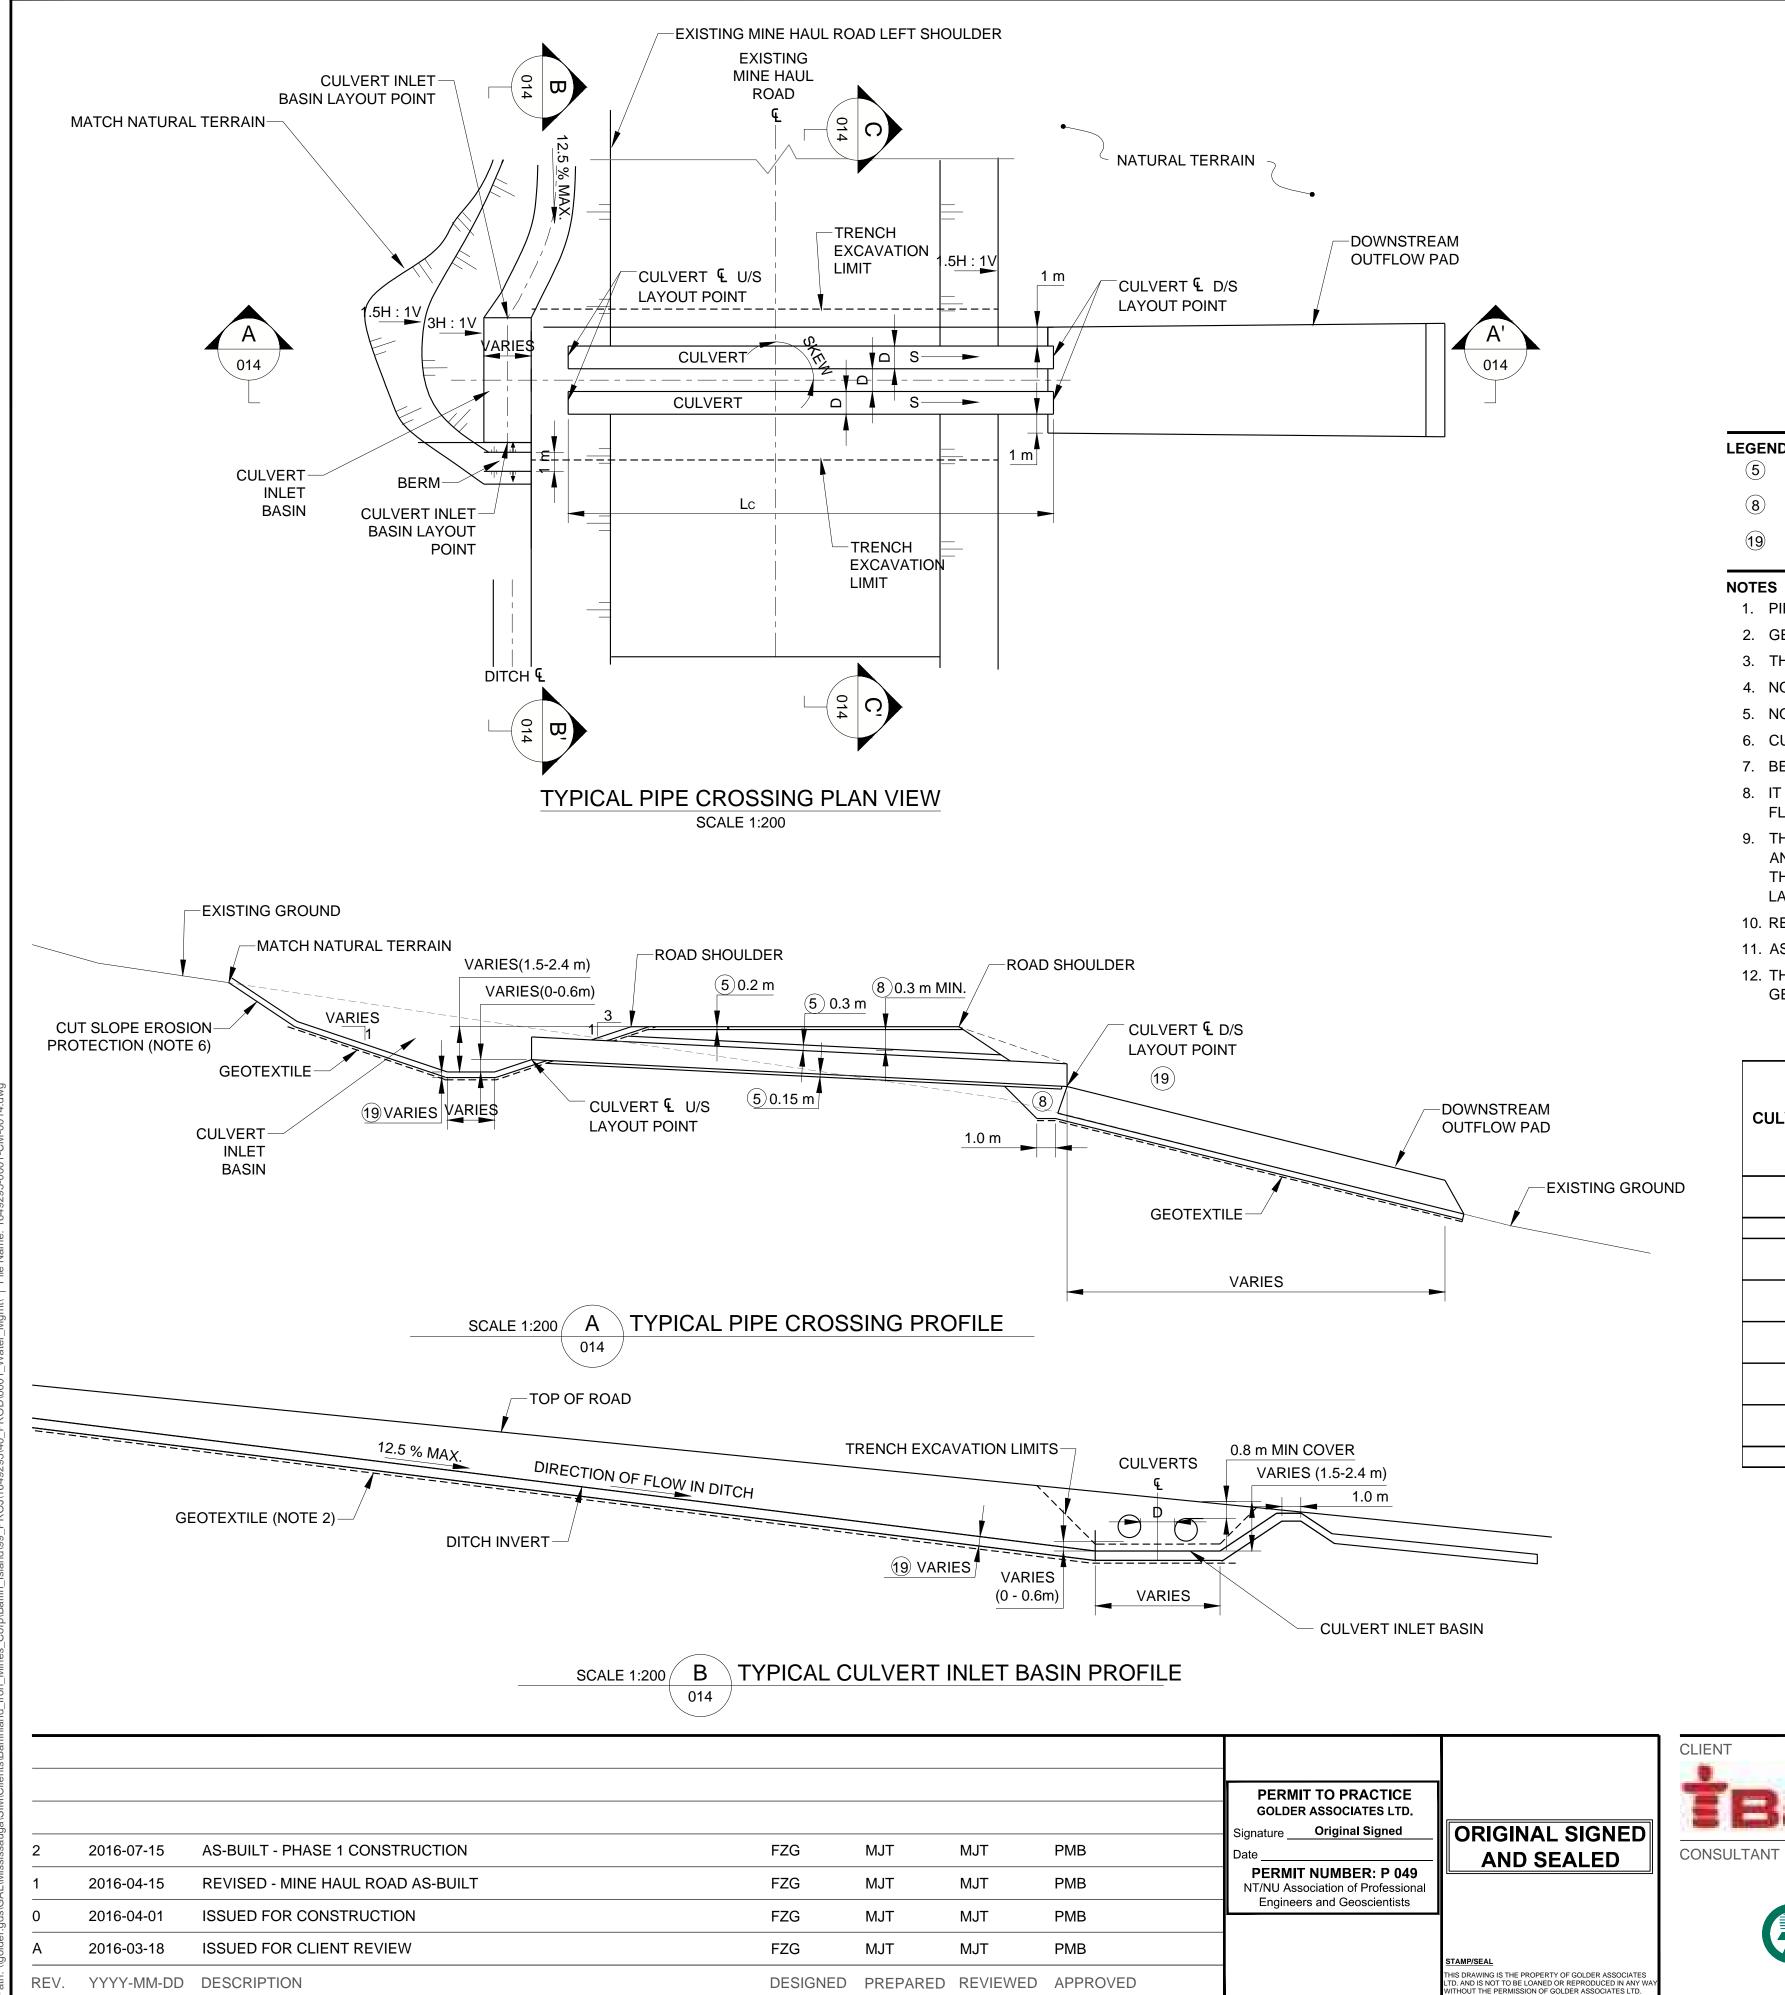
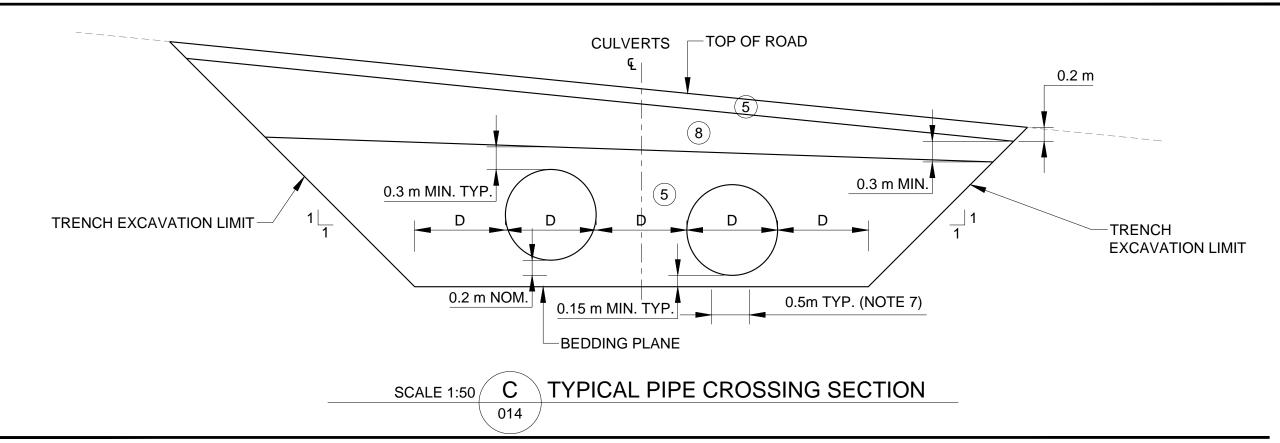
PROJECT NO.	PHASE	REV.	14 of 17	DRAWING
1649295	7000	2		014

- 3. THE INLET BASINS WERE NOT CONSTRUCTED TO DESIGN DIMENSIONS DUE TO THE FROZEN GROUND CONDITIONS.
- 4. NO SURVEY INFORMATION WAS PROVIDED FOR THE DOWNSTREAM OUTFLOW PADS.

- 9. THE EROSION PROTECTION ROCK SIZE IS SMALLER THAN REQUIRED FOR THE SELECTED 1:10 YEAR DESIGN FLOW. THIS IN IN RECOGNITION OF THE AVAILABLE MATERIAL AND AT THE OWNER'S REQUEST. RIPRAP BLOCKS COULD MOBILIZE EVEN DURING FREQUENT FLOOD EVENTS, WHICH MIGHT IMPACT SIGNIFICANTLY THE OPERATION OF THE DRAINAGE SYSTEM. REGULAR MAINTENANCE WILL BE REQUIRED. FUTURE IMPROVEMENTS (I.E. REPLACEMENT OF EROSION PROTECTION WITH MATERIAL WITH LARGER ROCK SIZES, PLACEMENT OF GABION MATS) ARE RECOMMENDED.

- 7. BEDDING WAS SHAPED TO RECEIVE THE PIPE.
- 8. IT IS RECOMMENDED THAT EROSION PROTECTION OF THE DOWNSTREAM OUTFLOW PAD BE EXTENDED TO A WATER BODY CAPABLE OF CONVEYING THE CONCENTRATED FLOW TO PREVENT EROSION OF THE NATURAL SOILS.
