### APPENDIX C.1 CONSTRUCTION SUMMARY REPORTS

#### Mine Site Raw Water Intake -Earthworks

# APPENDIX C.1.2 CONSTRUCTION SUMMARY REPORT MILNE PORT CAMP PAD NATURAL STREAM DIVERSION

Construction Summary Report: Milne Port Camp Pad Natural Stream Diversion

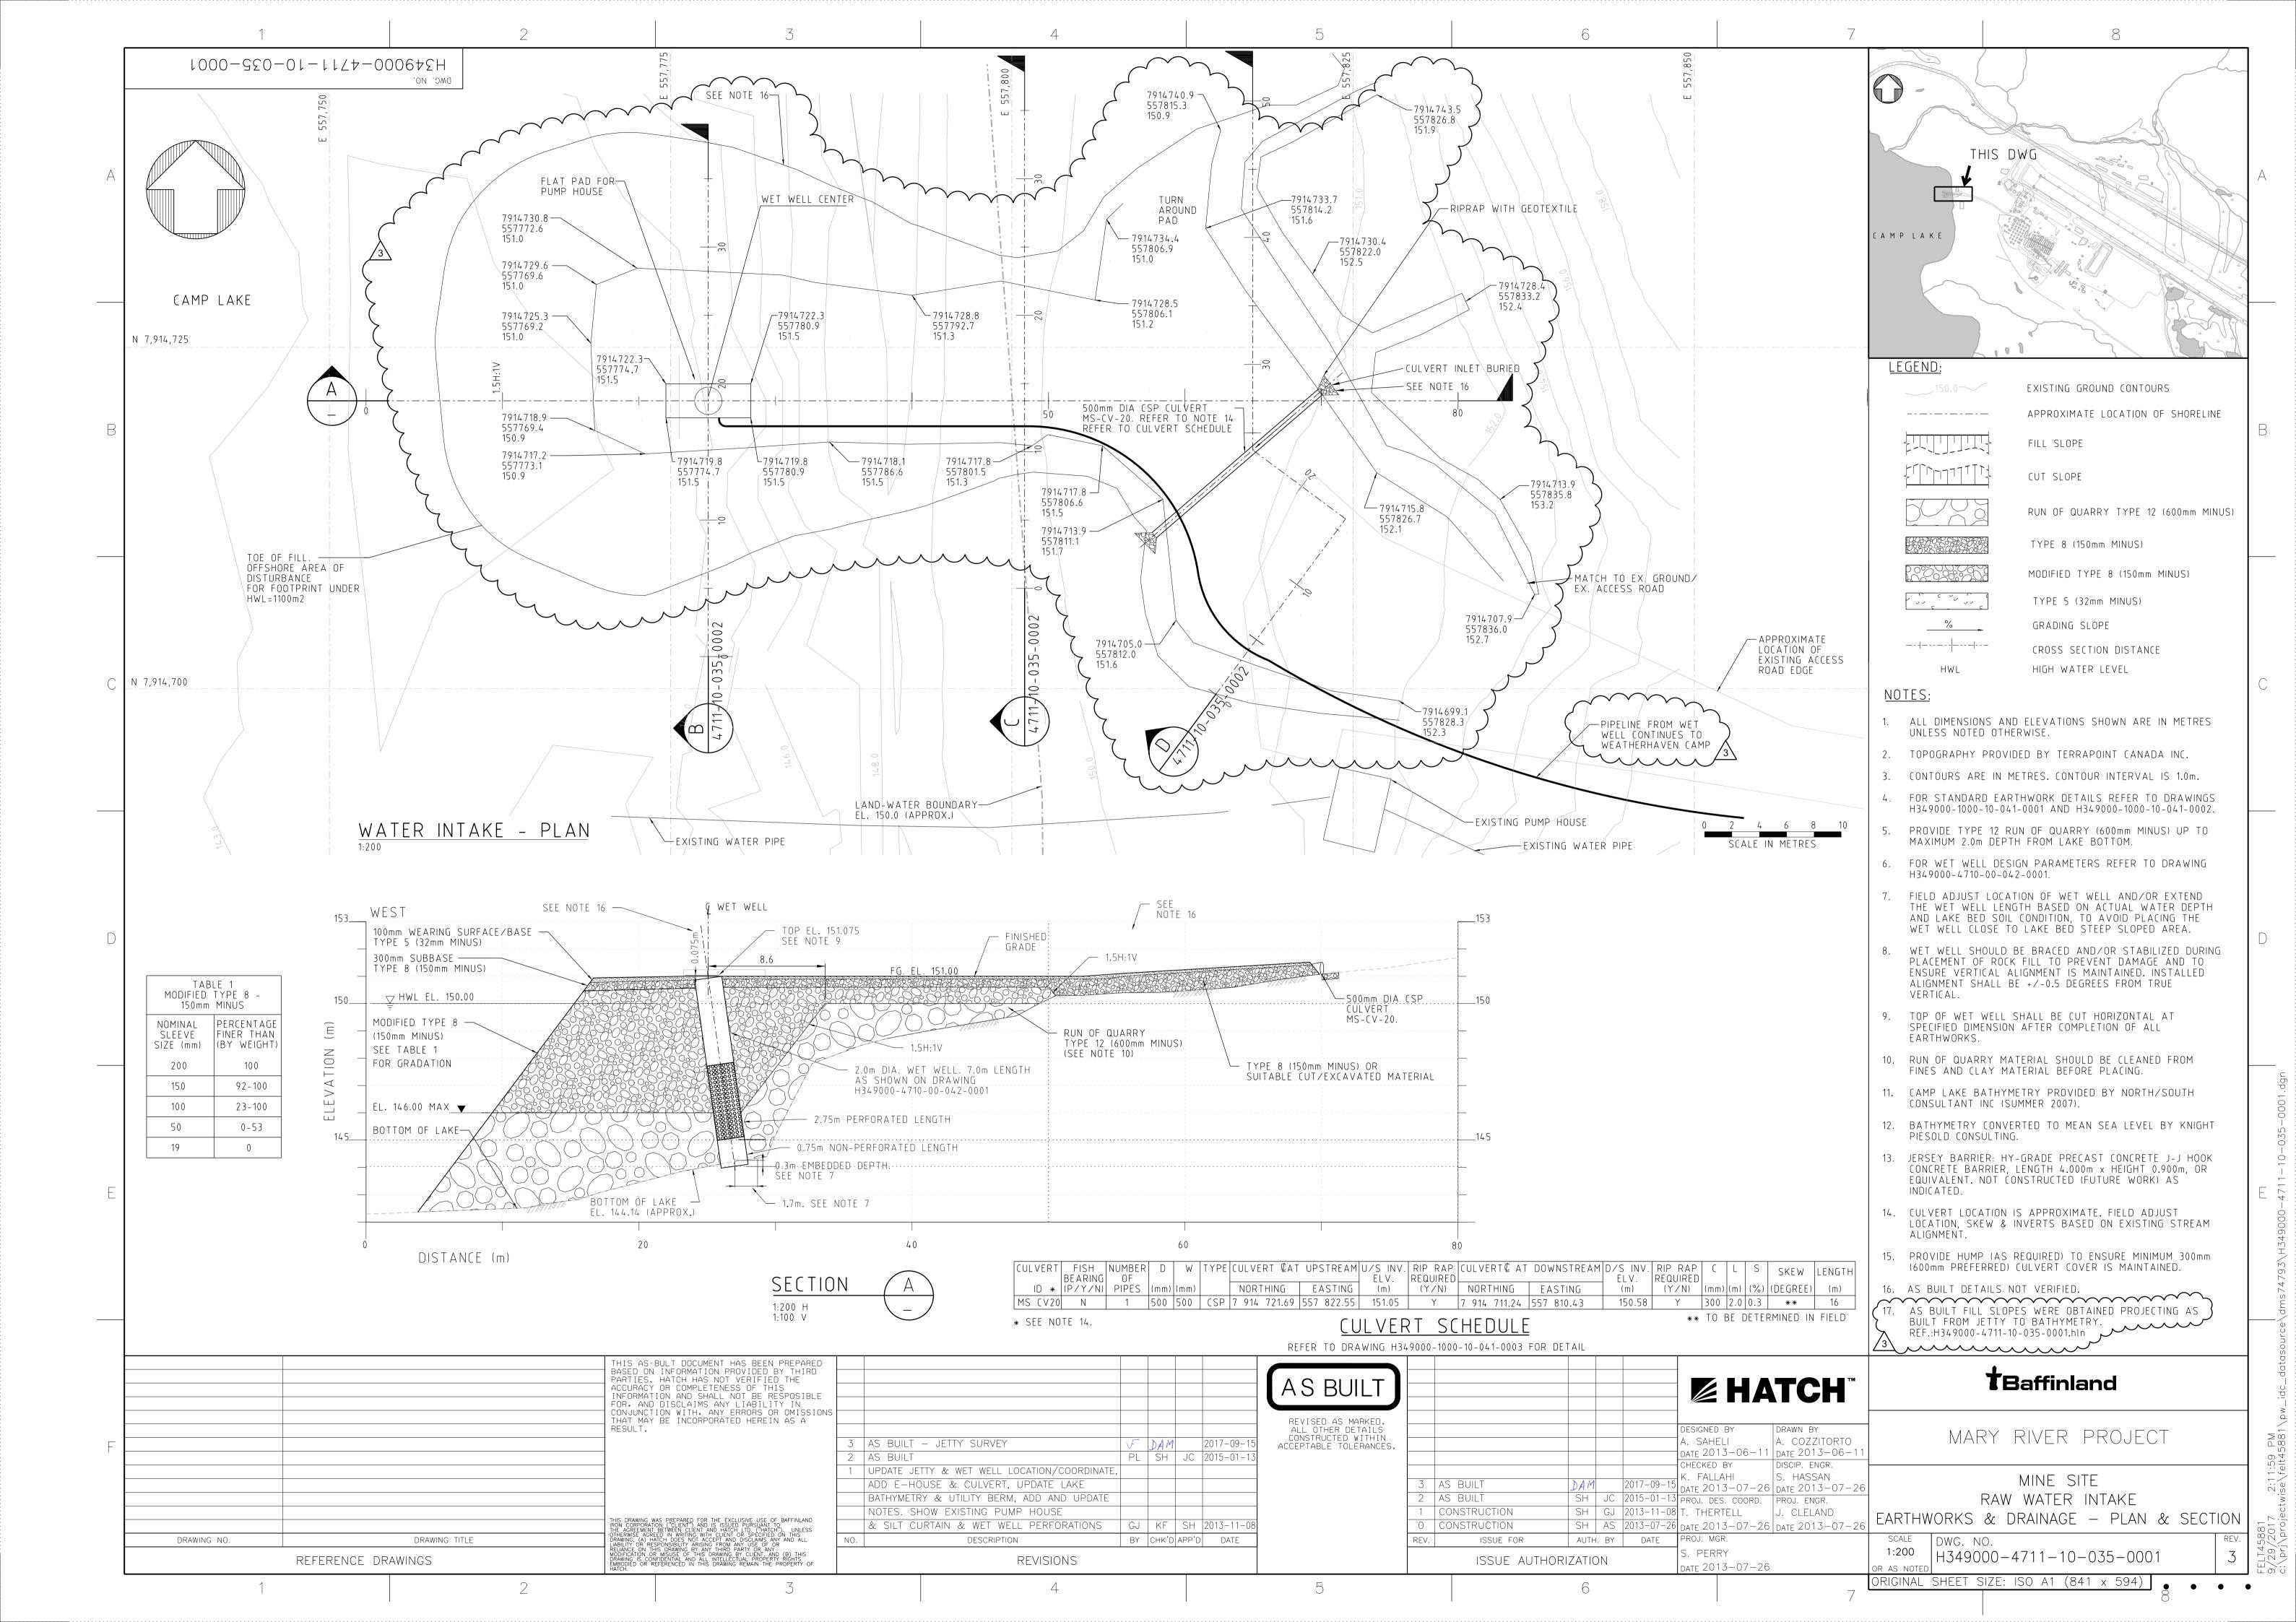
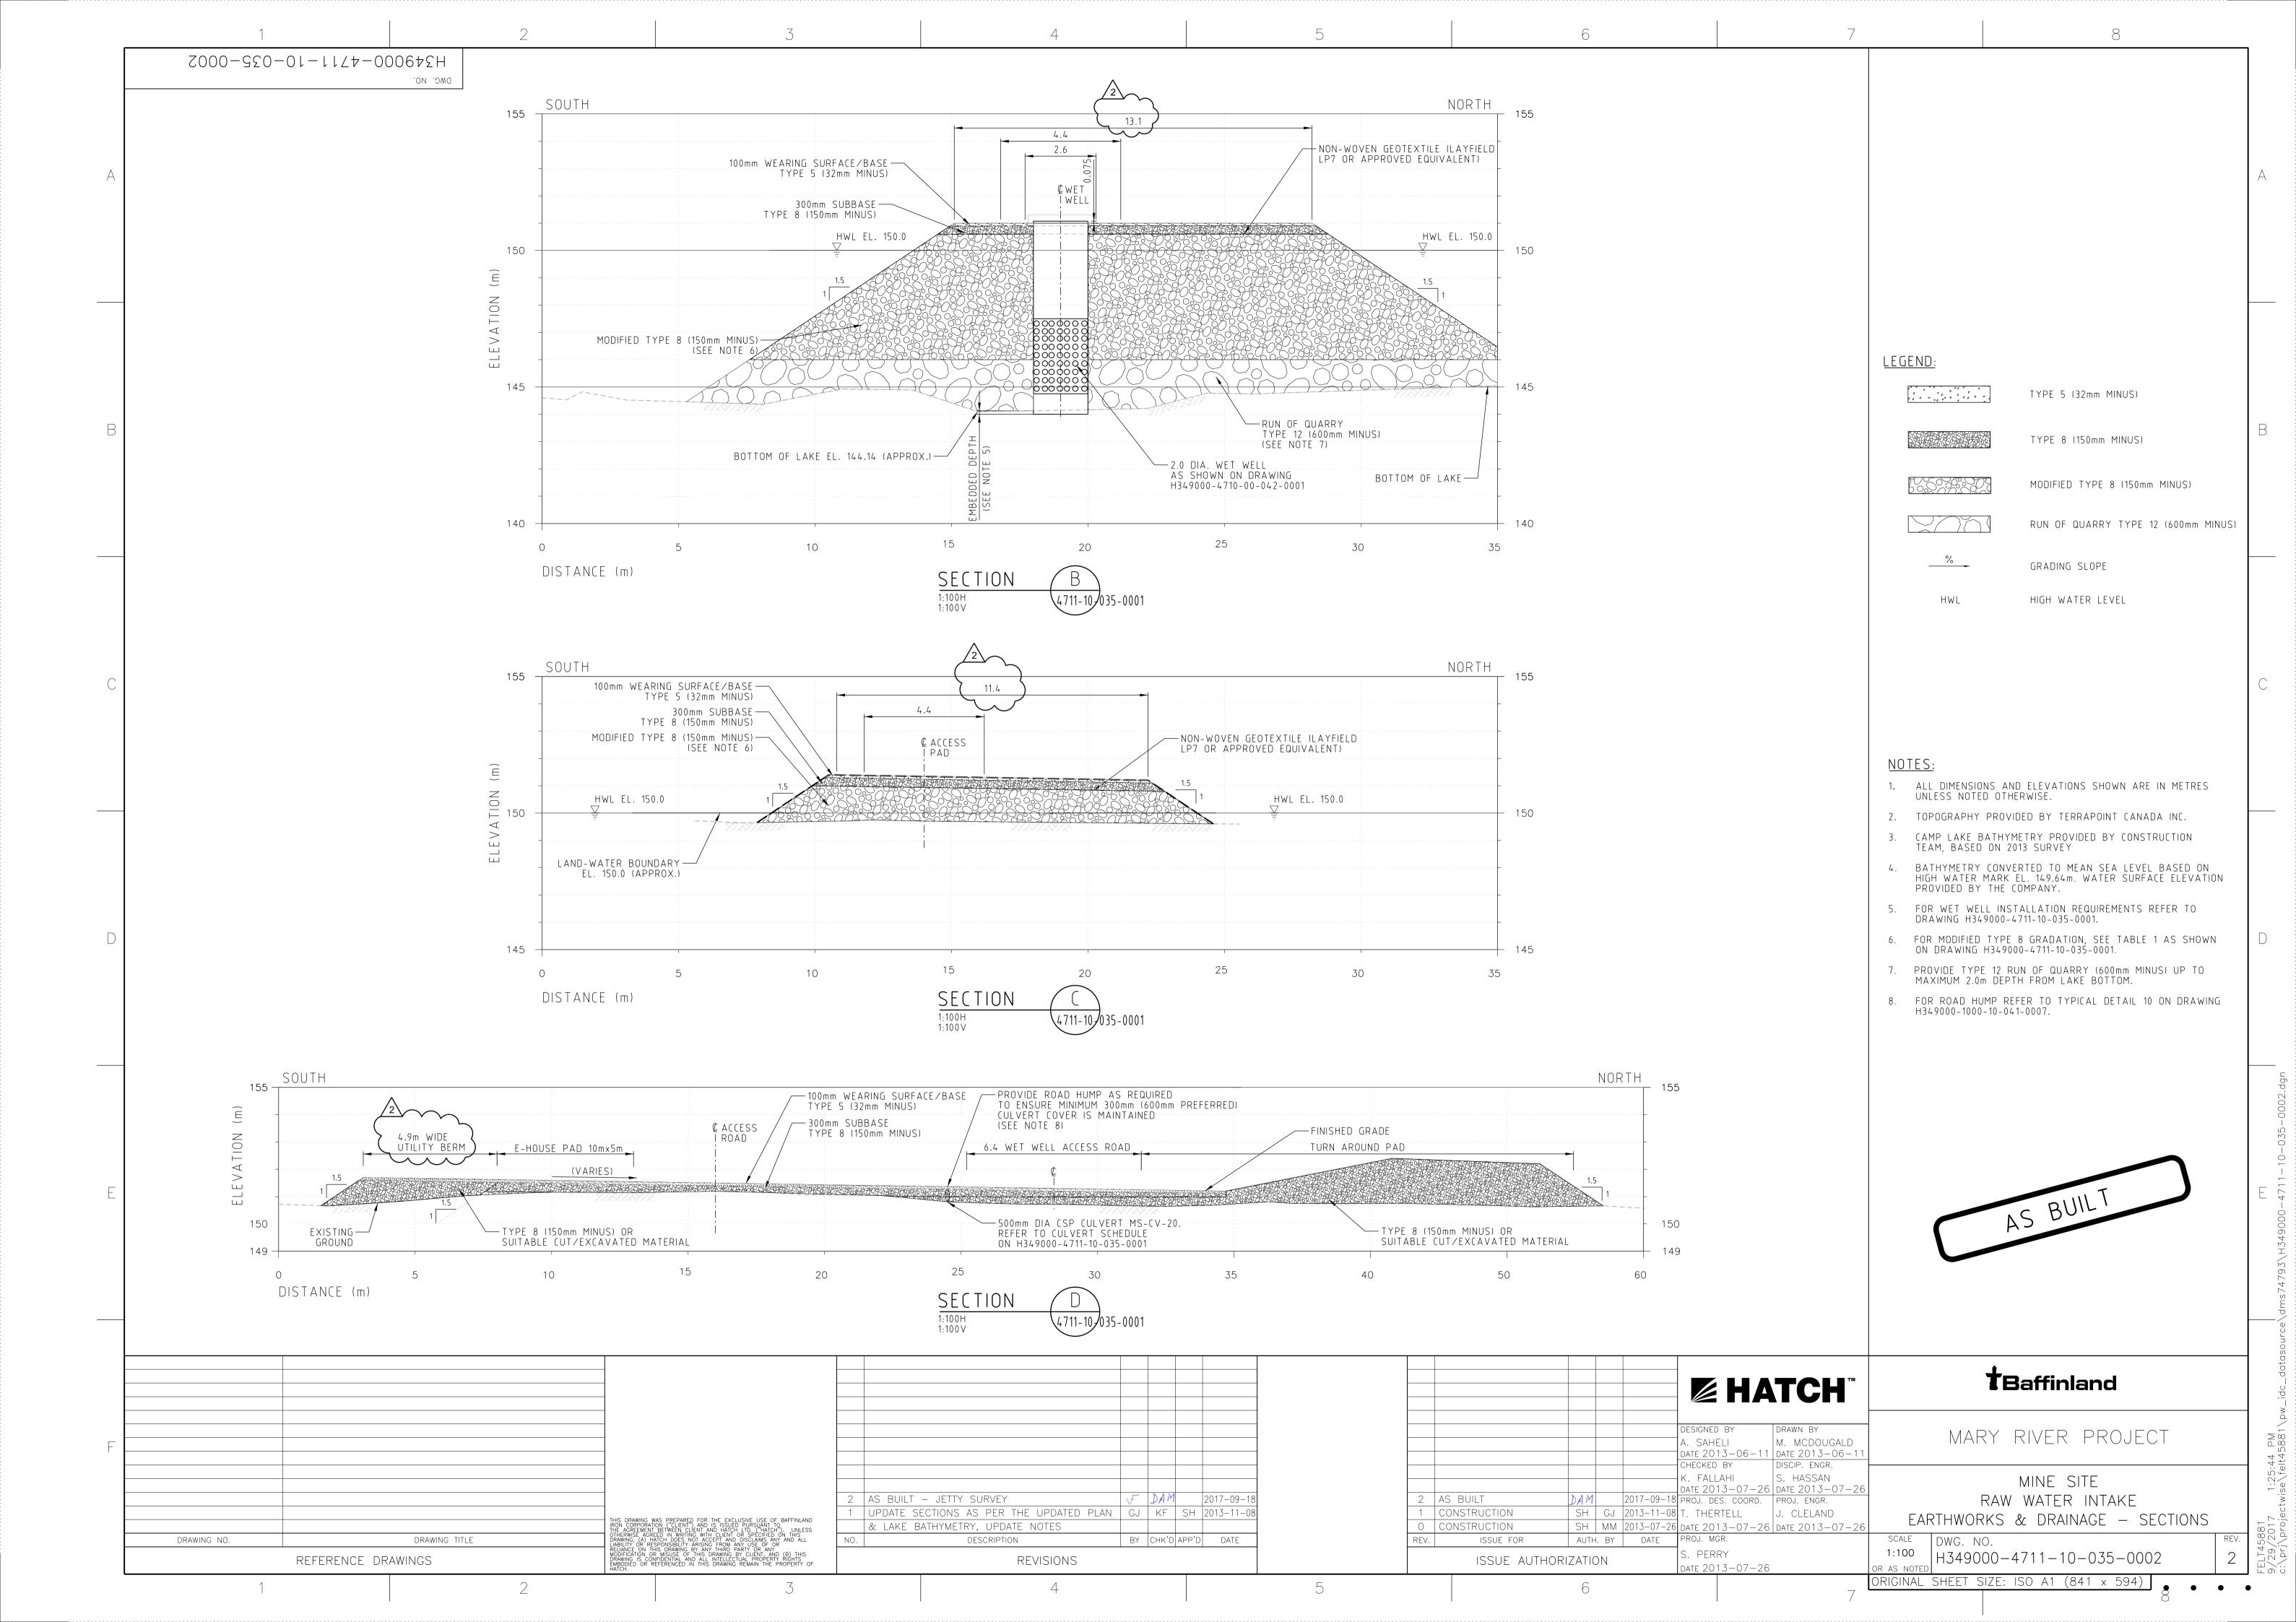
As requested, Hatch has revised and issued the Mine Site Raw Water Intake Earthworks & Drainage – Plan drawings and sections (H349000-4711-10-035-0001 rev3 and H349000-4711-10-035-0001 rev2) As-Built status. These revised two drawings show updated information to the following items as a result of field modifications undertaken by Baffinland in 2016:

- Jetty surface
- Jetty fill slopes and interface with bathymetry
- Approximate pipe alignment to Weatherheaven Camp

The drawing revision is based on survey data, photos and information provided by BIM. Fill slopes have been estimated by projecting surface survey points to bathymetry surface at design slopes. Backfill materials have not been confirmed and are shown as per original issued for construction drawings.

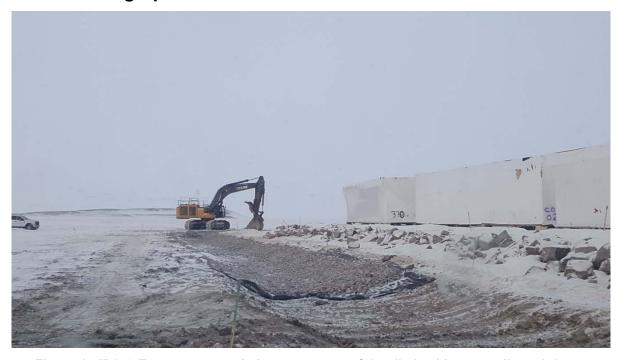
Figure 1: JD850 Excavator completing a segment of the ditch with geotextile and riprap placement. In the foreground, excavated ditch can be seen, which will be the next section for slope and grade final cut, along with geotextile and riprap placement.

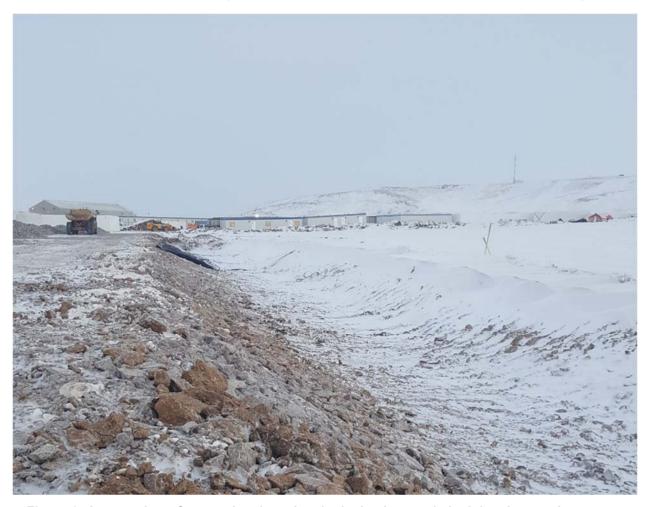
Figure 2: An overview of a completed section, in the background, the inlet plug can be seen to remain with riprap placement required and geotextile already installed.

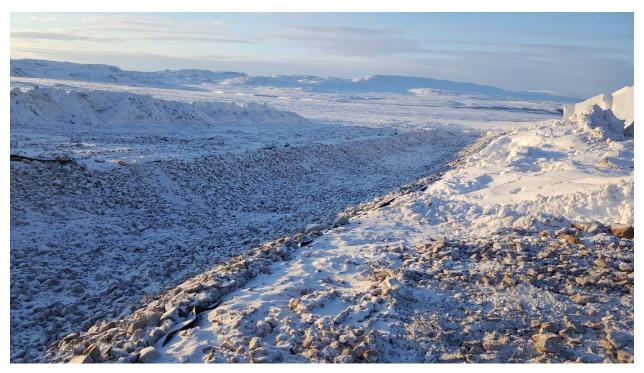
Figure 3: Post-Construction overview of the diversion ditch facing South. The downward sloping can be seen.

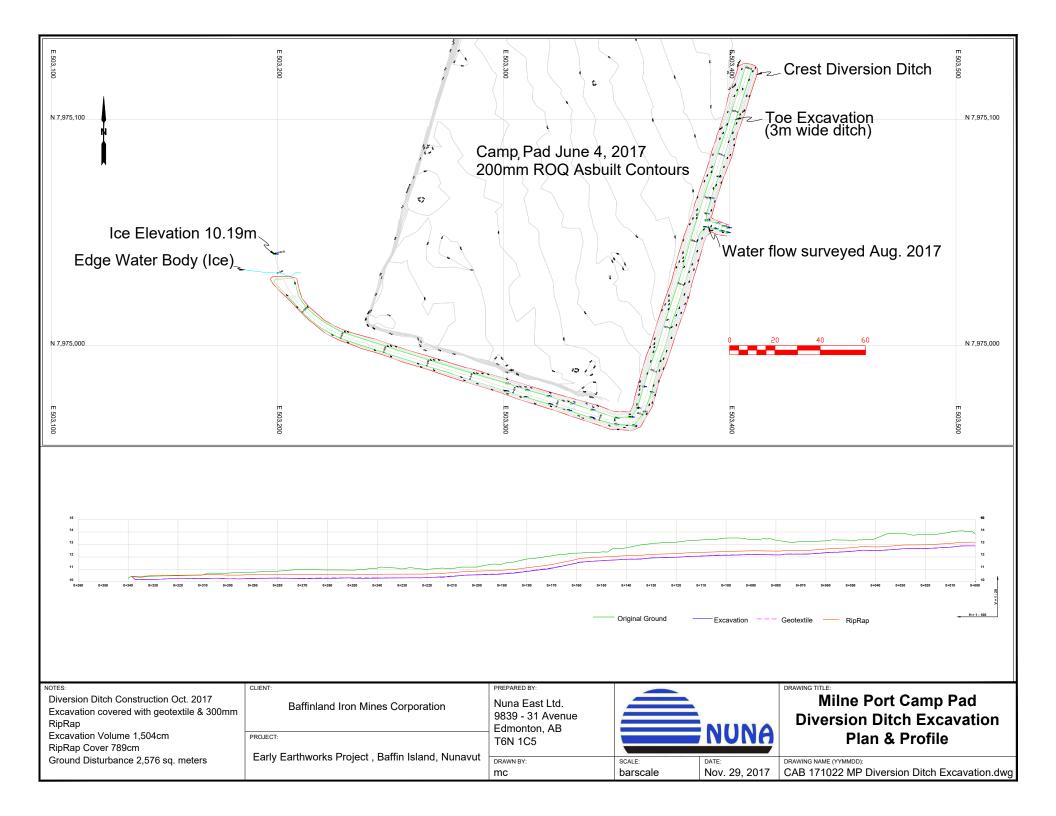
The as-built drawings incorporate contractor red line markups, field instructions, requests for information, field sketches, and all other inputs provided by the field engineering team. The as-built drawing is attached in Appendix A. This drawing is representative of the final as-built drawing, as there are no mark-ups made on the issued-for-construction drawings.

Near the end of the Diversion Ditch's construction, the Nuna surveyors' GPS data collector failed and could no longer be used. There was no other instrument available and therefore visual evaluation was required for slope cuts as well as bottom ditch width cuts. However, all final excavation data has been collected, including the invert elevations. Data collected was used to develop theas-built drawing in Appendix A, as described previously in the QA/QC Section. Data shown in Appendix B are for the elevations of the excavated surface (see Note on Section 3).
